LKK Auto Consultants Pte Ltd

Vehicle No. SHF 562T
Insured Veh. SKU 6575C
Claim No.
Policy No. DMCFHQ17-000185
Accident Date 29/11/2017
Inspection Date 30/11/2017

ADJUSTMENT ON REPAIR COST FOR VEHICLE NO. SHF 562T

PHOTOGRAPHS FOR VEHICLE NO. SHF 562T

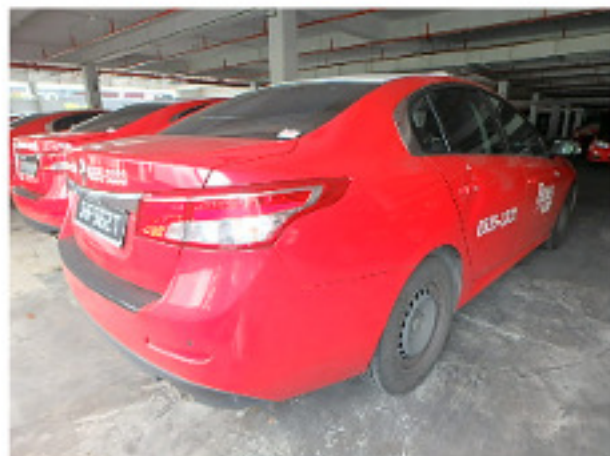
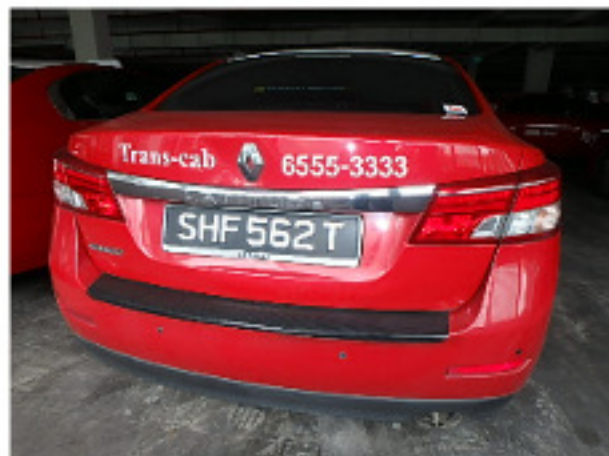
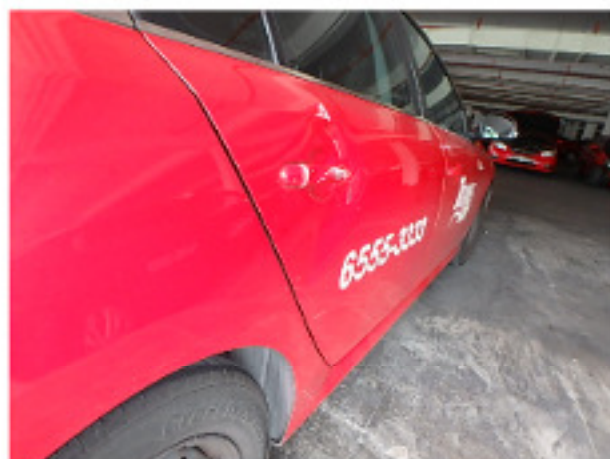
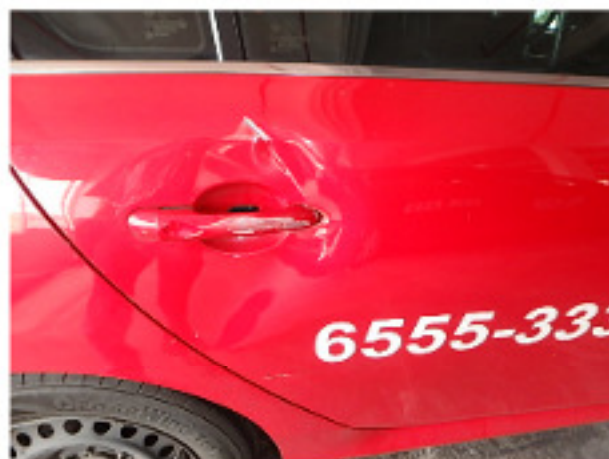
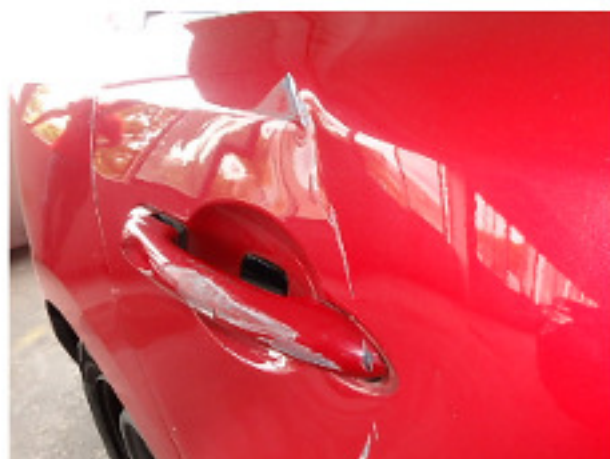
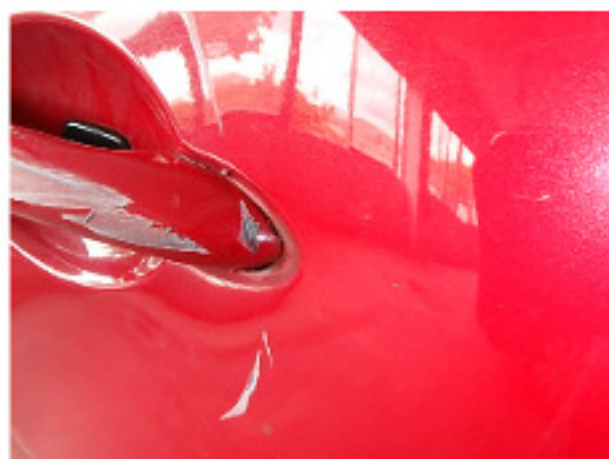
4. Description of Damages				
	THE VEHICLE SUSTAIEND DAMAGES AT THE REAR O/S DOOR. DAMAGES SEE DETAILS.			
5. General Information				
	Accident Date	29/11/2017	Inspection Date	30/11/2017
	Survey held at	TRANS-CAB AUTO SERVICES PTE LTD NO.2 ANG MO KIO ST 63 SINGAPORE 569111		
5a. Remarks				
	A)THE INSPECTION WAS CONDUCTED ON A"WITHOUT PREJUDICE" BASIS. B)IN ACCORDANCE TO YOUR INSTRUCTIONS, WE HAVE NOT AUTHORISED REPAIRS.			
5b. Estimate Days of Repair				
	ESTIMATED NORMAL PERIOD FOR REPAIR:		2 Working Days

Qty	Description of Parts	Condition	Estimate By Workshop (\$)	Our Adjusted (\$)
	TO CHECK STEERING GEOMETRY AND COMPUTER WHEEL ALIGNMENT.	NOT NECESSARY	220.00	-
	TO TRANSFER OF DOOR FITTINGS, ATTACHMENT AND PERFORM WATER SEEPAGE TEST.		170.00	60.00
	TO TRANSFER OF TIRE, RIM AND ON WHEEL BALANCING.	NOT NECESSARY	170.00	-
	TOWING FEES.	NOT NECESSARY	120.00	-
			7,370.00	590.00
GRAND TOTAL			24,628.26	3,331.14
RECOMMENDED COST OF LUMP SUM REPAIRS (TO ITS PRE-ACCIDENT CONDITION)				2,650.00
