LKK Auto Consultants Pte Ltd

Ref : CC3/CTI18017059/Kha3q2

ADJUSTMENT ON REPAIR COST FOR VEHICLE NO. SHB 9602Z

PHOTOGRAPHS FOR VEHICLE NO. SHB 9602Z

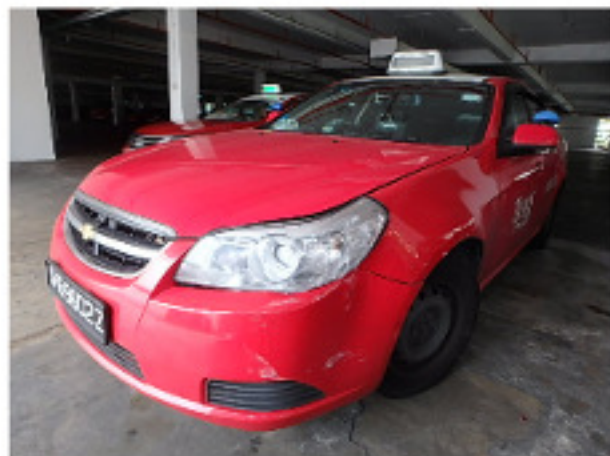
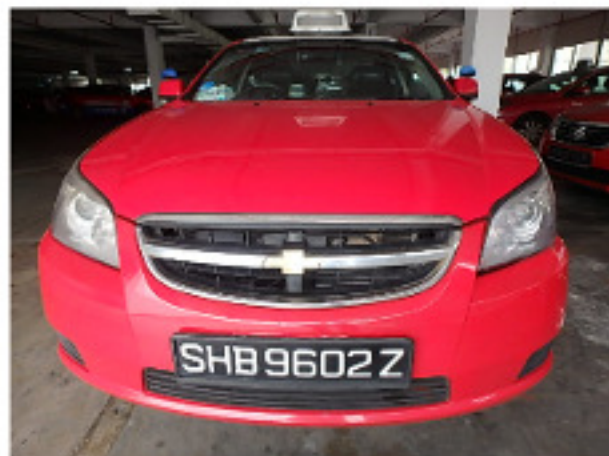
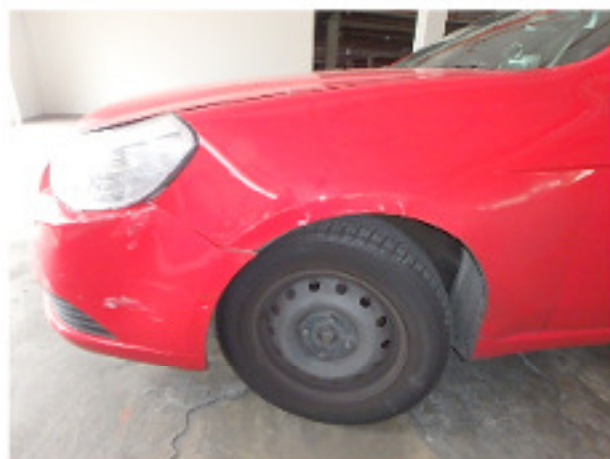
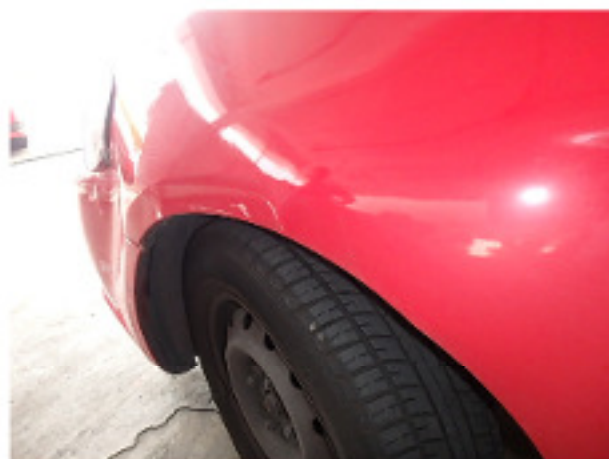
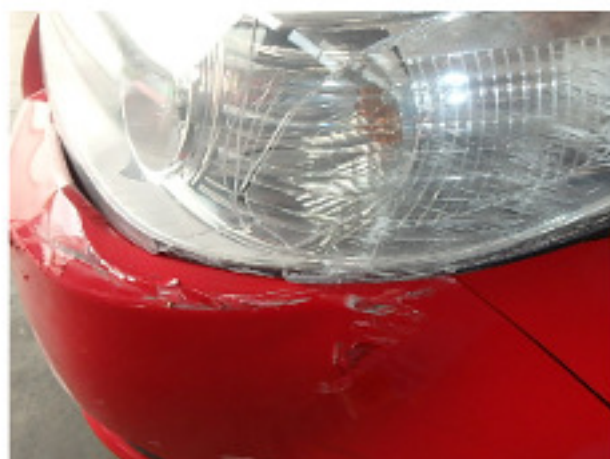
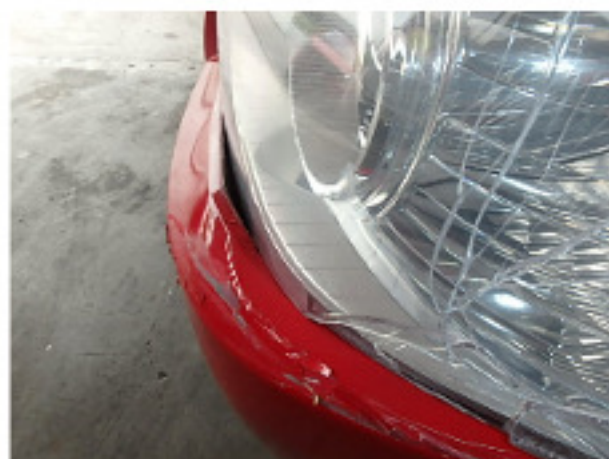
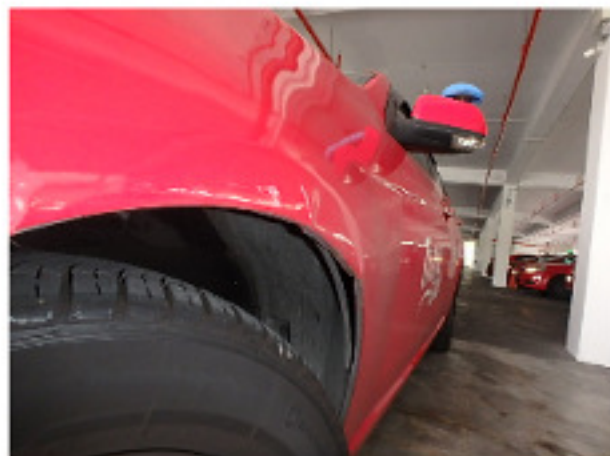
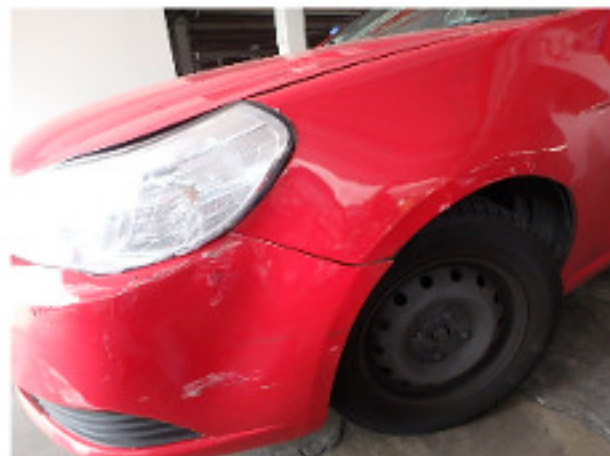
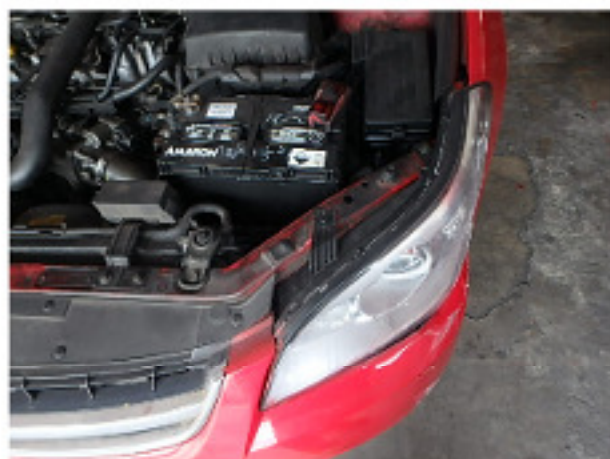
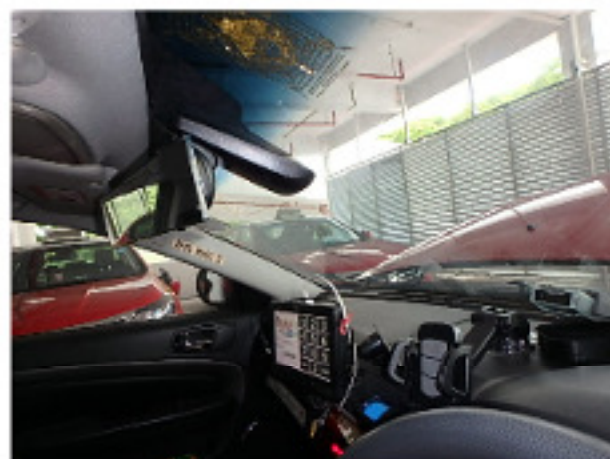
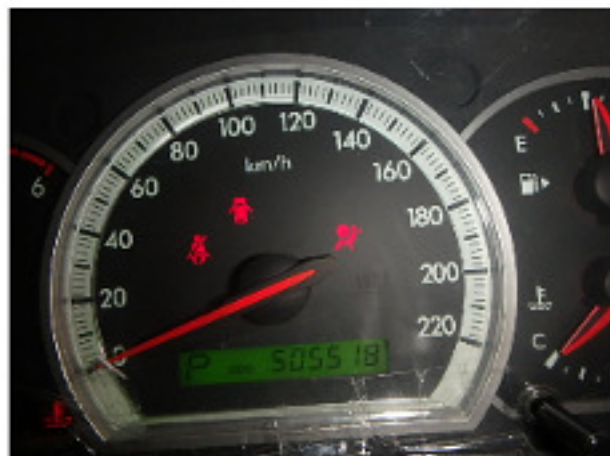
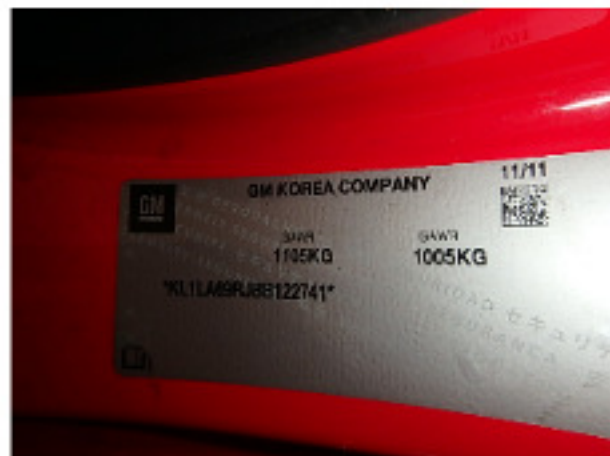
INSPECTION

THE VEHICLE SUSTAINED DAMAGES AT THE N/S FRONT PORTION. DAMAGES SEE DETAILS.

RECOMMENDED COST OF LUMP SUM REPAIRS (TO ITS PRE-ACCIDENT CONDITION)			2,800.00
---	--	--	----------
