Your Ref: S0M02XKV  
Our Ref : CS4/ASM20012979/N

4 December 2020

**TECHNICAL INVESTIGATION REPORT OF FIRE INCIDENT INVOLVING THE  
INSURED VEHICLE SLA 6784J ON 21 NOVEMBER 2020**

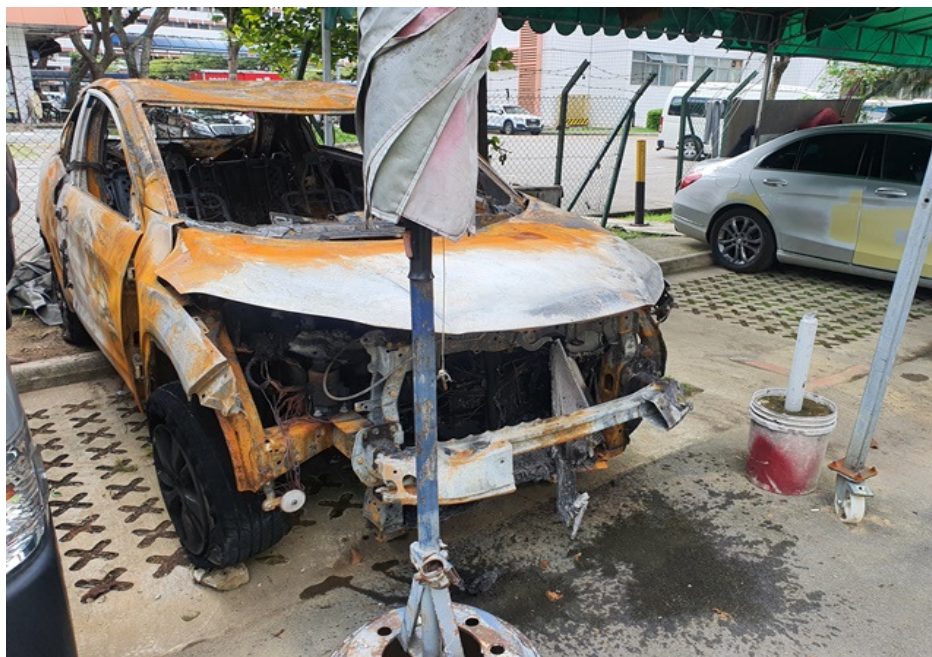
**Photo 1** shows a general view of the front right body of the Insured Vehicle at the time of inspection. The Insured Vehicle was observed to have sustained extensive fire damage. The body panels at the front body and the undercarriage components at the front underside were all found to have been burnt to char.

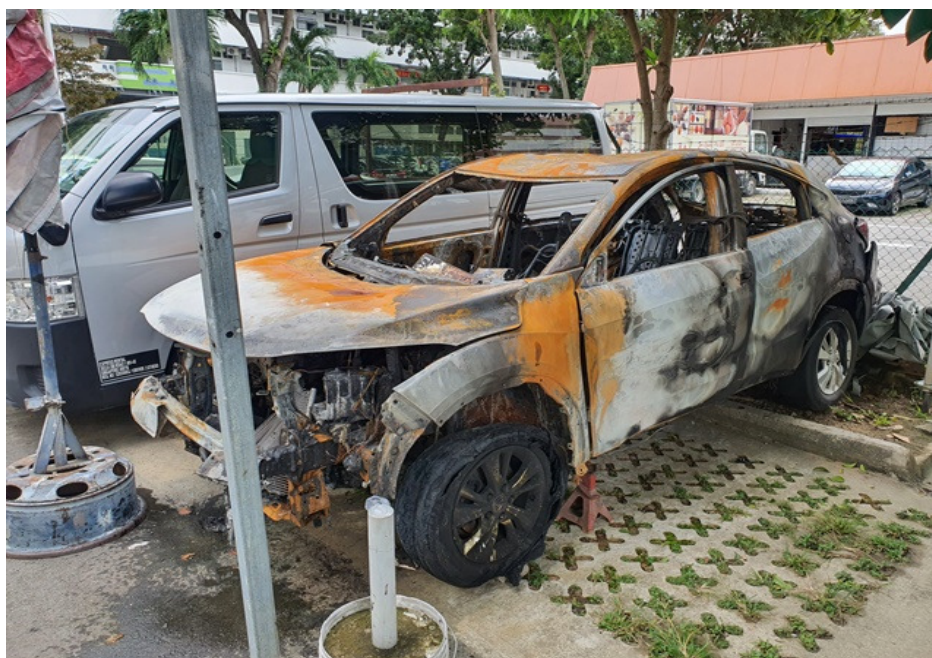
**Photo 2** shows a general view of the front left body of the Insured Vehicle at the time of inspection. The Insured Vehicle was observed to have sustained extensive fire damage. The body panels at the front body like the front bonnet, front fenders, front door amongst others were all burnt to bare metal state.

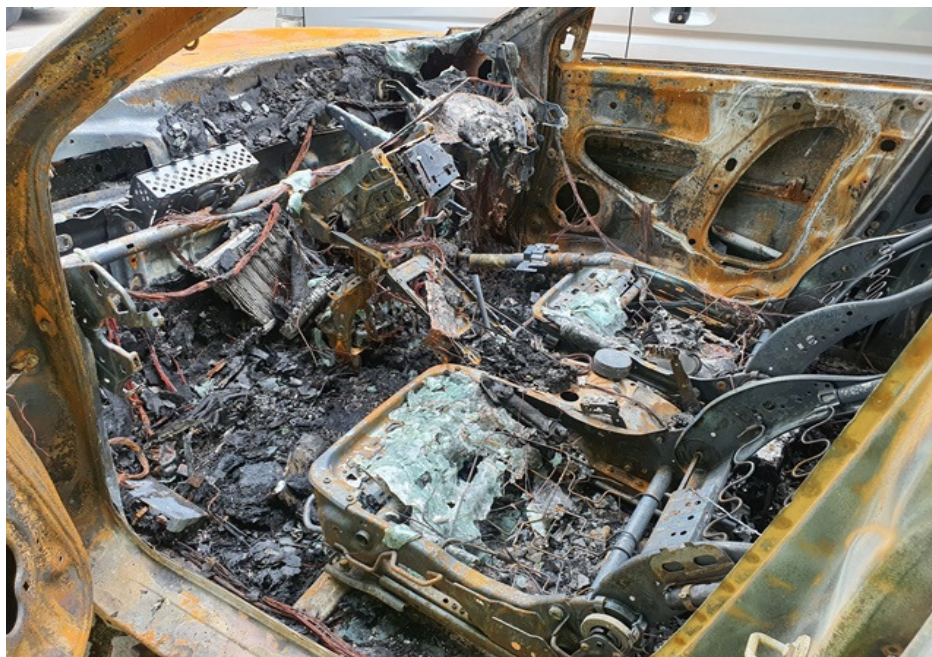
**Photo 3** shows the interior compartment of the Insured Vehicle. All the parts inside the interior compartment were found to be extensively burnt. Its front seats, rear seats, roof upholstery, carpet and various trims were all burnt and/or melted, leaving charred skeletal remains.

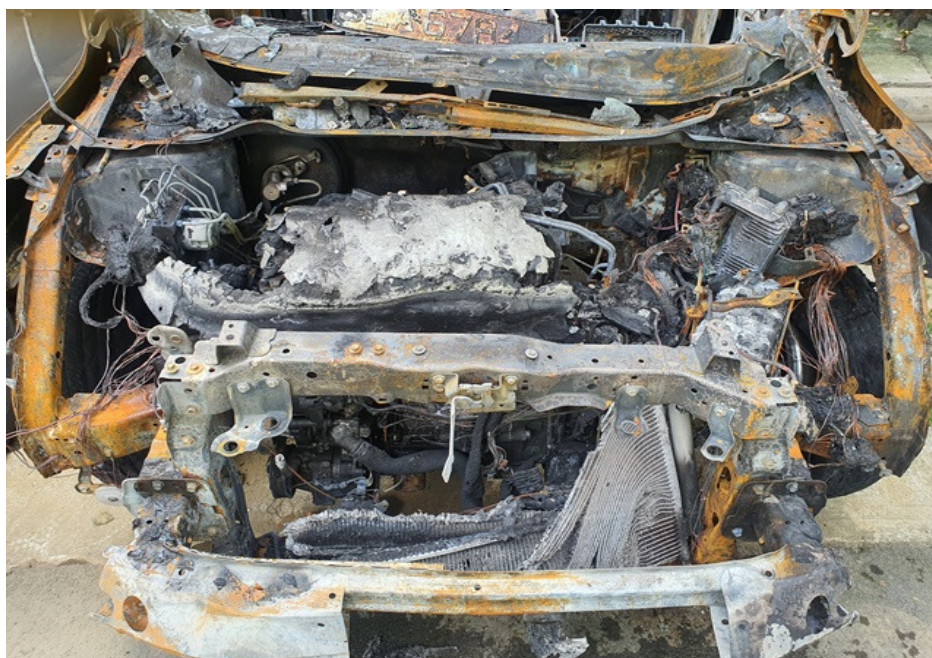
**Photo 4** shows the engine compartment of the Insured Vehicle. The various parts and components within the engine compartment of the Insured Vehicle were all extensively affected by the fire. This had included the engine and transmission of the Insured Vehicle.

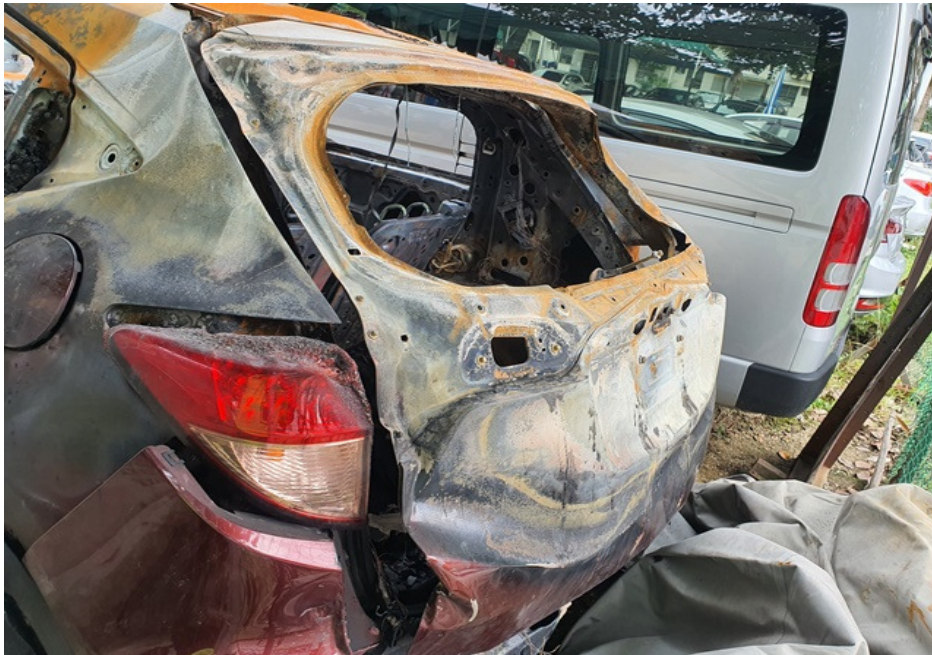
**Photo 5** shows the rear body of the Insured Vehicle. Comparing the overall extent of fire damage like the rear tyres vs the front tyres, condition of rear body panels vs front body panels etc, it would appear that the front body of the Insured Vehicle was more severely affected than its rear portion.

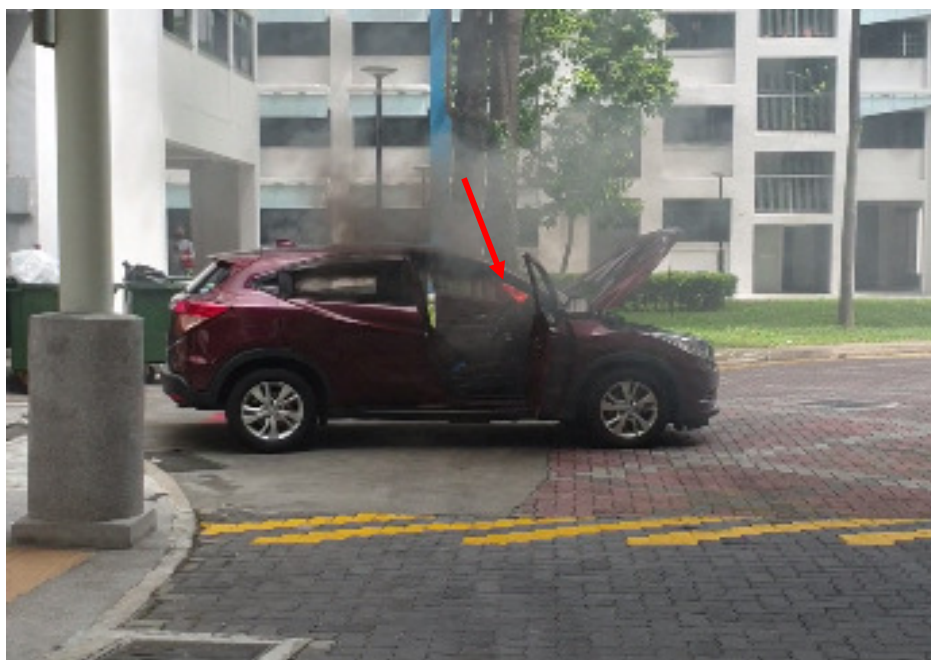
**Photo 6** shows a screenshot taken from the video recording that was provided by Mr Wong. The Insured Vehicle could be seen with black smoke and flames emitting from the left passenger side (arrowed).

15. For this case, Mr Wong first saw smoke coming out from the left portion of the interior compartment. Taking Mr Wong's observations into consideration, the fire to the Insured Vehicle had originated around the left side of the dashboard, at or near the glove compartment area; with the cause of fire related to a defective originally fitted component. The following paragraphs discuss this aspect.
16. The Insured Vehicle was involved in a manufacturer recall campaign in year 2016. The recall was for issue relating to a capacitor used in the engine idling stop system of the Insured Vehicle, which may be insufficient to protect against an overcurrent. Notably, the records had indicated that rectification to address the issue has not been carried out to the Insured Vehicle prior to this incident. See search result below obtained from LTA.

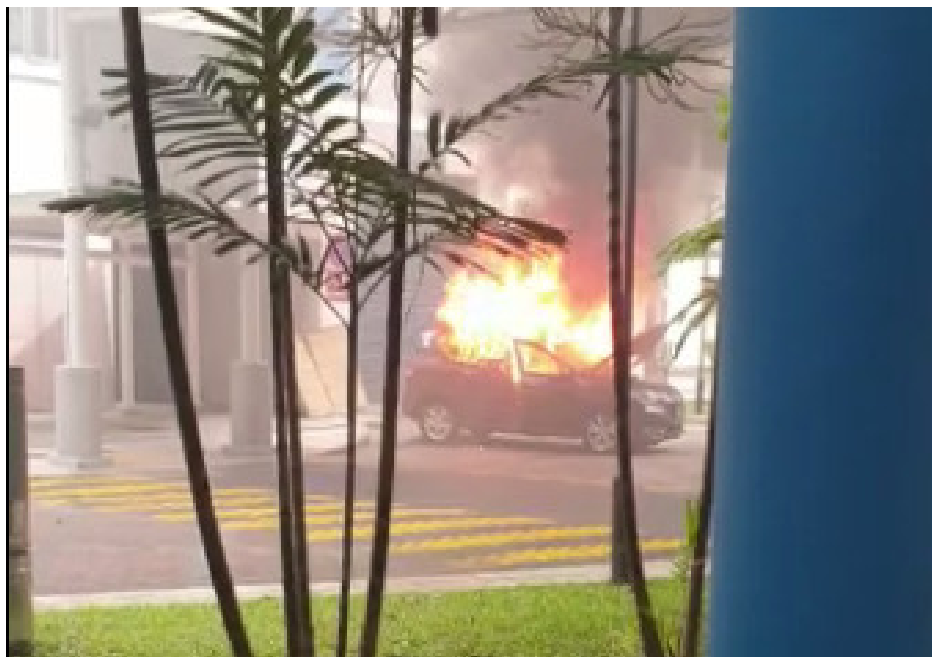
**Photo 7** shows a screenshot of the right body of the Insured Vehicle on fire taken from the video recording that was provided by Mr Wong. Comparing the overall extent of fire damage like the rear tyres vs the front tyres, condition of rear body panels vs front body panels etc, it would appear that the left of the Insured Vehicle was most affected by the fire.

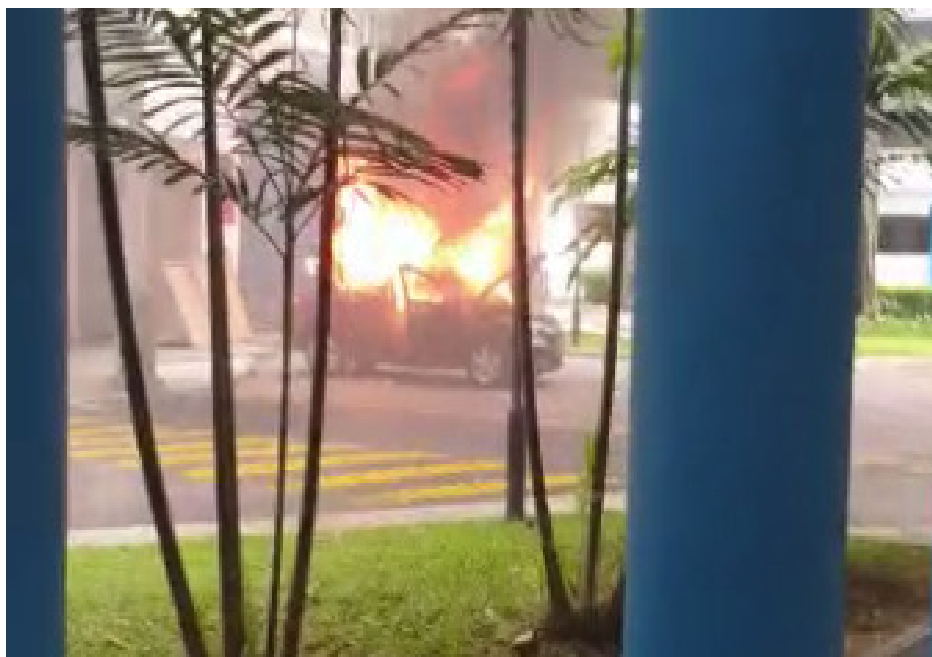
**Photo 8** shows a screenshot taken from the video recording that was provided by Mr Wong. The Insured Vehicle could be seen with flames engulfing its front body and interior compartment.

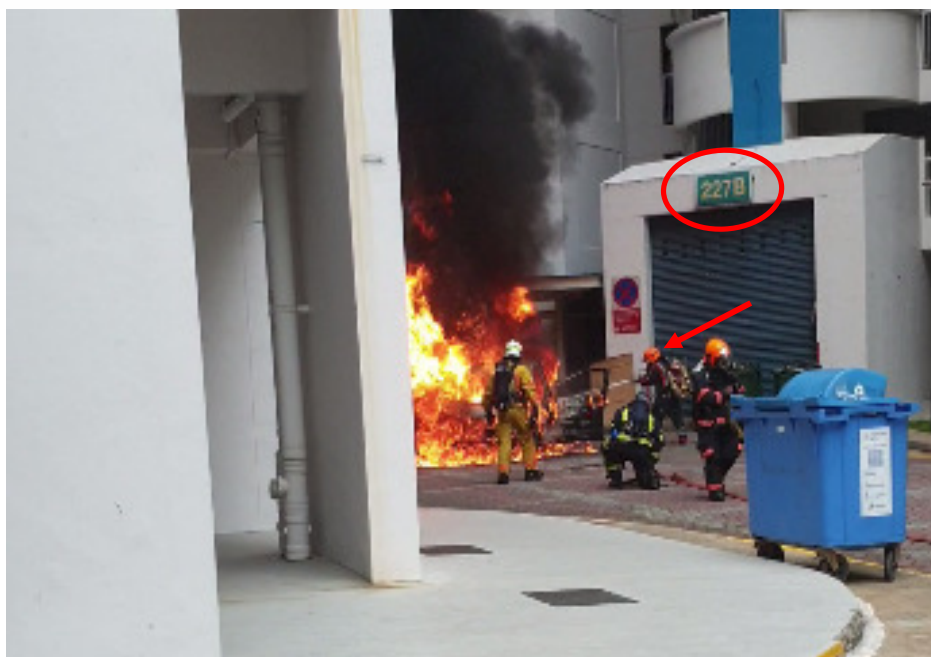
**Photo 9** shows a screenshot taken from the video recording that was provided by Mr Wong of firefighters attempting to put out the fire to the Insured Vehicle (arrowed). The background seen from the photograph had also corresponded to the incident occurring at Block 227B Compassvale Drive (circled).

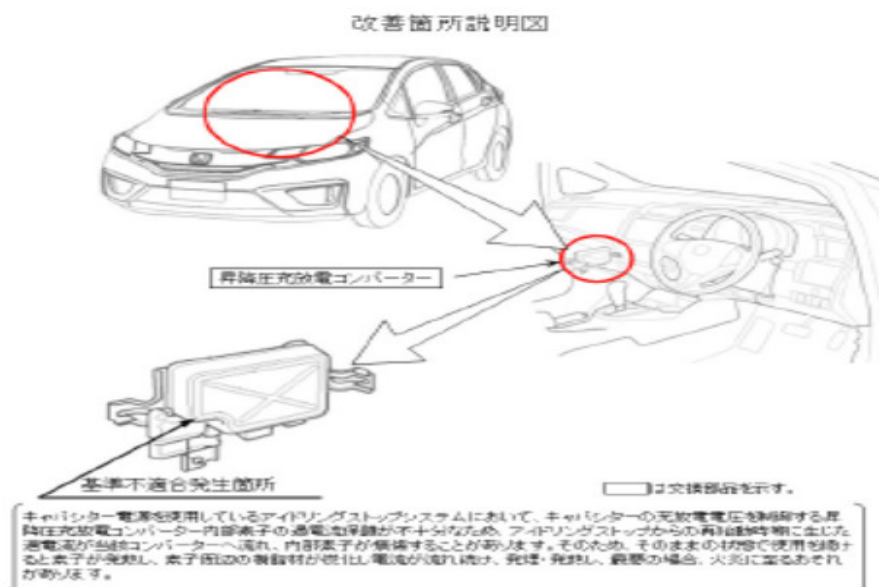
There have been no injuries related to the problems. Six fires were reported related to the faulty part that controls electricity for capacitors, and two minor accidents were reported to the defect in the steering, according to Honda Motor Co.

**Screenshot 1** shows the write up that we were able to gather pertaining to the manufacturer recall campaign of similar make and model vehicles as the Insured Vehicle.
