Your Ref: SKS 8895B
Our Ref : CI/TP20013056/D

AUTOMOBILE INSPECTION REPORT OF MOTOR CAR SKS 8895B

Vehicle Registration No.	: SKS 8895B
Make / Model	: Honda Civic SIR 4A
Chassis No	: JHMEK46500S003538
Year of Registration	: 1996 (December)
Mileage	: 349,591km

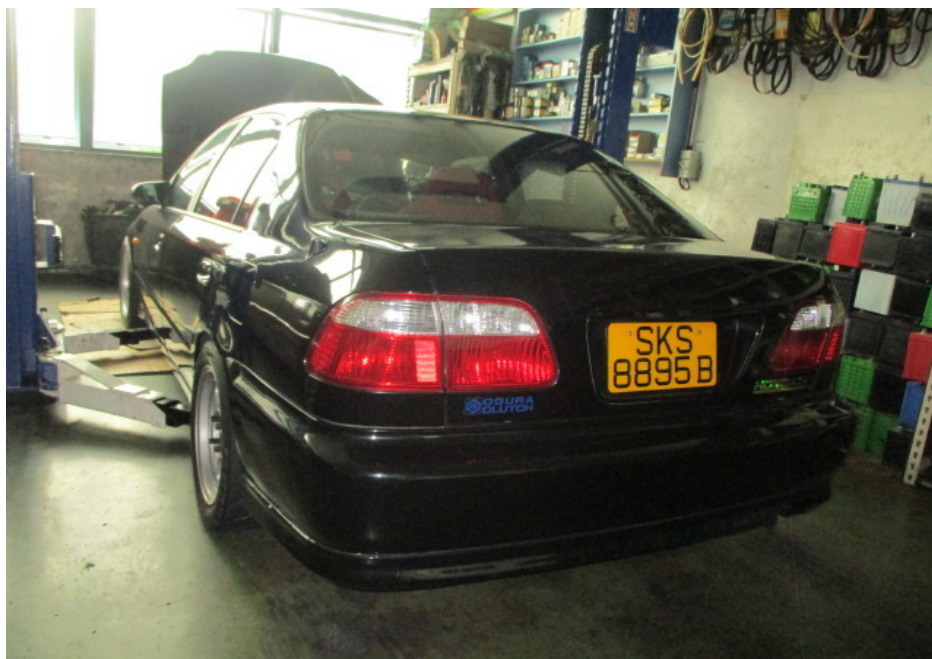
Photo 1 shows the Motor Car being hoisted up at the time of my inspection. The mileage of the Motor Car recorded was 349,591km.

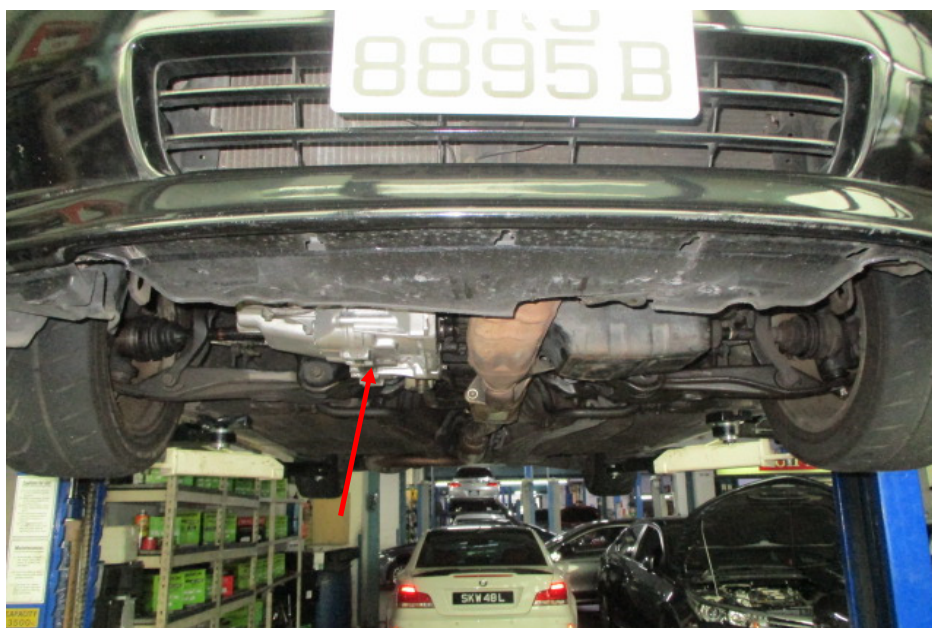
6. The Motor Car was fitted with a 5-speed manual transmission assembly. The input side of the transmission is bolted to the crankshaft side of the engine block. The left and right drive shafts were observed to be securely fitted from the main shaft, located inside the transmission, to the front left wheel and front right wheel respectively. There was also no crack and/or hole observed on the transmission housing.

Photo 2 shows a general view of the transmission assembly (arrowed) that was fitted on the Motor Car. The input side of the transmission is bolted to the crankshaft side of the engine block. The left and right drive shafts were observed to be securely fitted from the main shaft, located inside the transmission, to the front left wheel and front right wheel respectively. There was also no crack and/or hole observed on the transmission housing.

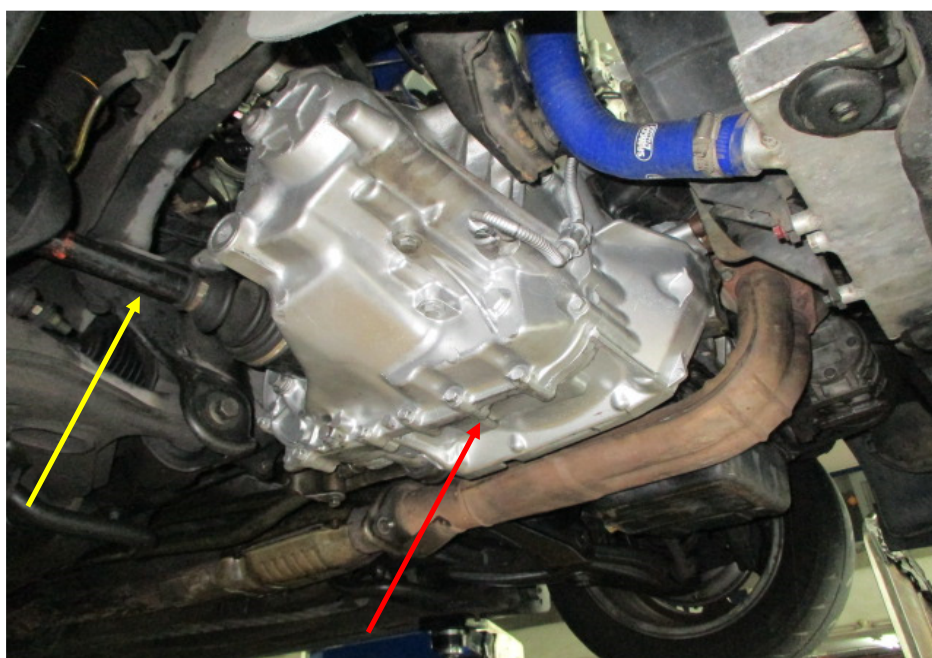
Photo 3 shows a general view of the transmission assembly (red arrow) that was fitted on the Motor Car. There was also no crack and/or hole observed on the transmission housing. The left and right drive shafts were observed to be securely fitted from the main shaft, located inside the transmission, to the front left wheel and front right wheel respectively. The right drive shaft is highlighted by the yellow arrow.

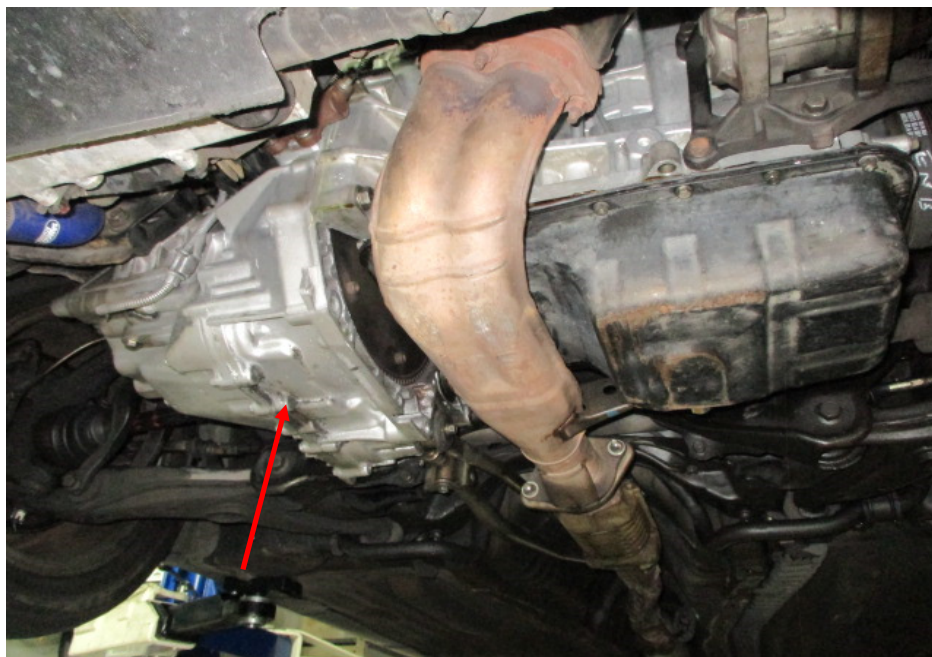
Photo 4 shows another view of the transmission assembly (arrowed) that was fitted on the Motor Car. This was at the input side where the transmission is bolted onto the crankshaft side of the engine block.

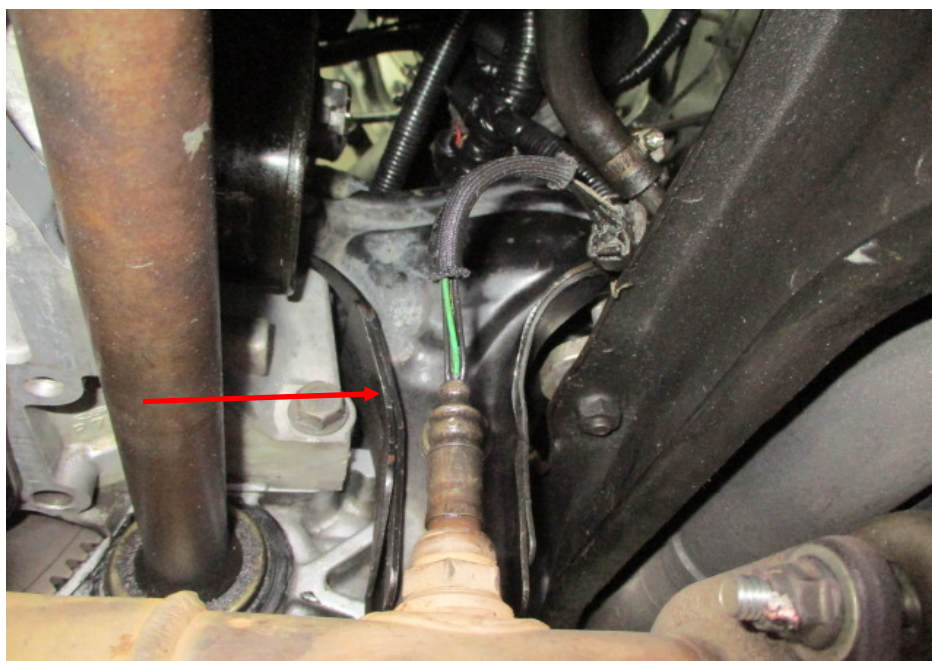
7. The transmission of the Motor Car was supported by 2 brackets. One was at the rear of the transmission while the other was at the right side of the transmission. The bracket at the rear of the transmission was mounted onto the engine cross member while the bracket at the right side was mounted onto the right side front chassis, adjacent to the right side front wheel house. Both brackets are with rubber bushings, which absorbs any vibrations arising from the rotation of the transmission gears, minimising any stress to the bracket and correspondingly also minimise any stress to the engine crossmember and right side front chassis that these brackets are mounted onto.

Photo 5 shows the bracket (arrowed) supporting the rear of the Motor Car's transmission. This bracket was mounted onto the engine cross member. The bracket was with rubber bushings that absorbs any vibrations arising from the rotation of the transmission gears, minimising any stress to the bracket and correspondingly also minimise any stress to the engine crossmember.

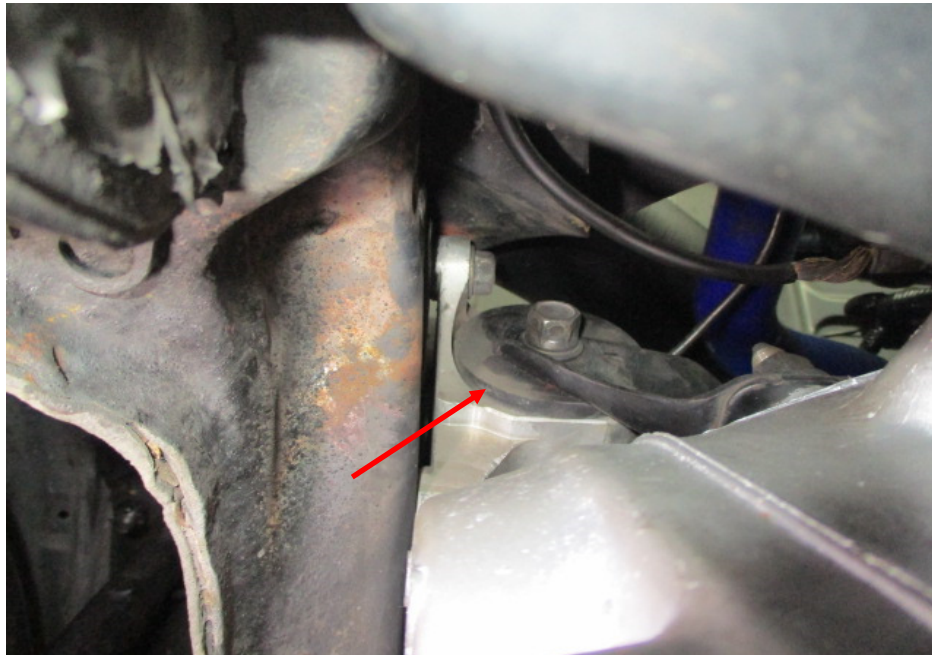
Photo 6 shows the bracket supporting the right side of the Motor Car's transmission (taken from the underside of the Motor Car). This bracket was mounted onto the right side front chassis, adjacent to the right side front wheel house. The bracket was with rubber bushings (arrowed) that absorbs any vibrations arising from the rotation of the transmission gears, minimising any stress to the bracket and correspondingly also minimise any stress to the right side front chassis member.

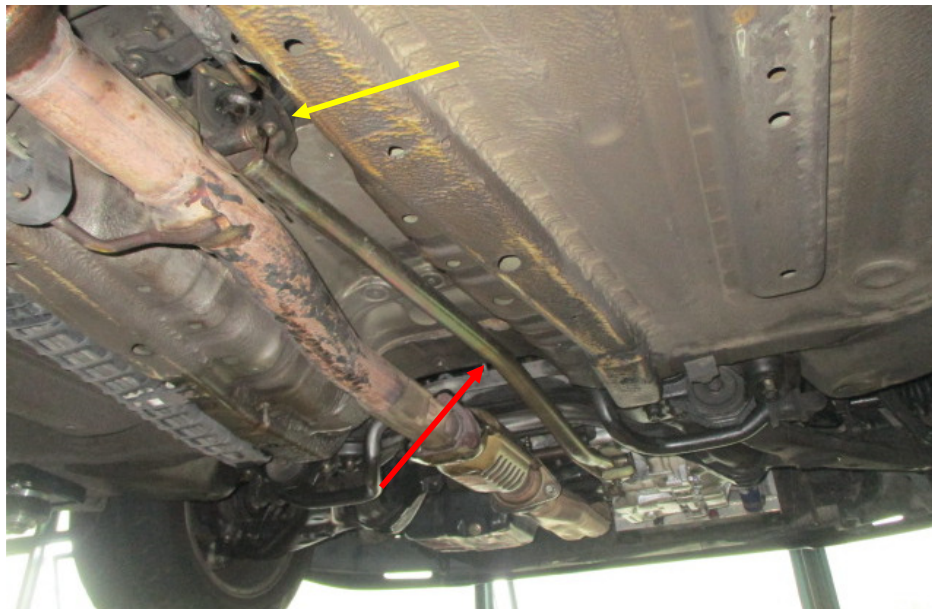
8. The gear selector fork from the transmission to the gear shifter of the Motor Car was observed to be securely fitted on the underside of the Motor Car. The gear selector fork connects to the gear shifter in the interior compartment of the Motor Car through the floorboard. See photo 1 – 8 below.

Photo 7 shows the gear selector fork (red arrow) from the transmission to the gear shifter of the Motor Car. The gear selector fork was observed to be securely fitted on the underside of the Motor Car. This gear selector fork connects to the gear shifter in the interior compartment of the Motor Car through the floorboard (yellow arrow).

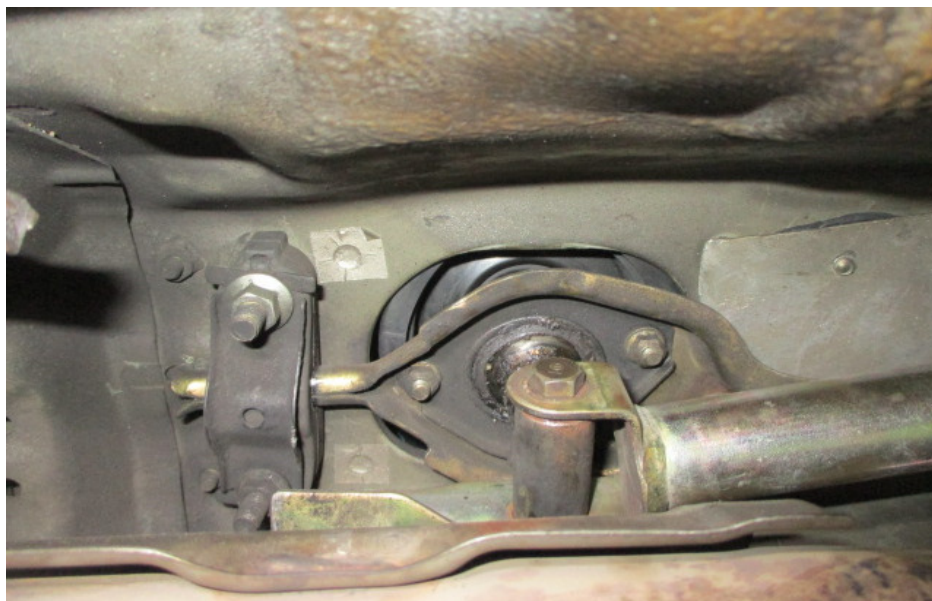
Photo 8 shows a closer view of the gear selector fork, at the side where it connects to the gear shifter in the interior compartment of the Motor Car through the floorboard.

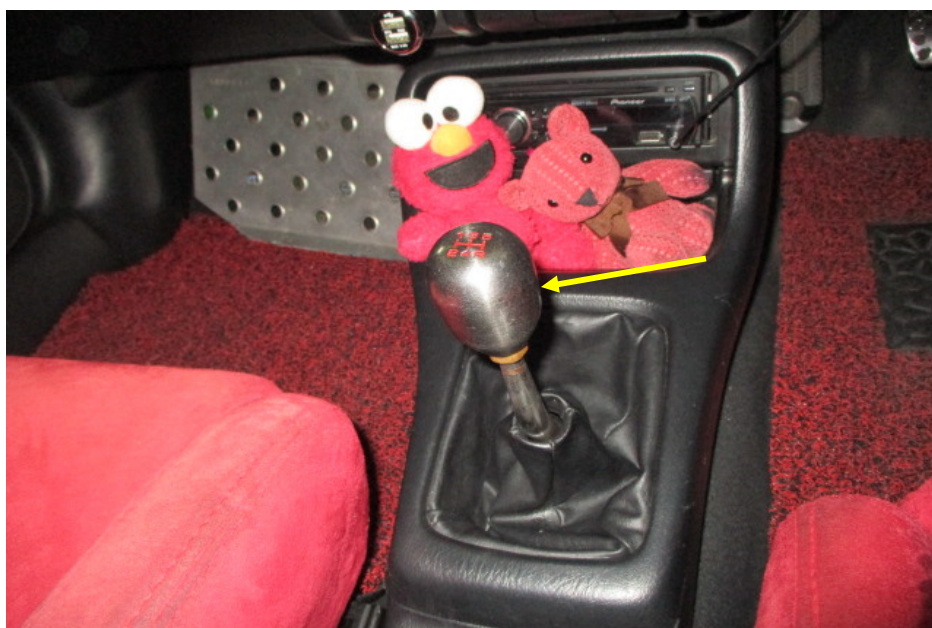
9. The transmission of the Motor Car was operated by a clutch pedal, for engaging and disengaging the transmission gears, and a gear shifter for manually upshifting and downshifting of the transmission gear to be engaged. See photo 9 & 10 below.

Photo 9 shows the gear shifter (arrowed) that was fitted on the Motor Car, for manually selecting the transmission gear to be engaged. The gear selector fork from the underside of the Motor Car (refer to photograph 7 above) connects to this gear shifter through the floorboard.

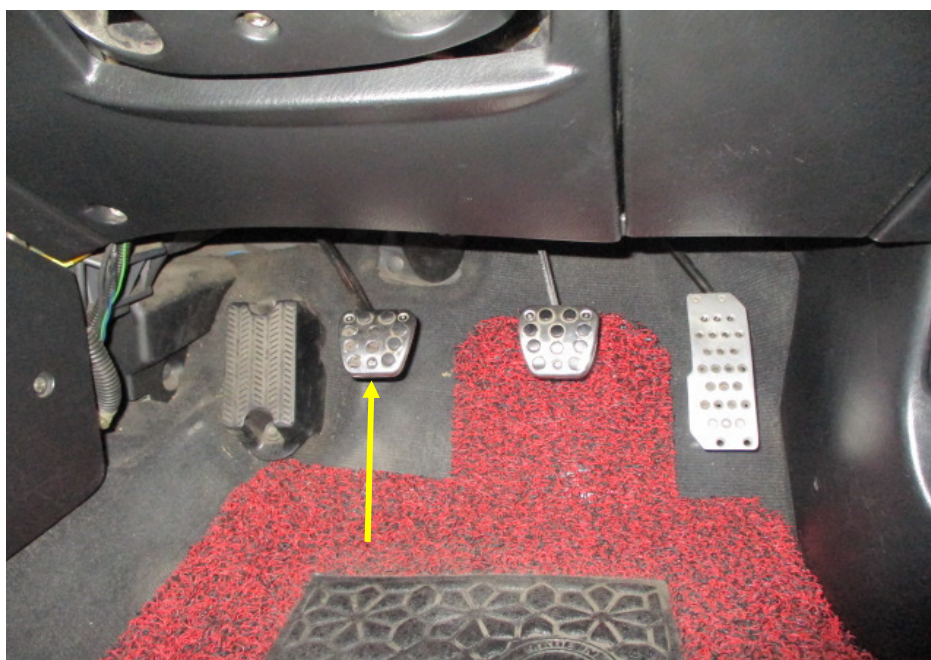
Photo 10 shows the clutch pedal (arrowed) of the Motor Car, for engaging and disengaging the transmission gears.
