Your Ref: Mercedes Benz C300  
(chassis number WDD2050832R529975)  
Our Ref : CI/TP20013150/D

01 December 2020

**INSPECTION REPORT OF AN UNREGISTERD MERCEDES BENZ C300  
MOTOR CAR WITH CHASSIS NUMBER WDD2050832R529975**

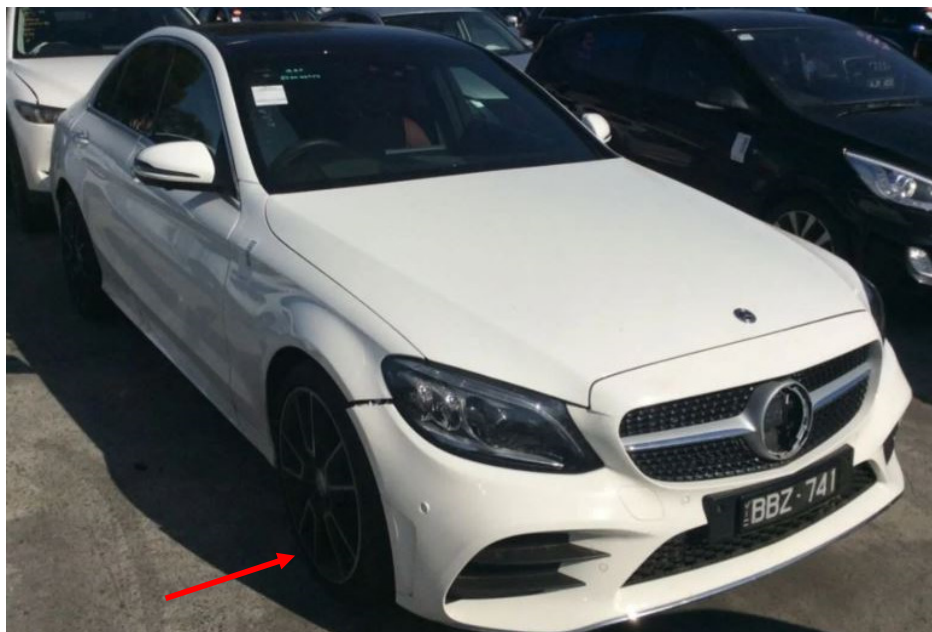
3. From the photographs provided to me, it was observed that the Motor Car had sustained damages at its frontal portion. Body parts observed to have been damaged include its front bumper, front radiator grille and front radiator grille logo amongst others. The front left undercarriage parts of the Motor Car appear to be also affected as upon my close observation of the photographs provided, I had observed that the orientation of the front left wheel was slightly to the left direction as compared to the front right wheel which was in a straight direction.
4. Parts and components within the engine compartment were unaffected as seen from the photographs that were provided to me. The airbags of the Motor Car were also not deployed. See photo 1 – 3 below.

**Photo 1** shows the front right body of the Motor Car prior to any repairs being carried out (photograph provided to me). The Motor Car was observed to have sustained damages at its frontal portion. The body parts damaged had included its front bumper, front radiator grille and front radiator grille logo amongst others. Note that the front right wheel (arrowed) was orientated in a straight direction.

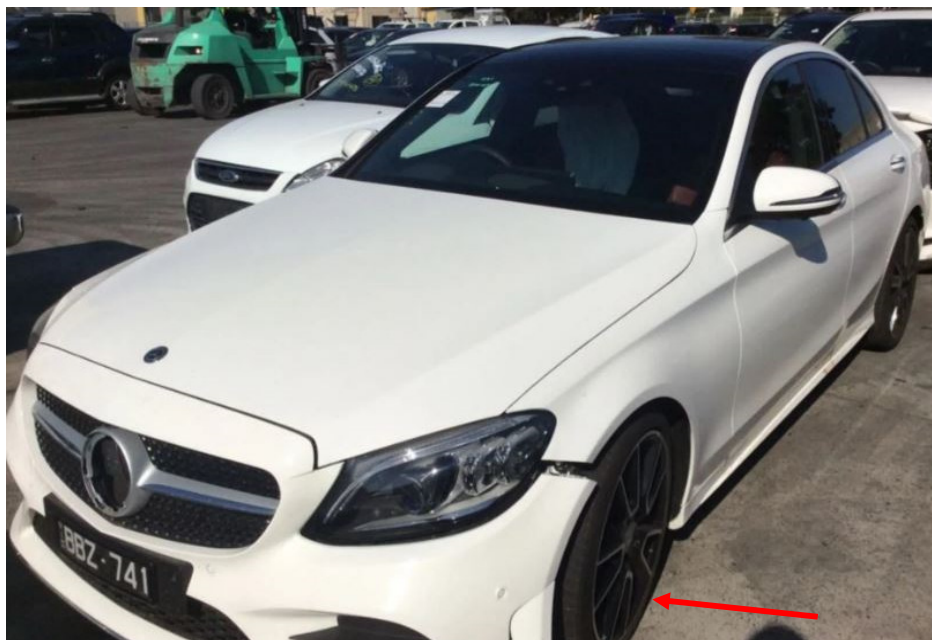
**Photo 2** shows the front left body of the Motor Car prior to any repairs being carried out (photograph provided to me). Apart for the front bumper, front radiator grille and front radiator grille logo amongst others, the front left undercarriage parts of the Motor Car appear to be also affected as I had observed that the orientation of the front left wheel (arrowed) was slightly to the left direction as compared to the front right wheel which was in a straight direction (refer to photograph 1 above).

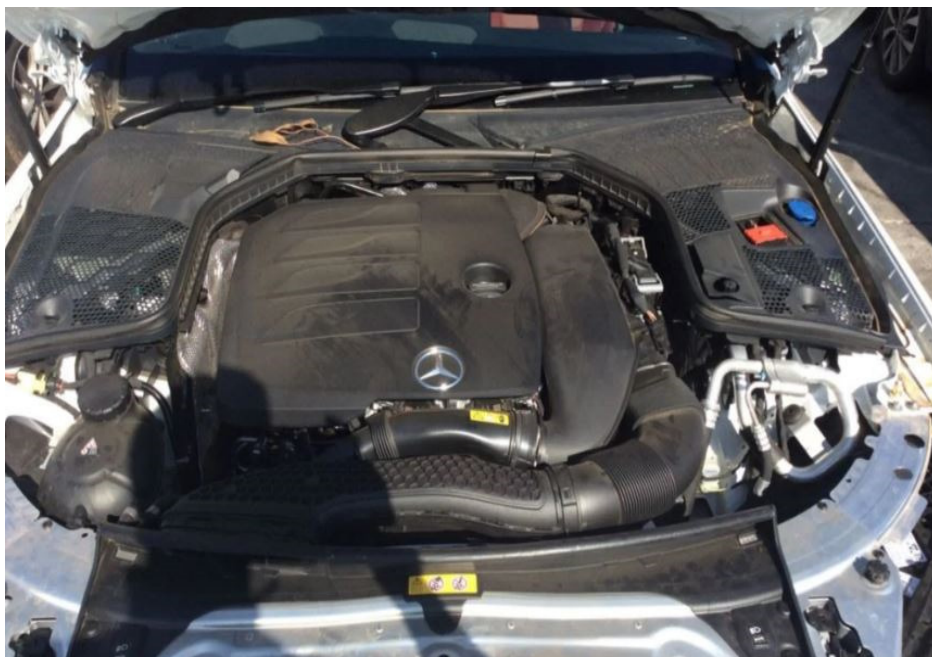
**Photo 3** shows the engine compartment of the Motor Car prior to any repairs being carried out (photograph provided to me). Parts and components within the engine compartment were unaffected.

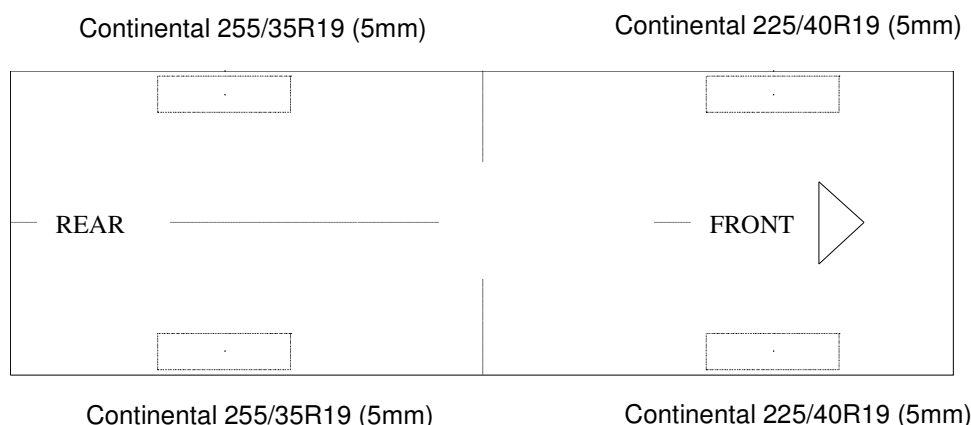
8. It was fitted with 19inch sport wheel rims that were wrapped with tyres that were observed to be of serviceable condition. The tyres were also sufficiently inflated for vehicular operation. The tyre brand, tyre size and approximate remaining tread depth of the 4 tyres of the Motor Car were recorded as follows: -

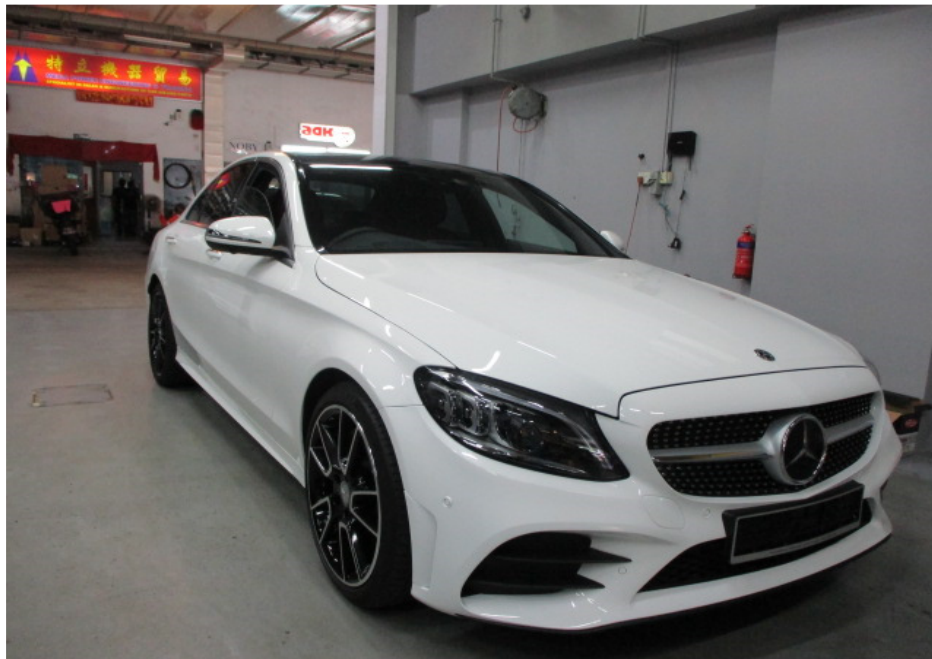
**Photo 4** shows a general view of the front right body of the Motor Car at the time of my inspection. The Motor Car was observed to be in a relatively good general condition with no loose exterior fittings observed. The body parts at the frontal portion of the Motor Car were visually examined and it was observed that the repair/restoration works carried out to the damaged area of the Motor Car (refer photograph 1 & 2 above) were reasonably adequate and in order.

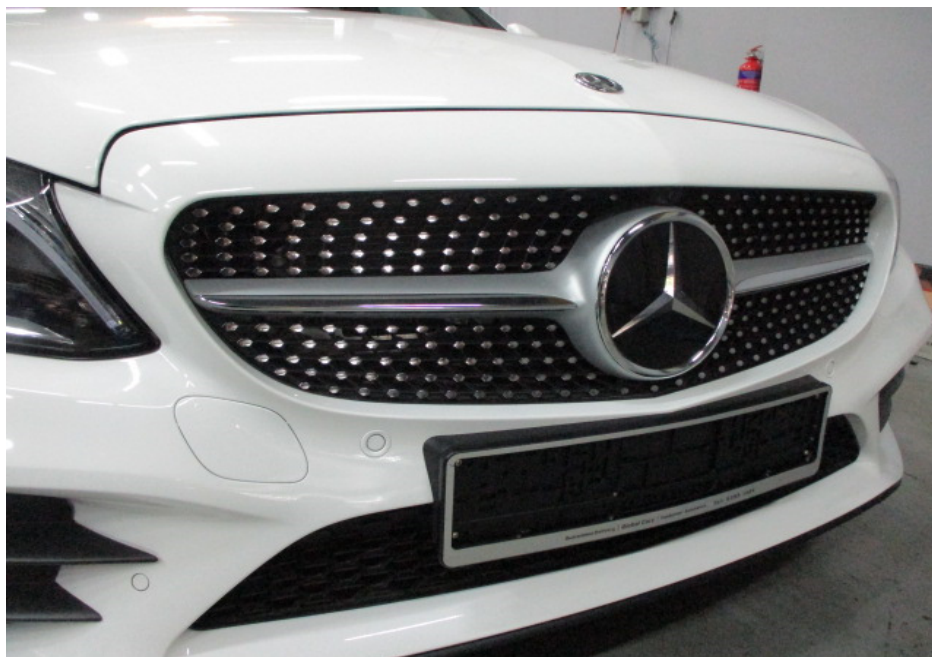
**Photo 5** shows a closer view of the front bumper, front radiator grille and front radiator grille logo of the Motor Car. The body parts at the frontal portion of the Motor Car were visually examined and it was observed that the repair/restoration works carried out to the damaged area of the Motor Car (refer photograph 1 & 2 above) were reasonably adequate and in order.

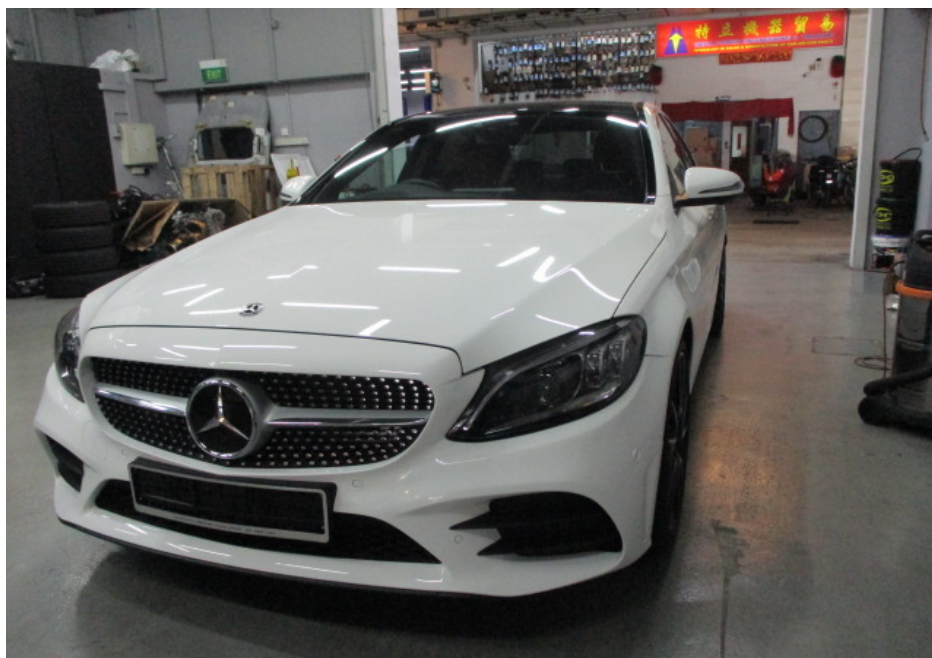
**Photo 6** shows a general view of the front left body of the Motor Car at the time of my inspection. The Motor Car was observed to be in a relatively good general condition with no loose exterior fittings observed. The body parts at the frontal portion of the Motor Car were visually examined and it was observed that the repair/restoration works carried out to the damaged area of the Motor Car (refer photograph 1 & 2 above) were reasonably adequate and in order.

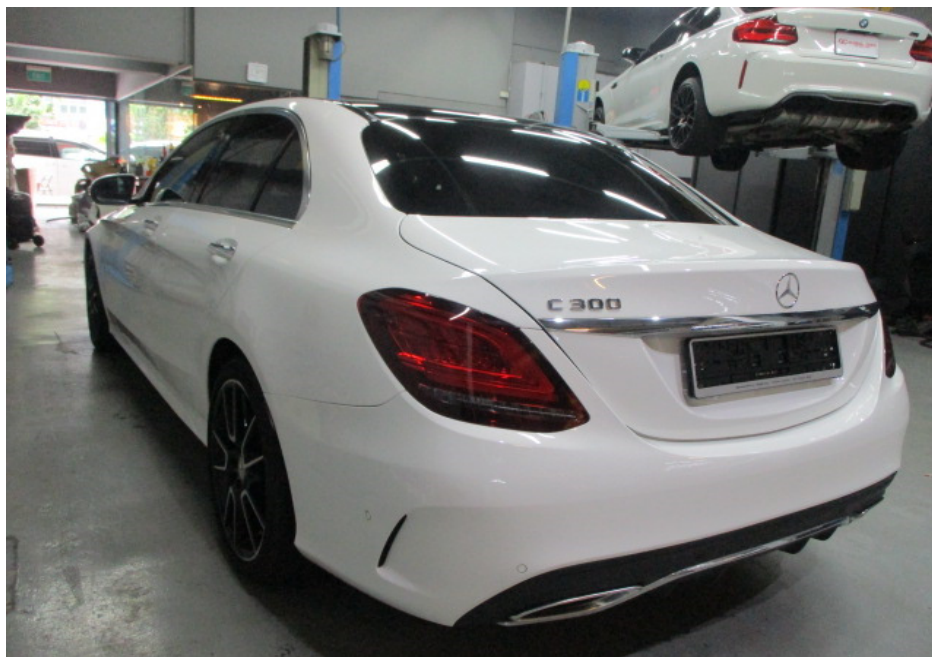
**Photo 7** shows a general view of the rear left body of the Motor Car at the time of my inspection. The Motor Car was observed to be in a relatively good general condition with no loose exterior fittings observed. The mileage of the Motor Car recorded at the time of my inspection was 10,833km.

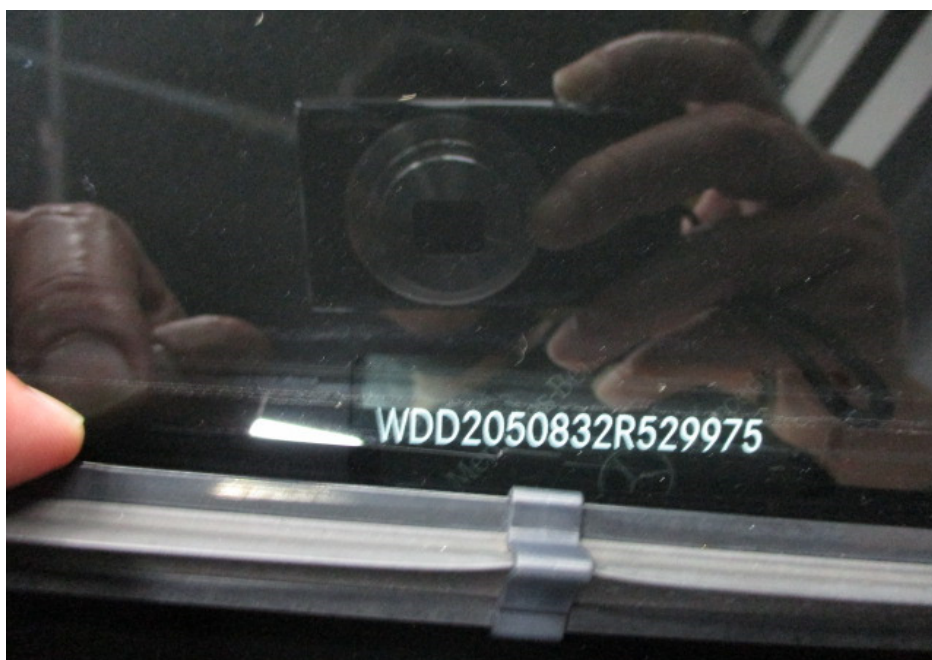
**Photo 8** shows the chassis number of the Motor Car. The chassis number recorded was WDD2050832R529975.

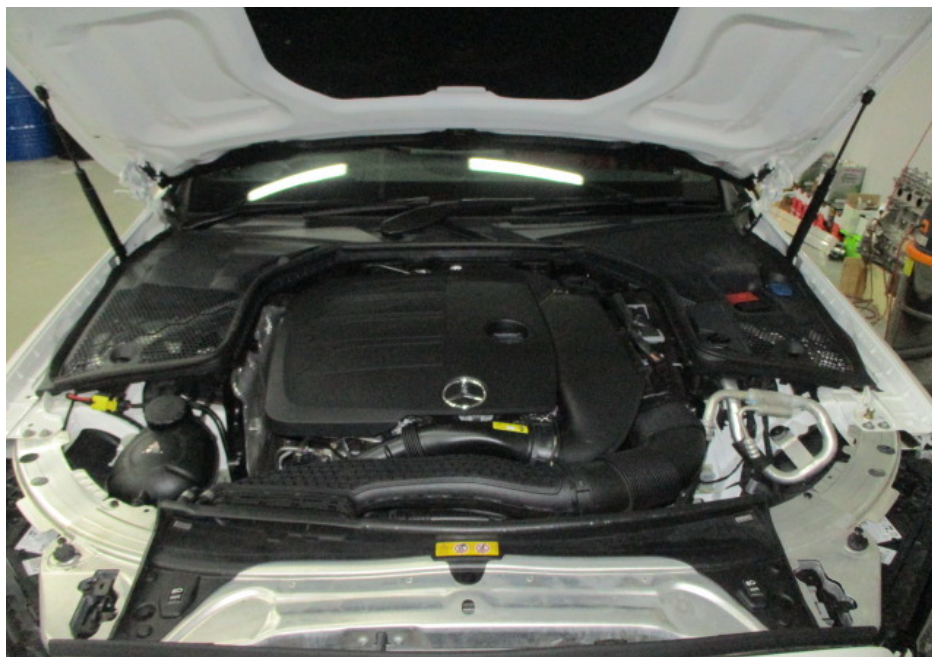
14. My examination of the engine compartment of the Motor Car revealed that the various parts and components inside the engine compartment were all intact and properly fitted. The engine oil, brake fluid and engine coolant were all found to be of sufficient level for operating purposes. Visually, there was also no contamination found to these fluids.
15. My checks on the underside of the Motor Car revealed no sign(s) or indication(s) of fluid leakage and/or fluid stain(s). The engine block and automatic transmission assembly were both secured properly. All undercarriage components of the Motor Car were also observed to be intact and secured in an appropriate manner.

**Photo 9** shows a general view of the engine compartment of the Motor Car at the time of my inspection. The various parts and components inside the engine compartment were all observed to be intact and properly fitted. There was also no sign(s) or indication(s) of fluid leak and/or fluid stain found inside the engine compartment.

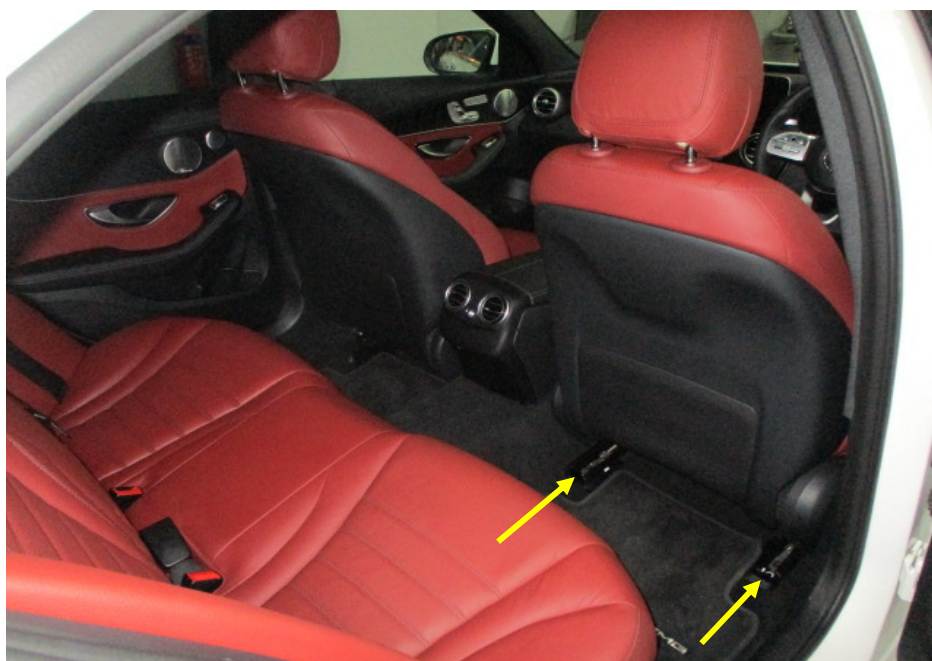
12. The seats of the Motor Car were found to be secured to the floorboard of the Motor Car via seat rails bolted onto the floorboard. Retractable seat belt reels and pre-tensioners were fitted on all seats of the Motor Car. The seat belts were tested and were able to be fastened securely into the respective pre-tensioners that were fixed to the side of all the seats.

**Photo 10** shows the interior compartment of the Motor Car. The seats of the Motor Car were secured via seat rails (arrowed) to the floorboard. All the seats of the Motor Car were fitted with a retractable seat belt reel and a pre-tensioner. The seat belts were tested and were able to be fastened into the respective pre-tensions that were fitted on the side of each individual seat.

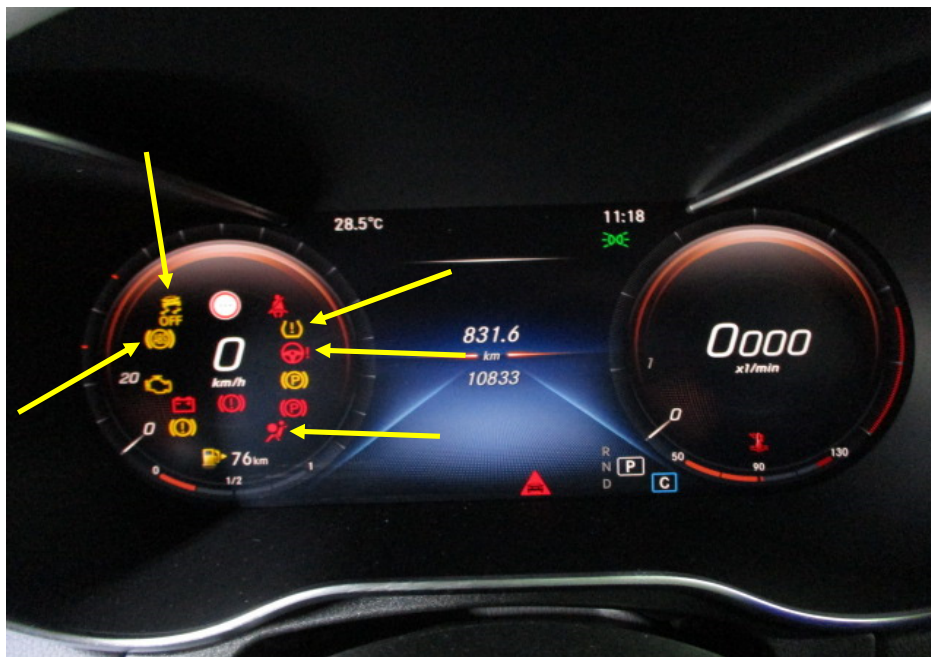
**Photo 11** shows the warning lights for the various electronic safety features appearing on the instrument panel of the Motor Car during its self-test when the engine is cranked, in particular the ABS, SRS, EPS, TPM and ESP lights (arrowed).

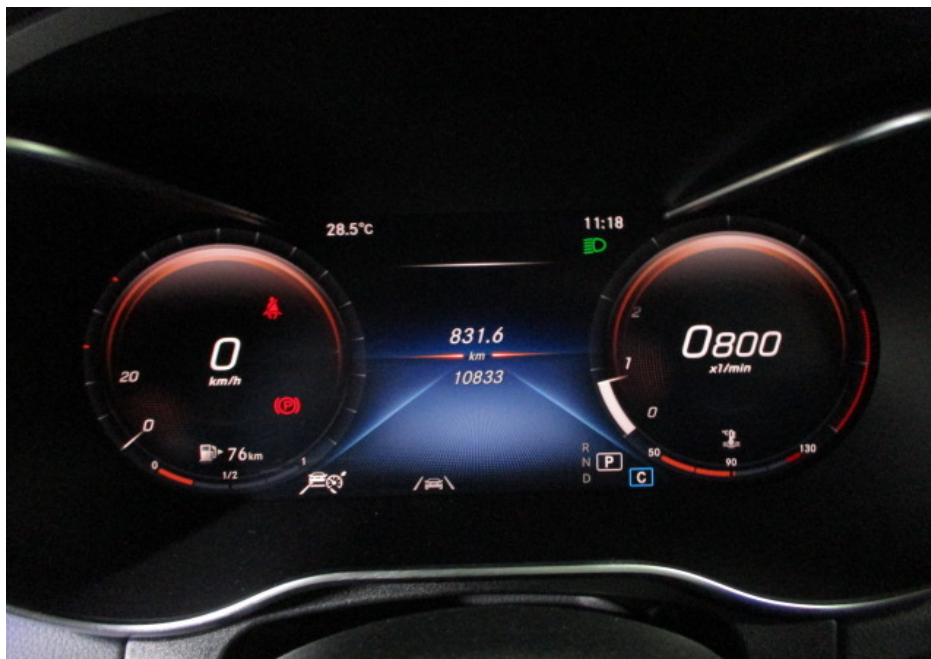
13. The Motor Car's automatic self-test of the functionality of its various electronic safety features like the Anti-Lock Brake System (ABS), Supplemental Restraint System (SRS), Electric Power Steering (EPS), Tyre Pressure Monitor (TPM) and Electronic Stability Program (ESP) during cranking of the engine had indicated that these electronic systems were in working condition. This was determined from the respective warning lights disappearing from the instrument panel after the self-test.

**Photo 12** shows the respective warning lights no longer illuminated, indicating that there is no fault detected to the ABS, SRS, EPS, TPM and ESP systems of the Motor Car during the self-test. These electronic systems were hence in working condition at the time of my inspection.

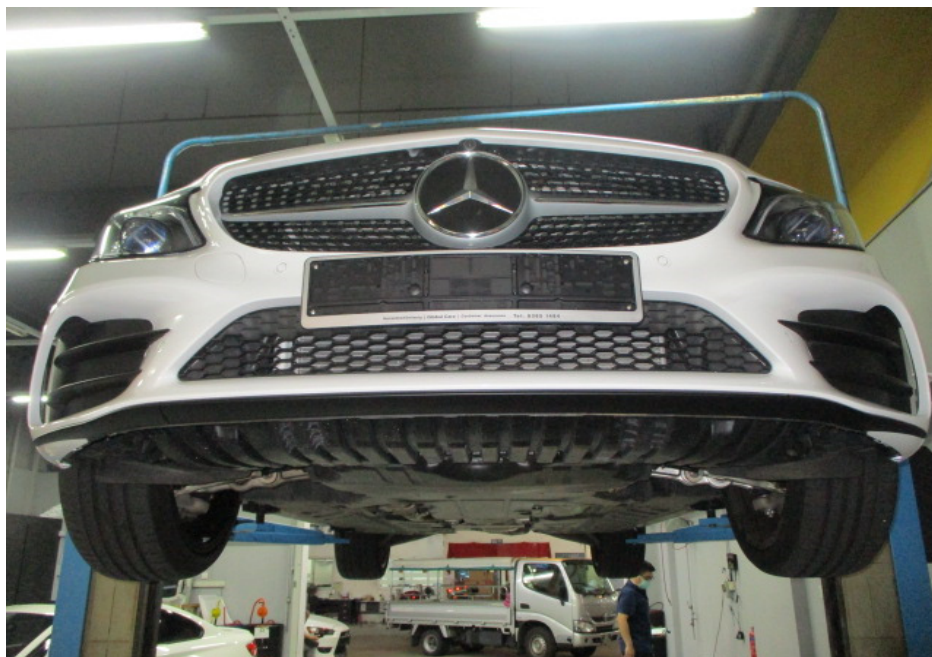
**Photo 13** shows the Motor Car hoisted up for checks on its undercarriage. There was no sign(s) or indication(s) of fluid leakage and/or fluid stain(s) on the underside of the Motor Car. The undercarriage components of the Motor Car were also all observed to be intact and secured in an appropriate manner.

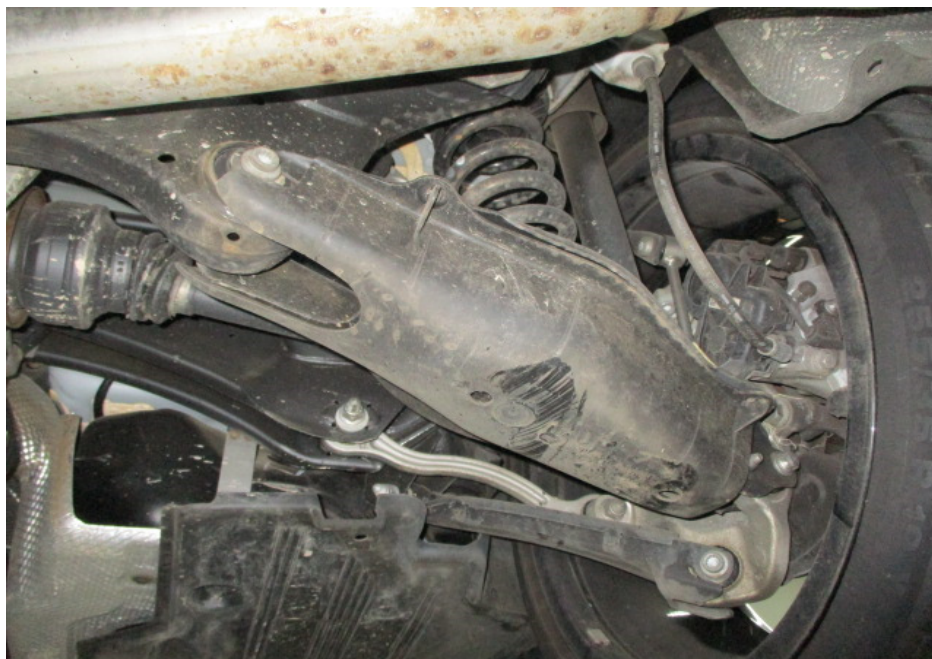
**Photo 14** shows a general view of the control arms and linkages at the rear right wheel of the Motor Car. I did not observe any fluid leak and/or fluid stain on the underside of the Motor Car. All of the Motor Car's undercarriage components were observed to be intact and secured in an appropriate manner.

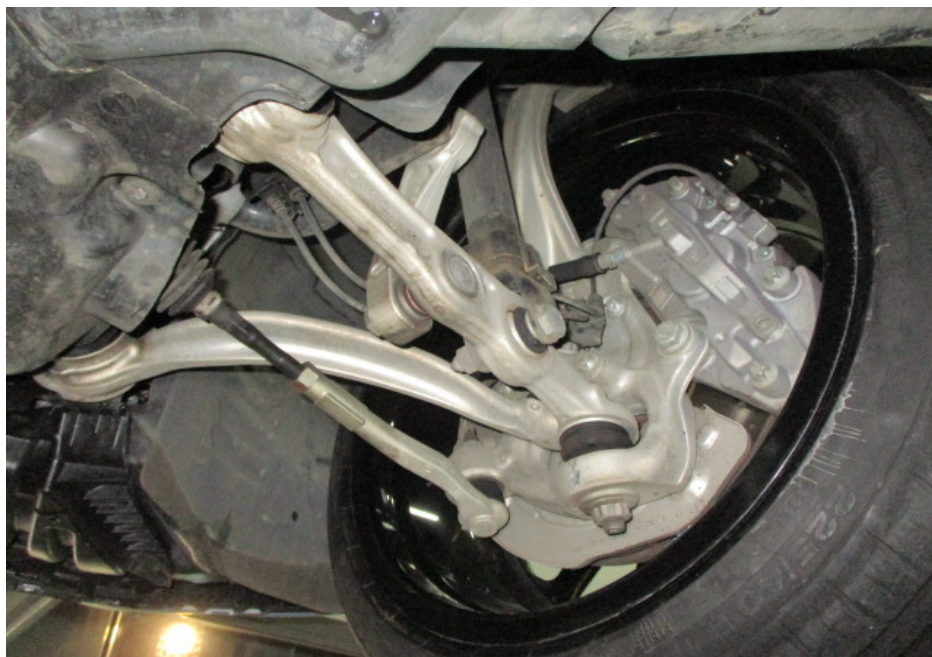
**Photo 15** shows the various undercarriage components at the front right wheel of the Motor Car. The mechanical components, control arms and linkages were all found to be intact and secured in an appropriate manner.

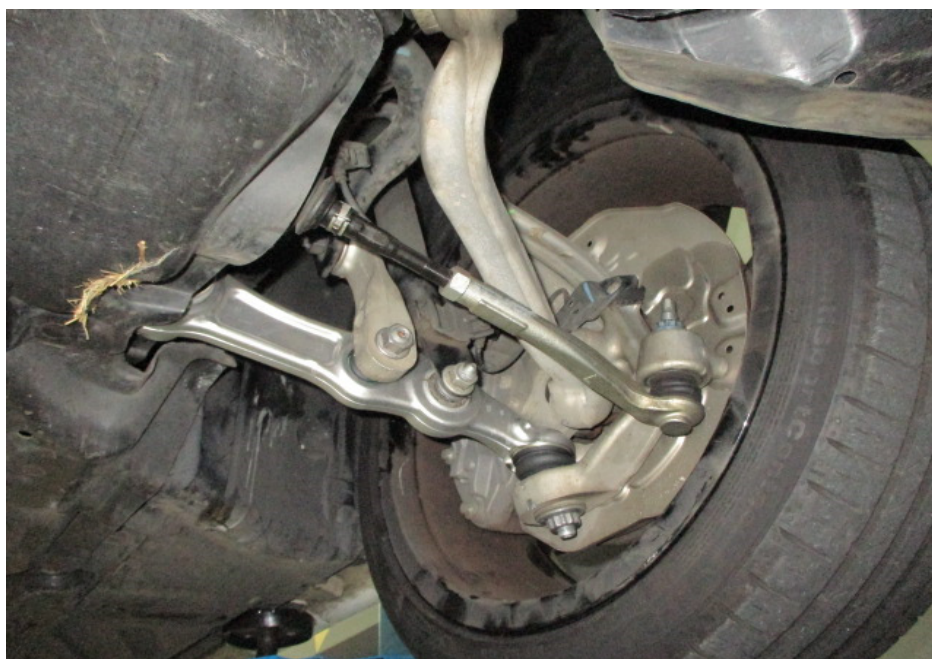
**Photo 16** shows the various undercarriage components at the front left wheel of the Motor Car. The mechanical components, control arms and linkages were all found to be intact and secured in an appropriate manner. I also did not observe any fluid leak and/or fluid stain on the underside of the Motor Car.

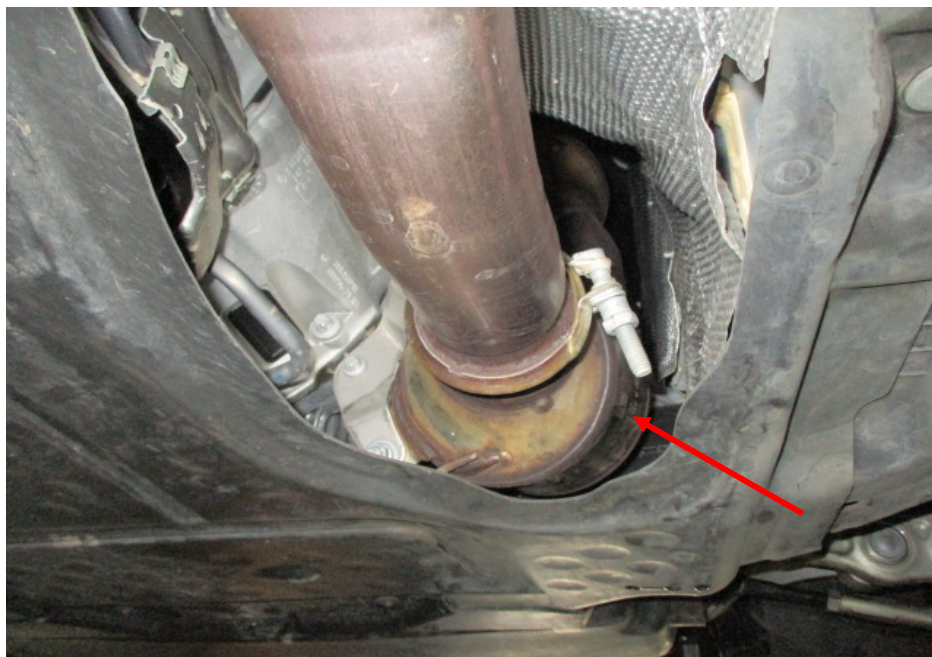
**Photo 17** shows the Motor Car's catalytic convertor (arrowed). My examination of the Motor Car's exhaust system revealed no sign(s) or indication(s) of any cut or weld marks along its exhaust pipes and on its rear muffler.

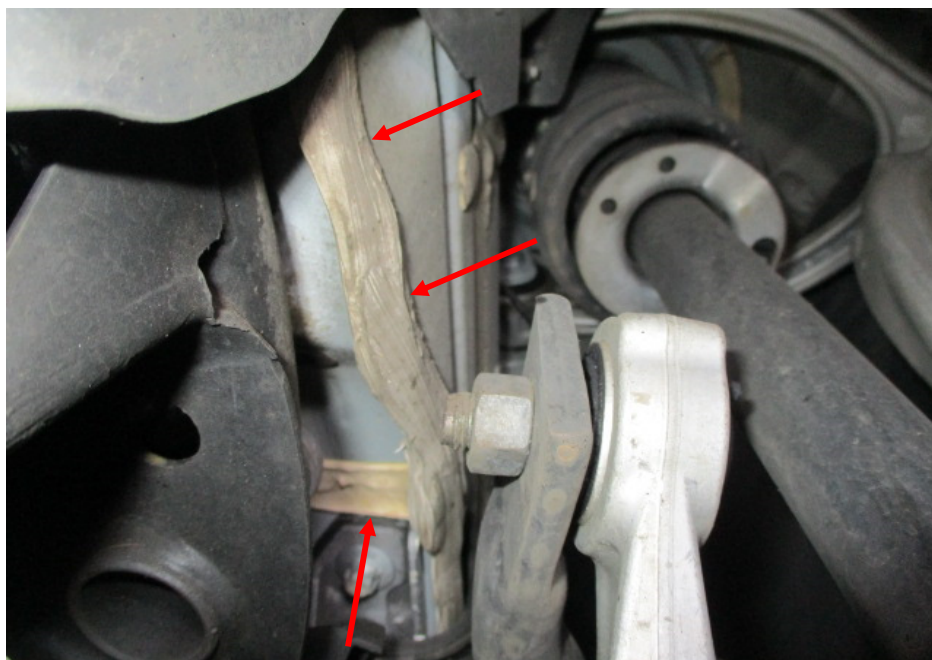
11. Visually, I did not find any weld marks, other than the original spot weld marks, on the chassis/structural body of the Motor Car. The original factory sealant at the joints along the chassis/structural body was also untouched, again indicating that no replacement of the chassis/structural body was carried out; and that the chassis/structural body was originally fitted.

**Photo 18** shows the chassis/structural body at the underside front right of the Motor Car. Visually, I did not find any weld marks other than original spot weld marks on the chassis/structural body of the Motor Car. The original factory sealant (arrowed) at the joints along the chassis/structural body was also untouched, indicating no work was done on the chassis/structural body of the Motor Car and that the chassis/structural body was originally fitted.

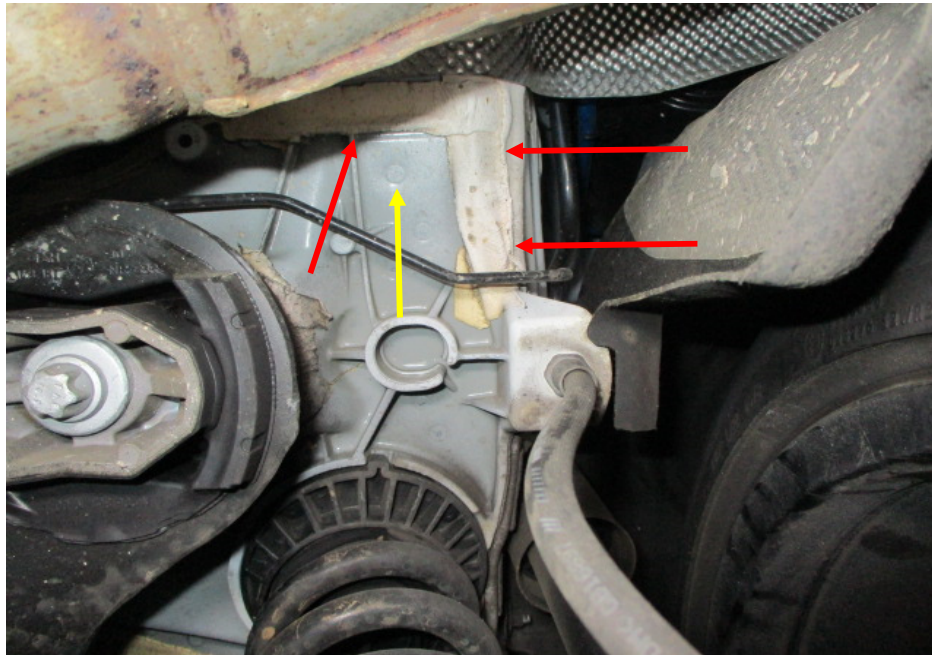
**Photo 19** shows the chassis/structural body at the underside rear right of the Motor Car. Visually, I did not find any weld marks other than original spot weld marks (yellow arrow) on the chassis/structural body of the Motor Car. The original factory sealant (red arrow) at the joints along the chassis/structural body was also untouched, indicating no work was done on the chassis/structural body of the Motor Car and that the chassis/structural body was originally fitted.

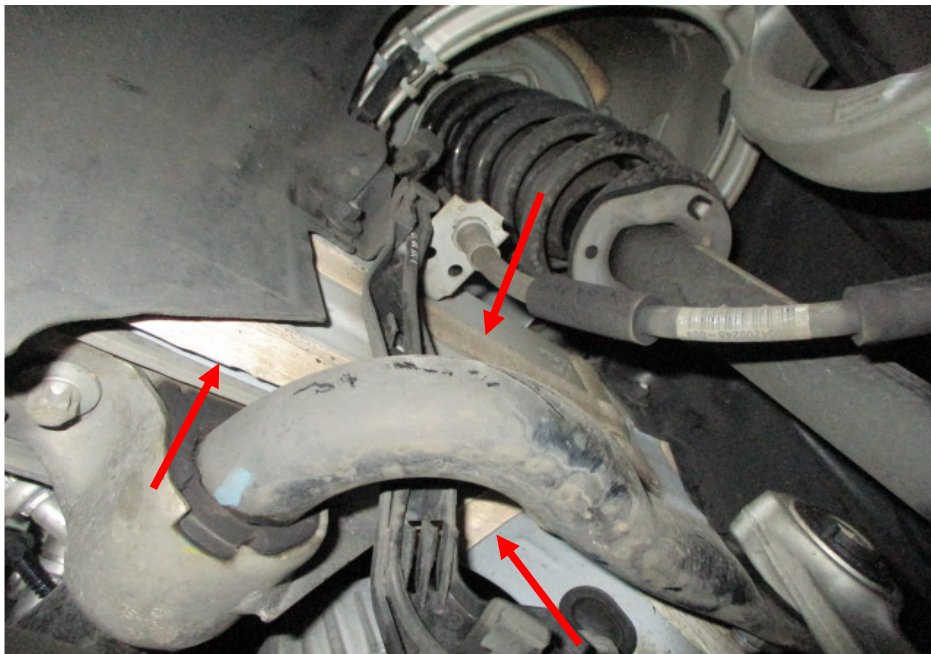
**Photo 20** shows the chassis/structural body at the underside front left of the Motor Car. In general, I had found the original factory sealant (arrowed) at the joints along the chassis/structural body of the Motor Car to be untouched, indicating no work was done on the chassis/structural body of the Motor Car and that the chassis/structural body was originally fitted.

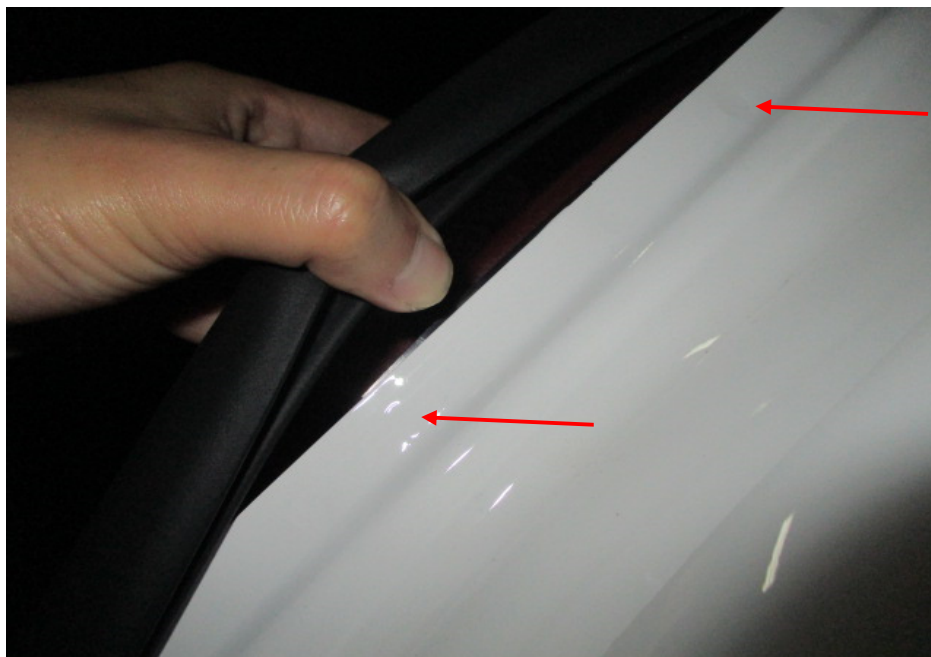
9. The detachable body panels of the Motor Car like the front fenders, front bumper, rear bumper, doors, bonnet and rear bootlid amongst others were all found to be fitted securely.
10. Checks on the non-detachable body panels like the rear fenders, floorboard, roof panel, pillars and rocker panels amongst others, revealed that these body panels were spot welded onto the chassis/structural body of the Motor Car. The original factory sealant at the joints of the non-detachable body panels was all untouched indicating no replacement of the non-detachable body panels was carried out; and that these body panels were all originally fitted.

**Photo 21** shows the left "C" pillar of the Motor Car. I did not find any weld marks other than original spot weld marks (arrowed) on the left "C" pillar of the Motor Car. In general, I had found all the non-detachable body panels of the Motor Car to be originally fitted at the time of my inspection.
