Your Ref: BMW M2
(chassis number WBS2U72090VB10076)
Our Ref : CI/TP20013151/D

01 December 2020

INSPECTION REPORT OF AN UNREGISTERD BMW M2 MOTOR CAR WITH CHASSIS NUMBER WBS2U72090VB10076

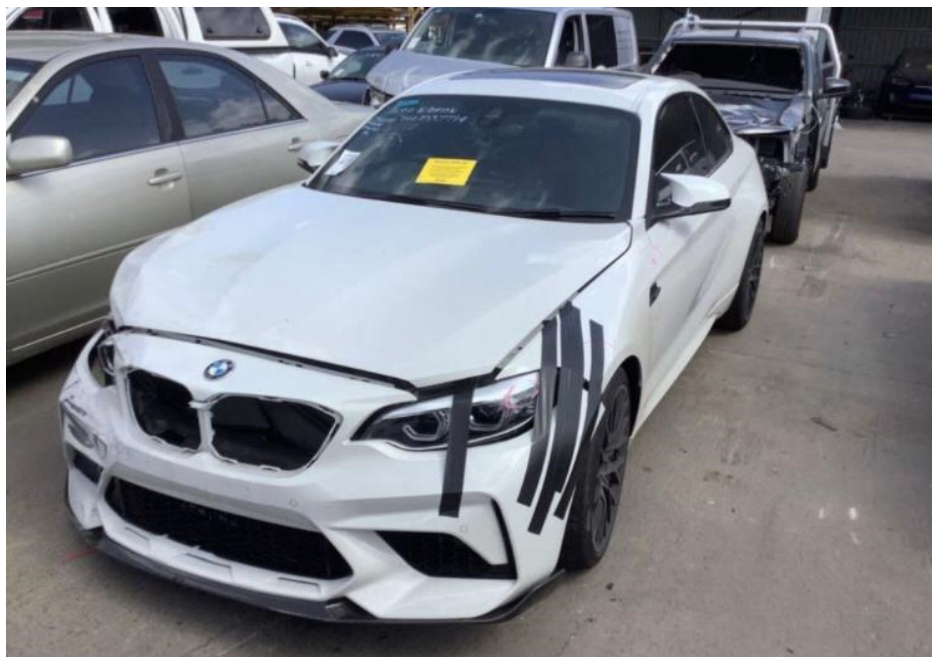
3. From the photographs provided to me, it was observed that the Motor Car had sustained damages at its front right portion. Body parts observed to have been damaged include the front bumper, front bonnet, front right headlamp, front radiator grilles, front centre lower grille, front right lower grille and front right fender amongst others. The airbags of the Motor Car were not deployed as seen from the photographs that were provided to me. See photo 1 - 3 below

Photo 1 shows the front left body of the Motor Car prior to any repairs being carried out (photograph provided to me). The Motor Car was observed to have sustained damages at its front right portion. The body parts observed to be damaged had include the front bumper, front radiator grilles and front centre lower grille amongst others.

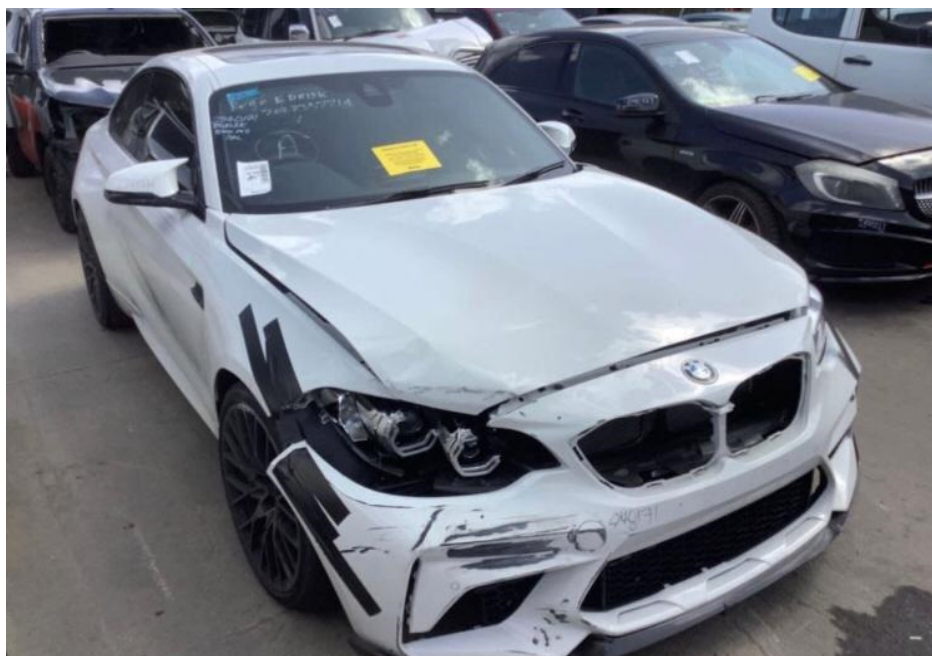
Photo 2 shows the front right body of the Motor Car prior to any repairs being carried out (photograph provided to me). The Motor Car was observed to have sustained damages at its front right portion. Amongst others, I had observed damage to the Motor Car's front bumper, front right headlamp, front bonnet, front right lower grille and front right fender.

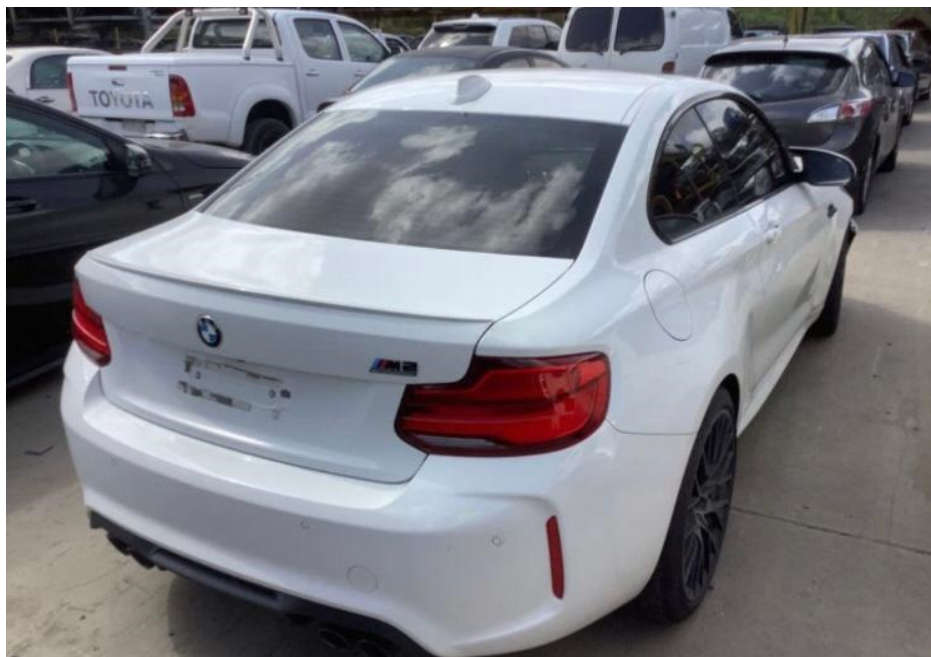
Photo 3 shows the rear right body of the Motor Car prior to any repairs being carried out (photograph provided to me). Apart for the front right portion, I did not observe damage to other areas of the Motor Car.

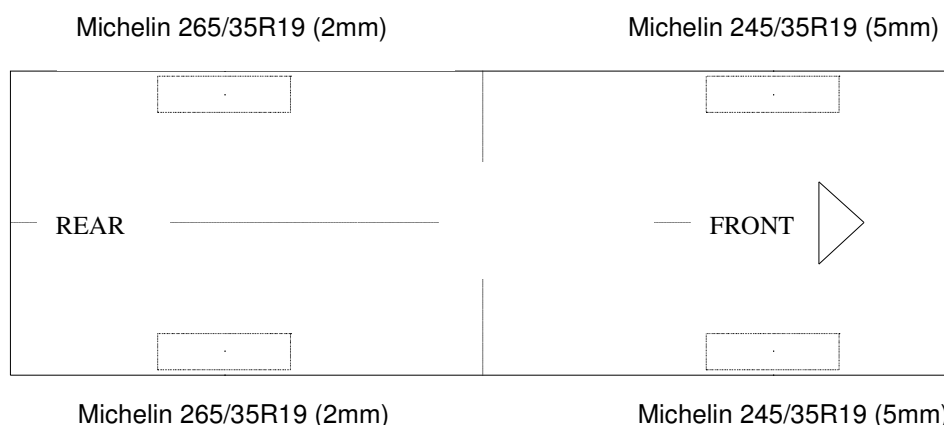
7. It was fitted with 19inch sport wheel rims that were wrapped with tyres that were observed to be of serviceable condition. The tyres were also sufficiently inflated for vehicular operation. The tyre brand, tyre size and approximate remaining tread depth of the 4 tyres of the Motor Car were recorded as follows: -

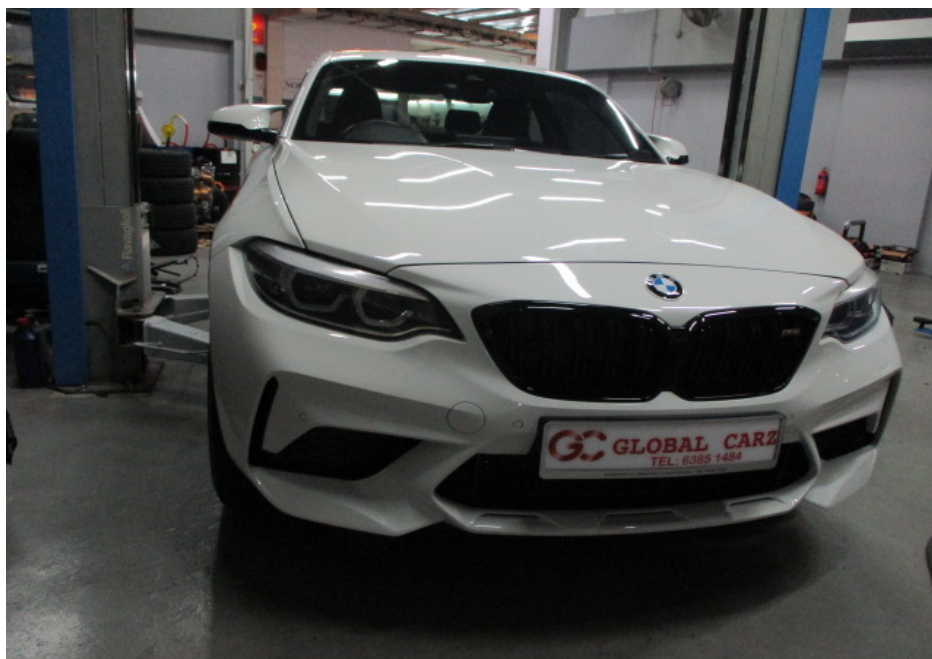
Photo 4 shows a general view of the front right body of the Motor Car at the time of my inspection. The Motor Car was observed to be in a relatively good general condition with no loose exterior fittings observed. The body parts at the front right portion of the Motor Car were visually examined and it was observed that the repair/restoration works carried out to the damaged area of the Motor Car (refer photograph 1 & 2 above) were reasonably adequate and in order.

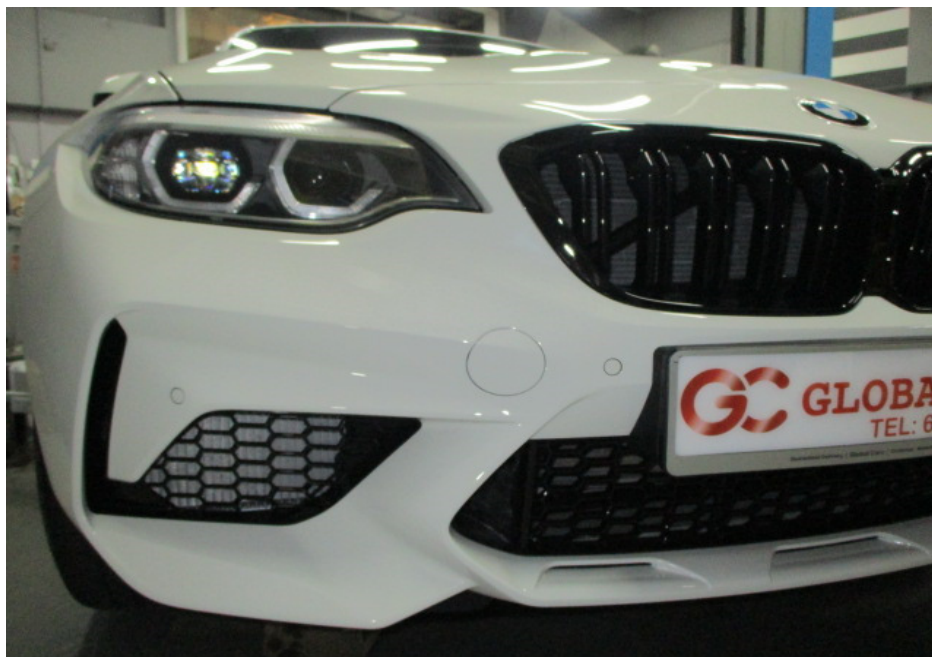
Photo 5 shows a closer view of the front bumper, front right lower grille, front centre lower grille, front radiator grilles and front right headlamp of the Motor Car at the time of my inspection. The body parts at the front right portion of the Motor Car were visually examined and it was observed that the repair/restoration works carried out to the damaged area of the Motor Car (refer photograph 1 & 2 above) were reasonably adequate and in order.

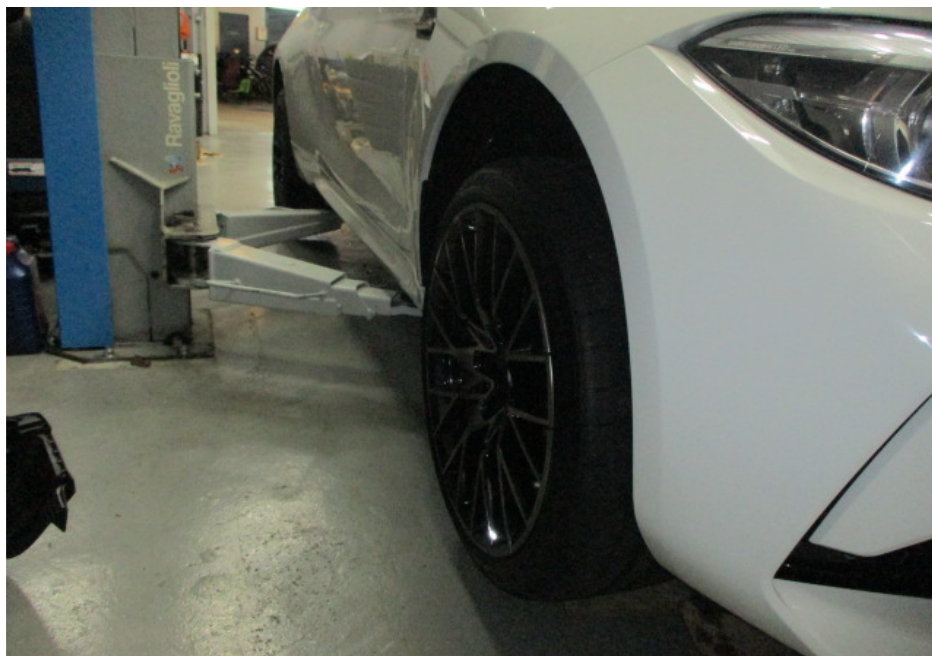
Photo 6 shows a closer view of the front bumper, front right headlamp and front right fender of the Motor Car at the time of my inspection. The body parts at the front right portion of the Motor Car were visually examined and it was observed that the repair/restoration works carried out to the damaged area of the Motor Car (refer photograph 1 & 2 above) were reasonably adequate and in order.

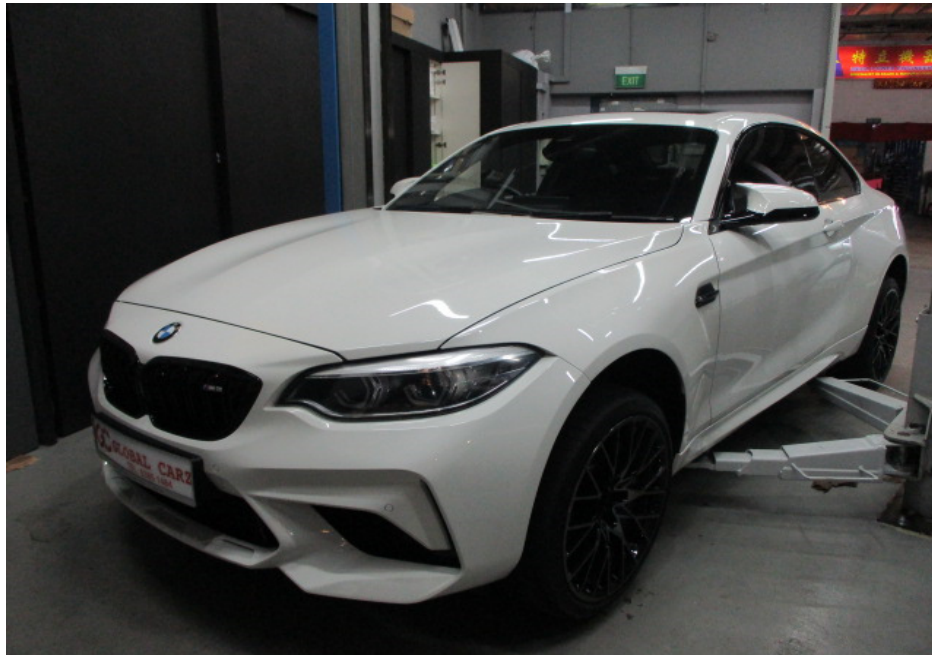
Photo 7 shows a general view of the front left body of the Motor Car at the time of my inspection. The Motor Car was observed to be in a relatively good general condition with no loose exterior fittings observed. The body parts at the front right portion of the Motor Car were visually examined and it was observed that the repair/restoration works carried out to the damaged area of the Motor Car (refer photograph 1 & 2 above) were reasonably adequate and in order.

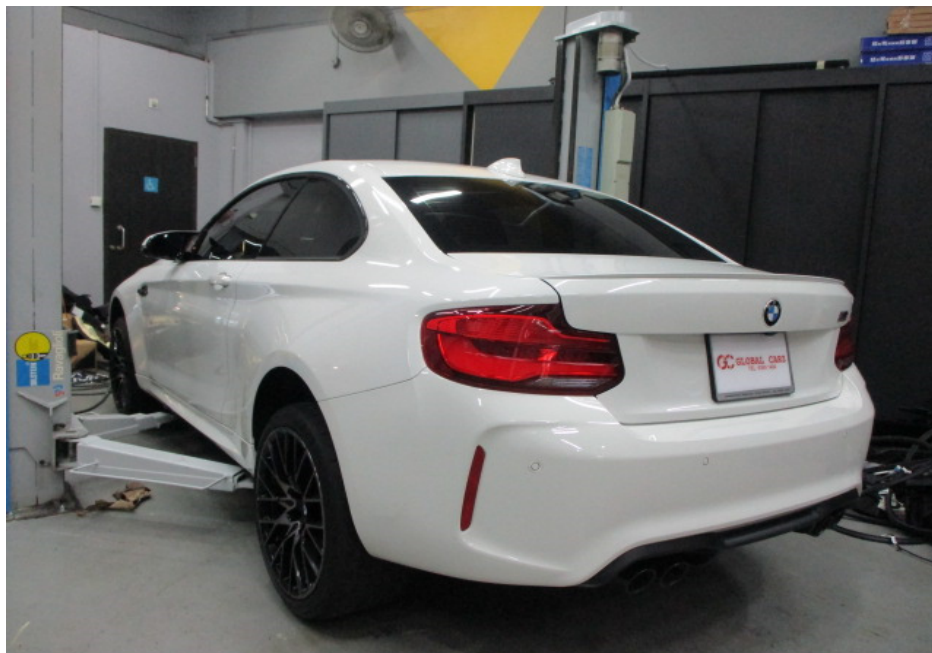
Photo 8 shows a general view of the rear left body of the Motor Car at the time of my inspection. The Motor Car was observed to be in a relatively good general condition with no loose exterior fittings observed. The mileage of the Motor Car recorded at the time of my inspection was 14,097km.

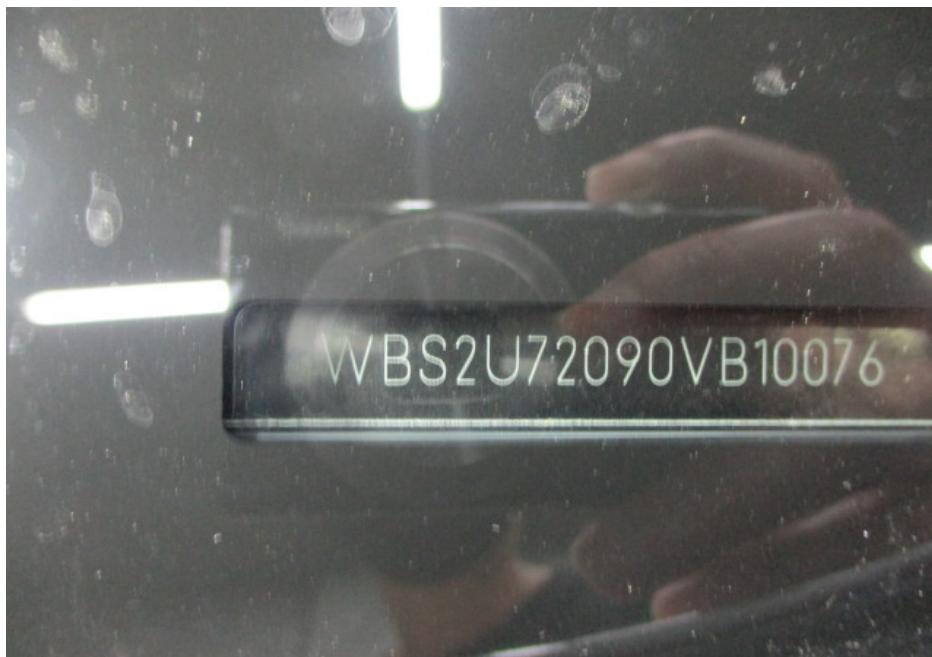
Photo 9 shows the chassis number of the Motor Car. The chassis number recorded was WBS2U72090VB10076.

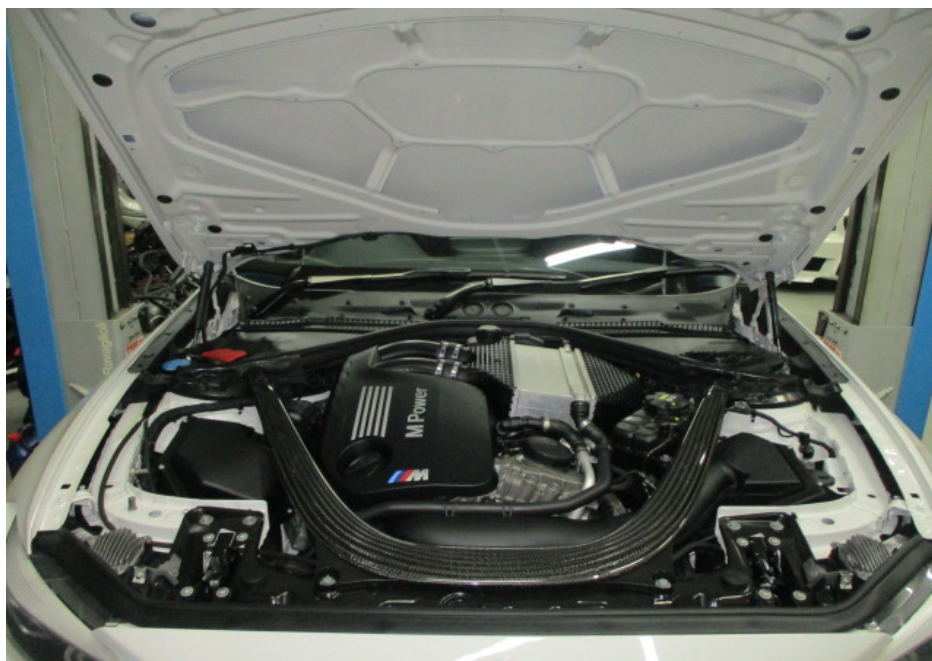
Photo 10 shows a general view of the engine compartment of the Motor Car at the time of my inspection. The various parts and components inside the engine compartment were all observed to be intact and properly fitted. There was also no sign(s) or indication(s) of fluid leak and/or fluid stain found within the engine compartment.

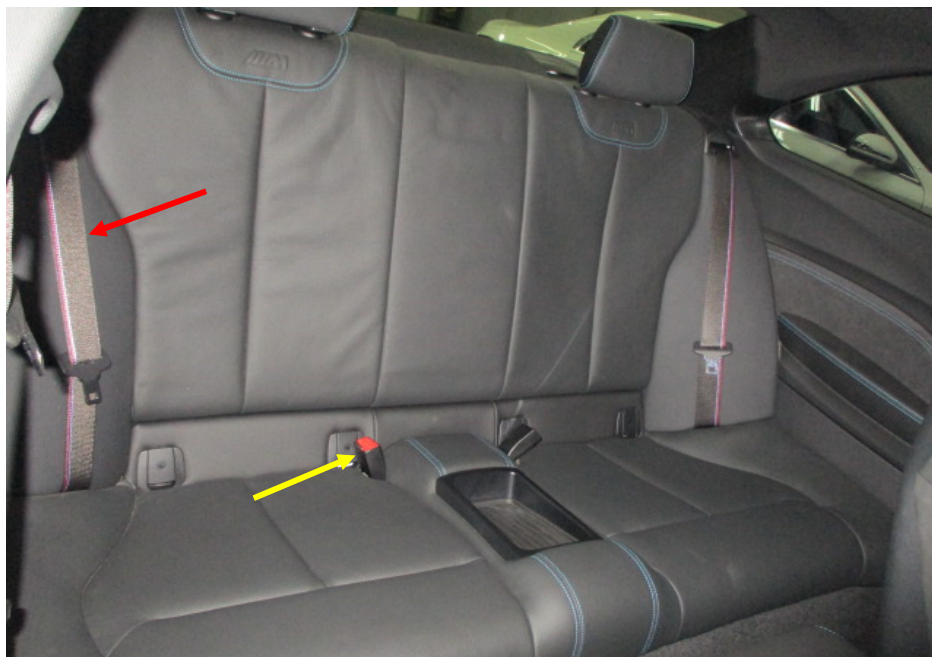
Photo 11 shows the rear seats of the Motor Car. All the seats of the Motor Car were secured via seat rails to the floorboard. They were also fitted with a retractable seat belt reel (red arrow) and a pre-tensioner (yellow arrow). The seat belts were tested and were able to be fastened securely to the respective pretension that was fitted on the side of each individual seat.

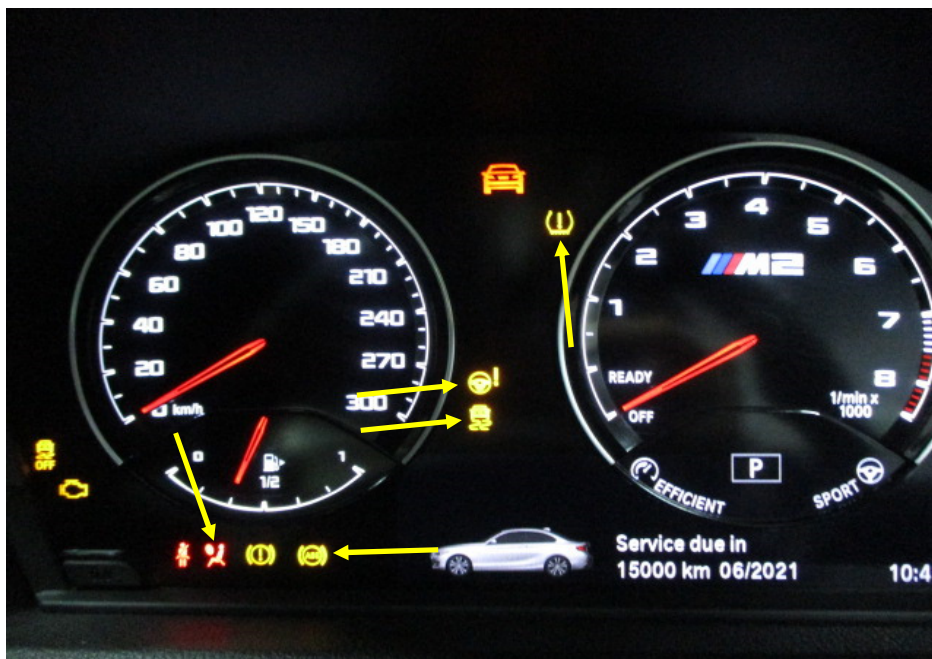
Photo 12 shows the warning lights for the various electronic safety features appearing on the instrument panel of the Motor Car during its self-test when the engine is cranked, in particular the ABS, SRS, IAS, TPM and DSC lights (arrowed).

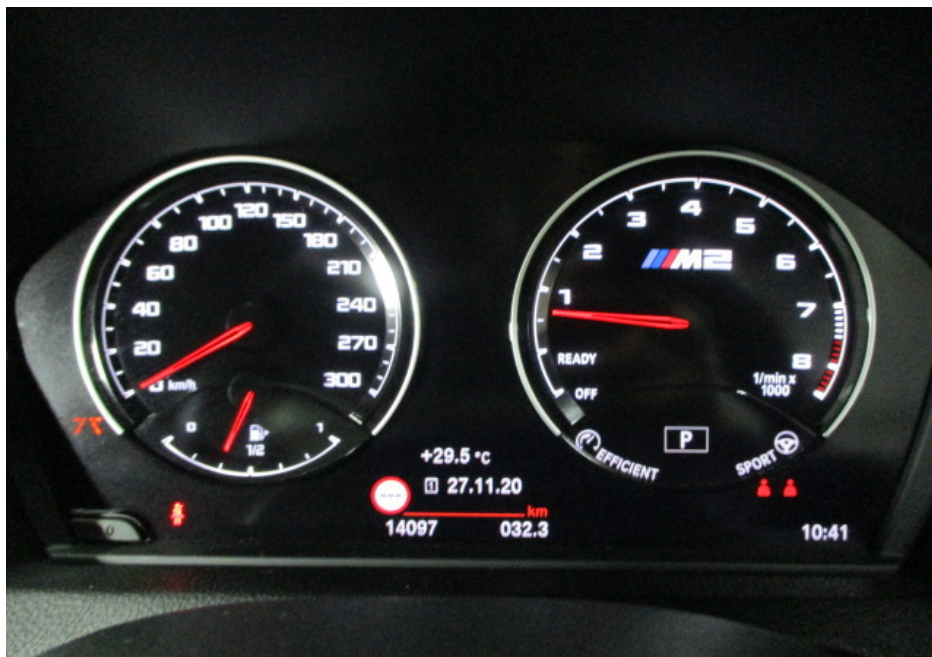
Photo 13 shows the respective warning lights no longer illuminated, indicating that there is no fault detected to the ABS, SRS, IAS, TPM and DSC systems of the Motor Car during the self-test. These electronic systems were hence in working condition at the time of my inspection.

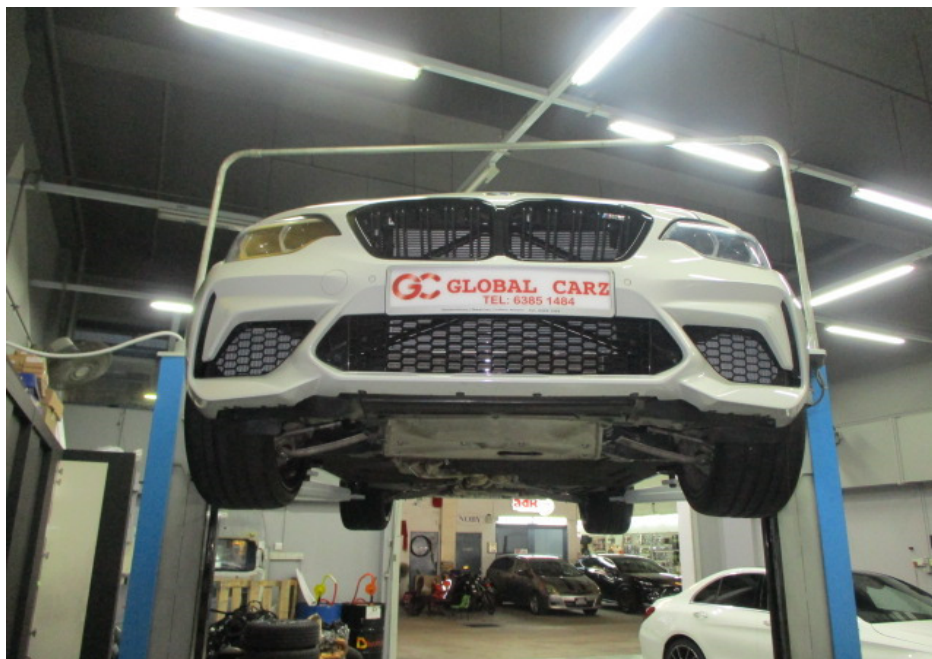
Photo 14 shows the Motor Car hoisted up for checks on its undercarriage. There was no sign(s) or indication(s) of fluid leakage and/or fluid stain(s) on the underside of the Motor Car. The undercarriage components of the Motor Car were also all observed to be intact and secured in an appropriate manner.

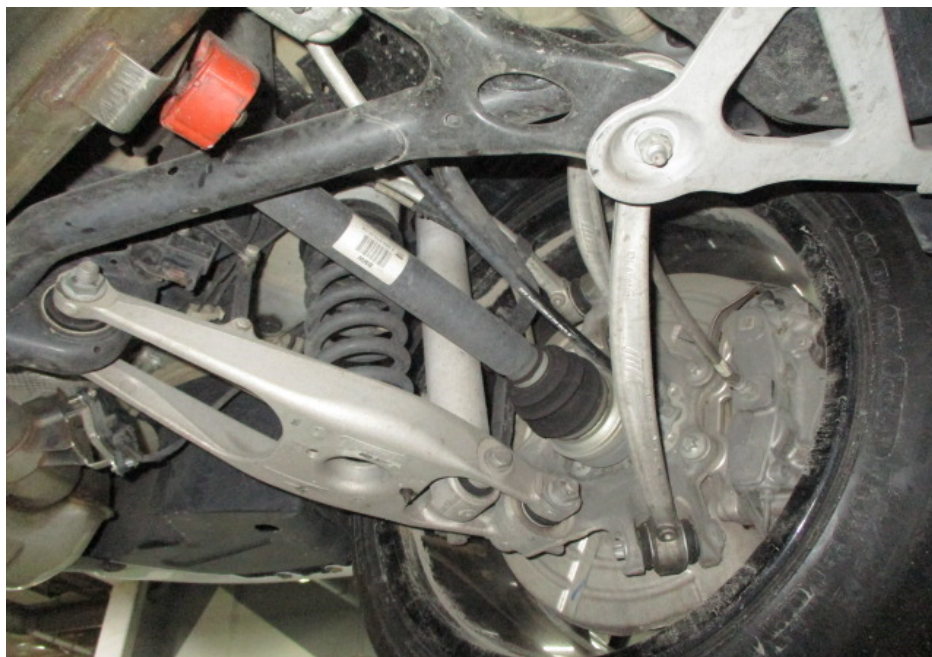
Photo 15 shows a general view of the control arms and linkages at the rear left wheel of the Motor Car. I did not observe any fluid leak and/or fluid stain on the underside of the Motor Car. All of the Motor Car's undercarriage components were observed to be intact and secured in an appropriate manner.

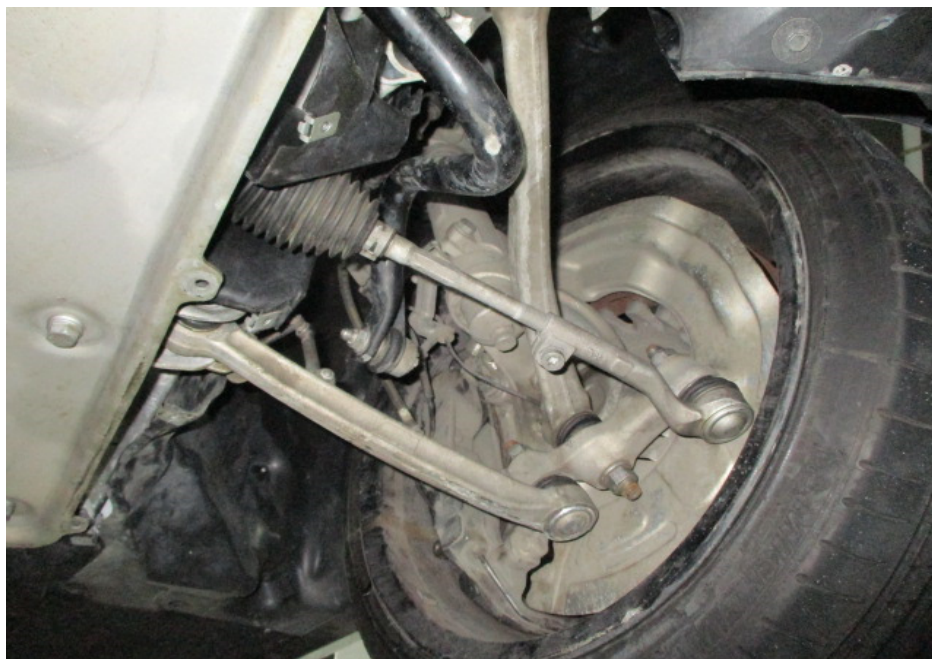
Photo 16 shows the various undercarriage components at the front left wheel of the Motor Car. The mechanical components, control arms and linkages were all found to be intact and secured in an appropriate manner.

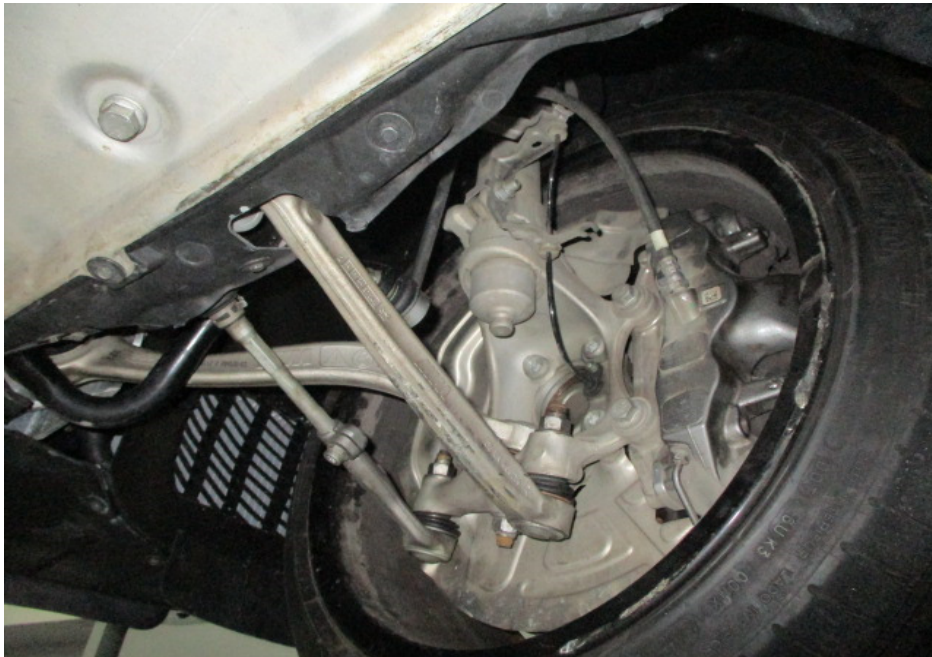
Photo 17 shows the various undercarriage components at the front right wheel of the Motor Car. The mechanical components, control arms and linkages were all found to be intact and secured in an appropriate manner. All of the Motor Car's undercarriage components were observed to be intact and secured in an appropriate manner.

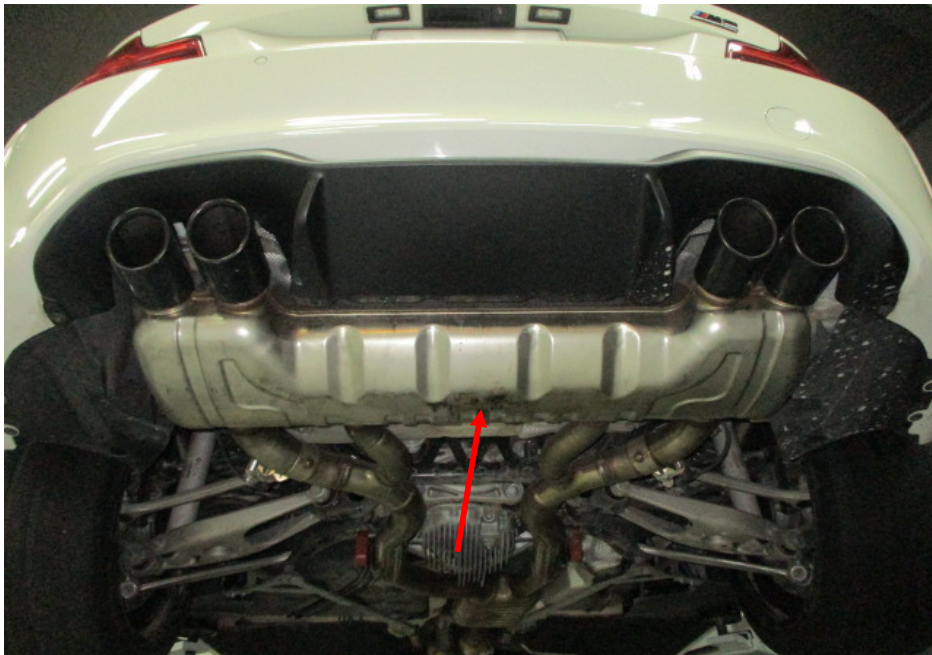
Photo 18 shows the Motor Car's rear exhaust muffler (arrowed). My examination of the Motor Car's exhaust system revealed no sign(s) or indication(s) of any cut or weld marks along its exhaust pipes and on its catalytic converters.

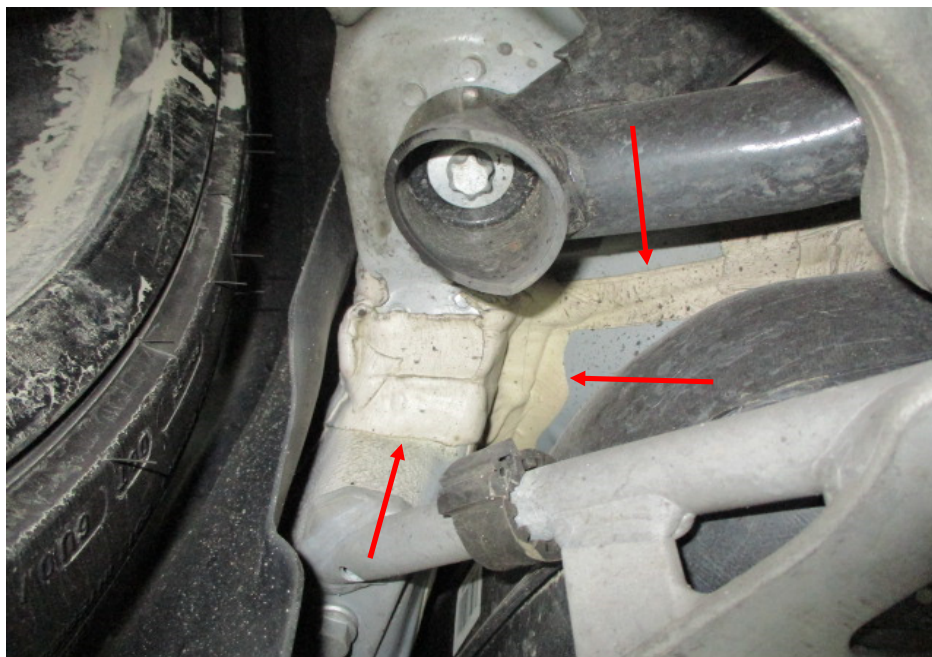
Photo 19 shows the chassis/structural body at the underside rear left of the Motor Car. In general, I had found the original factory sealant (arrowed) at the joints along the chassis/structural body to be untouched, indicating no work was done on the chassis/structural body of the Motor Car and that the chassis/structural body was originally fitted.

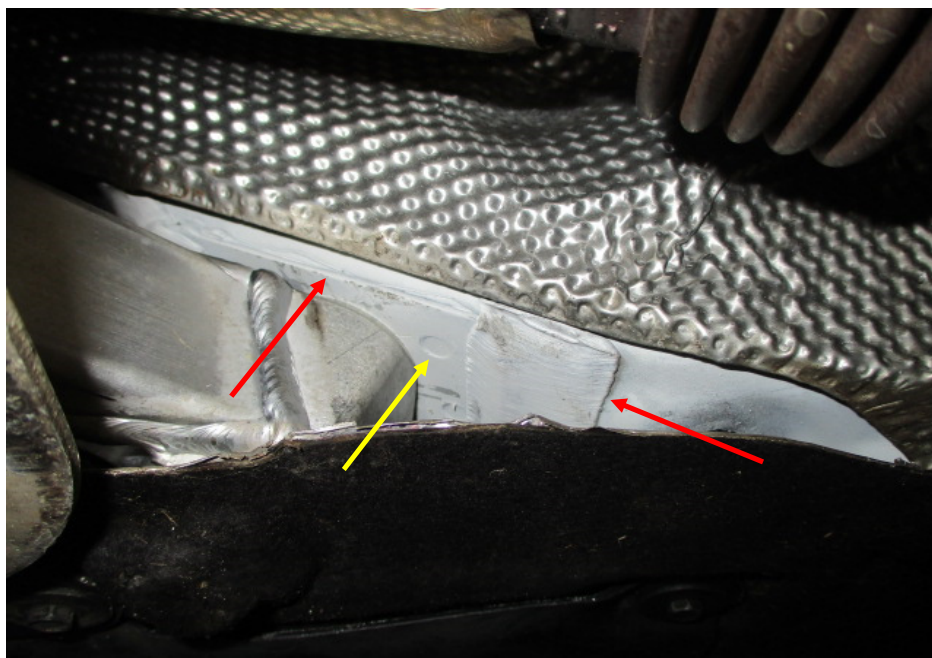
Photo 20 shows the chassis/structural body at the underside front right of the Motor Car. Visually, I did not find any weld marks other than original spot weld marks (yellow arrow) on the chassis/structural body of the Motor Car. The original factory sealant (red arrow) at the joints along the chassis/structural body was also untouched, indicating no work was done on the chassis/structural body of the Motor Car and that the chassis/structural body was originally fitted.

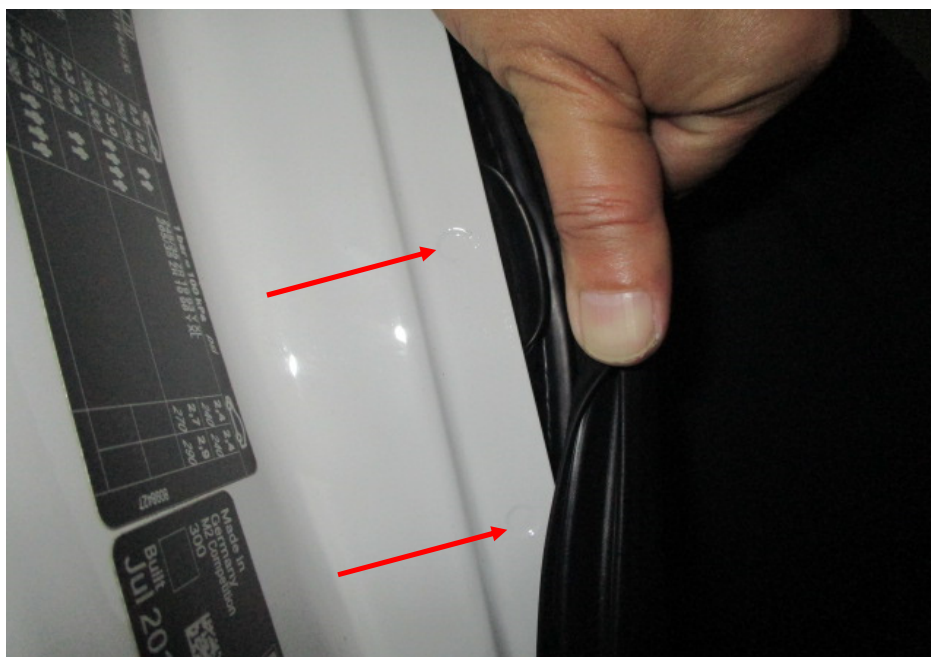
Photo 21 shows the rear right body panel of the Motor Car. I did not find any weld marks other than original spot weld marks (arrowed) on the rear right body panel of the Motor Car. In general, I had found all the non-detachable body panels of the Motor Car to be originally fitted at the time of my inspection.
