**SINGLE JOINT EXPERT REPORT OF SKN 4080M ("the Plaintiff's car")**

## VEHICLE DAMAGE INSPECTION REPORT

Reg No:	SKN4080M	Engine No:	R18A1753209
Make & Model:	HONDA STREAM, 1.8 (A)	Chassis No:	RN61047493
Reg. Date:	29/11/2007 (Man. Year: 2007)	Odometer:	85521 km
Colour:	Black		
Engine Capacity:	1799 cc		
Market Value/New Car Price:	N/A		
Sum Insured (S\$):	Market Value/New Car Price

## VEHICLE INSPECTION REPORT

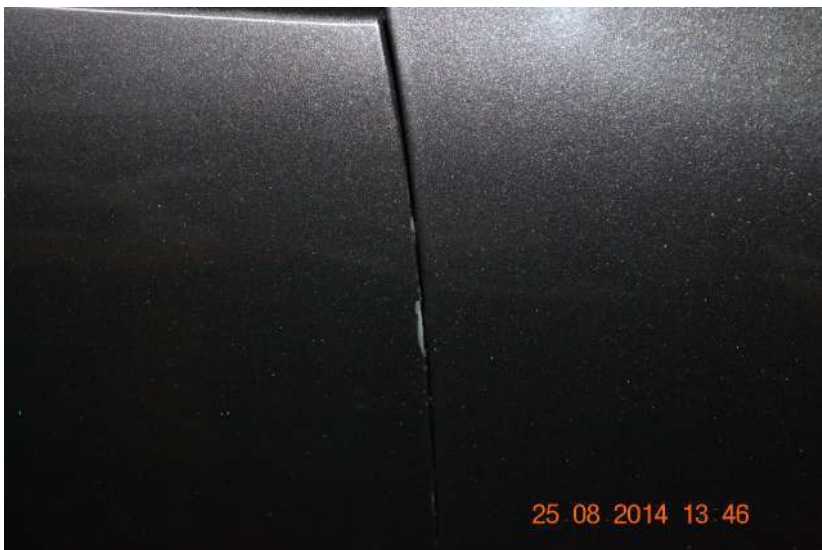
**5/36: Front door cut/dented**

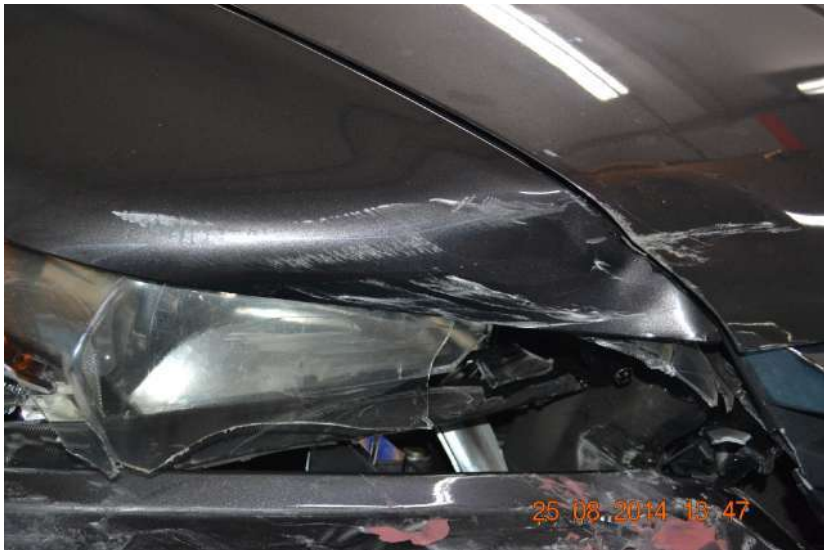
**7/36: Front fender, headlamp bent/cracked**

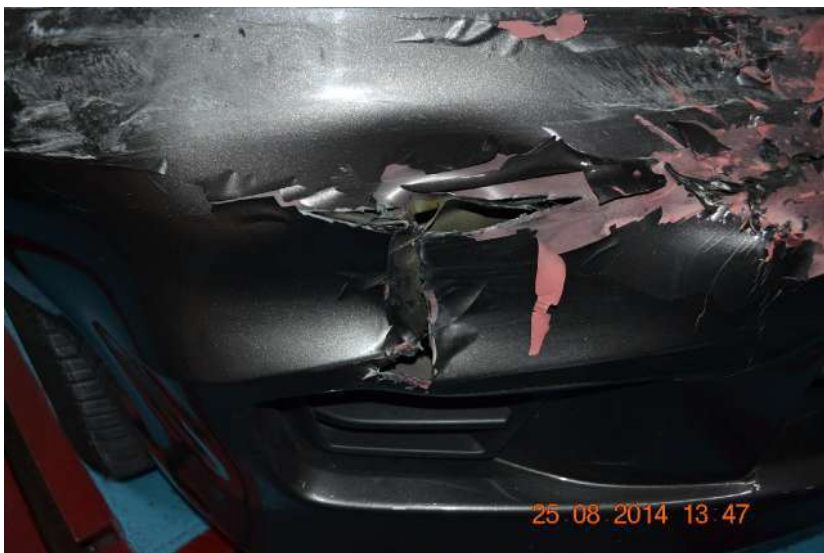
**9/36: Front bumper cracked/deformed**

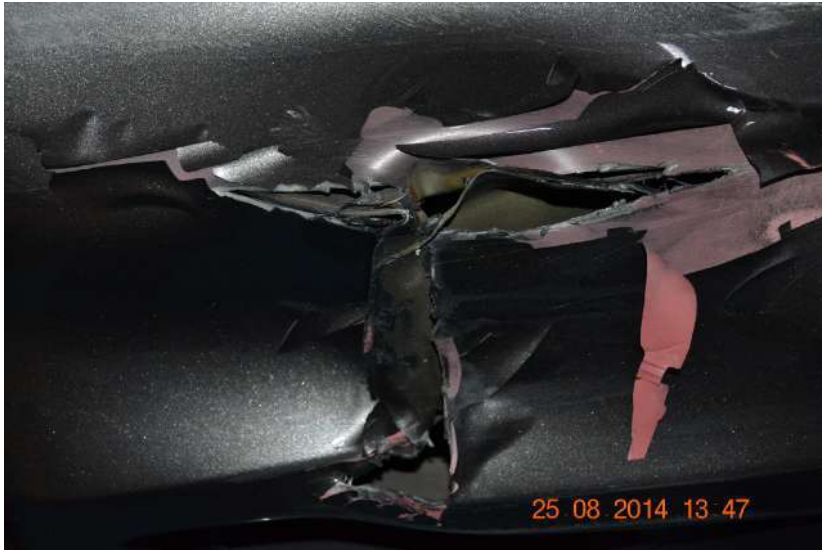
10/36: **Front reinforcement bent**

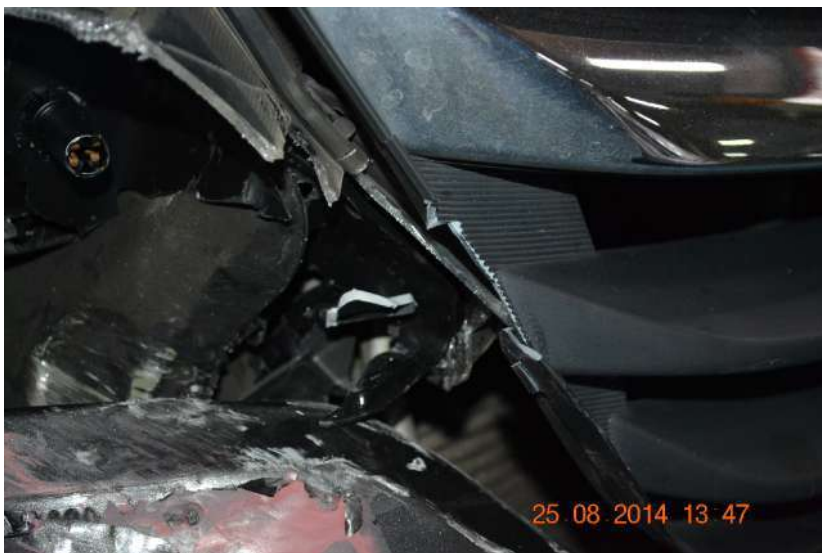
12/36: **Front grille cracked**

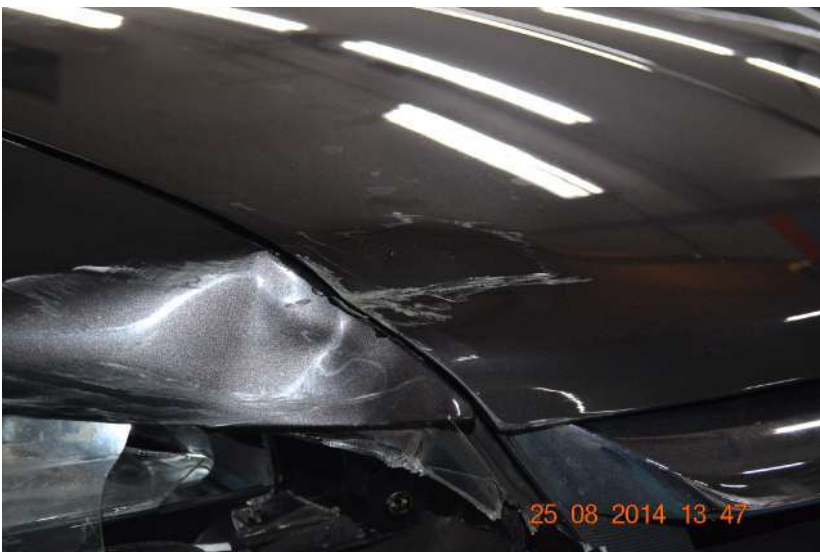
14/36: **Front bonnet bent**

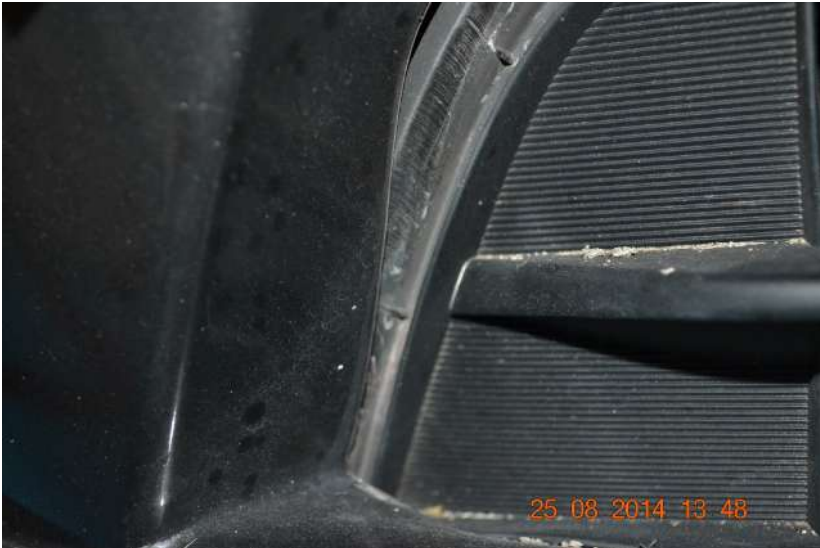
16/36: **Front grille deformed**

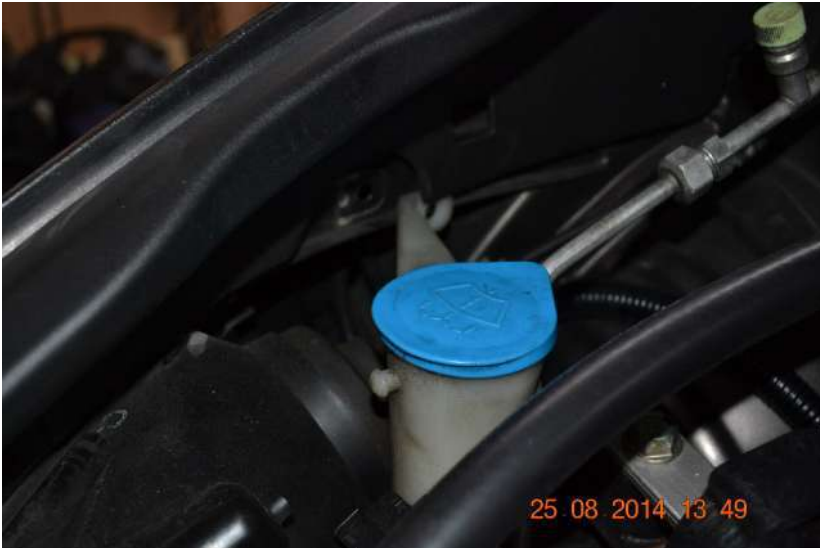
19/36: **Front washer tank neck dislodged**

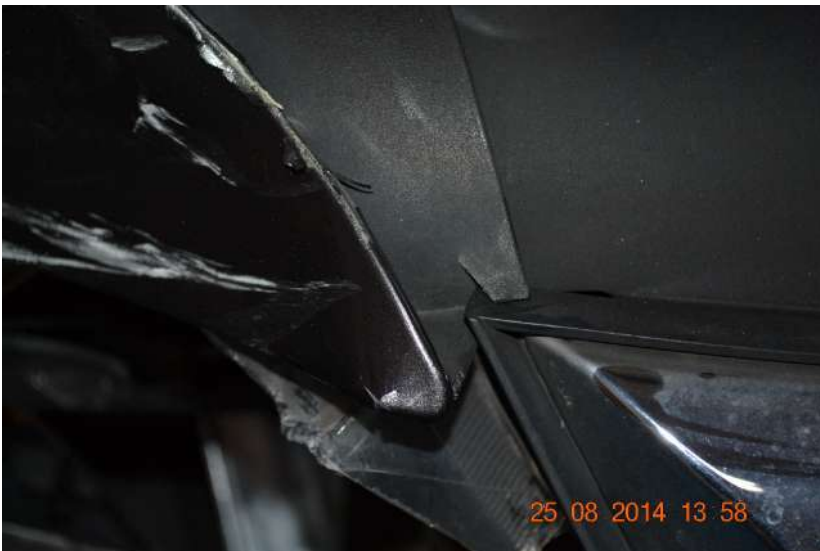
21/36: **Front side trim cracked**

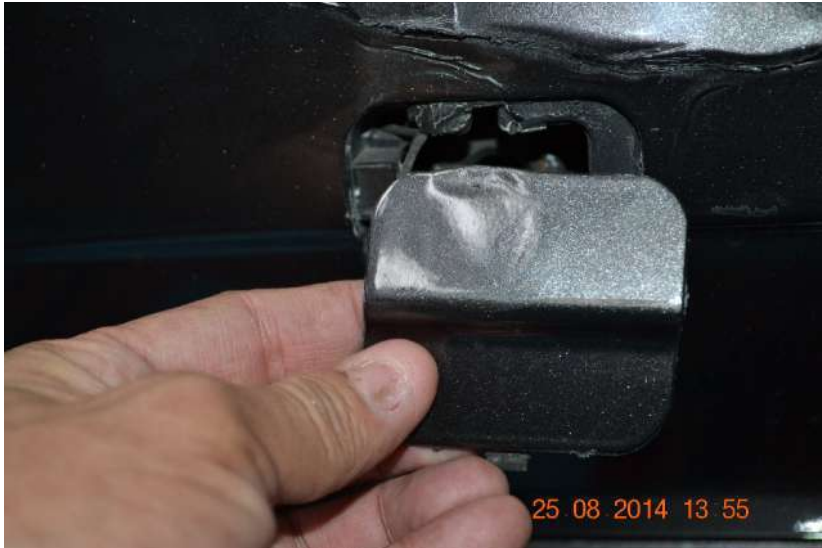
25/36: Rear tow cover deformed

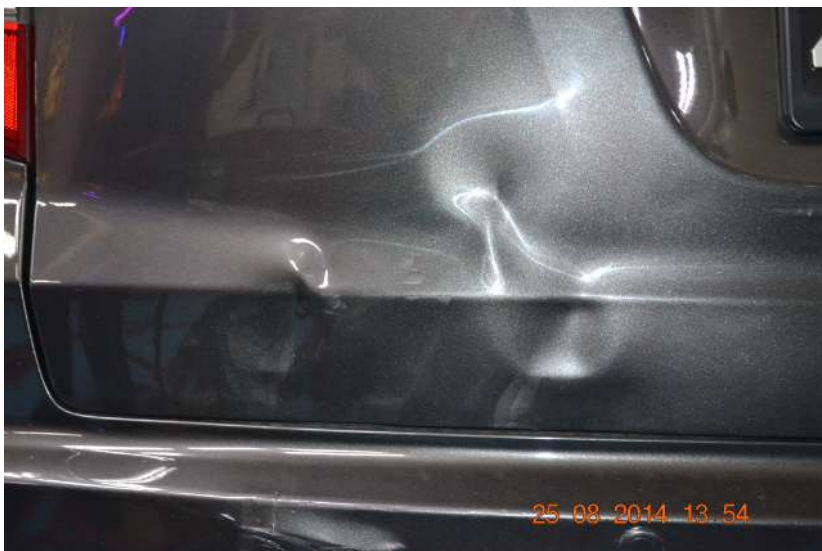
27/36: Rear tailgate bent

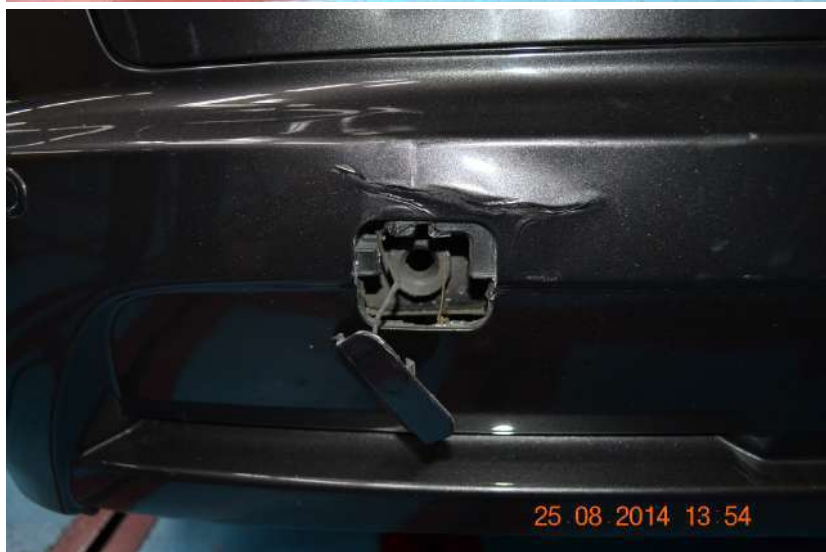
29/36: **Rear bumper deformed**

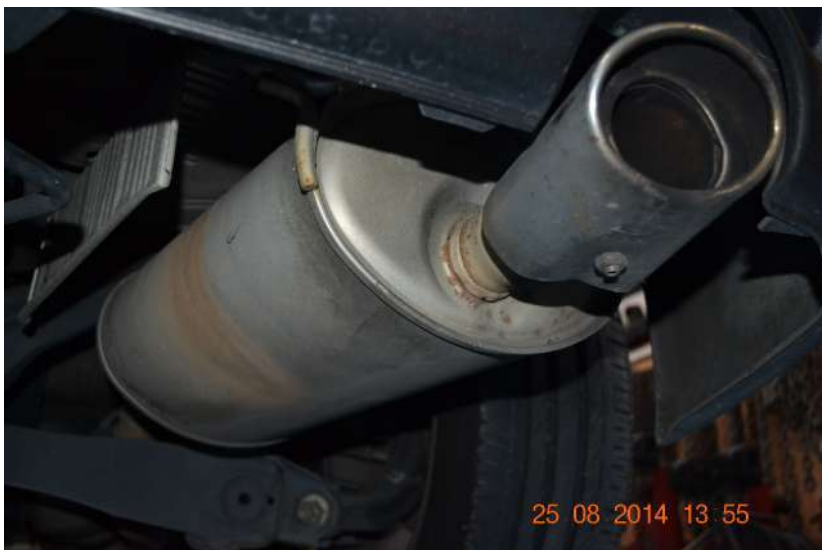
**32/36: Rear exhaust bent**

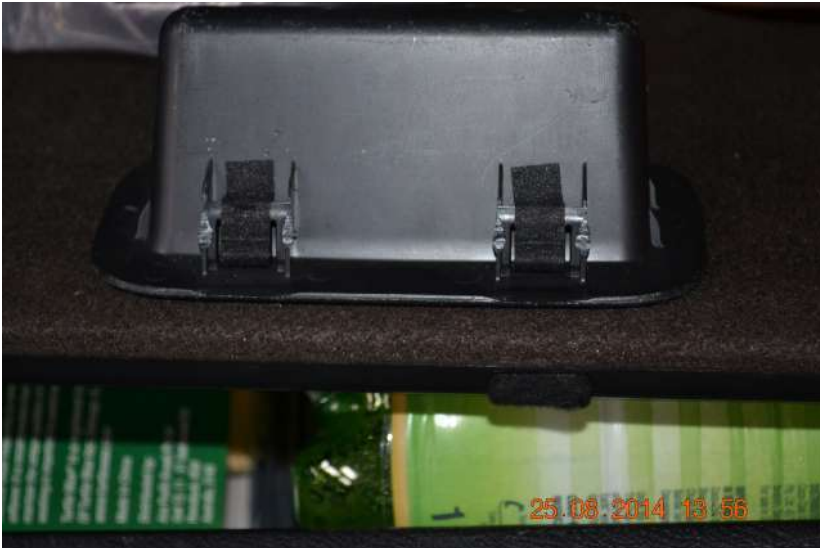
34/36: **Rear tailgate handle deformed**
