## VEHICLE DAMAGE INSPECTION REPORT

Our Ref: 195/TP/2020

Reg No:	SFV5688X	Make &	Suzuki
Reg date:	20/4/2012	Model	Swift Sport Manual
Colour:	Grey	Engine No:	M16A1656961
Type:	Motor Car	Chassis No:	JSAFZC32S00100727
Type of Claims:	Third Party	Odometer No:	269712km
		Engine Cap:	1586cc

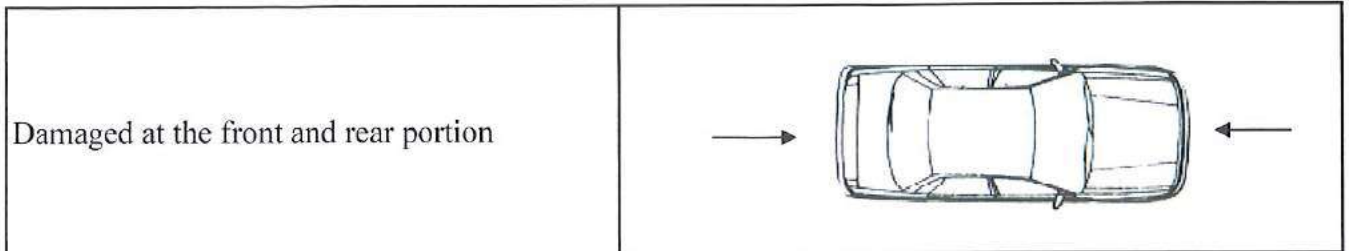
### POINT OF IMPACT

The Insured's vehicle collided onto the Third Party's vehicle along Yishun Dam towards Yishun Town.

Our visual inspection of the vehicle revealed that the damages noted are at the front and rear portion.
