Your Ref: SKD 3004T  
Our Ref : CI/TP20013785/D

14 December 2020

### **TECHNICAL INVESTIGATION REPORT OF FIRE INCIDENT INVOLVING AN AUDI A5 SPORTBACK 2.0 TFSI MOTOR CAR WITH REGISTRATION NUMBER SKD 3004T**

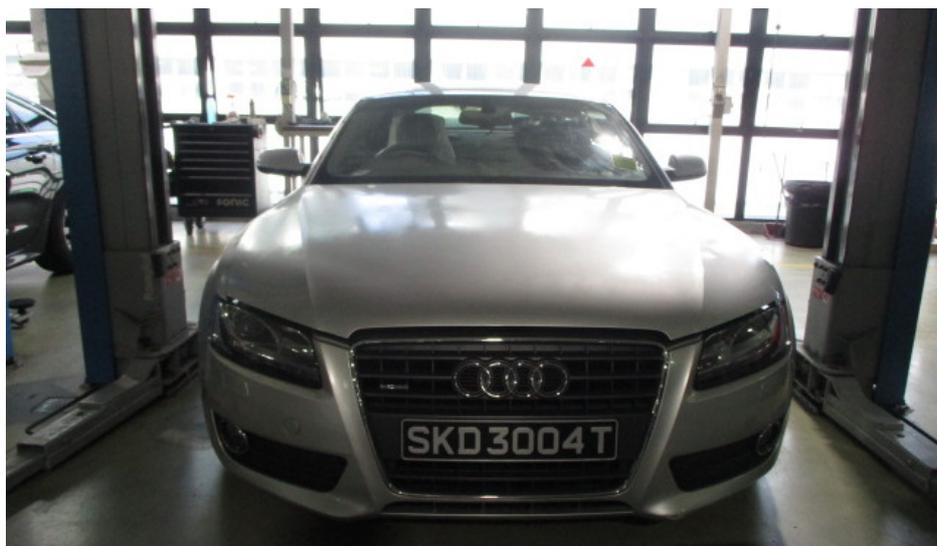
**Photo 1** shows a general view of the front body of the Motor Car at the time of my inspection. The exterior body of the Motor Car was relatively unaffected by the incident.

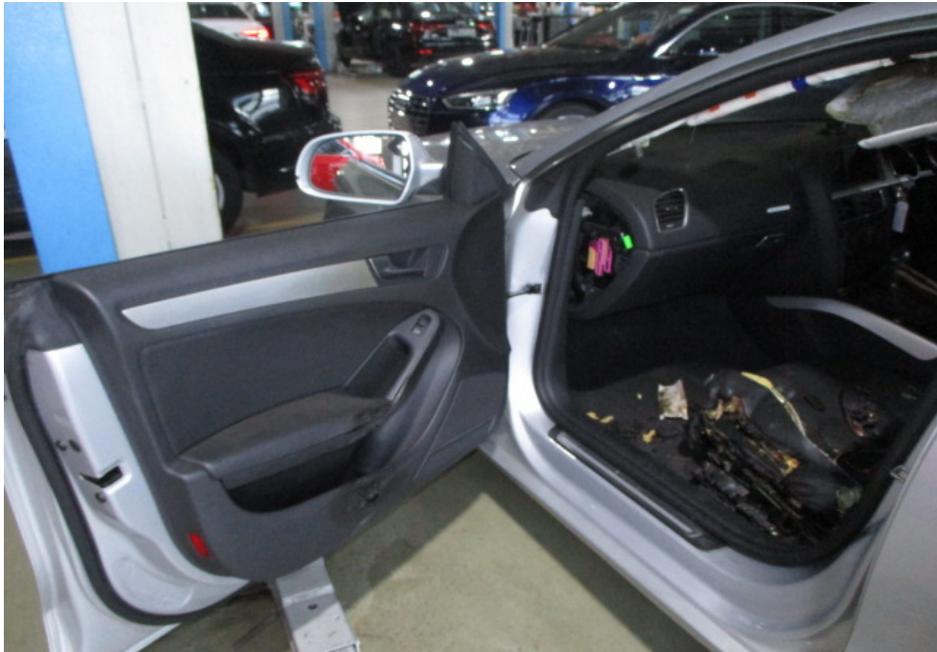
**Photo 2** shows a general view of the interior compartment of the Motor Car, at the front left area. The Motor Car was observed to have sustained fire damage that was confined to within the interior compartment, at the front left passenger seat area. The front left passenger seat, front left door trim and front left "A" pillar trim were amongst the parts that were observed to have been affected.

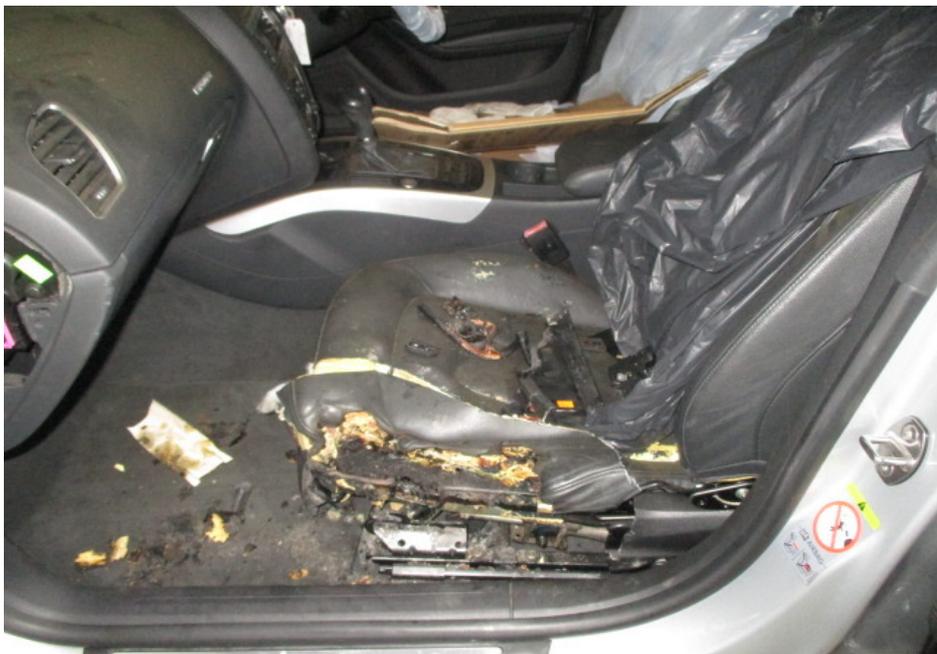
**Photo 3** shows the front left passenger seat of the Motor Car at the time of my inspection. The damage of fire nature was observed to have been confined to within the interior compartment, at the front left passenger seat area.

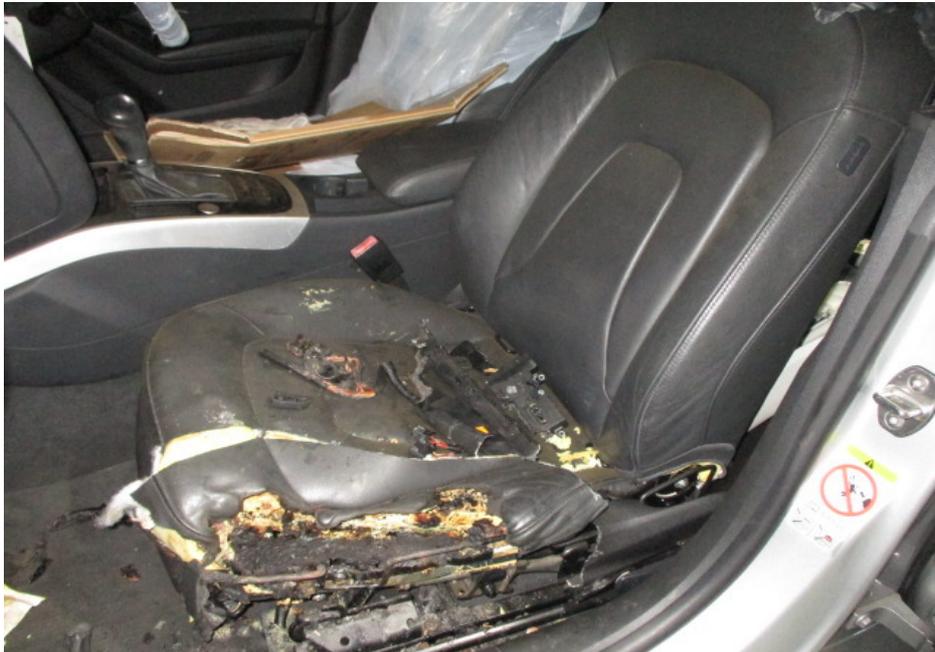
**Photo 4** shows the front left passenger seat of the Motor Car. The damage of fire nature was observed to have been confined to within the interior compartment, at the front left passenger seat area.

5. For this case, given that there was no damage of fire nature to other areas of the Motor Car, the origin of fire can then be simply established to be from within the interior compartment of the Motor Car, at its front left passenger seat area.

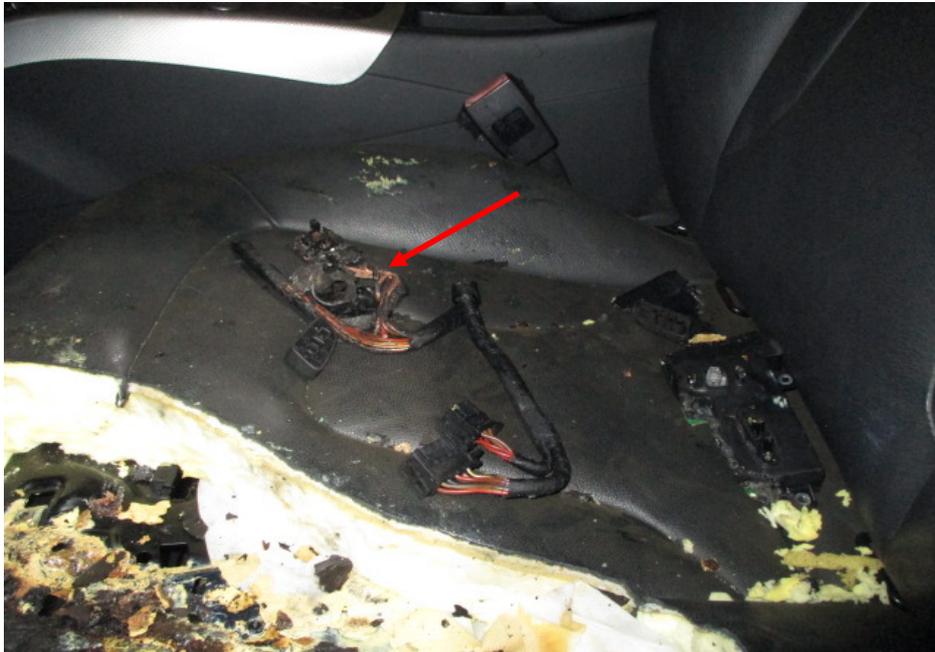
7. At the time of my inspection of the Motor Car, I did not find any unusual burnt remnants on the carpet surrounding the front left passenger seat to suggest that the fire to the Motor Car was possibly due to external factor. I did, however, found a stretch of burnt wirings leading to a burnt wire connector, which would indicate to me that the cause of fire to the Motor Car was due to electrical nature (an electrical short of the wirings). See photo 5 – 8 below.

**Photo 5** shows the stretch of burnt wirings (arrowed) that I had found on the front left passenger seat of the Motor Car. The condition of this stretch of burnt wirings and burnt wire connector suggests to me that the cause of fire to the Motor Car was due to electrical in nature (an electrical short of the wirings).

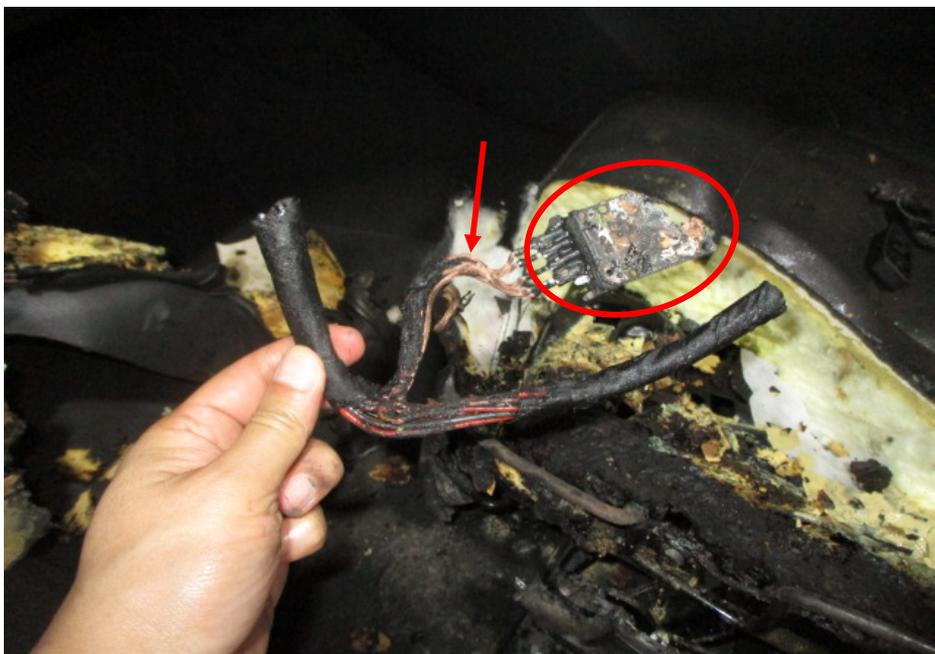
**Photo 6** shows a closer view of the stretch of burnt wirings (arrowed) that I had found on the front left passenger seat of the Motor Car. The burnt wirings led to a wire connector (circled) that was also observed to be burnt. I was informed that this stretch of wirings was cut prior to my inspection for the purpose of manufacturer's own investigation into the cause of fire.

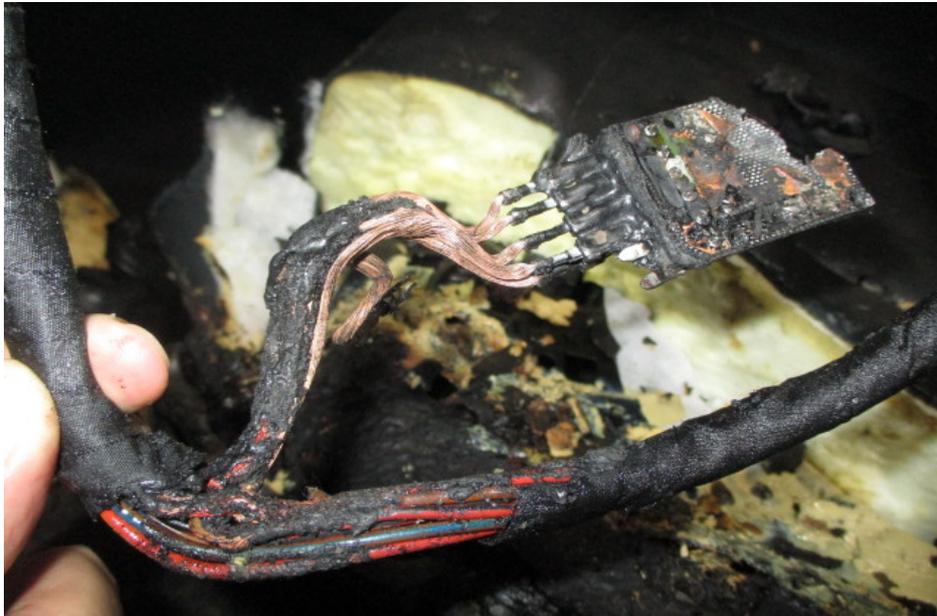
**Photo 7** shows a closer view of the burnt wirings and burnt wire connector. The wirings were found to be burnt to its bare copper state. Such condition normally indicates internal heating of copper wires where the copper wires were exposed to high heat from a sudden surge in electric current flow. The condition of the wirings suggests that the cause of fire to the Motor Car was due to electrical in nature (an electrical short of the wirings).

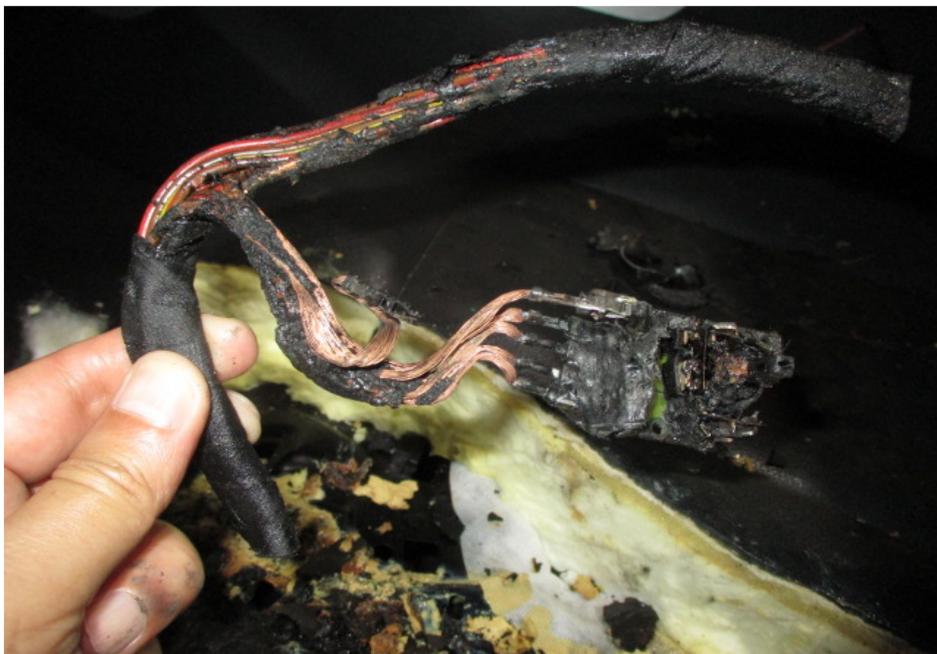
**Photo 8** shows another close view of the burnt wirings and burnt wire connector. The wirings were found to be burnt to its bare copper state. Such condition normally indicates internal heating of copper wires where the copper wires were exposed to high heat from a sudden surge in electric current flow. The condition of the wirings suggests that the cause of fire to the Motor Car was due to electrical in nature (an electrical short of the wirings).

16. Having investigated and technically analysed the damages of burnt nature to the Motor Car, I am of the view that the cause of fire to the Motor Car was of electrical in nature (electrical short of the wirings). For this case, the fire had originated along the wirings and wire connector at the Motor Car's front left passenger seat lumbar controller.

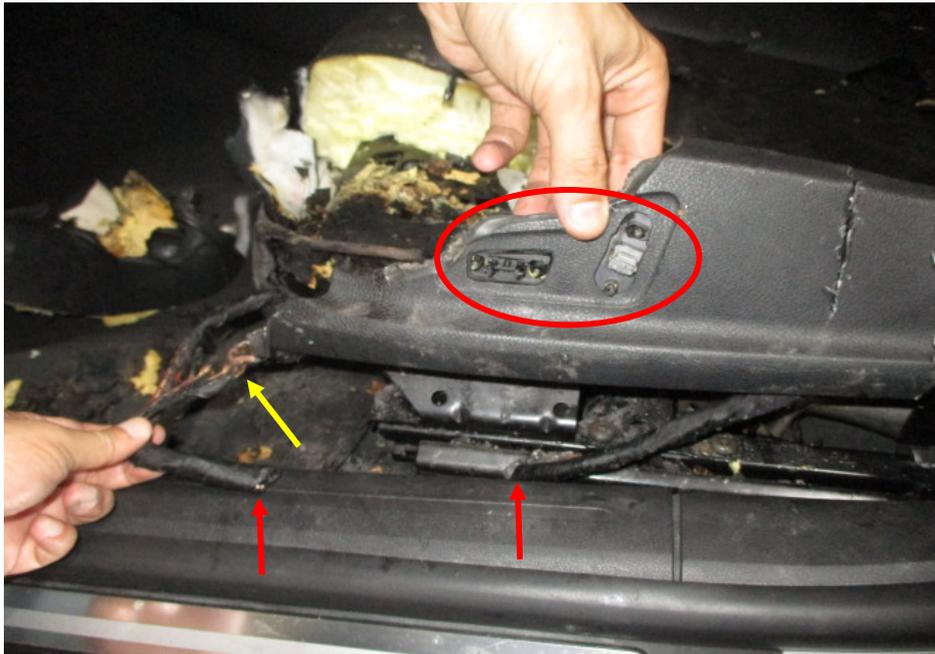
9. Upon my further checks, I had found that the stretch of burnt wirings and burnt wire connector was for the Motor Car's front left passenger seat lumbar controller. The controller, together with the stretch of burnt wirings and burnt wire connector, are located at the left side of the front left passenger seat. See photo 9 - 11 below.

**Photo 9** shows where the stretch of burnt wirings is located. The 2 red arrows show the cut point of the stretch of burnt wirings. By placing the cut off point together, the stretch of burnt wirings (yellow arrow) was established to be located at the left side of the Motor Car's front left passenger seat. The circled area shows where the controllers for the seat and backrest of the front left passenger seat are located. The wire connectors and wirings for these 2 controllers were without any signs of an electrical short (refer to photo 10 below). Hence the stretch of burnt wirings and burnt wire connector was determined to be for the Motor Car's front left passenger seat lumbar controller (refer to photo 11 below).

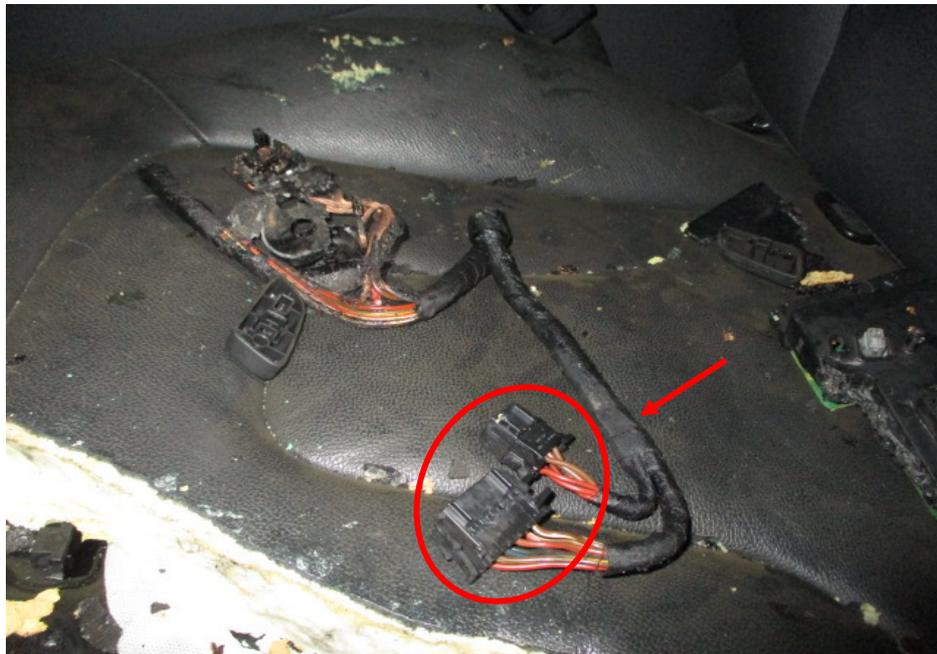
**Photo 10** shows the wire connectors and wirings for the controllers for the seat and backrest of the front left passenger seat. The wire connectors (circled) and wirings (arrowed) for these 2 controllers were without any signs of an electrical short.

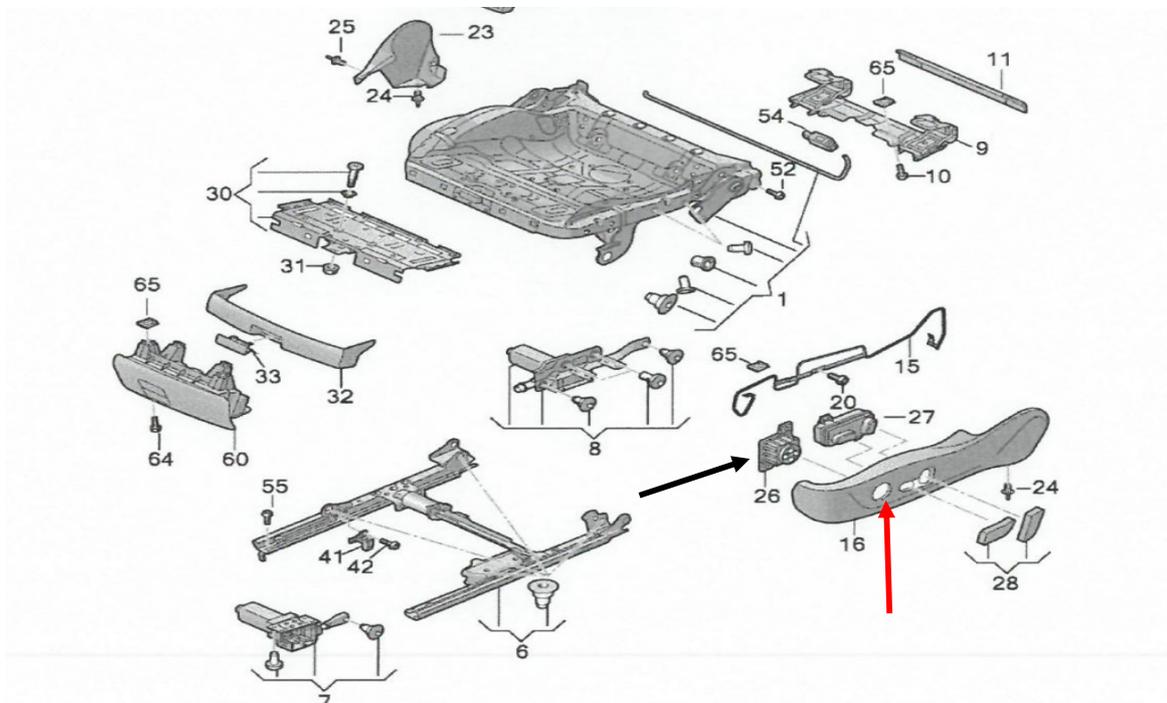
**Photo 11** shows the parts catalogue for the front left passenger seat of the Motor Car. The location of the Motor Car's front left passenger seat lumbar controller is indicated by the red arrow. The stretch of burnt wirings and burnt wire connector was for the Motor Car's front left passenger seat lumbar controller, indicated by the black arrow.

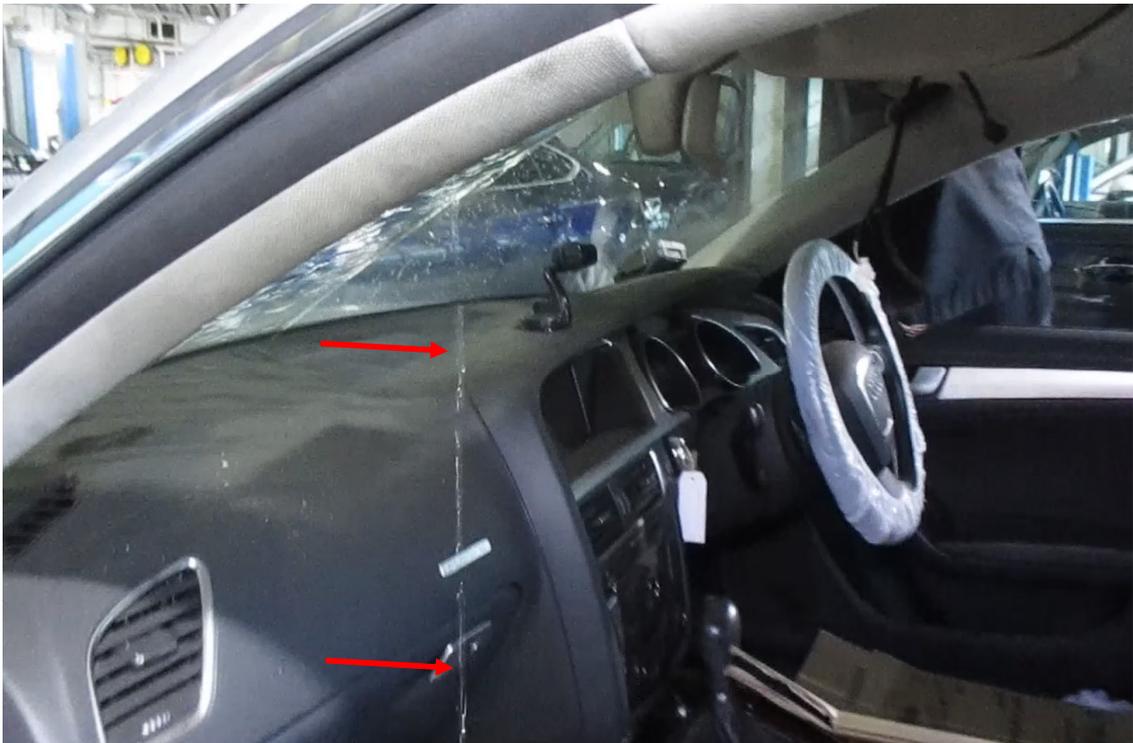
12. During my inspection of the Motor Car, a water test was carried out to check on the possibility of water seeping into the interior compartment of the Motor Car when raining and/or car washing. This was done by spraying water onto the Motor Car and it was observed that water had seeped into the interior compartment from around the top centre of the Motor Car's front windscreen.
13. Upon further testing, where water was poured directly at the top centre of the Motor Car's front windscreen, I had observed water dripping from the left "A" pillar trim directly onto the location where the Motor Car's front left passenger seat lumbar controller was located. A video recording of this water test is annexed together with this report. See photo 12 – 15 below extracted from the video recording.

**Photo 12** shows water (arrowed) dripping from the left "A" pillar trim of the Motor Car during the water test (screenshot extracted from the water test video recording).

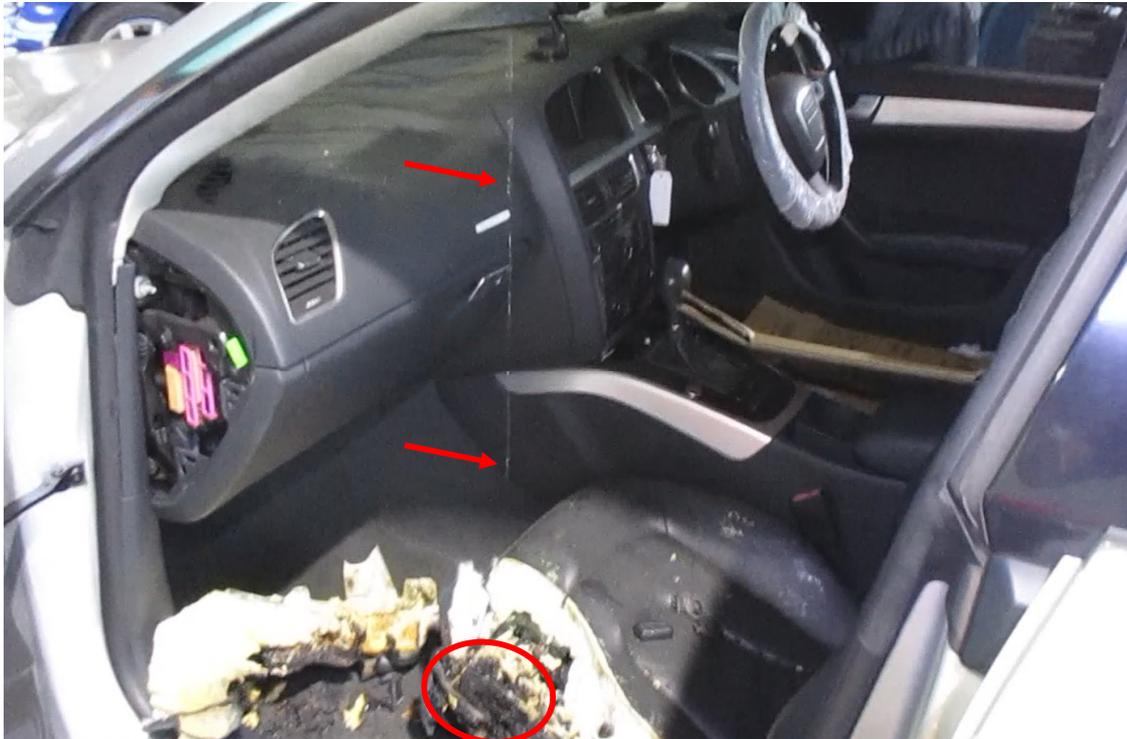
**Photo 13** shows water (arrowed) dripping from the left "A" pillar trim of the Motor Car during the water test. The water was observed to have dripped from the left "A" pillar trim directly onto the location (circled) where the Motor Car's front left passenger seat lumbar controller was located (screenshot extracted from the water test video recording).

17. The electrical short was due to external cause where a water test carried out to the Motor Car revealed water seeping into the interior compartment, and thereafter dripping directly onto the location where the Motor Car's front left passenger seat lumbar controller was located. The cause of the electrical short was not due to product defect.

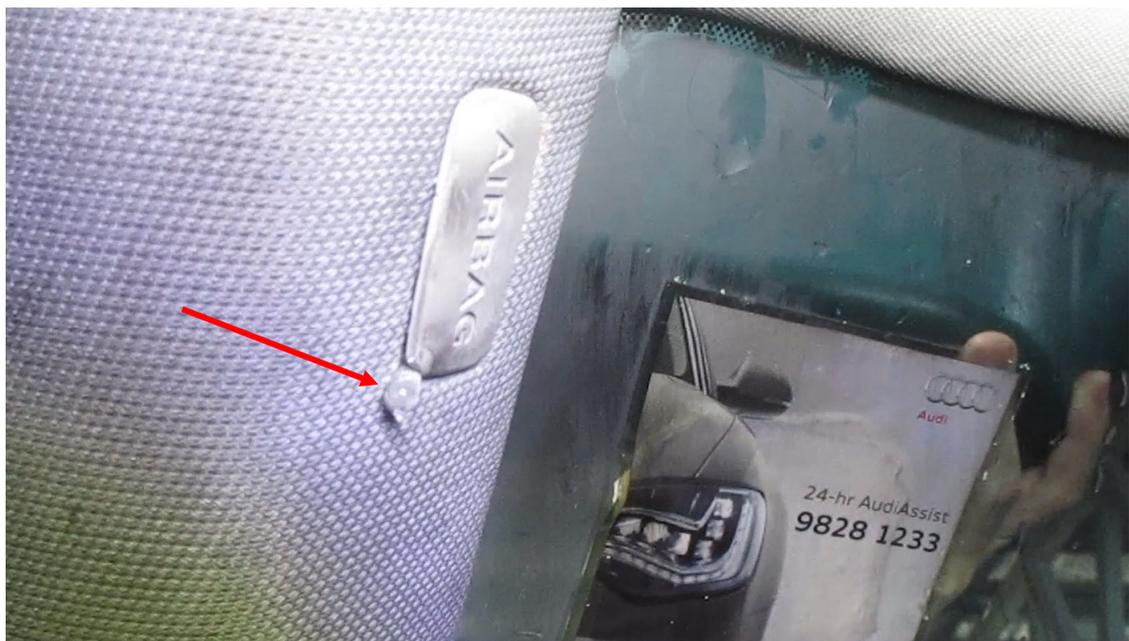
**Photo 14** shows a closer view of the water (arrowed) dripping from the left "A" pillar trim of the Motor Car during the water test (screenshot extracted from the water test video recording).

14. Water seeping into the interior compartment from the front windscreen of a motor vehicle is usually due to inadequate sealing capability at the front windscreen of the Motor Car. The front windscreen is fixed onto the body of a motor vehicle via rubber moulding and sealant along the sides of the front windscreen. Besides holding the front windscreen in place, the rubber moulding and sealant also provides a sealing effect preventing water and minimising external noise and wind from entering the interior compartment of a motor vehicle. Over time, the rubber moulding and/or sealant can lose its sealing capability progressively due to deterioration of rubber compound and allow water, noise and/or wind to enter the interior compartment of a vehicle.

18. The ability for water to seep into the interior compartment of the Motor Car was a result of inadequate sealing capability at the front windscreen of the Motor Car where the condition of the front windscreen rubber moulding and/or sealant had deteriorated over a period of time allowing water to seep into the interior compartment progressively.

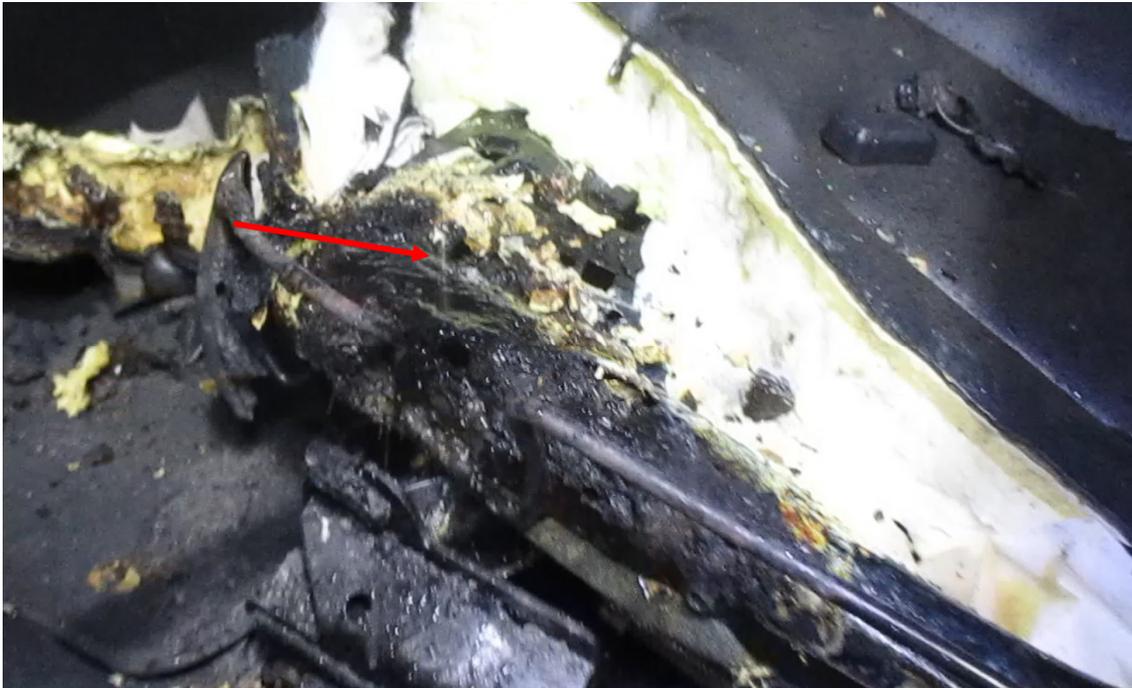
**Photo 15** shows a closer view of the water (arrowed) dripping onto the left side of the Motor Car's front left passenger seat, which was where the Motor Car's front left passenger seat lumbar controller was located (refer to photo 11 above). Screenshot extracted from the water test video recording.

15. Basing on paragraphs 11 to 14 above, in particular the observations gathered from the water test, the cause of the electrical short of the wirings and wire connector at the Motor Car's front left passenger seat lumbar controller can reasonably be established to be due to external cause and not due to product defect.
