LKK Auto Consultants Pte Ltd

Vehicle No. SJC 280Z
Insured Veh. SHA2937J
Claim No. D20005089MFSH
Policy No. D-20094922MFSH
Accident Date 14/12/2020
Inspection Date 18/12/2020

ADJUSTMENT ON REPAIR COST FOR VEHICLE NO. SJC 280Z

PHOTOGRAPHS FOR VEHICLE NO. SJC 280Z

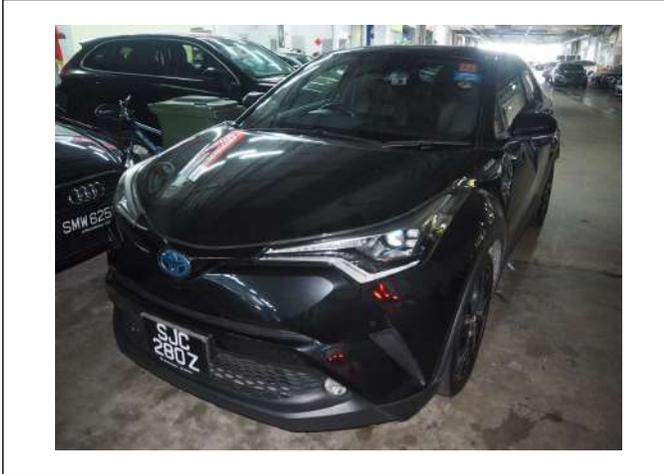
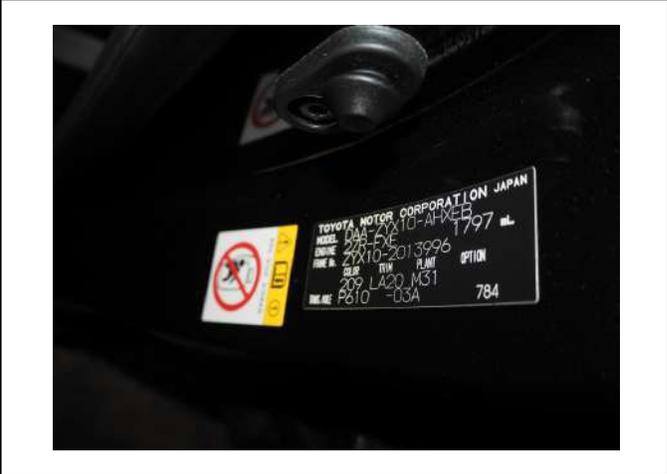
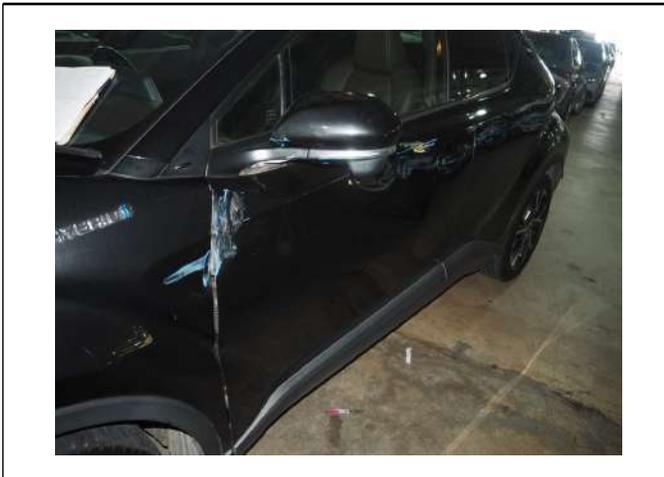
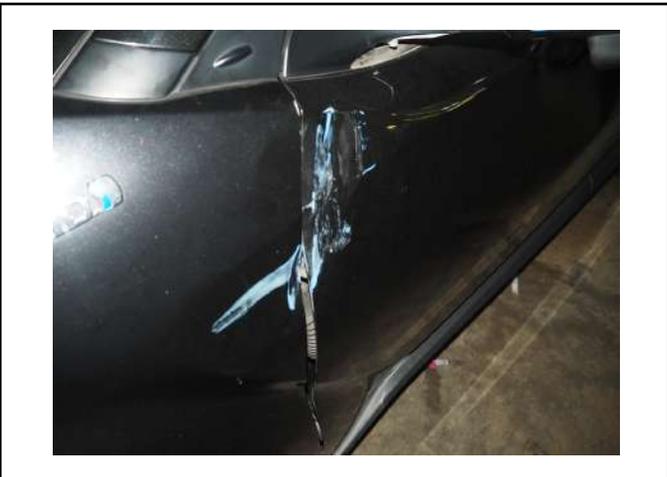
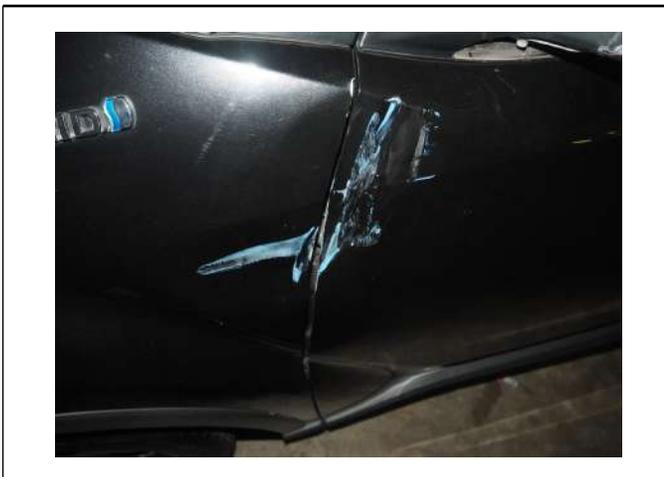
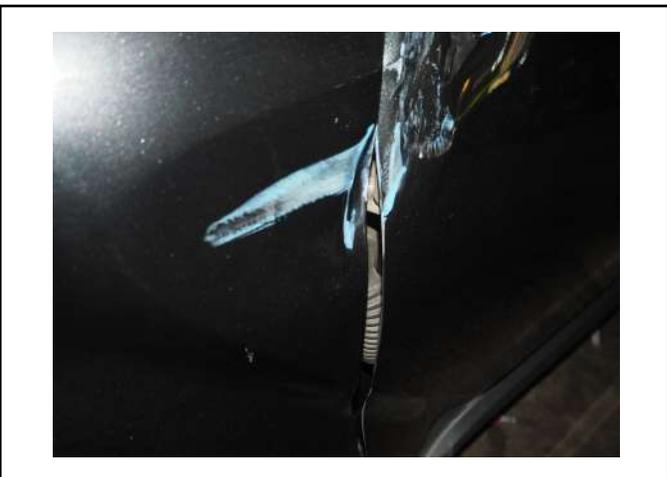
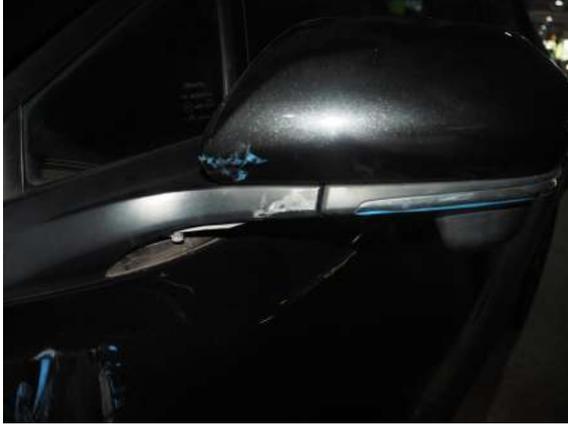
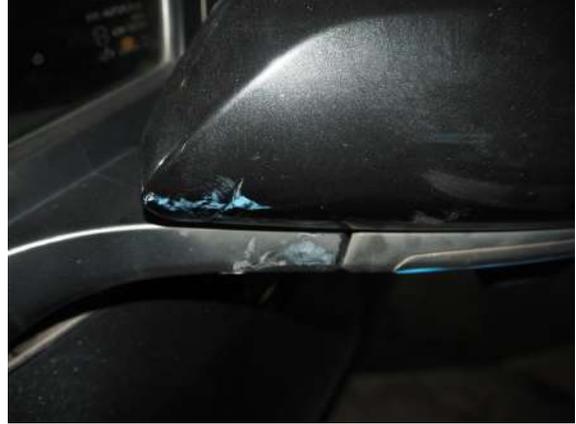
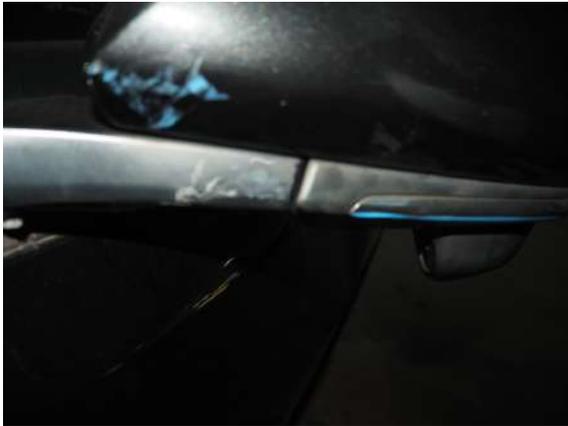
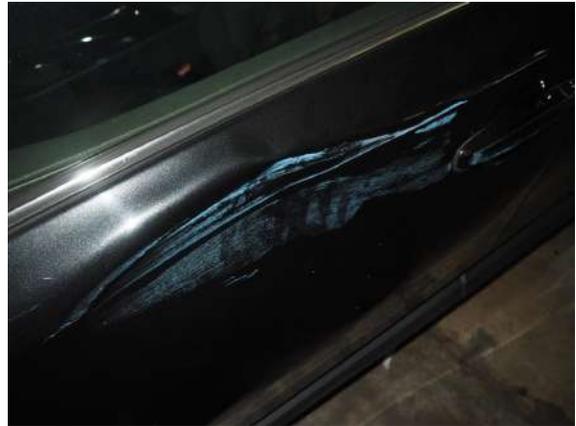
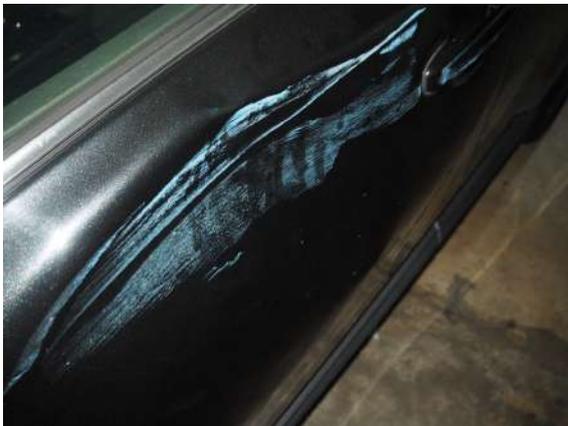
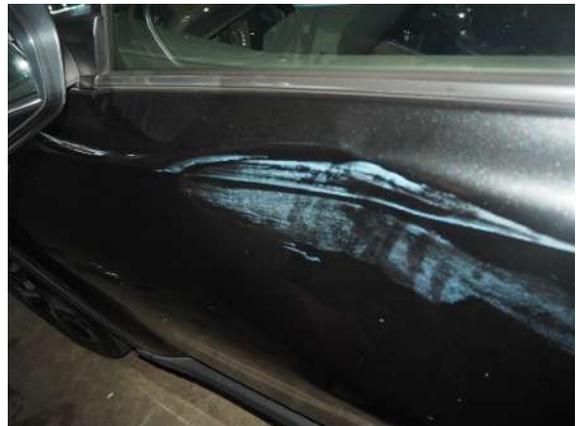
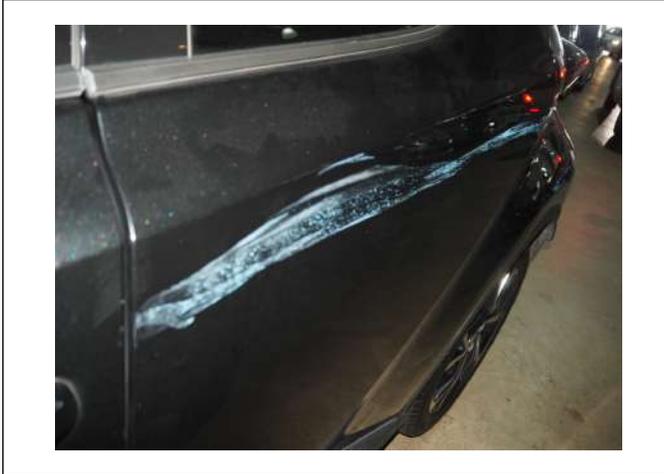
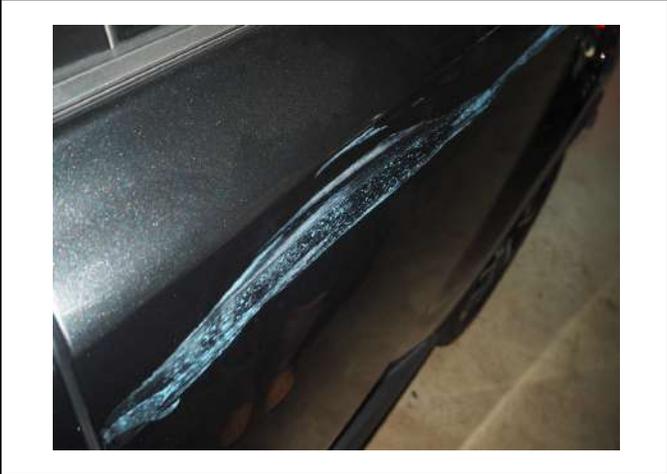
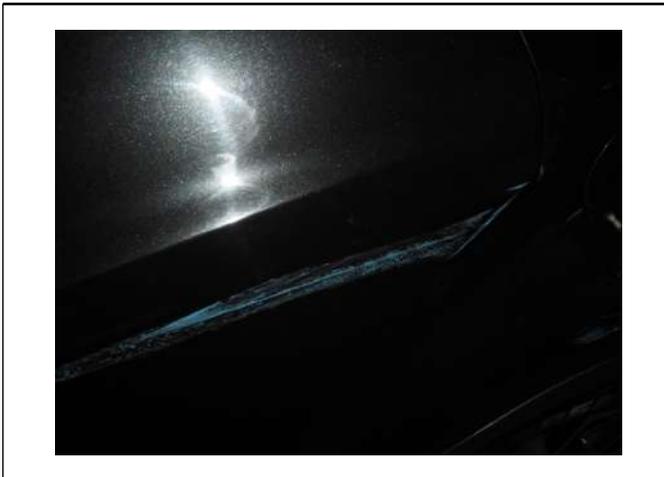
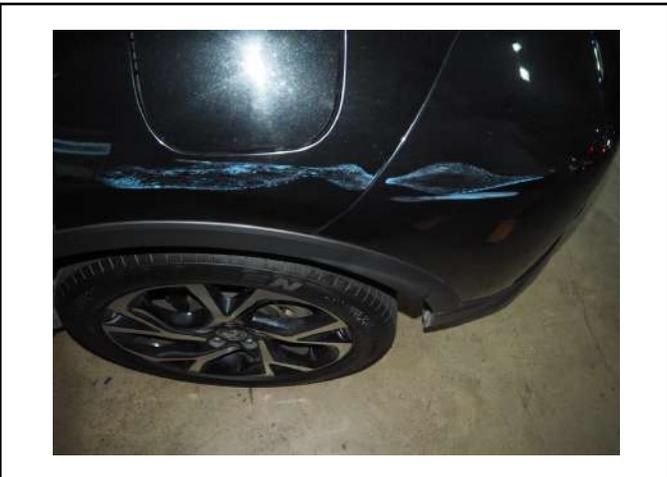
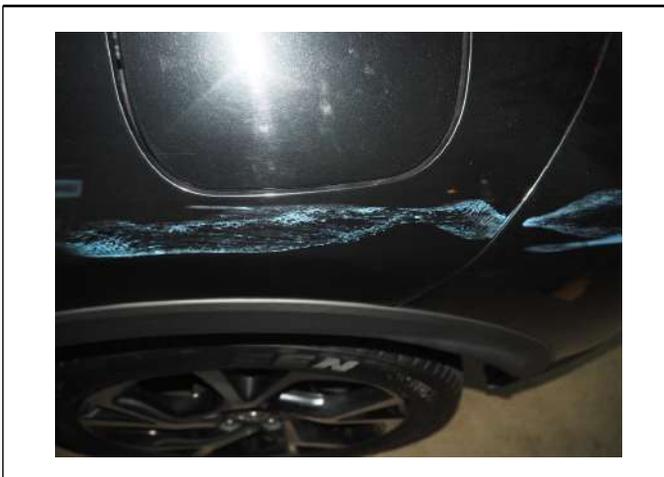
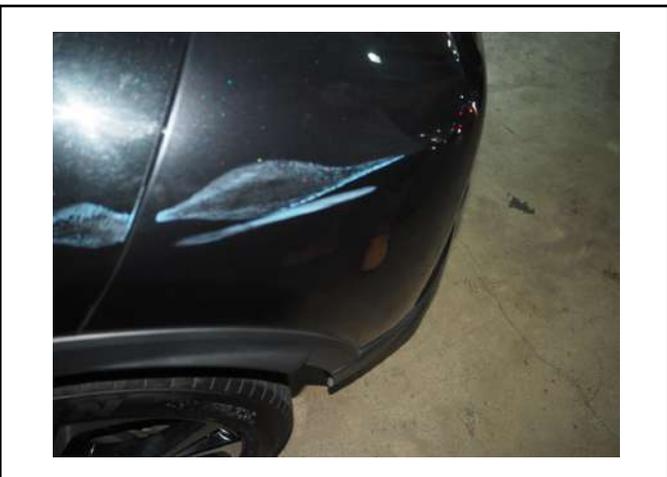
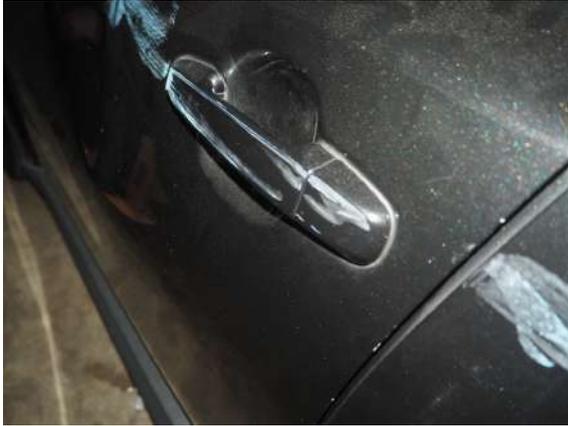
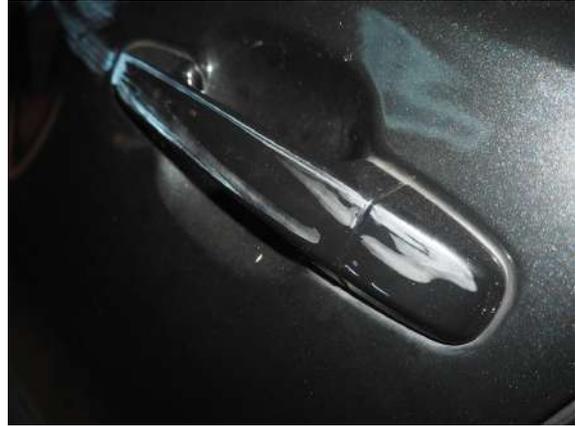
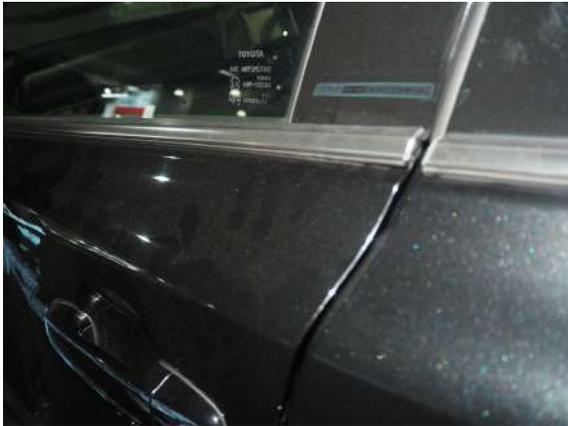
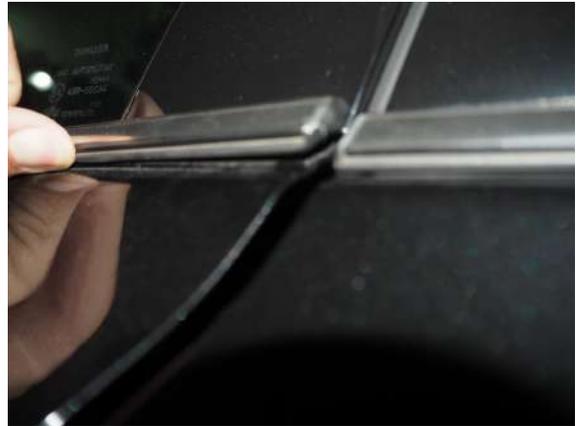
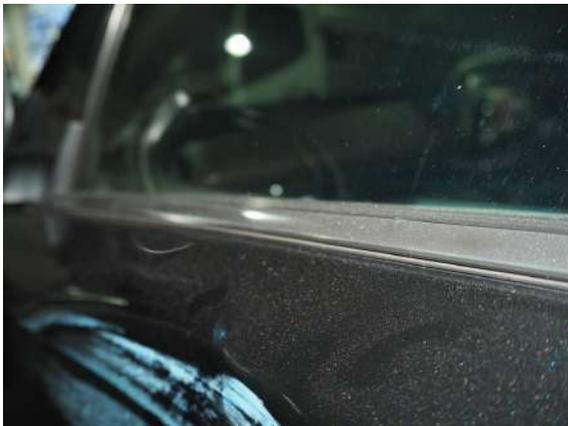
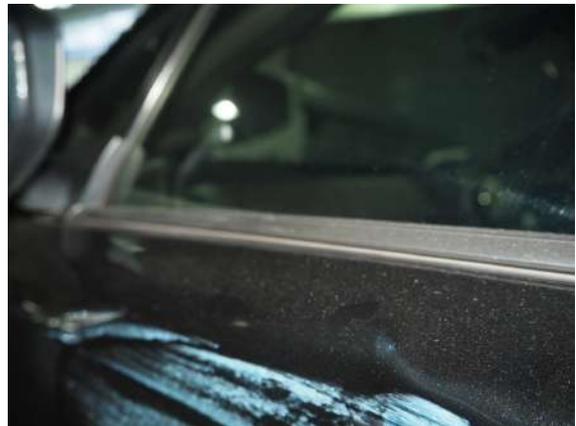
4. Description of Damages			
THE VEHICLE SUSTAINED DAMAGES AT THE N/S BODY. DAMAGES SEE DETAILS.			
5. General Information			
Accident Date	14/12/2020	Inspection Date	18/12/2020
Survey held at	TRIDENT AUTO SERVICE CENTRE PTE LTD 8 KAKI BUKIT AVENUE 4, #02-42, PREMIER @ KAKI BUKIT, SINGAPORE 415875		
5a. Remarks			
A)THE INSPECTION WAS CONDUCTED ON A"WITHOUT PREJUDICE" BASIS. B)IN ACCORDANCE TO YOUR INSTRUCTIONS, WE HAVE NOT AUTHORISED REPAIRS.			
5b. Estimate Days of Repair			
ESTIMATED NORMAL PERIOD FOR REPAIR:		7 Working Days
