Your Ref: BMW 420i  
(chassis number WBA4H32060BP26696)  
Our Ref : CI/TP20014158/D

14 December 2020

**INSPECTION REPORT OF AN UNREGISTERD BMW 420i MOTOR CAR WITH CHASSIS NUMBER WBA4H32060BP26696**

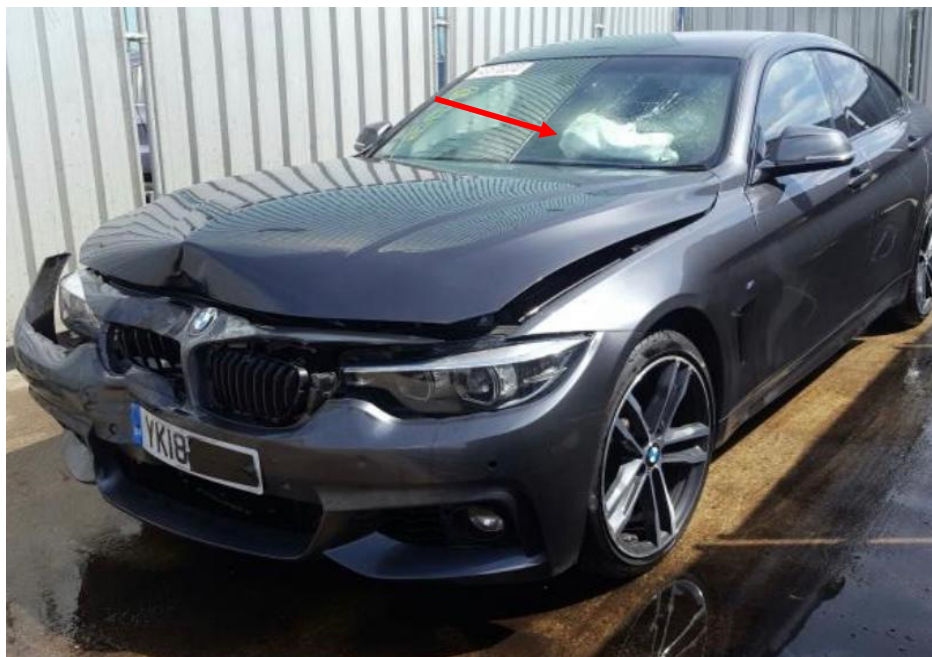
3. From the photographs provided to me, it was observed that the Motor Car had sustained damages at its frontal portion. Body parts damaged include the front bumper, front right headlamp, front bonnet, front right fender, front grilles and front bumper lower grille amongst others.
4. My review of the photographs provided had also revealed that the front windscreen was cracked, and the front left passenger airbag was deployed. See photo 1 – 4 below.

**Photo 1** shows the front left body of the Motor Car (photograph provided to me). The Motor Car was observed to have sustained damage at its frontal portion. The front bumper, front grilles, front bonnet and front windscreen were amongst the body parts that were observed to have been damaged. The front left passenger airbag (arrowed) was also observed to be deployed.

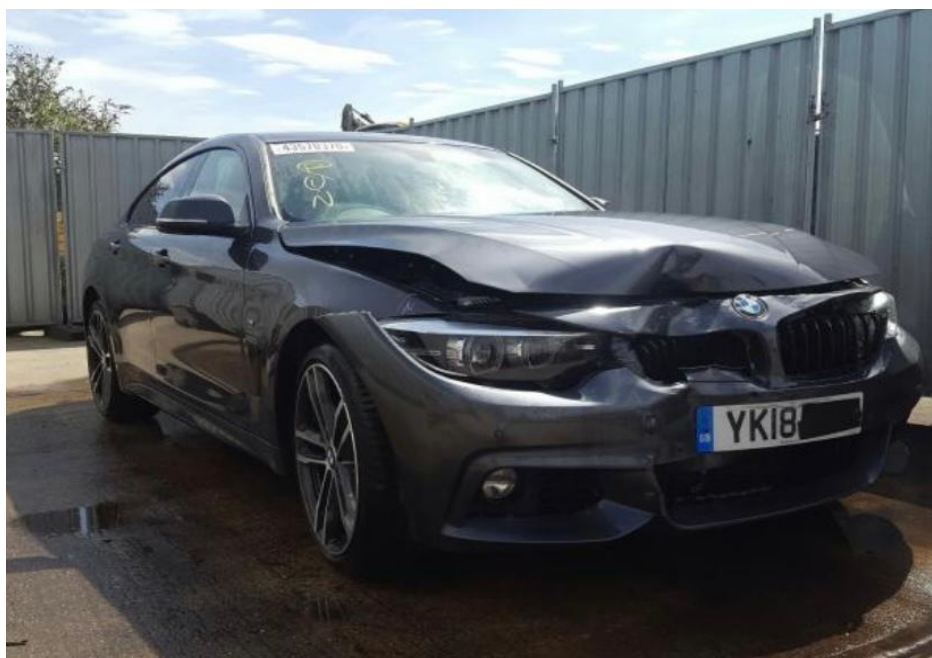
**Photo 2** shows the front right body of the Motor Car (photograph provided to me). The Motor Car was observed to have sustained damage at its frontal portion. The front bumper, front grilles, front bonnet, front bumper lower grille, front right headlamp and front right fender were amongst the body parts that were observed to have been damaged.

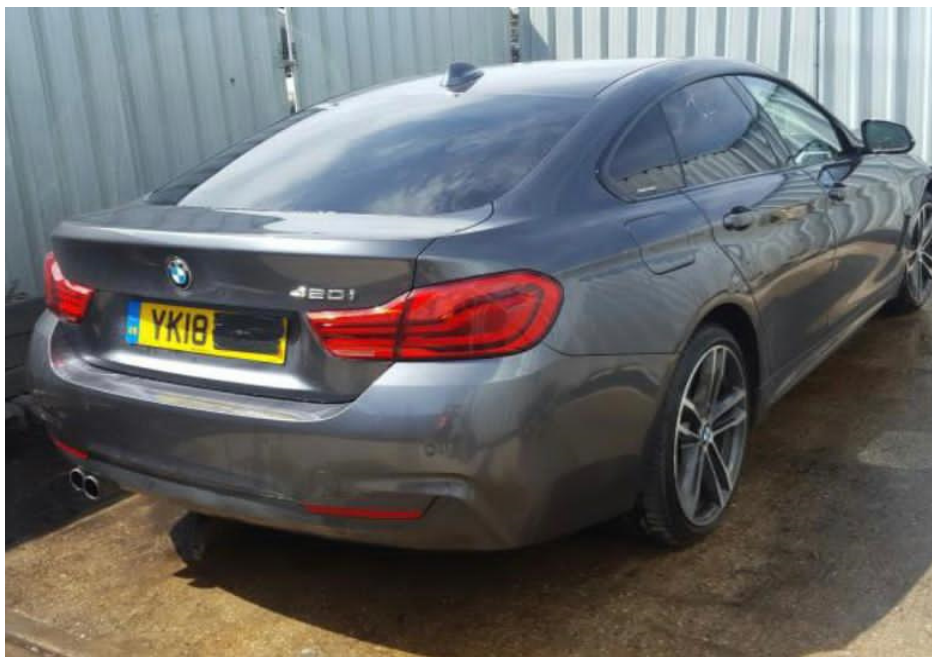
**Photo 3** shows the rear right body of the Motor Car (photograph provided to me). Apart for the frontal portion, there was no physical damage seen to other areas of the Motor Car.

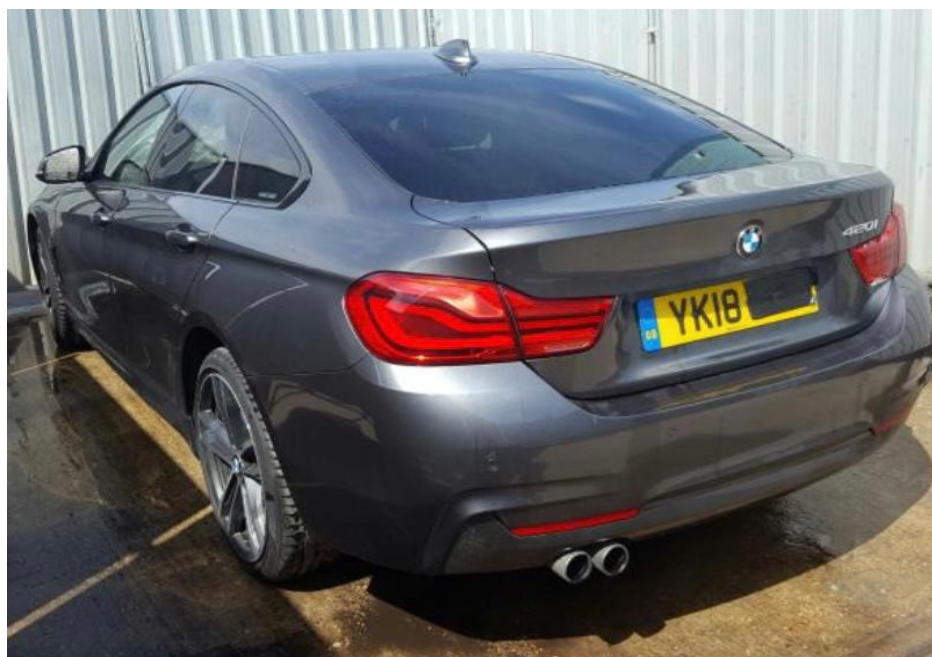
**Photo 4** shows the rear left body of the Motor Car (photograph provided to me). Apart for the frontal portion, there was no physical damage seen to other areas of the Motor Car.

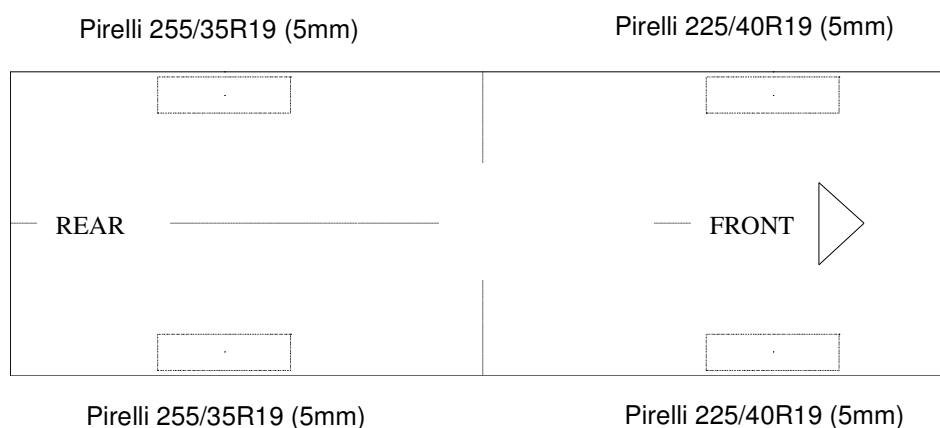
8. It was fitted with 19inch sport wheel rims that were wrapped with tyres that were observed to be of serviceable condition. The tyres were also sufficiently inflated for vehicular operation. The tyre brand, tyre size and approximate remaining tread depth of the 4 tyres of the Motor Car were recorded as follows: -

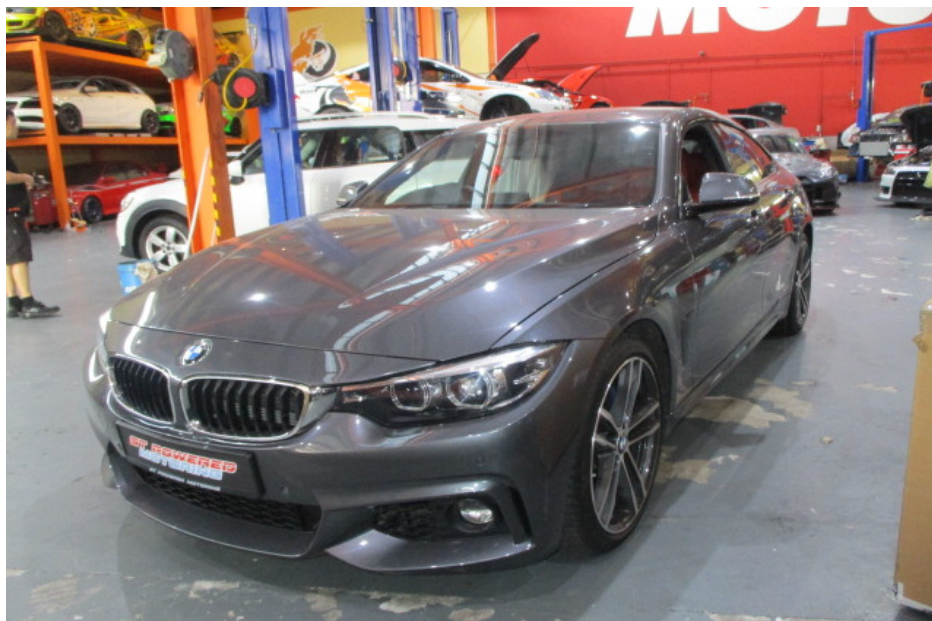
22. The body parts at the frontal portion of the Motor Car were visually examined and it was noted that the repair/restoration works carried out to the damaged area of the Motor Car (refer photograph 1 & 2 above) were reasonably adequate and in order.

**Photo 5** shows a general view of the front left body of the Motor Car at the time of my inspection. The Motor Car was observed to be in a relatively good general condition with no loose exterior fittings observed. The body parts at the frontal portion of the Motor Car were visually examined and it was observed that the repair/restoration works carried out to the damaged area of the Motor Car (refer to photograph 1 & 2 above) were reasonably adequate and in order.

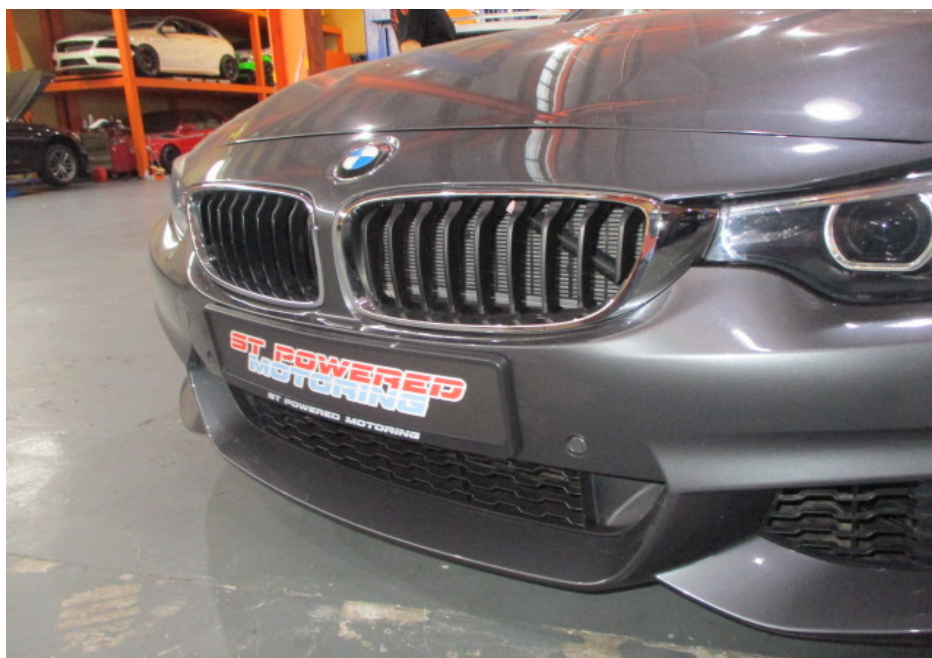
**Photo 6** shows a closer view of the front bumper, front bumper lower grille, front grilles and front bonnet of the Motor Car at the time of my inspection. The body parts at the frontal portion of the Motor Car were visually examined and it was observed that the repair/restoration works carried out to the damaged area of the Motor Car (refer to photograph 1 & 2 above) were reasonably adequate and in order.

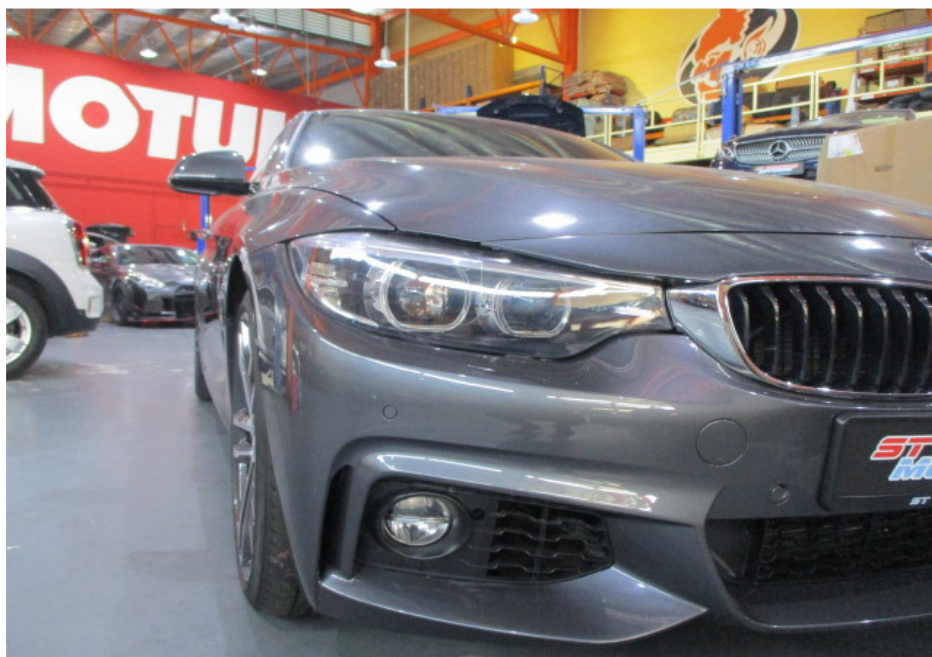
**Photo 7** shows a closer view of the front bumper, front right headlamp and front bonnet of the Motor Car at the time of my inspection. The body parts at the frontal portion of the Motor Car were visually examined and it was observed that the repair/restoration works carried out to the damaged area of the Motor Car (refer to photograph 1 & 2 above) were reasonably adequate and in order.

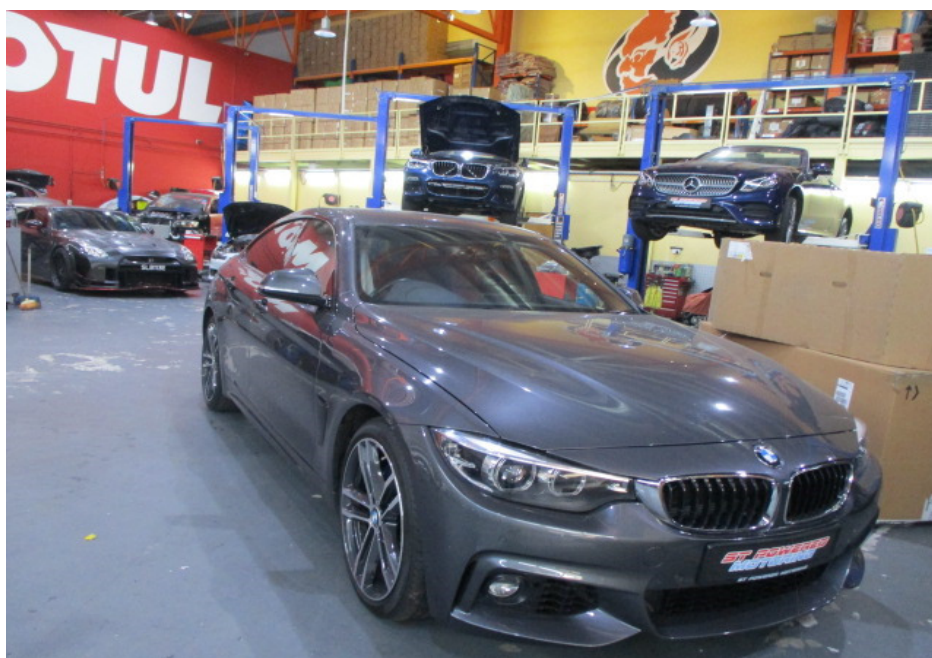
**Photo 8** shows a general view of the front right body of the Motor Car at the time of my inspection. The Motor Car was observed to be in a relatively good general condition with no loose exterior fittings observed. The body parts at the frontal portion of the Motor Car were visually examined and it was observed that the repair/restoration works carried out to the damaged area of the Motor Car (refer to photograph 1 & 2 above) were reasonably adequate and in order.

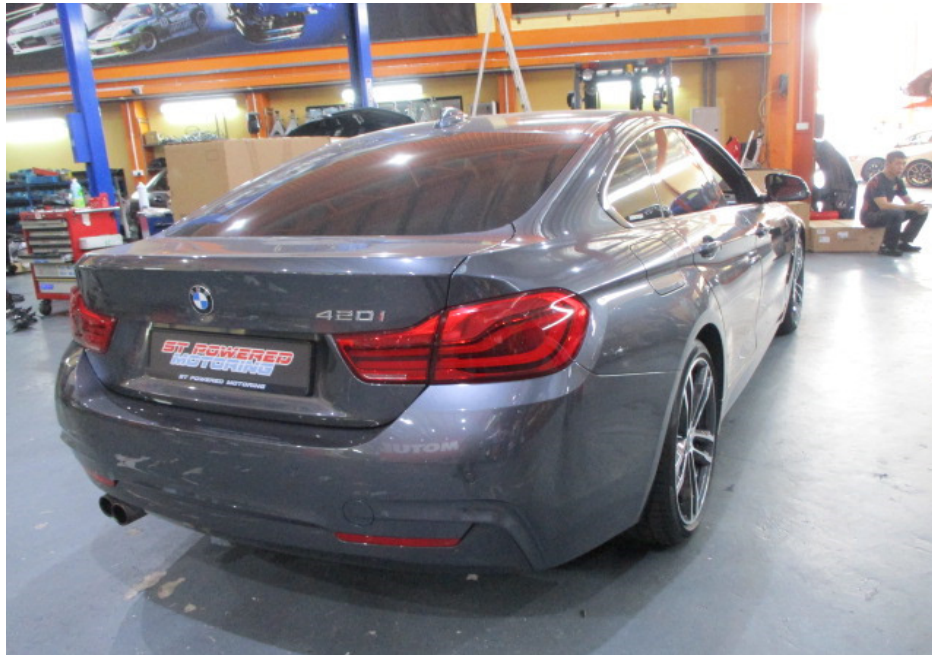
**Photo 9** shows a general view of the rear right body of the Motor Car at the time of my inspection. The Motor Car was observed to be in a relatively good general condition with no loose exterior fittings observed. The mileage of the Motor Car recorded at the time of my inspection was 11,177km.

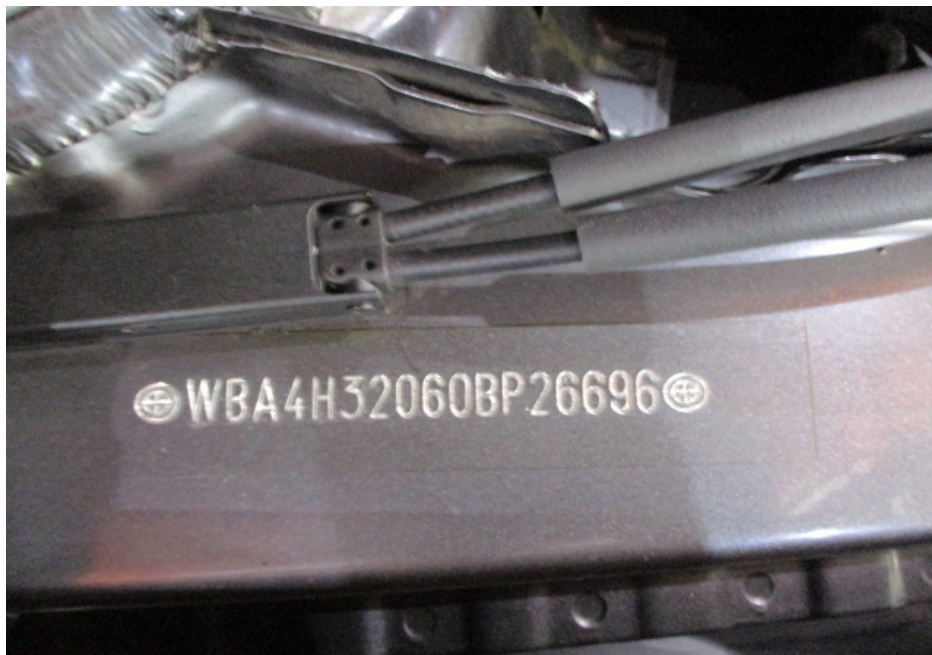
**Photo 10** shows the chassis number of the Motor Car. The chassis number recorded was WBA4H32060BP26696.

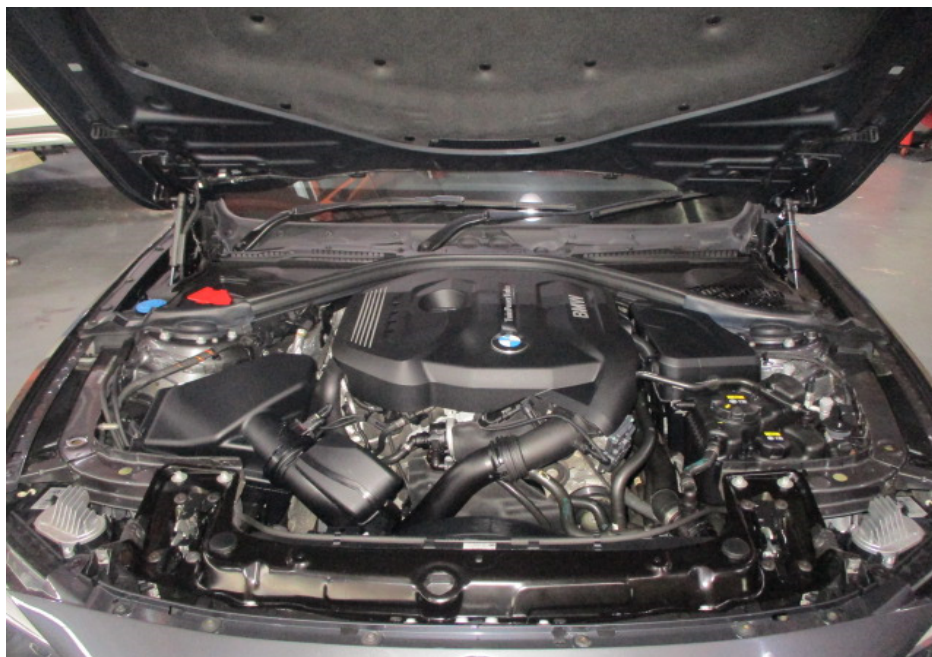
14. My examination of the engine compartment of the Motor Car revealed that the various parts and components inside the engine compartment were all intact and properly fitted. The engine oil, brake fluid and engine coolant were all found to be of sufficient level for operating purposes. Visually, there was also no contamination found to these fluids.
15. My checks on the underside of the Motor Car revealed no sign(s) or indication(s) of fluid leakage and/or fluid stain(s). The engine block and automatic transmission assembly were both secured properly. All undercarriage components of the Motor Car were also observed to be intact and secured in an appropriate manner.

**Photo 11** shows a general view of the engine compartment of the Motor Car at the time of my inspection. The various parts and components inside the engine compartment were all observed to be intact and properly fitted. There was also no sign(s) or indication(s) of fluid leak and/or fluid stain found inside the engine compartment.

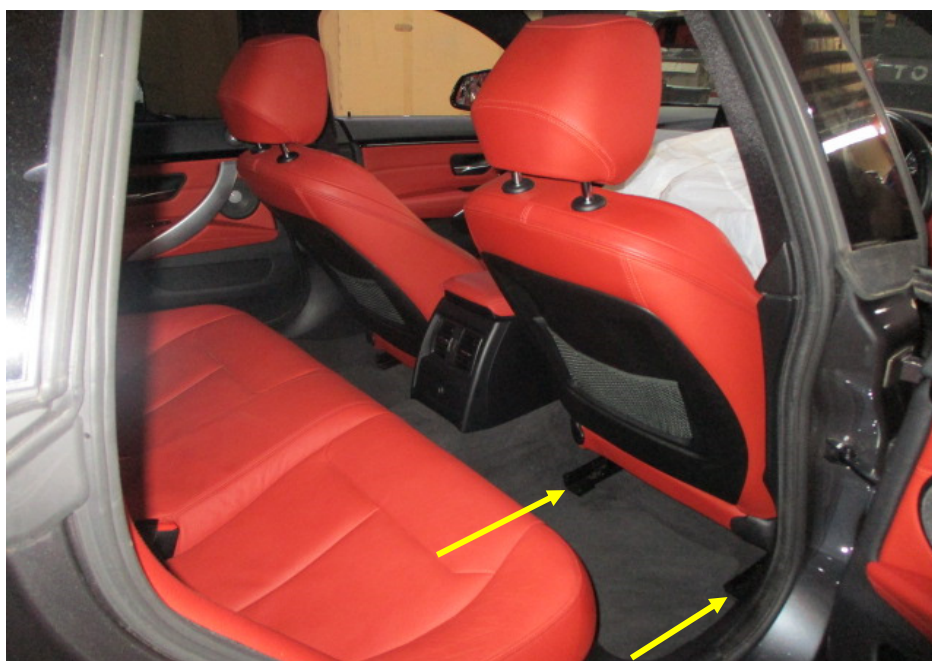
12. The seats of the Motor Car were found to be secured to the floorboard of the Motor Car via seat rails bolted onto the floorboard. Retractable seat belt reels and pre-tensioners were fitted on all seats of the Motor Car. The seat belts were tested and were able to be fastened securely into the respective pre-tensioners that were fixed to the side of all the seats.

**Photo 12** shows the seats of the Motor Car, which were secured via seat rails (arrowed) to the floorboard. All the seats of the Motor Car were fitted with a retractable seat belt reel and pre-tensioner. The seat belts were tested and were able to be fastened into the respective pre-tensions that were fitted on the side of each individual seat.

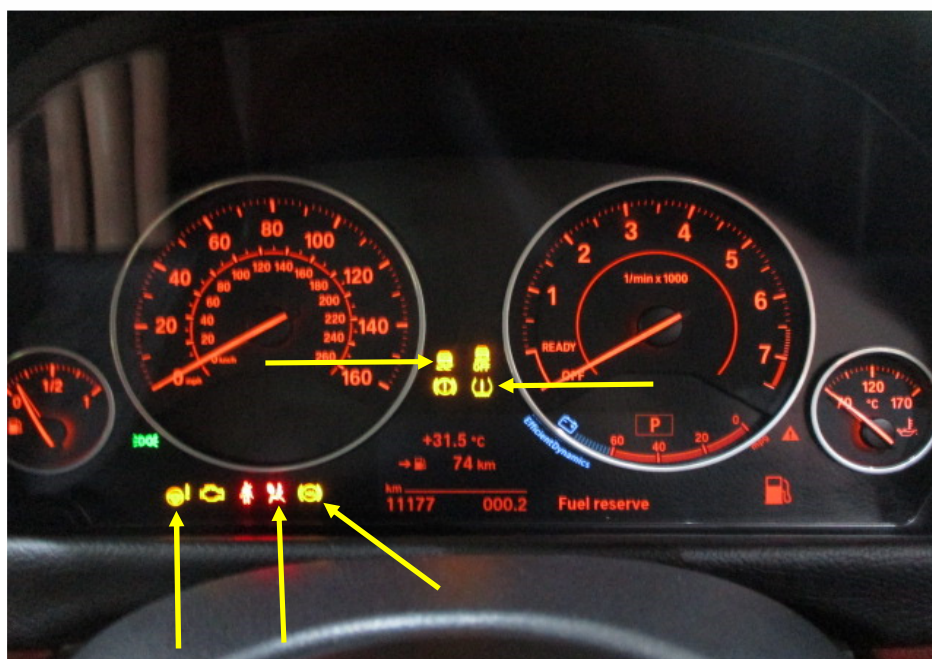
**Photo 13** shows the warning lights for the various electronic safety features appearing on the instrument panel of the Motor Car during its self-test when the engine is cranked, in particular the ABS, SRS, IAS, TPM and DSC lights (arrowed).

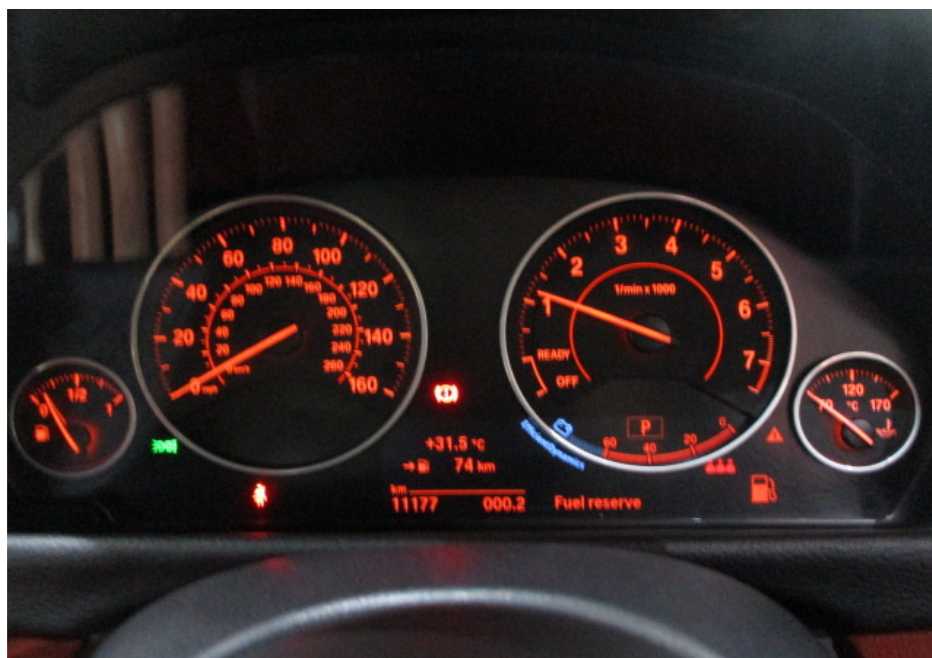
13. The Motor Car's automatic self-test of the functionality of its various electronic safety features like the Anti-Lock Brake System (ABS), Supplemental Restraint System (SRS), Integral Active Steering (IAS), Tyre Pressure Monitor (TPM) and Dynamic Stability Control (DSC) during cranking of the engine had indicated that these electronic systems were in working condition. This was determined from the respective warning lights disappearing from the instrument panel after the self-test.

**Photo 14** shows the respective warning lights no longer illuminated, indicating that there is no fault detected to the ABS, SRS, IAS, TPM and DSC systems of the Motor Car during the self-test. These electronic systems were hence in working condition at the time of my inspection.

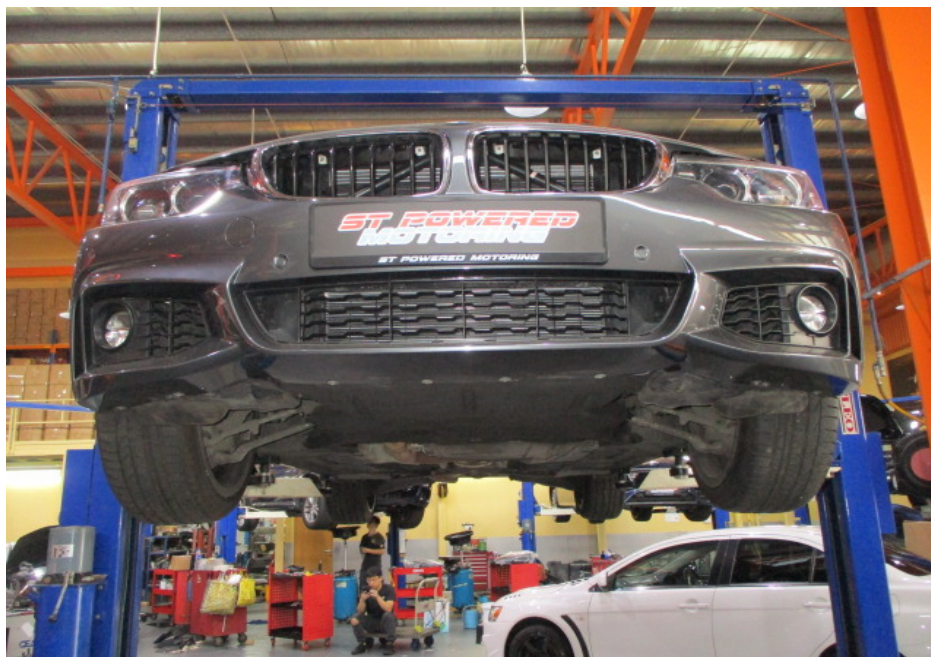
**Photo 15** shows the Motor Car hoisted up for checks on its undercarriage. There was no sign(s) or indication(s) of fluid leakage and/or fluid stain(s) on the underside of the Motor Car. The undercarriage components of the Motor Car were also all observed to be intact and secured in an appropriate manner.

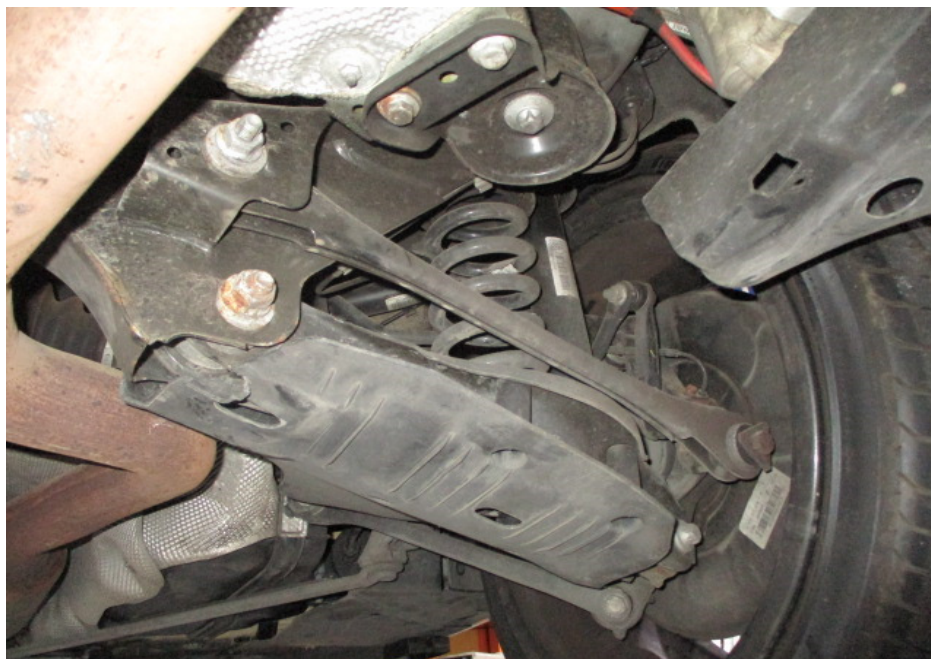
**Photo 16** shows a general view of the control arms and linkages at the rear right wheel of the Motor Car. I did not observe any fluid leak and/or fluid stain on the underside of the Motor Car. All of the Motor Car's undercarriage components were observed to be intact and secured in an appropriate manner.

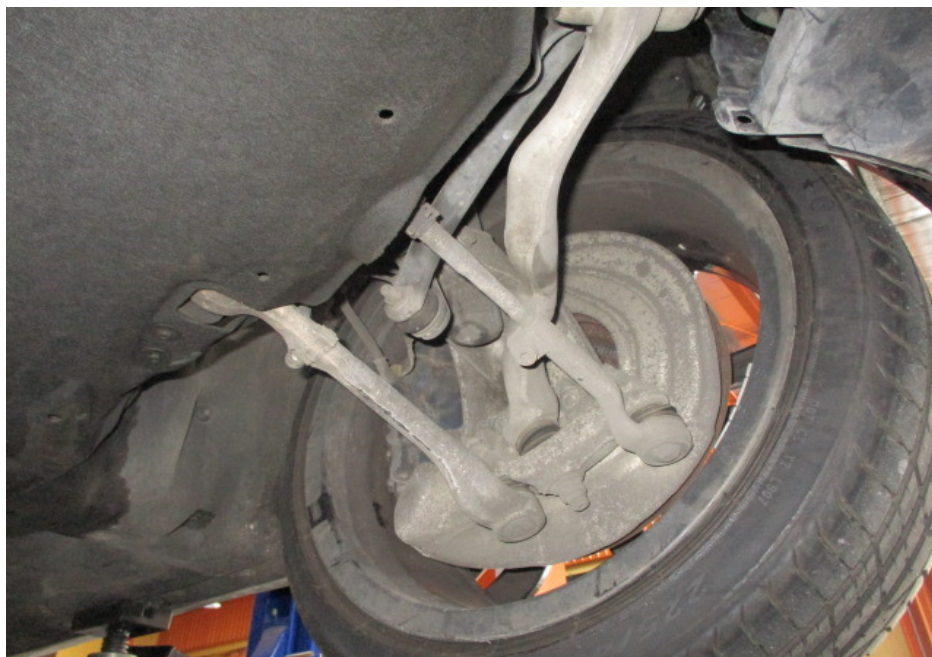
**Photo 17** shows the various undercarriage components at the front left wheel of the Motor Car. The mechanical components, control arms and linkages were all found to be intact and secured in an appropriate manner.

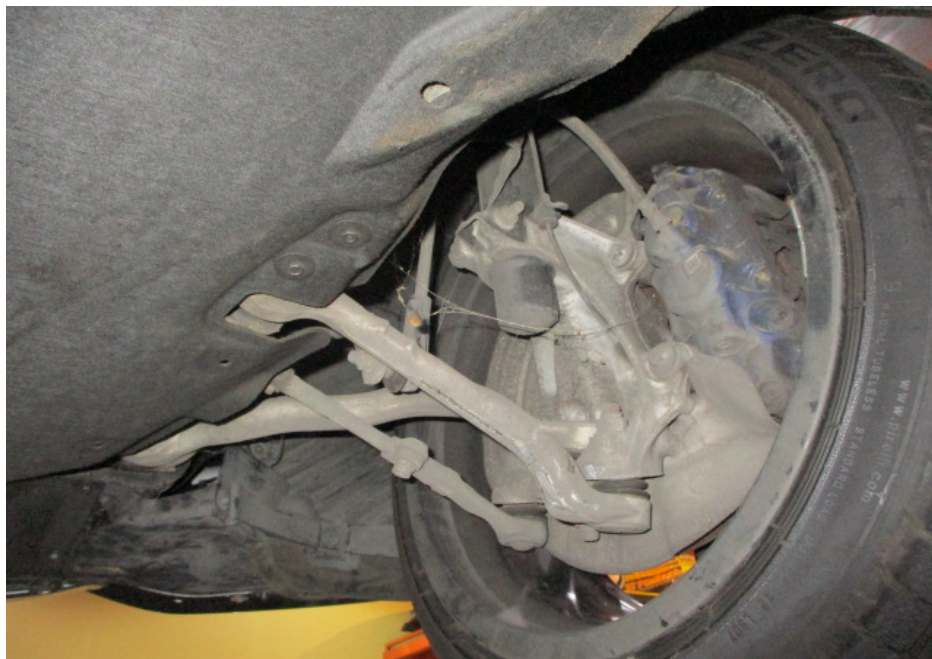
**Photo 18** shows the various undercarriage components at the front right wheel of the Motor Car. The mechanical components, control arms and linkages were all found to be intact and secured in an appropriate manner. I also did not observe any fluid leak and/or fluid stain on the underside of the Motor Car.

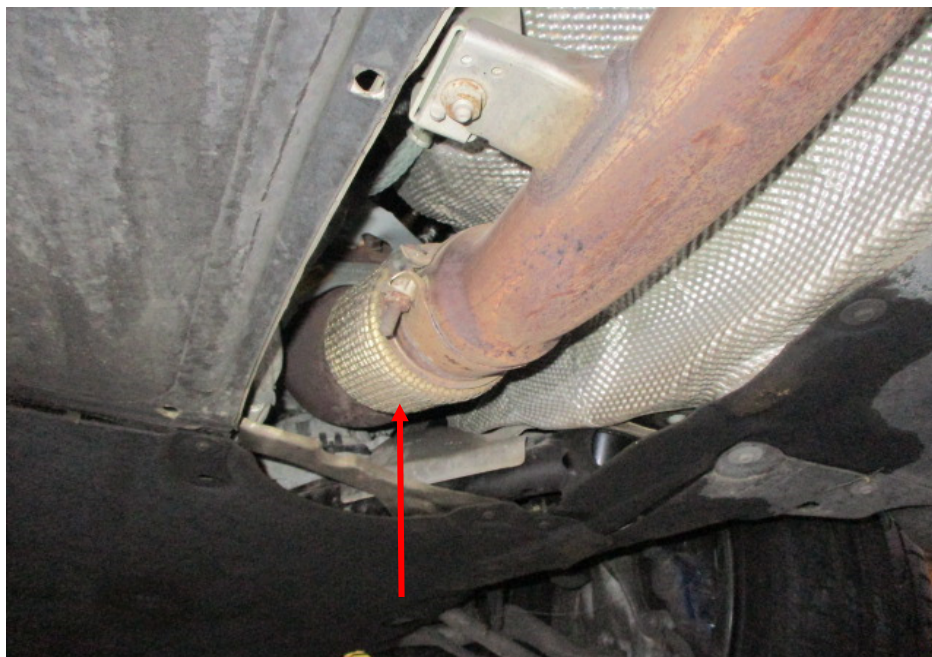
**Photo 19** shows the Motor Car's catalytic converter (arrowed). My examination of the Motor Car's exhaust system revealed no sign(s) or indication(s) of any cut or weld marks along its exhaust pipes and on its rear muffler.

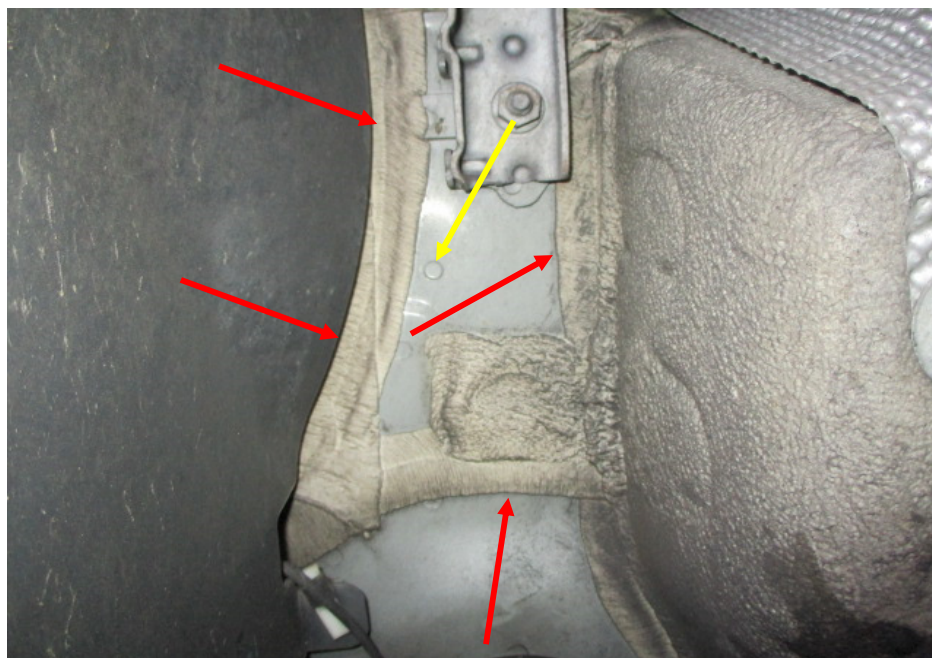
11. Visually, I did not find any weld marks, other than the original spot weld marks, on the chassis/structural body of the Motor Car. The original factory sealant at the joints along the chassis/structural body was also untouched, again indicating that no replacement of the chassis/structural body was carried out; and that the chassis/structural body was originally fitted.

**Photo 20** shows the chassis/structural body at the underside rear left of the Motor Car. I did not find any weld marks other than original spot weld marks (yellow arrow) on the chassis/structural body of the Motor Car. The original factory sealant (red arrow) at the joints along the chassis/structural body was untouched, indicating no work was done on the chassis/structural body of the Motor Car and that the chassis/structural body was originally fitted.

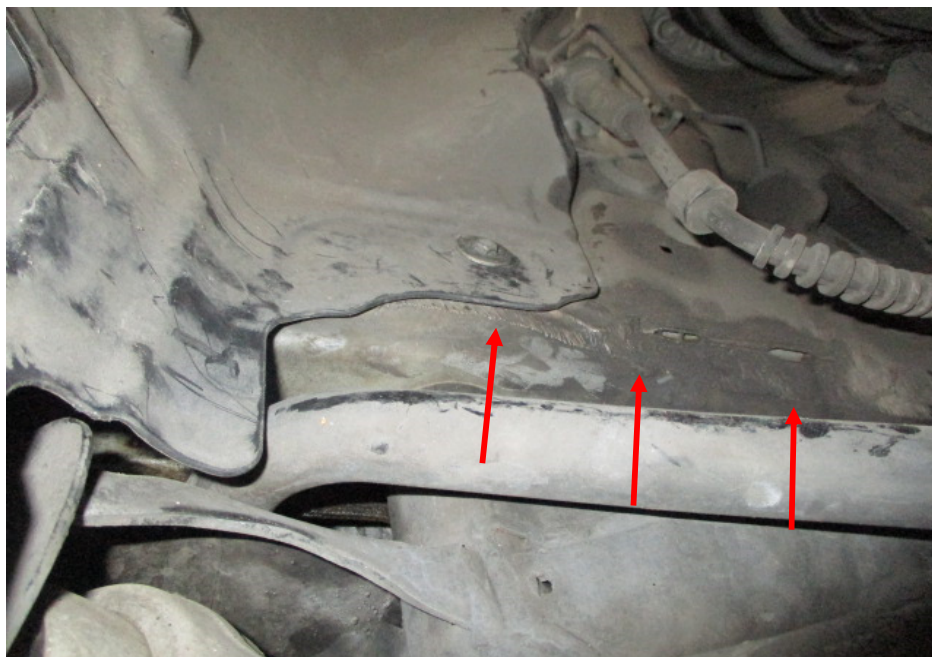
**Photo 21** shows the chassis/structural body at the underside front left of the Motor Car. The original factory sealant (arrowed) at the joints along the chassis/structural body was observed to be untouched. In general, I had found no work was carried out on the chassis/structural body of the Motor Car. The chassis/structural body of the Motor Car was originally fitted.

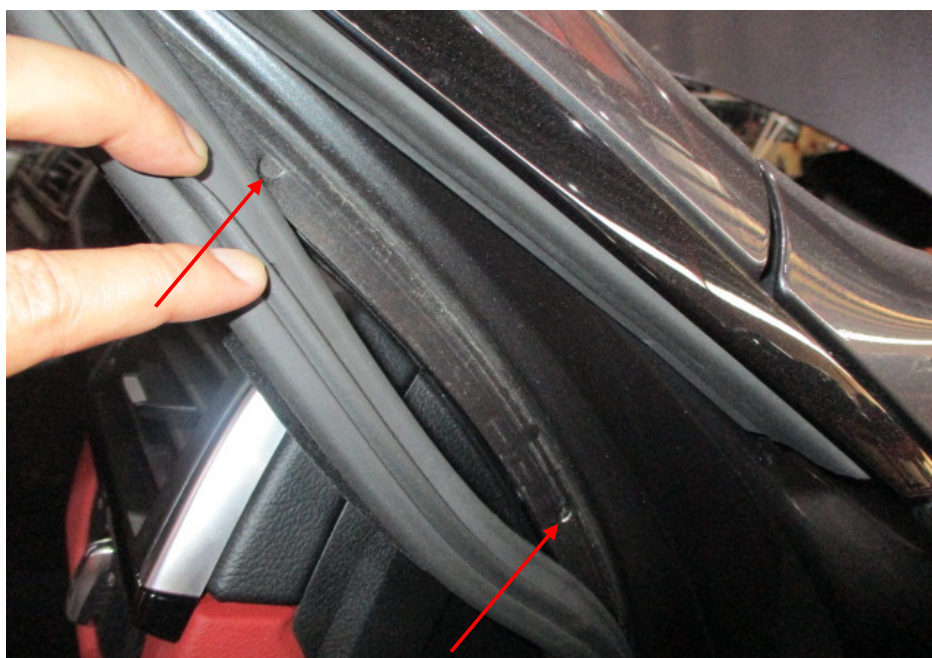
**Photo 22** shows the right side "A" pillar of the Motor Car. I did not find any weld marks other than original spot weld marks (arrowed) on the right side "A" pillar of the Motor Car which, indicates that there was no re-welding works carried out. In general, I had found all the non-detachable body panels of the Motor Car to be originally fitted at the time of my inspection.

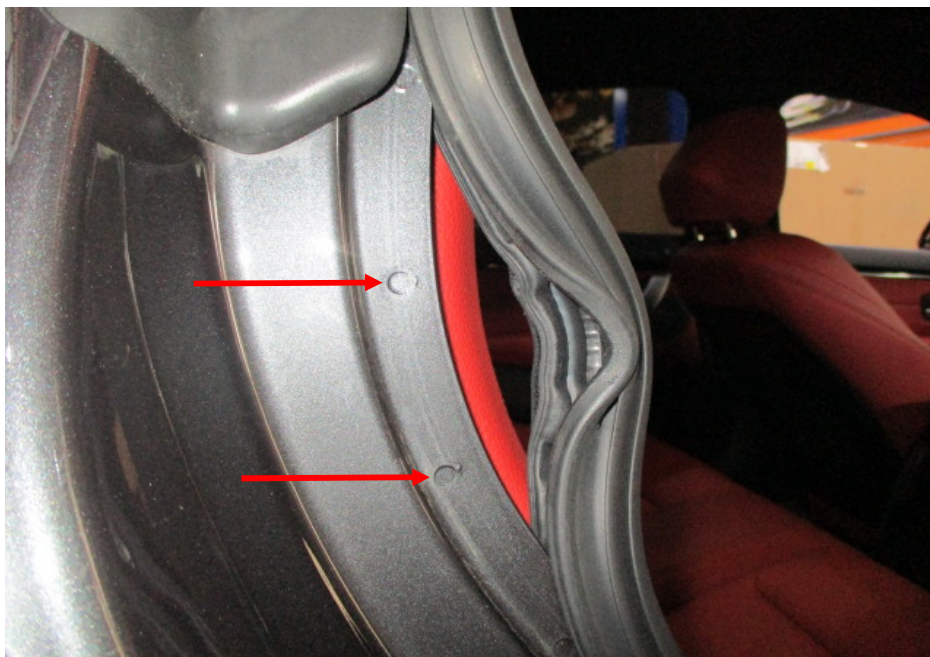
**Photo 23** shows the right side "C" pillar of the Motor Car. I did not find any weld marks other than original spot weld marks (arrowed) on the right side "C" pillar of the Motor Car which, indicates that there was no re-welding works carried out. In general, I had found all the non-detachable body panels of the Motor Car to be originally fitted at the time of my inspection.
