Your Ref: BMW 520i  
(chassis number WBAJK52040BN95946)  
Our Ref : CI/TP20014159/D

18 December 2020

**INSPECTION REPORT OF AN UNREGISTERD BMW 520i MOTOR CAR WITH CHASSIS NUMBER WBAJK52040BN95946**

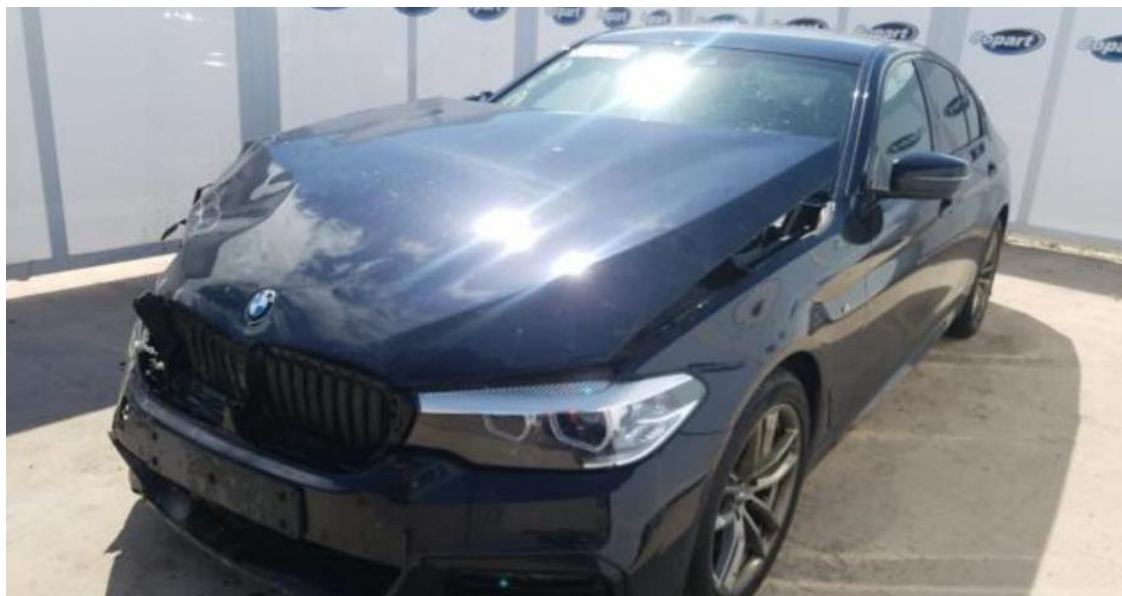
**Photo 1** shows the front left body of the Motor Car (photograph provided to me). The Motor Car was observed to have sustained damage at its front right portion. The front bumper, front radiator grilles and front bonnet were amongst the body parts that were observed to have been damaged.

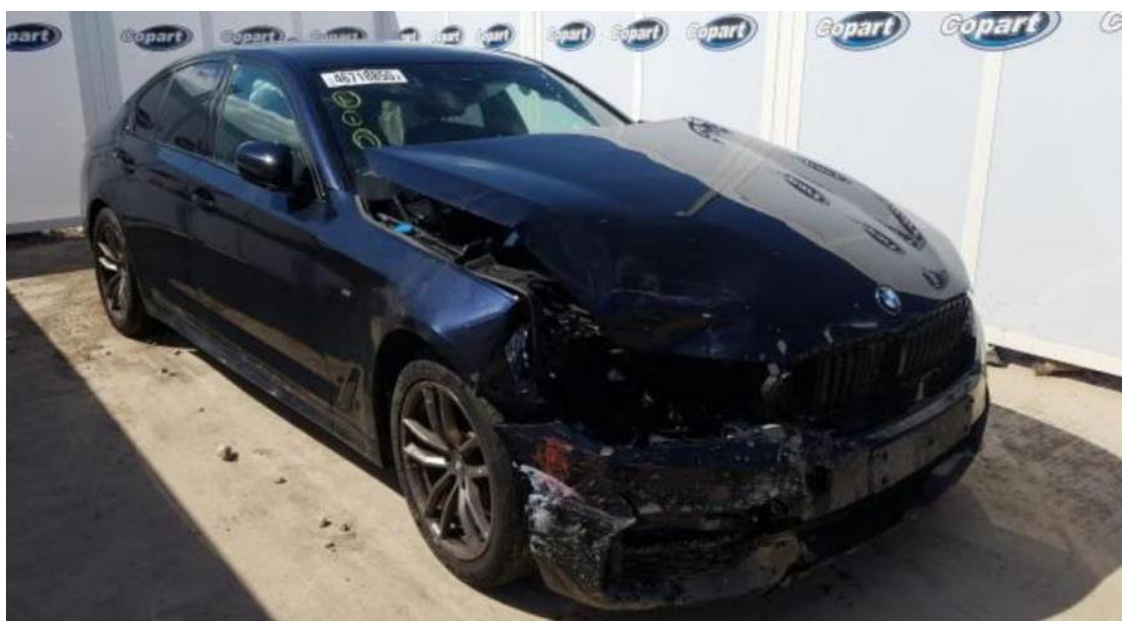
**Photo 2** shows the front right body of the Motor Car (photograph provided to me). The Motor Car was observed to have sustained damage at its front right portion. The front bumper, front radiator grilles, front bonnet, front bumper right lower grille, front right headlamp and front right fender were amongst the body parts that were observed to have been damaged.

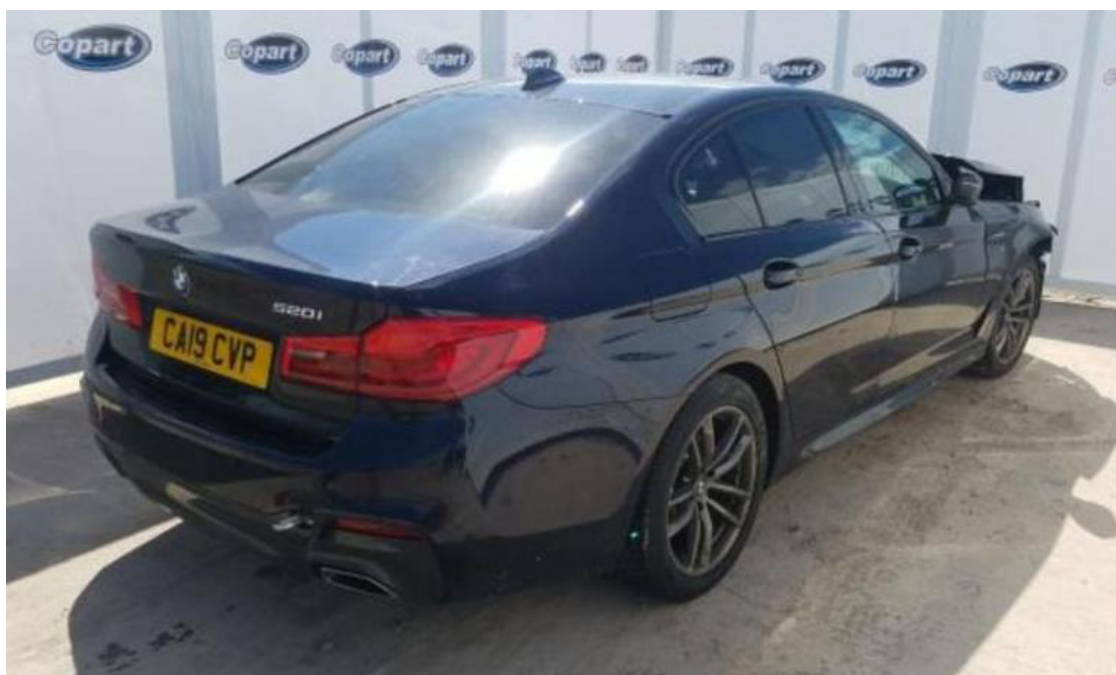
**Photo 3** shows the rear right body of the Motor Car (photograph provided to me). Apart for the front right portion, there was no physical damage seen to other areas of the Motor Car. The airbags of the Motor Car were also not deployed as seen from the photographs that were provided to me.

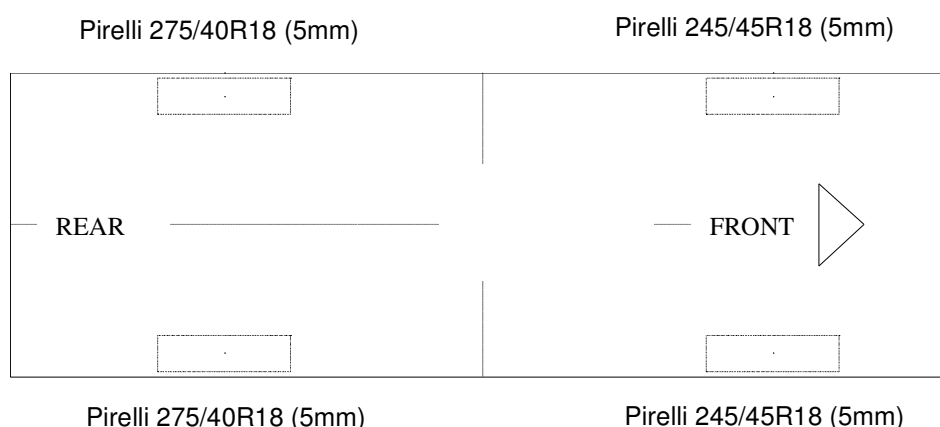
8. It was fitted with 18inch sport wheel rims that were wrapped with tyres that were observed to be of serviceable condition. The tyres were also sufficiently inflated for vehicular operation. The tyre brand, tyre size and approximate remaining tread depth of the 4 tyres of the Motor Car were recorded as follows: -

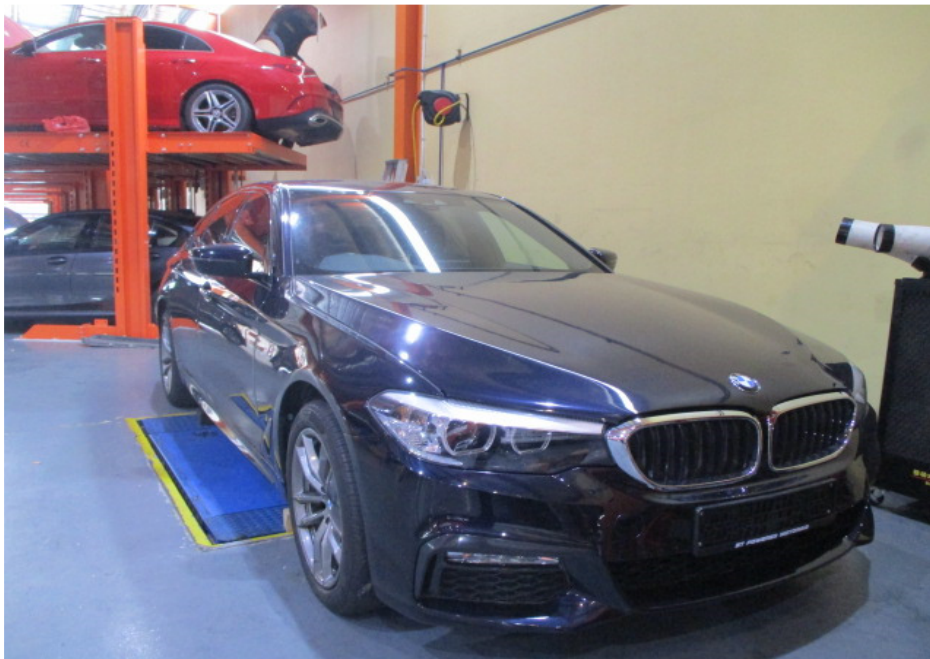
**Photo 4** shows a general view of the front right body of the Motor Car at the time of my inspection. The Motor Car was observed to be in a relatively good general condition with no loose exterior fittings observed. The body parts at the front right portion of the Motor Car were visually examined and it was observed that the repair/restoration works carried out to the damaged area of the Motor Car (refer to photograph 1 & 2 above) were reasonably adequate and in order.

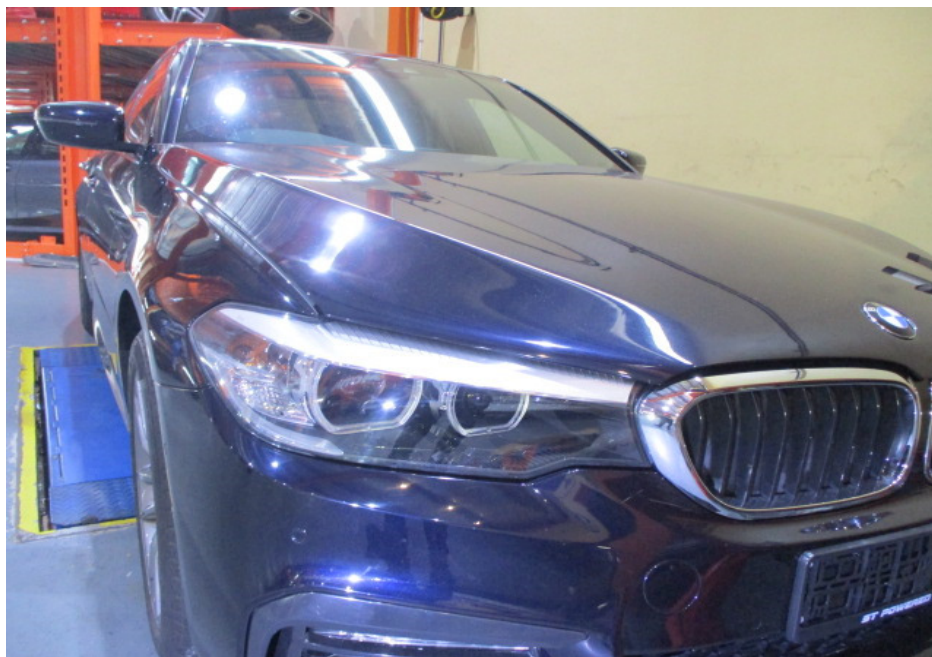
**Photo 5** shows a closer view of the front bumper, front right headlamp, front right fender and front bonnet of the Motor Car at the time of my inspection. The body parts at the front right portion of the Motor Car were visually examined and it was observed that the repair/restoration works carried out to the damaged area of the Motor Car (refer to photograph 1 & 2 above) were reasonably adequate and in order.

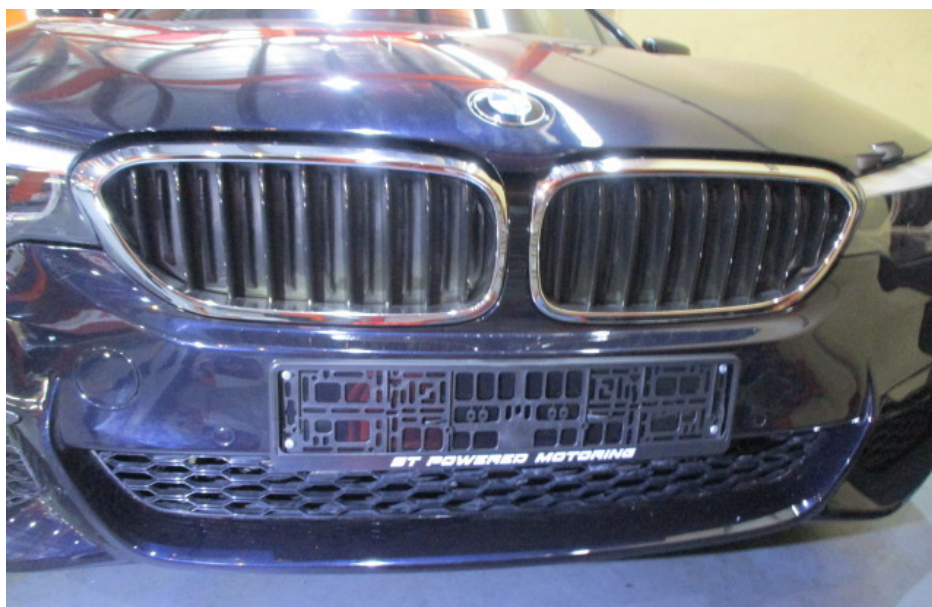
**Photo 6** shows a closer view of the front bumper, front bumper centre lower grille and front radiator grilles of the Motor Car at the time of my inspection. The body parts at the front right portion of the Motor Car were visually examined and it was observed that the repair/restoration works carried out to the damaged area of the Motor Car (refer to photograph 1 & 2 above) were reasonably adequate and in order.

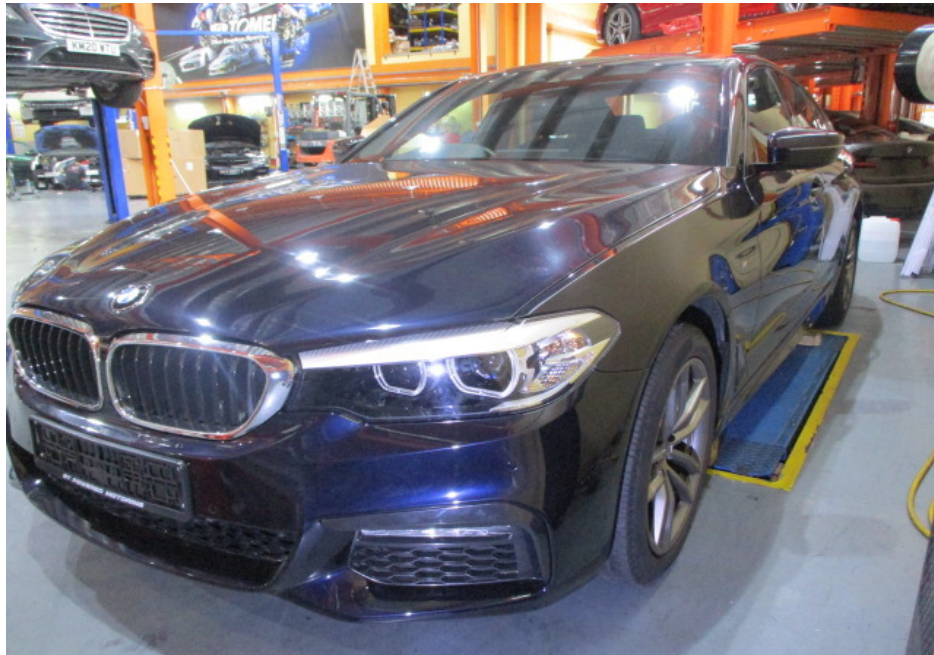
**Photo 7** shows a general view of the front left body of the Motor Car at the time of my inspection. The Motor Car was observed to be in a relatively good general condition with no loose exterior fittings observed. The body parts at the front right portion of the Motor Car were visually examined and it was observed that the repair/restoration works carried out to the damaged area of the Motor Car (refer to photograph 1 & 2 above) were reasonably adequate and in order.

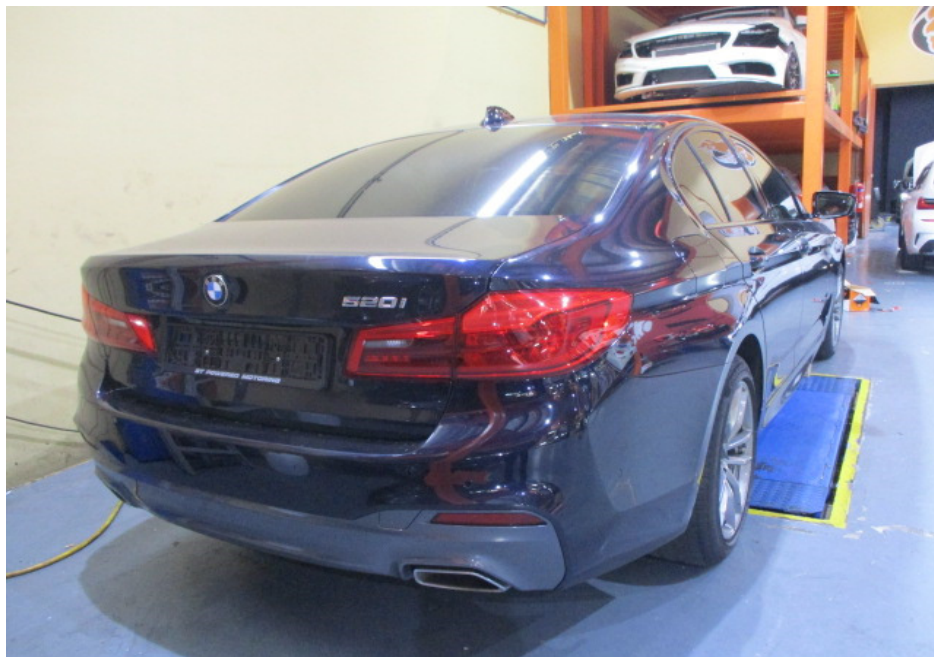
**Photo 8** shows a general view of the rear right body of the Motor Car at the time of my inspection. The Motor Car was observed to be in a relatively good general condition with no loose exterior fittings observed. The mileage of the Motor Car recorded at the time of my inspection was 39,270km.

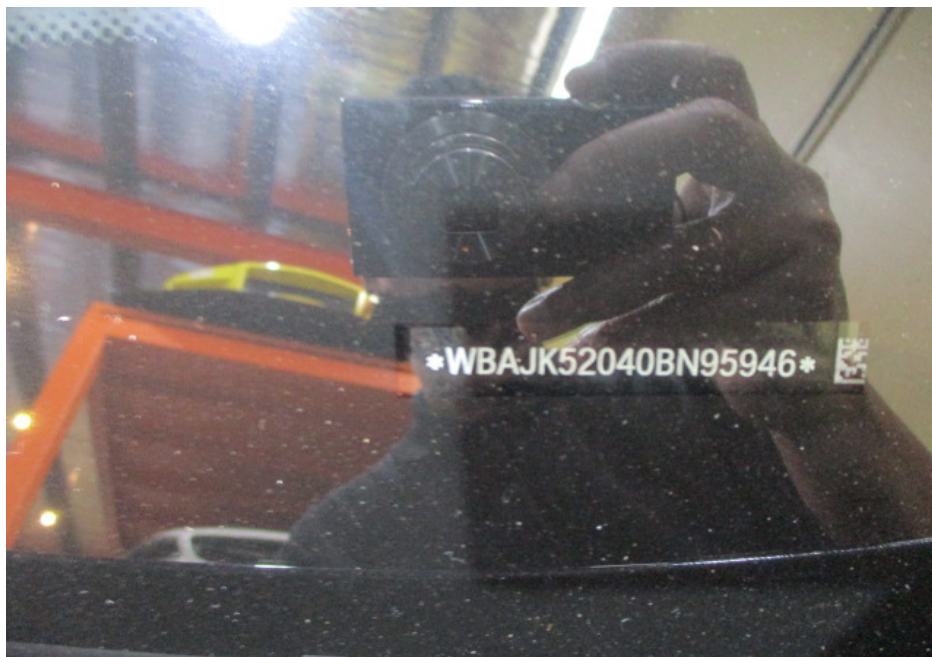
**Photo 9** shows the chassis number of the Motor Car. The chassis number recorded was WBAJK52040BN95946.

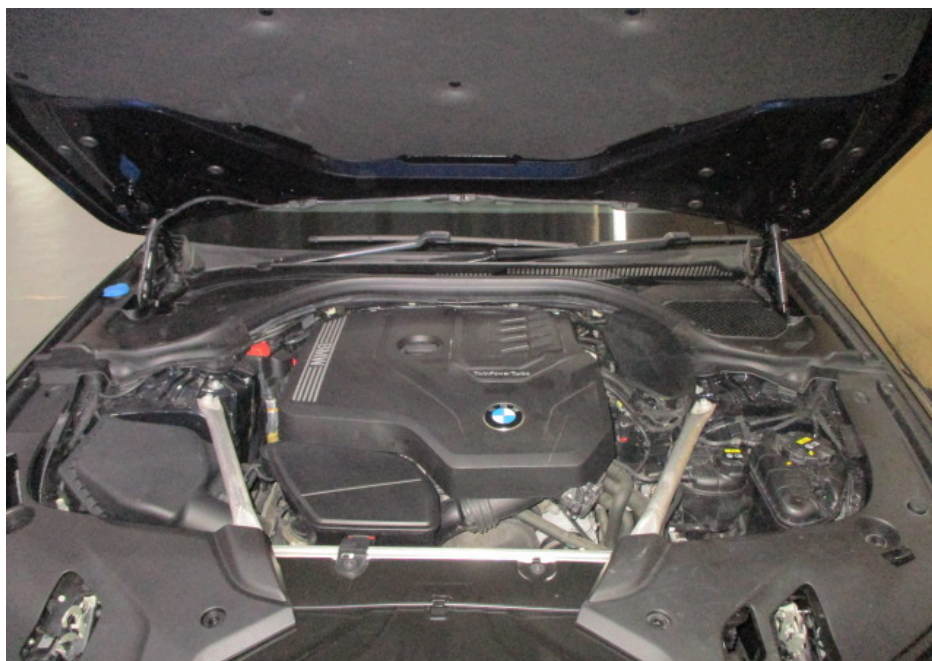
14. My examination of the engine compartment of the Motor Car revealed that the various parts and components inside the engine compartment were all intact and properly fitted. The engine oil, brake fluid and engine coolant were all found to be of sufficient level for operating purposes. Visually, there was also no contamination found to these fluids.
15. My checks on the underside of the Motor Car revealed no sign(s) or indication(s) of fluid leakage and/or fluid stain(s). The engine block and automatic transmission assembly were both secured properly. All undercarriage components of the Motor Car were also observed to be intact and secured in an appropriate manner.

**Photo 10** shows a general view of the engine compartment of the Motor Car at the time of my inspection. The various parts and components inside the engine compartment were all observed to be intact and properly fitted. There was also no sign(s) or indication(s) of fluid leak and/or fluid stain found inside the engine compartment.

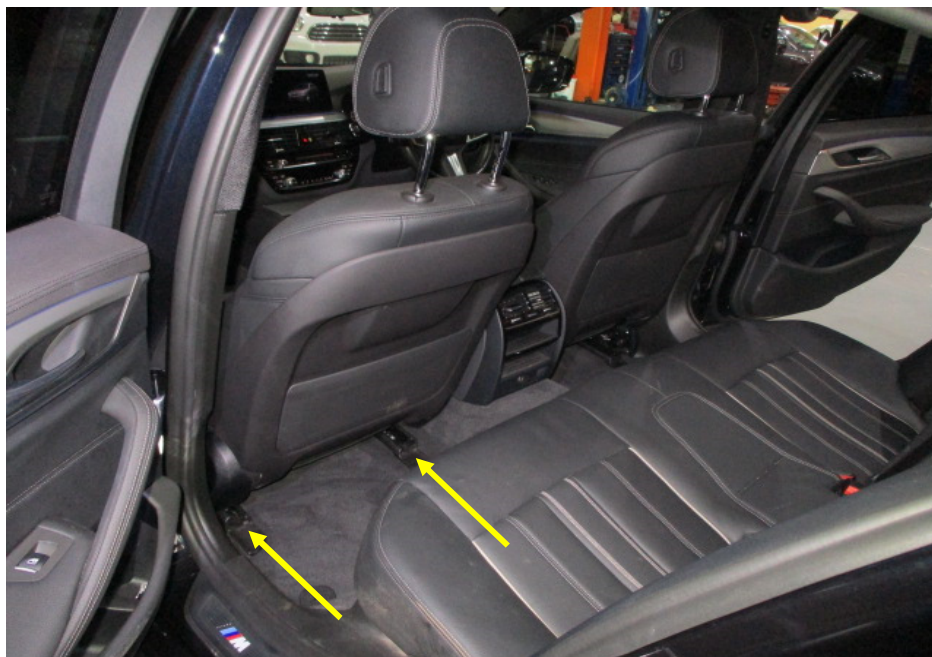
12. The seats of the Motor Car were found to be secured to the floorboard of the Motor Car via seat rails bolted onto the floorboard. Retractable seat belt reels and pre-tensioners were fitted on all seats of the Motor Car. The seat belts were tested and were able to be fastened securely into the respective pre-tensioners that were fixed to the side of all the seats.

**Photo 11** shows the seats of the Motor Car, which were secured via seat rails (arrowed) to the floorboard. All the seats of the Motor Car were fitted with a retractable seat belt reel and pre-tensioner. The seat belts were tested and were able to be fastened into the respective pre-tensions that were fitted on the side of each individual seat.

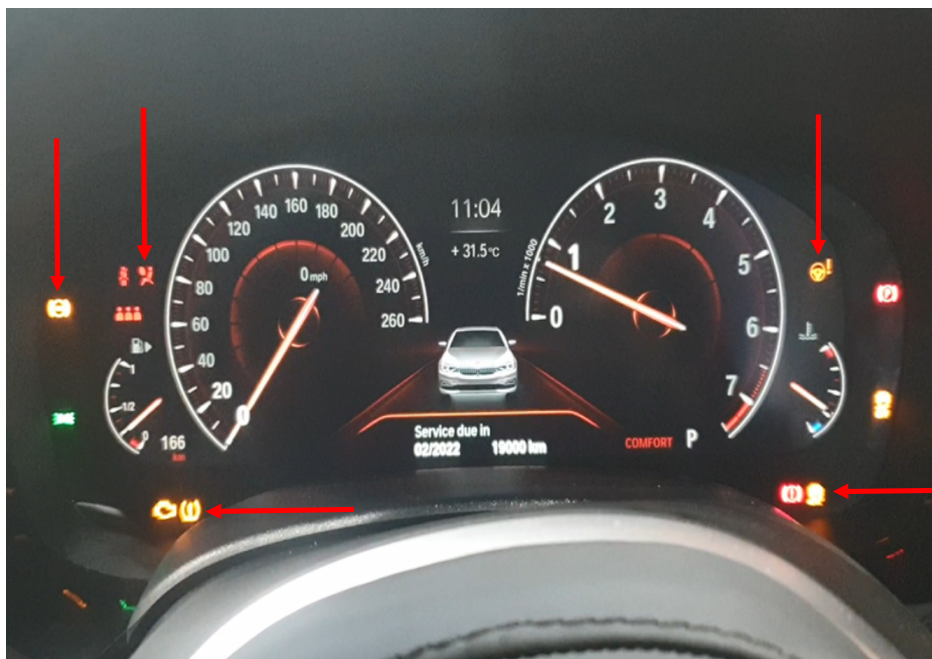
**Photo 12** shows the warning lights for the various electronic safety features appearing on the instrument panel of the Motor Car during its self-test when the engine is cranked, in particular the ABS, SRS, IAS, TPM and DSC lights (arrowed).

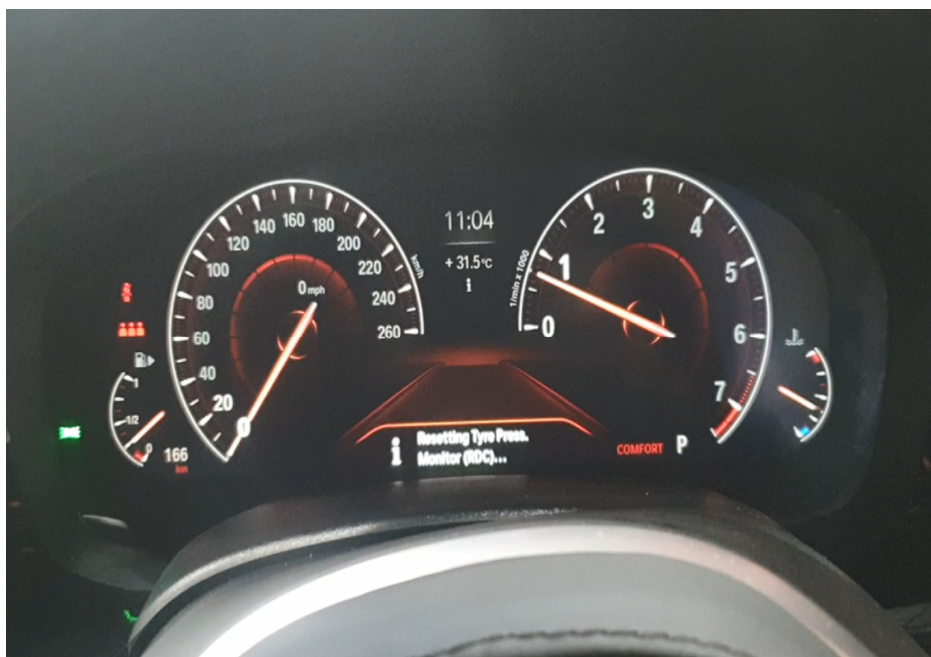
13. The Motor Car's automatic self-test of the functionality of its various electronic safety features like the Anti-Lock Brake System (ABS), Supplemental Restraint System (SRS), Integral Active Steering (IAS), Tyre Pressure Monitor (TPM) and Dynamic Stability Control (DSC) during cranking of the engine had indicated that these electronic systems were in working condition. This was determined from the respective warning lights disappearing from the instrument panel after the self-test.

**Photo 13** shows the respective warning lights no longer illuminated, indicating that there is no fault detected to the ABS, SRS, IAS, TPM and DSC systems of the Motor Car during the self-test. These electronic systems were hence in working condition at the time of my inspection.

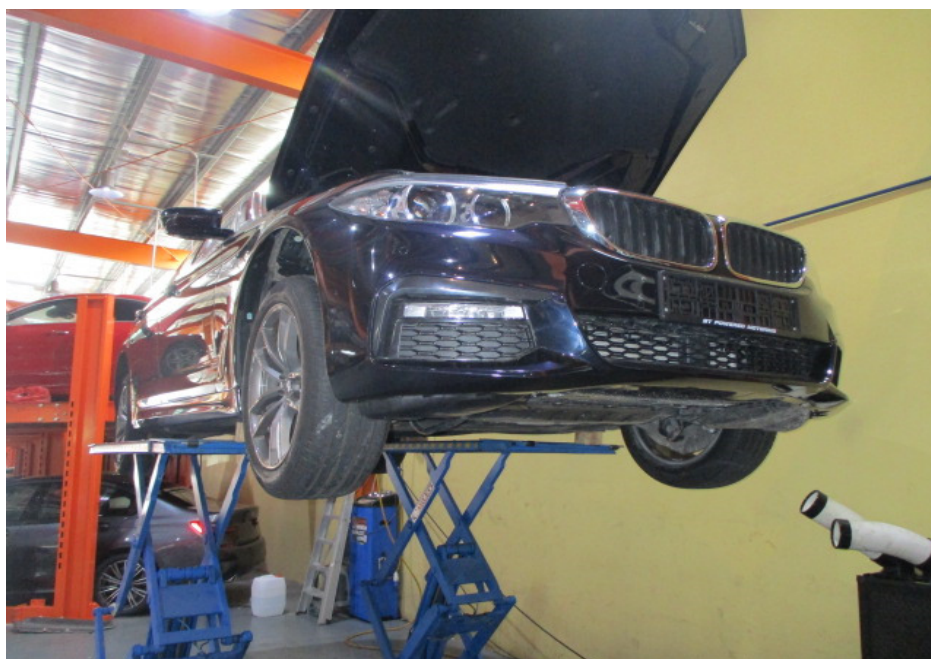
**Photo 14** shows the Motor Car hoisted up for checks on its undercarriage. There was no sign(s) or indication(s) of fluid leakage and/or fluid stain(s) on the underside of the Motor Car. The undercarriage components of the Motor Car were also all observed to be intact and secured in an appropriate manner.

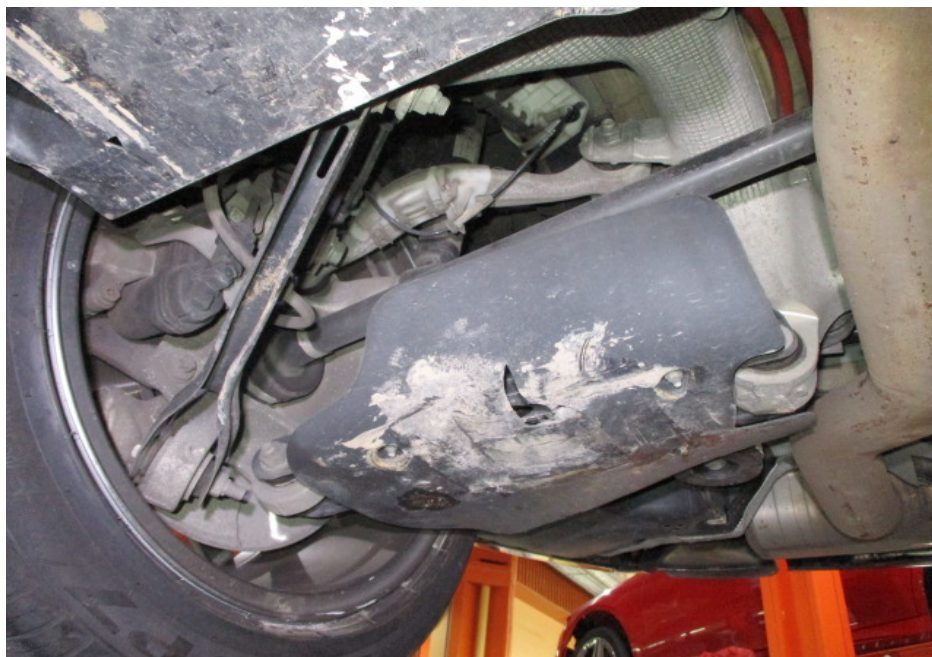
**Photo 15** shows a general view of the control arms and linkages at the rear right wheel of the Motor Car. I did not observe any fluid leak and/or fluid stain on the underside of the Motor Car. All of the Motor Car's undercarriage components were observed to be intact and secured in an appropriate manner.

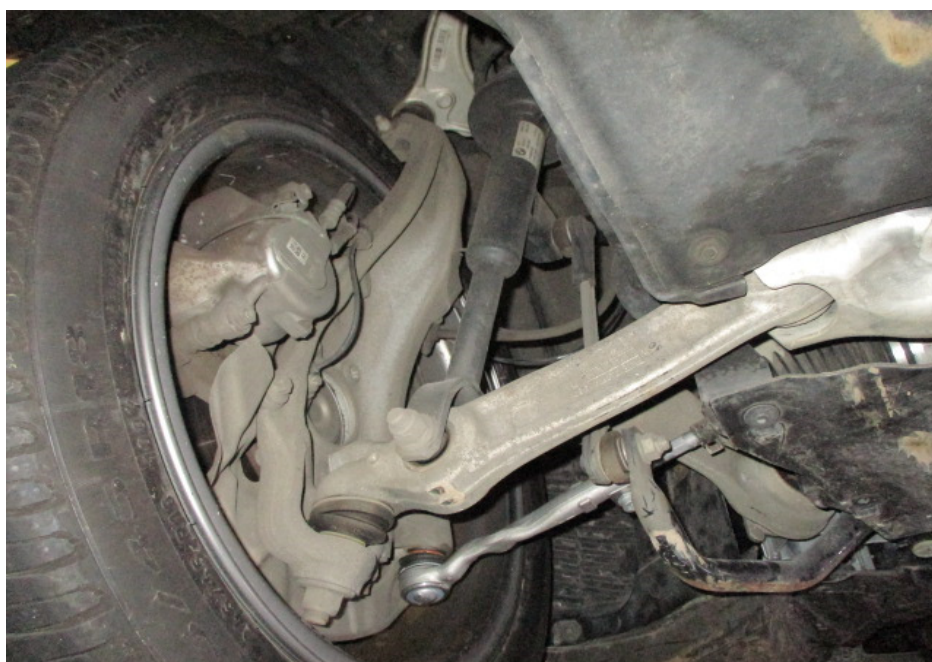
**Photo 16** shows the various undercarriage components at the front left wheel of the Motor Car. The mechanical components, control arms and linkages were all found to be intact and secured in an appropriate manner.

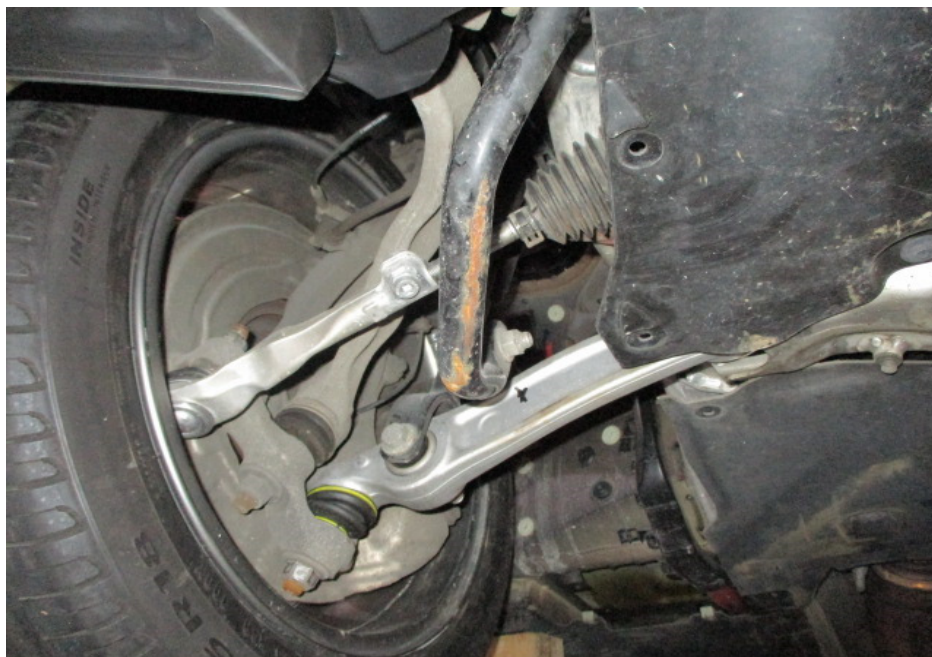
**Photo 17** shows the various undercarriage components at the front right wheel of the Motor Car. The mechanical components, control arms and linkages were all found to be intact and secured in an appropriate manner. I also did not observe any fluid leak and/or fluid stain on the underside of the Motor Car.

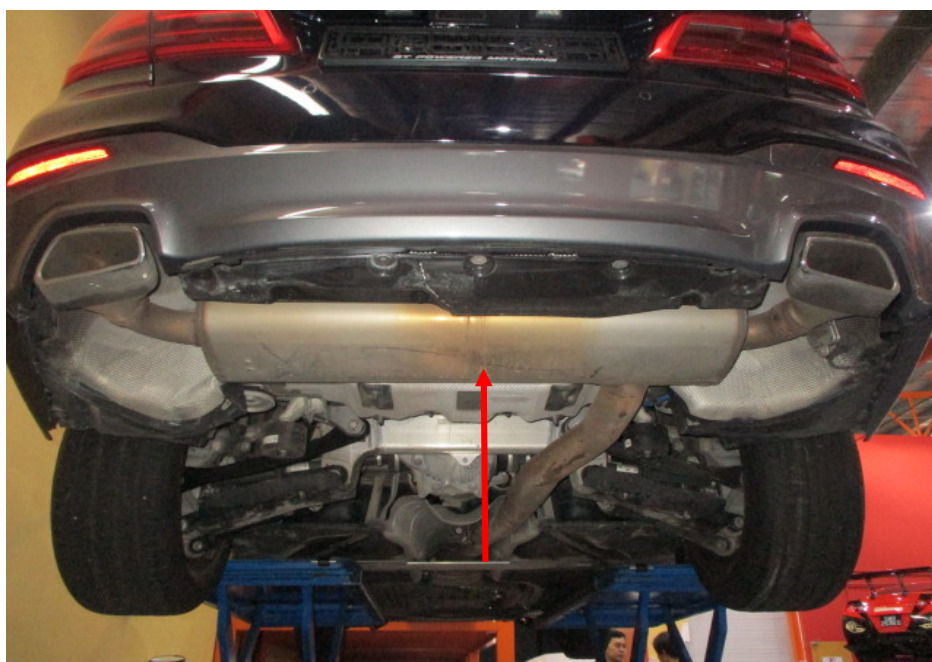
**Photo 18** shows the Motor Car's rear muffler (arrowed). My examination of the Motor Car's exhaust system revealed no sign(s) or indication(s) of any cut or weld marks along its exhaust pipes and on its catalytic converter.

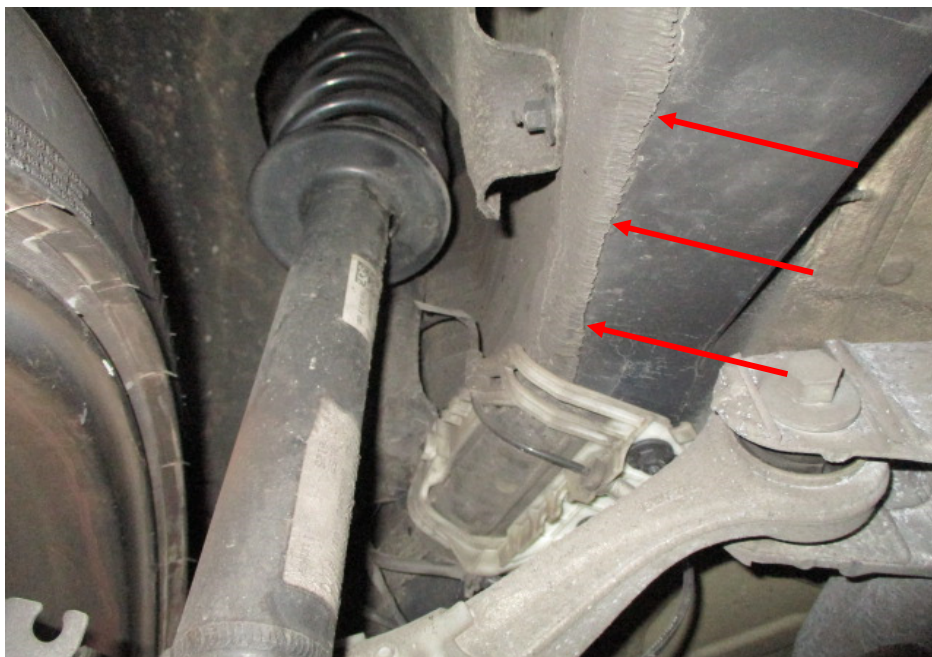
11. Visually, I did not find any weld marks, other than the original spot weld marks, on the chassis/structural body of the Motor Car. The original factory sealant at the joints along the chassis/structural body was also untouched, again indicating that no replacement of the chassis/structural body was carried out; and that the chassis/structural body was originally fitted.

**Photo 19** shows the chassis/structural body at the underside rear left of the Motor Car. I did not find any weld marks other than original spot weld marks on the chassis/structural body of the Motor Car. The original factory sealant (arrowed) at the joints along the chassis/structural body was untouched, indicating no work was done on the chassis/structural body of the Motor Car and that the chassis/structural body was originally fitted.

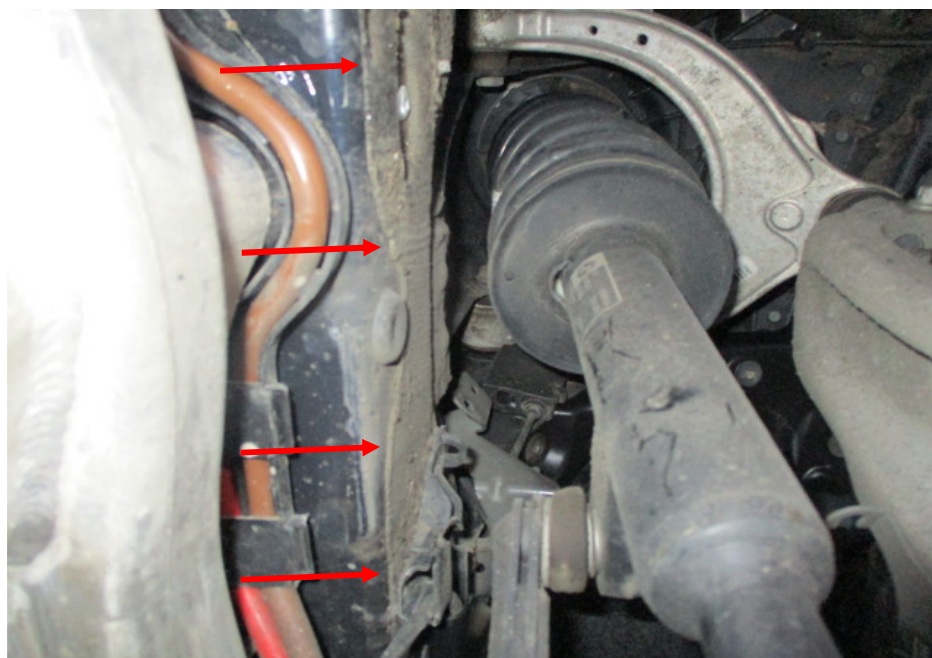
**Photo 20** shows the chassis/structural body at the underside front right of the Motor Car. The original factory sealant (arrowed) at the joints along the chassis/structural body was observed to be untouched. In general, I had found no work was carried out on the chassis/structural body of the Motor Car. The chassis/structural body of the Motor Car was originally fitted.

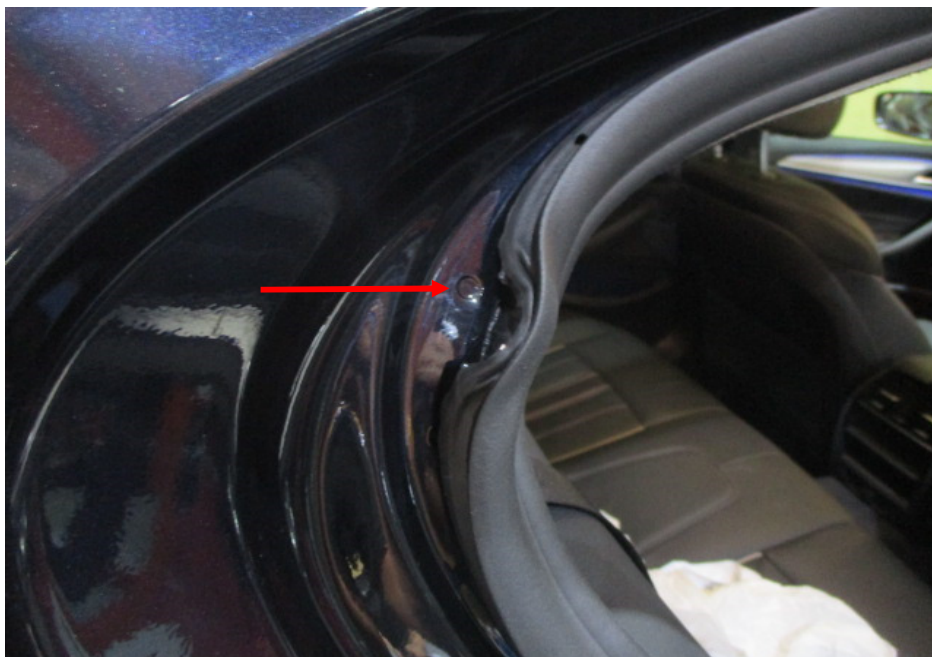
9. The detachable body panels of the Motor Car like the front fenders, front bumper, rear bumper, doors, bonnet and rear bootlid amongst others were all found to be fitted securely.
10. Checks on the non-detachable body panels like the rear fenders, floorboard, roof panel, pillars and rocker panels amongst others, revealed that these body panels were spot welded onto the chassis/structural body of the Motor Car. The original factory sealant at the joints of the non-detachable body panels was all untouched indicating no replacement of the non-detachable body panels was carried out; and that these body panels were all originally fitted.

**Photo 21** shows the right side "C" pillar of the Motor Car. I did not find any weld marks other than original spot weld marks (arrowed) on the right side "C" pillar of the Motor Car which, indicates that there was no re-welding works carried out. In general, I had found all the non-detachable body panels of the Motor Car to be originally fitted at the time of my inspection.
