Your Ref: Mini Countryman
(chassis number WMWYW320103H69511)
Our Ref : CI/TP20014160/D

18 December 2020

INSPECTION REPORT OF AN UNREGISTERD MINI COUNTRYMAN MOTOR CAR WITH CHASSIS NUMBER WMWYW320103H69511

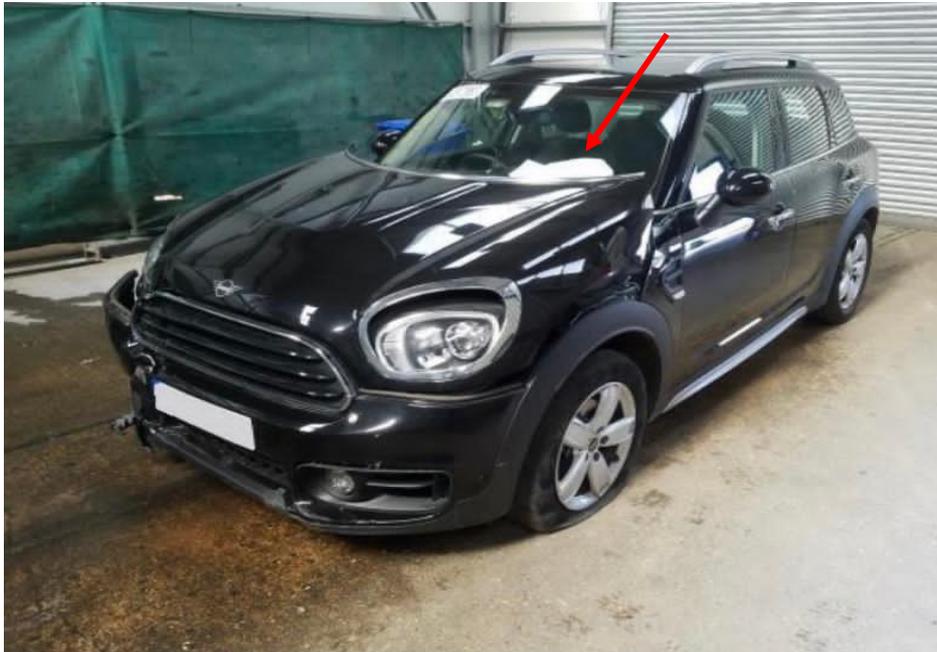
3. From the photographs provided to me, it was observed that the Motor Car had sustained damages at its frontal portion. Body parts damaged include the front bumper, front bumper centre lower grille, front radiator grille, front right foglamp, front right foglamp garnish, front right headlamp chrome moulding and front bonnet amongst others.
4. My review of the photographs provided had also revealed that the front left passenger airbag was deployed. See photo 1 – 4 below.

Photo 1 shows the front left body of the Motor Car (photograph provided to me). The Motor Car was observed to have sustained damage at its frontal portion. The front bumper and front bonnet were amongst the body parts that were observed to have been damaged. The front left passenger airbag (arrowed) was also observed to be deployed.

22. The body parts at the frontal portion of the Motor Car were visually examined and it was noted that the repair/restoration works carried out to the damaged area of the Motor Car (refer photograph 1 & 2 above) were reasonably adequate and in order.

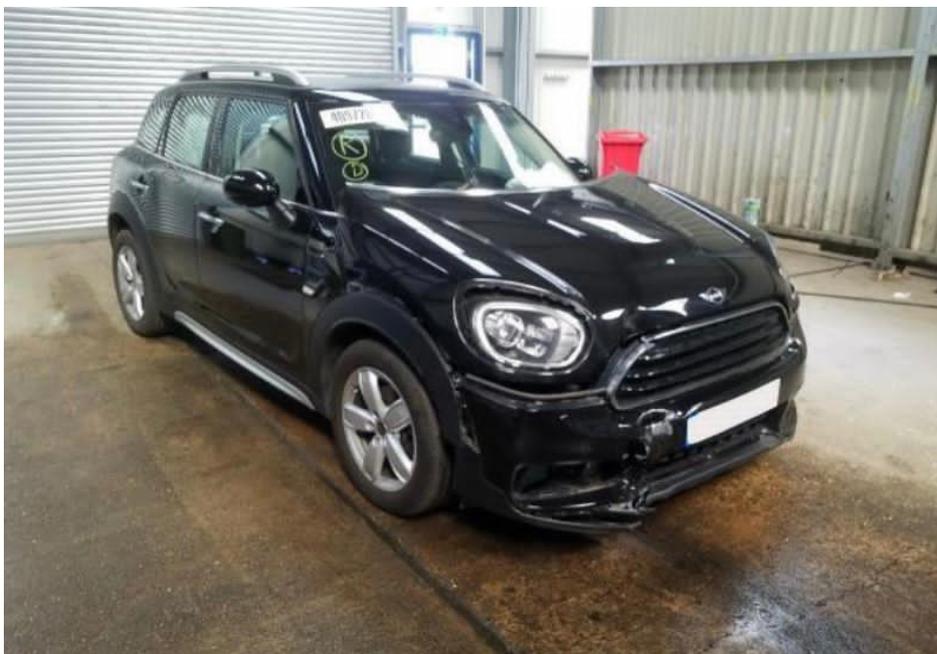
Photo 2 shows the front right body of the Motor Car (photograph provided to me). The Motor Car was observed to have sustained damage at its frontal portion. The front bumper, front radiator grille, front bonnet, front right foglamp, front right foglamp garnish and front right headlamp chrome moulding were amongst the body parts that were observed to have been damaged.

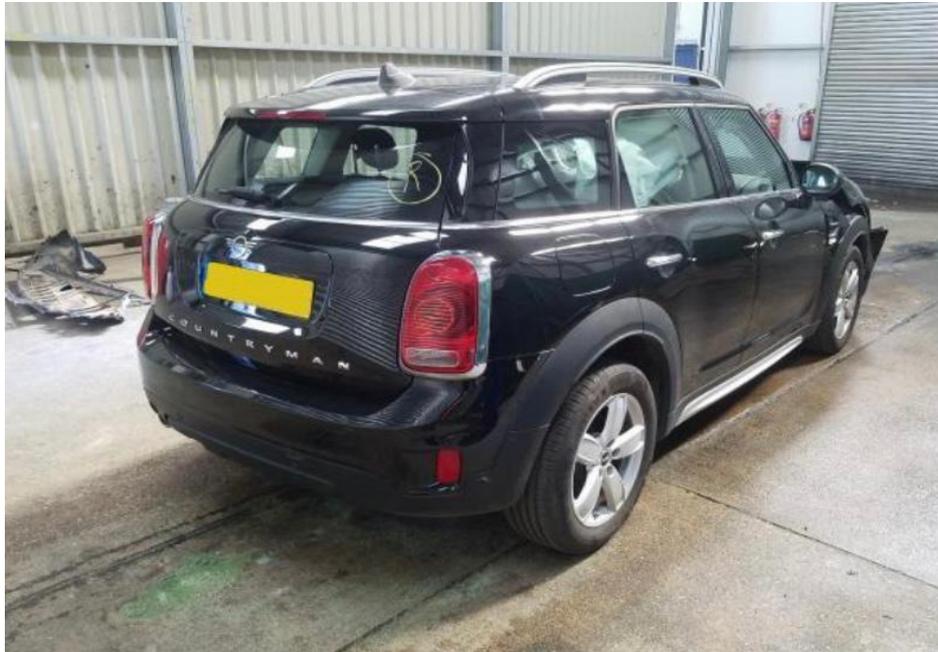
Photo 3 shows the rear right body of the Motor Car (photograph provided to me). Apart for the frontal portion, there was no physical damage seen to other areas of the Motor Car.

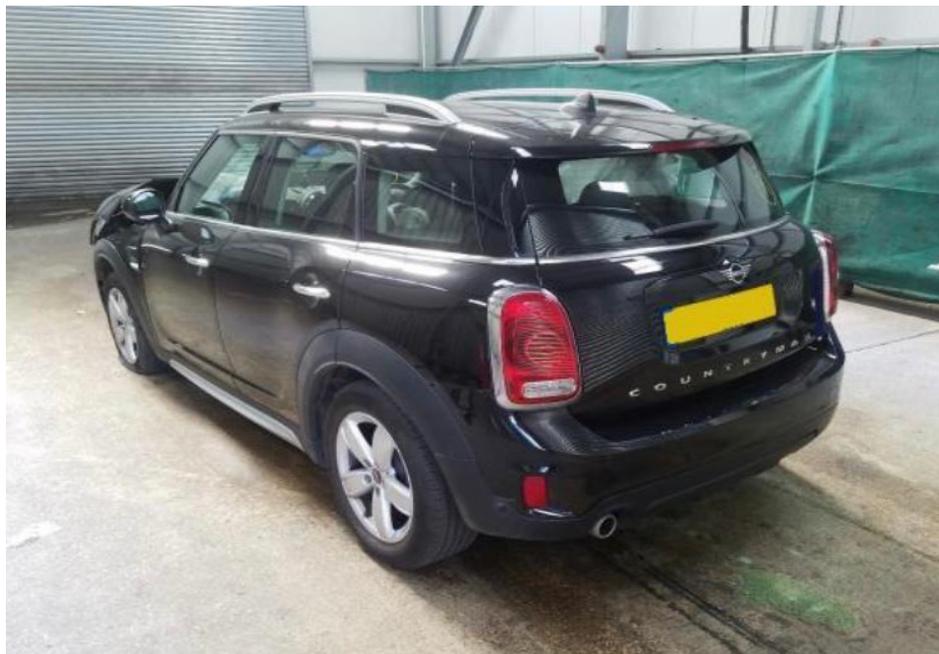
Photo 4 shows the rear left body of the Motor Car (photograph provided to me). Apart for the frontal portion, there was no physical damage seen to other areas of the Motor Car.

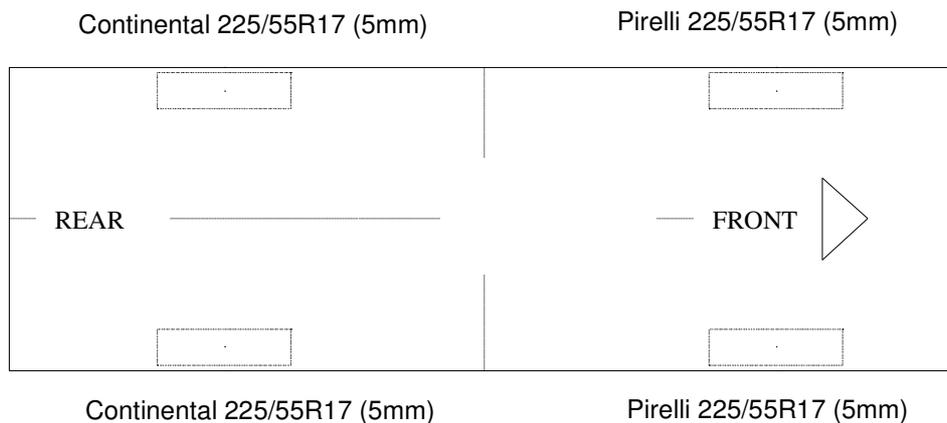
8. It was fitted with 17inch sport wheel rims that were wrapped with tyres that were observed to be of serviceable condition. The tyres were also sufficiently inflated for vehicular operation. The tyre brand, tyre size and approximate remaining tread depth of the 4 tyres of the Motor Car were recorded as follows: -

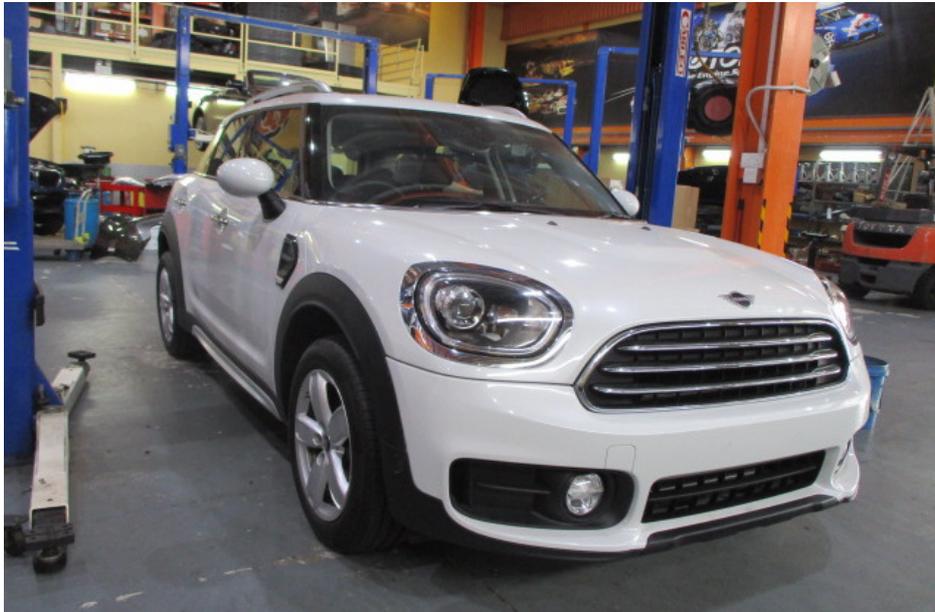
Photo 5 shows a general view of the front right body of the Motor Car at the time of my inspection. The Motor Car was observed to be in a relatively good general condition with no loose exterior fittings observed. The body parts at the frontal portion of the Motor Car were visually examined and it was observed that the repair/restoration works carried out to the damaged area of the Motor Car (refer to photograph 1 & 2 above) were reasonably adequate and in order.

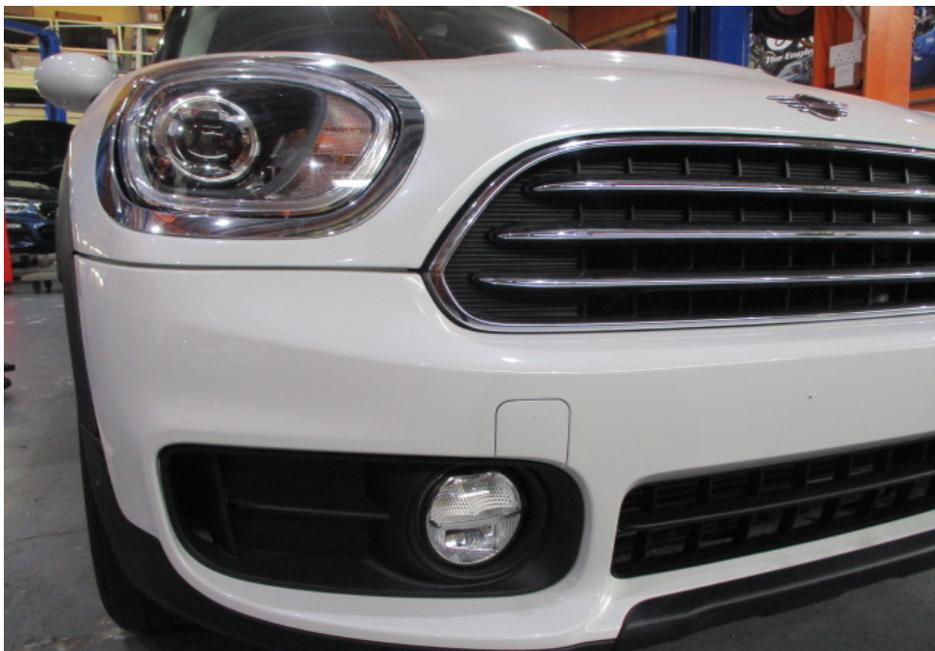
Photo 6 shows a closer view of the front bumper, front bumper centre lower grille, front right foglamp, front right foglamp garnish and front bonnet of the Motor Car at the time of my inspection. The body parts at the frontal portion of the Motor Car were visually examined and it was observed that the repair/restoration works carried out to the damaged area of the Motor Car (refer to photograph 1 & 2 above) were reasonably adequate and in order.

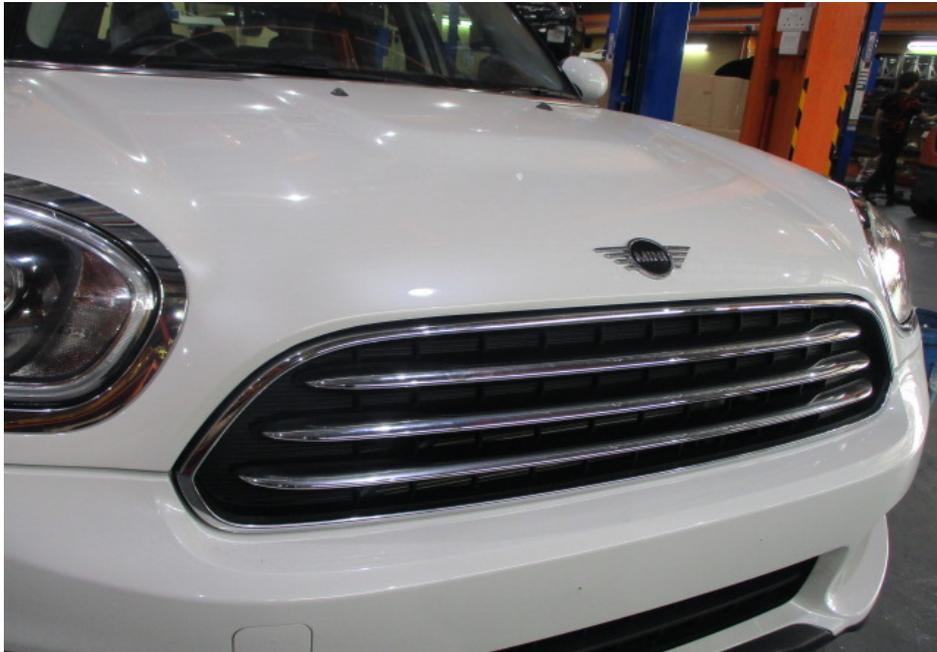
Photo 7 shows a closer view of the front bumper, front radiator grille and front bonnet of the Motor Car at the time of my inspection. The body parts at the frontal portion of the Motor Car were visually examined and it was observed that the repair/restoration works carried out to the damaged area of the Motor Car (refer to photograph 1 & 2 above) were reasonably adequate and in order.

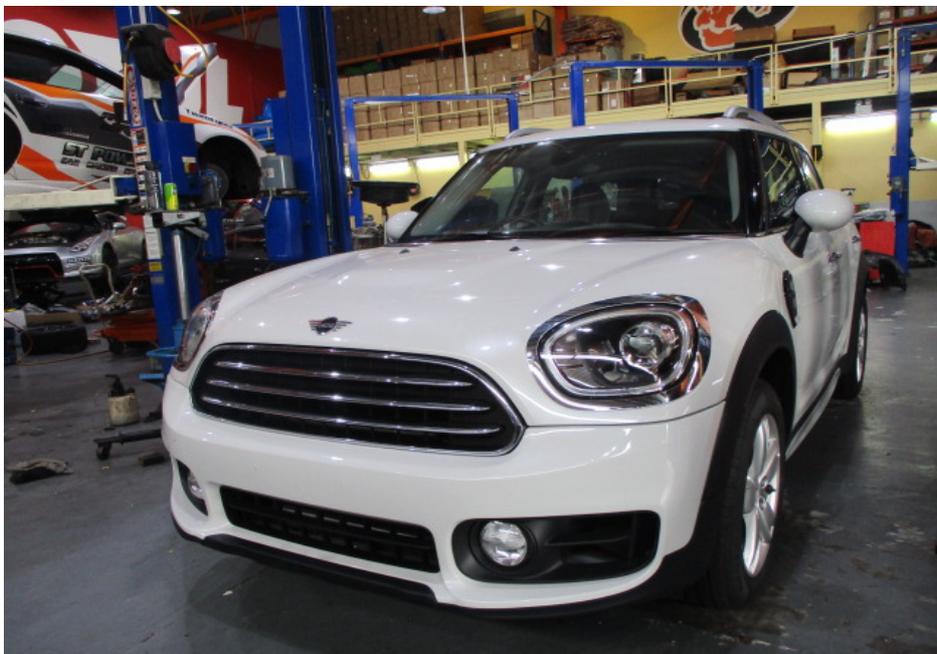
Photo 8 shows a general view of the front left body of the Motor Car at the time of my inspection. The Motor Car was observed to be in a relatively good general condition with no loose exterior fittings observed. The body parts at the frontal portion of the Motor Car were visually examined and it was observed that the repair/restoration works carried out to the damaged area of the Motor Car (refer to photograph 1 & 2 above) were reasonably adequate and in order.

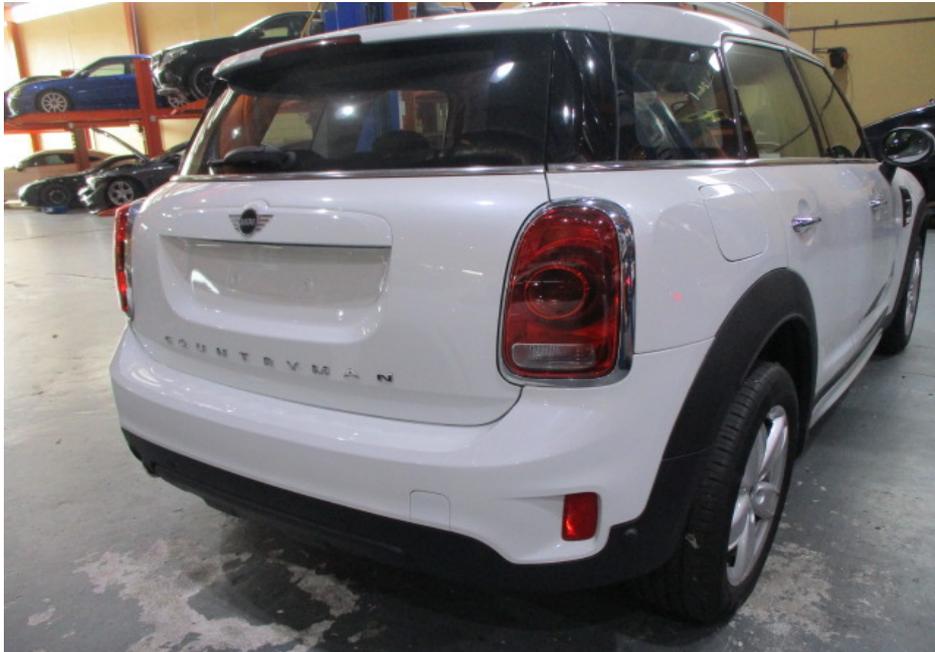
Photo 9 shows a general view of the rear right body of the Motor Car at the time of my inspection. The Motor Car was observed to be in a relatively good general condition with no loose exterior fittings observed. The body colour of the Motor Car was changed from black colour to white colour. The mileage of the Motor Car recorded at the time of my inspection was 12,940km.

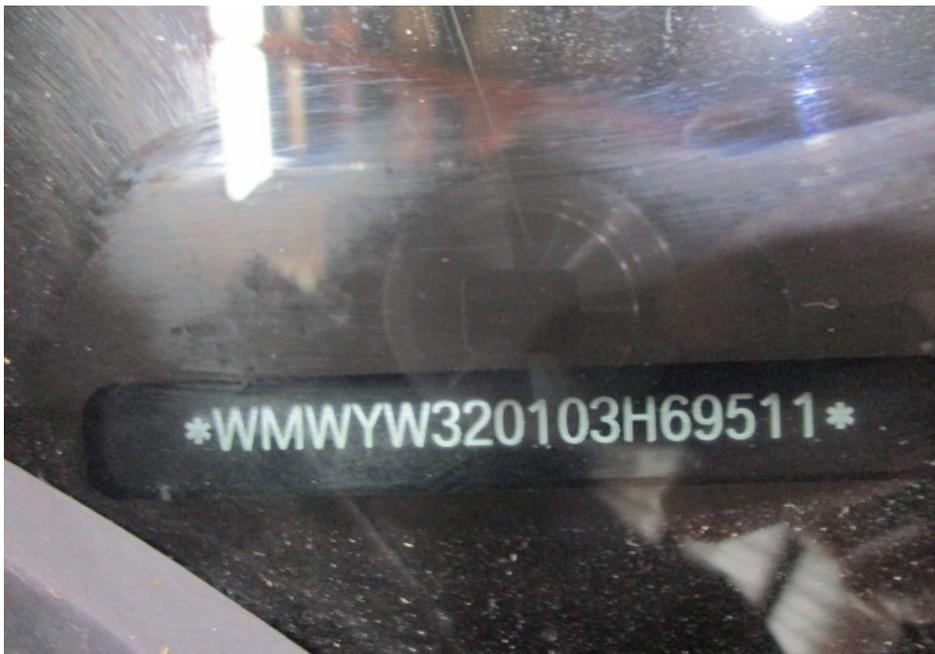
Photo 10 shows the chassis number of the Motor Car. The chassis number recorded was WMWYW320103H69511.

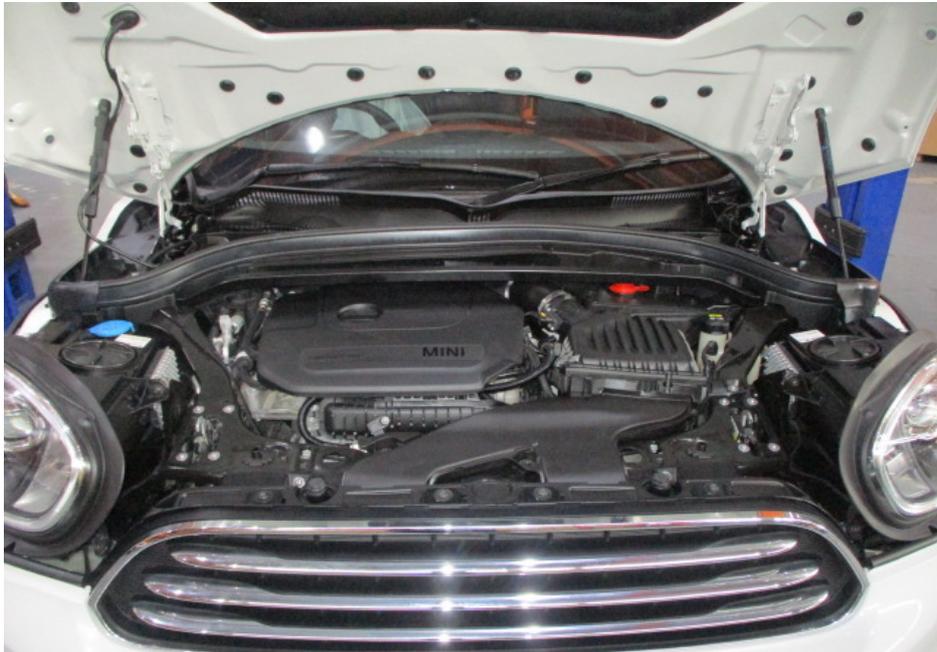
Photo 11 shows a general view of the engine compartment of the Motor Car at the time of my inspection. The various parts and components inside the engine compartment were all observed to be intact and properly fitted. There was also no sign(s) or indication(s) of fluid leak and/or fluid stain found inside the engine compartment.

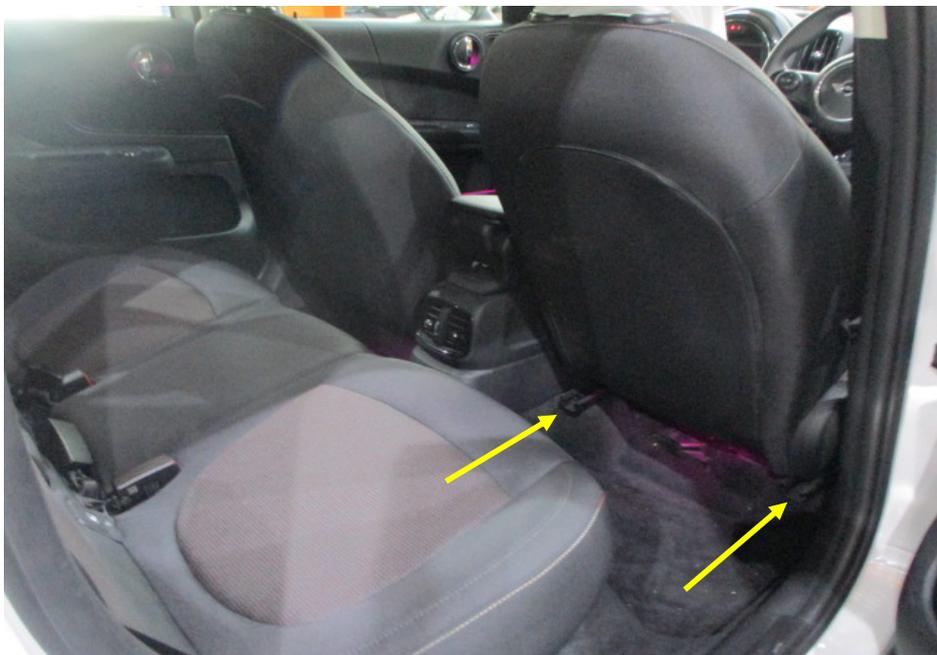
Photo 12 shows the seats of the Motor Car, which were secured via seat rails (arrowed) to the floorboard. All the seats of the Motor Car were fitted with a retractable seat belt reel and pre-tensioner. The seat belts were tested and were able to be fastened into the respective pre-tensions that were fitted on the side of each individual seat.

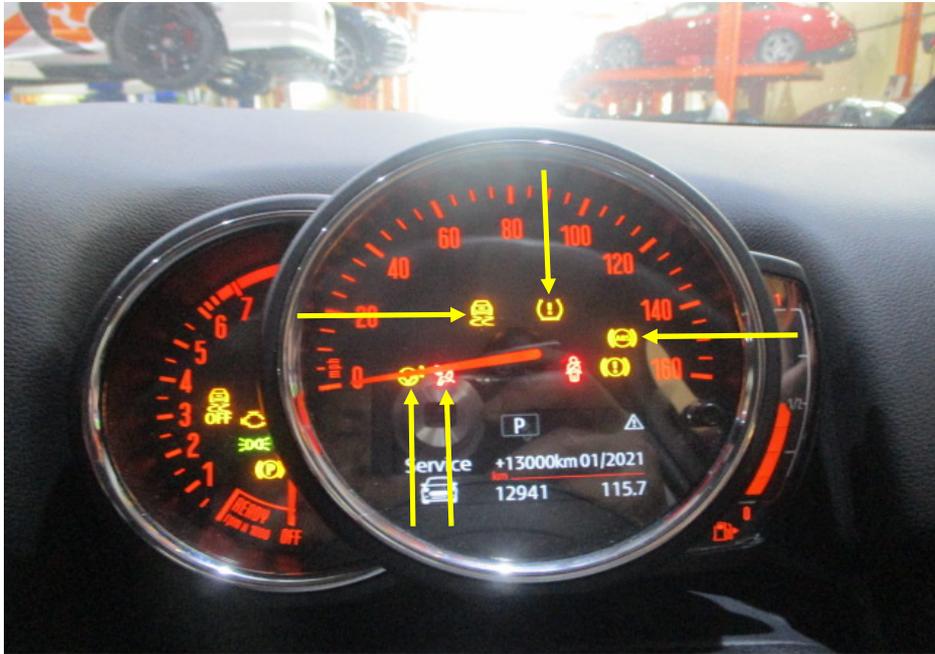
Photo 13 shows the warning lights for the various electronic safety features appearing on the instrument panel of the Motor Car during its self-test when the engine is cranked, in particular the ABS, SRS, PAS, TPM and DSC lights (arrowed).

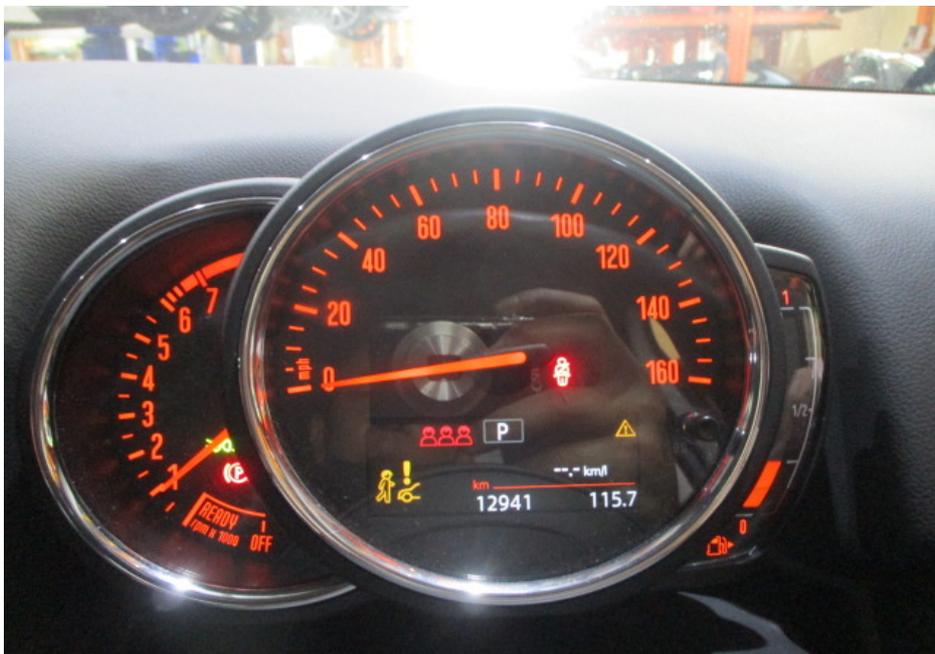
Photo 14 shows the respective warning lights no longer illuminated, indicating that there is no fault detected to the ABS, SRS, PAS, TPM and DSC systems of the Motor Car during the self-test. These electronic systems were hence in working condition at the time of my inspection.

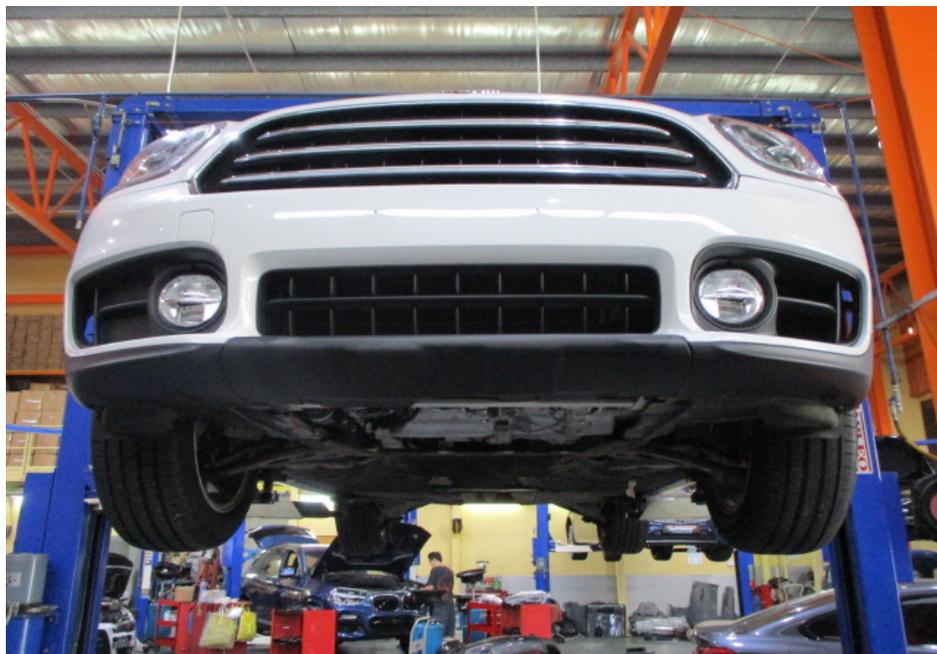
Photo 15 shows the Motor Car hoisted up for checks on its undercarriage. There was no sign(s) or indication(s) of fluid leakage and/or fluid stain(s) on the underside of the Motor Car. The undercarriage components of the Motor Car were also all observed to be intact and secured in an appropriate manner.

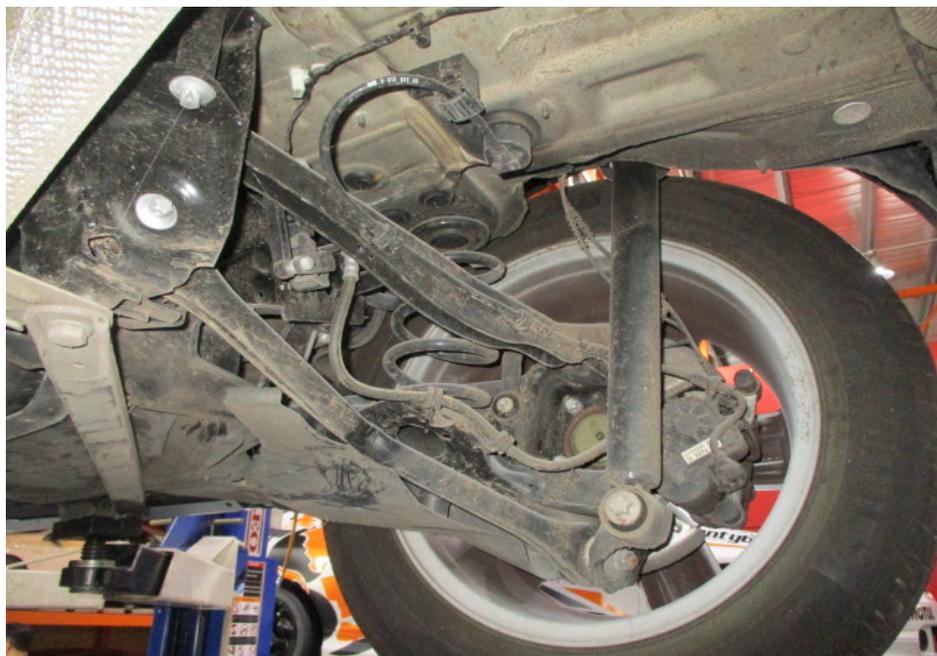
Photo 16 shows a general view of the control arms and linkages at the rear right wheel of the Motor Car. I did not observe any fluid leak and/or fluid stain on the underside of the Motor Car. All of the Motor Car's undercarriage components were observed to be intact and secured in an appropriate manner.

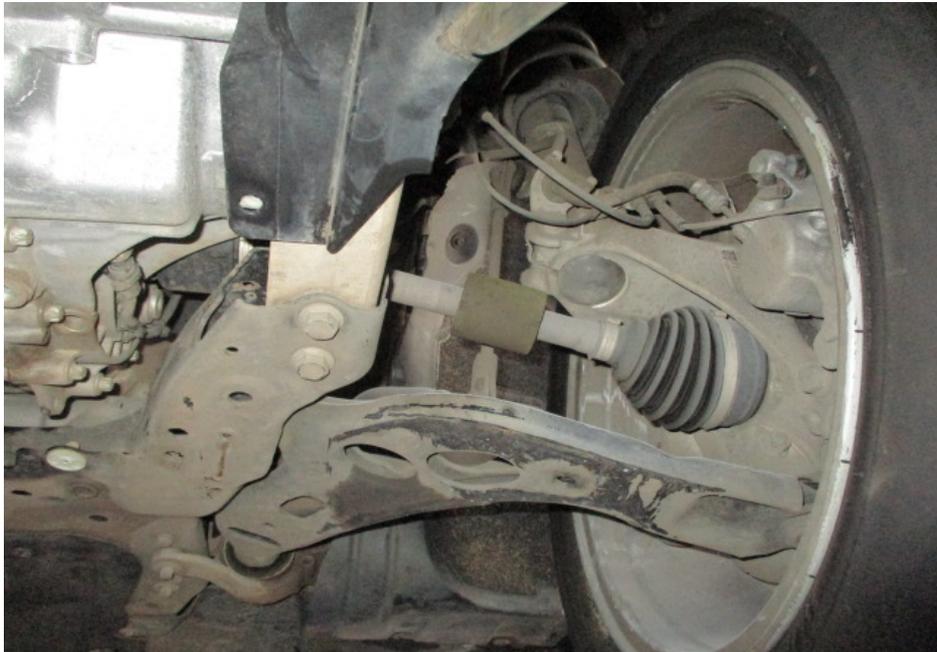
Photo 17 shows the various undercarriage components at the front left wheel of the Motor Car. The mechanical components, control arms and linkages were all found to be intact and secured in an appropriate manner.

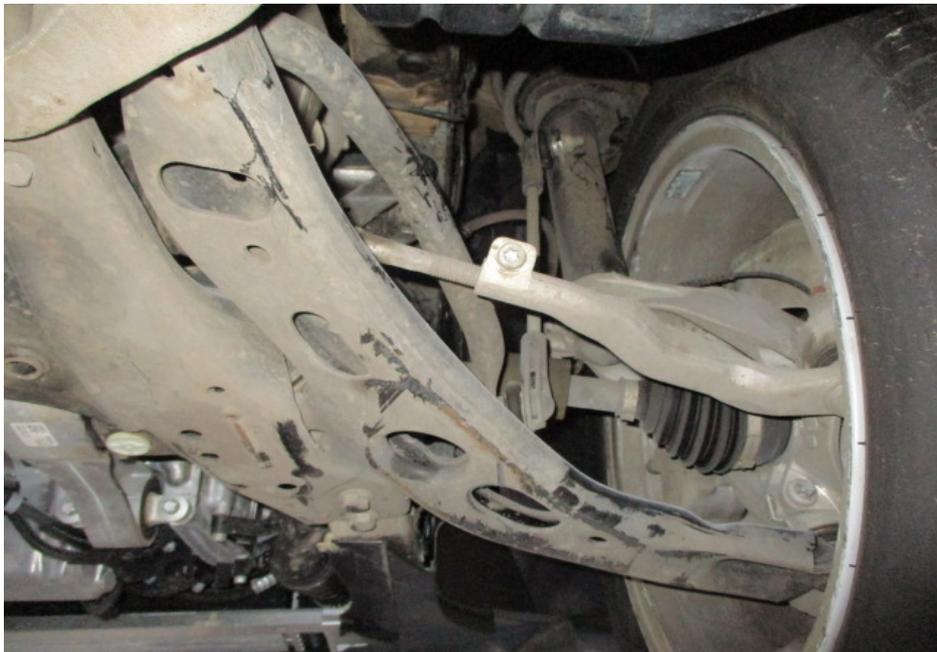
Photo 18 shows the various undercarriage components at the front right wheel of the Motor Car. The mechanical components, control arms and linkages were all found to be intact and secured in an appropriate manner. I also did not observe any fluid leak and/or fluid stain on the underside of the Motor Car.

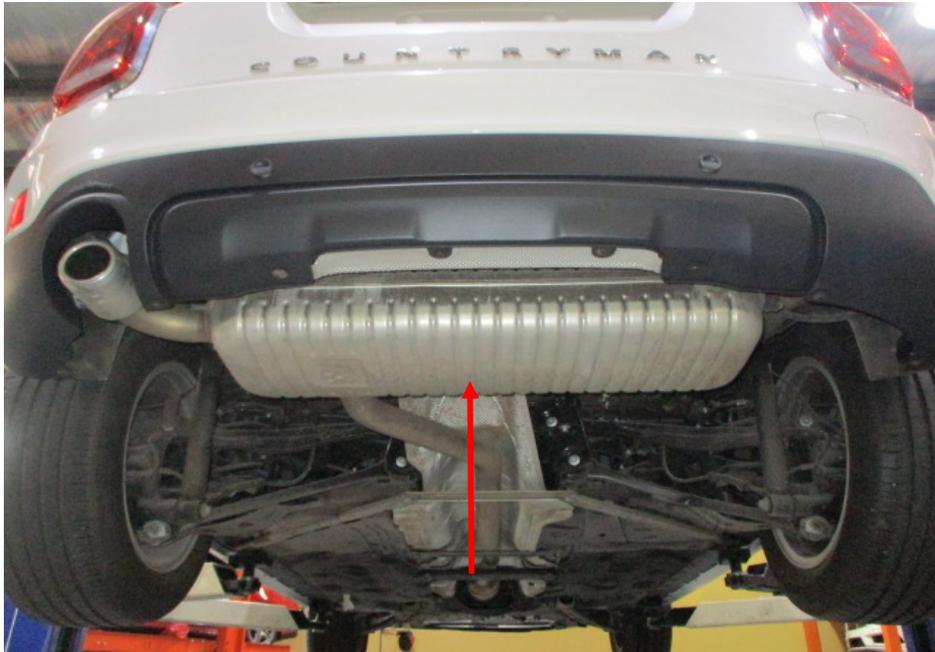
Photo 19 shows the Motor Car's rear muffler (arrowed). My examination of the Motor Car's exhaust system revealed no sign(s) or indication(s) of any cut or weld marks along its exhaust pipes and on its catalytic converter.

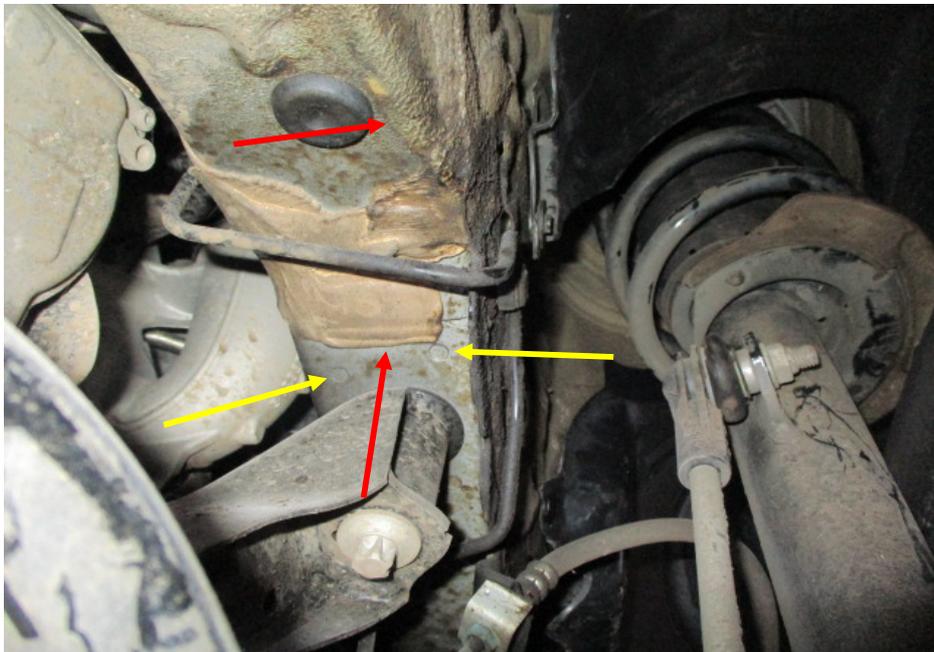
Photo 20 shows the chassis/structural body at the underside front right of the Motor Car. I did not find any weld marks other than original spot weld marks (yellow arrow) on the chassis/structural body of the Motor Car. The original factory sealant (red arrow) at the joints along the chassis/structural body was untouched, indicating no work was done on the chassis/structural body of the Motor Car and that the chassis/structural body was originally fitted.

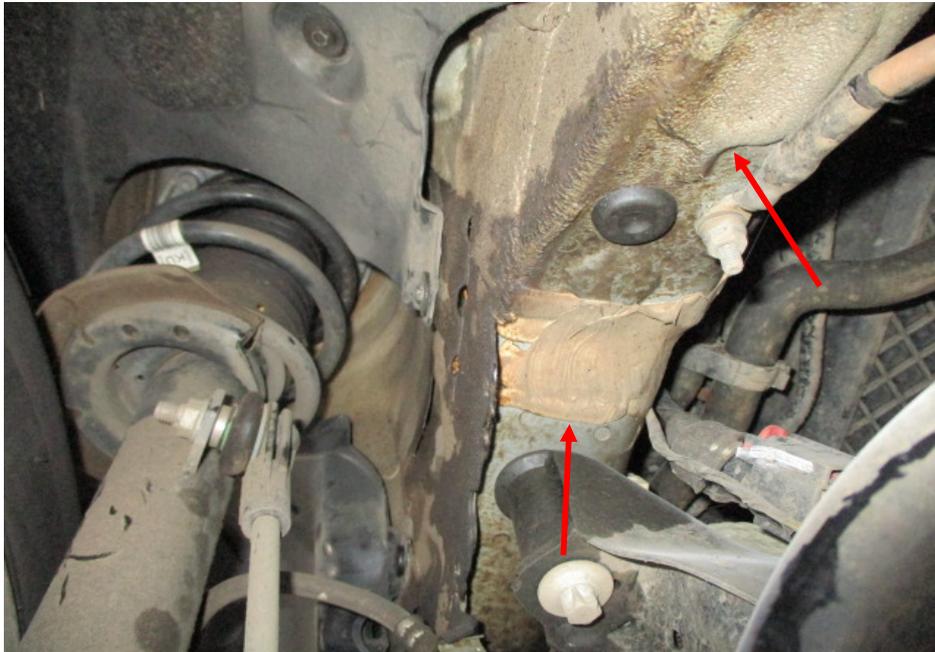
Photo 21 shows the chassis/structural body at the underside front left of the Motor Car. The original factory sealant (arrowed) at the joints along the chassis/structural body was observed to be untouched. In general, I had found no work was carried out on the chassis/structural body of the Motor Car. The chassis/structural body of the Motor Car was originally fitted.

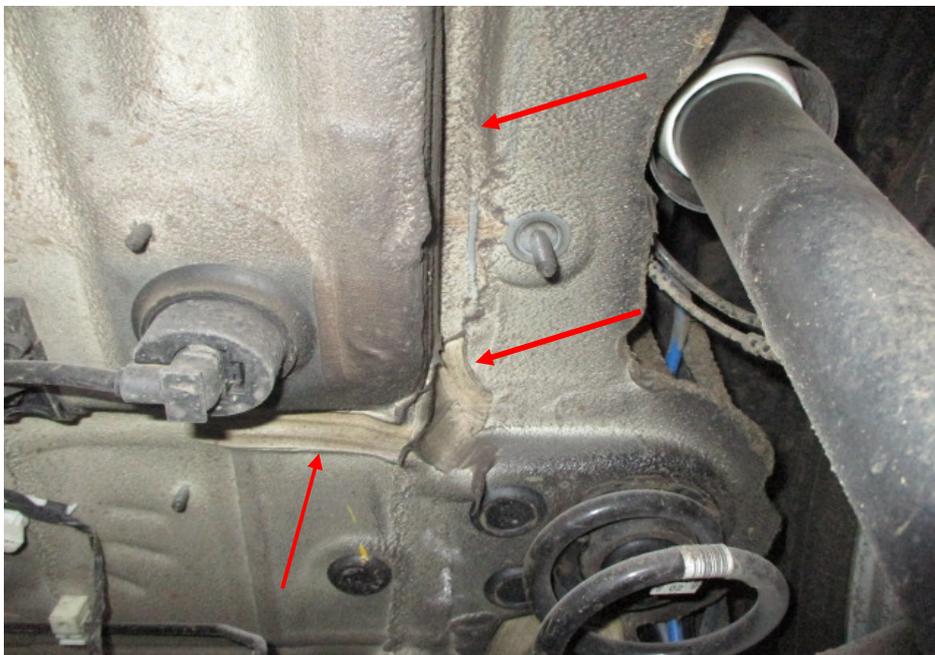
Photo 22 shows the chassis/structural body at the underside rear right of the Motor Car. The original factory sealant (arrowed) at the joints along the chassis/structural body was observed to be untouched. In general, I had found no work was carried out on the chassis/structural body of the Motor Car. The chassis/structural body of the Motor Car was originally fitted.

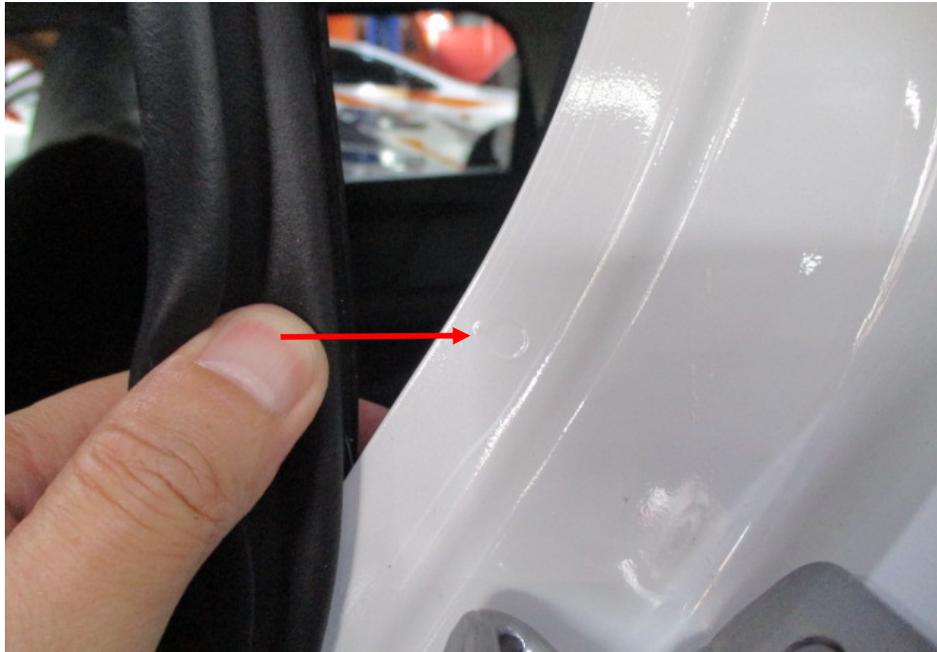
Photo 23 shows the left side "C" pillar of the Motor Car. I did not find any weld marks other than original spot weld marks (arrowed) on the left side "C" pillar of the Motor Car which, indicates that there was no re-welding works carried out. In general, I had found all the non-detachable body panels of the Motor Car to be originally fitted at the time of my inspection.
