Your Ref: Honda Type R
(chassis number SHHFK8730JU600800)

19 December 2020

Our Ref : CI/TP20014161/D

**INSPECTION REPORT OF AN UNREGISTERD HONDA TYPE R MOTOR CAR
WITH CHASSIS NUMBER SHHFK8730JU600800**

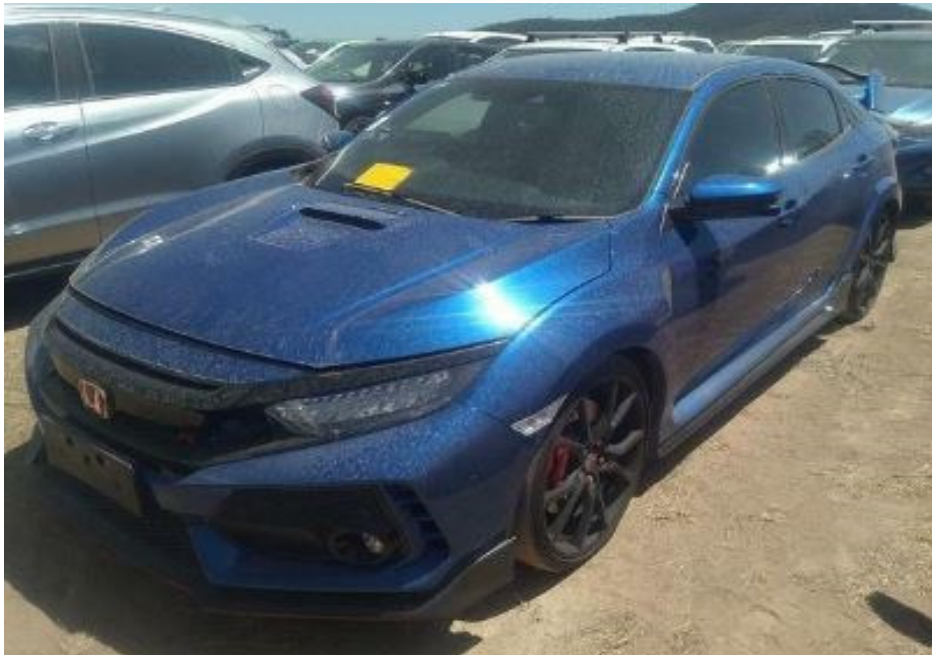
Photo 1 shows the front left body of the Motor Car (photograph provided to me). There was no physical damage seen to the Motor Car from the photographs that were provided to me.

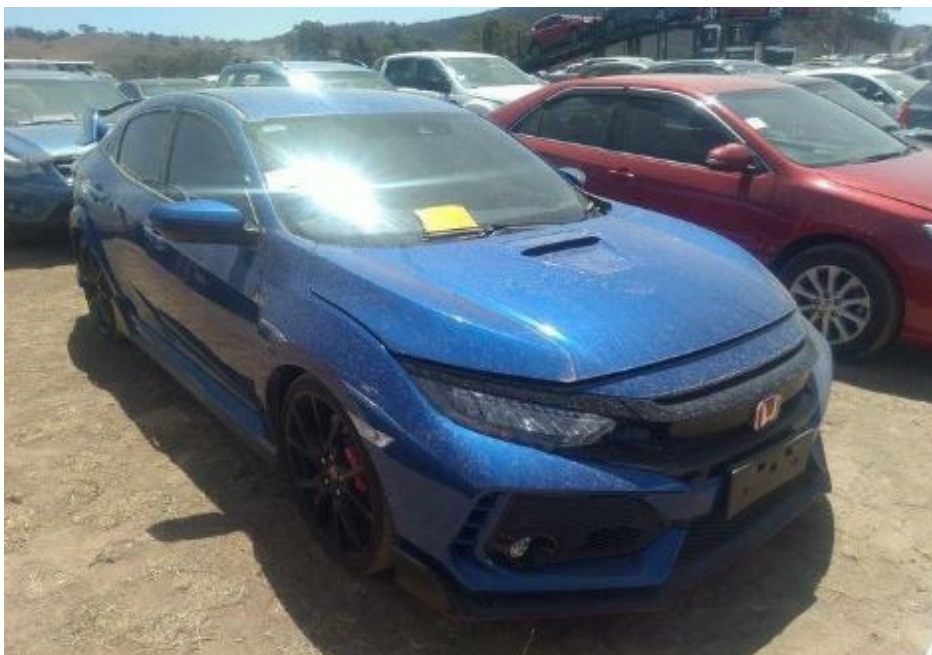
Photo 2 shows the front right body of the Motor Car (photograph provided to me). There was no physical damage seen to the Motor Car from the photographs that were provided to me.

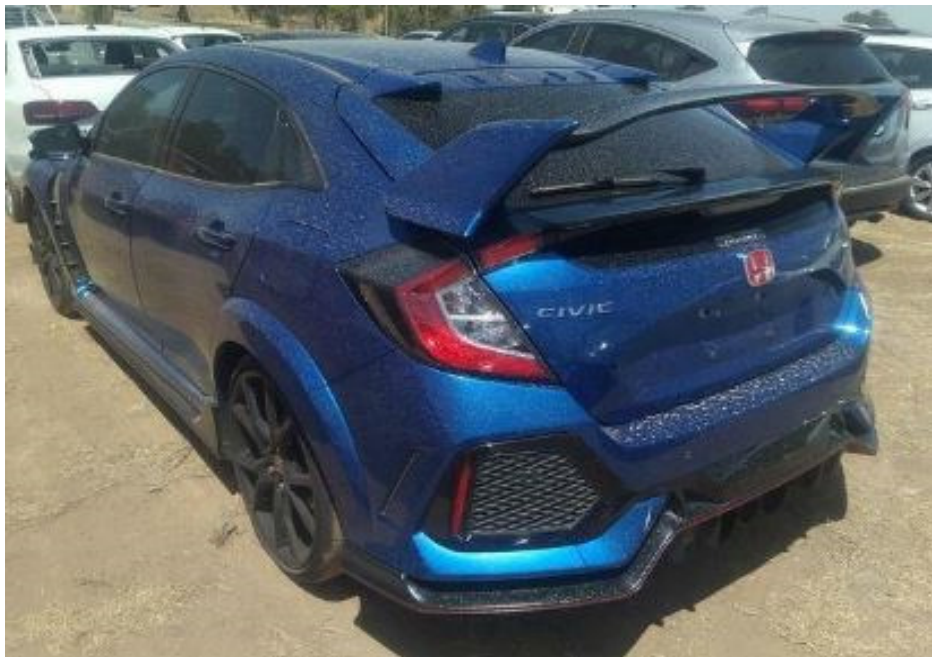
Photo 3 shows the rear left body of the Motor Car (photograph provided to me). There was no physical damage seen to the Motor Car from the photographs that were provided to me.

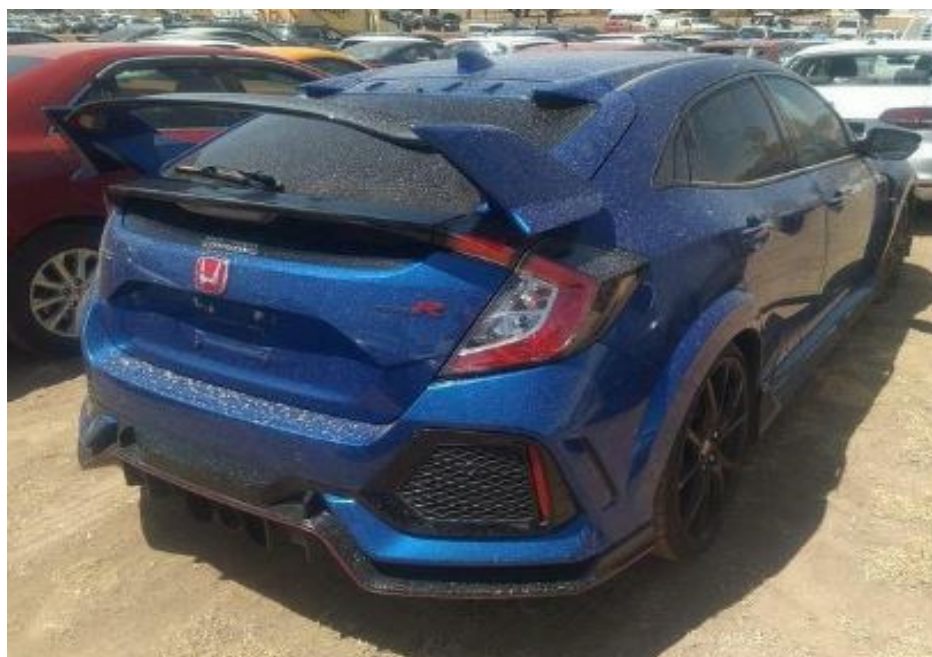
Photo 4 shows the rear right body of the Motor Car (photograph provided to me). There was no physical damage seen to the Motor Car from the photographs that were provided to me.

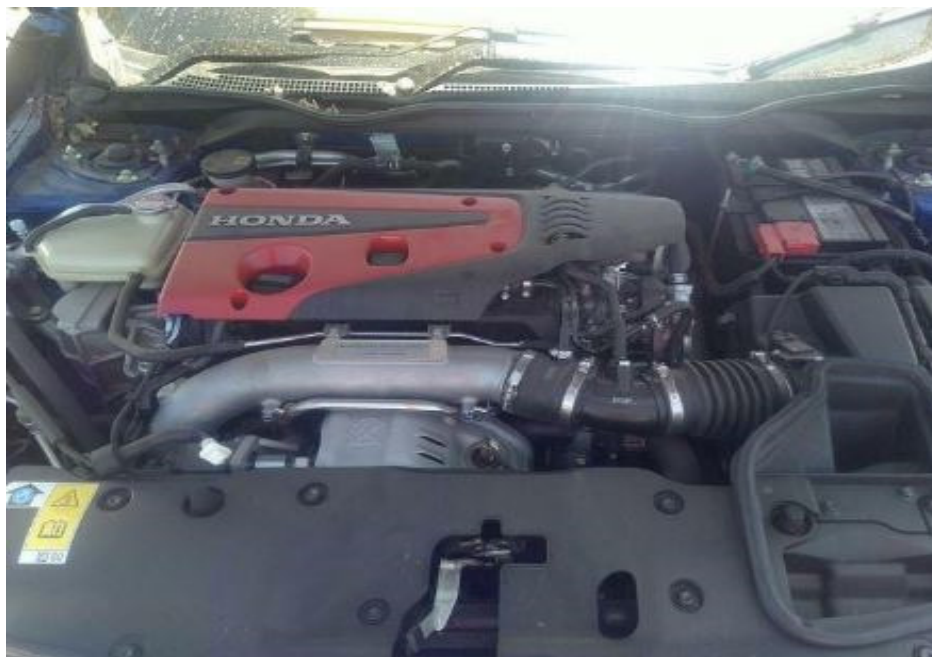
Photo 5 shows the engine compartment of the Motor Car (photograph provided to me). There was no physical damage seen to the various parts and components within the engine compartment of the Motor Car.

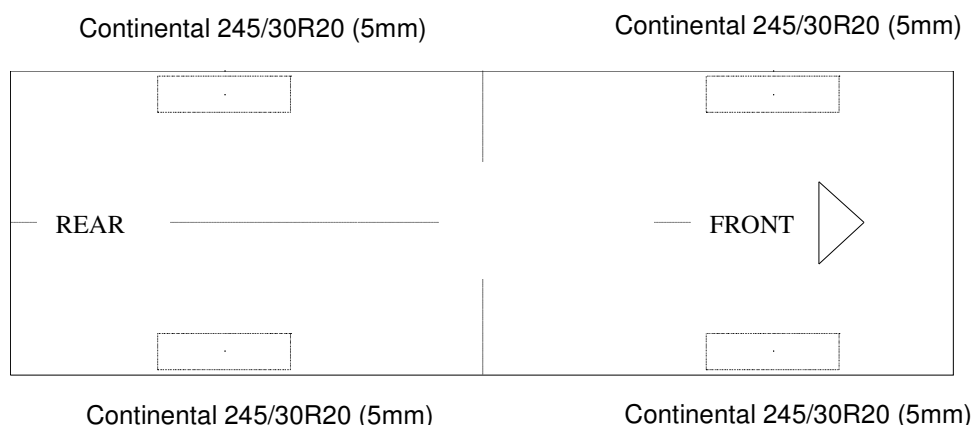
7. It was fitted with 20inch sport wheel rims that were wrapped with tyres that were observed to be of serviceable condition. The tyres were also sufficiently inflated for vehicular operation. The tyre brand, tyre size and approximate remaining tread depth of the 4 tyres of the Motor Car were recorded as follows: -

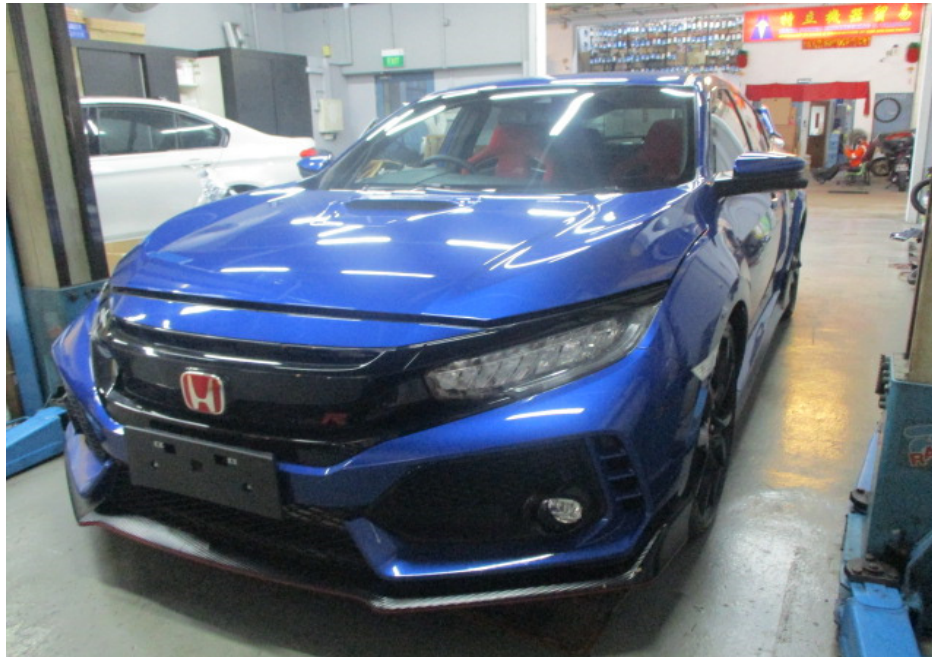
Photo 6 shows a general view of the front left body of the Motor Car at the time of my inspection. The Motor Car was observed to be in a relatively good general condition with no loose exterior fittings observed.

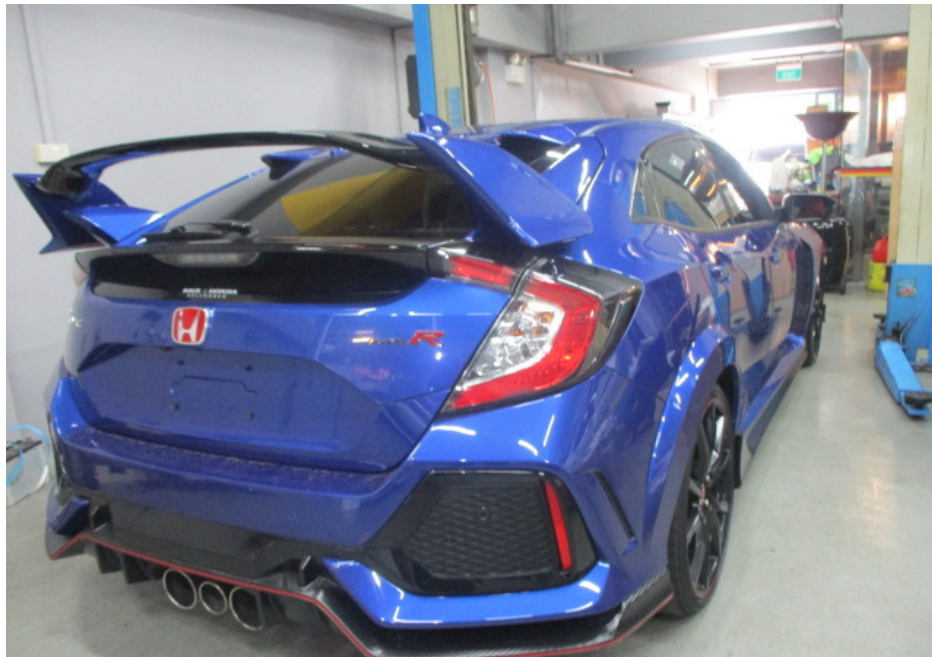
Photo 7 shows a general view of the rear right body of the Motor Car at the time of my inspection. The Motor Car was observed to be in a relatively good general condition with no loose exterior fittings observed. The mileage of the Motor Car recorded at the time of my inspection was 15,185km.

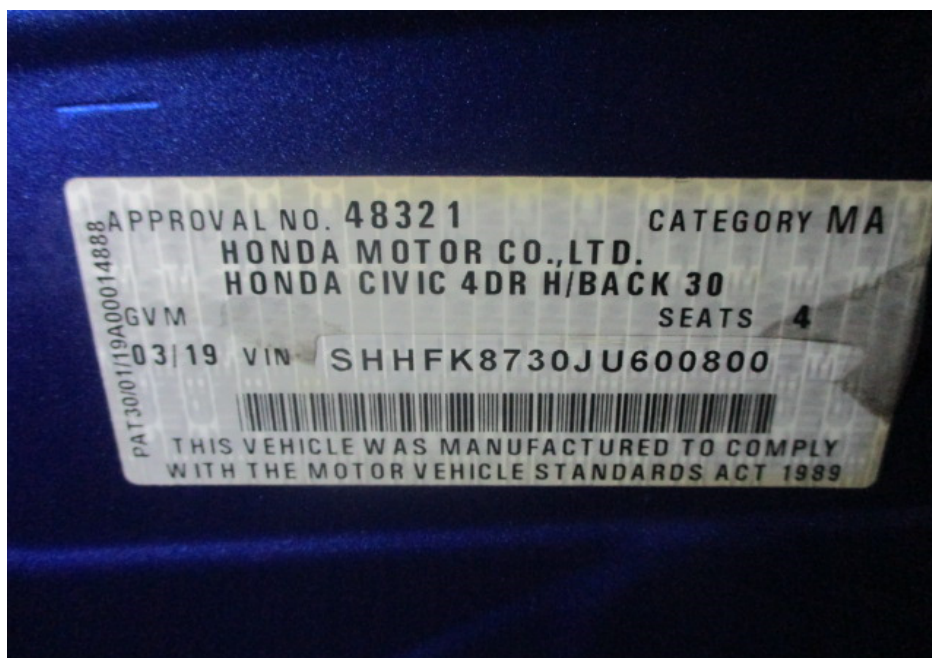
Photo 8 shows the chassis number of the Motor Car. The chassis number recorded was SHHFK8730JU600800.

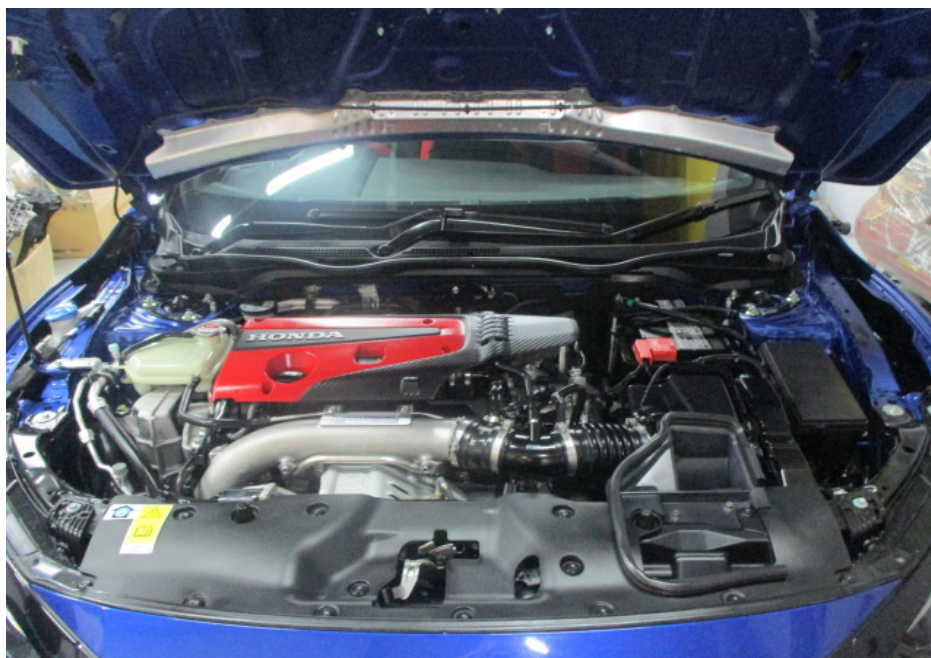
13. My examination of the engine compartment of the Motor Car revealed that the various parts and components inside the engine compartment were all intact and properly fitted. The engine oil, brake fluid and engine coolant were all found to be of sufficient level for operating purposes. Visually, there was also no contamination found to these fluids.
14. My checks on the underside of the Motor Car revealed no sign(s) or indication(s) of fluid leakage and/or fluid stain(s). The engine block and automatic transmission assembly were both secured properly. All undercarriage components of the Motor Car were also observed to be intact and secured in an appropriate manner.

Photo 9 shows a general view of the engine compartment of the Motor Car at the time of my inspection. The various parts and components inside the engine compartment were all observed to be intact and properly fitted. There was also no sign(s) or indication(s) of fluid leak and/or fluid stain found inside the engine compartment.

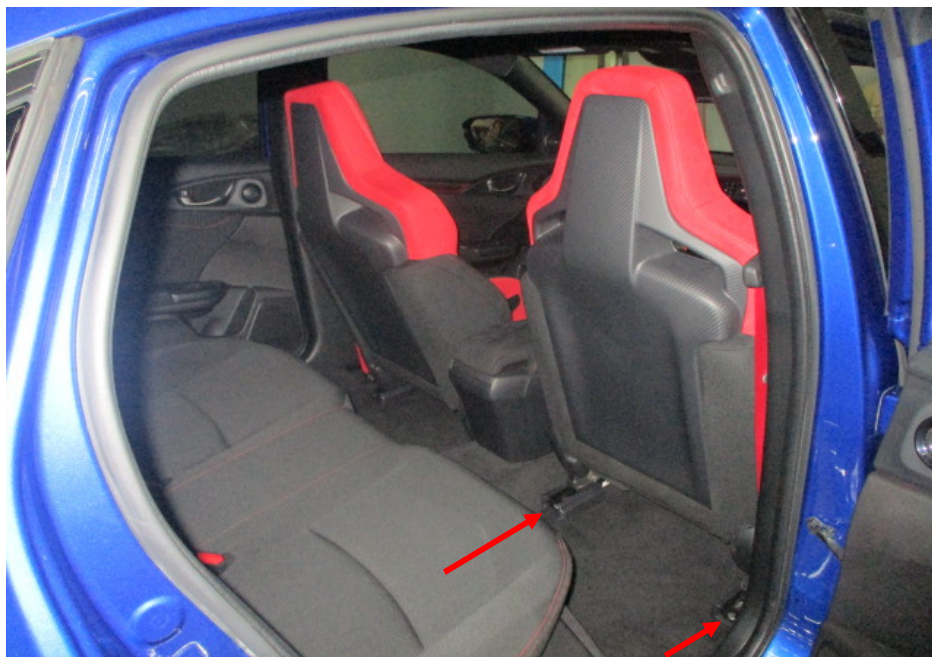
11. The seats of the Motor Car were found to be secured to the floorboard of the Motor Car via seat rails bolted onto the floorboard. Retractable seat belt reels and pre-tensioners were fitted on all seats of the Motor Car. The seat belt reels were tested and were able to be fastened securely into the respective pre-tensioners that were fixed to the side of all the seats.

Photo 10 shows the seats of the Motor Car, which were secured via seat rails (arrowed) to the floorboard. All the seats of the Motor Car were fitted with a retractable seat belt reel and pre-tensioner. The seat belts were tested and able to be fastened into the respective pre-tensions that were fitted on the side of each individual seat.

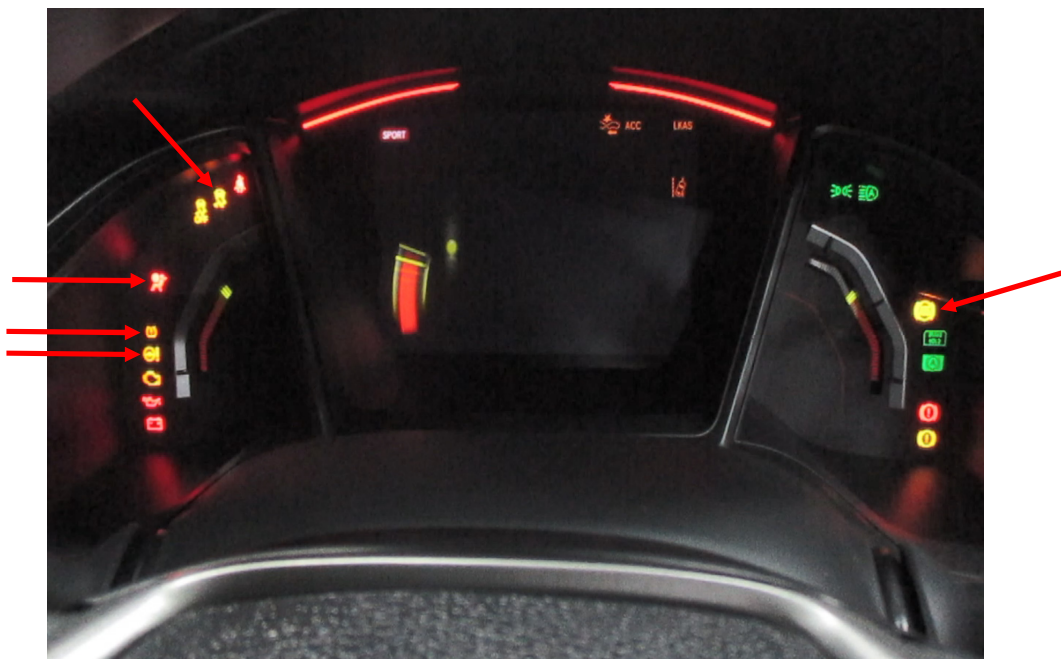
Photo 11 shows the warning lights for the various electronic safety features appearing on the instrument panel of the Motor Car during its self-test when the engine is cranked, in particular the ABS, SRS, VSA, TPM and EPS lights (arrowed).

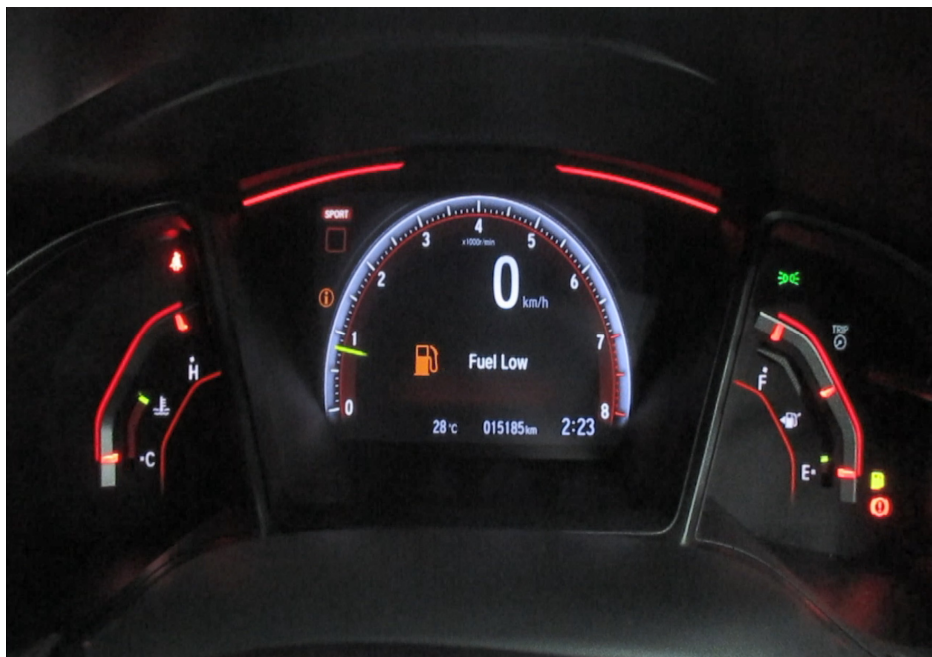
12. The Motor Car's automatic self-test of the functionality of its various electronic safety features like the Anti-Lock Brake System (ABS), Supplemental Restraint System (SRS), Vehicle Stability Assist (VSA), Tyre Pressure Monitor (TPM) and Electric Power Steering (EPS) during cranking of the engine had indicated that these electronic systems were in working condition. This was determined from the respective warning lights disappearing from the instrument panel after the self-test.

Photo 12 shows the respective warning lights no longer illuminated, indicating that there is no fault detected to the ABS, SRS, VSA, TPM and EPS systems of the Motor Car during the self-test. These electronic systems were hence in working condition at the time of my inspection.

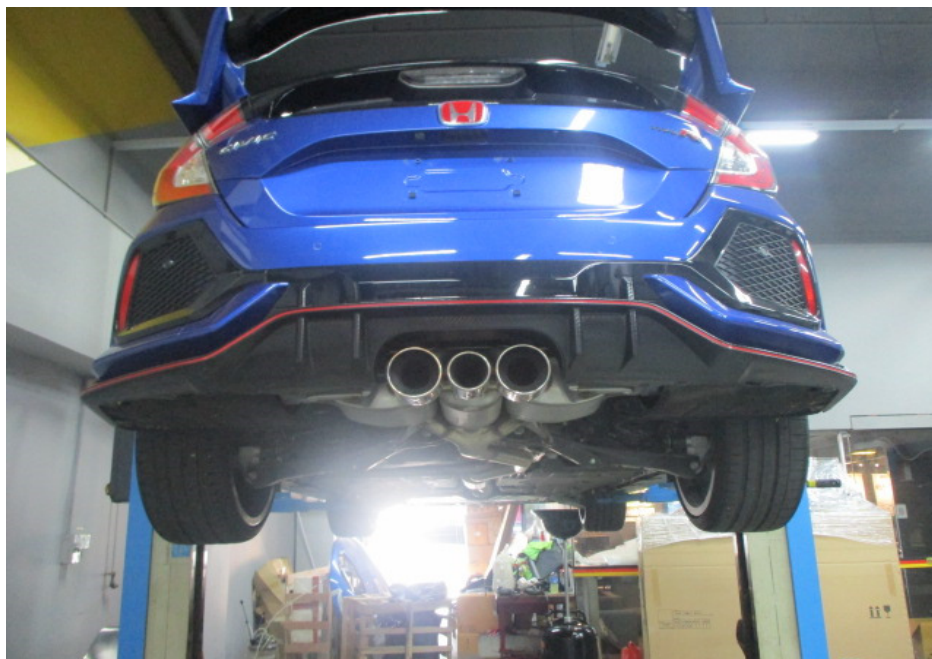
Photo 13 shows the Motor Car hoisted up for checks on its undercarriage. There was no sign(s) or indication(s) of fluid leakage and/or fluid stain(s) on the underside of the Motor Car. The undercarriage components of the Motor Car were also all observed to be intact and secured in an appropriate manner.

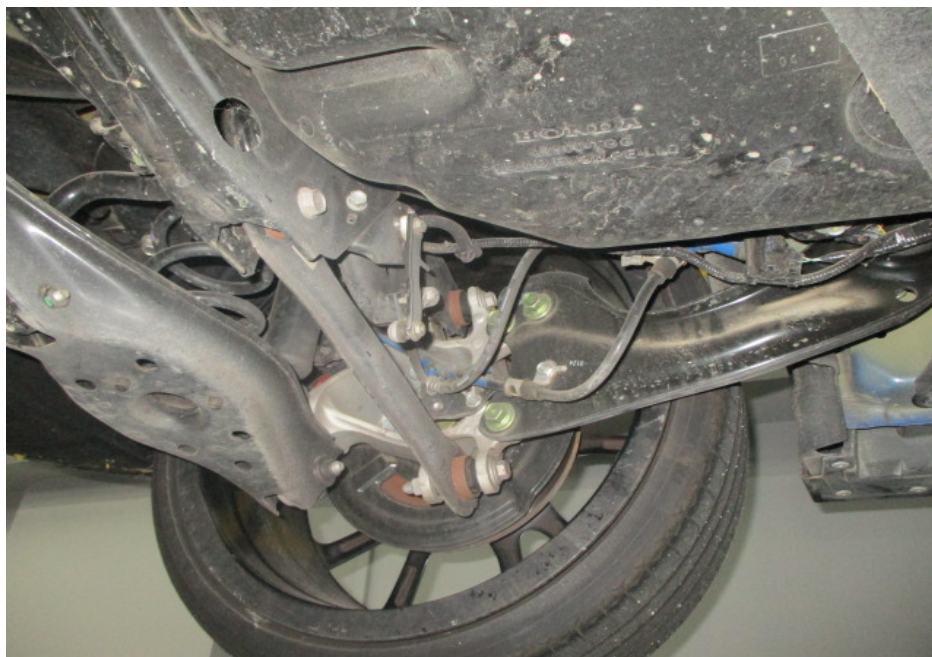
Photo 14 shows a general view of the control arms and linkages at the rear left wheel of the Motor Car. I did not observe any fluid leak and/or fluid stain on the underside of the Motor Car. All of the Motor Car's undercarriage components were observed to be intact and secured in an appropriate manner.

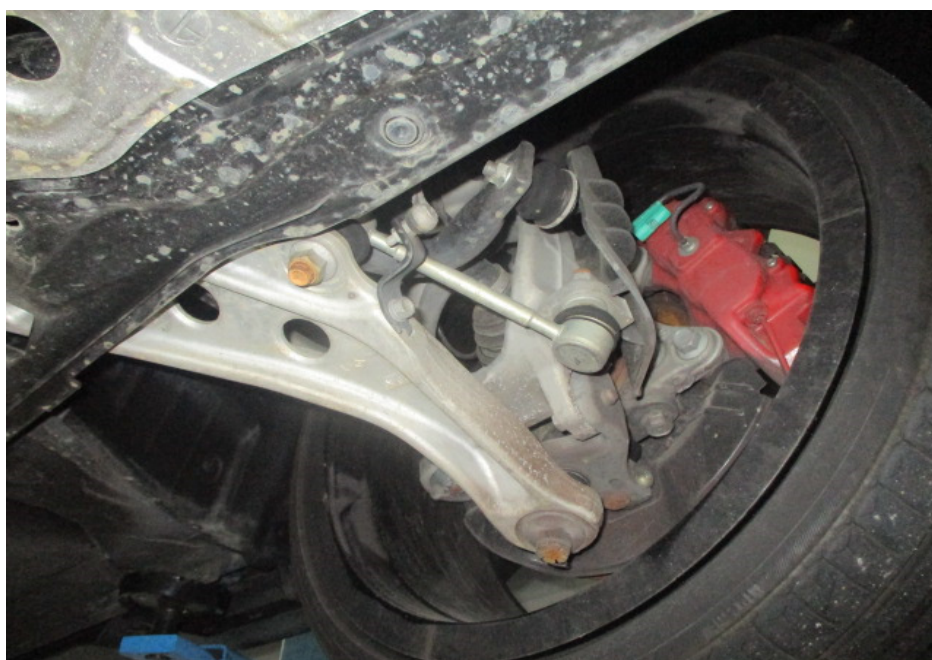
Photo 15 shows the various undercarriage components at the front left wheel of the Motor Car. The mechanical components, control arms and linkages were all found to be intact and secured in an appropriate manner.

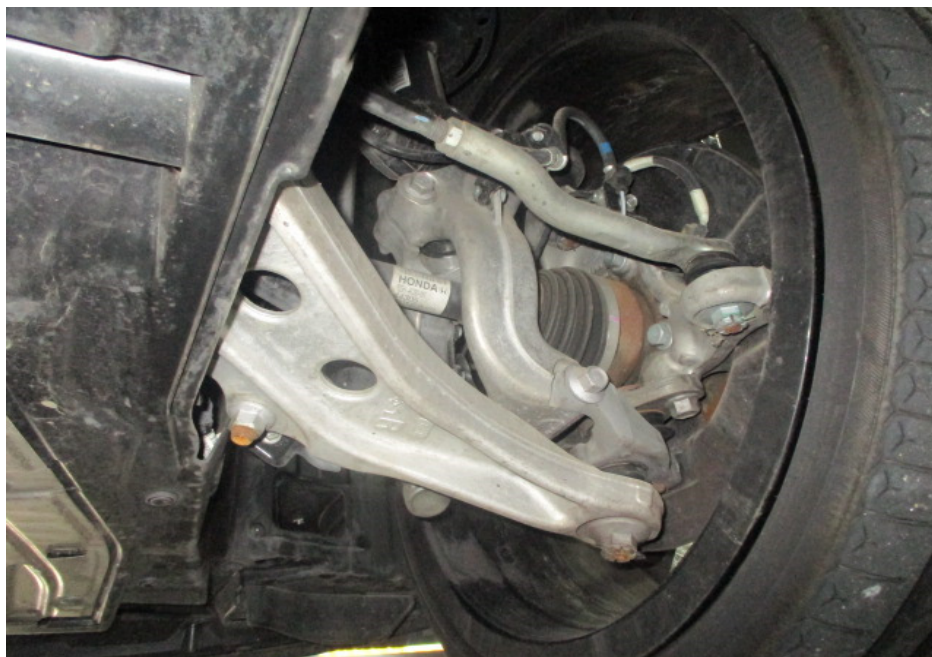
Photo 16 shows the various undercarriage components at the front right wheel of the Motor Car. The mechanical components, control arms and linkages were all found to be intact and secured in an appropriate manner. I also did not observe any fluid leak and/or fluid stain on the underside of the Motor Car.

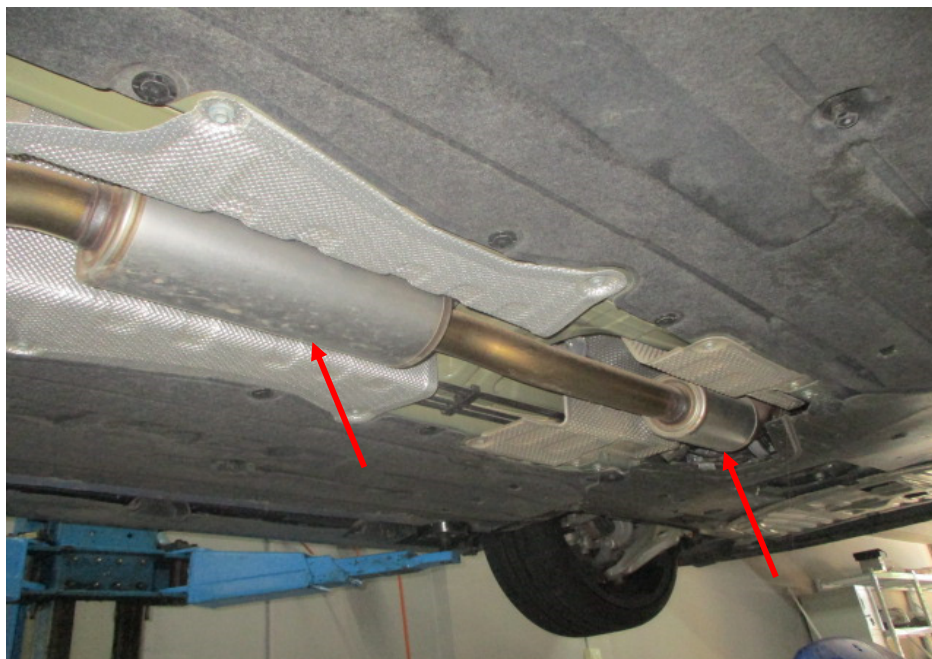
Photo 17 shows the Motor Car's centre pipe (arrowed). My examination of the Motor Car's exhaust system revealed no sign(s) or indication(s) of any cut or weld marks along its exhaust pipes and on its catalytic converter and rear mufflers.

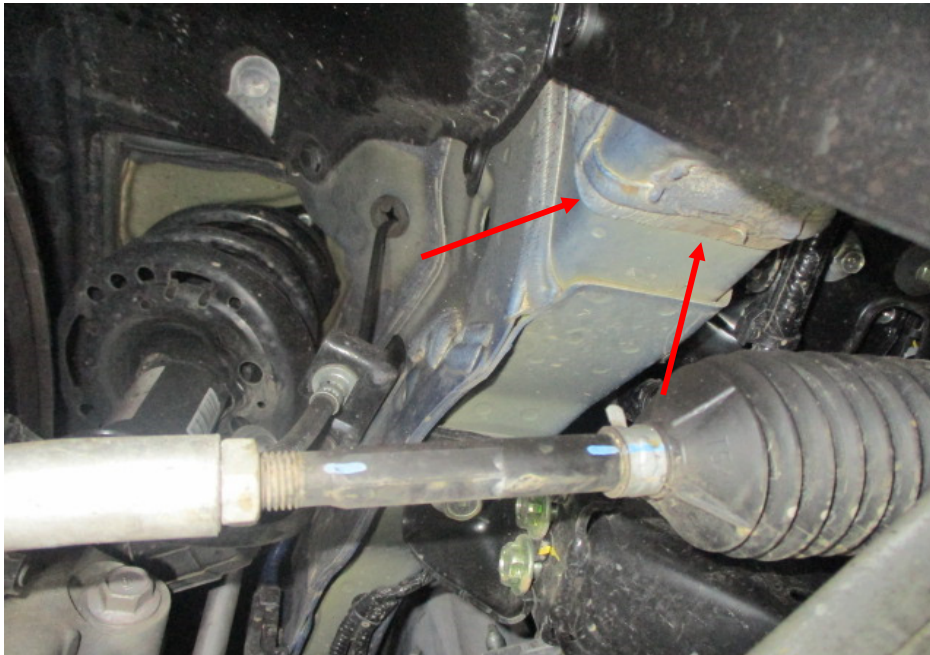
10. Visually, I did not find any weld marks, other than the original spot weld marks, on the chassis/structural body of the Motor Car. The original factory sealant at the joints along the chassis/structural body was also untouched, again indicating that no replacement of the chassis/structural body was carried out; and that the chassis/structural body was originally fitted.

Photo 18 shows the chassis/structural body at the underside front left of the Motor Car. I did not find any weld marks other than original spot weld marks on the chassis/structural body of the Motor Car. The original factory sealant (arrowed) at the joints along the chassis/structural body was untouched, indicating no work was done on the chassis/structural body of the Motor Car and that the chassis/structural body was originally fitted.

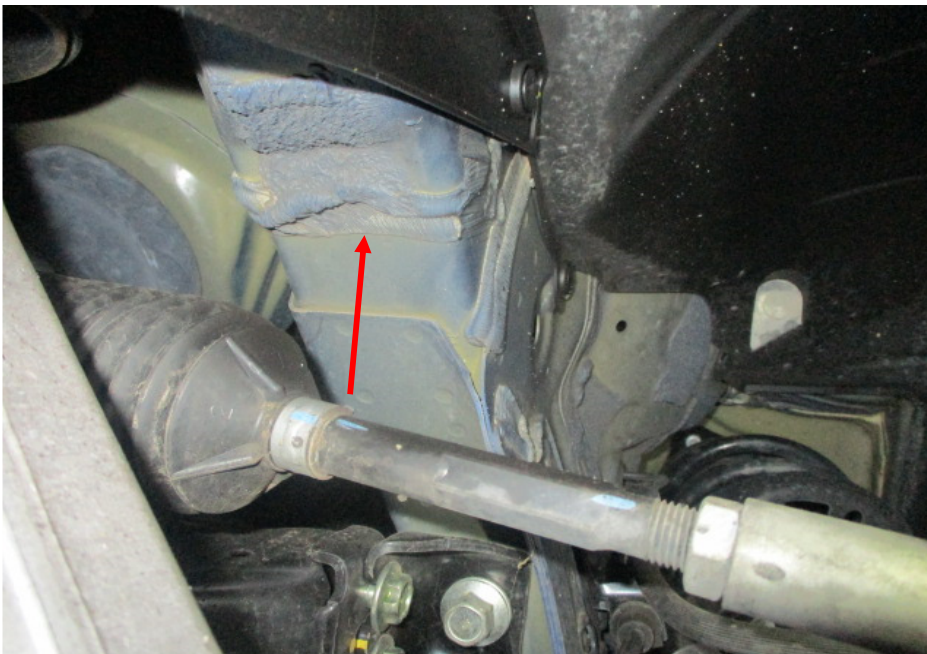
Photo 19 shows the chassis/structural body at the underside front right of the Motor Car. The original factory sealant (arrowed) at the joints along the chassis/structural body was observed to be untouched. In general, I had found no work was carried out on the chassis/structural body of the Motor Car. The chassis/structural body of the Motor Car was originally fitted.

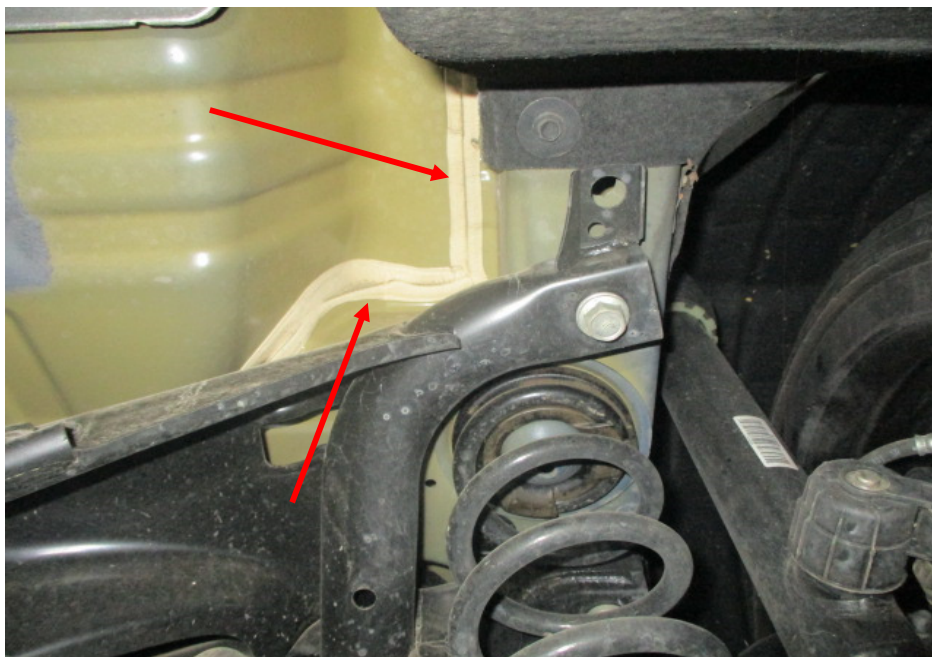
Photo 20 shows the chassis/structural body at the underside rear right of the Motor Car. The original factory sealant (arrowed) at the joints along the chassis/structural body was observed to be untouched. In general, I had found no work was carried out on the chassis/structural body of the Motor Car. The chassis/structural body of the Motor Car was originally fitted.

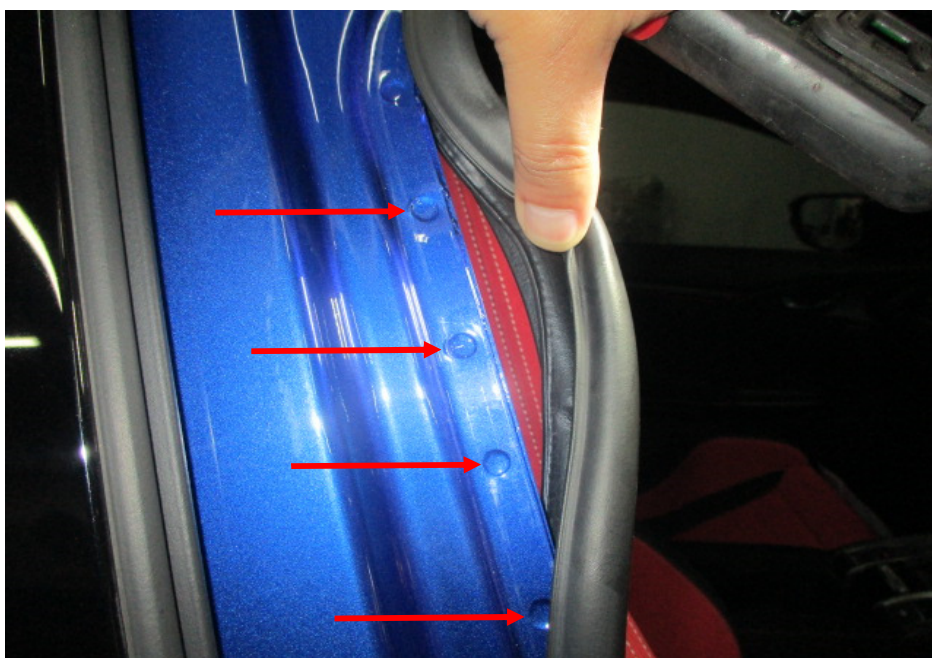
Photo 21 shows the right side "B" pillar of the Motor Car. I did not find any weld marks other than original spot weld marks (arrowed) on the right side "B" pillar of the Motor Car which, indicates that there was no re-welding works carried out. In general, I had found all the non-detachable body panels of the Motor Car to be originally fitted at the time of my inspection.

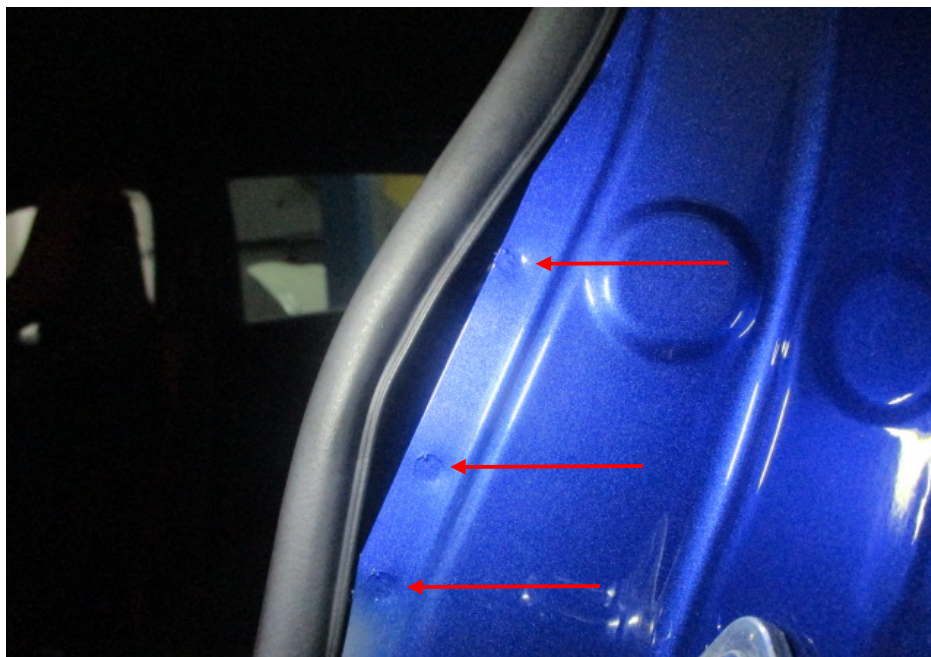
Photo 22 shows the left side "C" pillar of the Motor Car. I did not find any weld marks other than original spot weld marks (arrowed) on the left side "C" pillar of the Motor Car which, indicates that there was no re-welding works carried out. In general, I had found all the non-detachable body panels of the Motor Car to be originally fitted at the time of my inspection.
