Your Ref: Honda Engine

(number R18A1758633)

Our Ref: CI/TP20014196/D

#### **INSPECTION REPORT OF A HONDA ENGINE WITH NUMBER R18A1758633**

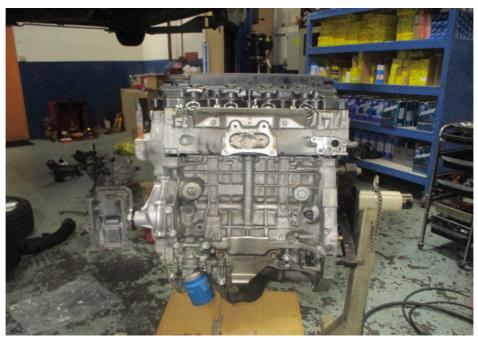
**Photo 1** shows a general view of the Honda engine that I had inspected. The Honda engine was observed to be a used engine and was not fitted on any motor car. It was also observed to be a complete assembly with all mechanical parts still intact, within the engine housing.

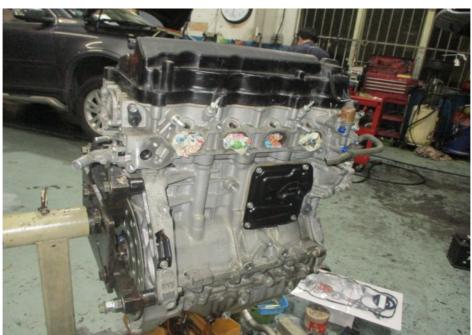
**Photo 2** shows a general view of the Honda engine that I had inspected. My visual examination of the engine housing revealed the housing to be of serviceable/satisfactory condition. There was no crack and/or hole observed on the engine housing.

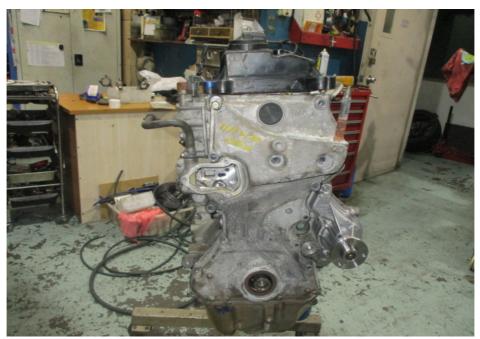
**Photo 3** shows a general view of the Honda engine that I had inspected. My visual examination of the engine housing revealed the housing to be of serviceable/satisfactory condition. There was no crack and/or hole observed on the engine housing.

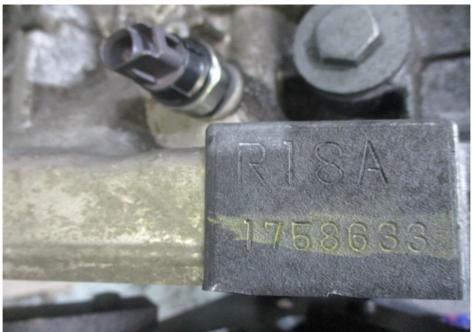
**Photo 4** shows the engine number engraved on the housing of the Honda engine that I had inspected. The engine number was R18A1758633.

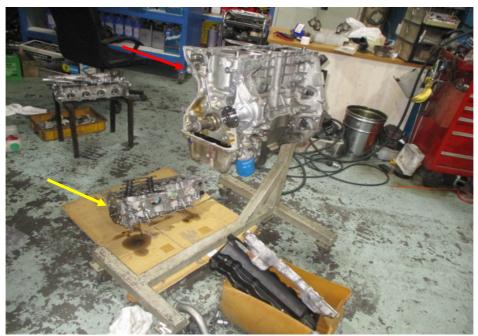
**Photo 5** shows the top block (yellow arrow) of the Honda engine separated from its bottom block (red arrow). This was to enable me to carry out measurements of its cylinders, in particular the bore and stroke measurements of each cylinder, which typically can be used to determine the engine displacement or more commonly referred to as engine cc.

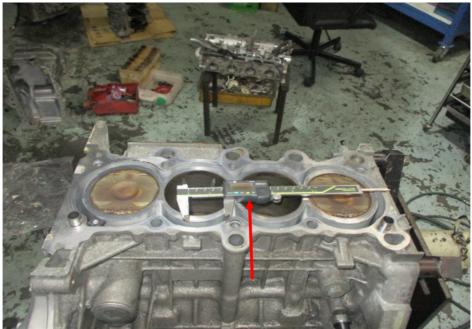
**Photo 6** shows the bottom block of the Honda engine and the digital Vernier Caliper (arrowed) that was used to measure the bore and stroke measurements of each cylinder. The digital Vernier Caliper was calibrated before the start of the measurements.

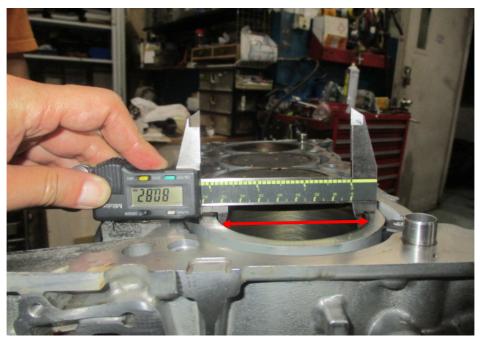
**Photo 7** shows measurement being carried out to the bore (arrowed) of cylinder 1 of the Honda engine. The measurements were carried out using a digital Vernier Caliper that was calibrated before the start of the measurements. The bore measurement of cylinder 1 was recorded to be 80.82mm.

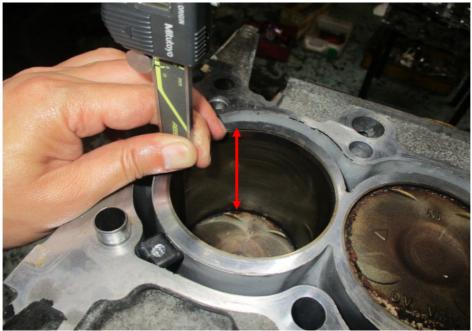
**Photo 8** shows measurement being carried out to the stroke (arrowed) of cylinder 1 of the Honda engine. The bore and stroke measurements of the Honda engine were carried out using a digital Vernier Caliper that was calibrated before the start of the measurements.

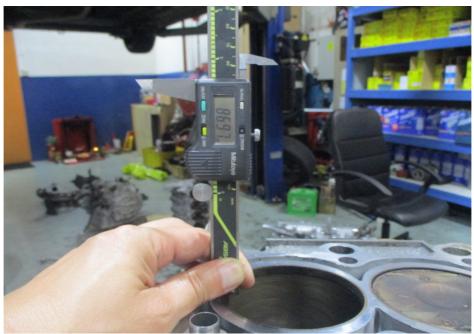
**Photo 9** shows the stroke measurement of cylinder 1, which was recorded to be 86.97mm.

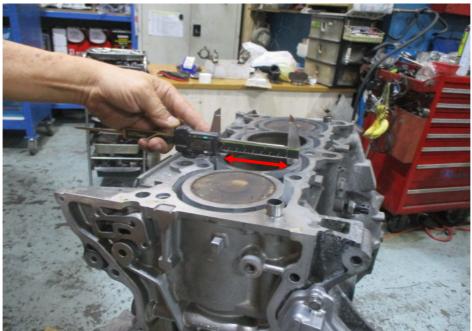
**Photo 10** shows measurement being carried out to the bore (arrowed) of cylinder 2 of the Honda engine. The bore and stroke measurements of the Honda engine were carried out using a digital Vernier Caliper that was calibrated before the start of the measurements.

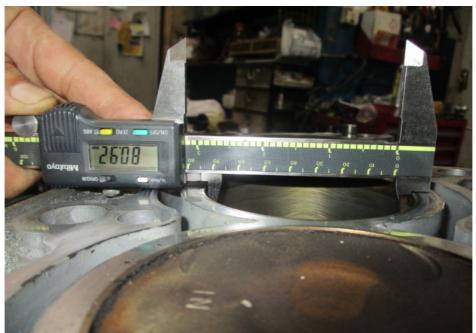
**Photo 11** shows measurement being carried out to the bore of cylinder 2 of the Honda engine. The bore measurement of cylinder 2 was recorded to be 80.92mm.

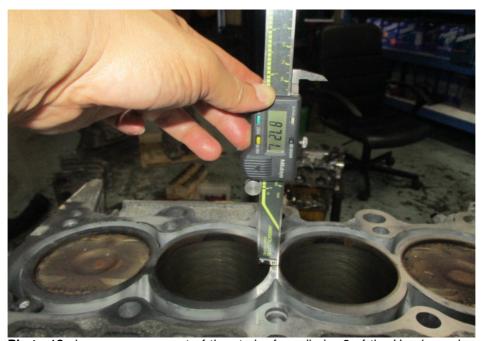
**Photo 12** shows measurement of the stroke for cylinder 2 of the Honda engine that I had inspected. The bore and stroke measurements of the Honda engine were carried out using a digital Vernier Caliper that was calibrated before the start of the measurements. the stroke measurement of cylinder 2 was recorded to be 87.21mm.

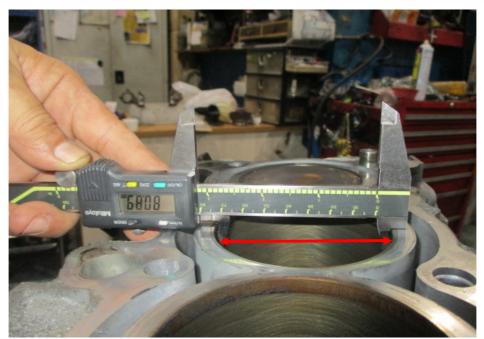
**Photo 13** shows measurement being carried out to the bore (arrowed) of cylinder 3 of the Honda engine. The bore and stroke measurements of the Honda engine were carried out using a digital Vernier Caliper that was calibrated before the start of measurements. The bore measurement of cylinder 3 was recorded to be 80.89mm.

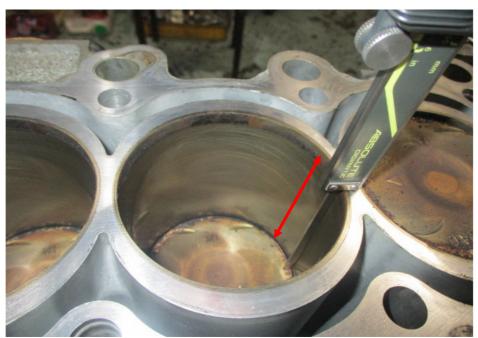
**Photo 14** shows measurement of the stroke (arrowed) for cylinder 3 of the Honda engine that I had inspected. The bore and stroke measurements of the Honda engine were carried out using a digital Vernier Caliper that was calibrated before the start of measurements.

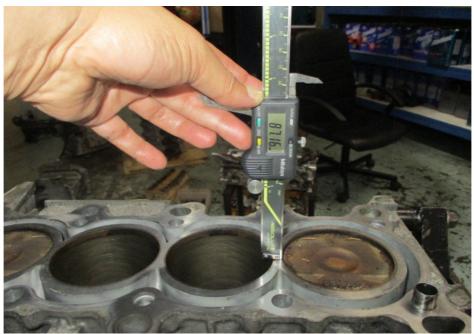
**Photo 15** shows the stroke measurement of cylinder 3, which was recorded to be 87.16mm.

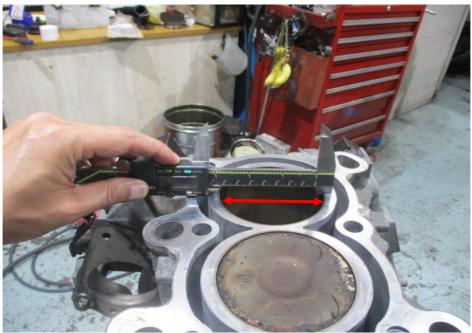
**Photo 16** shows measurement being carried out to the bore (arrowed) of cylinder 4 of the Honda engine. The bore and stroke measurements of the Honda engine were carried out using a digital Vernier Caliper that was calibrated before the start of measurements.

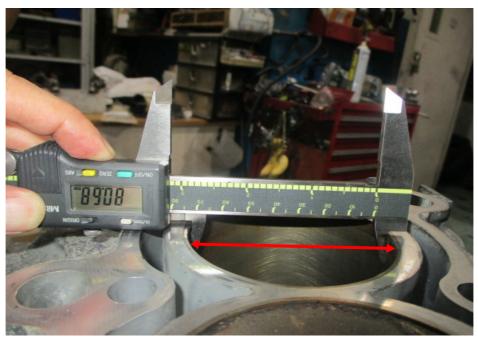
**Photo 17** shows measurement being carried out to the bore (arrowed) of cylinder 4 of the Honda engine. The bore measurement of cylinder 4 was recorded to be 80.68mm.

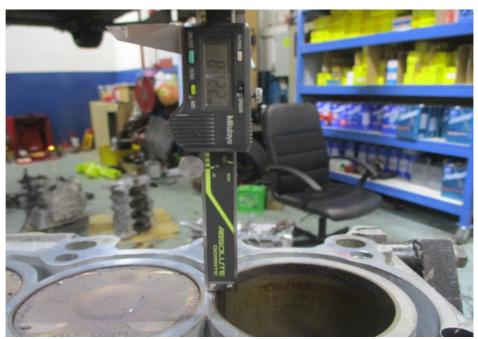
**Photo 18** shows measurement being carried out to the stroke of cylinder 4 of the Honda engine. The bore and stroke measurements of the Honda engine were carried out using a digital Vernier Caliper that was calibrated prior to the start of measurements.

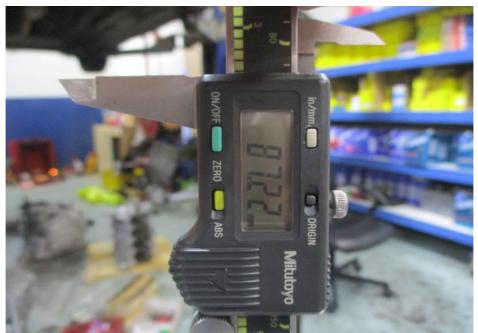
**Photo 19** shows the stroke measurement of cylinder 4, which was recorded to be 87.22mm.
