ASSIGNMENT

SMN 4972X Yr Regn: 07, 19

ACCIDENT STATEMENT

ACCIDENT REPAIR ESTIMATE

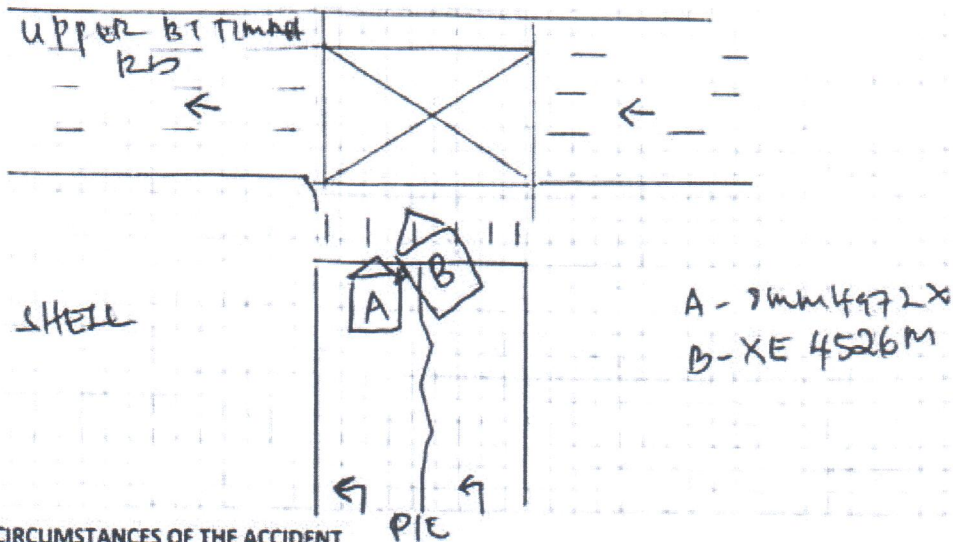
SKETCH PLAN

On 8/12/20, at about 0720hrs, I was driving my vehicle 3mm 4972X along PIE towards Upper BT Timah Rd. While my vehicle was stationary before make a left turn, a truck XE 4526M which was on my right side made a wide turn and swiped onto my right side front bumper. Exchanged particulars. Nobody was injured.
