Your Ref: SNM20D204954
Our Ref : CS/CTI20014255/P

TECHNICAL INVESTIGATION REPORT OF FLOODING INCIDENT INVOLVING THE INSURED VEHICLE SFH 5233Z ON 17th DECEMBER 2020

Vehicle Registration No.	: SFH 5233Z
Make / Model	: HONDA CIVIC 2.0L M
Chassis No	: JHMFD25408S201586
Year of Registration	: JUNE 2008

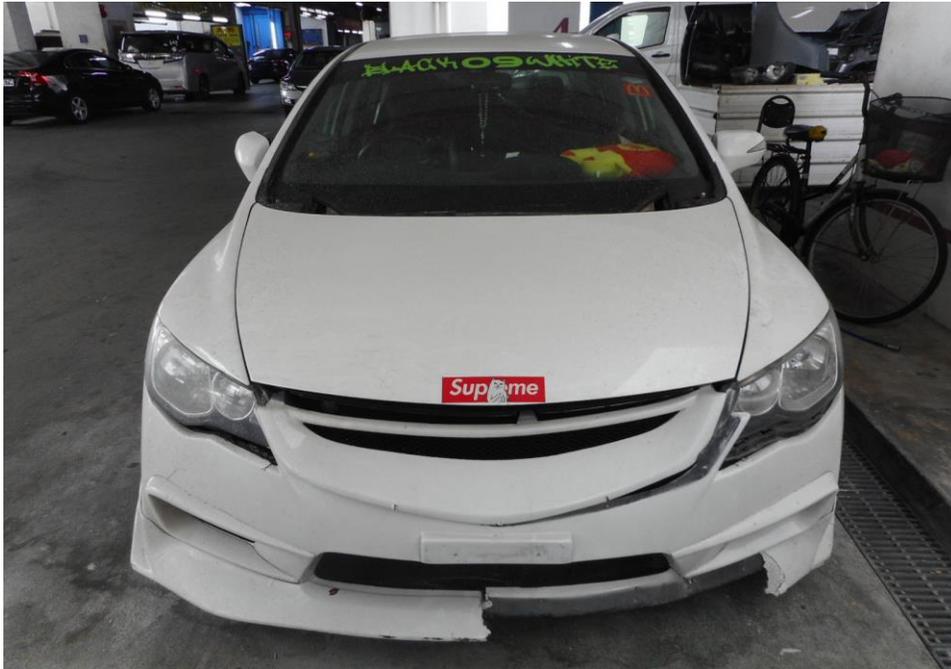
Photo 1 shows a general view of the Motor Car's front body at the time of my inspection. The front portion of the Motor Car was observed to have sustained damage. Its front bumper was damaged as a result of the accident.

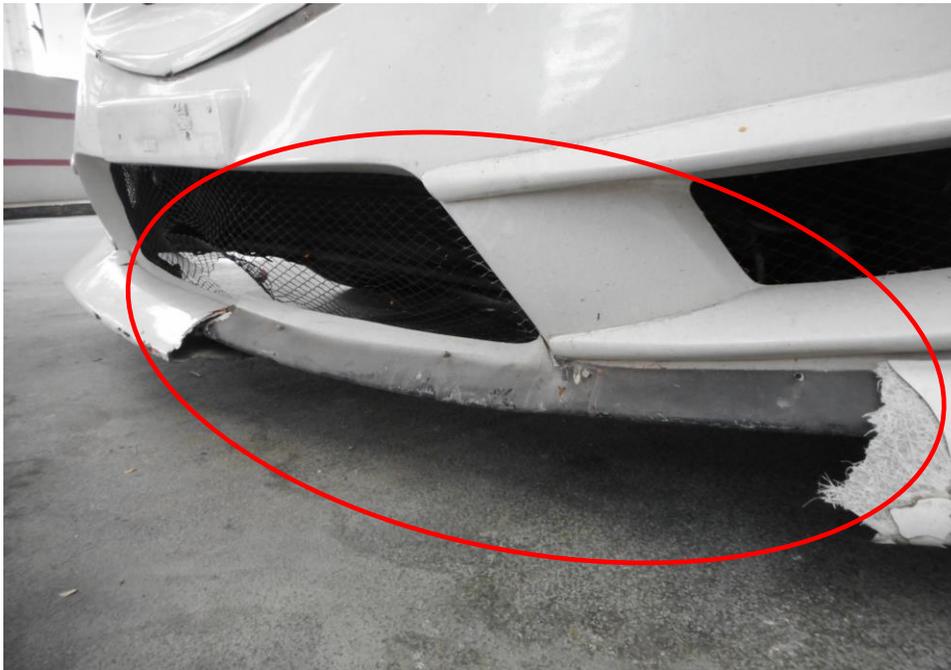
Photo 2 shows the close up view of the Motor Car's front body at the time of my inspection. The Motor Car was observed to have sustained damage at its front bumper (circled), as a result of the accident.

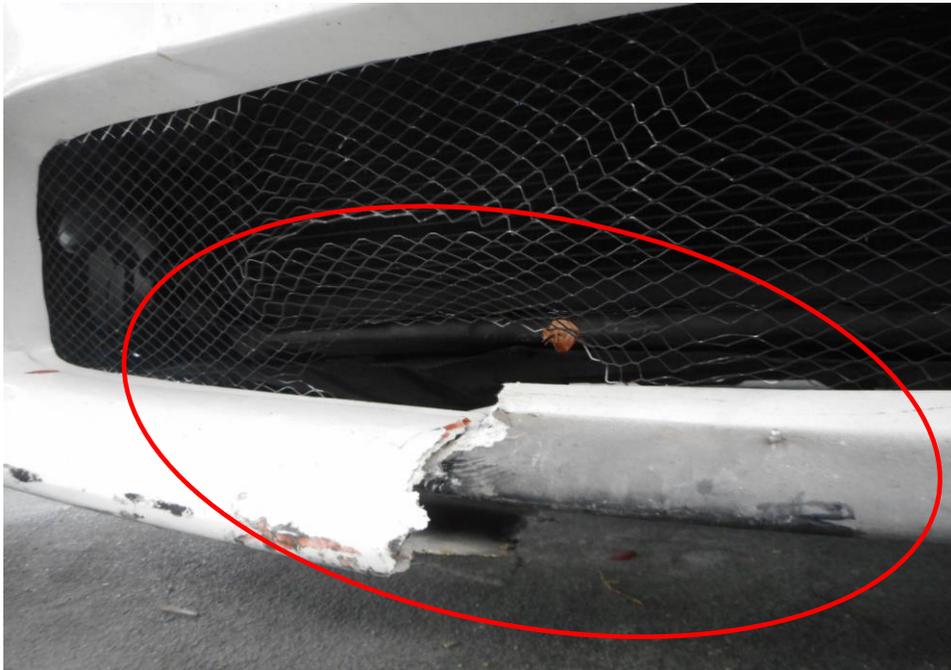
Photo 3 shows the close up view of the Motor Car's front body at the time of my inspection. The Motor Car was observed to have sustained damage at its front bumper (circled), as a result of the accident.

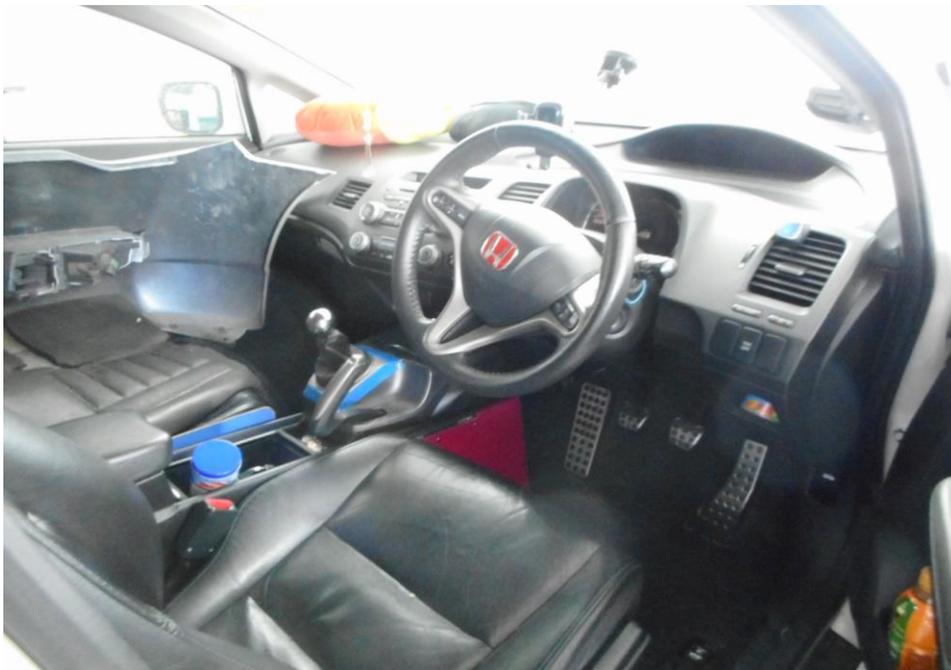
Photo 4 shows the interior view from the right side of the Insured Vehicle at the time of our inspection. The interior of the Insured Vehicle was observed to be unaffected by the accident.

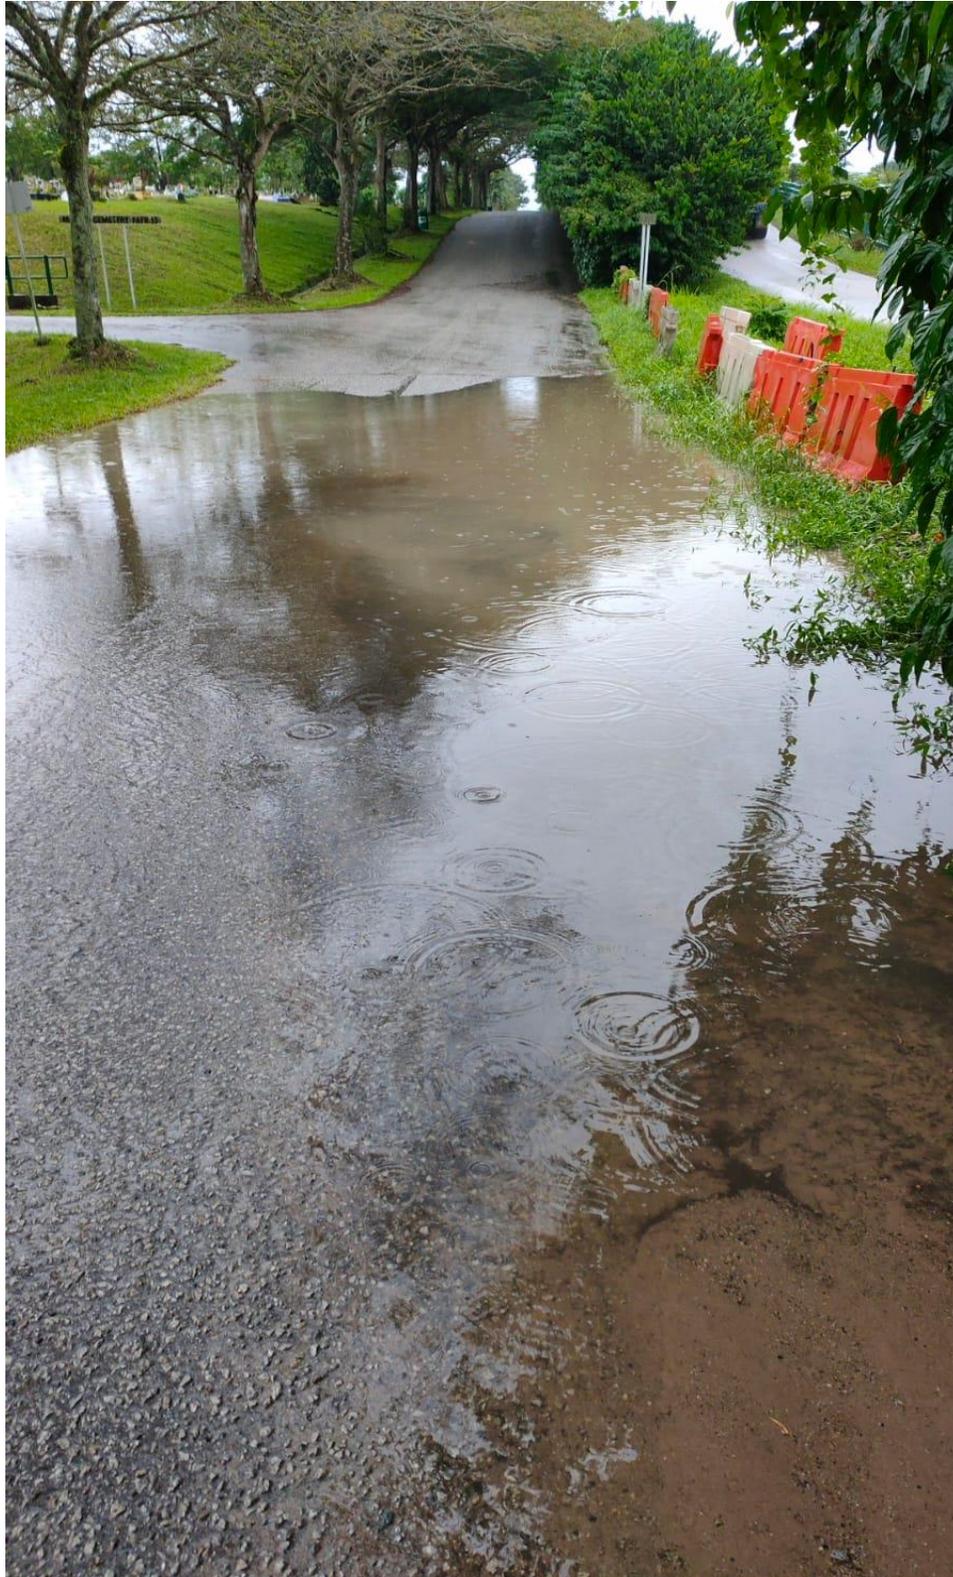
Photo 5 shows the puddle of water that the Insured Vehicle had drove into and through at the material time. In general, the information that could be gathered from this photograph had corresponded to the events that were related to us by Mr Nizzaar, location where the accident happened.

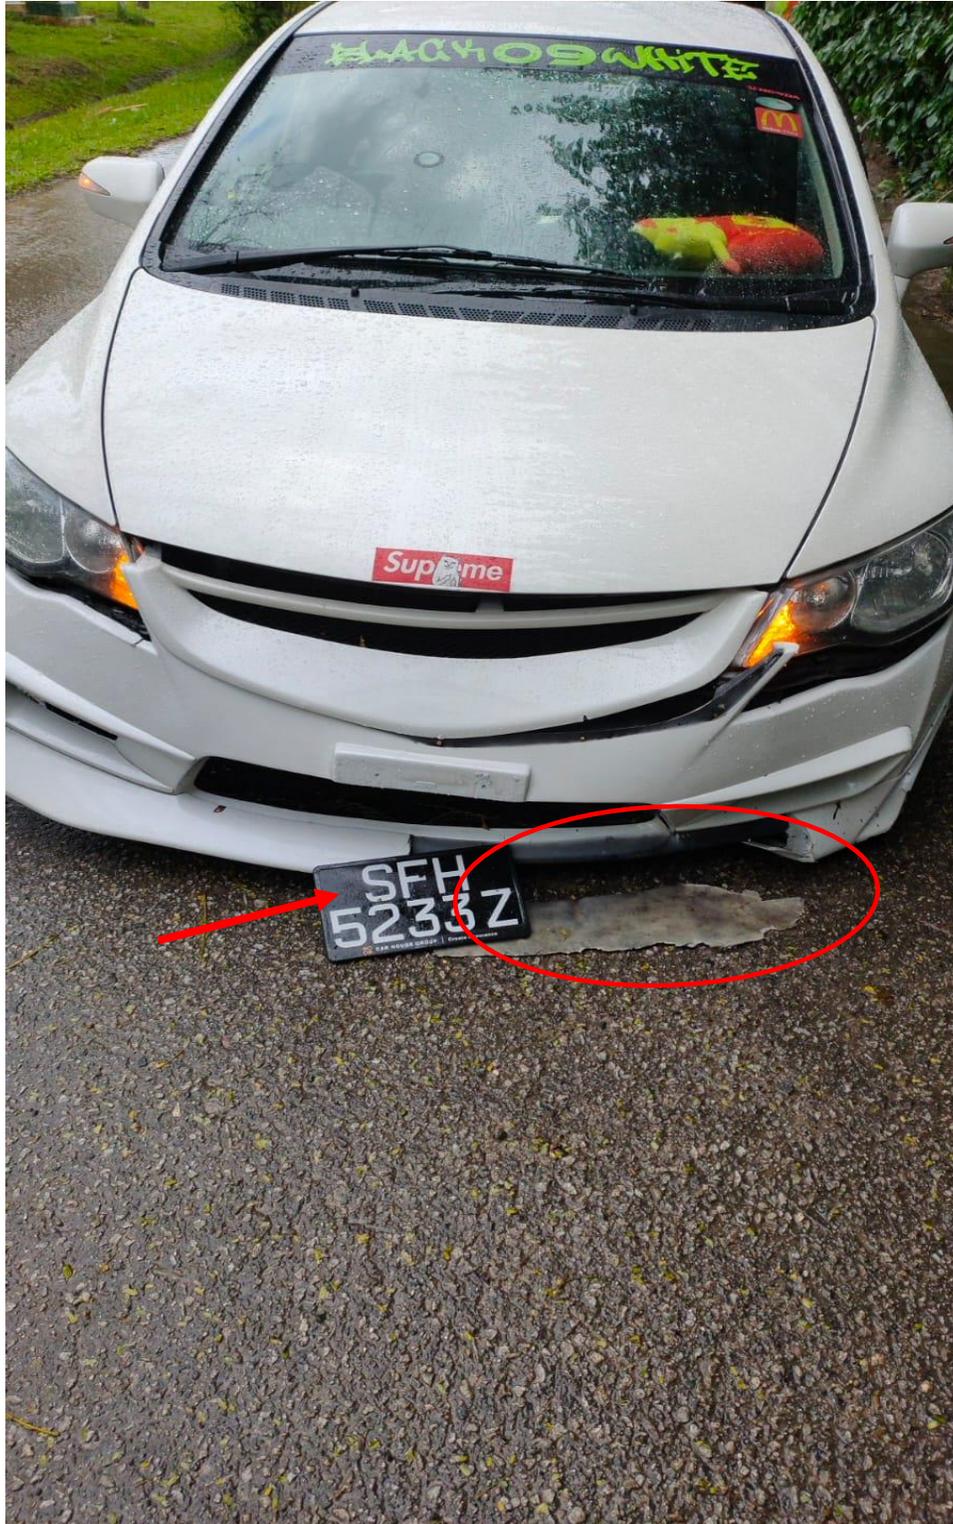
Photo 6 shows the damages the Insured Vehicle had sustained after driving through the puddle of water, its front bumper had broken off (circled) and its number plate had fallen off (arrowed) . In general, the information that could be gathered from this photograph had corresponded to the events that were related to us by Mr Nizzaar, location when the fire broke out.

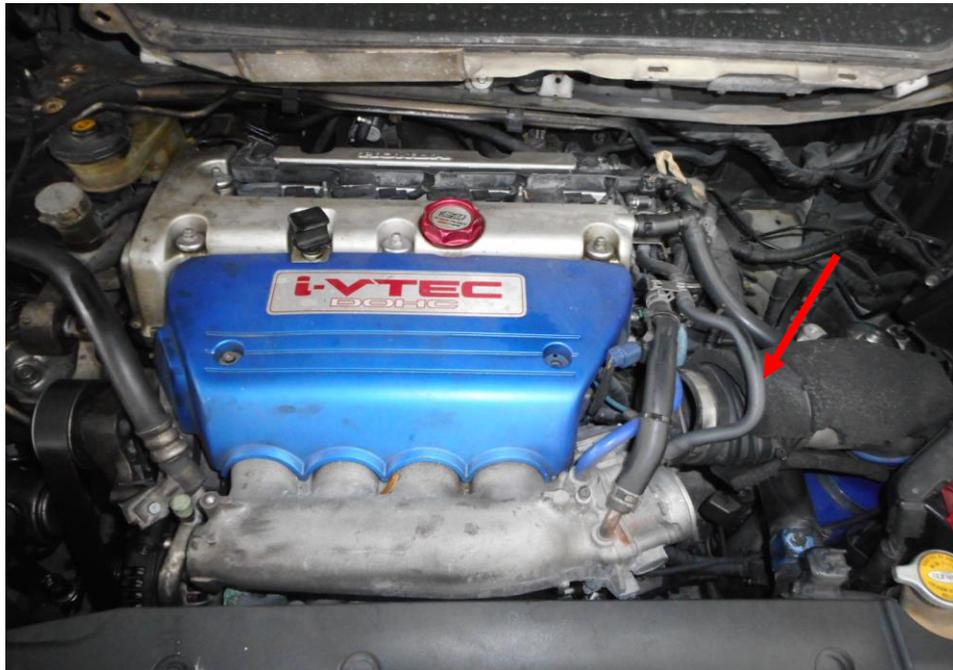
16. For this particular case, we understand that the Insured Vehicle had stalled upon driving through the puddle of water and to our understanding, the stalling of the engine might be caused by water entering the engine. At the time of inspection of the Insured Vehicle, we observed an aftermarket air intake and filter in the Insured Vehicle engine compartment. See photo 7 below.

Photo 7 shows an aftermarket air intake and filter (arrowed) fitted on the engine of the Insured Vehicle at the time of our inspection.

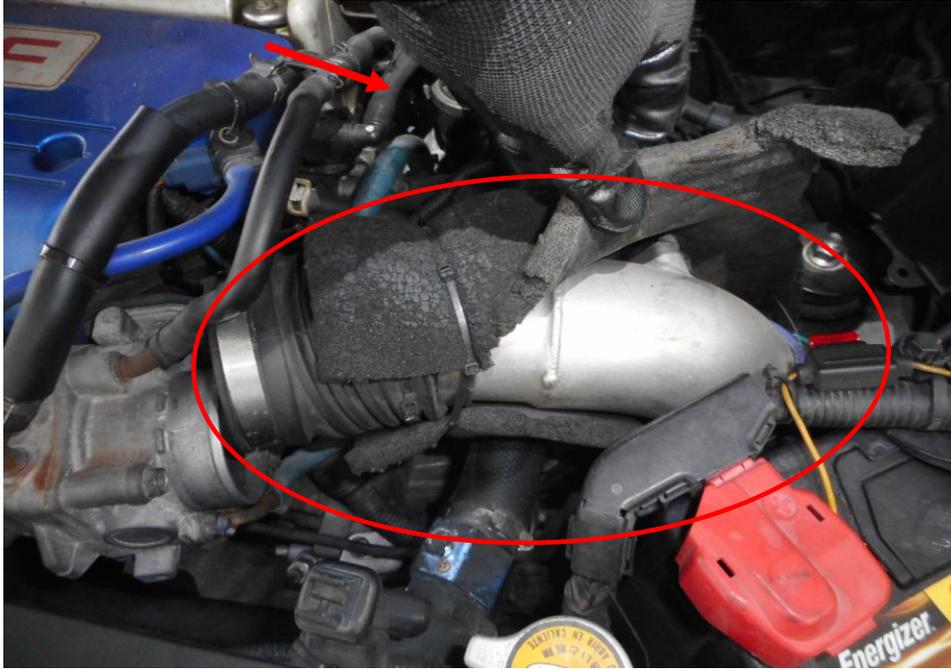
Photo 8 shows an aftermarket air intake and filter (arrowed) on the Insured Vehicle at the time of our inspection. It was observed to be installed in a way that it is directed down to the bottom of the engine compartment.

22. The stalling of the engine on the Insured Vehicle from our understanding, was caused by water entering from the aftermarket air intake and filter that was mounted at the bottom of the engine compartment as shown in the height measurement.
23. The aftermarket air intake and filter that were fitted on the Insured Vehicle (although LTA compliant) had contributed to the damage sustained to the Insured Vehicle as a result of the flood incident. The damage could have been avoided if the air intake and filter were of original type and/or if the opening of the Insured Vehicle's air intake was not fitted at a relatively low height above ground level.

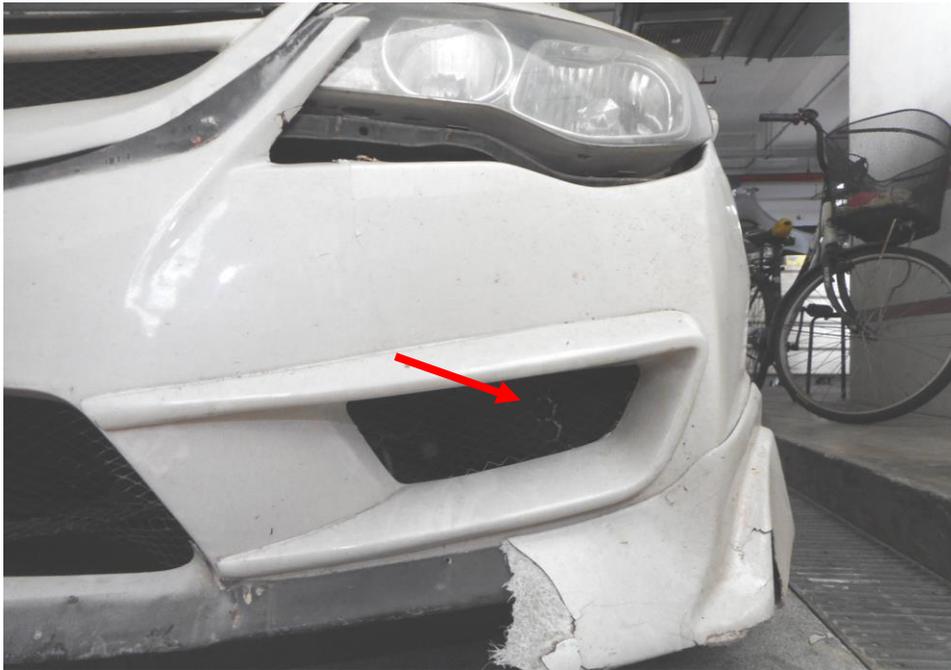
Photo 9 shows general view of where the aftermarket air intake and filter (arrowed) on the Insured Vehicle at the time of our inspection. It was observed to be installed in a way that it is directed down to the bottom of the engine compartment.

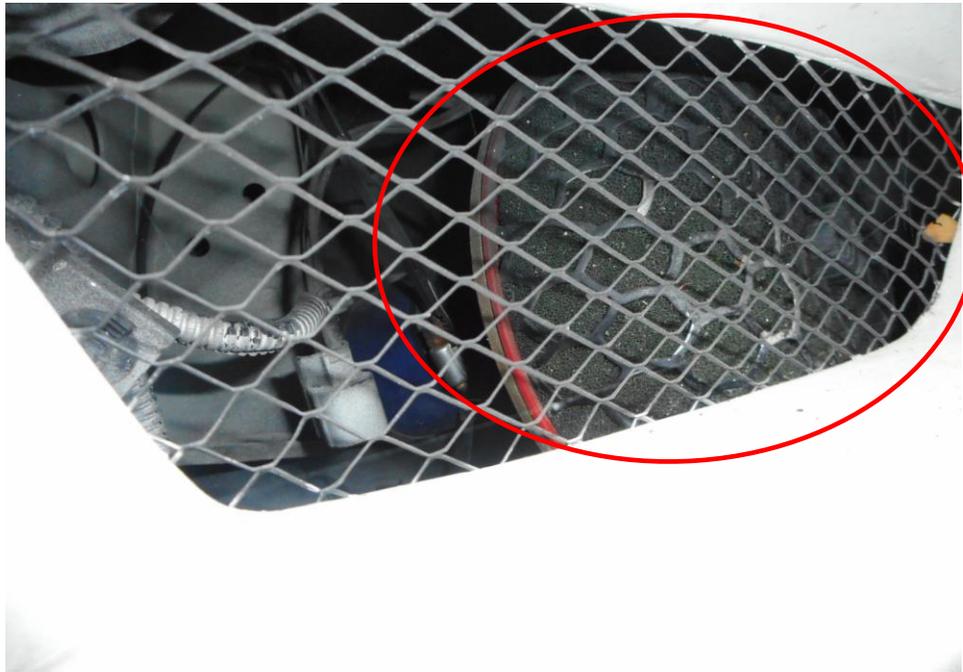
Photo 10 shows the close up view of the aftermarket air intake and filter (circled) on the Insured Vehicle at the time of our inspection. It was observed to be installed in a way that it is directed down to the bottom of the engine compartment.

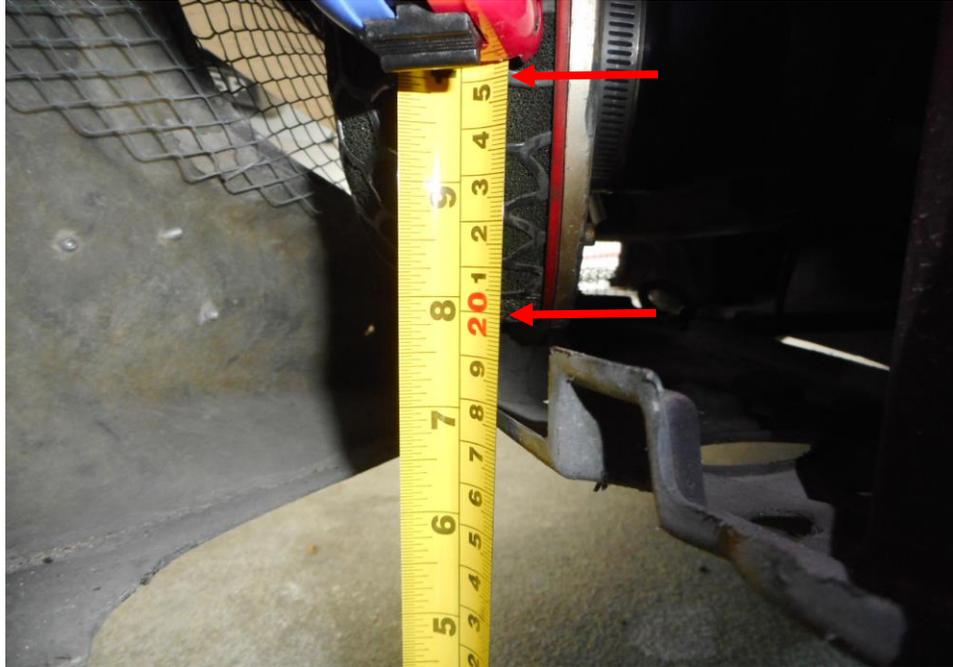
Photo 11 shows the close up view of the height measurements taken on the aftermarket air intake and filter on the Insured Vehicle at the time of our inspection. It was observed to be at a height of 20cm to 25cm from the ground (arrowed).

- a) the height above ground level of the aftermarket air intake and filter was measured to be approximately between 20cm to 25cm;
- b) the height above ground level of the water puddle level that was pointed out to us by Mr Nizzaar was measured to be approximately at 24cm;
- c) the height measurements appear to support the findings of possible water entering the engine from the aftermarket air intake and filter when the Insured Vehicle was driven through the puddle of water at the material time.

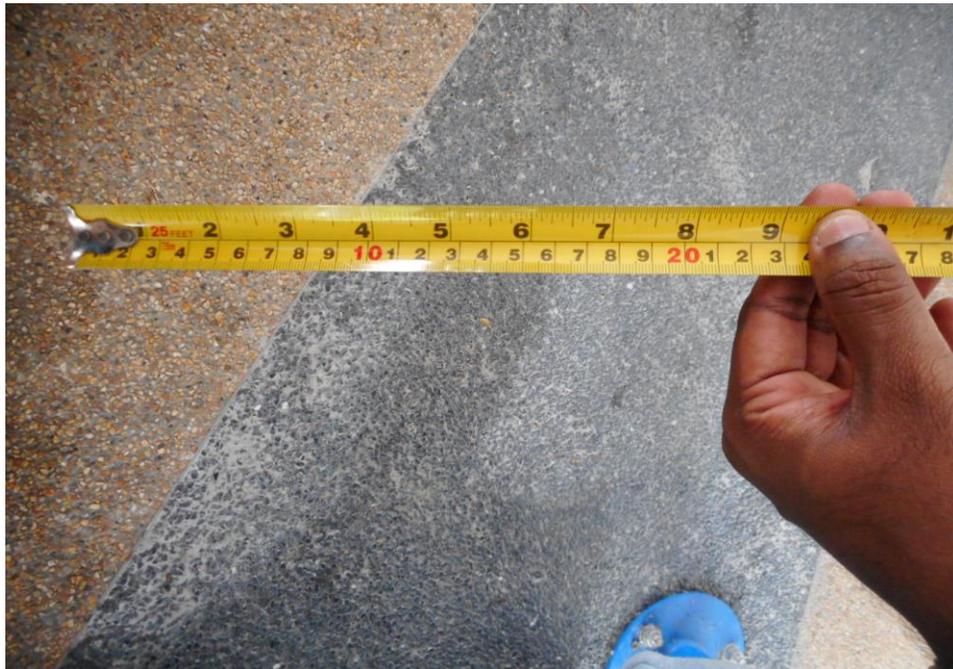
Photo 12 shows the view of the height measurements taken during the interview from Mr Nizzaar on the estimated height of the puddle of water that the Insured Vehicle had driven through at the material time. It was observed to be at a height of 24cm from the ground (arrowed).

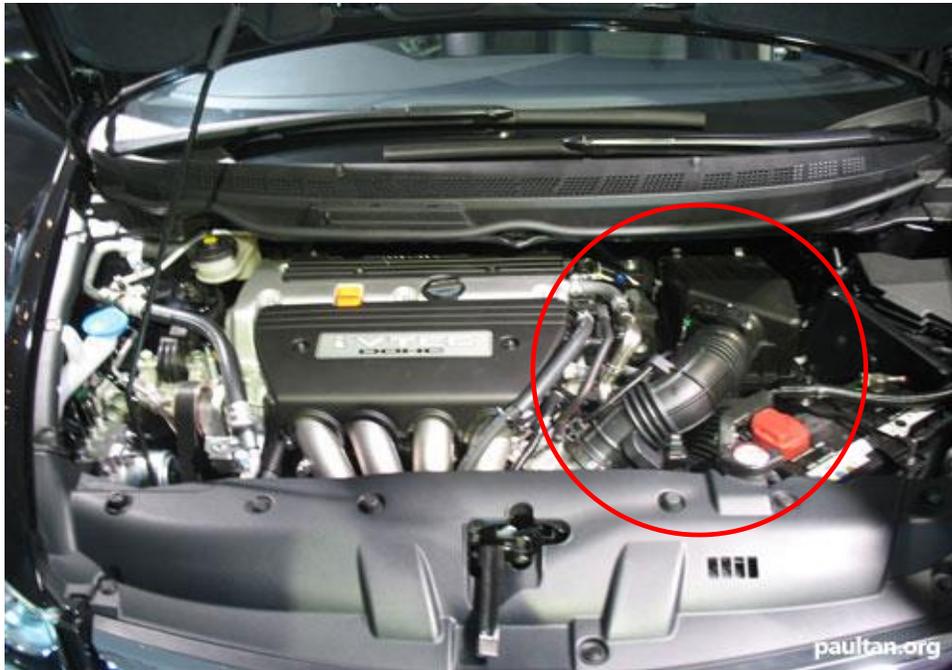
Photo 13 shows the view of the engine bay. The original air intake and filter are located at the top of the engine compartment (circled).

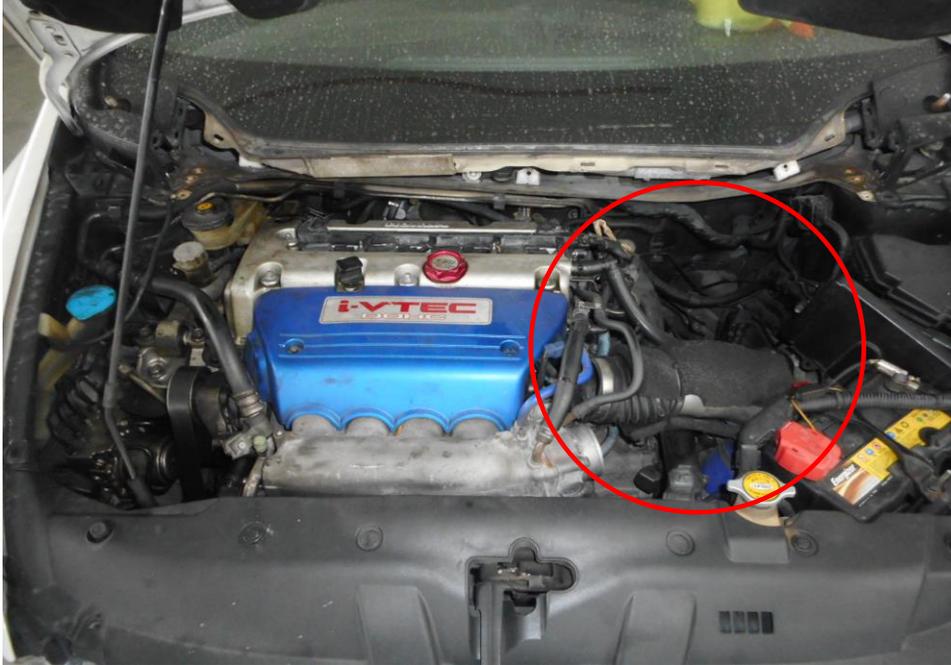
Photo 14 shows the view of the engine bay. The original air intake and filter are located at the top of the engine compartment (circled).
