You're Ref: TP/IP/26629/2020
Our Ref: CI/TPD20014306/P

28th December 2020

MECHANICAL INSPECTION REPORT OF MOTOR CAR SLV 6976L

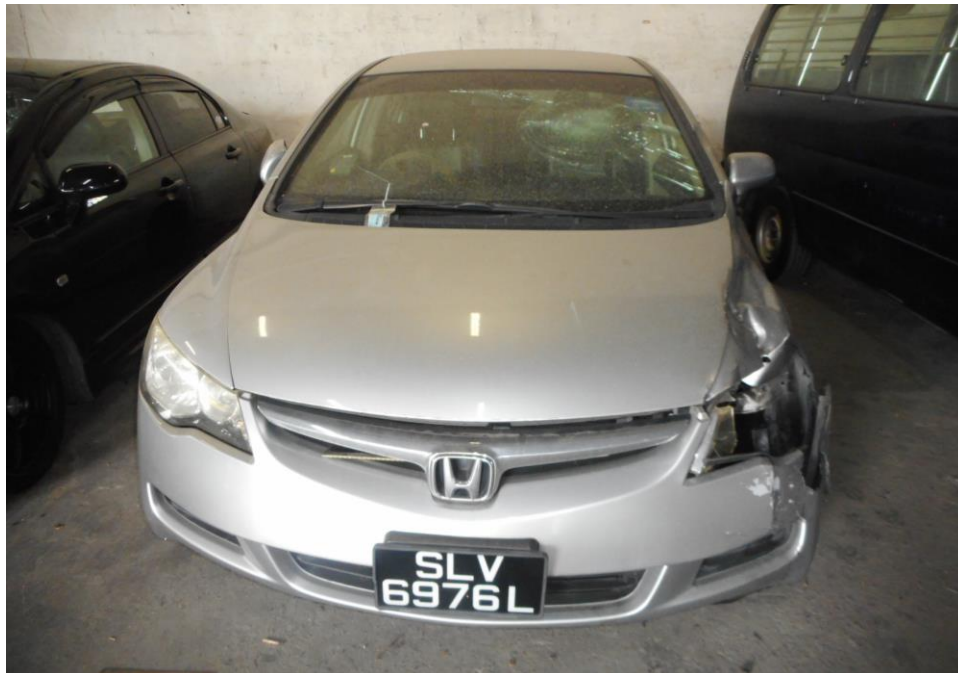
Photo 1 shows a general view of the Motor Car's front body at the time of my inspection. The front portion of the Motor Car was observed to have sustained damage. Its front windscreen, front bonnet, front bumper, front left fender, front left headlamp and various engine components that were damaged as a result of the accident.

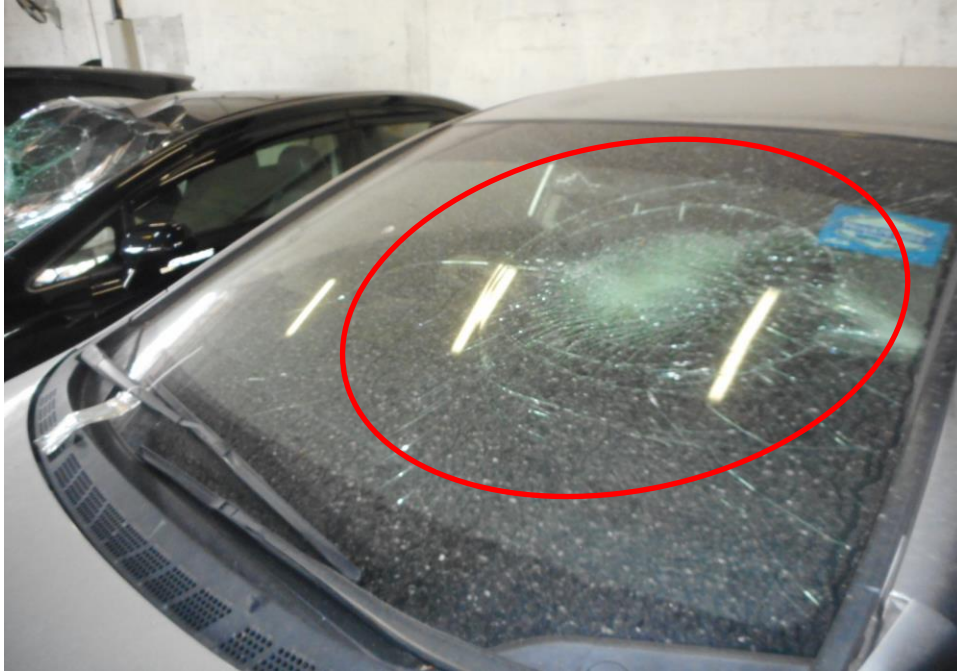
Photo 2 shows the close up view of the Motor Car's front body at the time of my inspection. The Motor Car was observed to have sustained damage at its front windscreen (circled), as a result of the accident.

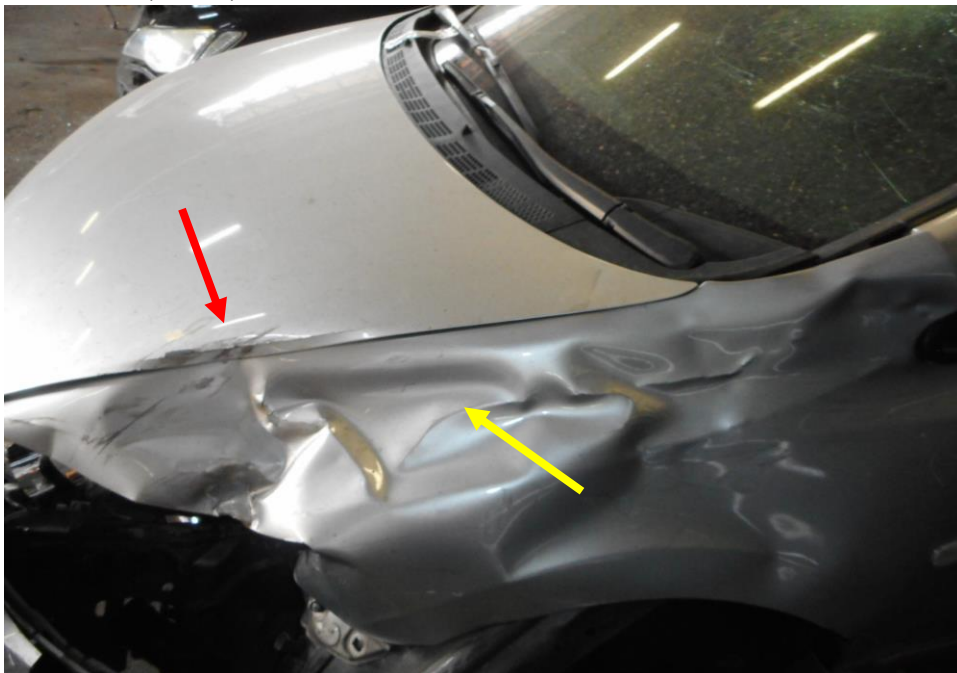
Photo 3 shows the close up view of the Motor Car's front body at the time of my inspection. The Motor Car was observed to have sustained damage at its front bonnet (red arrow) and front left fender (yellow arrow) as a result of the accident.

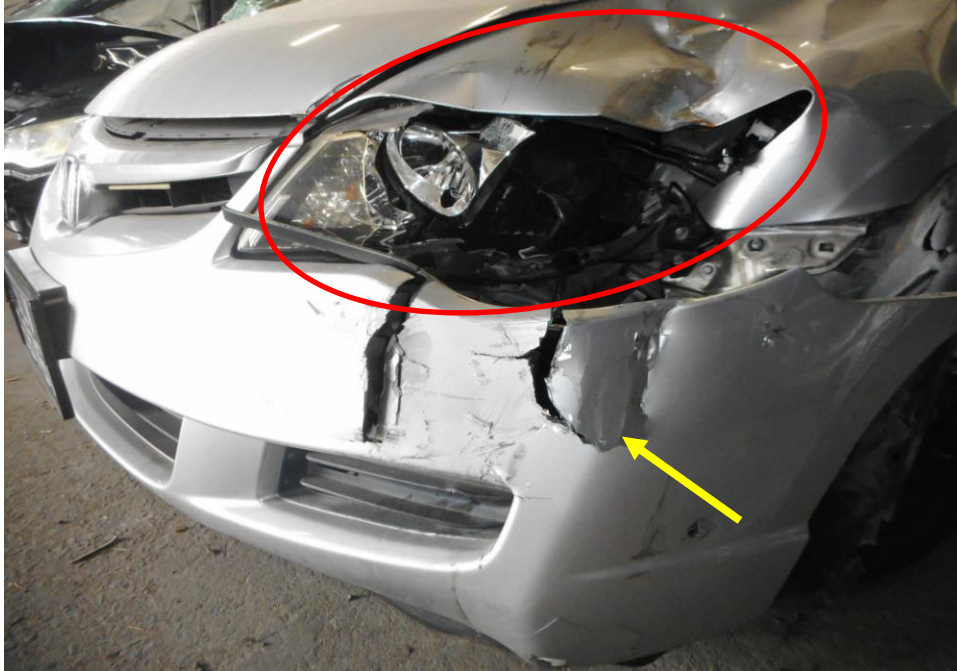
Photo 4 shows the close up view of the Motor Car's front body at the time of my inspection. The Motor Car was observed to have sustained damage at its front left headlamp (circled) and front bumper (arrowed), as a result of the accident.

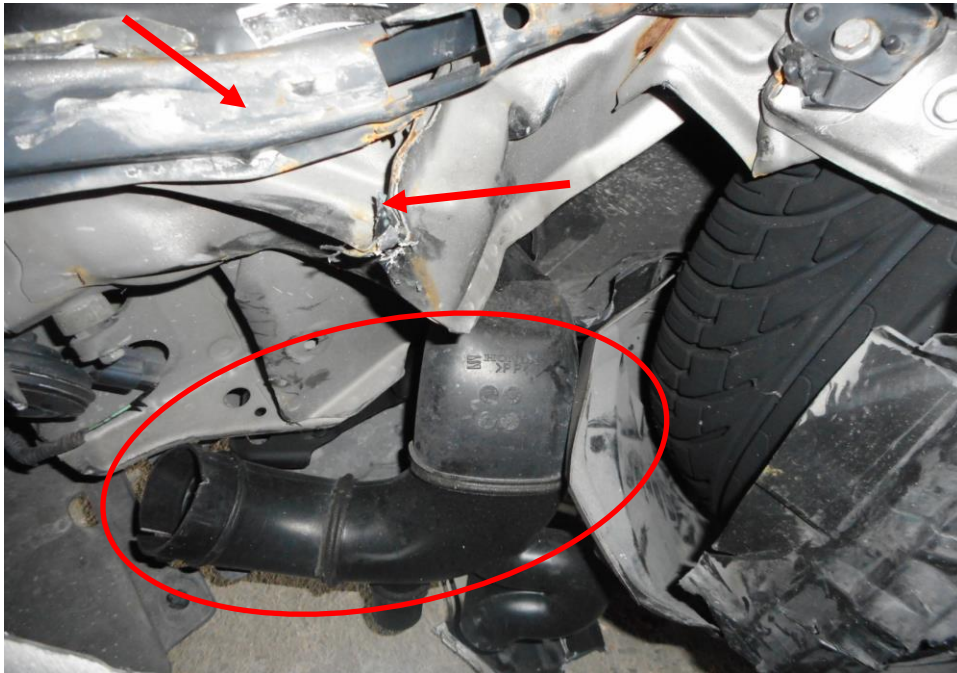
Photo 5 shows the close up view of the Motor Car's engine compartment body at the time of my inspection. The air filter box (circled) and body panels (arrowed) was observed to have sustained damage as a result of the accident.

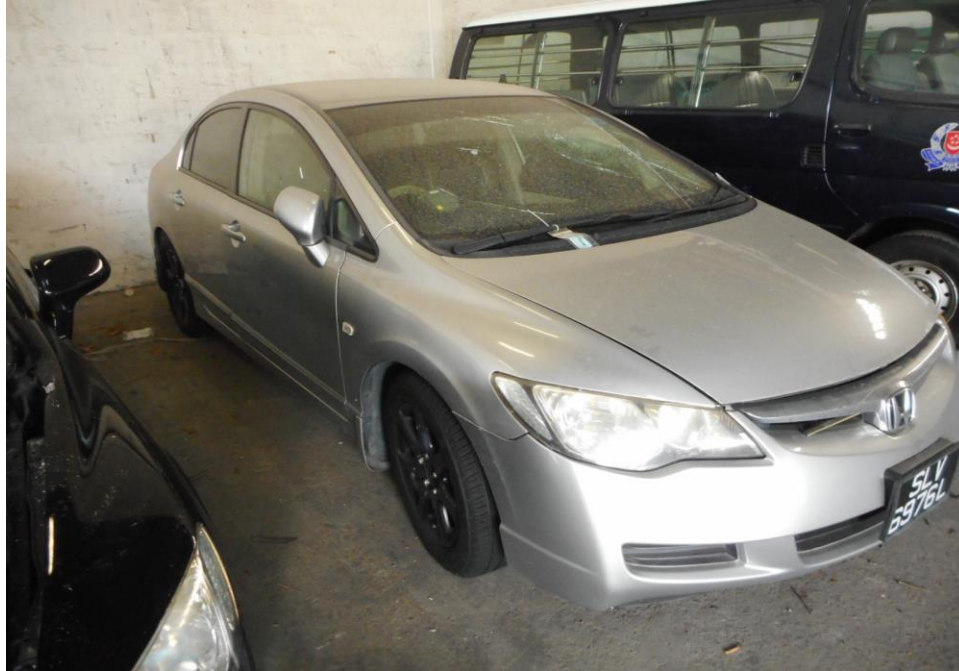
Photo 6 shows a general view of the Motor Car's right body at the time of my inspection. The right portion of the Motor Car was observed to have been unaffected by the accident.

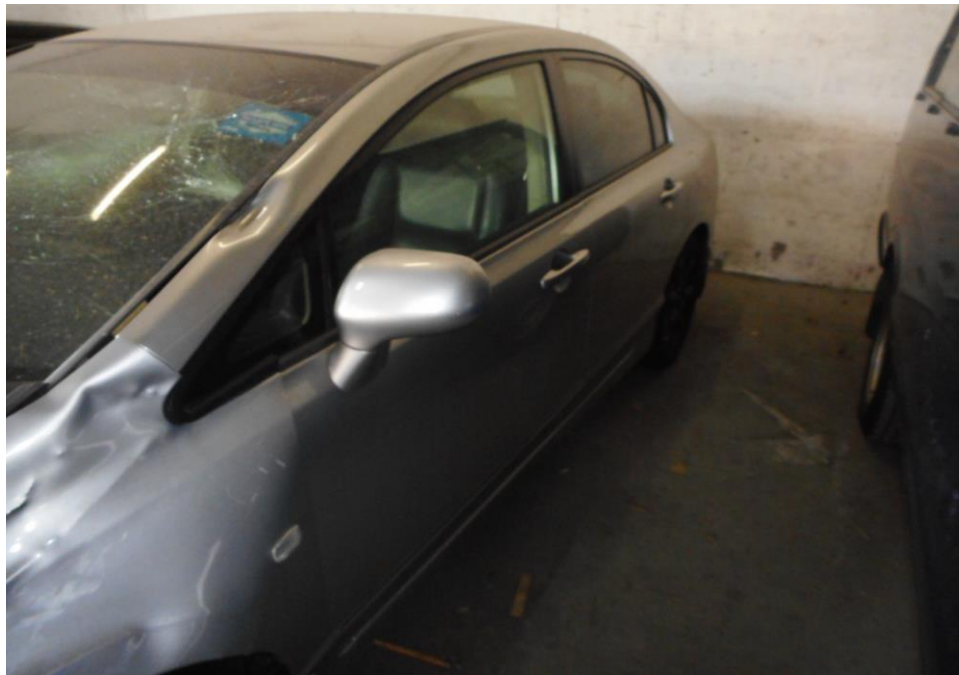
Photo 7 shows a general view of the Motor Car's left body at the time of my inspection. The left portion of the Motor Car was observed to have been unaffected by the accident.

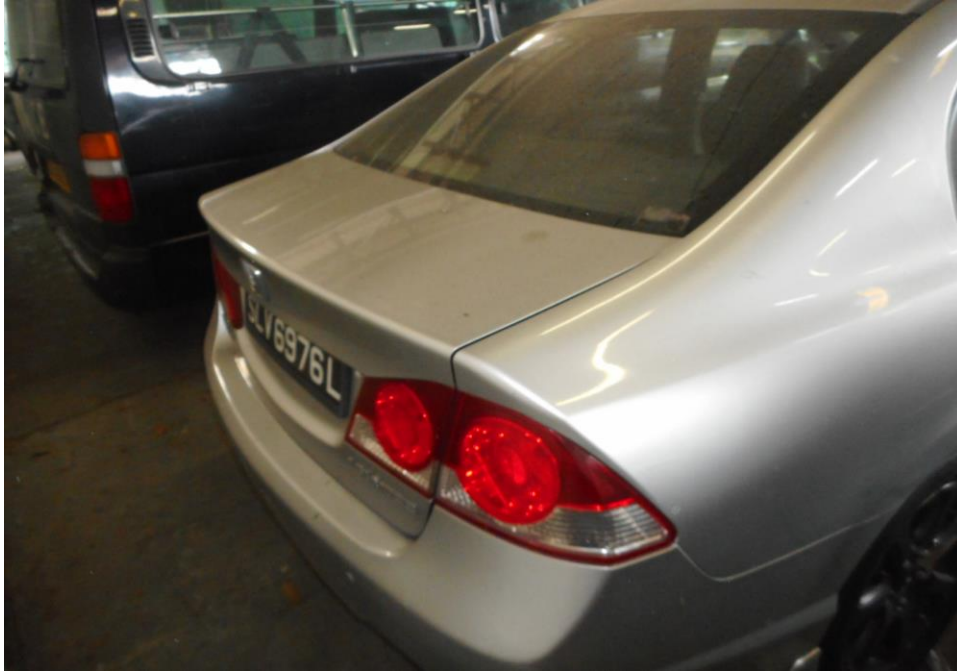
Photo 8 shows the general view of the Motor Car's rear body at the time of my inspection. The Motor Car rear was observed to be unaffected by the accident.

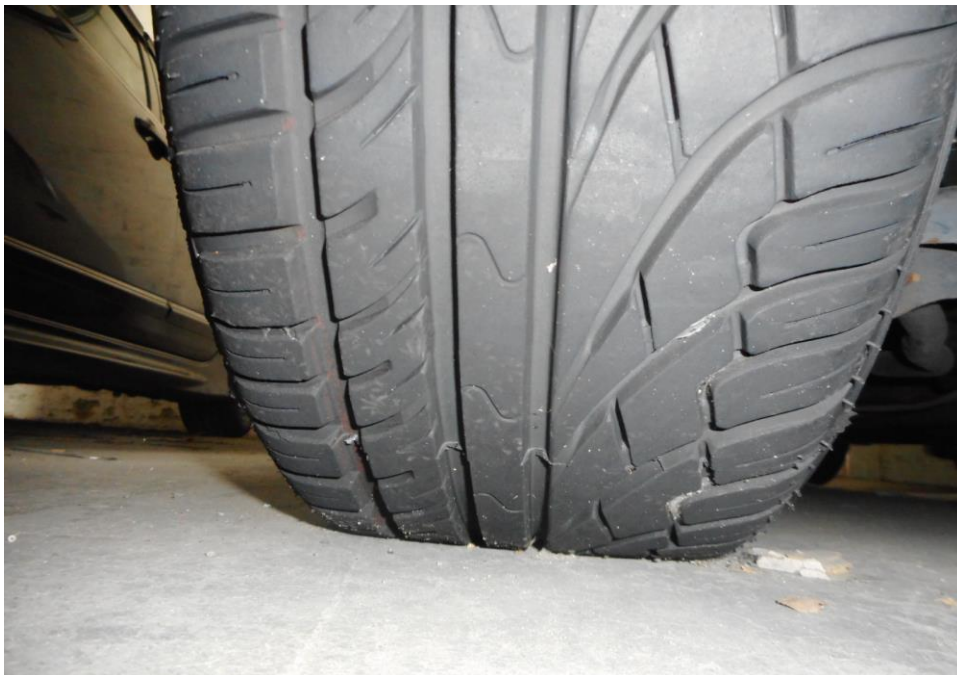
Photo 9 shows the condition of the front right tyre of the Motor Car, which was observed to be in serviceable condition with remaining tread depth of approximately 7.2mm. The tyre was sufficiently inflated for vehicular operation with no tear, cut or burst mark(s) on the outer and the inner sidewalls as well as across the tread. The 4 tyres of the Motor Car were wrapped around standard steel wheel rims without any damage.

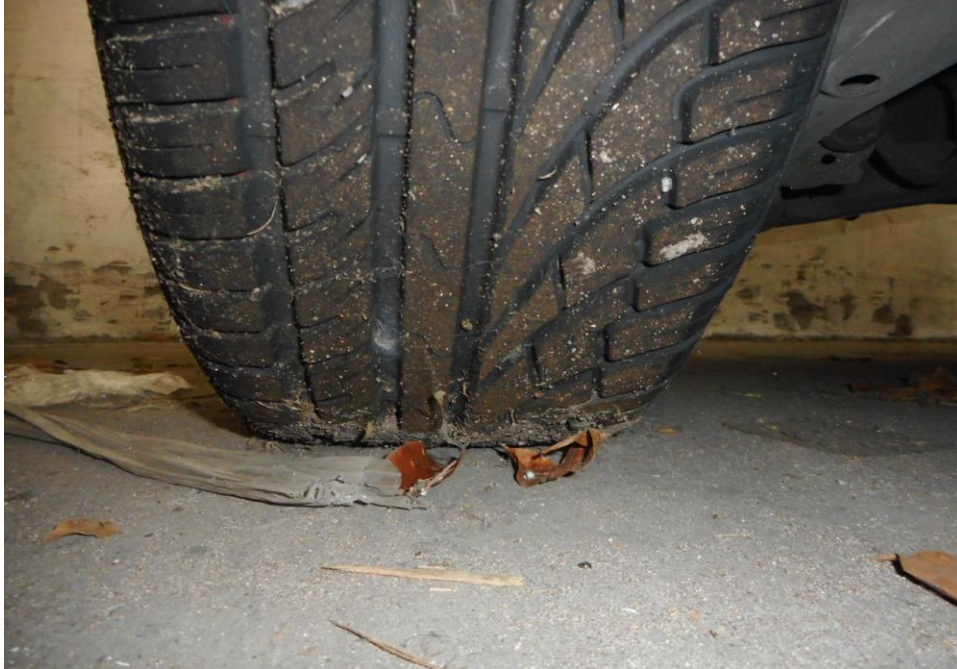
Photo 10 shows the condition of the rear right tyre of the Motor Car, which was observed to be in serviceable condition with remaining tread depth of approximately 7.1mm. The tyre was also observed to be sufficiently inflated for vehicular operation with no tear, cut or burst mark(s).

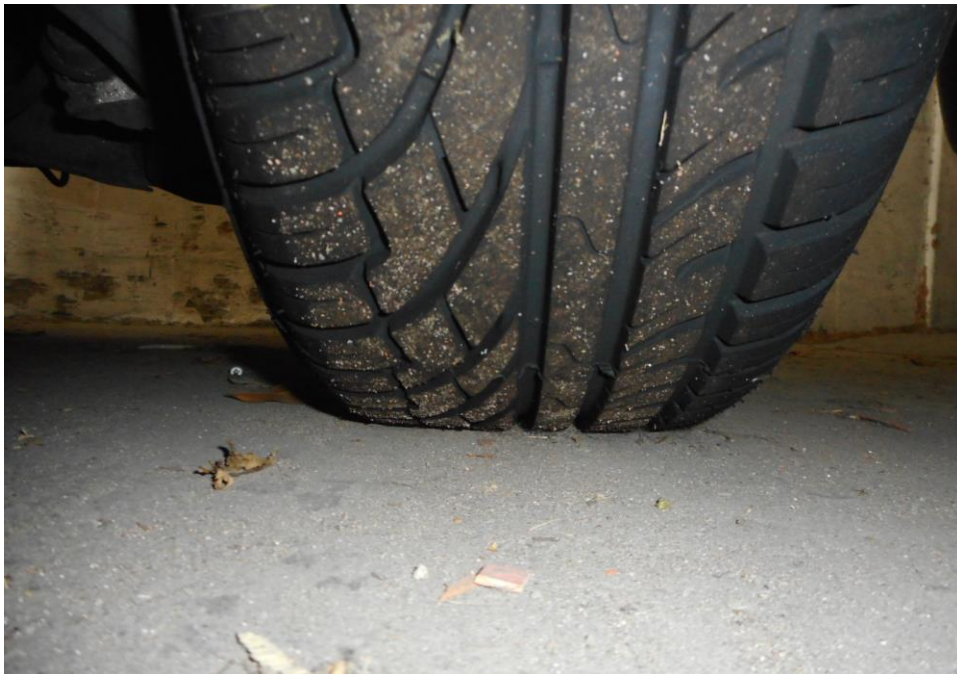
Photo 11 shows the condition of the rear left tyre of the Motor Car, which was observed to be in serviceable condition with remaining tread depth of approximately 7.2mm. The tyre, which was wrapped around steel wheel rim, was also observed to be sufficiently inflated for vehicular operation. The 4 tyres of the Motor Car were wrapped around standard steel wheel rims.

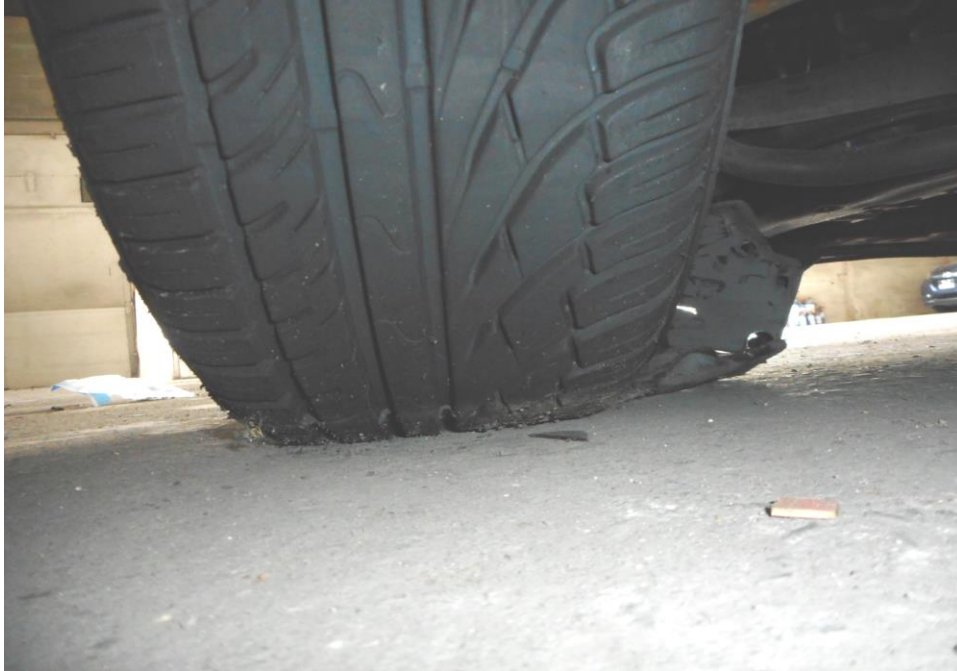
Photo 12 shows the condition of the front left tyre of the Motor Car, which was observed to be in serviceable condition with remaining tread depth of approximately 7.3mm. There was also no tear, cut or burst mark(s) on the outer and the inner sidewalls as well as across the tread of the Motor Car's 4 tyres.

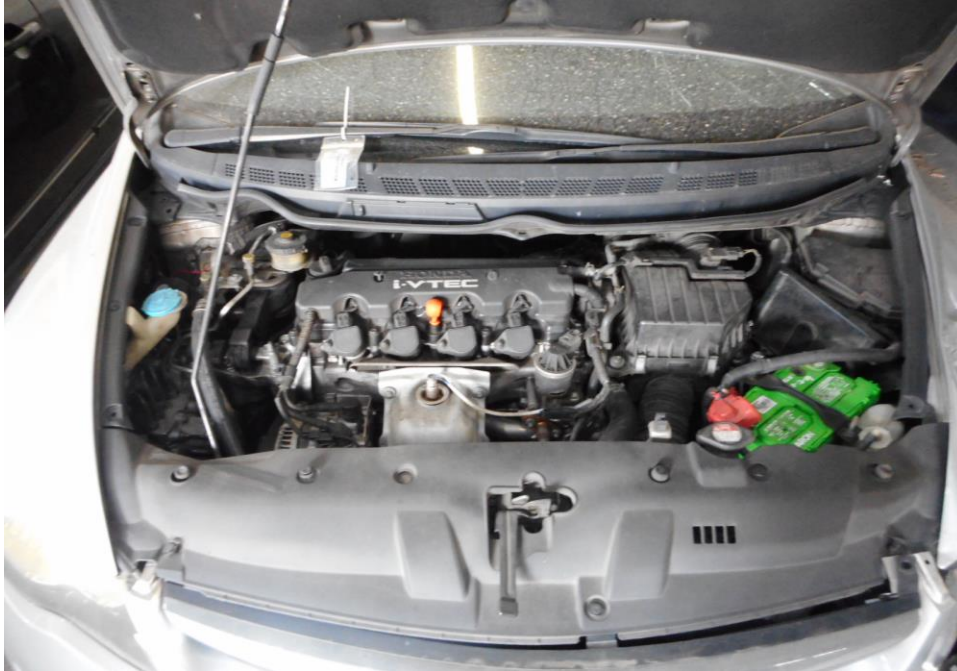
Photo 13 shows a general view of the Motor Car's engine compartment. The various parts and components inside the engine compartment were unaffected by the accident. There was also no sign(s) or indication(s) of fluid leakage and/or fluid stain within the engine compartment.

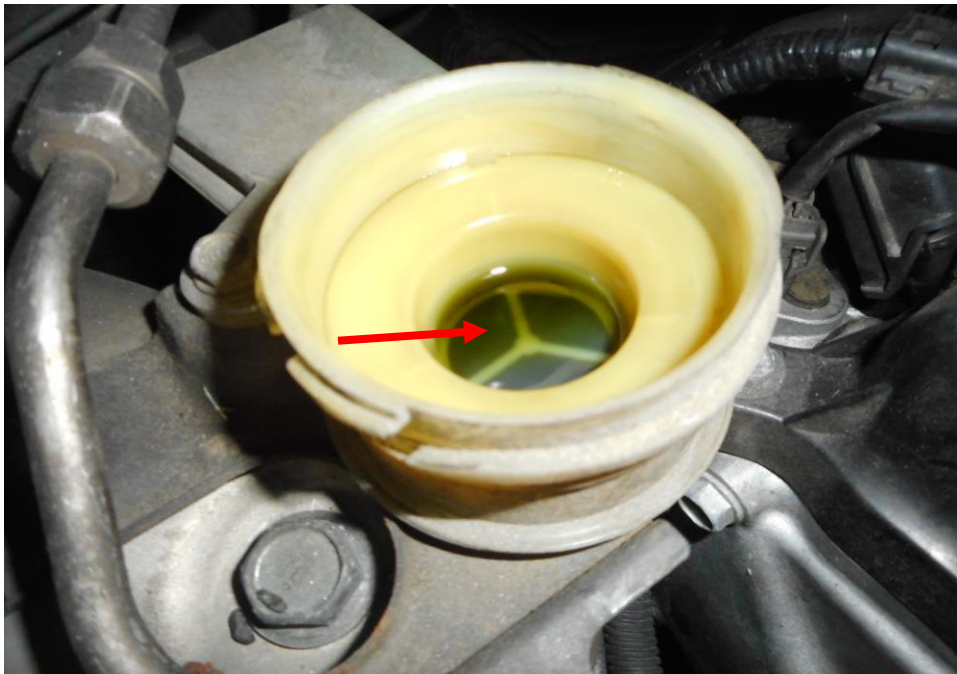
Photo 14 shows the brake fluid reservoir of the Motor Car at the time of my inspection. The brake fluid was observed to be of sufficient level (arrowed) and without any visible contamination.

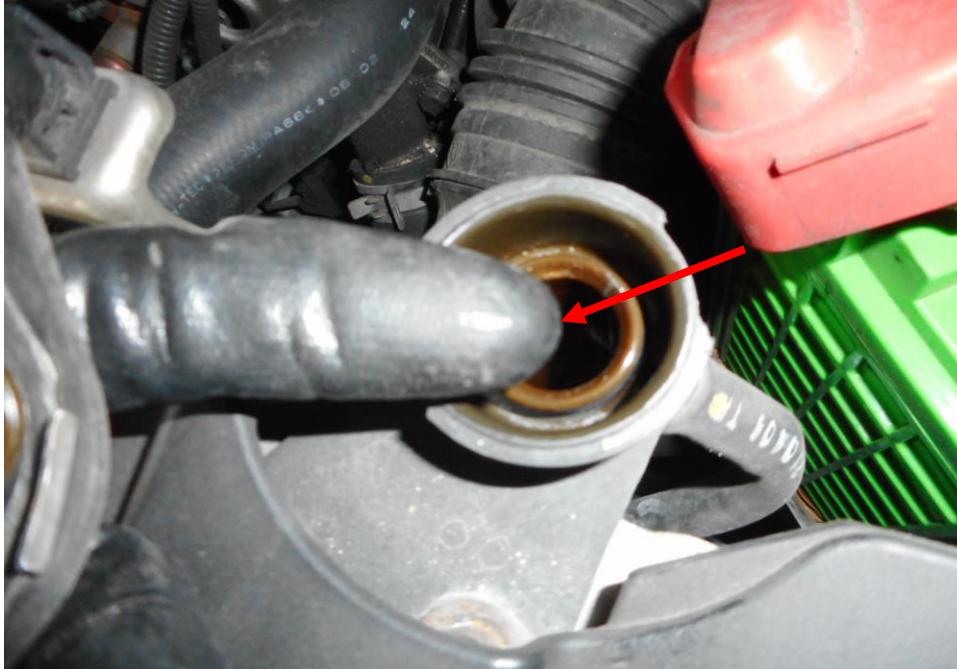
Photo 15 shows checks being carried out to the engine coolant of the Motor Car at the time of my inspection. The engine coolant was observed to be of insufficient level (arrowed).

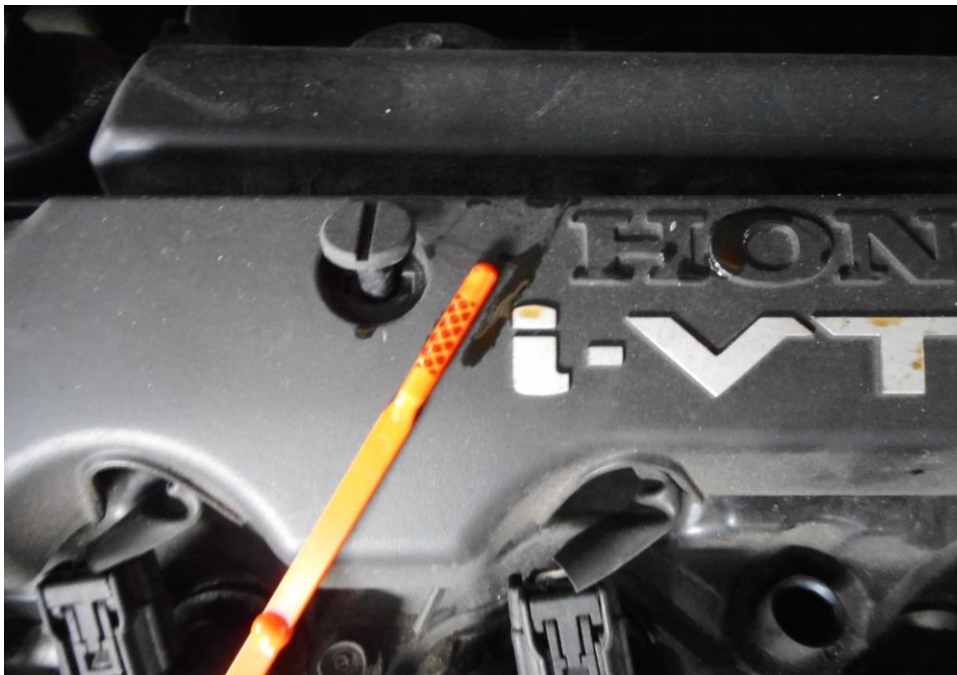
Photo 16 shows the engine oil dip stick of the Motor Car at the time of my inspection. The engine oil was observed to be of sufficient level and without any visible contamination.

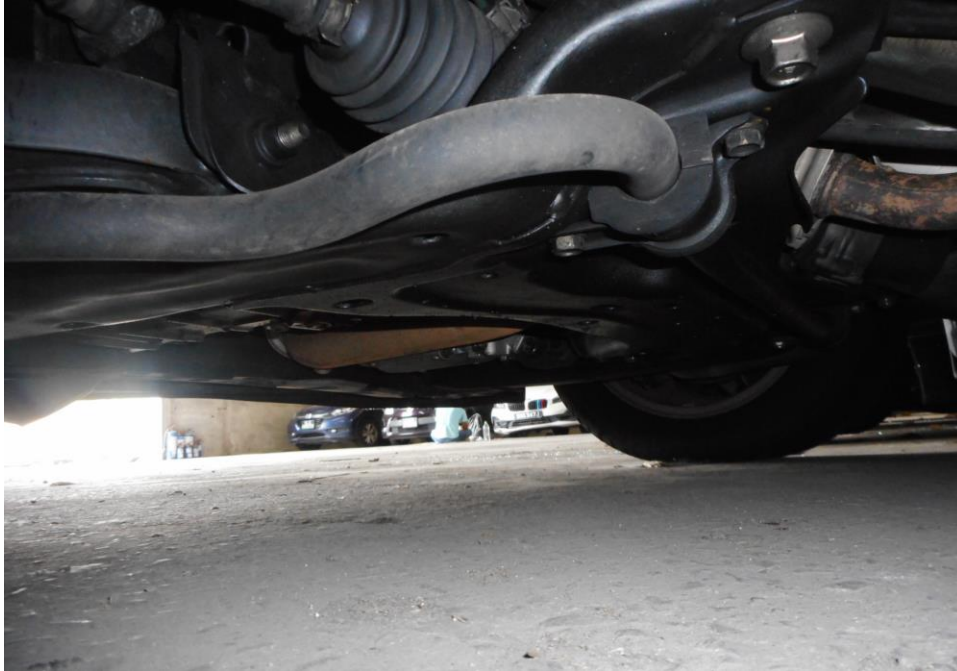
Photo 17 shows the undercarriage of the Motor Car, at the area where the engine housing and transmission housing are located. I did not find any sign(s) or indication(s) of fluid leak and/or fluid stain(s) on the underside of the Motor Car.

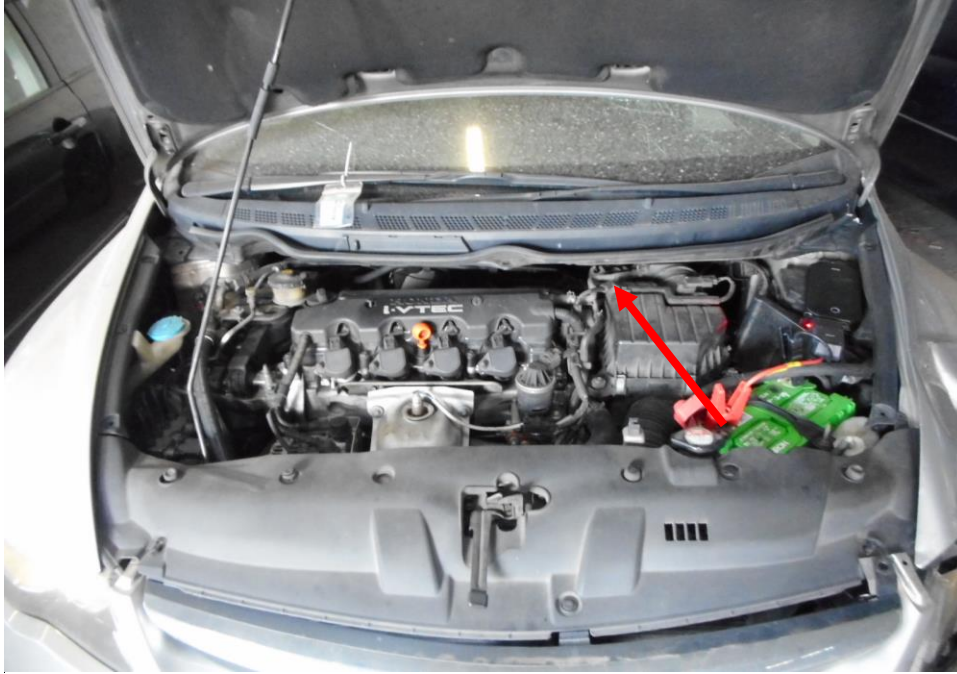
Photo 18 shows the jumpstarting process of the Motor Car's engine. The engine of the Motor Car was unable to be jumpstarted up despite multiple attempts in starting it.

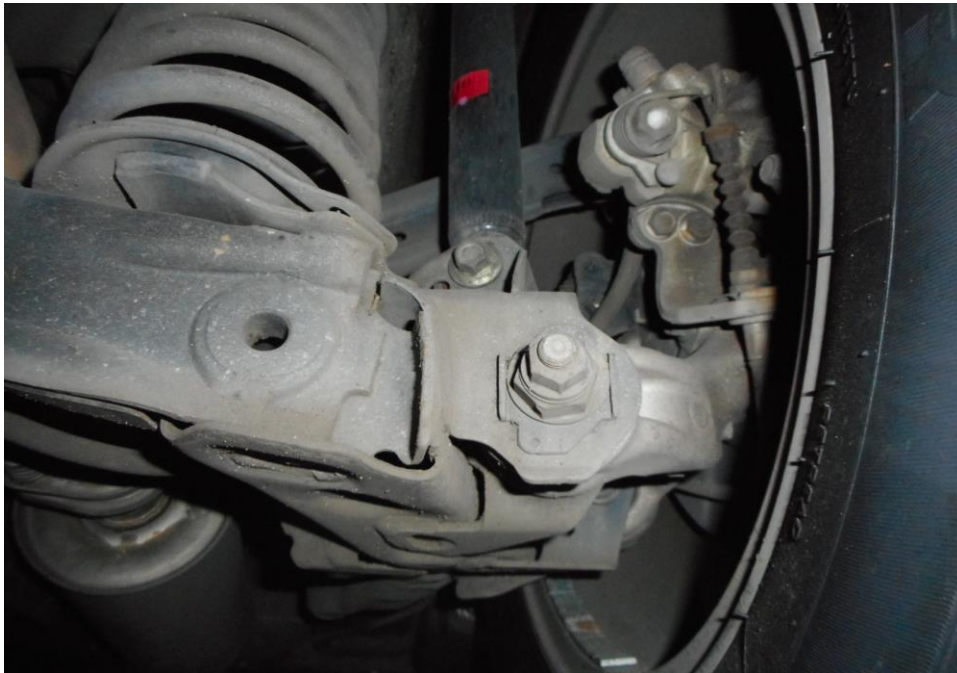
Photo 19 shows the brake hose/pipe (arrowed) at the rear right wheel of the Motor Car. No leakage of brake fluid was observed. Visual examination of the various components of the braking system like the drum brake, brake booster, brake pedal etc. had revealed all to be intact and without visible damage.

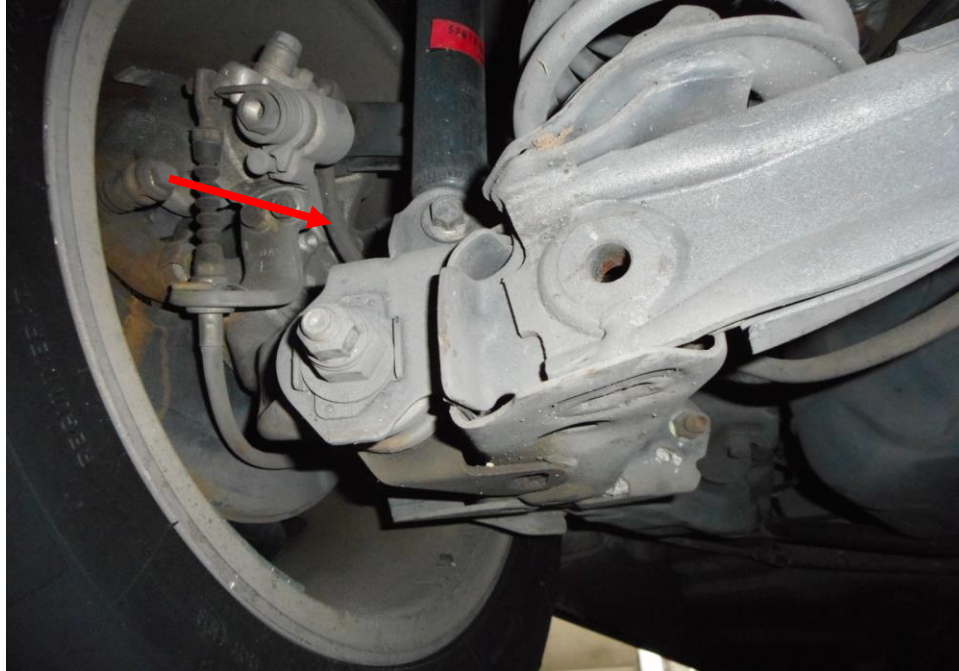
Photo 20 shows the brake hose/pipe (arrowed) at the rear left wheel of the Motor Car. I did not observe any leakage of brake fluid at the time of my inspection of the Motor Car. Static tests of the Motor Car's braking system had indicated that there was no internal leakage of pressure/vacuum. The undercarriage components of the Motor Car were also all found to be intact and without any visible damage.

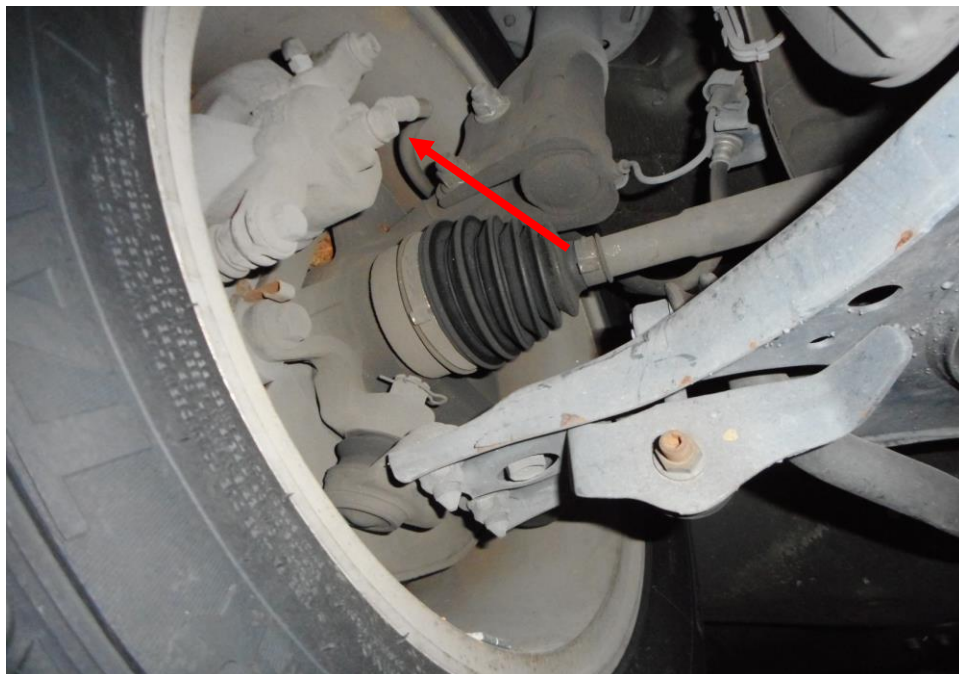
Photo 21 shows the brake hose/pipe (arrowed) at the front right wheel of the Motor Car. I did not observe any leakage of brake fluid at the time of my inspection of the Motor Car. Static tests of the Motor Car's braking system had indicated that there was no internal leakage of pressure/vacuum. The undercarriage components of the Motor Car were also all found to be intact and without any visible damage.

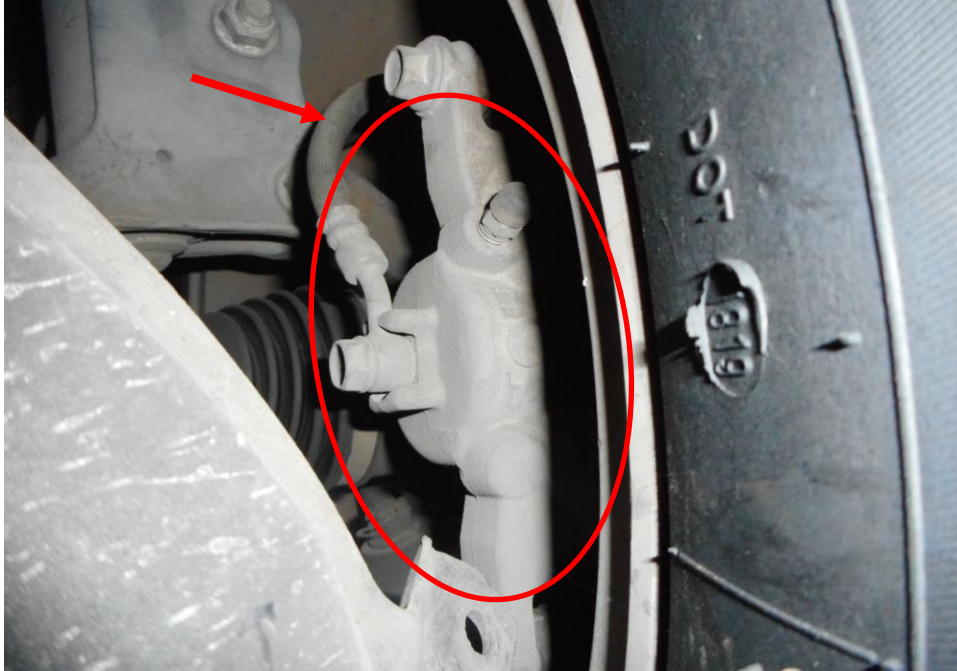
Photo 22 shows the brake hose/pipe (arrowed) at the front left wheel of the Motor Car. No leakage of brake fluid was observed. Visual examination of the various components of the braking system like the brake caliper (circled), brake booster, brake pedal etc had revealed all to be intact and without visible damage.

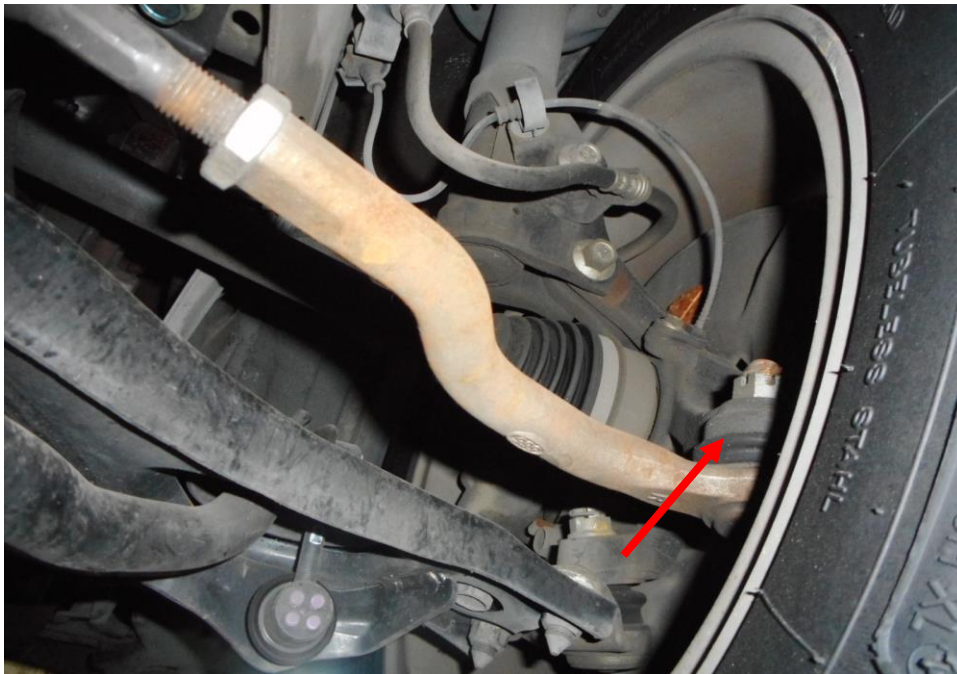
Photo 23 shows the various undercarriage components at the front right wheel of the Motor Car, in particular the steering tie rod (red arrow). The various steering components were all found to be intact, suggesting that the steering system of the Motor Car was likely to be in serviceable condition at the material time of accident. There was also no sign of fluid stain observed on the various undercarriage components at the front right wheel of the Motor Car.

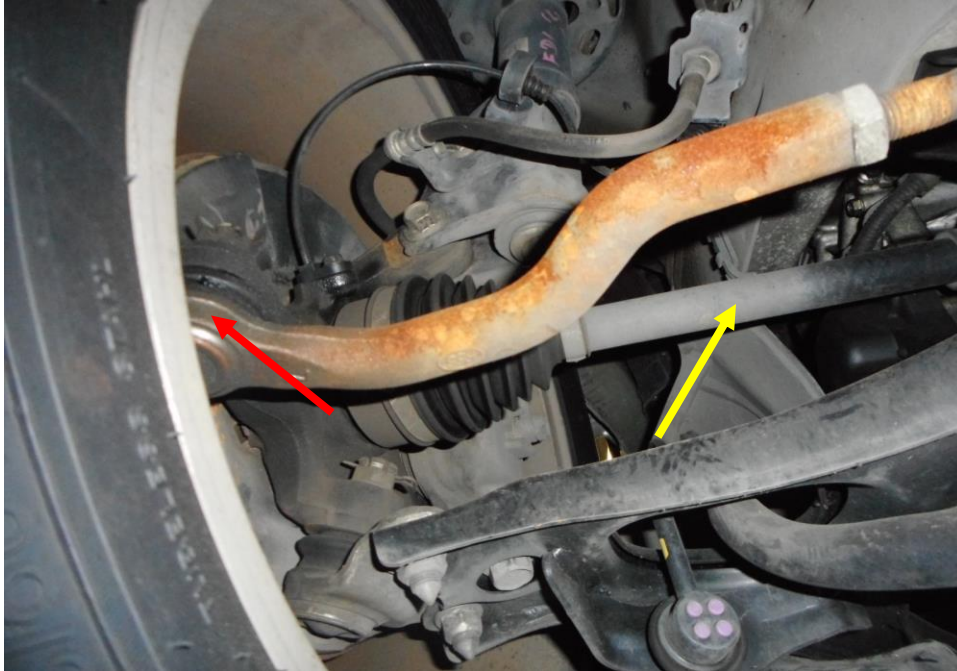
Photo 24 shows the various undercarriage components at the front left wheel of the Motor Car, which had included the steering tie rod (red arrow) and drive shaft (yellow arrow). The various undercarriage components of the Motor Car were all found to be intact without any visible damage.
