You're Ref: TP/IP/45617/2020
Our Ref: CI/TPD20014307/P

7th January 2021

MECHANICAL INSPECTION REPORT OF MOTOR CAR SJP 4779H

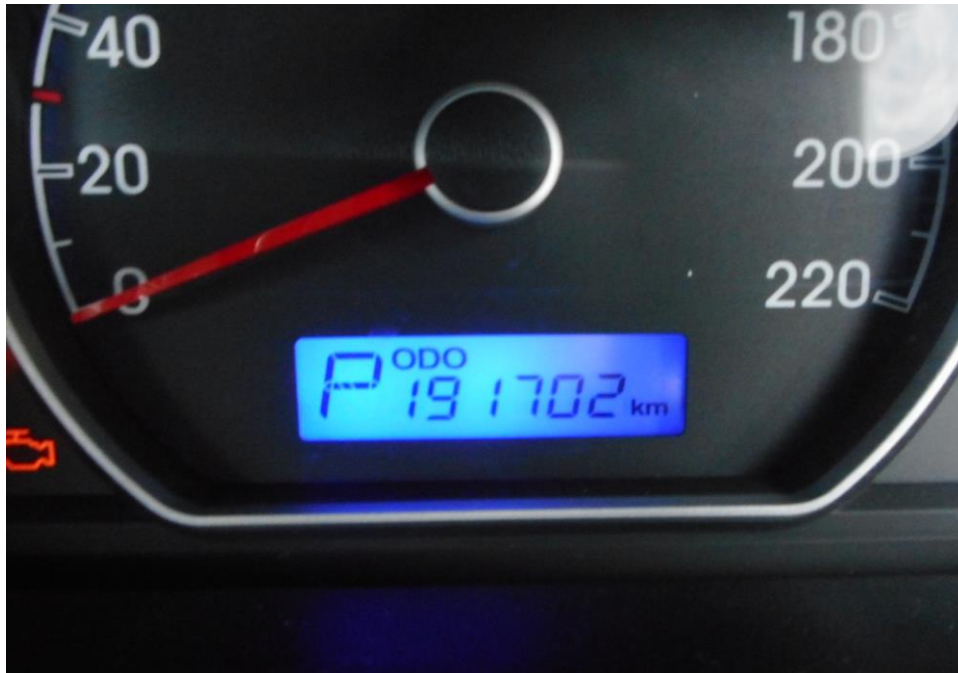
Photo 1 shows the mileage of the Motor Car at the time of my inspection. The mileage observed was 191,702km.

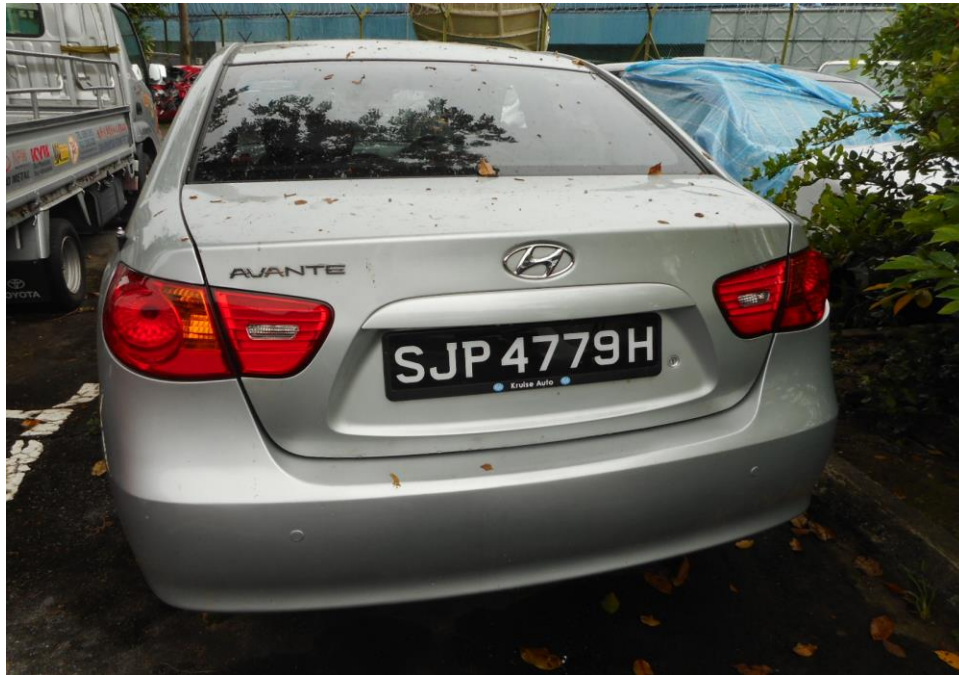
Photo 2 shows the general view of the Motor Car's rear body at the time of my inspection. The Motor Car rear was observed to be unaffected by the accident.

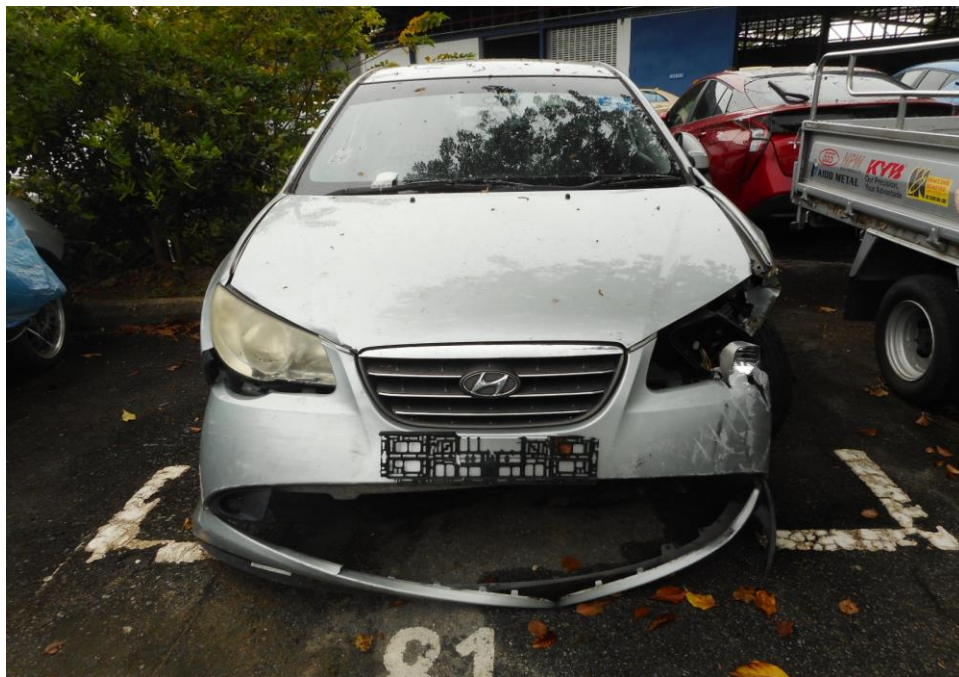
4. The mileage of the Motor Car at the time of my inspection was 191,702km.
5. The Motor Car was observed to have sustained damage at its front portion. Its front bonnet, front bumper, front left and right fender, front left headlamp and the right rear view mirror are the body parts that were damaged as a result of the accident.

Photo 3 shows a general view of the Motor Car's front body at the time of my inspection. Its front bonnet, front bumper, front left and right fender, front left headlamp and the right rear view mirror are the body parts that were damaged as a result of the accident.

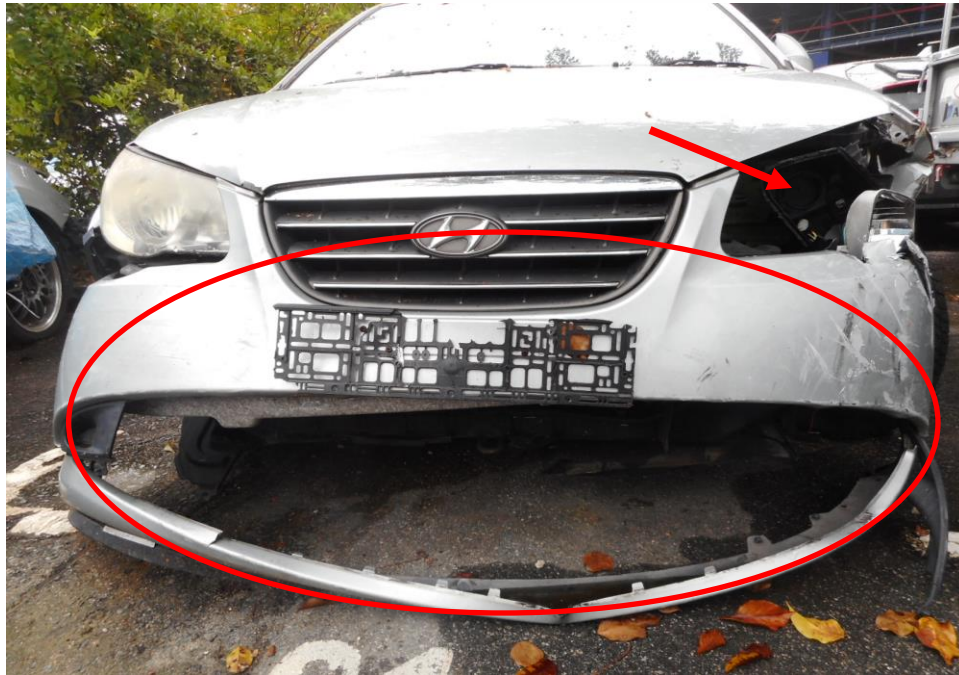
Photo 4 shows the close up view of the Motor Car's front body at the time of my inspection. Its front bumper (circled) and front left headlamp (arrowed) are the body parts that were damaged as a result of the accident.

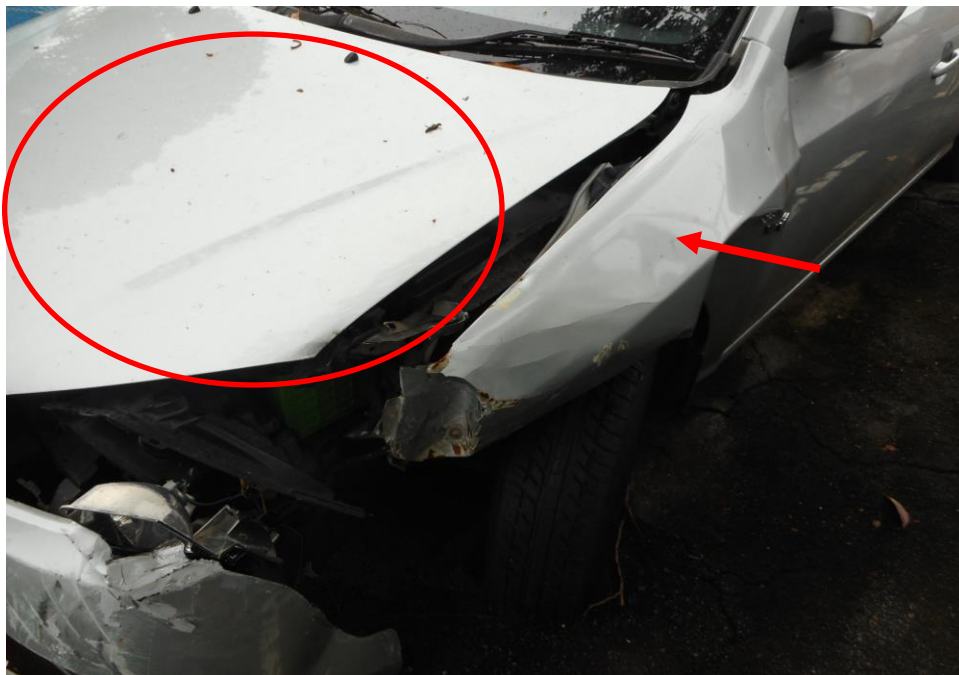
Photo 5 shows the close up view of the Motor Car's front body at the time of my inspection. Its front bonnet (circled) and front left fender (arrowed) are the body parts that were damaged as a result of the accident.

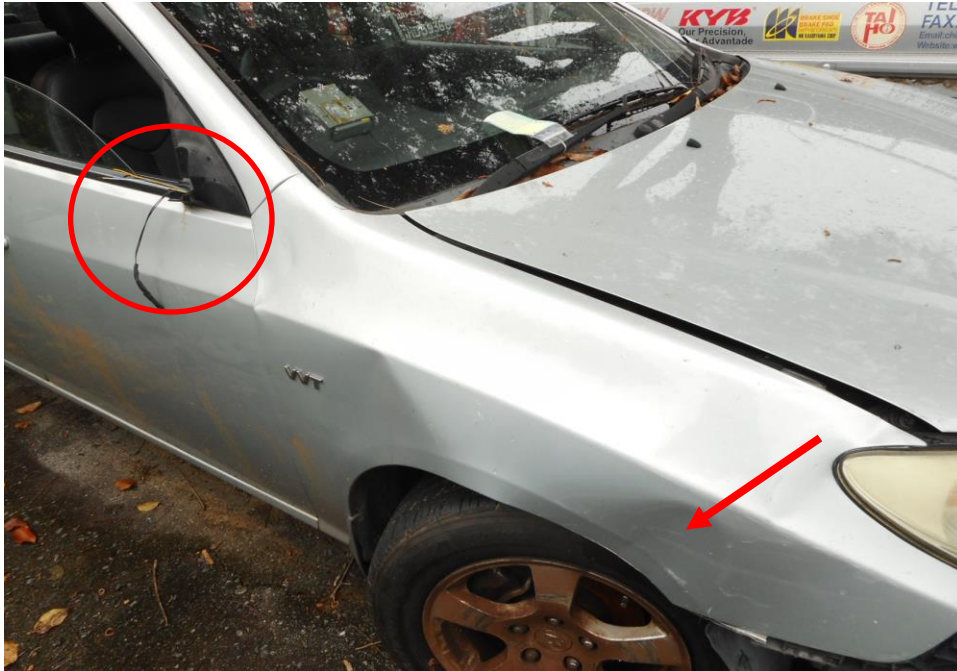
Photo 6 shows the close up view of the Motor Car's front body at the time of my inspection. Its right rear view mirror (circled) and front right fender (arrowed) are the body parts that were damaged as a result of the accident.

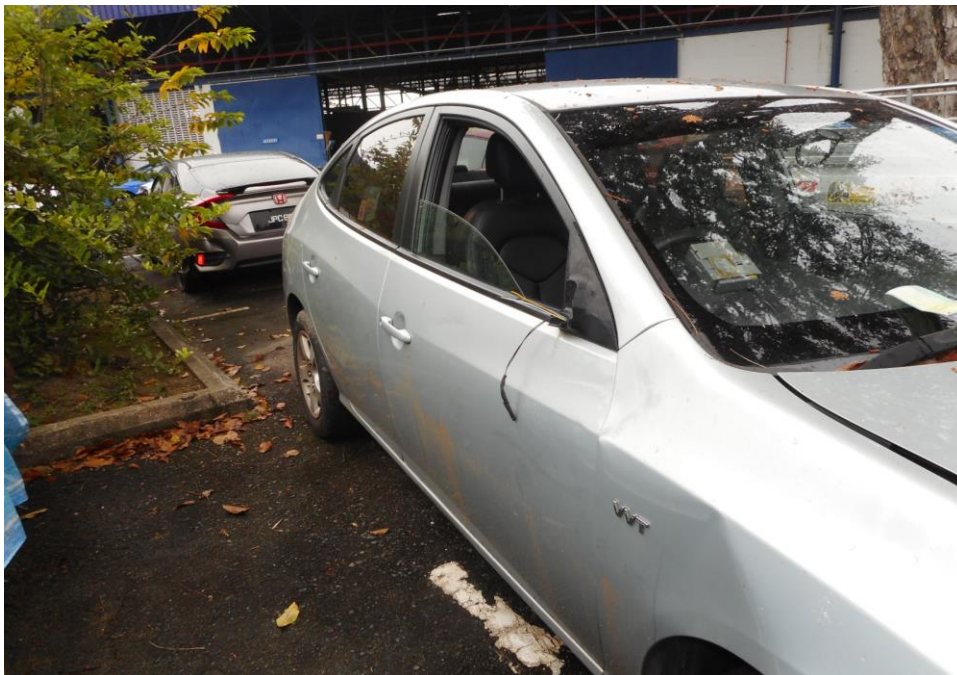
Photo 7 shows a general view of the Motor Car's right body at the time of my inspection. The right portion of the Motor Car was observed to have been unaffected by the accident.

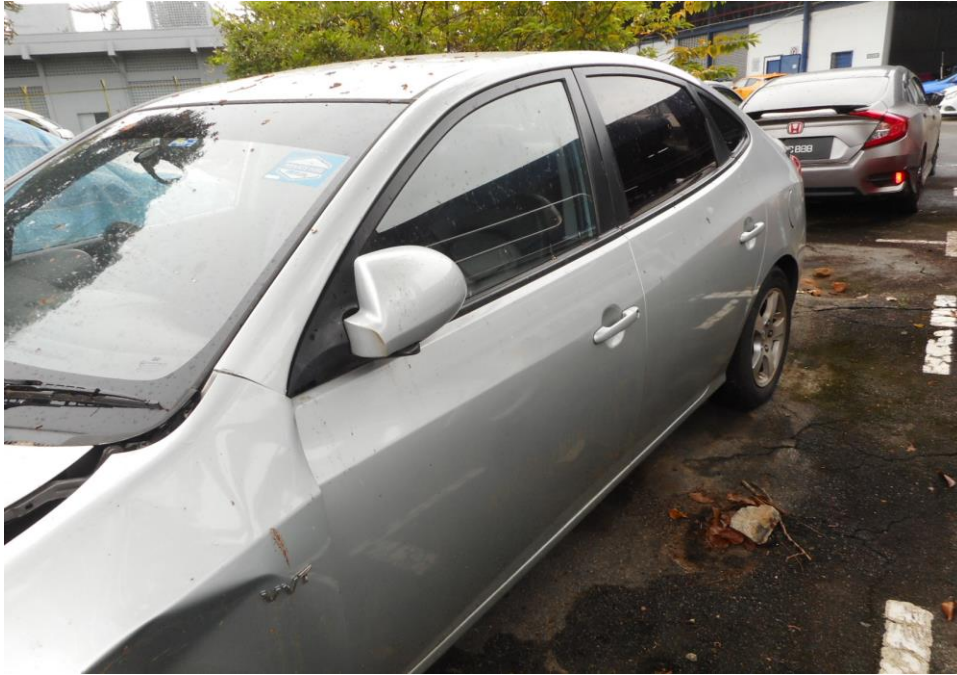
Photo 8 shows a general view of the Motor Car's left body at the time of my inspection. The left portion of the Motor Car was observed to have been unaffected by the accident.

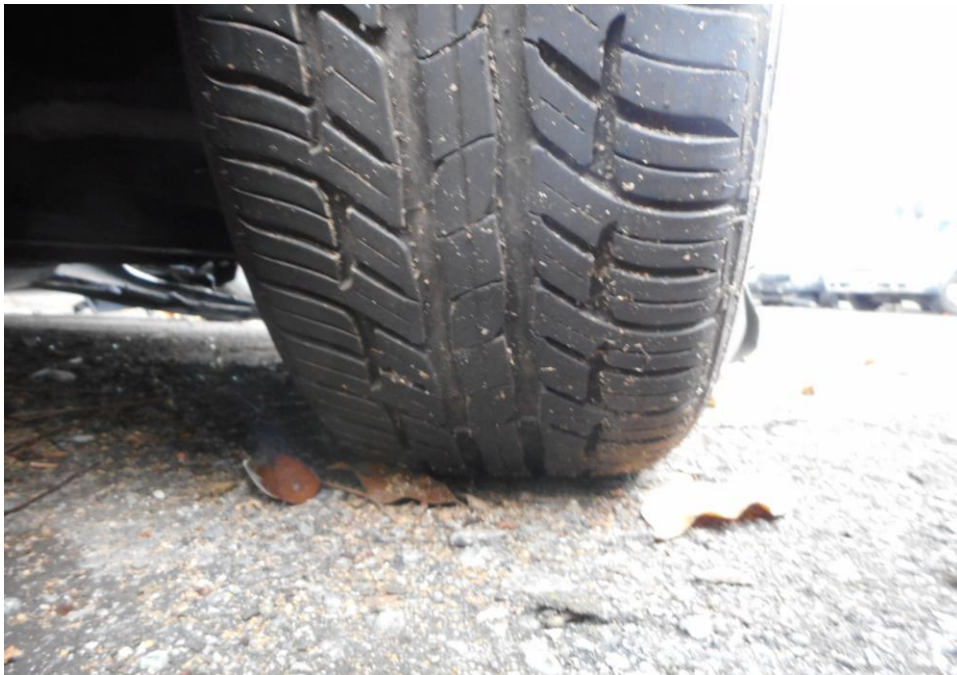
Photo 9 shows the condition of the front right tyre of the Motor Car, which was observed to be in serviceable condition with remaining tread depth of approximately 5.5mm. The tyre was sufficiently inflated for vehicular operation with no tear, cut or burst mark(s) on the outer and the inner sidewalls as well as across the tread. The 3 tyres of the Motor Car were wrapped around standard steel wheel rims without any damage.

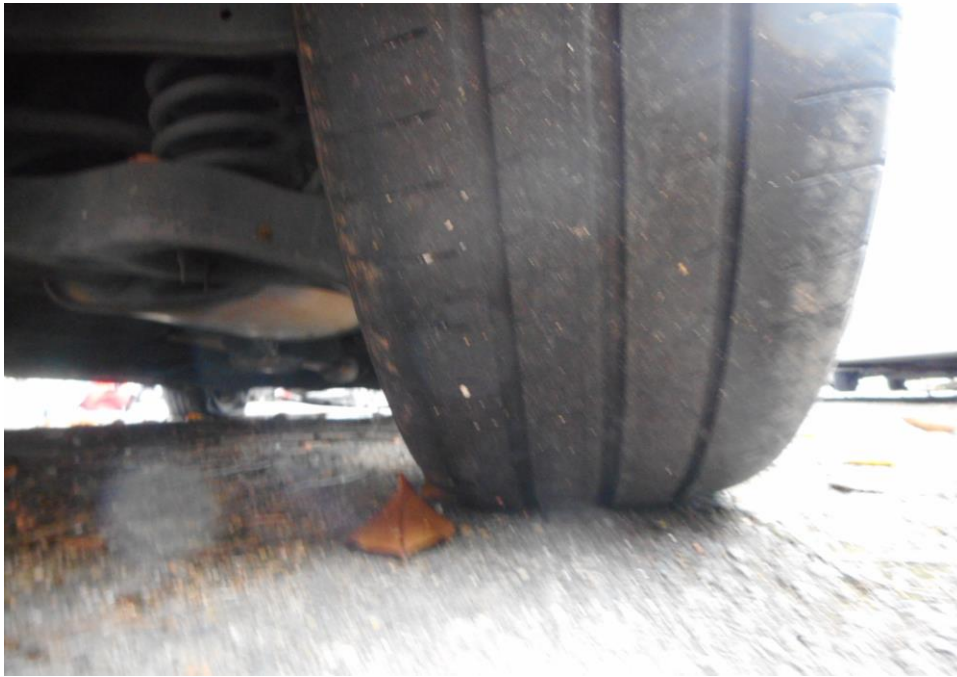
Photo 10 shows the condition of the rear right tyre of the Motor Car, which was observed to be in serviceable condition with remaining tread depth of approximately 2.8mm. The tyre was also observed to be sufficiently inflated for vehicular operation with no tear, cut or burst mark(s).

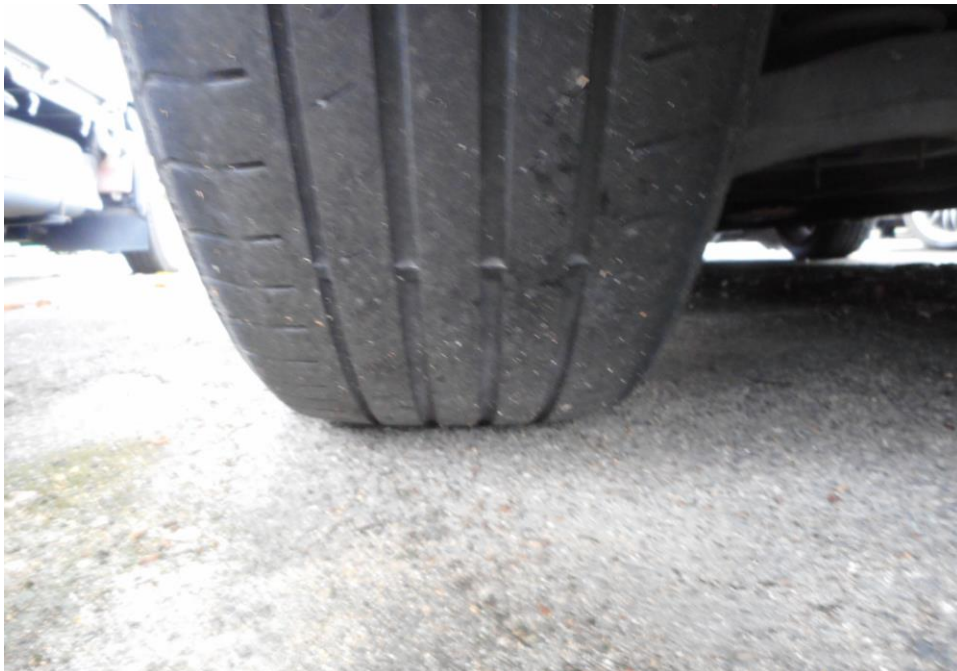
Photo 11 shows the condition of the rear left tyre of the Motor Car, which was observed to be in serviceable condition with remaining tread depth of approximately 2.3mm. The tyre, which was wrapped around steel wheel rim, was also observed to be sufficiently inflated for vehicular operation. The 3 tyres of the Motor Car were wrapped around standard steel wheel rims.

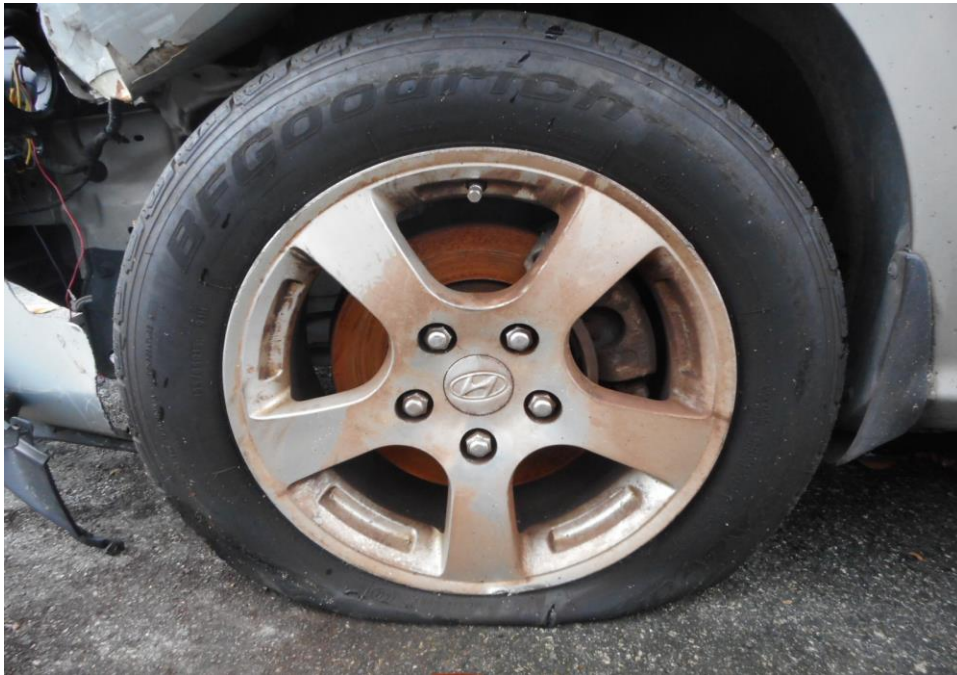
Photo 12 shows the condition of the front left tyre of the Motor Car, which was observed to be cut and deflated likely due to the result of the accident. The with remaining tread depth of approximately 5.3mm

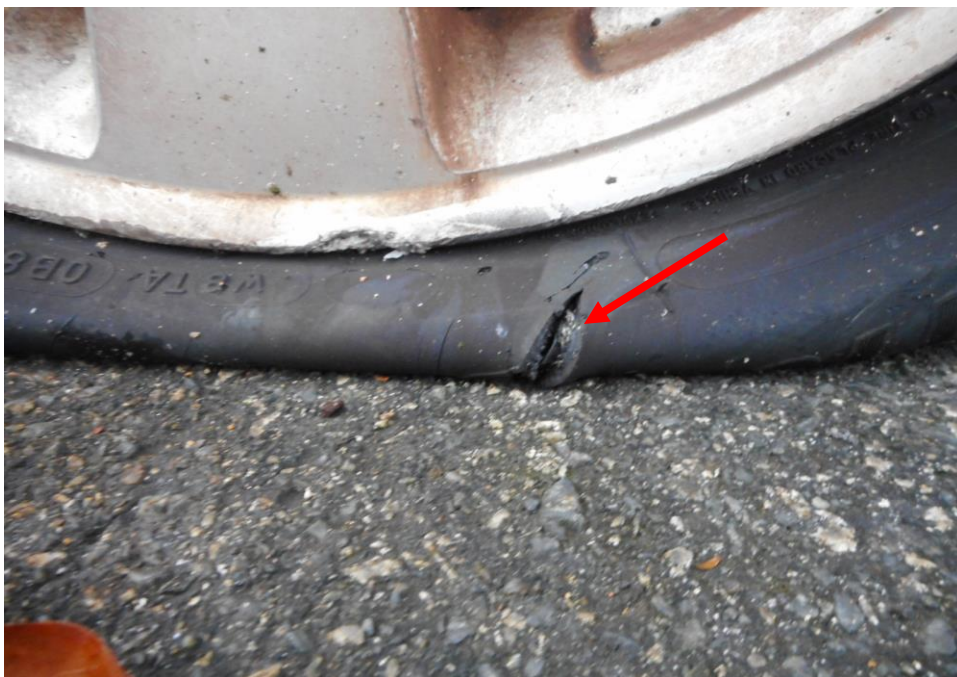
Photo 13 shows the close up condition of the front left tyre of the Motor Car, which was observed to be cut and deflated (arrowed) likely due to the result of the accident.

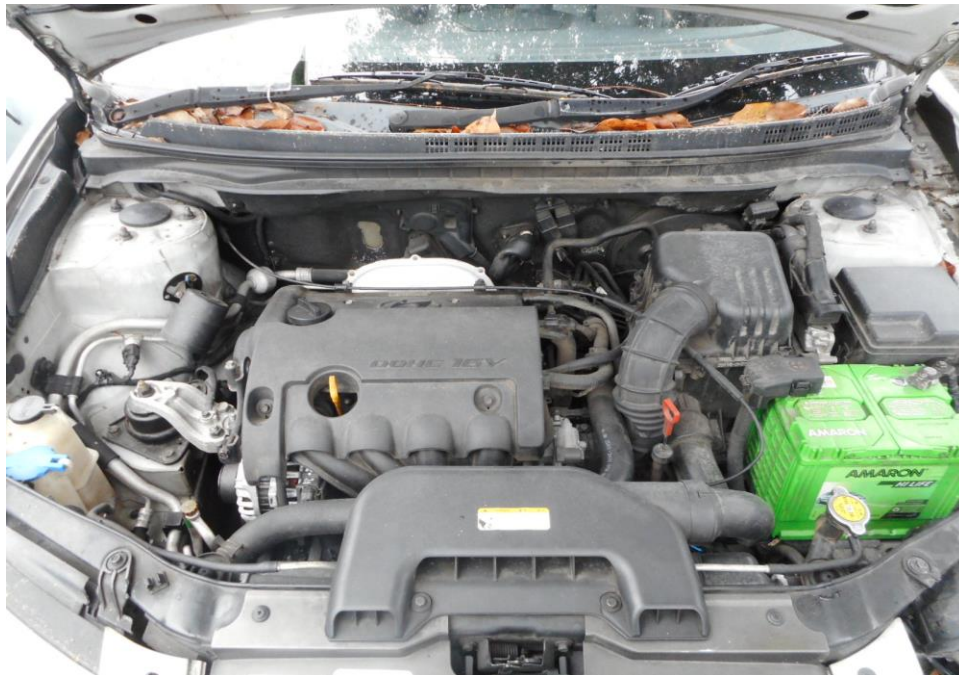
Photo 14 shows a general view of the Motor Car's engine compartment. The various parts and components inside the engine compartment were unaffected by the accident. There was also no sign(s) or indication(s) of fluid leakage and/or fluid stain within the engine compartment.

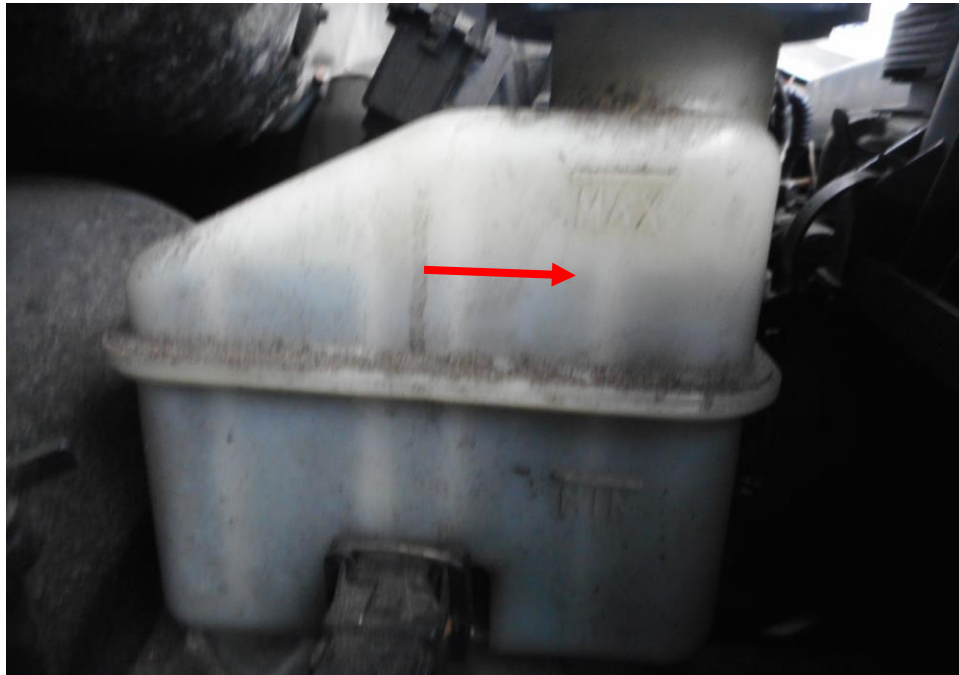
Photo 15 shows the brake fluid reservoir of the Motor Car at the time of my inspection. The brake fluid was observed to be of sufficient level (arrowed) and without any visible contamination.

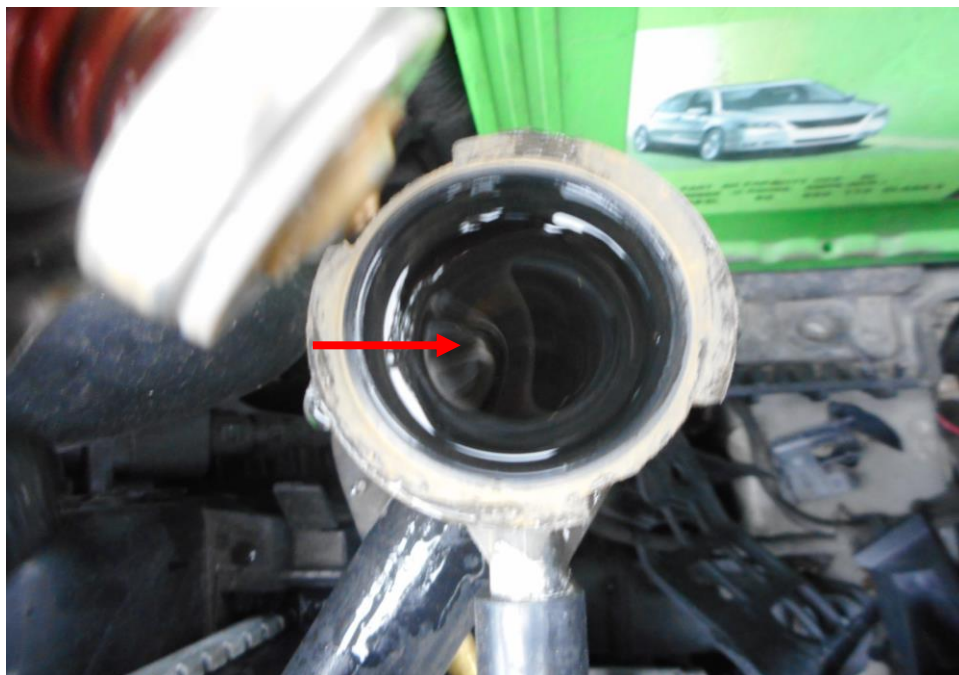
Photo 16 shows checks being carried out to the engine coolant of the Motor Car at the time of my inspection. The engine coolant was observed to be of sufficient level (arrowed) and without any visible contamination.

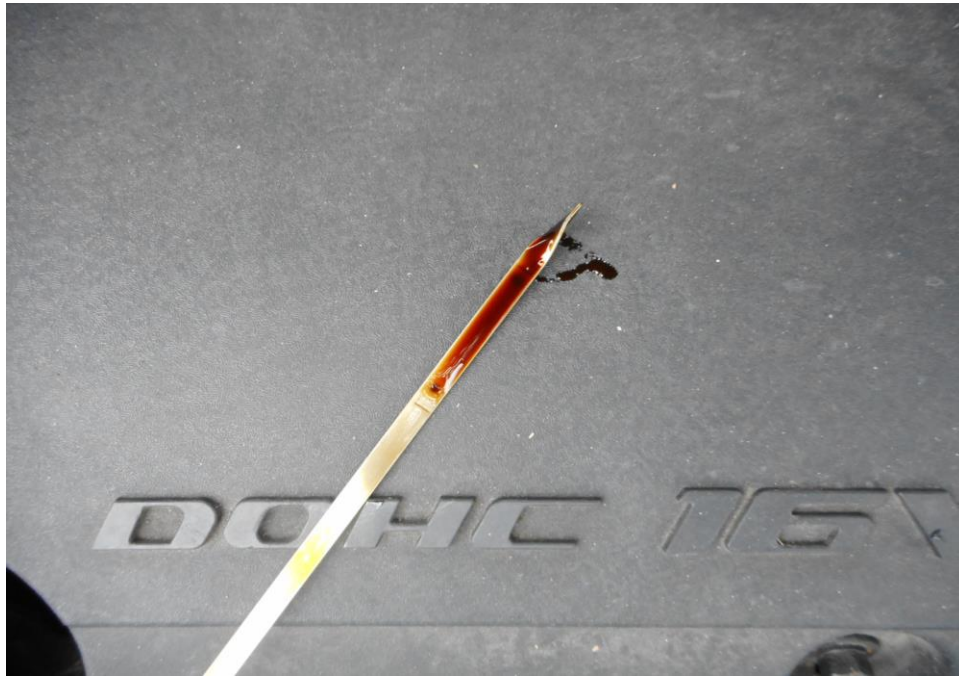
Photo 17 shows the engine oil dip stick of the Motor Car at the time of my inspection. The engine oil was observed to be of sufficient level and without any visible contamination.

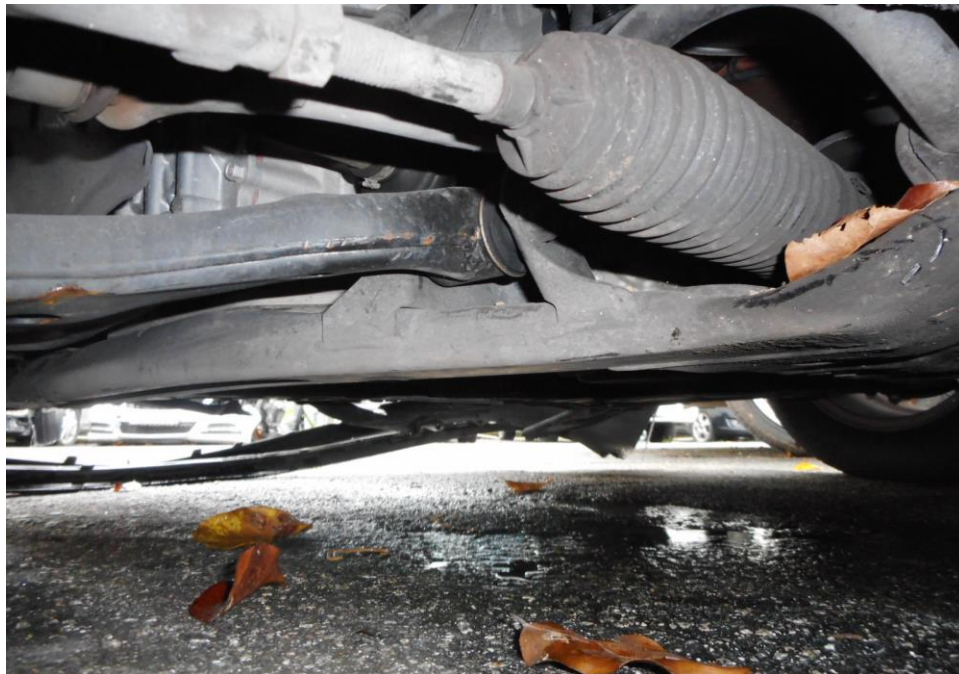
Photo 18 shows the undercarriage of the Motor Car, at the area where the engine housing and transmission housing are located. I did not find any sign(s) or indication(s) of fluid leak and/or fluid stain(s) on the underside of the Motor Car.

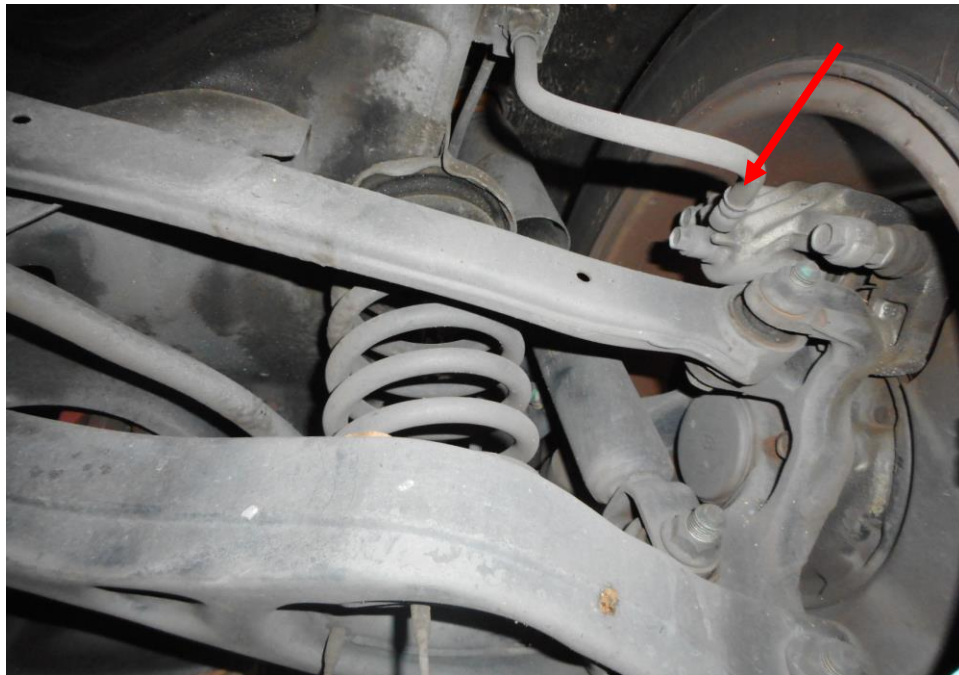
Photo 19 shows the brake hose/pipe (arrowed) at the rear right wheel of the Motor Car. No leakage of brake fluid was observed. Visual examination of the various components of the braking system like the brake caplier, brake booster, brake pedal etc. had revealed all to be intact and without visible damage.

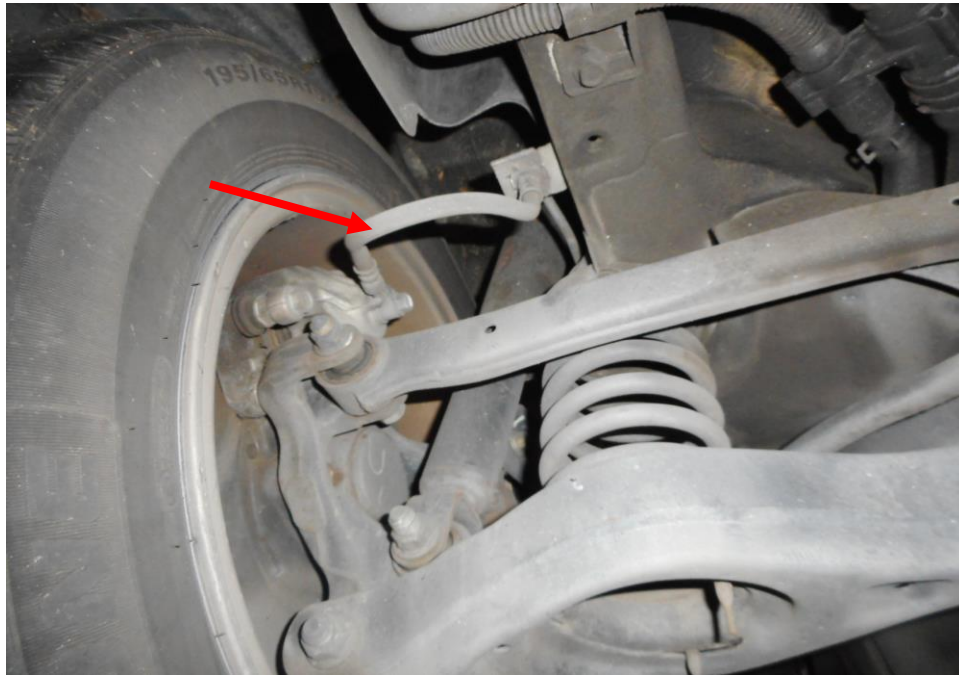
Photo 20 shows the brake hose/pipe (arrowed) at the rear left wheel of the Motor Car. I did not observe any leakage of brake fluid at the time of my inspection of the Motor Car. Static tests of the Motor Car's braking system had indicated that there was no internal leakage of pressure/vacuum. The undercarriage components of the Motor Car were also all found to be intact and without any visible damage.

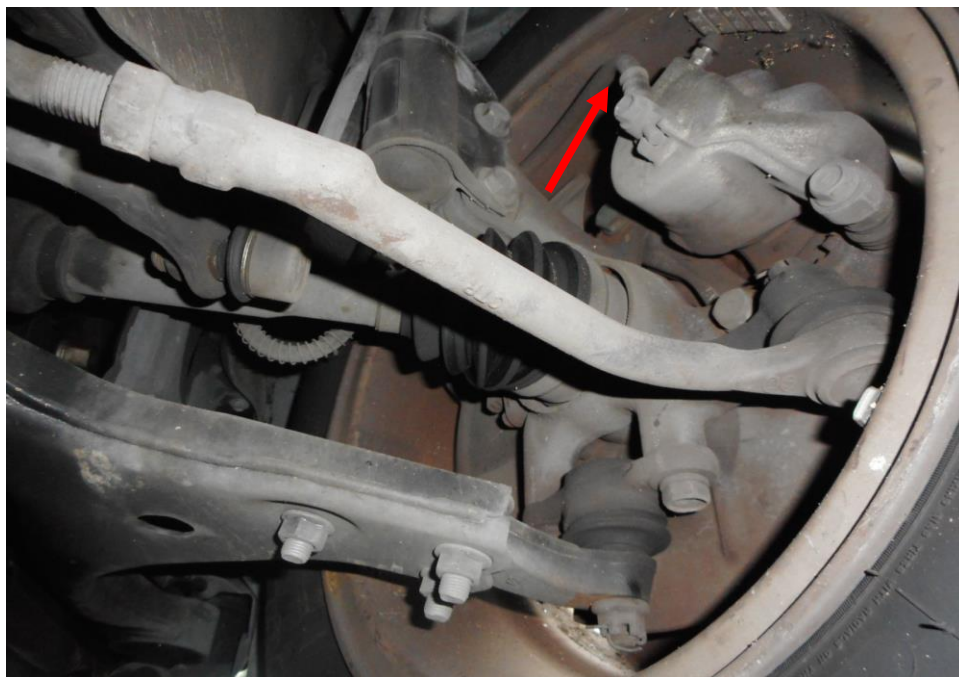
Photo 21 shows the brake hose/pipe (arrowed) at the front right wheel of the Motor Car. I did not observe any leakage of brake fluid at the time of my inspection of the Motor Car. Static tests of the Motor Car's braking system had indicated that there was no internal leakage of pressure/vacuum. The undercarriage components of the Motor Car were also all found to be intact and without any visible damage.

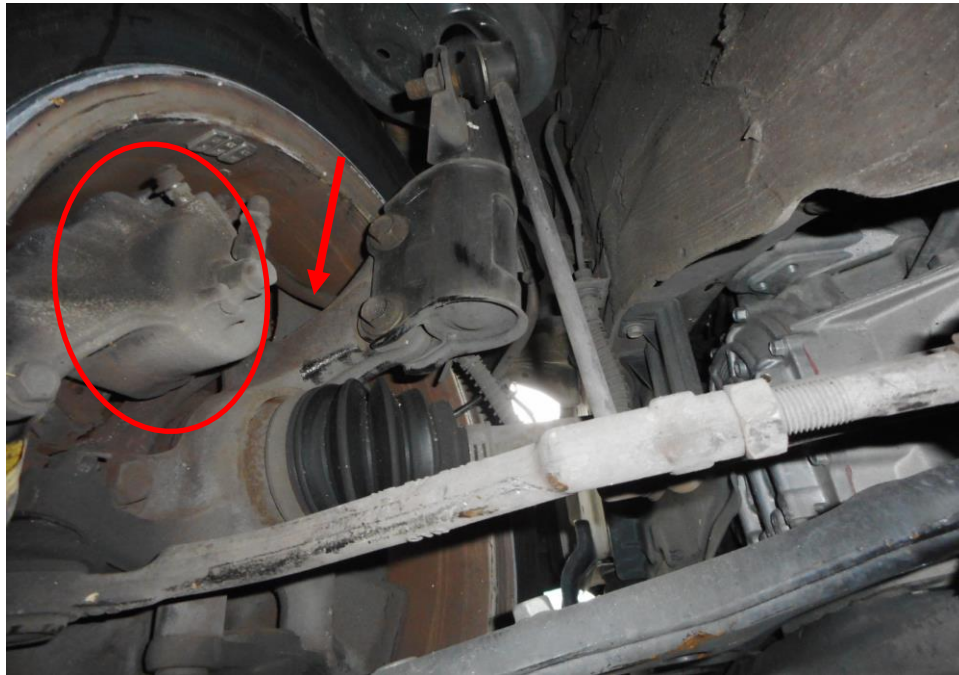
Photo 22 shows the brake hose/pipe (arrowed) at the front left wheel of the Motor Car. No leakage of brake fluid was observed. Visual examination of the various components of the braking system like the brake caliper (circled), brake booster, brake pedal etc had revealed all to be intact and without visible damage.

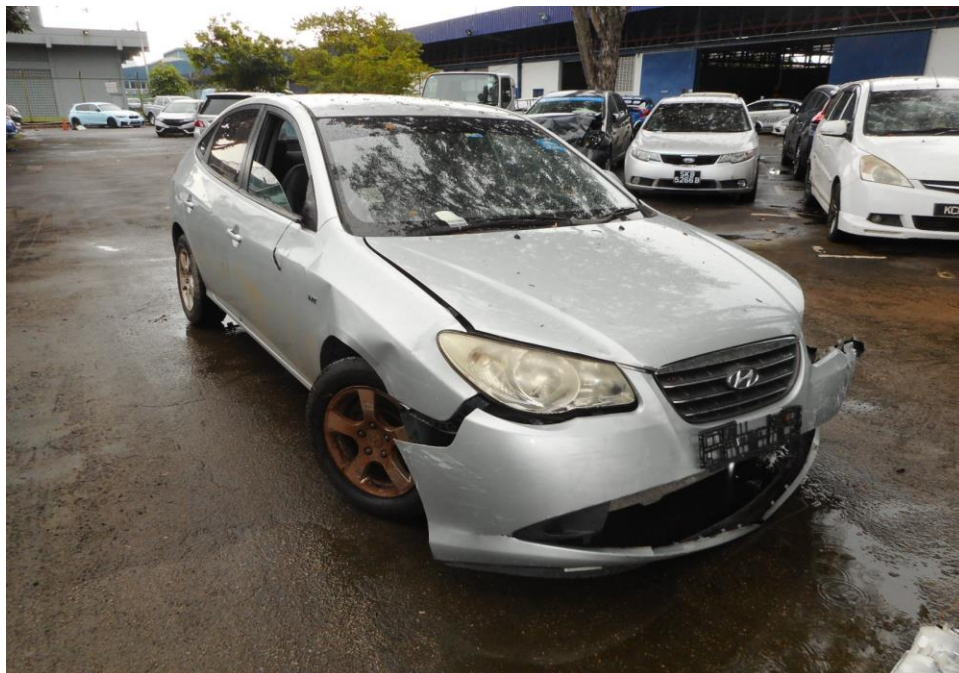
Photo 23 shows the front right wheel of the Motor Car turned to its full left. During my steering system test, I did not experience any abnormal free play and/or resistance when I had turned the steering wheel towards the left and right. This would suggest that the steering system of the Motor Car was likely to be in serviceable condition at the material time of accident.

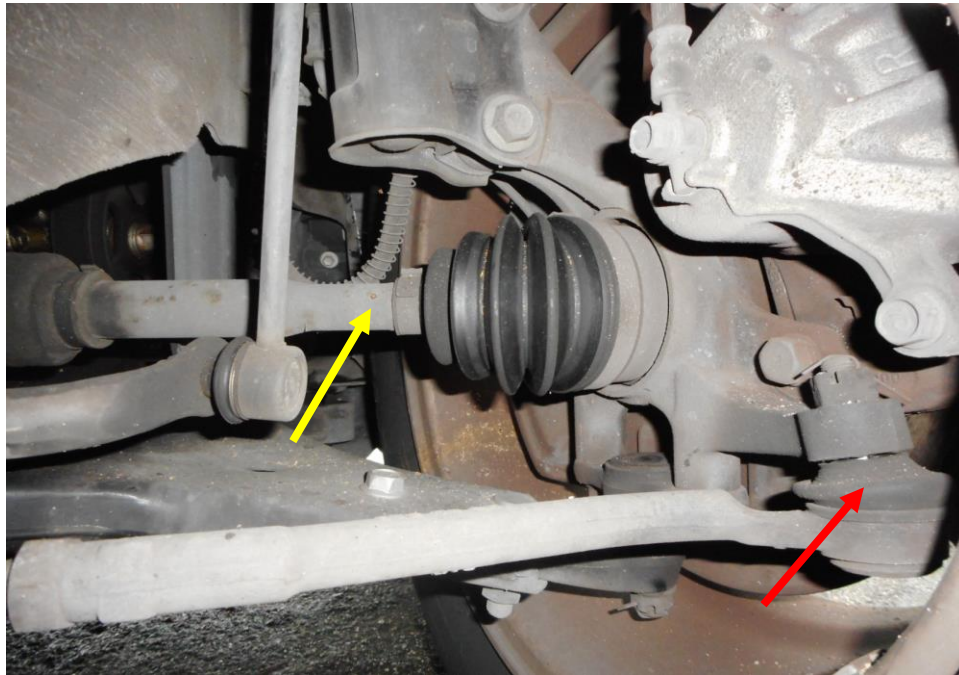
Photo 24 shows the various undercarriage components at the front right wheel of the Motor Car, in particular the steering tie rod (red arrow) and drive shaft (yellow arrow). The various steering components were all found to be intact, suggesting that the steering system of the Motor Car was likely to be in serviceable condition at the material time of accident. There was also no sign of fluid stain observed on the various undercarriage components at the front right wheel of the Motor Car.

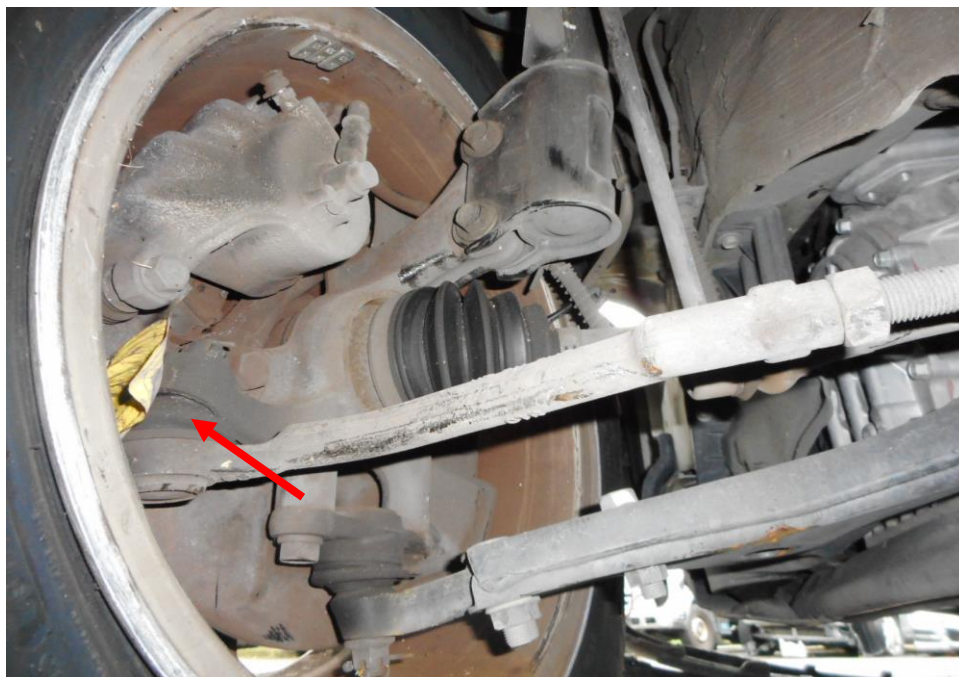
Photo 25 shows the various undercarriage components at the front left wheel of the Motor Car, which had included the steering tie rod (red arrow). The various undercarriage components of the Motor Car were all found to be intact without any visible damage.

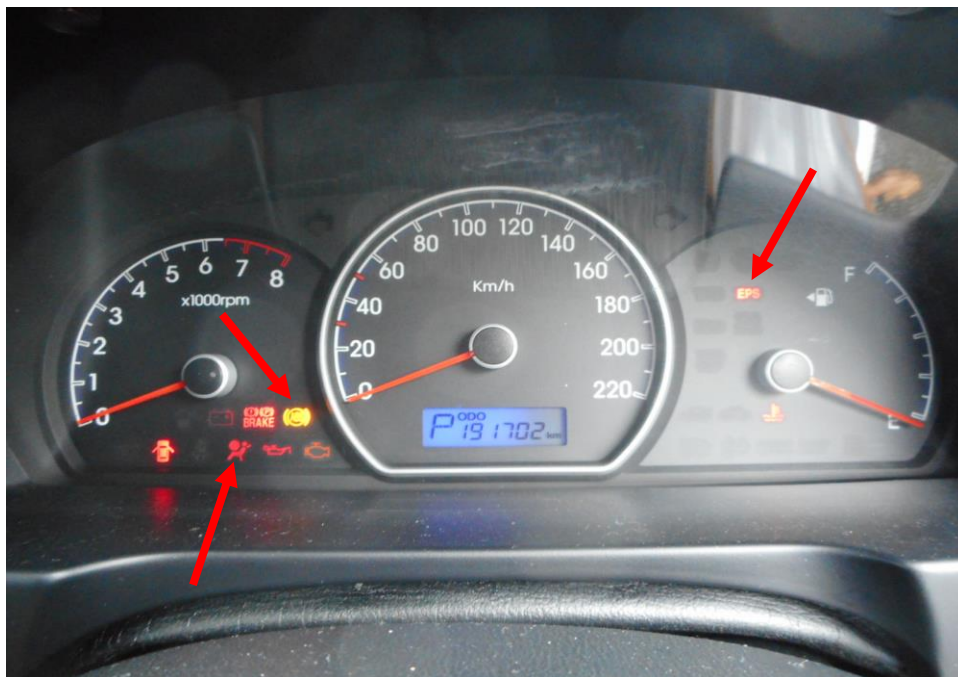
Photo 26 shows the warning light for Anti-Lock Brake System (ABS) and Power Steering System (EPS) and Supplemental Restraint System (SRS) (arrowed) appearing on the instrument panel of the Motor Car during the self-test of its various electronic operating systems when its engine was cranked.

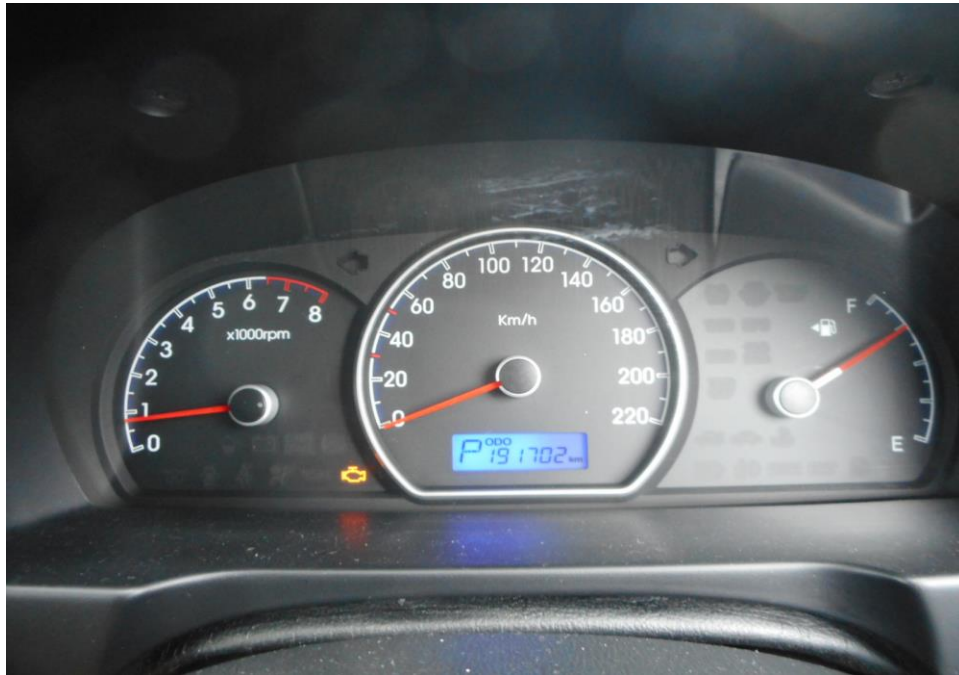
Photo 27 shows no warning lights illuminated on the instrument panel of the Motor Car after the engine was cranked. This would suggest that there was no abnormality to the various electronic operating systems of the Motor Car, like the ABS, SRS and EPS.
