Your Ref: TP/IP/50115/2020
Our Ref : CI/TPD20014308/P

8th January 2021

MECHANICAL INSPECTION REPORT OF MOTOR CAR SLL 705U

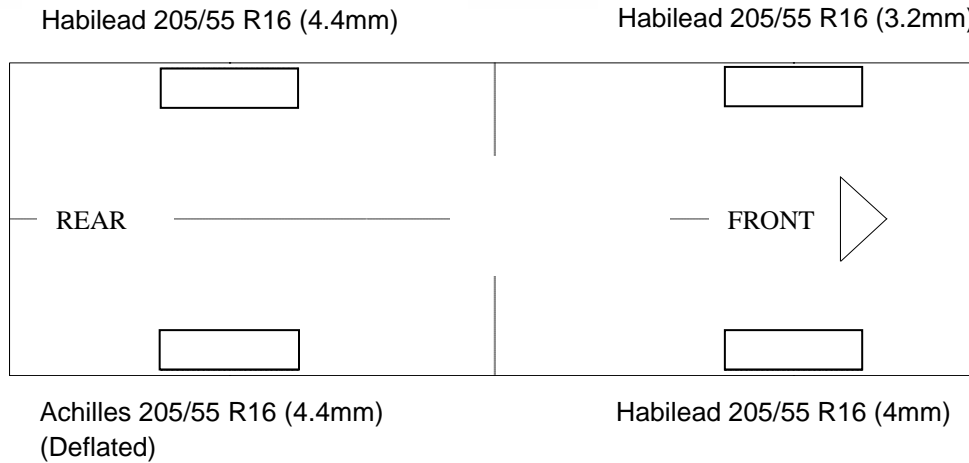
6. The condition of the Motor Car's 3 tyres was observed to be in serviceable condition. The 3 tyres were also observed to be sufficiently inflated for vehicular operation. However the rear right tyre was observed to be deflated likely due to the result of the accident. I did not find any tear, cut or burst mark(s) on the outer and the inner sidewalls as well as across the tread of the 4 tyres. The tyre brand, tyre size and remaining tread depth of the 4 tyres were recorded as follows:-

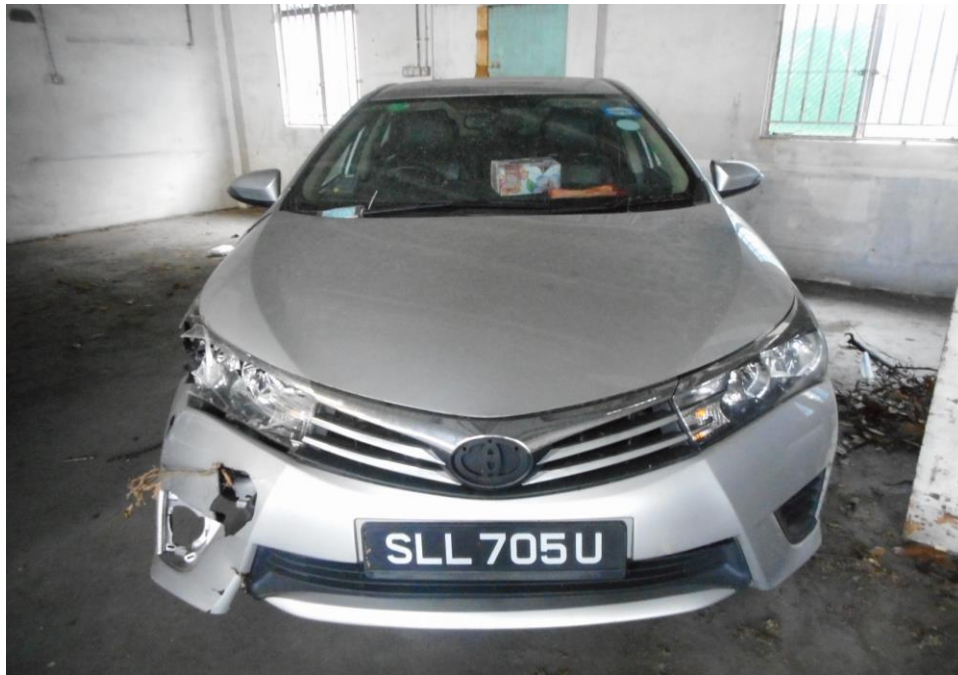
Photo 1 shows a general view of the Motor Car at the time of my inspection. The Motor Car was observed to have sustained damage at its front and rear portion. Its front bonnet, front right fender, front bumper, front right headlamp, rear right brake lamp and rear bumper was amongst the body parts that were damaged as a result of the accident.

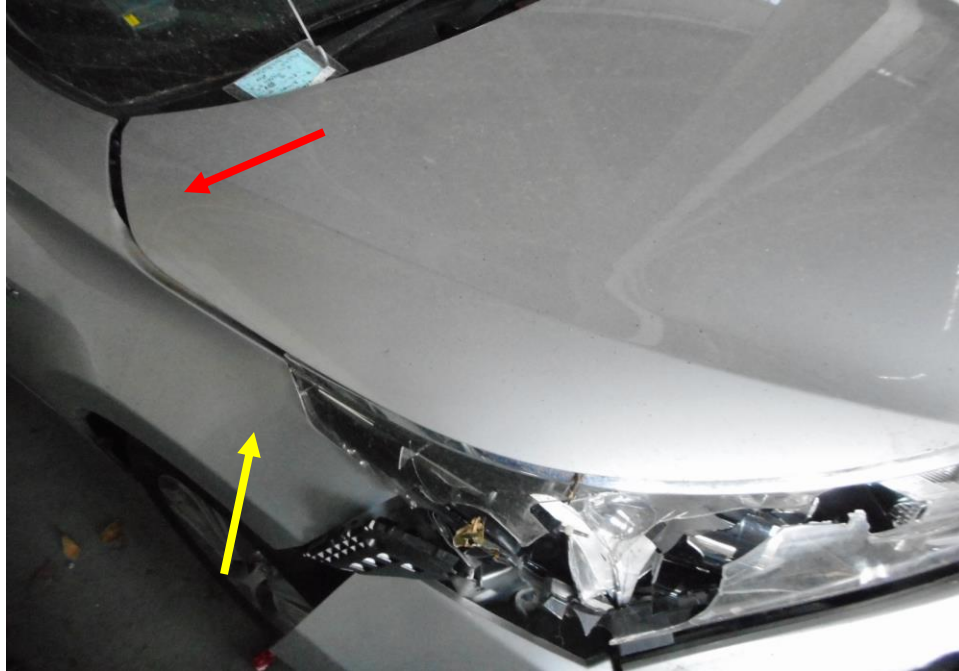
Photo 2 shows a close up view of the Motor Car at the time of my inspection. The Motor Car was observed to have sustained damage at its front portion. Its front bonnet (red arrow) and front right fender (red arrow) was amongst the body parts that were damaged as a result of the accident.

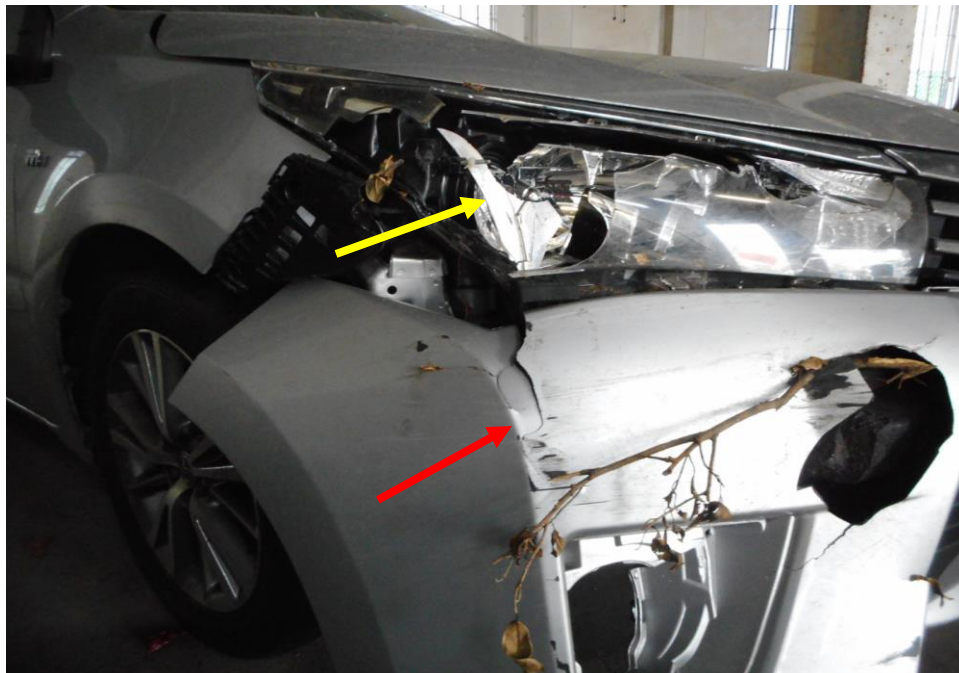
Photo 3 shows a close up view of the Motor Car at the time of my inspection. The Motor Car was observed to have sustained damage at its front portion. Its front bumper (red arrow) and front right headlamp (yellow arrow) was amongst the body parts that were damaged as a result of the accident.

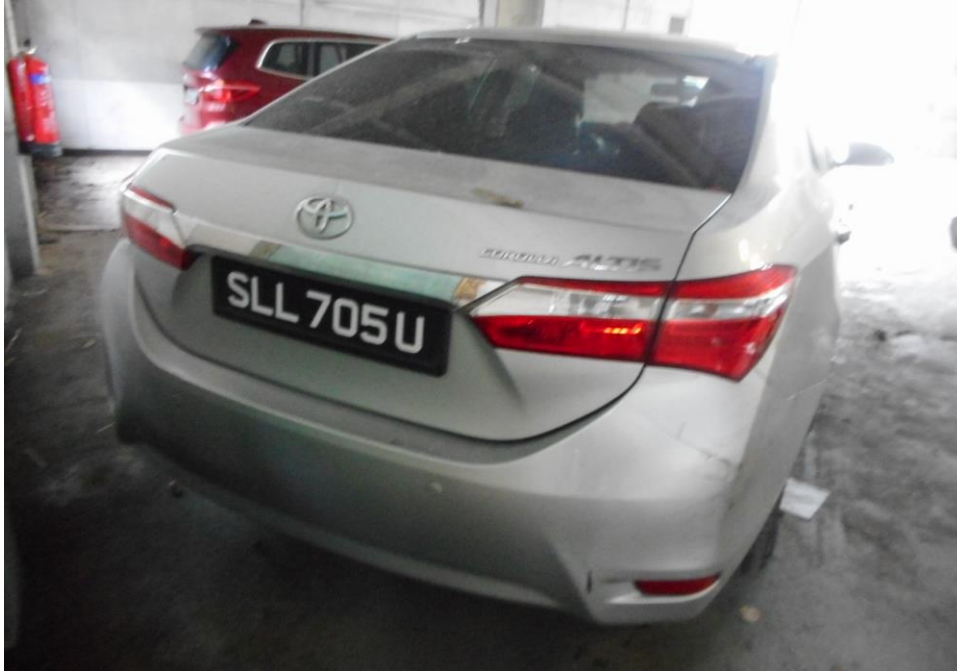
Photo 4 shows a general view of the rear body of the Motor Car at the time of my inspection. The Motor Car was observed to be sustained damage at its rear right brake lamp and rear bumper as a result of the accident

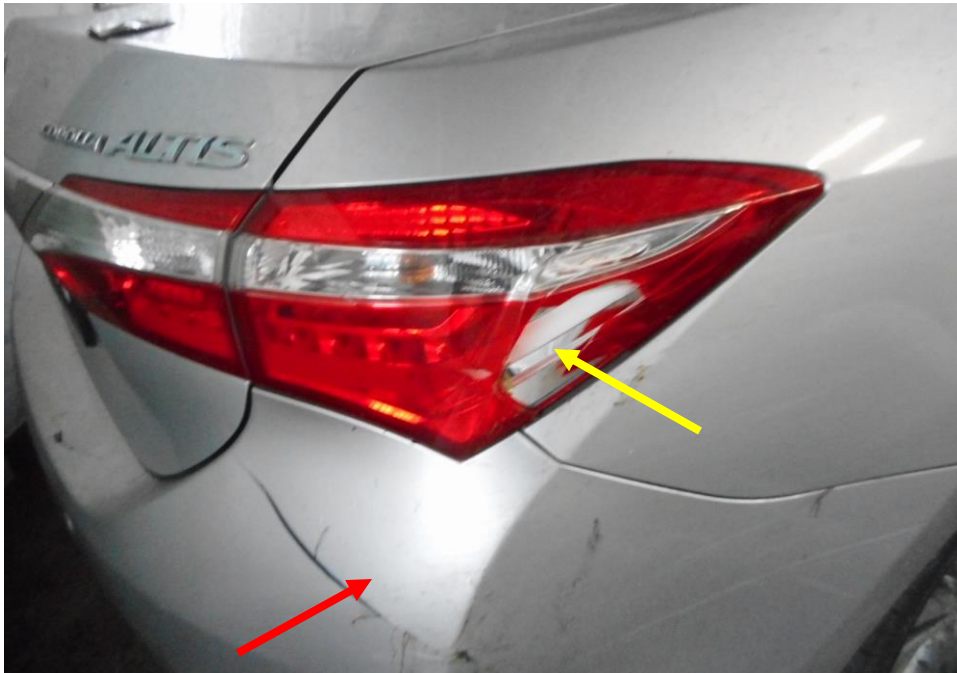
Photo 5 shows a close up view of the rear body of the Motor Car at the time of my inspection. The Motor Car was observed to be sustained damage at its rear right brake lamp (yellow arrow) and rear bumper (red arrow) as a result of the accident

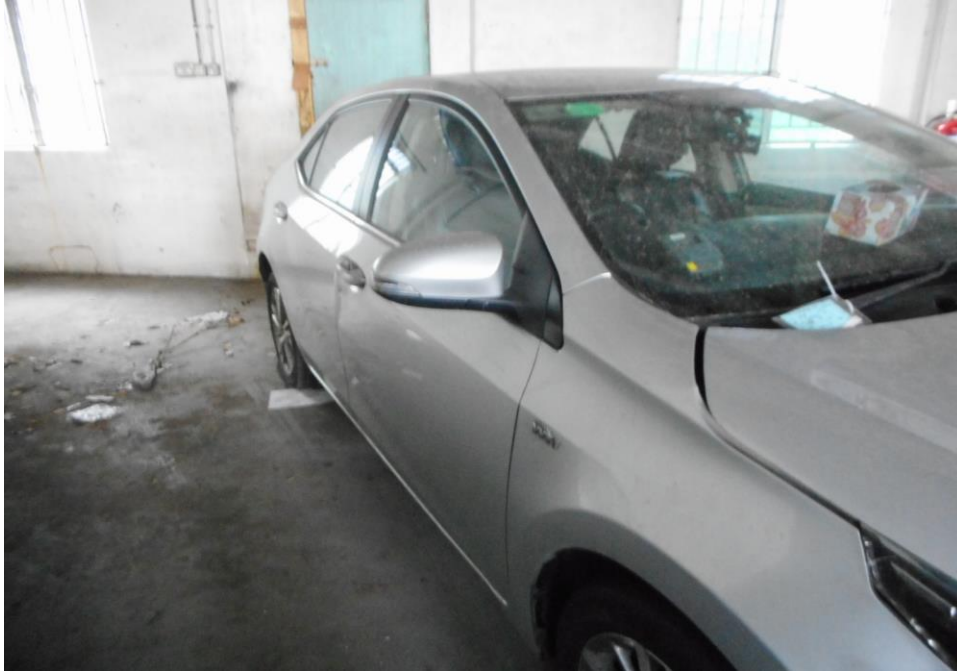
Photo 6 shows a general view of the right body of the Motor Car at the time of my inspection. The Motor Car was observed to be intact and unaffected by the accident.

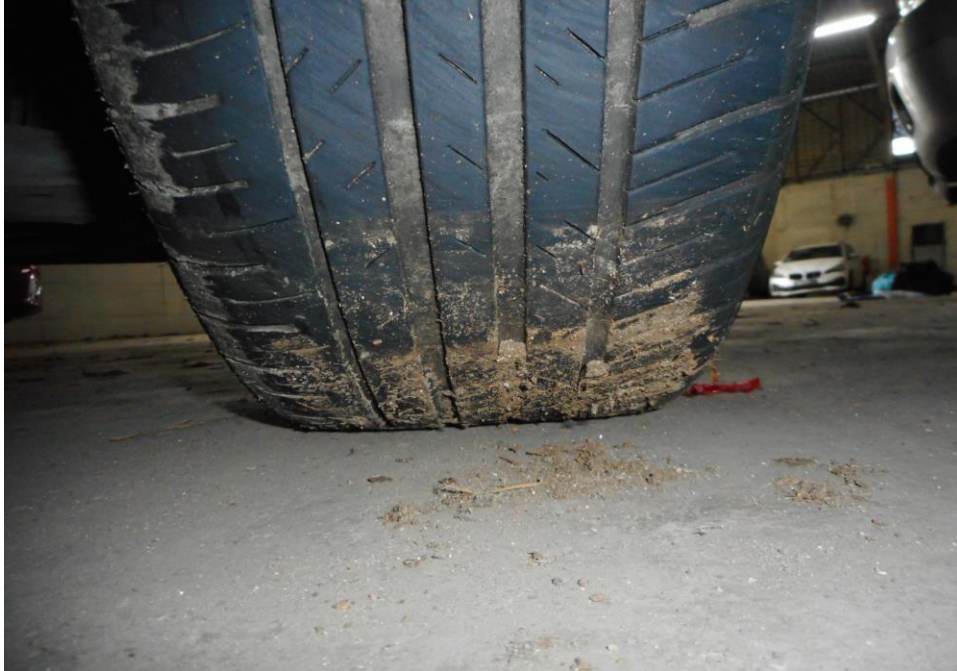
Photo 8 shows the condition of the front right tyre of the Motor Car, which was observed to be in serviceable condition with remaining tread depth of approximately 4mm. The tyre, which was wrapped around standard alloy wheel rim, was also observed to be sufficiently inflated for vehicular operation. There was no tear, cut or burst mark(s) on the outer and the inner sidewalls as well as across the tread of the 4 tyres that were fitted on the Motor Car.

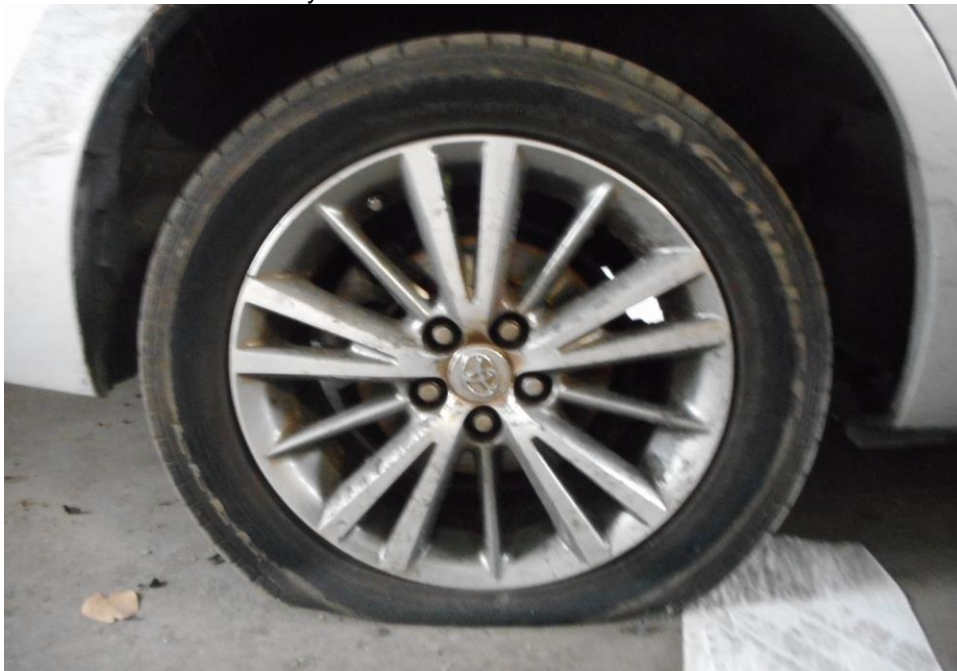
Photo 9 shows the condition of the rear right tyre of the Motor Car, which was observed to be deflated likely due to the result of the accident. The remaining tread depth was of approximately 4.4mm. There was no tear, cut or burst mark(s) on the outer and the inner sidewalls as well as across the tread of the tyre that were fitted on the Motor Car.

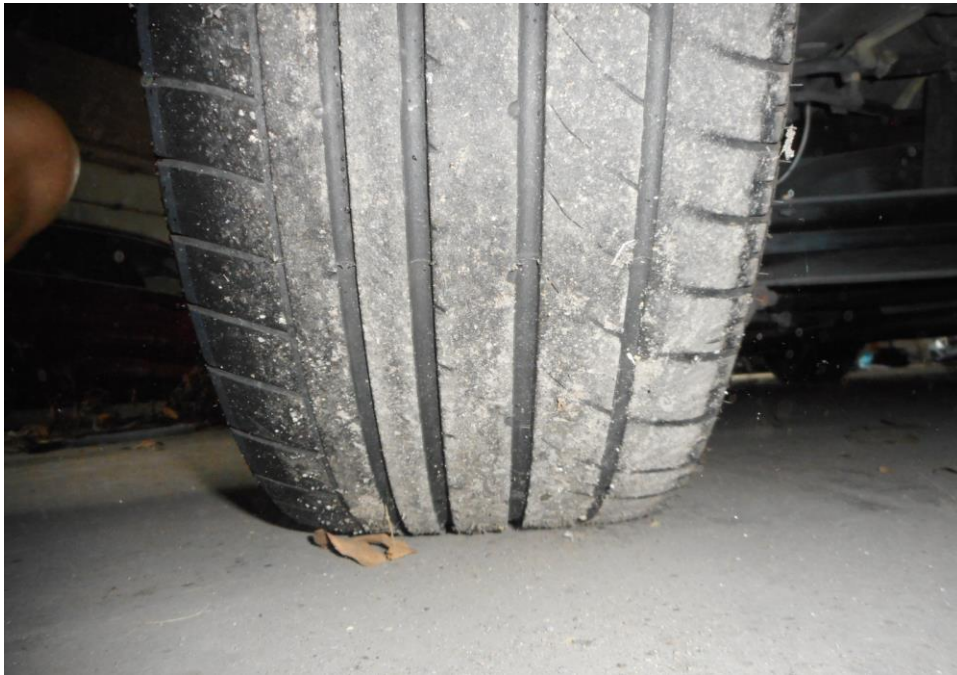
Photo 10 shows the condition of the rear left tyres of the Motor Car, which was observed to be in serviceable condition with remaining tread depth of approximately 4.4mm. The tyres, which were wrapped around standard alloy wheel rim, were also observed to be sufficiently inflated for vehicular operation. There was also no damage found on all 4 alloy wheel rims of the Motor Car.

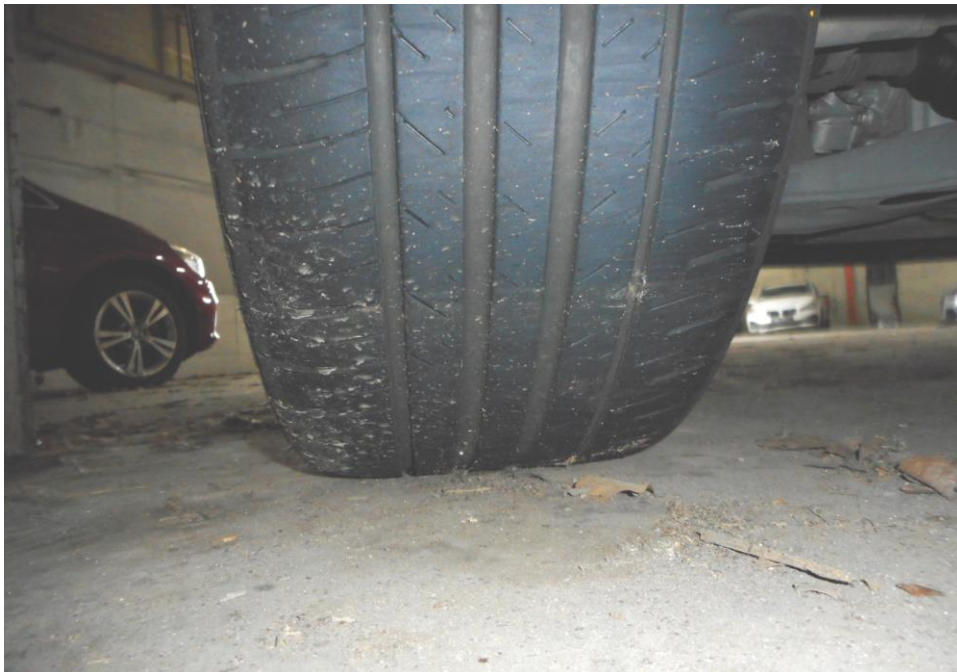
Photo 11 shows the condition of the rear right tyres of the Motor Car, which were observed to be in serviceable condition with remaining, tread depth of approximately 3.2mm. There was also no tear, cut or burst mark(s) on the outer and the inner sidewalls as well as across the tread of the 4 tyres that were fitted on the Motor Car.

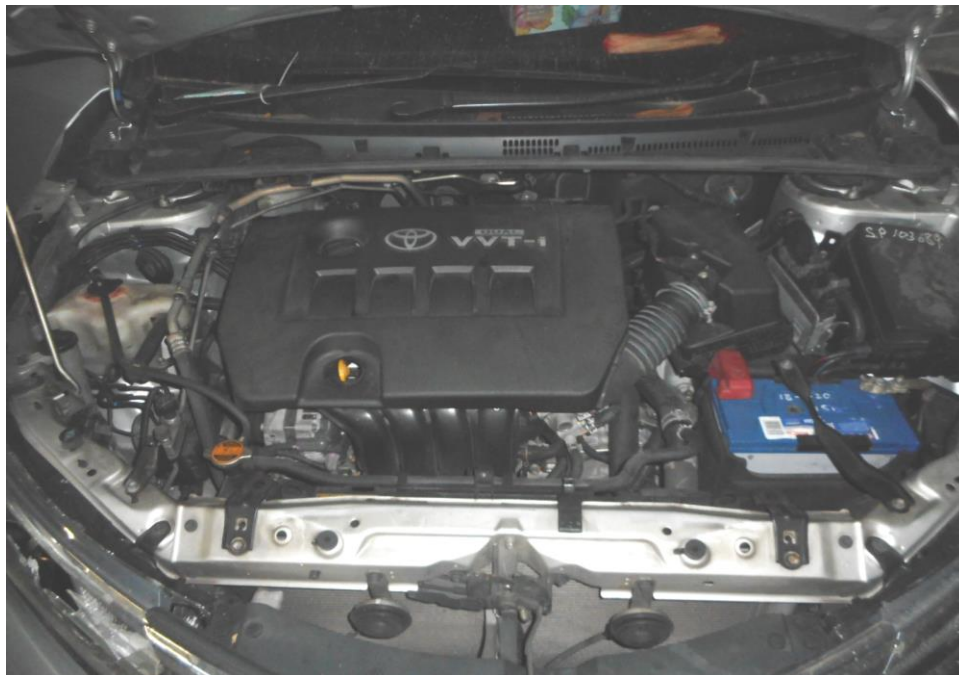
Photo 12 shows a general view of the Motor Car's engine compartment, which was accessed by lifting the front cabin of the Motor Car. The various parts and components inside the engine compartment were unaffected by the accident. There was also no sign(s) or indication(s) of fresh fluid leakage and/or fluid stain within the engine compartment

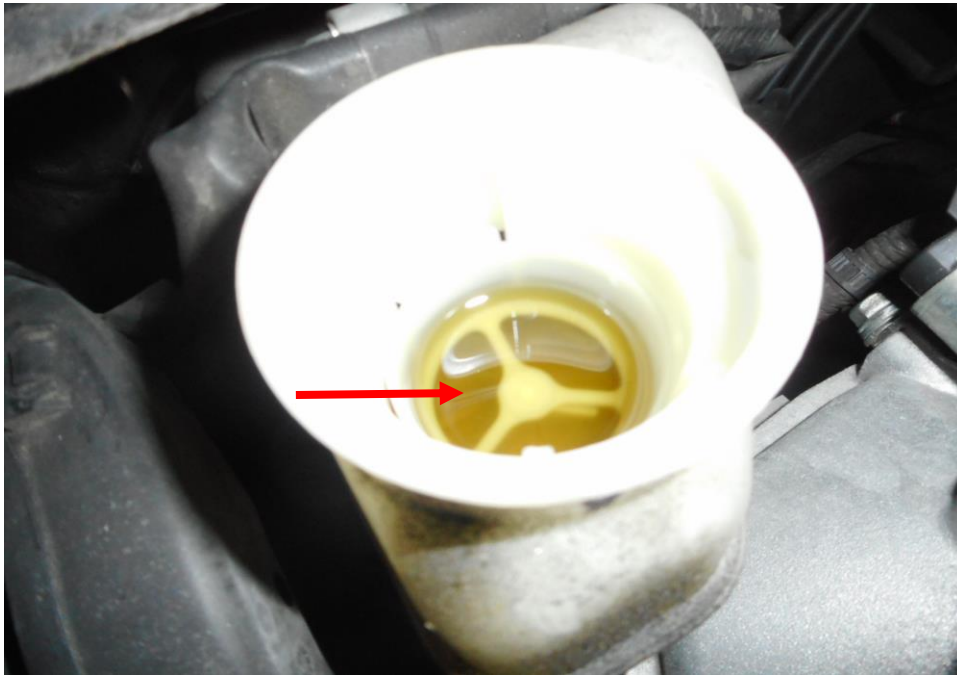
Photo 13 shows the brake fluid reservoir of the Motor Car at the time of my inspection. The brake fluid was observed to be of sufficient level (arrowed) and without any visible contamination.

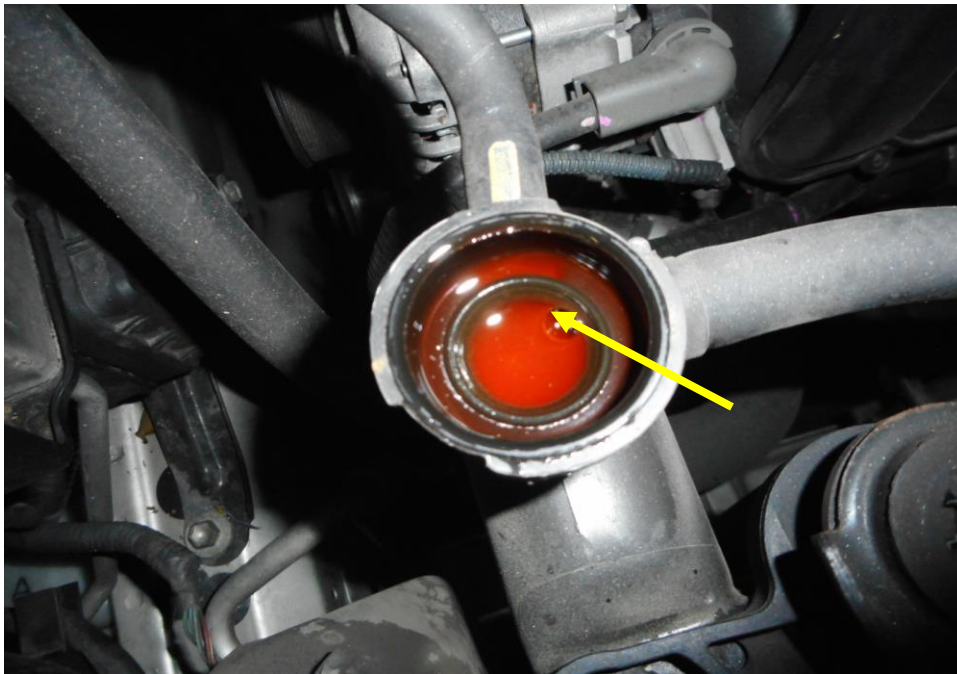
Photo 14 shows the engine coolant reservoir of the Motor Car at the time of my inspection. The engine coolant was observed to be of sufficient level (arrowed) and without any visible contamination.

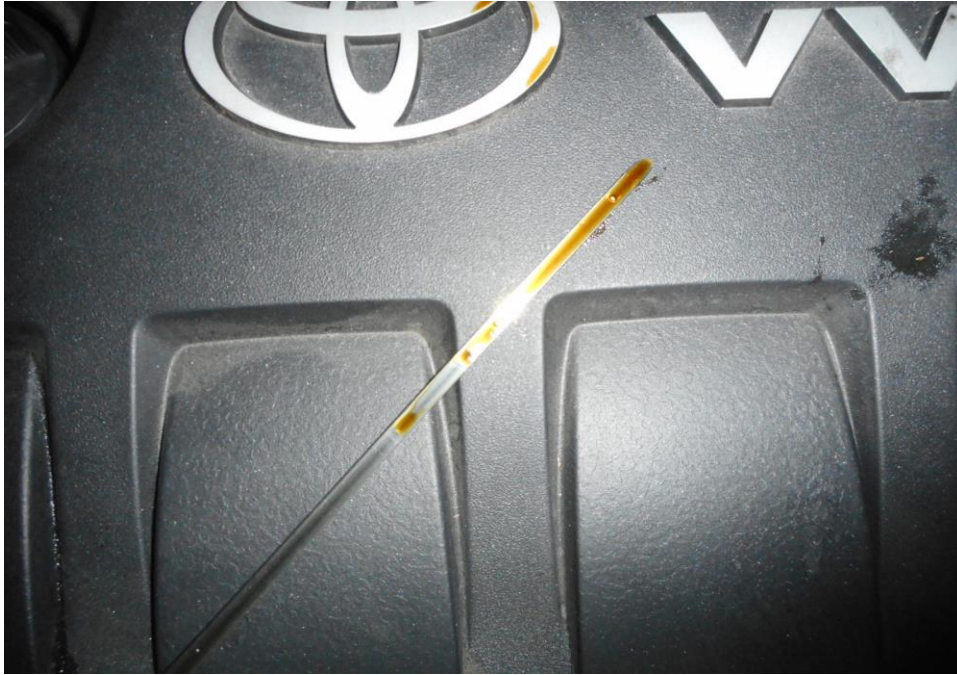
Photo 15 shows the engine oil dip stick of the Motor Car at the time of my inspection. The engine oil was observed to be of sufficient level and without any visible contamination.

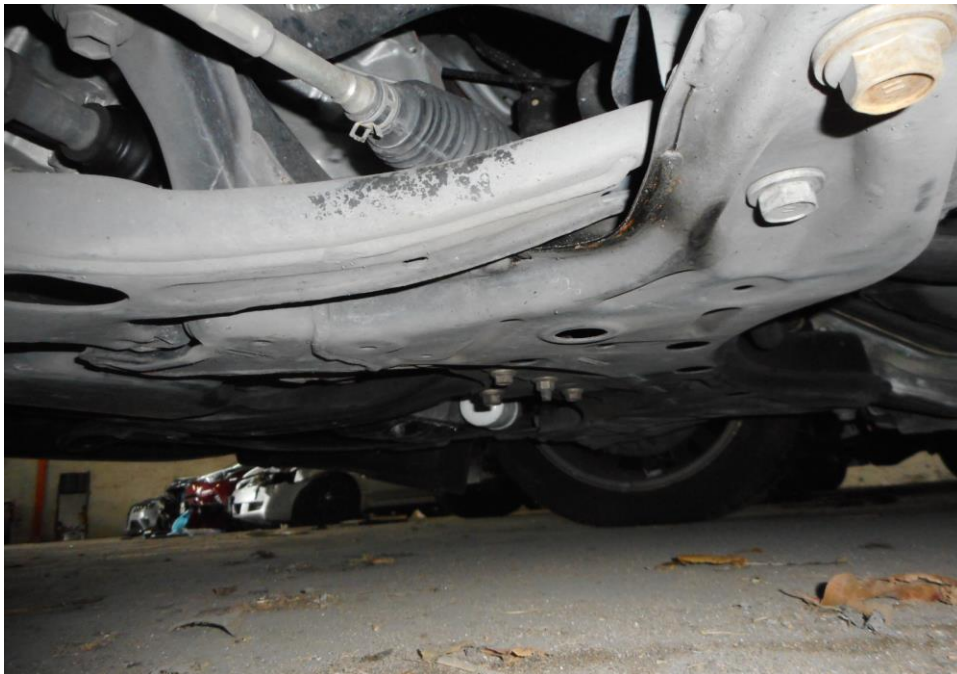
Photo 16 shows the undercarriage of the Motor Car, at the area where the engine housing and transmission housing are located. . I did not find any sign(s) or indication(s) of fluid leak and/or fluid stain(s) on the underside of the Motor Car.

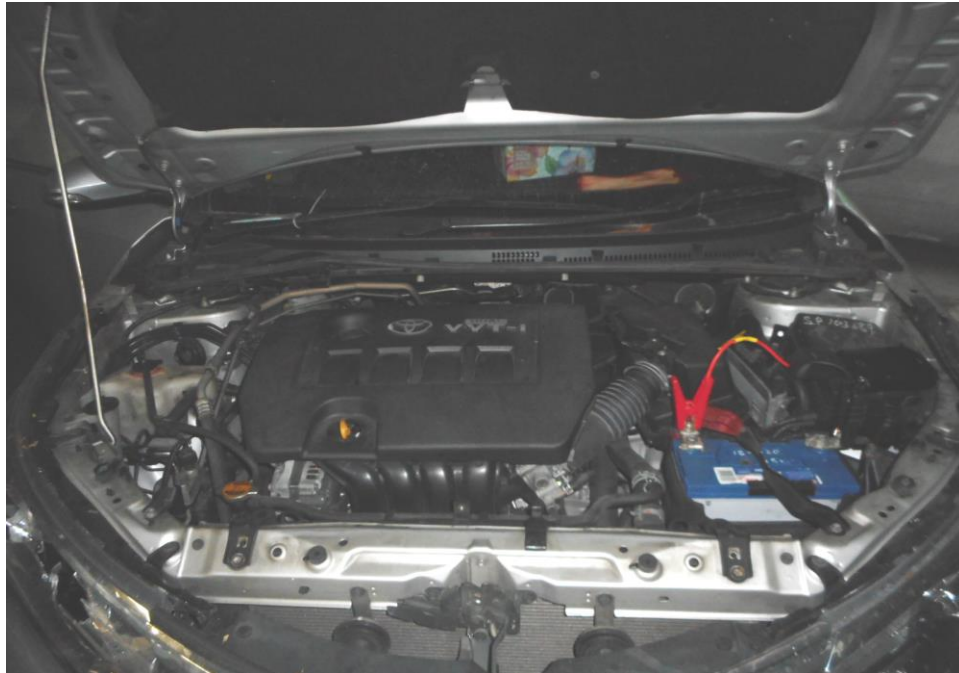
11. However the Motor car's engine was not able to be started up despite multiple attempts of jumpstarting it. See photo 17 below.

Photo 17 shows the jumpstarting of the Motor Car's engine, it was not able to be started up despite multiple attempts in jump starting the engine.

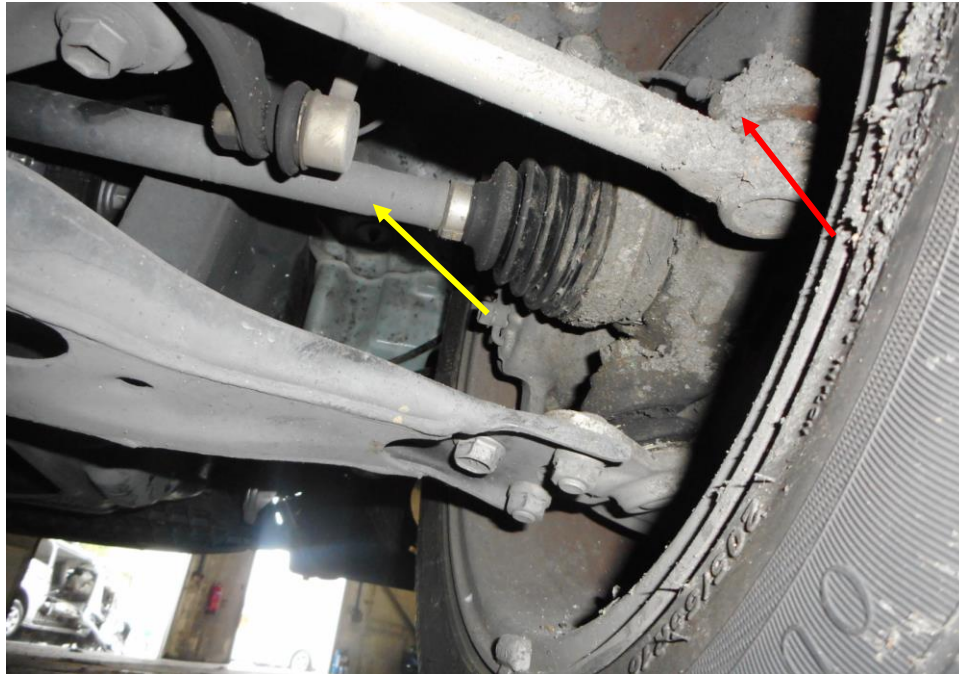
Photo 18 shows the various undercarriage components at the front right wheel of the Motor Car, in particular the steering tie rod end (red arrow) and drive shaft (yellow arrow). The various steering components were all found to be intact, suggesting that the steering system of the Motor Car was likely to be in serviceable condition at the material time of accident. There was also no sign of fluid stain(s) observed on the various undercarriage components.

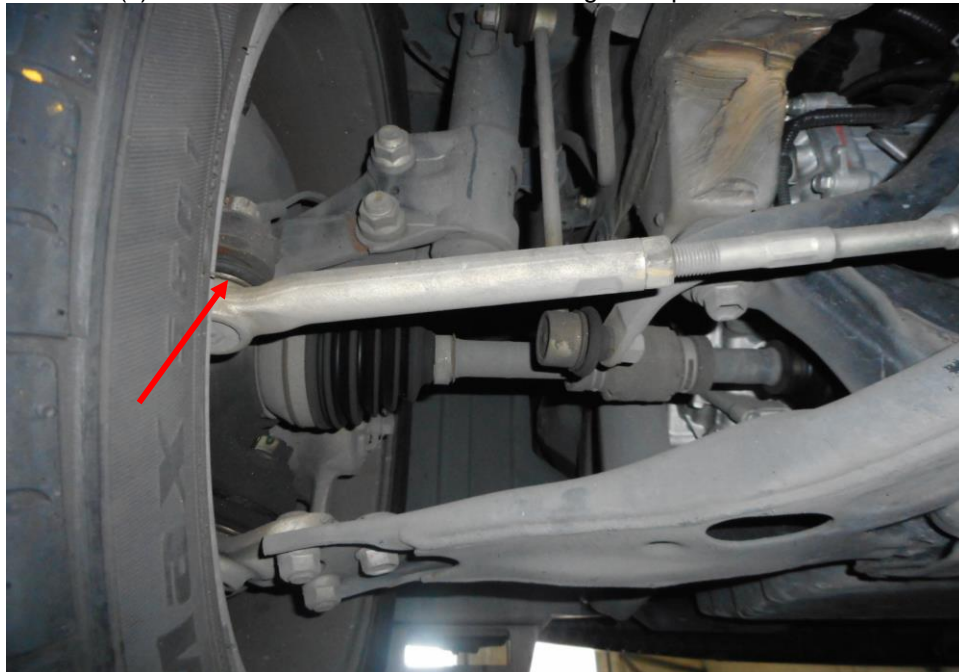
Photo 19 shows the various undercarriage components at the front left wheel of the Motor Car, in particular the steering tie rod end (arrowed). The various Undercarriage components of the Motor Car were all found to be intact without any visible damage. There was also no sign of fluid stain(s) observed on the various undercarriage components.

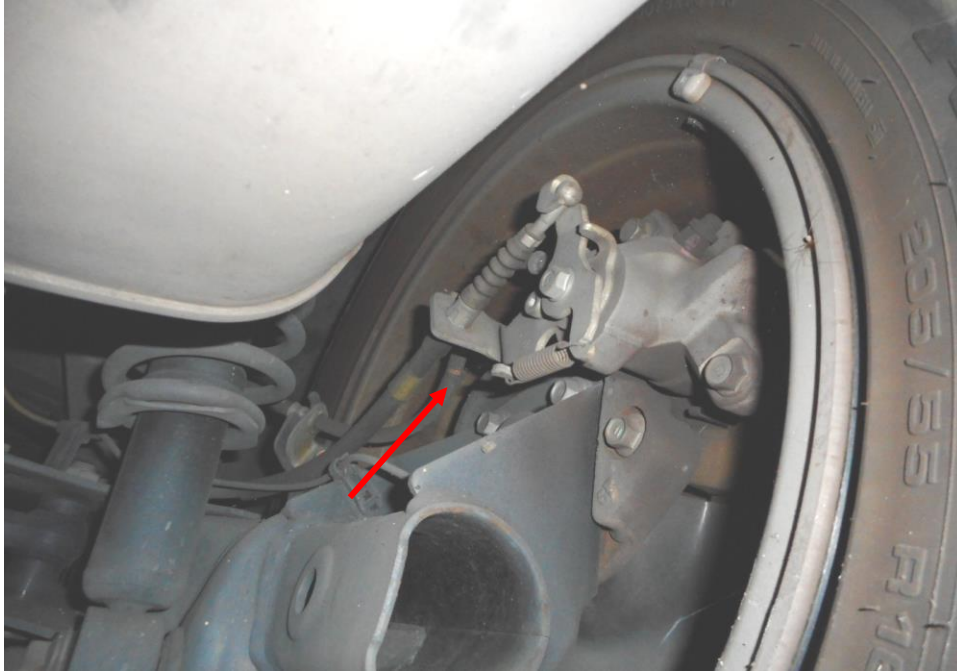
Photo 20 shows the brake pipe (arrowed) at the rear right wheel of the Motor Car. I did not observe any leakage of brake fluid at the time of my inspection of the Motor Car. My static tests of the Motor Car's braking system, along with my visual examination of the various mechanical components in the braking system, had indicated that there was no internal leakage of pressure/vacuum. Hence the braking system of the Motor Car was likely to be in serviceable condition at the material time of accident.

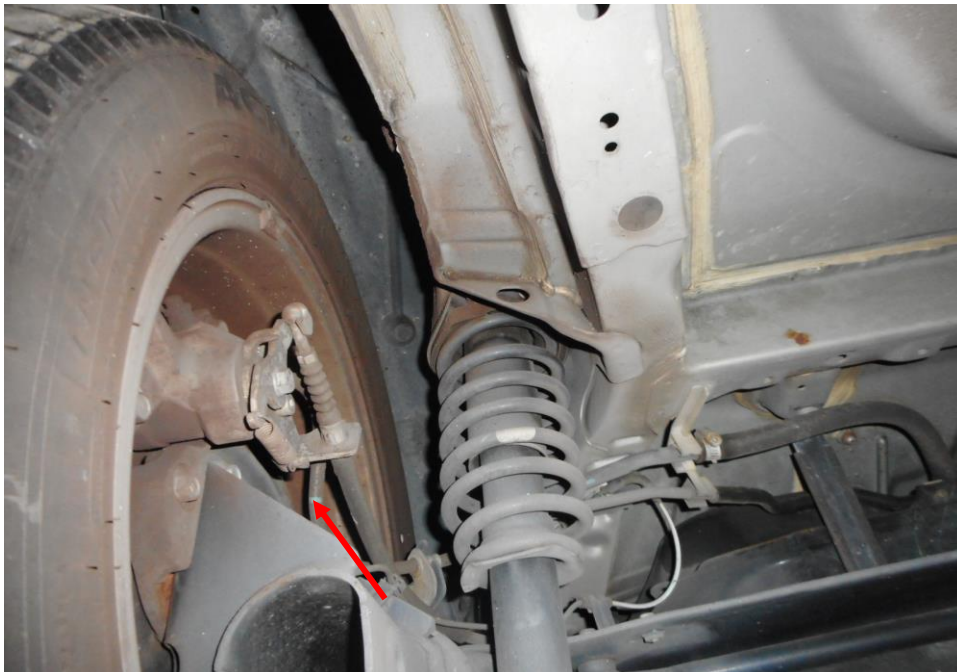
Photo 21 shows the brake pipe (arrowed) at the rear left wheel of the Motor Car. I did not observe any leakage of brake fluid at the time of my inspection of the Motor Car. My static tests of the Motor Car's braking system, along with my visual examination of the various mechanical components in the braking system had indicated that there was no internal leakage of pressure/vacuum. Hence the braking system of the Motor Car was likely to be in serviceable condition at the material time of accident.

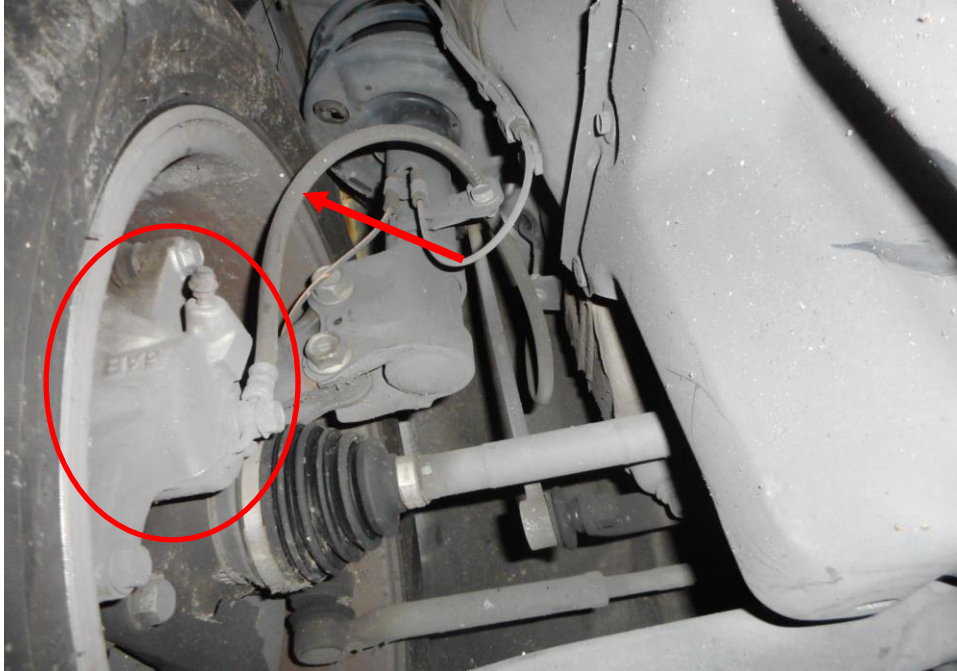
Photo 22 shows the brake hose/pipe (arrowed) at the front right wheel of the Motor Car. No leakage of brake fluid was observed. Visual examination of the various components of the braking system like the brake caliper (circled), brake booster, brake pedal etc had revealed all to be intact and without visible damage at the time of accident. There was also no sign of fluid stain(s) observed on the various undercarriage components.

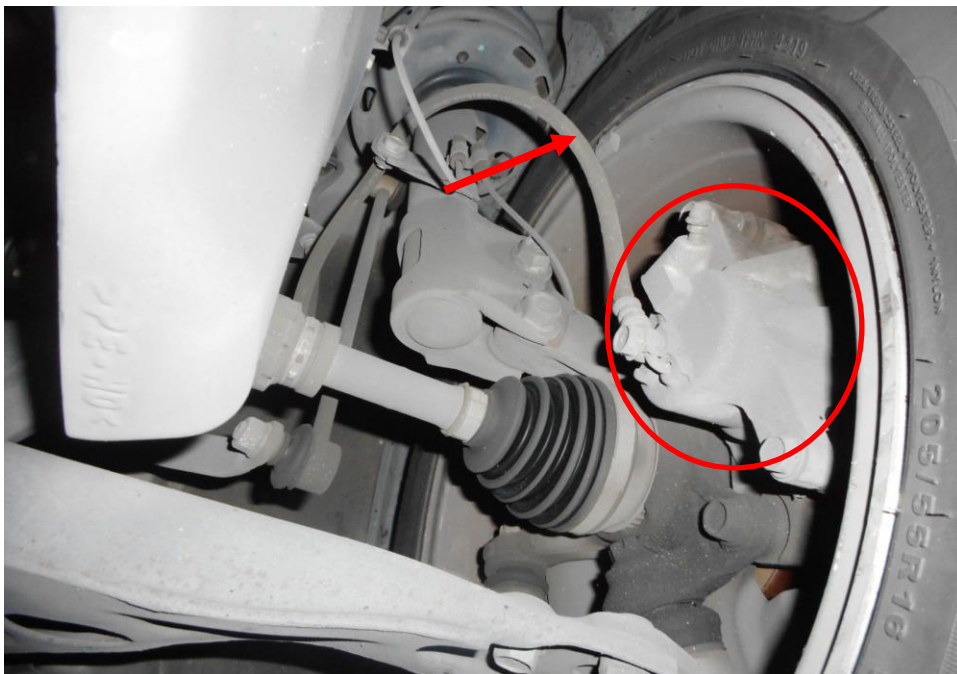
Photo 23 shows the brake hose/pipe (arrowed) at the front left wheel of the Motor Car. No leakage of brake fluid was observed. Visual examination of the various components of the braking system like the brake caliper (circled), brake booster, brake pedal etc had revealed all to be intact and without visible damage at the time of accident. There was also no sign of fluid stain(s) observed on the various undercarriage components.
