Your Ref: TP/IP/48875/2020  
Our Ref : CI/TPD20014311/P

14<sup>th</sup> January 2021

**MECHANICAL INSPECTION REPORT OF MOTOR CAR SLM 4872M**

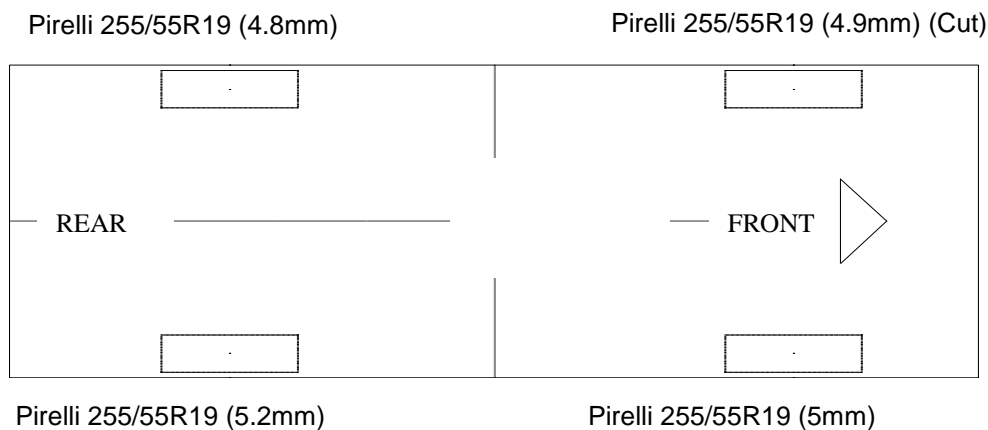
6. The front left tyre (Cut) and rims was observed to be damaged. However, the condition of the Motor Car's 3 other tyres was observed to be in serviceable condition. I did not find any tear, cut or burst mark(s) on the outer and the inner sidewalls as well as across the tread of the 3 tyres. The 3 tyres were also observed to be sufficiently inflated for vehicular operation. The tyre brand, tyre size and remaining tread depth of the 4 tyres were recorded as follows:-

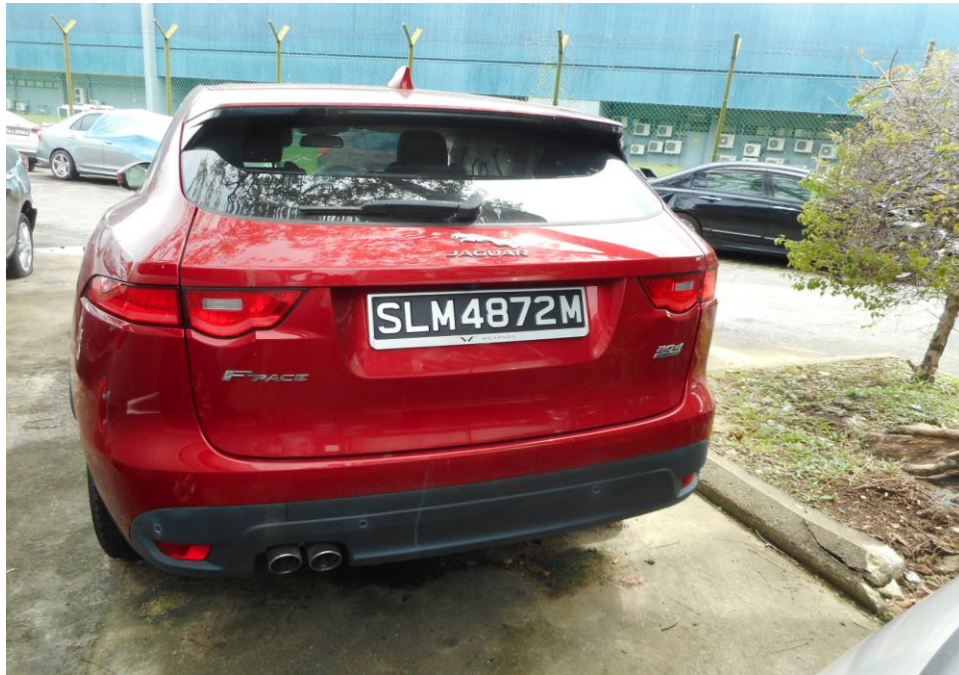
**Photo 1** shows a general view of the rear body of the Motor Car at the time of my inspection. The Motor Car was observed to be intact and unaffected by the accident.

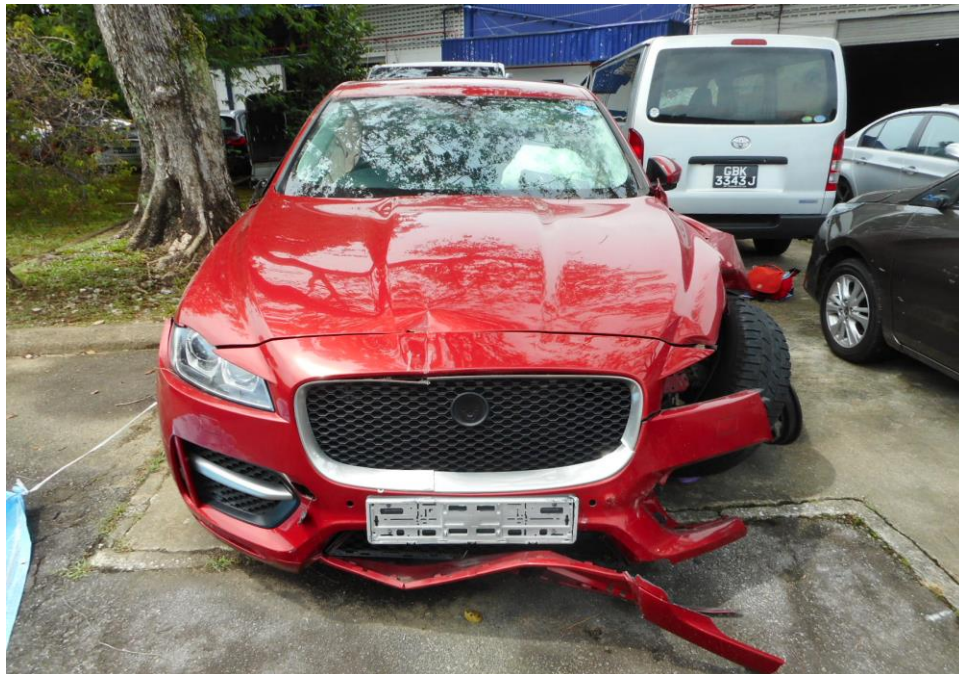
**Photo 2** shows a general view of the Motor Car's front body at the time of my inspection. The Motor Car was observed to have sustained damage all around. Its front windscreen, front bonnet, front bumper, front left headlamp, its front left fender, front right side mirror and right body panels, were amongst the body parts that were damaged as a result of the accident. The Supplemental Restraint System (SRS) was activated as a result of the accident.

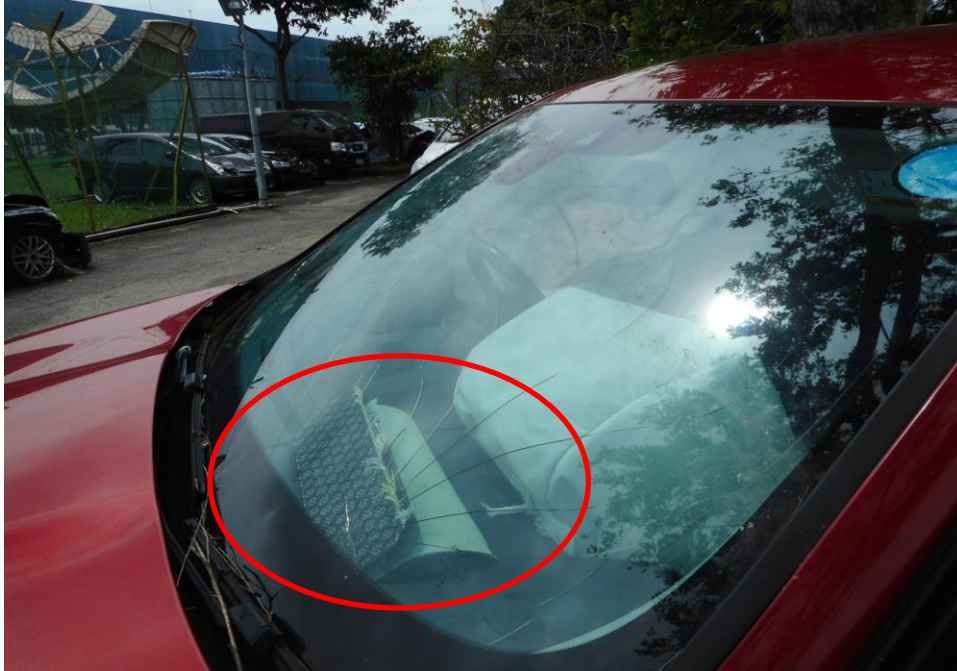
**Photo 3** shows a close up view of the Motor Car's front body at the time of my inspection. Its front windscreen (circled) were amongst the body parts that were damaged as a result of the accident.

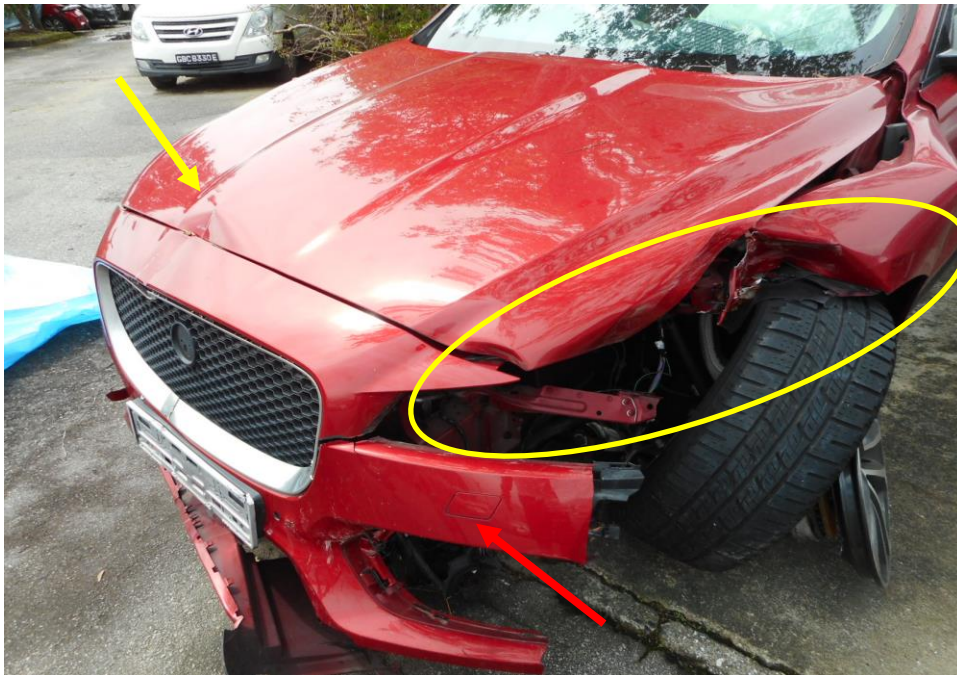
**Photo 4** shows a close up view of the Motor Car's front body at the time of my inspection. Its front bonnet, front left headlamp and front left fender (yellow circle) front bumper (red arrow) were amongst the body parts that were damaged as a result of the accident.

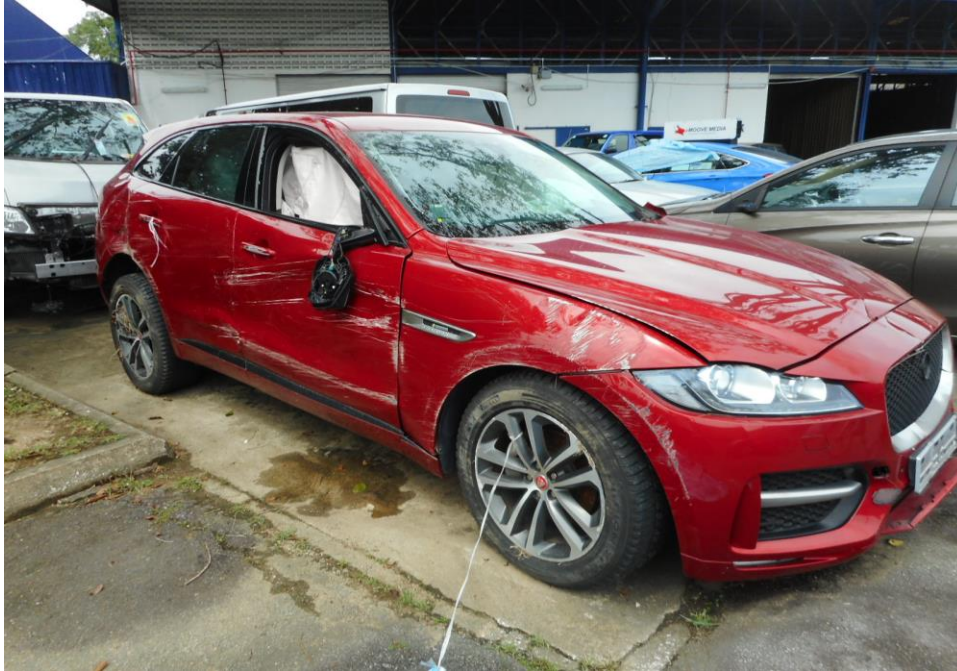
**Photo 5** shows the general view of the Motor Car's right body at the time of my inspection. The Motor Car was observed to have sustained damage on its right body panels were amongst the body parts that were damaged as a result of the accident.

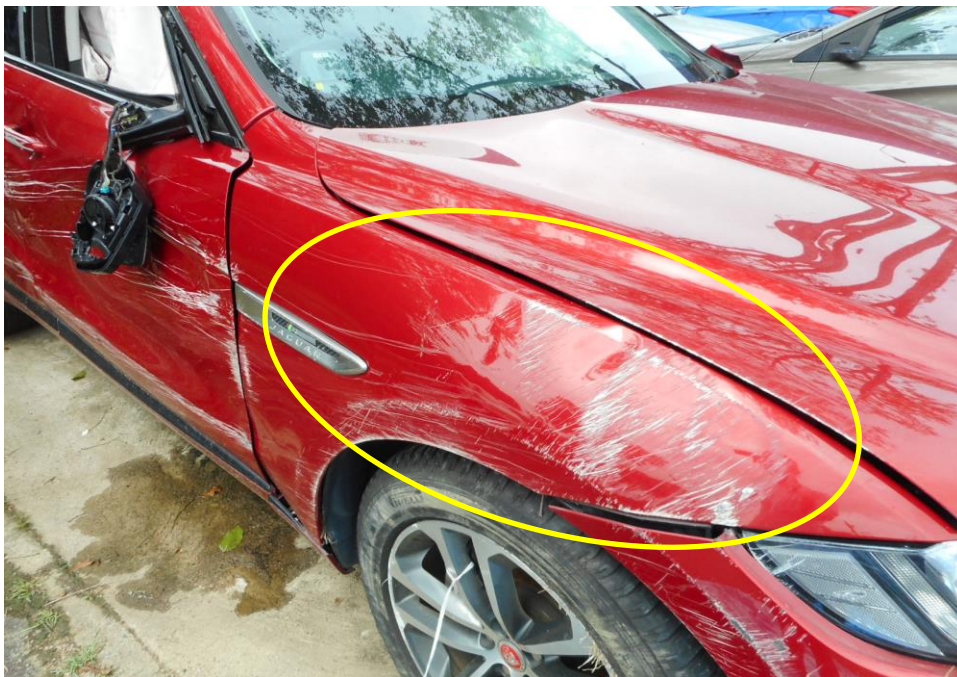
**Photo 6** shows the close view of the Motor Car's right body at the time of my inspection. The Motor Car was observed to have sustained damage on its right body panels (circled) were amongst the body parts that were damaged as a result of the accident.

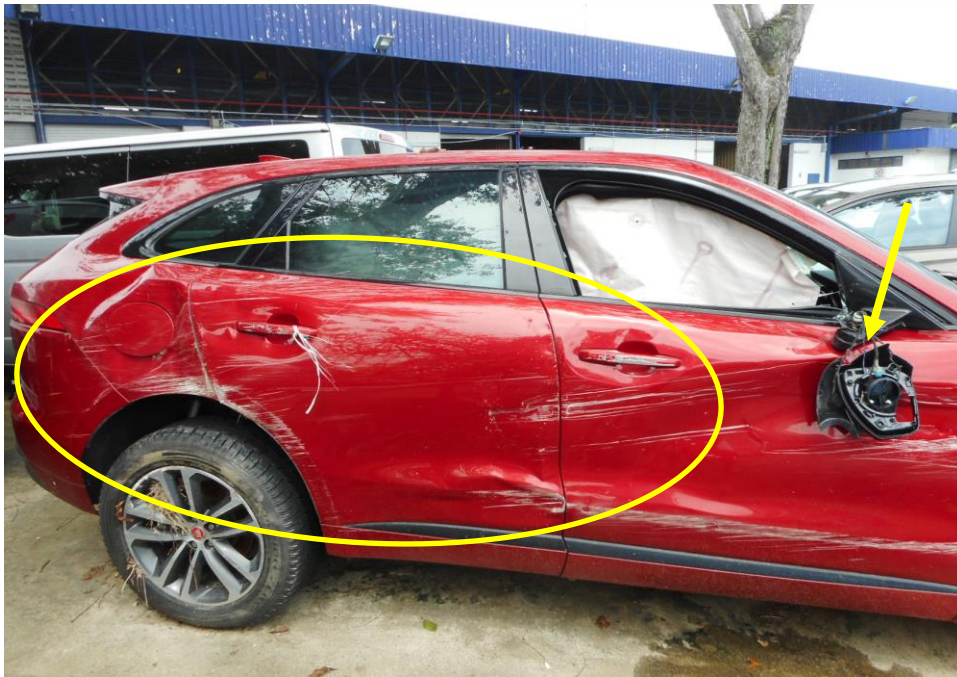
**Photo 7** shows the close view of the Motor Car's right body at the time of my inspection. The Motor Car was observed to have sustained damage on its right body panels (circled) and right side mirror (arrowed) were amongst the body parts that were damaged as a result of the accident.

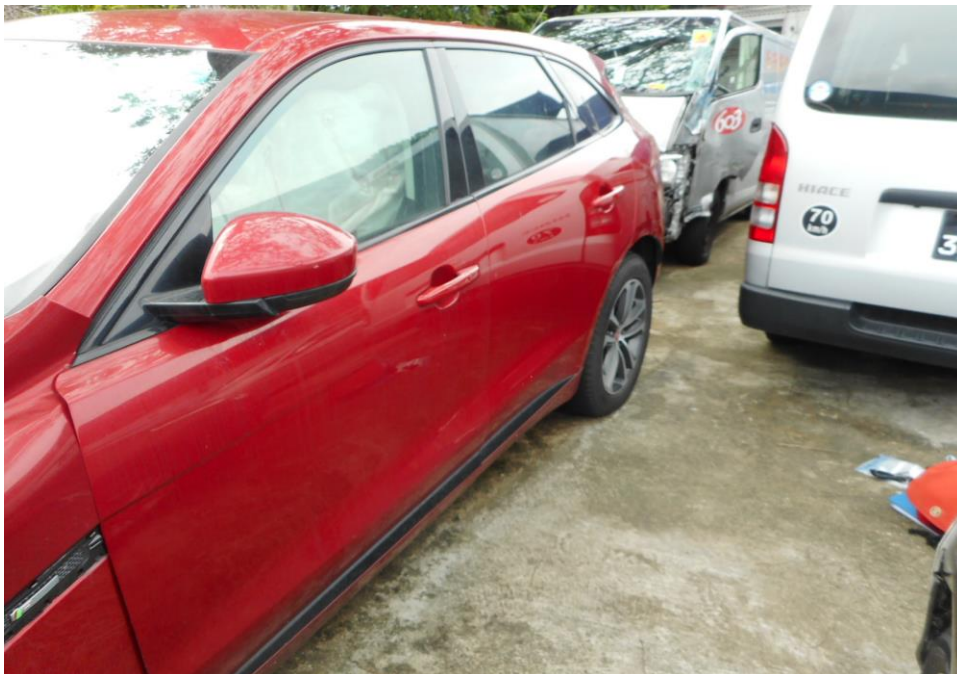
**Photo 8** shows a general view of the left body of the Motor Car at the time of my inspection. The Motor Car was observed to be intact and unaffected by the accident.

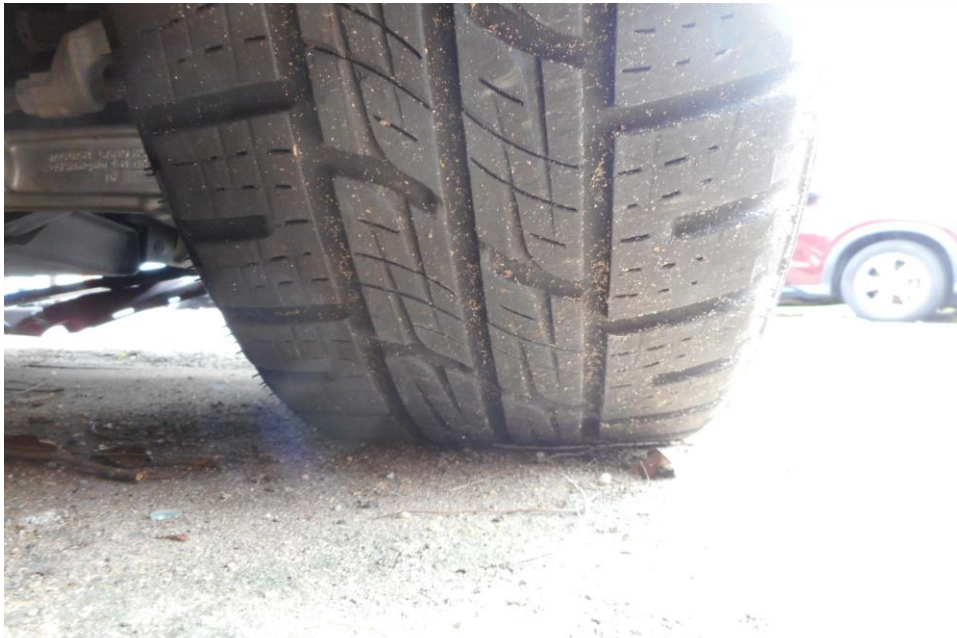
**Photo 9** shows the condition of the front right tyre of the Motor Car, which was observed to be in serviceable condition with remaining tread depth of approximately 5mm. There was also no tear, cut or burst mark(s) on the outer and the inner sidewalls as well as across the tread of the Motor Car's 3 left tyres.

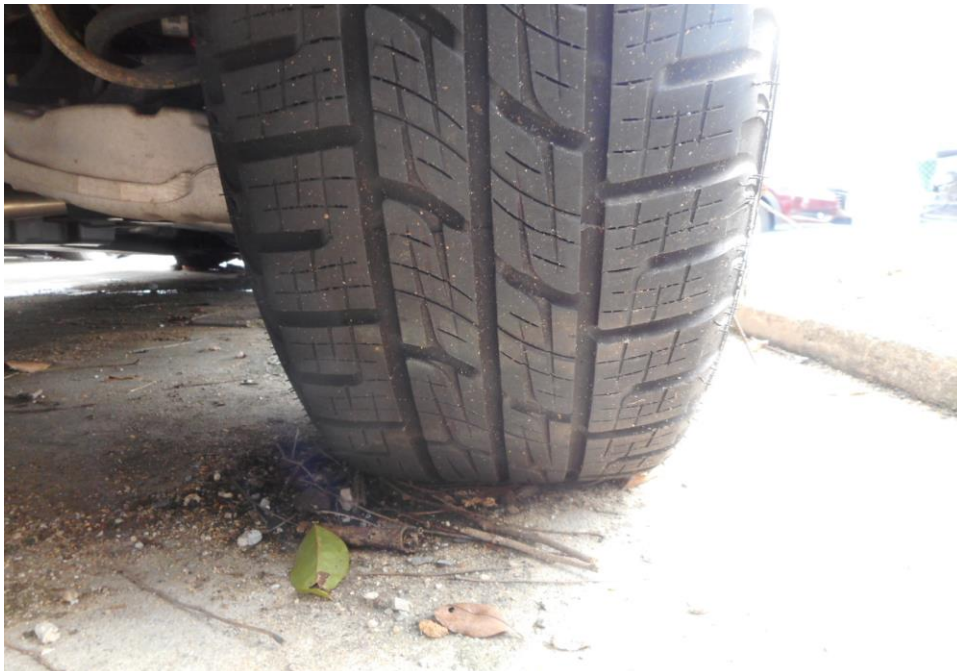
**Photo 10** shows the condition of the rear right tyre of the Motor Car, which was observed to be in serviceable condition with remaining tread depth of approximately 5.2mm. There was also no tear, cut or burst mark(s) on the outer and the inner sidewalls as well as across the tread of the Motor Car's 3 tyres.

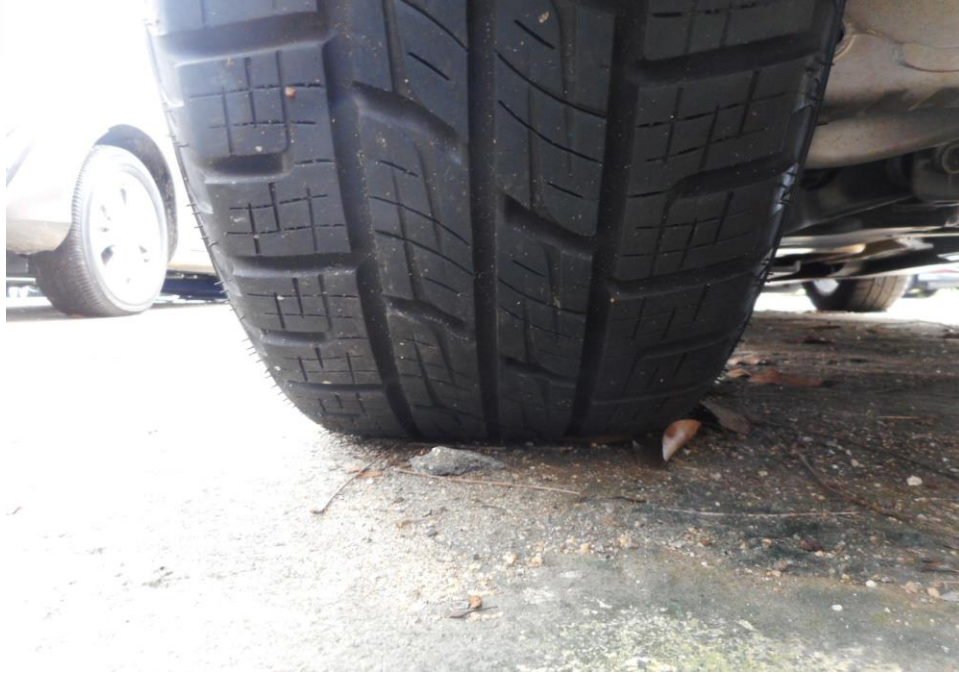
**Photo 11** shows the condition of the rear left tyre of the Motor Car, which was observed to be in serviceable condition with remaining tread depth of approximately 4.8mm. There was also no tear, cut or burst mark(s) on the outer and the inner sidewalls as well as across the tread of the Motor Car's 3 left tyres.

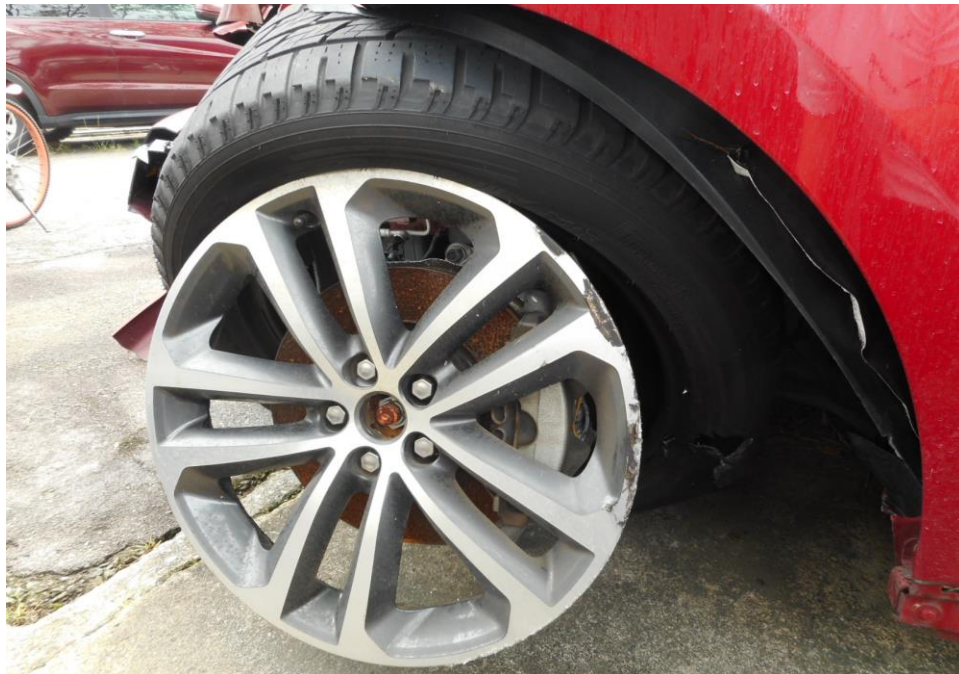
**Photo 12** shows the condition of the front left tyre and wheel rim of the Motor Car, which was observed to be in unserviceable condition as it was damaged and slipped off the wheel rim as a result of the accident with remaining tread depth of approximately 4.9mm.

19. The damaged to the front left tyre of the Motor Car were observed to be caused by the wheel rim of Motor Car itself due to the impact sustained from the collision which caused the rims to cut through the tyre wall as a result of the accident. Refer to photo 12 & 13 above.

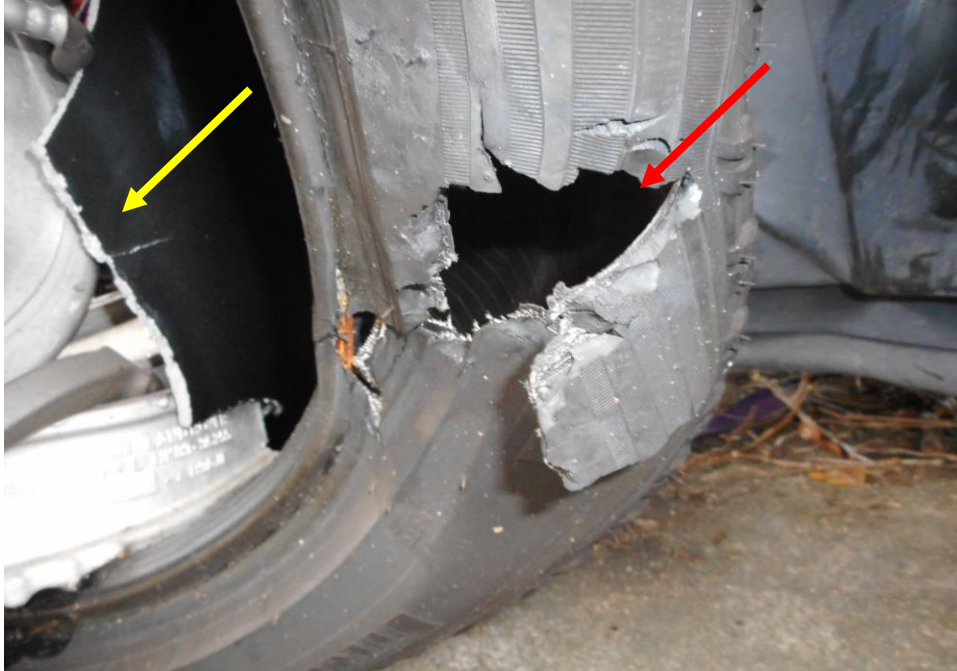
**Photo 13** shows the close up condition of the front left tyre and rim of the Motor Car, which was observed that the tyre was cut (red arrow) and the wheel rim (yellow arrow) was broken, the broken wheel rim had likely caused cut on the tyre in the midst of the accident due to the impact it sustained from the collision.

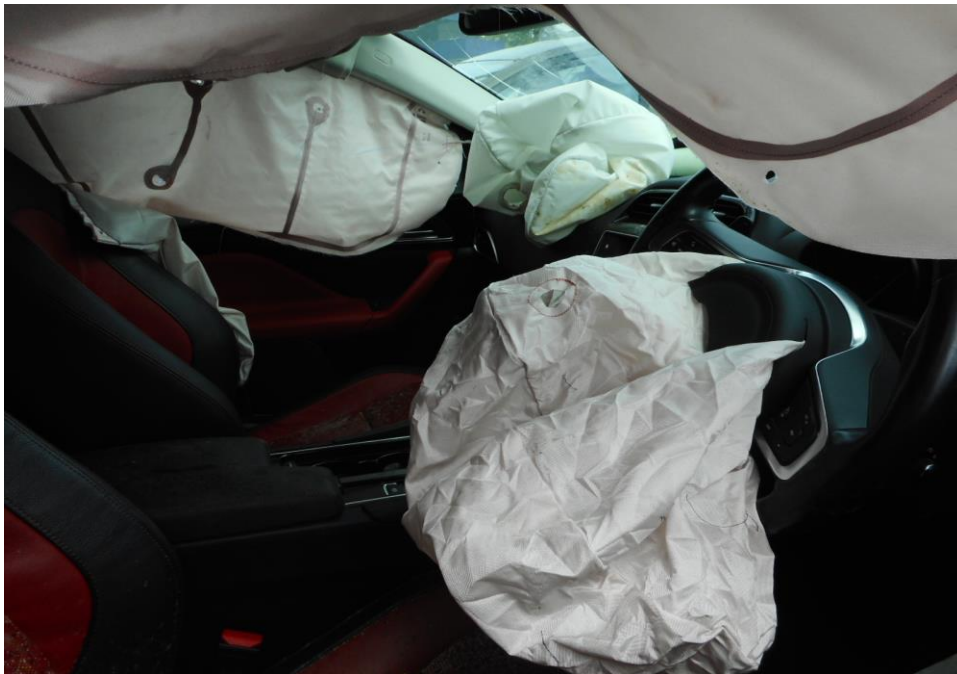
**Photo 14** shows the deployment of the Supplemental Restraint System (SRS) airbag in the Motor Car as a result of the accident.

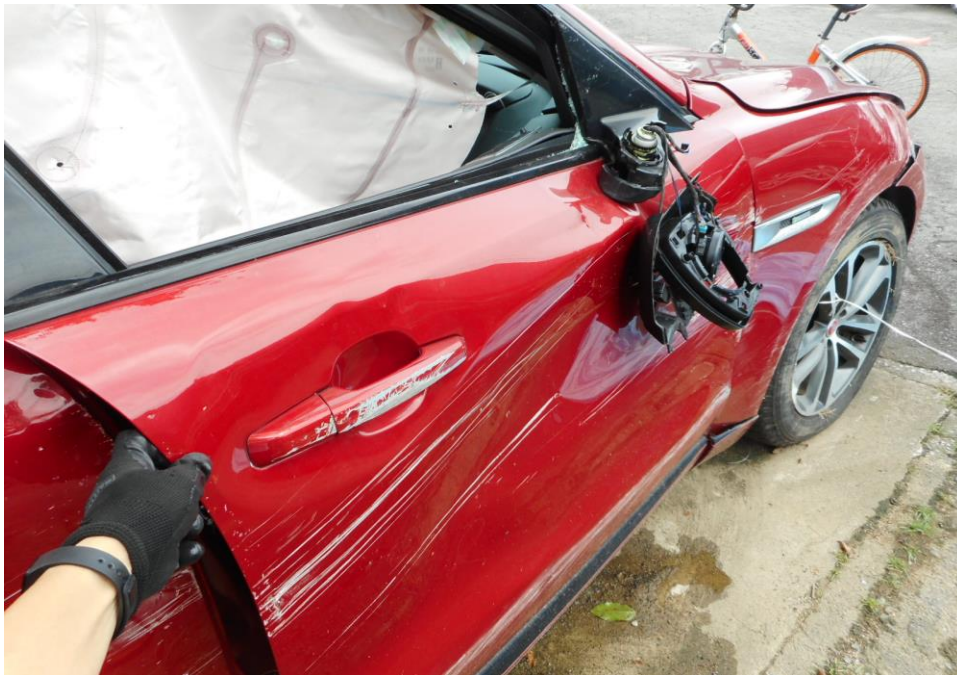
**Photo 15** shows the close view of the Motor Car's right body at the time of my inspection. The Motor Car was observed to have sustained damage on its right door and the door was unable to open due to the result of the accident.

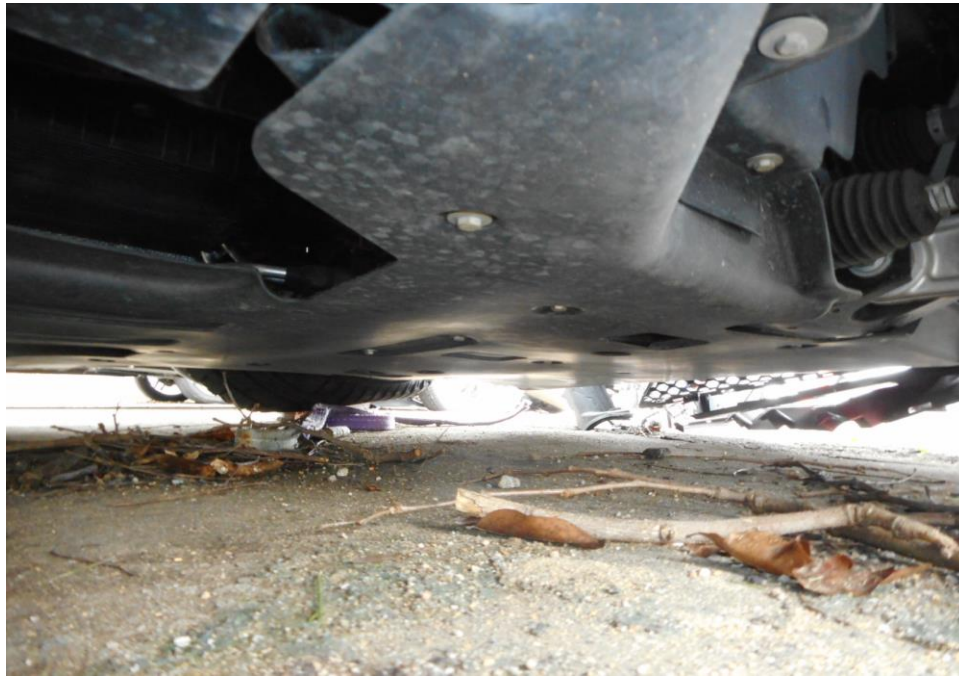
**Photo 16** shows the undercarriage of the Motor Car, at the area where the engine housing and transmission housing are located. . I did not find any sign(s) or indication(s) of fluid leak and/or fluid stain(s) on the underside of the Motor Car.

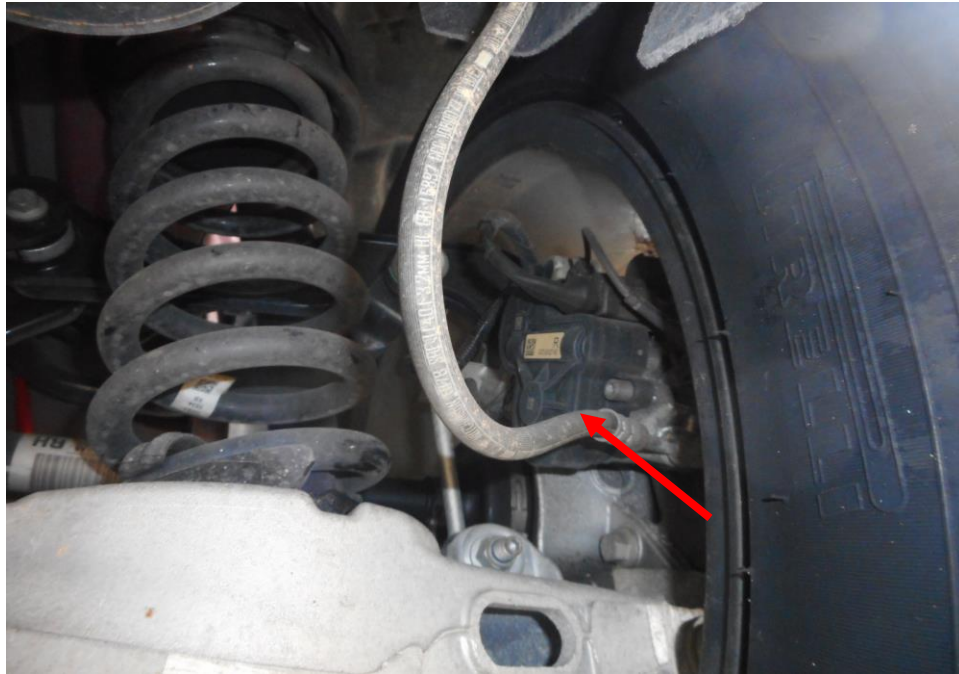
**Photo 17** shows the brake hose/pipe (arrowed) at the rear right wheel of the Motor Car. No leakage of brake fluid was observed. Visual examination of the various components of the braking system like the drum brake, brake booster, brake pedal etc. had revealed all to be intact and without visible damage.

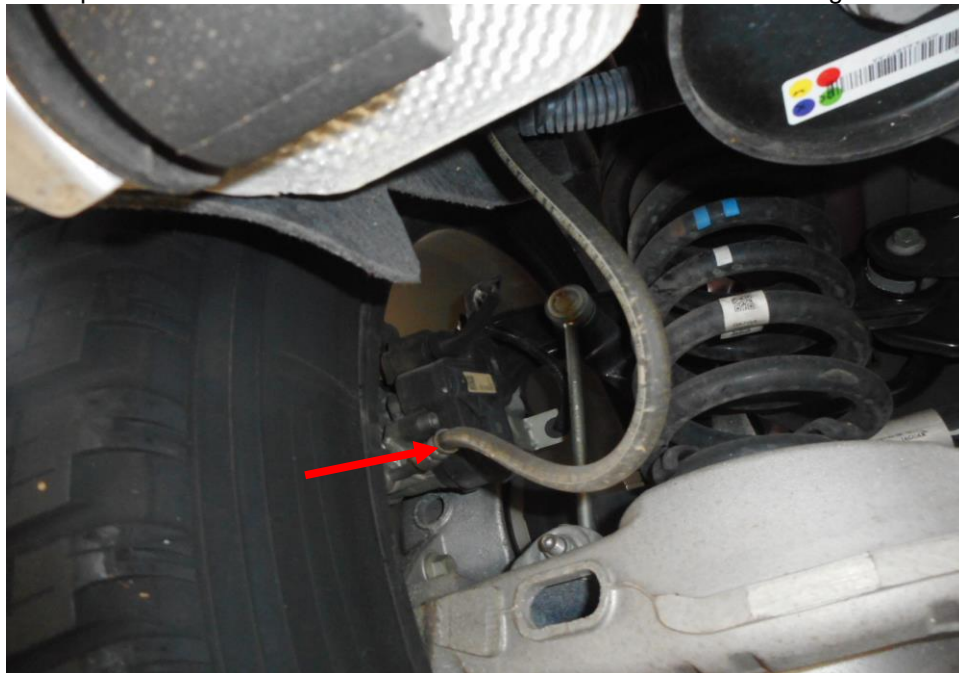
**Photo 18** shows the brake hose/pipe (arrowed) at the rear left wheel of the Motor Car. No leakage of brake fluid was observed. Visual examination of the various components of the braking system like the drum brake, brake booster, brake pedal etc. had revealed all to be intact and without visible damage.

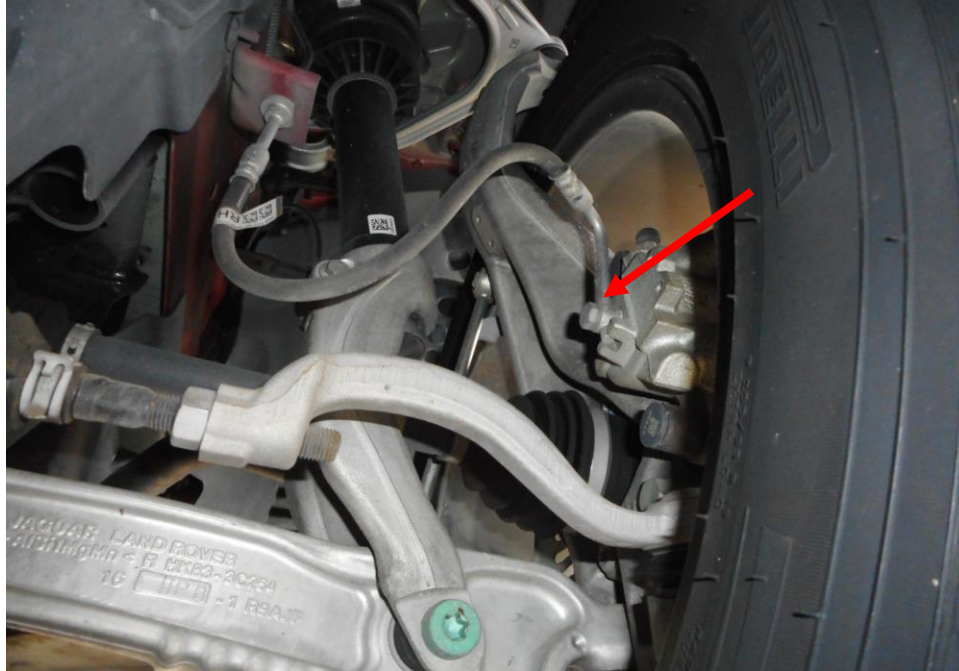
**Photo 19** shows the brake hose/pipe (arrowed) at the front right wheel of the Motor Car. I did not observe any leakage of brake fluid at the time of my inspection of the Motor Car. Static tests of the Motor Car's braking system had indicated that there was no internal leakage of pressure/vacuum. The undercarriage components of the Motor Car were also all found to be intact and without any visible damage.

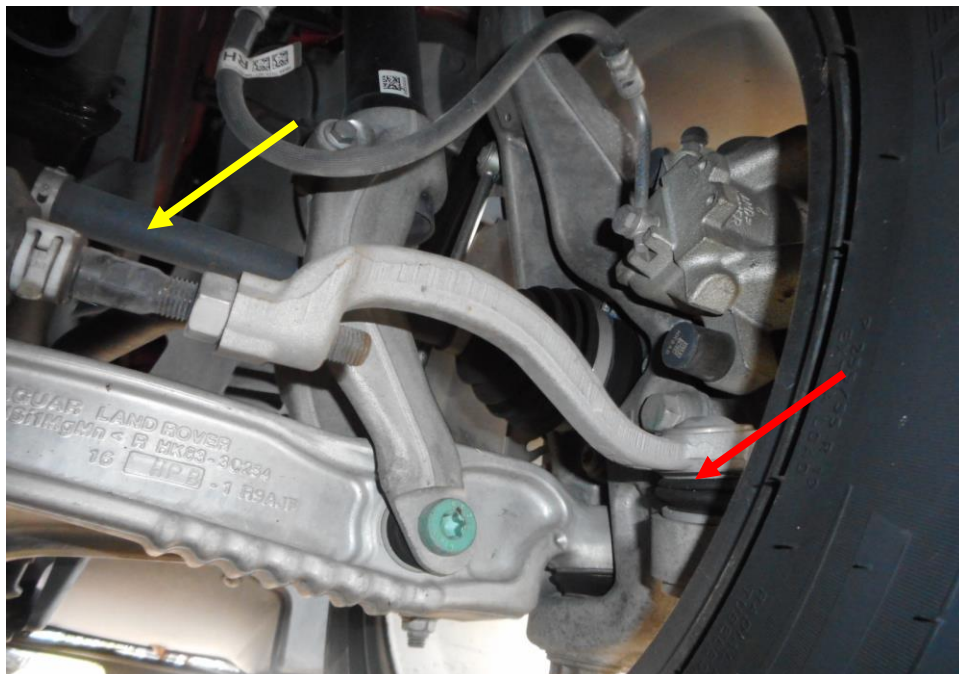
**Photo 20** shows the various undercarriage components at the front right wheel of the Motor Car, in particular the steering tie rod (red arrow) and the drive shaft (yellow arrow). The various steering components were all found to be intact, suggesting that the steering system of the Motor Car was likely to be in serviceable condition at the material time of accident. There was also no sign of fluid stain observed on the various undercarriage components at the front left wheel of the Motor Car.

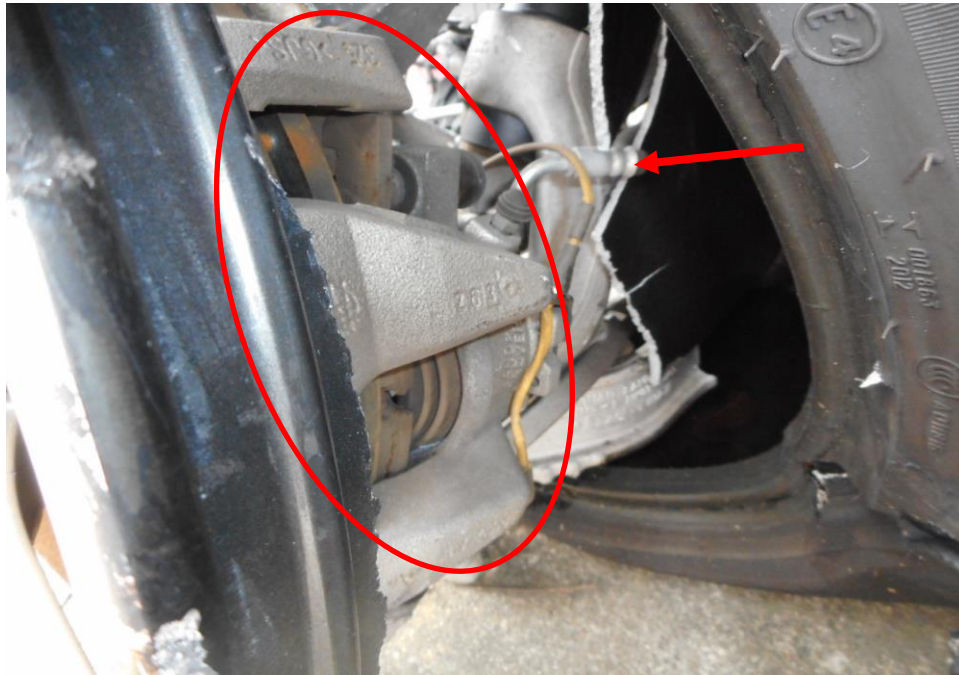
**Photo 21** shows the brake hose/pipe (arrowed) at the front left wheel of the Motor Car. No leakage of brake fluid was observed. Visual examination of the various components of the braking system like the brake caliper (circled), brake booster, brake pedal etc had revealed all to be intact and without visible damage.

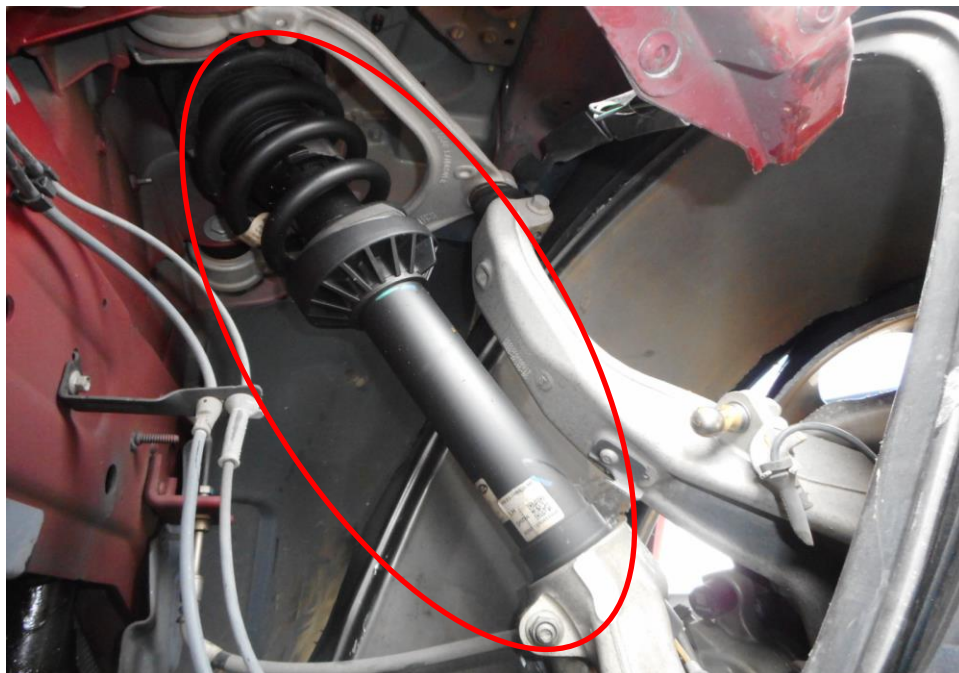
**Photo 22** shows the various undercarriage components at the front left wheel of the Motor Car, the suspension system (circled) was observed to be damaged as a result of the accident.

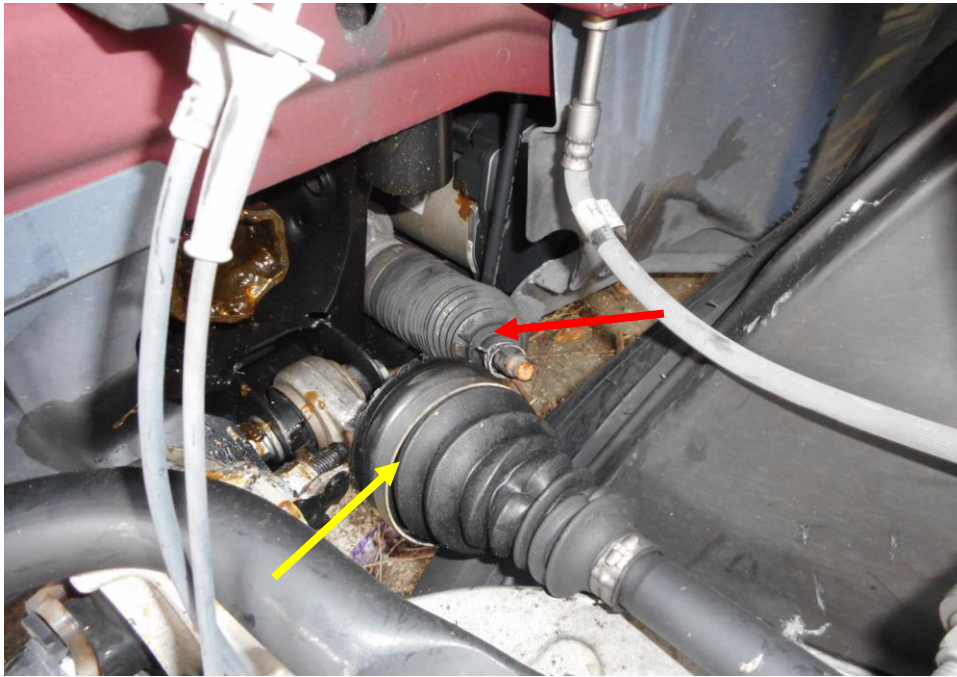
**Photo 23** shows the various undercarriage components at the front left wheel of the Motor Car, the steering tie rod (red arrow) and the drive shaft (yellow arrow) was observed to be damaged as a result of the accident.

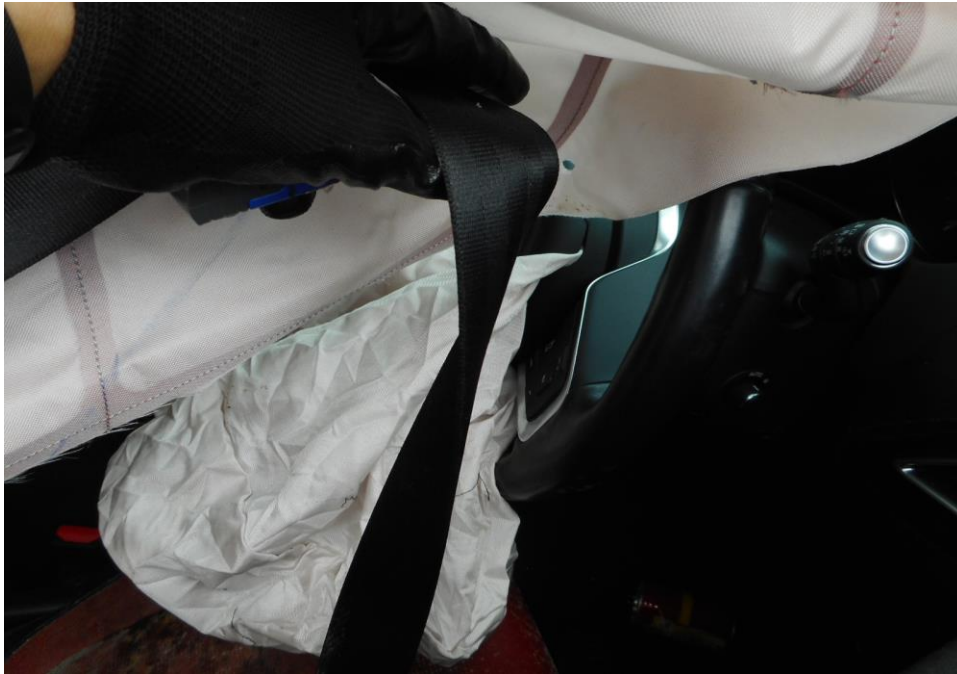
**Photo 24** shows that that the seat belt on the right seat was worn at the material time of accident as the safety pre-tensioners was activated at the moment of impact and caused the seat belt to be locked into the last position.

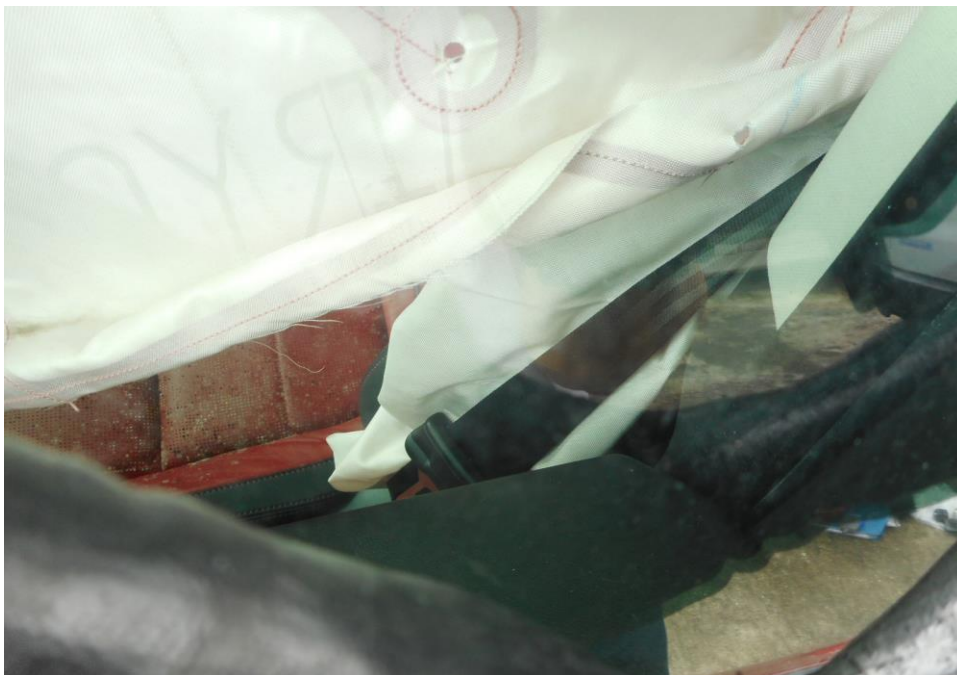
**Photo 25** shows that the seat belt on the left seat was not worn at the material time of accident as the safety pre-tensioners was activated at the moment of impact and caused the seat belt to be locked into the last position.
