You're Ref: TP/IP/53165/2020
Our Ref: CI/TPD20014312/P

27th January 2021

MECHANICAL INSPECTION REPORT OF MOTOR CAR EU 6336Y

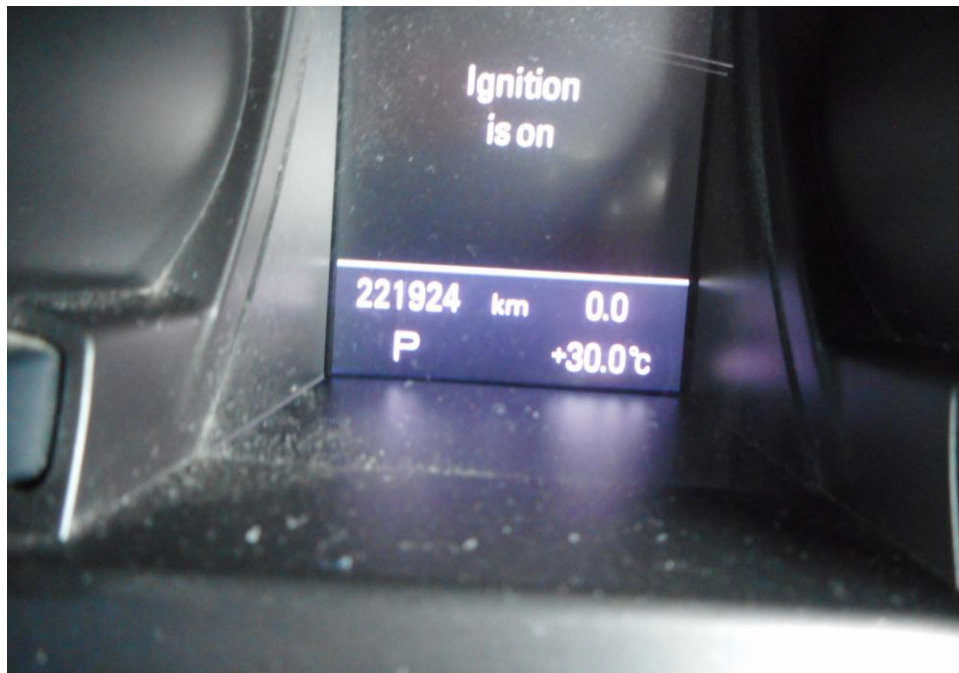
Photo 1 shows the mileage of the Motor Car at the time of my inspection. The mileage observed was 221,924km.

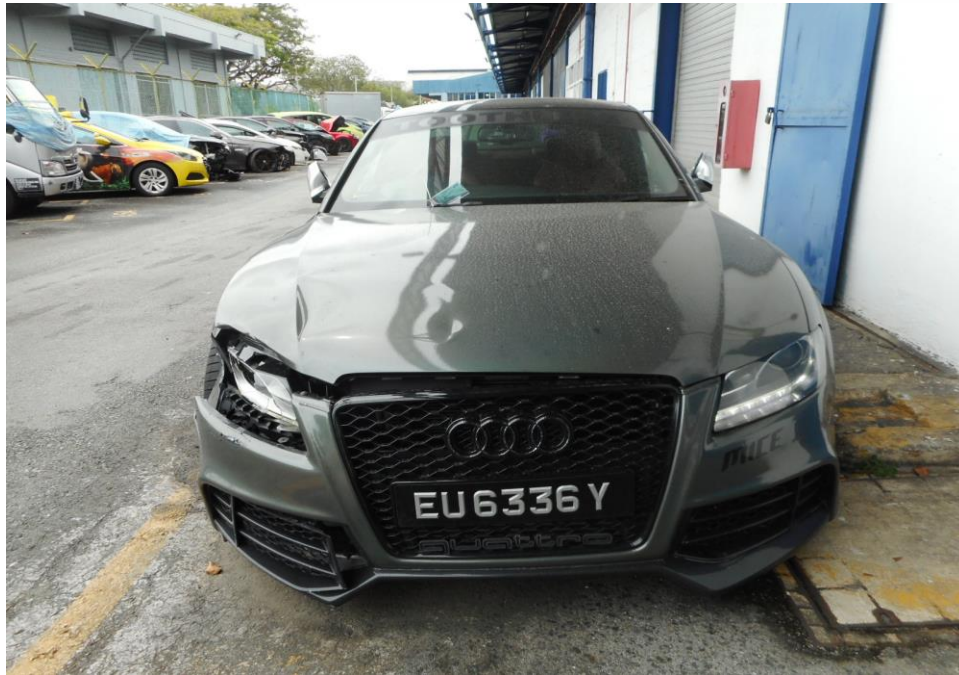
4. The mileage of the Motor Car at the time of my inspection was 221,924km.
5. The Motor Car was observed to have sustained damage at its front portion. Its front bonnet, front bumper, front right fender and front right headlamp are amongst the body parts that were damaged as a result of the accident.

Photo 2 shows a general view of the Motor Car's front body at the time of my inspection. Its front bonnet, front bumper, front right fender and front right headlamp are the body parts that were damaged as a result of the accident.

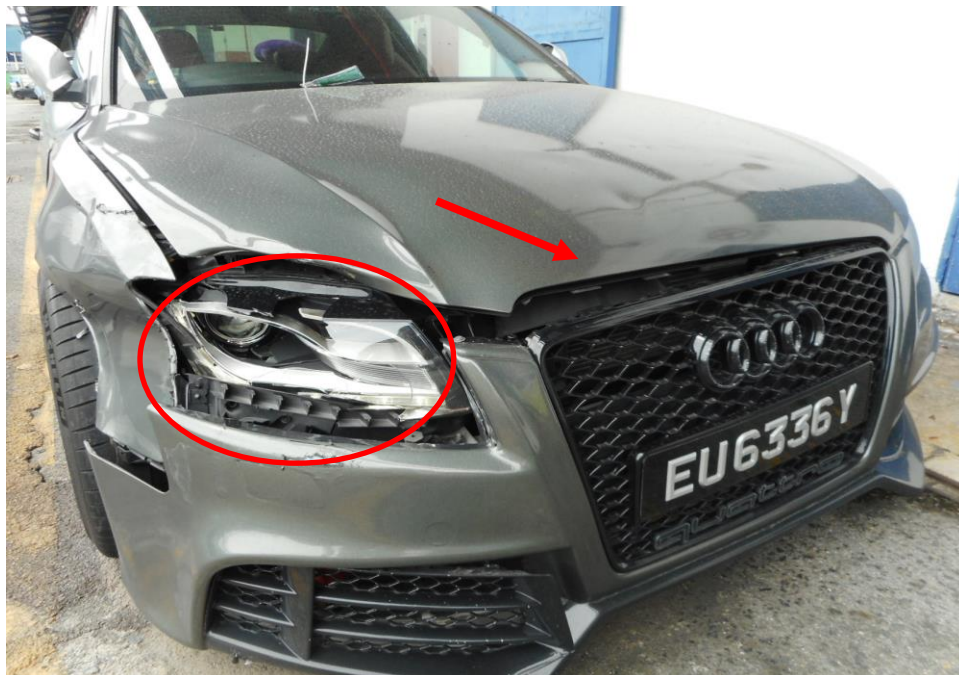
Photo 3 shows the close up view of the Motor Car's front body at the time of my inspection. Its front bonnet (arrowed) and front left headlamp (circled) are the body parts that were damaged as a result of the accident.

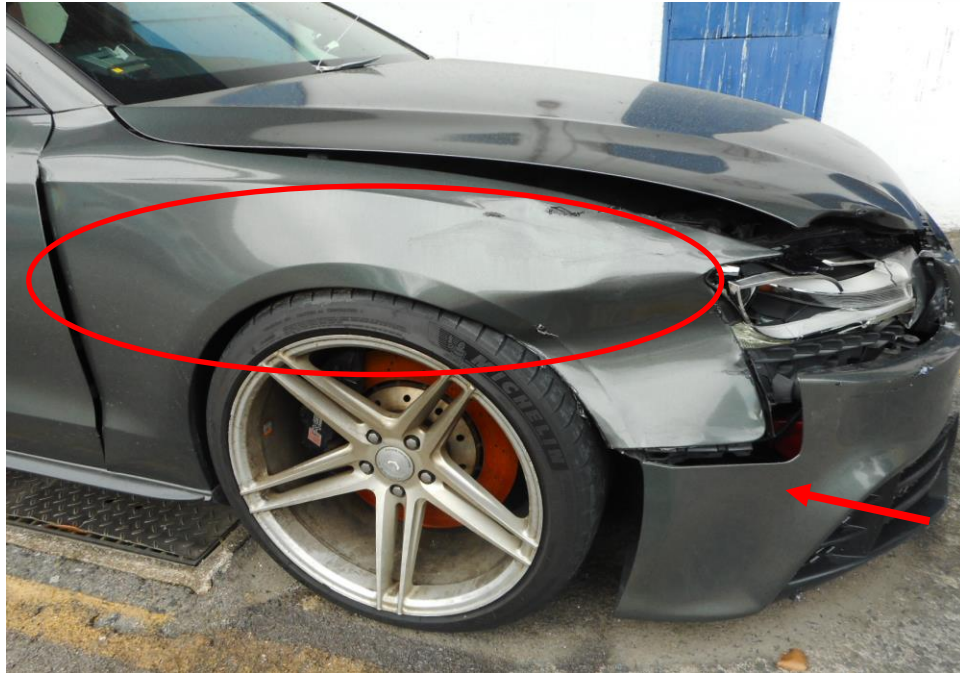
Photo 4 shows the close up view of the Motor Car's front body at the time of my inspection. Its front bumper (arrowed) and front right fender (circled) are the body parts that were damaged as a result of the accident.

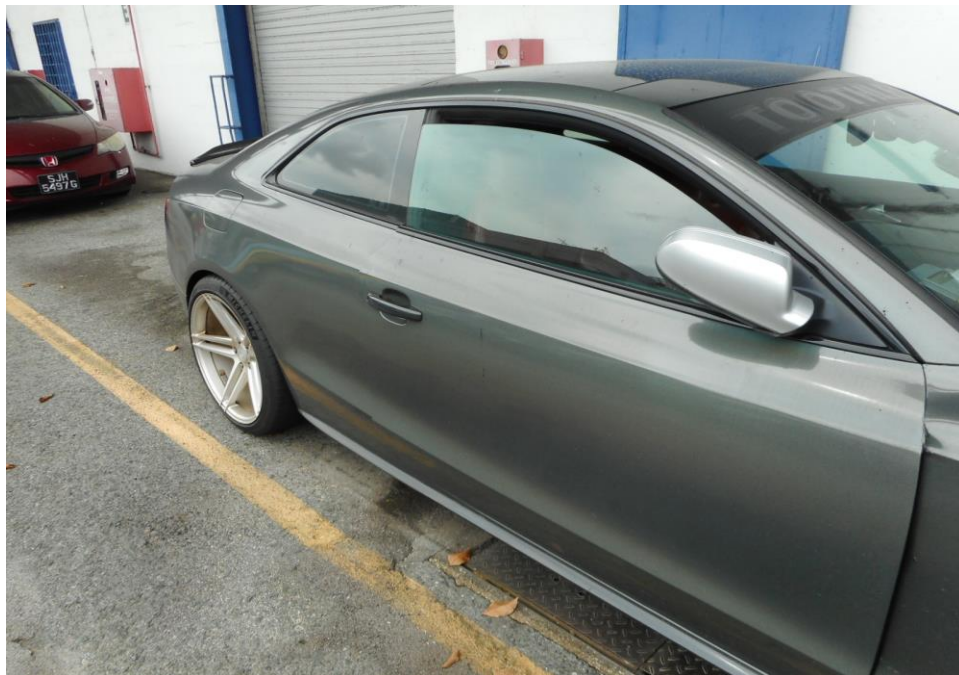
Photo 5 shows a general view of the Motor Car's right body at the time of my inspection. The right portion of the Motor Car was observed to have been unaffected by the accident.

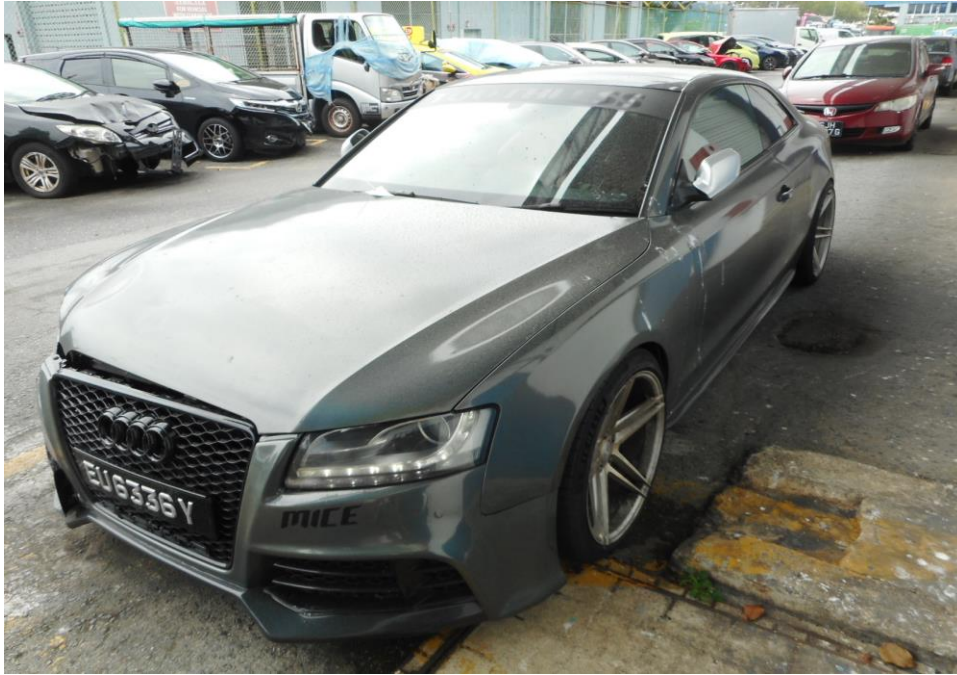
Photo 6 shows a general view of the Motor Car's left body at the time of my inspection. The left portion of the Motor Car was observed to have been unaffected by the accident.

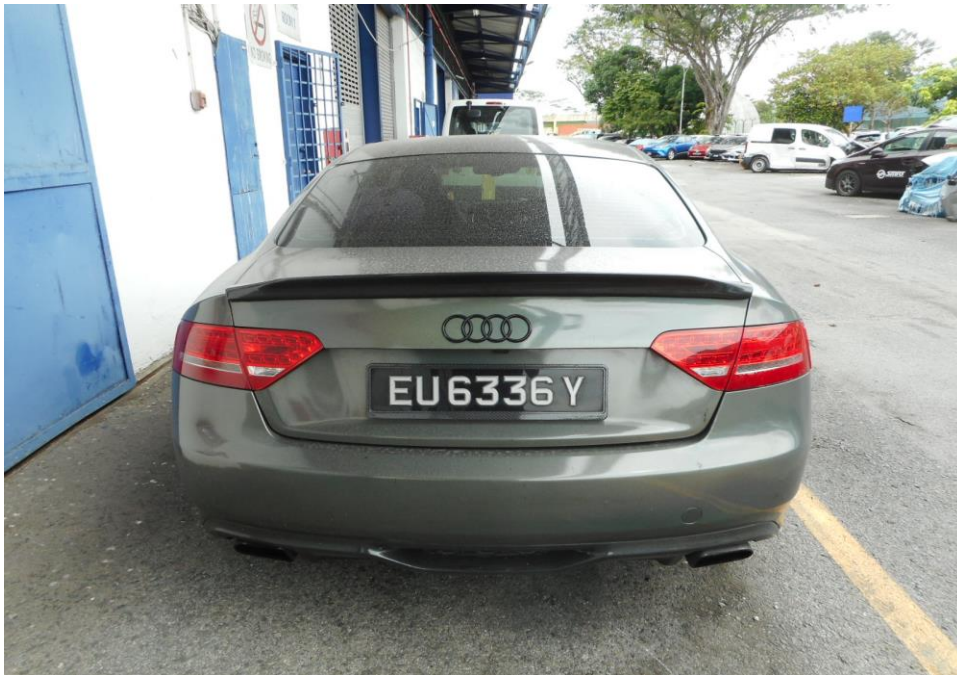
Photo 7 shows the general view of the Motor Car's rear body at the time of my inspection. The Motor Car rear was observed to be unaffected by the accident.

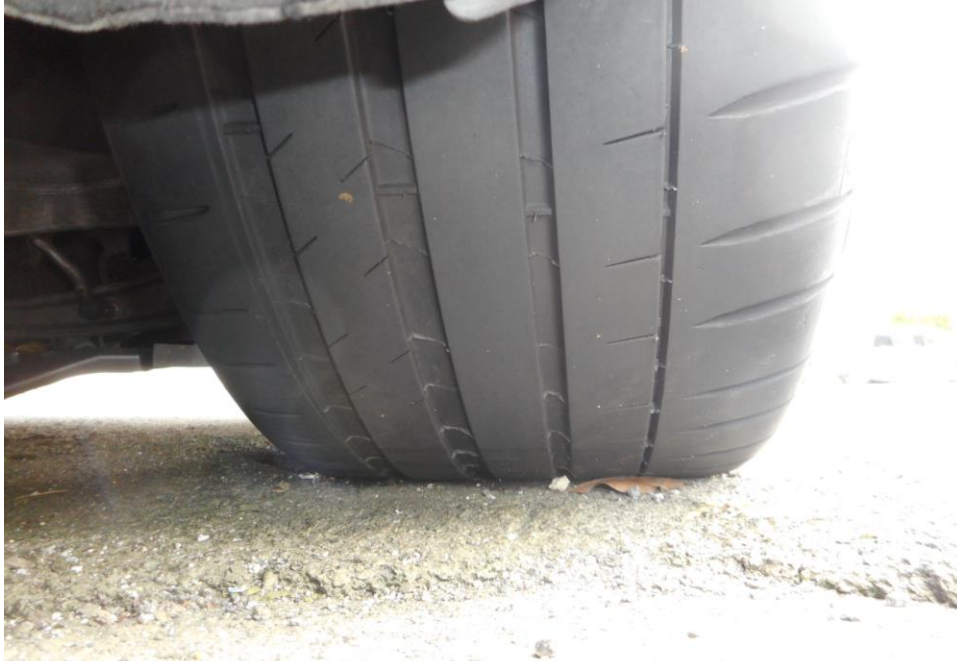
Photo 8 shows the condition of the front right tyre of the Motor Car, which was observed to be in serviceable condition with remaining tread depth of approximately 3.7mm. The tyre was sufficiently inflated for vehicular operation with no tear, cut or burst mark(s) on the outer and the inner sidewalls as well as across the tread. The 4 tyres of the Motor Car were wrapped around standard steel wheel rims without any damage.

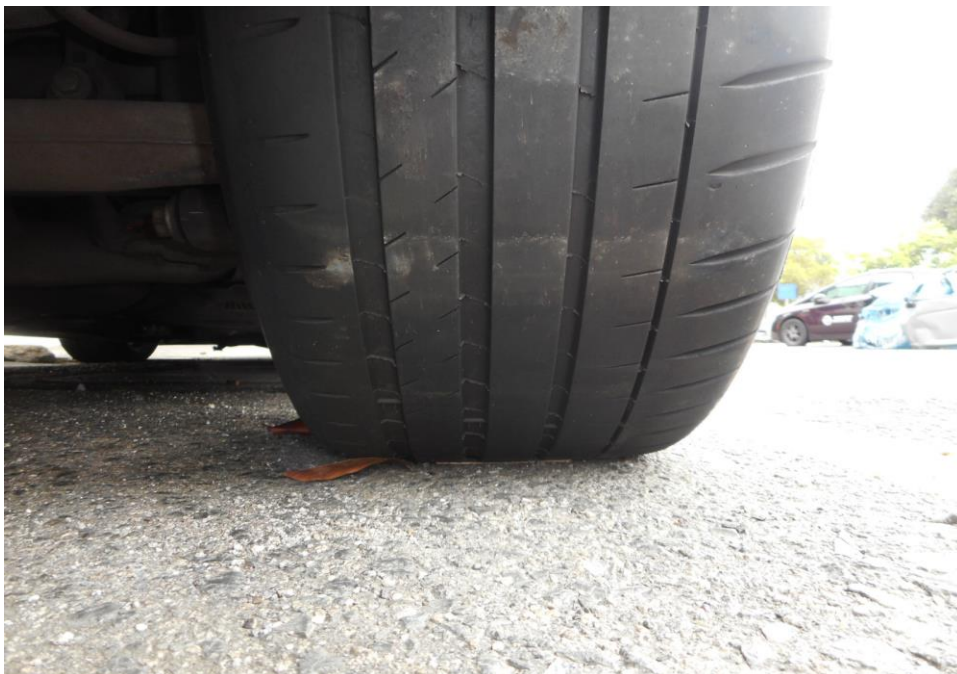
Photo 9 shows the condition of the rear right tyre of the Motor Car, which was observed to be in serviceable condition with remaining tread depth of approximately 3.7mm. The tyre was also observed to be sufficiently inflated for vehicular operation with no tear, cut or burst mark(s).

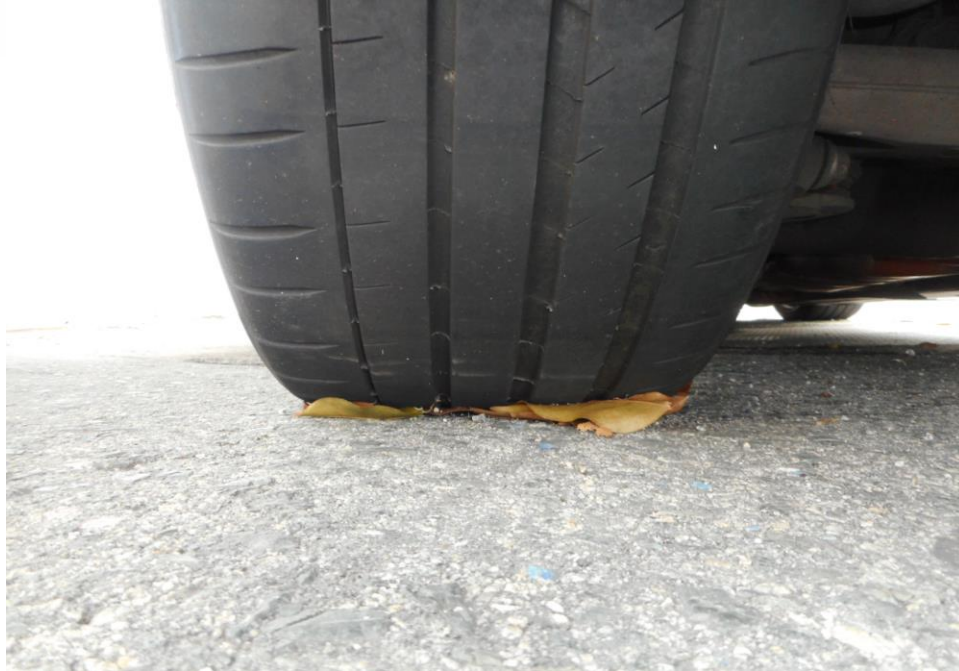
Photo 10 shows the condition of the rear left tyre of the Motor Car, which was observed to be in serviceable condition with remaining tread depth of approximately 3.8mm. The tyre, which was wrapped around steel wheel rim, was also observed to be sufficiently inflated for vehicular operation. The 4 tyres of the Motor Car were wrapped around standard steel wheel rims.

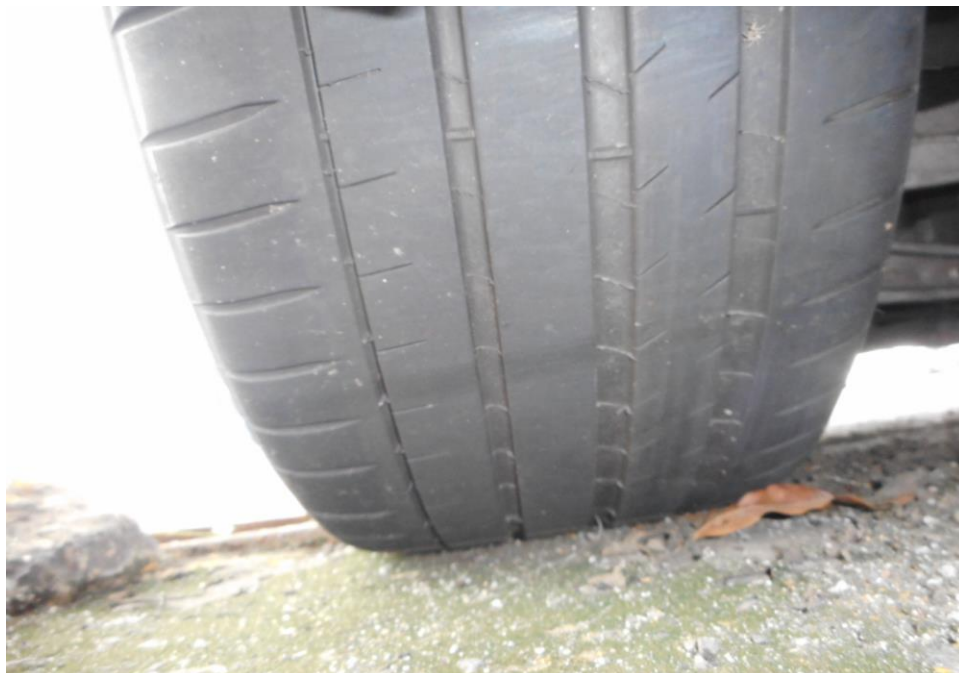
Photo 11 shows the condition of the front left tyre of the Motor Car, which was observed to be in serviceable condition with remaining tread depth of approximately 3.9mm. The tyre, which was wrapped around steel wheel rim, was also observed to be sufficiently inflated for vehicular operation. The 4 tyres of the Motor Car were wrapped around standard steel wheel rims.

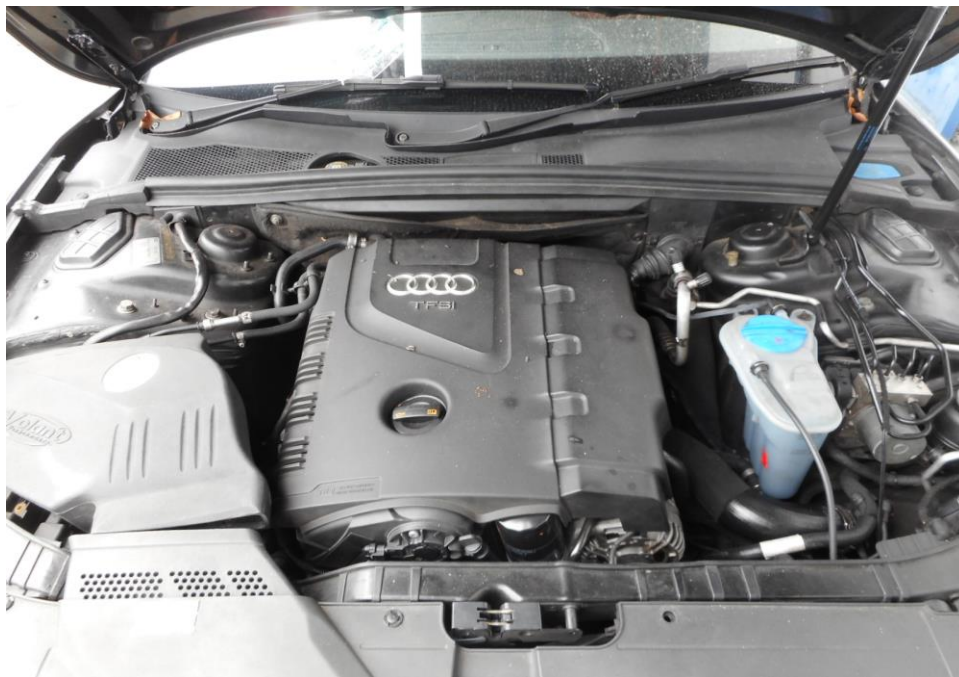
Photo 12 shows a general view of the Motor Car's engine compartment. The various parts and components inside the engine compartment were unaffected by the accident. There was also no sign(s) or indication(s) of fluid leakage and/or fluid stain within the engine compartment.

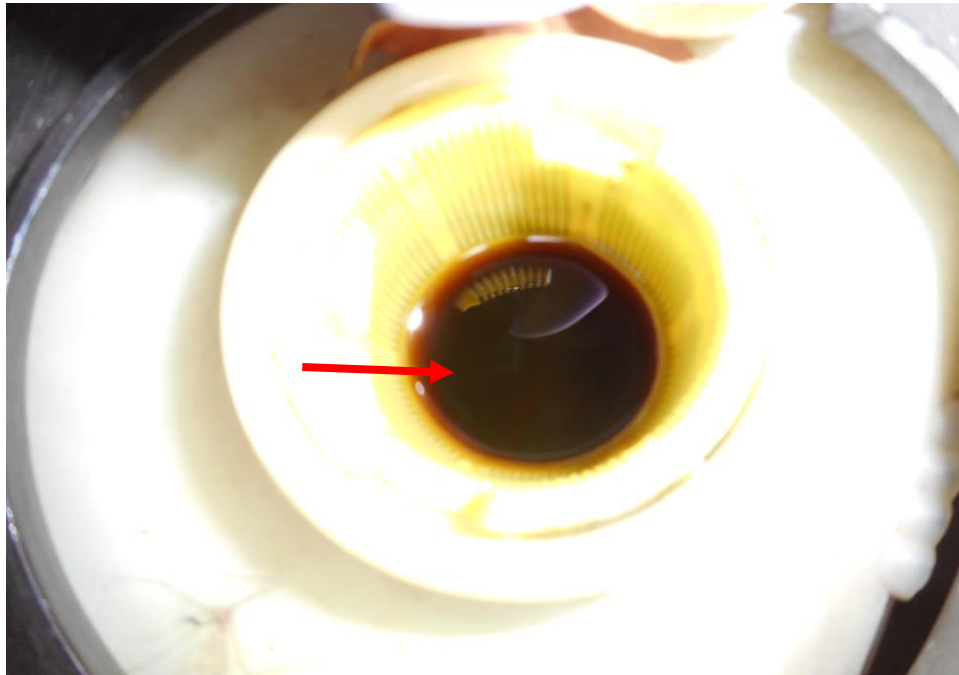
Photo 13 shows the brake fluid reservoir of the Motor Car at the time of my inspection. The brake fluid was observed to be of sufficient level (arrowed) and without any visible contamination.

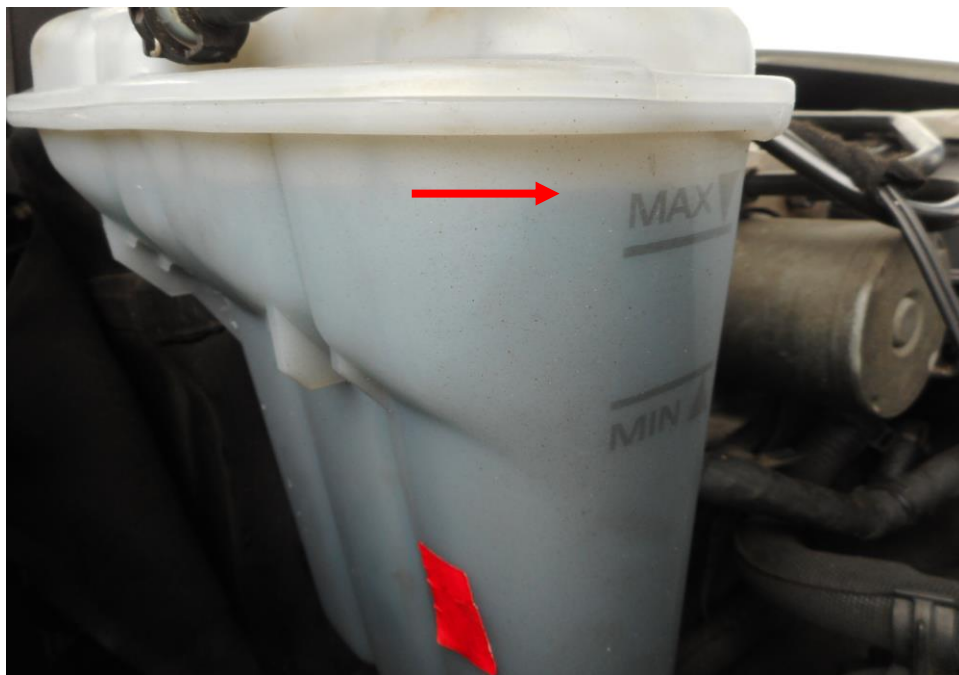
Photo 14 shows checks being carried out to the engine coolant of the Motor Car at the time of my inspection. The engine coolant was observed to be of sufficient level (arrowed) and without any visible contamination.

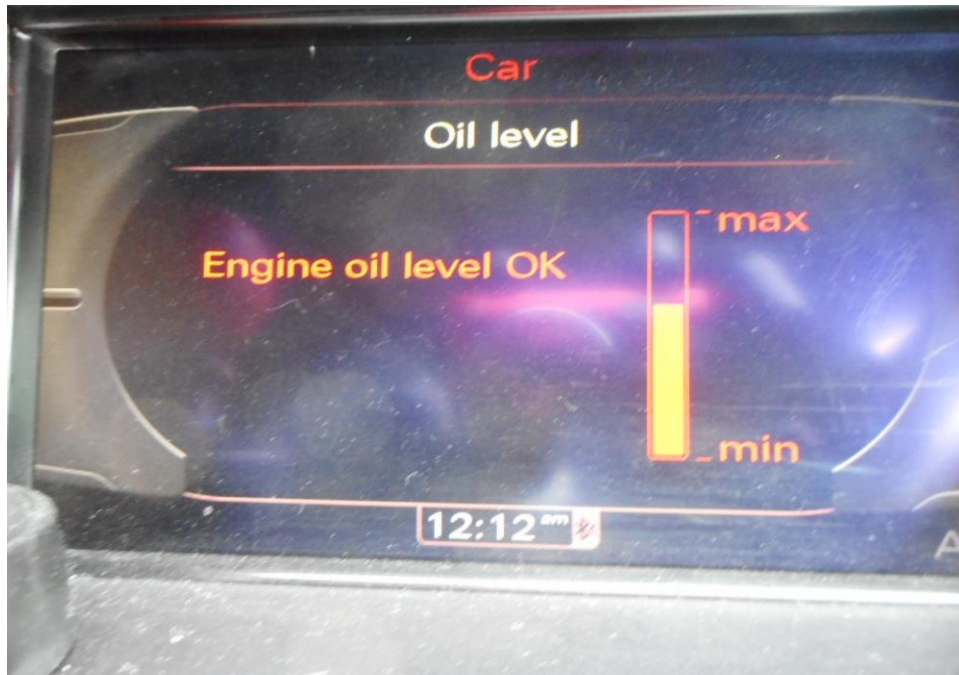
Photo 15 shows the engine oil level display of the Motor Car at the time of my inspection. The engine oil was observed to be of sufficient level and without any visible contamination.

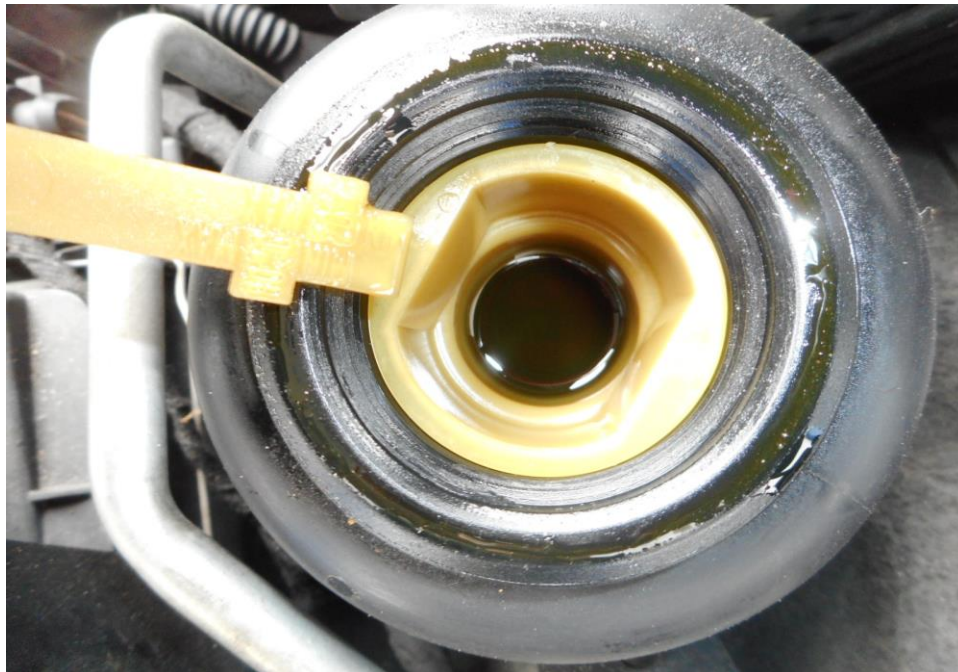
Photo 16 shows the power steering fluid dip stick of the Motor Car at the time of my inspection. The engine oil was observed to be of sufficient level and without any visible contamination.

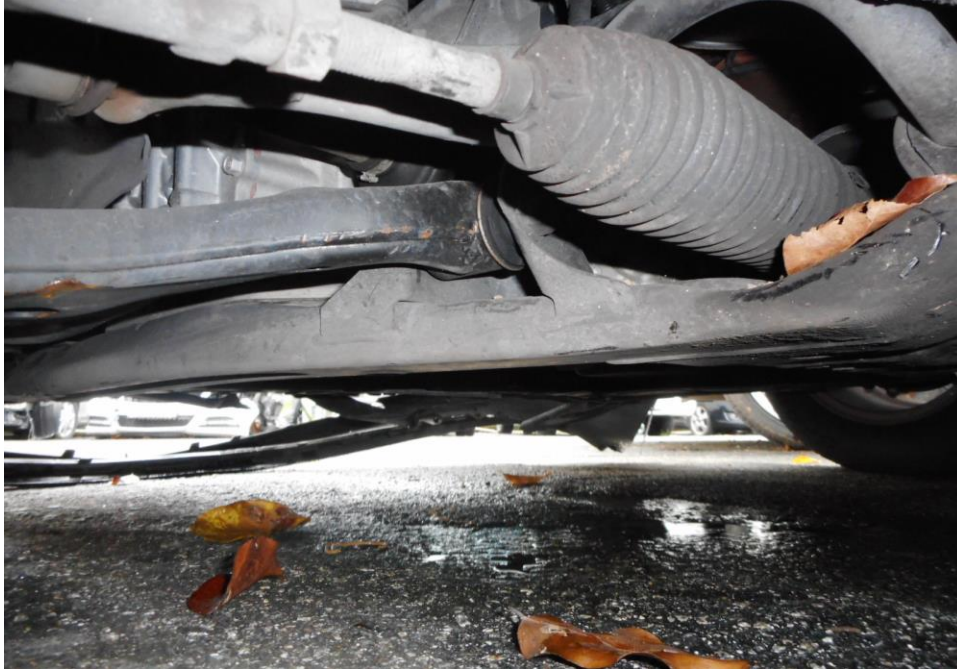
Photo 17 shows the undercarriage of the Motor Car, at the area where the engine housing and transmission housing are located. I did not find any sign(s) or indication(s) of fluid leak and/or fluid stain(s) on the underside of the Motor Car.

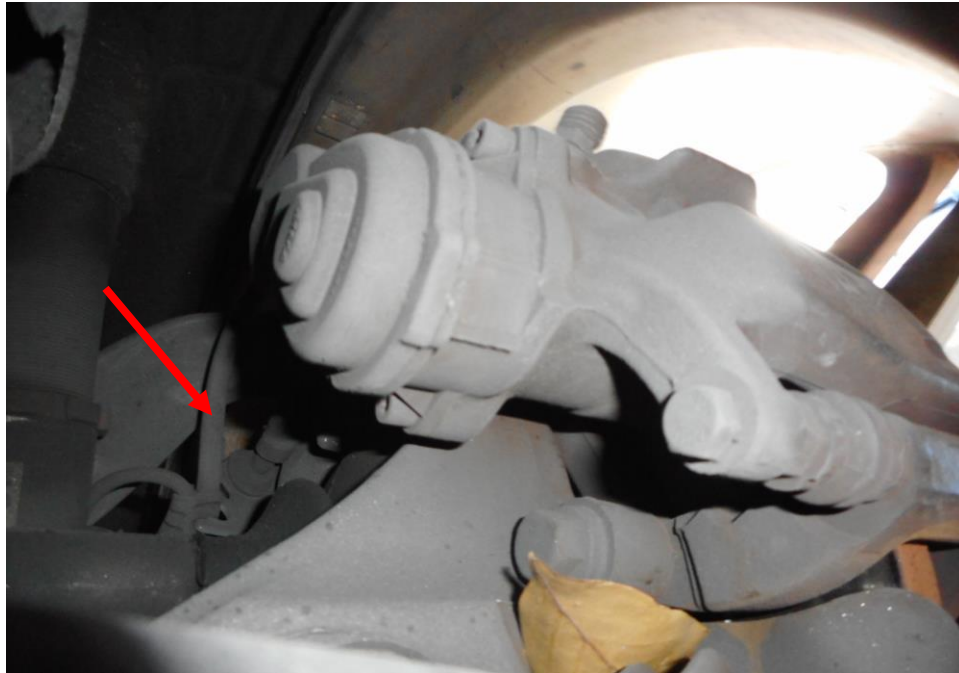
Photo 18 shows the brake hose/pipe (arrowed) at the rear right wheel of the Motor Car. No leakage of brake fluid was observed. Visual examination of the various components of the braking system like the brake caplier, brake booster, brake pedal etc. had revealed all to be intact and without visible damage.

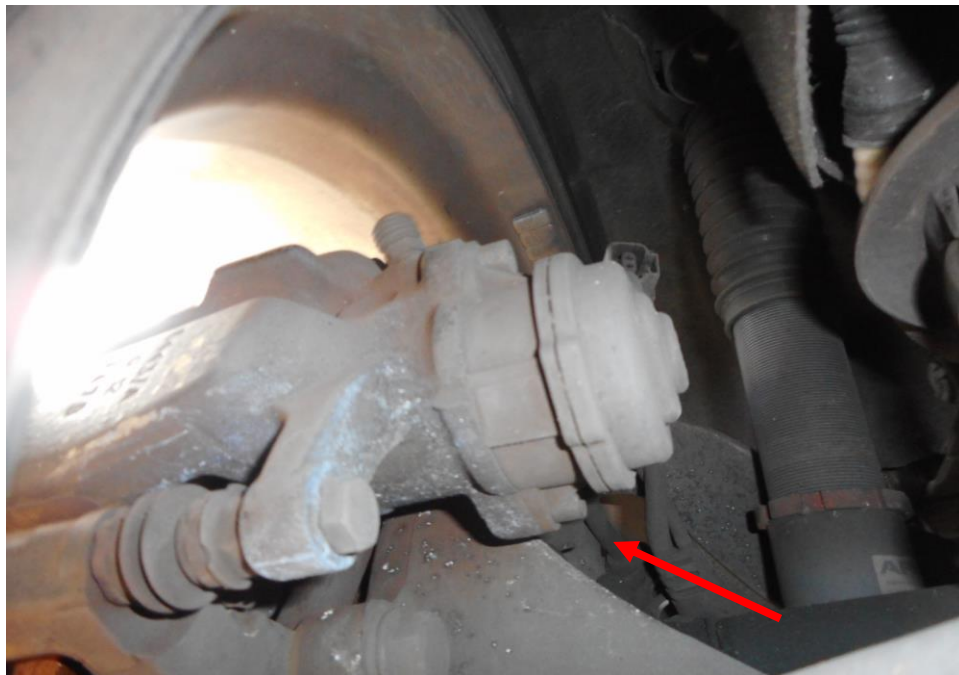
Photo 19 shows the brake hose/pipe (arrowed) at the rear left wheel of the Motor Car. I did not observe any leakage of brake fluid at the time of my inspection of the Motor Car. Static tests of the Motor Car's braking system had indicated that there was no internal leakage of pressure/vacuum. The undercarriage components of the Motor Car were also all found to be intact and without any visible damage.

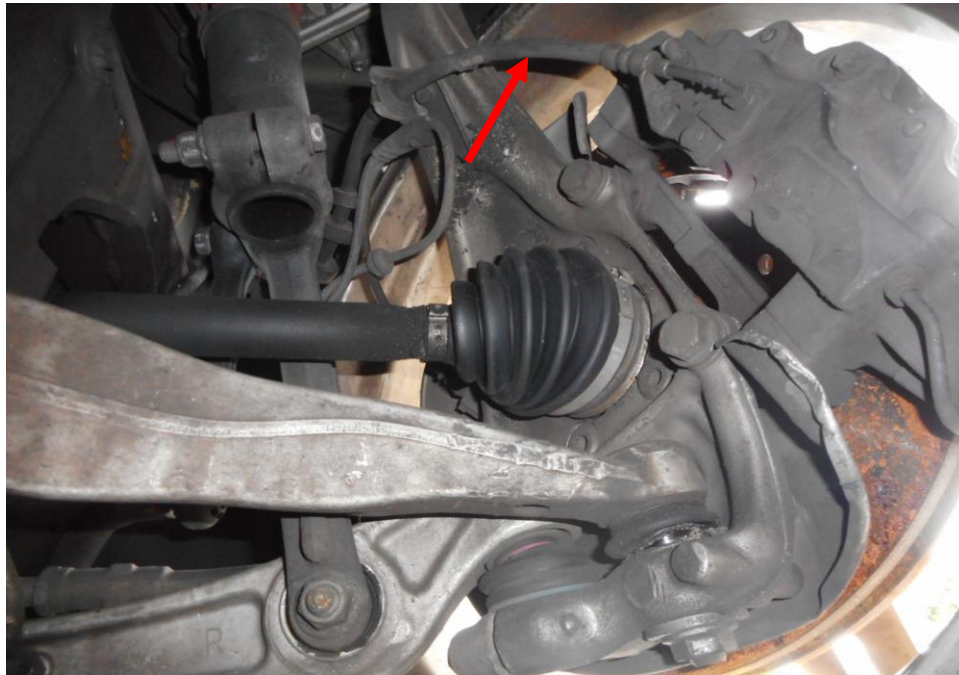
Photo 20 shows the brake hose/pipe (arrowed) at the front right wheel of the Motor Car. I did not observe any leakage of brake fluid at the time of my inspection of the Motor Car. Static tests of the Motor Car's braking system had indicated that there was no internal leakage of pressure/vacuum. The undercarriage components of the Motor Car were also all found to be intact and without any visible damage.

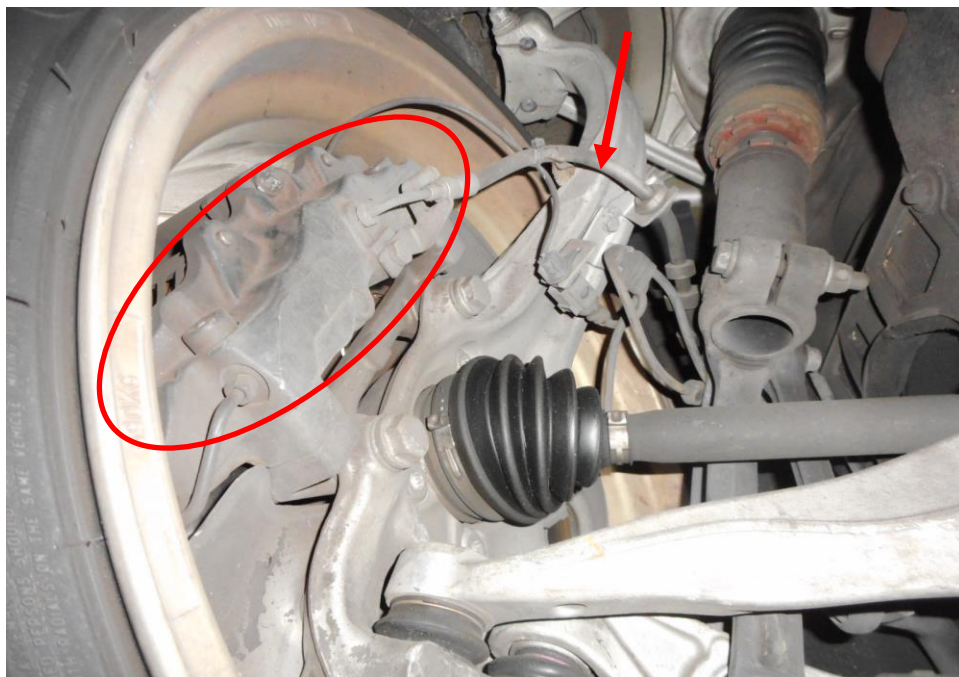
Photo 21 shows the brake hose/pipe (arrowed) at the front left wheel of the Motor Car. No leakage of brake fluid was observed. Visual examination of the various components of the braking system like the brake caliper (circled), brake booster, brake pedal etc had revealed all to be intact and without visible damage.

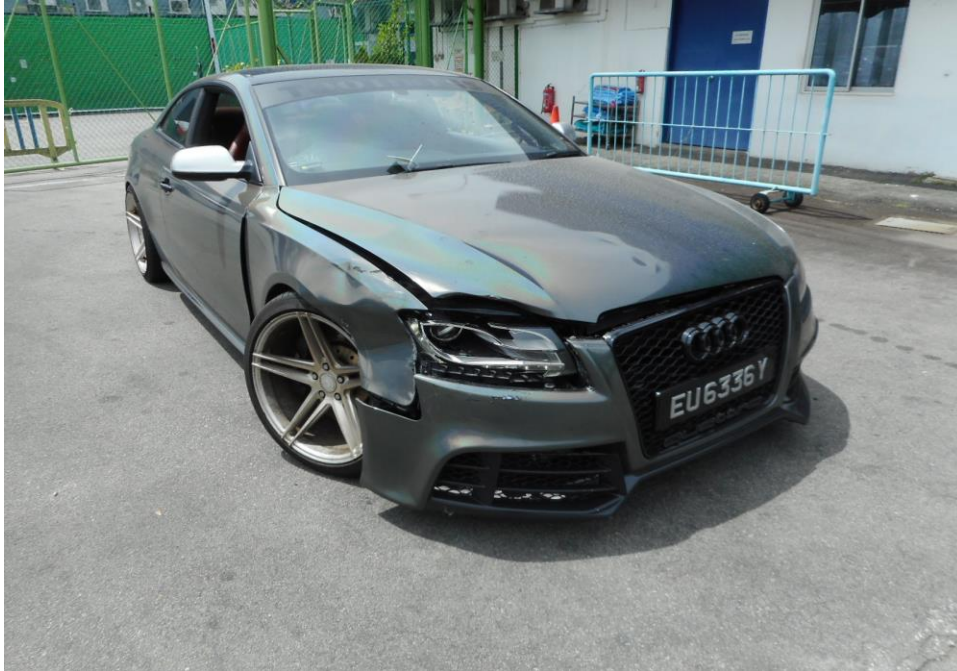
Photo 22 shows the front right wheel of the Motor Car turned to its full left. During my steering system test, I did not experience any abnormal free play and/or resistance when I had turned the steering wheel towards the left and right. This would suggest that the steering system of the Motor Car was likely to be in serviceable condition at the material time of accident.

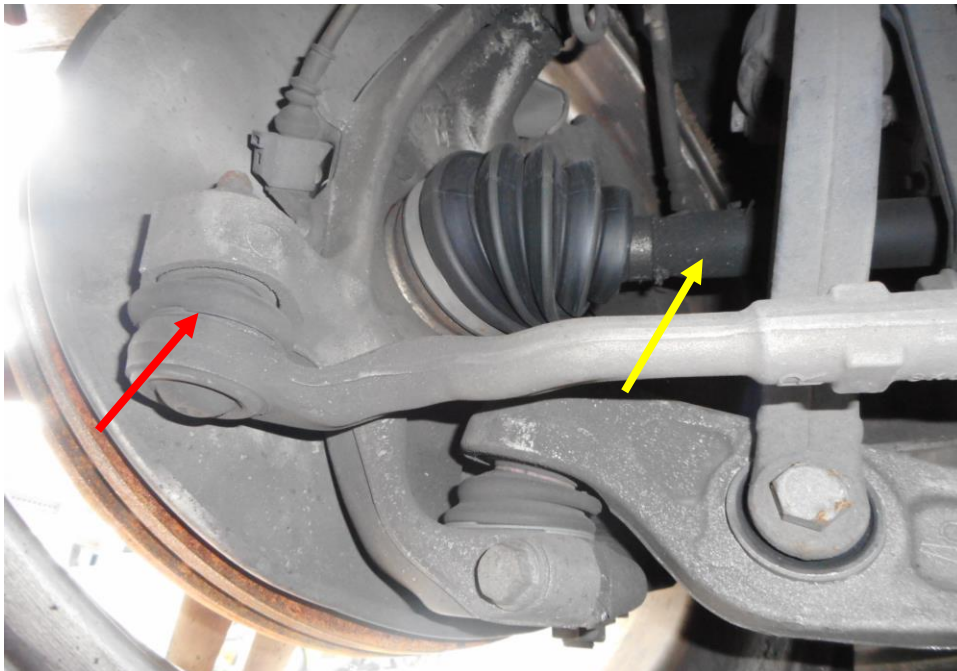
Photo 23 shows the various undercarriage components at the front right wheel of the Motor Car, in particular the steering tie rod (red arrow) and drive shaft (yellow arrow). The various steering components were all found to be intact, suggesting that the steering system of the Motor Car was likely to be in serviceable condition at the material time of accident. There was also no sign of fluid stain observed on the various undercarriage components at the front right wheel of the Motor Car.

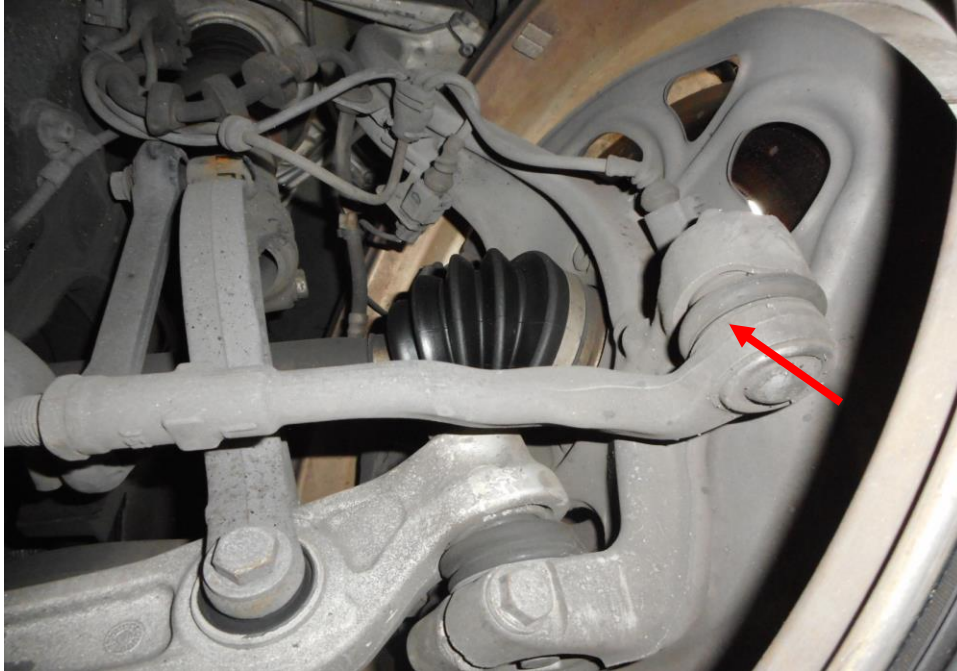
Photo 24 shows the various undercarriage components at the front left wheel of the Motor Car, which had included the steering tie rod (red arrow). The various undercarriage components of the Motor Car were all found to be intact without any visible damage.

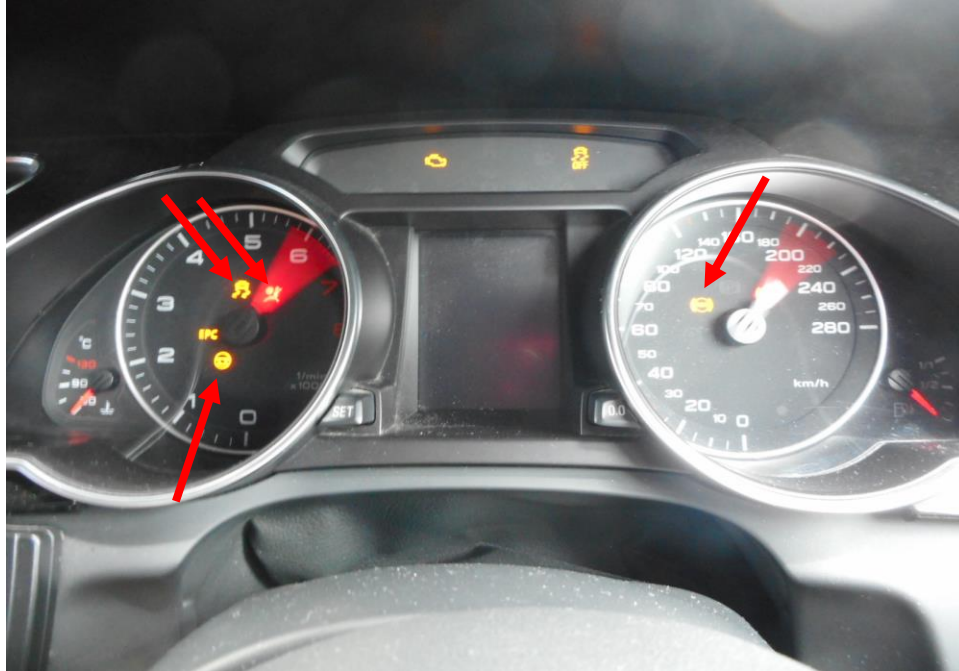
Photo 25 shows the warning light for Anti-Lock Brake System (ABS) and Power Steering System (EPS), Traction Control System (TCS) and Supplemental Restraint System (SRS) (arrowed) appearing on the instrument panel of the Motor Car during the self-test of its various electronic operating systems when its engine was cranked.

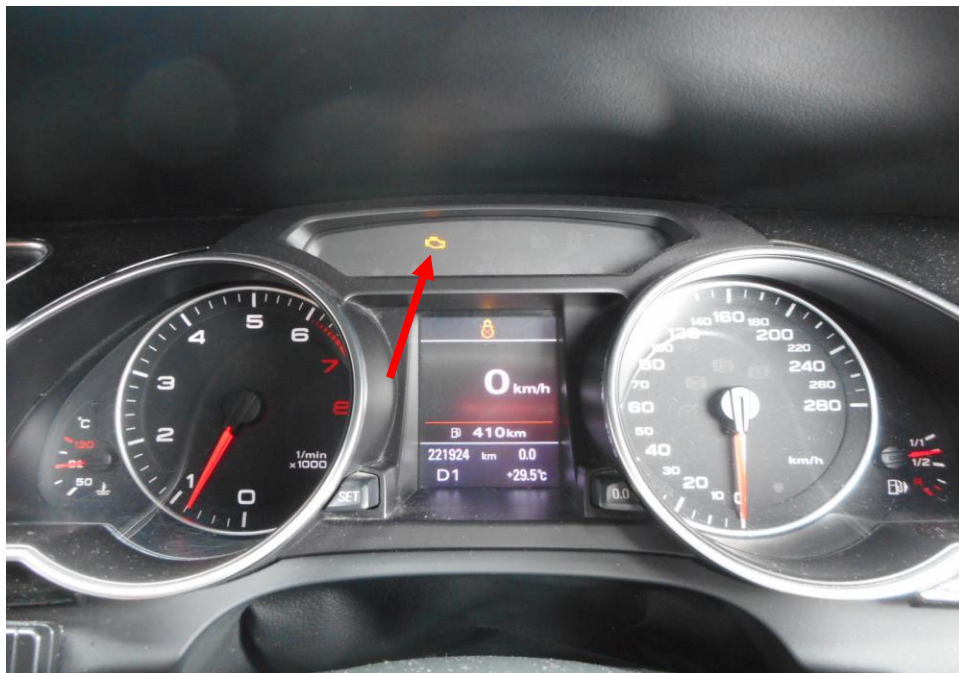
Photo 26 shows only the engine check light remained illuminated up (arrowed) However, no other warning lights were illuminated on the instrument panel of the Motor Car after the engine was cranked. This would suggest that there was no abnormality to the various electronic operating systems of the Motor Car, like the ABS, SRS, TCS and EPS.
