Your Ref: TP/IP/46953/2020  
Our Ref : CI/TPD20014313/N

**Fatal Accident Investigation Team**

**MECHANICAL INSPECTION REPORT OF MOTOR CAR SKQ 2091D**

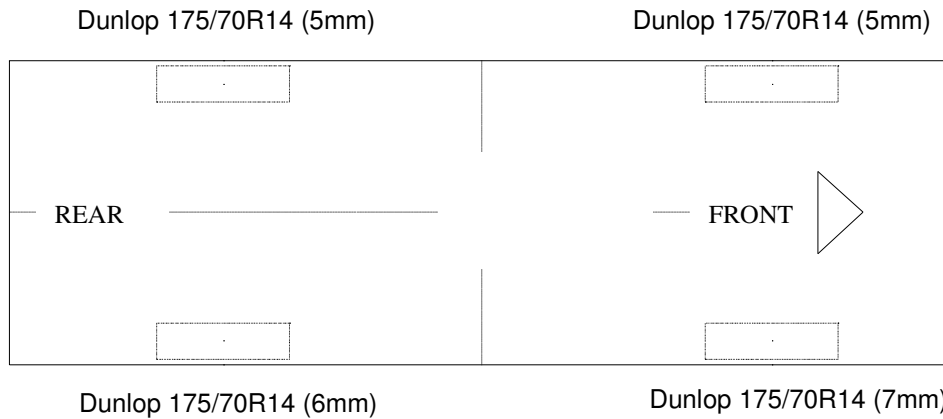
6. The condition of the Motor Car's 4 tyres was observed to be in serviceable condition. We did not find any tear, cut or burst mark(s) on the outer and the inner sidewalls as well as across the tread of the 4 tyres. The 4 tyres were also observed to be sufficiently inflated for vehicular operation. The tyre brand, tyre size and remaining tread depth of the 4 tyres were recorded as follows:-

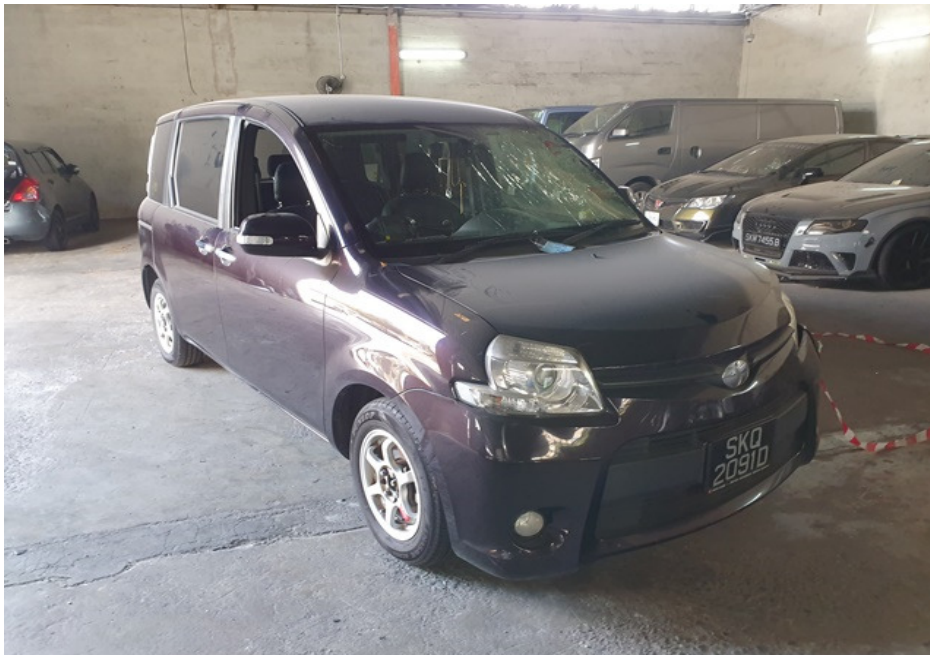
**Photo 1** shows a general view of the front right body of the Motor Car at the time of our inspection. The Motor Car was observed to be in good general condition except for some relatively minor impact damage at its left frontal portion. The mileage of the Motor Car was recorded to be 169, 780km.

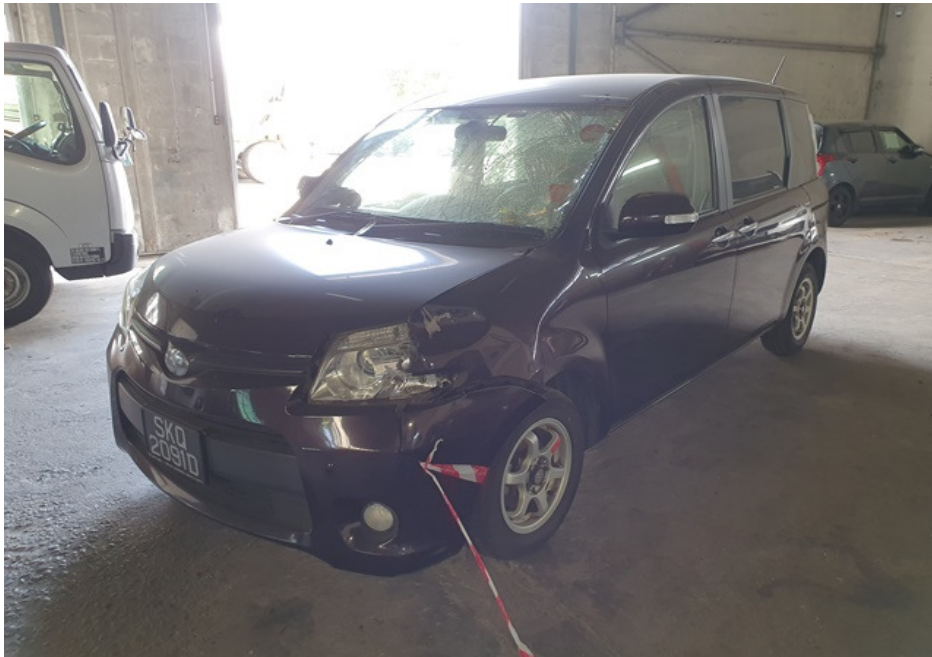
4. The mileage of the Motor Car at the time of our inspection was 169, 780km.
5. The Motor Car had sustained relatively minor impact damage that was confined to its left frontal portion. Its front bonnet and left front fender was observed to have been dented; its front bumper and left front headlamp were observed to have cracked while its front windscreen was observed to have shattered.

**Photo 2** shows a general view of the front left body of the Motor Car at the time of our inspection. The Motor Car was observed to be in good general condition. However we had observed relatively minor impact damage that was confined to its left frontal portion. Its front bonnet and left front fender was observed to have been dented at the left portion; its front bumper and left front headlamp were observed to have cracked while its front windscreen was observed to be shattered.

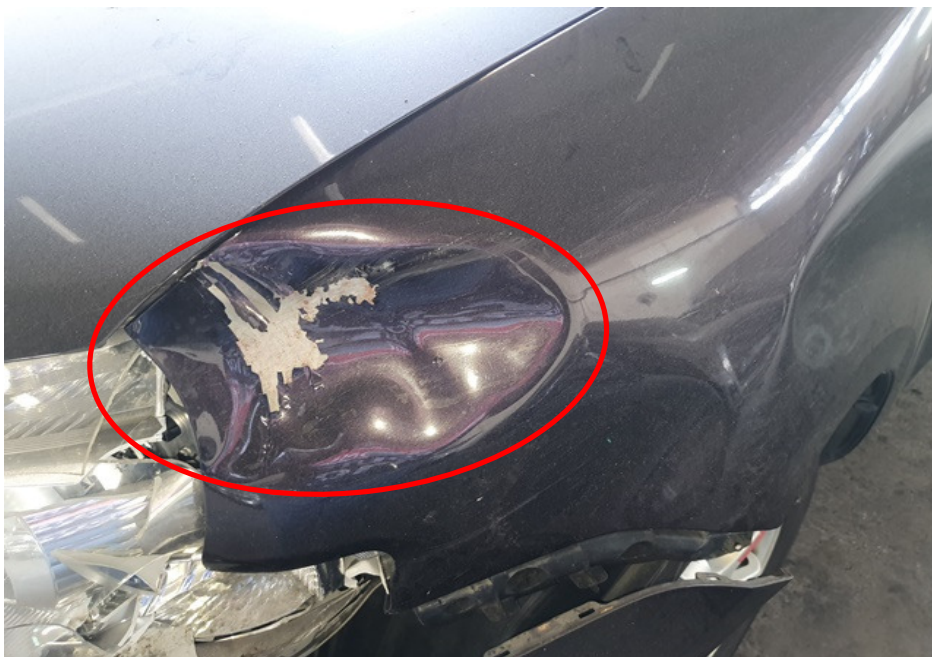
**Photo 3** shows a closer view of the dented front bonnet and left front fender of the Motor Car at the time of our inspection (circled).

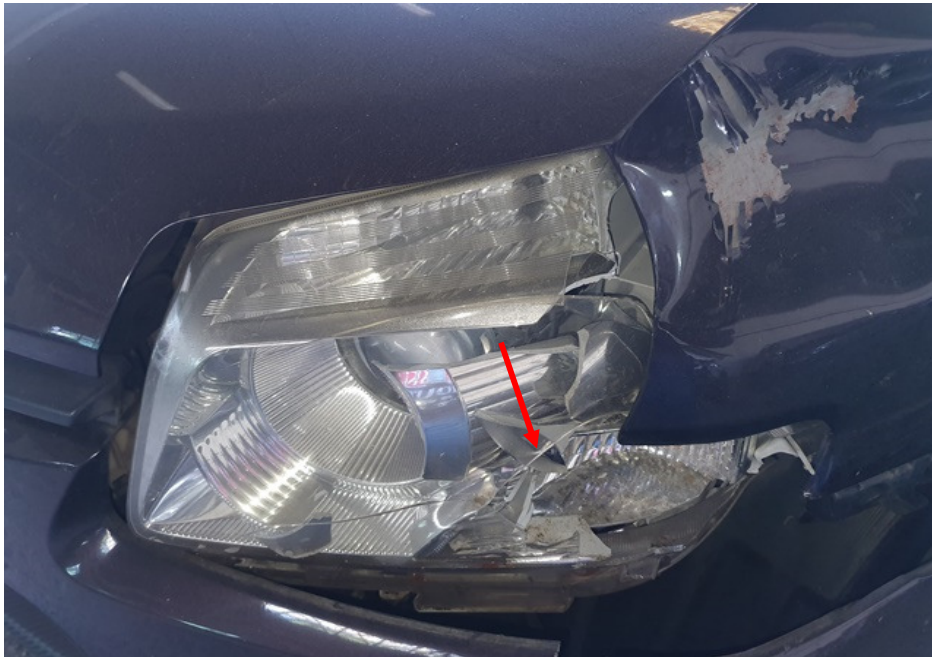
**Photo 4** shows a closer view of the cracked left front headlamp (arrowed) of the Motor Car at the time of our inspection

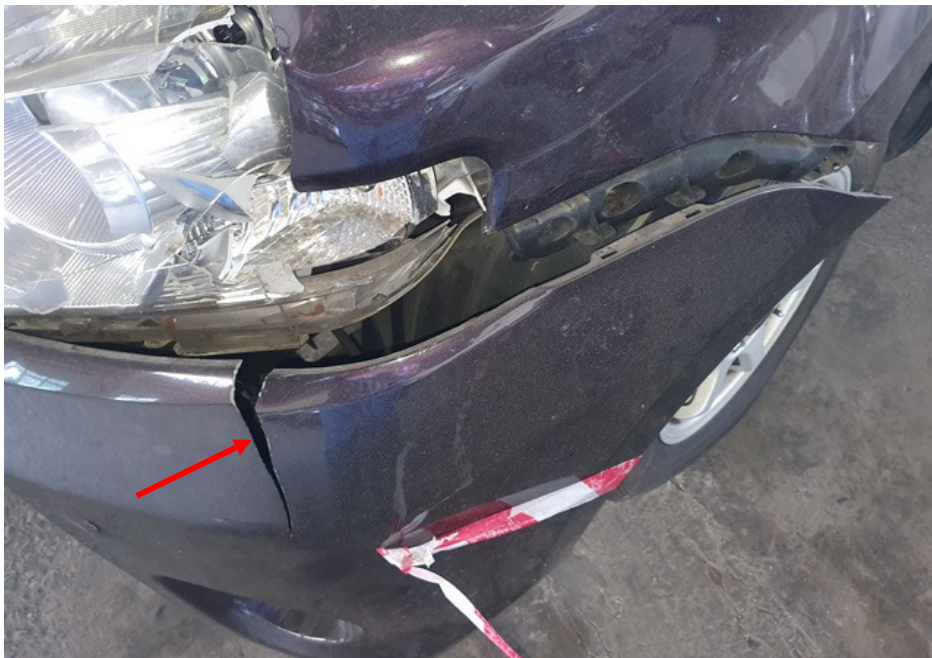
**Photo 5** shows a closer view of the cracked front bumper (arrowed) of the Motor Car at the time of our inspection

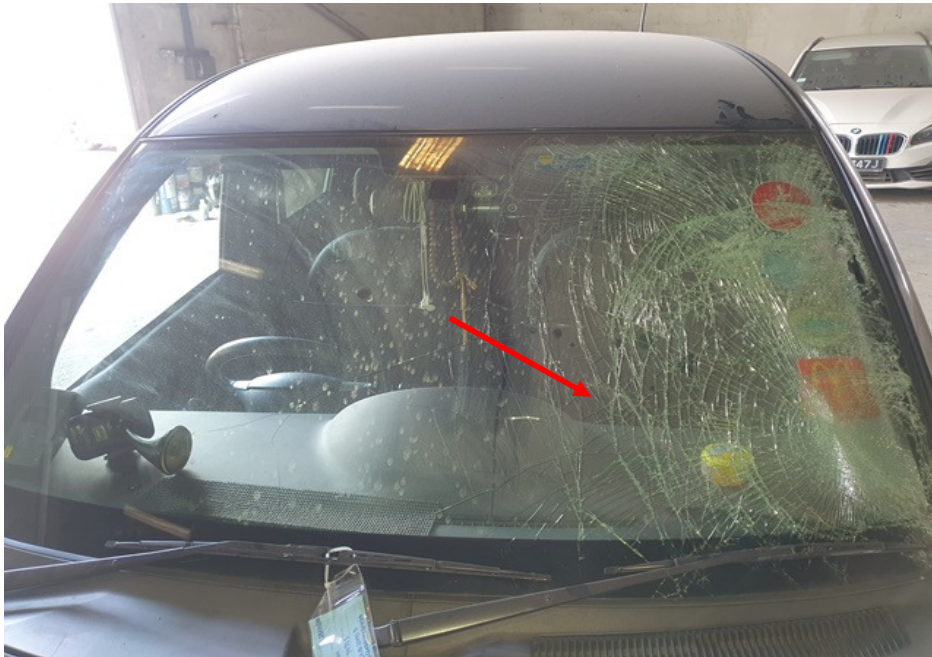
**Photo 6** shows a closer view of the shattered front windscreen (arrowed) of the Motor Car at the time of our inspection.

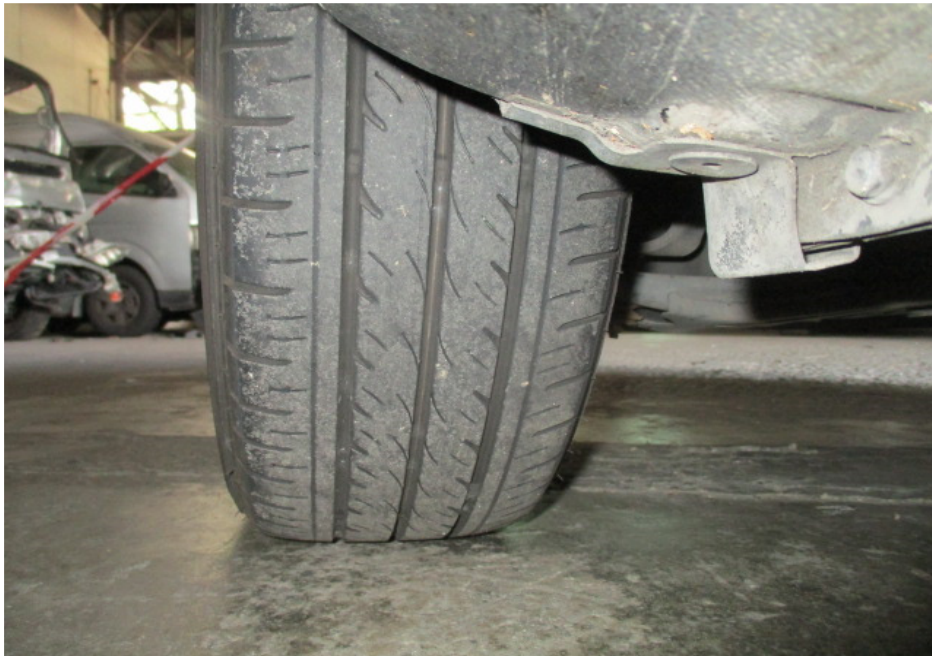
**Photo 7** shows the condition of the front left tyre of the Motor Car, which was observed to be in serviceable condition with remaining tread depth of approximately 5mm. The tyre, which was wrapped around alloy wheel rim, was also observed to be sufficiently inflated for vehicular operation. There was no tear, cut or burst mark(s) on the outer and the inner sidewalls as well as across the tread of the 4 tyres.

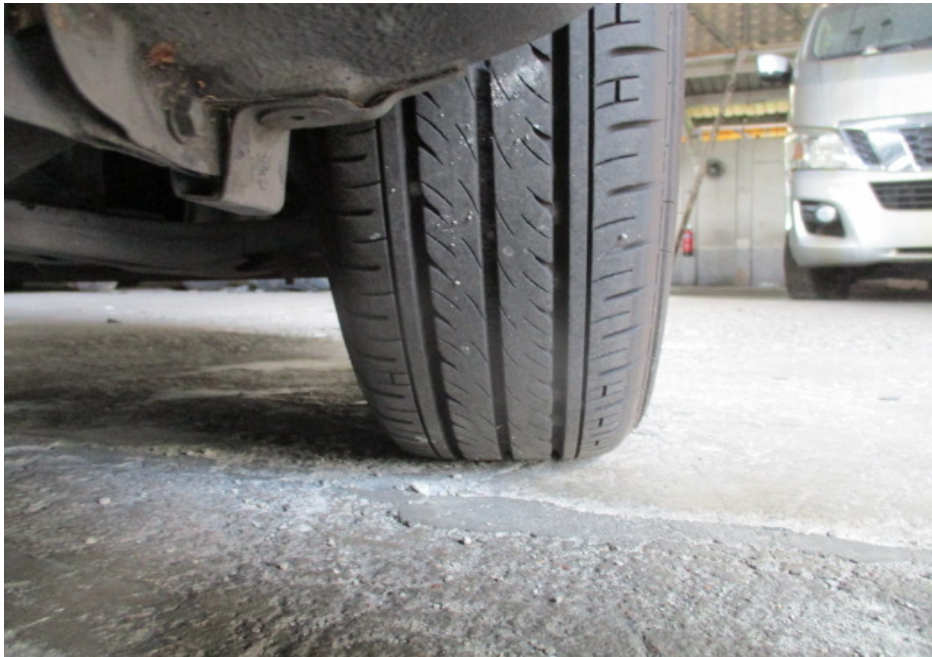
**Photo 8** shows the condition of the front right tyre of the Motor Car, which was observed to be in serviceable condition with remaining tread depth of approximately 7mm. The tyre, which was wrapped around alloy wheel rim, was also observed to be sufficiently inflated for vehicular operation.

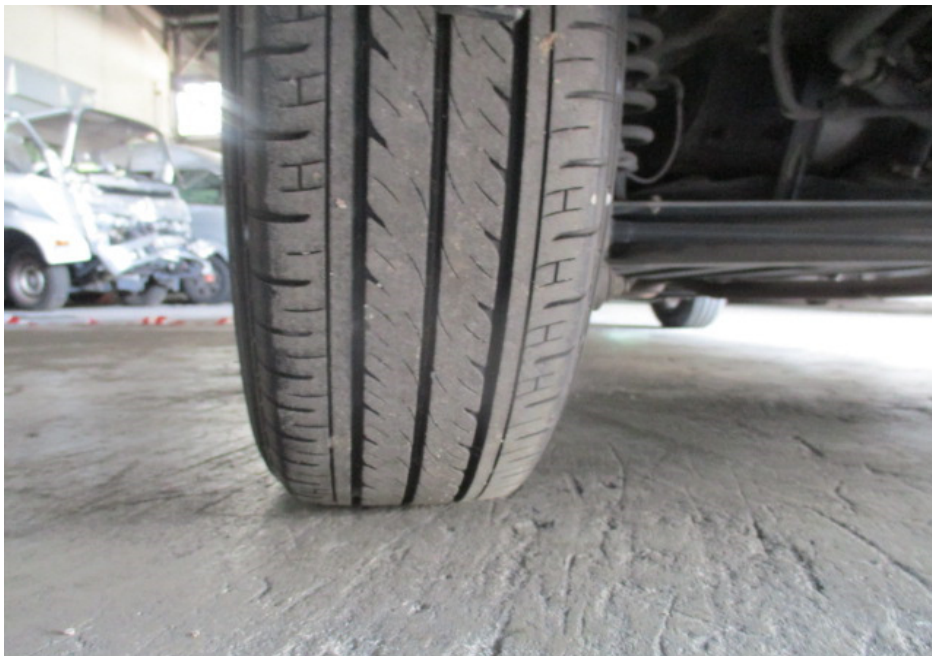
**Photo 9** shows the condition of the rear left tyre of the Motor Car, which was observed to be in serviceable condition with remaining tread depth of approximately 5mm. The tyre, which was wrapped around alloy wheel rim, was also observed to be sufficiently inflated for vehicular operation. There was also no damage found on the 4 wheel rims of the Motor Car.

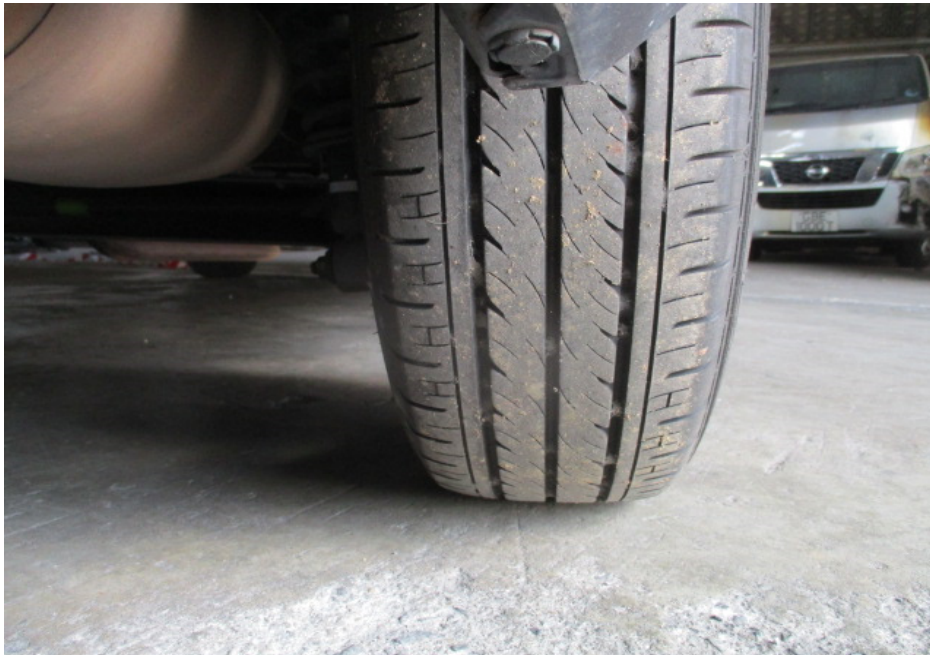
**Photo 10** shows the condition of the rear right tyre of the Motor Car, which was observed to be in serviceable condition with remaining tread depth of approximately 6mm. There was also no tear, cut or burst mark(s) on the outer and the inner sidewalls as well as across the tread of the 4 tyres.

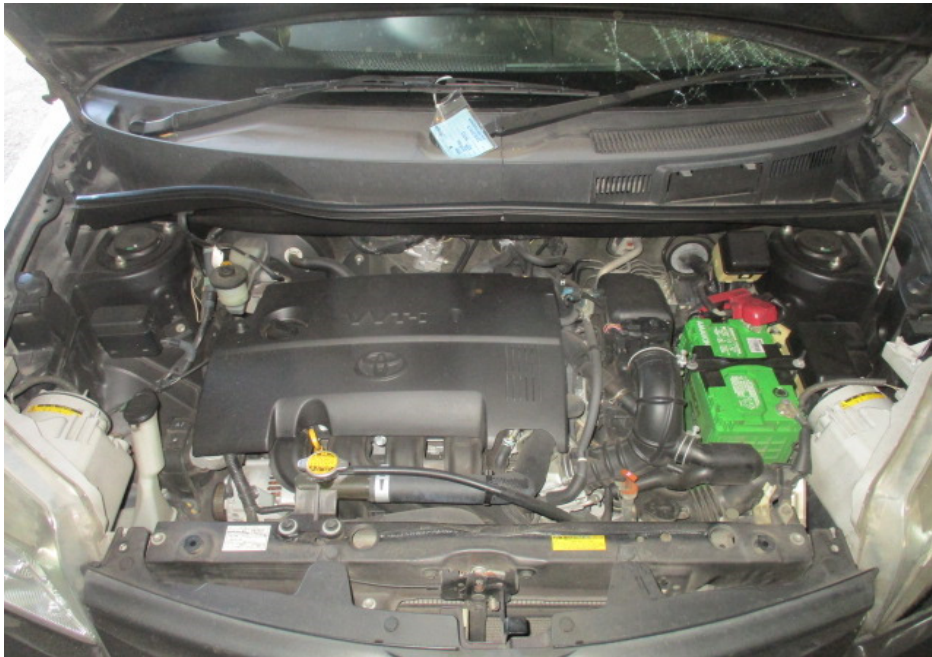
**Photo 11** shows a general view of the Motor Car's engine compartment. The various parts and components inside the engine compartment were unaffected by the accident. There was also no sign(s) or indication(s) of fluid leakage and/or fluid stain within the engine compartment.

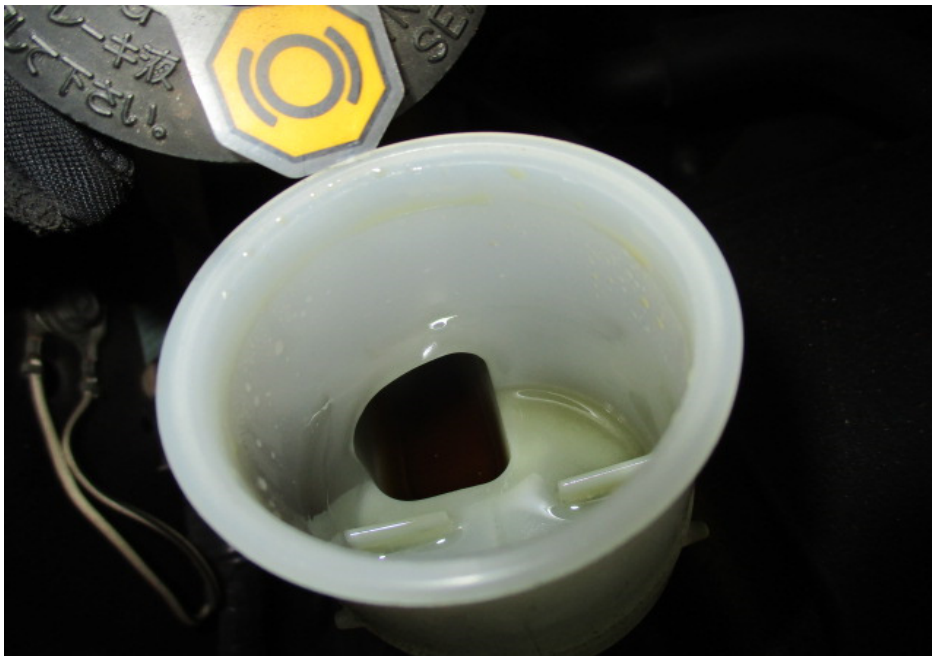
**Photo 12** shows the brake fluid reservoir of the Motor Car at the time of our inspection. The brake fluid was observed to be of sufficient level and without any visible contamination.

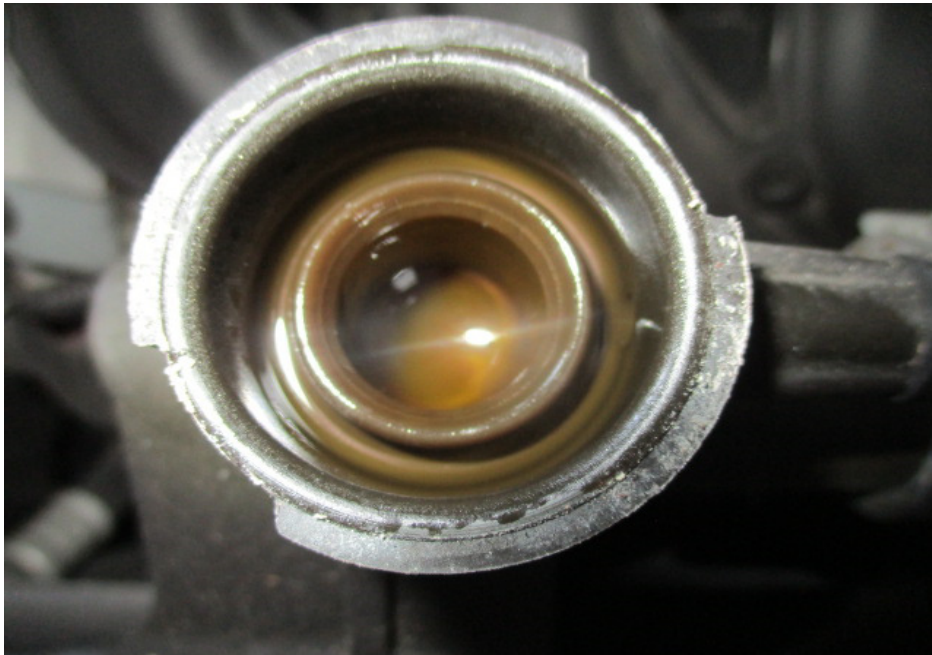
**Photo 13** shows checks being carried out to the engine coolant of the Motor Car at the time of our inspection. The engine coolant was observed to be of sufficient level and without any visible contamination.

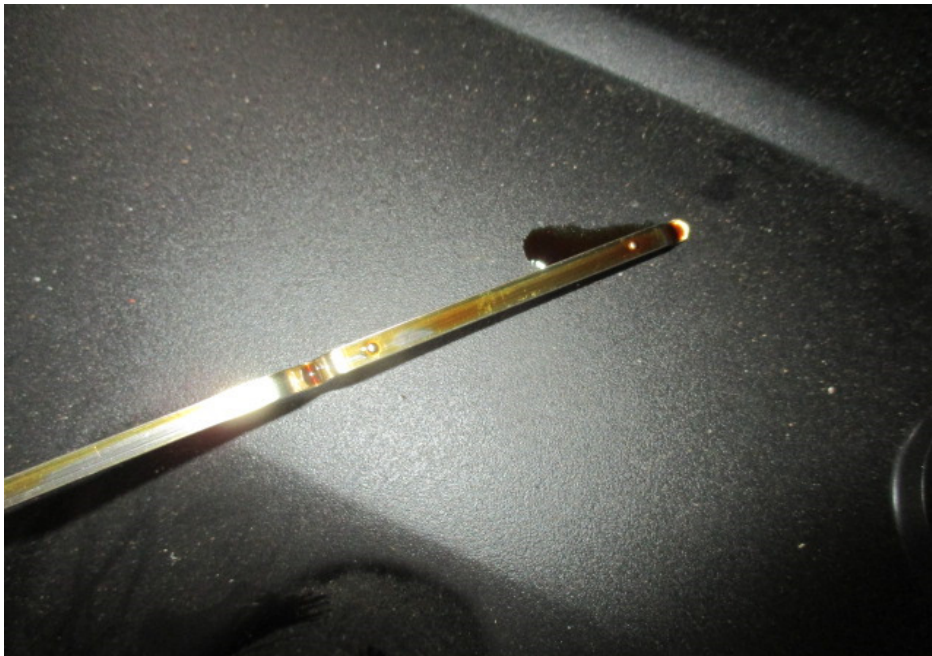
**Photo 14** shows the engine oil dip stick of the Motor Car at the time of our inspection. The engine oil was observed to be of sufficient level and without any visible contamination.

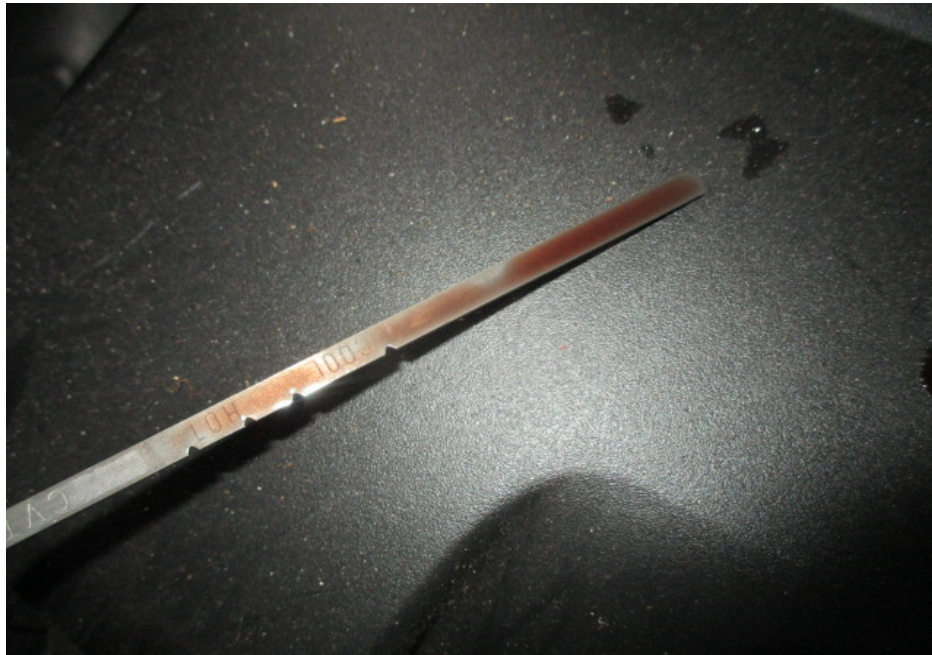
**Photo 15** shows the automatic transmission fluid (ATF) dip stick of the Motor Car at the time of our inspection. The ATF was observed to be of sufficient level and without any visible contamination.

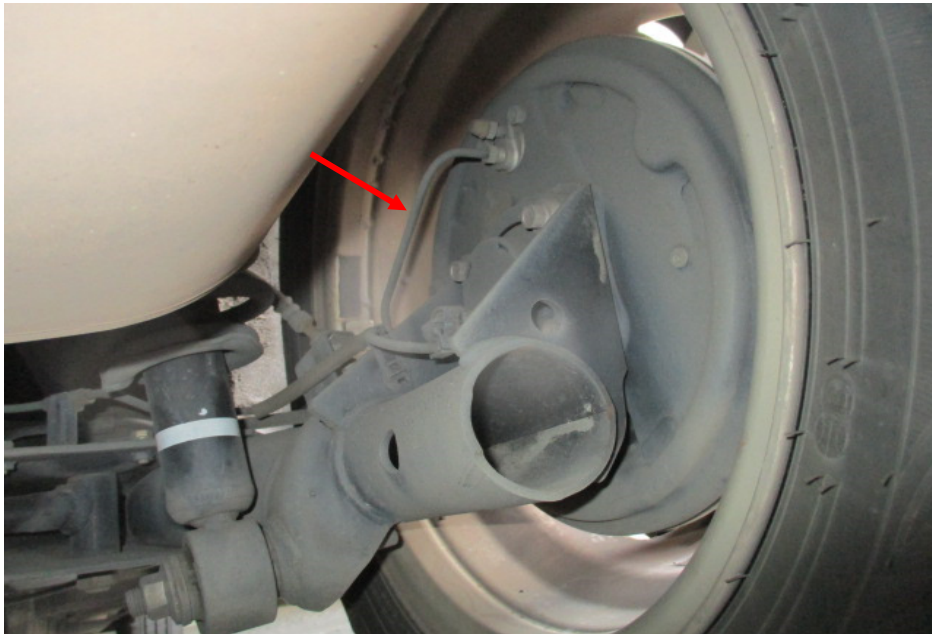
**Photo 16** shows the brake hose/pipe (arrowed) at the rear right wheel of the Motor Car. We did not observe any leakage of brake fluid at the time of our inspection of the Motor Car. Static tests of the Motor Car's braking system had indicated that there was no internal leakage of pressure/vacuum. Hence the braking system was likely to be in serviceable condition at the material time of accident. The undercarriage components of the Motor Car were also all found to be intact and without any visible damage.

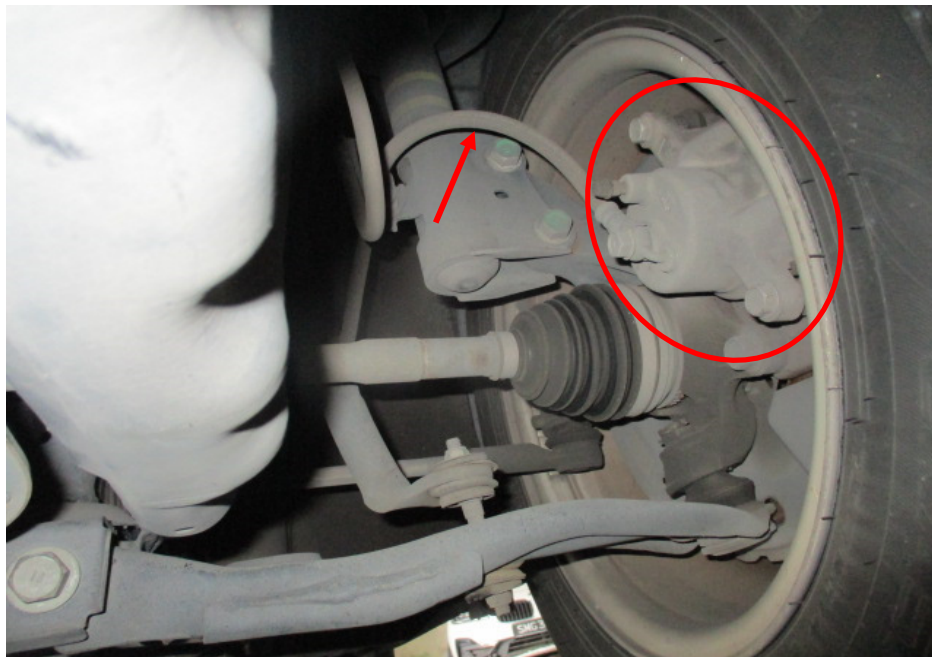
**Photo 17** shows the brake hose/pipe (arrowed) at the front left wheel of the Motor Car. No leakage of brake fluid was observed. Visual examination of the various components of the braking system like the brake caliper (circled), brake pedal etc. had revealed all to be intact and without visible damage.

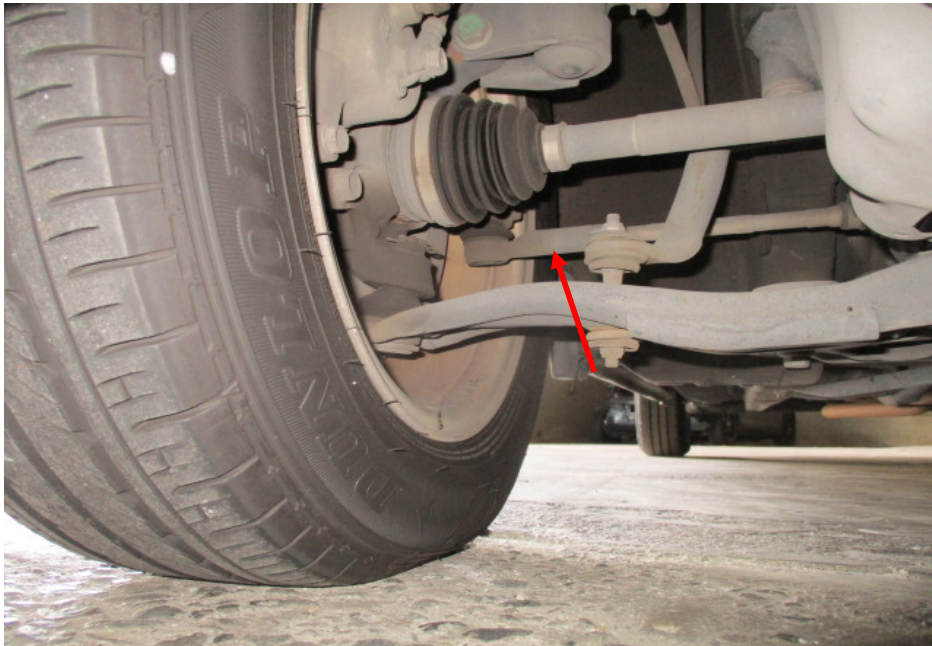
**Photo 18** shows the various undercarriage components at the front right wheel of the Motor Car, in particular the steering tie rod (arrowed). The various steering components were all found to be intact, suggesting that the steering system of the Motor Car was likely to be in serviceable condition at the material time of accident. There was also no sign of fluid stain observed on the various undercarriage components at the front right wheel of the Motor Car.

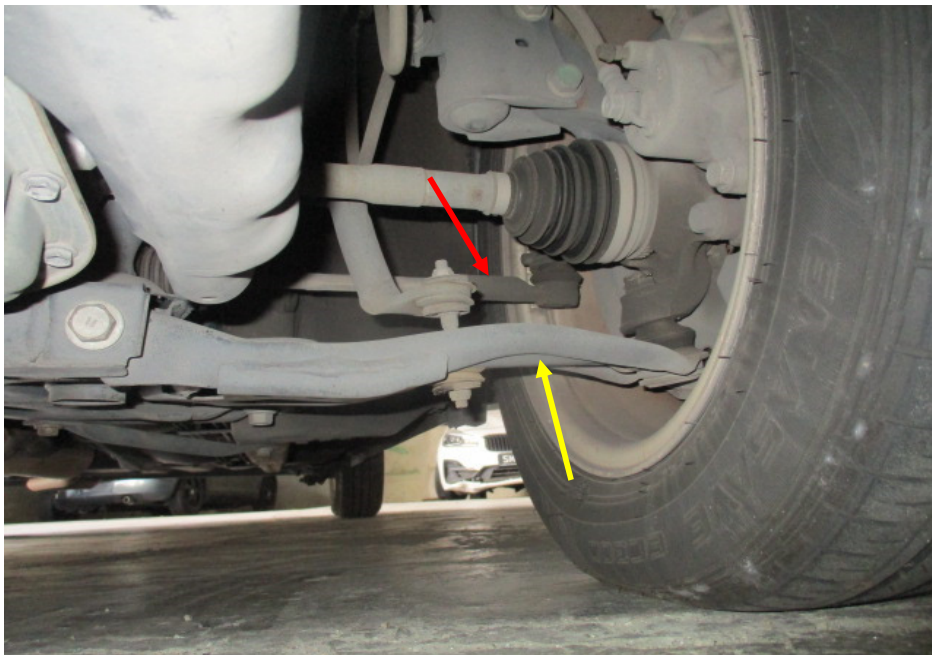
**Photo 19** shows the various undercarriage components at the front left wheel of the Motor Car, which had included the steering tie rod (red arrow) and left drive shaft (yellow arrow). The various undercarriage components of the Motor Car were all found to be intact without any visible damage.

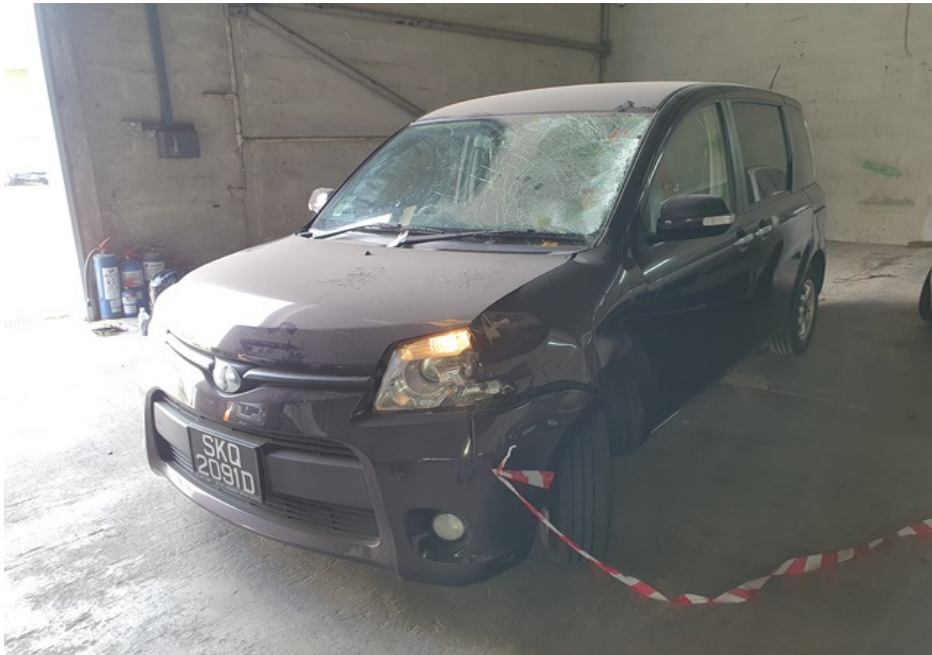
**Photo 20** shows the front left wheel of the Motor Car turned to its full left. During our steering system test, we did not experience any abnormal free play and/or resistance when we had turned the steering wheel towards the left and right. This would suggest that the steering system of the Motor Car was likely to be in serviceable condition at the material time of accident.

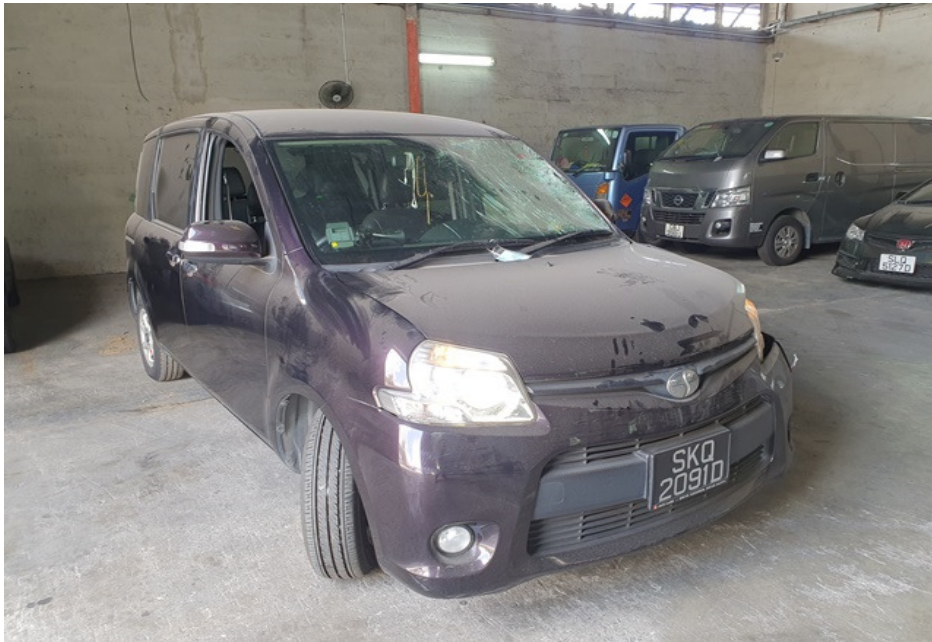
**Photo 21** shows the front right wheel of the Motor Car turned to its full right. During our steering system test, we did not experience any abnormal free play and/or resistance when we had turned the steering wheel towards the left and right. This would suggest that the steering system of the Motor Car was likely to be in serviceable condition at the material time of accident.

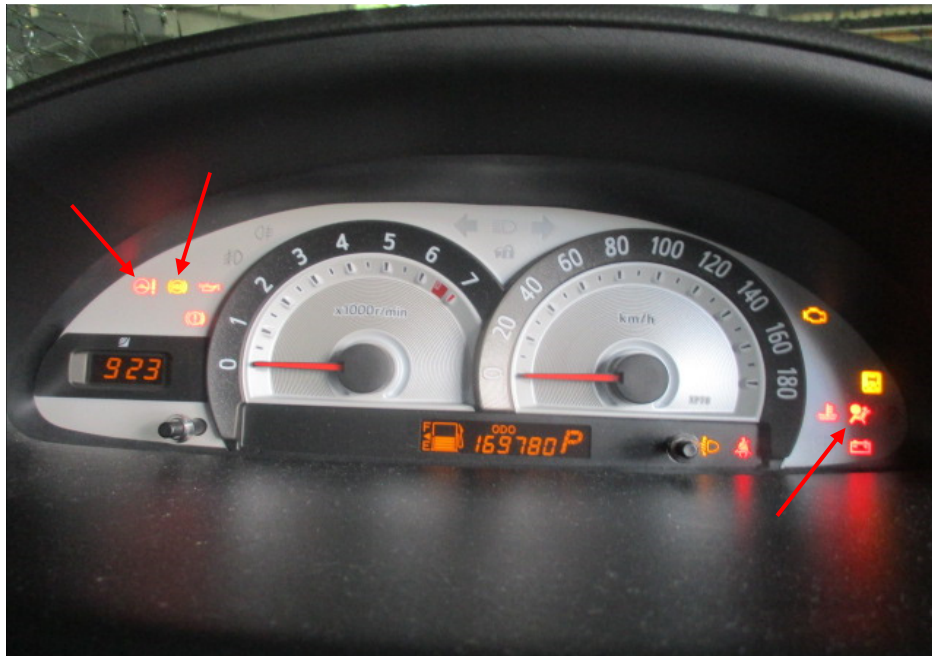
**Photo 22** shows the warning lights for the various electronic operating systems of the Motor Car appearing on its instrument panel during the self-test when the engine is cranked, in particular the ABS light, EPS light and SRS light (arrowed).

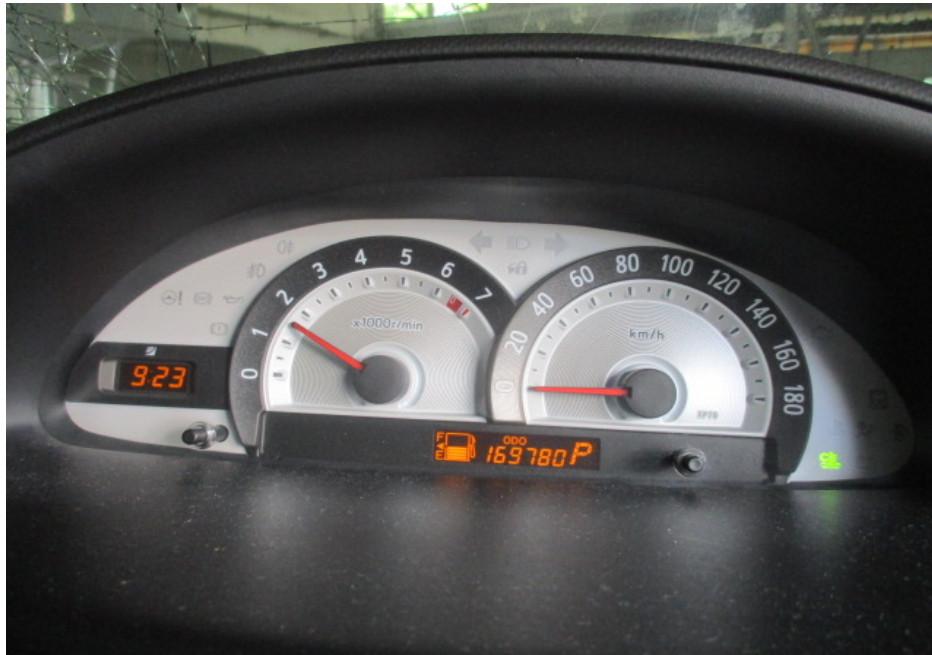
**Photo 23** shows no warning lights illuminated on the instrument panel of the Motor Car after the engine was cranked. This would suggest that there was no abnormality to the various electronic operating systems of the Motor Car, like the ABS, EPS and SRS etc.
