Your Ref: TP/IP/50607/2020
Our Ref : CI/TPD20014314/P

22nd December 2020

MECHANICAL INSPECTION REPORT OF MOTOR TRAILER JRF 4239

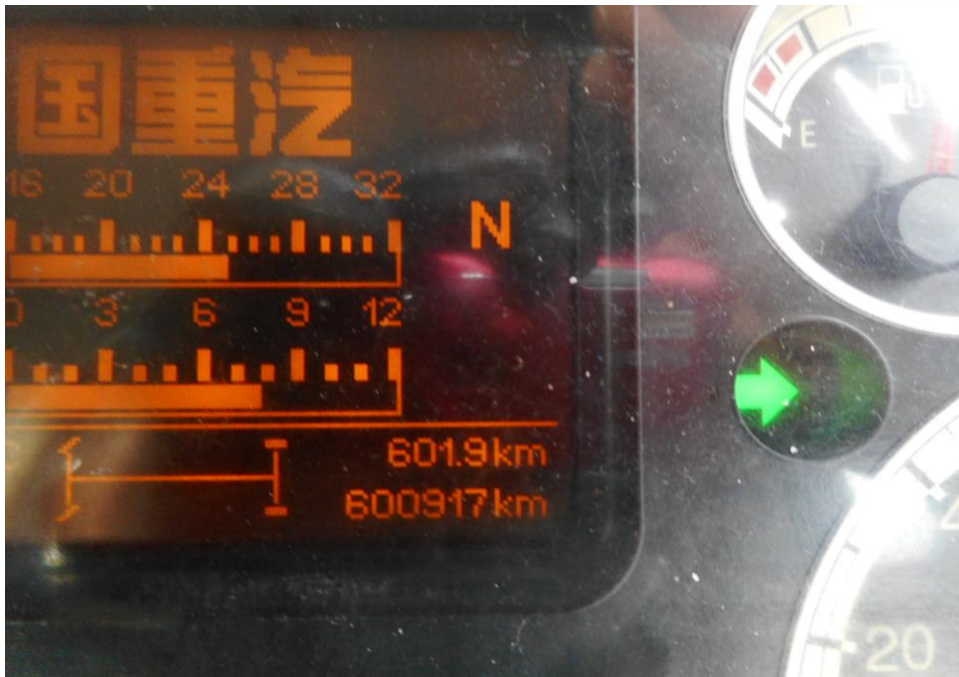
4. The mileage of the Motor Trailer at the time of my inspection was 600,917km.
5. There was no visible damage observed on Motor Trailer at the time of my inspection.

Photo 1 shows a general view of the instrument cluster of the Motor Trailer at the time of my inspection. The mileage of the Motor Trailer was 600,917km

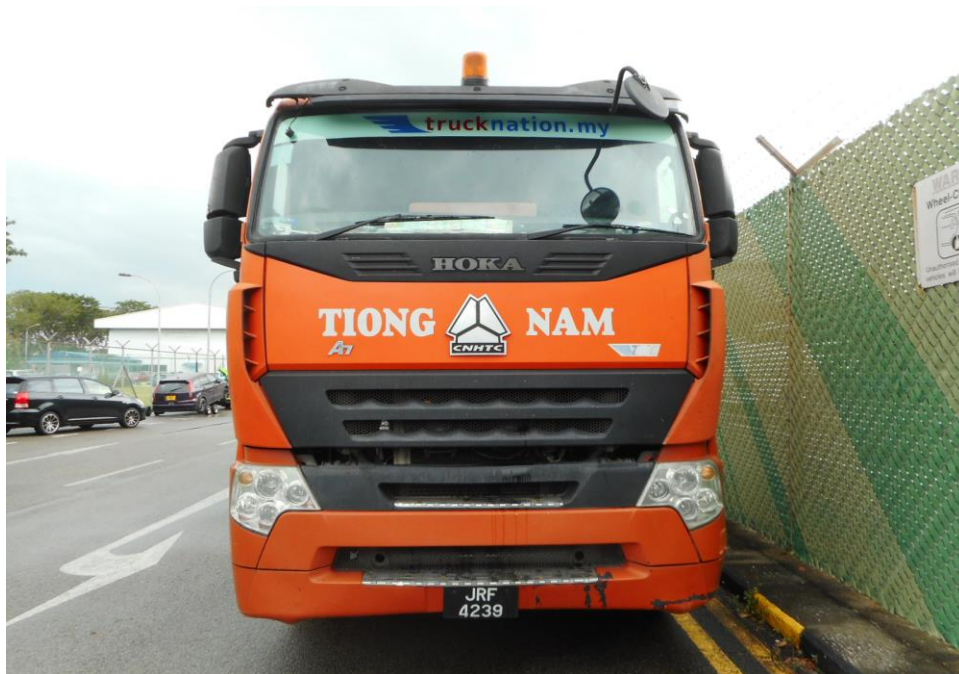
Photo 2 shows a general view of the front body of the Motor Trailer at the time of my inspection. The Motor Trailer was observed to be intact and unaffected by the accident.

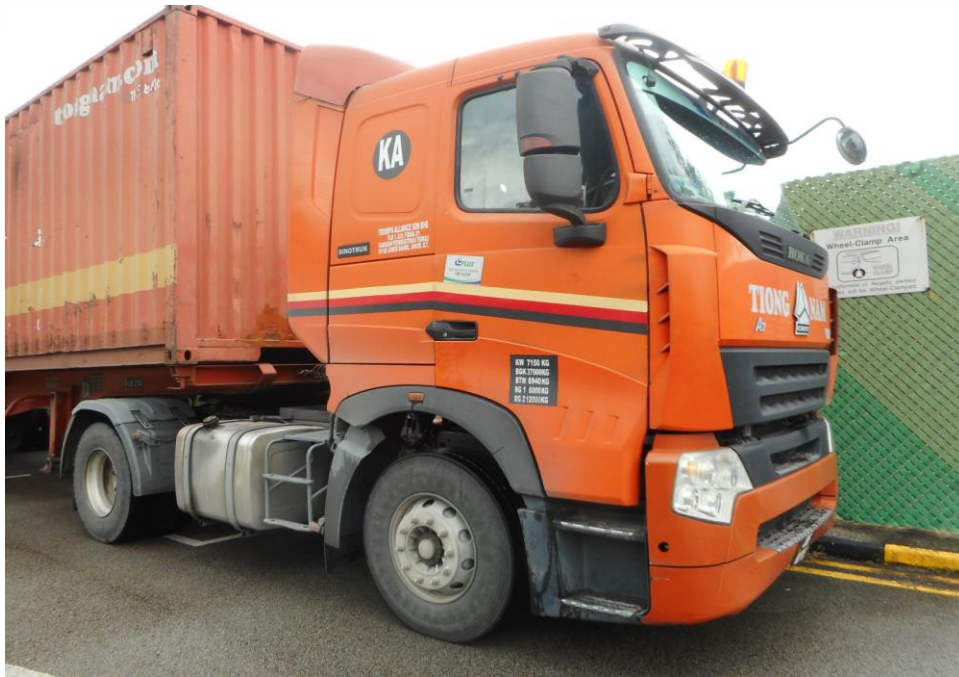
Photo 3 shows a general view of the front right body of the Motor Trailer at the time of my inspection. The Motor Trailer was observed to be intact and unaffected by the accident.

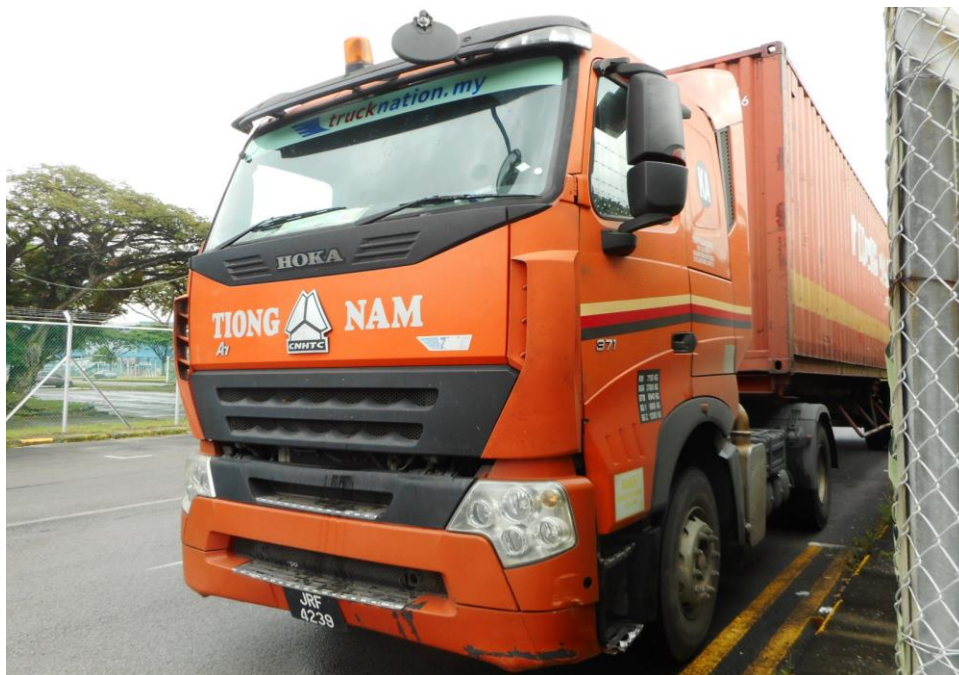
Photo 4 shows a general view of the front left body of the Motor Trailer at the time of my inspection. The Motor Trailer was observed to be intact and unaffected by the accident.

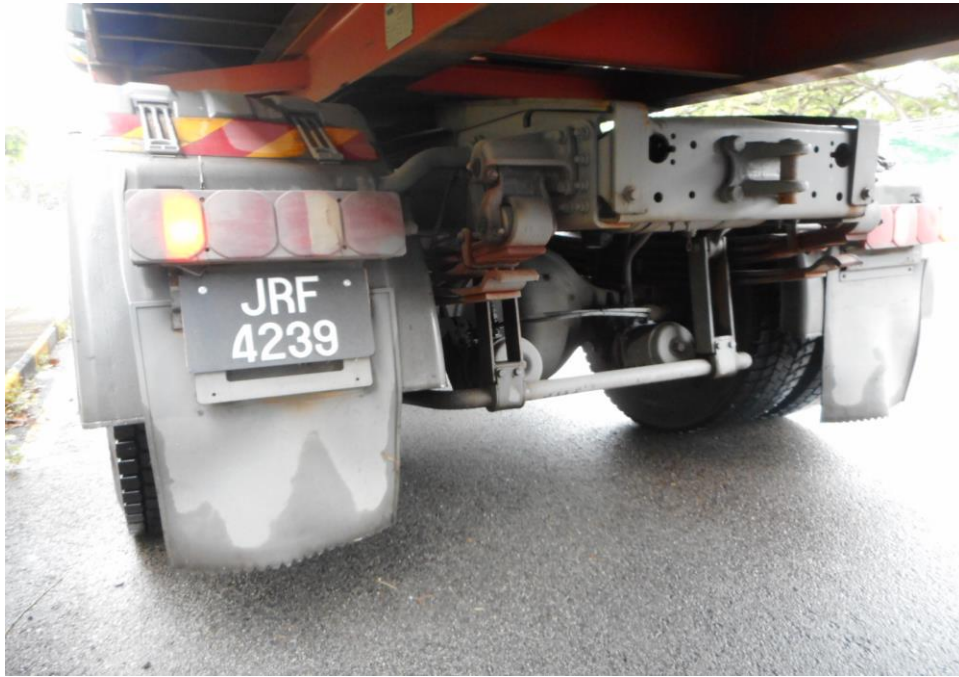
Photo 5 shows a general view of the Motor Trailer's rear body at the time of my inspection. The Motor Trailer was observed to be intact and unaffected by the accident.

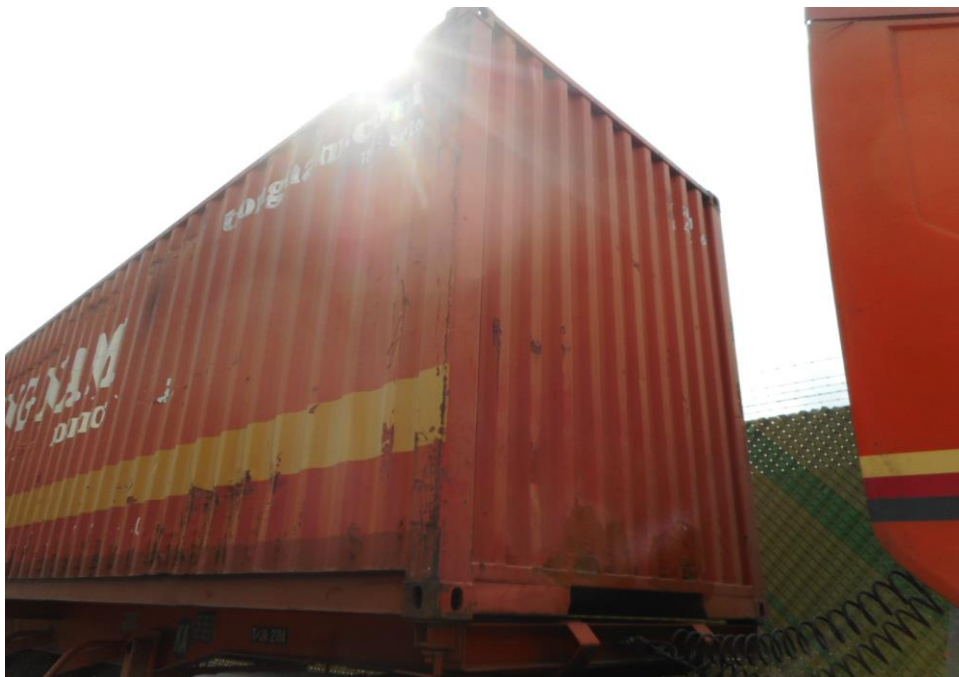
Photo 6 shows a general view of the front body of the trailer at the time of my inspection. The Motor Trailer was observed to be intact and unaffected by the accident.

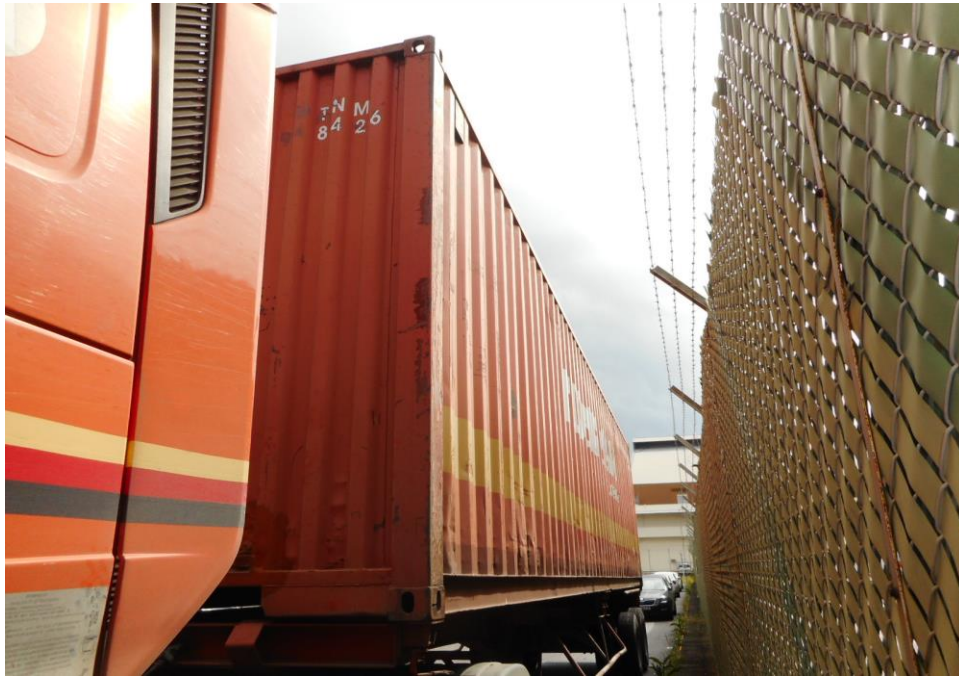
Photo 7 shows a general view of the trailer's left body at the time of my inspection. The Motor Trailer was observed to be intact and unaffected by the accident.

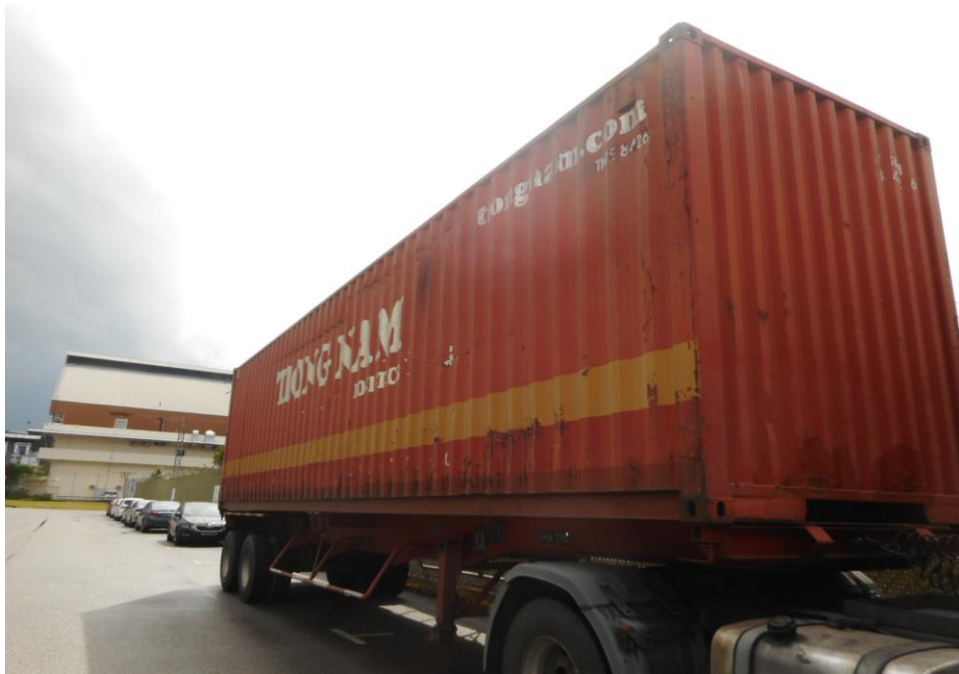
Photo 8 shows a general view of the trailer's right body at the time of my inspection. The Motor Trailer was observed to be intact and unaffected by the accident.

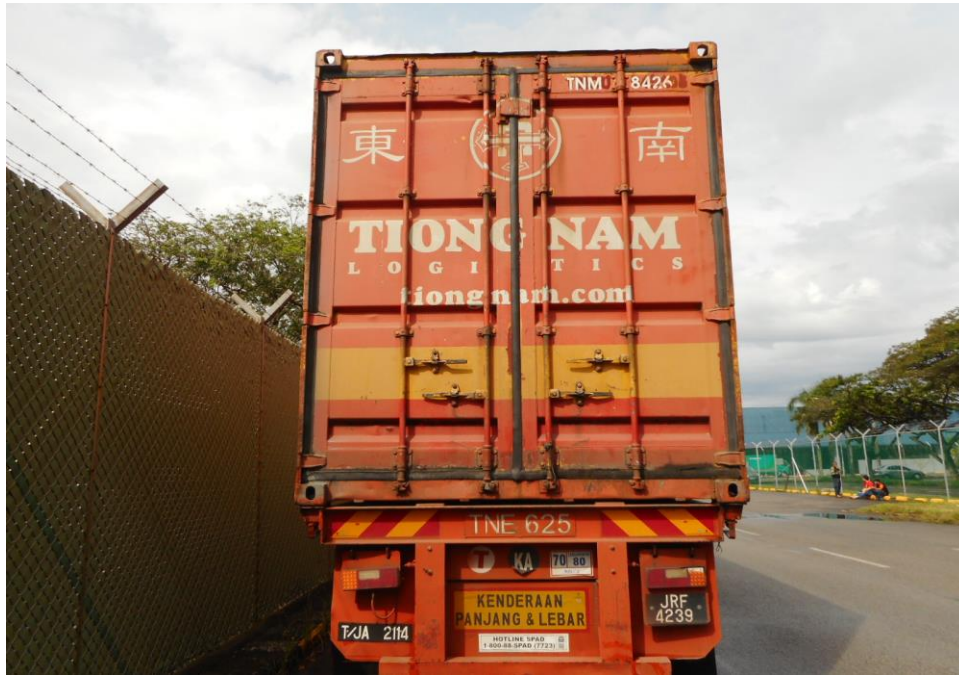
Photo 9 shows a general view of the trailer's rear body at the time of my inspection. The Motor Trailer was observed to be intact.

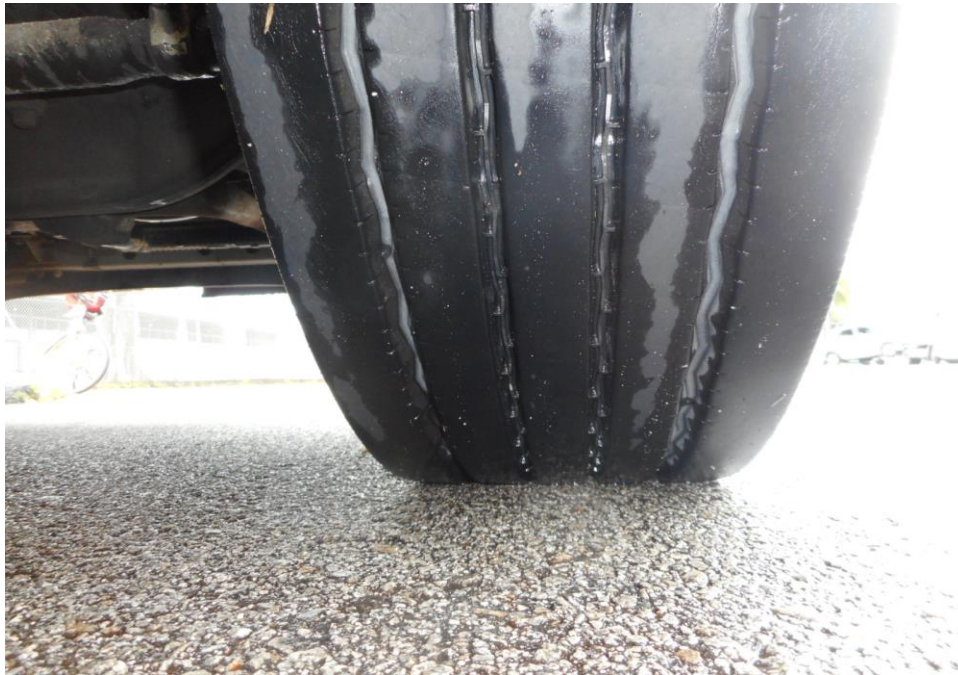
Photo 10 shows the condition of the front right tyre of the Motor Trailer, which was observed to be in serviceable condition with remaining tread depth of approximately 12.6 mm. The tyre, which was wrapped around standard steel wheel rim, was also observed to be sufficiently inflated for vehicular operation. There was no tear, cut or burst mark(s) on the outer and the inner sidewalls as well as across the tread of the 6 tyres that were fitted on the Motor Trailer.

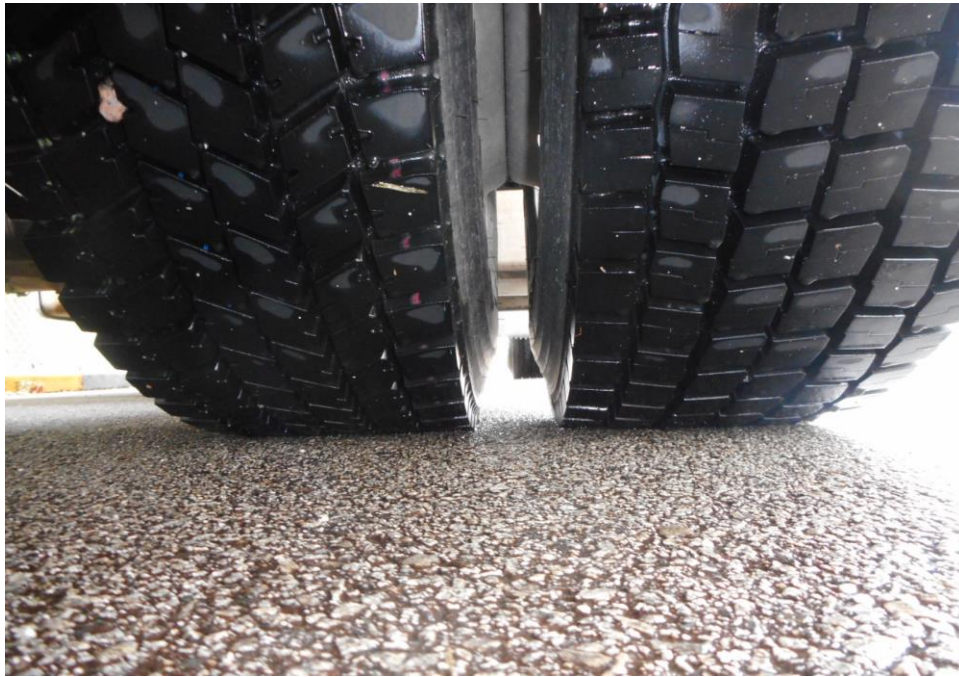
Photo 11 shows the condition of the rear right tyre of the Motor Trailer, which was observed to be in serviceable condition with remaining tread depth of approximately 14.4mm. The tyre, which was wrapped around standard steel wheel rim, was also observed to be sufficiently inflated for vehicular operation.

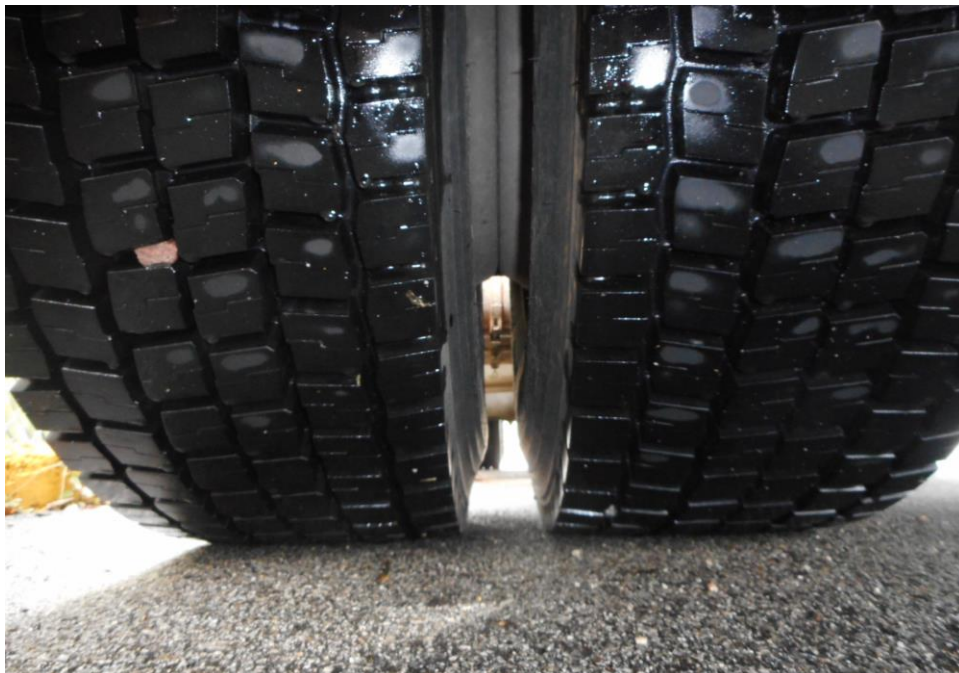
Photo 12 shows the condition of the rear left tyres of the Motor Trailer, which was observed to be in serviceable condition with remaining tread depth of approximately 14.7mm. The tyres, which were wrapped around standard steel wheel rim, were also observed to be sufficiently inflated for vehicular operation. There was also no damage found on all 6 steel wheel rims of the Motor Trailer.

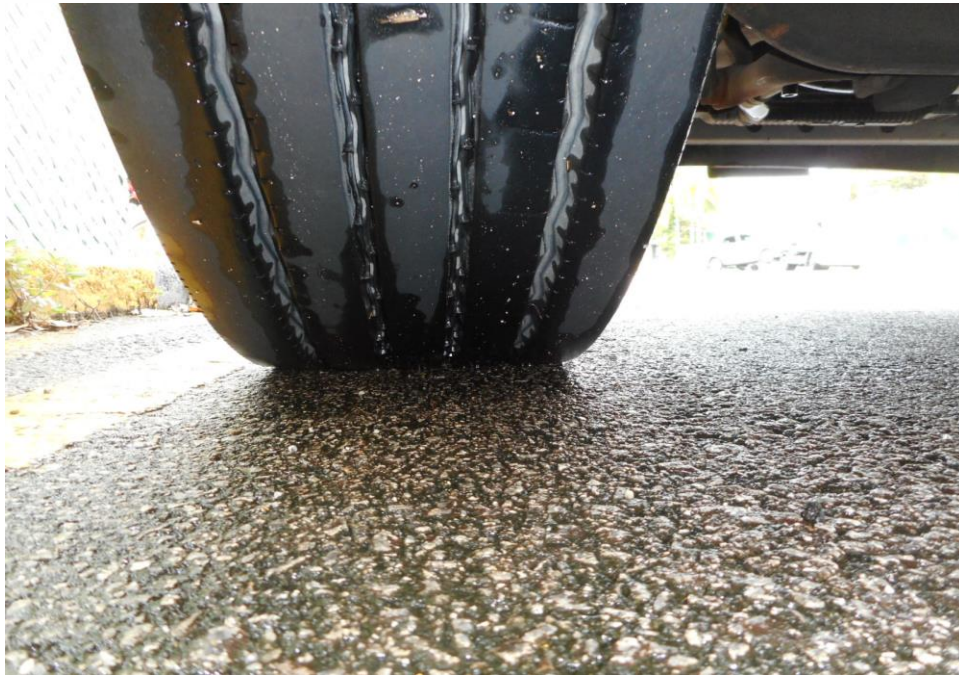
Photo 13 shows the condition of the front left tyres of the Motor Trailer, which were observed to be in serviceable condition with remaining tread depth of approximately 12.4mm. There was also no tear, cut or burst mark(s) on the outer and the inner sidewalls as well as across the tread of the 6 tyres that were fitted on the Motor Trailer.

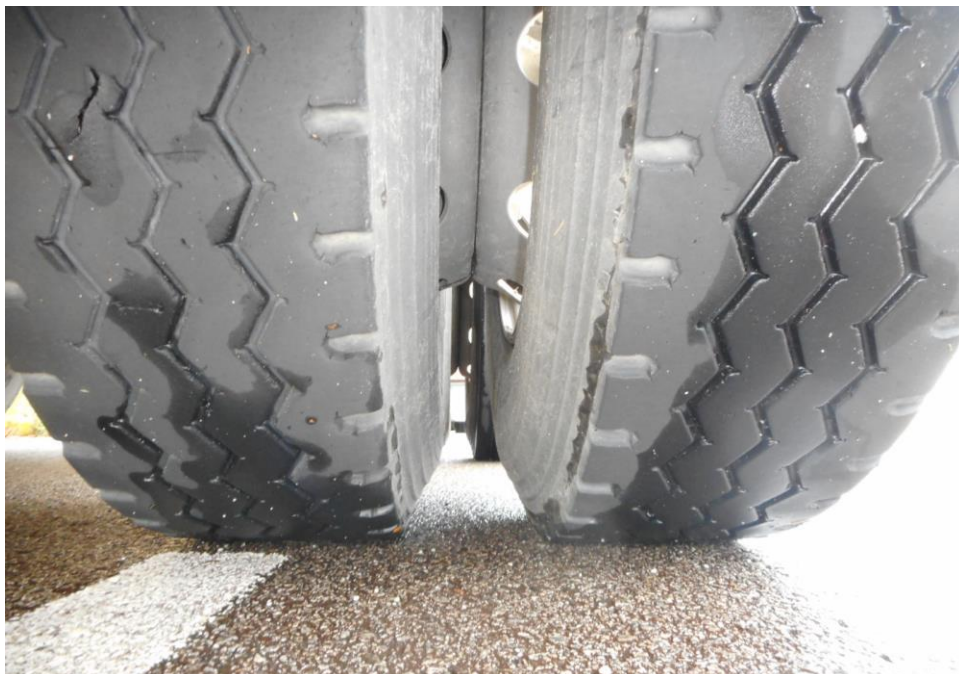
Photo 14 shows the condition of the right tyres of the trailer, which was observed to be in serviceable condition with remaining, tread depth of approximately 5.9mm. The tyre, which was wrapped around standard steel wheel rim, was also observed to be sufficiently inflated for vehicular operation.

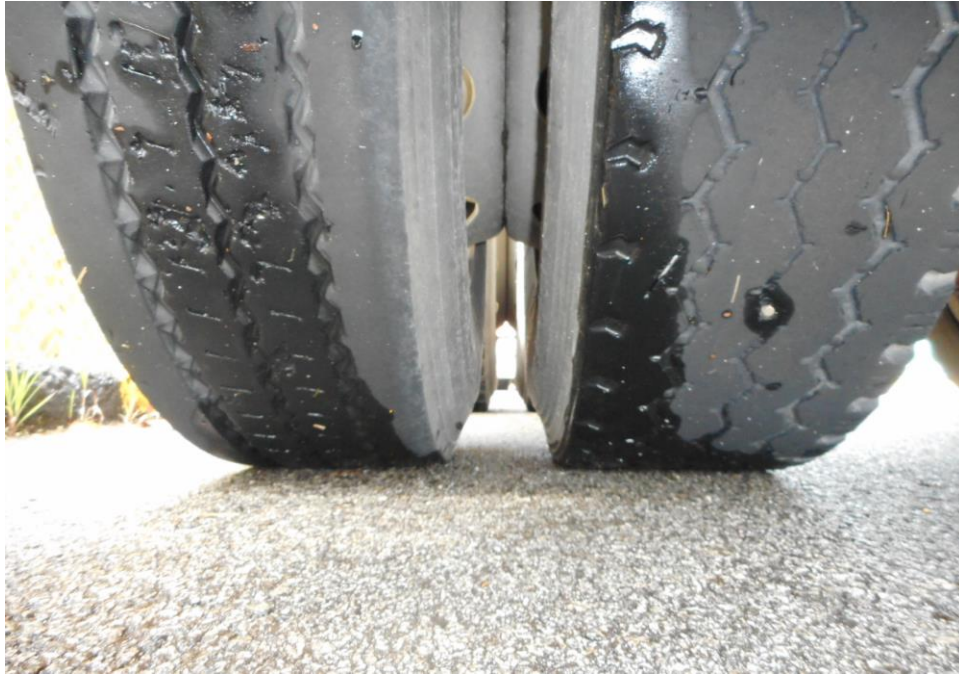
Photo 15 shows the condition of the left tyres of the trailer, which was observed to be in serviceable condition with remaining tread depth of approximately 6mm. The tyres, which were wrapped around standard steel wheel rim, were also observed to be sufficiently inflated for vehicular operation. There was also no damage found on all 6 steel wheel rims of the Motor Trailer.

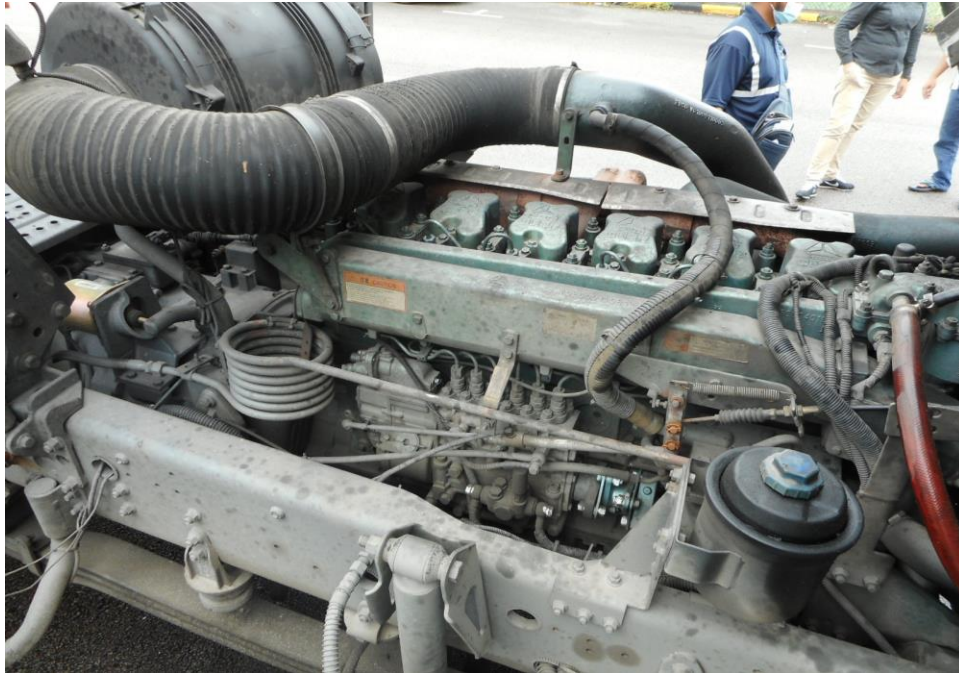
Photo 16 shows a general view of the Motor Trailer's engine compartment, which was accessed by lifting the front cabin of the Motor Trailer. The various parts and components inside the engine compartment were unaffected by the accident. There was also no sign(s) or indication(s) of fresh fluid leakage and/or fluid stain within the engine compartment

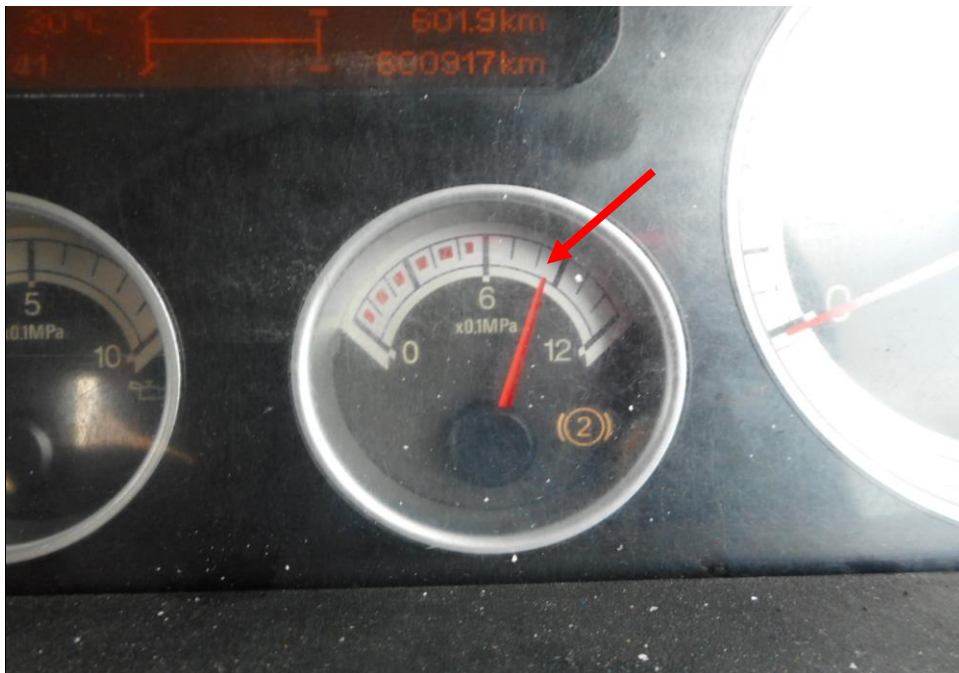
Photo 17 shows the air in the air brake cylinders of the Motor Trailer at the time of my inspection. The air in the cylinder was observed to be of sufficient level & serviceable at the time of the accident.

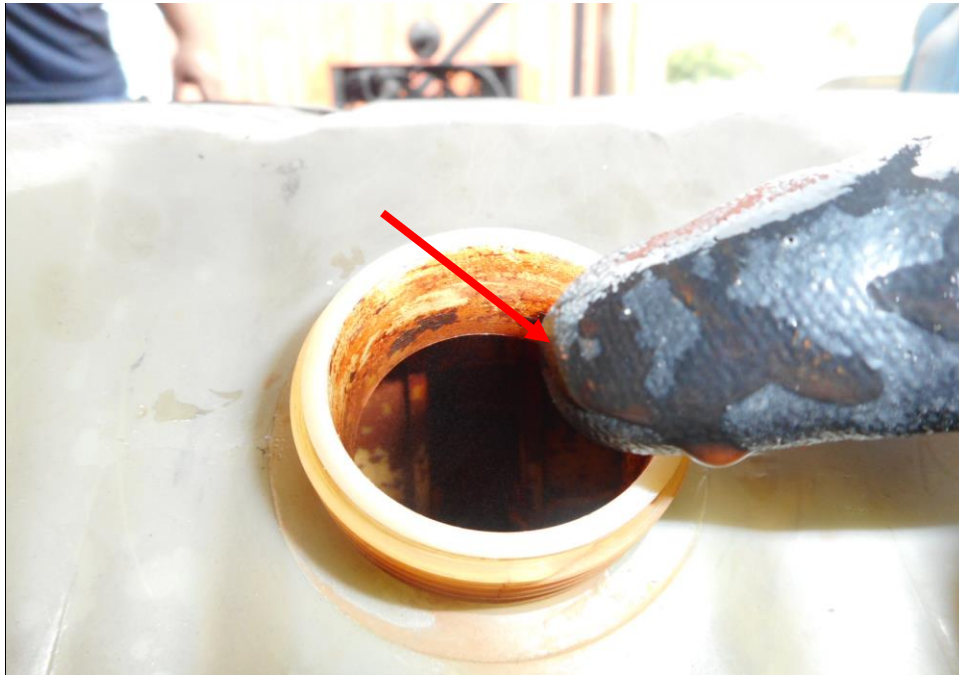
Photo 18 shows the engine coolant reservoir of the Motor Trailer at the time of my inspection. The engine coolant was observed to be of sufficient level (arrowed) and without any visible contamination.

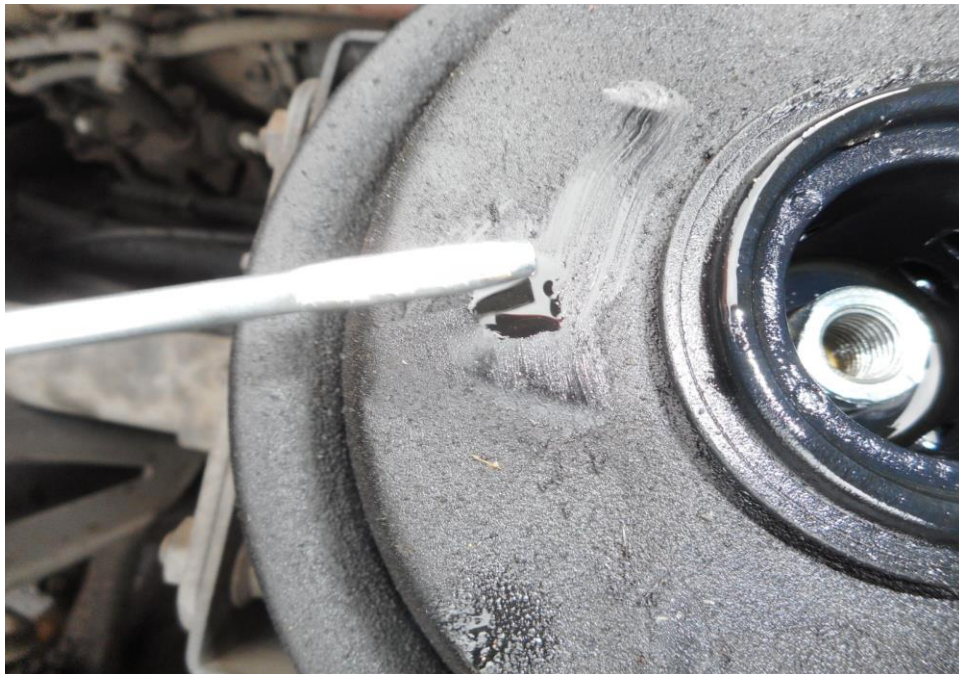
Photo 19 shows the power steering fluid reservoir of the Motor Trailer at the time of my inspection. The power steering fluid was observed to be of sufficient level and without any visible contamination.

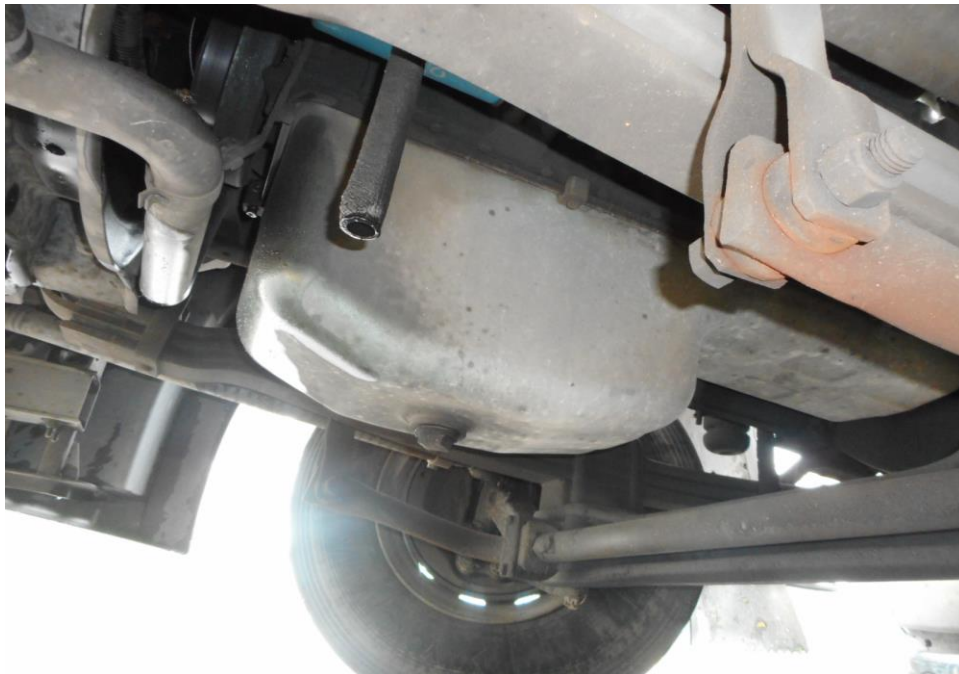
Photo 21 shows the undercarriage of the Motor Trailer, at the area where the engine housing located. I did not find any sign(s) or indication(s) of fluid leak, however old fluid stain(s) was observed on the underside of the Motor Trailer.

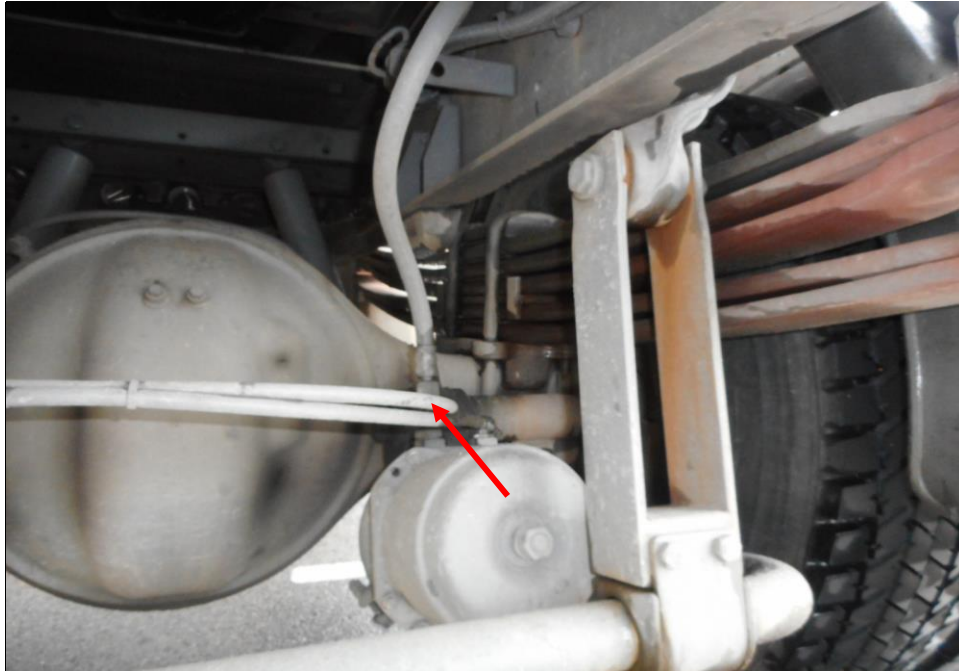
Photo 22 shows the brake pipe (arrowed) at the rear right wheel of the Motor Trailer. I did not observe any leakage of brake fluid at the time of my inspection of the Motor Trailer. My static tests of the Motor Trailer's braking system, along with my visual examination of the various mechanical components in the braking system, had indicated that there was no internal leakage of pressure/vacuum. Hence the braking system of the Motor Trailer was likely to be in serviceable condition at the material time of accident.

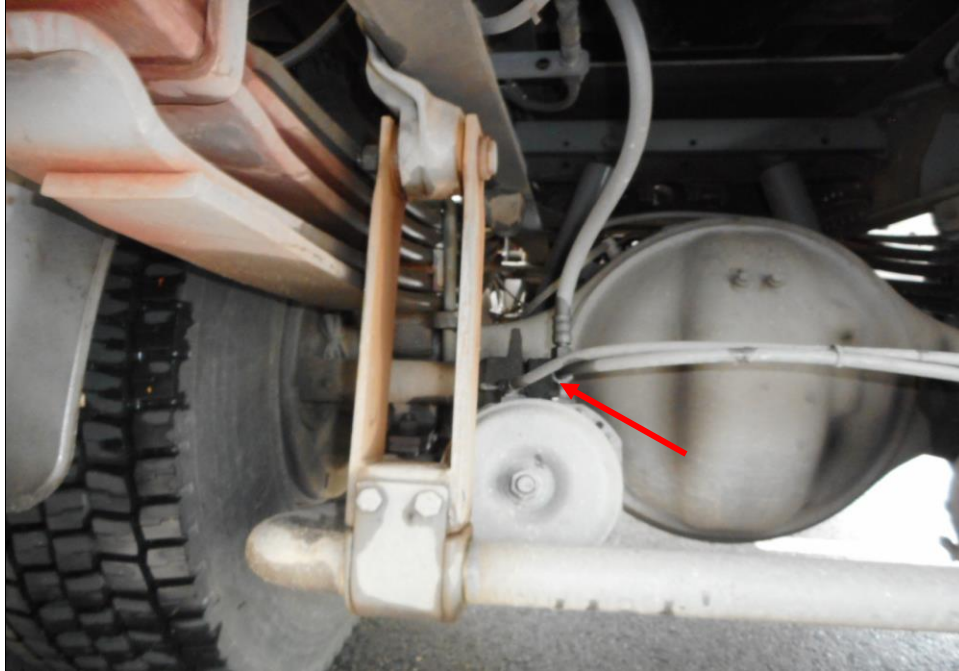
Photo 23 shows the brake pipe (arrowed) at the rear left wheel of the Motor Trailer. I did not observe any leakage of brake fluid at the time of my inspection of the Motor Trailer. My static tests of the Motor Trailer's braking system, along with my visual examination of the various mechanical components in the braking system, had indicated that there was no internal leakage of pressure/vacuum. Hence the braking system of the Motor Trailer was likely to be in serviceable condition at the material time of accident.

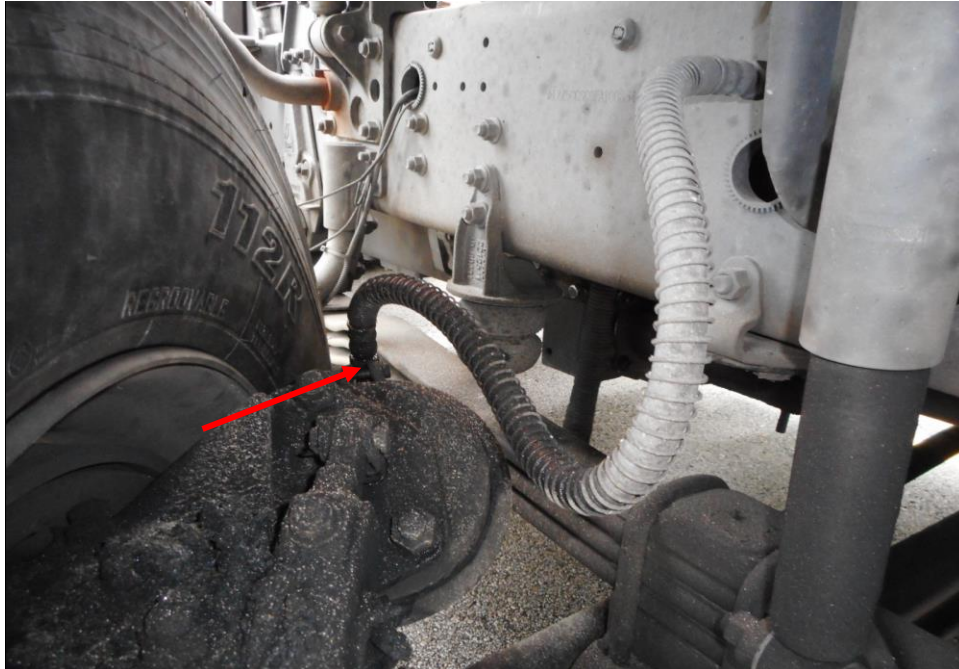
Photo 24 shows the brake pipe (arrowed) at the front right wheel of the Motor Trailer. I did not observe any leakage of brake fluid at the time of my inspection of the Motor Trailer. My static tests of the Motor Trailer's braking system, along with my visual examination of the various mechanical components in the braking system, had indicated that there was no internal leakage of pressure/vacuum. Hence the braking system of the Motor Trailer was likely to be in serviceable condition at the material time of accident.

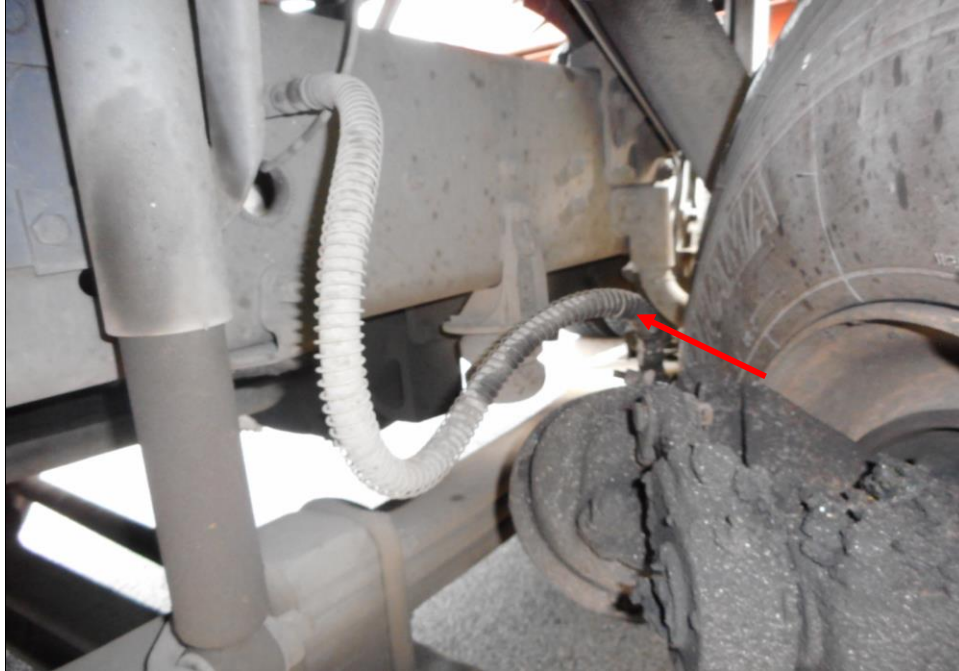
Photo 25 shows the brake pipe (arrowed) at the front left wheel of the Motor Trailer. I did not observe any leakage of brake fluid at the time of my inspection of the Motor Trailer. My static tests of the Motor Trailer's braking system, along with my visual examination of the various mechanical components in the braking system had indicated that there was no internal leakage of pressure/vacuum. Hence the braking system of the Motor Trailer was likely to be in serviceable condition at the material time of accident.

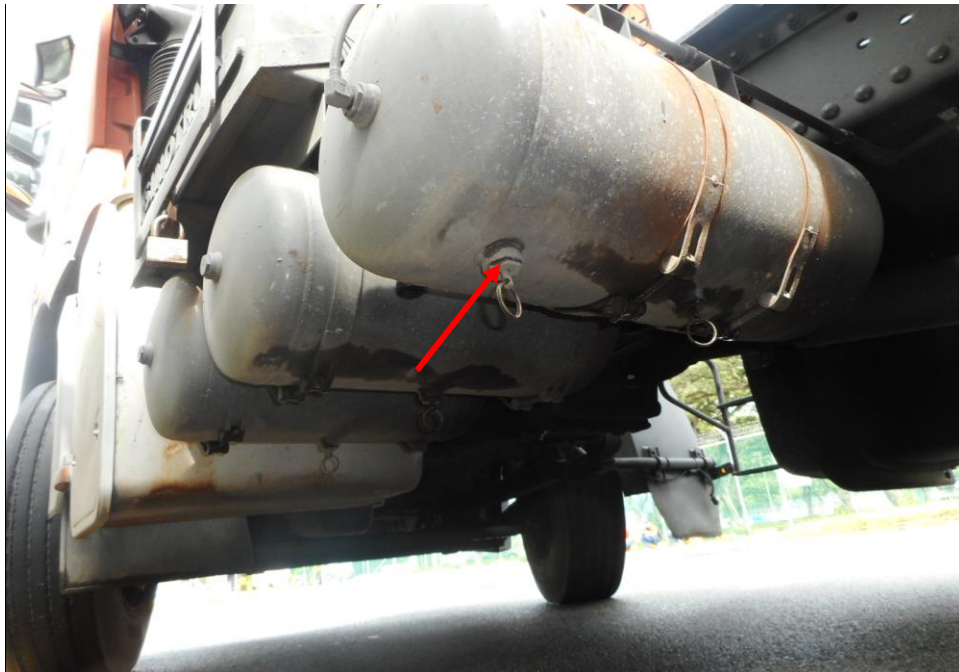
Photo 26 shows the air brake cylinders (arrowed) at the undercarriage of the Motor Trailer. I did not observe any leakage of air brake fluid at the time of my inspection of the Motor Trailer. My static tests of the Motor Trailer's braking system, along with my visual examination of the various mechanical components in the braking system had indicated that there was no internal leakage of pressure/vacuum. Hence the braking system of the Motor Trailer was likely to be in serviceable condition at the material time of accident.

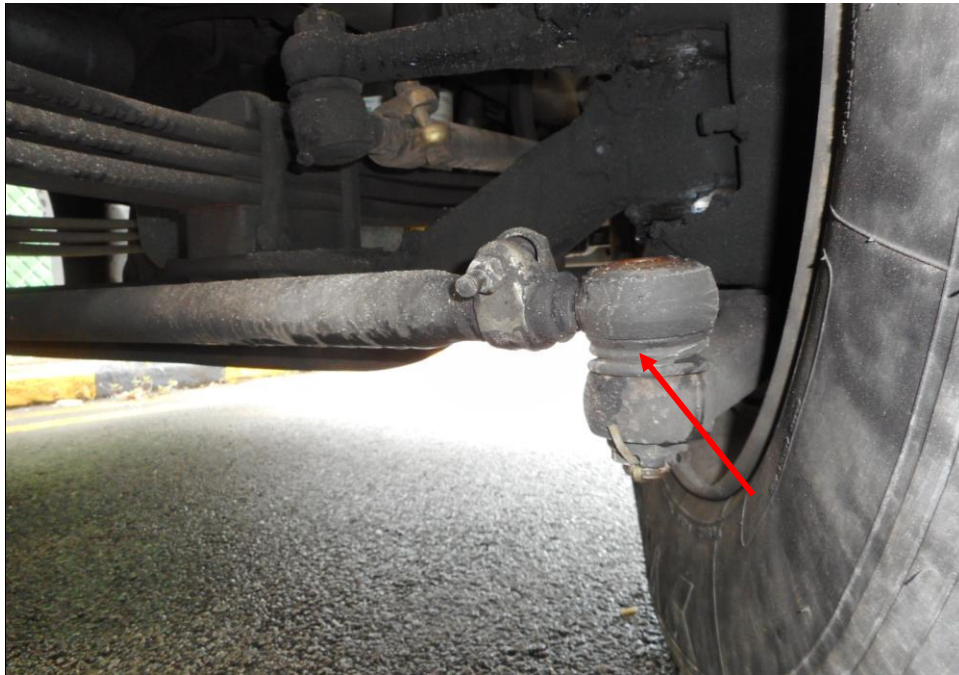
Photo 27 shows the various undercarriage components at the front right wheel of the Motor Trailer, in particular the steering tie rod end (arrowed). The various steering components were all found to be intact, suggesting that the steering system of the Motor Trailer was likely to be in serviceable condition at the material time of accident. There was also no sign of fluid stain(s) observed on the various undercarriage components.

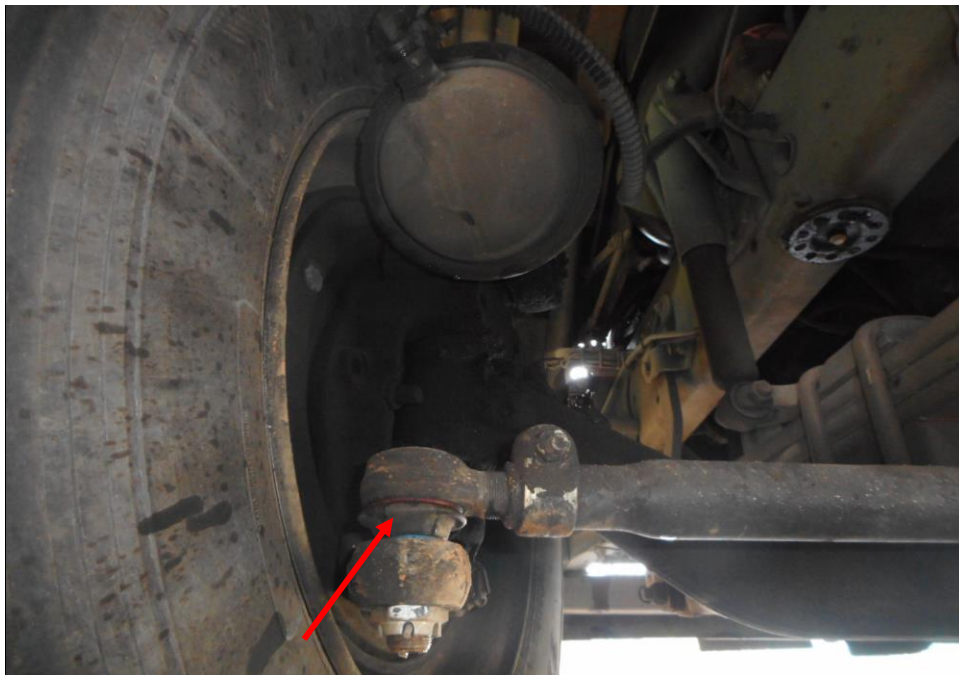
Photo 28 shows the various undercarriage components at the front left wheel of the Motor Trailer, in particular the steering tie rod end (arrowed). The various undercarriage components of the Motor Trailer were all found to be intact without any visible damage. There was also no sign of fluid stain(s) observed on the various undercarriage components.

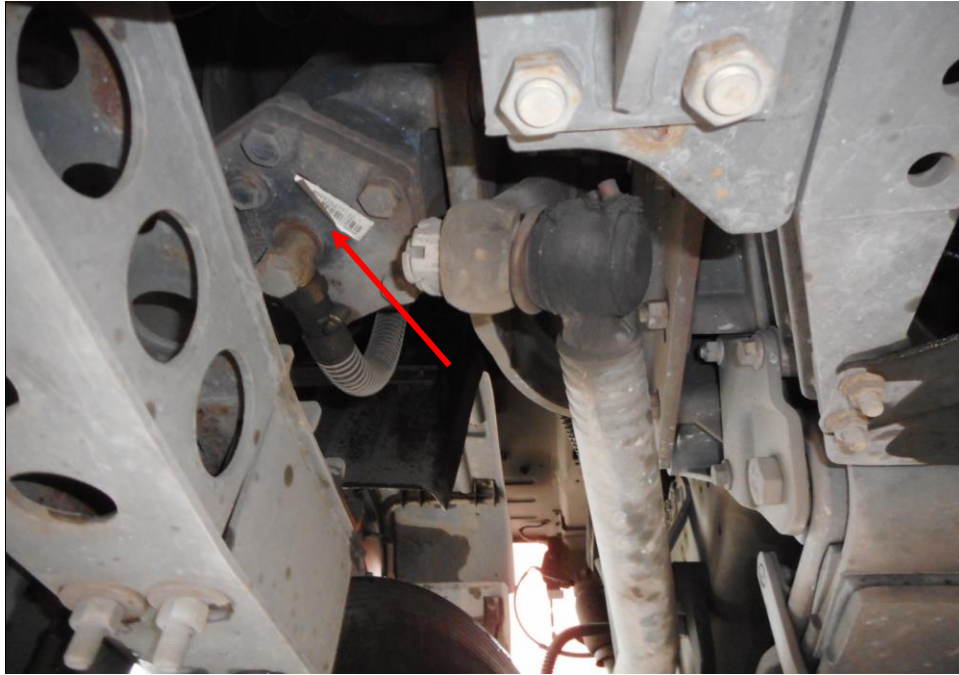
Photo 29 shows the steering box component (arrowed) at the undercarriage of the Motor Trailer was found to be intact without any visible damage. There was also no sign of fluid stain(s) observed on the various undercarriage components.

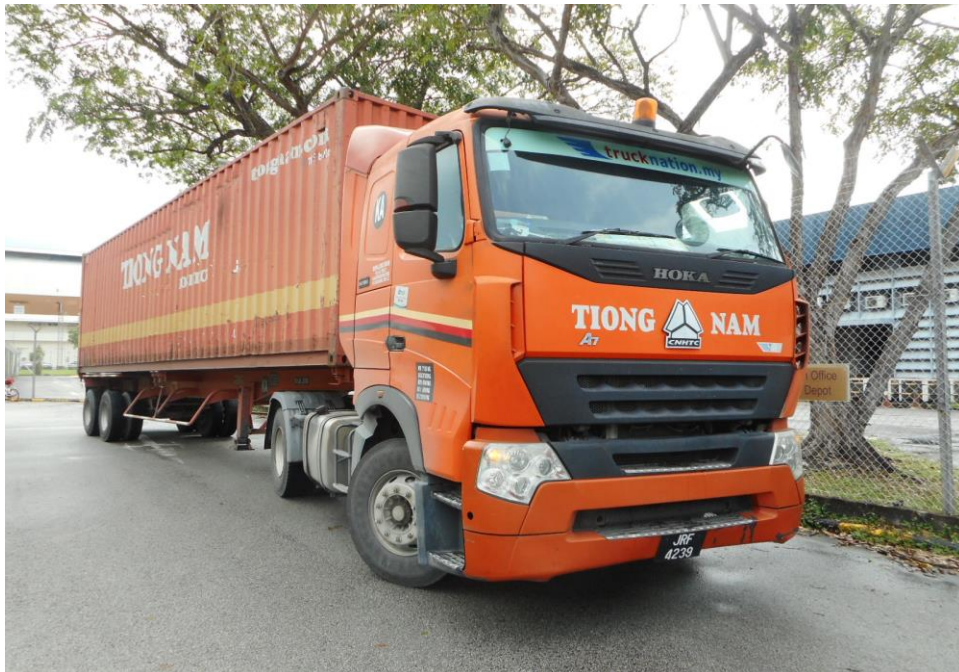
Photo 30 shows the front right wheel of the Motor Trailer turned to its full left. During my steering system test, I did not experience any abnormal free play and/or resistance when I had turned the steering wheel towards full left and full right. This would suggest that the steering system of the Motor Trailer was likely to be in serviceable condition at the material time of accident.

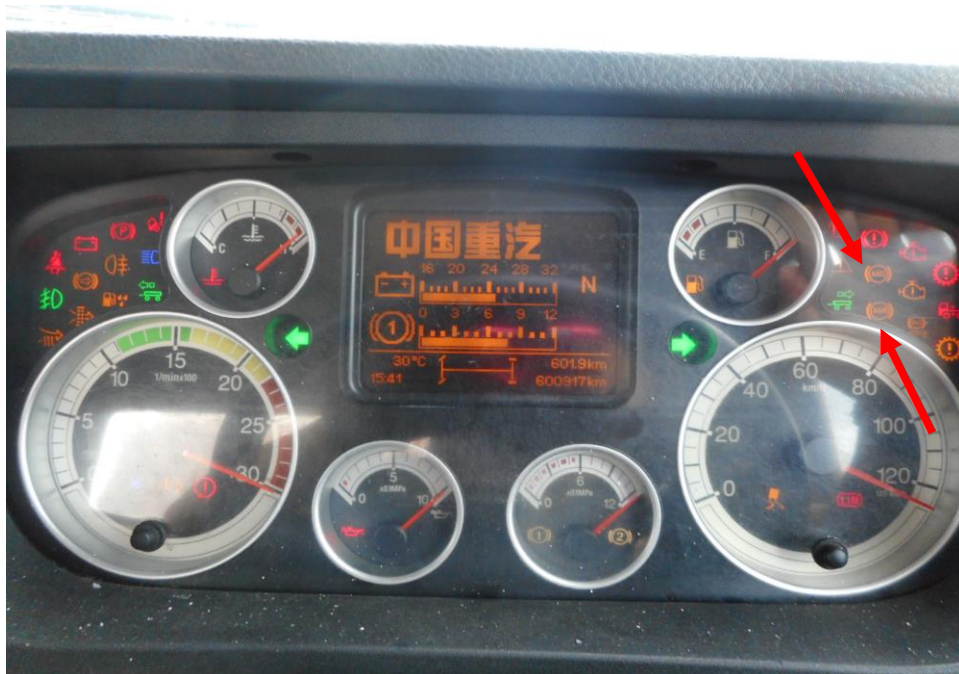
Photo 31 shows the warning light for Anti-Lock Brake System (ABS) and Traction Control System (TC) appearing on the instrument panel of the Motor Trailer during the self-test of its various electronic operating systems when its engine was cranked.

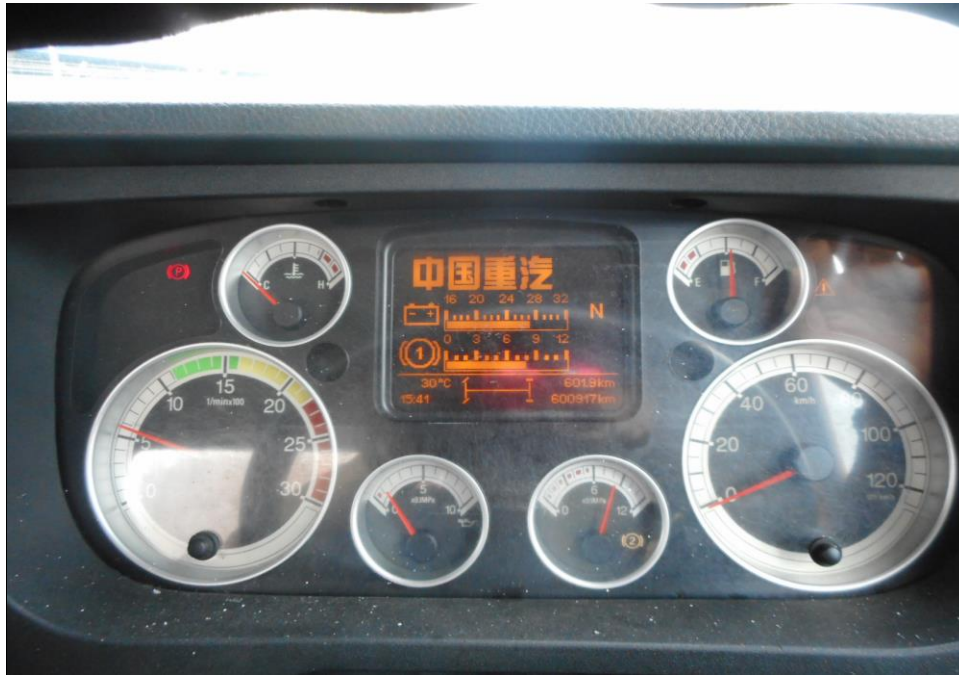
Photo 32 shows no warning lights illuminated on the instrument panel of the Motor Trailer after the engine was cranked. This would suggest that there was no abnormality to the various electronic operating systems of the Motor Trailer, like the ABS and TC.
