## LKK Auto Consultants Pte Ltd

## ADJUSTMENT ON REPAIR COST FOR VEHICLE NO. GBJ 9072G

PHOTOGRAPHS FOR VEHICLE NO. GBJ 9072G

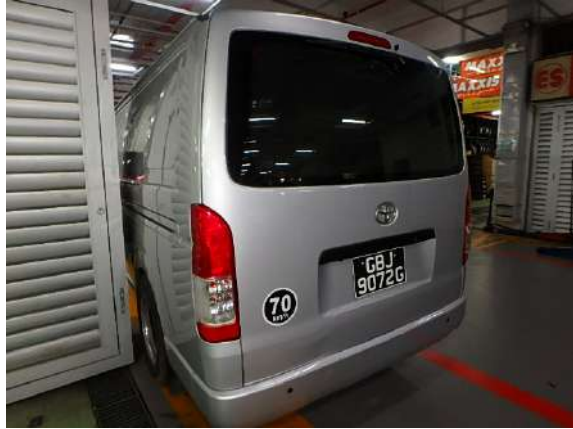
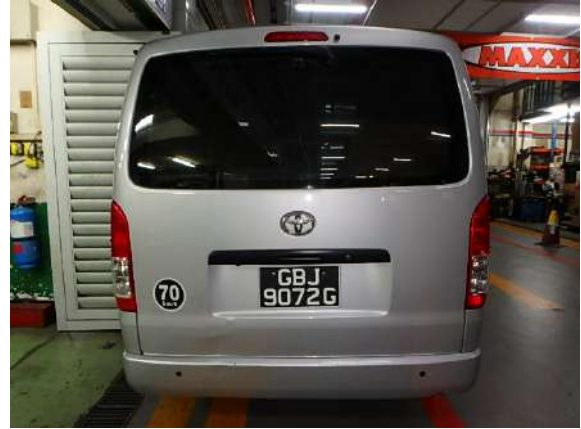
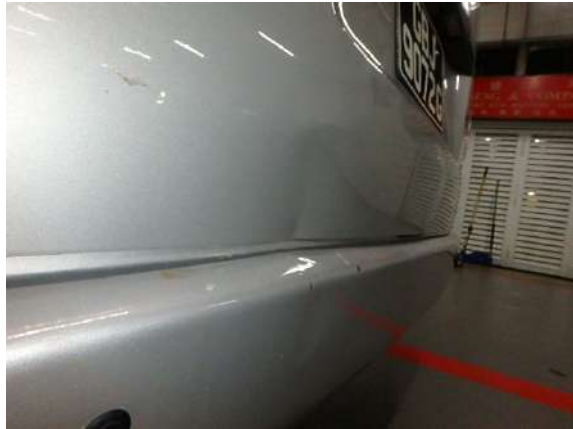
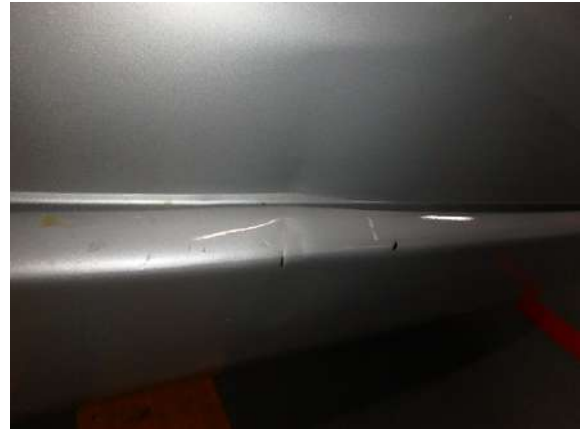
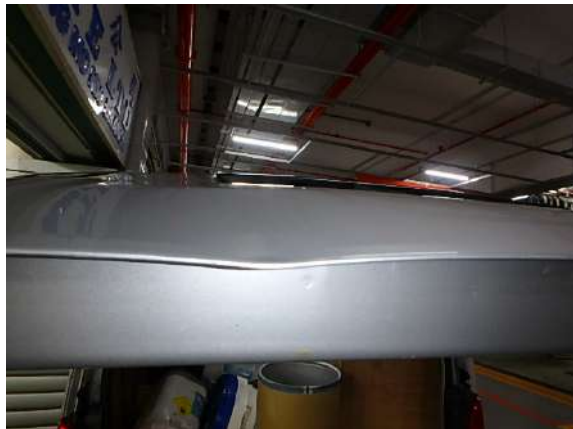
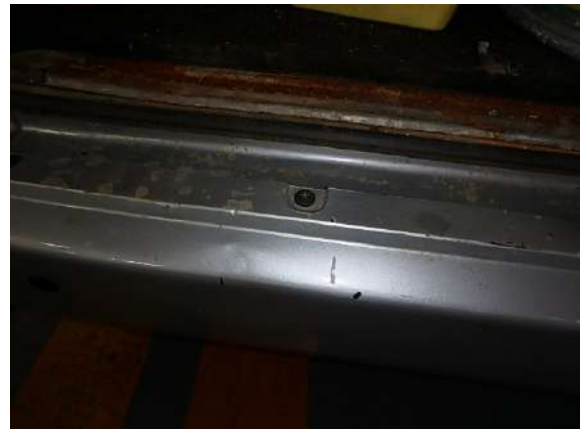
INSPECTION

| Affiliated to Federation Internationale Des Experts En Automobile | | | | |
|---|---|---|---|--|
| THE VEHICLE SUSTAINED DAMAGES AT THE REAR N/S PORTION.<br>DAMAGES SEE DETAILS. | | | | |
