Affiliated to Federation Internationale Des Experts En Automobile			
CHINA TAIPING INSURANCE (S) PTE LTD 3 ANSON ROAD #16-00 SPRINGLEAF TOWERSINGAPORE 079909		Ref: CC3/CTI20014485/Kra3q2 Date: 09/04/2021 Code: CTI

1. Policy Particulars :- THIRD PARTY CLAIM			
Insured Veh.	SJF 5985A	Veh. Inspected	SHD 401K
Policy No.	DMPCSNA00176252002	Coverage (\$)	0.00
Claim No.	SNM20D205066	Excess (\$)	0.00
Assign From		Assign Date	23/12/2020

ADJUSTMENT ON REPAIR COST FOR VEHICLE NO. SHD 401K

PHOTOGRAPHS FOR VEHICLE NO. SHD 401K

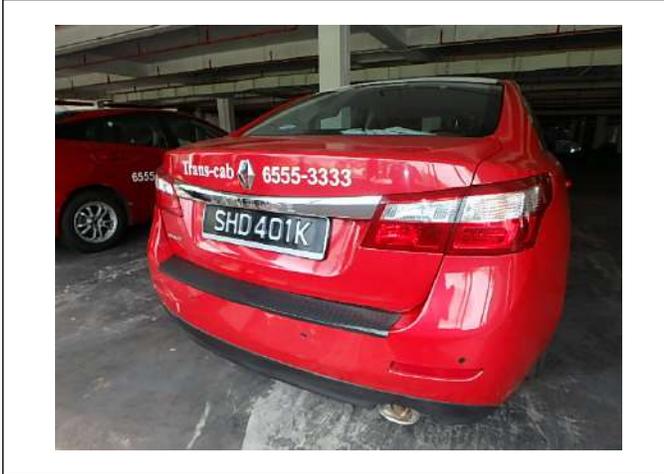
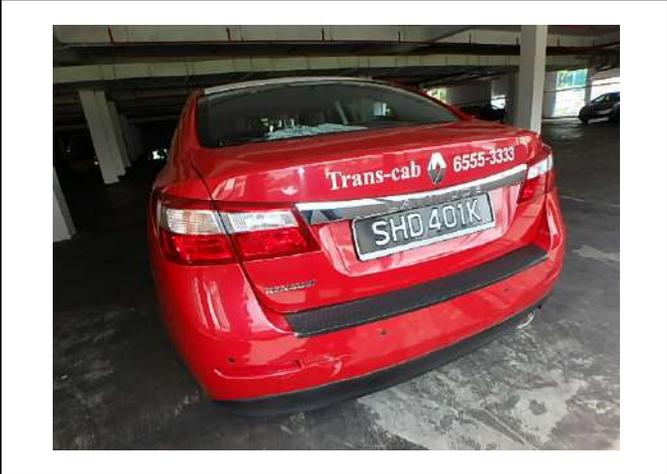
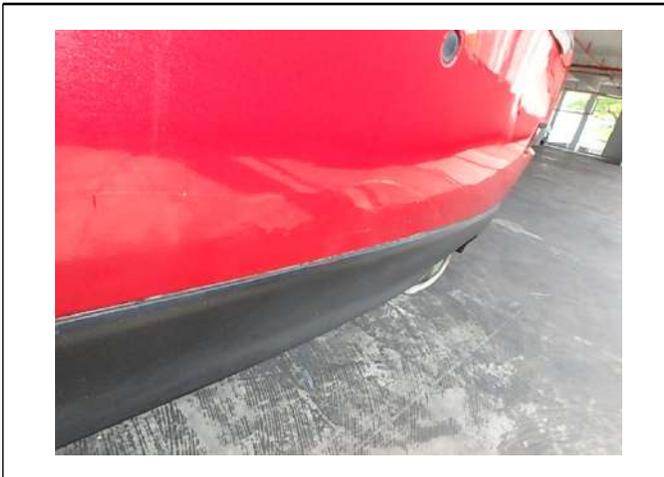
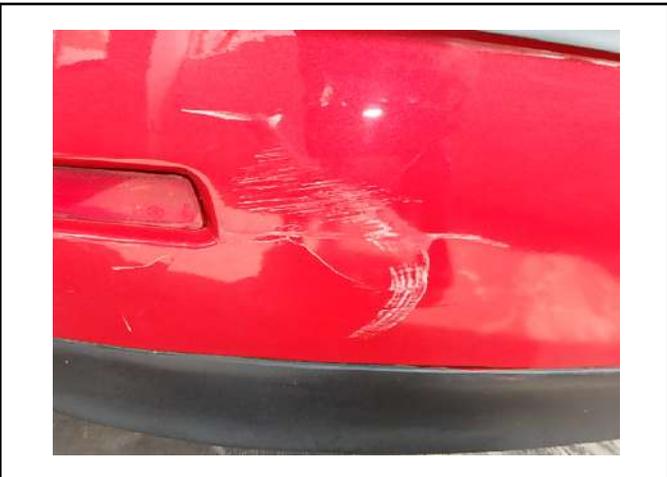
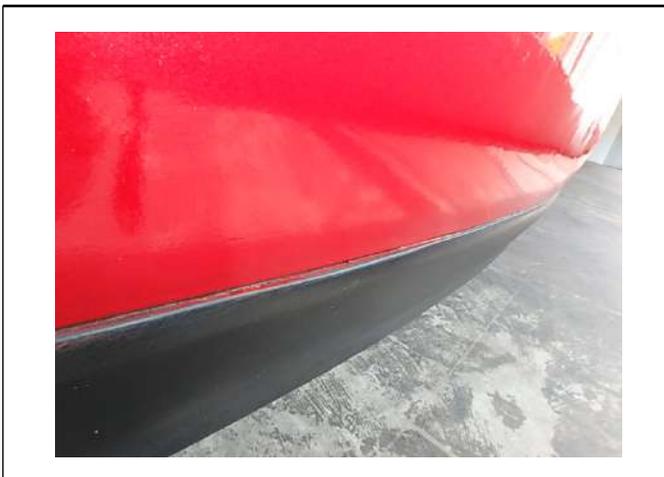
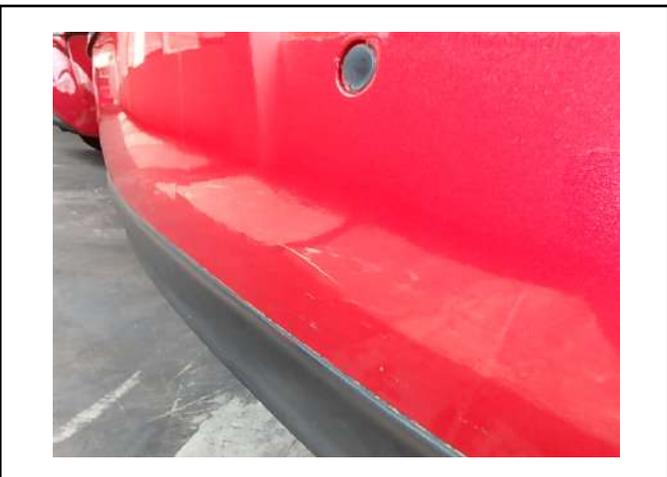
4. Description of Damages			
THE VEHICLE SUSTAINED DAMAGES AT THE REAR PORTION. DAMAGES SEE DETAILS.			
5. General Information			
Accident Date	21/12/2020	Inspection Date	23/12/2020
Survey held at	TRANS-CAB AUTO SERVICES PTE LTD NO.2 ANG MO KIO ST 63 SINGAPORE 569111		
5a. Remarks			
A)THE INSPECTION WAS CONDUCTED ON A"WITHOUT PREJUDICE" BASIS. B)IN ACCORDANCE TO YOUR INSTRUCTIONS, WE HAVE NOT AUTHORISED REPAIRS.			
5b. Estimate Days of Repair			
ESTIMATED NORMAL PERIOD FOR REPAIR:		2 Working Days
