LKK Auto Consultants Pte Ltd

Affiliated to Federation Internationale Des Experts En Automobile				
MS FIRST CAPITAL INSURANCE LTD 36 ROBINSON ROAD #16-01 CITY HOUSESINGAPORE 068877			Ref: CC4/FCI20014686/Kea3q2	
			Date: 17/03/2021	
			Code: FCI2

ADJUSTMENT ON REPAIR COST FOR VEHICLE NO. SKZ 4483X

PHOTOGRAPHS FOR VEHICLE NO. SKZ 4483X

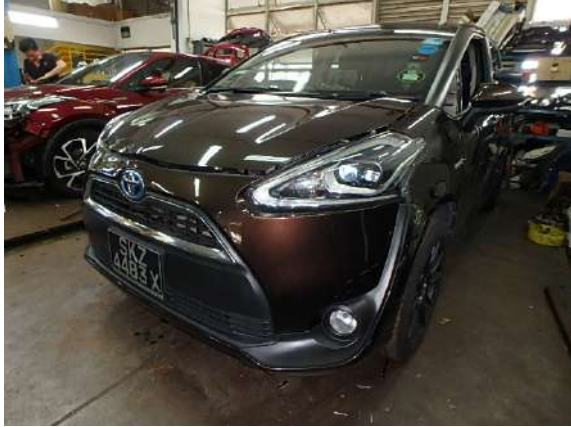
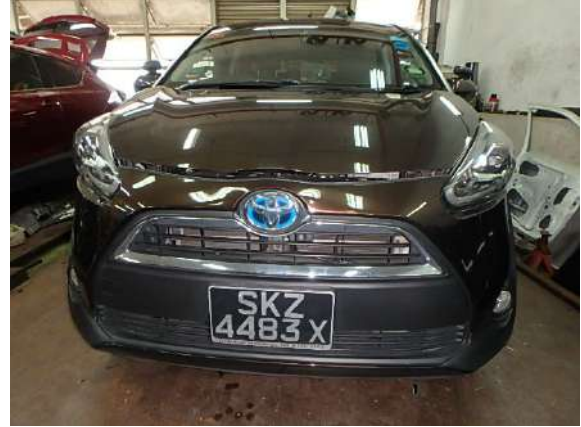
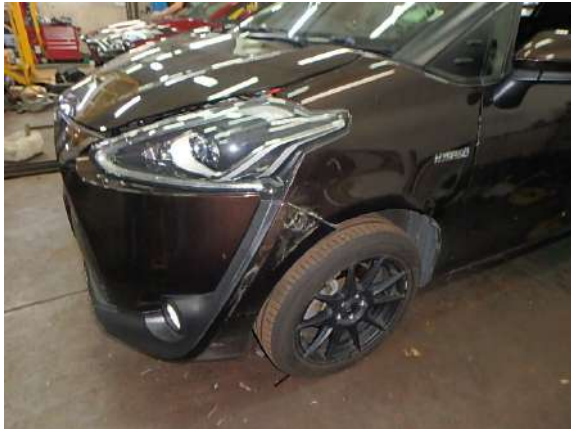
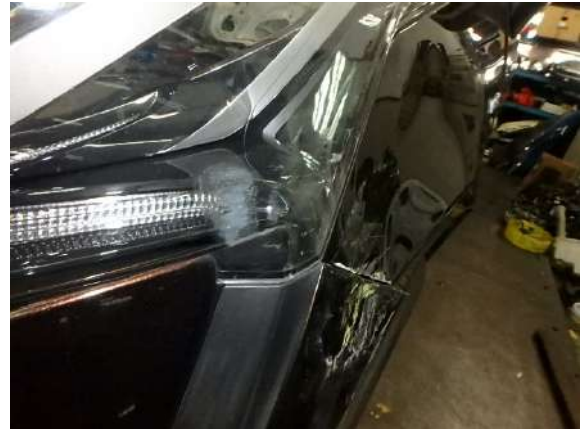
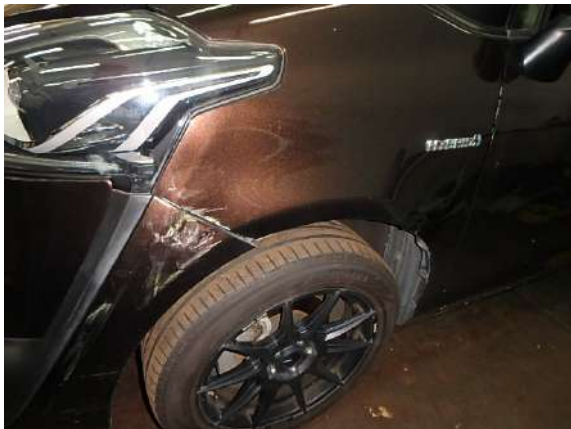
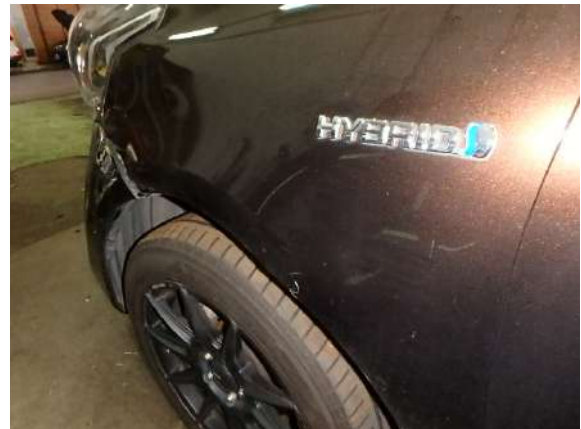
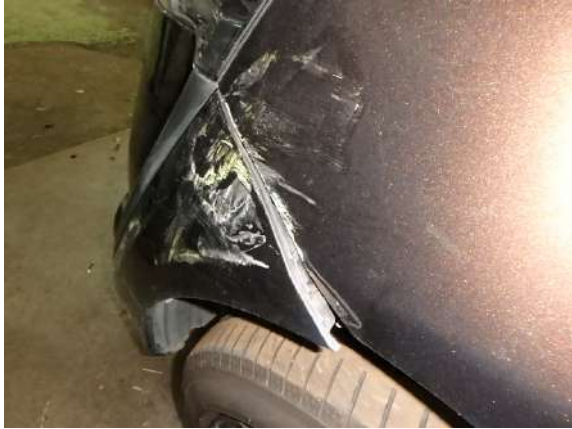
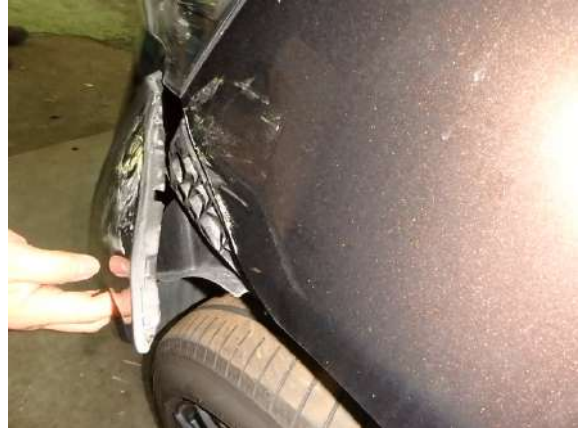
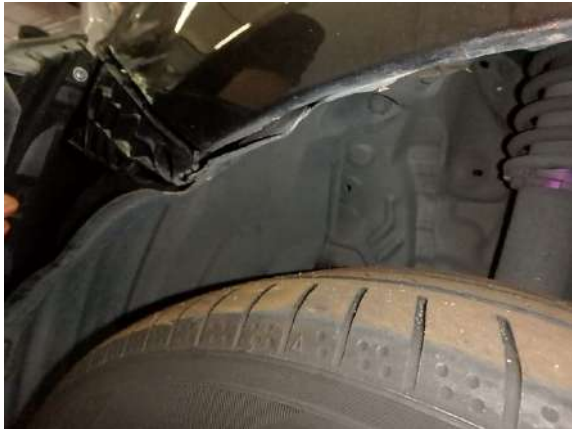
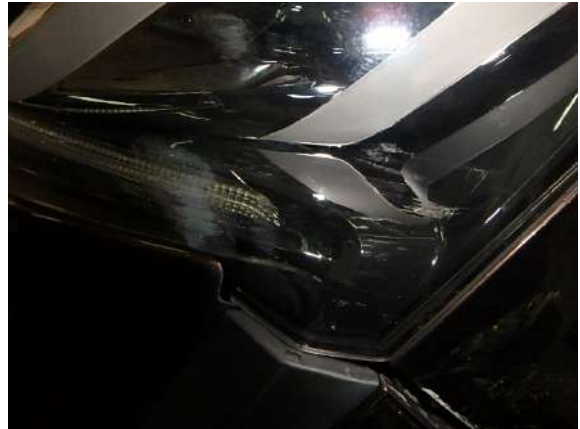
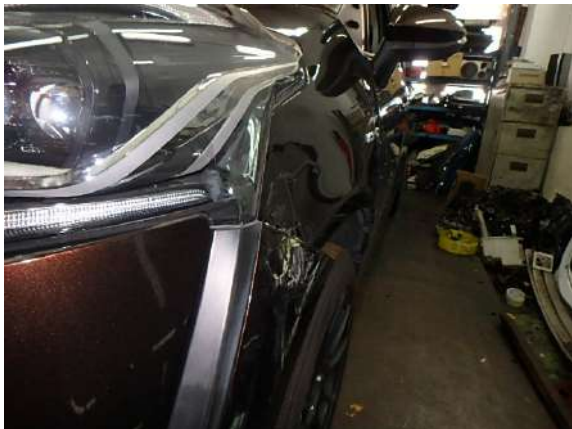
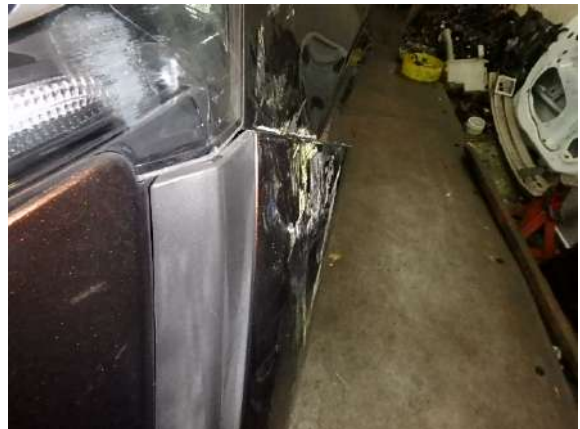
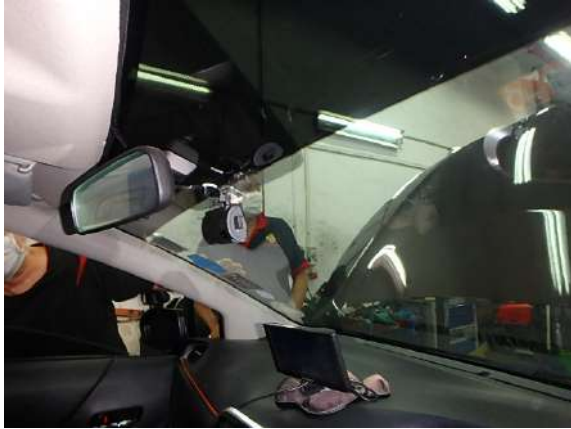
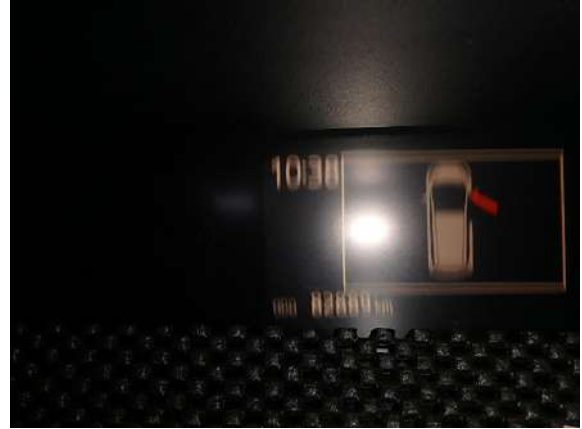
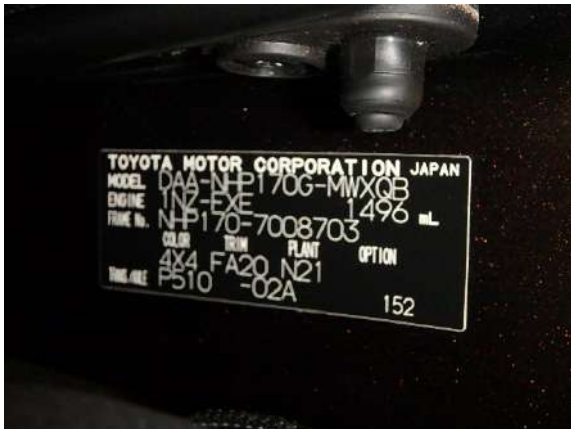
4. Description of Damages				
THE VEHICLE SUSTAINED DAMAGES AT THE N/S FRONT PORTION. DAMAGES SEE DETAILS.				
5. General Information				
Accident Date	27/12/2020	Inspection Date	04/01/2021	
Survey held at	BODYFIX NO 10 ANG MO KIO INDUSTRIAL PARK 2A #04-06 AMK AUTOPOINT SINGAPORE 568047			
5a. Remarks				
A)THE INSPECTION WAS CONDUCTED ON A"WITHOUT PREJUDICE" BASIS. B)IN ACCORDANCE TO YOUR INSTRUCTIONS, WE HAVE NOT AUTHORISED REPAIRS.				
5b. Estimate Days of Repair				
ESTIMATED NORMAL PERIOD FOR REPAIR:			4 Working Days

Qty	Description of Parts	Condition	Estimate By Workshop (\$)	Our Adjusted (\$)
	<u>REPLACEMENT OF PARTS</u>			
1	HEAD LAMP (LH)	CUT	1,812.45	1,812.45
1	HEAD LAMP BRACKET (LH)	TO REPAIR SEE LABOUR	182.00	-
1	FRONT FENDER (LH)	BENT	681.90	654.40
1	FRONT FENDER INNER SHIELD (LH)	DISTORTED	271.45	225.00
1	FRONT BUMPER	BUCKLED / DISTORTED	581.90	581.90
8	FRONT BUMPER CLIPS @\$3.50	NECESSARY	28.00	28.00
1	FRONT BUMPER SIDE RETAINER -LH	DISTORTED	178.85	178.85
1	EMBLEM 'HYBRID'	NECESSARY	89.20	89.20
1	FOG LAMP COVER LH	SCRATCHED	192.60	192.60
	LESS 25% DISCOUNT		-	-940.60
			4,018.35	2,821.80
	<u>LABOUR</u>			
	LABOUR TO REPLACE ABOVE PARTS ,PANEL BEAT ,REPAIR & RE-ALIGN DAMAGED PARTS.INCLUSIVE OF THE REPAIR OF HEAD LAMP BRACKET (LH).		1,000.00	400.00
	SPRAY PAINT LH FRONT FENDER ,FRONT BUMPER & OTHER AFFECTED AREAS.		900.00	440.00
			1,900.00	840.00
	GRAND TOTAL		5,918.35	3,661.80
	RECOMMENDED COST OF LUMP SUM REPAIRS (TO ITS PRE-ACCIDENT CONDITION)			2,900.00
