Your Ref: TP/IP/50553/2020  
Our Ref : CI/TPD21000233/P

18<sup>th</sup> February 2021

**MECHANICAL INSPECTION REPORT OF MOTOR CAR SKF 9185D**

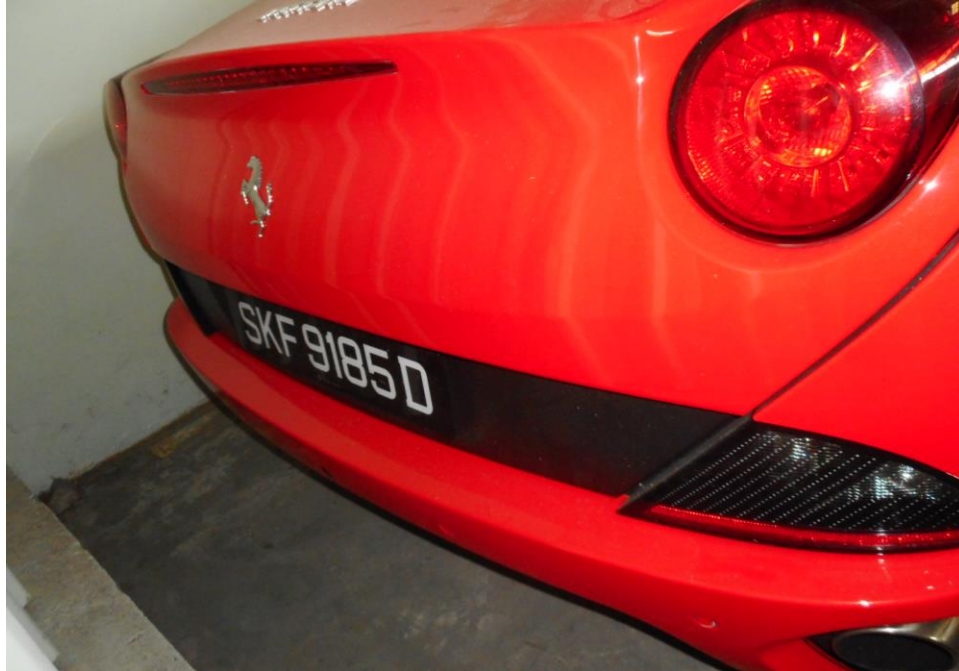
**Photo 1** shows a general view of the Motor Car's rear body at the time of my inspection. The rear portion of the Motor Car was observed to have been undamaged by the accident.

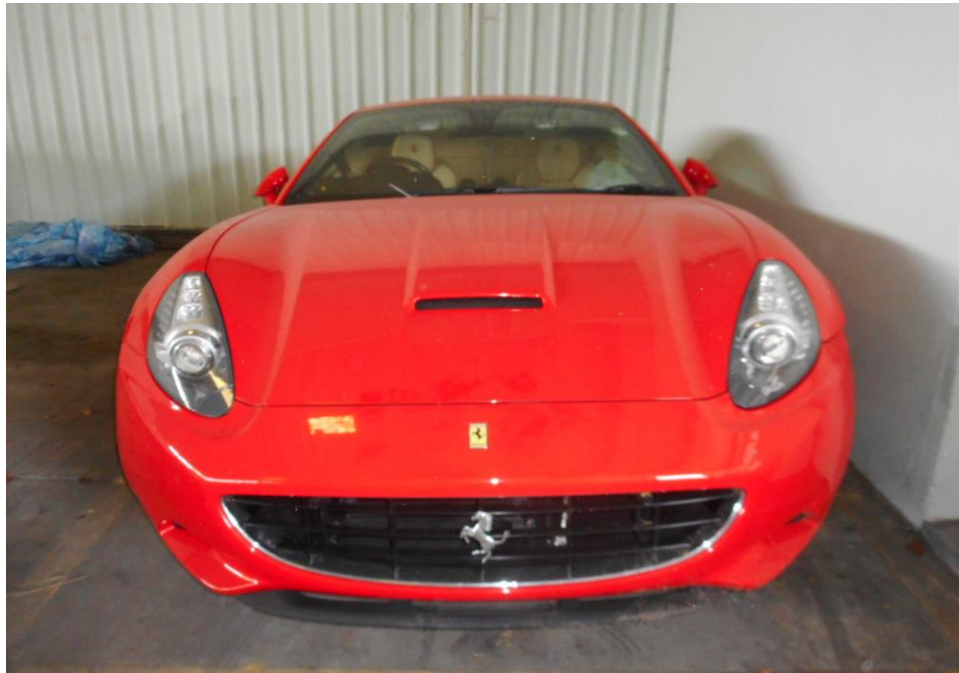
**Photo 2** shows a general view of the Motor Car's front body at the time of my inspection. The front portion of the Motor Car was observed to have been undamaged by the accident.

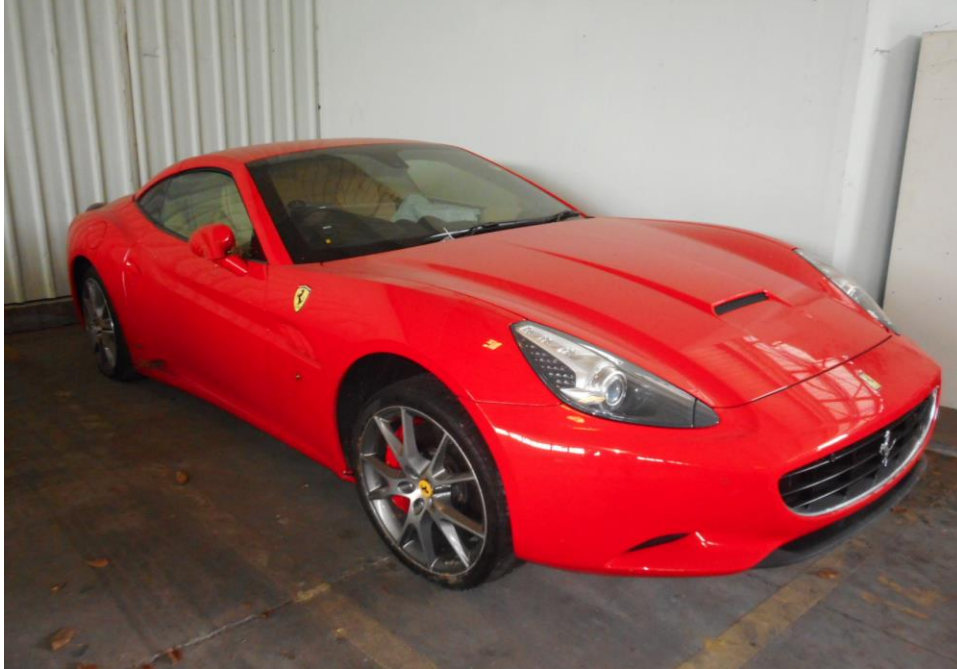
**Photo 3** shows a general view of the Motor Car's right body at the time of my inspection. The right portion of the Motor Car was observed to have been undamaged by the accident.

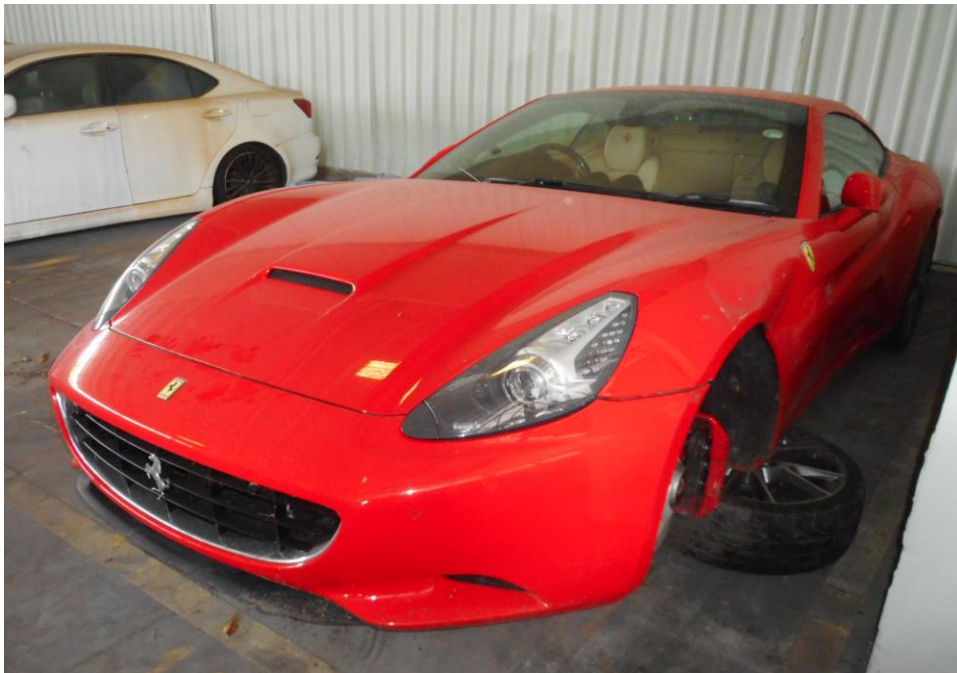
4. The mileage of the Motor car was not recorded as the engine was unable to be started despite multiple attempts to jumpstart the engine at the time of our inspection.
5. The Motor car was observed to have sustained damage at its left portion. Its front left fender were amongst the body parts that were damaged as a result of the accident.

**Photo 4** shows a general view of the Motor Car's left body at the time of my inspection. The left portion of the Motor Car was observed to have sustained damage to its front left fender were amongst the body part that were damaged as a result of the accident.

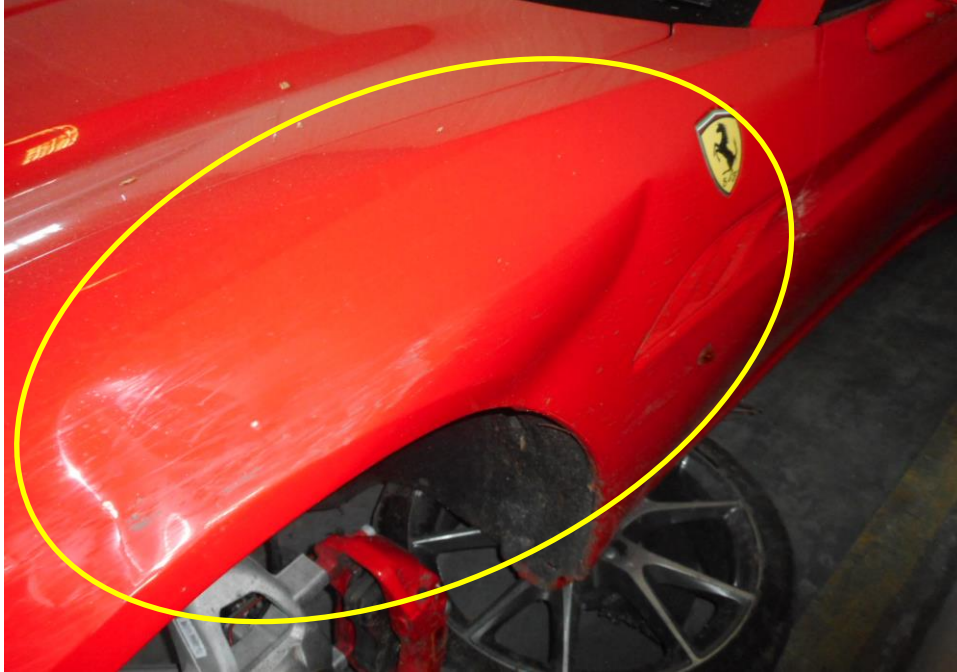
**Photo 5** shows a close up view of the Motor Car's front portion at the time of my inspection. The left portion of the Motor Car was observed to have sustained damage to its front left fender (circled) were amongst the body part that were damaged as a result of the accident.

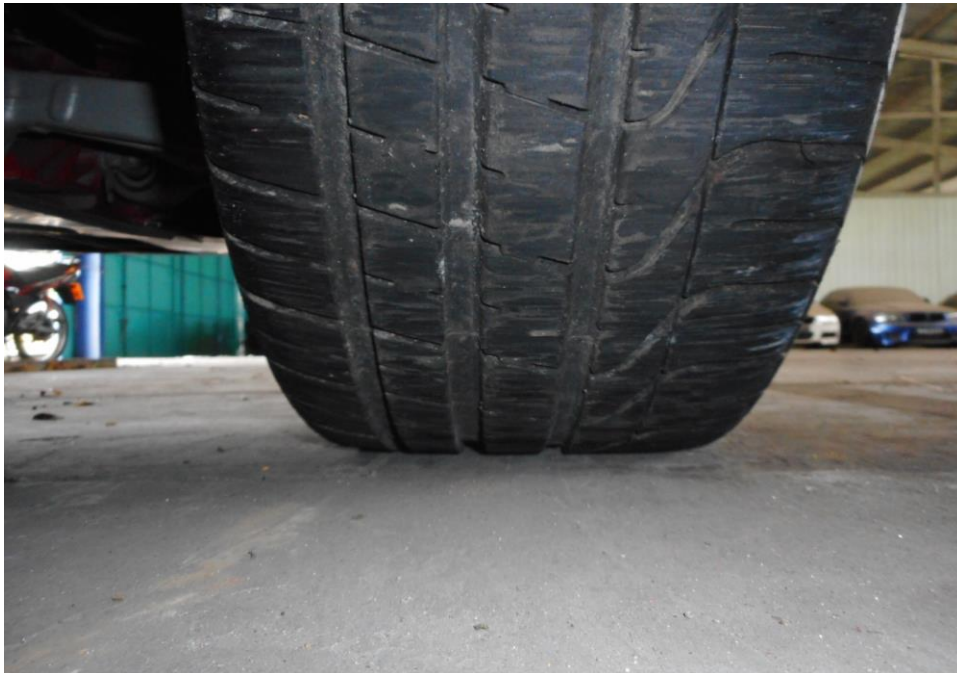
**Photo 6** shows the condition of the front right tyre of the Motor Car, which was observed to be in serviceable condition with remaining tread depth of approximately 6.1mm. The tyre was also observed to be sufficiently inflated for vehicular operation with no tear, cut or burst mark(s).

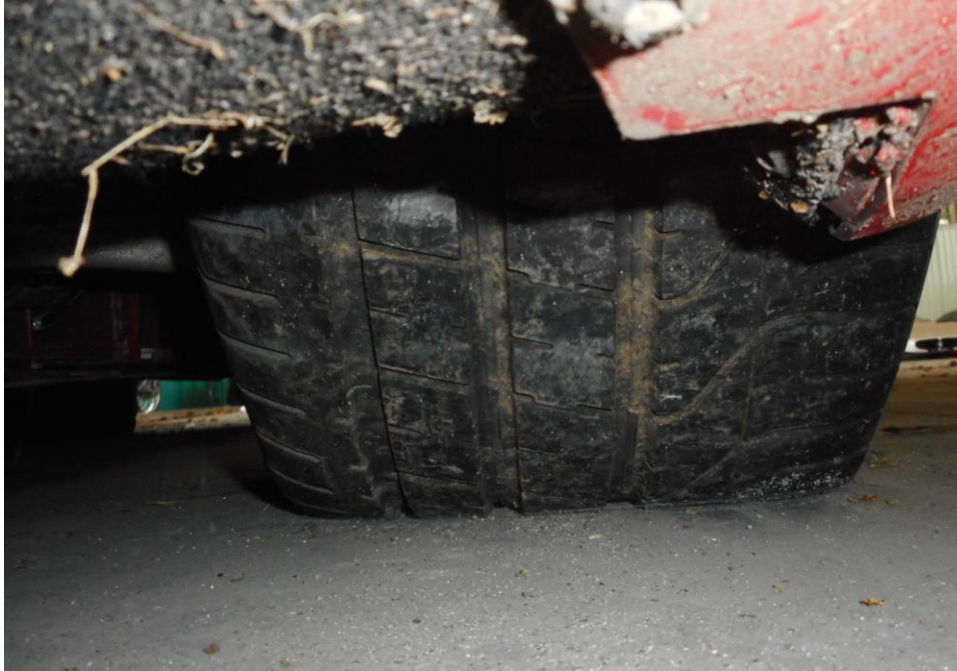
**Photo 7** shows the condition of the rear right tyre of the Motor Car, which was observed to be in serviceable condition with remaining tread depth of approximately 5.7mm. The tyre was also observed to be sufficiently inflated for vehicular operation with no tear, cut or burst mark(s).

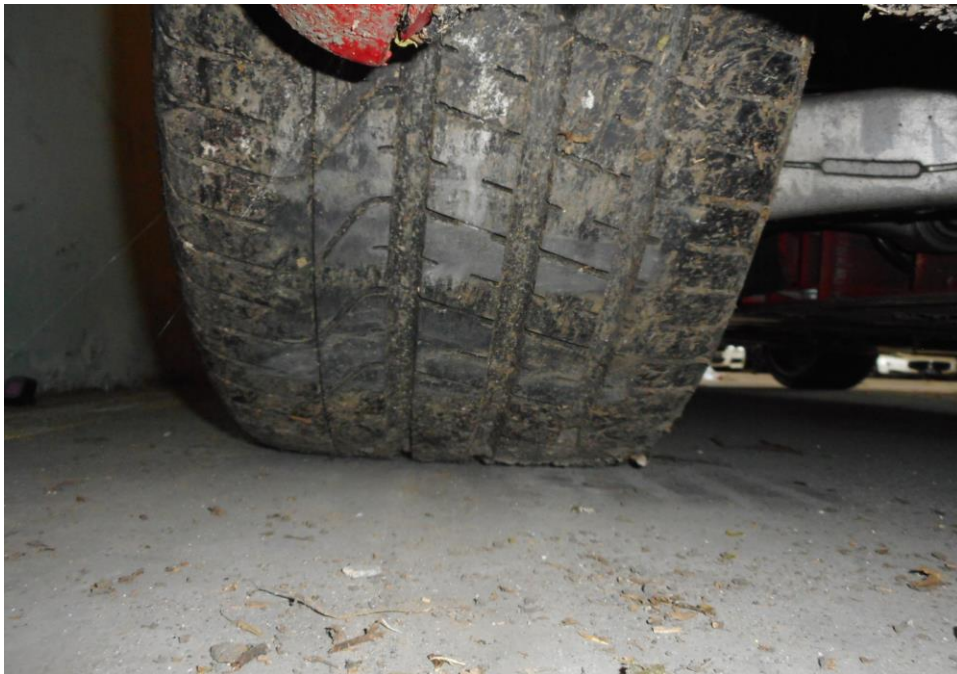
**Photo 8** shows the condition of the rear left tyre of the Motor Car, which was observed to be in serviceable condition with remaining tread depth of approximately 5.5mm. The tyre was also observed to be sufficiently inflated for vehicular operation with no tear, cut or burst mark(s).

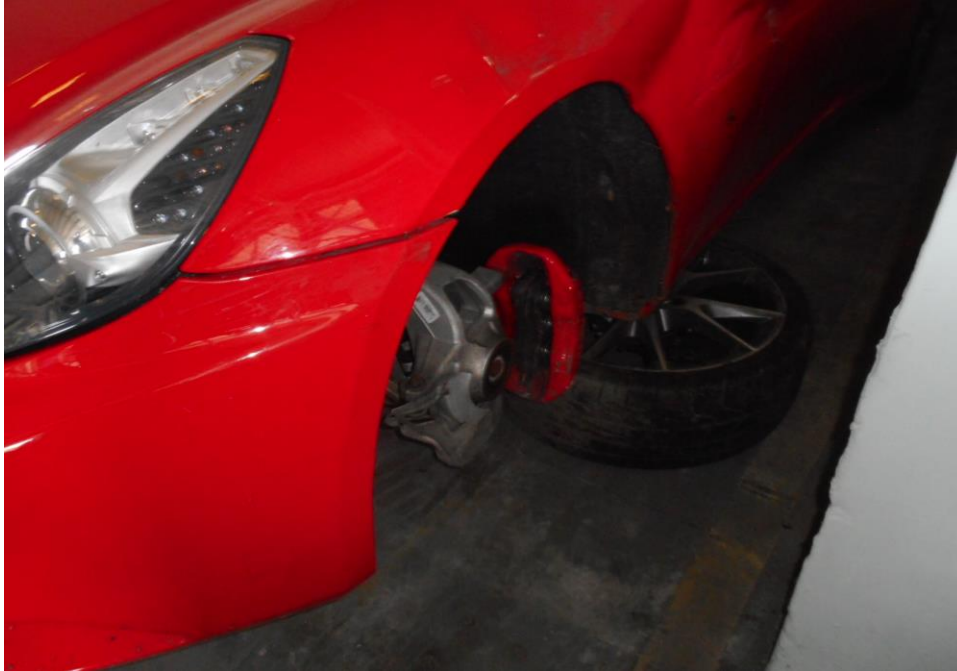
7. The 4 tyres were observed to be wrapped around standard alloy wheel rims, the front left wheel rims were found to be damaged and broken off as a result of the accident. However the front right and both rear rims were found to be without any damage. See photo 1 – 10 below.

**Photo 9** shows the condition of the front left tyre and rim of the Motor Car, which was observed to be broken off as a result of the accident.

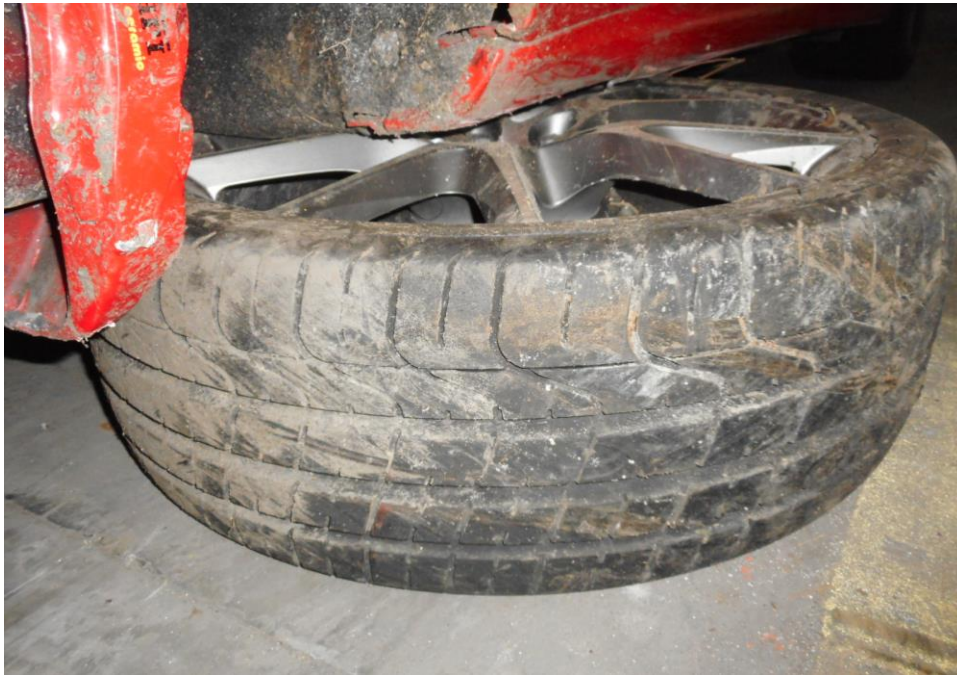
**Photo 10** shows the condition of the front left tyre of the Motor Car, which was observed to be in serviceable condition with remaining tread depth of approximately 5.7mm. The tyre was also observed to be sufficiently inflated for vehicular operation with no tear, cut or burst mark(s).

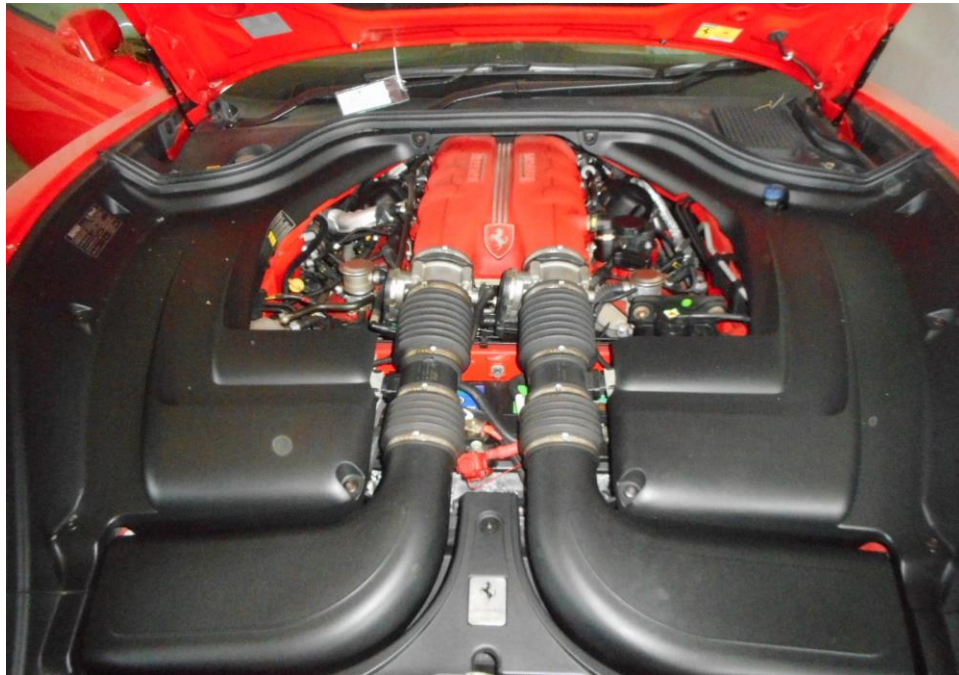
**Photo 11** shows a general view of the Motor Car's engine compartment. The various parts and components inside the engine compartment were unaffected by the accident. There was also no sign(s) or indication(s) of fluid leakage and/or fluid stain within the engine compartment.

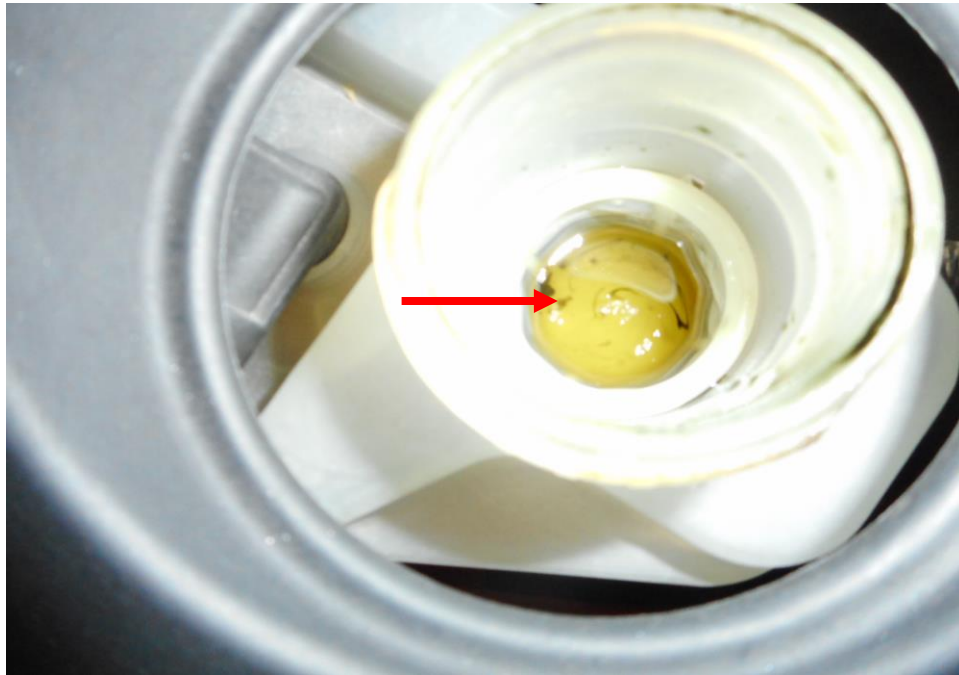
**Photo 12** shows the brake fluid reservoir of the Motor Car at the time of my inspection. The brake fluid was observed to be of sufficient level (arrowed) and without any visible contamination.

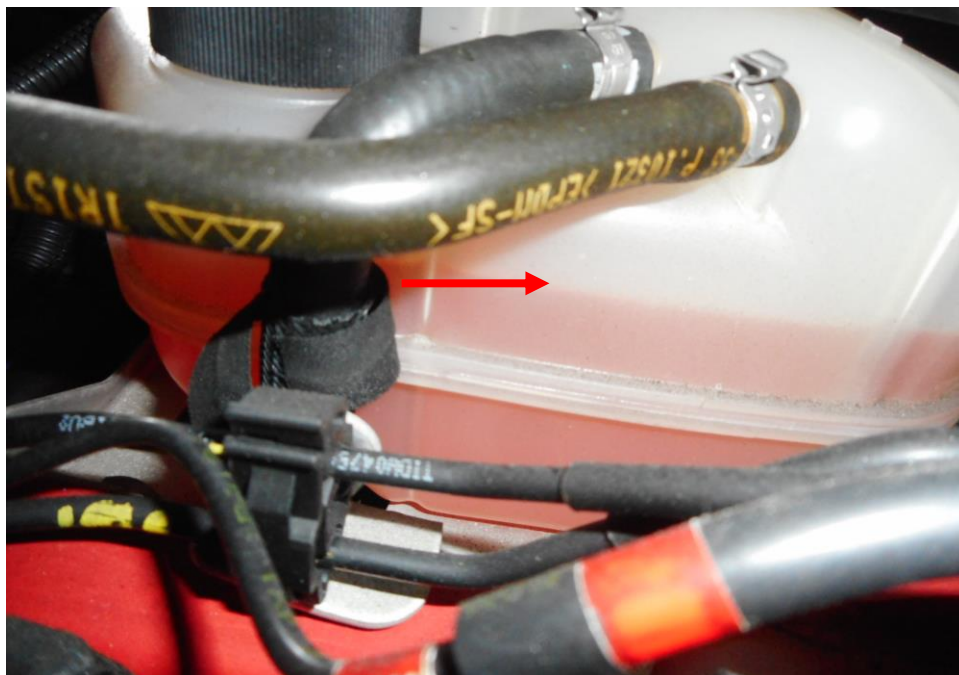
**Photo 13** shows checks being carried out to the engine coolant of the Motor Car at the time of my inspection. The engine coolant was observed to be of sufficient level (arrowed) and without any visible contamination.

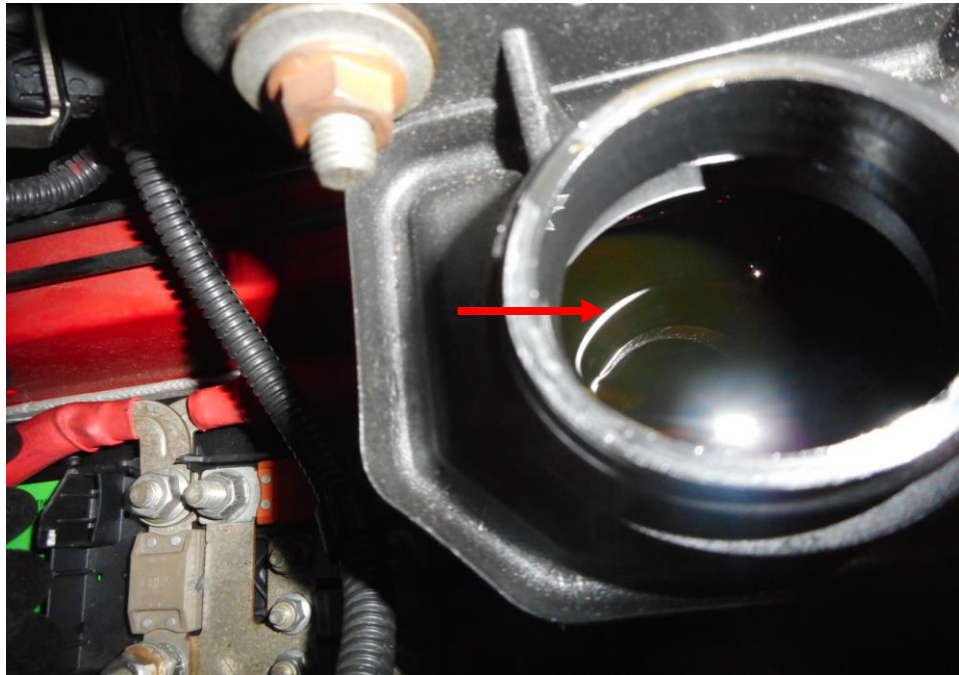
**Photo 14** shows checks being carried out to the engine coolant of the Motor Car at the time of my inspection. The engine coolant was observed to be of sufficient level (arrowed) and without any visible contamination.

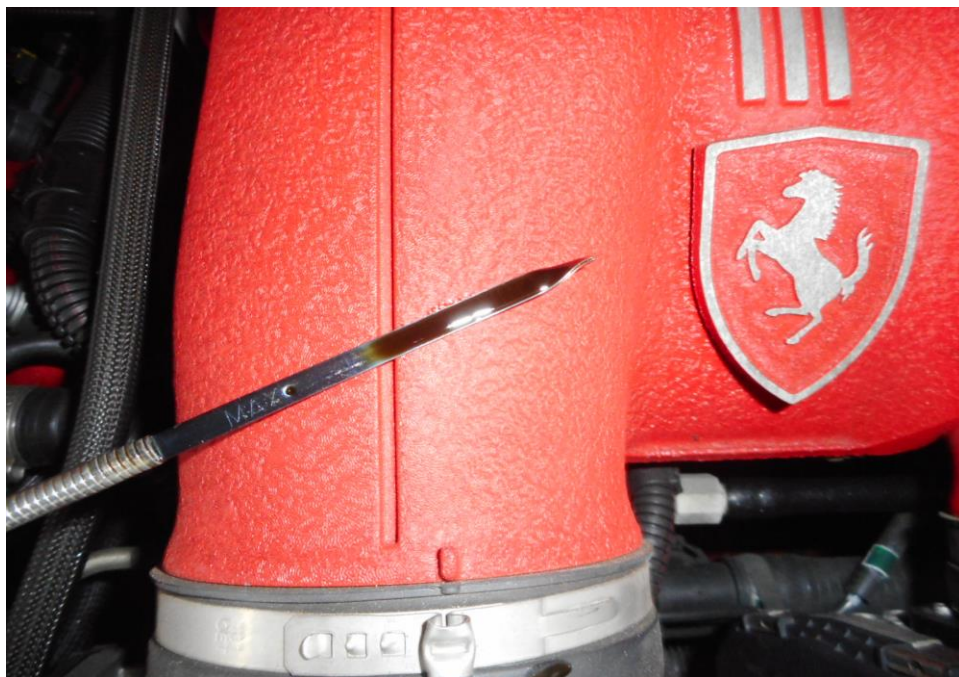
**Photo 15** shows the engine oil dip stick of the Motor Car at the time of my inspection. The engine oil was observed to be of sufficient level and without any visible contamination.

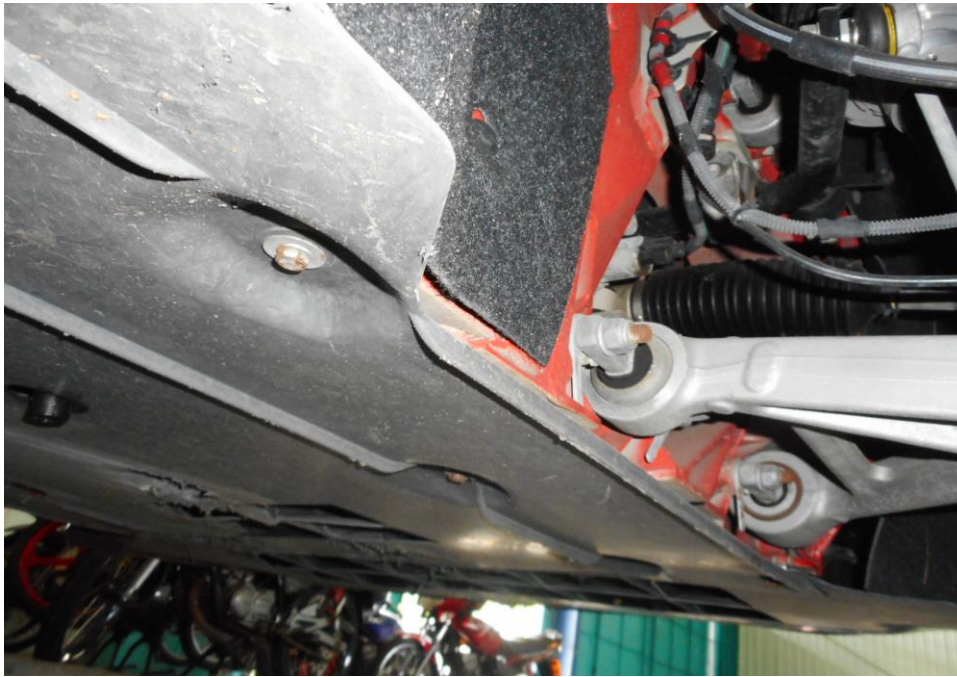
**Photo 16** shows the undercarriage of the Motor Car, at the area where the engine housing and transmission housing are located. I did not find any sign(s) or indication(s) of fluid leak and/or fluid stain(s) on the underside of the Motor Car.

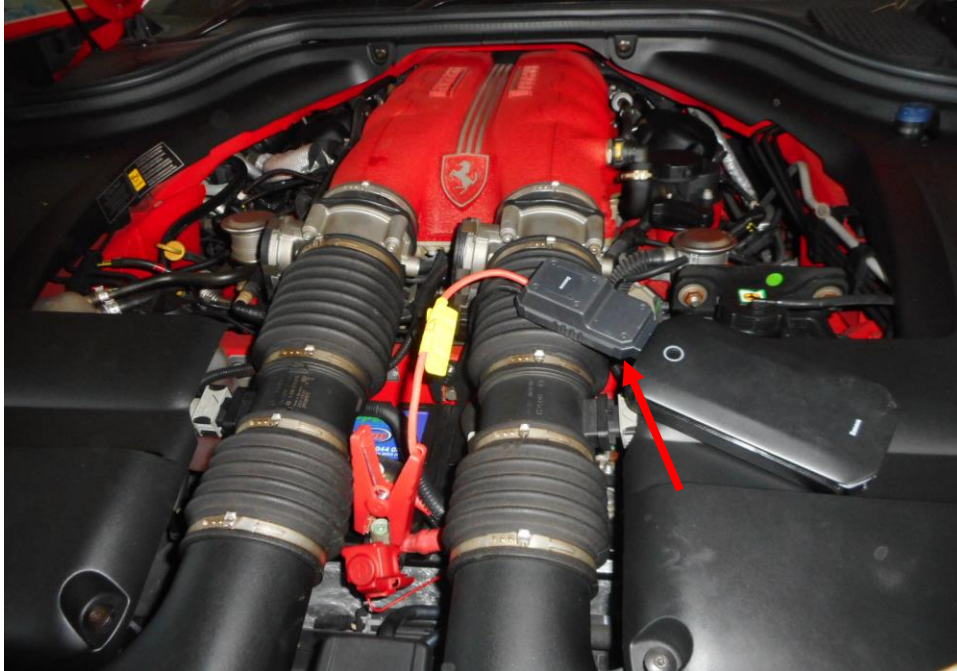
11. For this inspection, I was not able to conduct any tests on the steering system of the Motor Car due to the Motor Car running on electric power steering (EPS) which requires the Motor Car to be started. The engine was unable to be started up despite multiple attempts to jump start it.

**Photo 17** shows the use of a jump starter (arrowed) at the battery of the Motor Car. Despite multiple attempts in jumpstarting the Motor Car, the engine was not able to be started up.

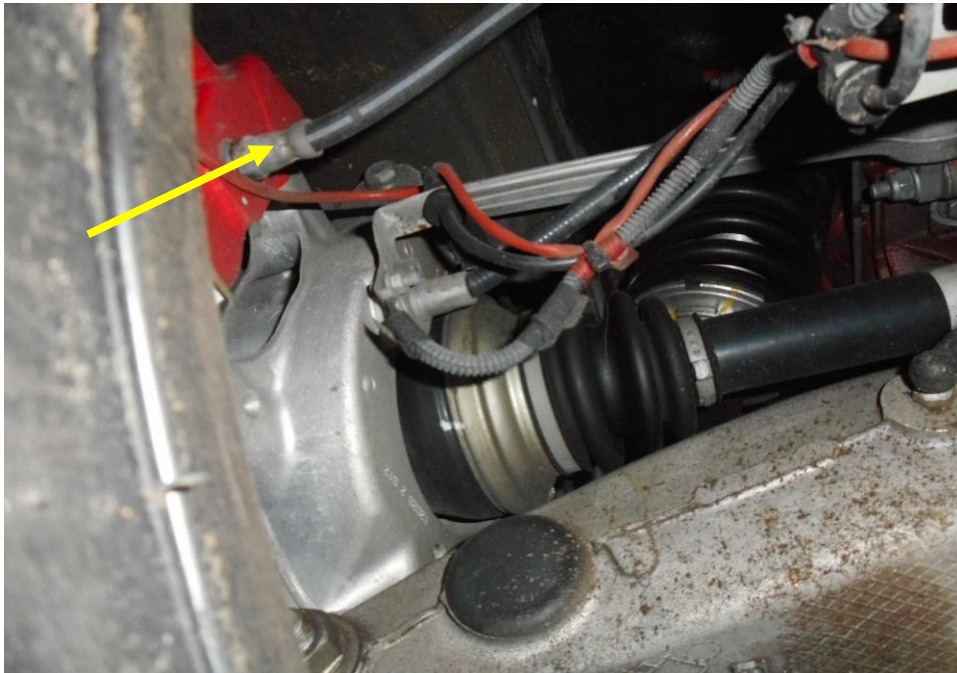
**Photo 18** shows the brake hose/pipe (arrowed) at the rear right wheel of the Motor Car. No leakage of brake fluid was observed. Visual examination of the various components of the braking system like the drum brake, brake booster, brake pedal etc. had revealed all to be intact and without visible damage.

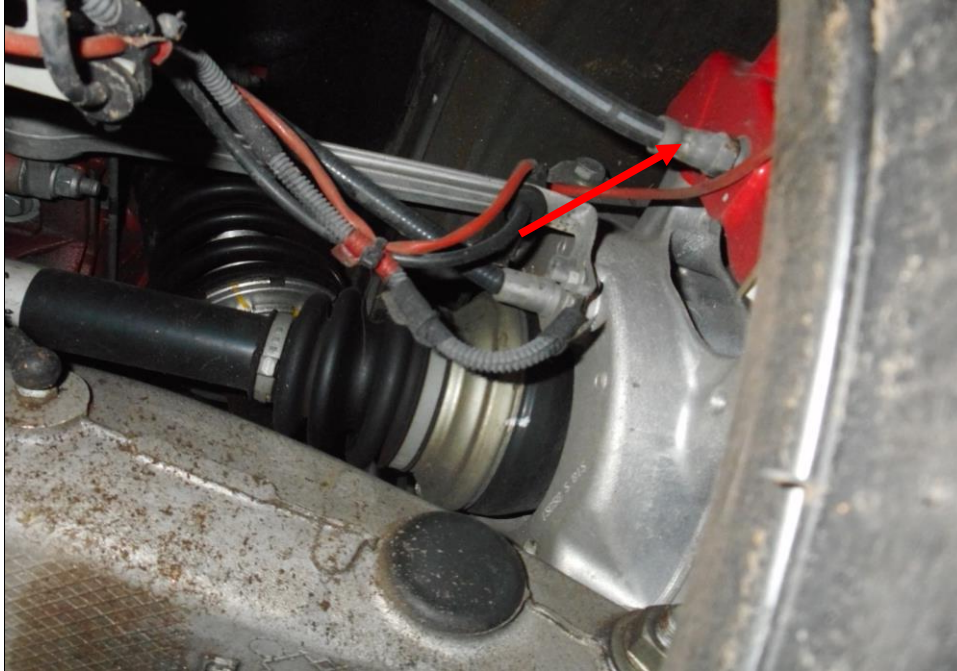
**Photo 19** shows the brake hose/pipe (arrowed) at the rear left wheel of the Motor Car. No leakage of brake fluid was observed. Visual examination of the various components of the braking system like the drum brake, brake booster, brake pedal etc. had revealed all to be intact and without visible damage.

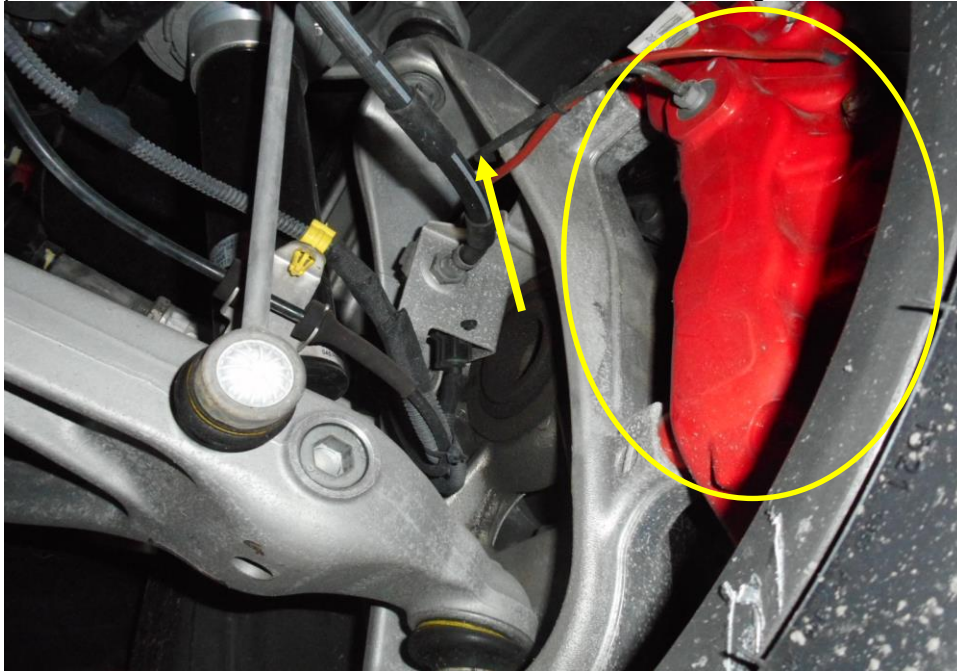
**Photo 20** shows the brake hose/pipe (arrowed) at the front right wheel of the Motor Car. No leakage of brake fluid was observed. Visual examination of the various components of the braking system like the brake caliper (circled), brake booster, brake pedal etc. had revealed all to be intact and without visible damage at the time of accident. There was also no sign of fluid stain(s) observed on the various undercarriage components.

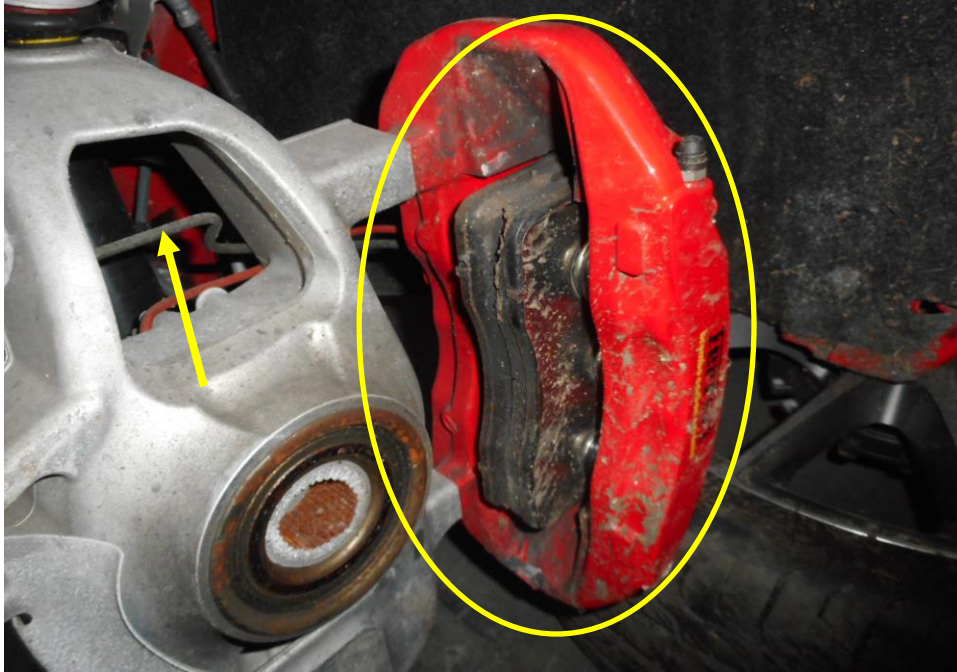
**Photo 21** shows the brake hose/pipe (arrowed) at the front left wheel of the Motor Car. No leakage of brake fluid was observed. Visual examination of the various components of the braking system like the brake caliper (circled), brake booster, brake pedal etc had revealed all to be intact and without visible damage at the time of accident. There was also no sign of fluid stain(s) observed on the various undercarriage components.

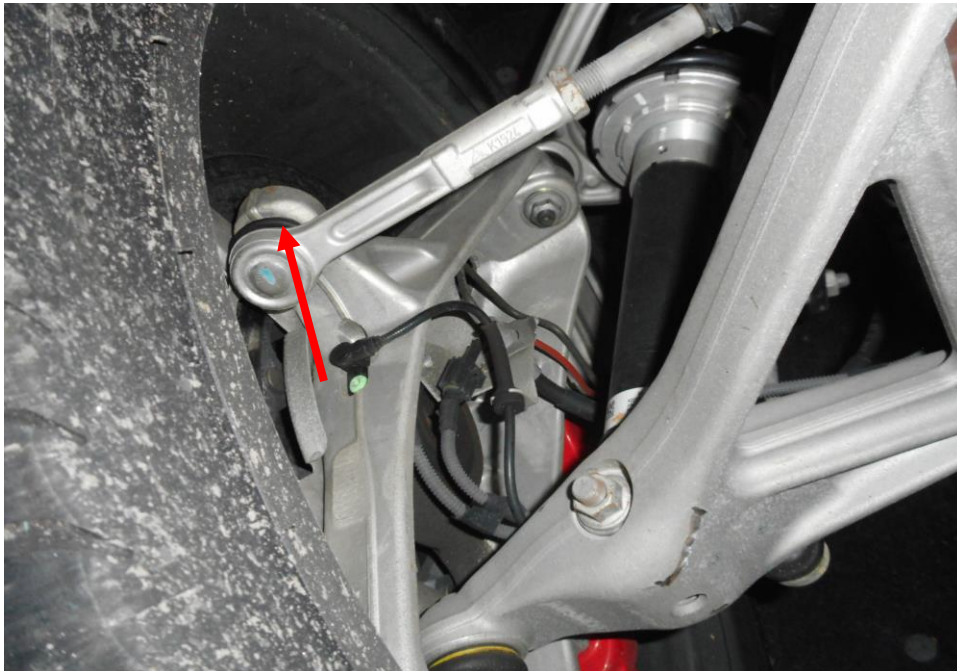
**Photo 22** shows the various undercarriage components at the front right wheel of the Motor Car, in particular the steering tie rod (red arrow) and drive shaft (yellow arrow). The various steering components were all found to be intact, suggesting that the steering system of the Motor Car was likely to be in serviceable condition at the material time of accident. There was also no sign of fluid stain observed on the various undercarriage components at the front right wheel of the Motor Car.

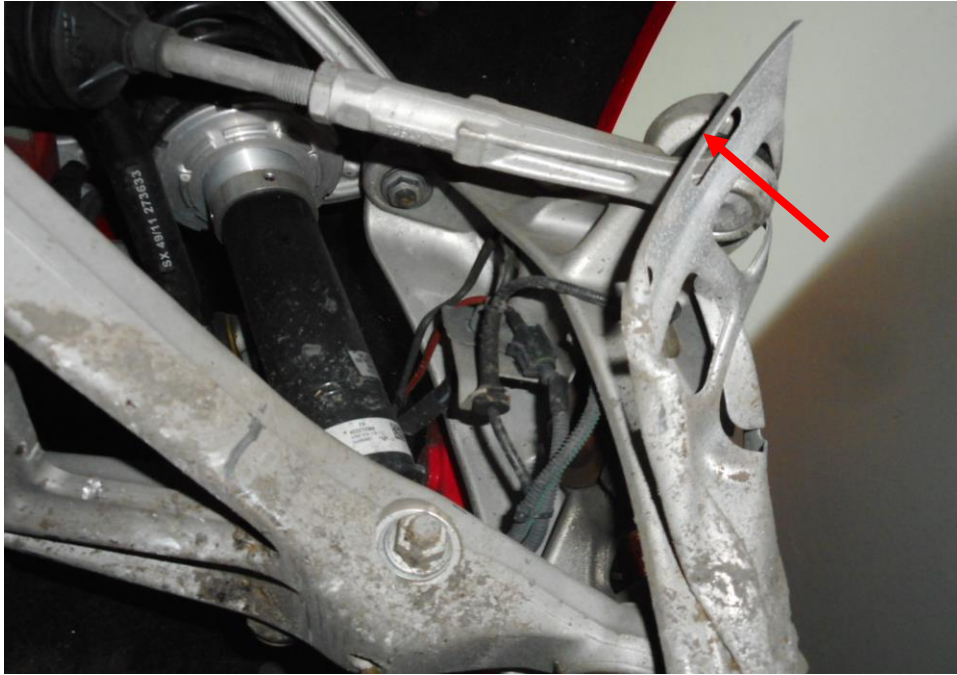
**Photo 23** shows the various undercarriage components at the front left wheel of the Motor Car, which had included the steering tie rod (arrowed). The various undercarriage components of the Motor Car were all found to be intact without any visible damage.

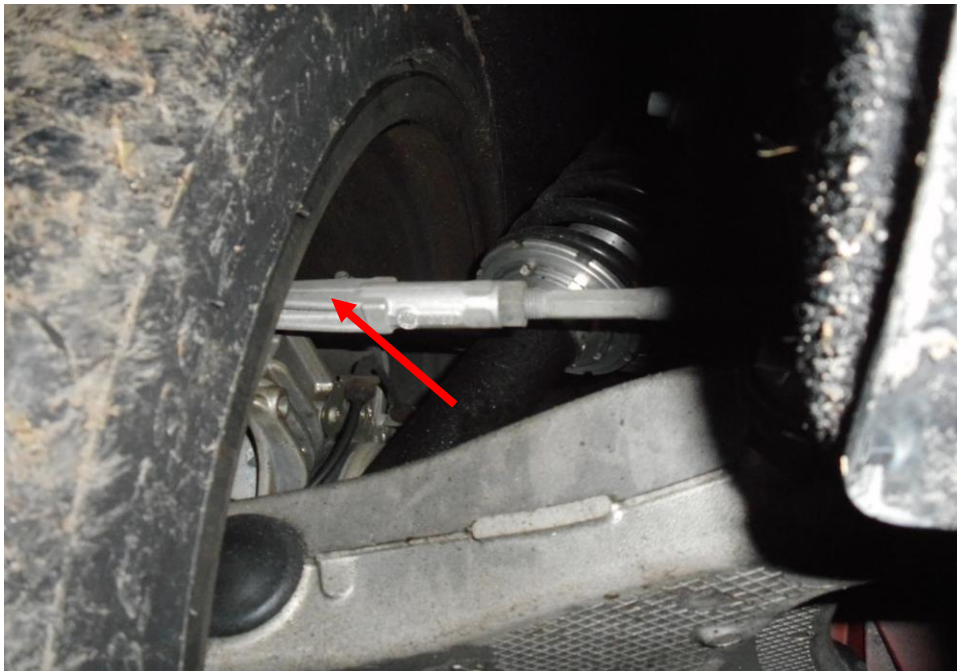
**Photo 24** shows the various undercarriage components at the rear left wheel of the Motor Car, which had included the rear tie rod (arrowed) were found to be intact without any visible damage.

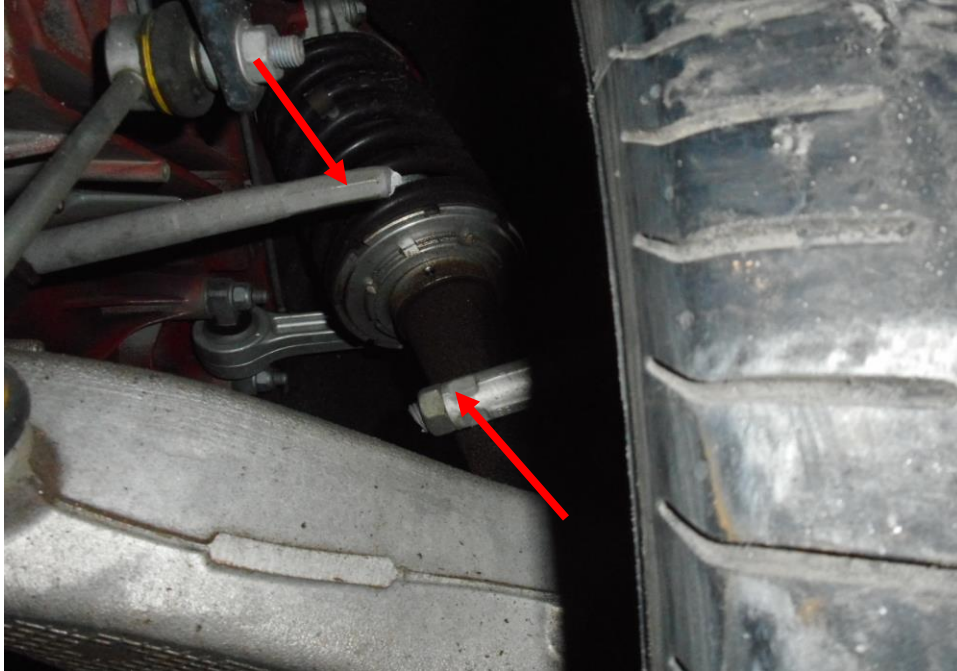
13. My visual examination of the various steering and braking components which had included the rack and pinion, brake hoses and brake pipes had revealed that these components were all generally intact. However the rear left tie rod was found to be damaged as a result of the accident. See photo 17 - 26 below.

**Photo 25** shows the various undercarriage components at the rear right wheel of the Motor Car, in particular the rear tie rod (arrowed) was observed to be damage as a result of the accident.

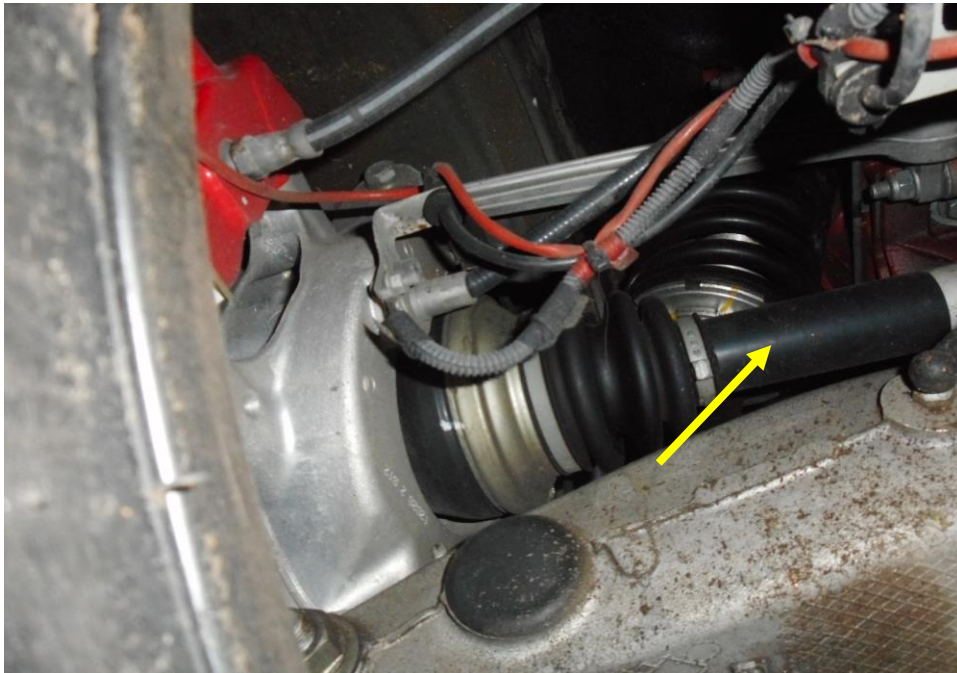
**Photo 26** shows the various undercarriage components at the rear left wheel of the Motor Car, in particular the drive shaft (yellow arrow). The various undercarriage components of the Motor Car were all found to be intact without any visible damage. There was also no sign of fluid stain(s) observed on the various undercarriage components.

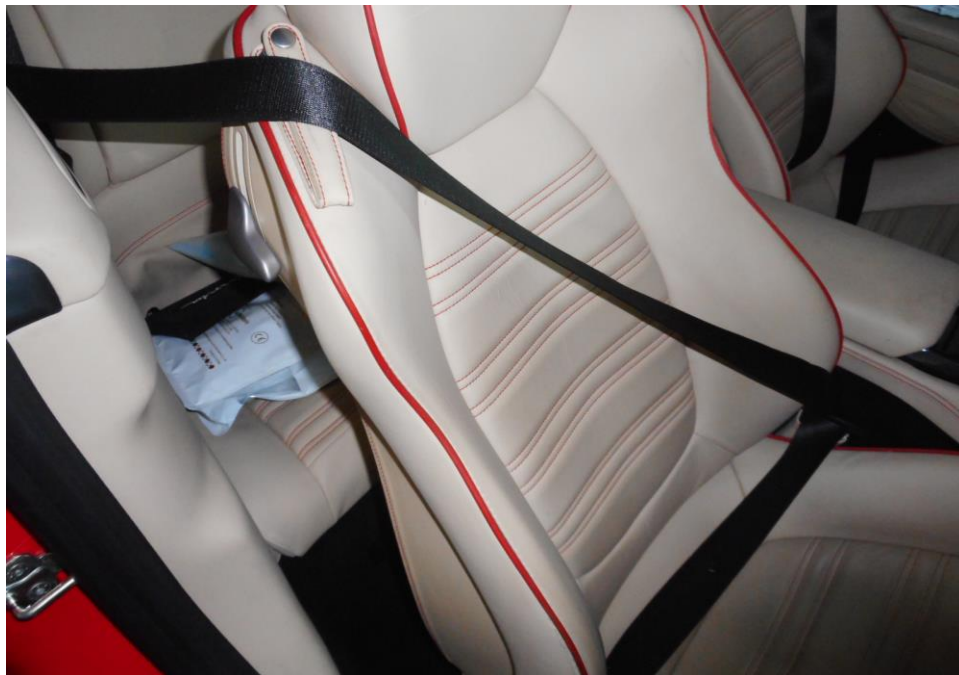
**Photo 27** shows that the seat belt on the right seat were able to be fastened securely into the respective pre-tensioners that were fitted at the sides of the each seat.

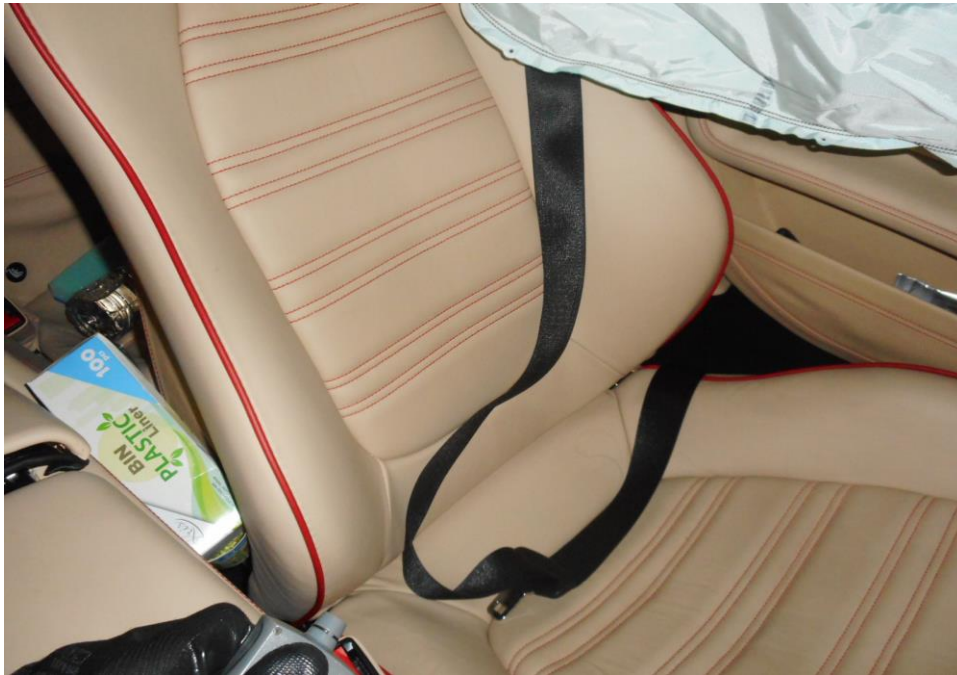
15. The right seat belt were tested and all the seat belts were able to be fastened securely into the respective pre-tensioners that were fitted at the sides of each seat. The left seat belt of was worn at the material time of accident as the respective pre-tensioners that were fitted at the side of each seat was activated upon the material time. See photo 27 and 28 below.

**Photo 28** shows that the seat belt on the left seat was worn at the material time of accident as the safety pre-tensioners was activated at the moment of impact and caused the seat belt to be locked into the last position. The airbag was also deployed as of result of the accident.
