You're Ref: TP/IP/54933/2020
Our Ref: CI/TPD21000234/P

2nd February 2021

MECHANICAL INSPECTION REPORT OF MOTOR VAN GBB 2538T

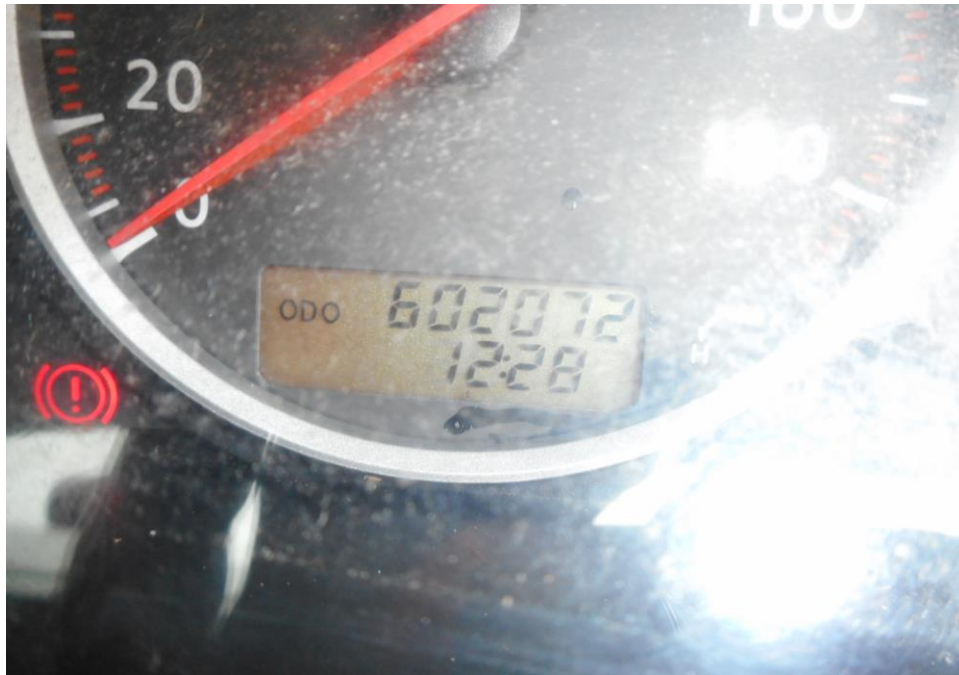
Photo 1 shows the mileage of the Motor Van at the time of my inspection. The mileage observed was 602,072km.

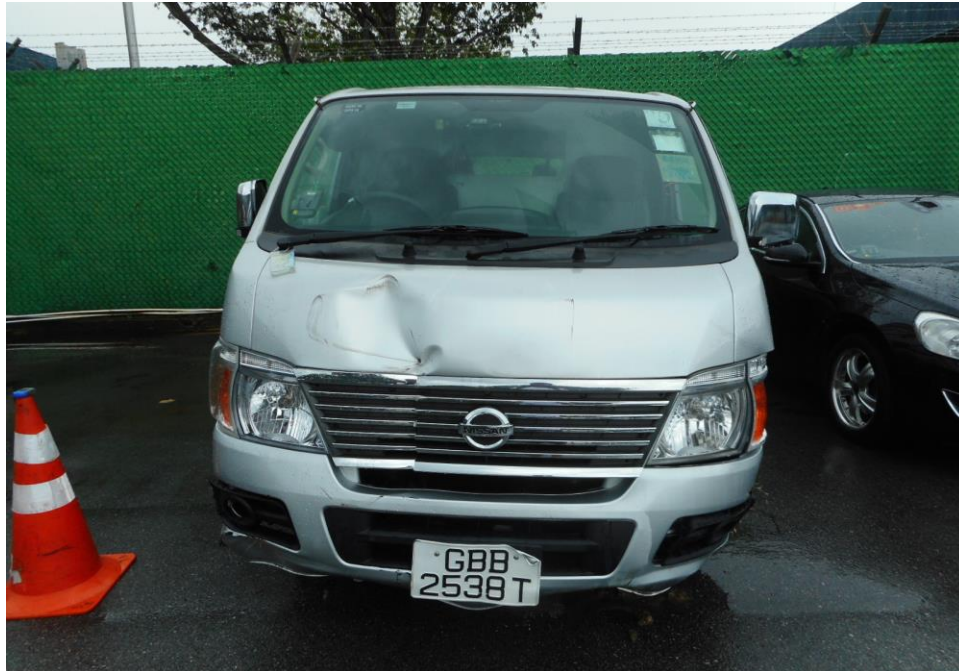
4. The mileage of the Motor Van at the time of my inspection was 602,072km.
5. The Motor Van was observed to have sustained damage at its front portion. Its front body panel, front grille and front bumper are the body parts that were damaged as a result of the accident. The Motor van was unable to be started up due to a mechanical issue to its clutch pedal.

Photo 2 shows a general view of the Motor Van's front body at the time of my inspection. Its front body panel, front grille and front bumper are the body parts that were damaged as a result of the accident.

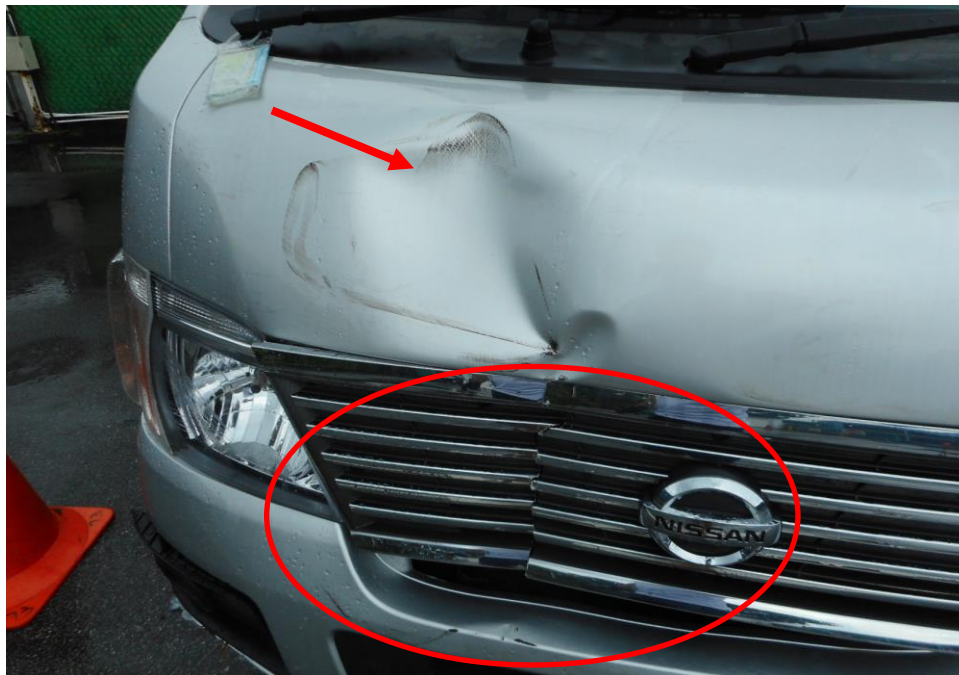
Photo 3 shows the close up view of the Motor Van's front body at the time of my inspection. Its front body panel (arrowed) and front grille (circled) are the body parts that were damaged as a result of the accident.

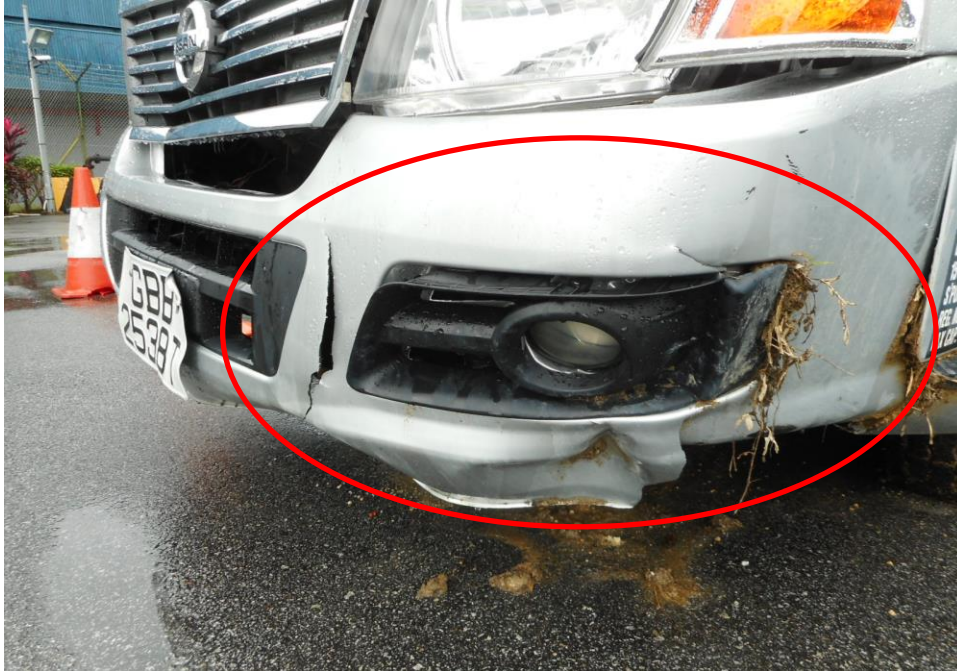
Photo 4 shows the close up view of the Motor Van's front body at the time of my inspection. Its front bumper (circled) are the body parts that were damaged as a result of the accident.

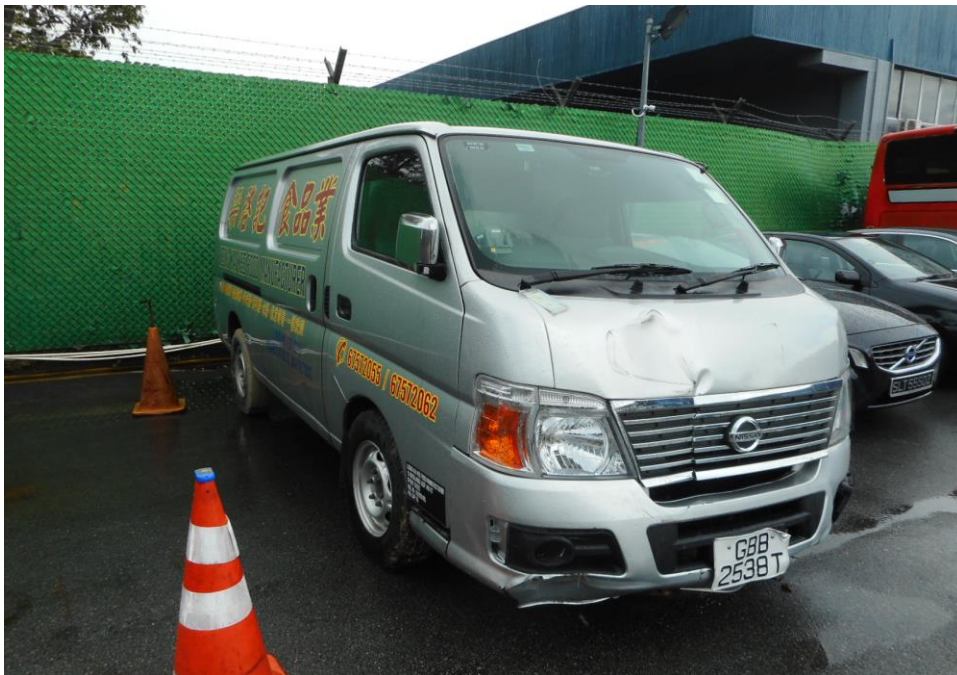
Photo 5 shows a general view of the Motor Van's right body at the time of my inspection. The right portion of the Motor Van was observed to have been unaffected by the accident.

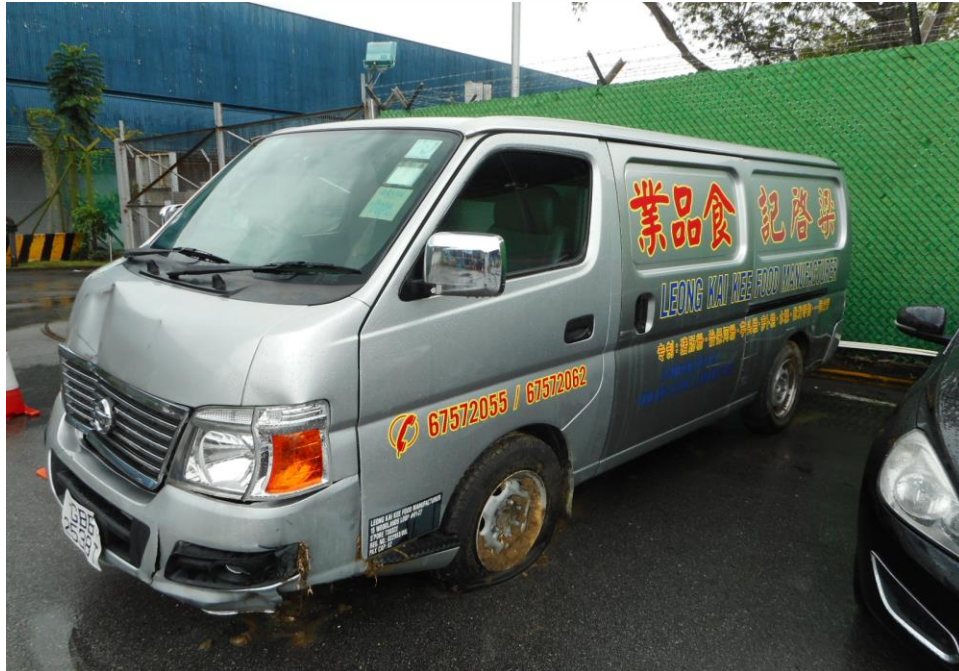
Photo 6 shows a general view of the Motor Van's left body at the time of my inspection. The left portion of the Motor Van was observed to have been unaffected by the accident.

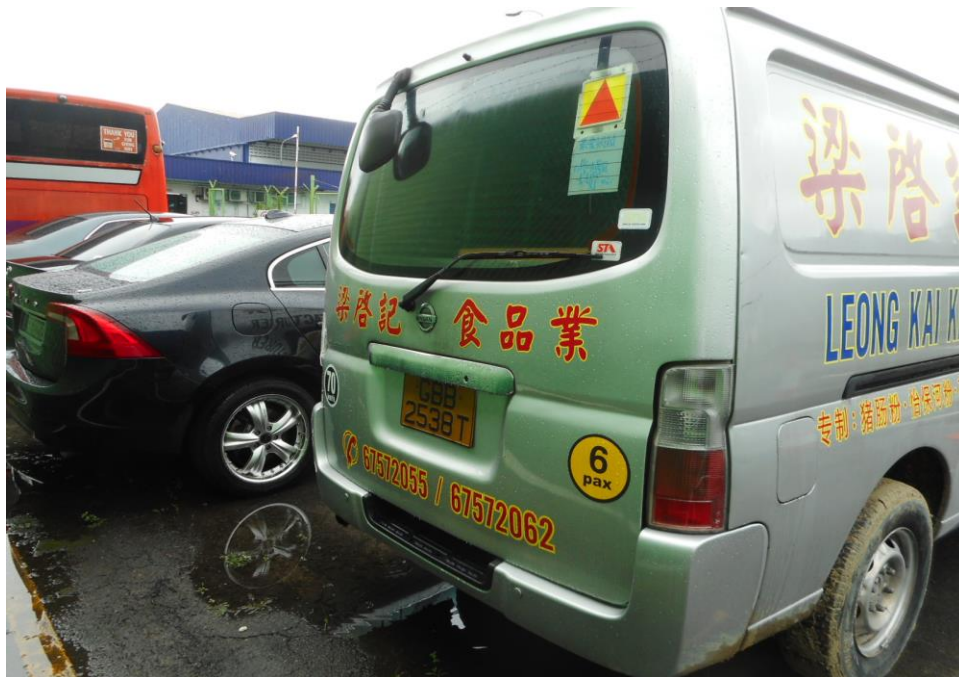
Photo 7 shows the general view of the Motor Van's rear body at the time of my inspection. The Motor Van rear was observed to be unaffected by the accident.

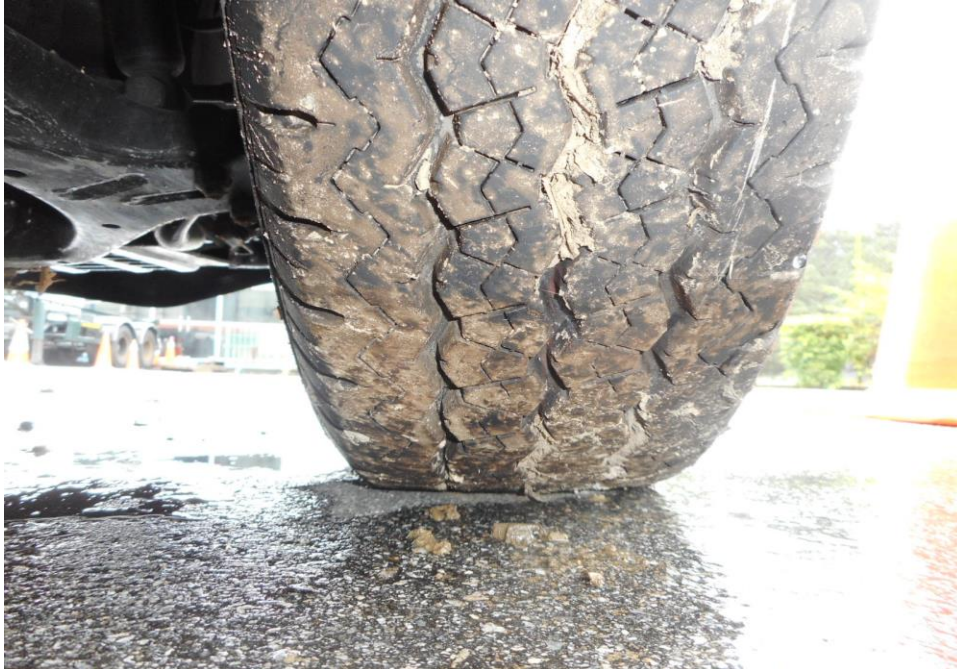
Photo 8 shows the condition of the front right tyre of the Motor Van, which was observed to be in serviceable condition with remaining tread depth of approximately 8.2mm. The tyre was sufficiently inflated for vehicular operation with no tear, cut or burst mark(s) on the outer and the inner sidewalls as well as across the tread. The 4 tyres of the Motor Van were wrapped around standard steel wheel rims without any damage.

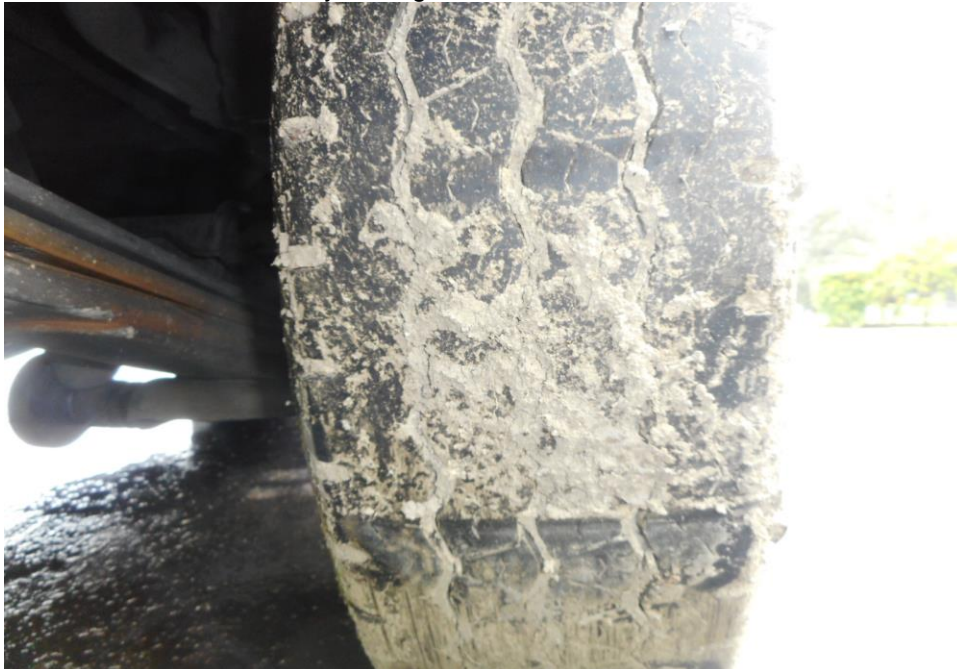
Photo 9 shows the condition of the rear right tyre of the Motor Van, which was observed to be in serviceable condition with remaining tread depth of approximately 4.8mm. The tyre was also observed to be sufficiently inflated for vehicular operation with no tear, cut or burst mark(s).

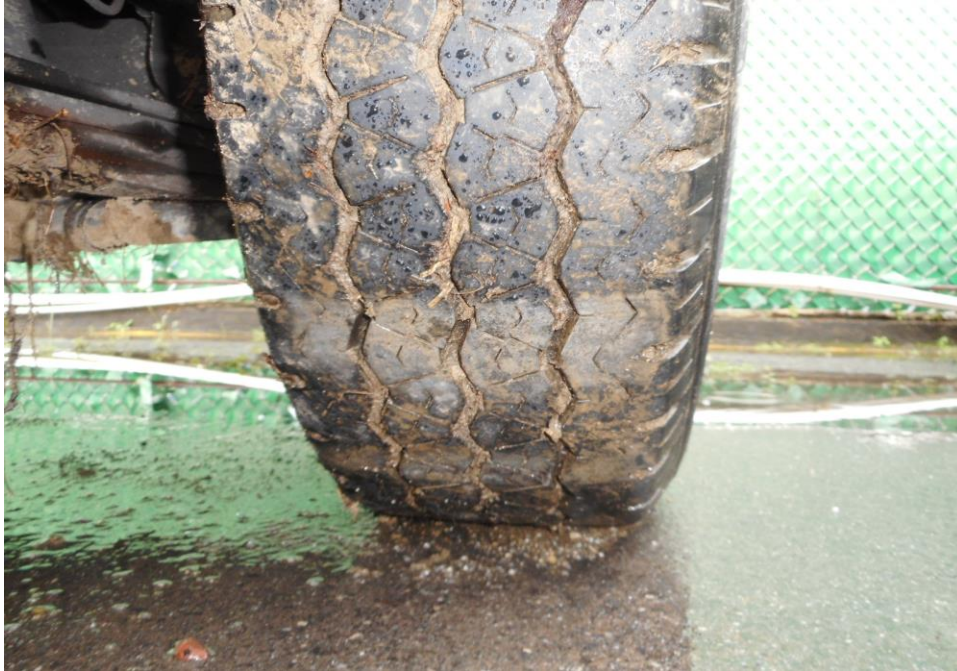
Photo 10 shows the condition of the rear left tyre of the Motor Van, which was observed to be in serviceable condition with remaining tread depth of approximately 5.2mm. The tyre, which was wrapped around steel wheel rim, was also observed to be sufficiently inflated for vehicular operation. The 4 tyres of the Motor Van were wrapped around standard steel wheel rims.

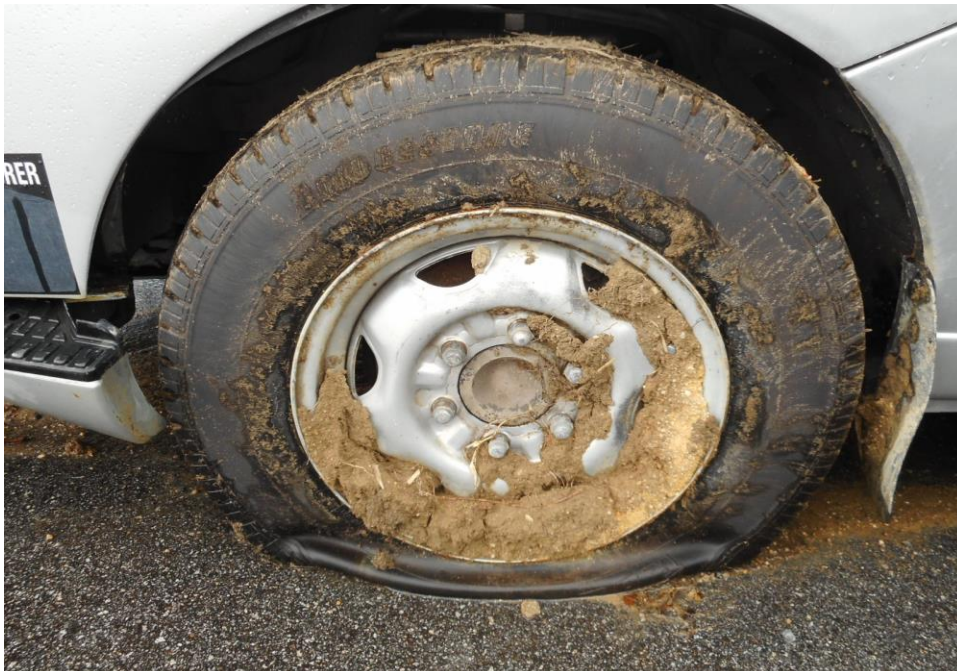
Photo 11 shows the condition of the front left tyre of the Motor Van, which was observed to be deflated likely due to the result of the accident. The with remaining tread depth of approximately 8.1mm

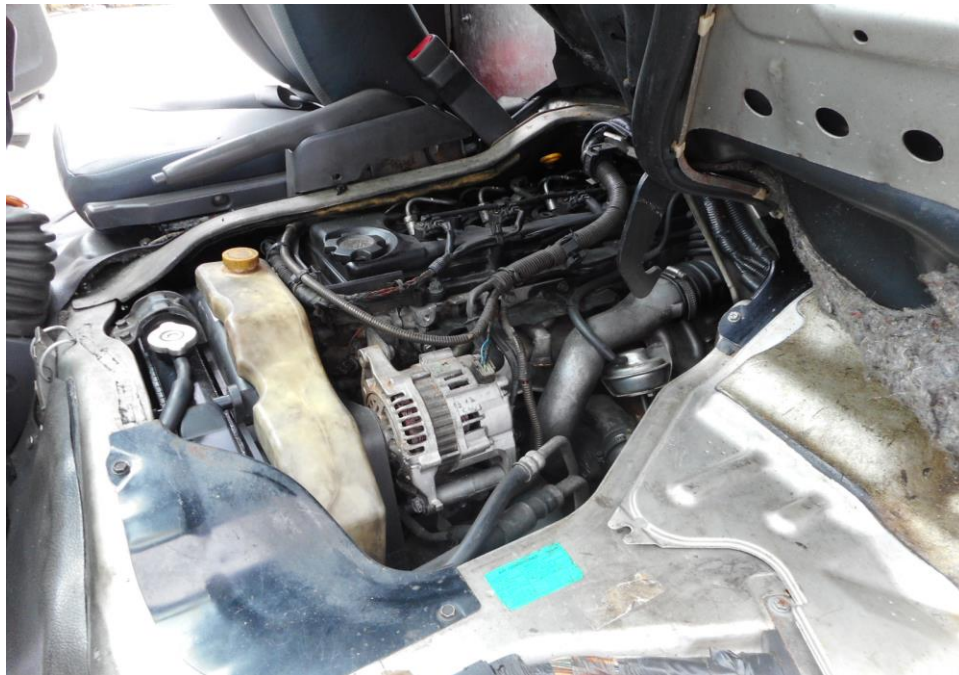
Photo 12 shows a general view of the Motor Van's engine compartment. The various parts and components inside the engine compartment were unaffected by the accident. There was also no sign(s) or indication(s) of fluid leakage and/or fluid stain within the engine compartment.

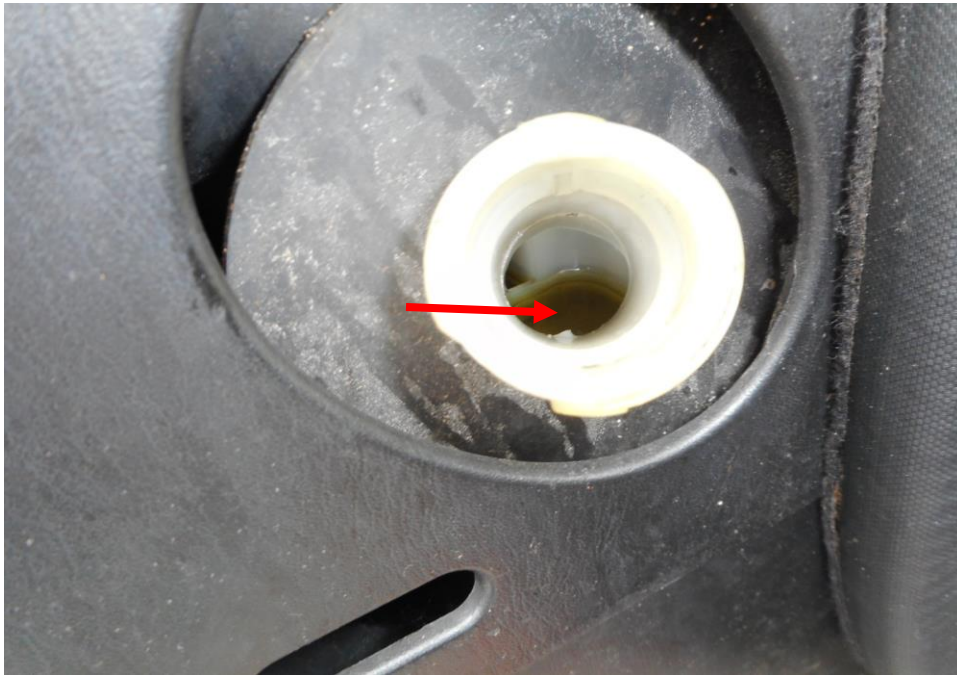
Photo 13 shows the brake fluid reservoir of the Motor Van at the time of my inspection. The brake fluid was observed to be of sufficient level (arrowed) and without any visible contamination.

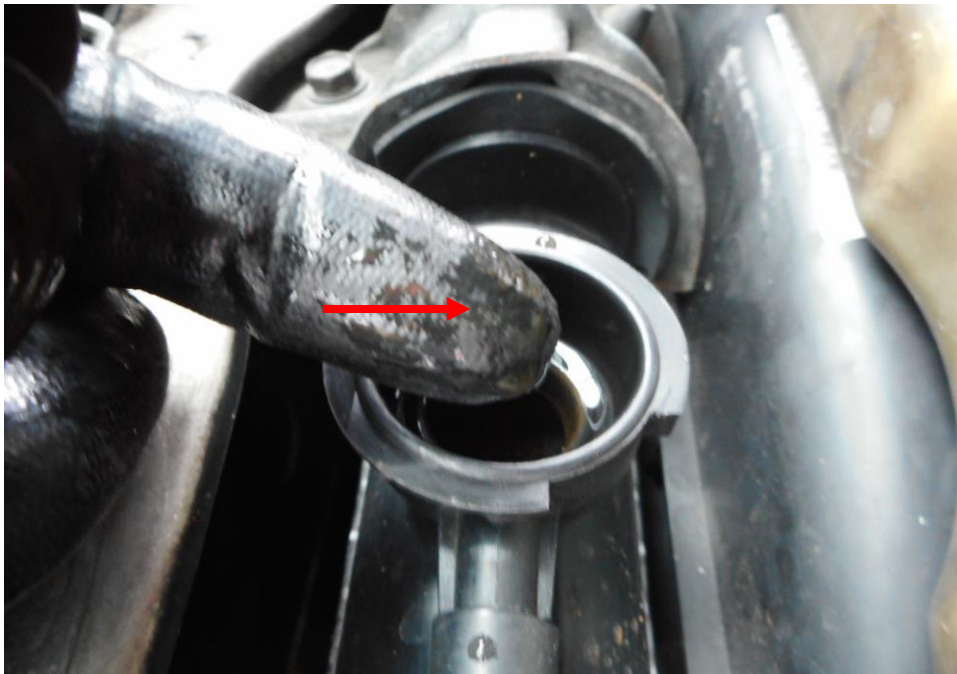
Photo 14 shows checks being carried out to the engine coolant of the Motor Van at the time of my inspection. The engine coolant was observed to be of sufficient level (arrowed) and without any visible contamination.

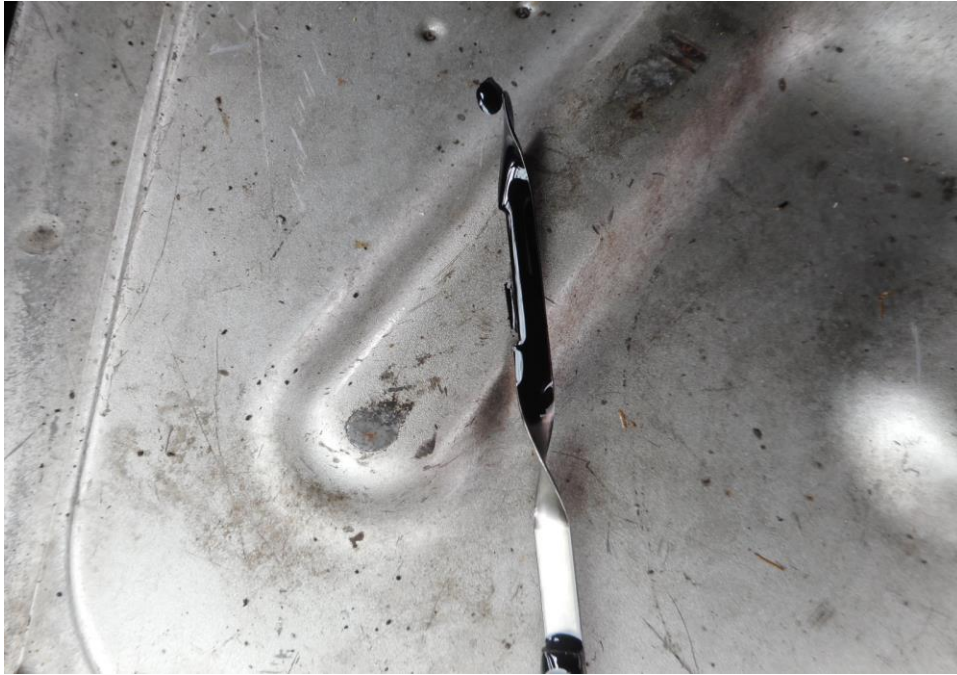
Photo 15 shows the engine oil dip stick of the Motor Van at the time of my inspection. The engine oil was observed to be of sufficient level and without any visible contamination.

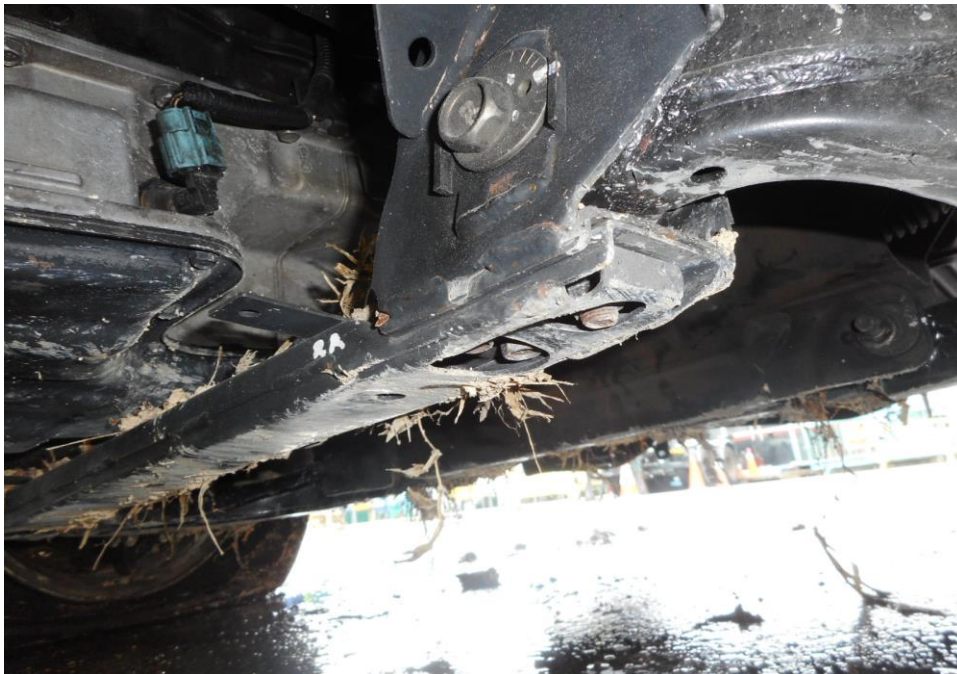
Photo 16 shows the undercarriage of the Motor Van, at the area where the engine housing and transmission housing are located. I did not find any sign(s) or indication(s) of fluid leak and/or fluid stain(s) on the underside of the Motor Van.

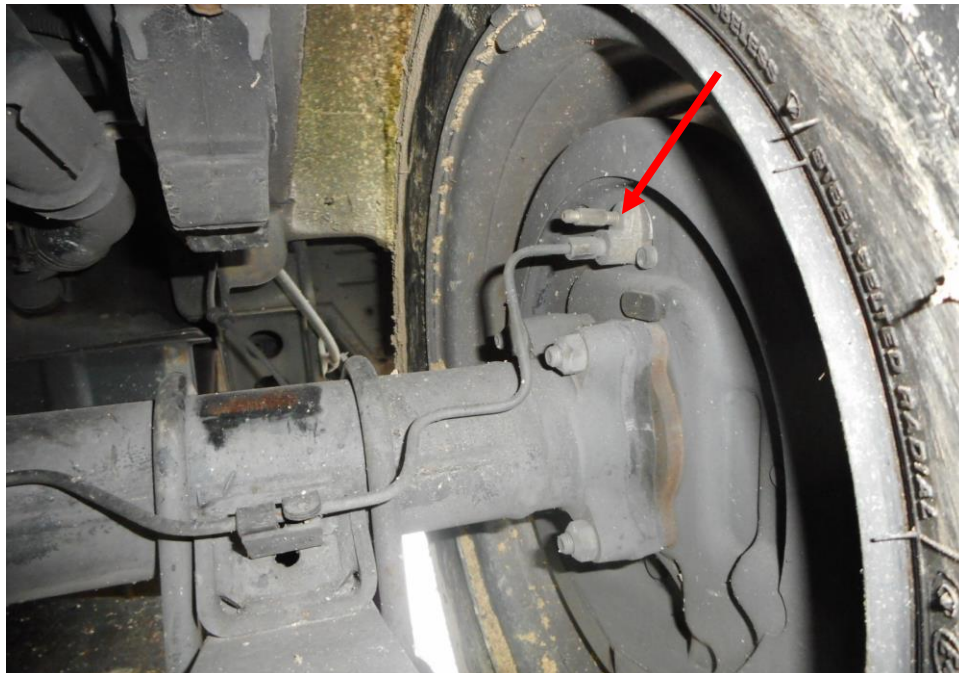
Photo 17 shows the brake hose/pipe (arrowed) at the rear right wheel of the Motor Van. No leakage of brake fluid was observed. Visual examination of the various components of the braking system like the brake caliper, brake booster, brake pedal etc. had revealed all to be intact and without visible damage.

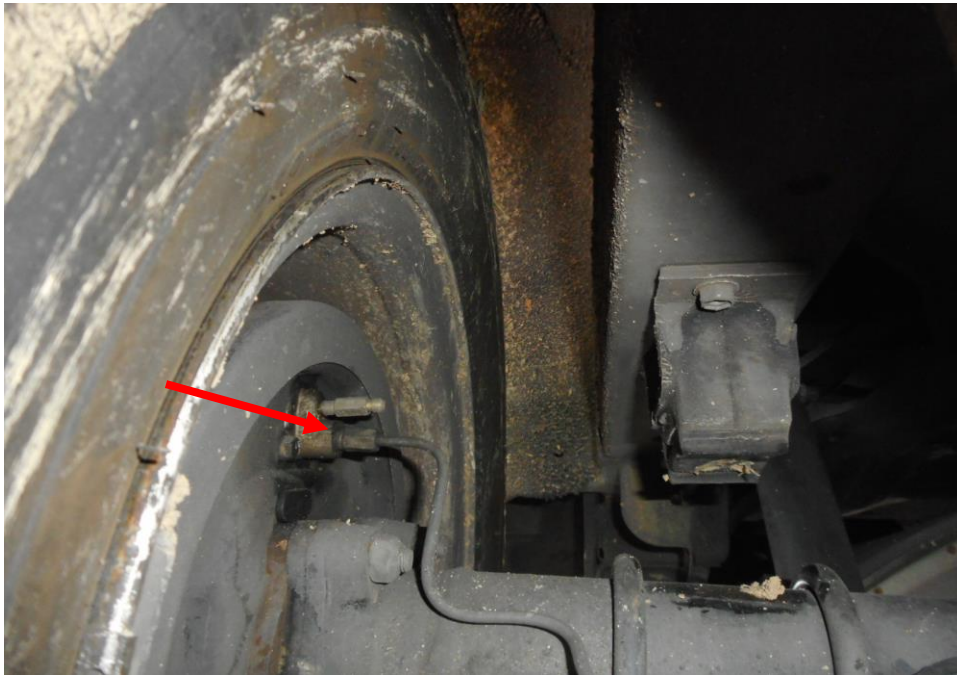
Photo 18 shows the brake hose/pipe (arrowed) at the rear left wheel of the Motor Van. I did not observe any leakage of brake fluid at the time of my inspection of the Motor Van. Static tests of the Motor Van's braking system had indicated that there was no internal leakage of pressure/vacuum. The undercarriage components of the Motor Van were also all found to be intact and without any visible damage.

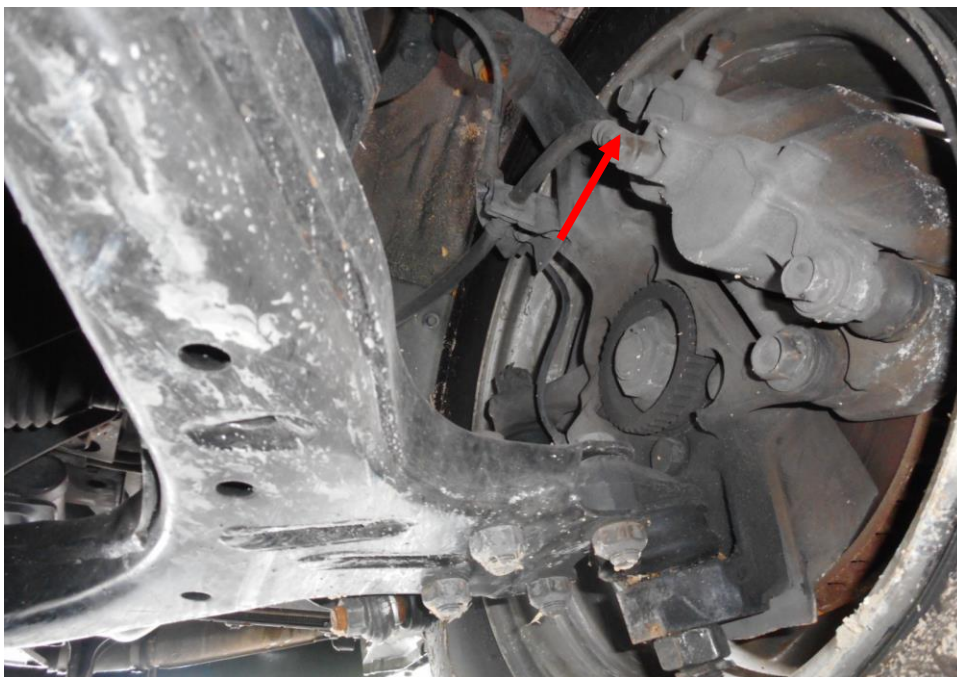
Photo 19 shows the brake hose/pipe (arrowed) at the front right wheel of the Motor Van. I did not observe any leakage of brake fluid at the time of my inspection of the Motor Van. Static tests of the Motor Van's braking system had indicated that there was no internal leakage of pressure/vacuum. The undercarriage components of the Motor Van were also all found to be intact and without any visible damage.

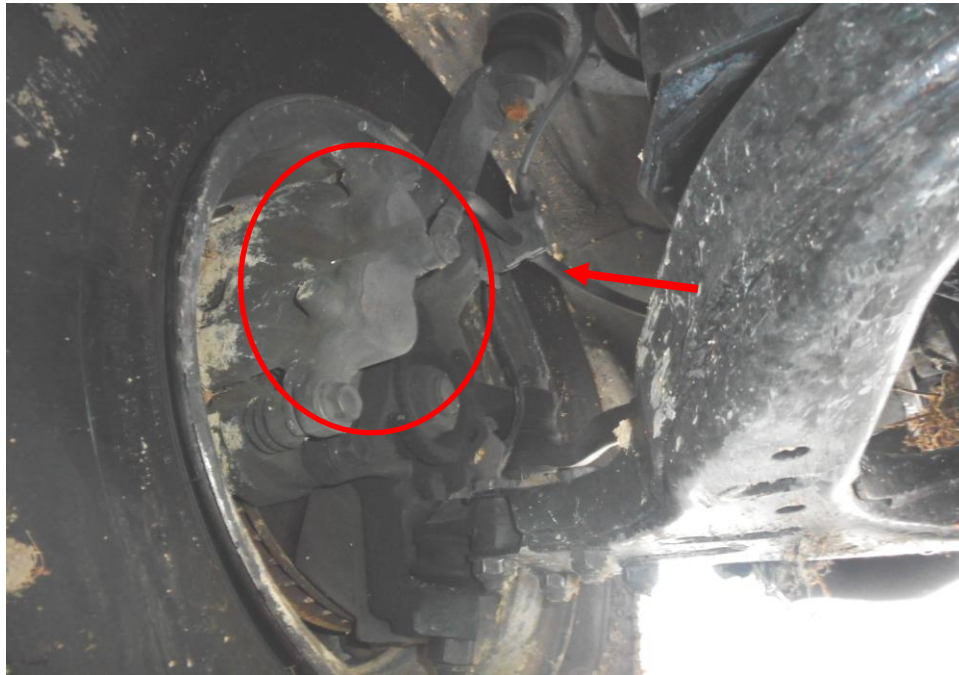
Photo 20 shows the brake hose/pipe (arrowed) at the front left wheel of the Motor Van. No leakage of brake fluid was observed. Visual examination of the various components of the braking system like the brake caliper (circled), brake booster, brake pedal etc had revealed all to be intact and without visible damage.

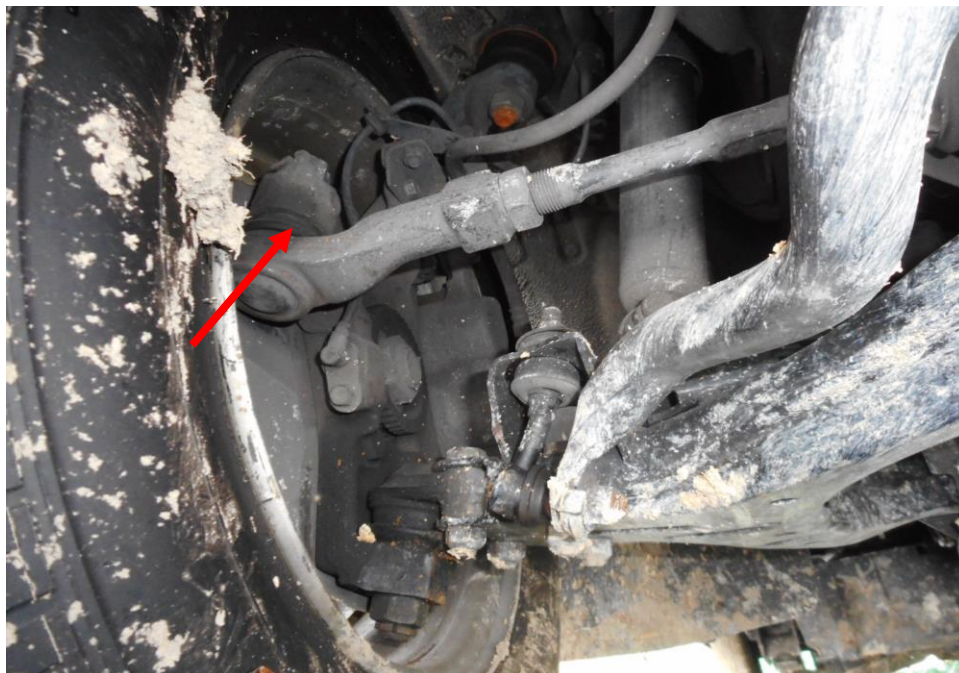
Photo 21 shows the various undercarriage components at the front right wheel of the Motor Van, in particular the steering tie rod (red arrow). The various steering components were all found to be intact, suggesting that the steering system of the Motor Van was likely to be in serviceable condition at the material time of accident. There was also no sign of fluid stain observed on the various undercarriage components at the front right wheel of the Motor Van.

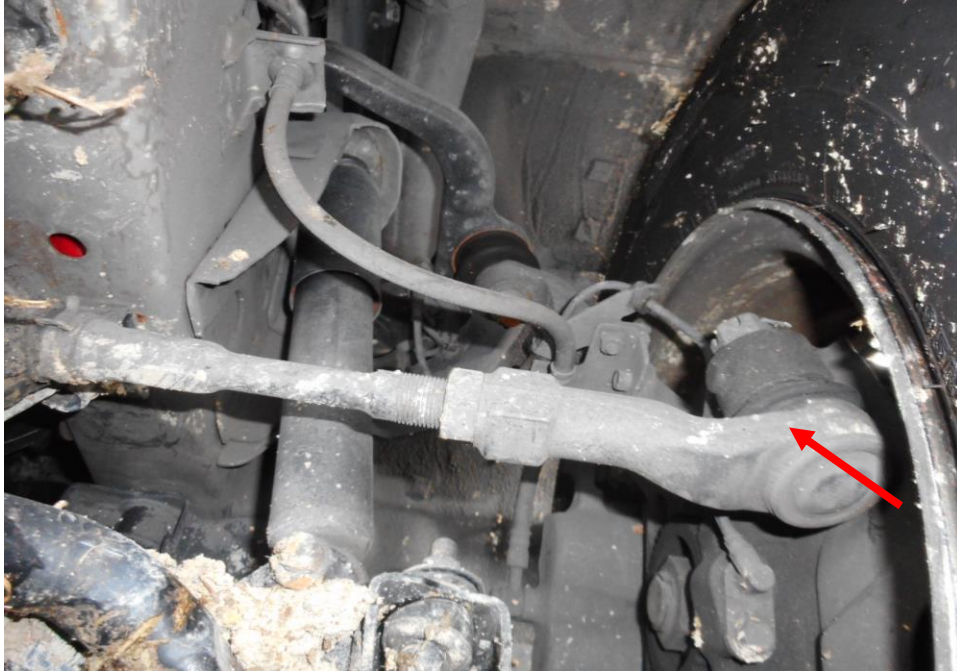
Photo 22 shows the various undercarriage components at the front left wheel of the Motor Van, which had included the steering tie rod (red arrow). The various undercarriage components of the Motor Van were all found to be intact without any visible damage.

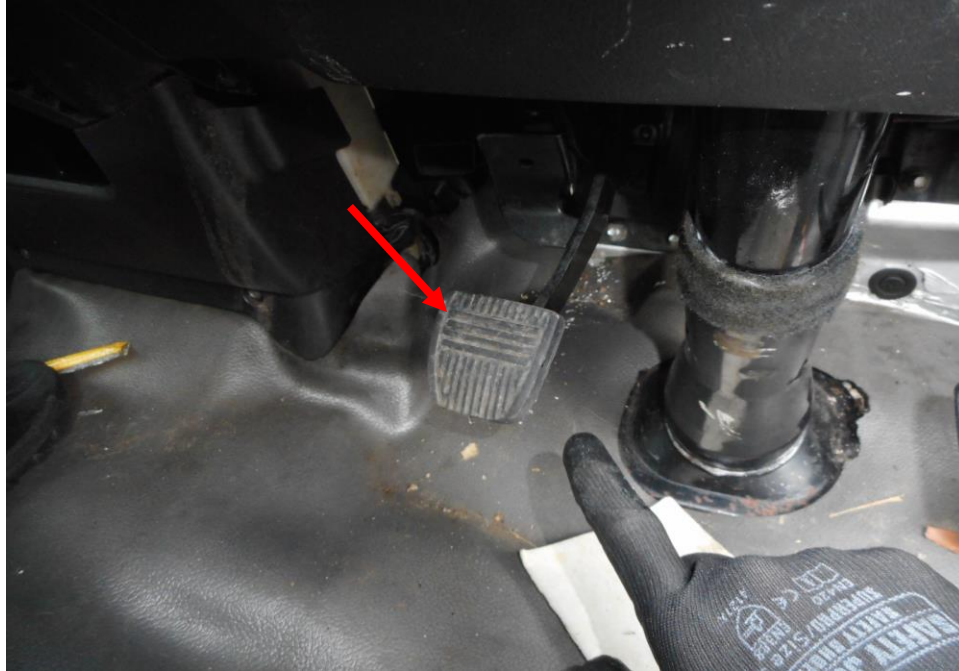
13. For this inspection, we observed that the clutch pedal was faulty and to our understanding, the clutch pedal would return to position when not depressed. However for this particular case, we observed that when the clutch pedal was depressed and upon releasing it would get stuck and not return to position, this would suggest that the clutch system was is faulty at the time material time of accident. See photo 23 and 24 below

Photo 23 shows the clutch pedal of the Motor Van, before depressing (red arrow).

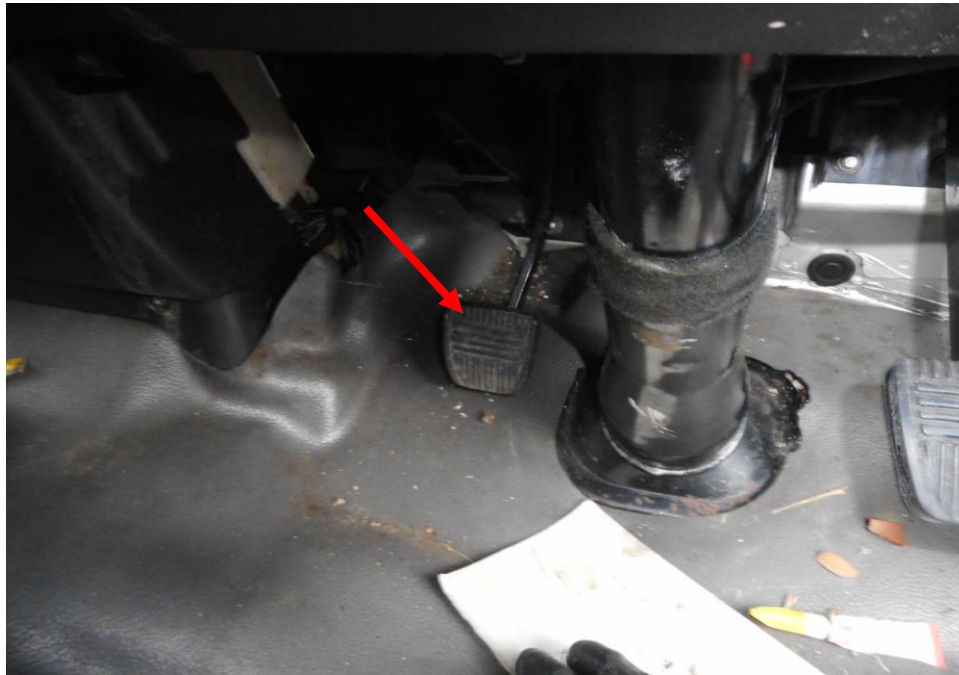
Photo 24 shows the clutch pedal of the Motor Van, after depressing (red arrow). The actual workings of the clutch pedal is that it will return to pre-depressing position when it is not depressed, however for this case the clutch pedal remained in depressed position even when there was no pressing motion on it. These suggest a mechanical fault to the clutch system of the Motor Van.

17. For this particular case, it appears that its clutch system was faulty as we found evidence(s) to suggest that there was mechanical failure to the Motor Van that may have caused and/or contributed to the accident.
18. Static brake tests was able to be conducted and In general our visual inspection of the mechanical components of the Motor Van's braking system appear to suggest that its braking system was in serviceable condition at the material time of accident and there was no leakage found at the braking components of the Motor Van.
