You're Ref: TP/IP/53687/2020  
Our Ref: CI/TPD21000235/P

2<sup>nd</sup> February 2021

**MECHANICAL INSPECTION REPORT OF MOTOR CAR SLK 3954C**

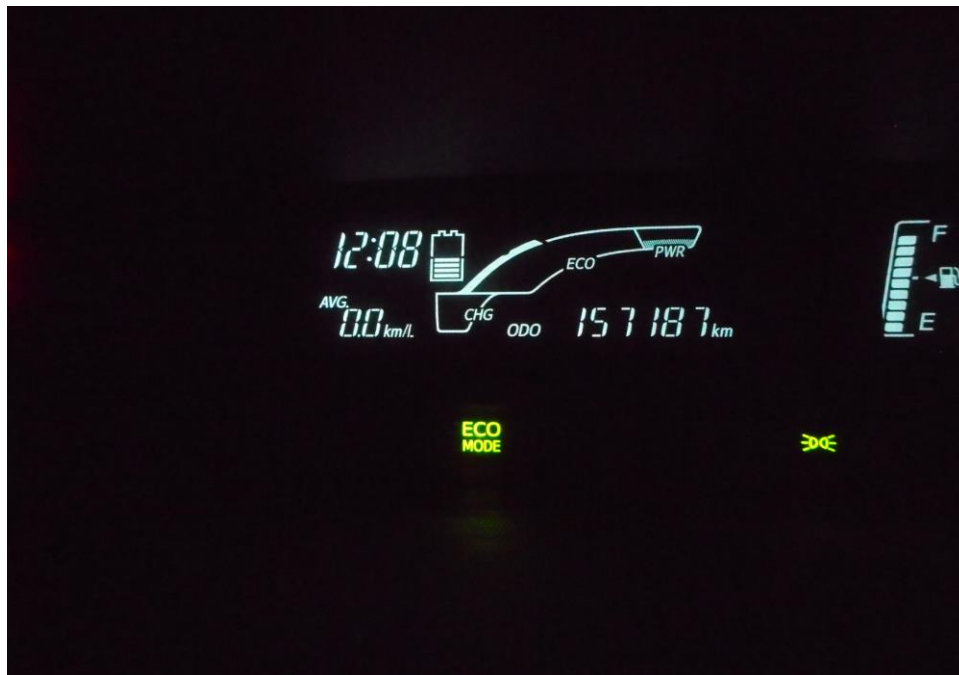
**Photo 1** shows the mileage of the Motor Car at the time of my inspection. The mileage observed was 157,187km.

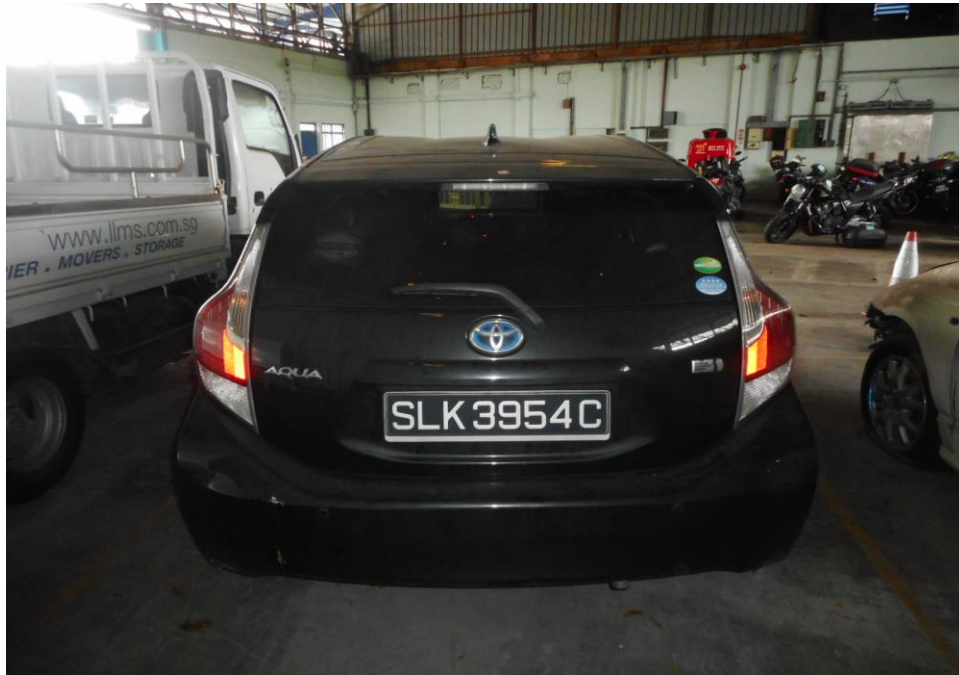
**Photo 2** shows the general view of the Motor Car's rear body at the time of my inspection. The Motor Car rear was observed to be unaffected by the accident.

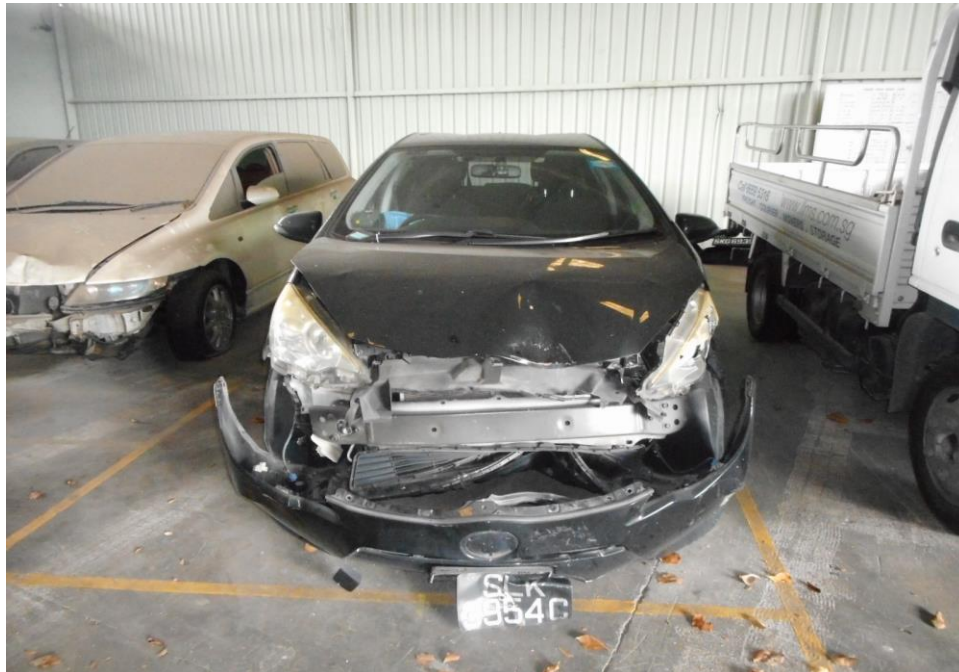
4. The mileage of the Motor Car at the time of my inspection was 157,187km.
5. The Motor Car was observed to have sustained damage at its front portion. Its front bonnet, front bumper, front left fender and front left headlamp are the body parts that were damaged as a result of the accident.

**Photo 3** shows a general view of the Motor Car's front body at the time of my inspection. Its front bonnet, front bumper, front left fender and front left headlamp are the body parts that were damaged as a result of the accident.

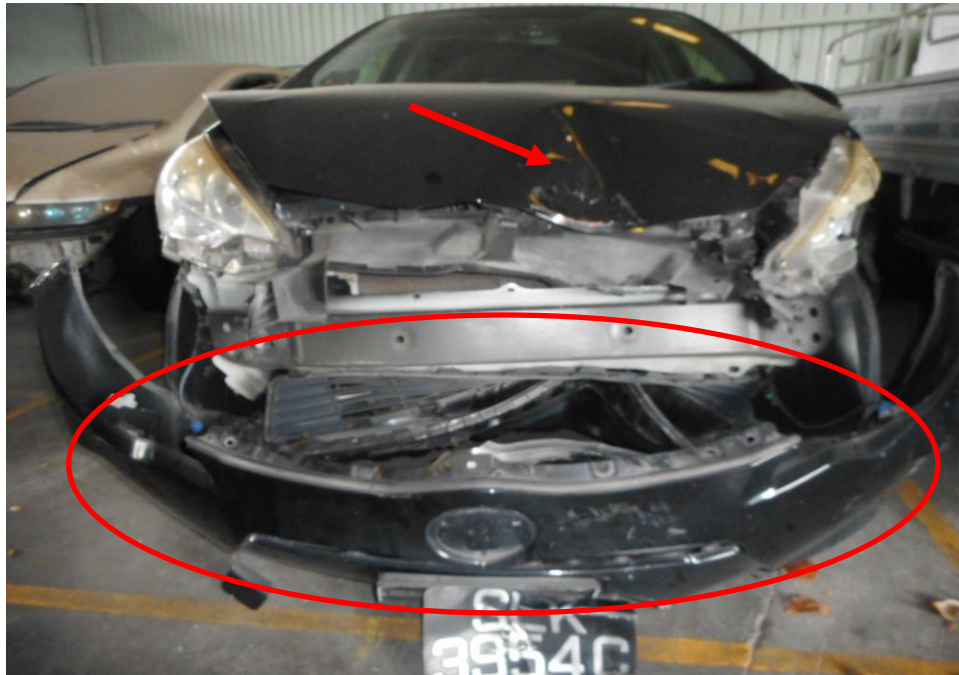
**Photo 4** shows the close up view of the Motor Car's front body at the time of my inspection. Its front bumper (circled) and front bonnet (arrowed) are the body parts that were damaged as a result of the accident.

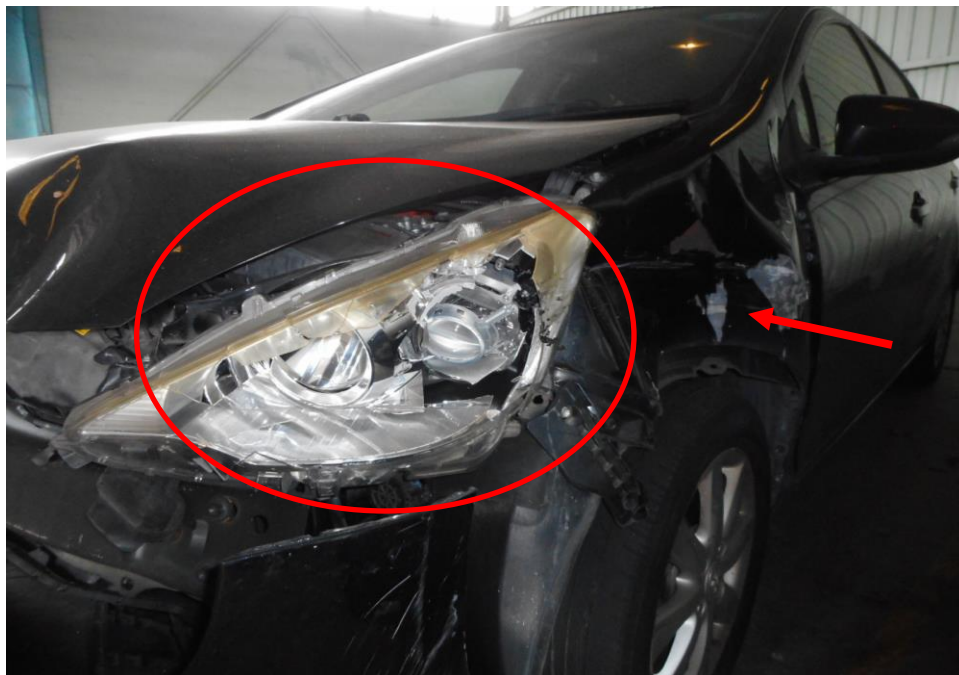
**Photo 5** shows the close up view of the Motor Car's front body at the time of my inspection. Its front left headlamp (circled) and front left fender (arrowed) are the body parts that were damaged as a result of the accident.

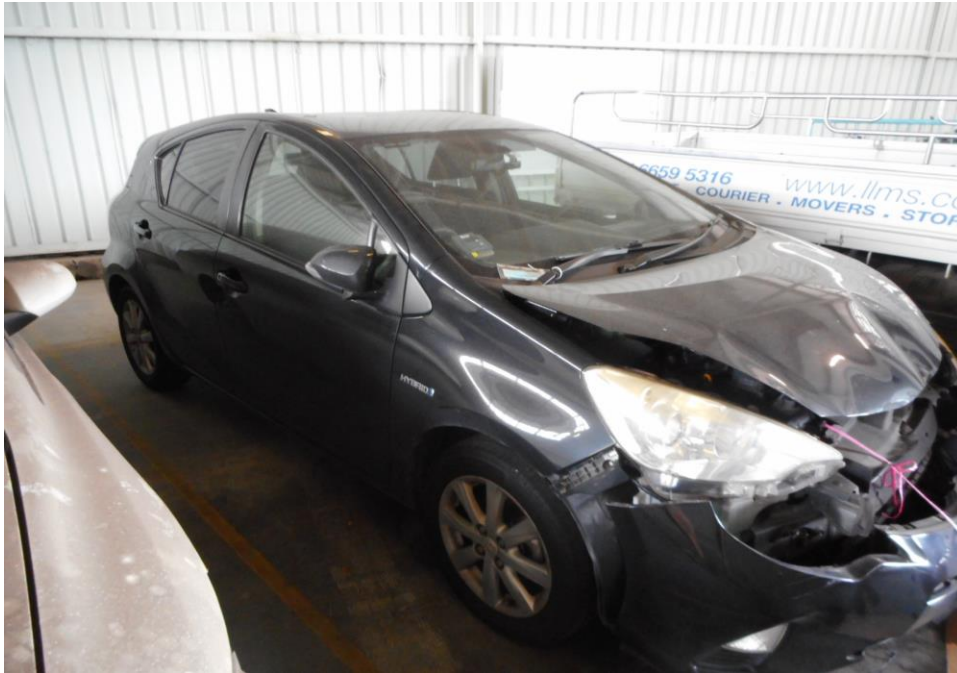
**Photo 6** shows a general view of the Motor Car's right body at the time of my inspection. The right portion of the Motor Car was observed to have been unaffected by the accident.

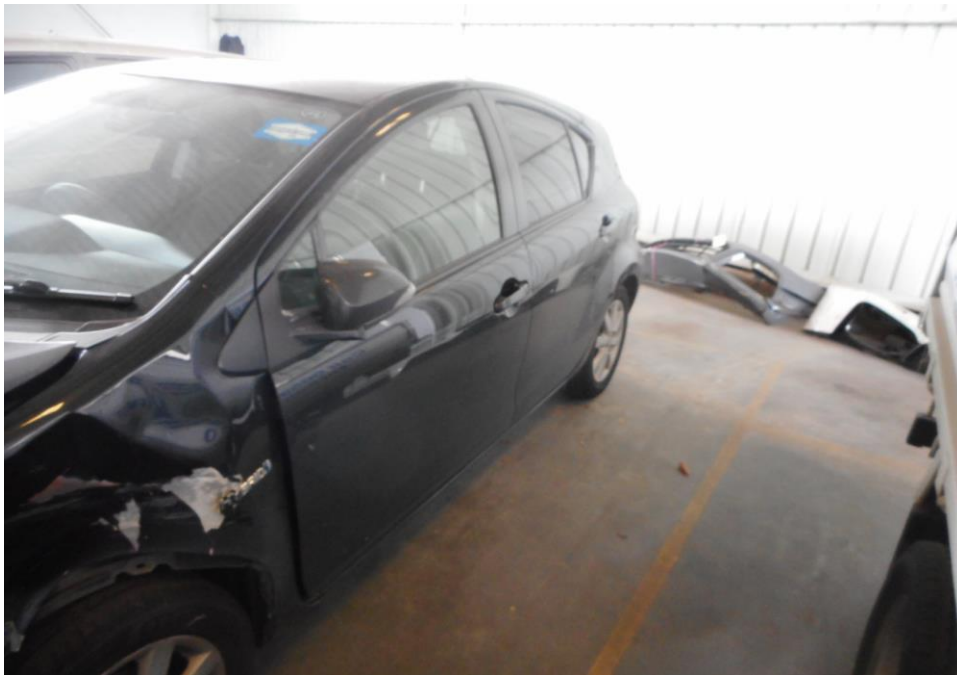
**Photo 7** shows a general view of the Motor Car's left body at the time of my inspection. The left portion of the Motor Car was observed to have been unaffected by the accident.

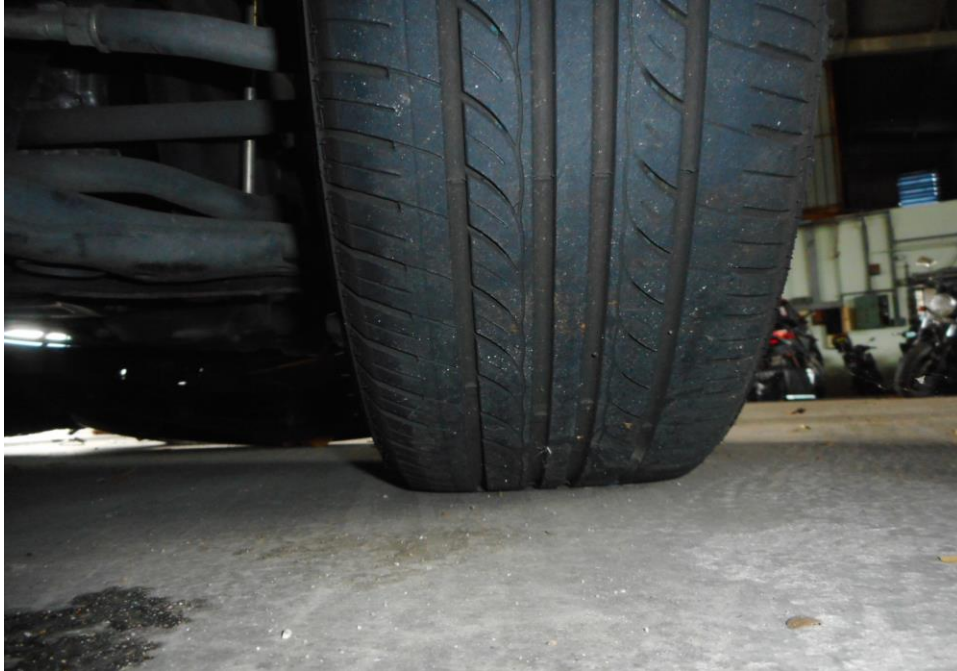
**Photo 8** shows the condition of the front right tyre of the Motor Car, which was observed to be in serviceable condition with remaining tread depth of approximately 4.1mm. The tyre was sufficiently inflated for vehicular operation with no tear, cut or burst mark(s) on the outer and the inner sidewalls as well as across the tread. The 4 tyres of the Motor Car were wrapped around standard steel wheel rims without any damage.

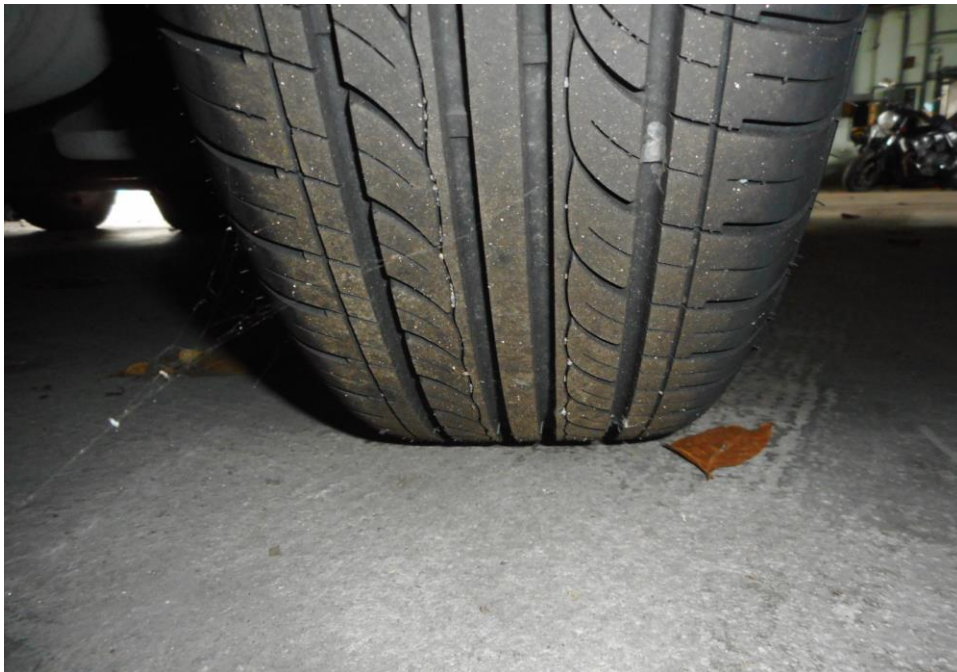
**Photo 9** shows the condition of the rear right tyre of the Motor Car, which was observed to be in serviceable condition with remaining tread depth of approximately 6.1mm. The tyre was also observed to be sufficiently inflated for vehicular operation with no tear, cut or burst mark(s).

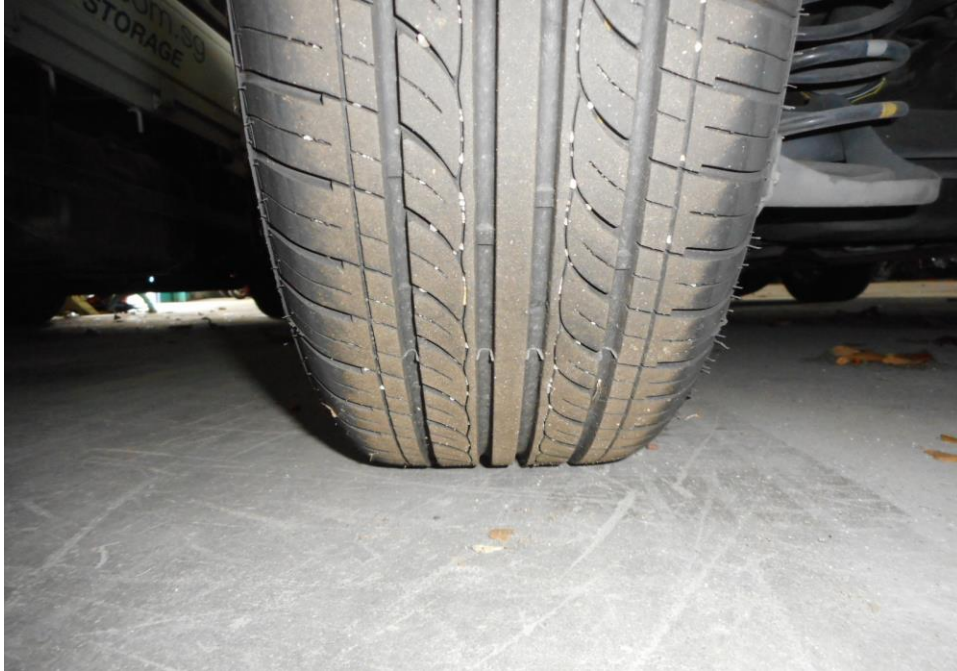
**Photo 10** shows the condition of the rear left tyre of the Motor Car, which was observed to be in serviceable condition with remaining tread depth of approximately 6.3mm. The tyre, which was wrapped around steel wheel rim, was also observed to be sufficiently inflated for vehicular operation. The 4 tyres of the Motor Car were wrapped around standard steel wheel rims.

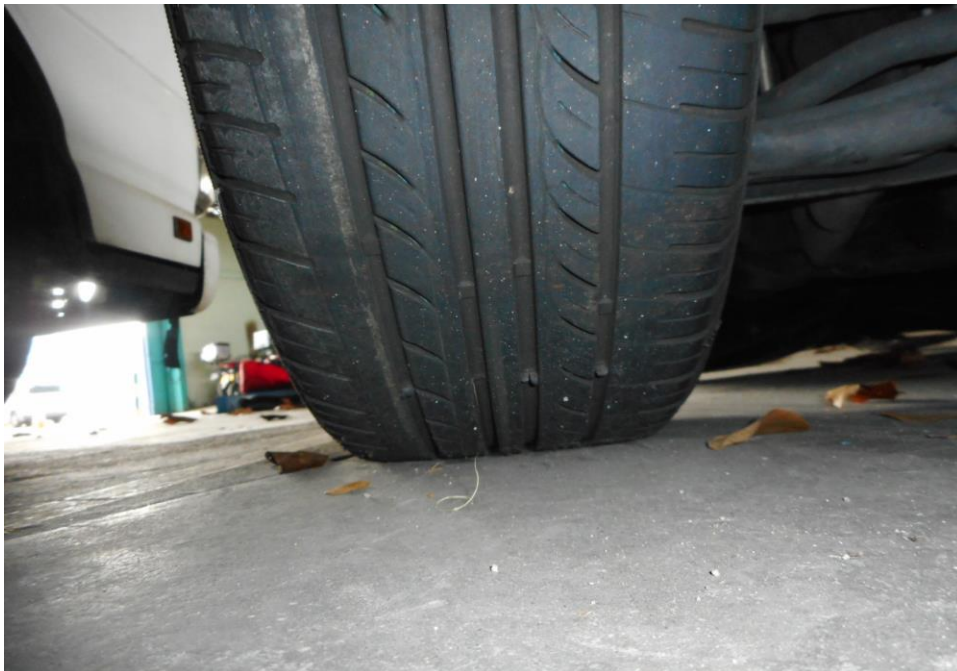
**Photo 11** shows the condition of the front left tyre of the Motor Car, which was observed to be in serviceable condition with remaining tread depth of approximately 3.8mm. The tyre, which was wrapped around steel wheel rim, was also observed to be sufficiently inflated for vehicular operation. The 4 tyres of the Motor Car were wrapped around standard steel wheel rims.

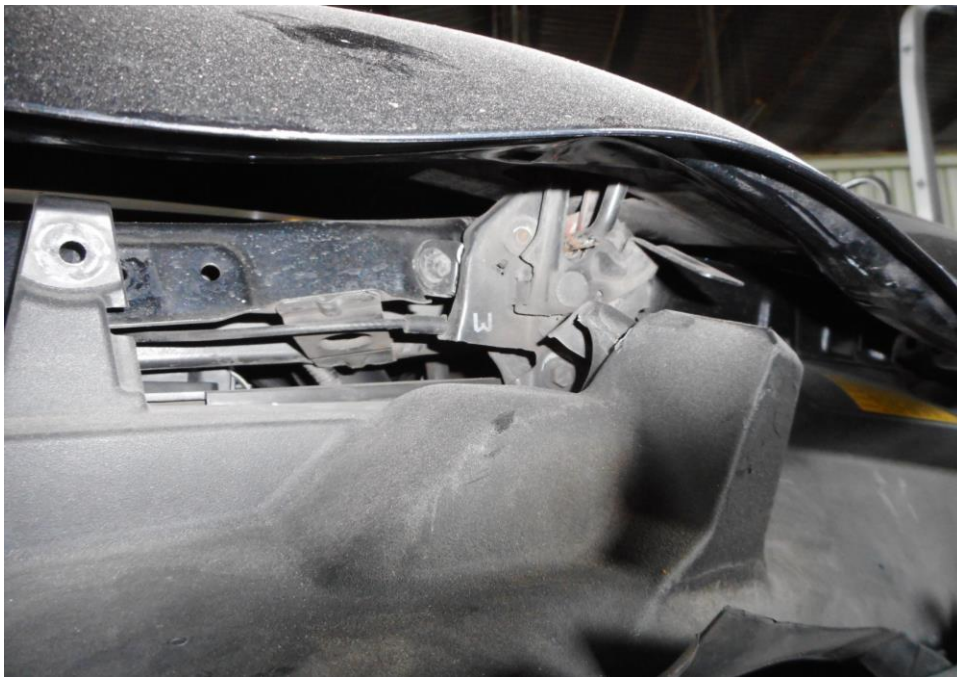
8. We were unable to raise the front bonnet of the Motor car to conduct the examination of the Motor Car's engine compartment because the damage caused by the accident had resulted in the damages to the lock mechanism of the bonnet and the structure of the engine compartment. (unable to open)
9. My subsequent checks on the underside of the Motor Car also revealed no fluid stain. Visually, the various undercarriage components of the Motor Car were all observed to be intact and without any visible damage. See photo 12 – 13 below.

**Photo 12** shows a close up view of the damaged front bonnet lock mechanism and the structure of the engine compartment of the Motor Car at the time of my inspection resulting it unable to open a result of the accident. (Unable to open)

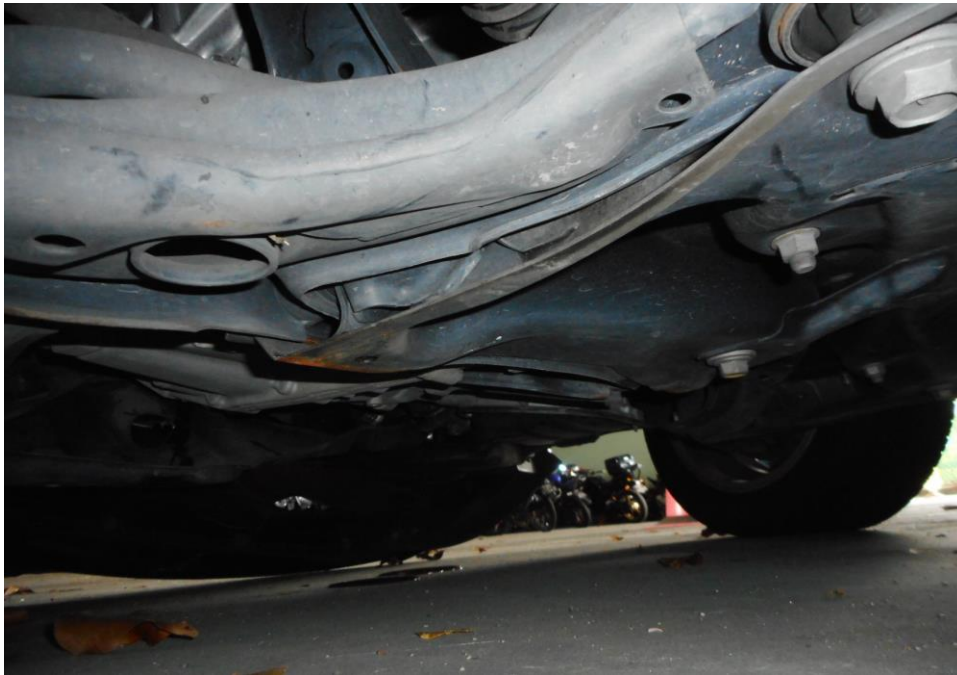
**Photo 13** shows the undercarriage of the Motor Car, at the area where the engine housing and transmission housing are located. I did not find any sign(s) or indication(s) of fluid leak and/or fluid stain(s) on the underside of the Motor Car.

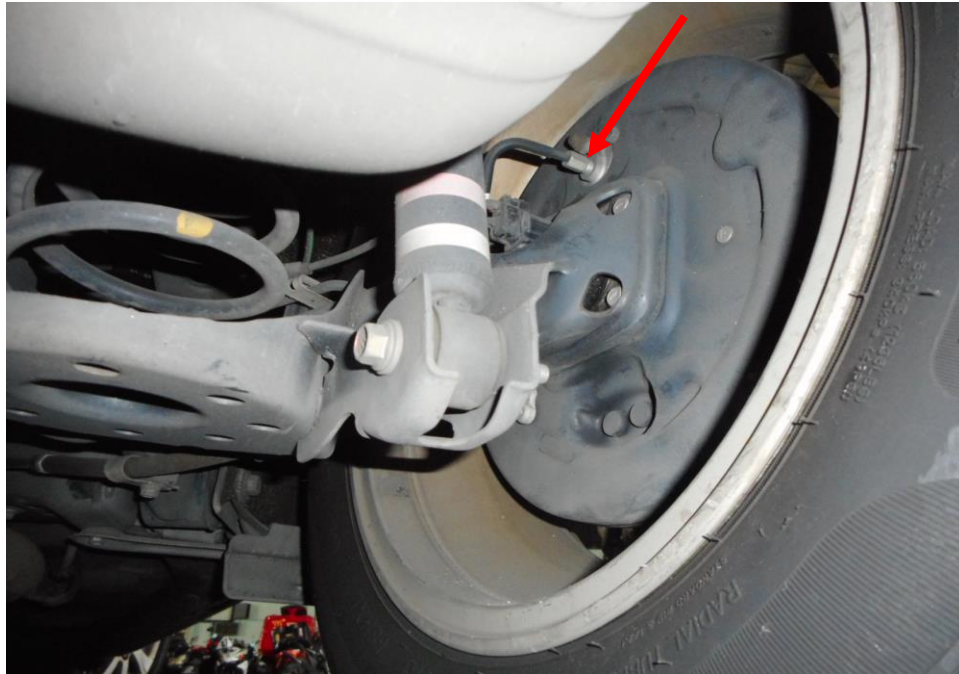
**Photo 14** shows the brake hose/pipe (arrowed) at the rear right wheel of the Motor Car. No leakage of brake fluid was observed. Visual examination of the various components of the braking system like the brake caplier, brake booster, brake pedal etc. had revealed all to be intact and without visible damage.

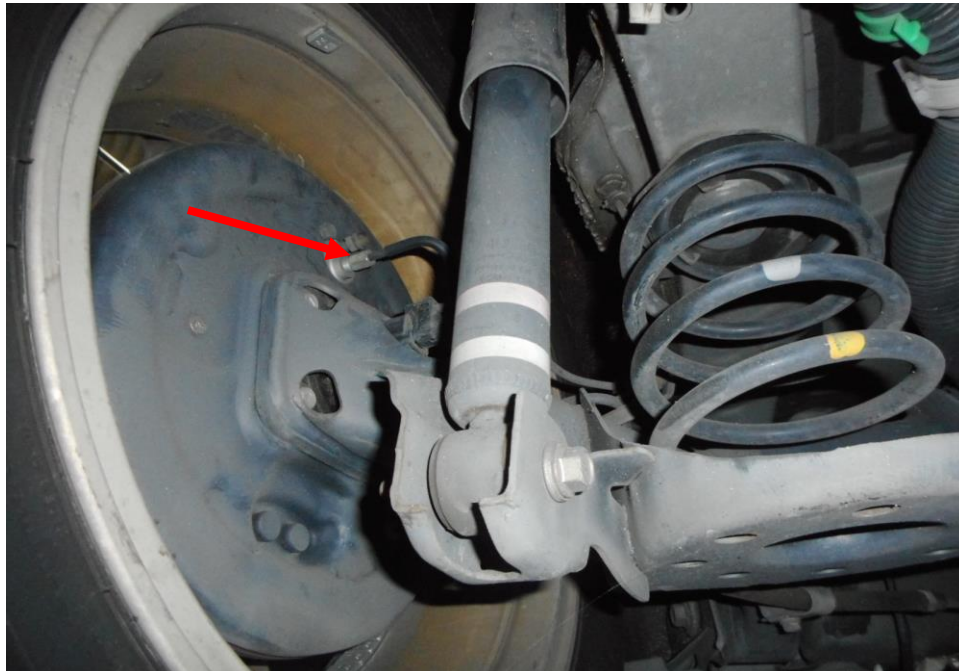
**Photo 15** shows the brake hose/pipe (arrowed) at the rear left wheel of the Motor Car. I did not observe any leakage of brake fluid at the time of my inspection of the Motor Car. Static tests of the Motor Car's braking system had indicated that there was no internal leakage of pressure/vacuum. The undercarriage components of the Motor Car were also all found to be intact and without any visible damage.

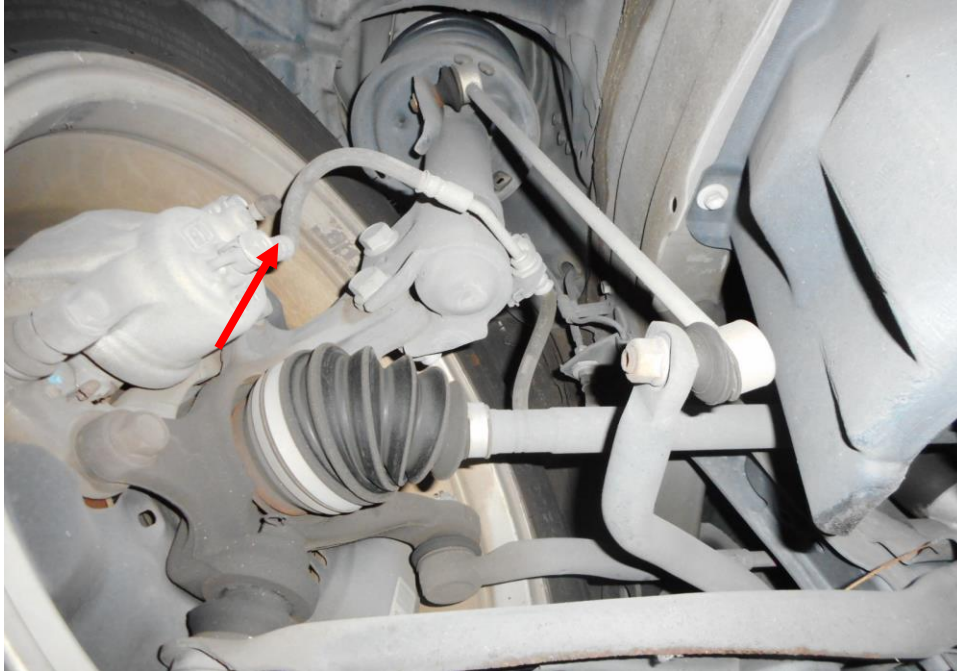
**Photo 16** shows the brake hose/pipe (arrowed) at the front right wheel of the Motor Car. I did not observe any leakage of brake fluid at the time of my inspection of the Motor Car. Static tests of the Motor Car's braking system had indicated that there was no internal leakage of pressure/vacuum. The undercarriage components of the Motor Car were also all found to be intact and without any visible damage.

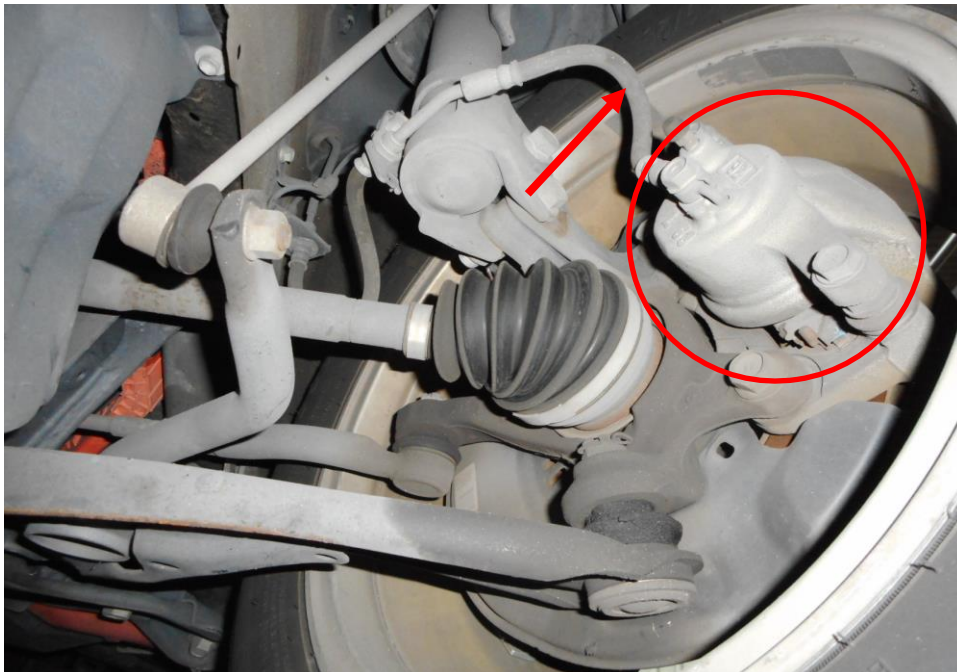
**Photo 17** shows the brake hose/pipe (arrowed) at the front left wheel of the Motor Car. No leakage of brake fluid was observed. Visual examination of the various components of the braking system like the brake caliper (circled), brake booster, brake pedal etc had revealed all to be intact and without visible damage.

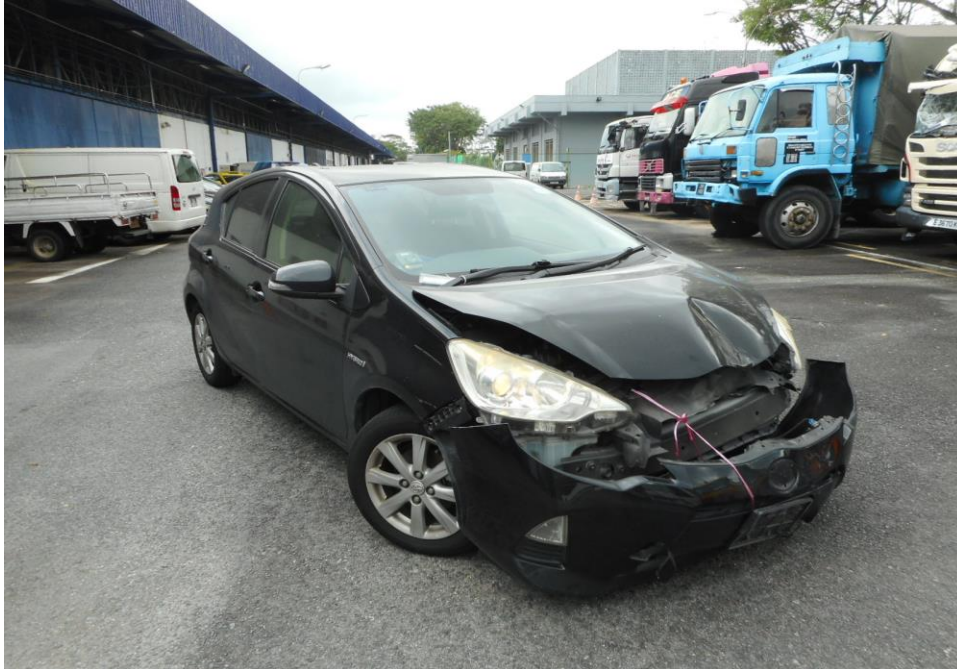
**Photo 18** shows the front right wheel of the Motor Car turned to its full left. During my steering system test, I did not experience any abnormal free play and/or resistance when I had turned the steering wheel towards the left and right. This would suggest that the steering system of the Motor Car was likely to be in serviceable condition at the material time of accident.

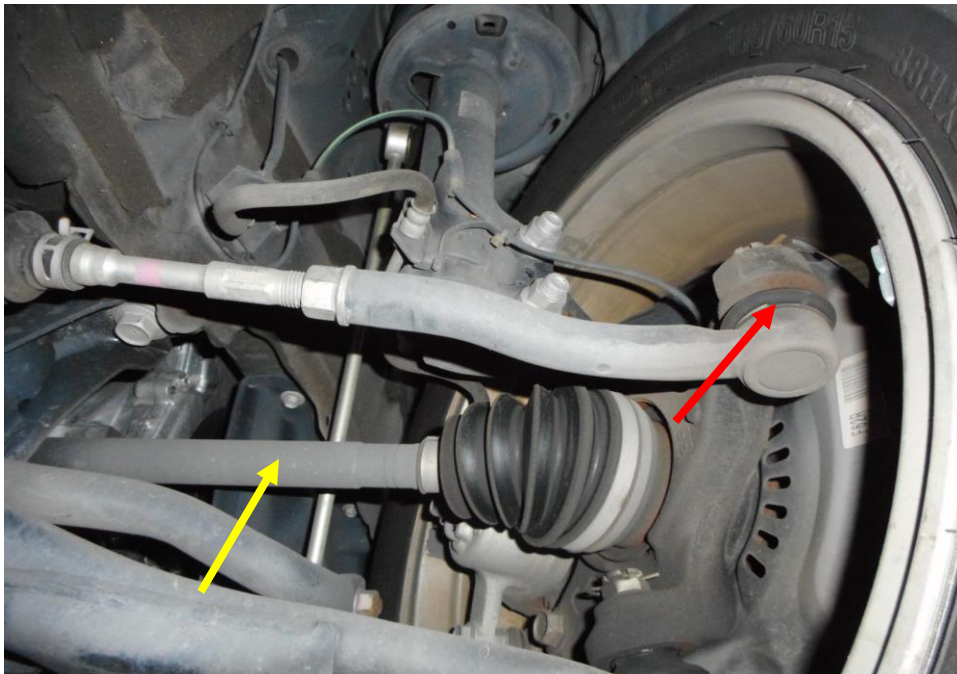
**Photo 19** shows the various undercarriage components at the front right wheel of the Motor Car, in particular the steering tie rod (red arrow) and drive shaft (yellow arrow). The various steering components were all found to be intact, suggesting that the steering system of the Motor Car was likely to be in serviceable condition at the material time of accident. There was also no sign of fluid stain observed on the various undercarriage components at the front right wheel of the Motor Car.

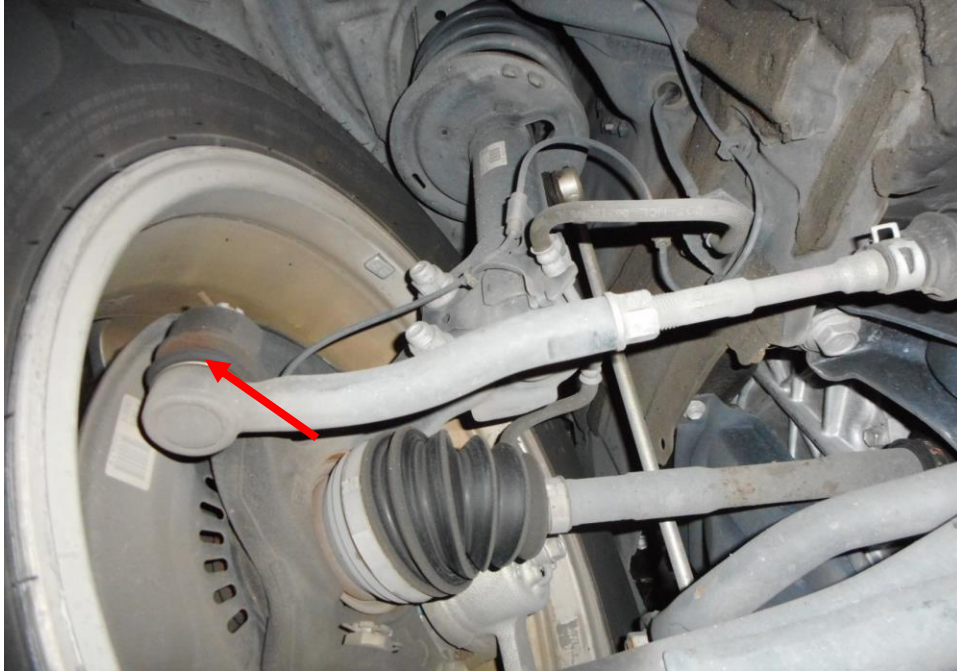
**Photo 20** shows the various undercarriage components at the front left wheel of the Motor Car, which had included the steering tie rod (red arrow). The various undercarriage components of the Motor Car were all found to be intact without any visible damage.

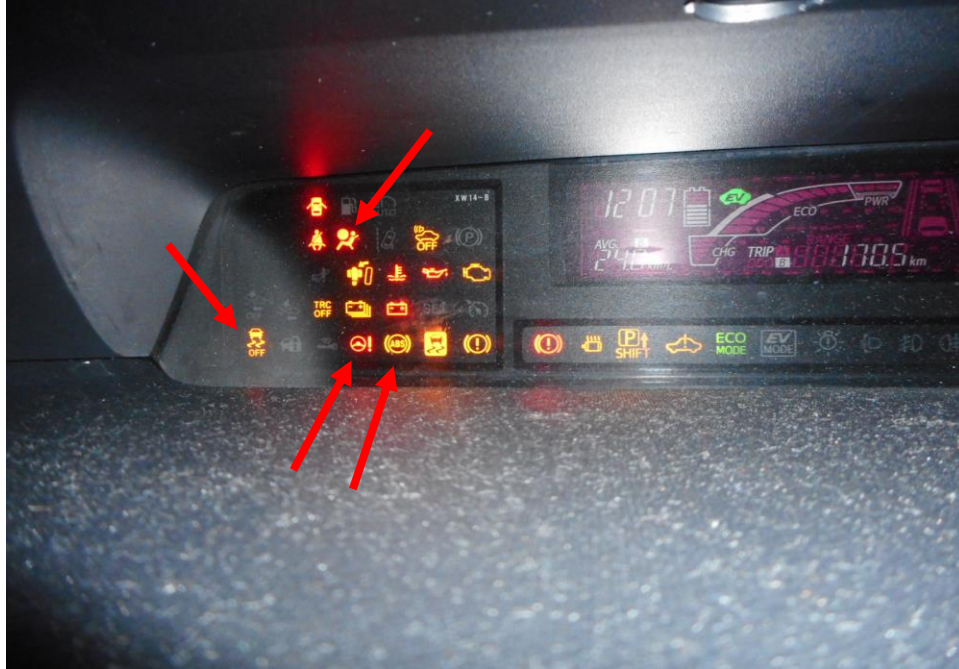
**Photo 21** shows the warning light for Anti-Lock Brake System (ABS), Traction Control System (TCS), Power Steering System (EPS) and Supplemental Restraint System (SRS) (arrowed) appearing on the instrument panel of the Motor Car during the self-test of its various electronic operating systems when its engine was cranked.

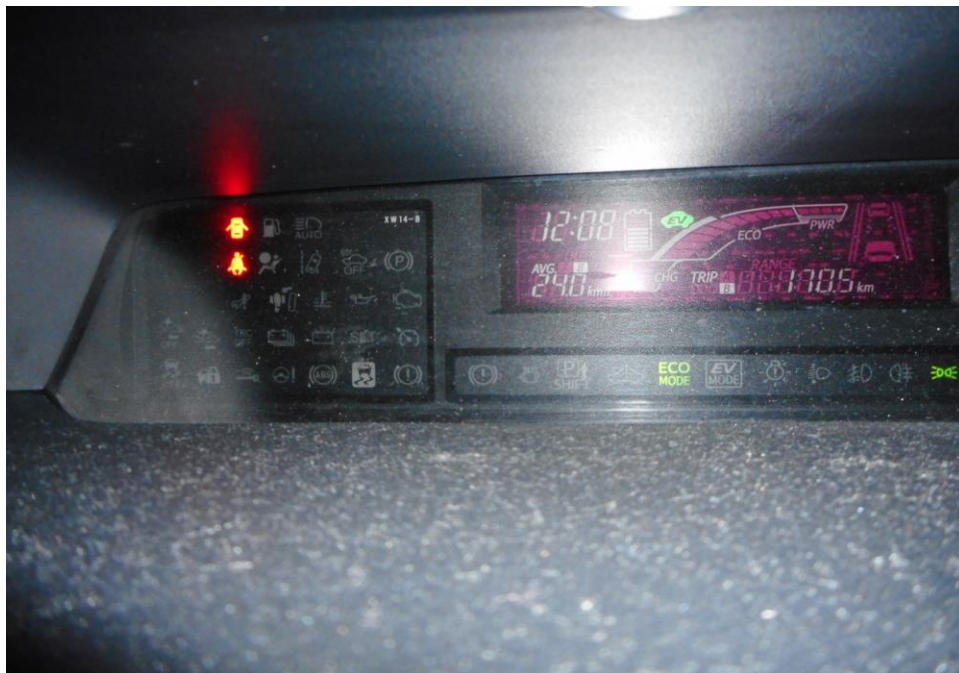
**Photo 22** shows no warning lights illuminated on the instrument panel of the Motor Car after the engine was cranked. This would suggest that there was no abnormality to the various electronic operating systems of the Motor Car, like the ABS, TCS, SRS and EPS.
