You're Ref: TP/IP/50287/2020
Our Ref: CI/TPD21000236/P

18th January 2021

MECHANICAL INSPECTION REPORT OF MOTOR CAR SGG 9435A

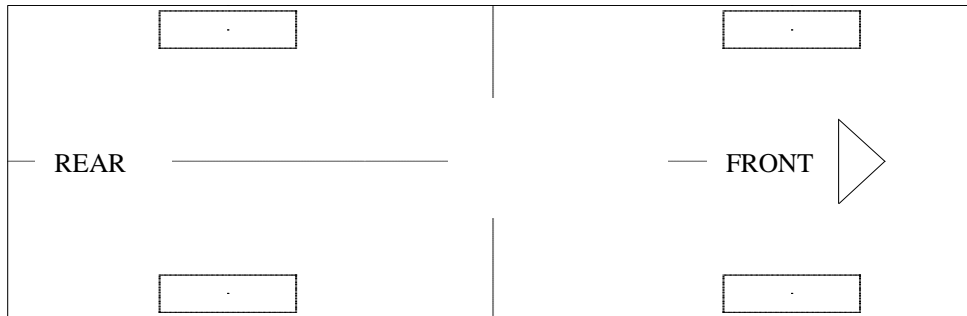
Yokohama 185/60R15 (6.2mm) (Deflated)

Yokohama 185/60R15 (6.3mm)

Yokohama 185/60R15 (6.5mm)

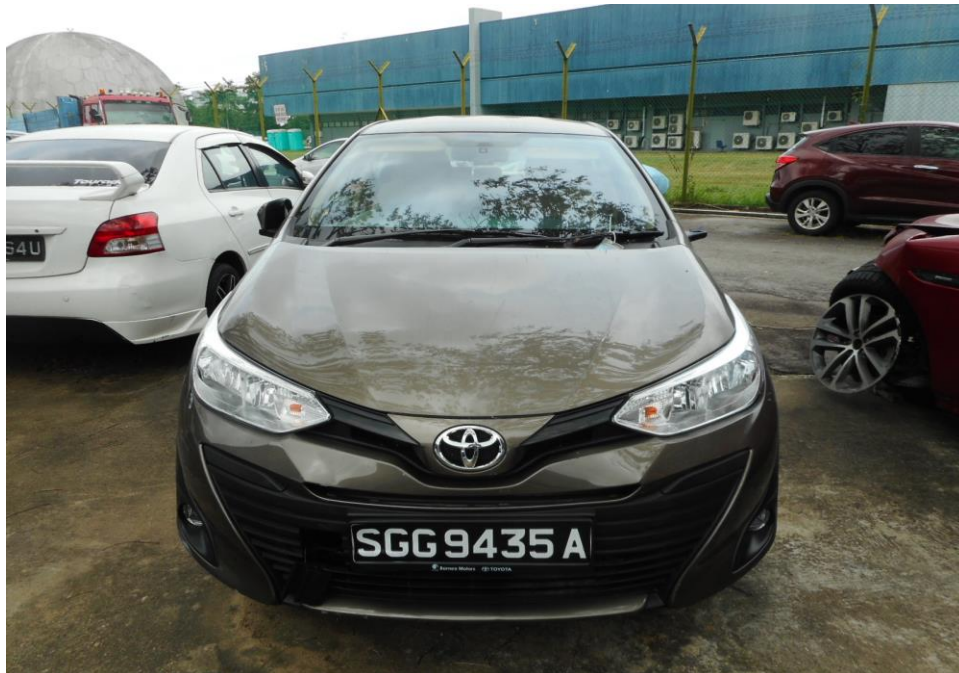
Photo 1 shows a general view of the Motor Car's front body at the time of my inspection. The front portion of the Motor Car was observed to have sustained damage. Its front bonnet, front bumper was damaged as a result of the accident.

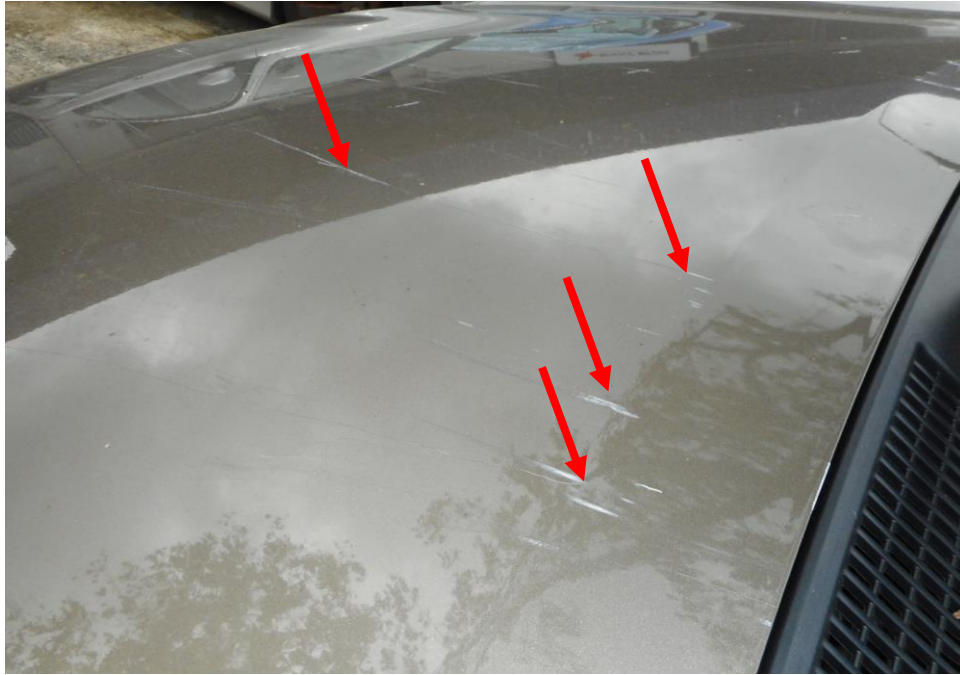
Photo 2 shows the close-up view of the Motor Car's front body at the time of my inspection. The Motor Car was observed to have sustained damage at its front bonnet (arrowed) as a result of the accident.

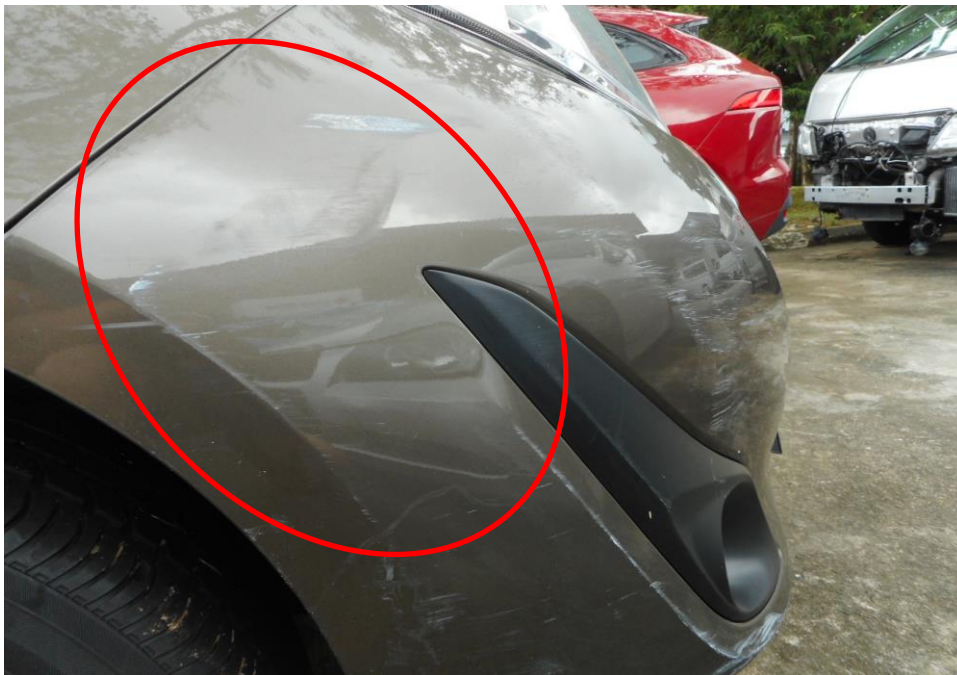
Photo 3 shows the close up view of the Motor Car's front body at the time of my inspection. The Motor Car was observed to have sustained damage at its front bumper (arrowed), as a result of the accident.

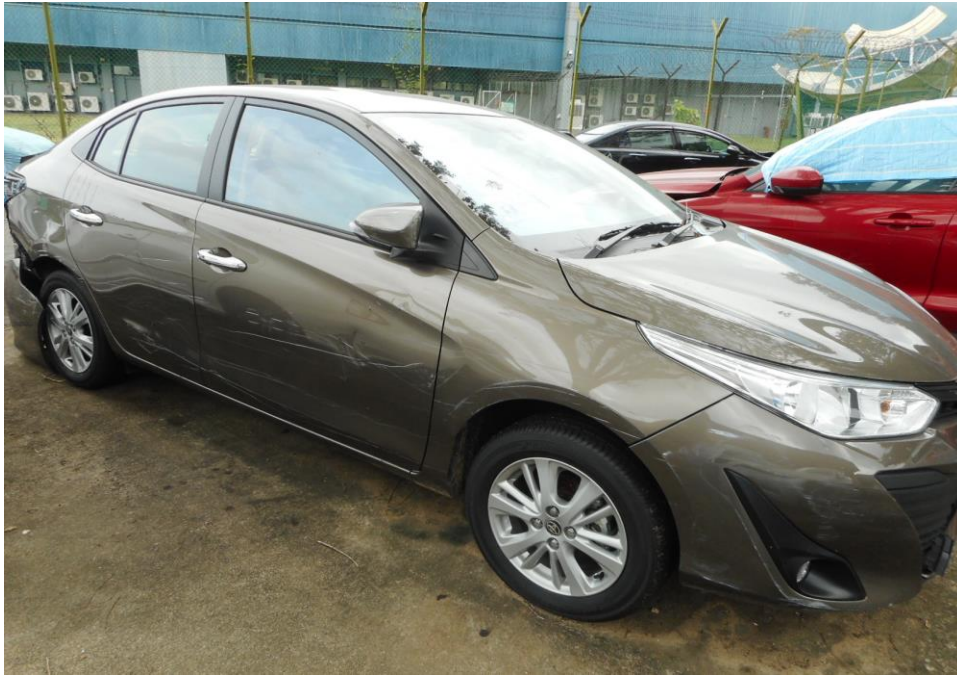
Photo 4 shows a general view of the Motor Car's right body at the time of my inspection. The right portion of the Motor Car was observed to have been damaged by the accident.

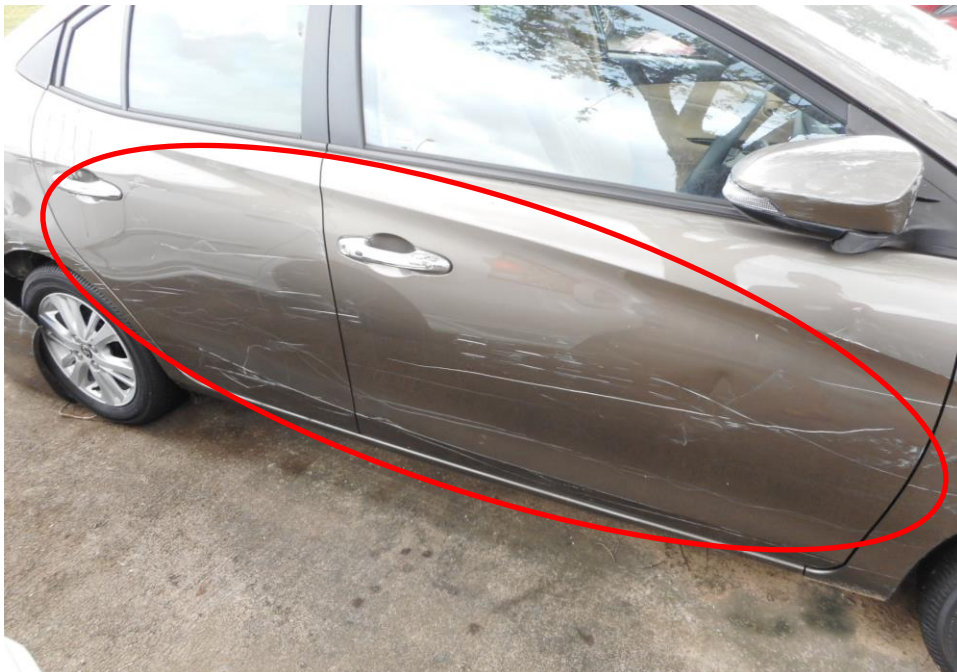
Photo 5 shows the close up view of the Motor Car's right body at the time of my inspection. The right body panels (circled) of the Motor Car was observed to have been damaged by the accident.

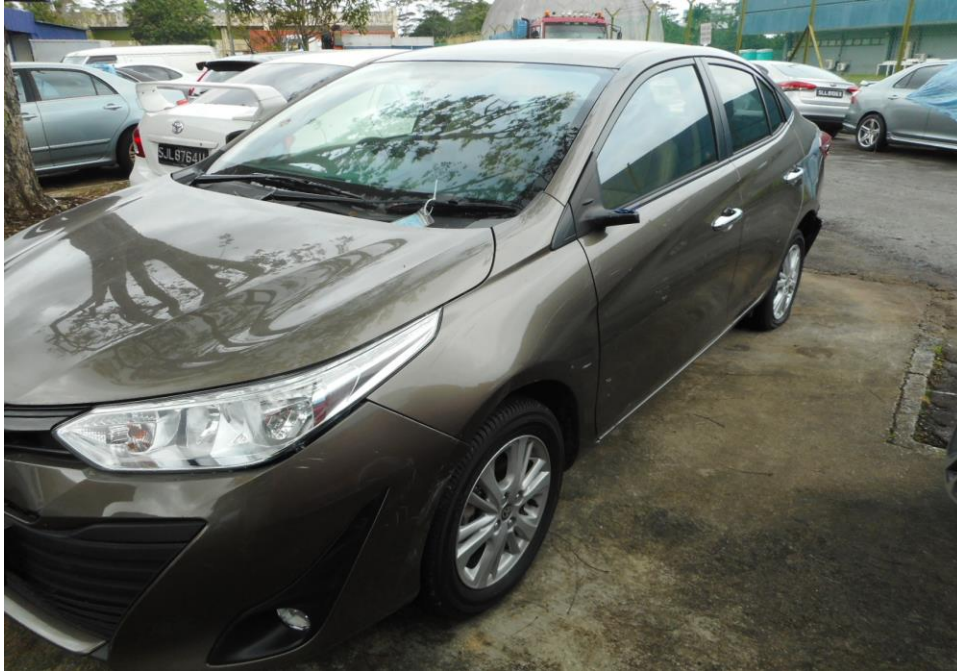
Photo 6 shows a general view of the Motor Car's left body at the time of my inspection. The left portion of the Motor Car was observed to have been damaged by the accident.

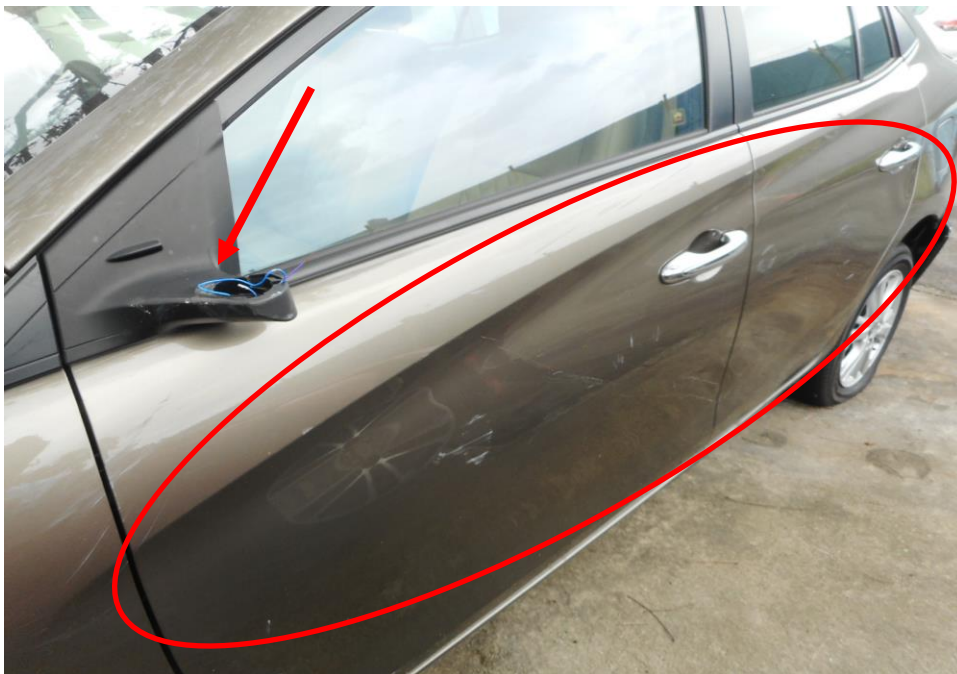
Photo 7 shows the close up view of the Motor Car's left body at the time of my inspection. The left body panels (circled) and left rear view mirror (arrowed) of the Motor Car was observed to have been damaged by the accident.

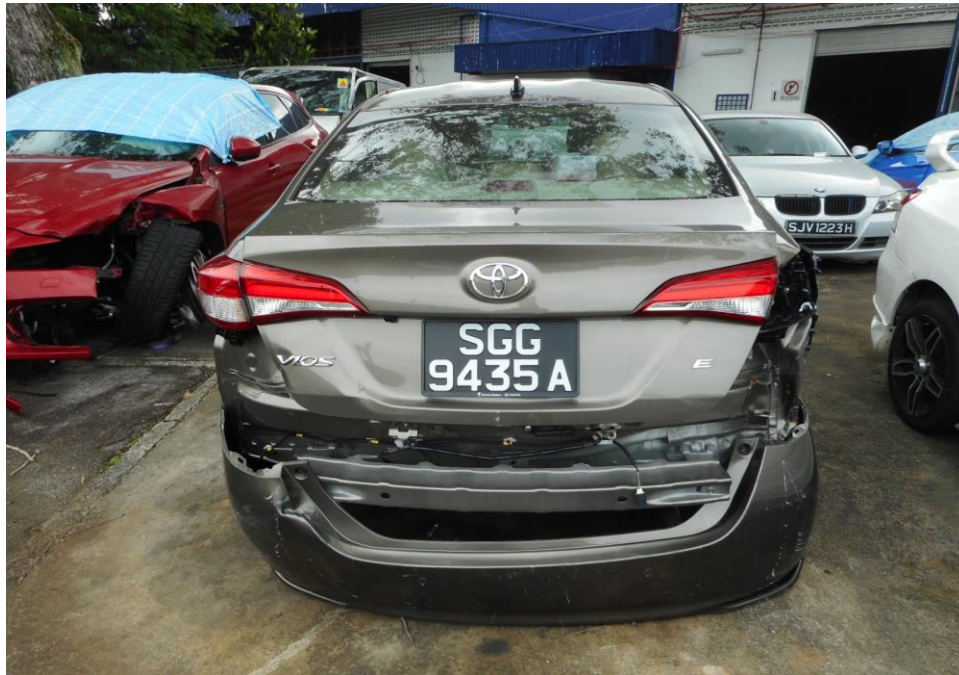
Photo 8 shows a general view of the Motor Car's rear body at the time of my inspection. The rear portion of the Motor Car was observed to have been damaged by the accident.

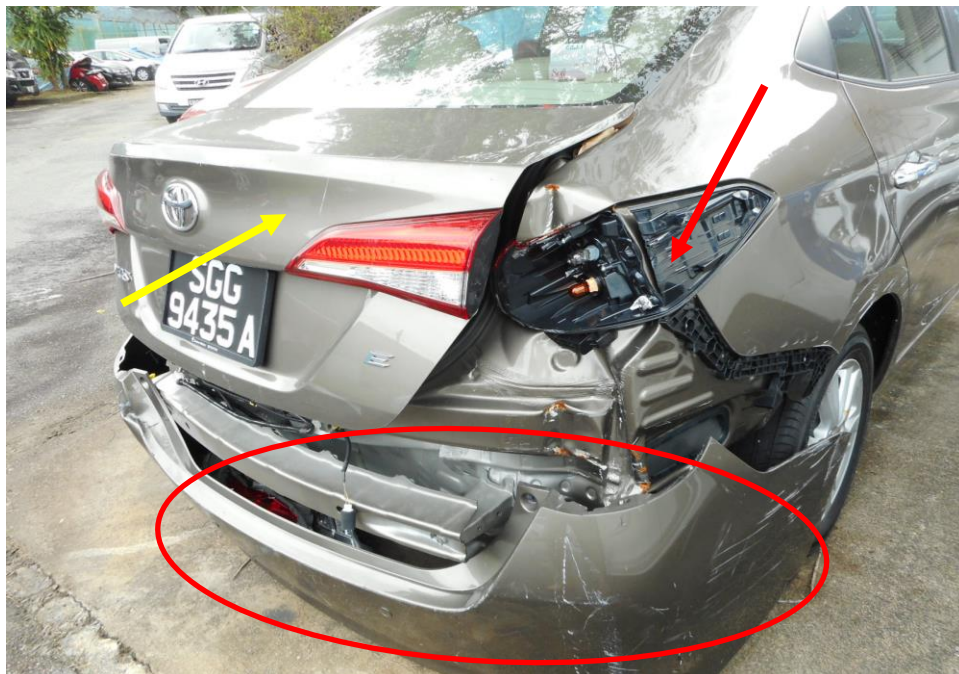
Photo 9 shows the close up view of the Motor Car's left body at the time of my inspection. The rear boot (yellow arrow) rear right brake lamp (red arrow) and the rear bumper (circled) of the Motor Car was observed to have been damaged by the accident.

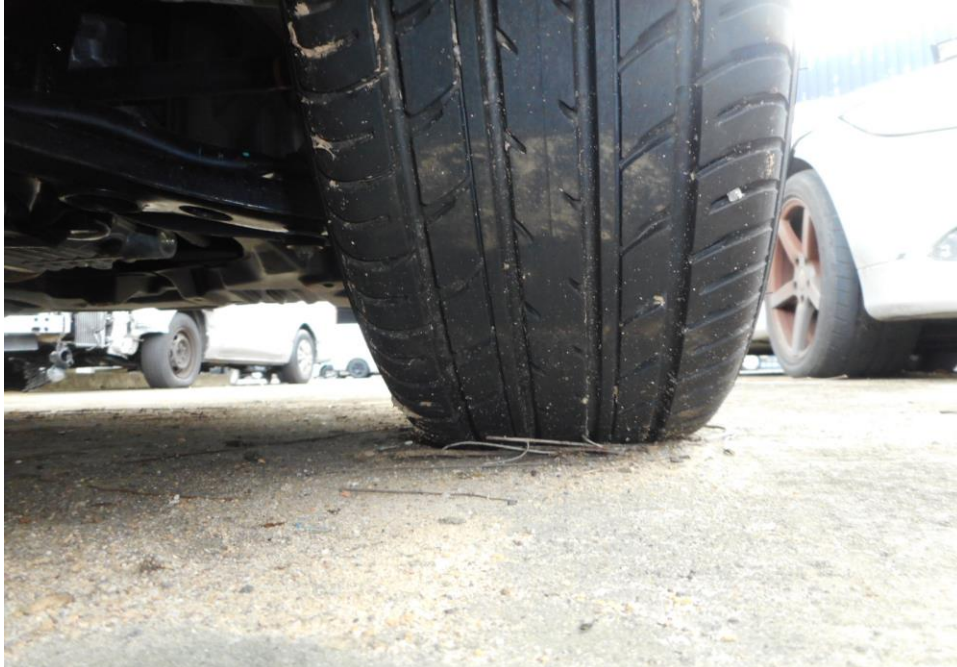
Photo 10 shows the condition of the front right tyre of the Motor Car, which was observed to be in serviceable condition with remaining tread depth of approximately 6.5mm. The tyre was sufficiently inflated for vehicular operation with no tear, cut or burst mark(s) on the outer and the inner sidewalls as well as across the tread. The 4 tyres of the Motor Car were wrapped around standard steel wheel rims without any damage.

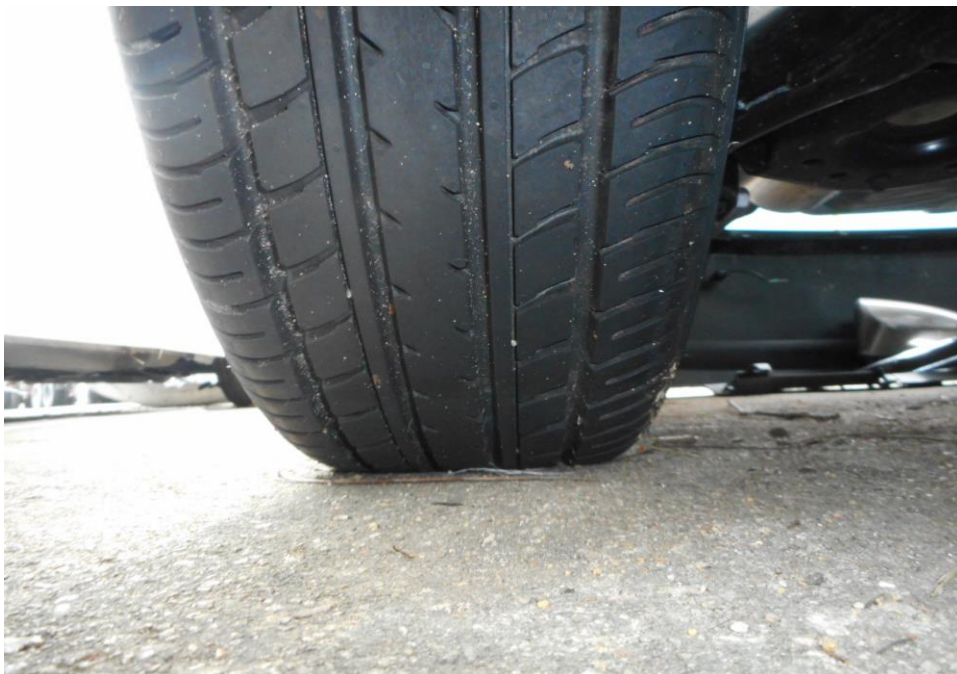
Photo 11 shows the condition of the rear right tyre of the Motor Car, which was observed to be in serviceable condition with remaining tread depth of approximately 6.3mm. The tyre was also observed to be sufficiently inflated for vehicular operation with no tear, cut or burst mark(s).

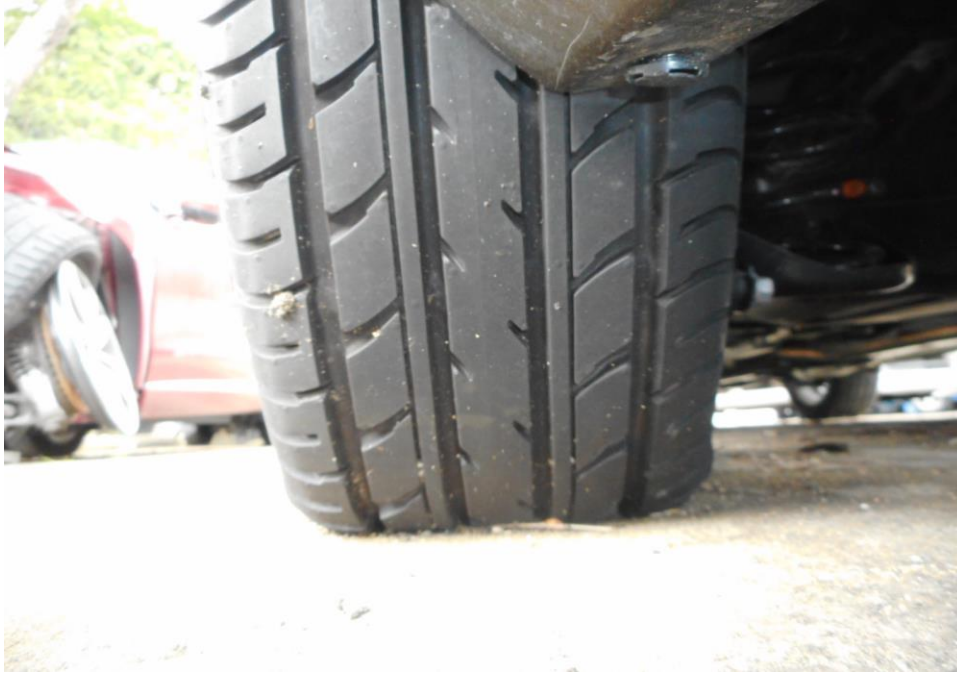
Photo 12 shows the condition of the rear left tyre of the Motor Car, which was observed to be deflated with remaining tread depth of approximately 6.2mm. There was also no tear, cut or burst mark(s) on the outer and the inner sidewalls as well as across the tread of the Motor Car's 4 tyres.

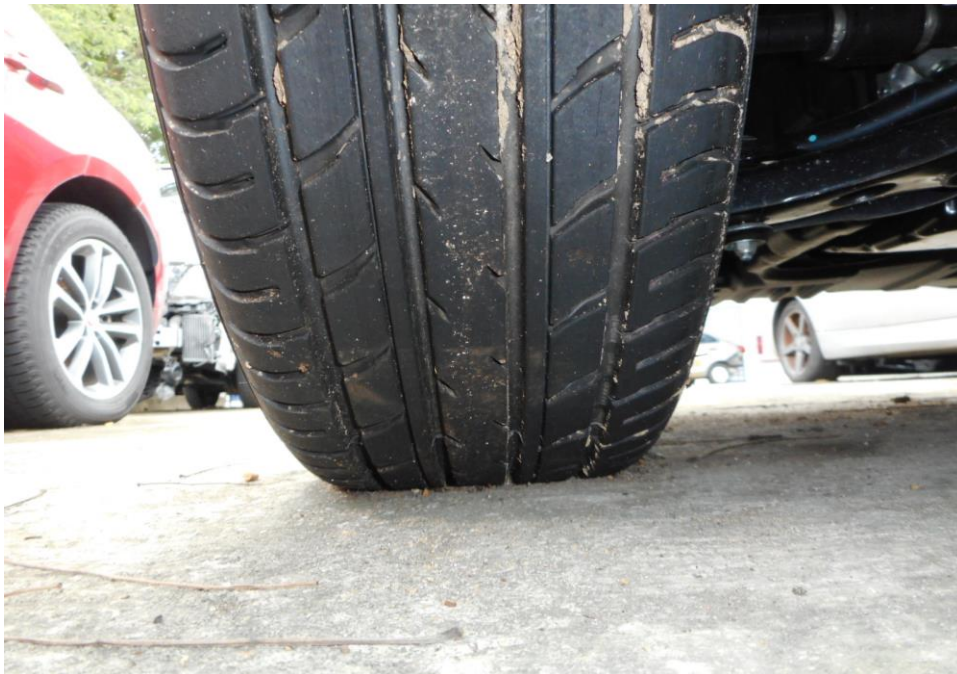
Photo 13 shows the condition of the front left tyre of the Motor Car, which was observed to be in serviceable condition with remaining tread depth of approximately 6.3mm. There was also no tear, cut or burst mark(s) on the outer and the inner sidewalls as well as across the tread of the Motor Car's 4 tyres.

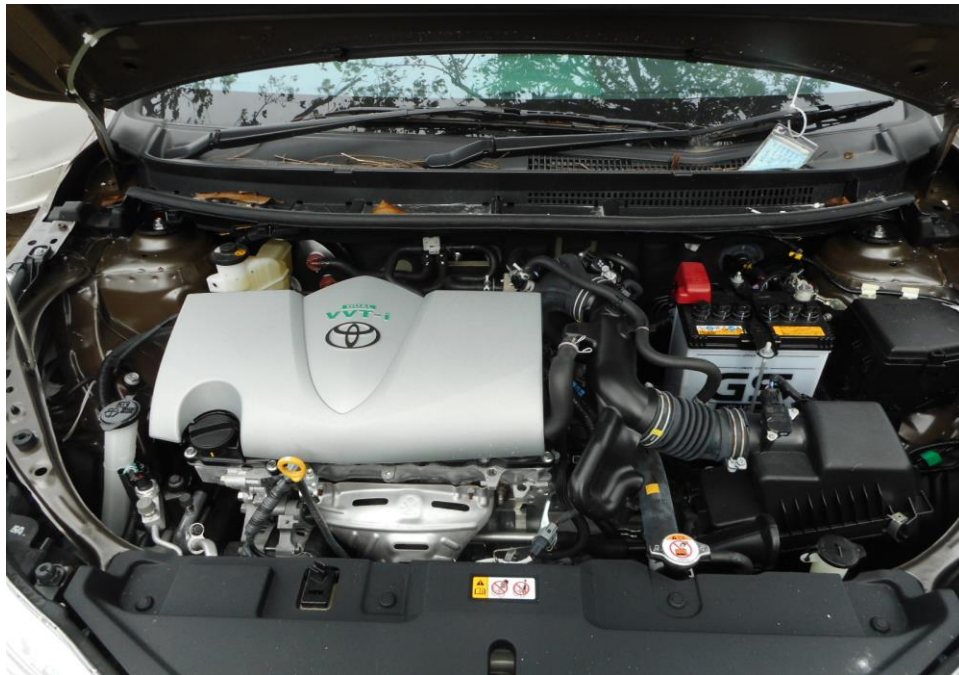
Photo 14 shows a general view of the Motor Car's engine compartment. The various parts and components inside the engine compartment were unaffected by the accident. There was also no sign(s) or indication(s) of fluid leakage and/or fluid stain within the engine compartment.

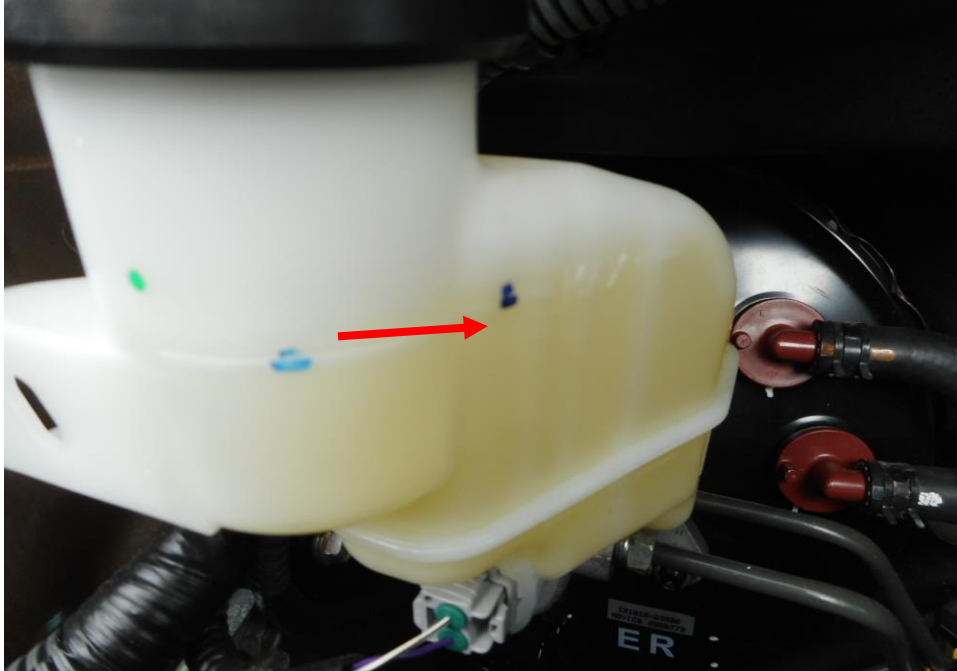
Photo 15 shows the brake fluid reservoir of the Motor Car at the time of my inspection. The brake fluid was observed to be of sufficient level (arrowed) and without any visible contamination.

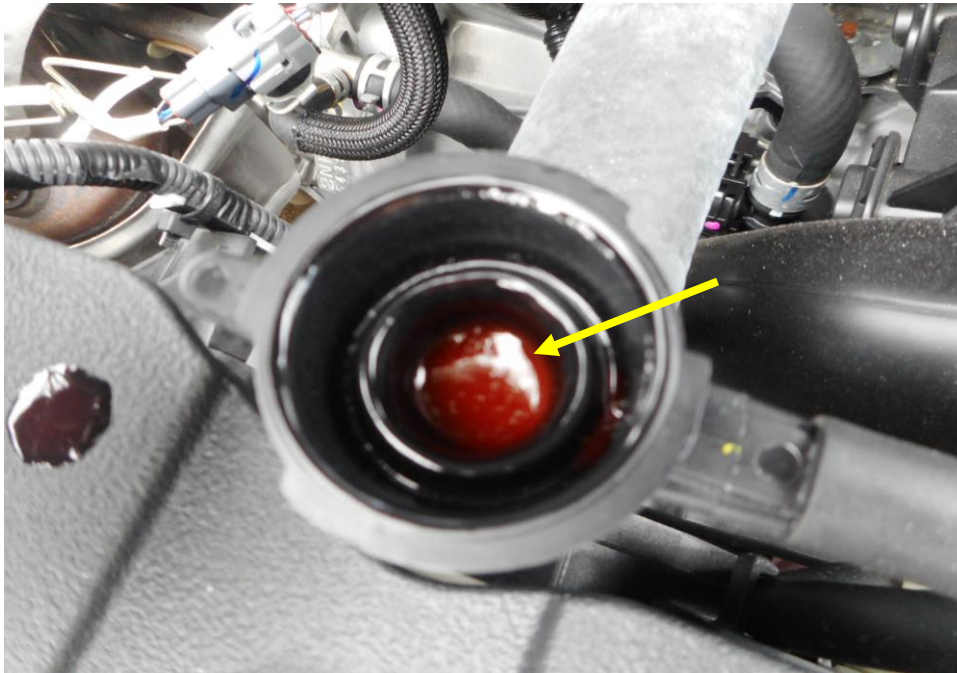
Photo 16 shows checks being carried out to the engine coolant of the Motor Car at the time of my inspection. The engine coolant was observed to be of sufficient level (arrowed) and without any visible contamination.

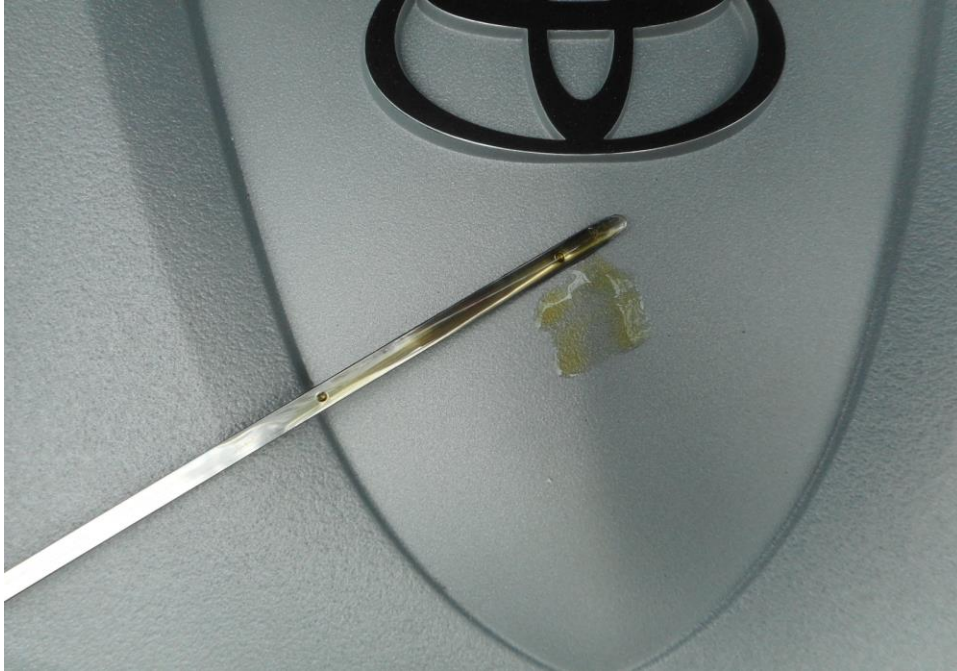
Photo 17 shows the engine oil dip stick of the Motor Car at the time of my inspection. The engine oil was observed to be of sufficient level and without any visible contamination.

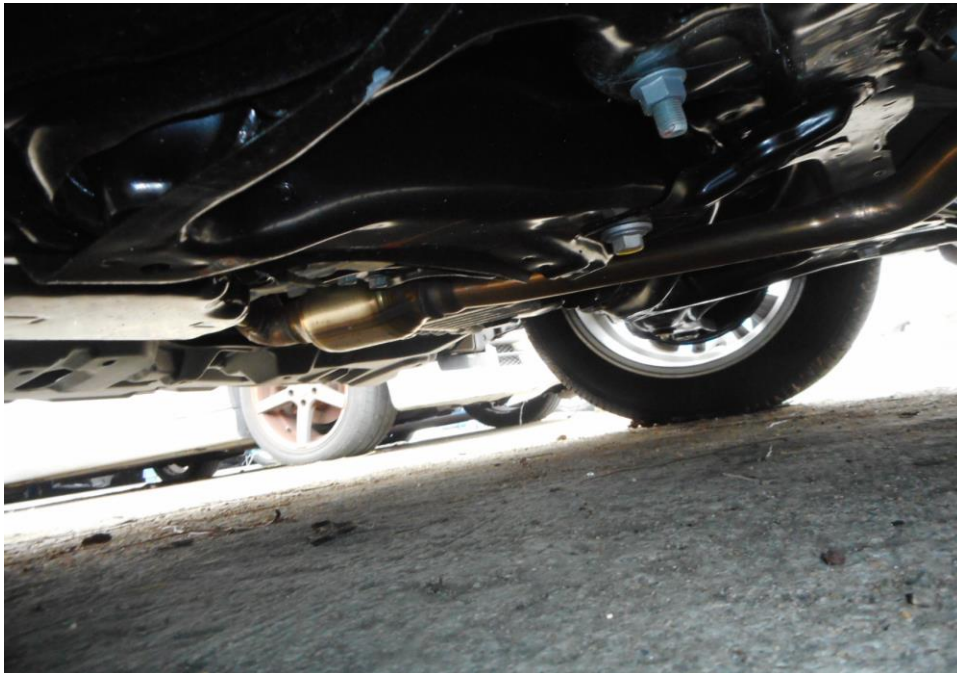
Photo 18 shows the undercarriage of the Motor Car, at the area where the engine housing and transmission housing are located. I did not find any sign(s) or indication(s) of fluid leak and/or fluid stain(s) on the underside of the Motor Car.

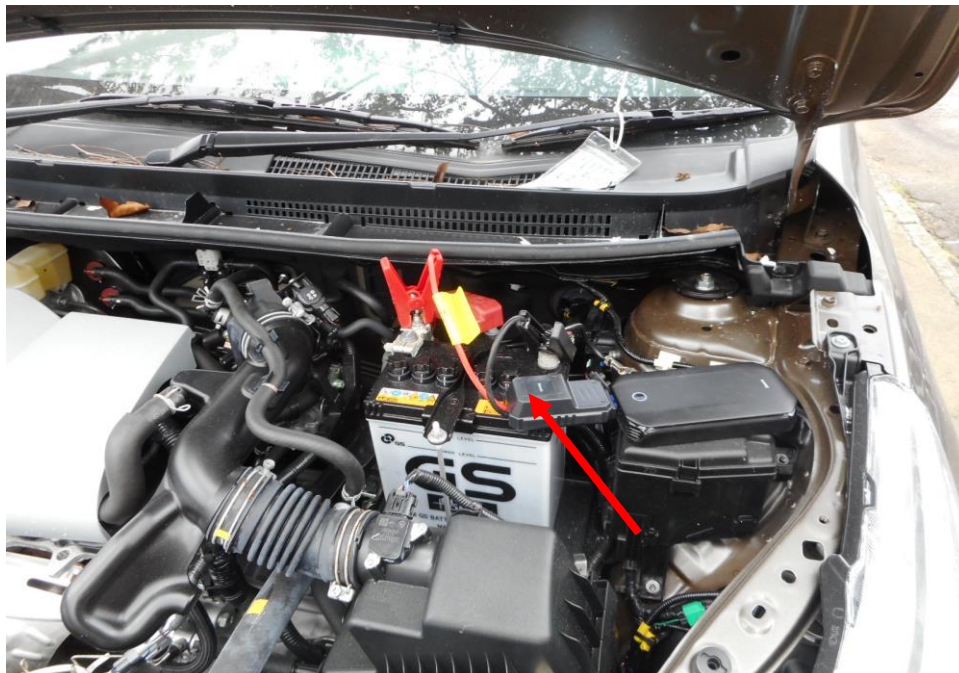
Photo 19 shows the jumpstarting process of the Motor Car's engine. The engine of the Motor Car was unable to be jumpstarted up despite multiple attempts in starting it.

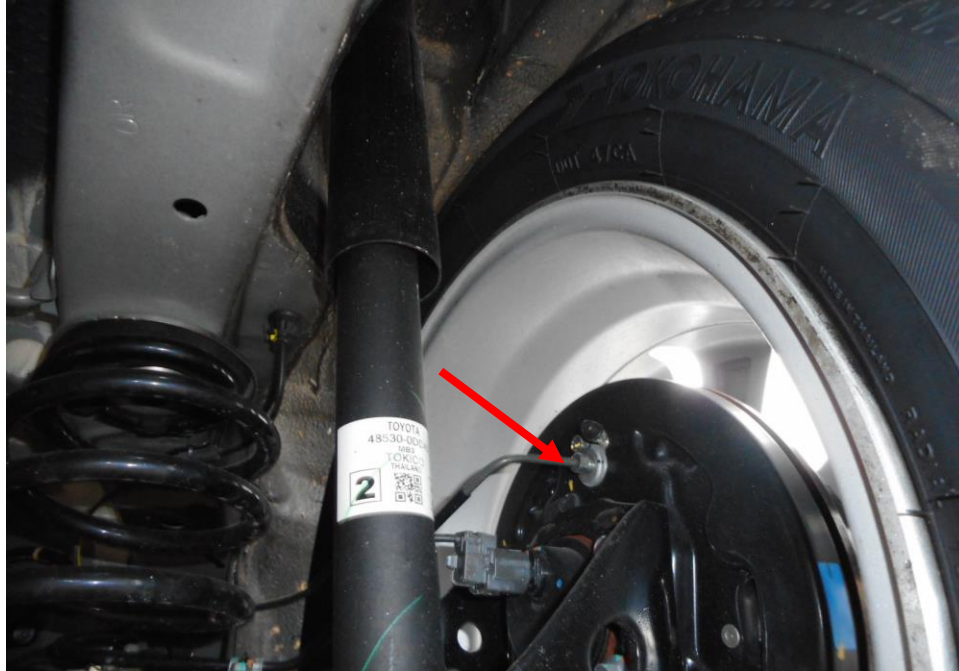
Photo 20 shows the brake hose/pipe (arrowed) at the rear right wheel of the Motor Car. No leakage of brake fluid was observed. Visual examination of the various components of the braking system like the drum brake, brake booster, brake pedal etc. had revealed all to be intact and without visible damage.

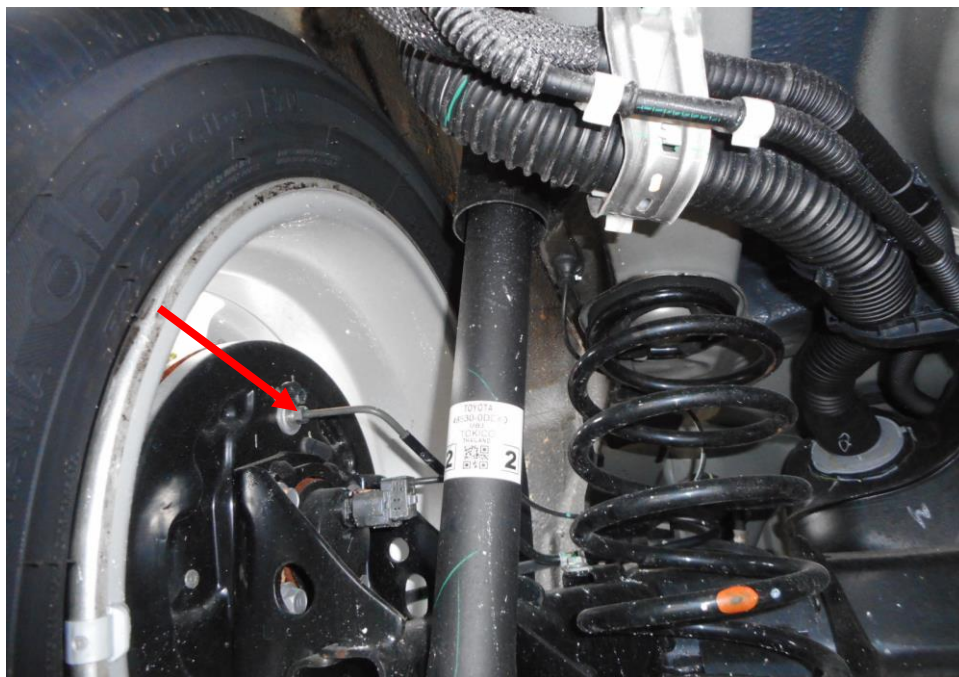
Photo 21 shows the brake hose/pipe (arrowed) at the rear left wheel of the Motor Car. I did not observe any leakage of brake fluid at the time of my inspection of the Motor Car. Static tests of the Motor Car's braking system had indicated that there was no internal leakage of pressure/vacuum. The undercarriage components of the Motor Car were also all found to be intact and without any visible damage.

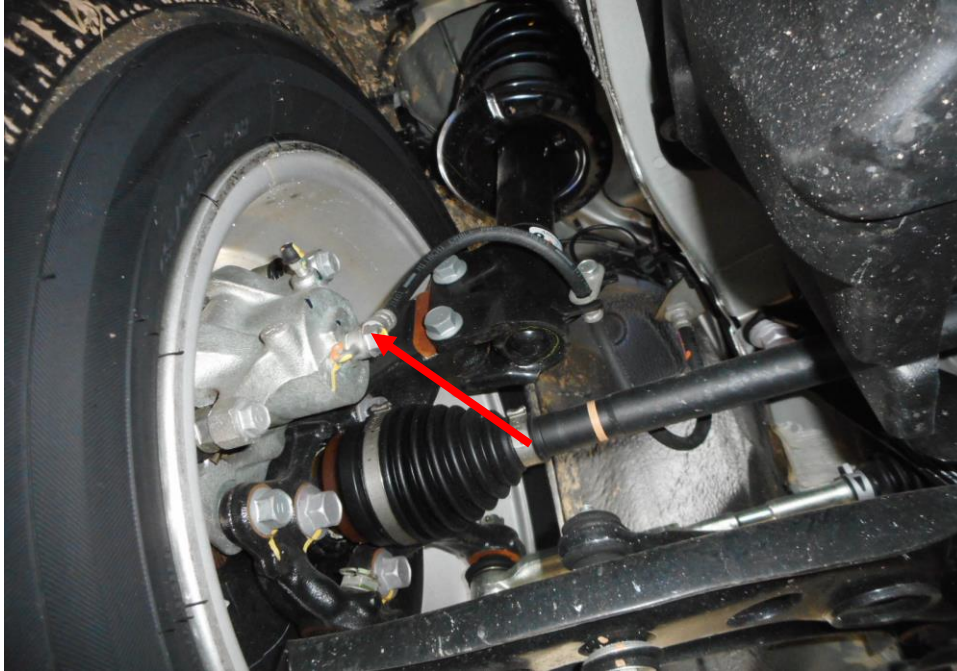
Photo 22 shows the brake hose/pipe (arrowed) at the front right wheel of the Motor Car. I did not observe any leakage of brake fluid at the time of my inspection of the Motor Car. Static tests of the Motor Car's braking system had indicated that there was no internal leakage of pressure/vacuum. The undercarriage components of the Motor Car were also all found to be intact and without any visible damage.

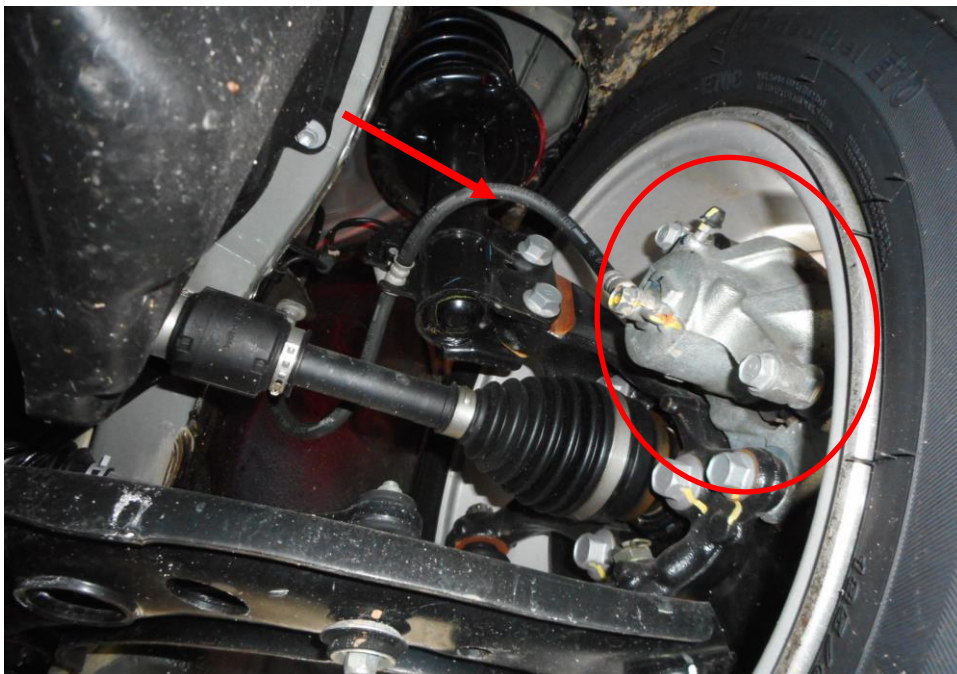
Photo 23 shows the brake hose/pipe (arrowed) at the front left wheel of the Motor Car. No leakage of brake fluid was observed. Visual examination of the various components of the braking system like the brake caliper (circled), brake booster, brake pedal etc had revealed all to be intact and without visible damage.

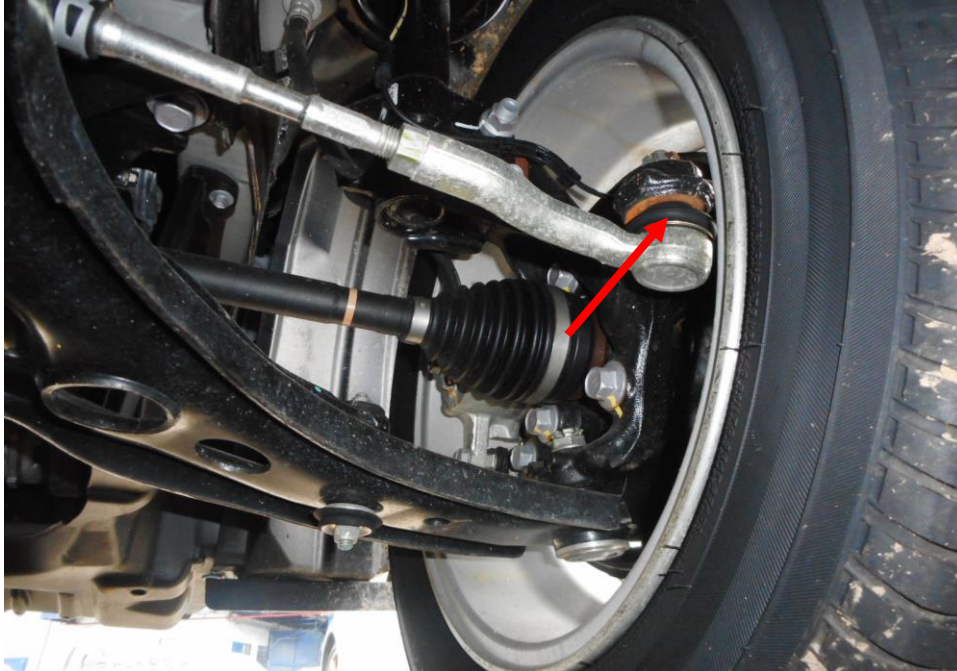
Photo 24 shows the various undercarriage components at the front right wheel of the Motor Car, in particular the steering tie rod (red arrow). The various steering components were all found to be intact, suggesting that the steering system of the Motor Car was likely to be in serviceable condition at the material time of accident. There was also no sign of fluid stain observed on the various undercarriage components at the front right wheel of the Motor Car.

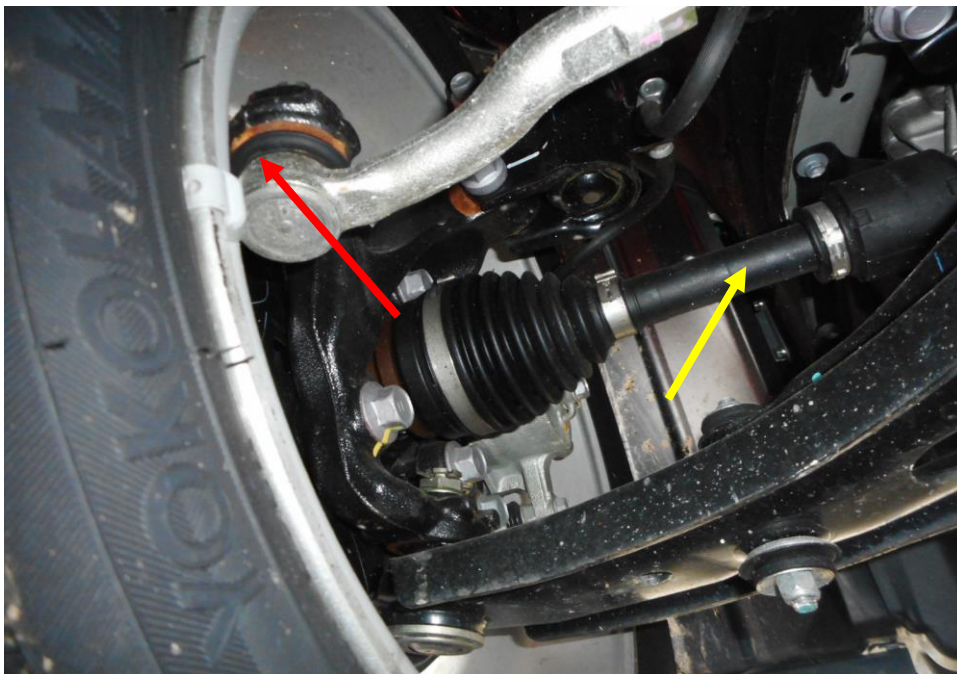
Photo 25 shows the various undercarriage components at the front left wheel of the Motor Car, which had included the steering tie rod (red arrow) and drive shaft (yellow arrow). The various undercarriage components of the Motor Car were all found to be intact without any visible damage.
