Your Ref: TP/IP/50349/2020
Our Ref : CI/TPD21000237/P

18th January 2021

MECHANICAL INSPECTION REPORT OF MOTOR LORRY YL 1643D

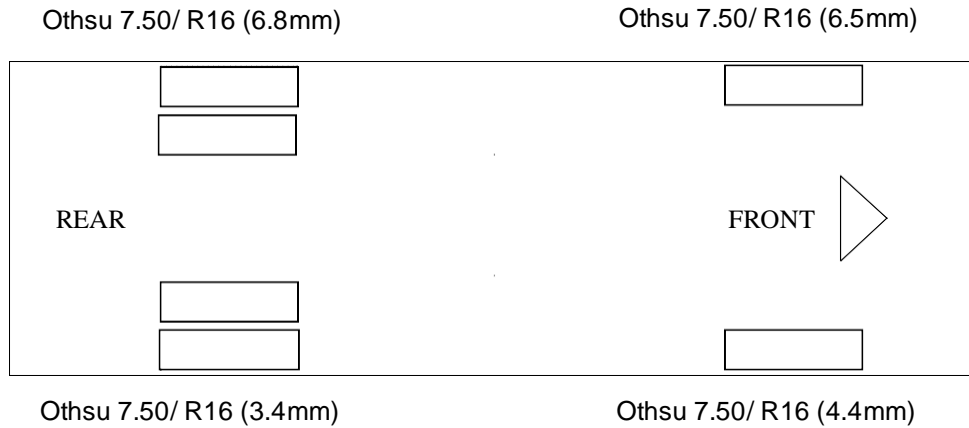
6. The 6 tyres of the Motor Lorry were observed to be in serviceable condition and sufficiently inflated for vehicular operation. I did not find any tear, cut or burst mark(s) on the outer and the inner sidewalls as well as across the tread of the 6 tyres. The tyre brand, tyre size and remaining tread depth of the 6 tyres of the Motor Lorry were recorded as follows:-

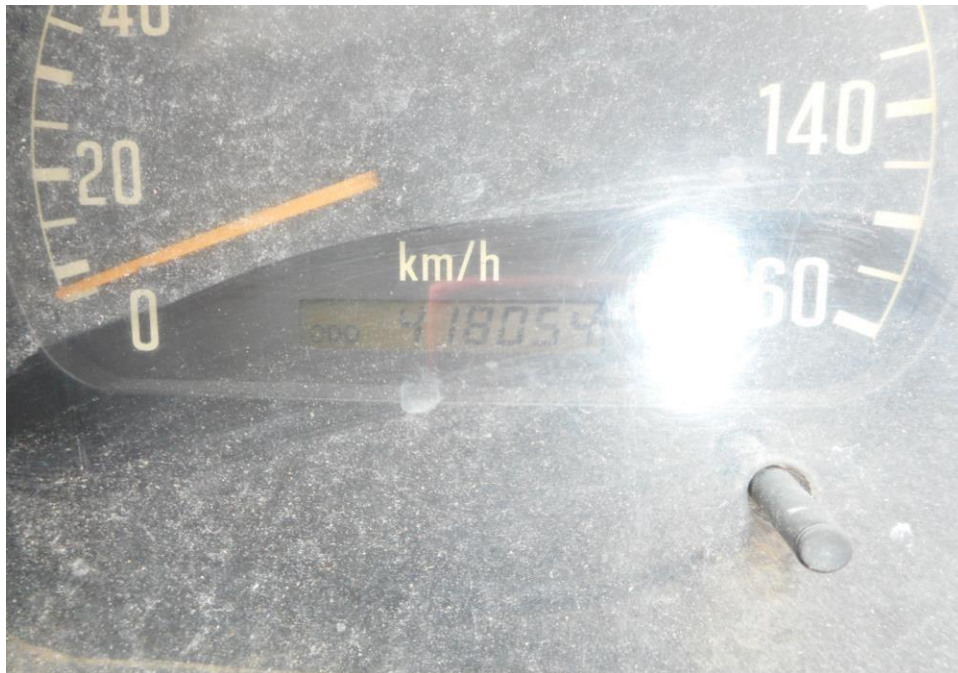
Photo 1 shows a general view of the instrument cluster of the Motor Lorry at the time of my inspection. The mileage of the Motor Lorry was 418,054 km

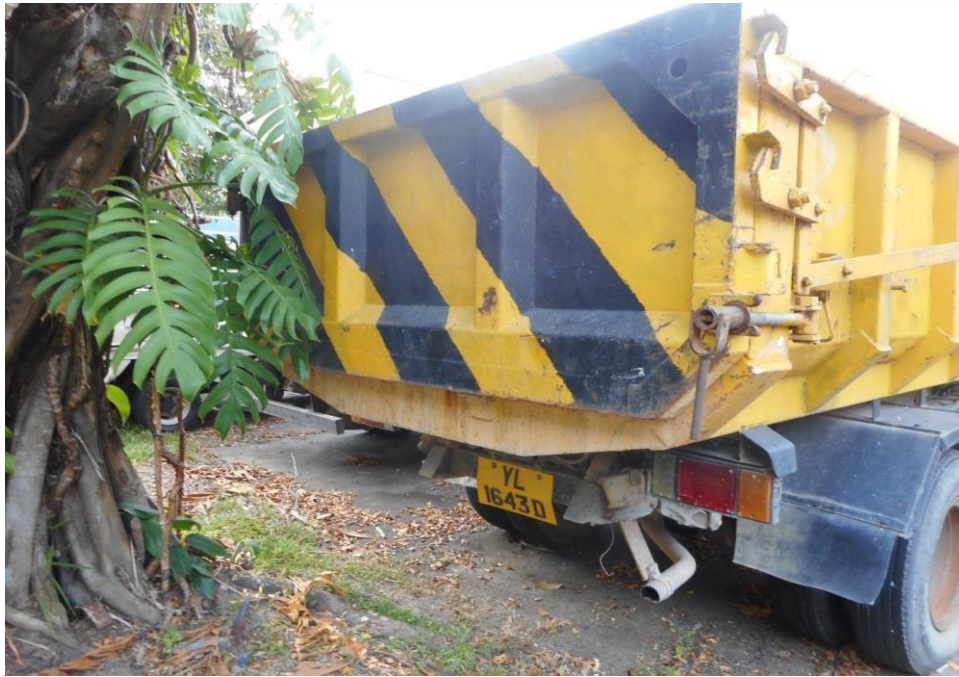
Photo 2 shows a general view of the rear body of the Motor Lorry at the time of my inspection. The Motor Lorry was observed to be intact and unaffected by the accident.

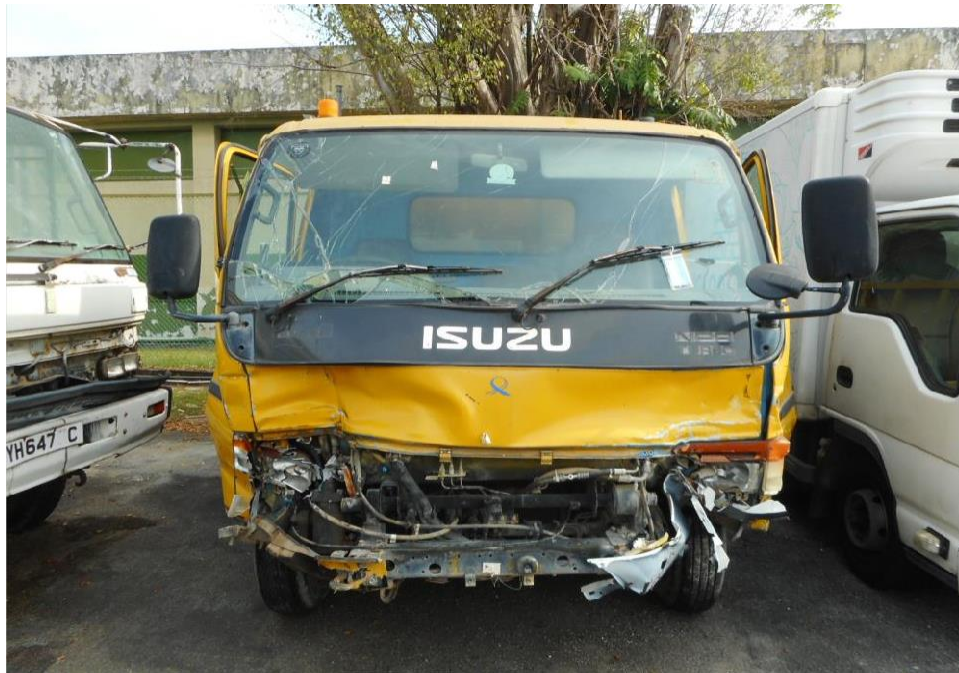
4. The mileage of the Motor Lorry at the time of my inspection was 418,054km.
5. The Motor Lorry appeared to have sustained damage at its frontal portion. Its front windscreen, front body panel, front bumper, both front headlamps, left and right doors were damage at the time of my inspection.

Photo 3 shows a general view of the Motor Lorry's frontal portion at the time of my inspection. It appeared to have sustained damage at its frontal portion. Its front windscreen, front body panel, front bumper, both front headlamps, left and right doors were damage at the time of my inspection.

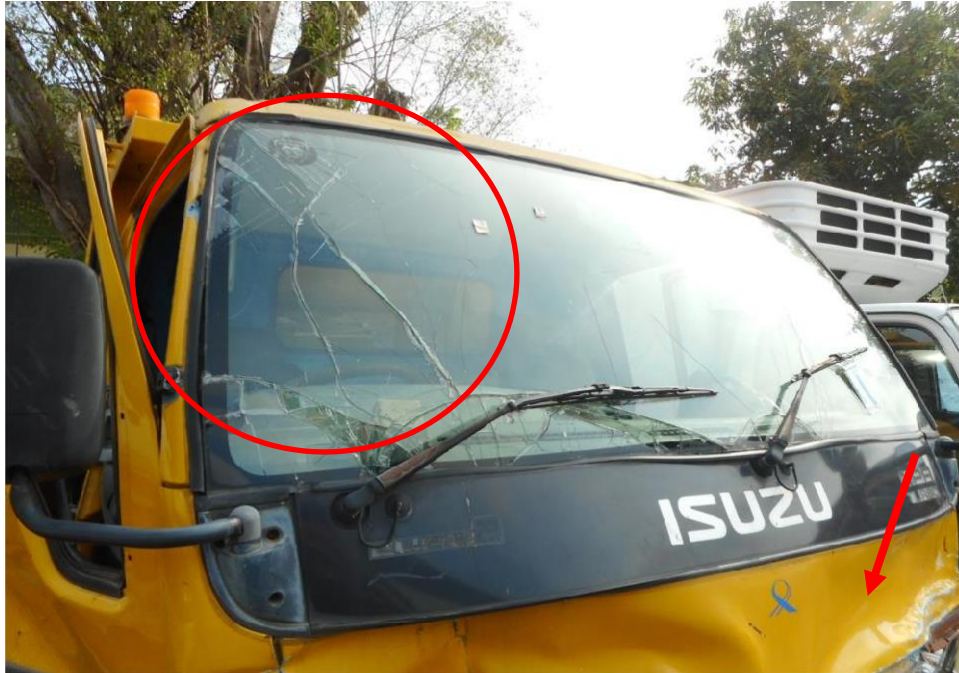
Photo 4 shows a close up view of the Motor Lorry's frontal portion at the time of my inspection. It appeared to have sustained damage at its frontal portion. Its front windscreen (circled) and front body panel (arrowed) was damage at the time of my inspection as a result of the accident.

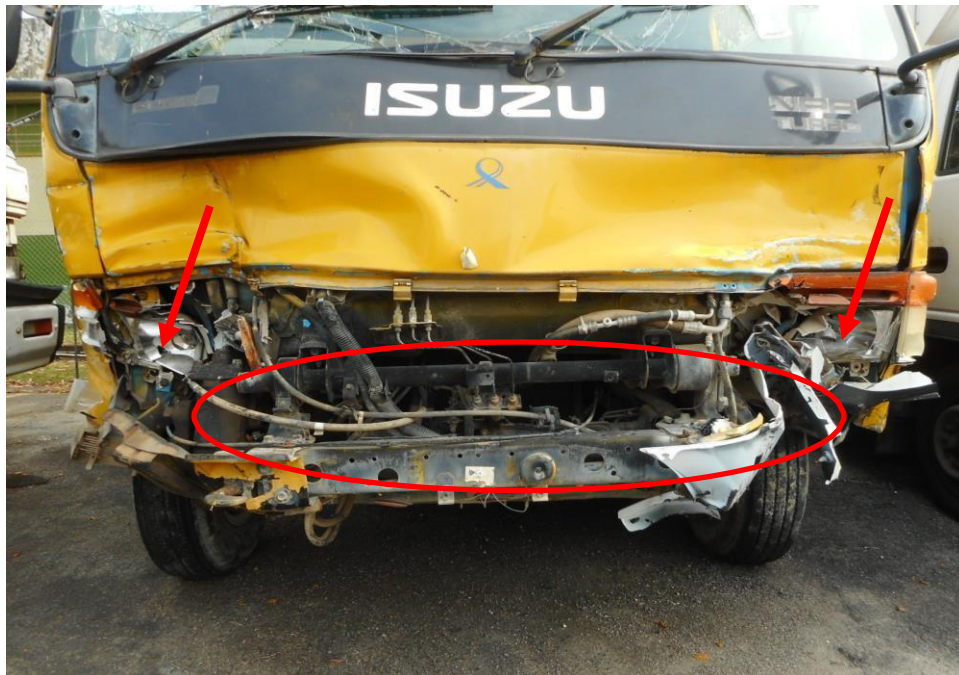
Photo 5 shows a close up view of the Motor Lorry's frontal portion at the time of my inspection. It appeared to have sustained damage at its frontal portion. Its front bumper (circled) and both front headlamps (arrowed) was damage at the time of my inspection as a result of the accident.

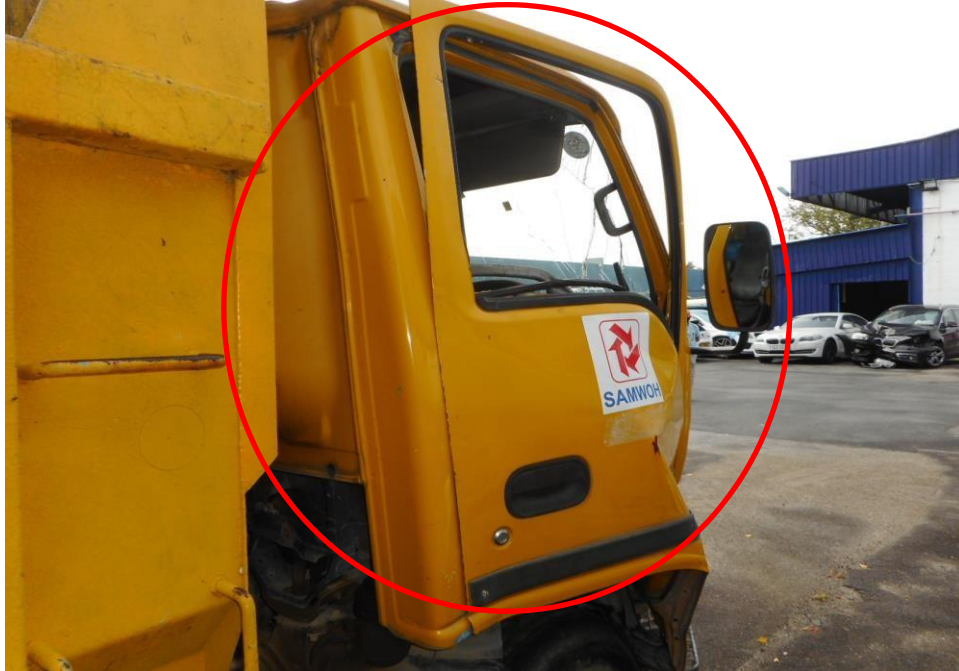
Photo 6 shows a close up view of the Motor Lorry's frontal portion at the time of my inspection. It appeared to have sustained damage at its frontal portion. Its right door (circled) was damage at the time of my inspection as a result of the accident.

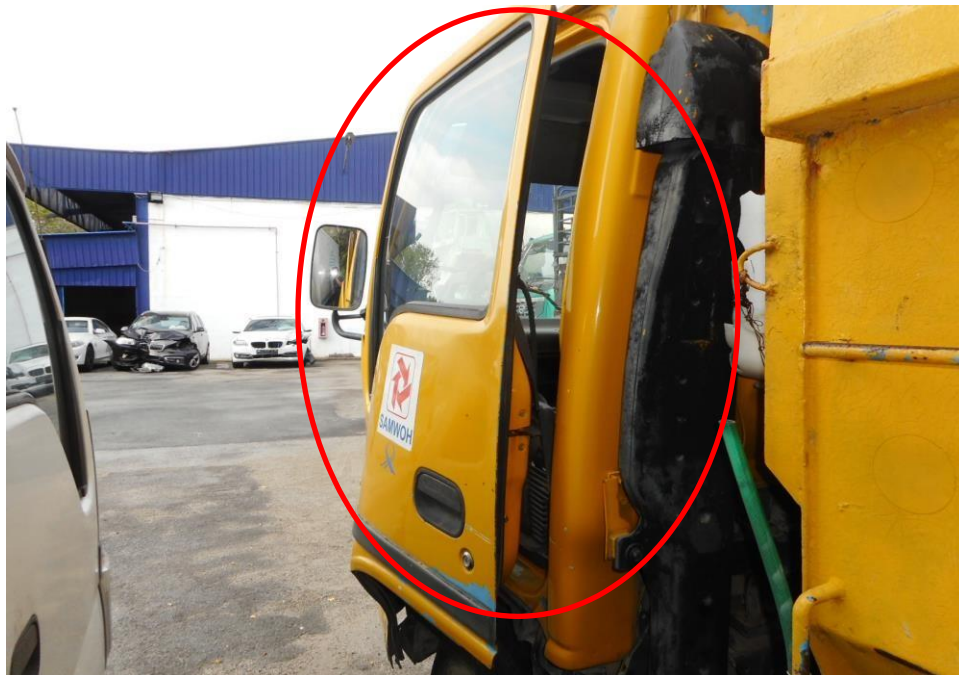
Photo 7 shows a close up view of the Motor Lorry's frontal portion at the time of my inspection. It appeared to have sustained damage at its frontal portion. Its left door (circled) was damage at the time of my inspection as a result of the accident.

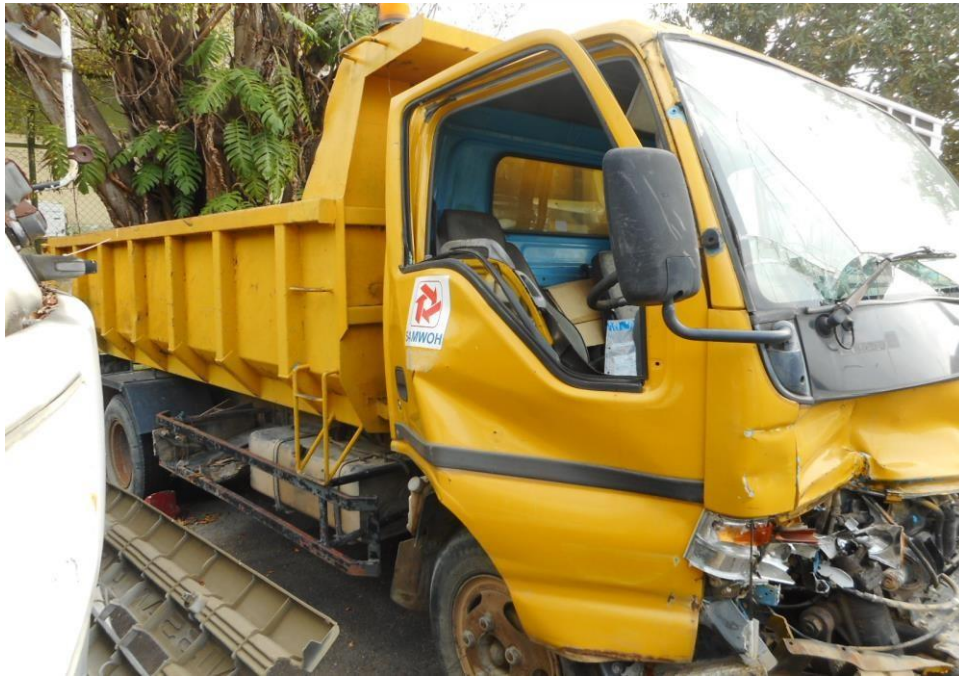
Photo 8 shows a general view of the right body of the Motor Lorry at the time of my inspection. The Motor Lorry was observed to be intact and unaffected by the accident.

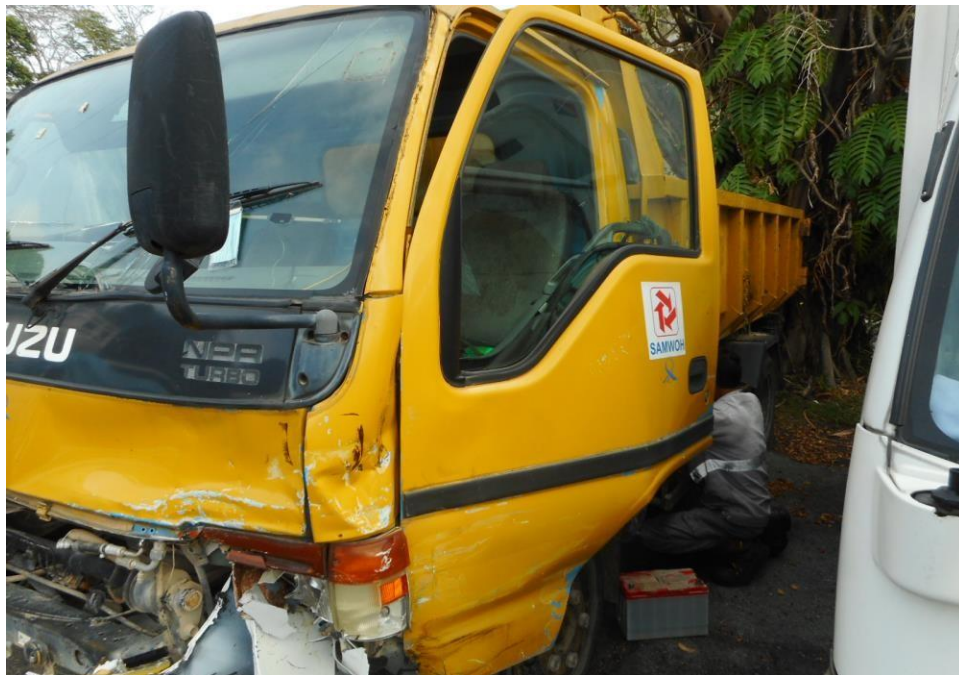
Photo 9 shows a general view of the left body of the Motor Lorry at the time of my inspection. The Motor Lorry was observed to be intact and unaffected by the accident.

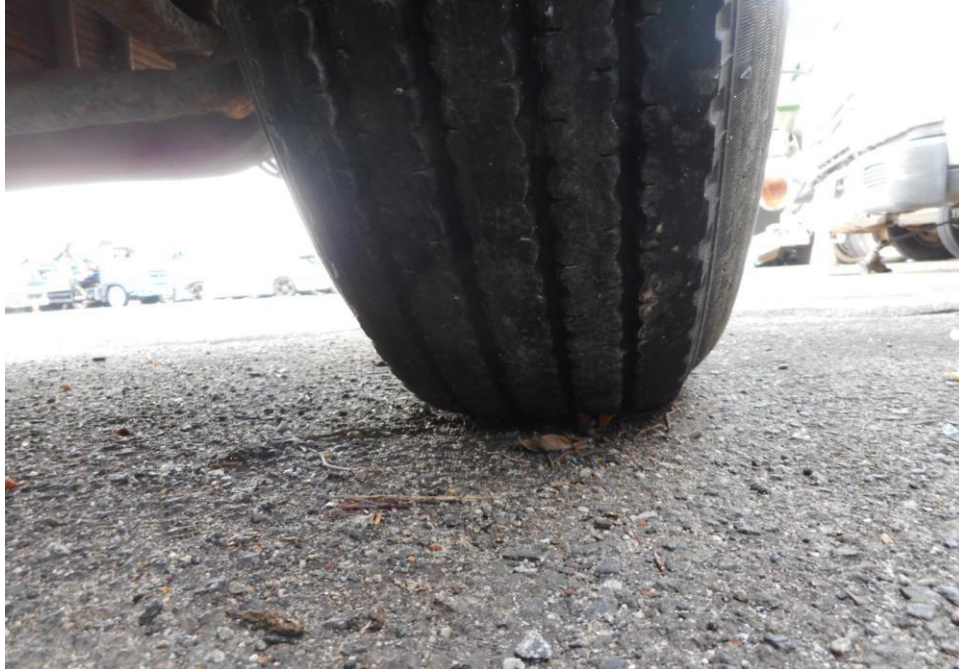
Photo 10 shows the condition of the front right tyre of the Motor Lorry, which was observed to be in serviceable condition with remaining tread depth of approximately 4.4mm. The tyre, which was wrapped around standard steel wheel rim, was also observed to be sufficiently inflated for vehicular operation. There was no tear, cut or burst mark(s) on the outer and the inner sidewalls as well as across the tread of the 6 tyres that were fitted on the Motor Lorry.

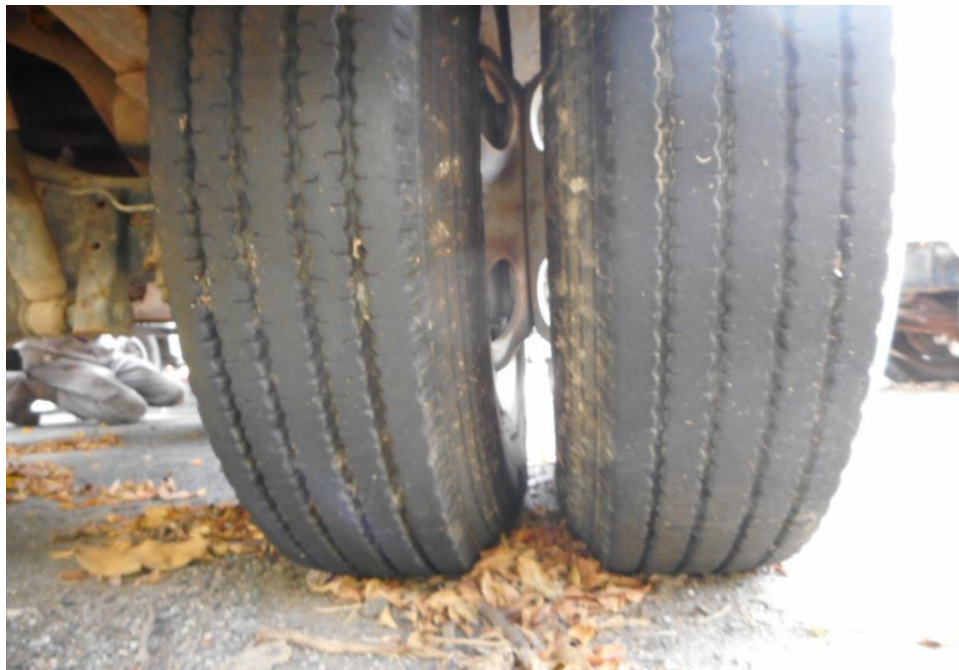
Photo 11 shows the condition of the rear right tyre of the Motor Lorry, which was observed to be in serviceable condition with remaining tread depth of approximately 3.4mm. The tyre, which was wrapped around standard steel wheel rim, it was observed to be sufficiently inflated for vehicular operation.

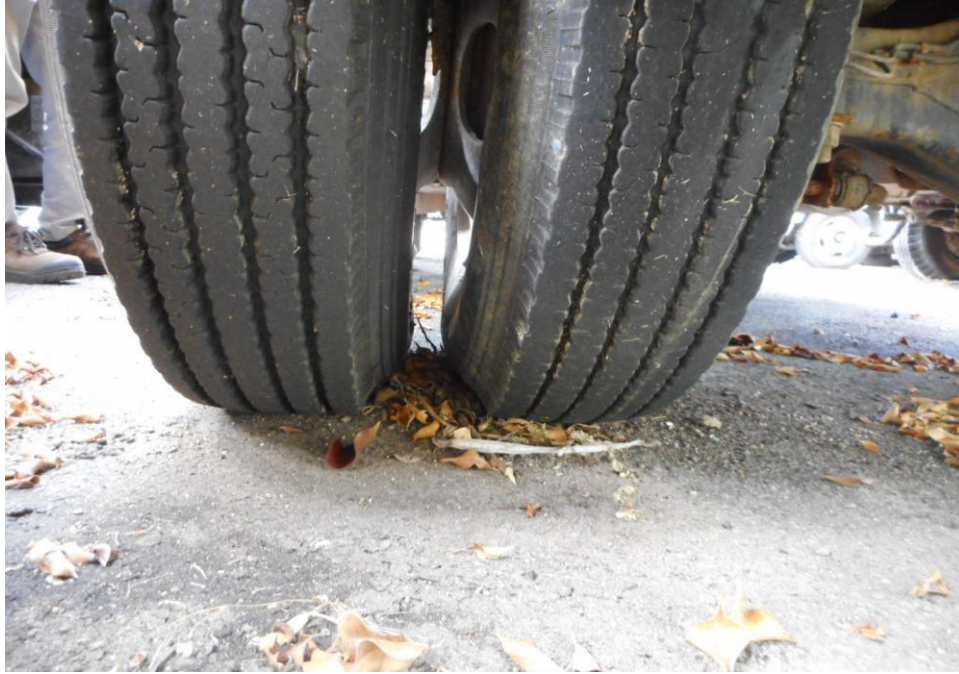
Photo 12 shows the condition of the rear left tyres of the Motor Lorry, which was observed to be in serviceable condition with remaining tread depth of approximately 6.8mm. The tyres, which were wrapped around standard steel wheel rim, were also observed to be sufficiently inflated for vehicular operation. There was also no damage found on all 6 steel wheel rims of the Motor Lorry.

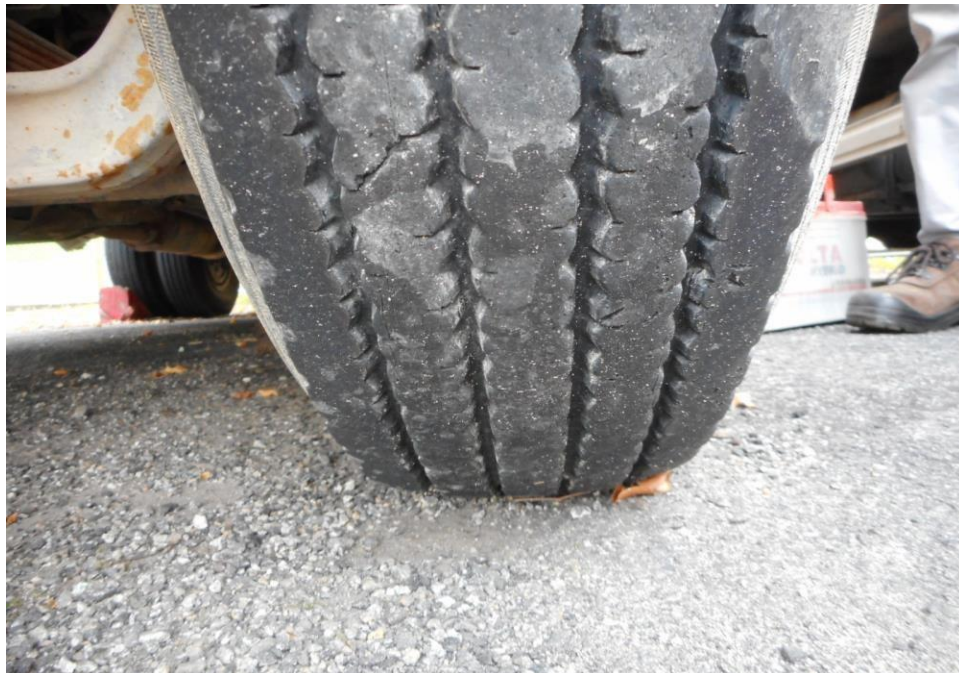
Photo 13 shows the condition of the rear right tyres of the Motor Lorry, which were observed to be in serviceable condition with remaining, tread depth of approximately 6.5mm. There was also no tear, cut or burst mark(s) on the outer and the inner sidewalls as well as across the tread of the 6 tyres that were fitted on the Motor Lorry.

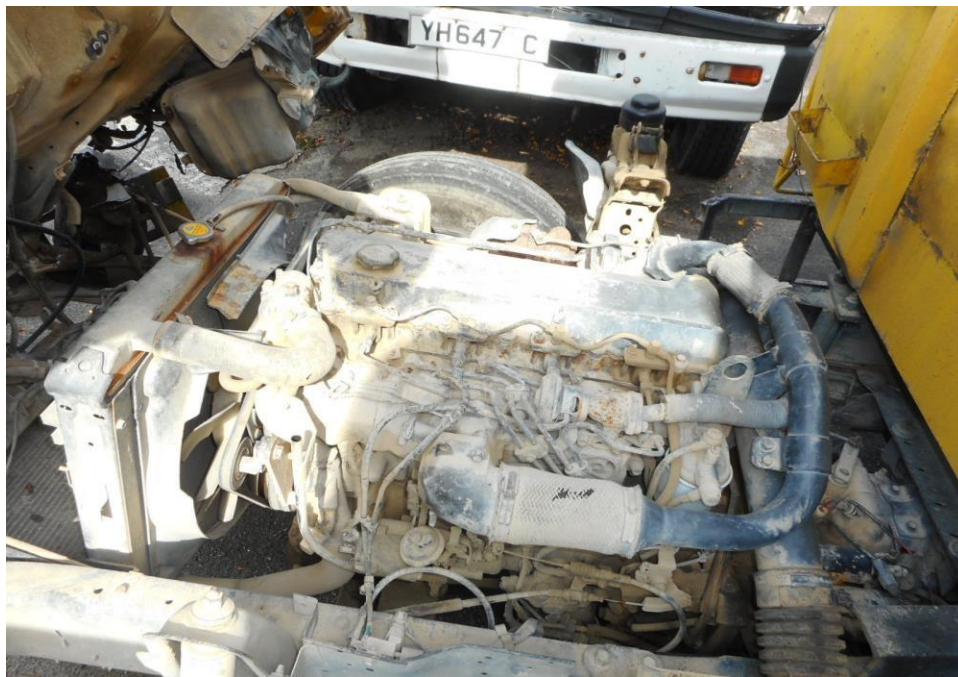
Photo 14 shows a general view of the Motor Lorry's engine compartment, which was accessed by lifting the front cabin of the Motor Lorry. The various parts and components inside the engine compartment were unaffected by the accident. There was also no sign(s) or indication(s) of fresh fluid leakage and/or fluid stain within the engine compartment

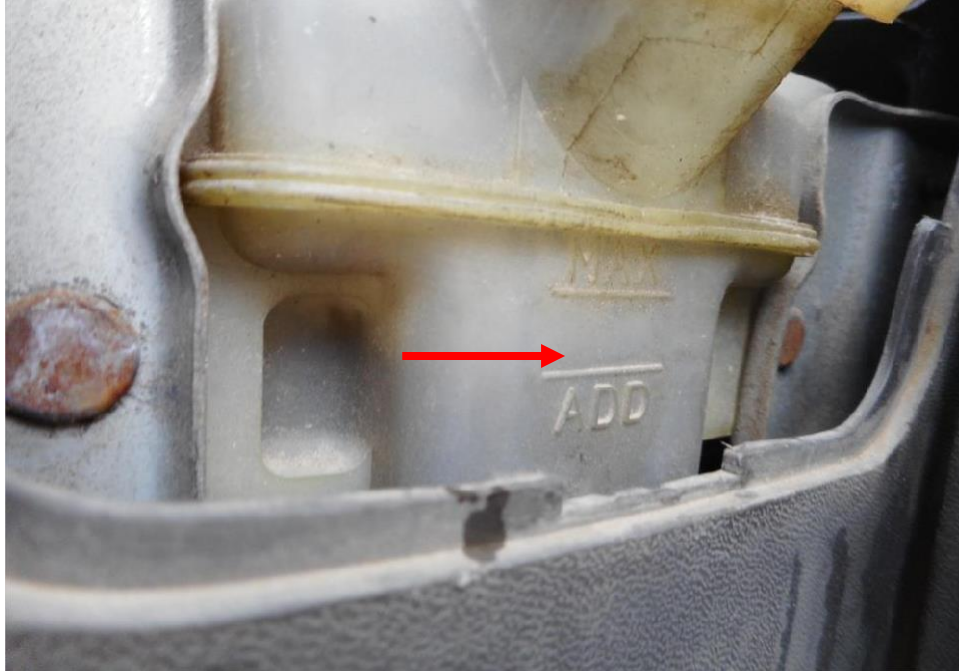
Photo 15 shows the brake fluid reservoir of the Motor Lorry at the time of my inspection. The brake fluid was observed to be of sufficient level (arrowed) and without any visible contamination.

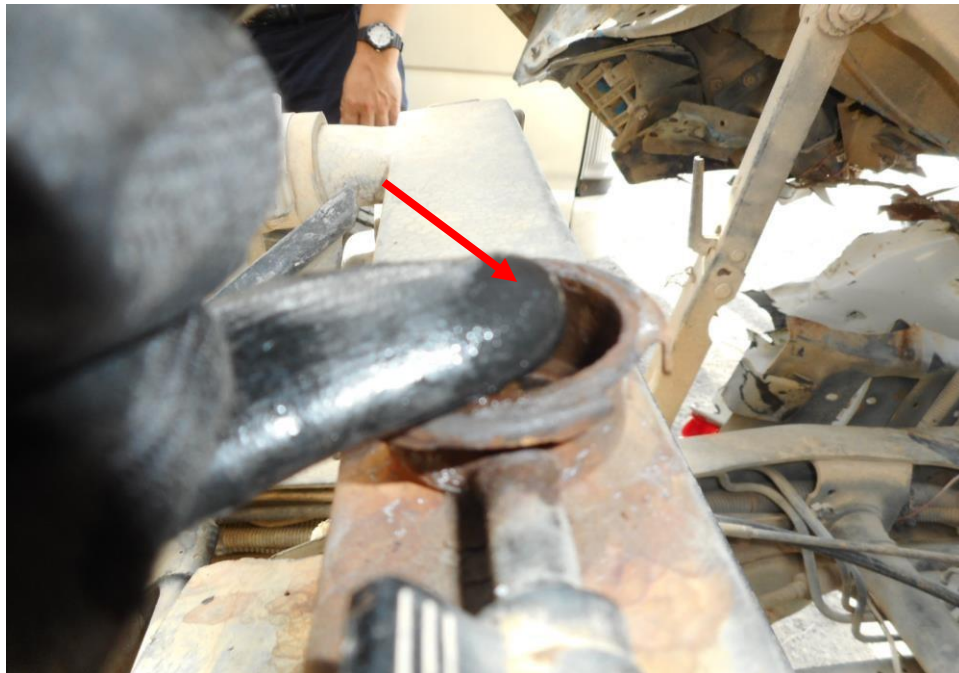
Photo 16 shows the engine coolant reservoir of the Motor Lorry at the time of my inspection. The engine coolant was observed to be of sufficient level (arrowed) and without any visible contamination.

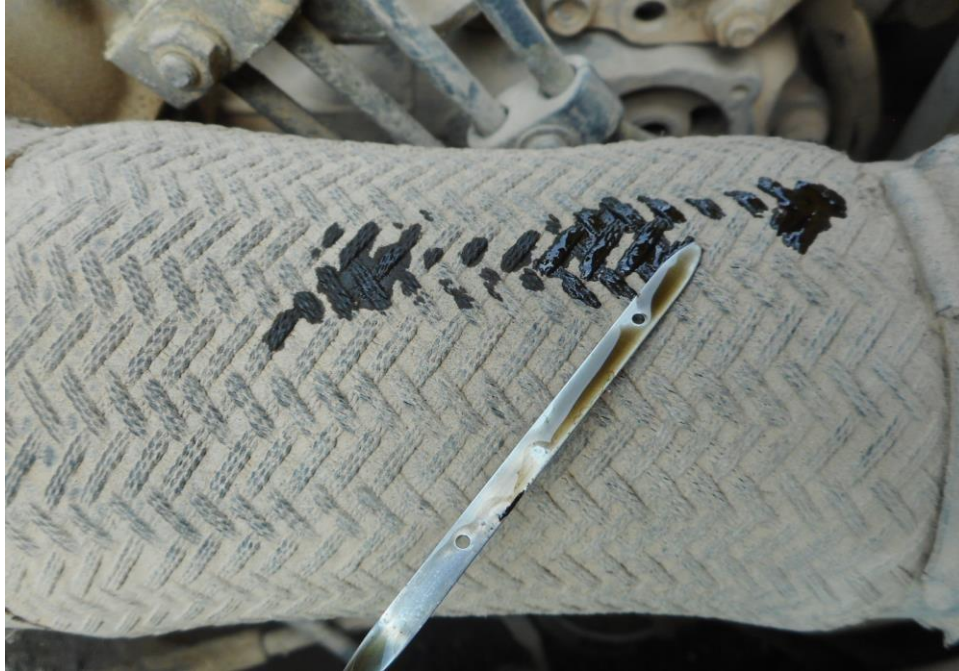
Photo 17 shows the engine oil dip stick of the Motor Lorry at the time of my inspection. The engine oil was observed to be of sufficient level and without any visible contamination.

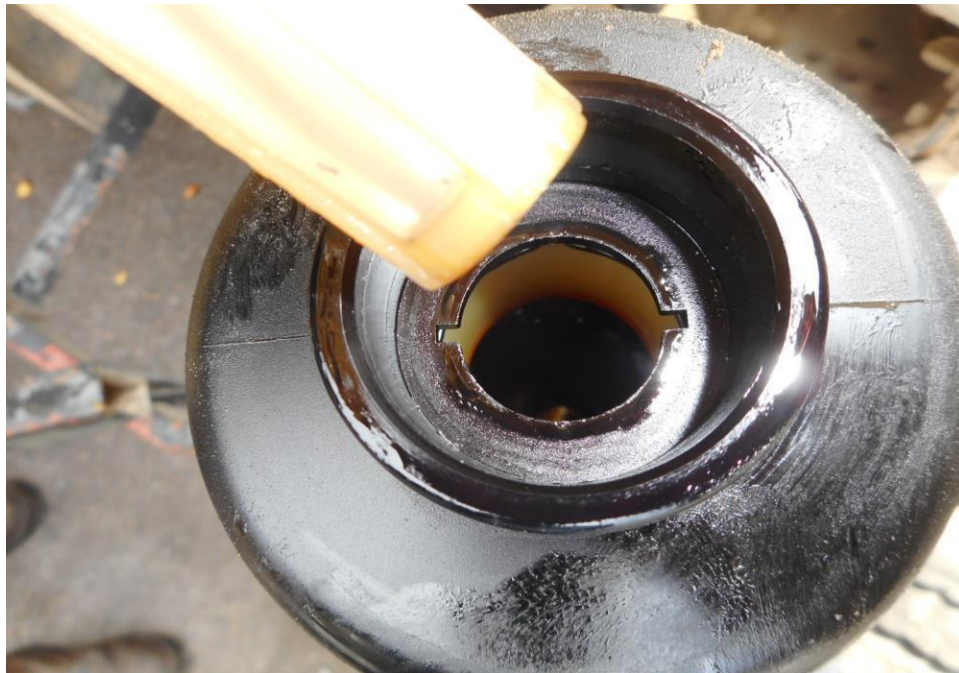
Photo 18 shows the power steering fluid reservoir of the Motor Lorry at the time of my inspection. The power steering fluid was observed to be of sufficient level (arrowed) and without any visible contamination.

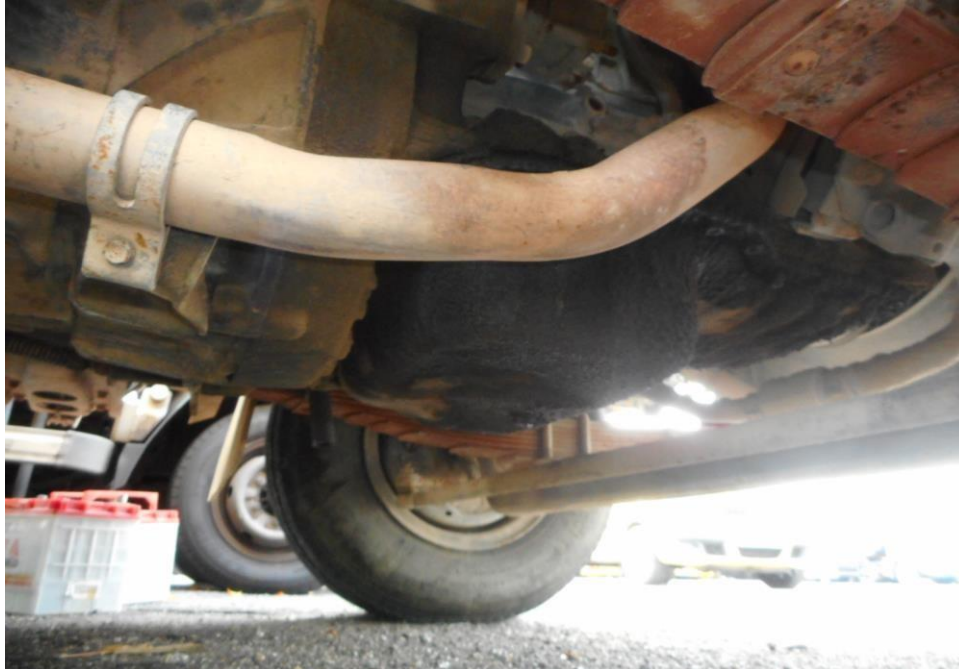
Photo 19 shows the undercarriage of the Motor Lorry, at the area where the engine housing and transmission housing are located. I did not find any sign(s) or indication(s) of fluid leak and/or fluid stain(s) on the underside of the Motor Lorry.

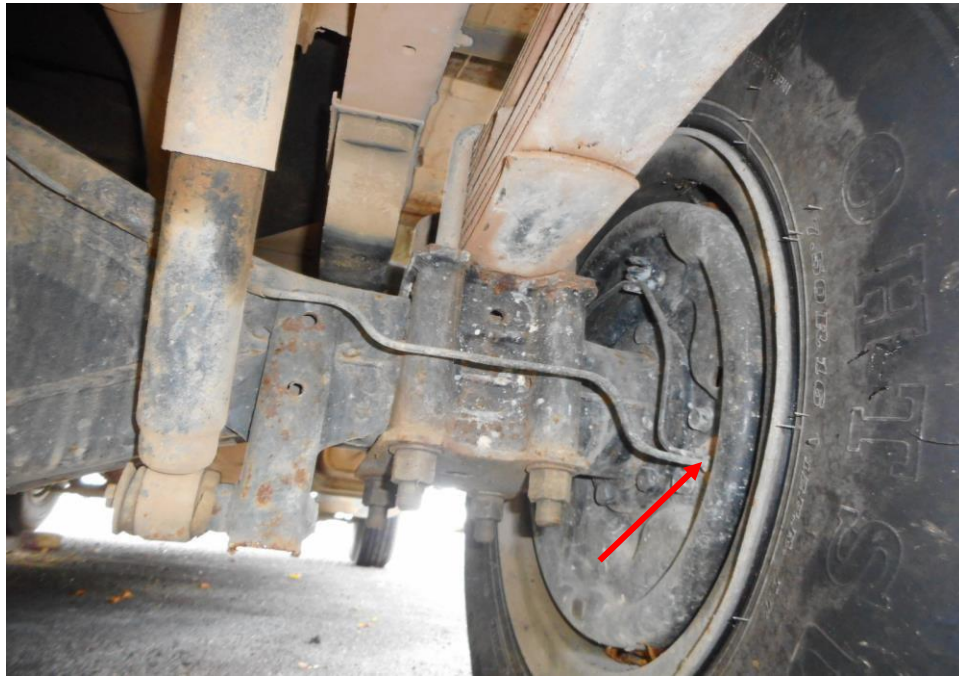
Photo 20 shows the brake pipe (arrowed) at the rear right wheel of the Motor Lorry. I did not observe any leakage of brake fluid at the time of my inspection of the Motor Lorry.

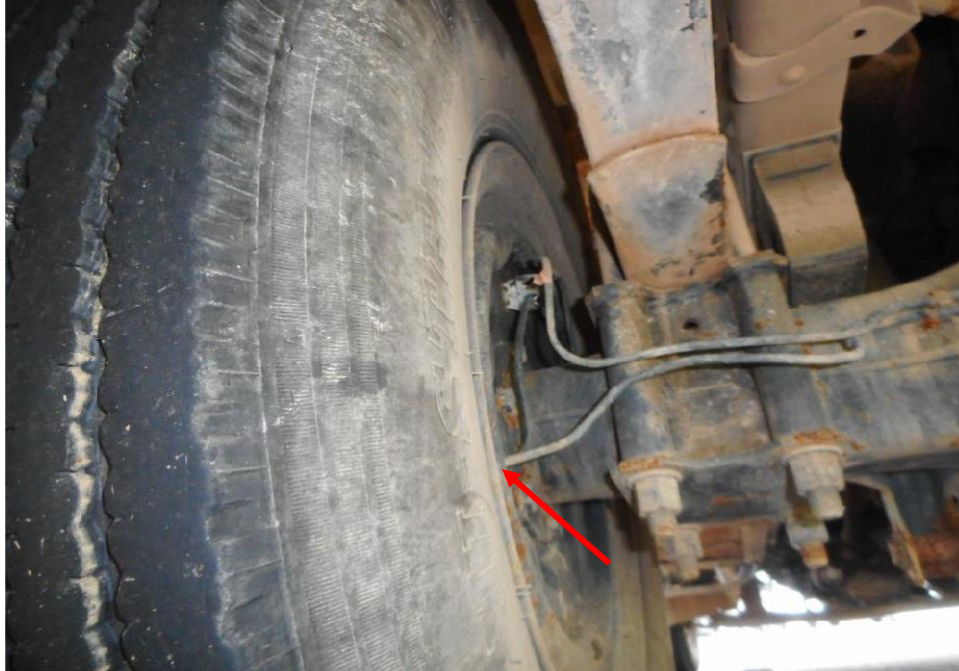
Photo 21 shows the brake pipe (arrowed) at the rear left wheel of the Motor Lorry. I did not observe any leakage of brake fluid at the time of my inspection of the Motor Lorry.

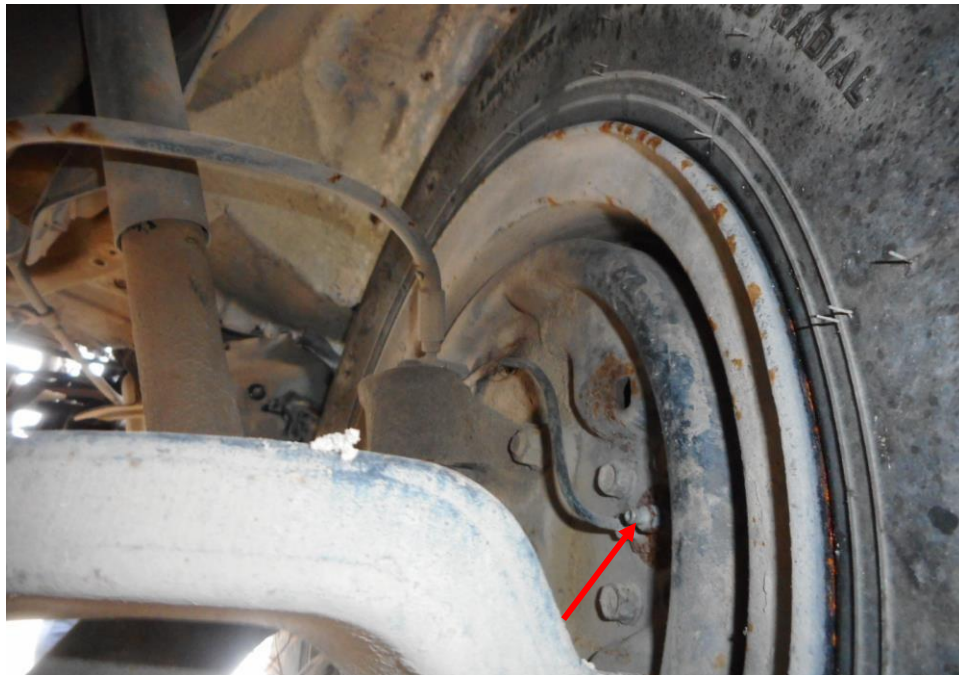
Photo 22 shows the brake hose/pipe (arrowed) at the front right wheel of the Motor Lorry. No leakage of brake fluid was observed. Visual examination of the various components of the braking system like the brake drum (circled), brake pedal etc had revealed all to be intact and without visible damage at the time of accident. There was also no sign of fluid stain(s) observed on the various undercarriage components.

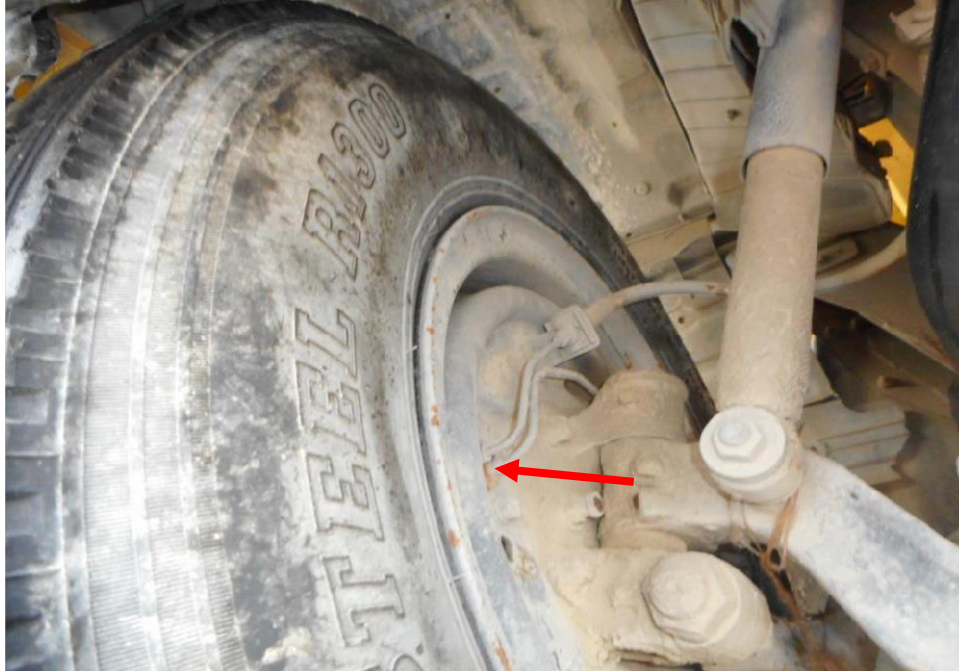
Photo 23 shows the brake hose/pipe (arrowed) at the front left wheel of the Motor Lorry. No leakage of brake fluid was observed. Visual examination of the various components of the braking system like the brake drum (circled), brake pedal etc had revealed all to be intact and without visible damage at the time of accident. There was also no sign of fluid stain(s) observed on the various undercarriage components.

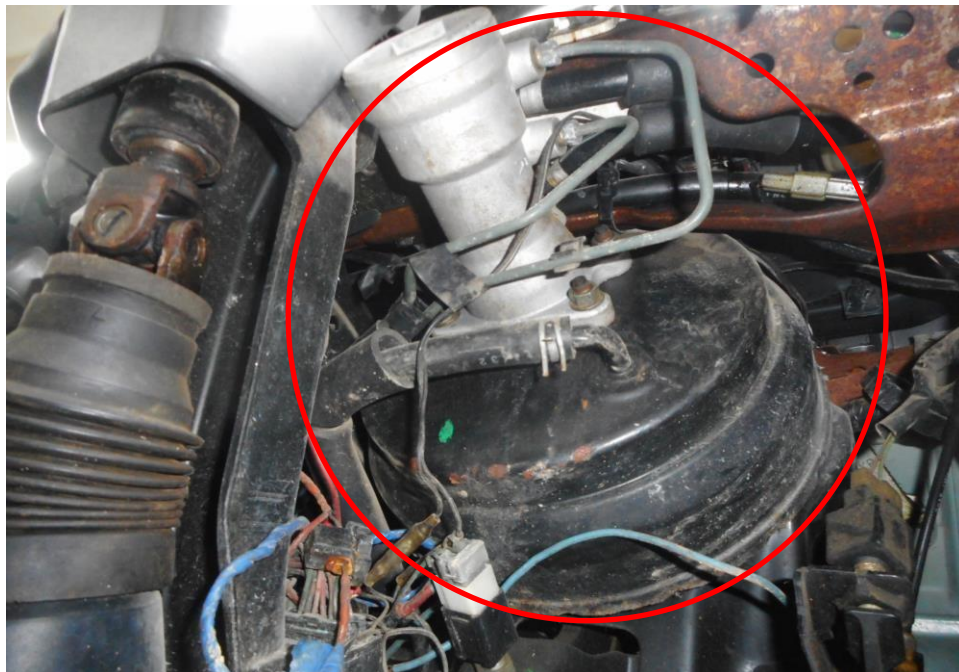
11. Static brake tests conducted on the Motor Lorry revealed abnormality. The brake booster do not responded well to the various tests conducted as there was abnormal movement of the brake pedal when it was depressed.
12. In general, the static brake tests had suggested that there was internal leakage of pressure/vacuum in the braking system of the Motor Lorry and braking system of the Motor Lorry was likely to be unserviceable condition at the material time. This was also taking into consideration that the brake fluid was of sufficient level, and also that there was no sign(s) of brake fluid leakage along the brake hoses and brake pipes. This was likely the cause that had resulted in the accident of the Motor Lorry.

Photo 24 shows the brake booster (arrowed) of the Motor Lorry. No leakage of brake fluid was observed. Visual examination of the various components of the brake booster had revealed all to be intact and without visible damage at the time of inspection. There was also no sign of fluid stain(s) observed on the various undercarriage components.

17. For this particular case, I was able to determine possible mechanical failure to the Motor Lorry that may have contributed to the accident. During the static test conducted to its braking system. The brake booster do not responded well to the various tests conducted as there was abnormal movement of the brake pedal when it was depressed.

18. We were able to determine that there was internal leakage of pressure/vacuum in the braking system of the Motor Lorry and the braking system of the Motor Lorry was likely to be unserviceable condition at the material time. As this was also taking into consideration that there was no damaged the exterior casing of the brake booster and brake fluid was of sufficient level, also that there was no sign(s) of brake fluid leakage along the brake hoses and brake pipes. This abnormality to the braking system of the Motor Lorry had likely caused the accident.

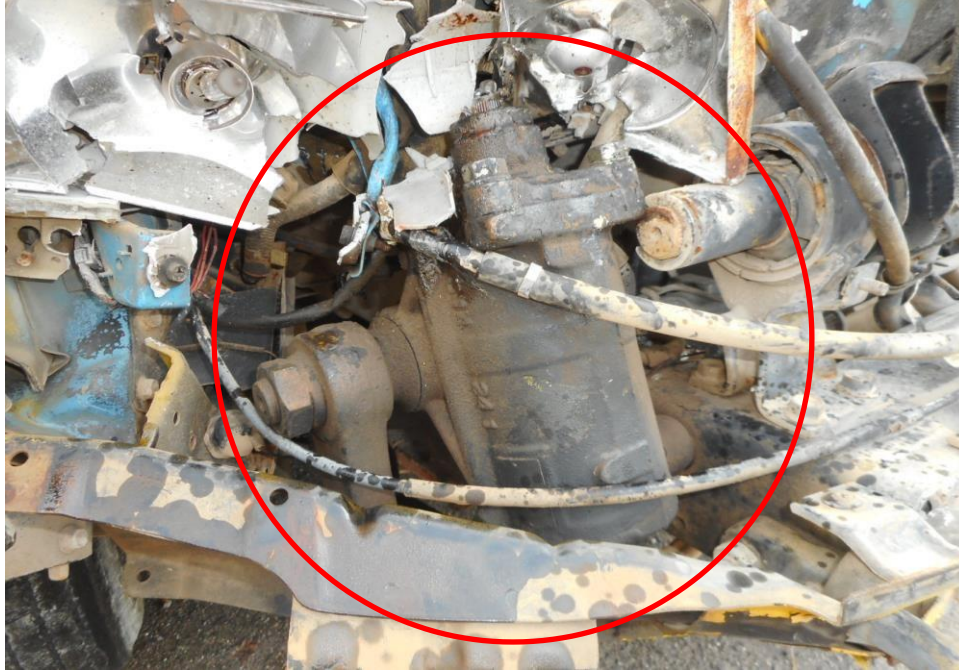
13. Static test on the steering system of the Motor Lorry had revealed abnormality to the steering system. I had experience abnormal free play when turning the steering wheel left and right to full lock positions. This was due to the steering box that had been damaged as a result of the accident.
14. However, my visual examination of the other various steering components which had included the rack and pinion, tie rods, tie rod ends and ball joints had revealed that these components were all generally in good condition. See photo 20 - 28 below.

Photo 25 shows a general view of the steering box (circled) of the Motor Lorry at the time of my inspection. The steering box was observed to be damaged as result of the accident.

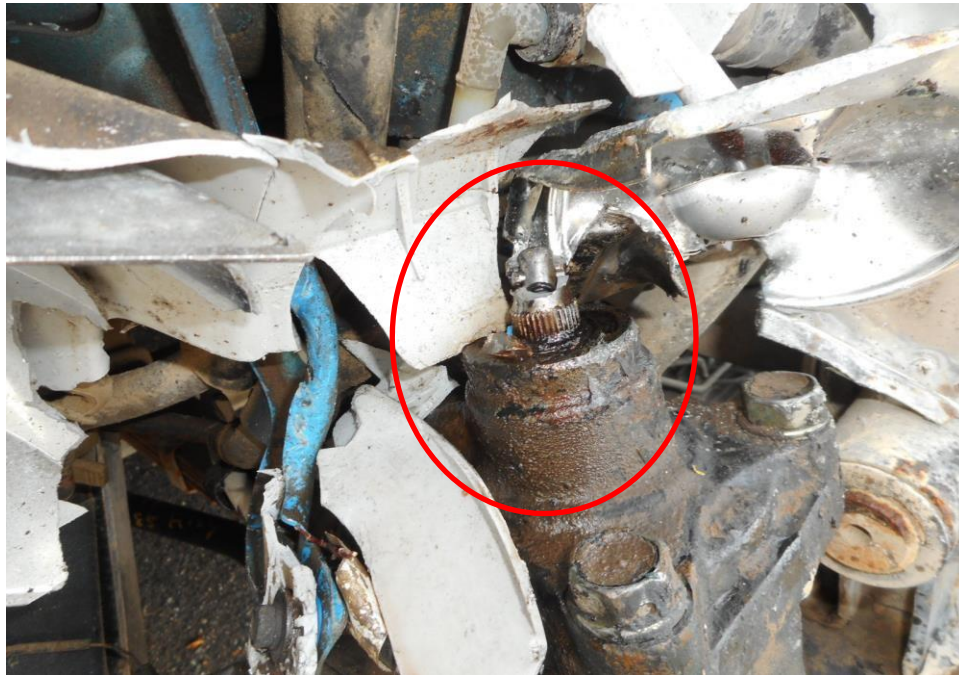
Photo 26 shows a close up view of the steering box (circled) of the Motor Lorry at the time of my inspection. The steering box was observed to be damaged as result of the accident.

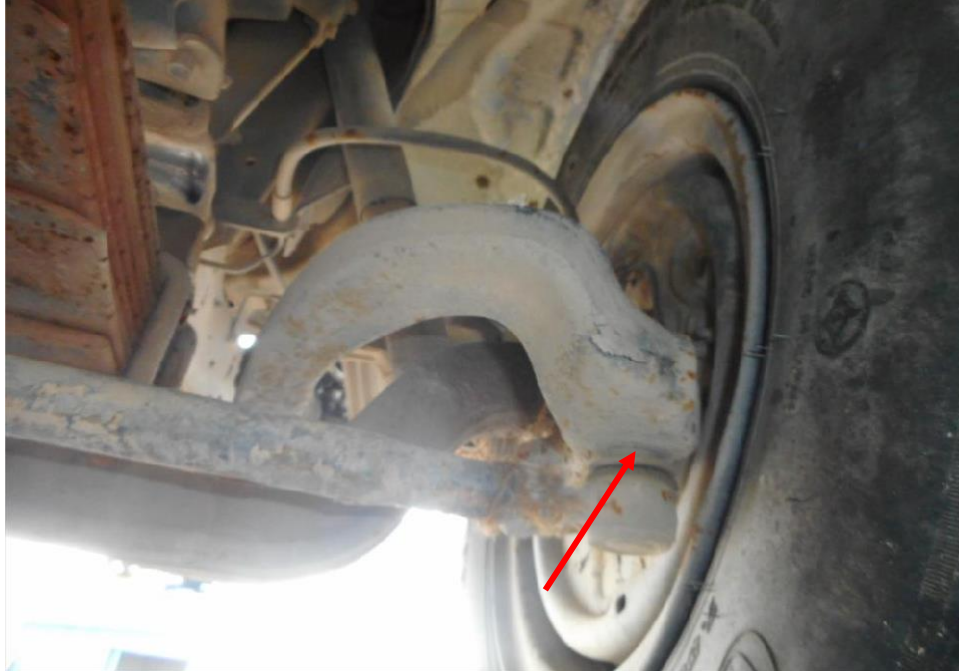
Photo 27 shows the various undercarriage components at the front right wheel of the Motor Lorry, in particular the steering tie rod end (arrowed). The various steering components were all found to be intact, suggesting that the steering system of the Motor Lorry was likely to be in serviceable condition at the material time of accident. There was also no sign of fluid stain(s) observed on the various undercarriage components.

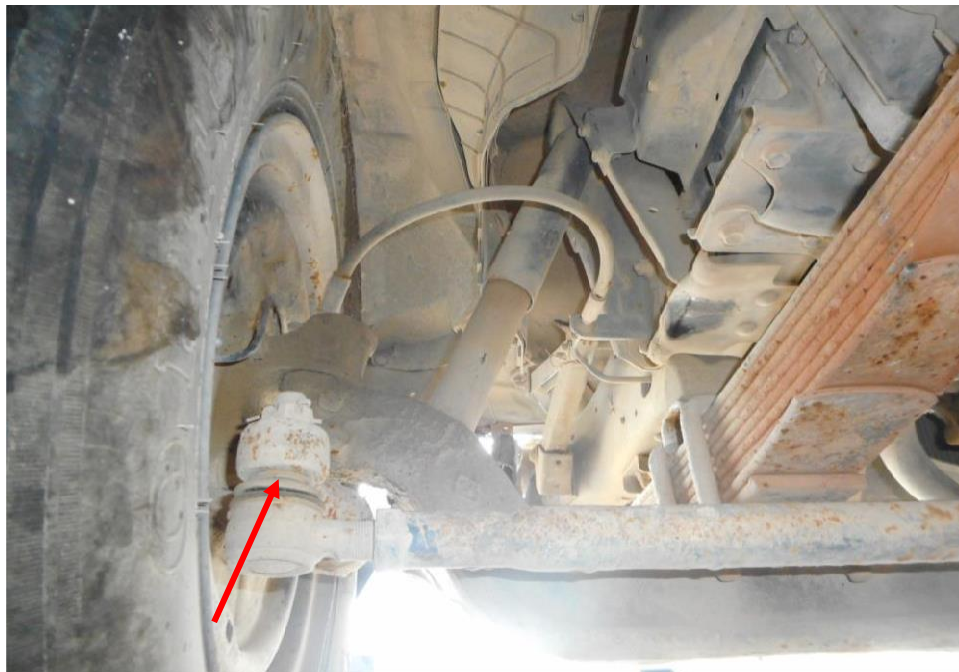
Photo 28 shows the various undercarriage components at the front left wheel of the Motor Lorry, in particular the steering tie rod end (arrowed). The various undercarriage components of the Motor Lorry were all found to be intact without any visible damage. There was also no sign of fluid stain(s) observed on the various undercarriage components.
