Your Ref: TP/IP/31607/2020  
Our Ref : CI/TPD21000238/P

**Fatal Accident Investigation Team**

**MECHANICAL INSPECTION REPORT OF MOTOR CAR SMT 8310T**

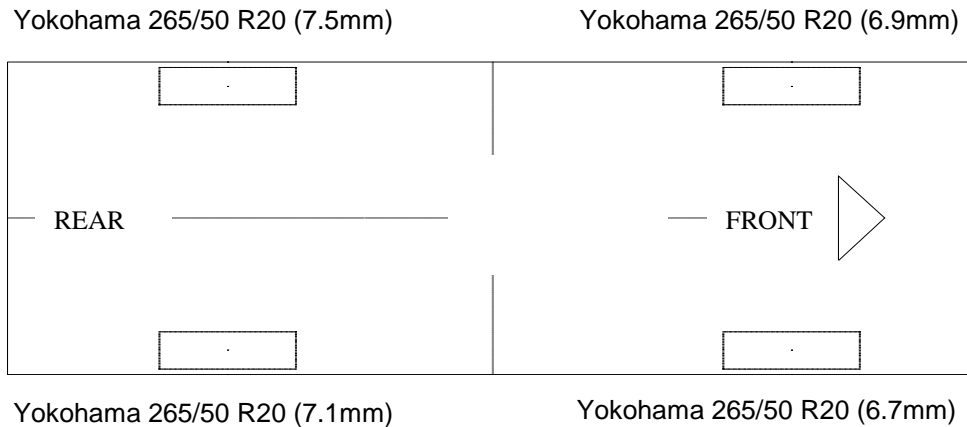
6. The condition of the Motor Car's 4 tyres was observed to be in serviceable condition. I did not find any tear, cut or burst mark(s) on the outer and the inner sidewalls as well as across the tread of the 4 tyres. The 4 tyres were also observed to be sufficiently inflated for vehicular operation. The tyre brand, tyre size and remaining tread depth of the 4 tyres were recorded as follows:-

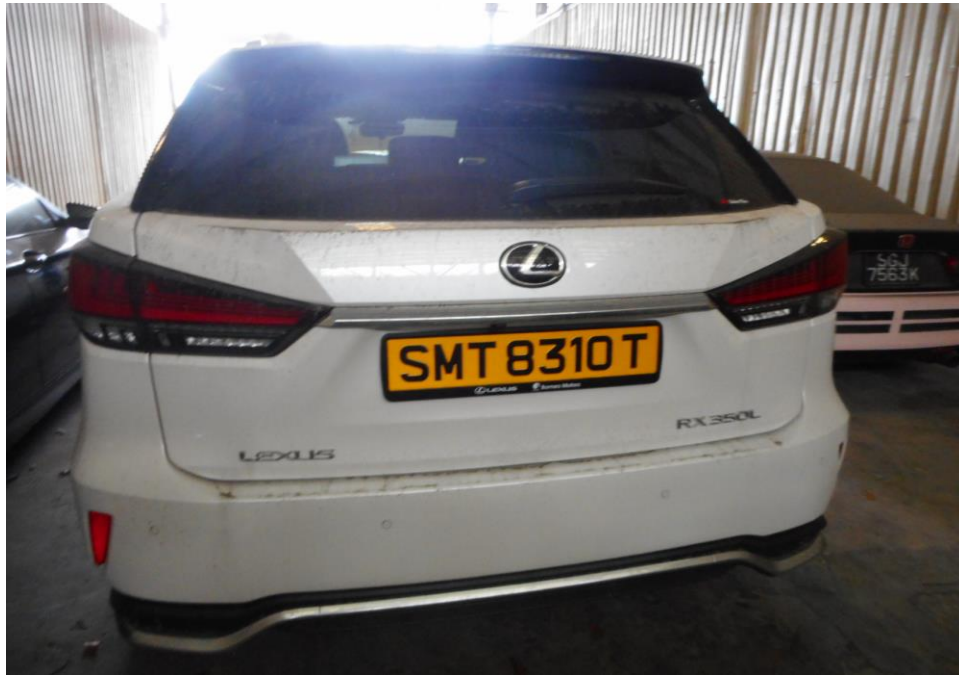
**Photo 1** shows a general view of the Motor Car's rear body at the time of my inspection. The rear portion of the Motor Car was observed to have been undamaged by the accident.

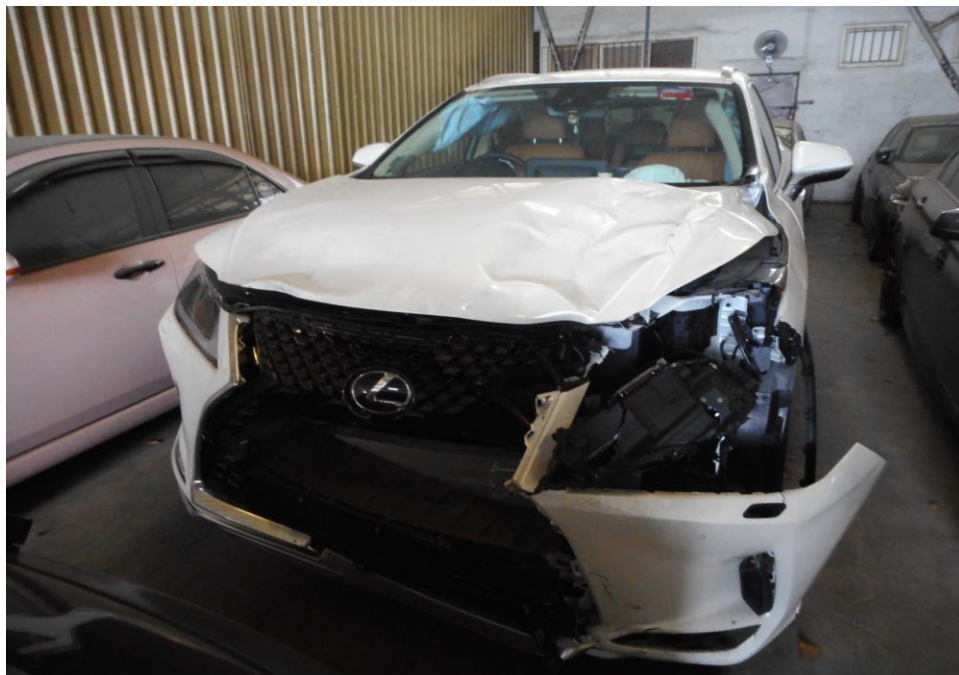
**Photo 2** shows a general view of the Motor Car's front body at the time of my inspection. The Motor car was observed to have sustained damage at its front portion. Its front bonnet, front bumper, front left headlamp was amongst the body parts and various components in the engine compartments were also damaged as a result of the accident. The Supplemental Restraint System (SRS) was activated as a result of the accident.

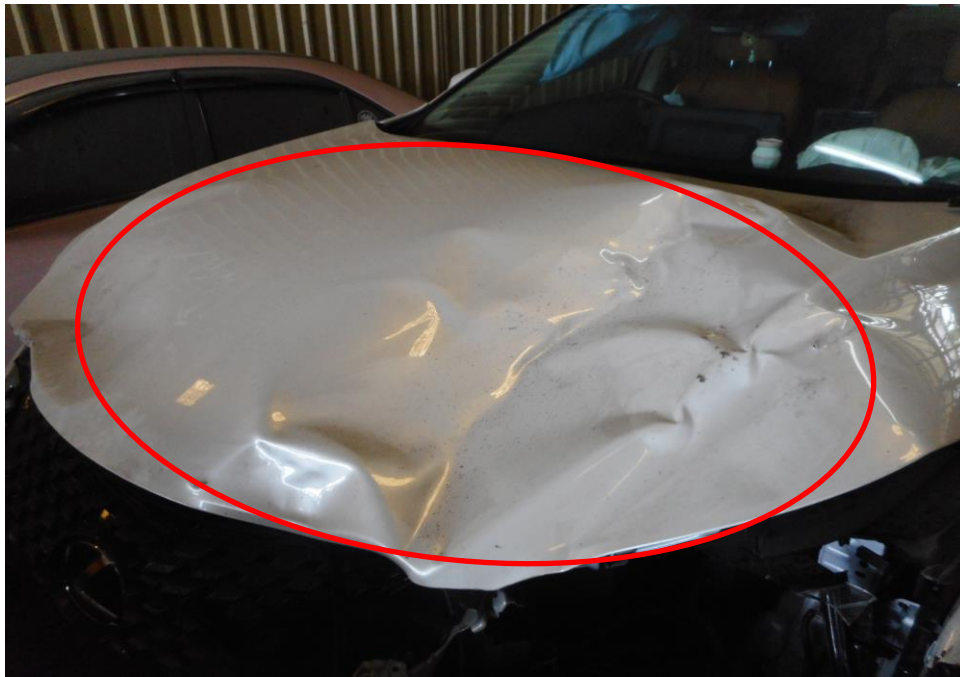
**Photo 3** shows the close up view of the Motor Car's front body at the time of my inspection. The Motor car was observed to have sustained damage at its front portion. Its front bonnet (circled) was amongst the body parts and various components in the engine compartments were also damaged as a result of the accident.

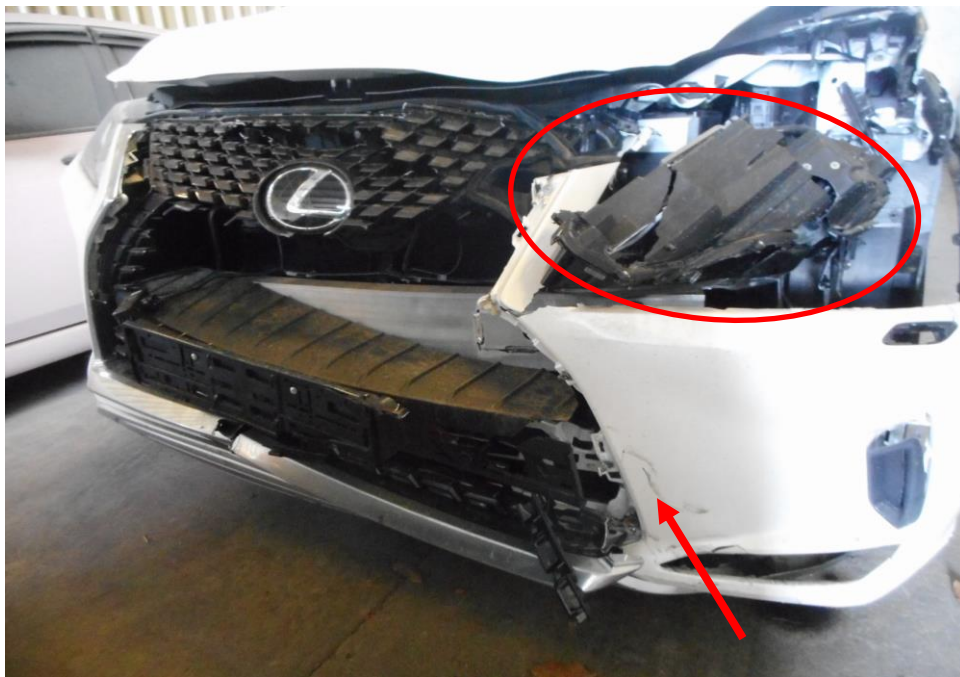
**Photo 4** shows the close up view of the Motor Car's front body at the time of my inspection. The Motor car was observed to have sustained damage at its front portion. Its front left headlamp (circled) and front bumper (arrowed) was amongst the body parts and various components in the engine compartments were also damaged as a result of the accident.

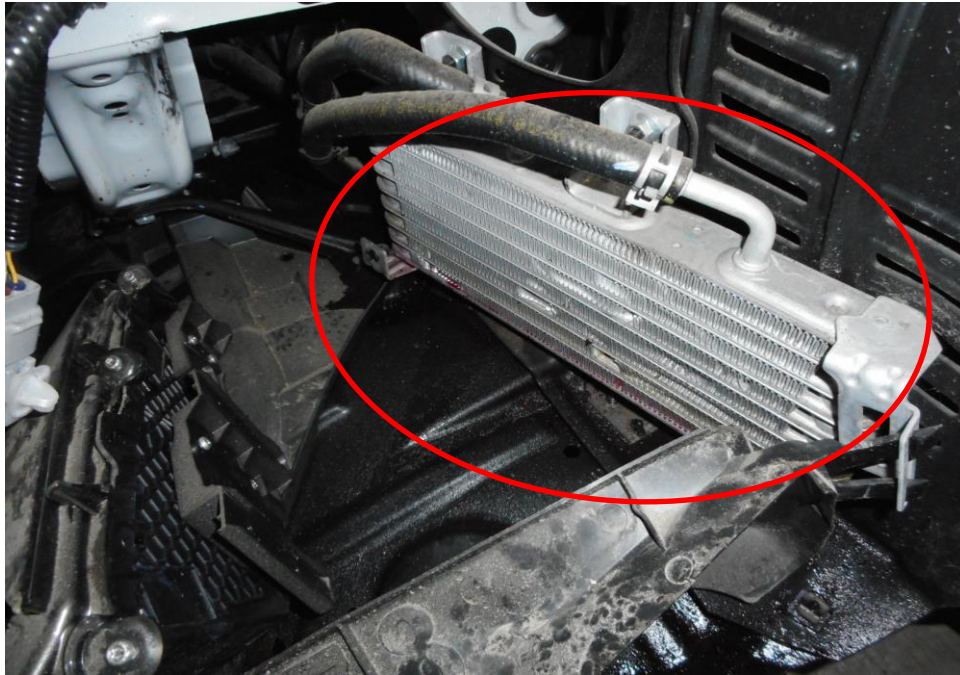
**Photo 5** shows the close up view of the Motor Car's front body at the time of my inspection. The Motor car was observed to have sustained damage at its front portion. Its engine component (circled) was amongst the various components in the engine compartments were also damaged as a result of the accident.

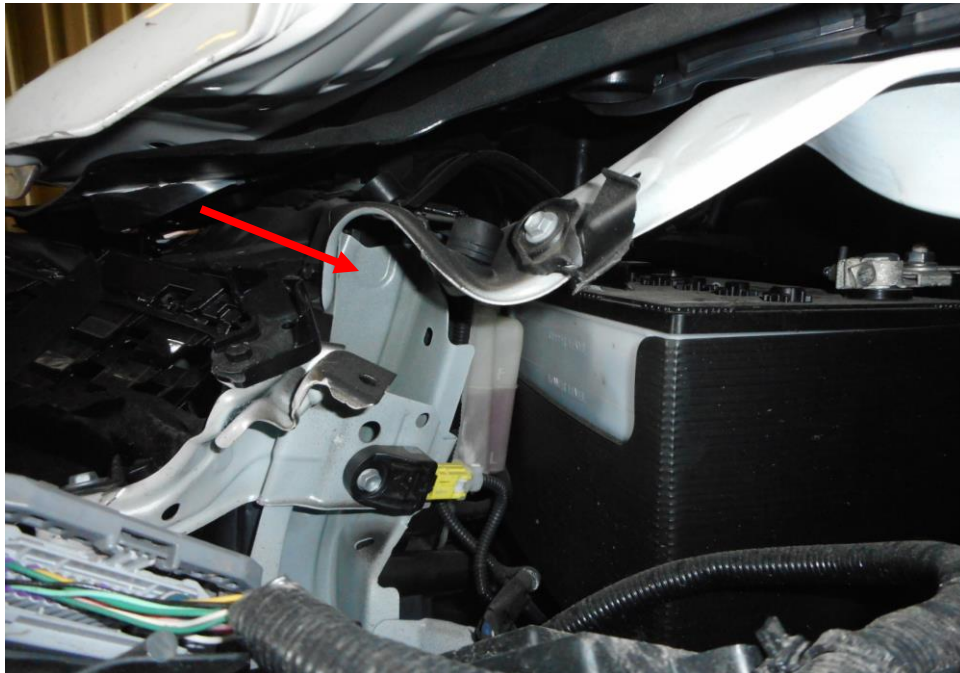
**Photo 6** shows the close up view of the Motor Car's front body at the time of my inspection. The Motor car was observed to have sustained damage at its front portion. Its engine reinforcement pillar (arrowed) was amongst the various components in the engine compartments were also damaged as a result of the accident.

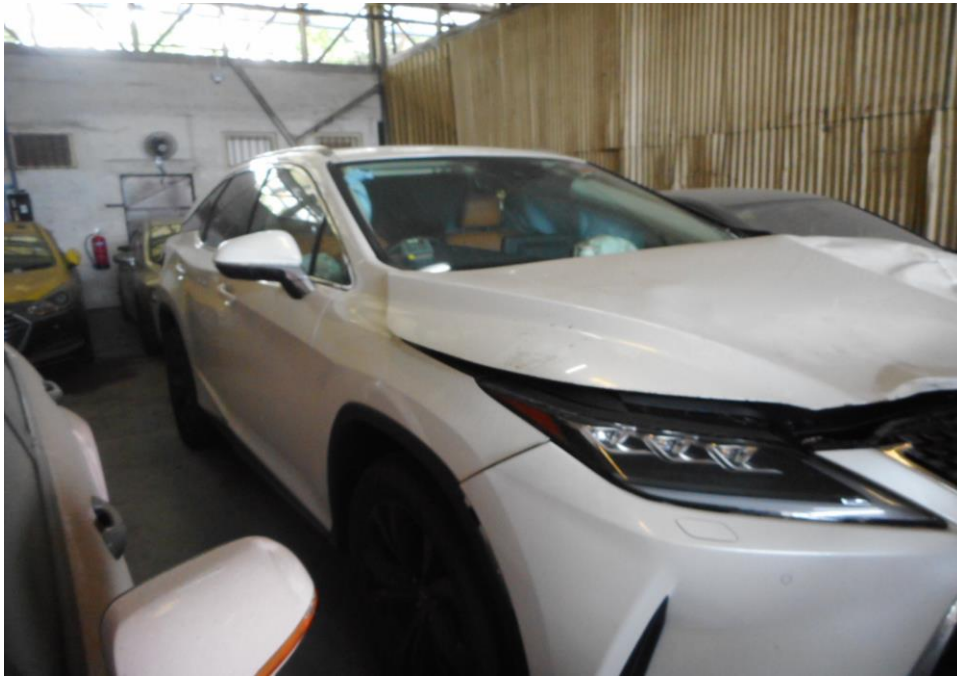
**Photo 7** shows a general view of the Motor Car's right body at the time of my inspection. The right portion of the Motor Car was observed to have been undamaged by the accident.

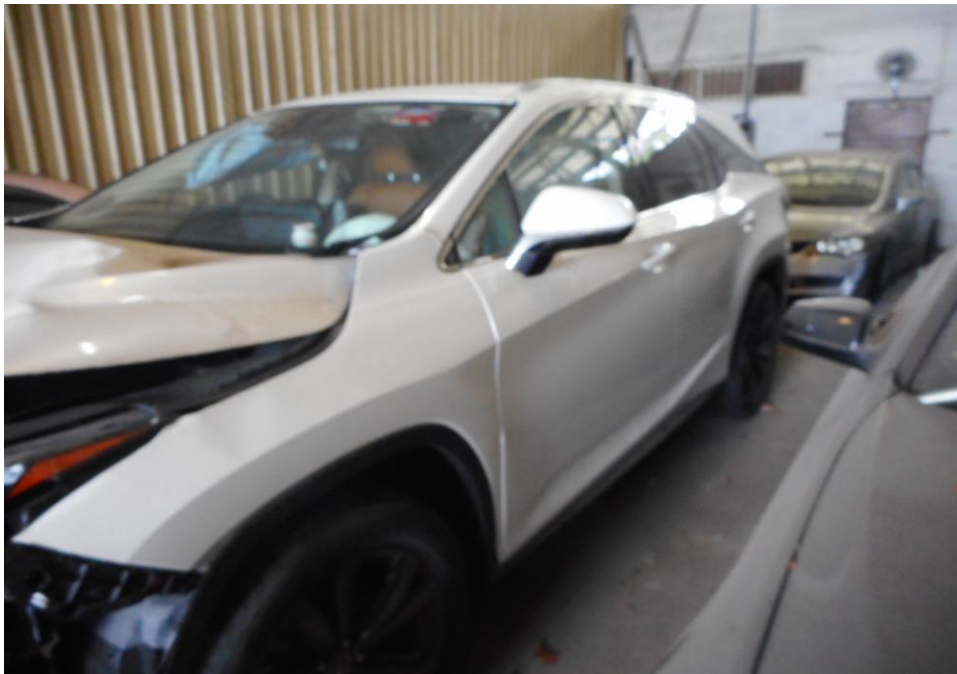
**Photo 8** shows a general view of the Motor Car's left body at the time of my inspection. The left portion of the Motor Car was observed to have been undamaged by the accident.

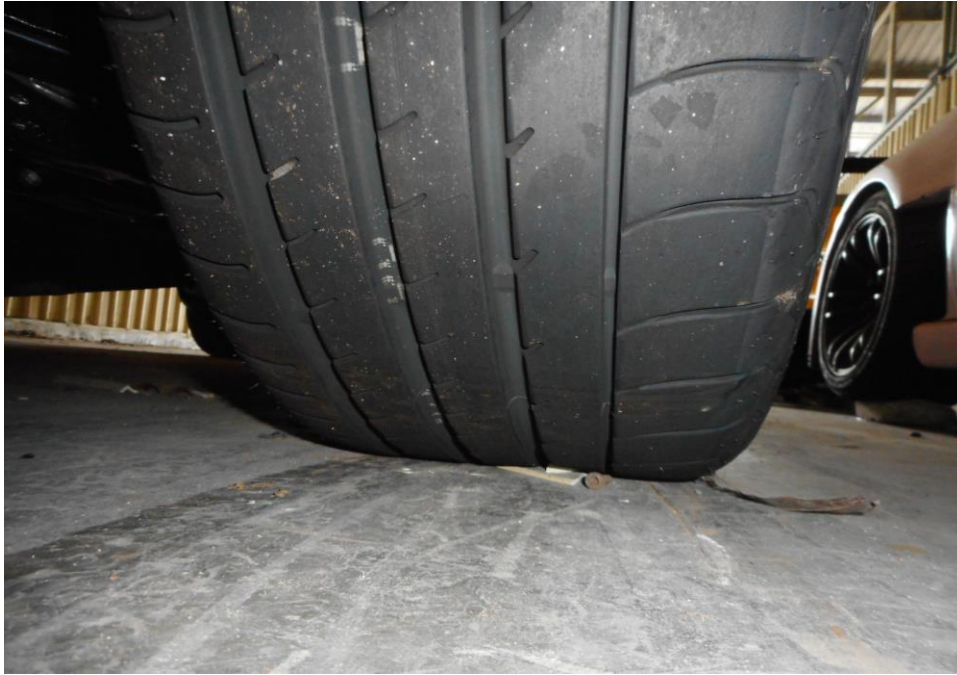
**Photo 9** shows the condition of the front right tyre of the Motor Car, which was observed to be in serviceable condition with remaining tread depth of approximately 6.7mm. The tyre, which was wrapped around alloy wheel rim, was also observed to be sufficiently inflated for vehicular operation.

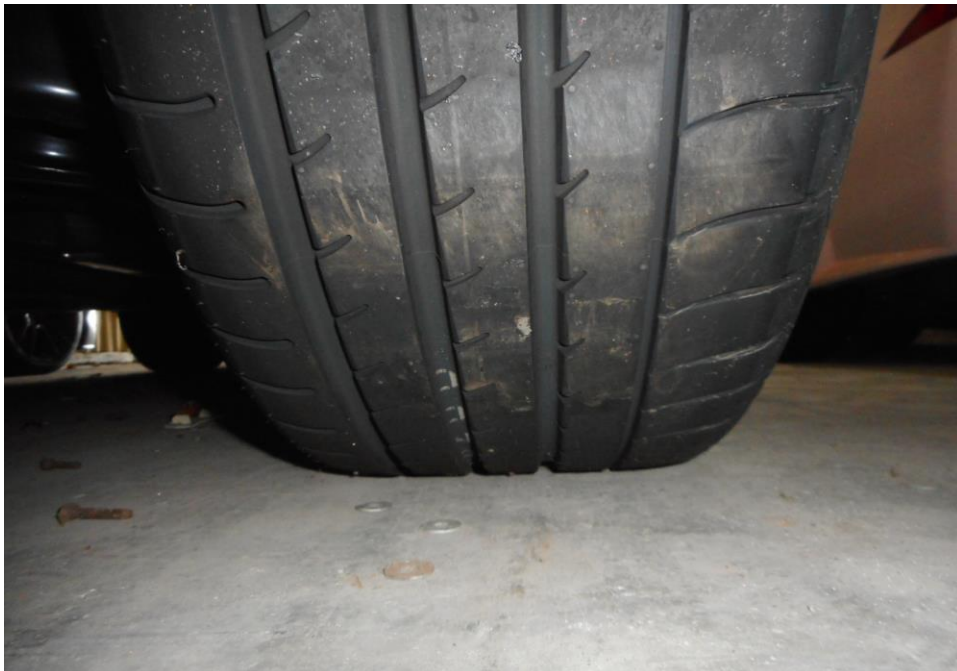
**Photo 10** shows the condition of the rear right tyre of the Motor Car, which was observed to be in serviceable condition with remaining tread depth of approximately 7.1mm. The tyre was also observed to be sufficiently inflated for vehicular operation with no tear, cut or burst mark(s).

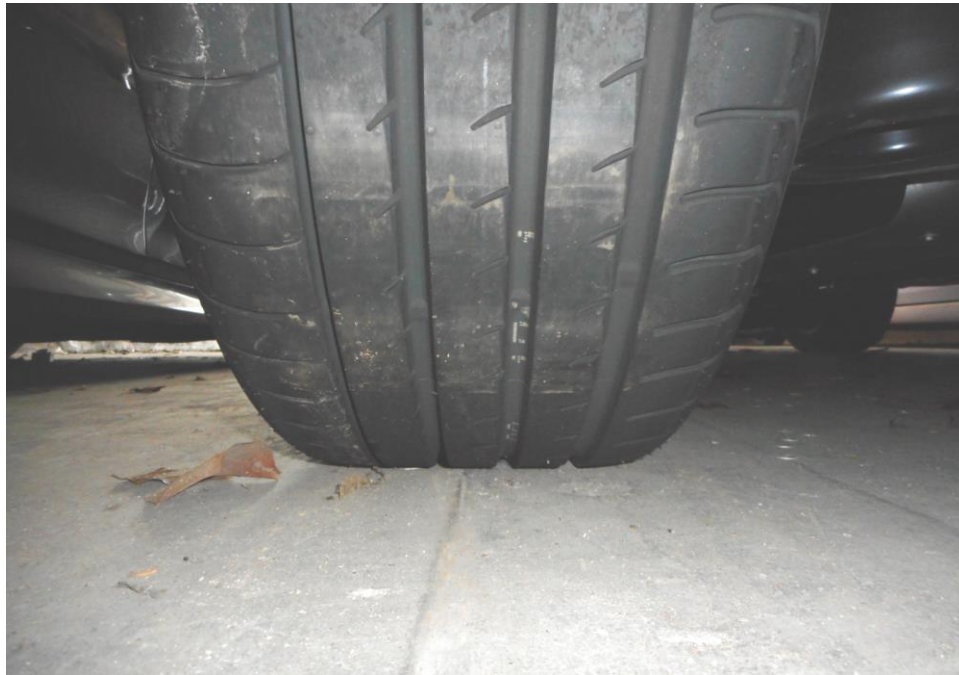
**Photo 11** shows the condition of the rear left tyre of the Motor Car, which was observed to be in serviceable condition with remaining tread depth of approximately 7.5mm. The tyre was also observed to be sufficiently inflated for vehicular operation with no tear, cut or burst mark(s).

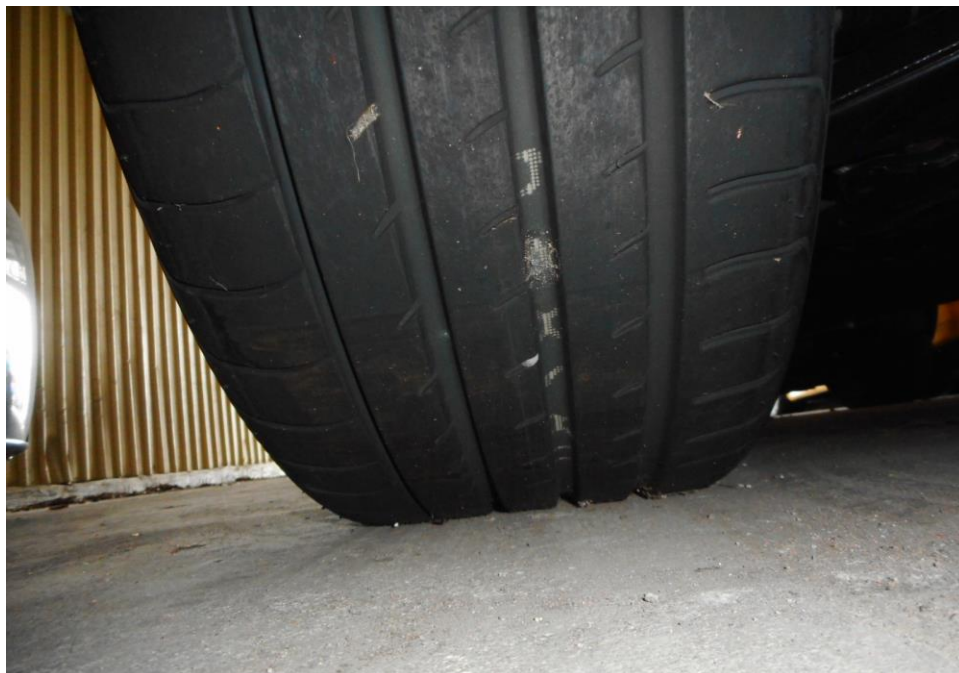
**Photo 12** shows the condition of the front left tyre of the Motor Car, which was observed to be in serviceable condition with remaining tread depth of approximately 6.9mm. The tyre was also observed to be sufficiently inflated for vehicular operation with no tear, cut or burst mark(s).

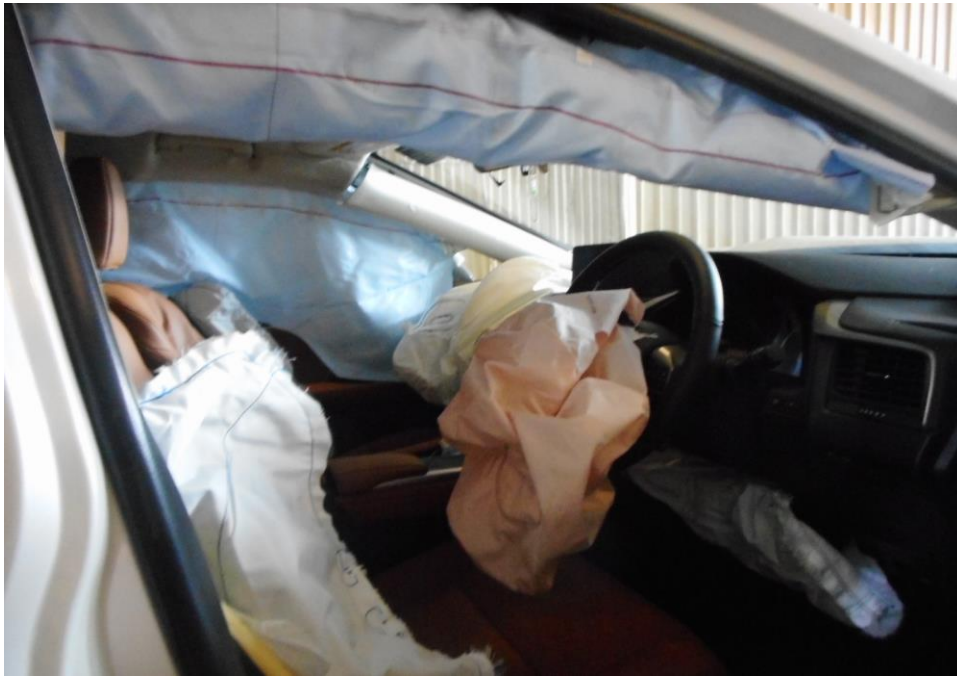
**Photo 13** shows the deployment of the Supplemental Restraint System (SRS) airbag in the Motor Car as a result of the accident.

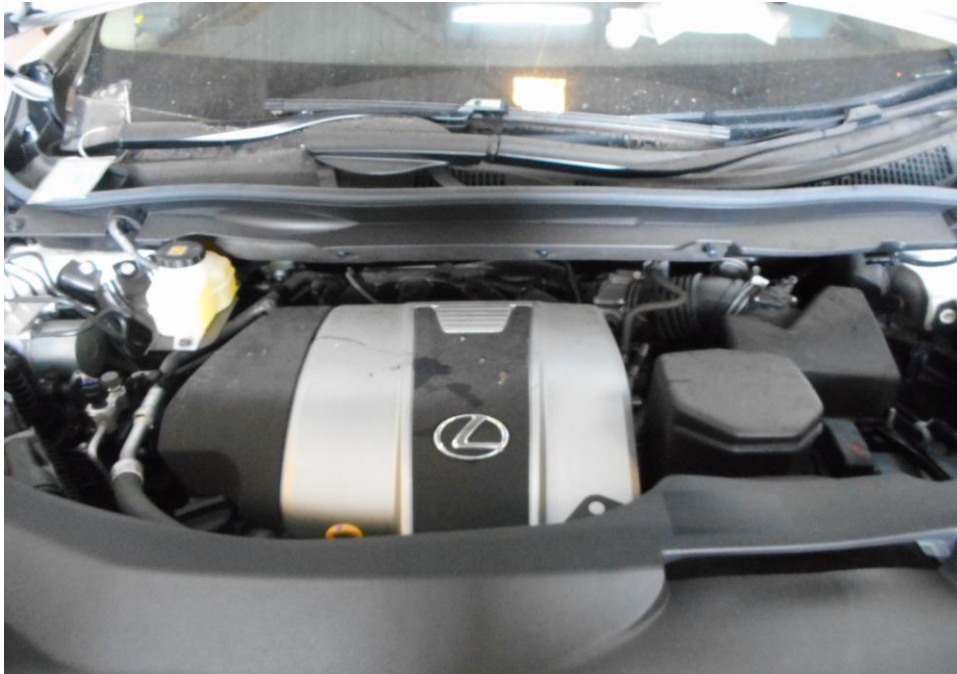
**Photo 14** shows a general view of the Motor Car's engine compartment, which was accessed by lifting the front cabin of the Motor Car. The various parts and components inside the engine compartment are shown. There was no sign(s) or indication(s) of fresh fluid leakage and/or fluid stain within the engine compartment

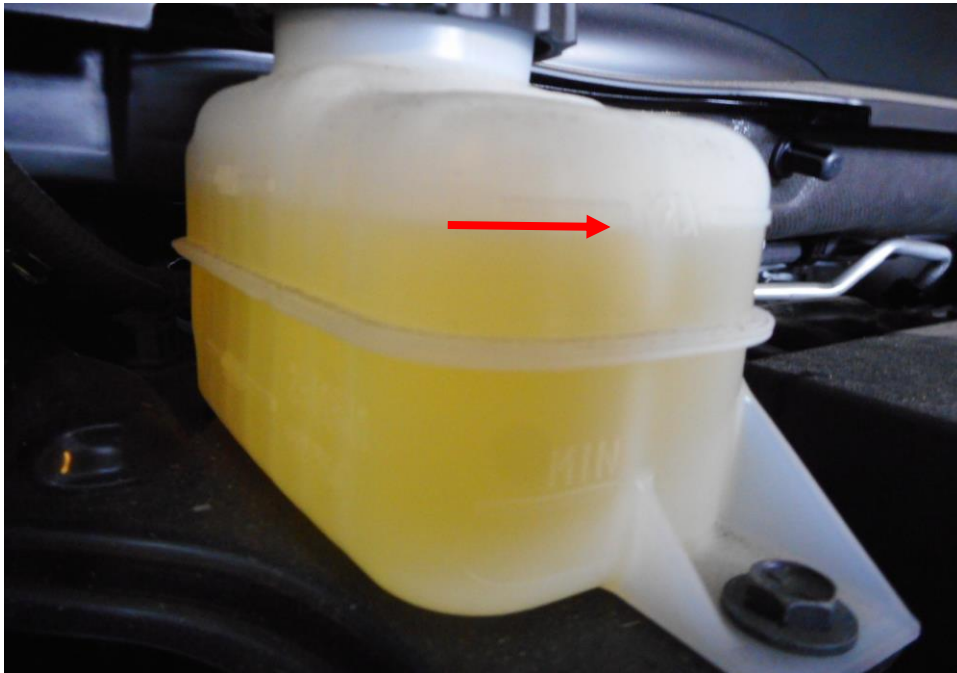
**Photo 15** shows the brake fluid reservoir of the Motor Car at the time of my inspection. The brake fluid was observed to be of sufficient level (arrowed) and without any visible contamination.

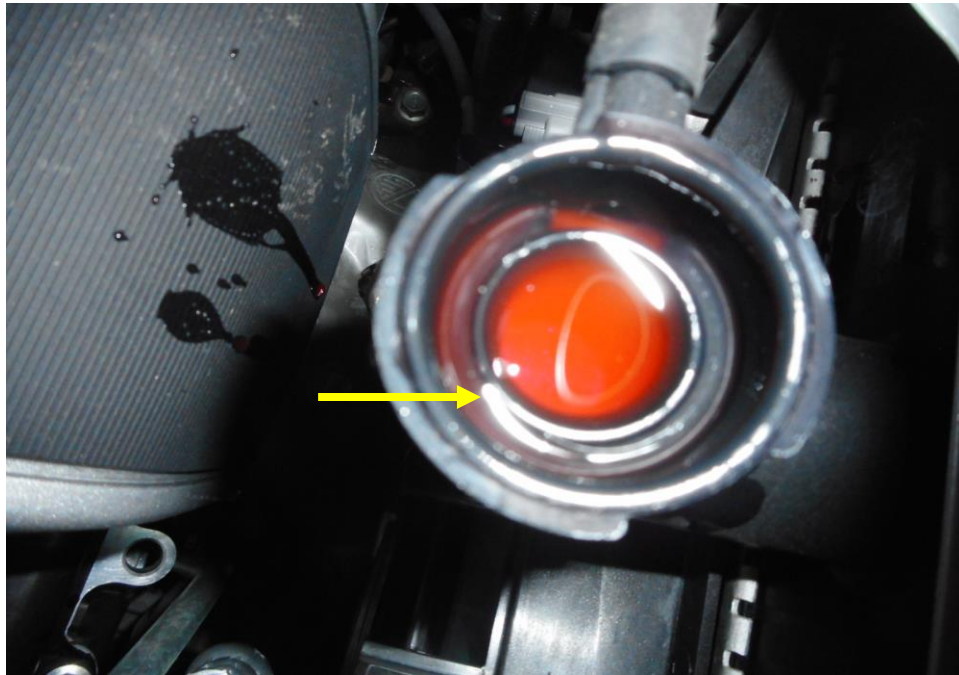
**Photo 16** shows the engine coolant reservoir of the Motor Car at the time of my inspection. The engine coolant was observed to be of sufficient level (arrowed) and without any visible contamination.

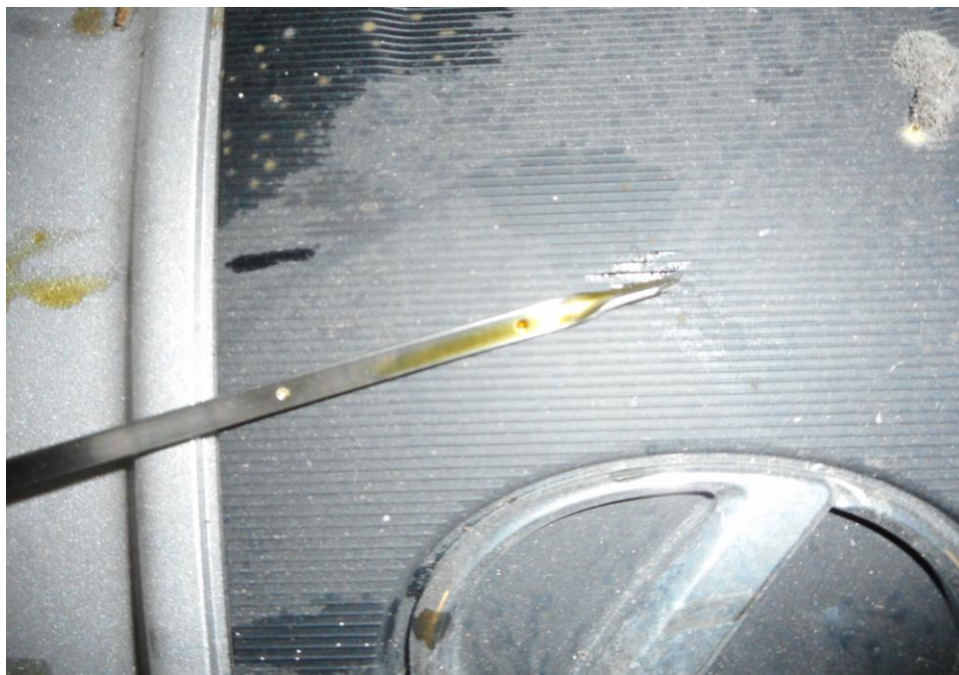
**Photo 17** shows the engine oil dip stick of the Motor Car at the time of my inspection. The engine oil was observed to be of sufficient level and without any visible contamination.

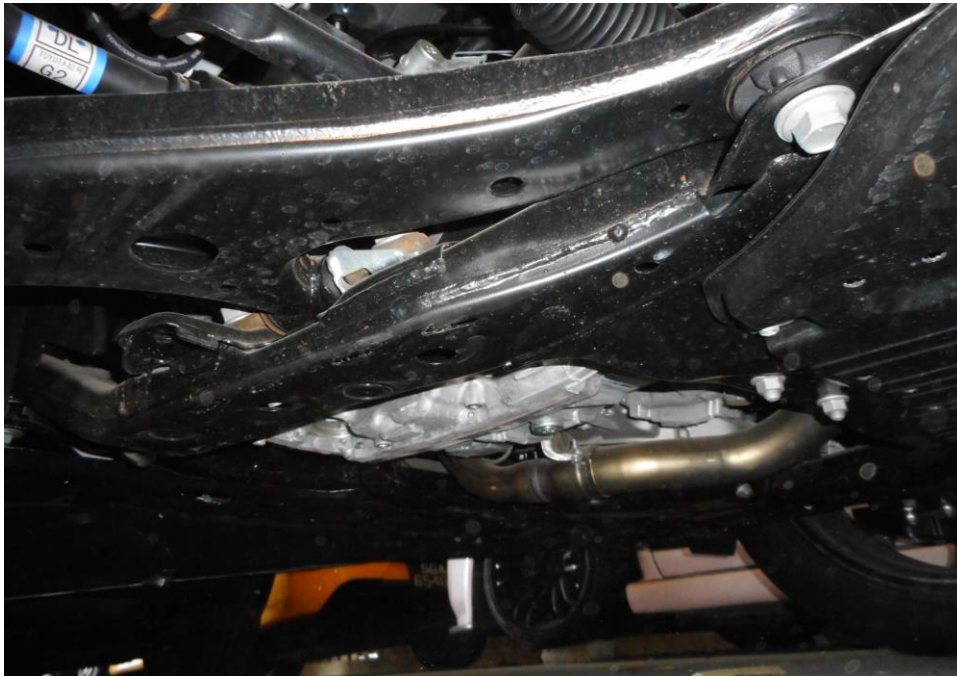
**Photo 18** shows the undercarriage of the Motor Car, at the area where the engine housing and transmission housing are located. . I did not find any sign(s) or indication(s) of fluid leak and/or fluid stain(s) on the underside of the Motor Car.

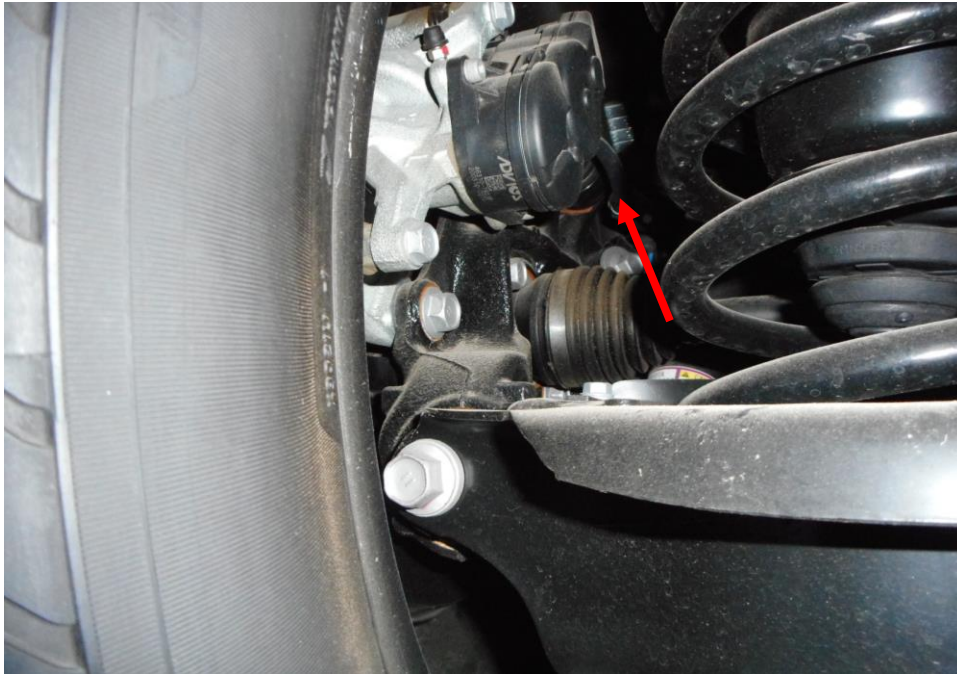
**Photo 19** shows the brake hose/pipe (arrowed) at the rear left wheel of the Motor Car. No leakage of brake fluid was observed. Visual examination of the various components of the braking system like the drum brake, brake booster, brake pedal etc. had revealed all to be intact and without visible damage.

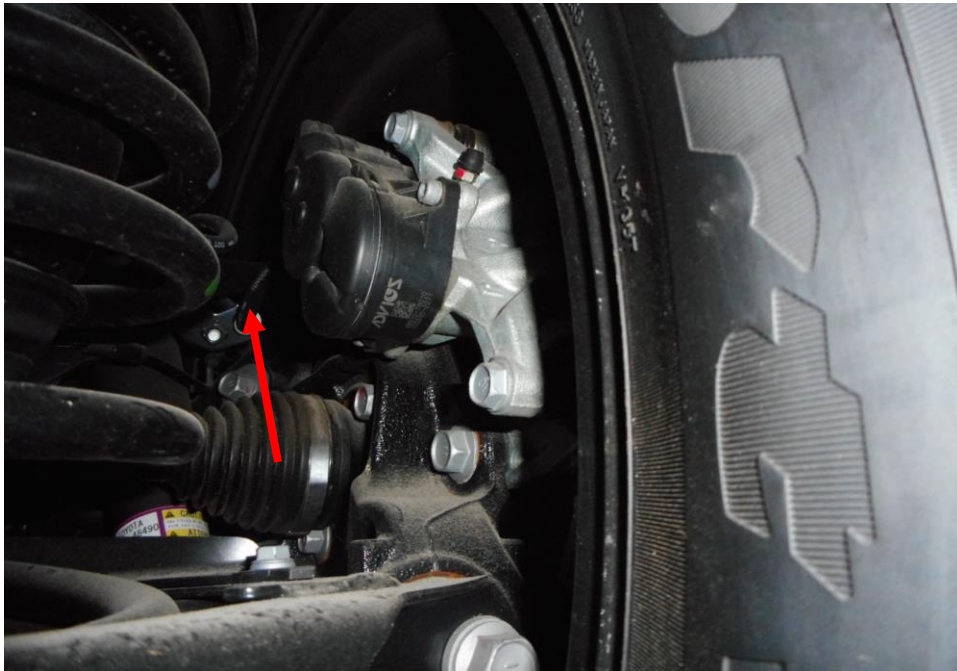
**Photo 20** shows the brake hose/pipe (arrowed) at the rear right wheel of the Motor Car. No leakage of brake fluid was observed. Visual examination of the various components of the braking system like the drum brake, brake booster, brake pedal etc. had revealed all to be intact and without visible damage.

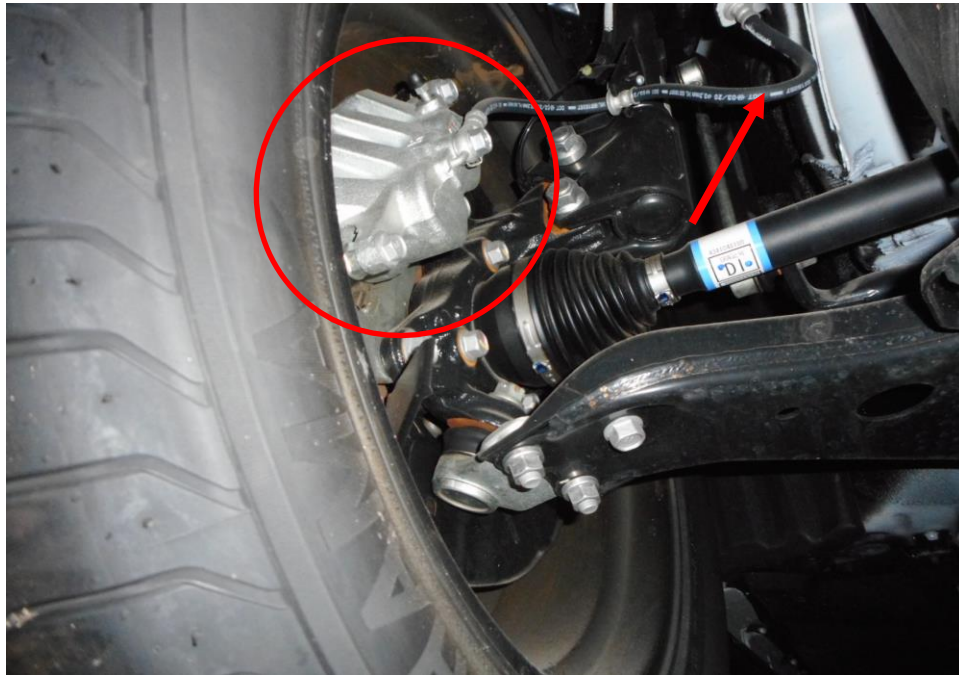
**Photo 21** shows the brake hose/pipe (arrowed) at the front right wheel of the Motor Car. No leakage of brake fluid was observed. Visual examination of the various components of the braking system like the brake caliper (circled), brake booster, brake pedal etc had revealed all to be intact and without visible damage at the time of accident. There was also no sign of fluid stain(s) observed on the various undercarriage components.

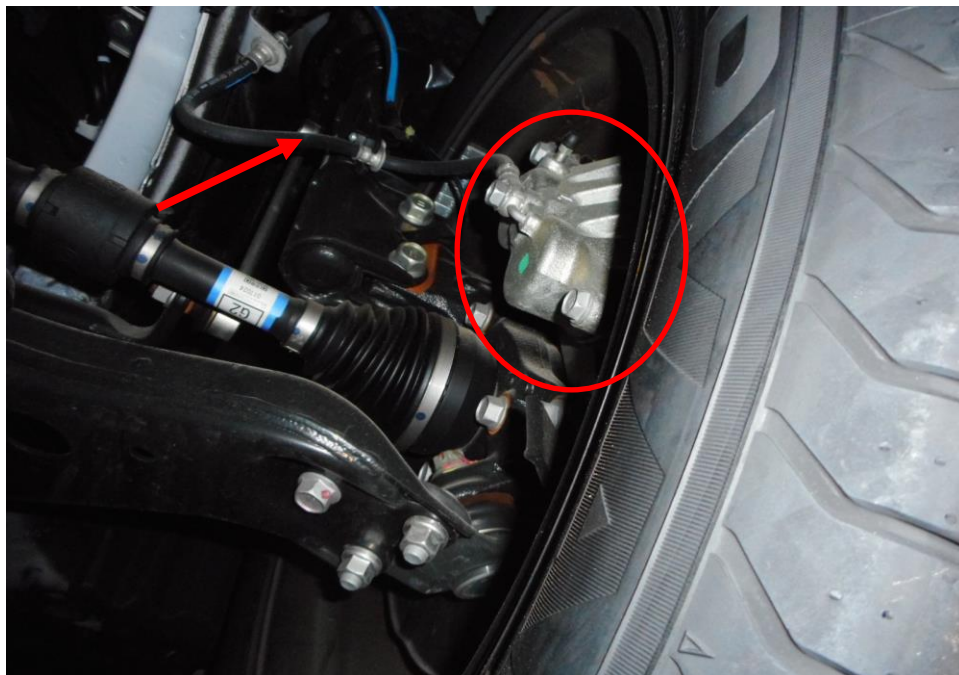
**Photo 22** shows the brake hose/pipe (arrowed) at the front left wheel of the Motor Car. No leakage of brake fluid was observed. Visual examination of the various components of the braking system like the brake caliper (circled), brake booster, brake pedal etc had revealed all to be intact and without visible damage at the time of accident. There was also no sign of fluid stain(s) observed on the various undercarriage components.

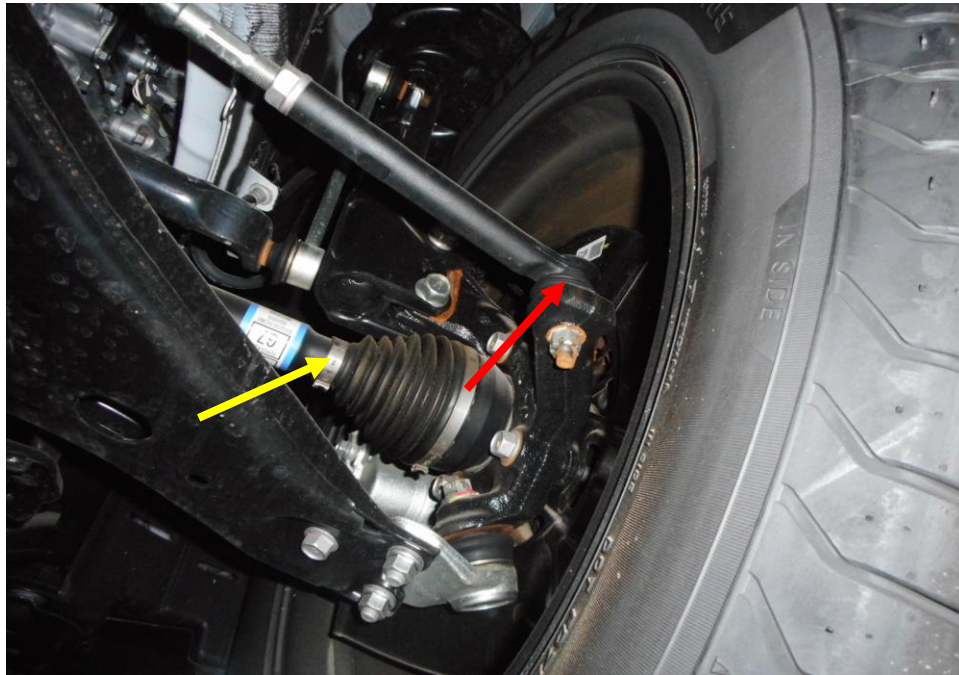
**Photo 23** shows the various undercarriage components at the front right wheel of the Motor Car, in particular the steering tie rod end (arrowed) and drive shaft (yellow arrow). The various steering components were all found to be intact, suggesting that the steering system of the Motor Car was likely to be in serviceable condition at the material time of accident. There was also no sign of fluid stain(s) observed on the various undercarriage components.

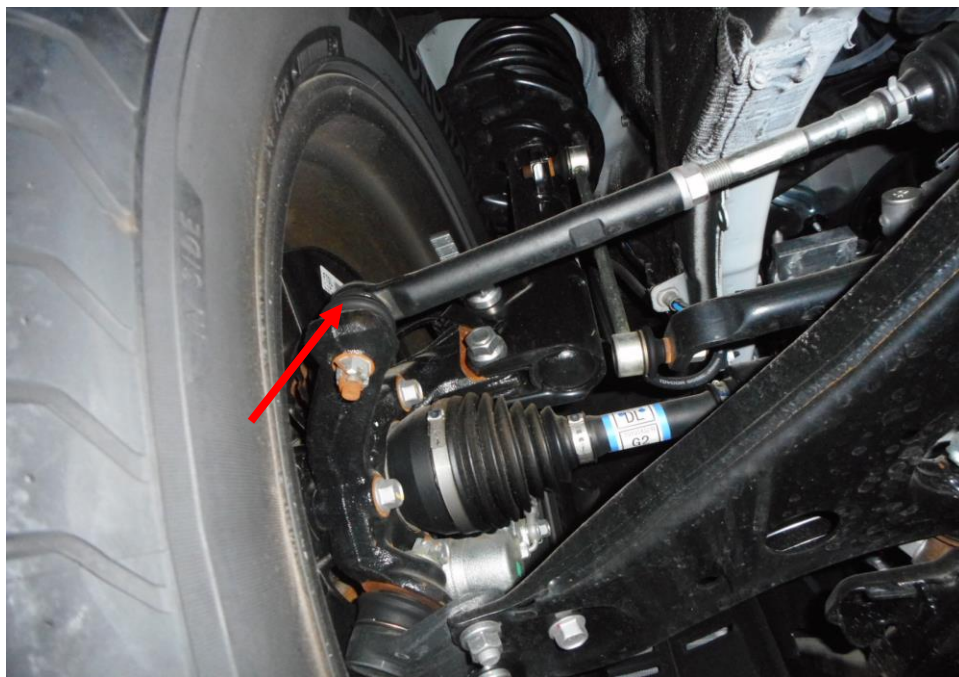
**Photo 24** shows the various undercarriage components at the front left wheel of the Motor Car, in particular the steering tie rod end (arrowed). The various Undercarriage components of the Motor Car were all found to be intact without any visible damage. There was also no sign of fluid stain(s) observed on the various undercarriage components.

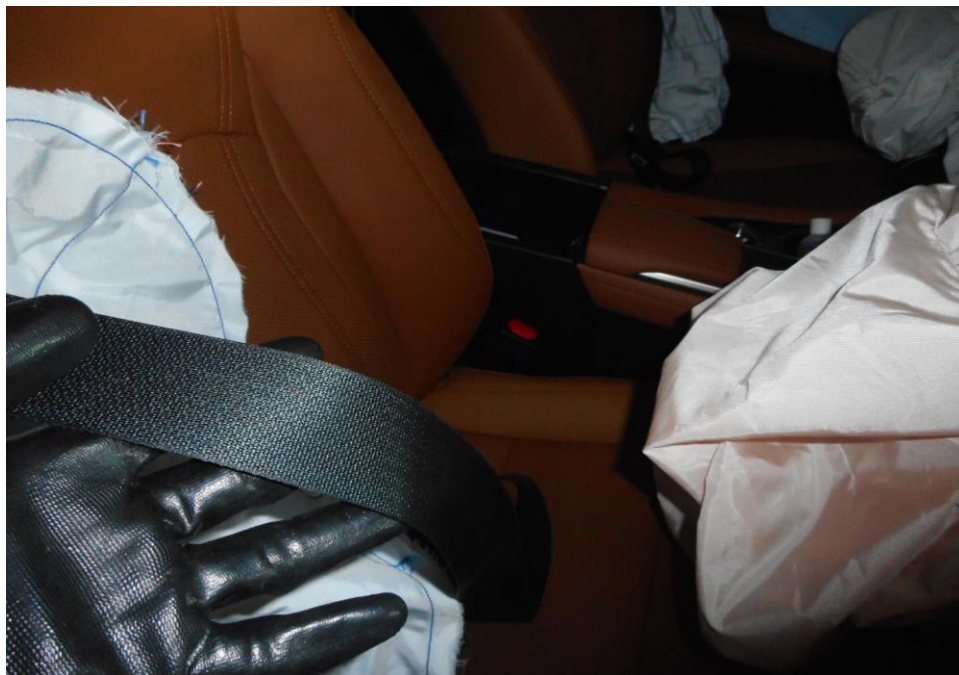
**Photo 25** shows that the seat belt on the right seat was worn at the material time of accident as the safety pre-tensioners was activated at the moment of impact and caused the seat belt to be locked into the last position.

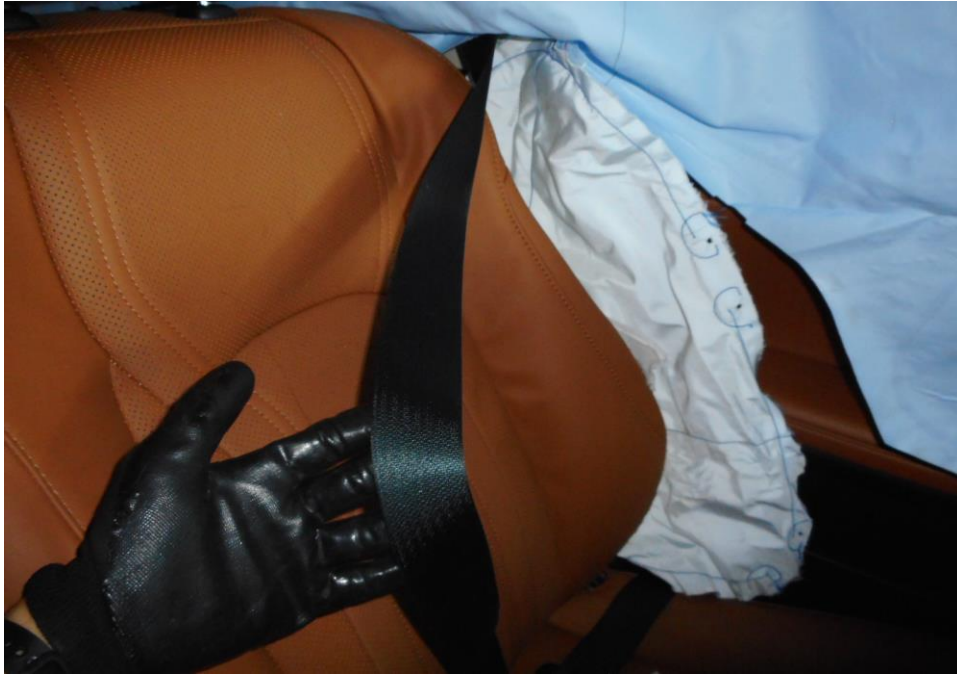
**Photo 26** shows that the seat belt on the left seat was worn at the material time of accident as the safety pre-tensioners was activated at the moment of impact and caused the seat belt to be locked into the last position.
