You're Ref: TP/IP/49619/2020  
Our Ref: CI/TPD21000239/P

**Fatal Accident Investigation Team**

**MECHANICAL INSPECTION REPORT OF MOTOR CAR SKX 8826A**

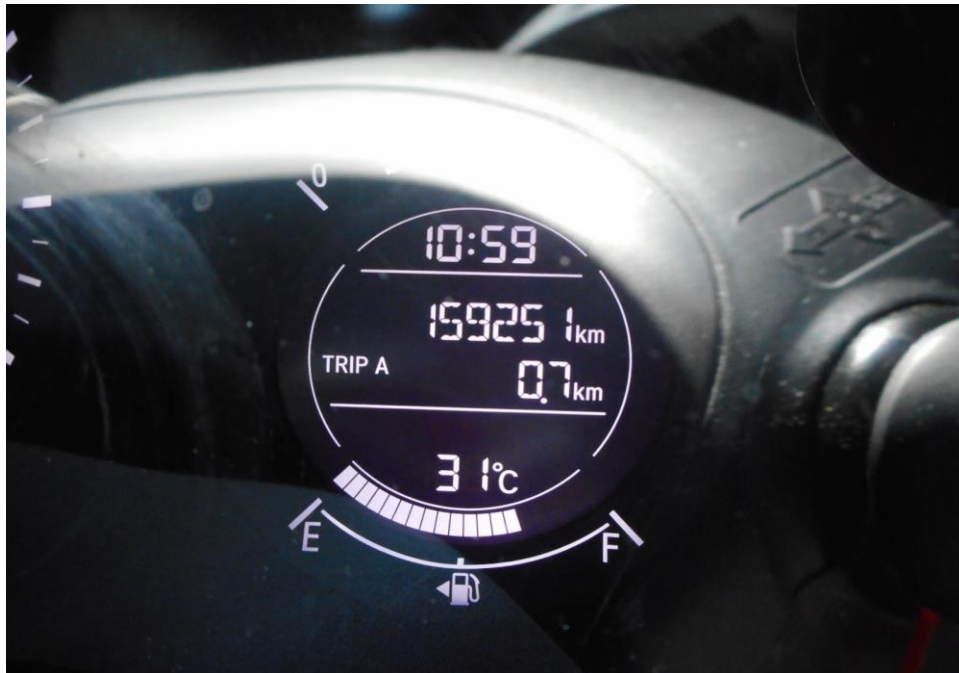
**Photo 1** shows the mileage of the Motor Car at the time of my inspection. The mileage observed was 159,251km.

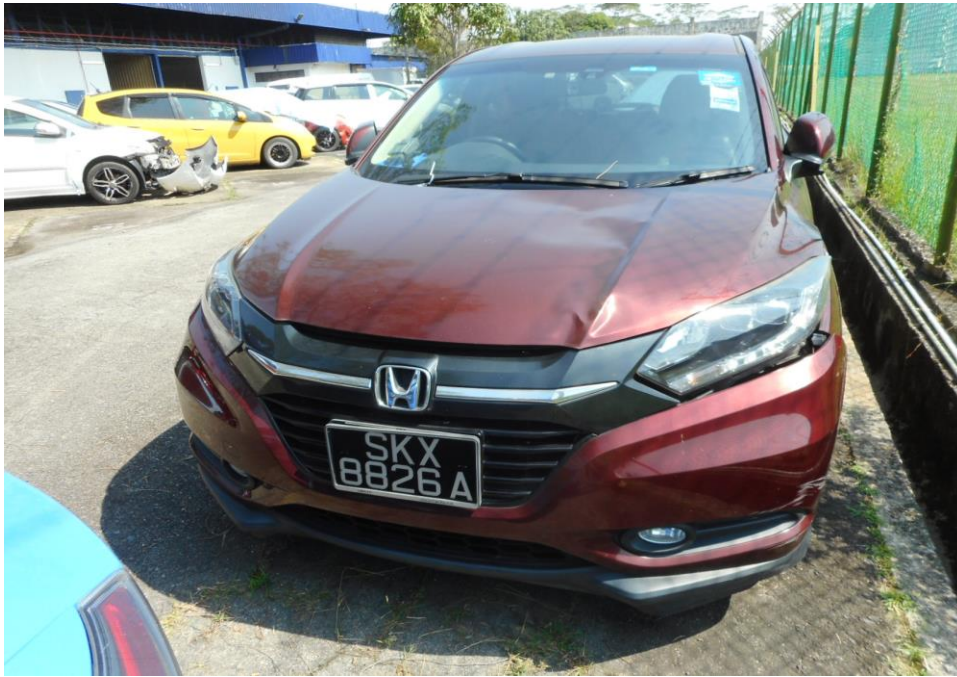
4. The mileage of the Motor Car at the time of my inspection was 159,251km.
5. The Motor Car was observed to have sustained damage at its front portion. Its front bonnet and front bumper was the body parts that were damaged as a result of the accident.

**Photo 2** shows a general view of the Motor Car's front body at the time of my inspection. The front portion of the Motor Car was observed to have sustained damage. Its front bonnet and front bumper was the body parts that were damaged as a result of the accident.

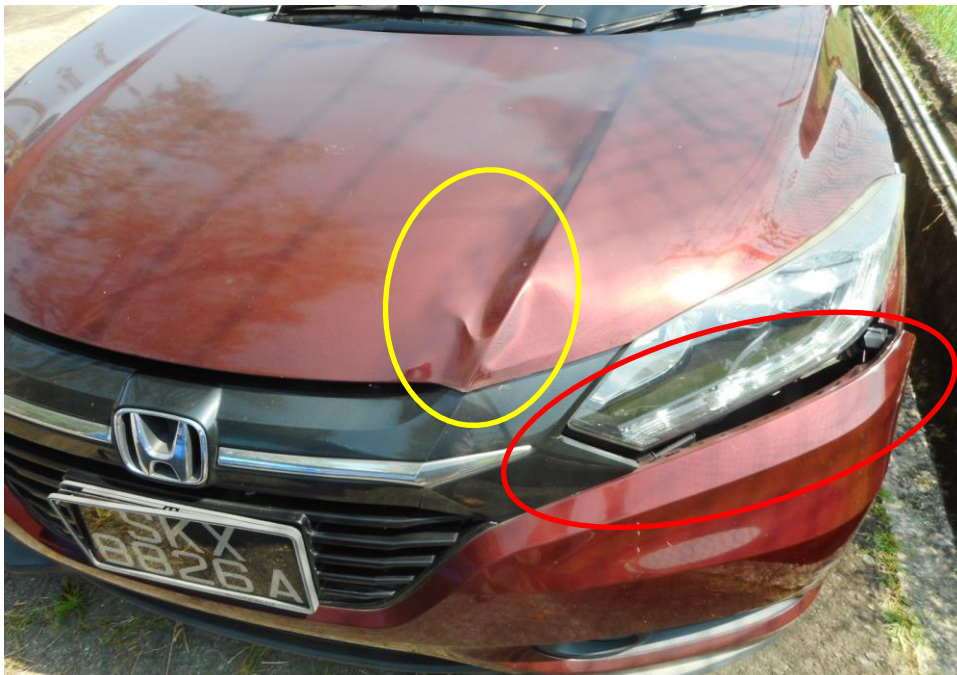
**Photo 3** shows the close up view of the Motor Car's front body at the time of my inspection. The Motor Car was observed to have sustained damage at its front bumper (red circle) and front bonnet (yellow circle), as a result of the accident.

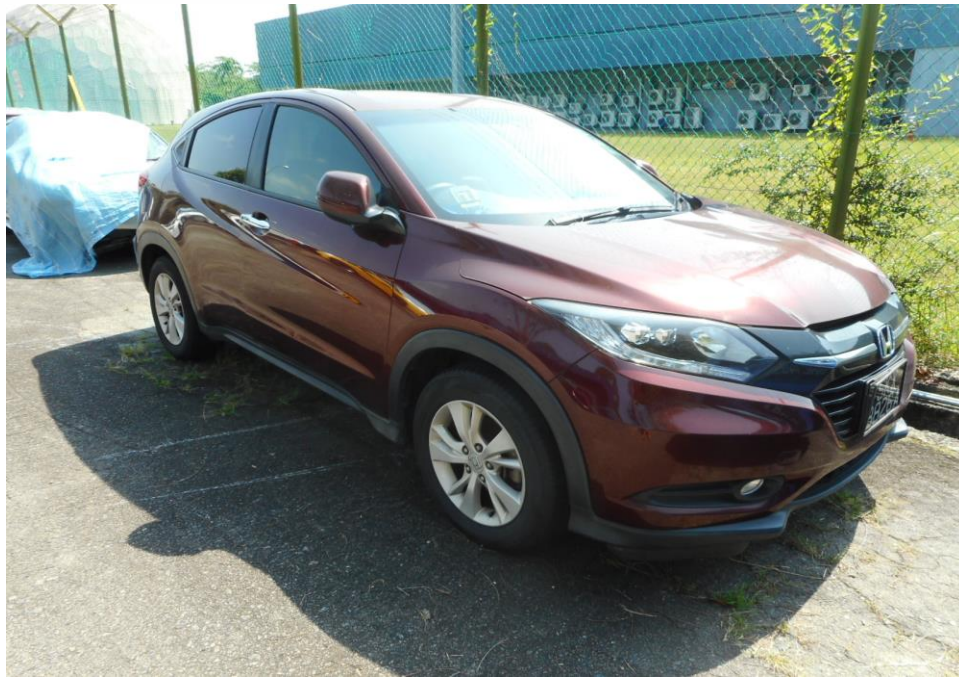
**Photo 4** shows a general view of the Motor Car's right body at the time of my inspection. The right portion of the Motor Car was observed to have been unaffected by the accident.

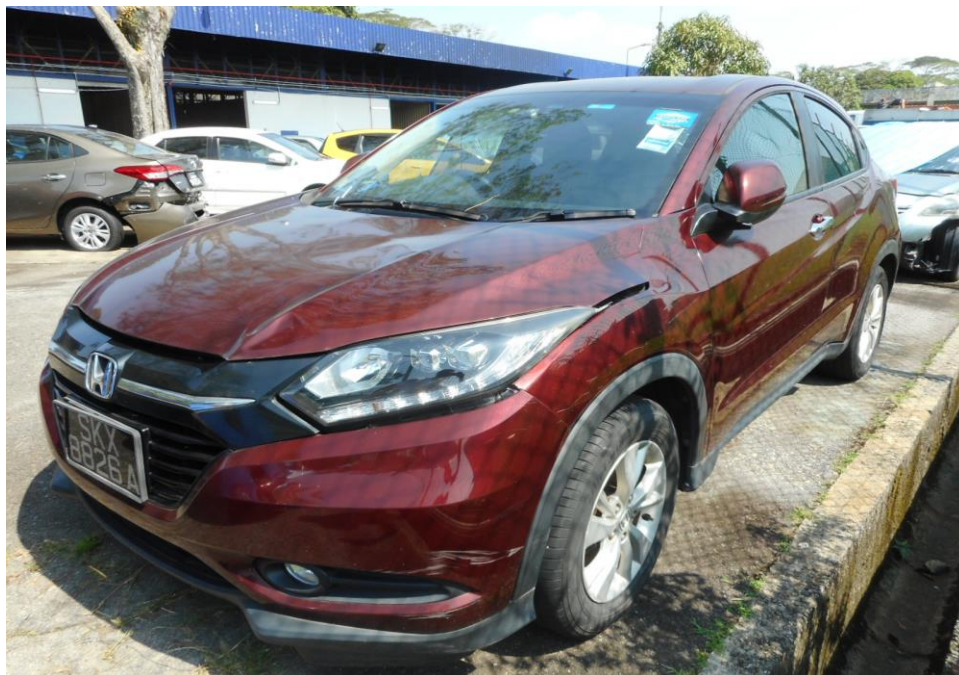
**Photo 5** shows a general view of the Motor Car's left body at the time of my inspection. The left portion of the Motor Car was observed to have been unaffected by the accident.

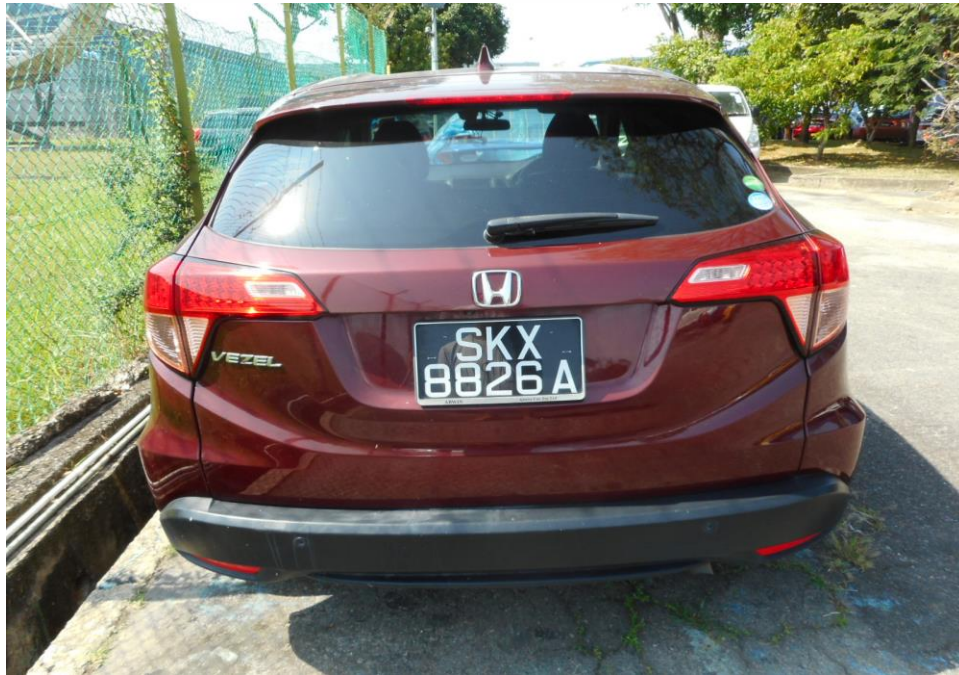
**Photo 6** shows the general view of the Motor Car's rear body at the time of my inspection. The Motor Car rear was observed to be unaffected by the accident.

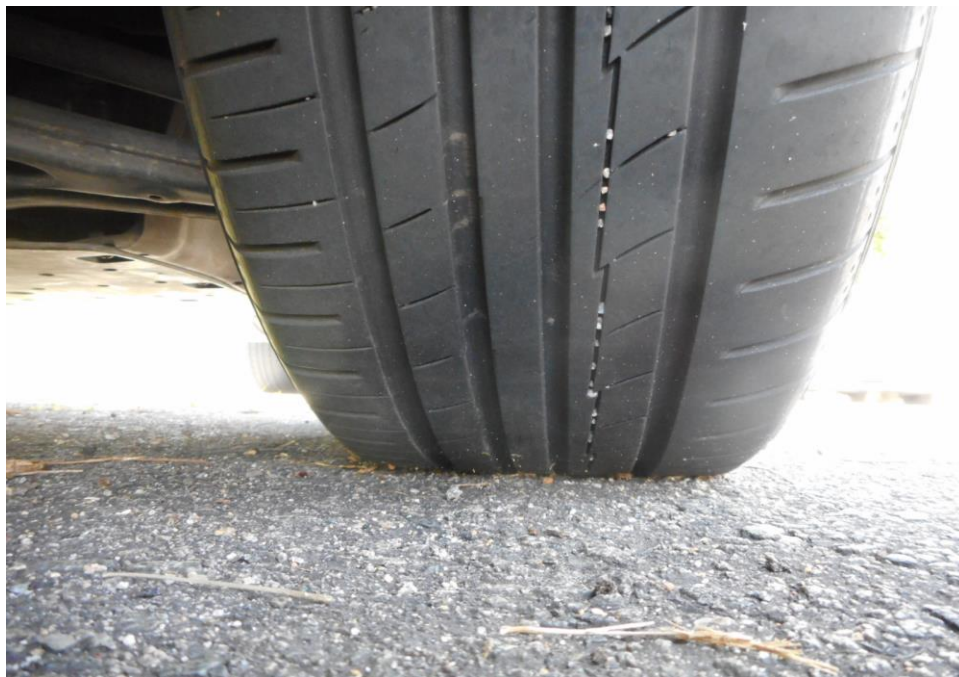
**Photo 7** shows the condition of the front right tyre of the Motor Car, which was observed to be in serviceable condition with remaining tread depth of approximately 5mm. The tyre was sufficiently inflated for vehicular operation with no tear, cut or burst mark(s) on the outer and the inner sidewalls as well as across the tread. The 4 tyres of the Motor Car were wrapped around standard steel wheel rims without any damage.

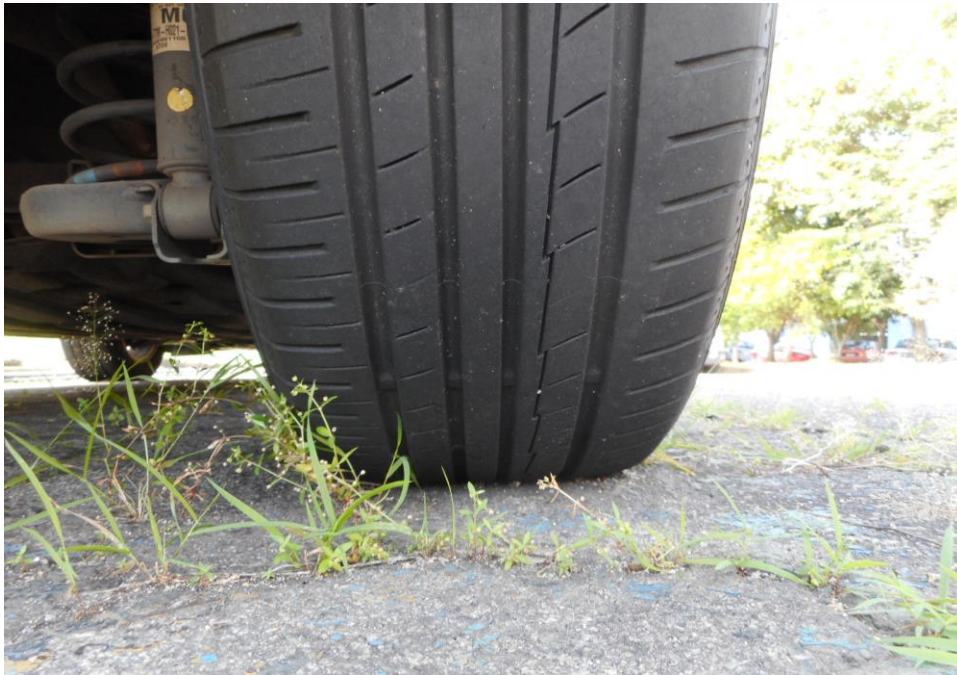
**Photo 8** shows the condition of the rear right tyre of the Motor Car, which was observed to be in serviceable condition with remaining tread depth of approximately 4.5mm. The tyre was also observed to be sufficiently inflated for vehicular operation with no tear, cut or burst mark(s).

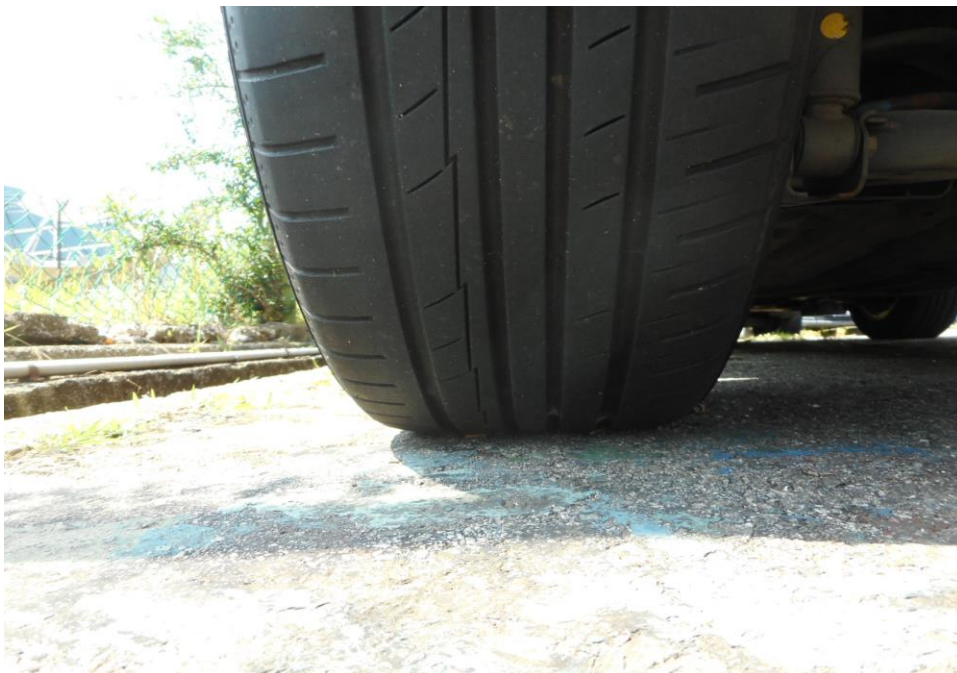
**Photo 9** shows the condition of the rear left tyre of the Motor Car, which was observed to be in serviceable condition with remaining tread depth of approximately 4mm. The tyre, which was wrapped around steel wheel rim, was also observed to be sufficiently inflated for vehicular operation. The 4 tyres of the Motor Car were wrapped around standard steel wheel rims.

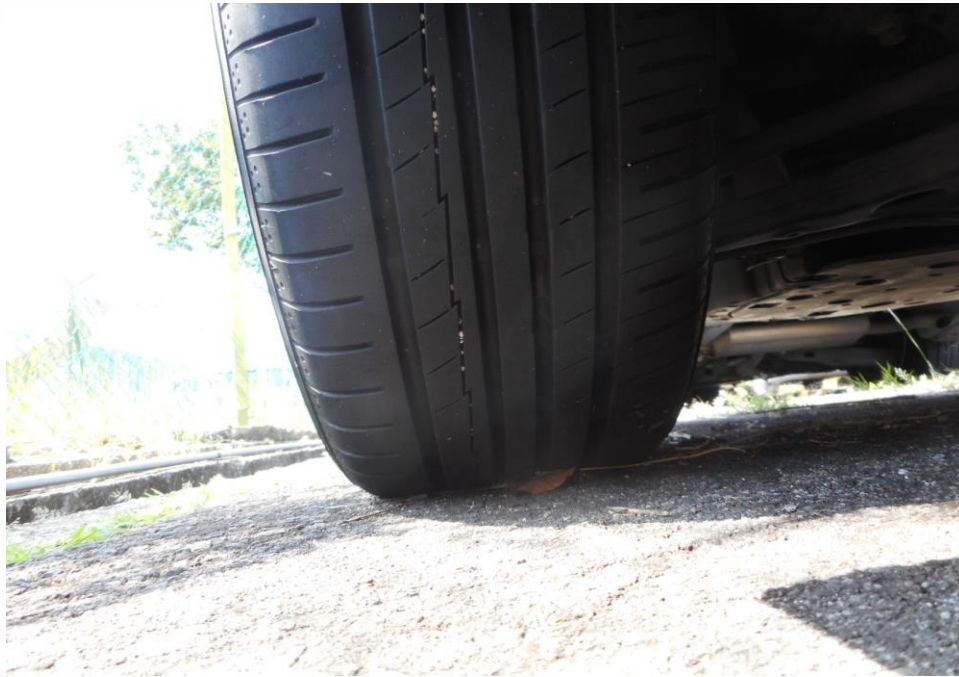
**Photo 10** shows the condition of the front left tyre of the Motor Car, which was observed to be in serviceable condition with remaining tread depth of approximately 4.8mm. There was also no tear, cut or burst mark(s) on the outer and the inner sidewalls as well as across the tread of the Motor Car's 4 tyres.

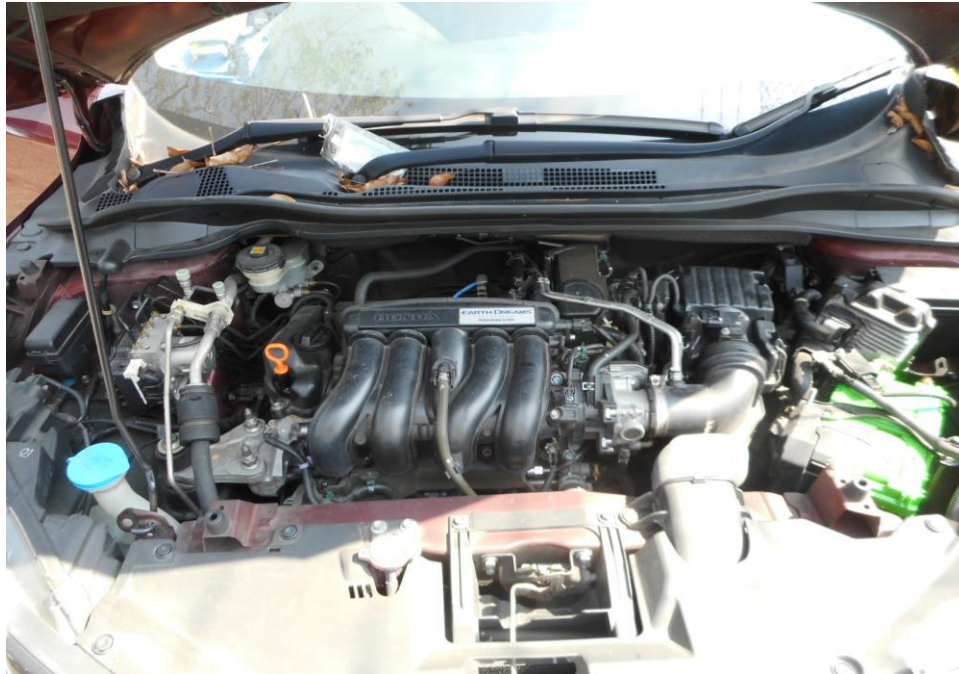
**Photo 11** shows a general view of the Motor Car's engine compartment. The various parts and components inside the engine compartment were unaffected by the accident. There was also no sign(s) or indication(s) of fluid leakage and/or fluid stain within the engine compartment.

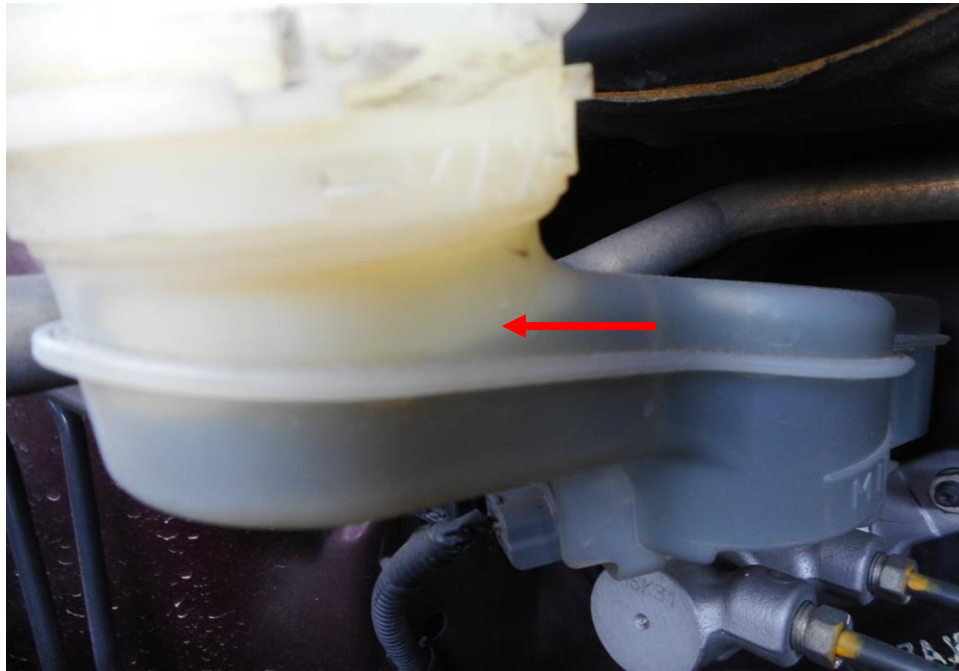
**Photo 12** shows the brake fluid reservoir of the Motor Car at the time of my inspection. The brake fluid was observed to be of sufficient level (arrowed) and without any visible contamination.

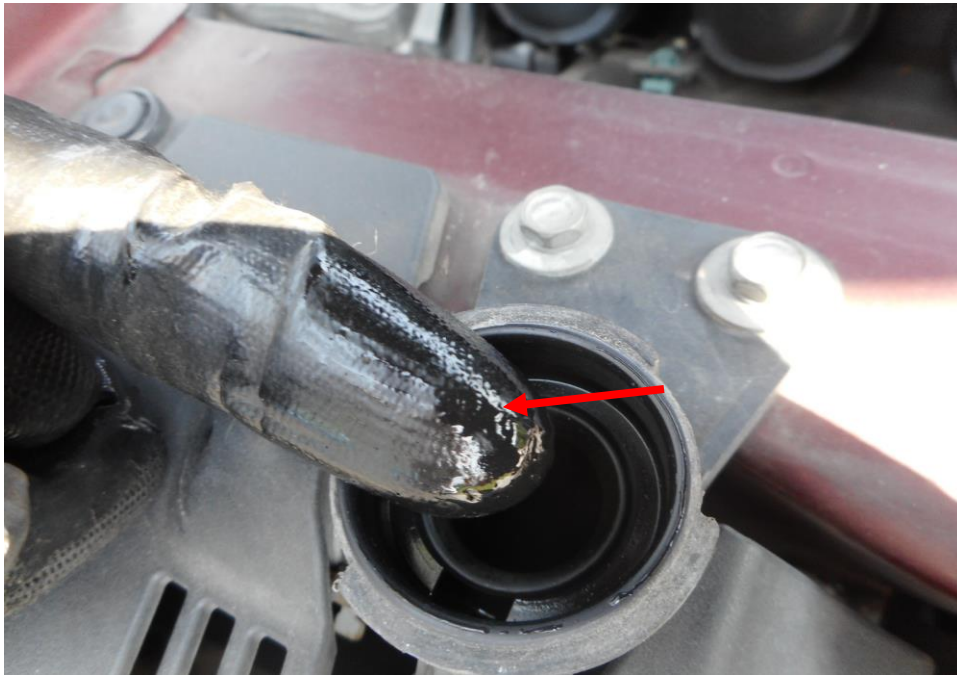
**Photo 13** shows checks being carried out to the engine coolant of the Motor Car at the time of my inspection. The engine coolant was observed to be of sufficient level (arrowed) and without any visible contamination.

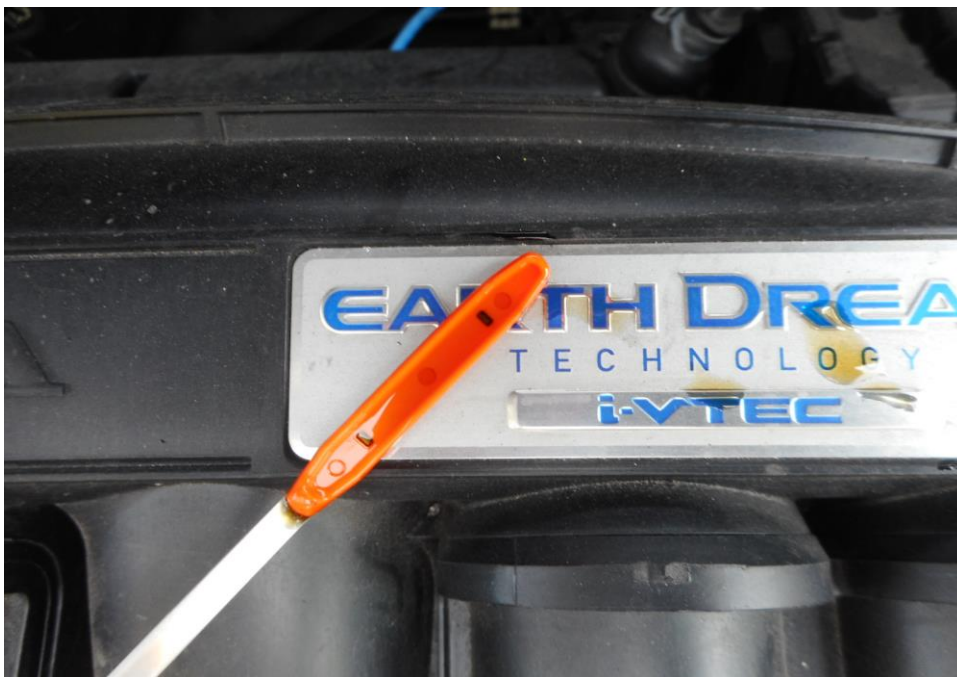
**Photo 14** shows the engine oil dip stick of the Motor Car at the time of my inspection. The engine oil was observed to be of sufficient level and without any visible contamination.

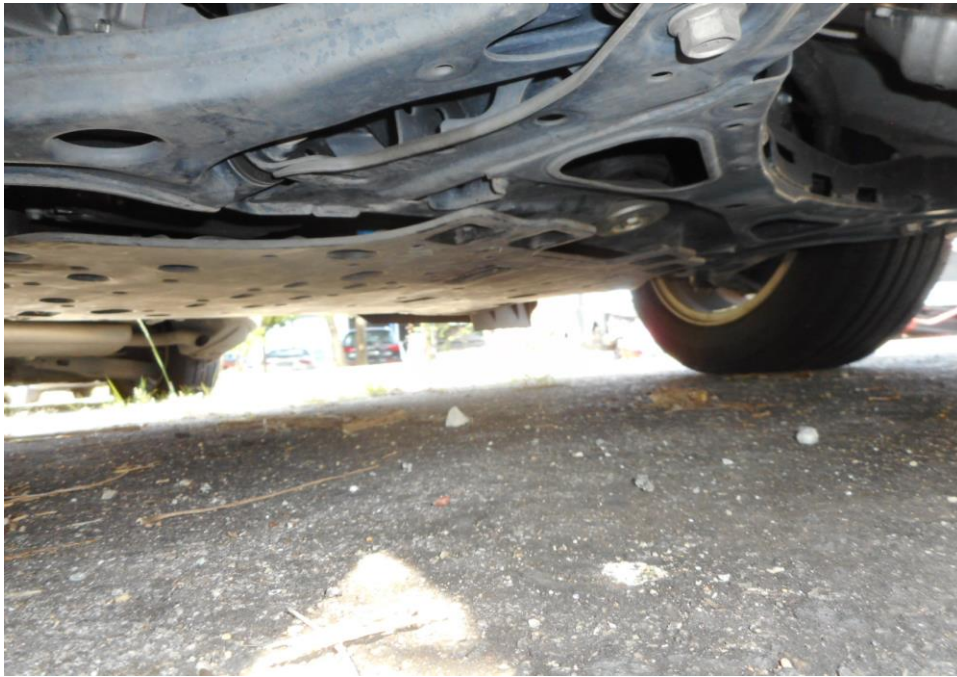
**Photo 15** shows the undercarriage of the Motor Car, at the area where the engine housing and transmission housing are located. I did not find any sign(s) or indication(s) of fluid leak and/or fluid stain(s) on the underside of the Motor Car.

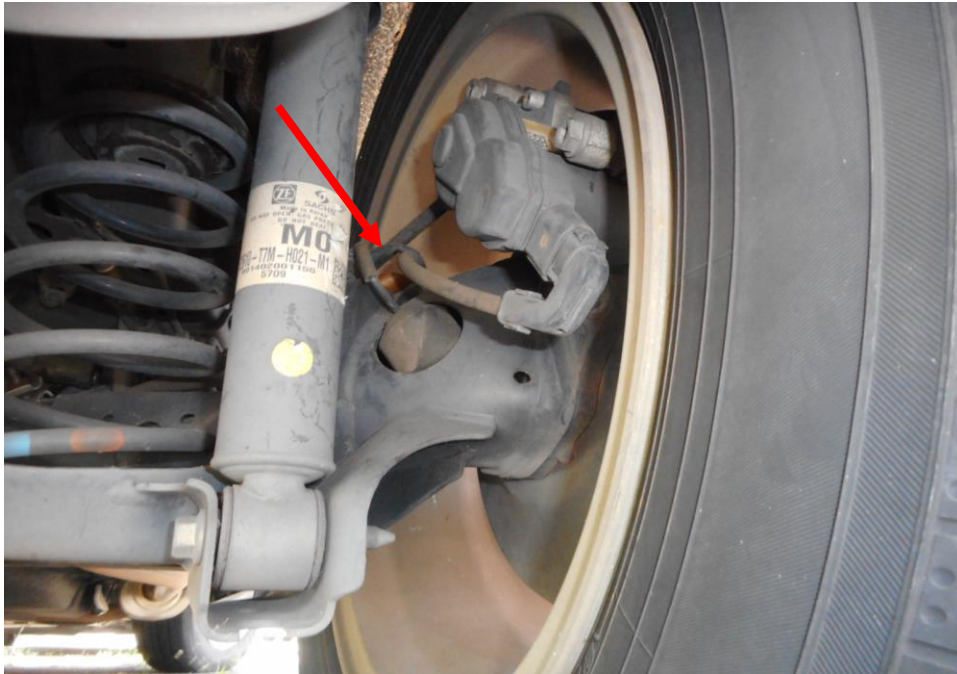
**Photo 16** shows the brake hose/pipe (arrowed) at the rear right wheel of the Motor Car. No leakage of brake fluid was observed. Visual examination of the various components of the braking system like the drum brake, brake booster, brake pedal etc. had revealed all to be intact and without visible damage.

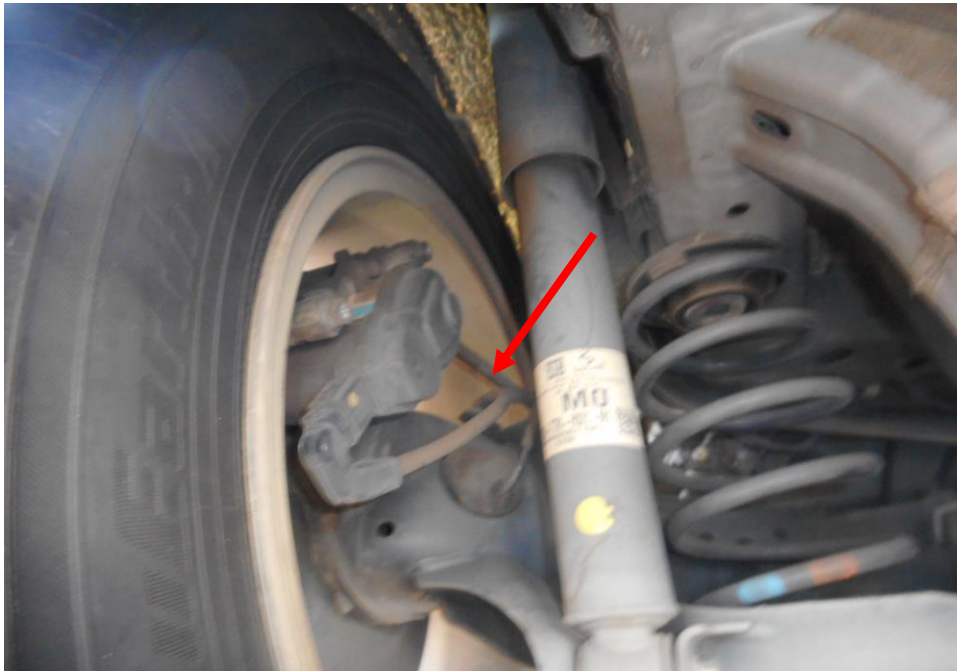
**Photo 17** shows the brake hose/pipe (arrowed) at the rear left wheel of the Motor Car. I did not observe any leakage of brake fluid at the time of my inspection of the Motor Car. Static tests of the Motor Car's braking system had indicated that there was no internal leakage of pressure/vacuum. The undercarriage components of the Motor Car were also all found to be intact and without any visible damage.

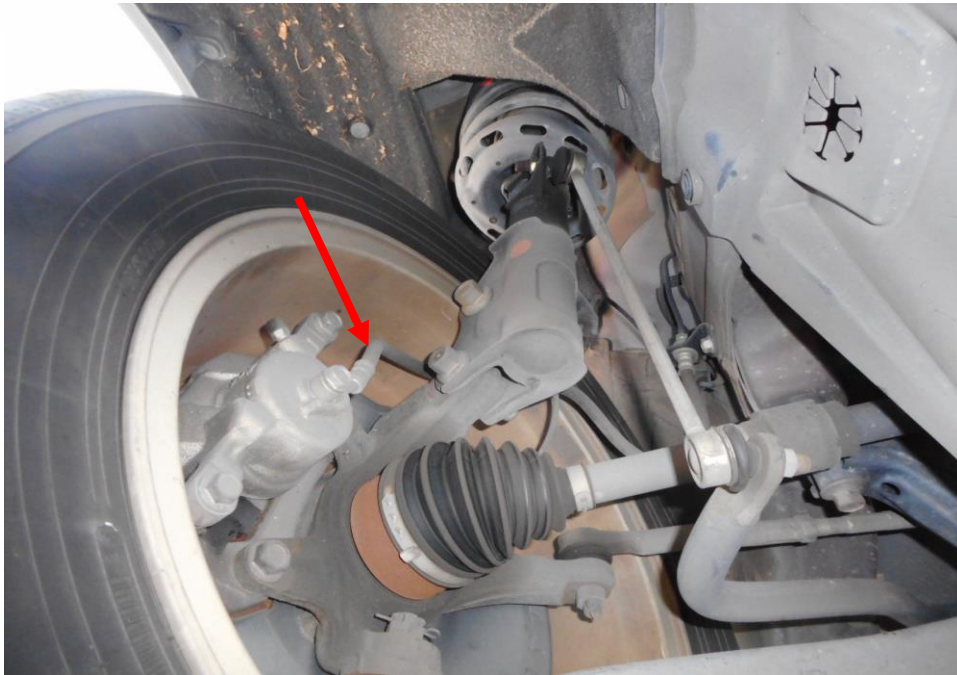
**Photo 18** shows the brake hose/pipe (arrowed) at the front right wheel of the Motor Car. I did not observe any leakage of brake fluid at the time of my inspection of the Motor Car. Static tests of the Motor Car's braking system had indicated that there was no internal leakage of pressure/vacuum. The undercarriage components of the Motor Car were also all found to be intact and without any visible damage.

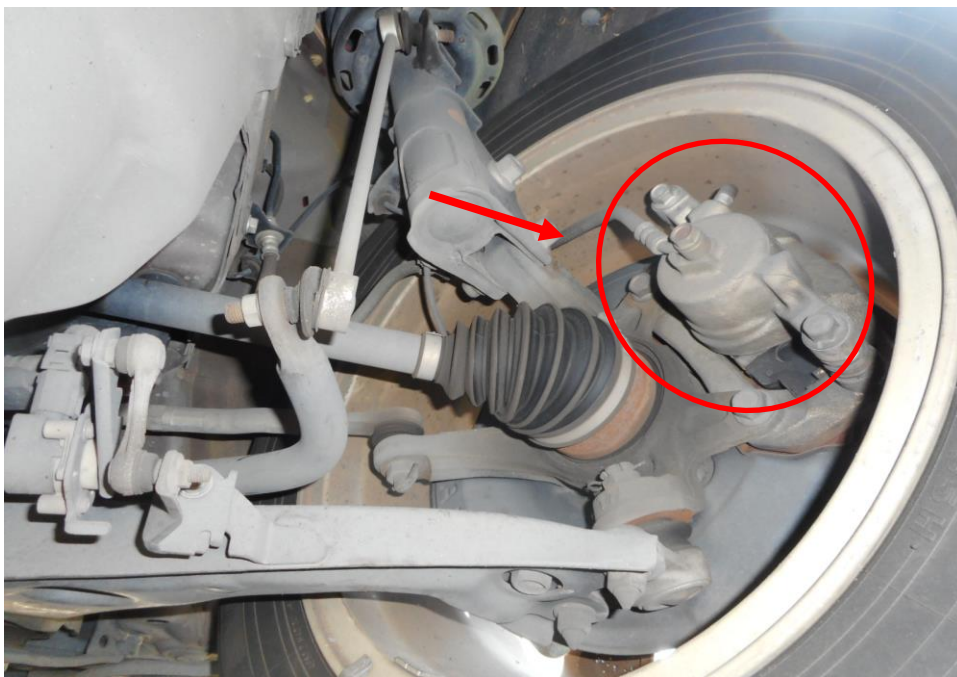
**Photo 19** shows the brake hose/pipe (arrowed) at the front left wheel of the Motor Car. No leakage of brake fluid was observed. Visual examination of the various components of the braking system like the brake caliper (circled), brake booster, brake pedal etc had revealed all to be intact and without visible damage.

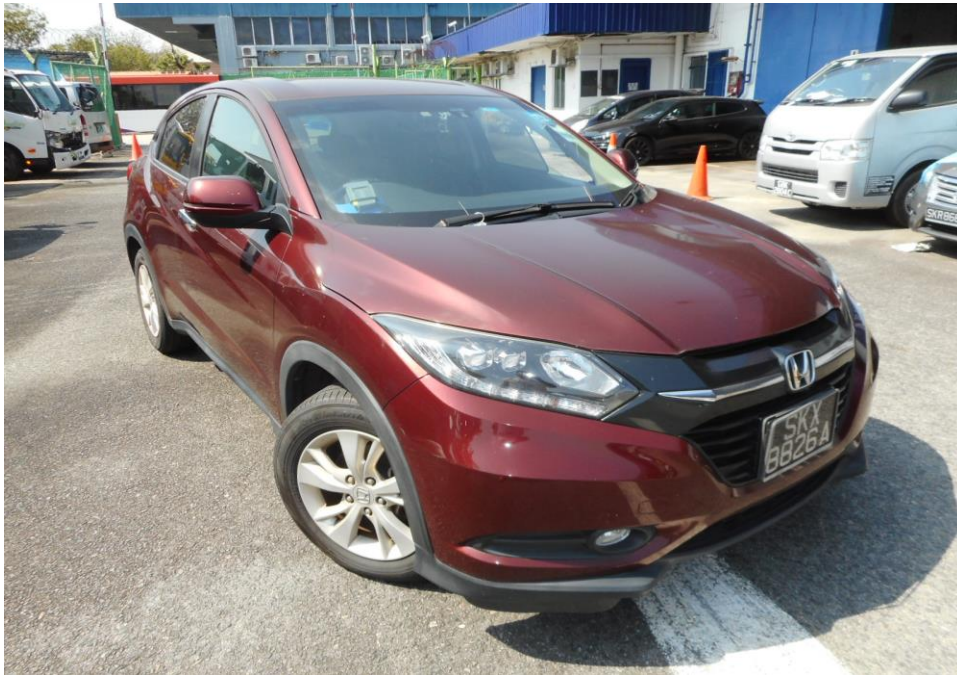
**Photo 20** shows the front right wheel of the Motor Car turned to its full left. During my steering system test, I did not experience any abnormal free play and/or resistance when I had turned the steering wheel towards the left and right. This would suggest that the steering system of the Motor Car was likely to be in serviceable condition at the material time of accident.

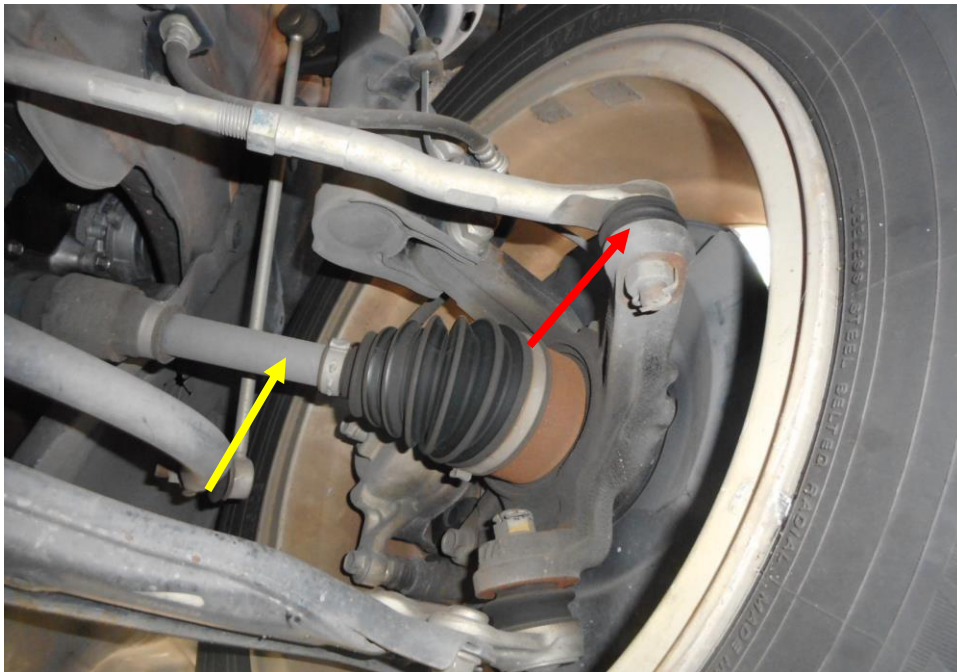
**Photo 21** shows the various undercarriage components at the front right wheel of the Motor Car, in particular the steering tie rod (red arrow) and drive shaft (yellow arrow). The various steering components were all found to be intact, suggesting that the steering system of the Motor Car was likely to be in serviceable condition at the material time of accident. There was also no sign of fluid stain observed on the various undercarriage components at the front right wheel of the Motor Car.

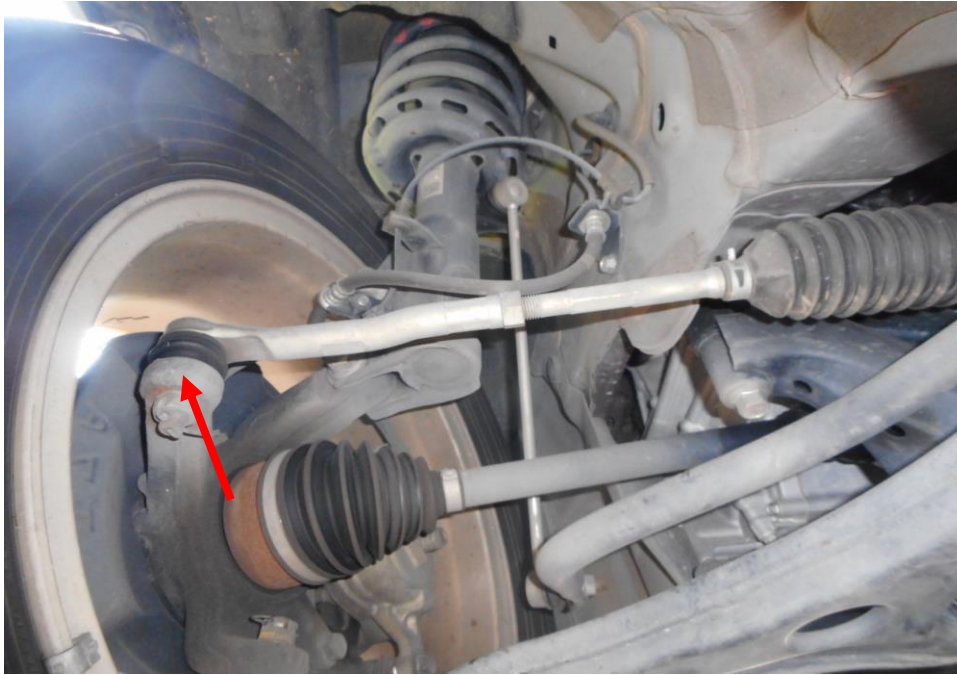
**Photo 22** shows the various undercarriage components at the front left wheel of the Motor Car, which had included the steering tie rod (red arrow). The various undercarriage components of the Motor Car were all found to be intact without any visible damage.

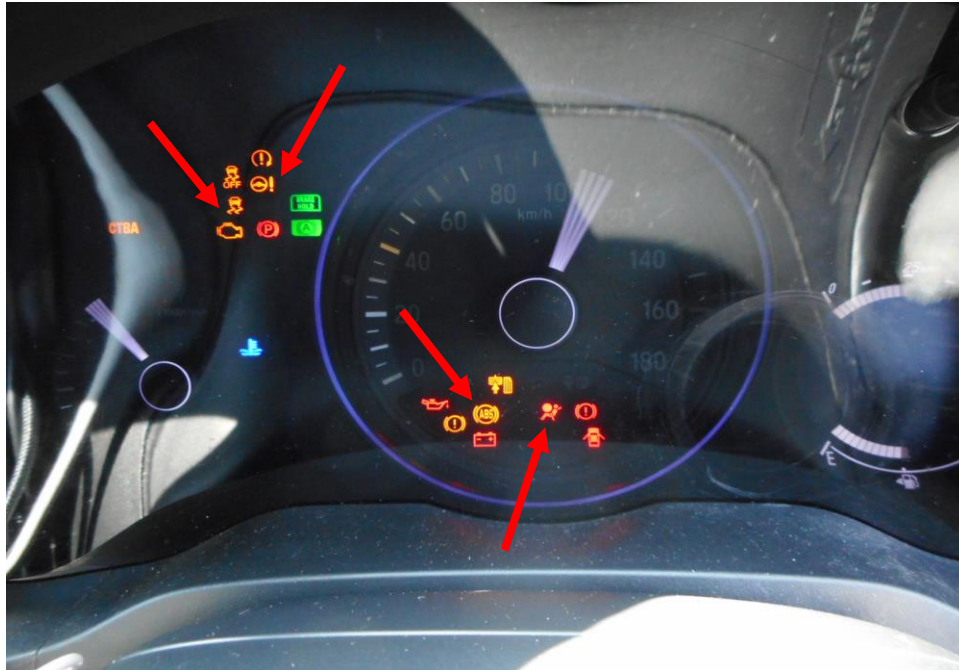
**Photo 23** shows the warning light for Anti-Lock Brake System (ABS) and Power Steering System (EPS), Supplemental Restraint System (SRS) and Traction Control (TC) (arrowed) appearing on the instrument panel of the Motor Car during the self-test of its various electronic operating systems when its engine was cranked.

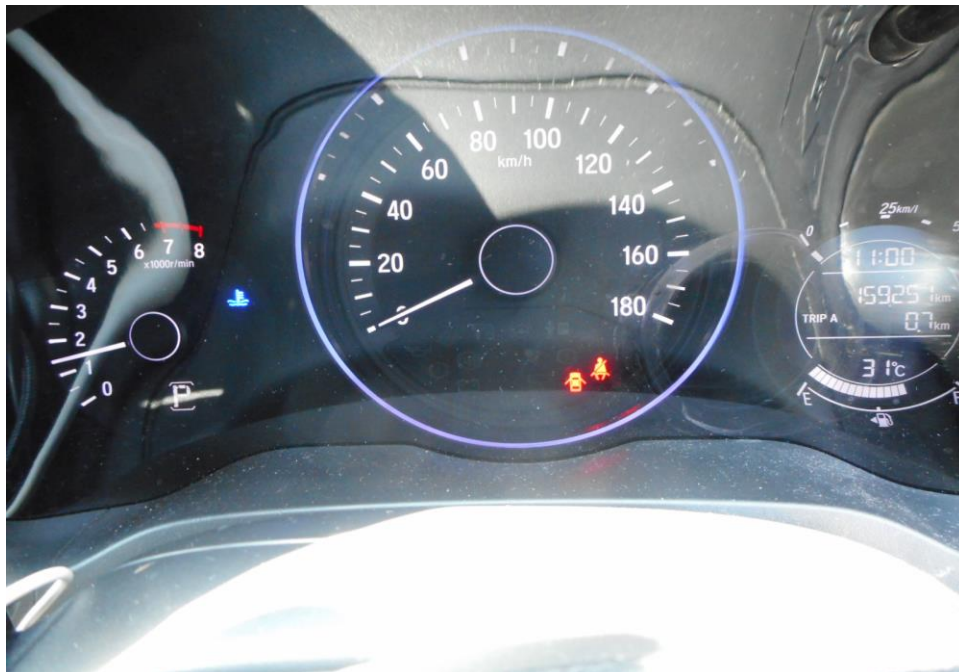
**Photo 24** shows no warning lights illuminated on the instrument panel of the Motor Car after the engine was cranked. This would suggest that there was no abnormality to the electronic operating system of the Motor Car, like the ABS, EPS, SRS, and TC etc.
