You're Ref: TP/IP/50957/2020  
Our Ref: CI/TPD21000240/P

15<sup>th</sup> February 2021

**Fatal Accident Investigation Team**

**MECHANICAL INSPECTION REPORT OF MOTOR TAXI SHD 1527A**

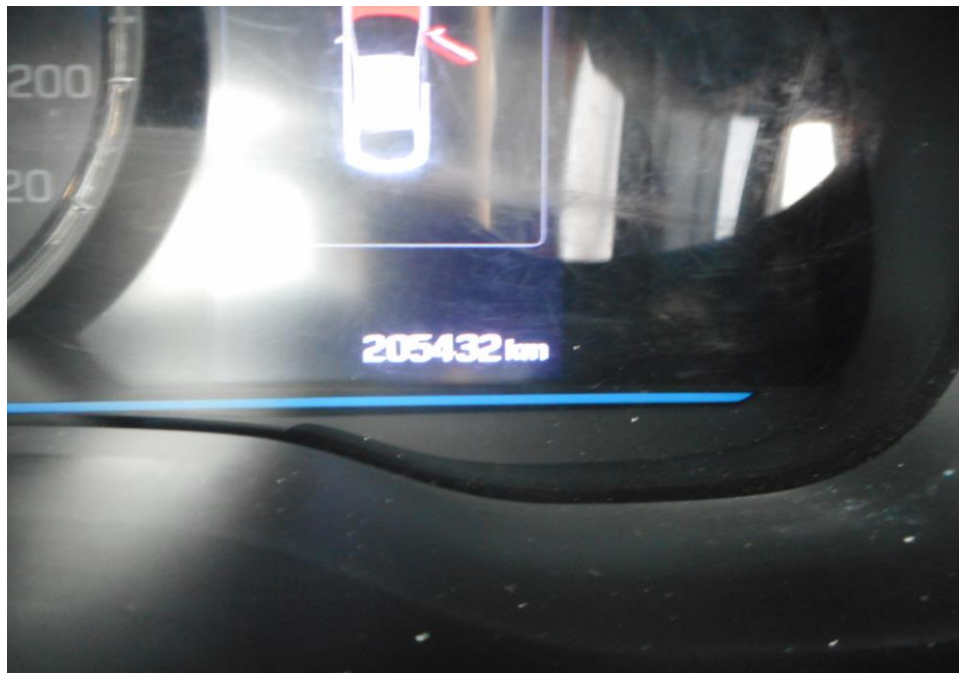
4. The mileage of the Motor Taxi at the time of my inspection was 205,432km.
5. The Motor Taxi was observed to have sustained damage at its front portion. Its front windscreen, left rear view mirror and front bumper was the body parts that were damaged as a result of the accident.

**Photo 1** shows the mileage of the Motor Taxi at the time of my inspection. The mileage observed was 205,432km.

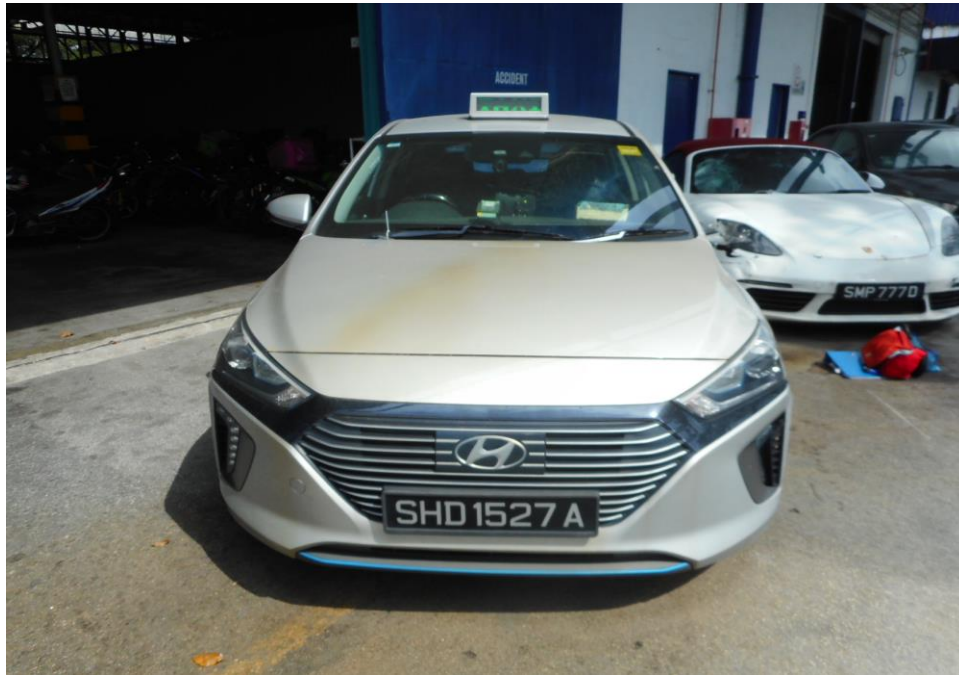
**Photo 2** shows a general view of the Motor Taxi's front body at the time of my inspection. The front portion of the Motor Taxi was observed to have sustained damage. Its front windscreen, left rear view mirror and front bumper was the body parts that were damaged as a result of the accident.

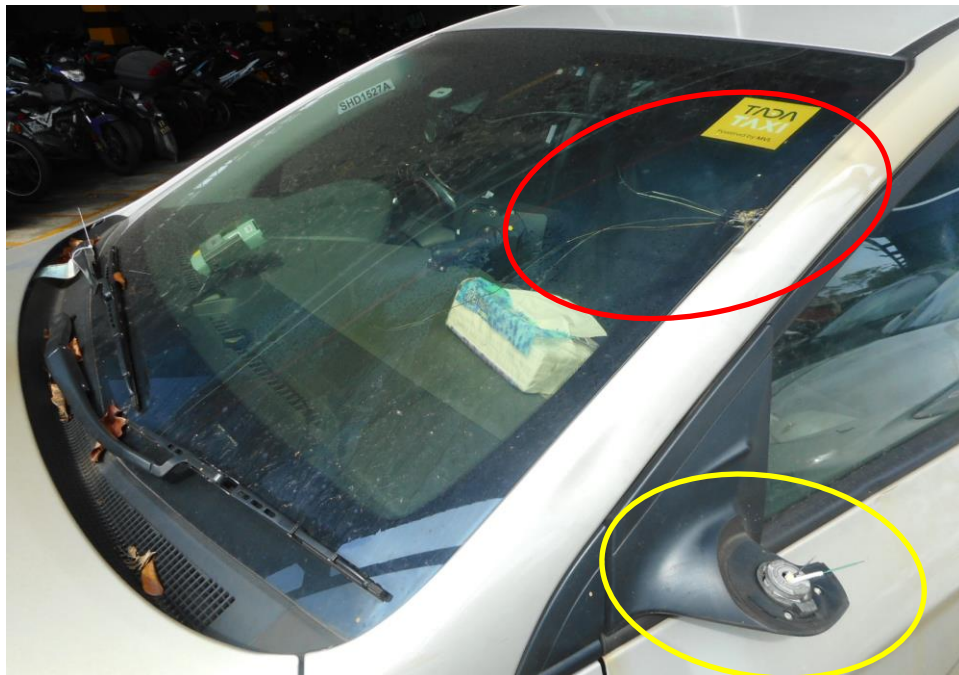
**Photo 3** shows the close up view of the Motor Taxi's front body at the time of my inspection. The Motor Taxi was observed to have sustained damage at its front windscreen (red circle) and left rear view mirror (yellow circle), as a result of the accident.

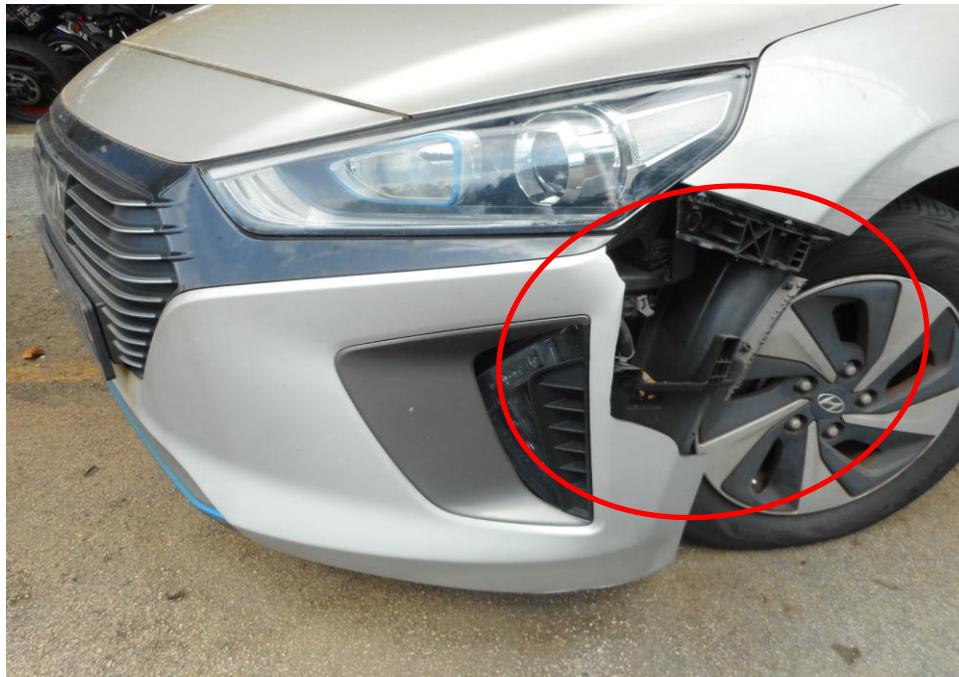
**Photo 4** shows the close up view of the Motor Taxi's front body at the time of my inspection. The Motor Taxi was observed to have sustained damage at its front bumper (circled) as a result of the accident.

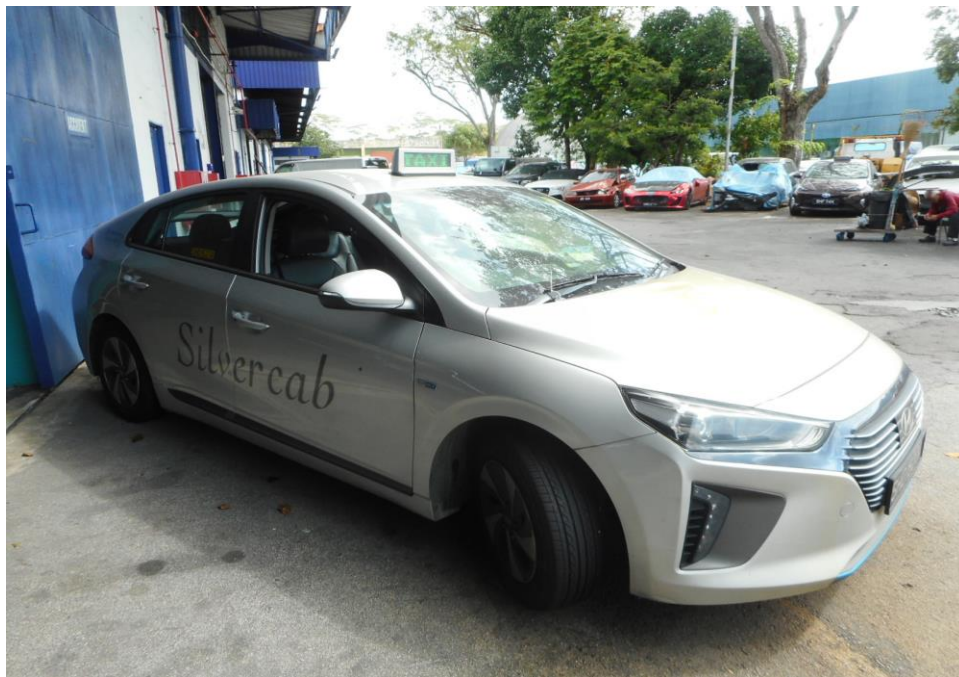
**Photo 5** shows a general view of the Motor Taxi's right body at the time of my inspection. The right portion of the Motor Taxi was observed to have been unaffected by the accident.

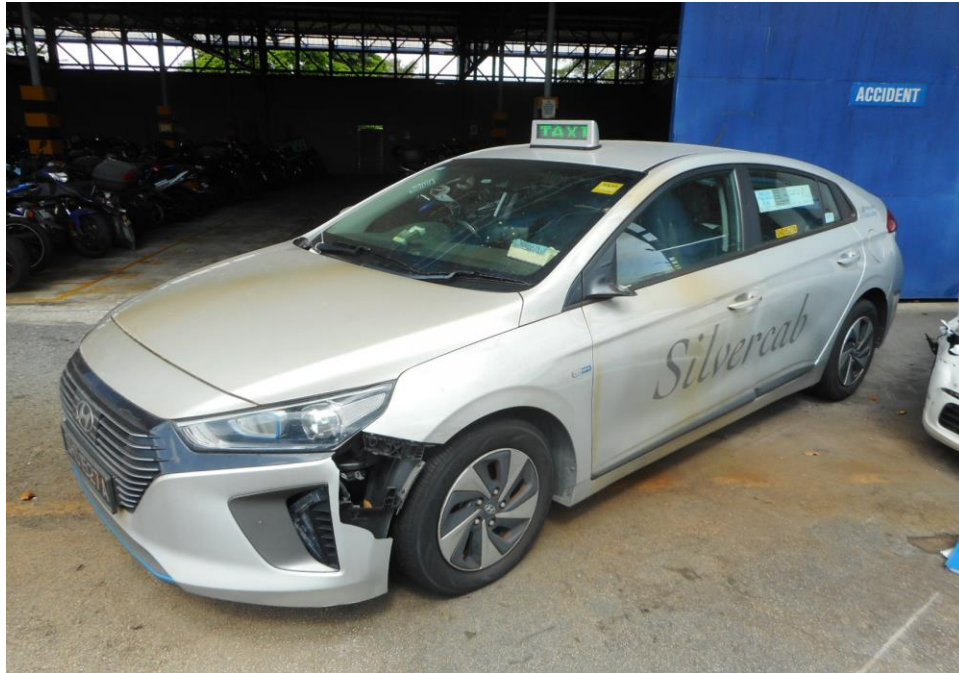
**Photo 6** shows a general view of the Motor Taxi's left body at the time of my inspection. The left portion of the Motor Taxi was observed to have been unaffected by the accident.

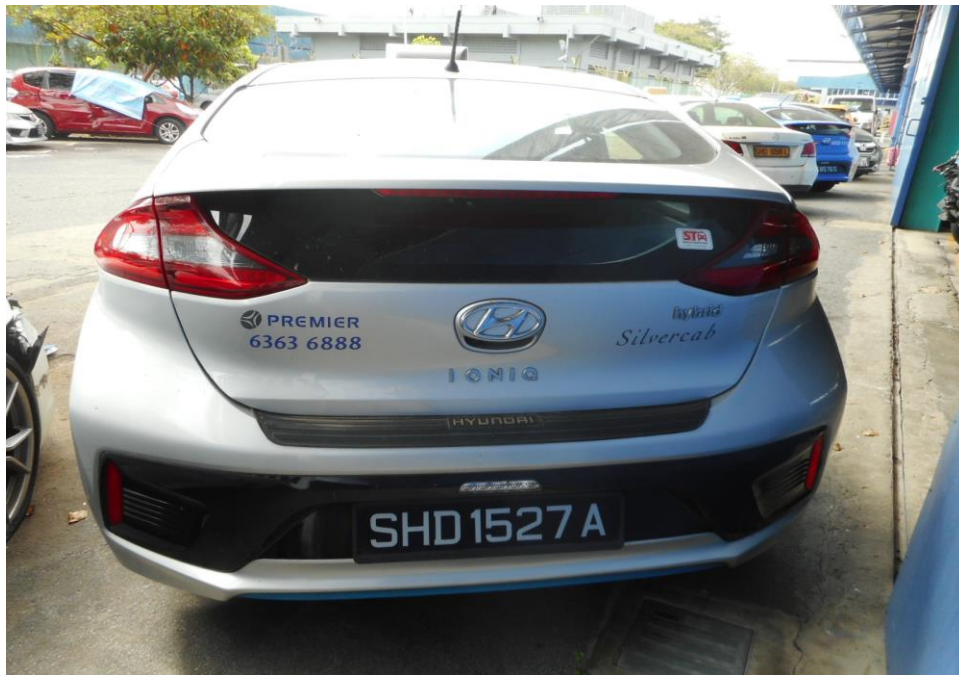
**Photo 7** shows the general view of the Motor Taxi's rear body at the time of my inspection. The Motor Taxi rear was observed to be unaffected by the accident.

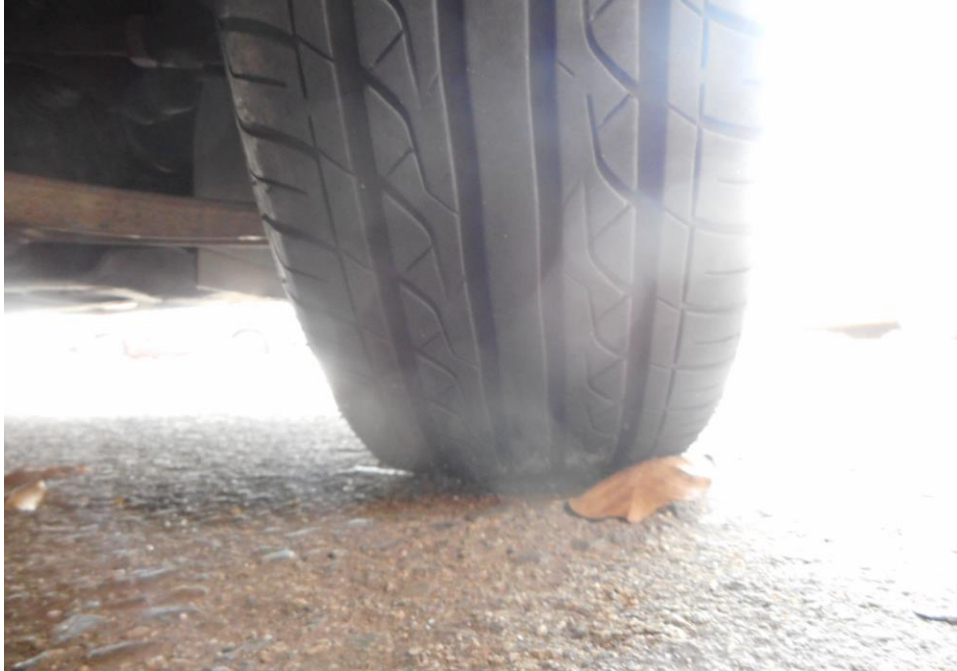
**Photo 8** shows the condition of the front right tyre of the Motor Taxi, which was observed to be in serviceable condition with remaining tread depth of approximately 5.1mm. The tyre was sufficiently inflated for vehicular operation with no tear, cut or burst mark(s) on the outer and the inner sidewalls as well as across the tread. The 4 tyres of the Motor Taxi were wrapped around standard steel wheel rims without any damage.

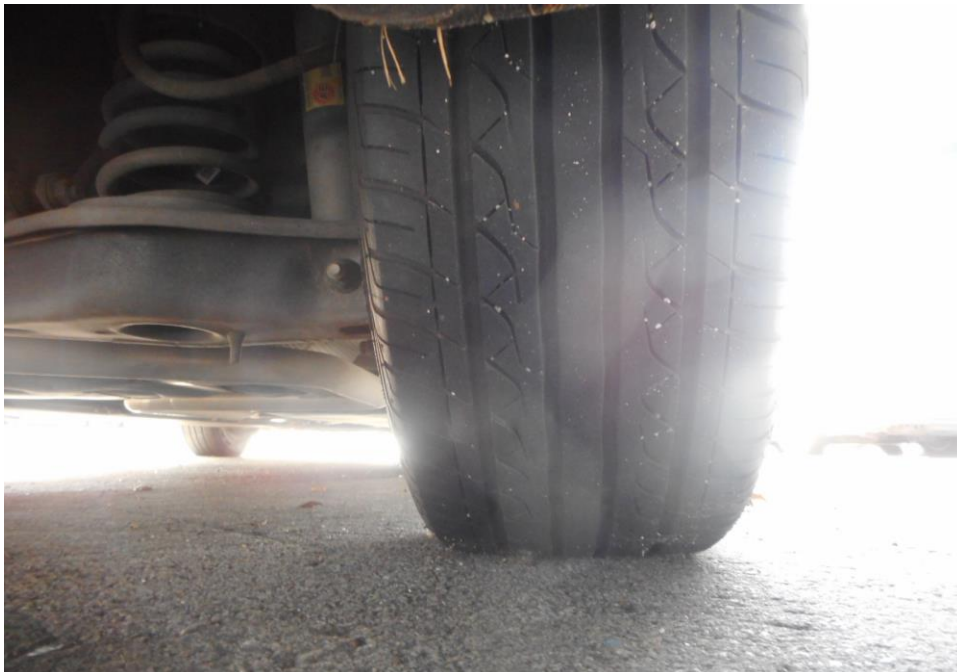
**Photo 9** shows the condition of the rear right tyre of the Motor Taxi, which was observed to be in serviceable condition with remaining tread depth of approximately 4.4mm. The tyre was also observed to be sufficiently inflated for vehicular operation with no tear, cut or burst mark(s).

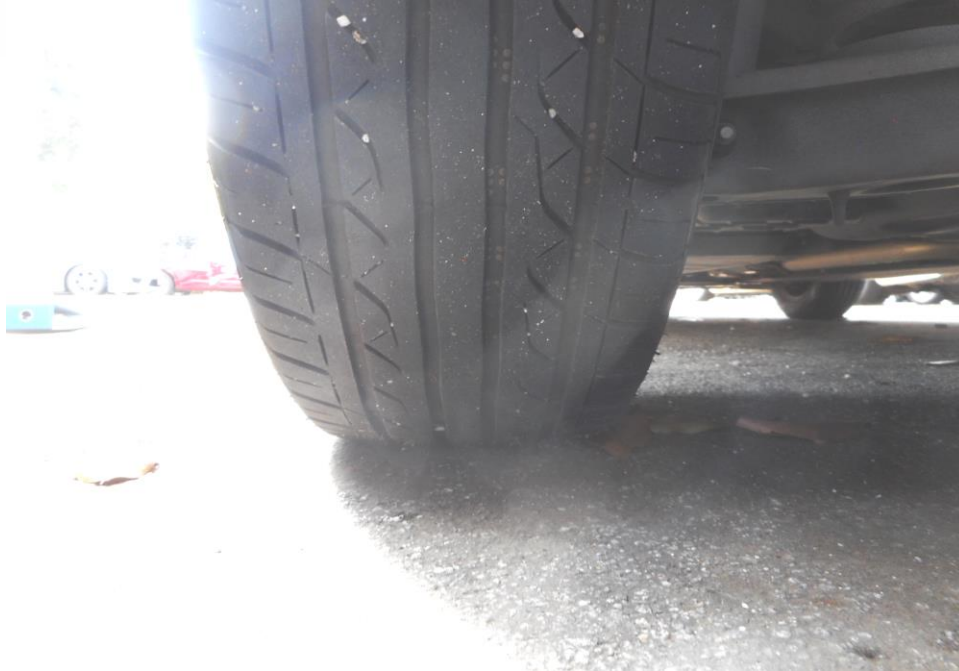
**Photo 10** shows the condition of the rear left tyre of the Motor Taxi, which was observed to be in serviceable condition with remaining tread depth of approximately 3.9mm. The tyre, which was wrapped around steel wheel rim, was also observed to be sufficiently inflated for vehicular operation. The 4 tyres of the Motor Taxi were wrapped around standard steel wheel rims.

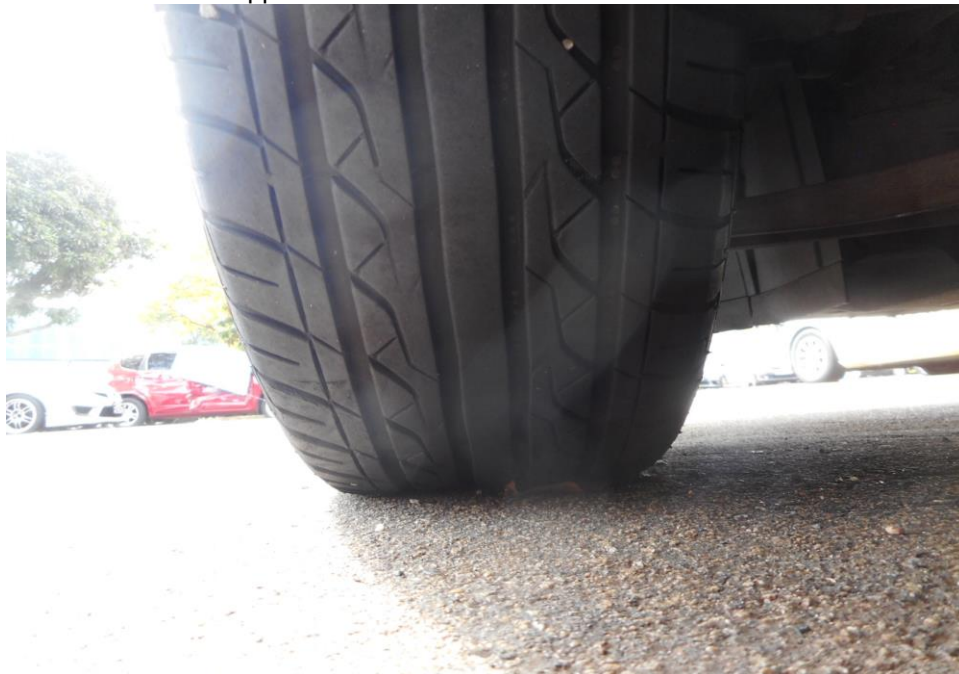
**Photo 11** shows the condition of the front left tyre of the Motor Taxi, which was observed to be in serviceable condition with remaining tread depth of approximately 4.6mm. There was also no tear, cut or burst mark(s) on the outer and the inner sidewalls as well as across the tread of the Motor Taxi's 4 tyres.

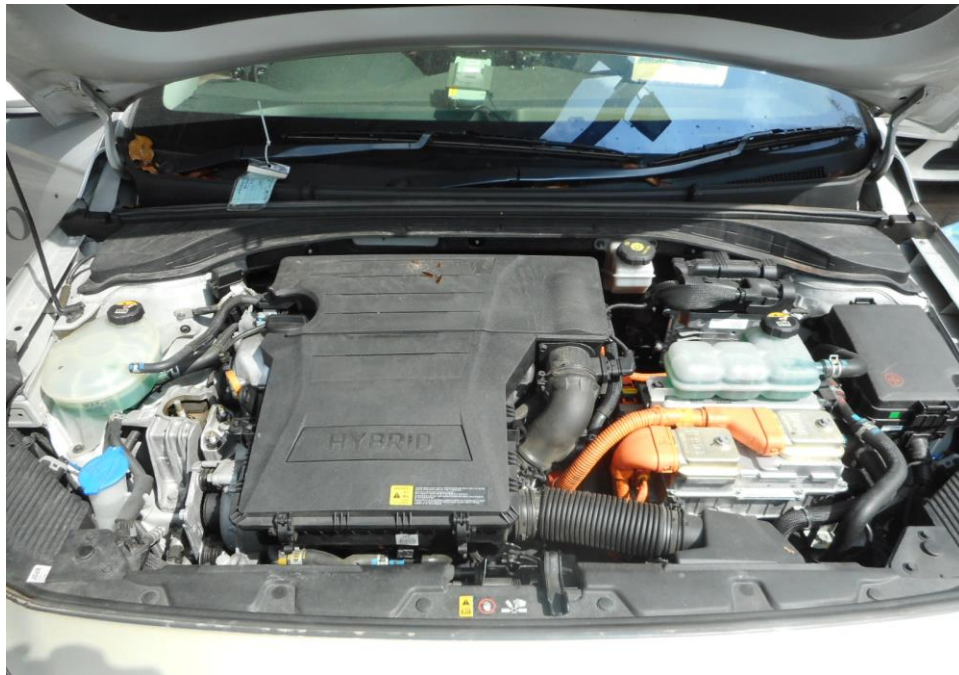
**Photo 12** shows a general view of the Motor Taxi's engine compartment. The various parts and components inside the engine compartment were unaffected by the accident. There was also no sign(s) or indication(s) of fluid leakage and/or fluid stain within the engine compartment.

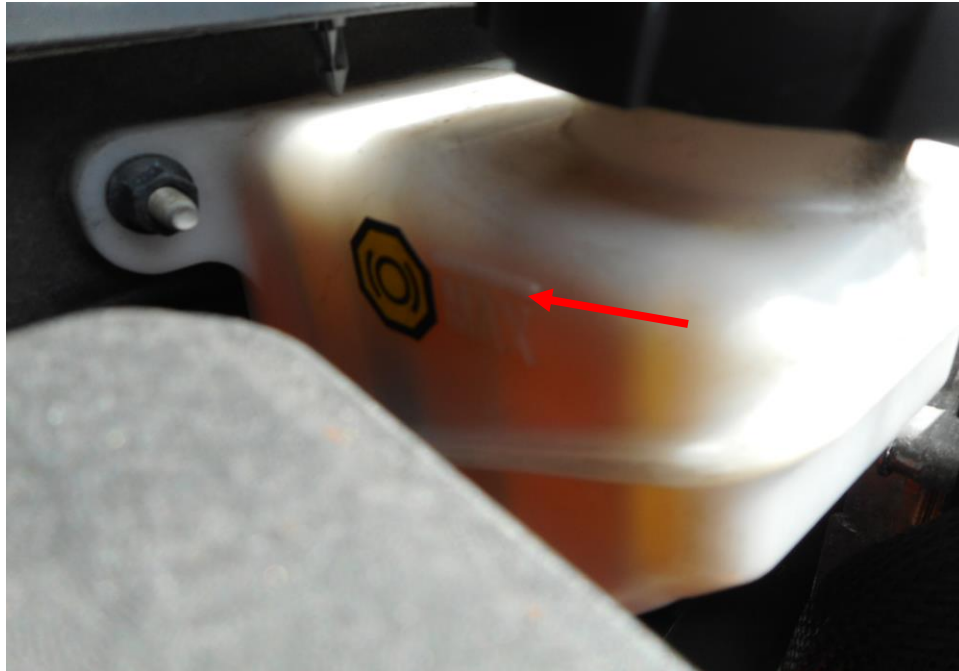
**Photo 13** shows the brake fluid reservoir of the Motor Taxi at the time of my inspection. The brake fluid was observed to be of sufficient level (arrowed) and without any visible contamination.

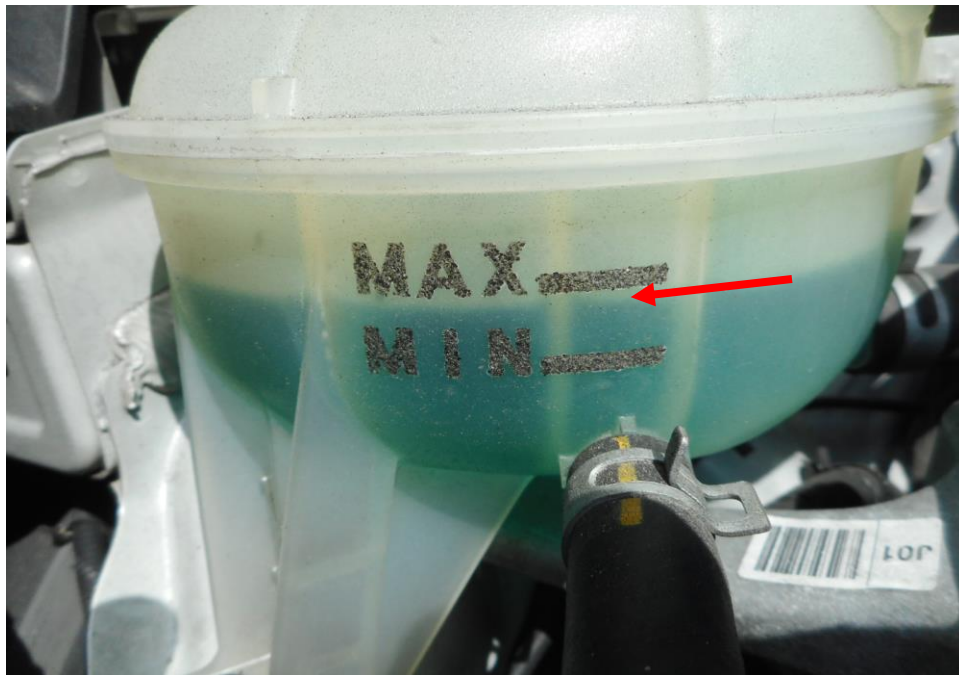
**Photo 14** shows checks being carried out to the engine coolant of the Motor Taxi at the time of my inspection. The engine coolant was observed to be of sufficient level (arrowed) and without any visible contamination.

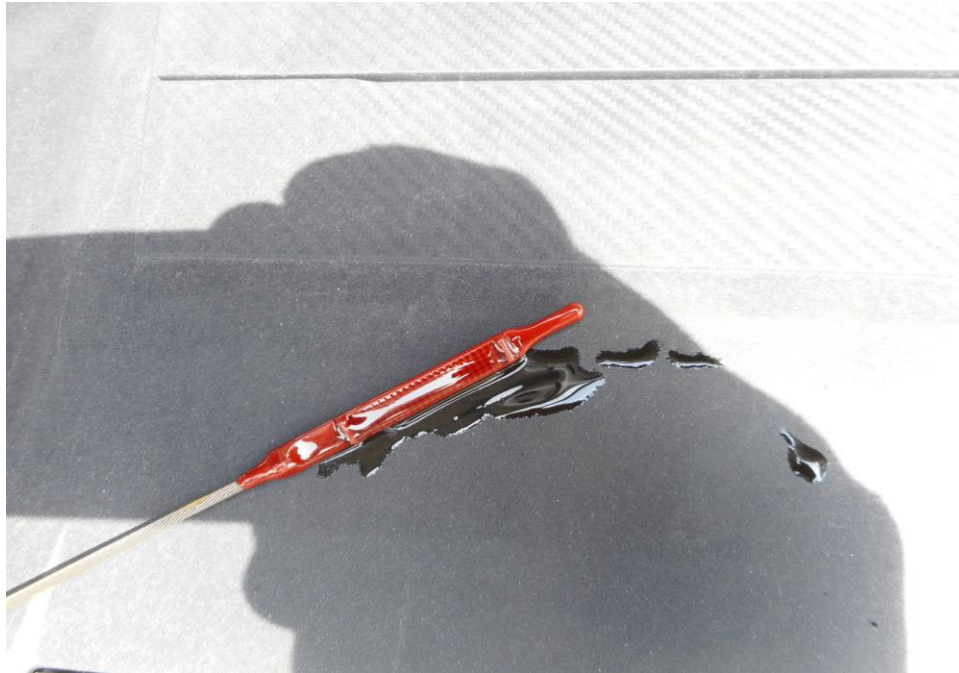
**Photo 15** shows the engine oil dip stick of the Motor Taxi at the time of my inspection. The engine oil was observed to be of sufficient level and without any visible contamination.

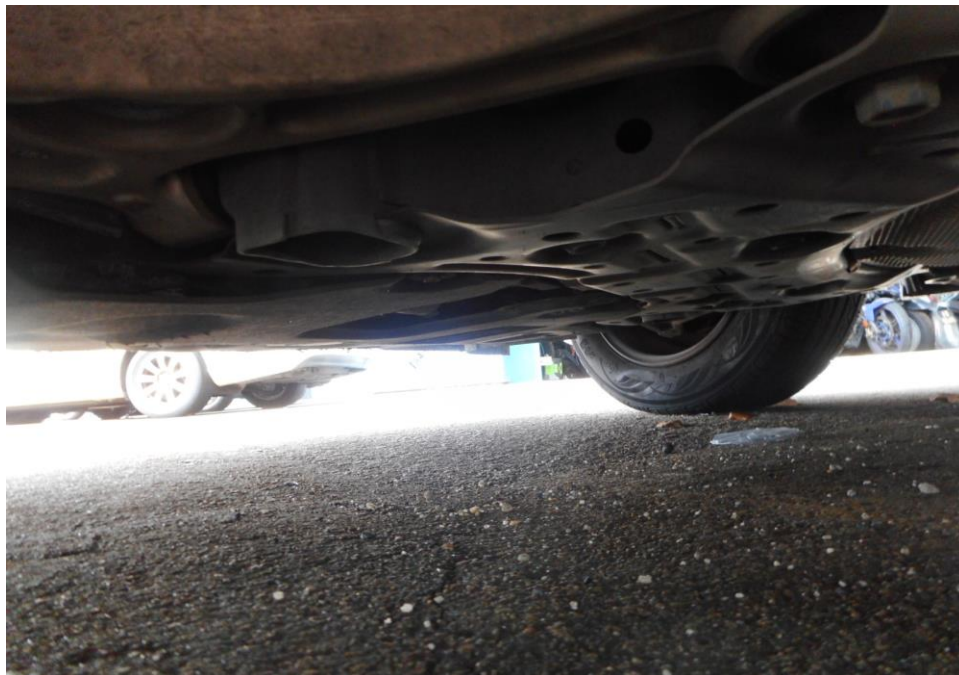
**Photo 16** shows the undercarriage of the Motor Taxi, at the area where the engine housing and transmission housing are located. I did not find any sign(s) or indication(s) of fluid leak and/or fluid stain(s) on the underside of the Motor Taxi.

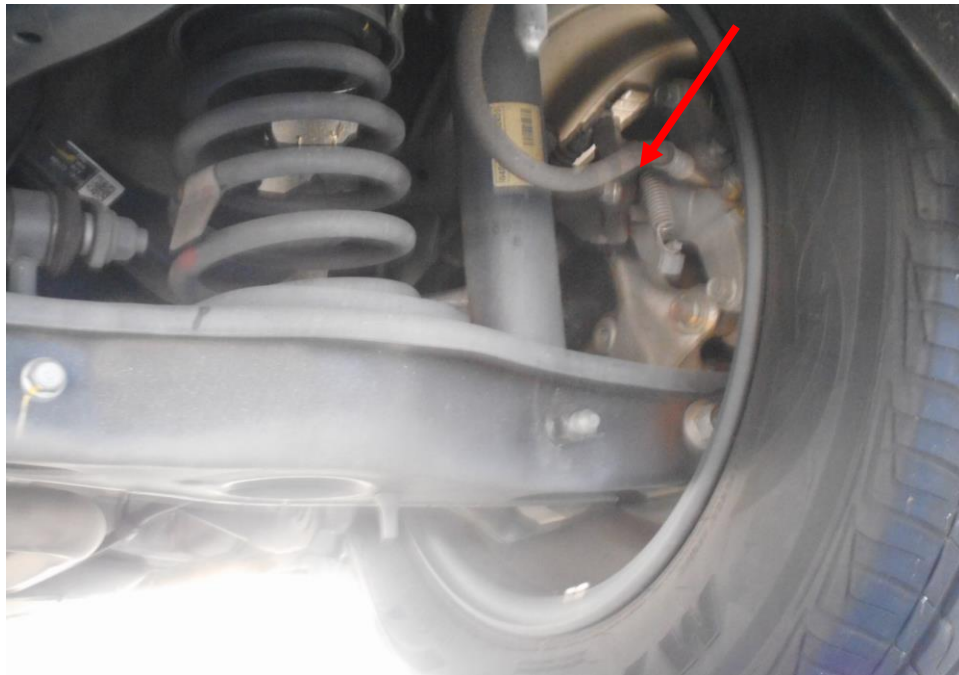
**Photo 17** shows the brake hose/pipe (arrowed) at the rear right wheel of the Motor Taxi. No leakage of brake fluid was observed. Visual examination of the various components of the braking system like the drum brake, brake booster, brake pedal etc. had revealed all to be intact and without visible damage.

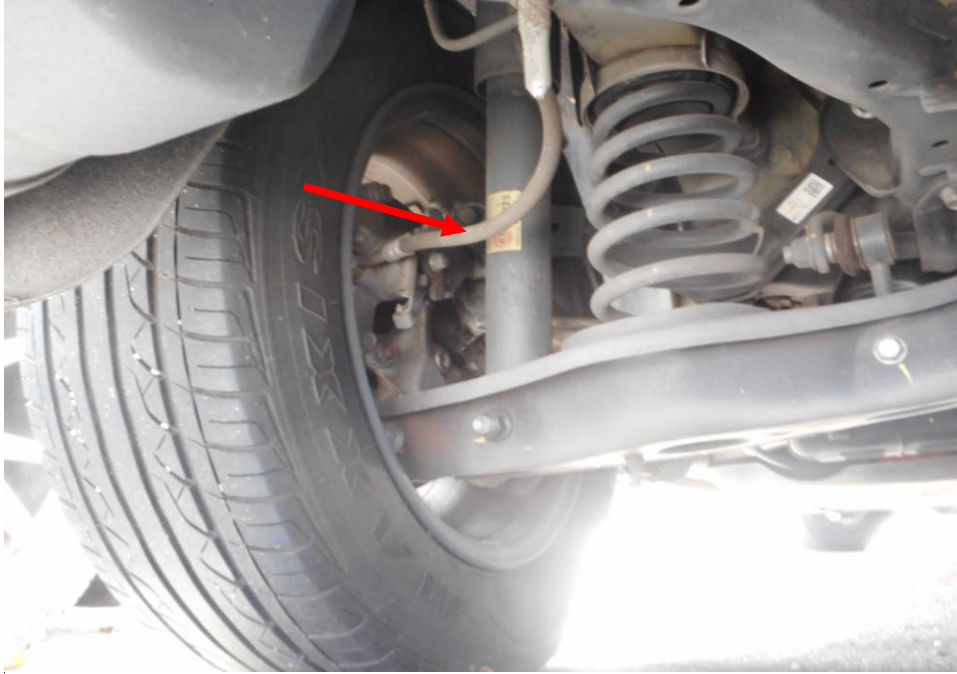
**Photo 18** shows the brake hose/pipe (arrowed) at the rear left wheel of the Motor Taxi. I did not observe any leakage of brake fluid at the time of my inspection of the Motor Taxi. Static tests of the Motor Taxi's braking system had indicated that there was no internal leakage of pressure/vacuum. The undercarriage components of the Motor Taxi were also all found to be intact and without any visible damage.

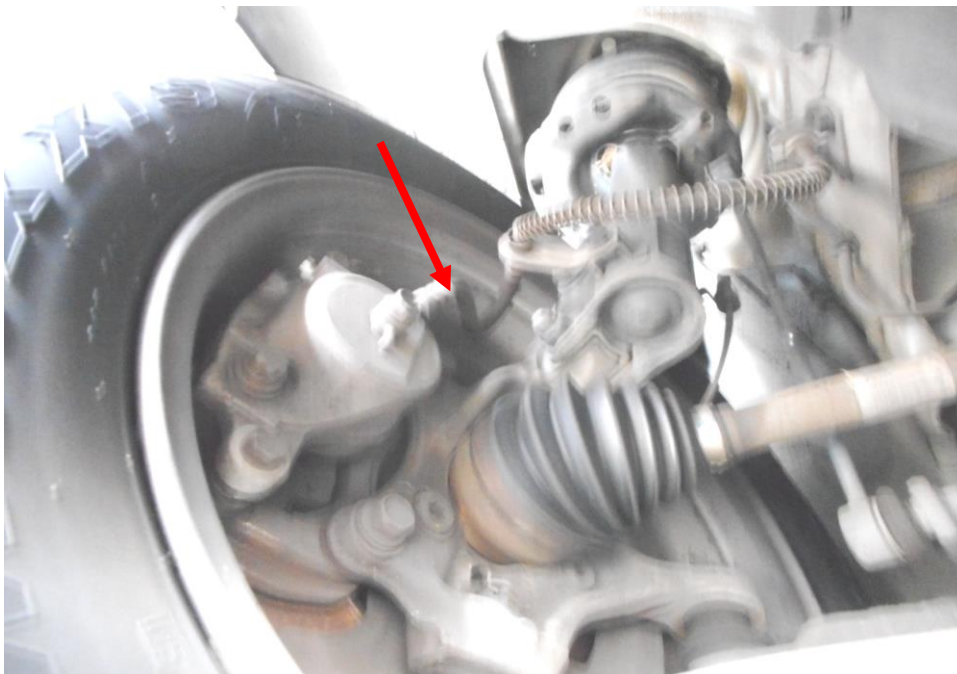
**Photo 19** shows the brake hose/pipe (arrowed) at the front right wheel of the Motor Taxi. I did not observe any leakage of brake fluid at the time of my inspection of the Motor Taxi. Static tests of the Motor Taxi's braking system had indicated that there was no internal leakage of pressure/vacuum. The undercarriage components of the Motor Taxi were also all found to be intact and without any visible damage.

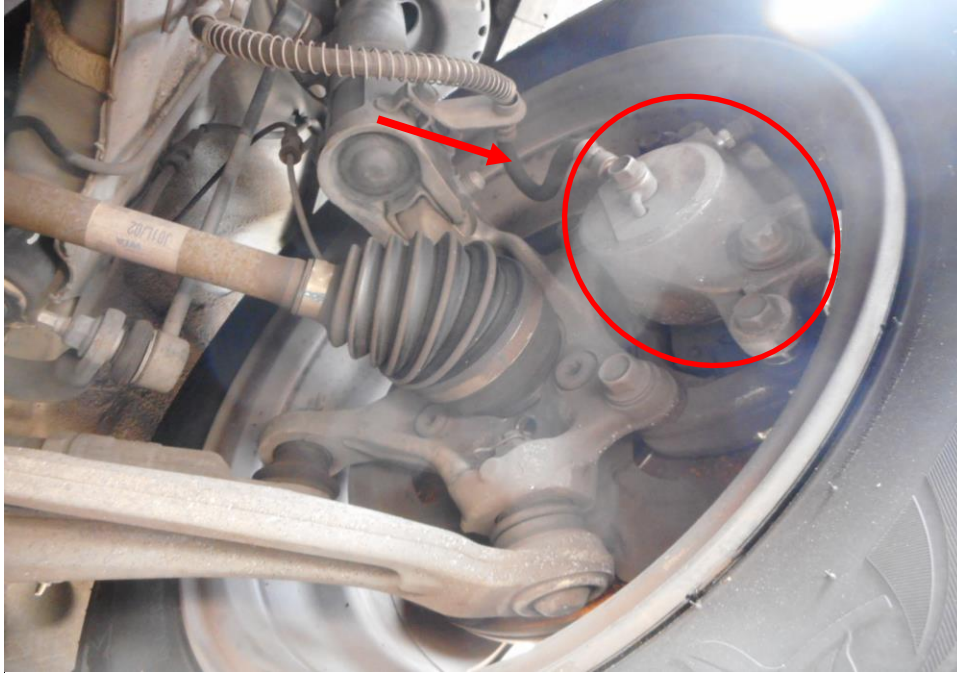
**Photo 20** shows the brake hose/pipe (arrowed) at the front left wheel of the Motor Taxi. No leakage of brake fluid was observed. Visual examination of the various components of the braking system like the brake caliper (circled), brake booster, brake pedal etc had revealed all to be intact and without visible damage.

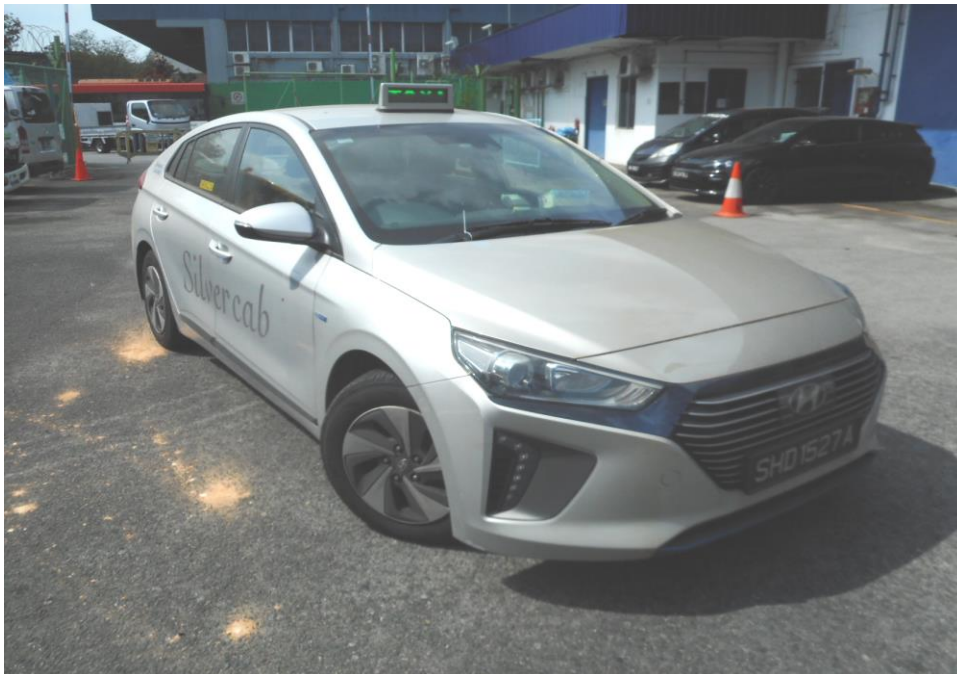
**Photo 21** shows the front right wheel of the Motor Taxi turned to its full left. During my steering system test, I did not experience any abnormal free play and/or resistance when I had turned the steering wheel towards the left and right. This would suggest that the steering system of the Motor Taxi was likely to be in serviceable condition at the material time of accident.

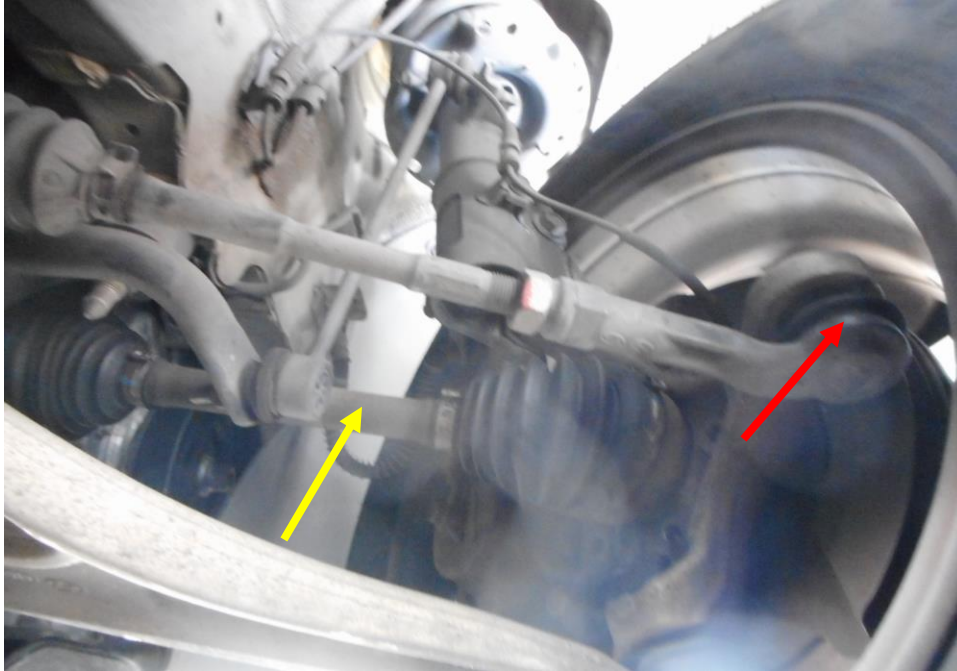
**Photo 22** shows the various undercarriage components at the front right wheel of the Motor Taxi, in particular the steering tie rod (red arrow) and drive shaft (yellow arrow). The various steering components were all found to be intact, suggesting that the steering system of the Motor Taxi was likely to be in serviceable condition at the material time of accident. There was also no sign of fluid stain observed on the various undercarriage components at the front right wheel of the Motor Taxi.

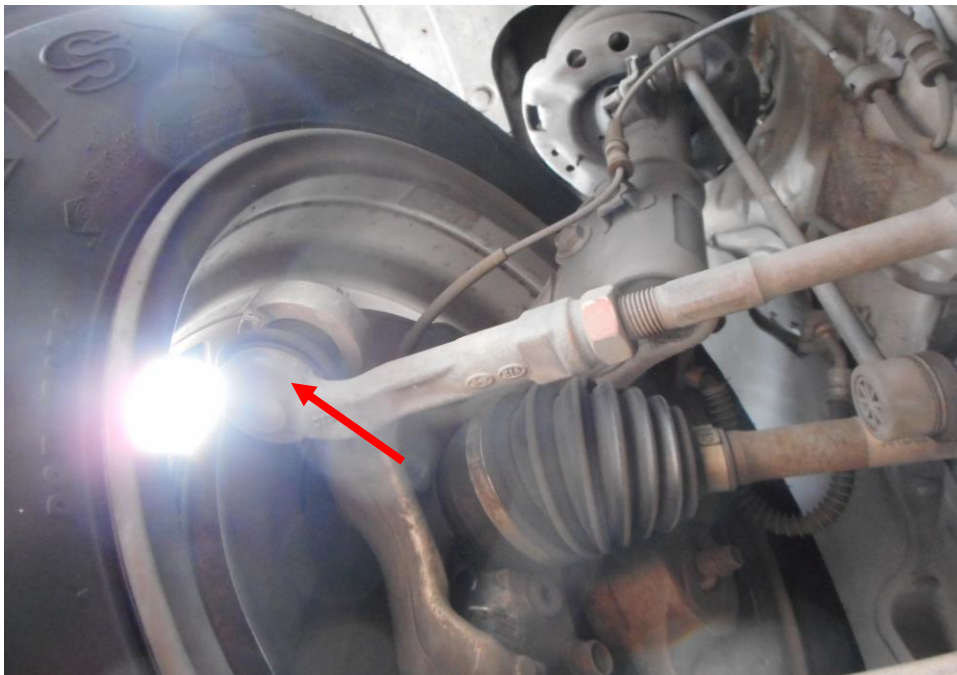
**Photo 23** shows the various undercarriage components at the front left wheel of the Motor Taxi, which had included the steering tie rod (red arrow). The various undercarriage components of the Motor Taxi were all found to be intact without any visible damage.

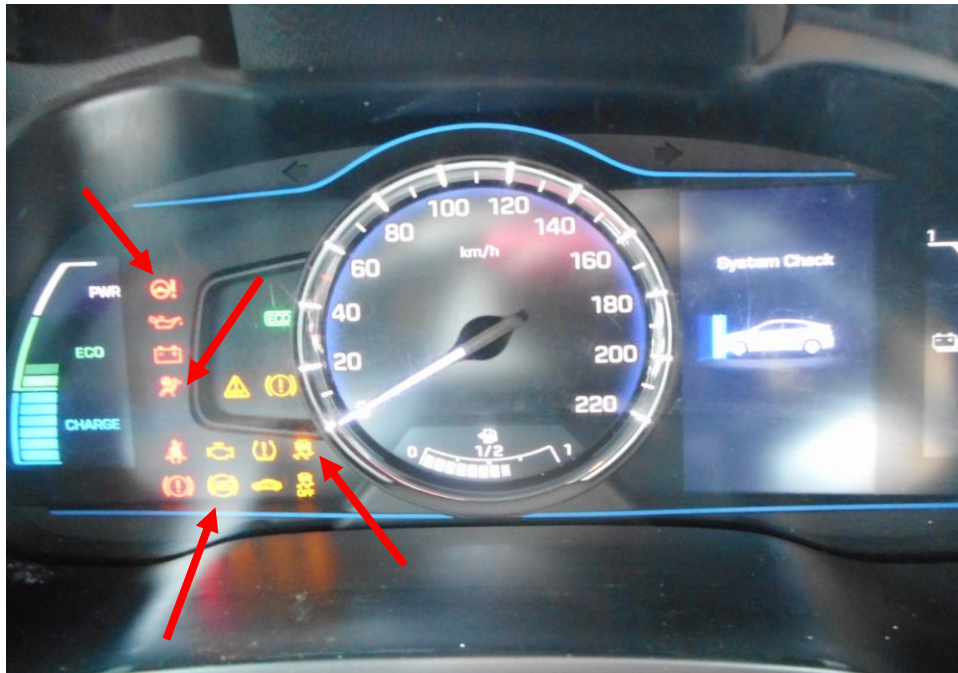
**Photo 24** shows the warning light for Anti-Lock Brake System (ABS) and Power Steering System (EPS), Supplemental Restraint System (SRS) and Traction Control (TC) (arrowed) appearing on the instrument panel of the Motor Taxi during the self-test of its various electronic operating systems when its engine was cranked.

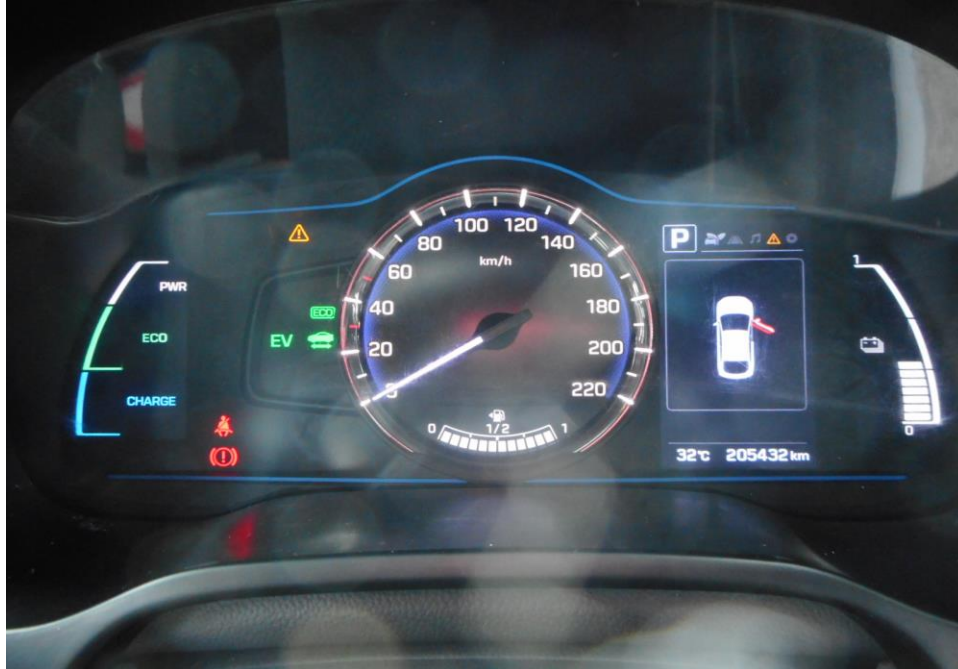
**Photo 25** shows no warning lights illuminated on the instrument panel of the Motor Taxi after the engine was cranked. This would suggest that there was no abnormality to the electronic operating system of the Motor Taxi, like the ABS, EPS, SRS, and TC etc.
