Your Ref: TP/IP/49507/2020  
Our Ref : CI/TPD21000241/P

18<sup>th</sup> January 2021

**General Investigation Team**

**MECHANICAL INSPECTION REPORT OF MOTOR LORRY GBD 8473X**

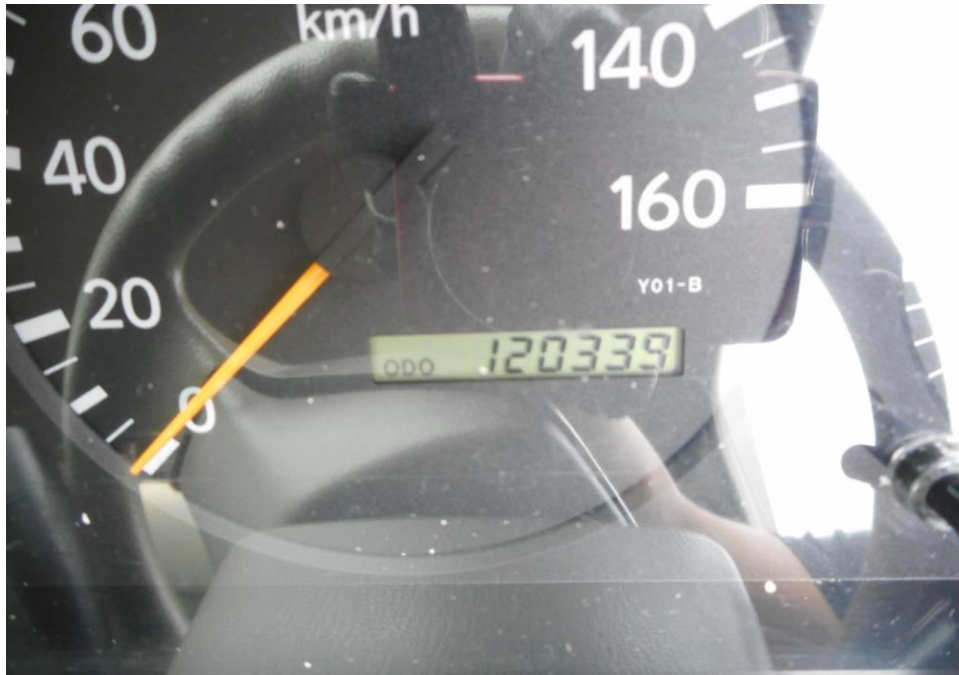
**Photo 1** shows a general view of the instrument cluster of the Motor Lorry at the time of my inspection. The mileage of the Motor Lorry was 120,339 km

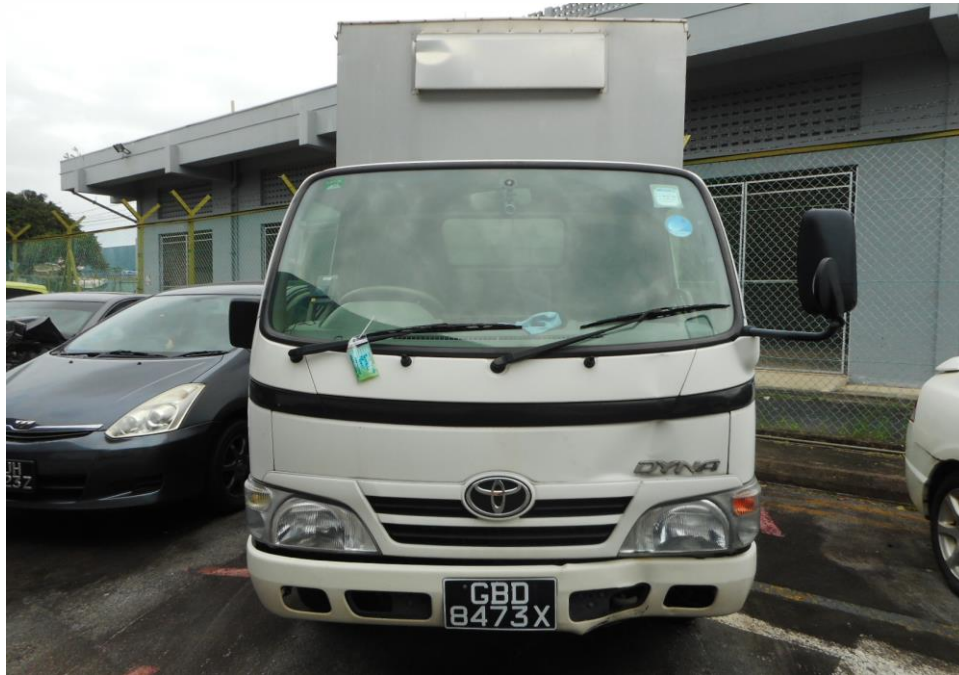
**Photo 2** shows a general view of the Motor Lorry's frontal portion at the time of my inspection. It appeared to have sustained damage at its frontal portion. Its front body panel and front bumper were damage at the time of my inspection.

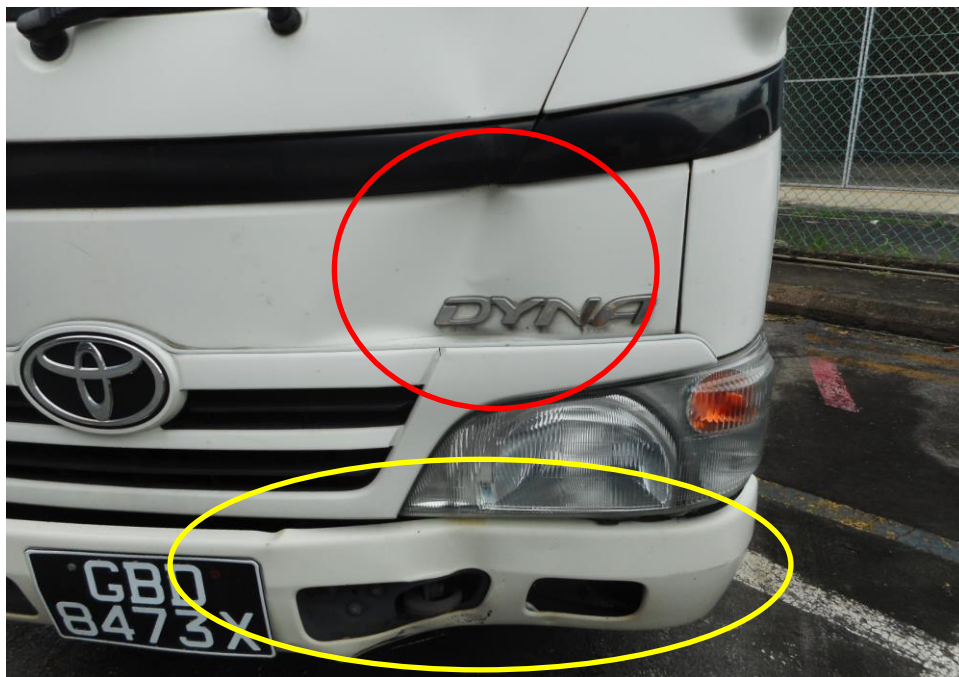
**Photo 3** shows a close up view of the Motor Lorry's frontal portion at the time of my inspection. It appeared to have sustained damage at its frontal portion. Its front body panel (red circle) and front bumper (yellow circle) was damage at the time of my inspection as a result of the accident.

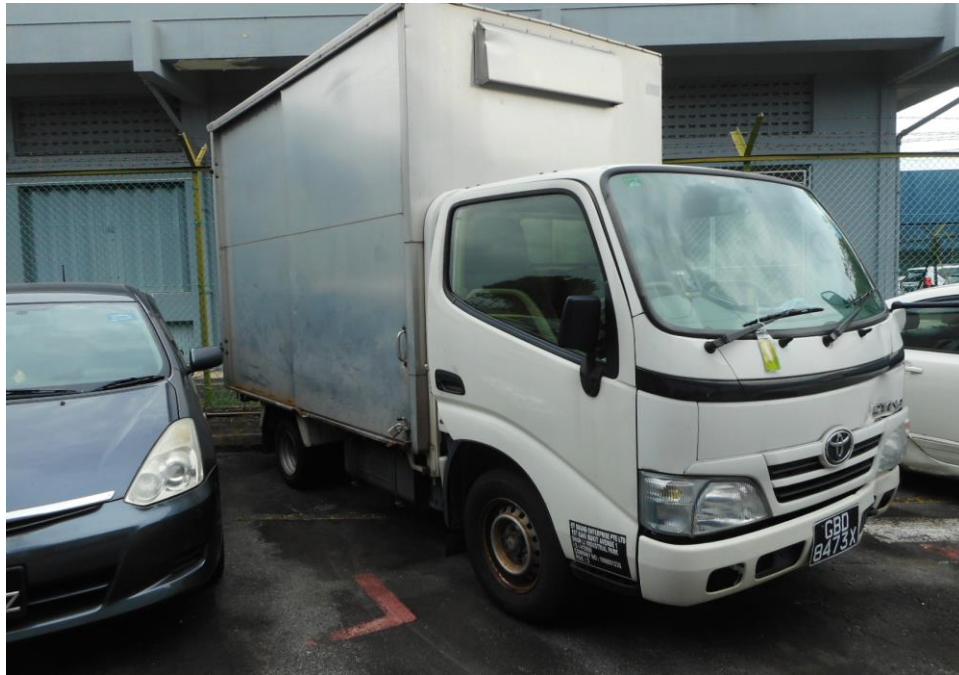
**Photo 4** shows a general view of the right body of the Motor Lorry at the time of my inspection. The Motor Lorry was observed to be intact and unaffected by the accident.

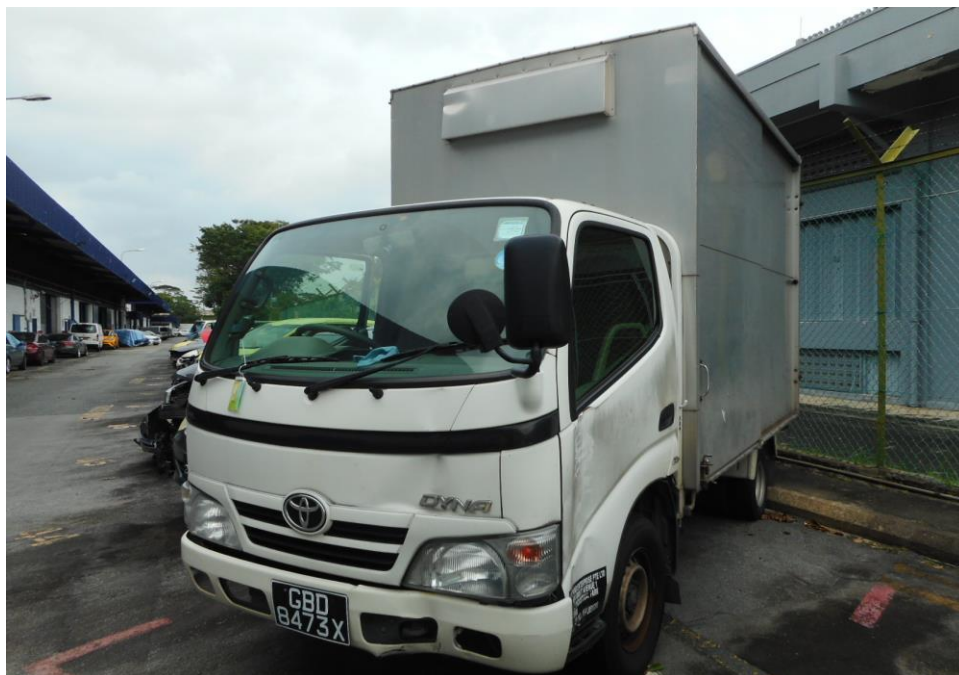
**Photo 5** shows a general view of the left body of the Motor Lorry at the time of my inspection. The Motor Lorry was observed to be intact and unaffected by the accident.

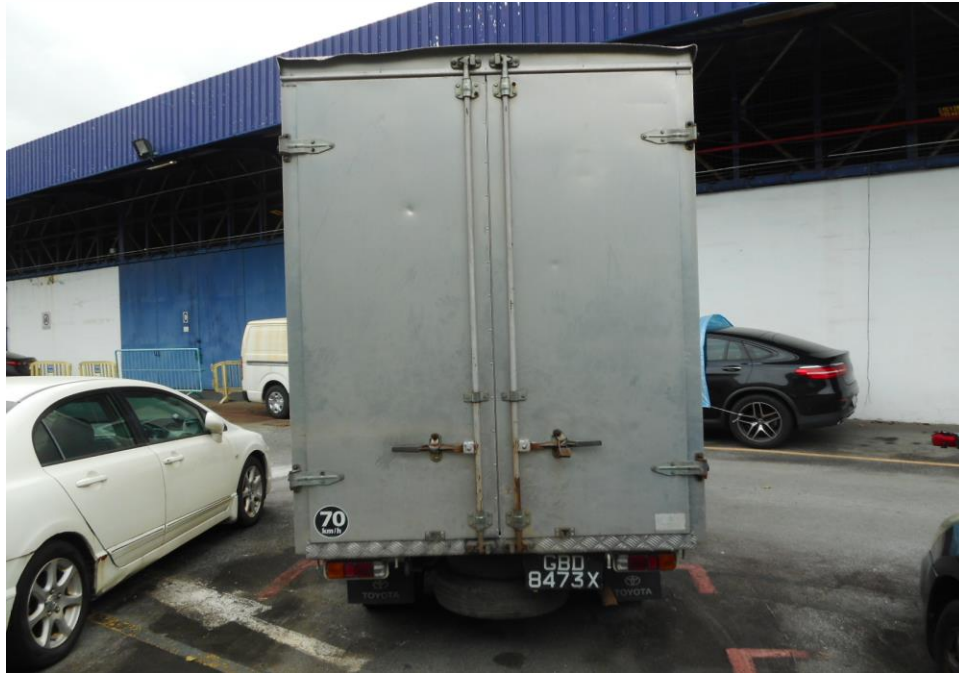
**Photo 6** shows a general view of the rear body of the Motor Lorry at the time of my inspection. The Motor Lorry was observed to be intact and unaffected by the accident.

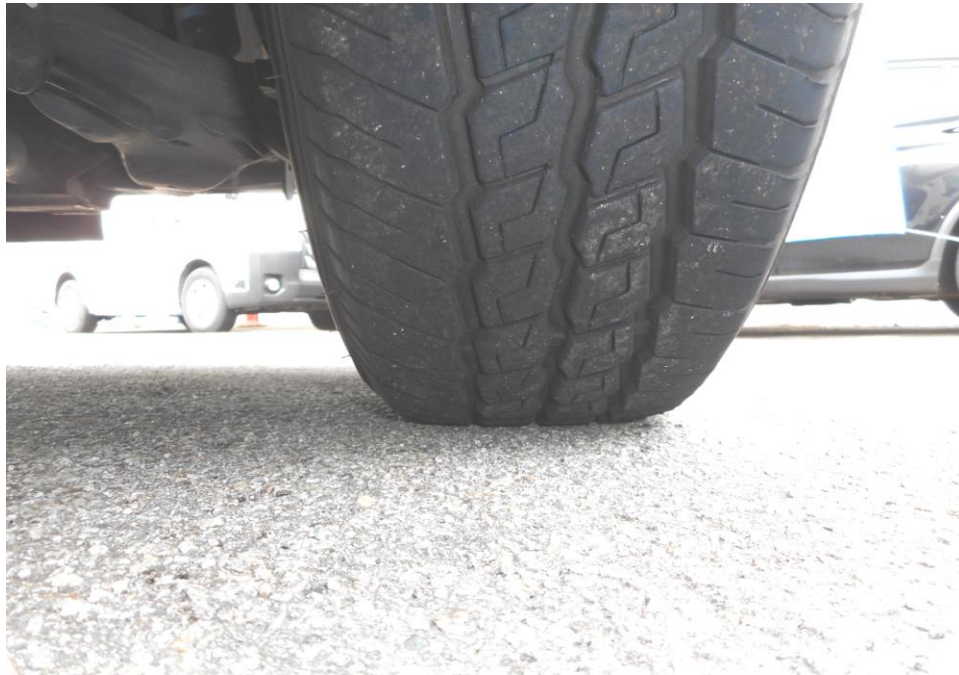
**Photo 7** shows the condition of the front right tyre of the Motor Lorry, which was observed to be in serviceable condition with remaining tread depth of approximately 6.6mm. The tyre, which was wrapped around standard steel wheel rim, was also observed to be sufficiently inflated for vehicular operation. There was no tear, cut or burst mark(s) on the outer and the inner sidewalls as well as across the tread of the 4 tyres that were fitted on the Motor Lorry.

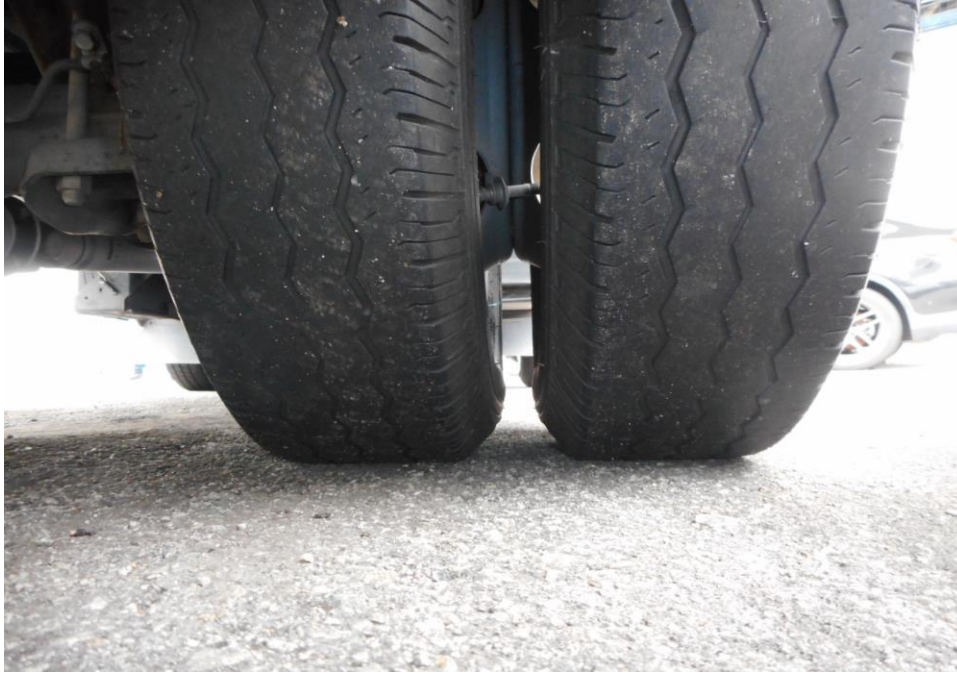
**Photo 8** shows the condition of the rear right tyre of the Motor Lorry, which was observed to be in serviceable condition with remaining tread depth of approximately 3 mm. The tyre, which was wrapped around standard steel wheel rim, it was observed to be sufficiently inflated for vehicular operation.

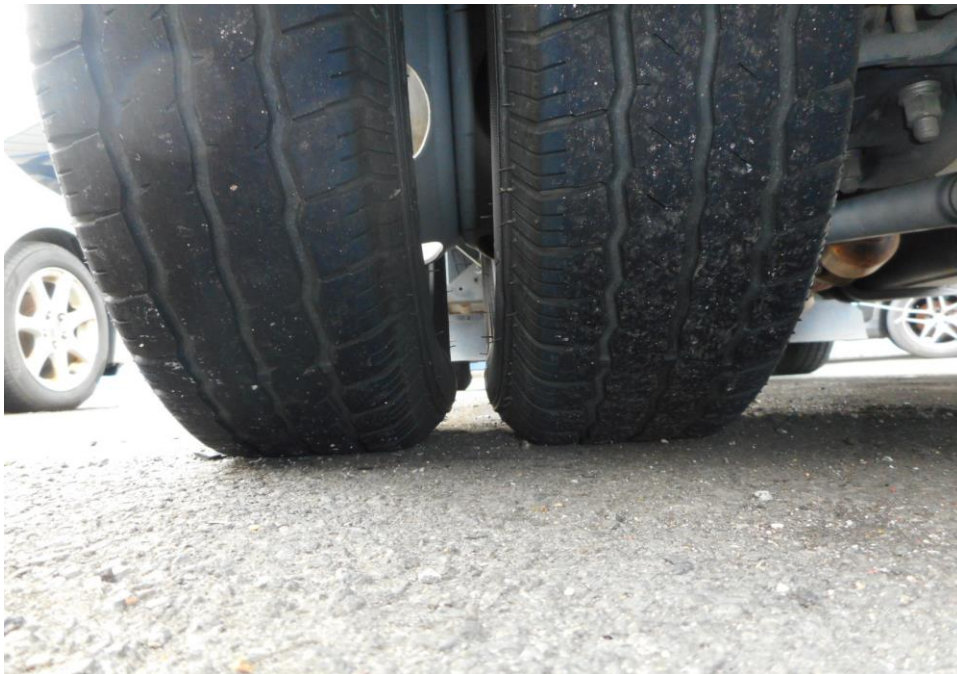
**Photo 9** shows the condition of the rear left tyres of the Motor Lorry, which was observed to be in serviceable condition with remaining tread depth of approximately 2.5mm. The tyres, which were wrapped around standard steel wheel rim, were also observed to be sufficiently inflated for vehicular operation. There was also no damage found on all 4 steel wheel rims of the Motor Lorry.

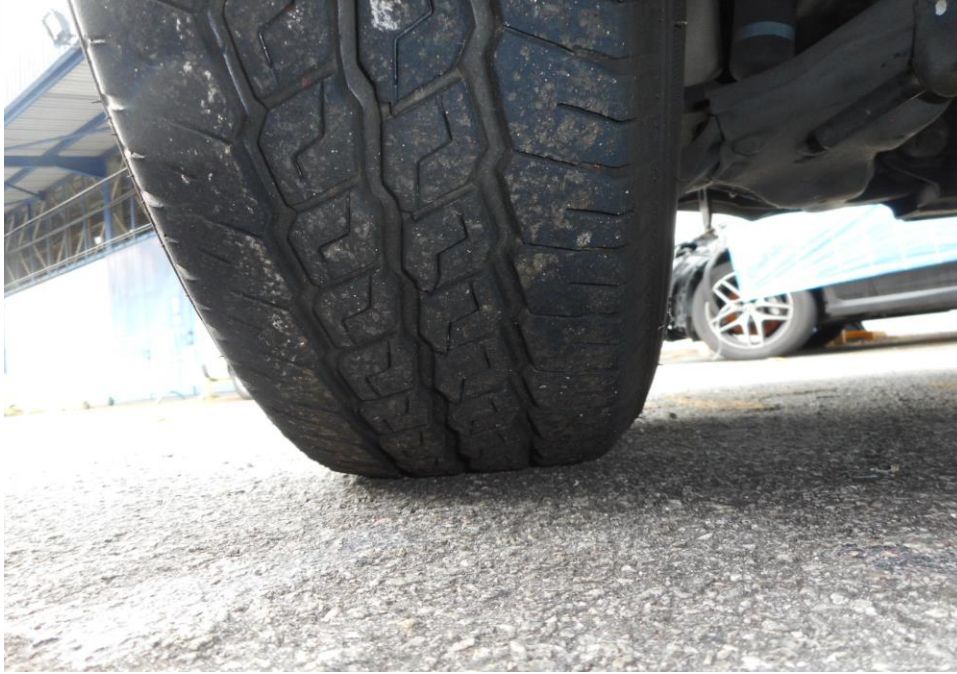
**Photo 10** shows the condition of the rear right tyres of the Motor Lorry, which were observed to be in serviceable condition with remaining, tread depth of approximately 6.5mm. There was also no tear, cut or burst mark(s) on the outer and the inner sidewalls as well as across the tread of the 4 tyres that were fitted on the Motor Lorry.

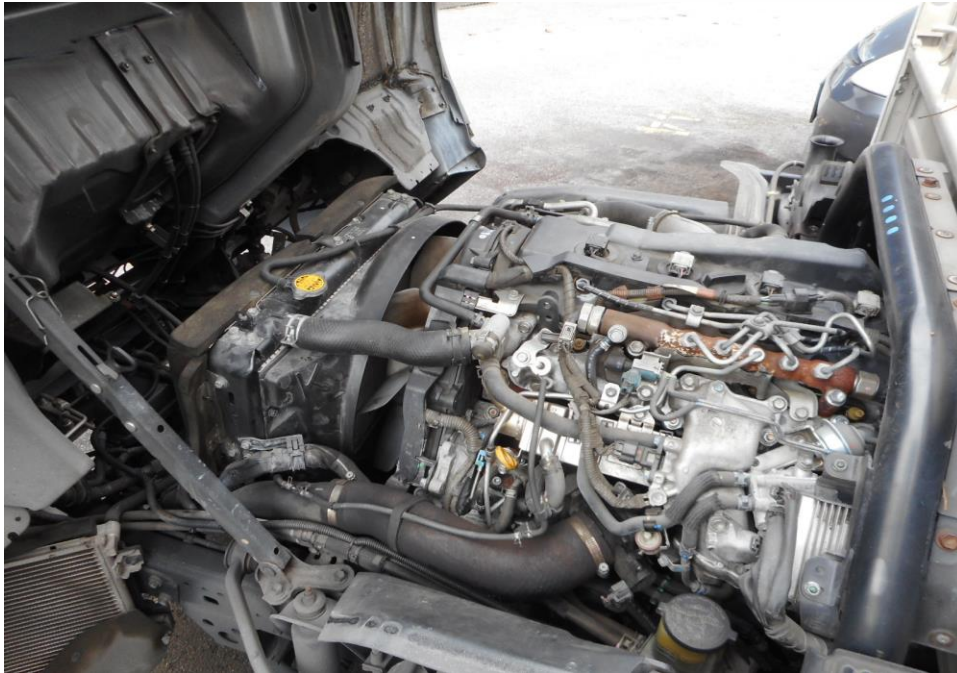
**Photo 11** shows a general view of the Motor Lorry's engine compartment, which was accessed by lifting the front cabin of the Motor Lorry. The various parts and components inside the engine compartment were unaffected by the accident. There was also no sign(s) or indication(s) of fresh fluid leakage and/or fluid stain within the engine compartment

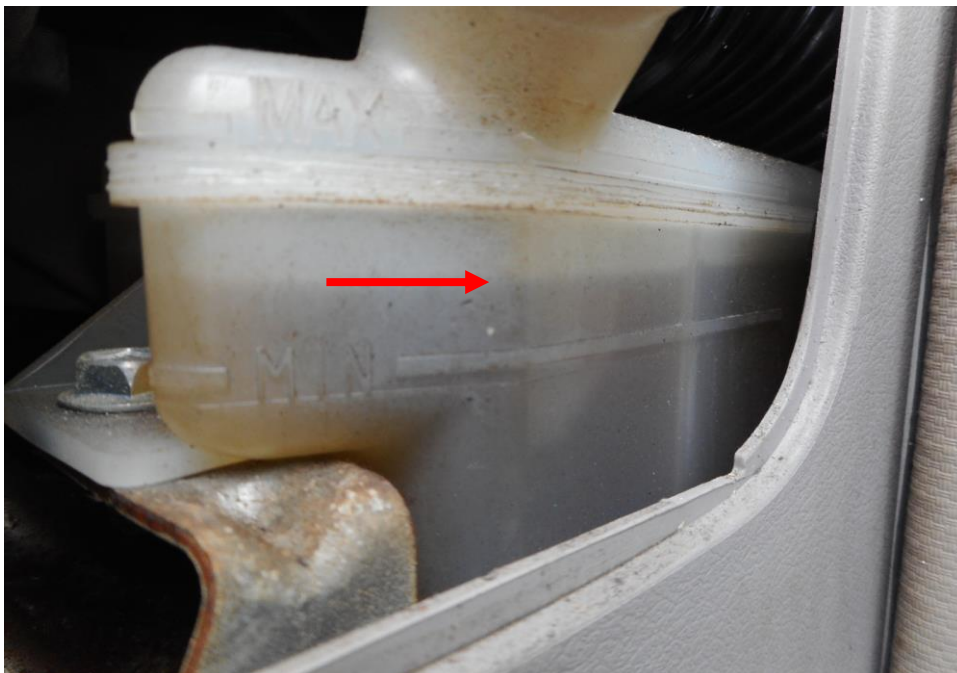
**Photo 12** shows the brake fluid reservoir of the Motor Lorry at the time of my inspection. The brake fluid was observed to be of sufficient level (arrowed) and without any visible contamination.

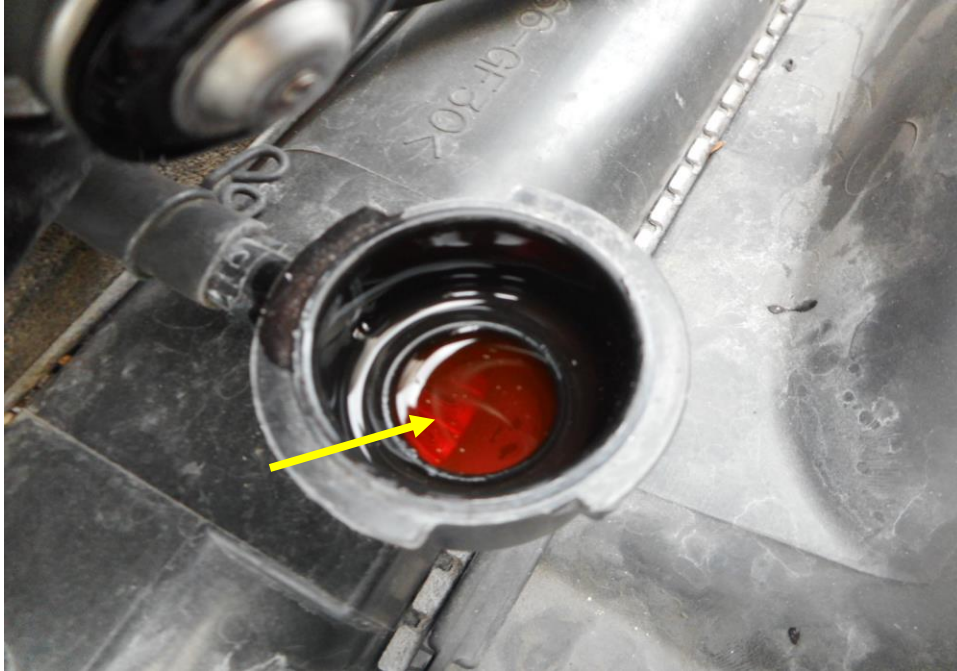
**Photo 13** shows the engine coolant reservoir of the Motor Lorry at the time of my inspection. The engine coolant was observed to be of sufficient level (arrowed) and without any visible contamination.

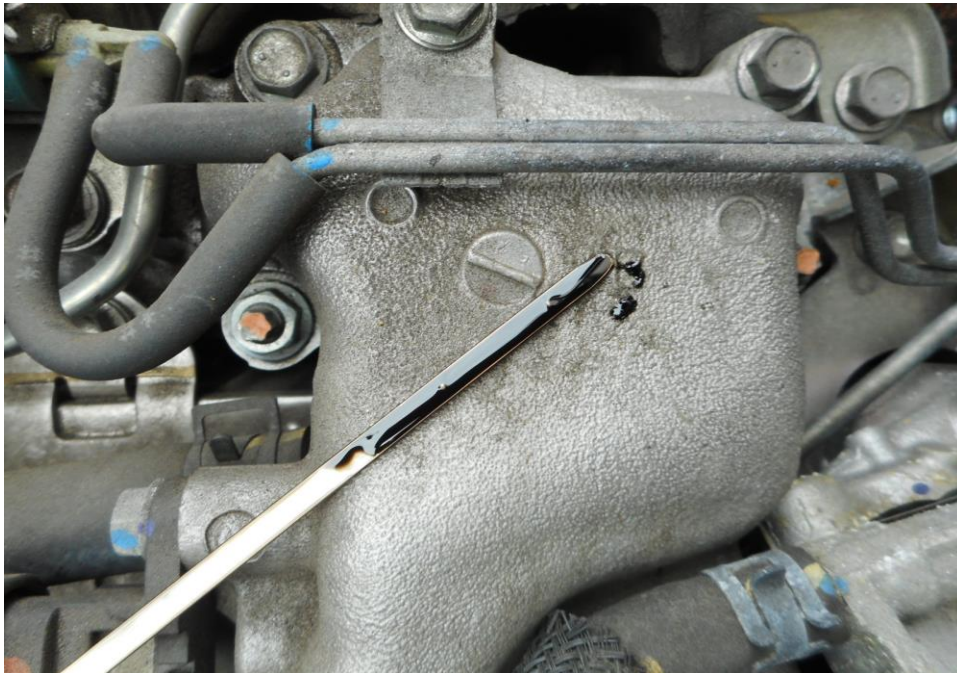
**Photo 14** shows the engine oil dip stick of the Motor Lorry at the time of my inspection. The engine oil was observed to be of sufficient level and without any visible contamination.

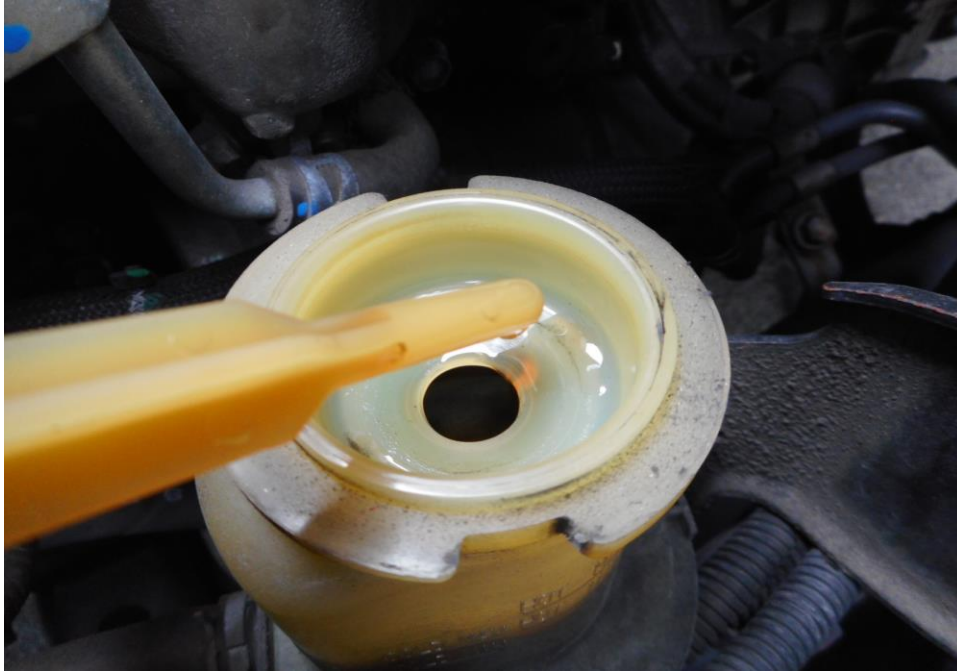
**Photo 15** shows the power steering fluid reservoir of the Motor Lorry at the time of my inspection. The power steering fluid was observed to be of sufficient level (arrowed) and without any visible contamination.

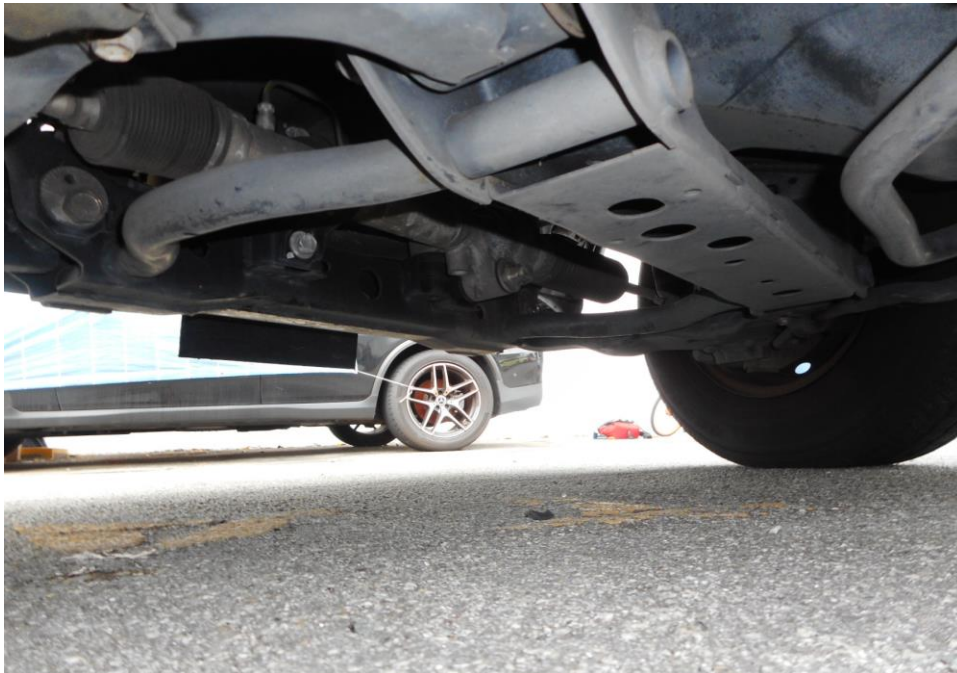
**Photo 16** shows the undercarriage of the Motor Lorry, at the area where the engine housing and transmission housing are located. I did not find any sign(s) or indication(s) of fluid leak and/or fluid stain(s) on the underside of the Motor Lorry.

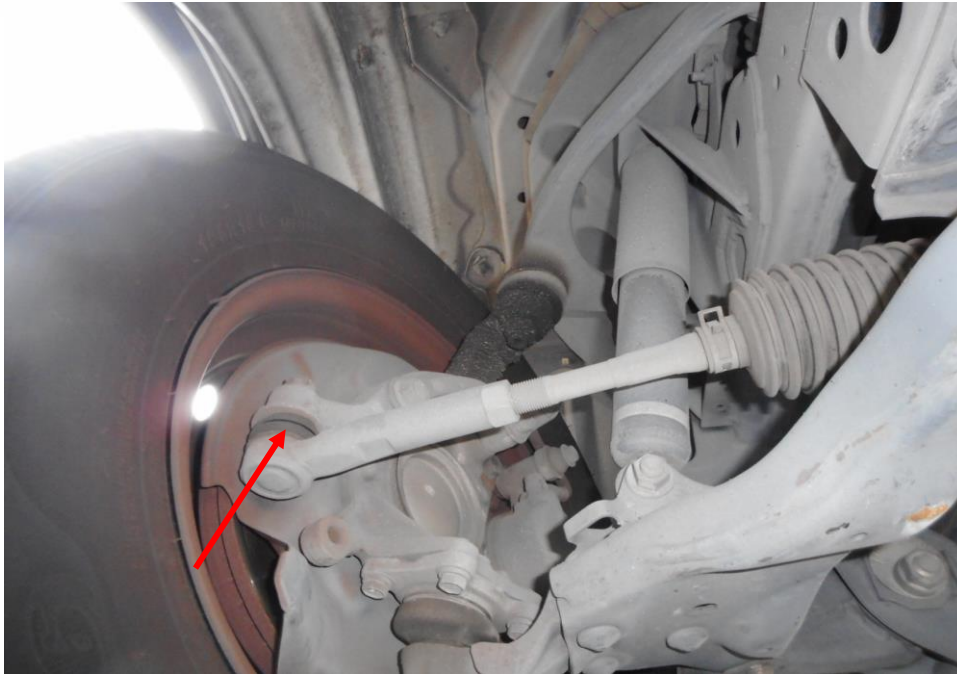
**Photo 17** shows the various undercarriage components at the front right wheel of the Motor Lorry, in particular the steering tie rod end (arrowed). The various steering components were all found to be intact, suggesting that the steering system of the Motor Lorry was likely to be in serviceable condition at the material time of accident. There was also no sign of fluid stain(s) observed on the various undercarriage components.

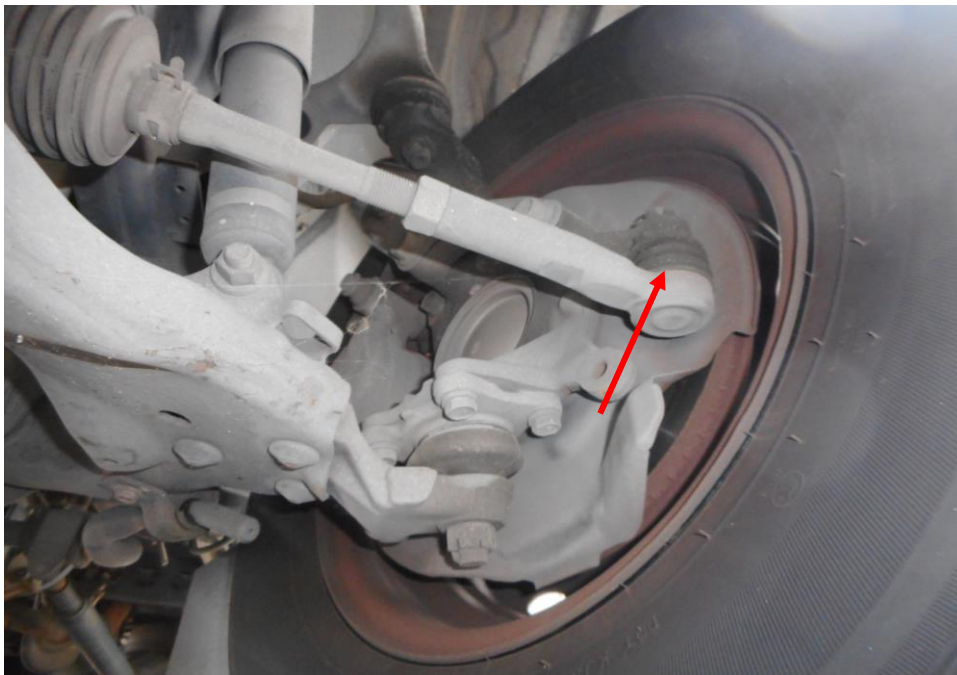
**Photo 18** shows the various undercarriage components at the front left wheel of the Motor Lorry, in particular the steering tie rod end (arrowed). The various undercarriage components of the Motor Lorry were all found to be intact without any visible damage. There was also no sign of fluid stain(s) observed on the various undercarriage components.

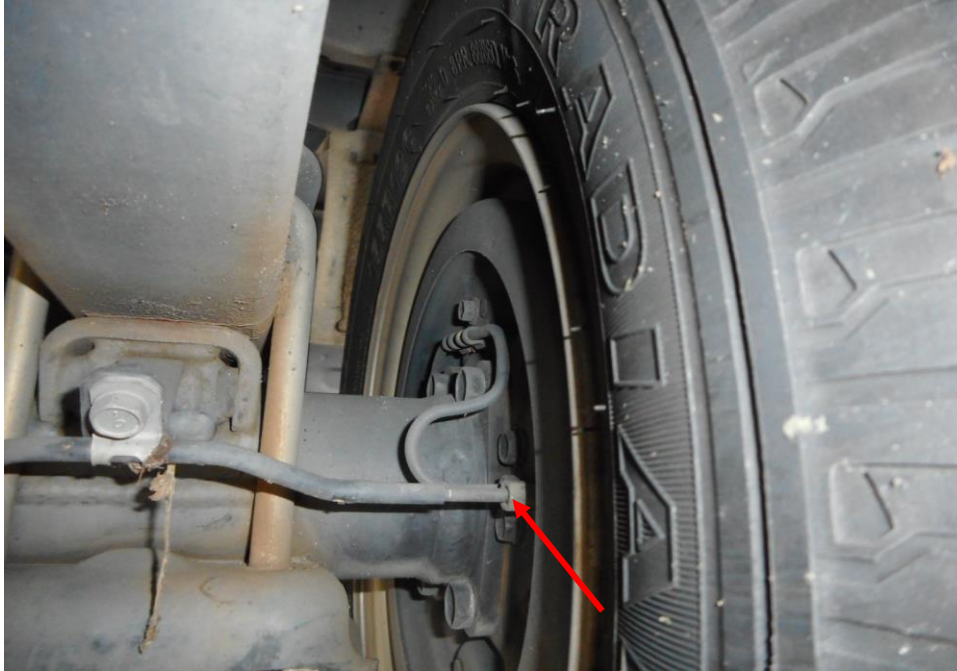
**Photo 19** shows the brake pipe (arrowed) at the rear right wheel of the Motor Lorry. I did not observe any leakage of brake fluid at the time of my inspection of the Motor Lorry. My static tests of the Motor Lorry's braking system, along with my visual examination of the various mechanical components in the braking system, had indicated that there was no internal leakage of pressure/vacuum. Hence the braking system of the Motor Lorry was likely to be in serviceable condition at the material time of accident.

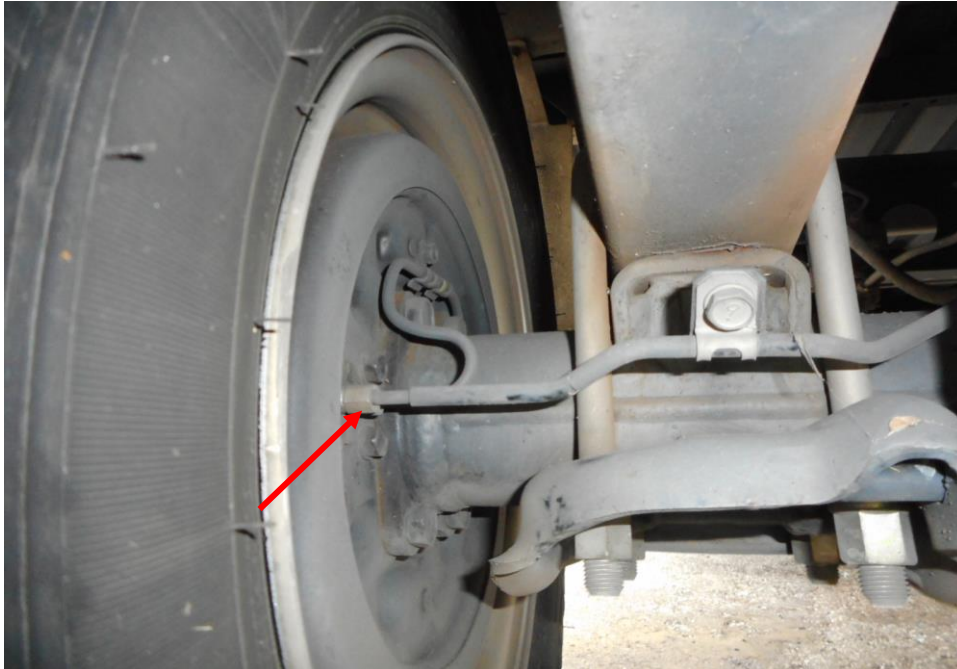
**Photo 20** shows the brake pipe (arrowed) at the rear left wheel of the Motor Lorry. I did not observe any leakage of brake fluid at the time of my inspection of the Motor Lorry. My static tests of the Motor Lorry's braking system, along with my visual examination of the various mechanical components in the braking system had indicated that there was no internal leakage of pressure/vacuum. Hence the braking system of the Motor Lorry was likely to be in serviceable condition at the material time of accident.

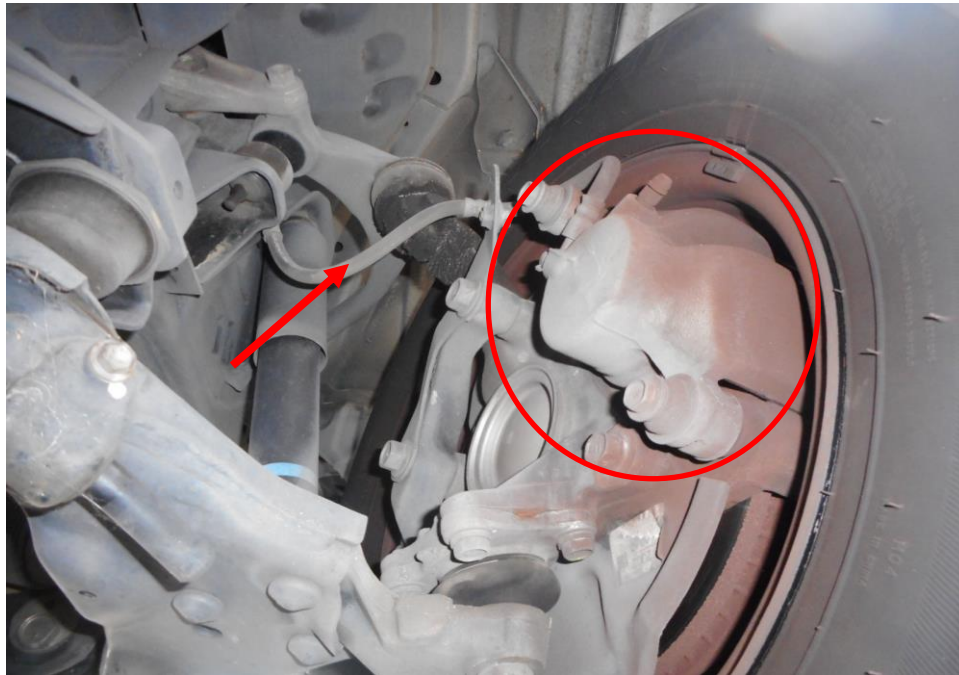
**Photo 21** shows the brake hose/pipe (arrowed) at the front right wheel of the Motor Lorry. No leakage of brake fluid was observed. Visual examination of the various components of the braking system like the brake caliper (circled), brake booster, brake pedal etc had revealed all to be intact and without visible damage at the time of accident. There was also no sign of fluid stain(s) observed on the various undercarriage components.

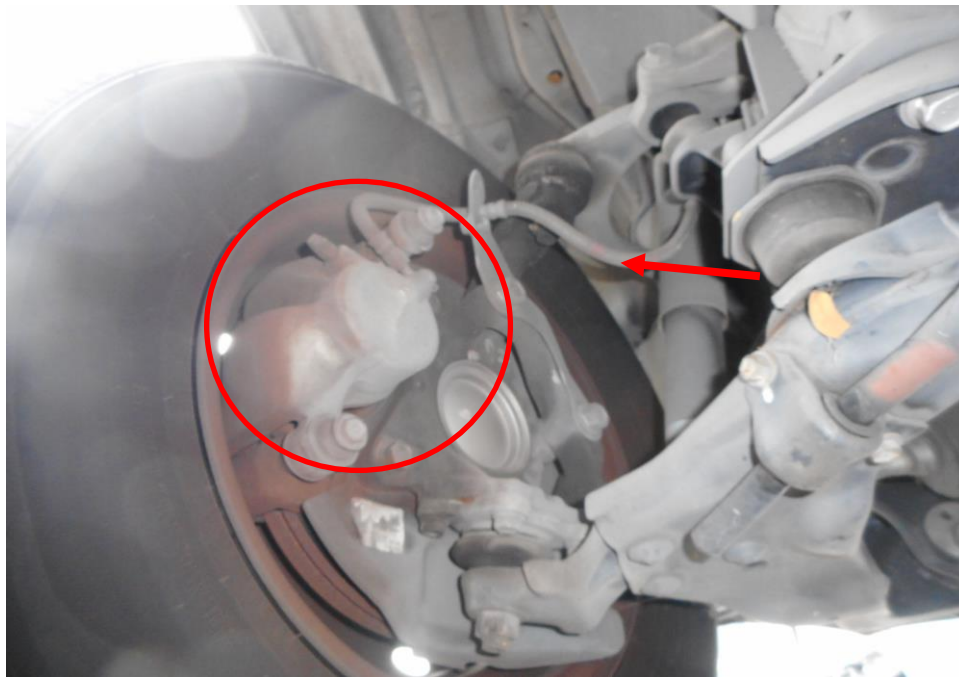
**Photo 22** shows the brake hose/pipe (arrowed) at the front left wheel of the Motor Lorry. No leakage of brake fluid was observed. Visual examination of the various components of the braking system like the brake caliper (circled), brake booster, brake pedal etc had revealed all to be intact and without visible damage at the time of accident. There was also no sign of fluid stain(s) observed on the various undercarriage components.

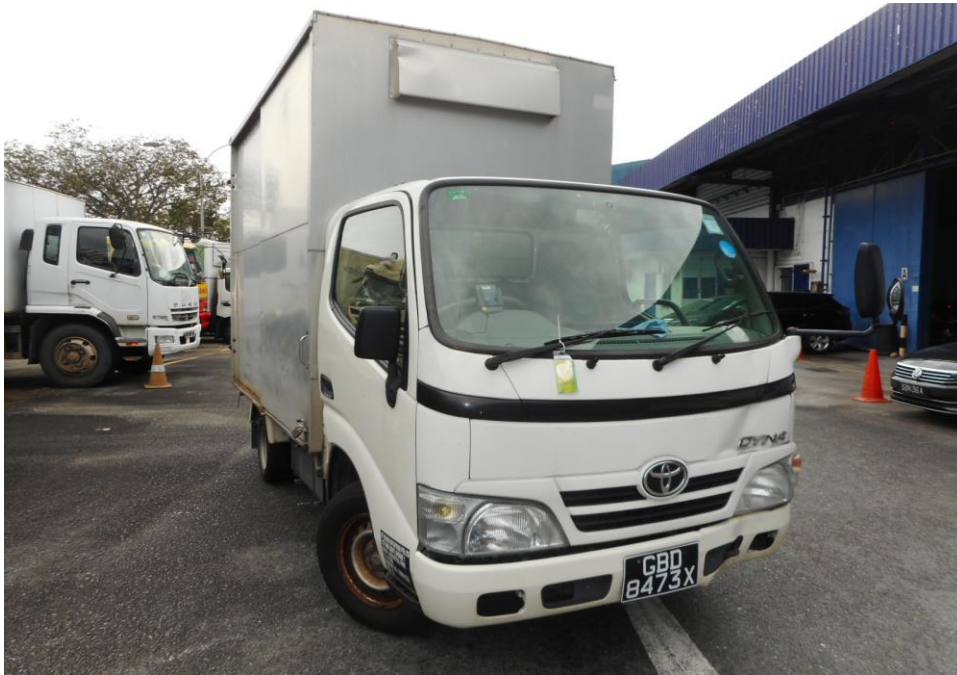
**Photo 23** shows the front right wheel of the Motor Lorry turned to its full left. During my steering system test, I did not experience any abnormal free play and/or resistance when I had turned the steering wheel towards full left and full right. This would suggest that the steering system of the Motor Lorry was likely to be in serviceable condition at the material time of accident.
