Your Ref: TP/IP/54791/2020  
Our Ref : CI/TPD21000243/P

24<sup>th</sup> February 2021

**MECHANICAL INSPECTION REPORT OF MOTOR CAR SMA 4853U**

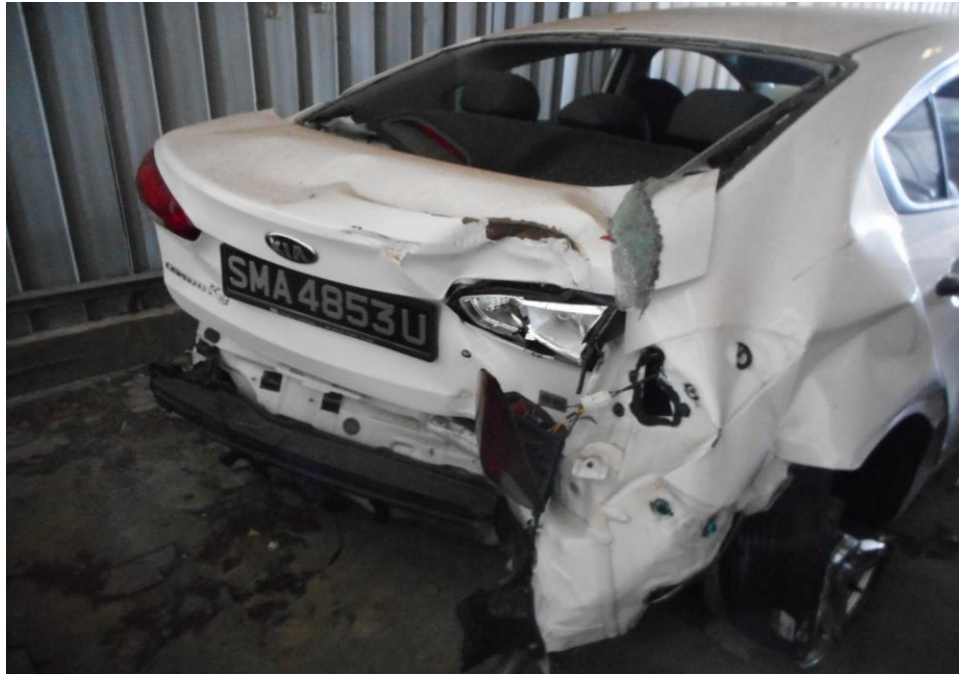
**Photo 1** shows a general view of the Motor Car's rear body at the time of my inspection. The rear portion of the Motor Car was observed to have sustained damaged as a result of the accident.

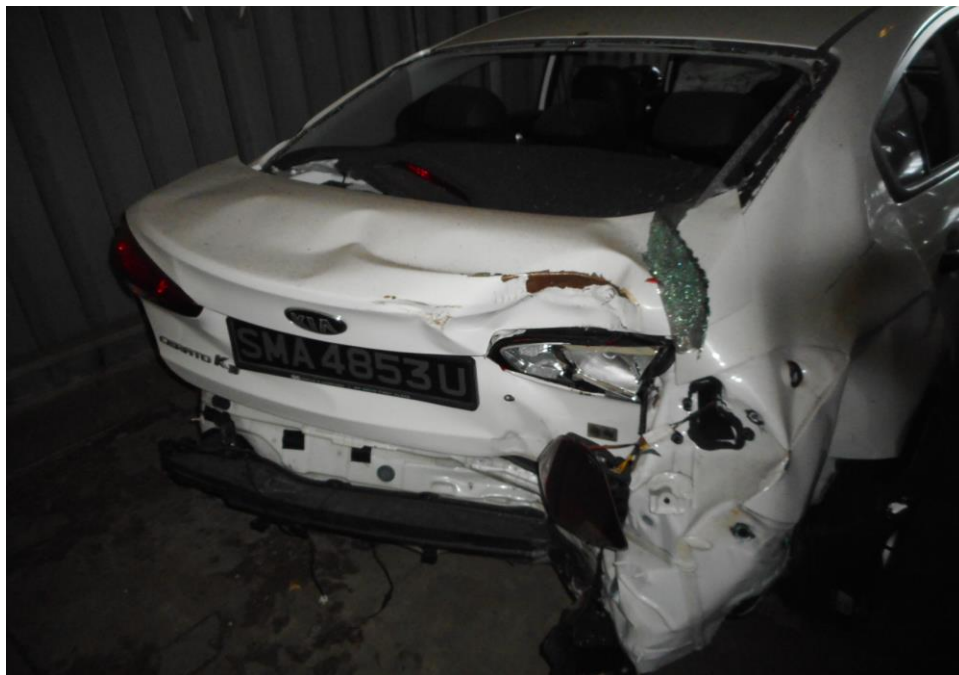
**Photo 2** shows a general view of the Motor Car's rear body at the time of my inspection. Its rear windscreen and rear bonnet (red circle), rear bumper (yellow circle) and its rear right brake lamp (arrowed) was amongst the body parts that were also damaged as a result of the accident.

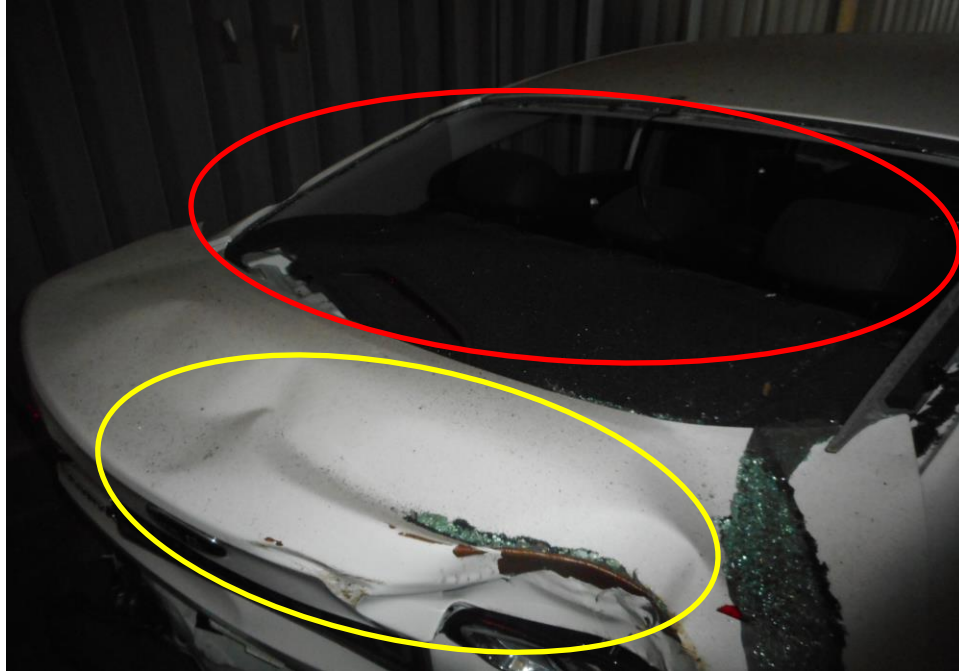
**Photo 3** shows a close up view of the Motor Car's rear body at the time of my inspection. Its rear windscreen (red circle) and rear bonnet (yellow circle) was amongst the body parts that were also damaged as a result of the accident.

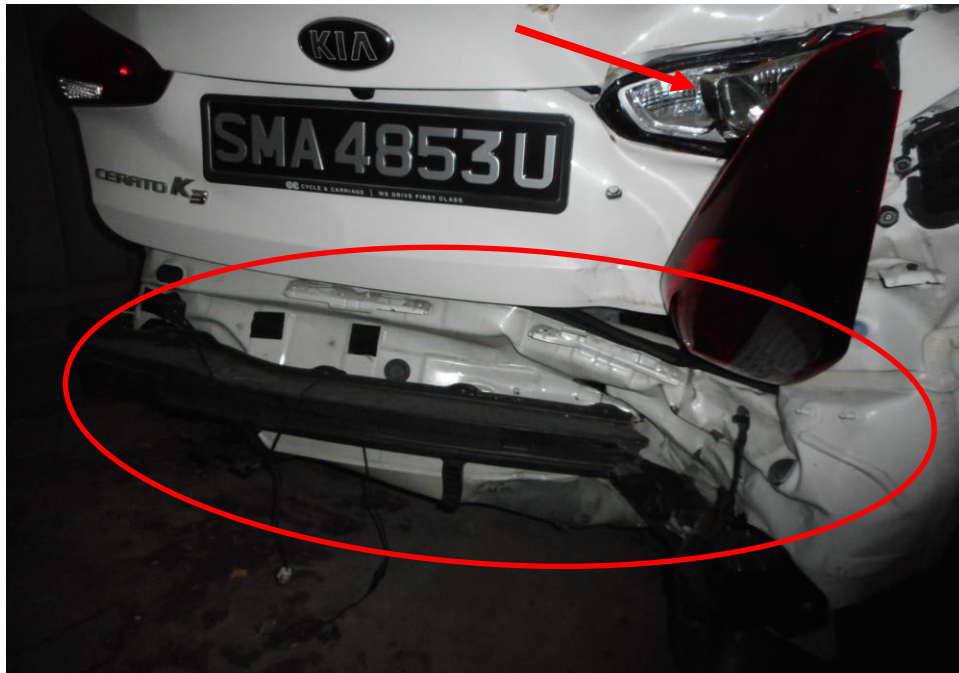
**Photo 4** shows a close up view of the Motor Car's rear body at the time of my inspection. Its rear bumper (circled) and its rear right brake lamp (arrowed) was amongst the body parts that were also damaged as a result of the accident.

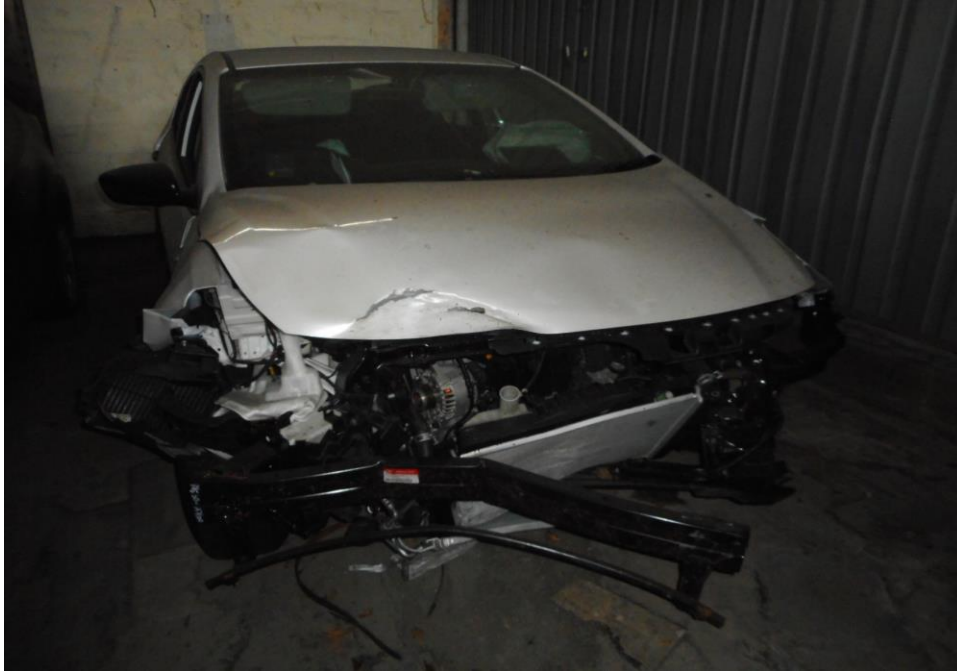
**Photo 5** shows a general view of the Motor Car's front body at the time of my inspection. Its front bonnet and front bumper was amongst the body parts and various components in the engine compartments were also damaged as a result of the accident. The Supplemental Restraint System (SRS) was activated as a result of the accident.

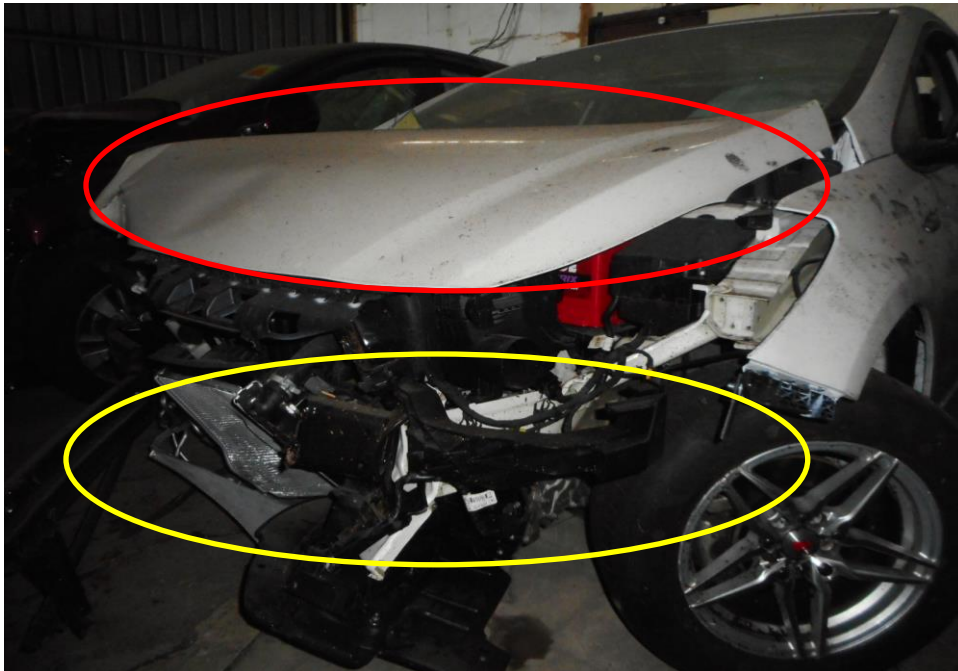
**Photo 6** shows the close up view of the Motor Car's front body at the time of my inspection. Its front bonnet (red circle) and front bumper (yellow circle) was amongst the body parts and various components in the engine compartments were also damaged as a result of the accident.

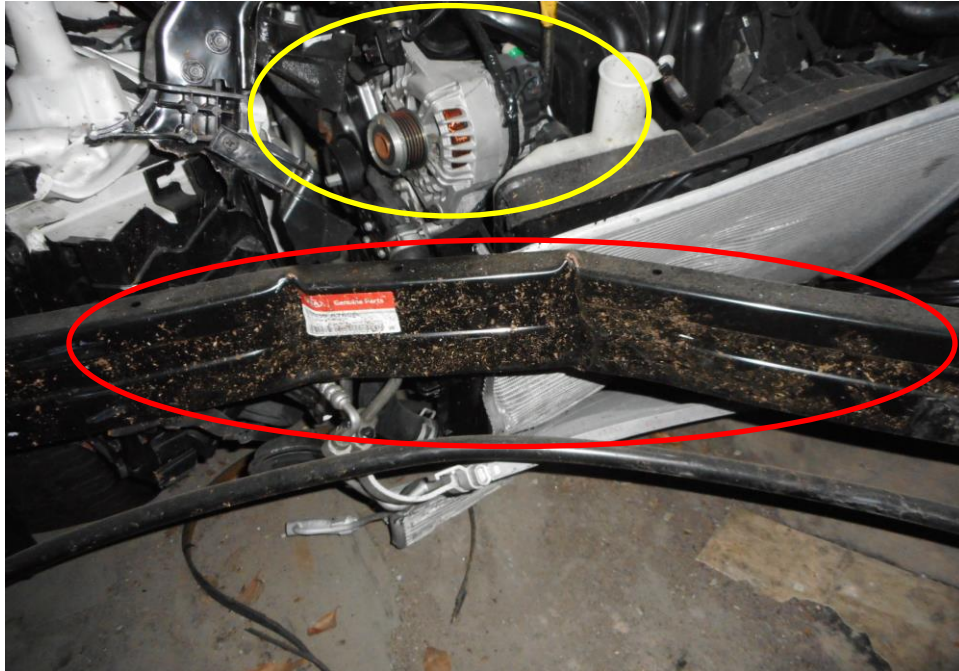
**Photo 7** shows the close up view of the Motor Car's front body at the time of my inspection. The Motor car was observed to have sustained damage at its front portion. Its alternator (yellow circle) and body reinforcement panel (red circle) was amongst the various components in the engine compartments were also damaged as a result of the accident.

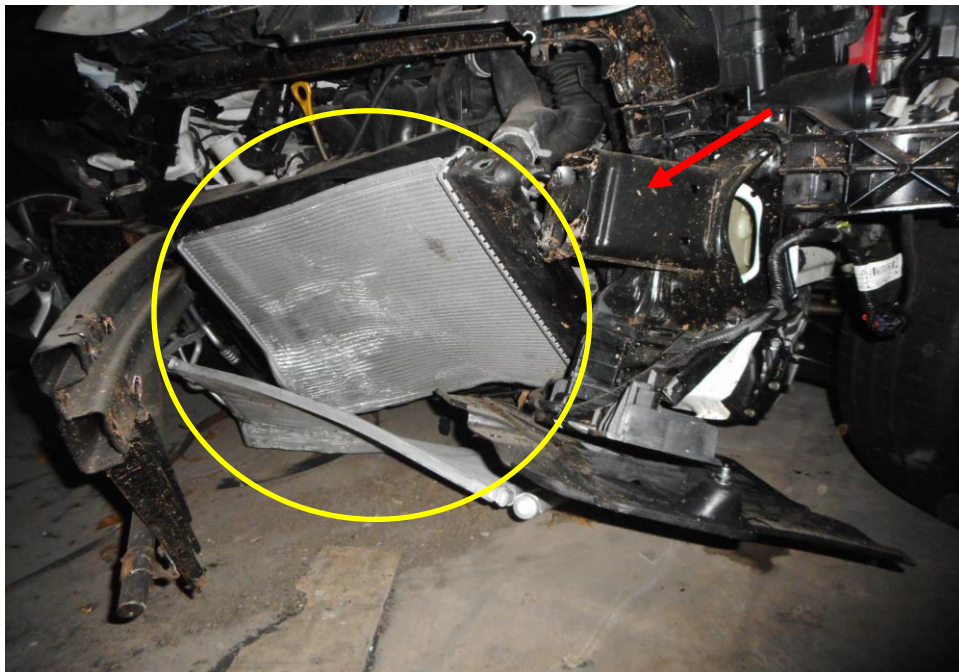
**Photo 8** shows the close up view of the Motor Car's front body at the time of my inspection. The Motor car was observed to have sustained damage at its front portion. Its engine radiator (circled) and air filter box (red arrow) was amongst the various components in the engine compartments were also damaged as a result of the accident.

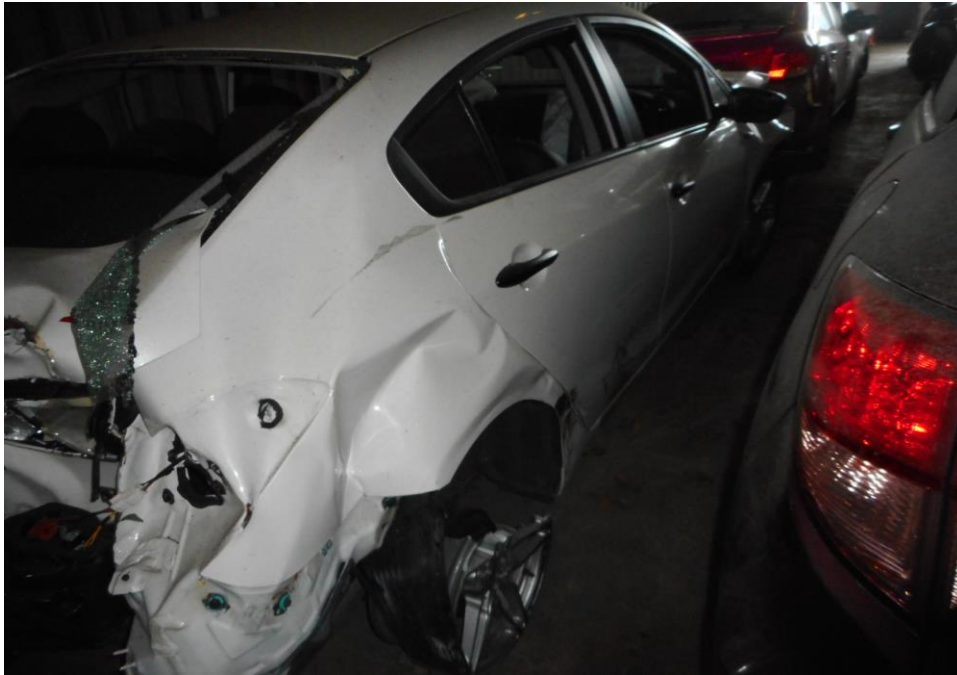
**Photo 9** shows the general view of the Motor Car's right body at the time of my inspection. The Motor car was observed to have sustained damage at its right portion. Its right body panel was damaged as a result of the accident.

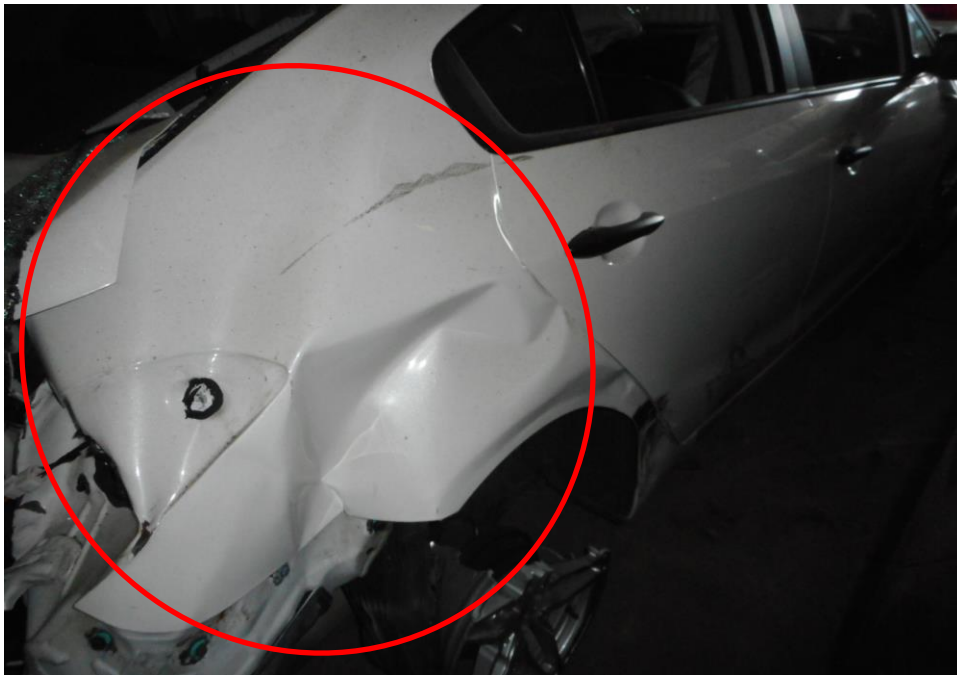
**Photo 10** shows the close up view of the Motor Car's right body at the time of my inspection. The Motor car was observed to have sustained damage at its right portion. Its right body panel (circled) was damaged as a result of the accident.

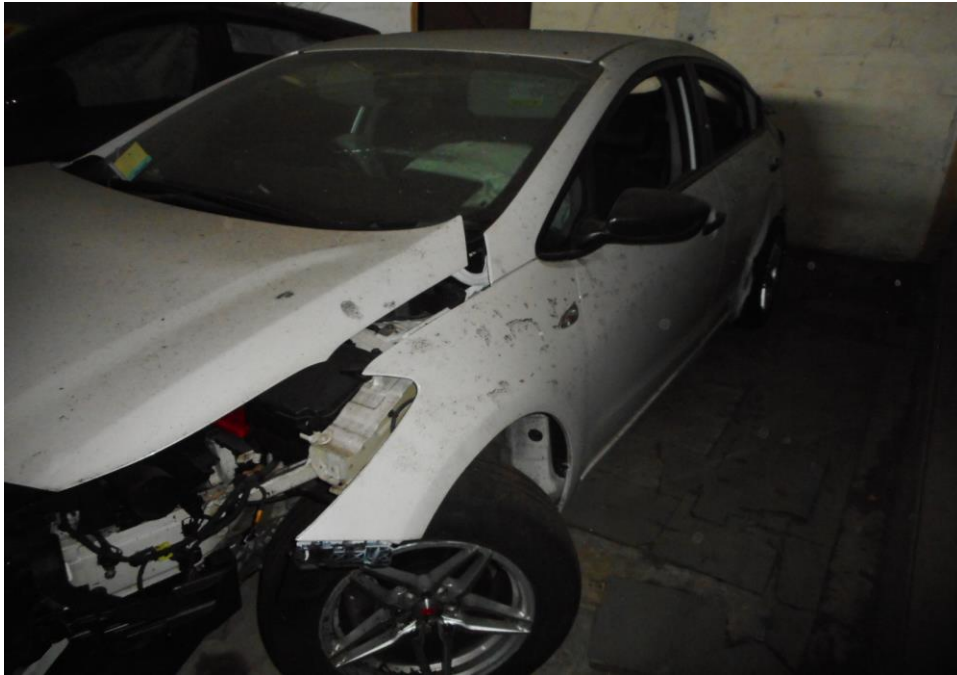
**Photo 11** shows the general view of the Motor Car's left body at the time of my inspection. The Motor car was observed to have sustained damage at its left portion. Its left body panel was damaged as a result of the accident.

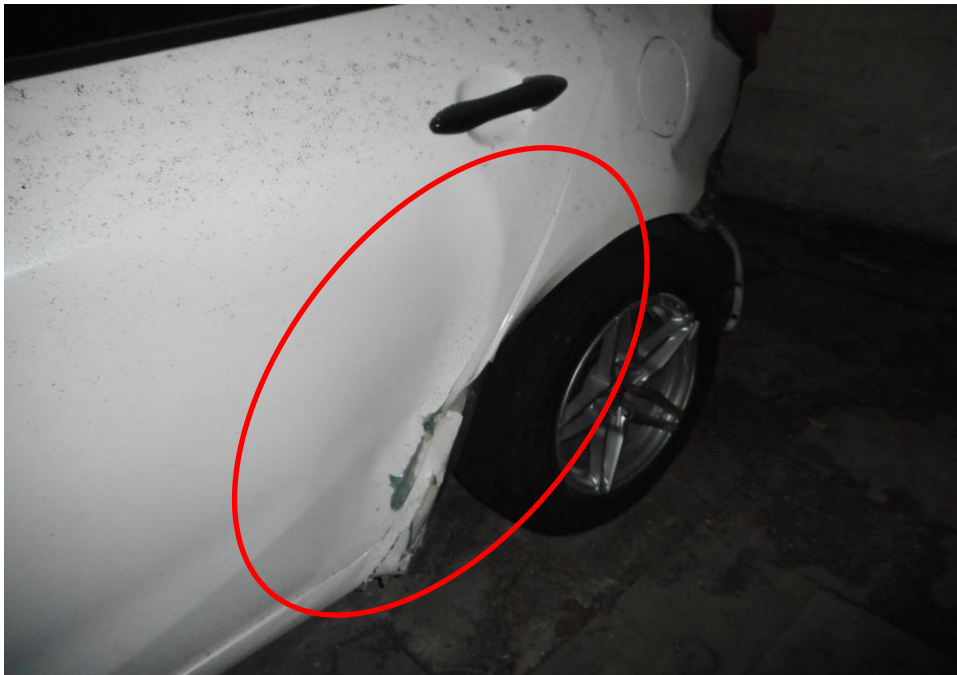
**Photo 12** shows the close up view of the Motor Car's left body at the time of my inspection. The Motor car was observed to have sustained damage at its left portion. Its left body panel (circled) was damaged as a result of the accident.

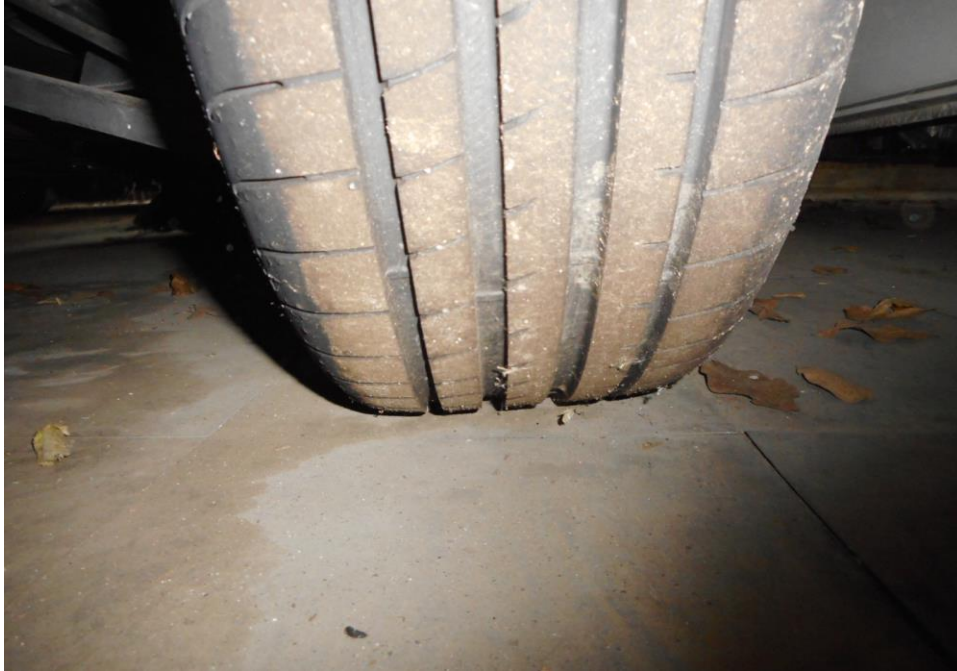
**Photo 13** shows the condition of the front right tyre of the Motor Car, which was observed to be in serviceable condition with remaining tread depth of approximately 5.1mm. The tyre was also observed to be sufficiently inflated for vehicular operation with no tear, cut or burst mark(s).

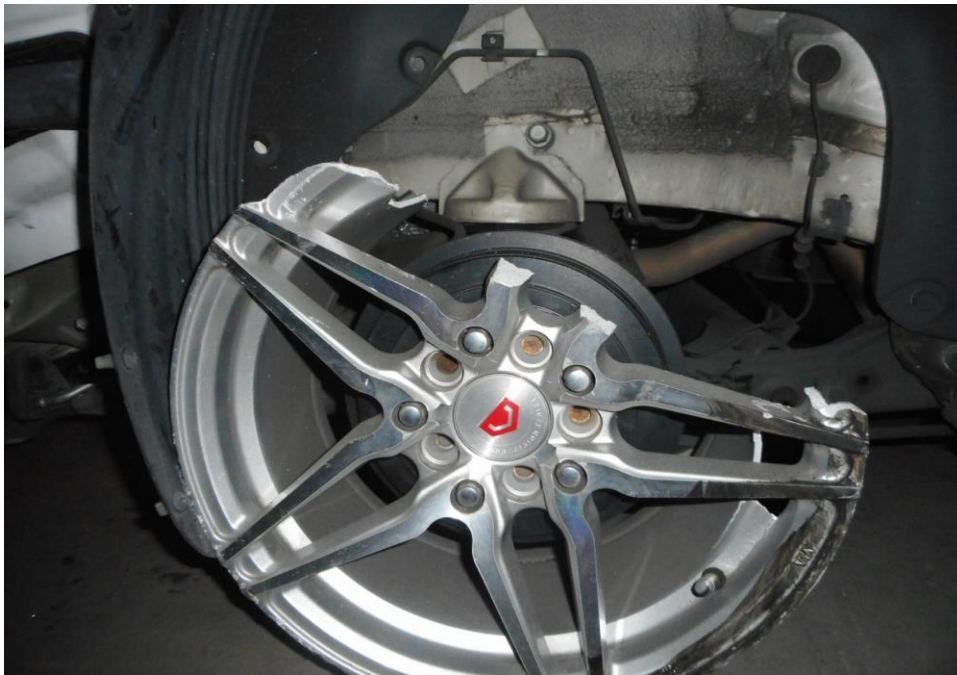
7. The rear right wheel rim was observed to be broken off as a result of the accident. However, the other 3 tyres were observed to be wrapped around alloy wheel rims that were found to be without any damage. See photo 1 – 17 below.

**Photo 14** shows the condition of the rear right tyre and rim of the Motor Car, the wheel rim was observed to be broken off as a result of the accident

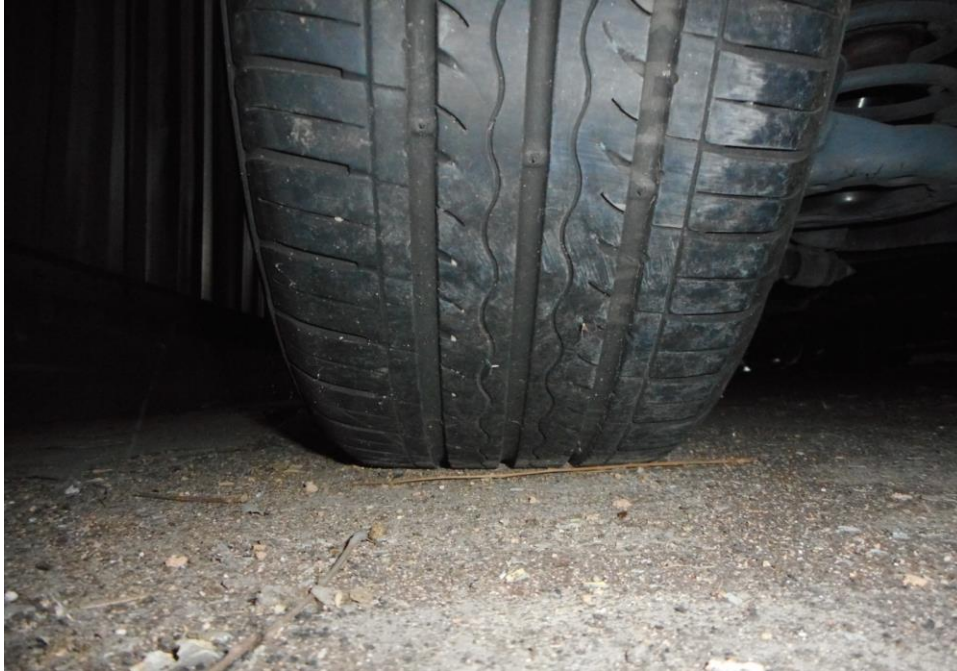
**Photo 15** shows the condition of the rear left tyre of the Motor Car, which was observed to be in serviceable condition with remaining tread depth of approximately 4.6mm. The tyre was also observed to be sufficiently inflated for vehicular operation with no tear, cut or burst mark(s).

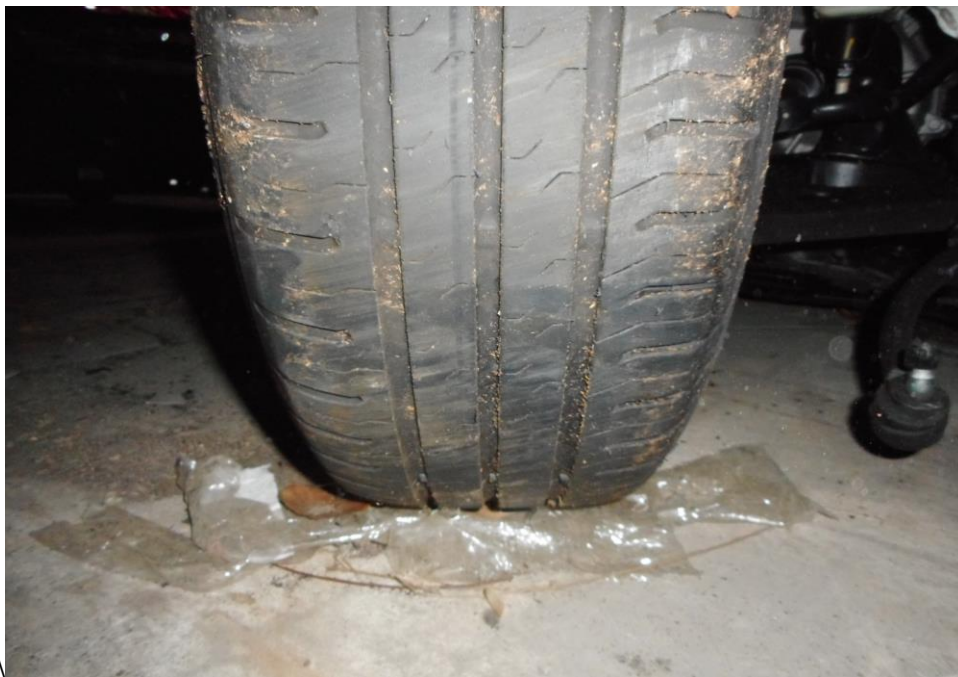
**Photo 16** shows the condition of the front left tyre of the Motor Car, which was observed to be in serviceable condition with remaining tread depth of approximately 4.7mm. The tyre was also observed to be sufficiently inflated for vehicular operation with no tear, cut or burst mark(s).

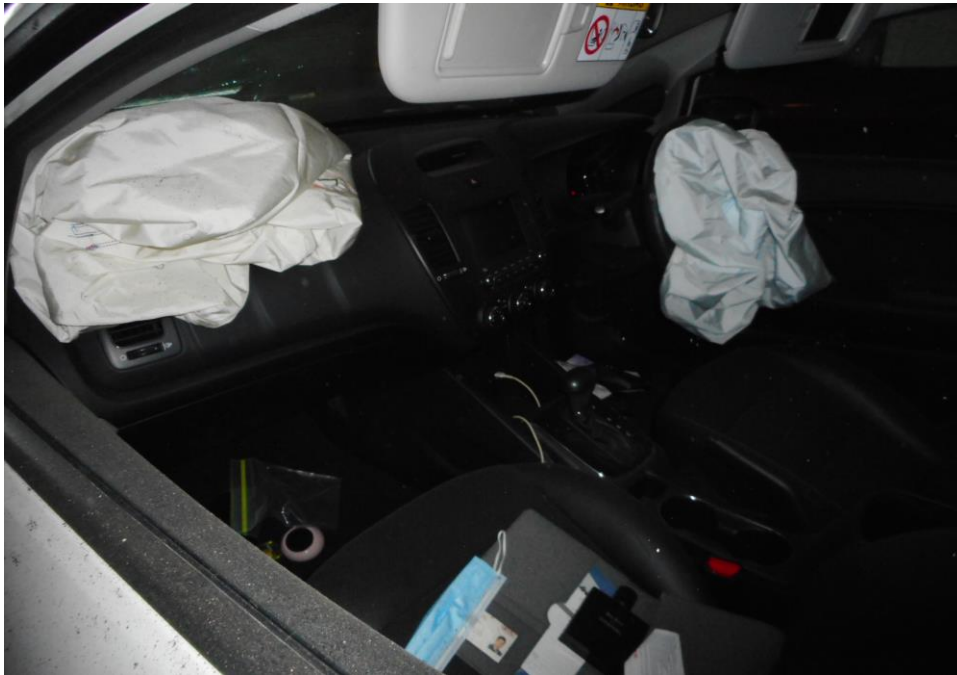
**Photo 17** shows the deployment of the Supplemental Restraint System (SRS) airbag in the Motor Car as a result of the accident.

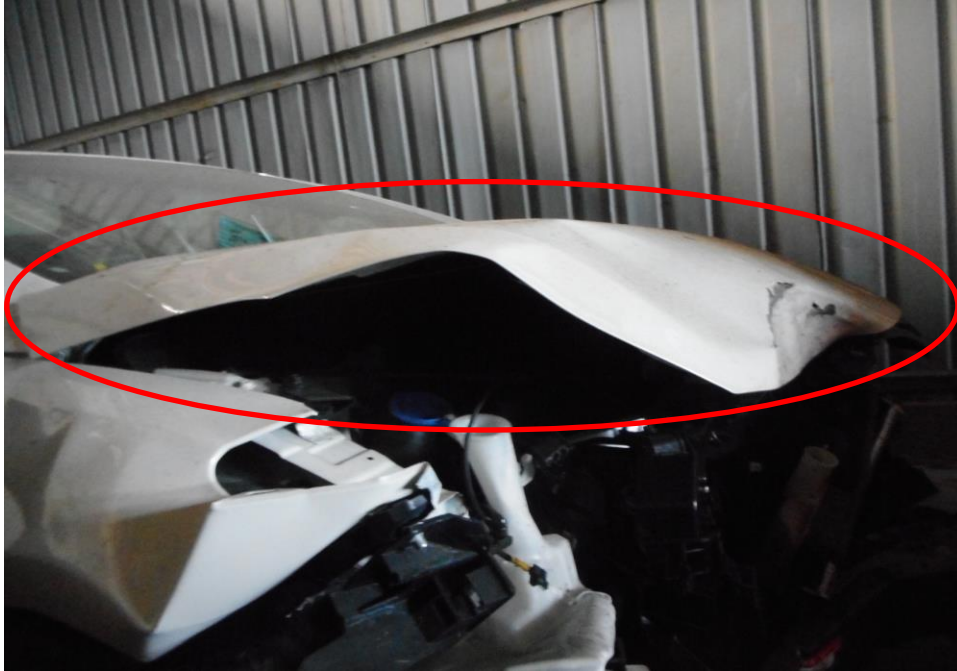
8. We were unable to raise the front bonnet of the Motor Car to conduct the examination of the Motor Car's engine compartment because the damage caused by the accident had resulted in the damages to the lock mechanism of the bonnet and the structure of the engine compartment. (unable to open)  
See photo 18 below

**Photo 18** shows a close up view of the damaged front bonnet lock mechanism and the structure of the engine compartment of the Motor Car at the time of my inspection resulting it unable to open a result of the accident (circled) (Unable to open)

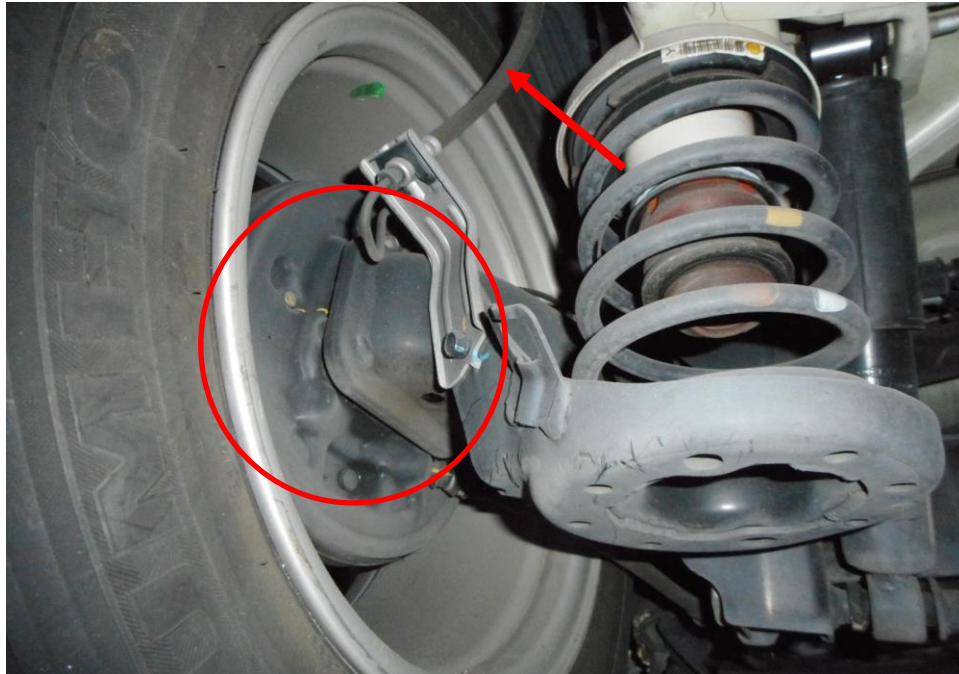
**Photo 19** shows the brake drum (circled) and brake hose/pipe (arrowed) at the rear left wheel of the Motor Car and it was observed to be intact

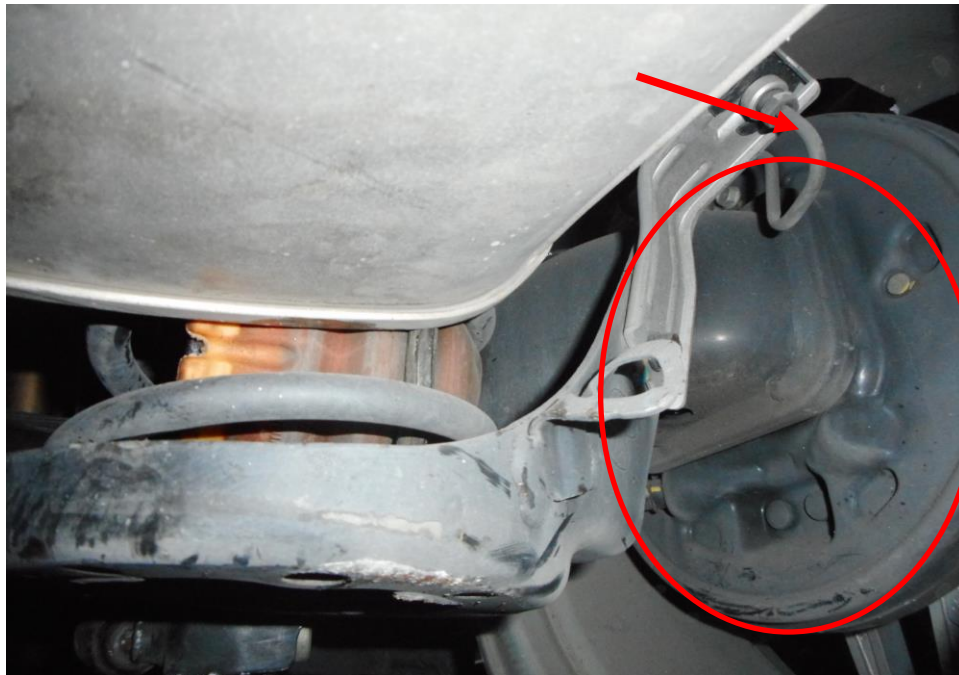
**Photo 20** shows the brake drum (circled) brake hose/pipe (arrowed) at the rear right wheel of the Motor Car and it was observed to be intact

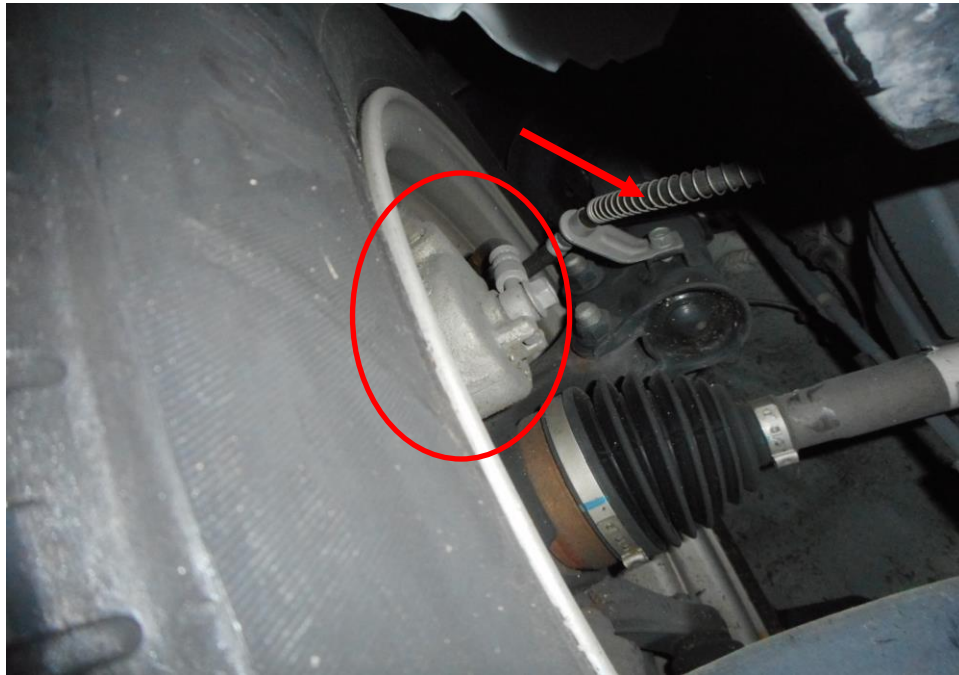
**Photo 21** shows the brake hose/pipe (arrowed) at the front right wheel of the Motor Car. No leakage of brake fluid was observed. Visual examination of the various components of the braking system like the brake caliper (circled) brake pedal etc had revealed all to be intact and without visible damage at the time of accident. There was also no sign of fluid stain(s) observed on the various undercarriage components.

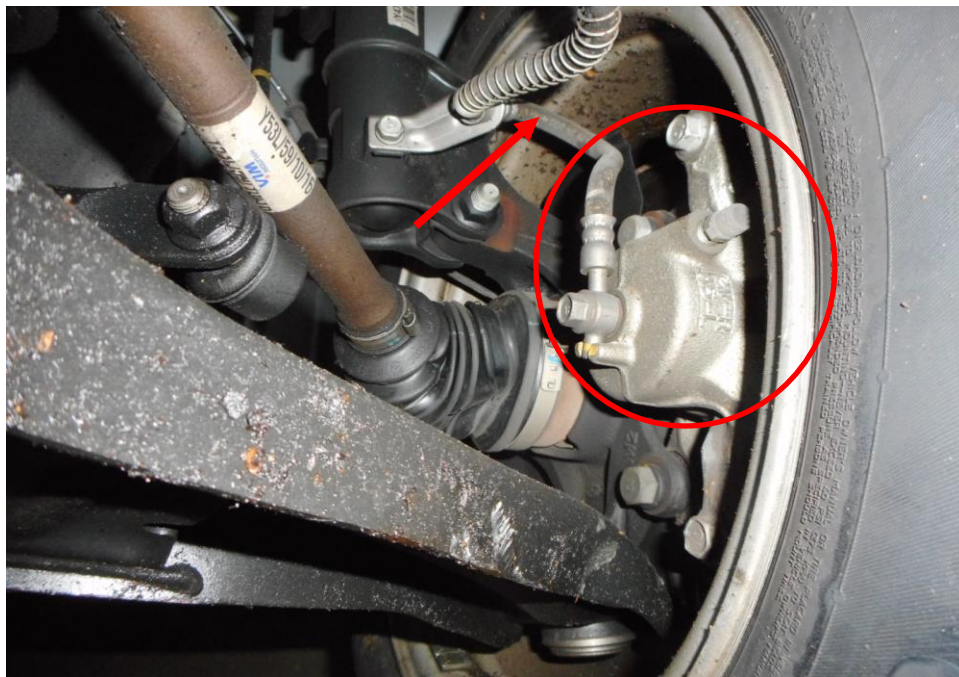
**Photo 22** shows the brake hose/pipe (arrowed) at the front left wheel of the Motor Car. No leakage of brake fluid was observed. Visual examination of the various components of the braking system like the brake caliper (circled), brake pedal etc had revealed all to be intact and without visible damage at the time of accident. There was also no sign of fluid stain(s) observed on the various undercarriage components.

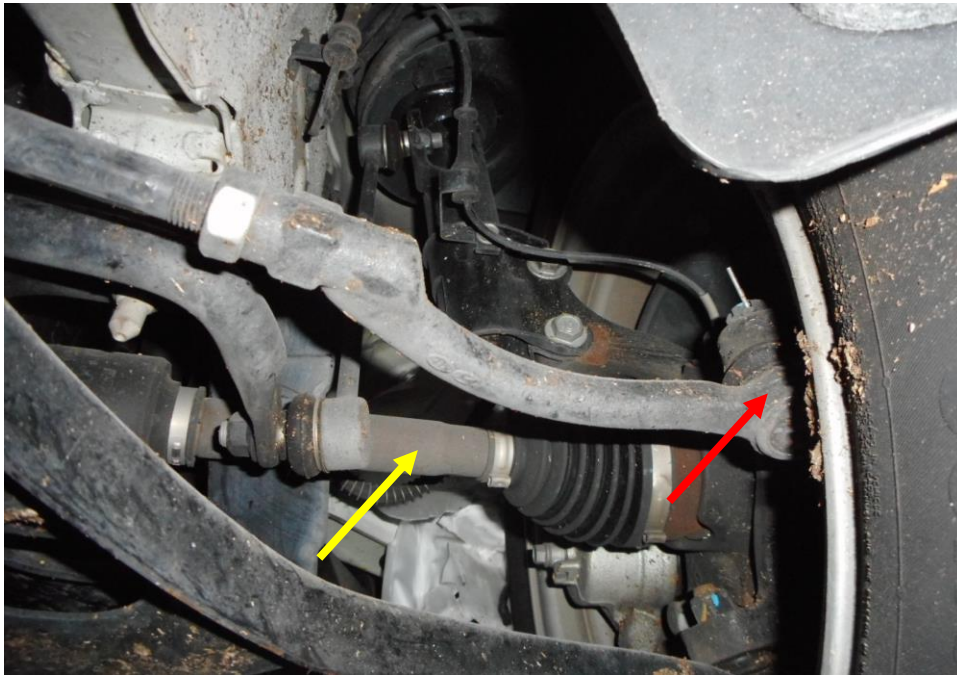
**Photo 23** shows the various undercarriage components at the front right wheel of the Motor Car, in particular the steering tie rod end (arrowed) and drive shaft (yellow arrow). The various steering components were all found to be intact, there was no sign of fluid stain(s) observed on the various undercarriage components.

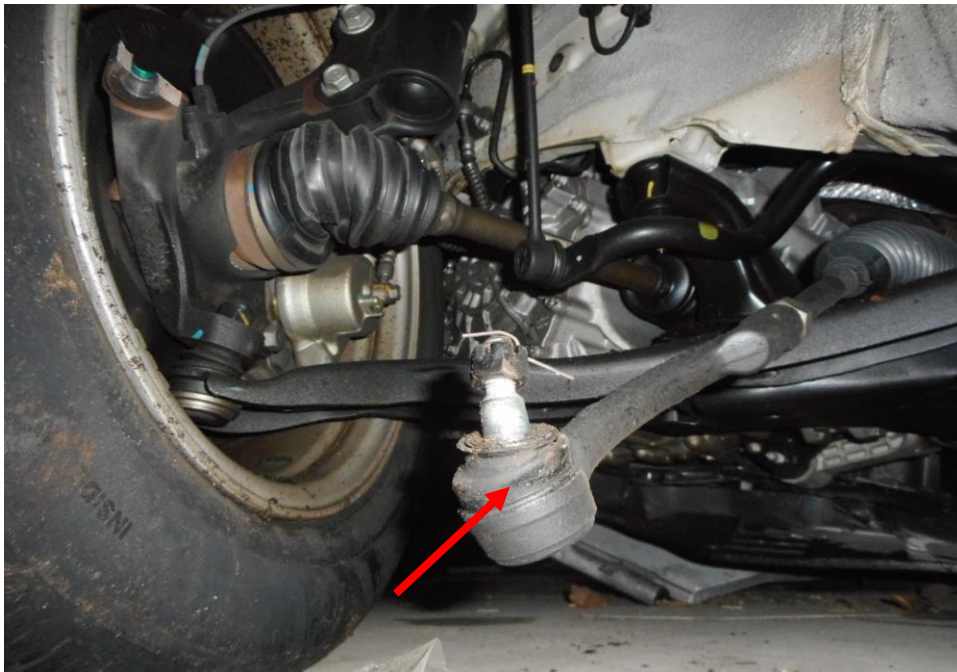
**Photo 24** shows the various undercarriage components at the front left wheel of the Motor Car, in particular the steering tie rod end (arrow) was observed to be damaged as a result of the accident.

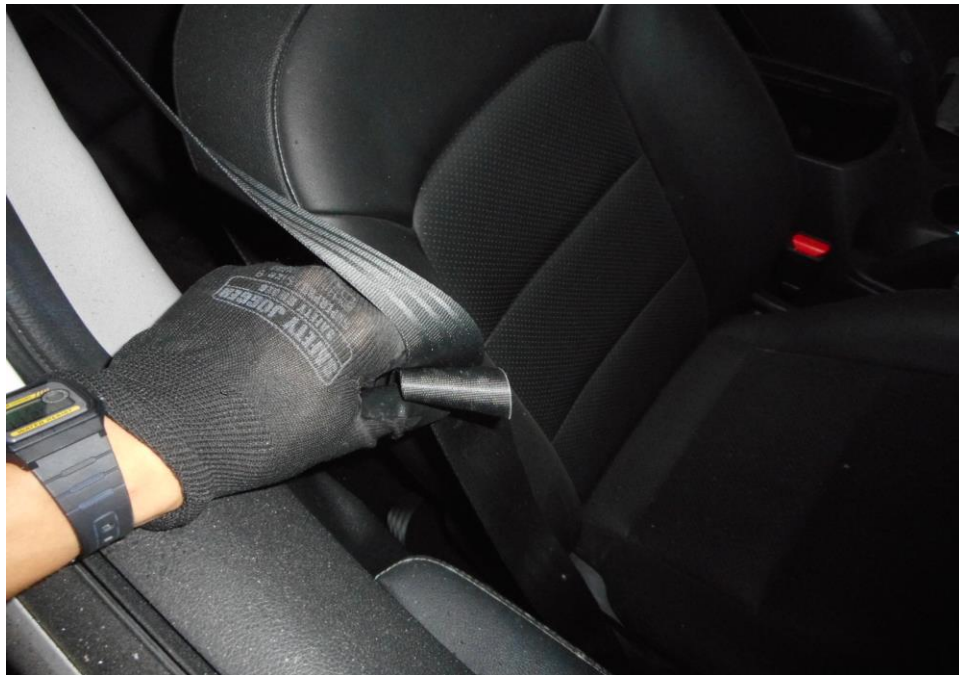
**Photo 25** shows that that the seat belt on the right seat was worn at the material time of accident as the safety pre-tensioners was activated at the moment of impact and caused the seat belt to be locked into the last position.

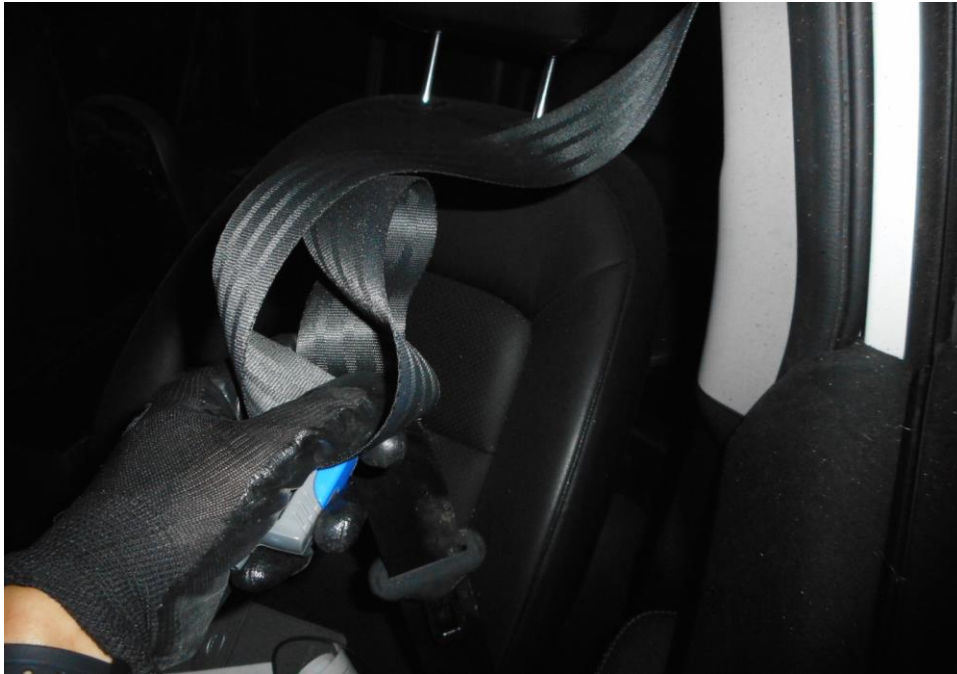
**Photo 26** shows that that the seat belt on the left seat was worn at the material time of accident as the safety pre-tensioners was activated at the moment of impact and caused the seat belt to be locked into the last position.
