VEHICLE DAMAGE INSPECTION REPORT

Our Ref: 229/TP/2020

Reg No:	SJU4330S	Make &	Honda
Reg date:	8/12/2009	Model	Stream 1.8X A
Colour:	Silver	Engine No:	R18A1770162
Type:	Motor Car	Chassis No:	RN61062995
Type of Claims:	Third Party	Odometer No:	145291km
		Engine Cap:	1799cc

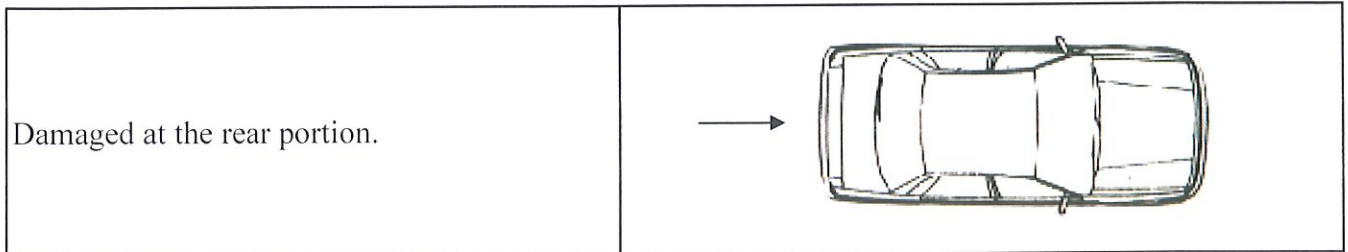
POINT OF IMPACT

Our visual inspection of the vehicle revealed that the damages noted are at the rear portion.
