LKK Auto Consultants Pte Ltd

Affiliated to Federation Internationale Des Experts En Automobile			
CHINA TAIPING INSURANCE (S) PTE LTD 3 ANSON ROAD #16-00 SPRINGLEAF TOWERSINGAPORE 079909		Ref: CC6/CTI21000435/Ars3q2 Date: 29/03/2021 Code: CTI

ADJUSTMENT ON REPAIR COST FOR VEHICLE NO. SLT 269U

PHOTOGRAPHS FOR VEHICLE NO. SLT 269U

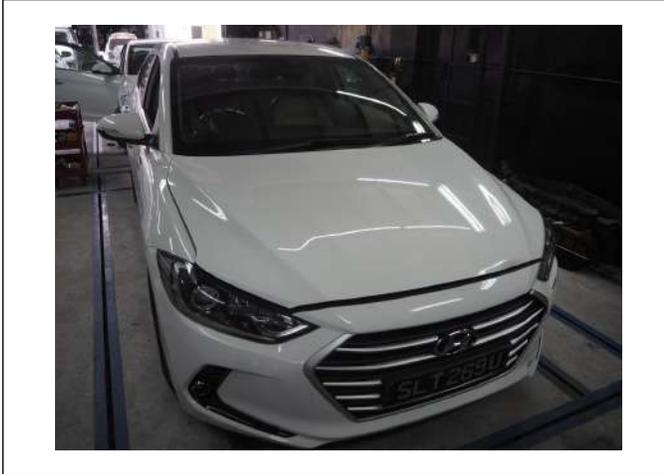
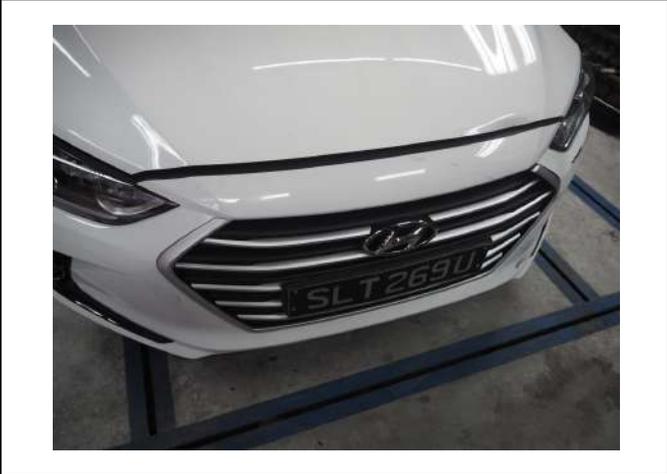
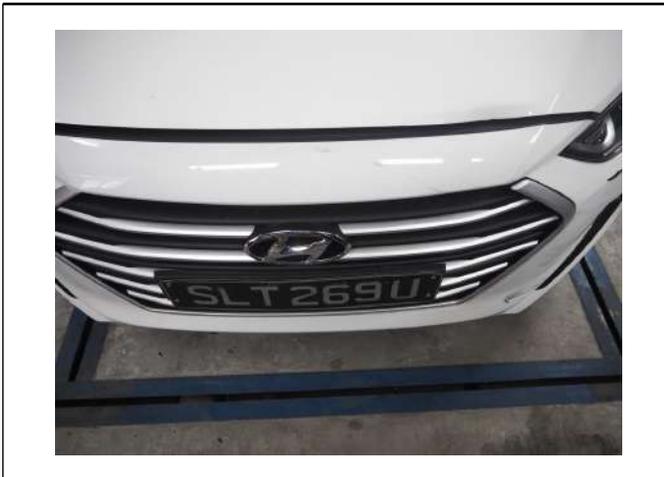
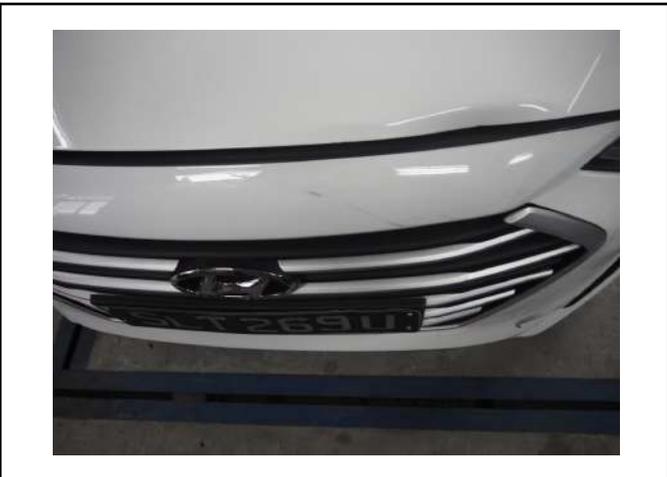
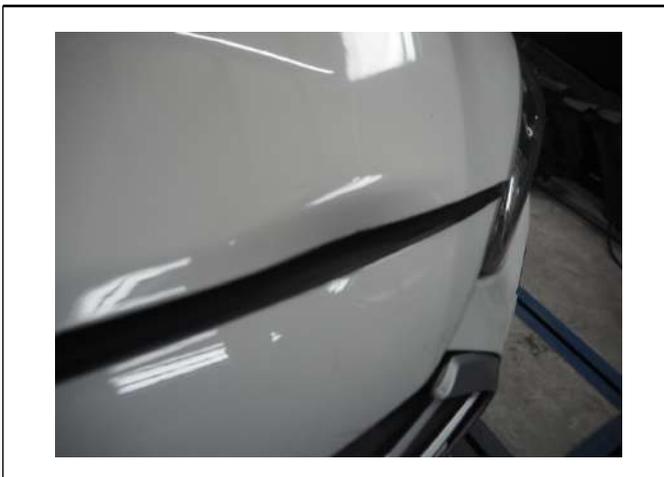
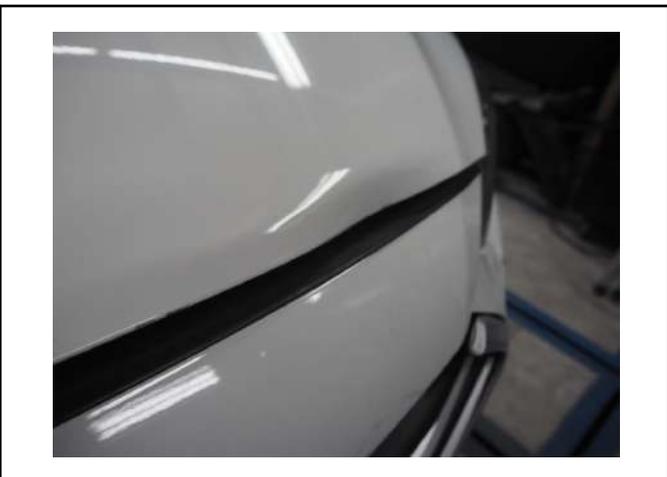
4. Description of Damages			
THE VEHICLE SUSTAINED DAMAGES AT THE FRONT PORTION. DAMAGES SEE DETAILS.			
5. General Information			
Accident Date	27/12/2020	Inspection Date	12/01/2021
Survey held at	CAS GARAGE PTE LTD NO. 1 KAKI BUKIT AVE 6, #02-22 AUTOBAY 417883 KAKI BUKIT		
5a. Remarks			
A)THE INSPECTION WAS CONDUCTED ON A"WITHOUT PREJUDICE" BASIS. B)IN ACCORDANCE TO YOUR INSTRUCTIONS, WE HAVE NOT AUTHORISED REPAIRS.			
5b. Estimate Days of Repair			
ESTIMATED NORMAL PERIOD FOR REPAIR:		6 Working Days
