Your Ref: TP/IP/31607/2020  
Our Ref : CI/TPD21000461/N

6 January 2021

**Fatal Accident Investigation Team**

**INSPECTION REPORT OF MOTORCYCLE FBK 9212P**

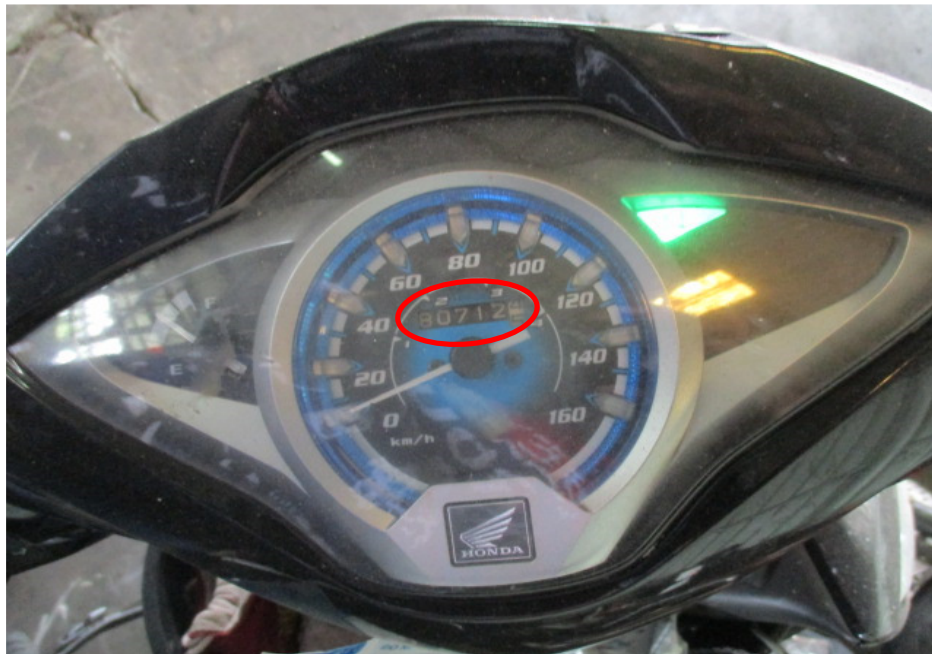
**Photo 1** shows the speedometer gauge of the Motorcycle. The mileage of the Motorcycle at the time of our inspection was 80, 712km (circled).

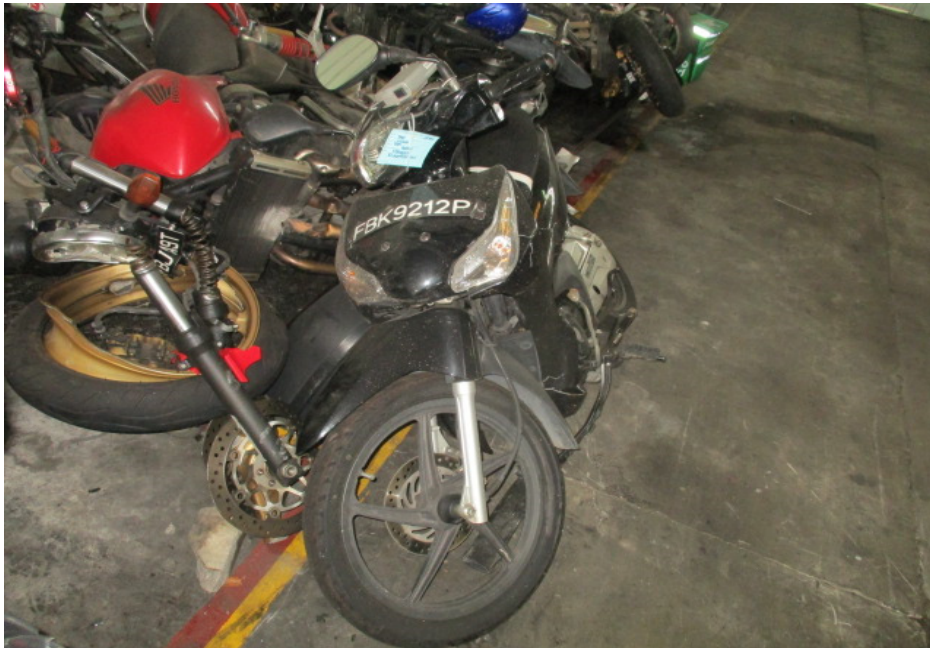
**Photo 2** shows a general view of the frontal portion of the Motorcycle at the time of our inspection. The Motorcycle was observed to have sustained damages all around.

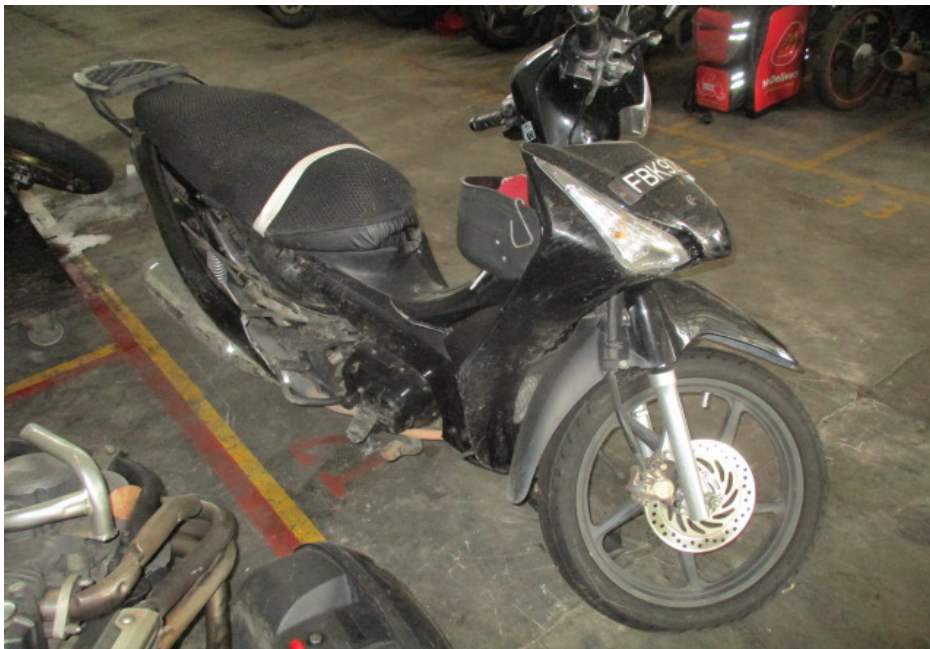
4. The mileage of the Motorcycle at the time of our inspection was 80, 712km.
5. The Motorcycle was observed to have sustained damages all around. The body parts that were found to have been damaged include its headlight assembly, front mudguard, front cowlings, side cowlings, right side mirror, right handlebar end, front brake lever, rear brake pedal, right front footrest, kickstarter pedal, exhaust muffler, exhaust muffler heat shield, right rear side cover and top box rack, amongst others.

**Photo 3** shows a general view of the right body of the Motorcycle at the time of our inspection. The Motorcycle was observed to have sustained damages all around. The body parts that were found to have been damaged include its headlight assembly, front mudguard, front cowling, side cowlings, right side mirror, right handlebar end, front brake lever, rear brake pedal, right front footrest, kickstarter pedal, exhaust muffler, exhaust muffler heat shield, right rear side cover and top box rack, amongst others.

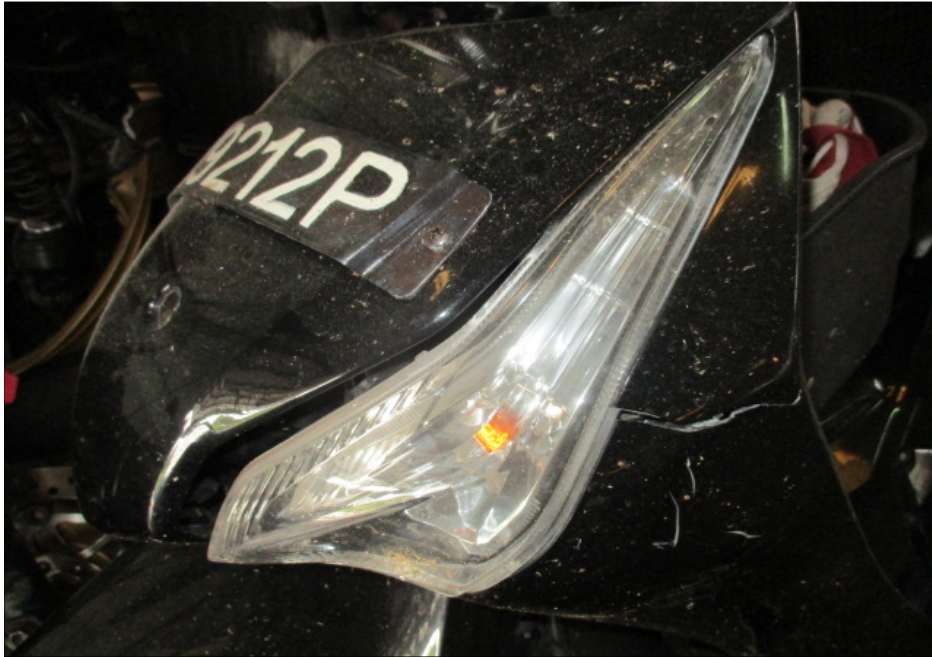
**Photo 4** shows a close up view of the headlight assembly which was amongst the body parts at the front of the Motorcycle that had sustained damage as a result of the accident.

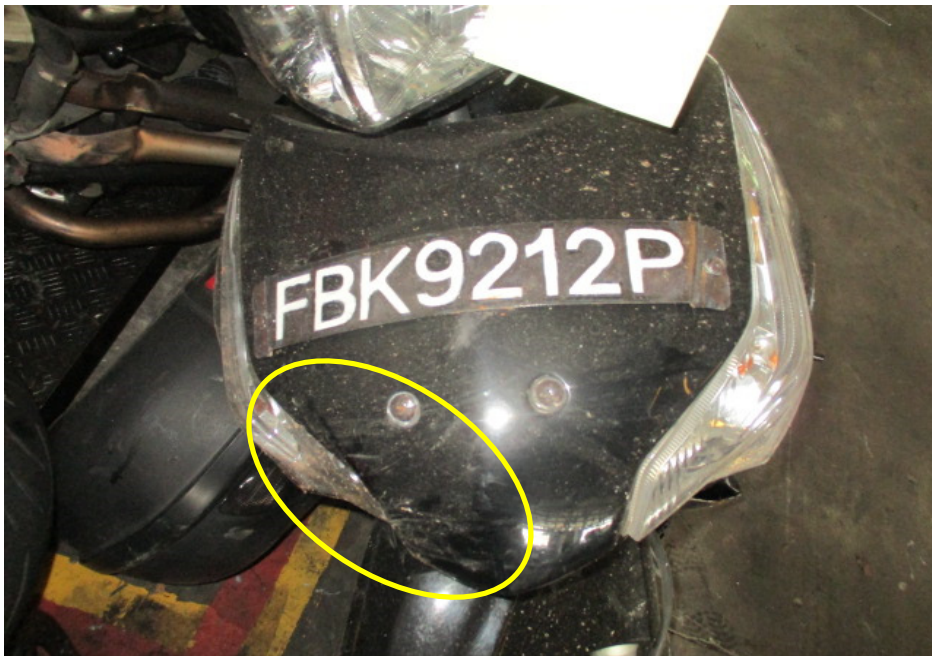
**Photo 5** shows a closer view of the front cowling (circled) which was amongst the body parts of the Motorcycle that had sustained damage as a result of the accident.

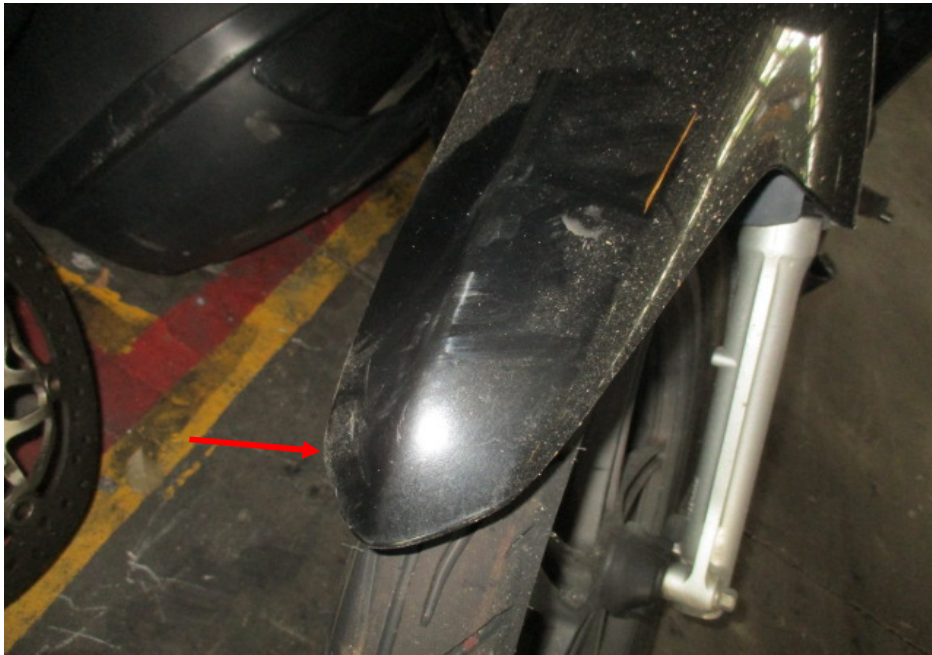
**Photo 6** shows a closer view of the front mudguard (arrowed) which was amongst the body parts of the Motorcycle that had sustained damage as a result of the accident.

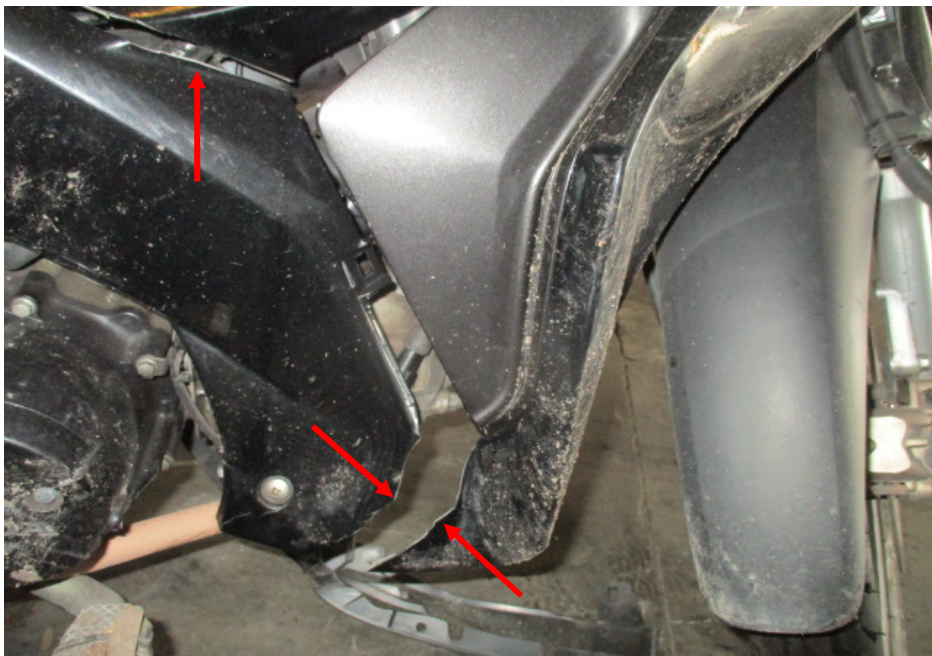
**Photo 7** shows the right cowling (arrowed), which were amongst the body parts of the Motorcycle that had sustained damage as a result of the accident.

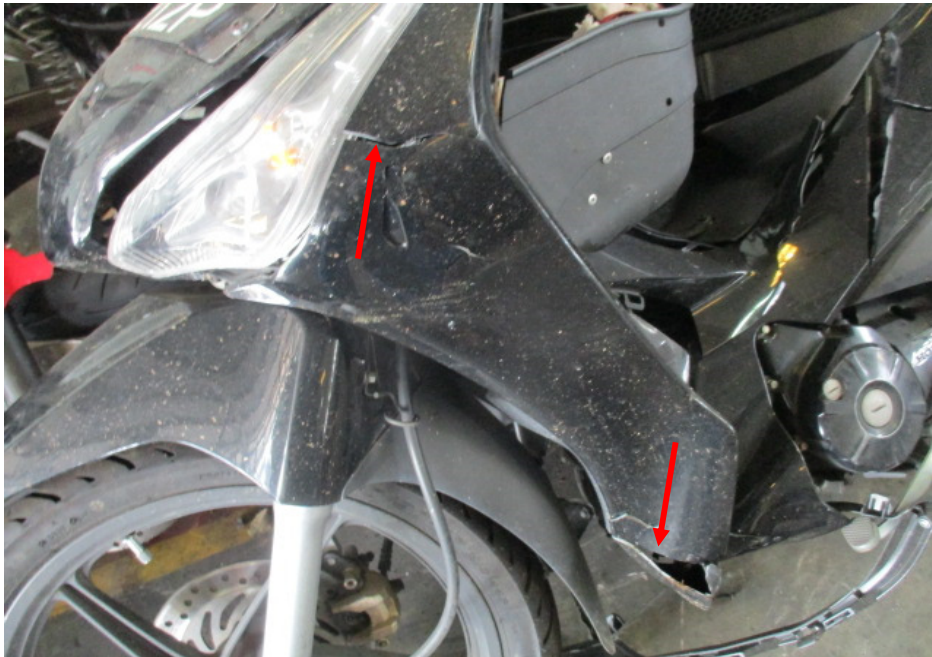
**Photo 8** shows the left cowling (arrowed), which were amongst the body parts of the Motorcycle that had sustained damage as a result of the accident.

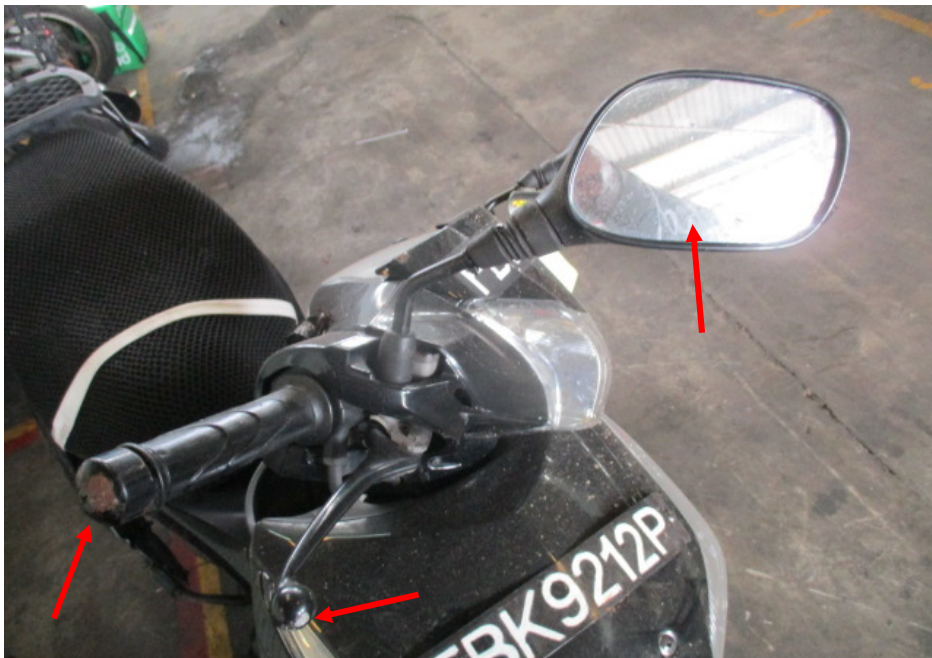
**Photo 9** shows the right handlebar end, right side mirror and front brake lever (arrowed), which were amongst the body parts of the Motorcycle that had sustained damage as a result of the accident.

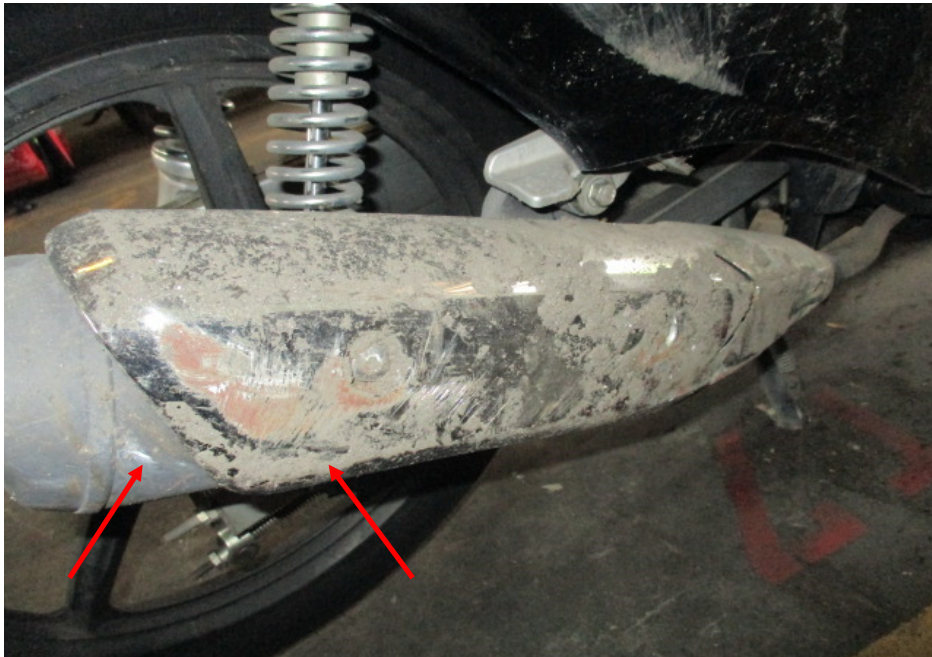
**Photo 10** shows a closer view of the exhaust muffler and exhaust muffler heat shield which was amongst the body parts of the Motorcycle that had sustained damages of grazing nature as a result of the accident (arrowed).

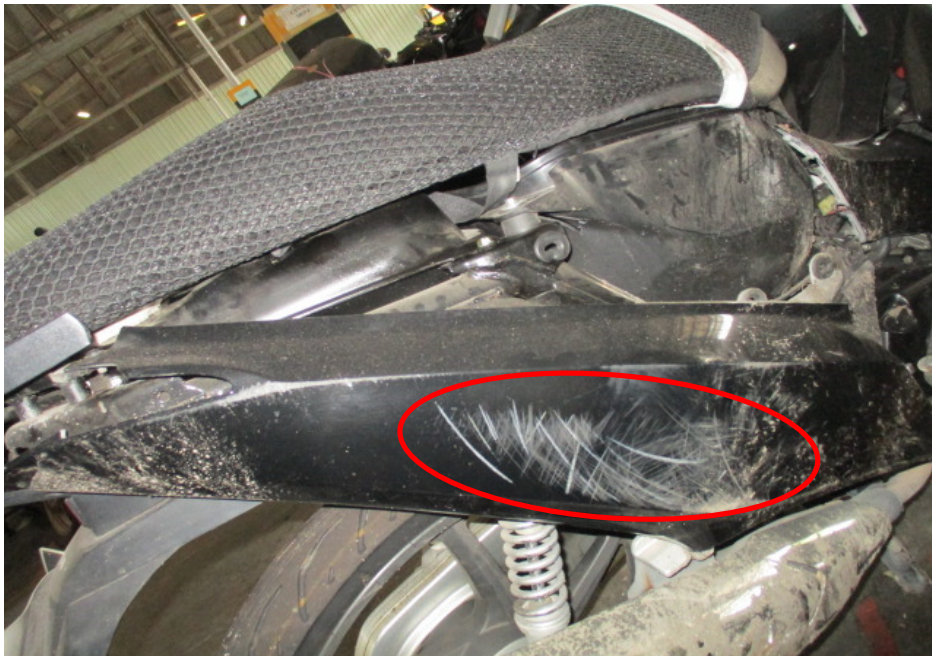
**Photo 11** shows a closer view of the right rear side cover which was amongst the body parts of the Motorcycle that had sustained damages of grazing nature as a result of the accident (circled).

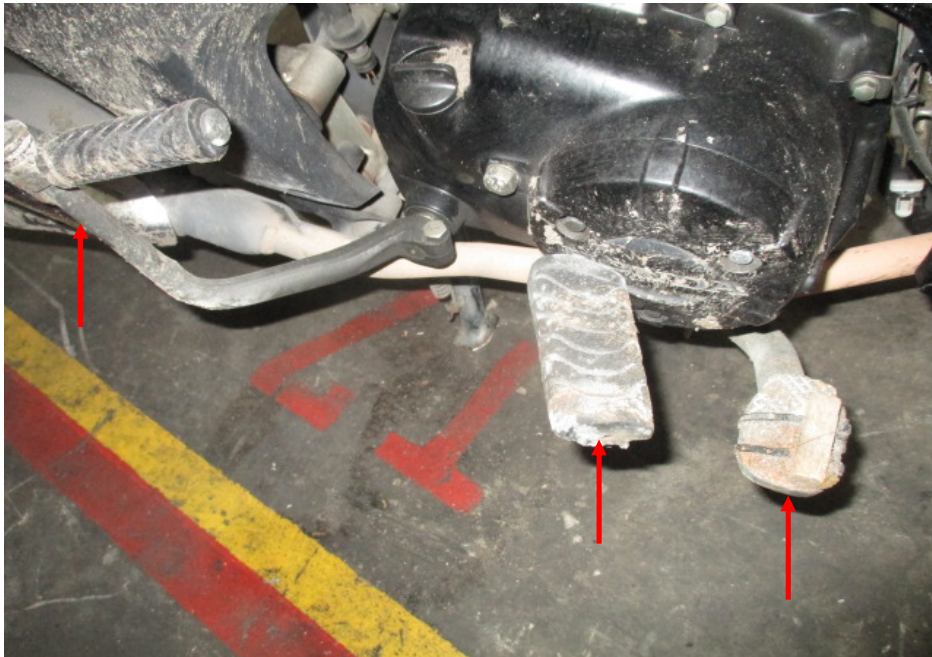
**Photo 12** shows the bent rear brake pedal, kickstarter pedal and right front footrest of the Motorcycle as a result of the accident (arrowed).

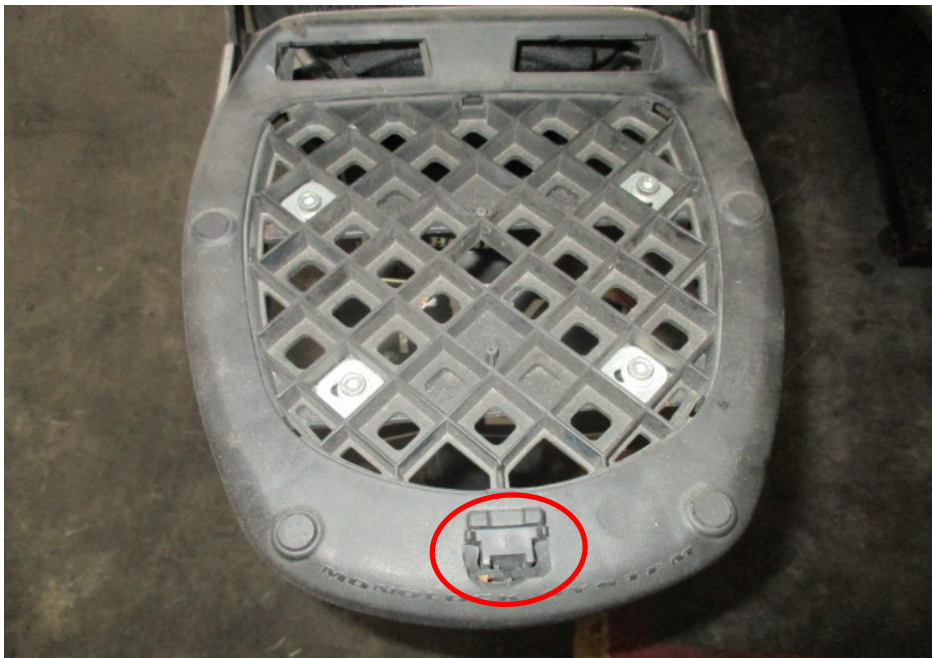
**Photo 13** shows the top box rack of the Motorcycle that had sustained damage as a result of the accident (circled).

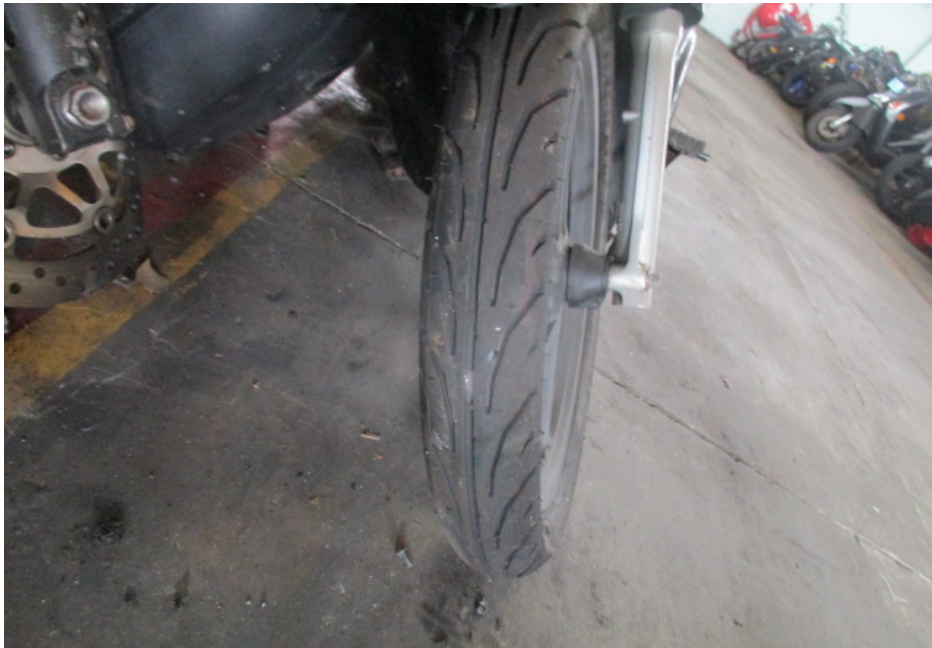
**Photo 14** shows the front tyre of the Motorcycle at the time of our inspection. The front tyre was observed to be in serviceable condition with remaining tread depth of approximately 3mm. The pattern of the tread was also clearly visible. There was no tear, burst mark(s) and/or punctured hole(s) on the sidewalls as well as across the tread of the front tyre.

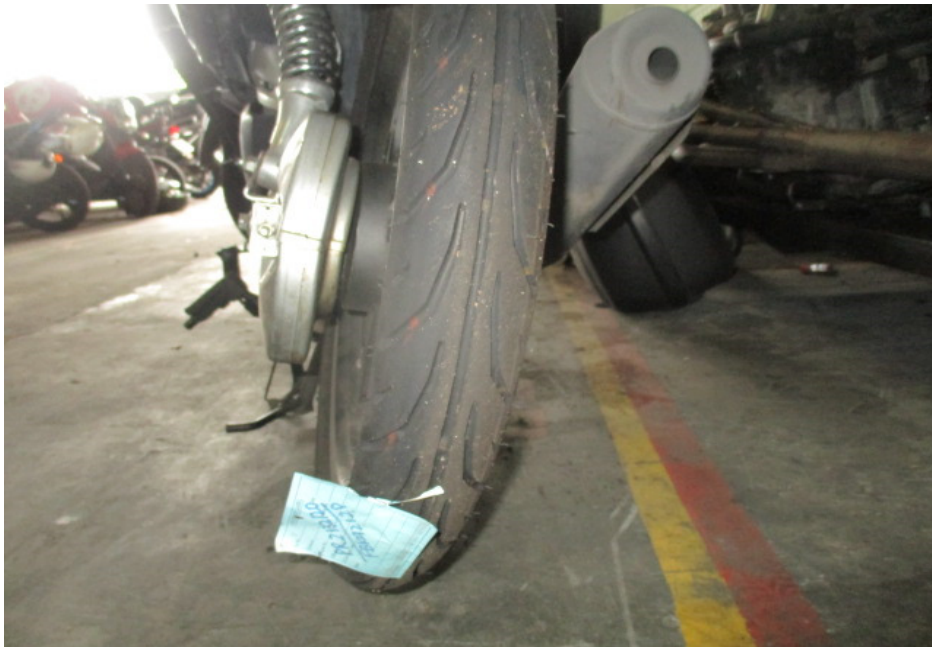
**Photo 15** shows the condition of the Motorcycle's rear tyre. The rear tyre was observed to be in serviceable condition with remaining tread depth of approximately 4mm. The tyre was also observed to be sufficiently inflated for vehicular operation. We did not observe any tear, burst mark(s) and/or punctured hole(s) on the sidewalls as well as across the tread of the rear tyre.

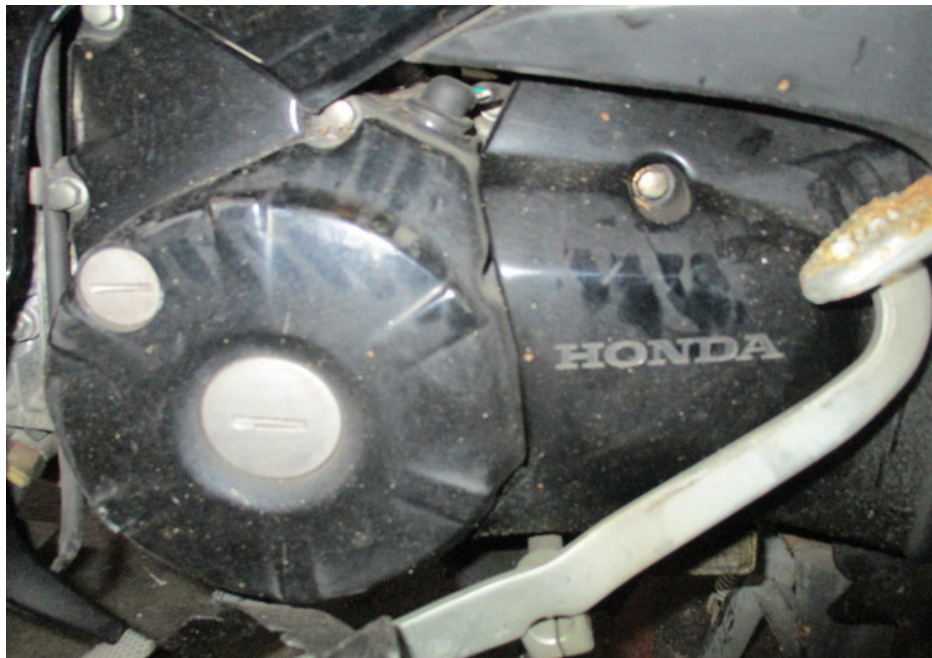
**Photo 16** shows the left side of the engine of the Motorcycle at the time of our inspection. The various engine related parts and components were found to be intact with no visible damage. There was also no sign(s) or indication(s) of fluid leak observed around the left engine area of the Motorcycle.

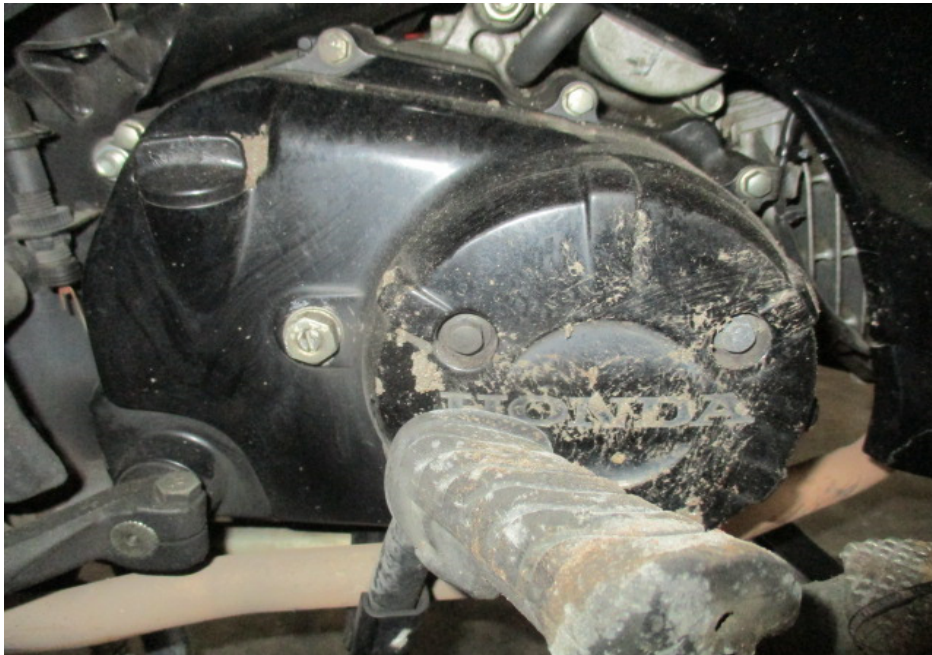
**Photo 17** shows the right side of the engine of the Motorcycle at the time of our inspection. The various engine related parts and components were found to be intact with no visible damage. There was also no sign(s) or indication(s) of fluid leak observed around the right engine area of the Motorcycle.

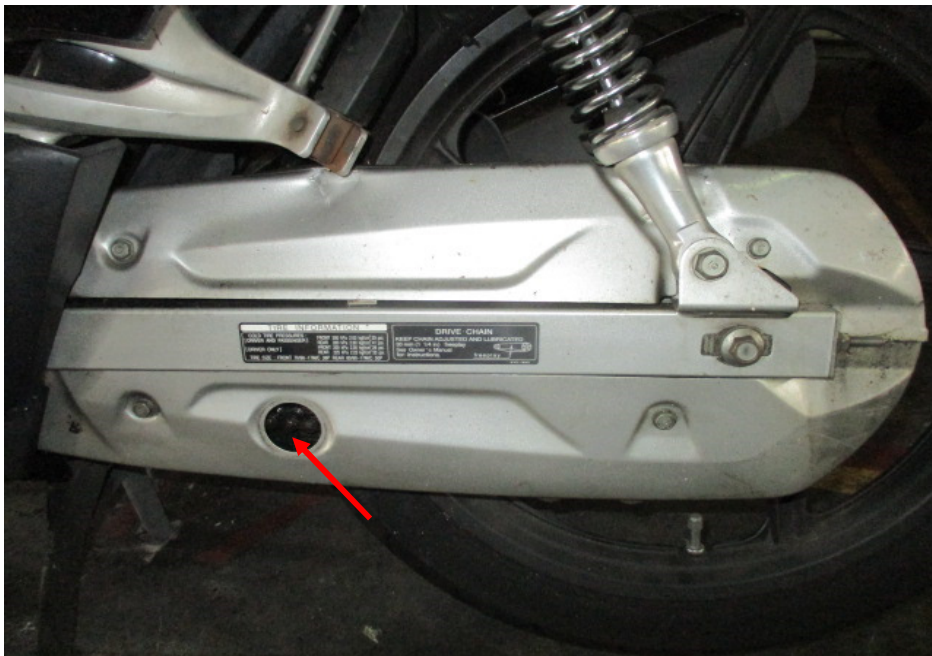
**Photo 18** shows the general view of the gear train (arrowed) of the Motorcycle, which was observed to be intact with no misalignment. It was also adequately lubricated for operating purposes.

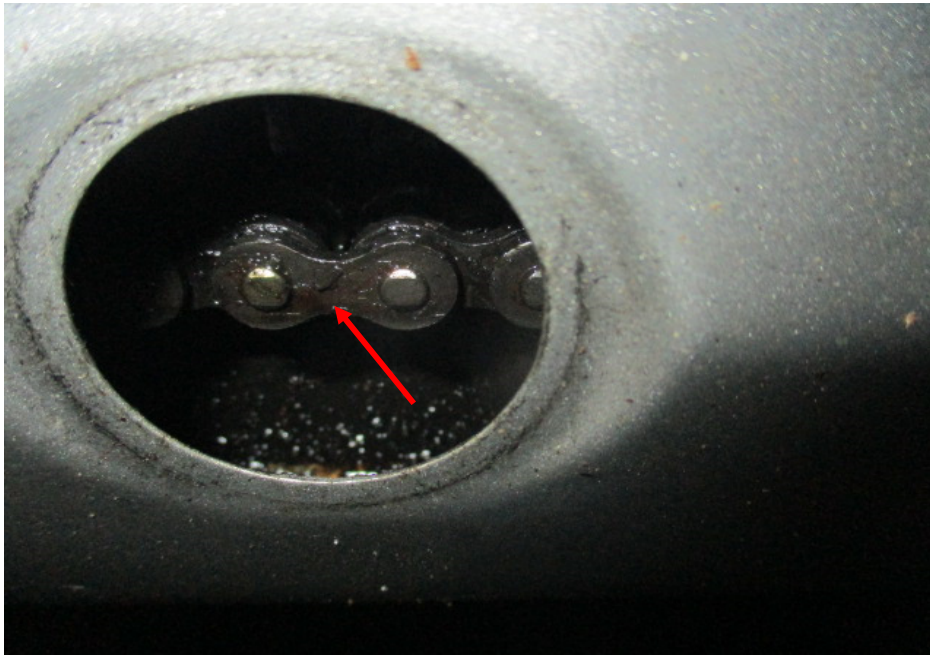
**Photo 19** shows a closer view of the gear train (arrowed) of the Motorcycle, which was observed to be intact with no misalignment. It was also adequately lubricated for operating purposes.

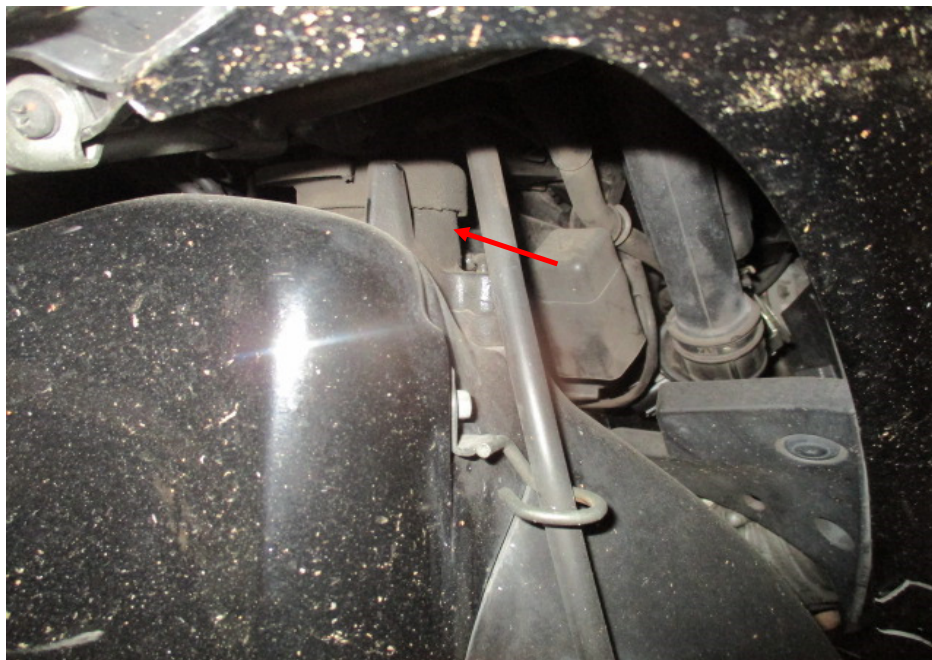
**Photo 20** shows the front fork (arrowed) of the Motorcycle. The front fork and fork bracket of the Motorcycle were both found to be intact and undamaged. Turning the Motorcycle's handle bar towards the left and right did not produce any abnormal free play. The steering system of the Motorcycle was in serviceable condition at the time of our inspection.

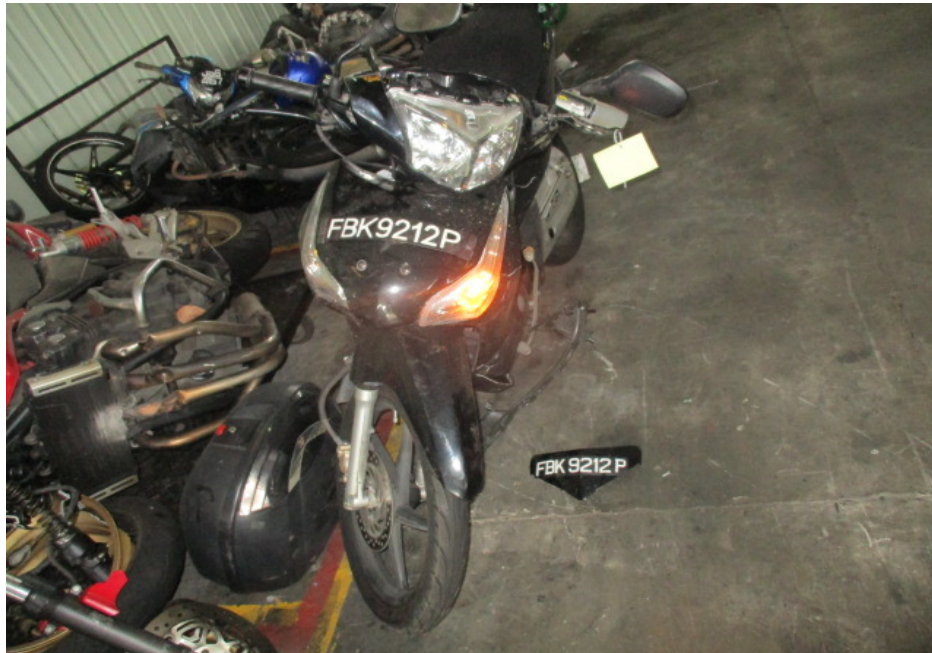
**Photo 21** shows the front wheel of the Motorcycle turned towards its full left. Turning the Motorcycle's handle bar towards the left did not produce any abnormal free play and/or resistance. This would indicate that the steering system of the Motorcycle was in serviceable condition at the time of our inspection.

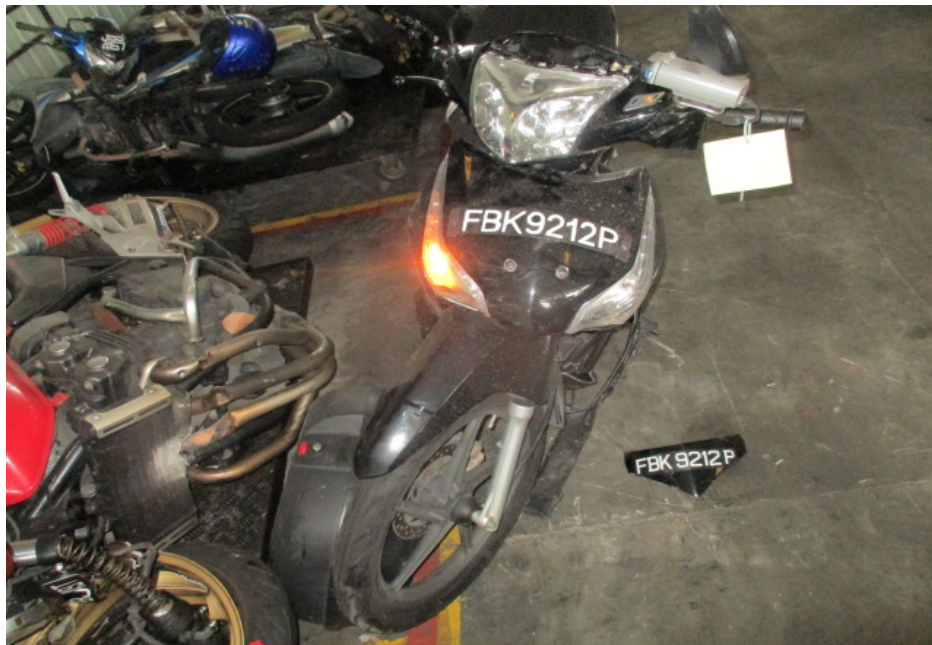
**Photo 22** shows the front wheel of the Motorcycle turned towards its full right. Turning the Motorcycle's handle bar towards the right did not produce any abnormal free play and/or resistance. This would indicate that the steering system of the Motorcycle was in serviceable condition at the time of our inspection.

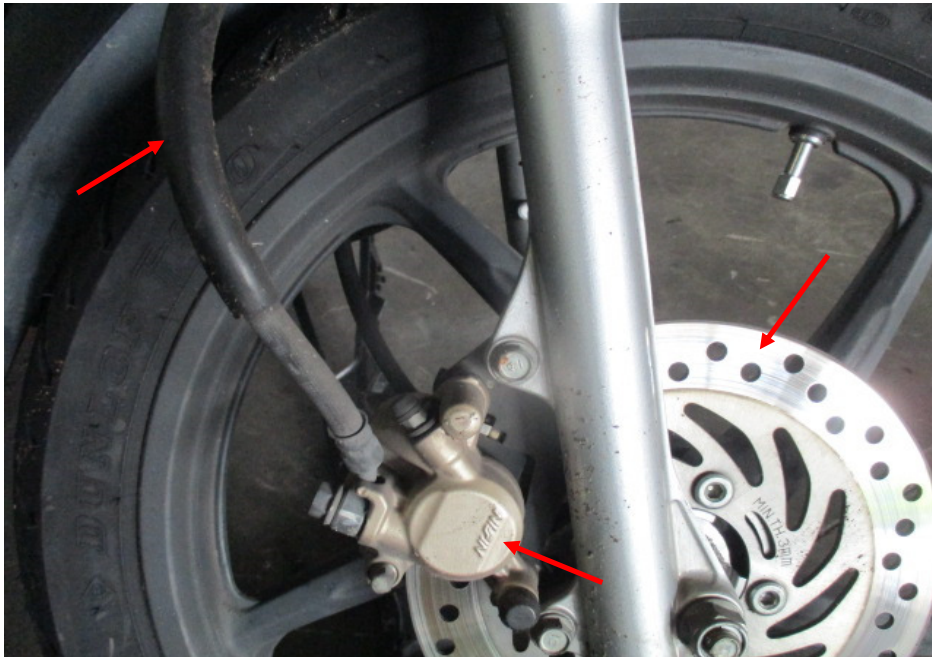
**Photo 23** shows a close up view of the front brake caliper, front brake disc and front brake hose (arrowed) of the Motorcycle, which are all part of the components in the hydraulic front brake system of the Motorcycle. Our visual checks of these various components had revealed all to be intact with no visible damage. No leakage of brake fluid was also observed.

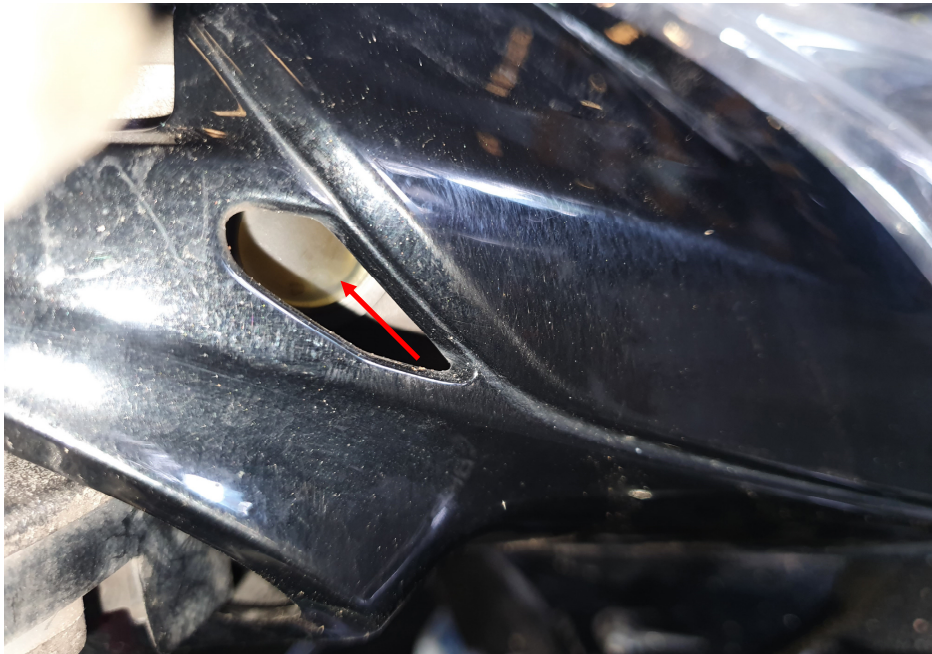
**Photo 24** shows the brake fluid reservoir for the front brake of the Motorcycle. The brake fluid was found to be without contamination and of sufficient level for operating purposes (arrowed).

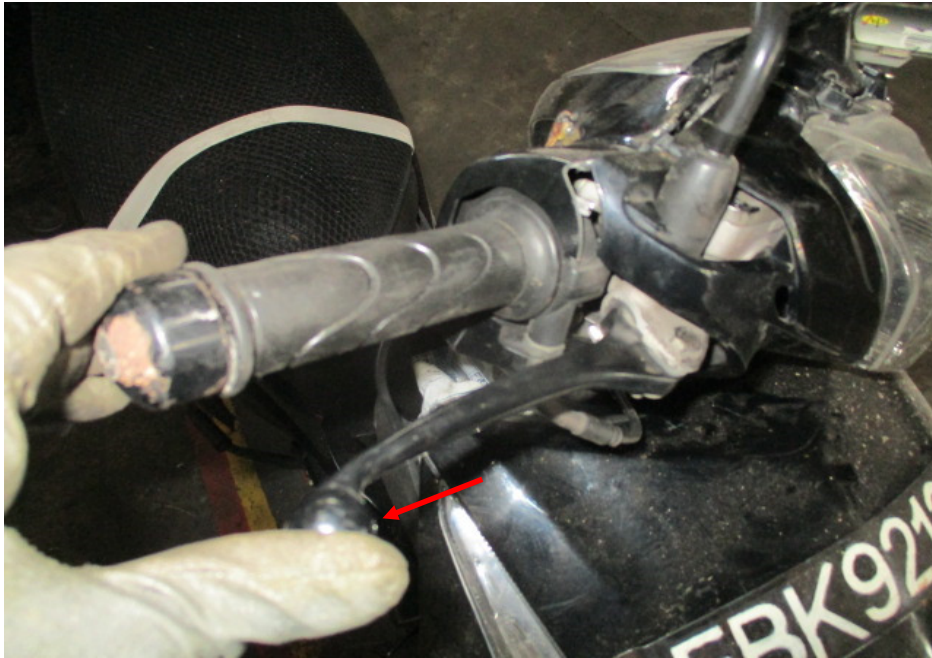
**Photo 25** shows the front brake lever being depressed. There was some resistance felt (spongy like feel) upon pressing the front brake lever (arrowed). This would indicate that there is no leakage of pressure/vacuum in the brake system.

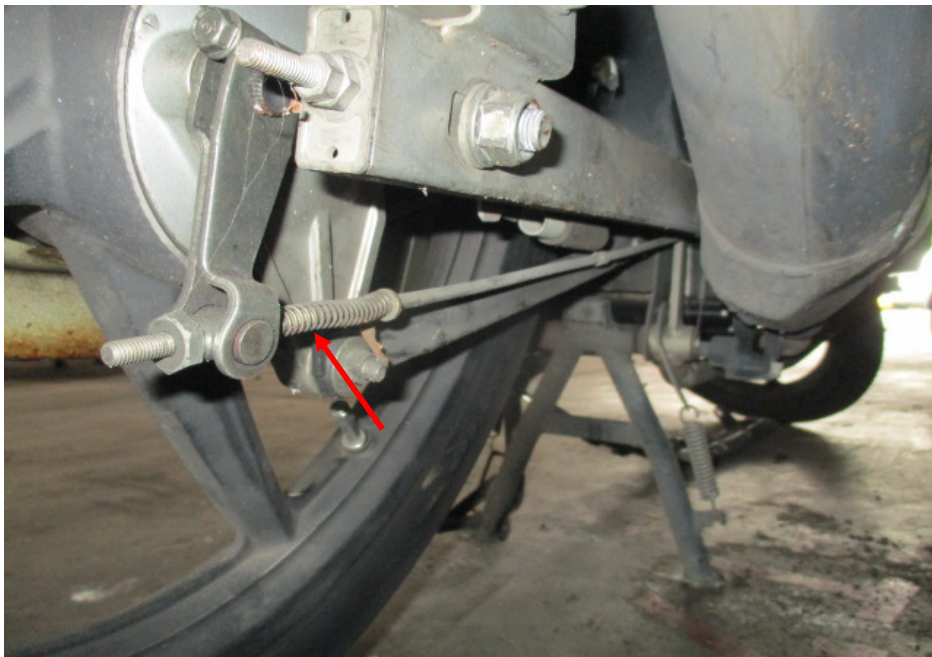
**Photo 26** shows the rear wheel of the Motorcycle. The type of brake system for the rear wheel was of a mechanical type, controlled by the brake foot pedal of the Motorcycle. Our checks of the cable (arrowed), spring and drum which are all part of the components in the rear brake system of the Motorcycle reveal all to be intact and without damage.
