Your Ref: TP/IP/36851/2020  
Our Ref : CI/TPD21000481/N

8 January 2021

**Fatal Accident Investigation Team**

**INSPECTION REPORT OF MOTORCYCLE JTY 1342**

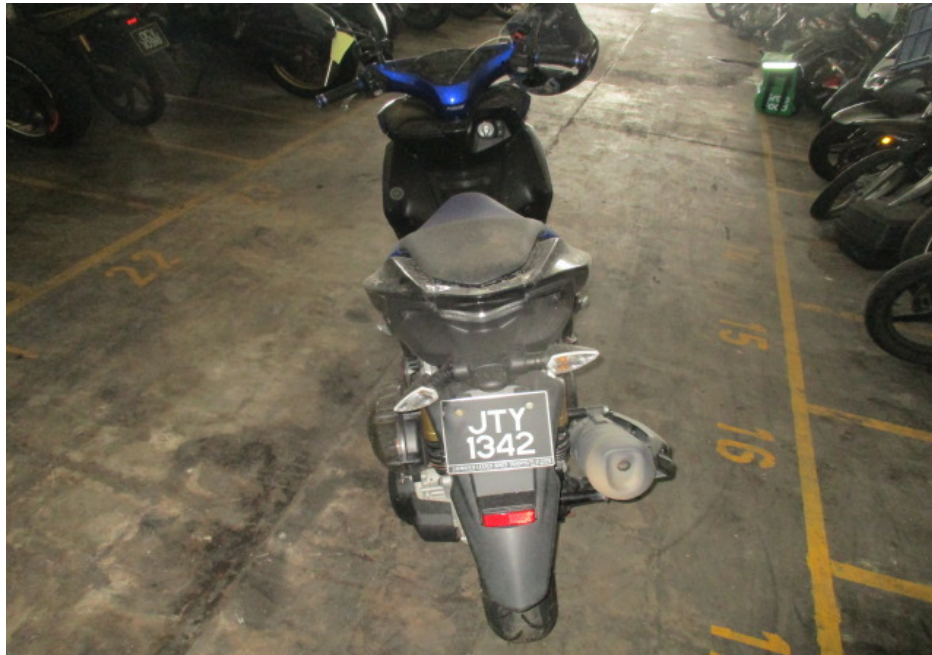
**Photo 1** shows a general view of the rear portion of the Motorcycle at the time of our inspection. The Motorcycle was observed to have sustained damages all around. The mileage of the Motorcycle could not be recorded at the time of our inspection despite several attempts to jump start the battery

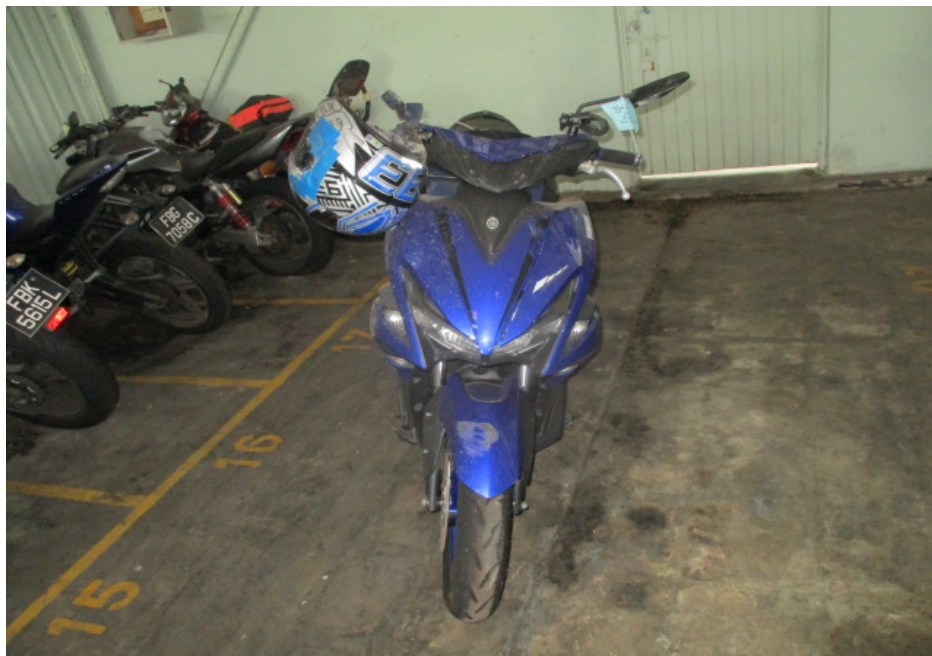
**Photo 2** shows a general view of the frontal portion of the Motorcycle at the time of our inspection. The Motorcycle was observed to have sustained damages all around.

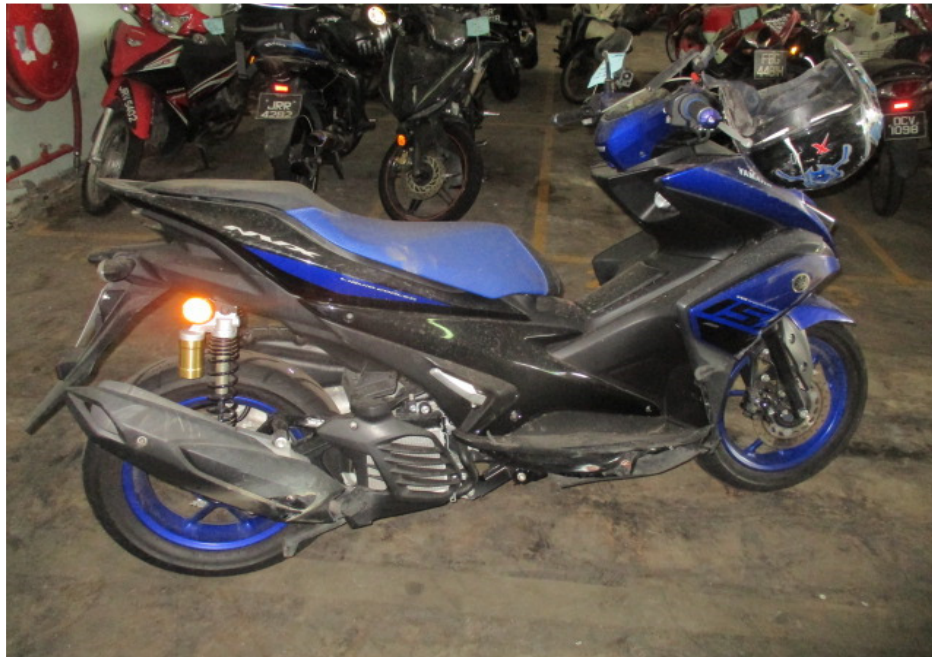
**Photo 3** shows a general view of the right body of the Motorcycle at the time of our inspection. The Motorcycle was observed to have sustained damages all around. The body parts that were found to have been damaged include its head cowlings, front cowlings, left side mirror, side cowlings, front mudguard, front brake lever, left handlebar end, drive train cover, exhaust muffler heat shield, left rear side cover, left rear signal lamp, left pillion foot peg and rear number plate, amongst others as a result of the accident.

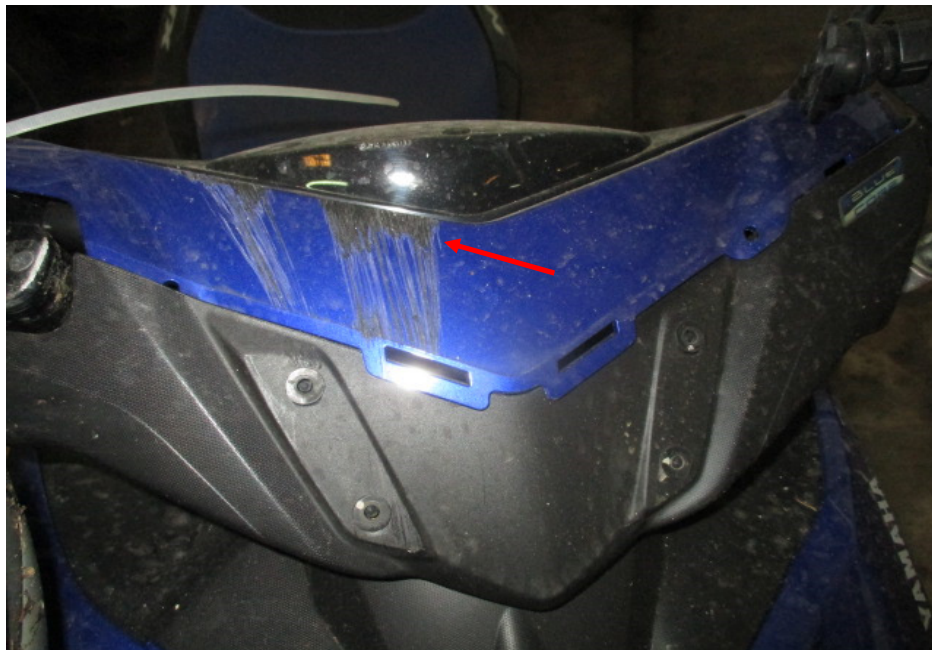
**Photo 4** shows a closer view of the grazed head cowlings (arrowed) which was amongst the body parts at the front body of the Motorcycle that had sustained damage as a result of the accident.

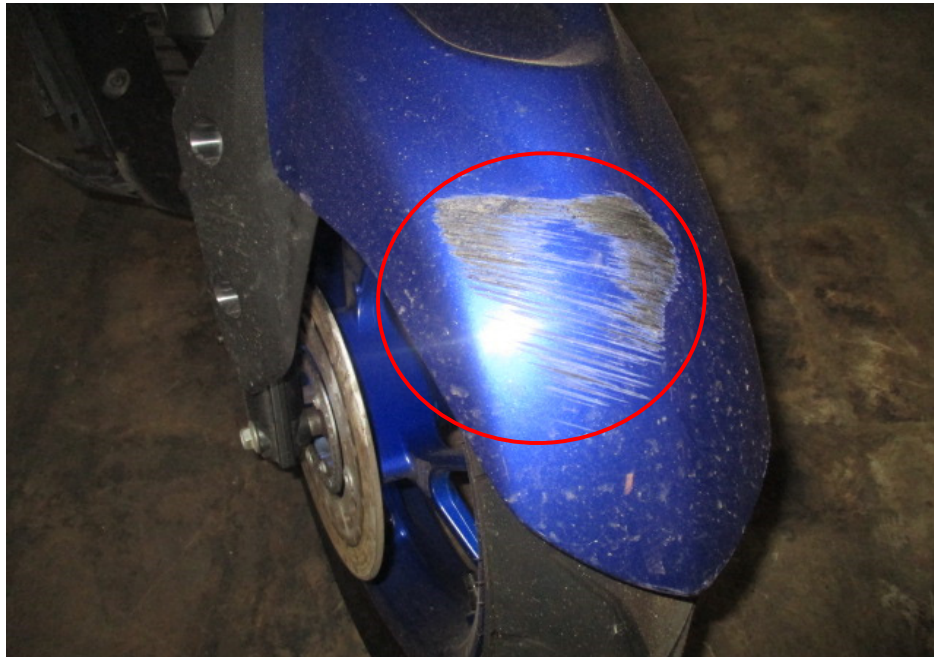
**Photo 5** shows a closer view of the front mudguard (circled) which was amongst the body parts at the front body of the Motorcycle that had sustained damage as a result of the accident.

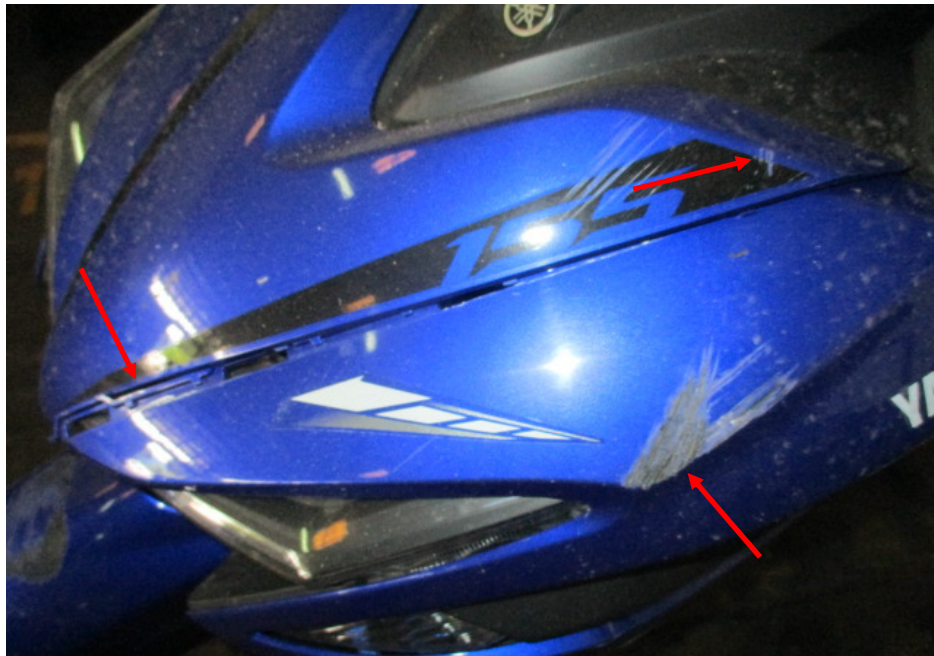
**Photo 6** shows a closer view of the front cowling of the Motorcycle which was observed to be damaged due to the accident (arrowed).

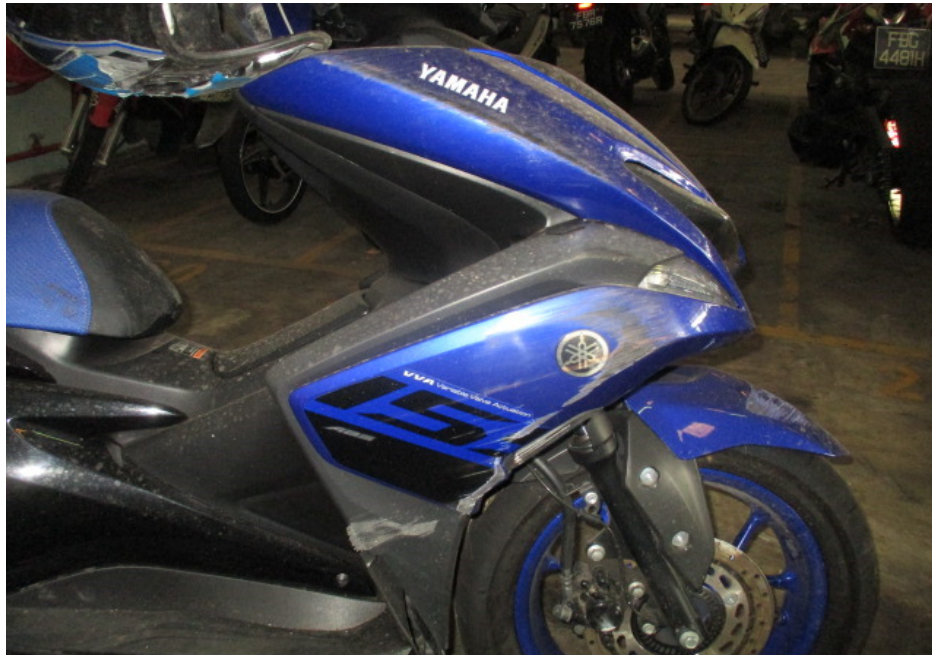
**Photo 7** shows a closer view of the right cowling which was amongst the body parts at the front body of the Motorcycle that had sustained damage as a result of the accident.

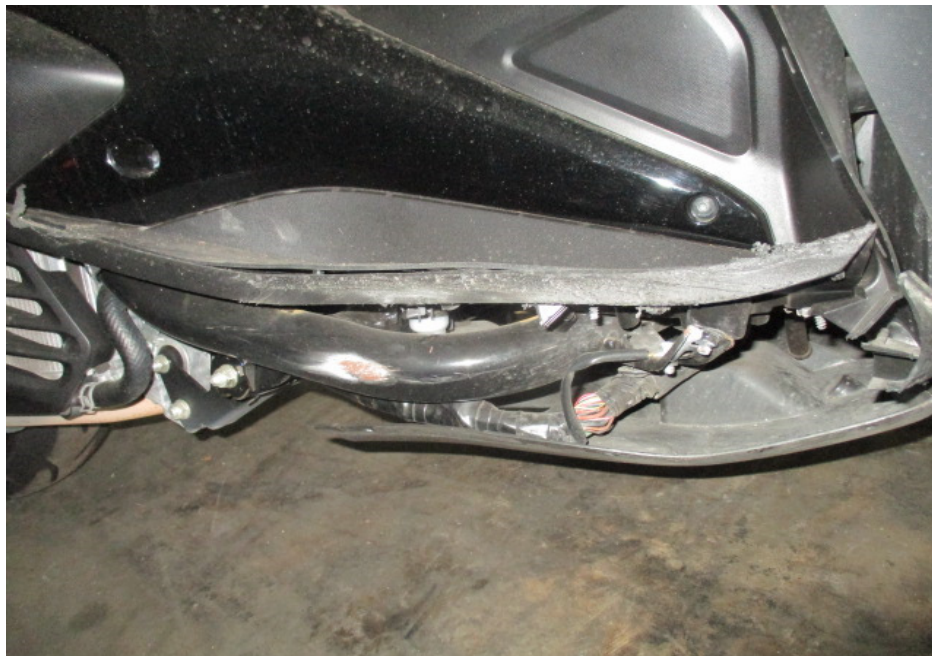
**Photo 8** shows a closer view of the right bottom cowling of the Motorcycle which was observed to be damaged due to the accident.

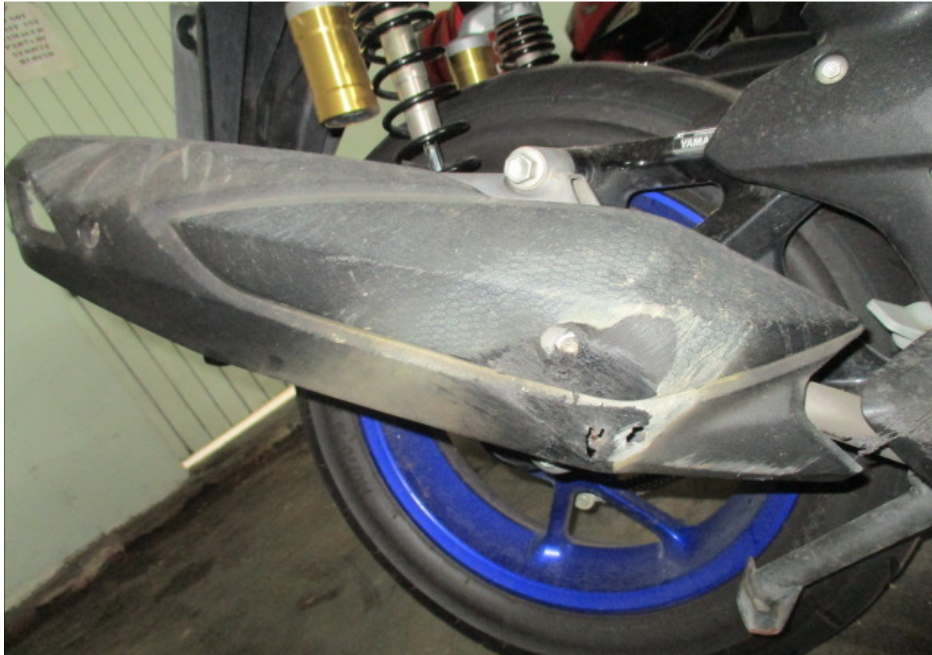
**Photo 9** shows a closer view of the exhaust muffler heat shield of the Motorcycle which had sustained damage due to the accident.

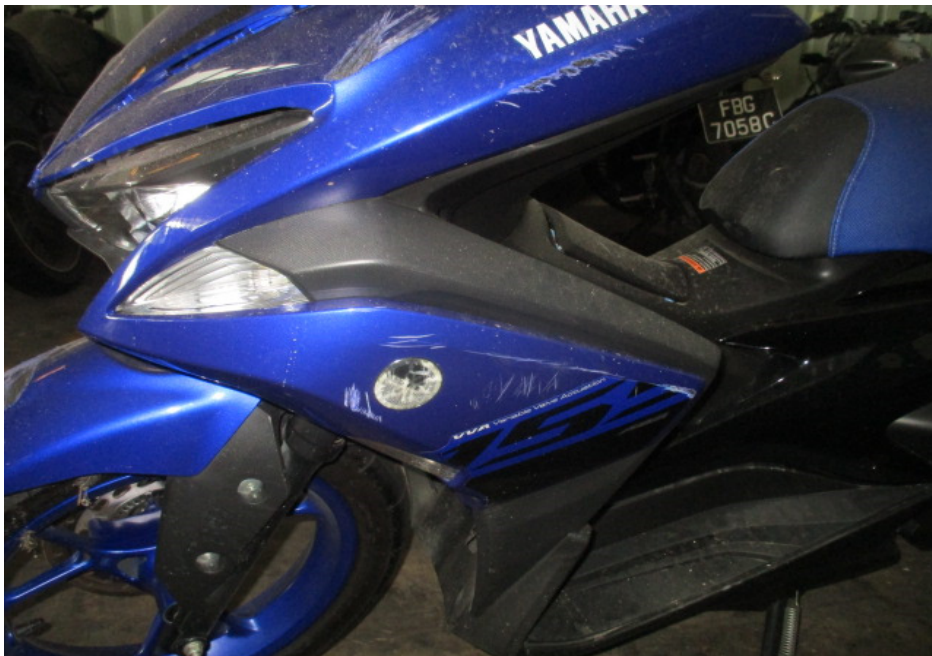
**Photo 10** shows a closer view of the left cowling which was amongst the body parts at the front body of the Motorcycle that had sustained damage as a result of the accident.

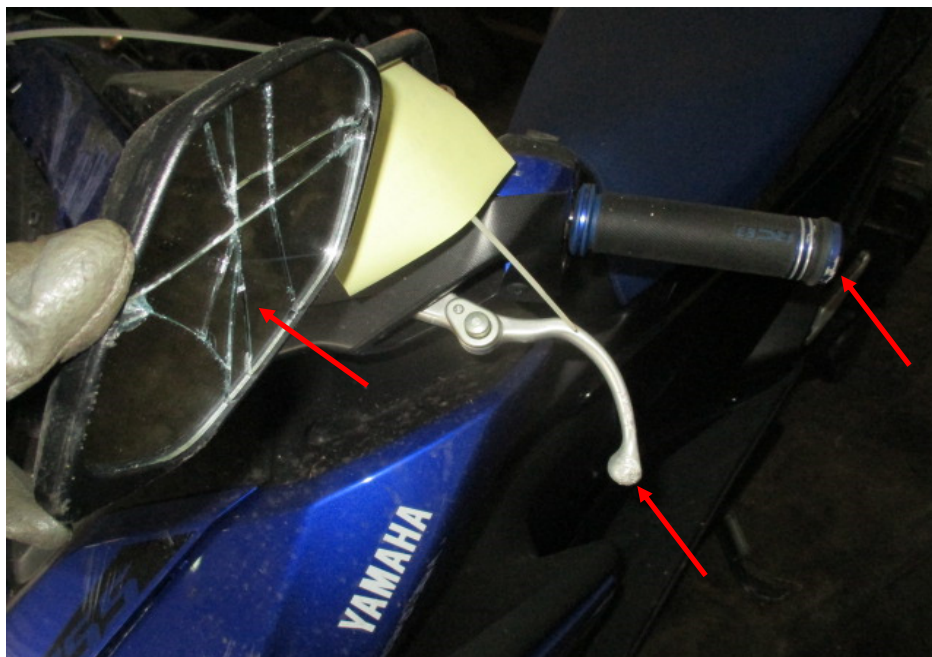
**Photo 11** shows a closer view of the rear brake lever, left side mirror and left handlebar end of the Motorcycle which were observed to be damaged due to the accident (arrowed).

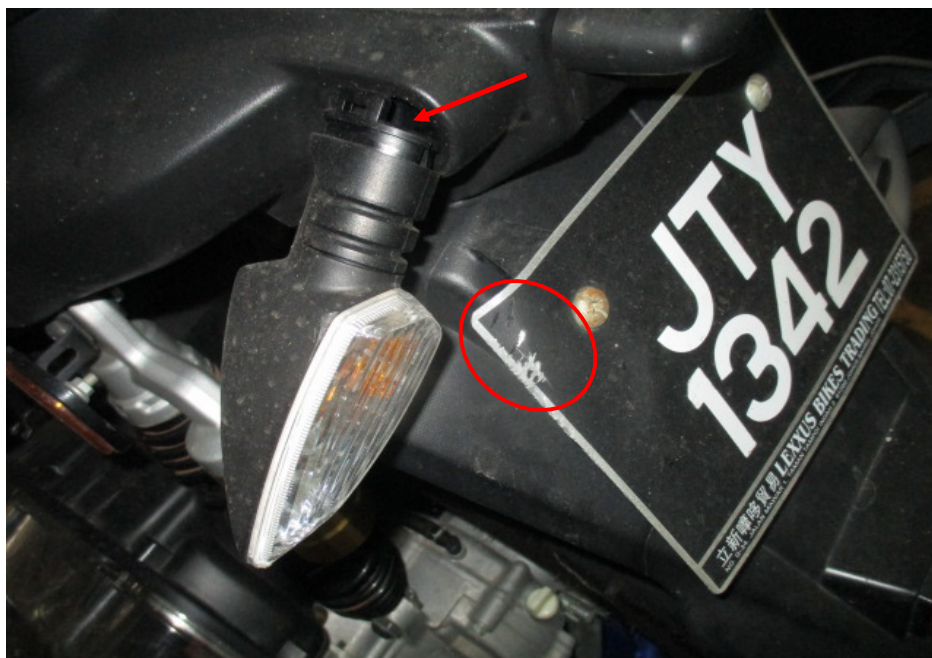
**Photo 12** shows the dislodged left rear signal lamp (arrowed) and dented rear number plate (circled) of the Motorcycle as a result of the accident.

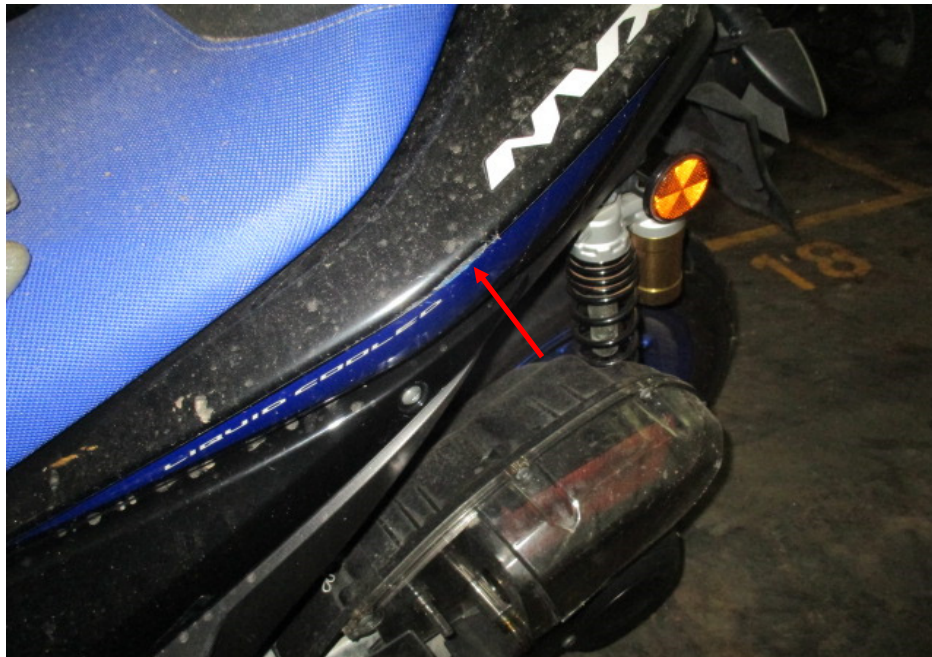
**Photo 13** show a closer view of the left rear side cover of the Motorcycle which was observed to be damaged due to the accident (arrowed).

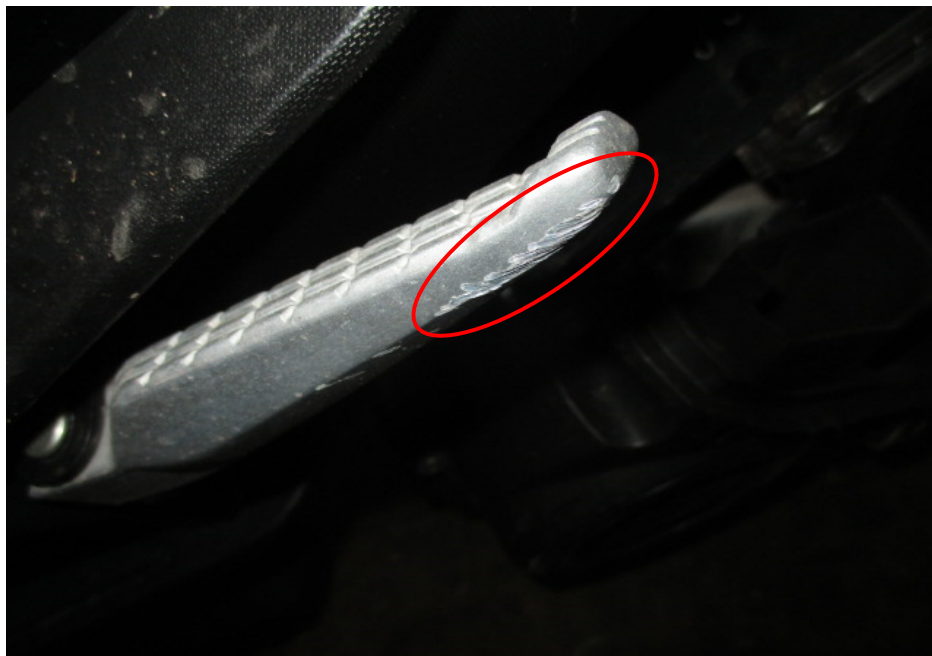
**Photo 14** shows a closer view of the grazed left pillion foot peg (circled) of the Motorcycle at the time of our inspection.

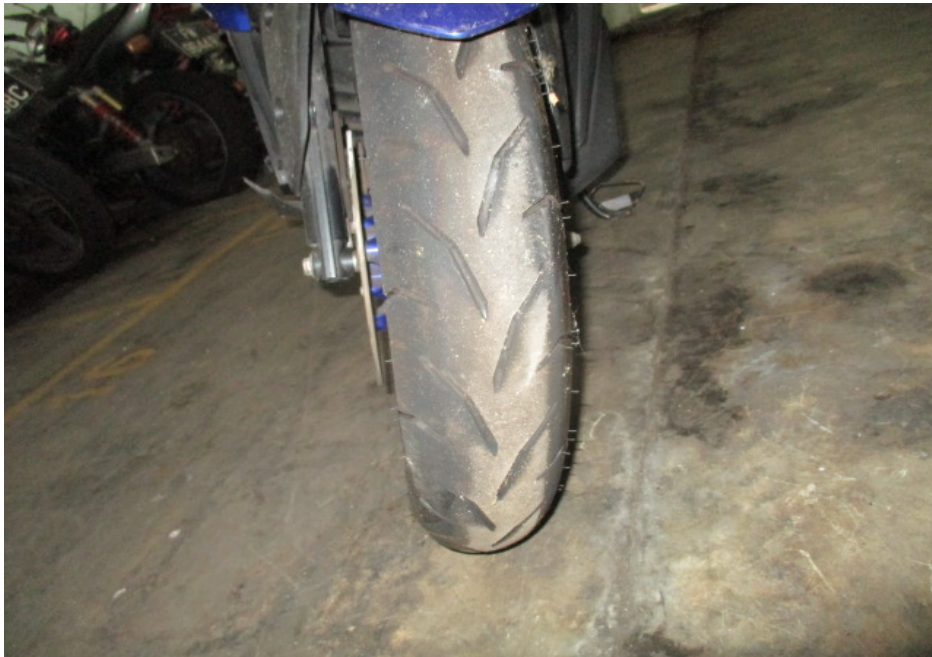
**Photo 15** shows the condition of the Motorcycle's front tyre. The front tyre was observed to be in serviceable condition with remaining tread depth of approximately 4mm. There was no tear, burst mark(s) and/or punctured hole(s) on the sidewalls as well as across the tread of the front tyre.

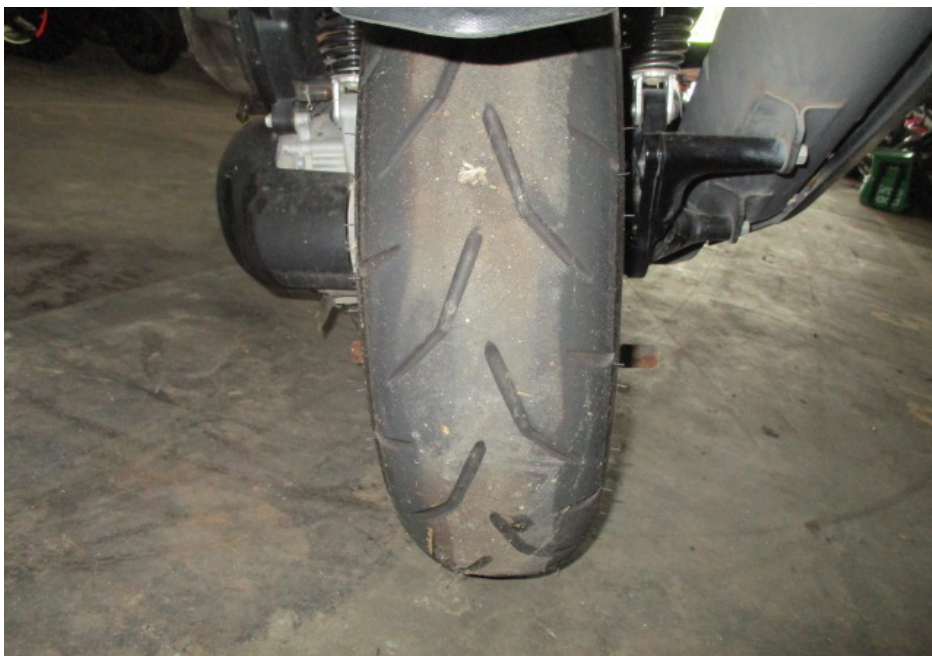
**Photo 16** shows the condition of the Motorcycle's rear tyre. The rear tyre was observed to be in serviceable condition with remaining tread depth of approximately 3mm. The tyre was also observed to be sufficiently inflated for vehicular operation. We did not observe any tear, burst mark(s) and/or punctured hole(s) on the sidewalls as well as across the tread of the rear tyre.

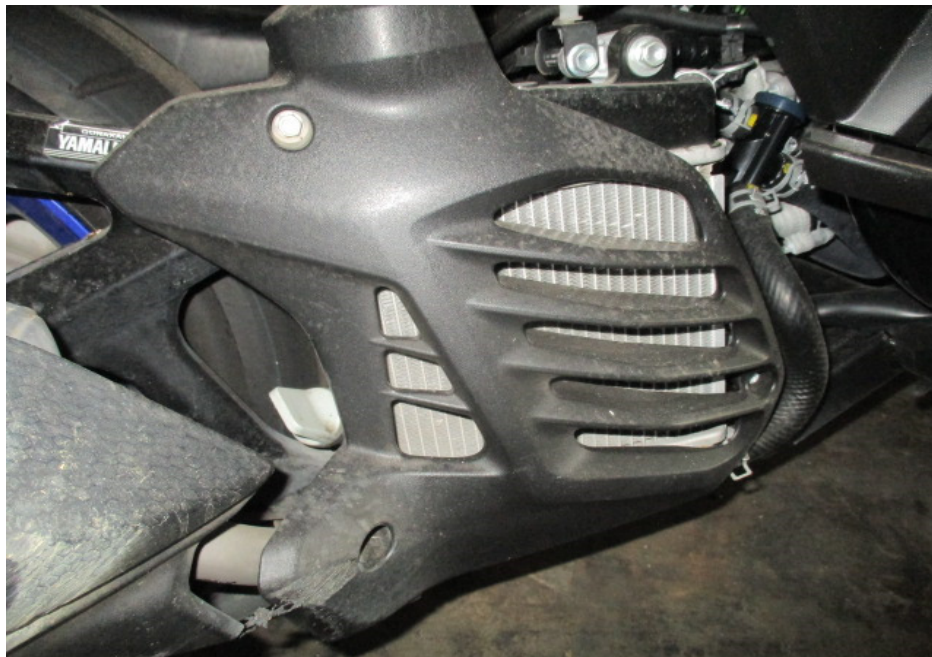
**Photo 17** shows the radiator of the Motorcycle at the time of our inspection. The radiator was found to be intact with no visible damage. There was also no sign(s) or indication(s) of fluid leak observed around the radiator of the Motorcycle.

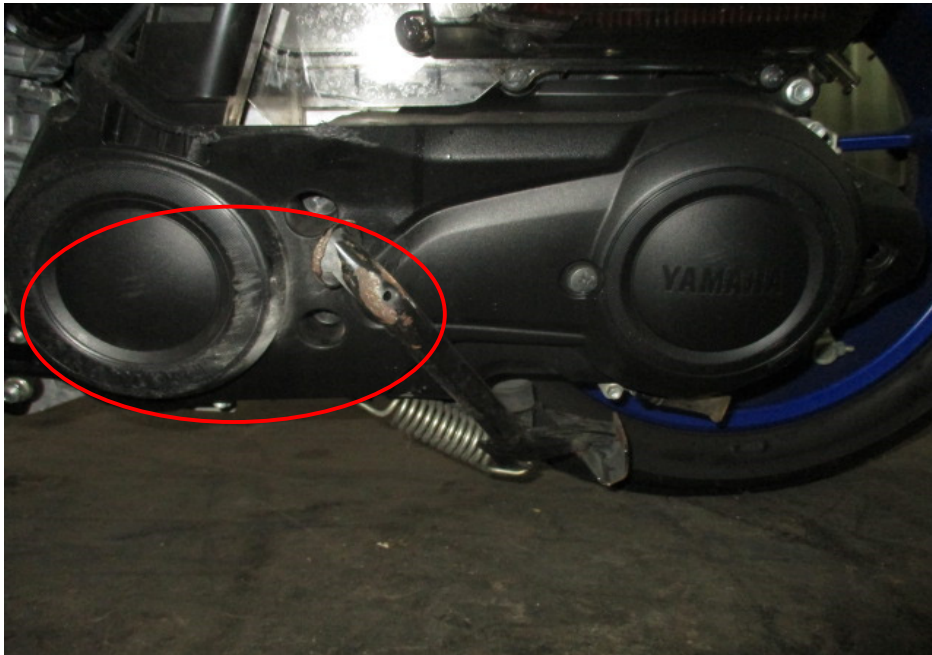
**Photo 18** shows the drive train cover of the Motorcycle which had sustained damages of grazing nature as a result of the accident (circled) however the engine components were still intact.

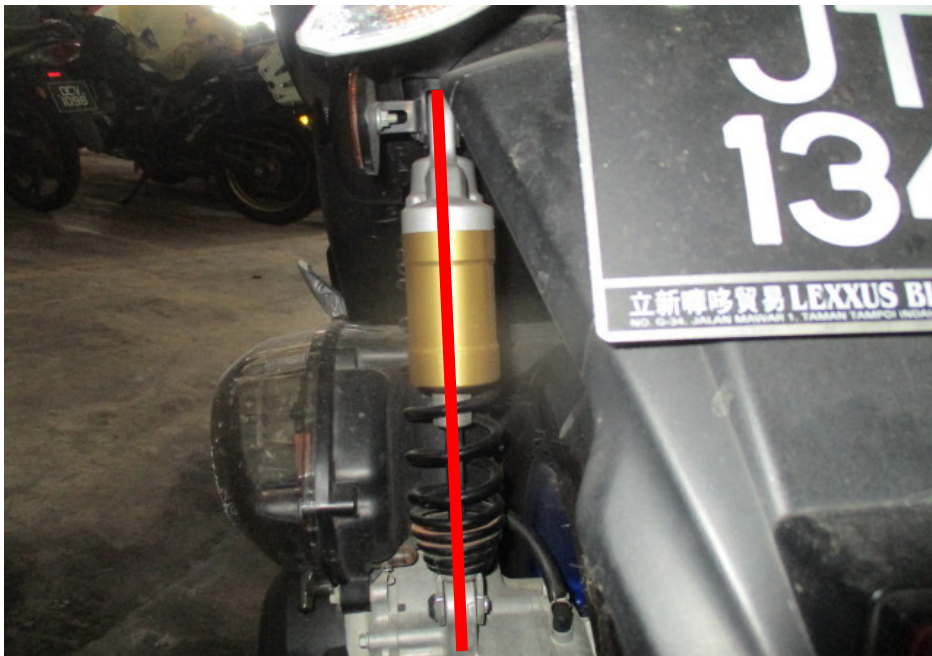
**Photo 19** shows the left shock absorber of the Motorcycle which was found to be intact without any misalignment.

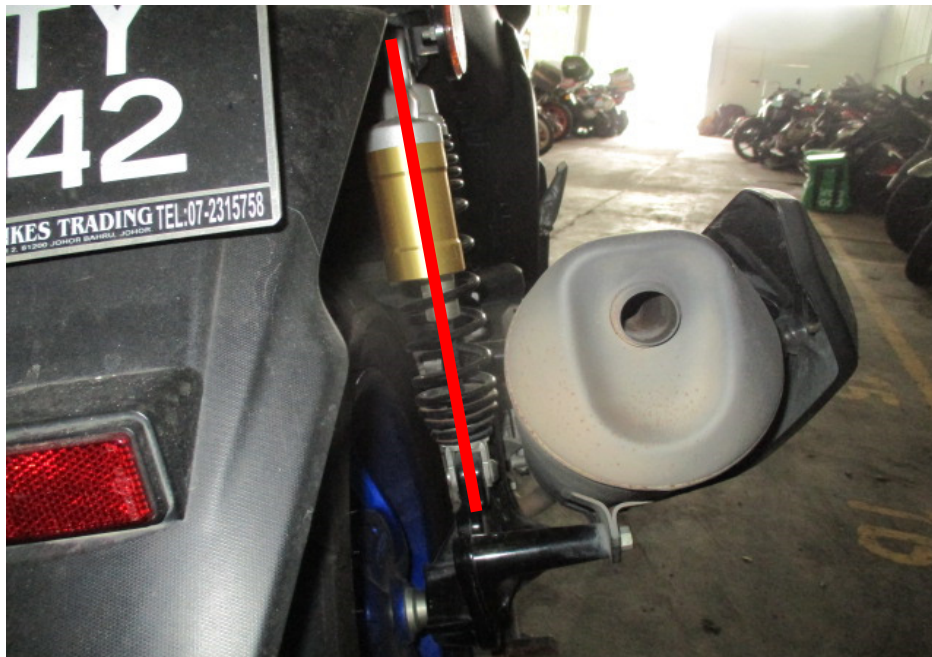
**Photo 20** shows the right shock absorber of the Motorcycle which was found to be intact without any misalignment.

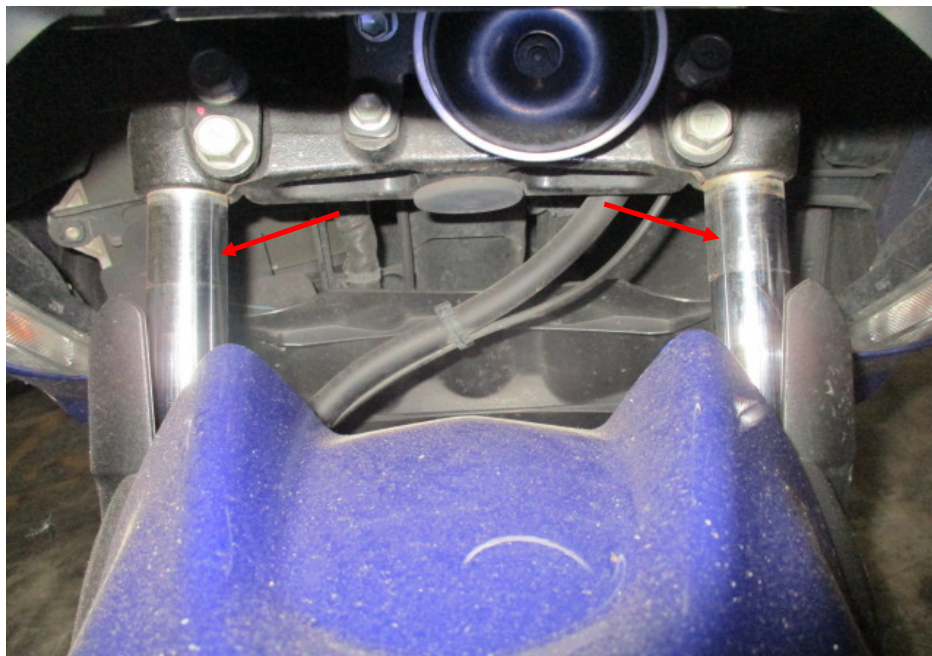
**Photo 21** shows the front forks (arrowed) of the Motorcycle. The front forks and fork brackets of the Motorcycle were both found to be intact and undamaged. Turning the Motorcycle's handle bar towards the left and right did not produce any abnormal free play and/or resistance. The steering system of the Motorcycle was in serviceable condition at the time of our inspection.

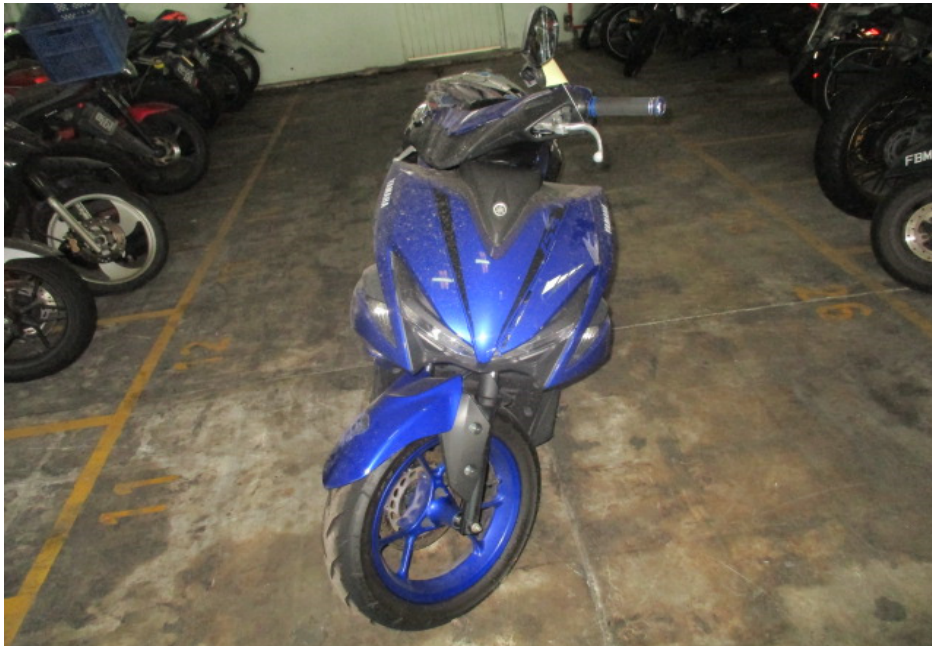
**Photo 22** shows the front wheel of the Motorcycle turned towards its full right. Turning the Motorcycle's handle bar towards the left and right did not produce any abnormal free play and/or resistance. This would indicate that the steering system of the Motorcycle was in serviceable condition at the time of our inspection.

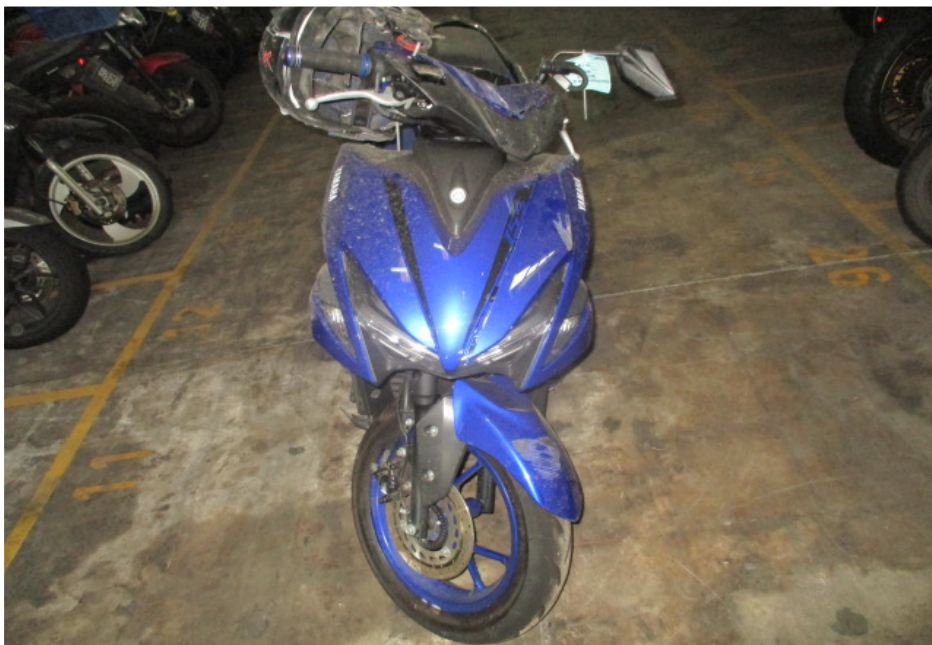
**Photo 23** shows the front wheel of the Motorcycle turned towards its full left. Turning the Motorcycle's handle bar towards the left and right did not produce any abnormal free play and/or resistance. This would indicate that the steering system of the Motorcycle was in serviceable condition at the time of our inspection.

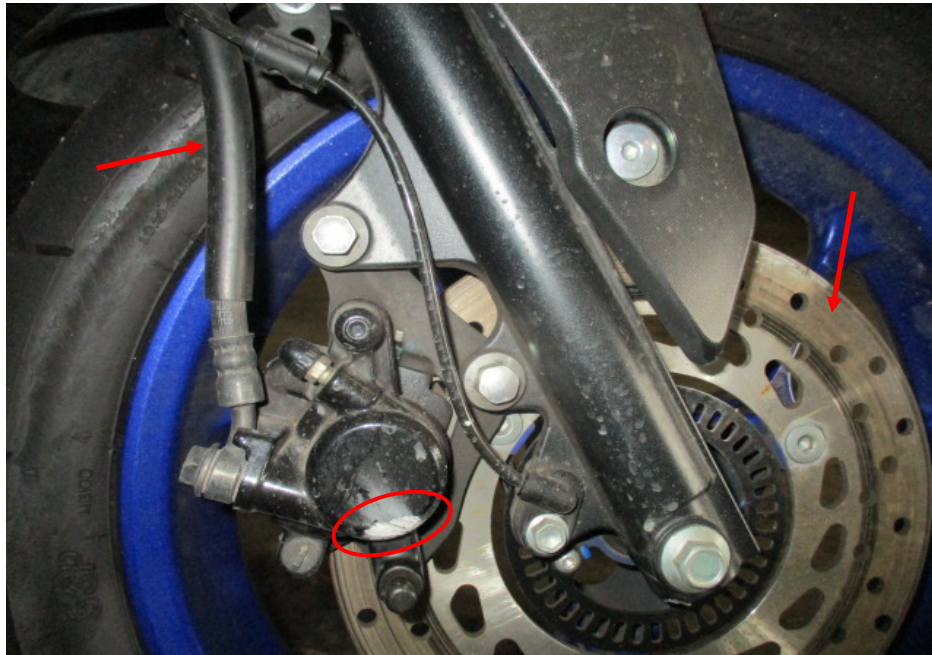
**Photo 24** shows a close up view of the front brake disc and front brake hose (arrowed) of the Motorcycle, which are part of the components in the hydraulic front brake system of the Motorcycle. Our visual checks of these various components had revealed all to be intact with no visible damage. The front brake caliper had sustained damages of grazing nature as a result of the accident (circled) however it was still intact. No leakage of brake fluid was also observed.

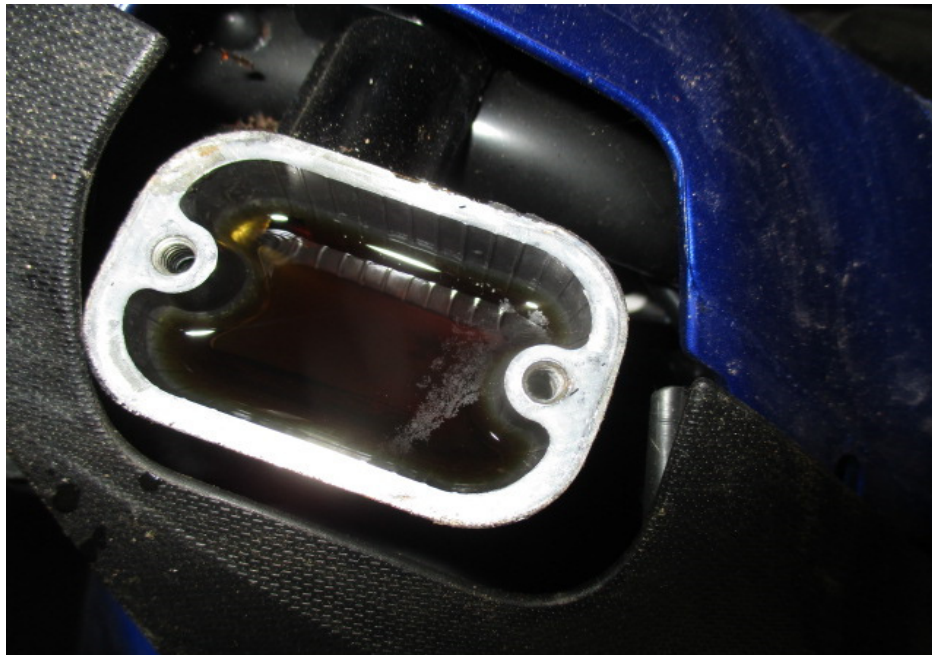
**Photo 25** shows a close up view of the brake fluid reservoir for the front brake of the Motorcycle. The brake fluid was observed to be of sufficient level and without contamination for operational purposes.

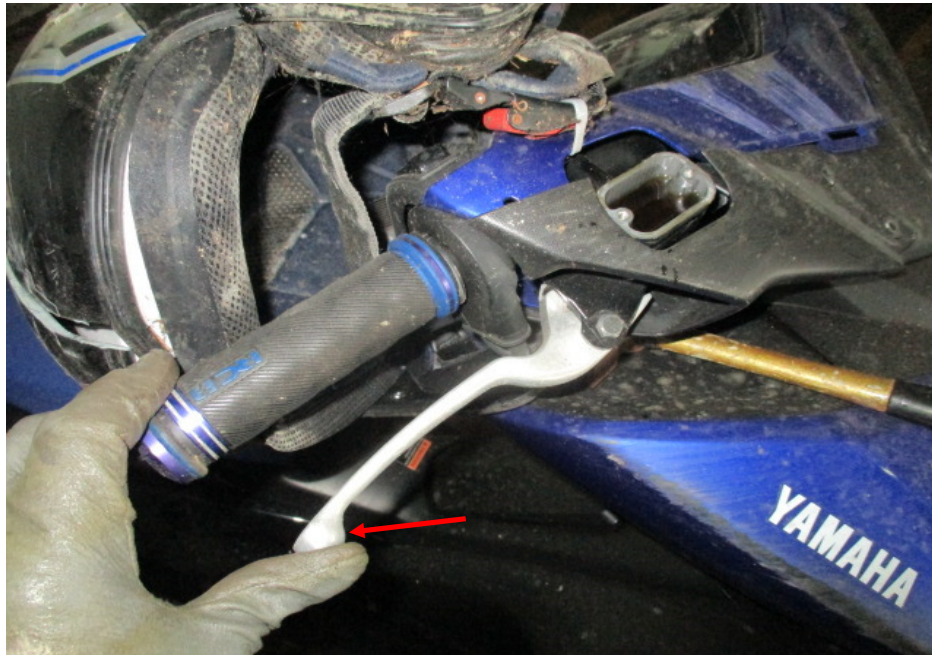
**Photo 26** shows the front brake lever being depressed. There was some resistance felt (spongy like feel) upon pressing the front brake lever (arrowed). This would indicate that there is no leakage of pressure/vacuum in the front brake system.

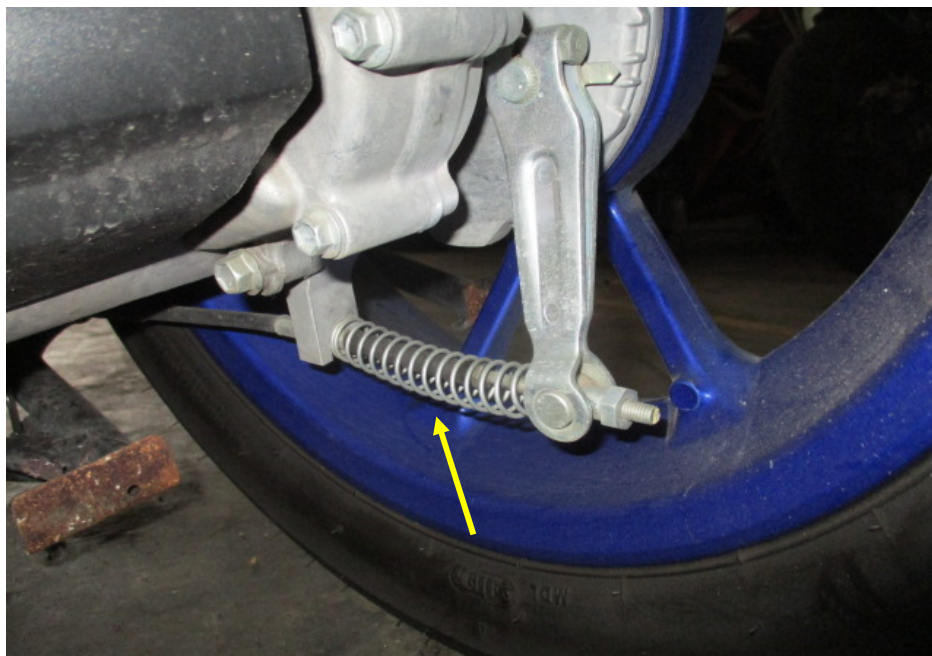
**Photo 27** shows the rear wheel of the Motorcycle. The type of brake system for the rear wheel was of a mechanical type, controlled by the brake foot pedal of the Motorcycle. Our checks of the cable (arrowed), spring and drum which are all part of the components in the rear brake system of the Motorcycle reveal all to be intact and without damage.
