Your Ref: TP/IP/37951/2020
Our Ref : CI/TPD21000482/N

8 January 2021

INSPECTION REPORT OF MOTORCYCLE FBK 4118L

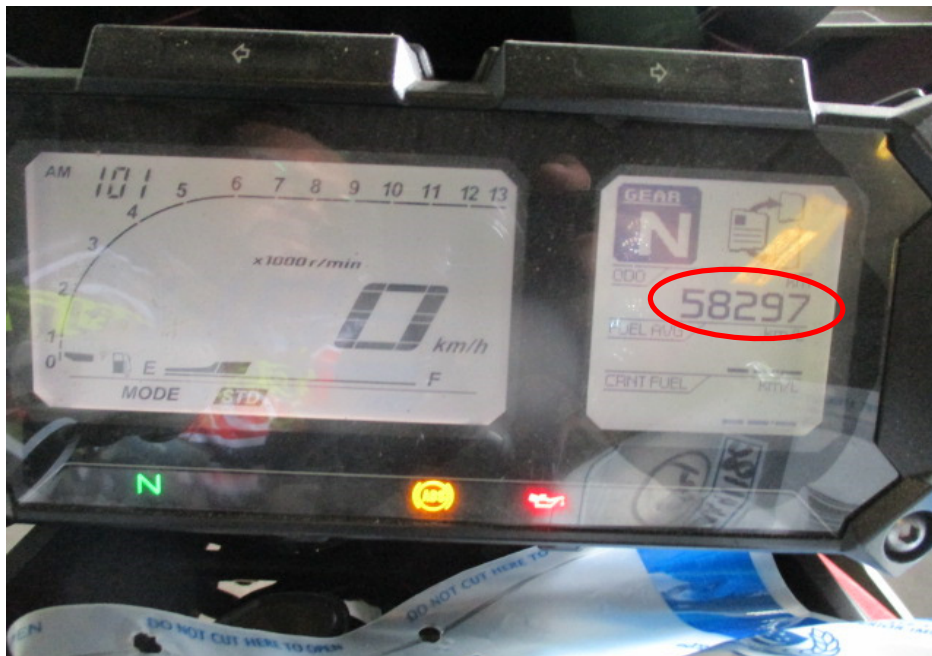
Photo 1 shows the speedometer gauge of the Motorcycle where the mileage recorded at the time of our inspection was 58, 297km (circled).

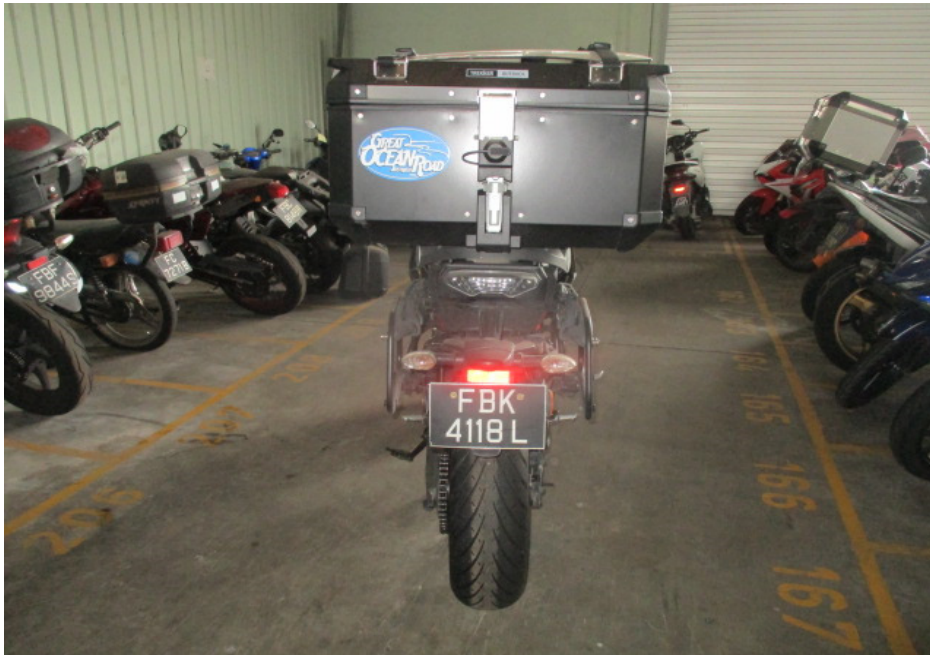
Photo 2 shows a general view of the rear portion of the Motorcycle at the time of our inspection. The Motorcycle was observed to have sustained damages all around.

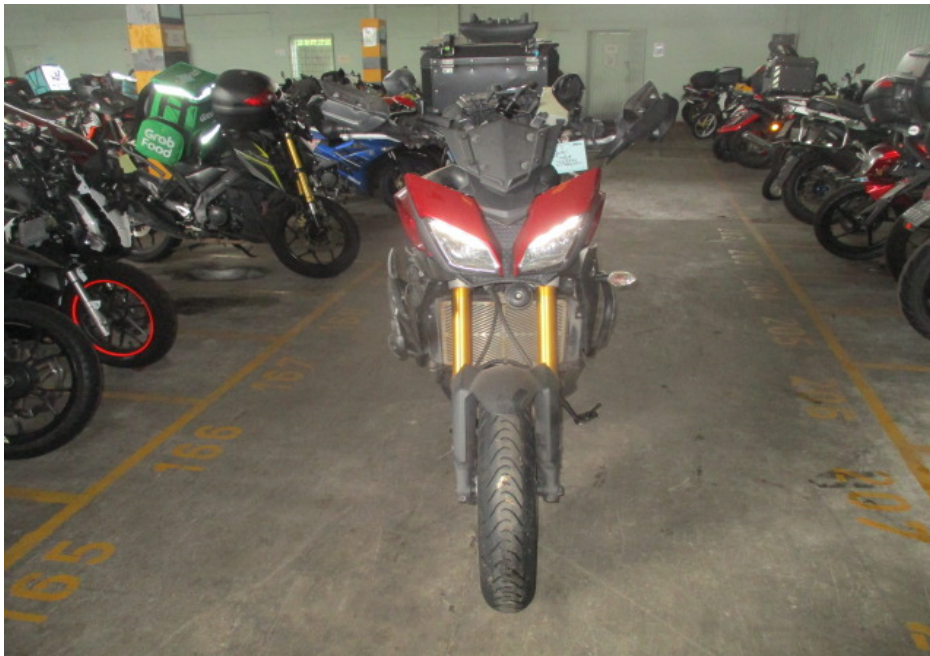
Photo 3 shows a general view of the frontal portion of the Motorcycle at the time of our inspection. The Motorcycle was observed to have sustained damages all around.

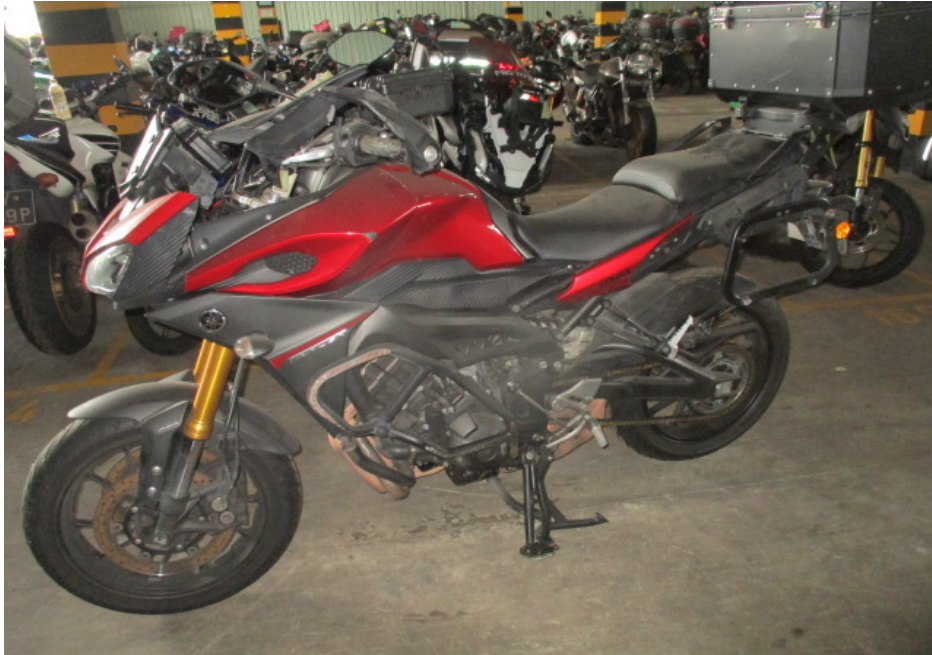
Photo 4 shows a general view of the left body of the Motorcycle at the time of our inspection. The Motorcycle was observed to have sustained damages all around. The body parts that were found to have been damaged include its head cowlings, side cowlings, front signal lamps, left tank cover, clutch lever guard, clutch lever, left side mirror, gear shift pedal, left front footrest, left engine crashbar and top box, amongst others.

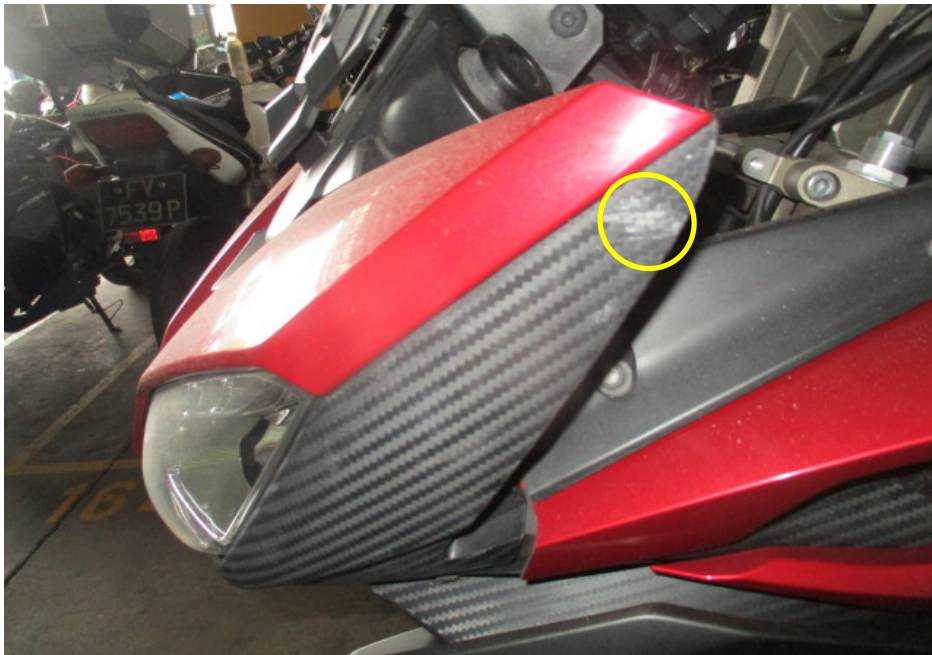
Photo 5 shows a close up view of the head cowlings was amongst the body parts of the Motorcycle that had sustained damage as a result of the accident (circled).

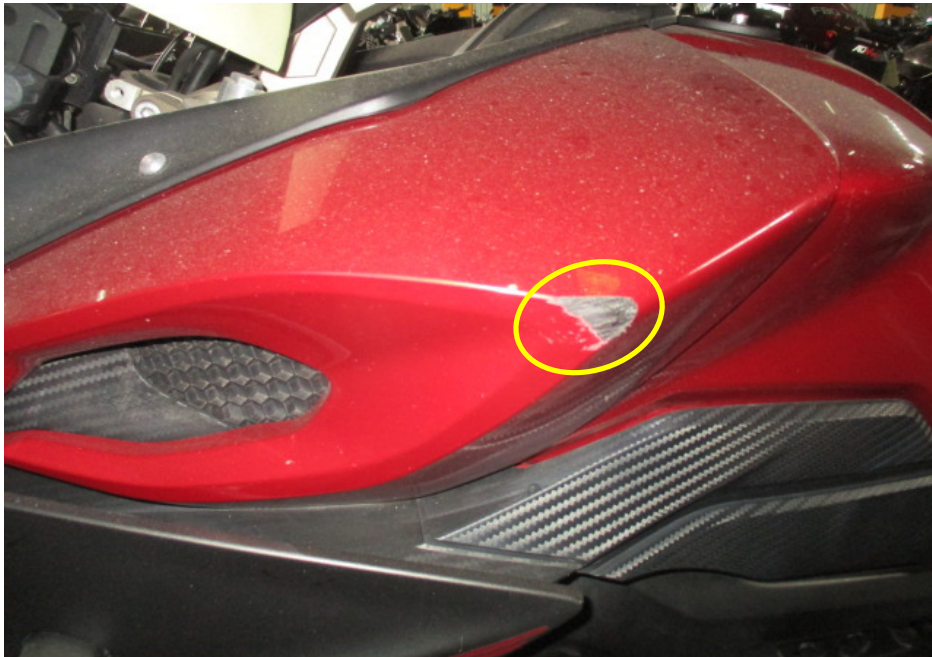
Photo 6 shows a closer view of the left tank cover which was amongst the body parts at the front body of the Motorcycle that had sustained damage as a result of the accident (circled).

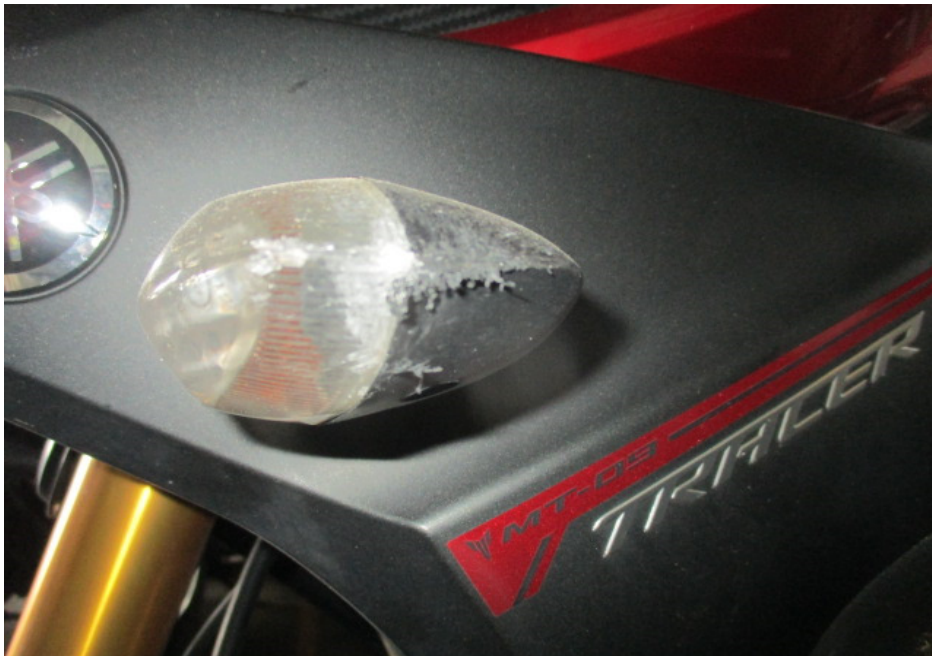
Photo 7 shows a closer view of the left front signal lamp of the Motorcycle that had sustained damages of grazing nature as a result of the accident.

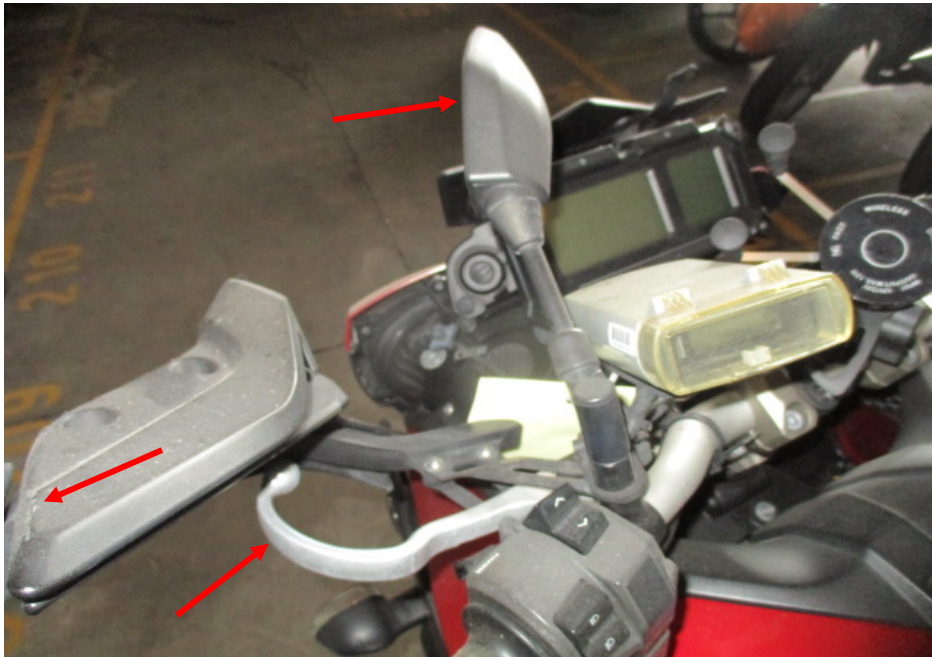
Photo 8 shows a closer view of the clutch lever guard, clutch lever and left side mirror (arrowed) which were amongst the body parts of the Motorcycle that had sustained damage as a result of the accident.

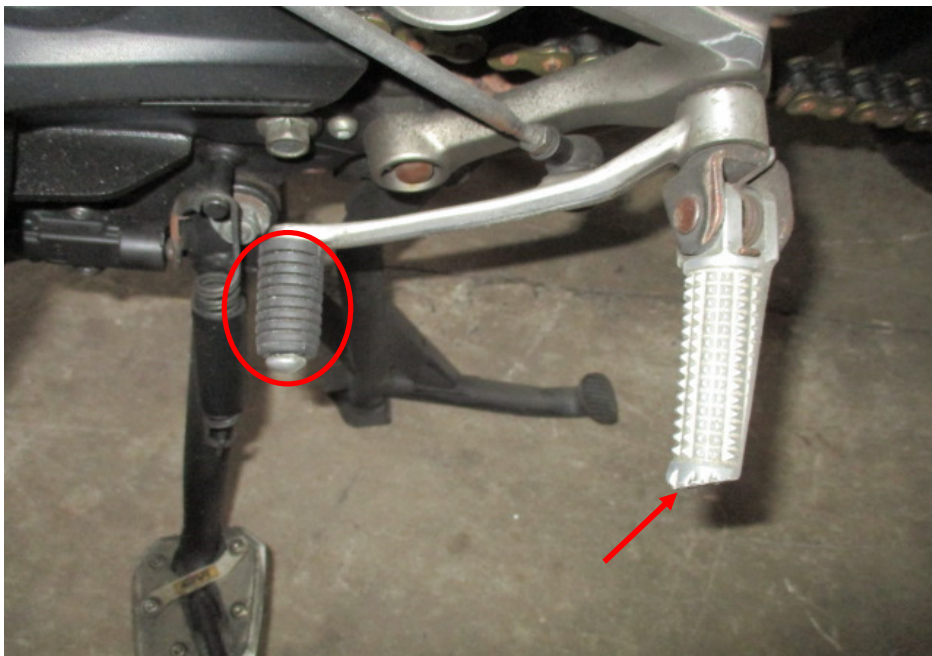
Photo 9 shows a closer view of the gear shift pedal (circled) and left front footrest (arrowed) which were amongst the body parts of the Motorcycle that had sustained damage as a result of the accident.

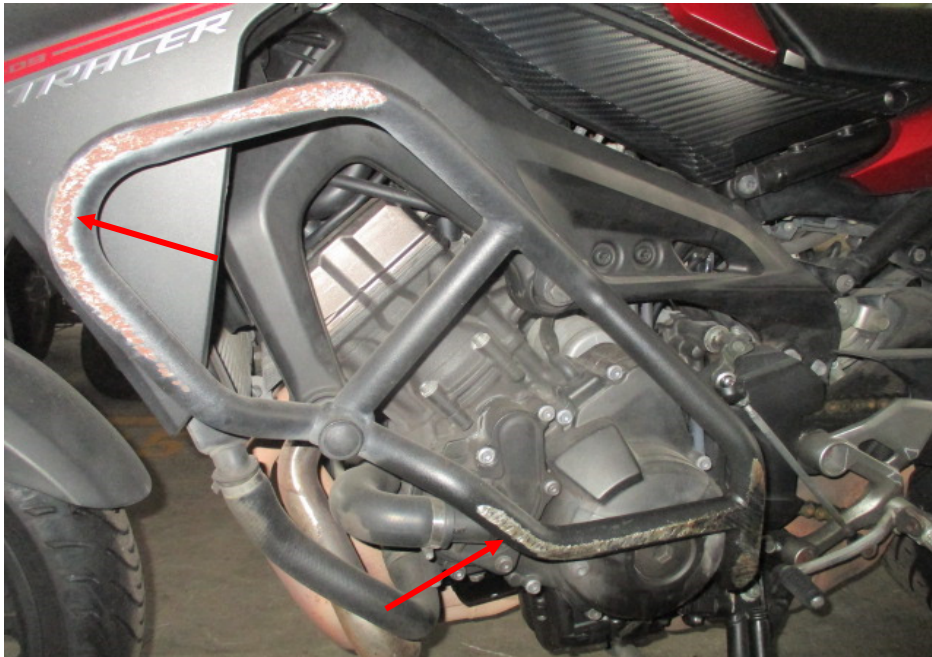
Photo 10 shows a closer view of the left engine crash bar which was amongst the body parts of the Motorcycle that had sustained damages of grazing nature as a result of the accident (arrowed).

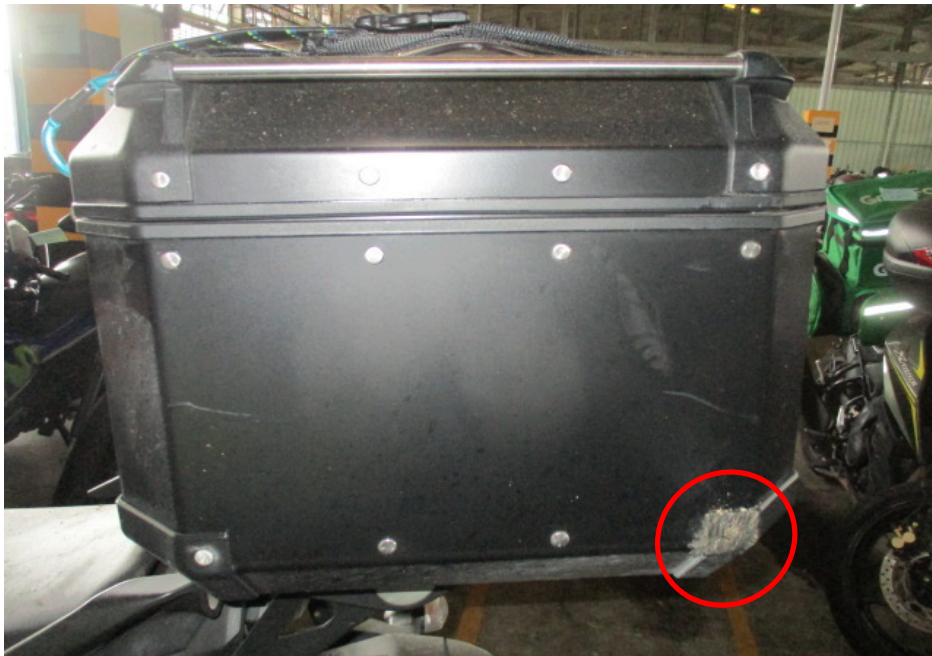
Photo 11 shows a closer view of the top box which was amongst the body parts of the Motorcycle that had sustained damages of grazing nature as a result of the accident (circled).

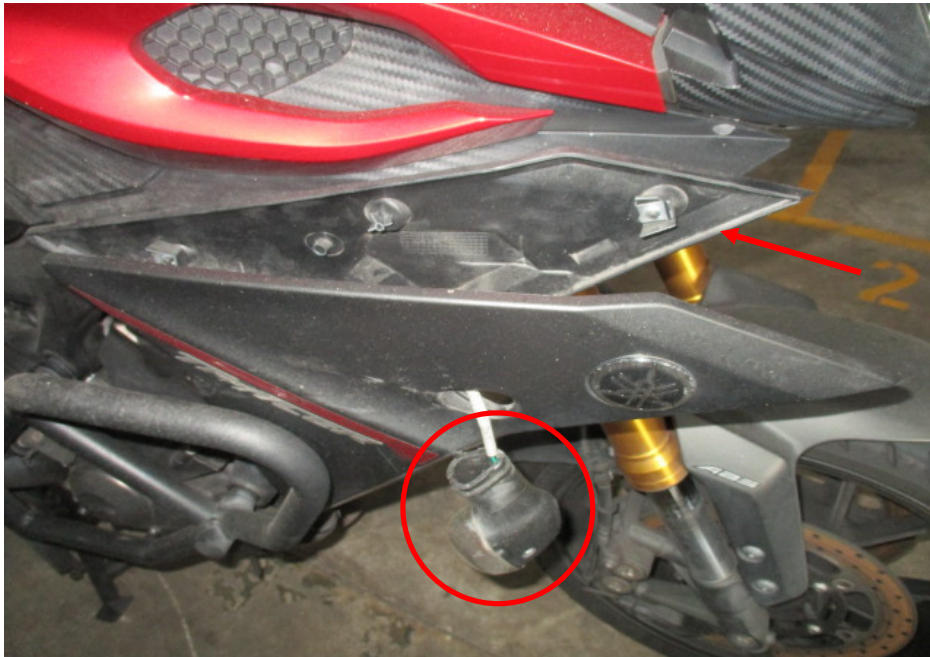
Photo 12 shows a closer view of the dislodged right cowling and right front signal lamp of the Motorcycle as a result of the accident (arrowed) (circled).

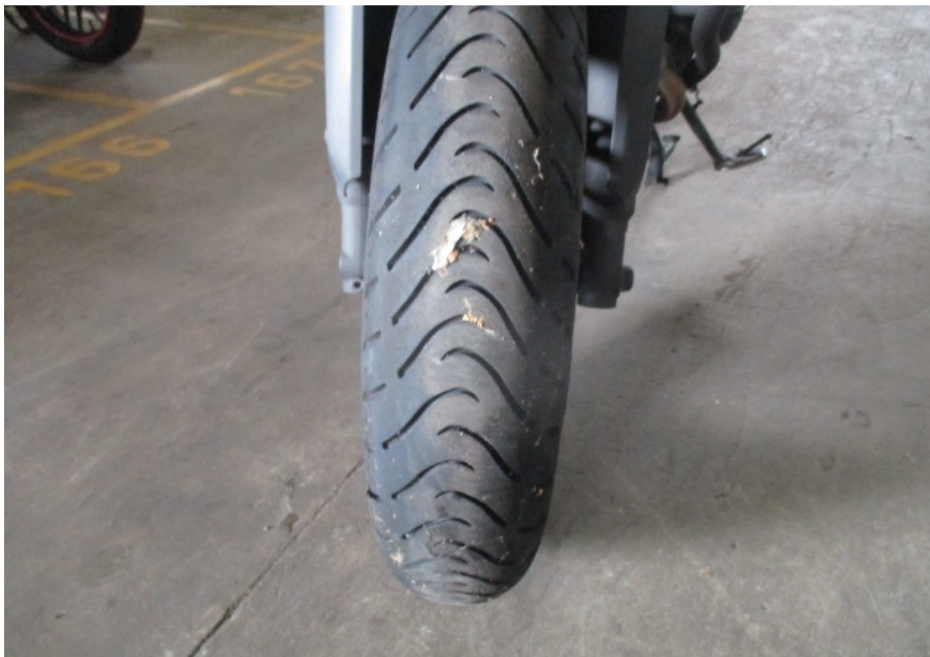
Photo 13 shows the condition of the Motorcycle's front tyre. The front tyre was observed to be in serviceable condition with remaining tread depth of approximately 4mm. There was no tear, burst mark(s) and/or punctured hole(s) on the sidewalls as well as across the tread of the front tyre.

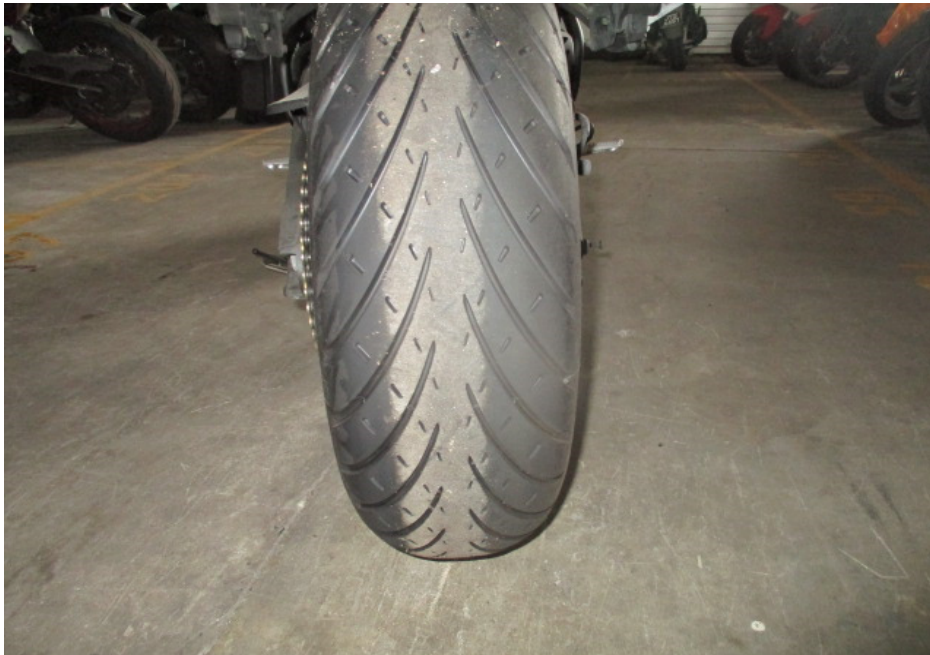
Photo 14 shows the condition of the Motorcycle's rear tyre. The rear tyre was observed to be in serviceable condition with remaining tread depth of approximately 3mm. The tyre was also observed to be sufficiently inflated for vehicular operation. We did not observe any tear, burst mark(s) and/or punctured hole(s) on the sidewalls as well as across the tread of the rear tyre.

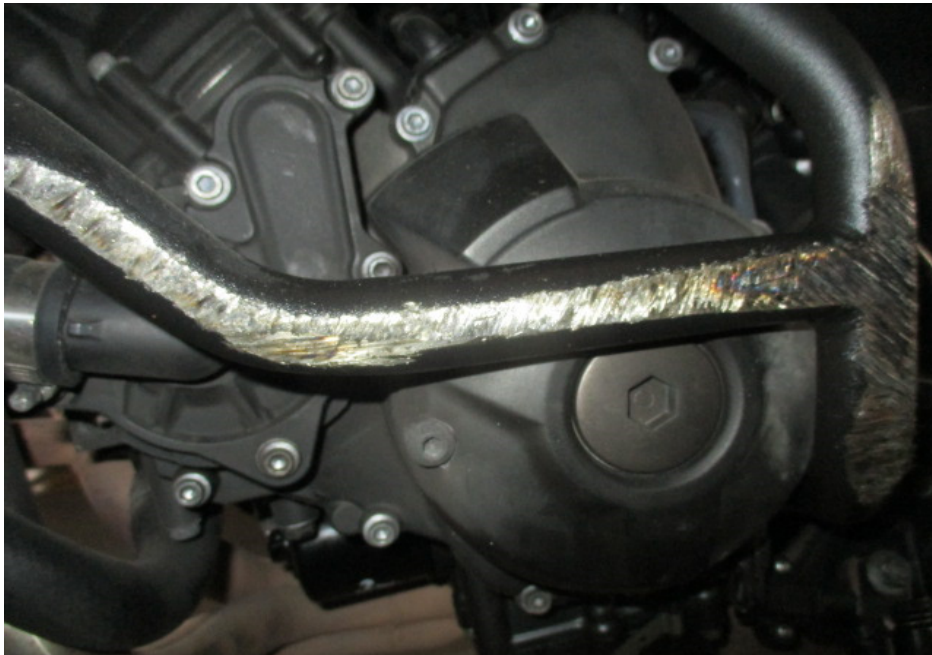
Photo 15 shows the left side of the engine of the Motorcycle at the time of our inspection. The various engine related parts and components were found to be intact with no visible damage. There was also no sign(s) or indication(s) of fluid leak observed around the left engine area of the Motorcycle.

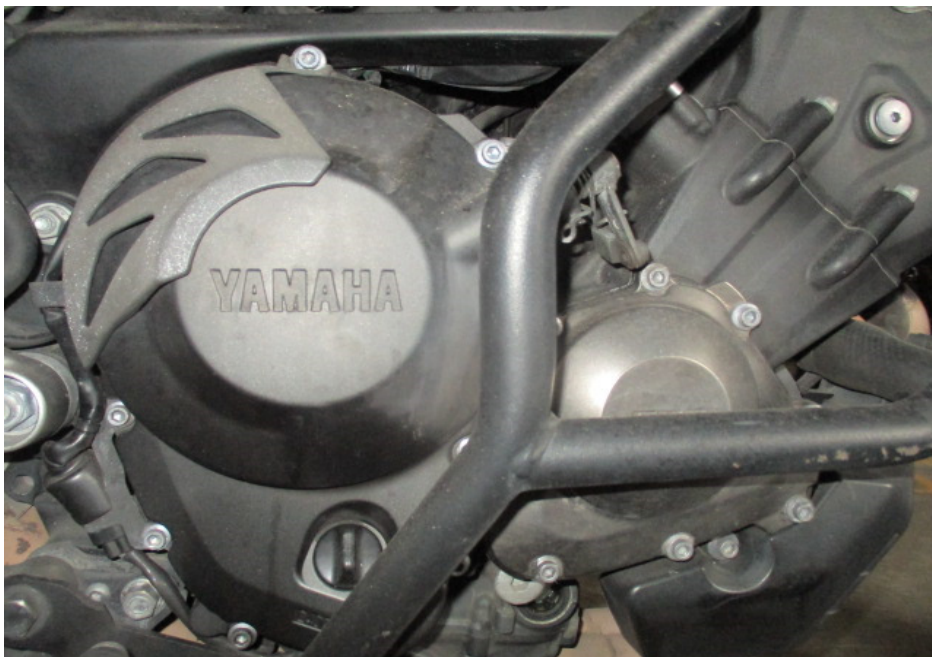
Photo 16 shows the right side of the engine of the Motorcycle at the time of our inspection. The various engine related parts and components were found to be intact with no visible damage. There was also no sign(s) or indication(s) of fluid leak observed around the right engine area of the Motorcycle.

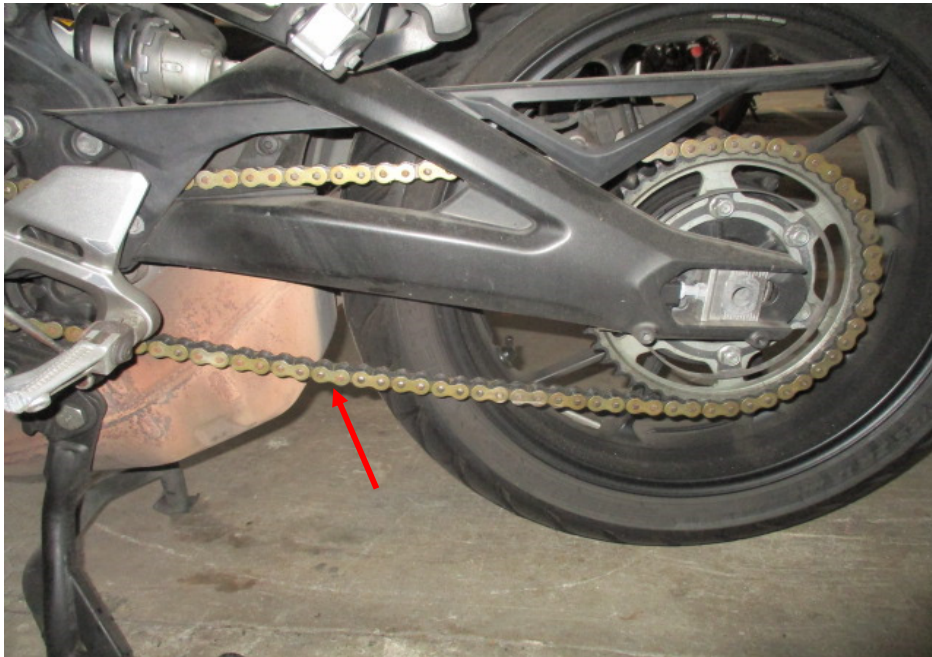
Photo 17 shows the general view of the gear train (arrowed) of the Motorcycle, which was observed to be intact with no misalignment. It was also adequately lubricated for operating purposes.

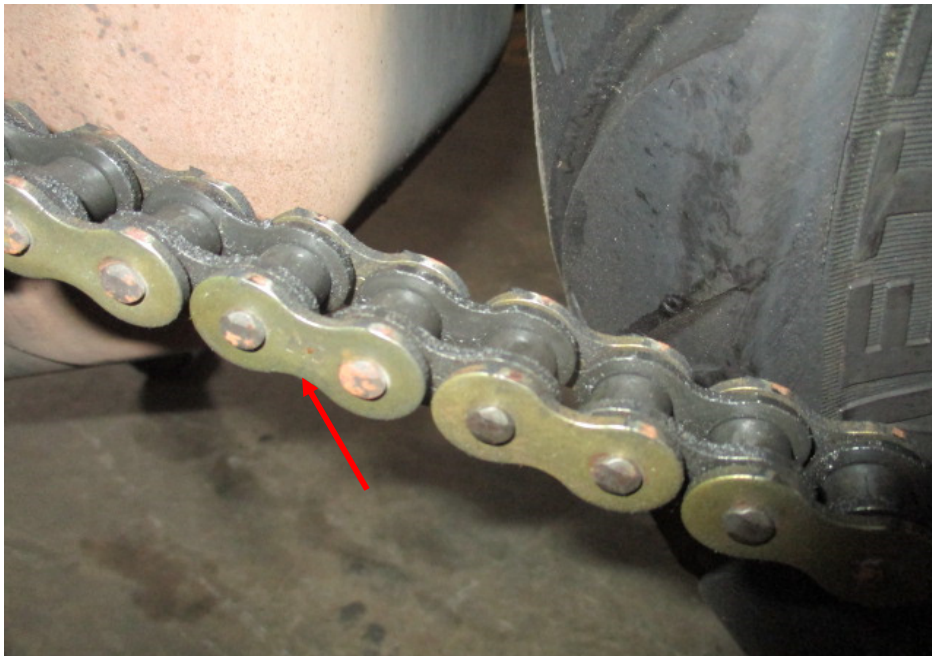
Photo 18 shows a closer view of the gear train (arrowed) of the Motorcycle, which was observed to be intact with no misalignment. It was also adequately lubricated for operating purposes.

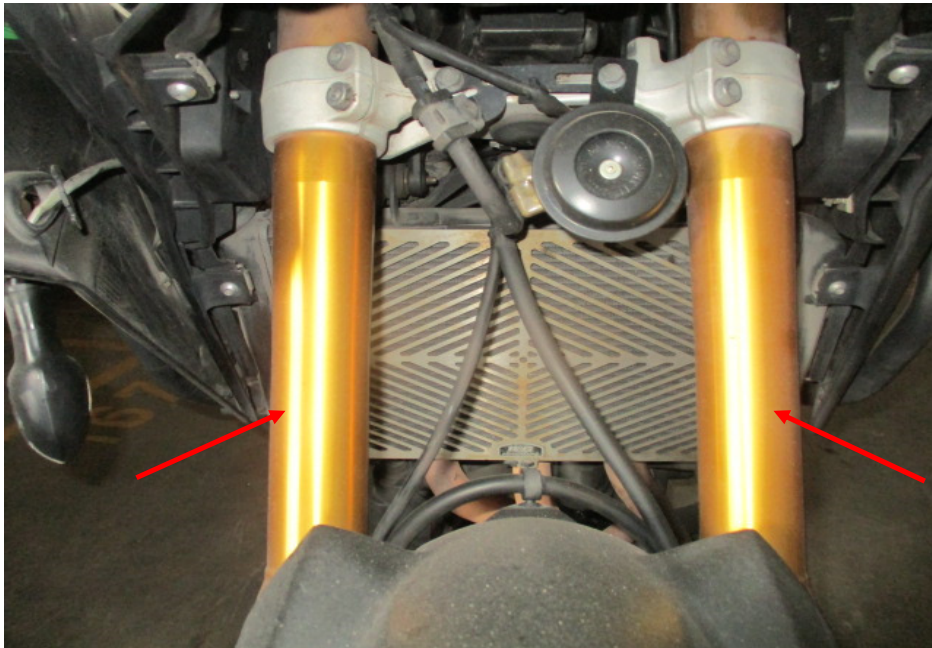
Photo 19 shows the front fork (arrowed) of the Motorcycle. The front fork and fork bracket of the Motorcycle were both found to be intact and undamaged. Turning the Motorcycle's handle bar towards the left and right did not produce any abnormal free play and/or resistance. The steering system of the Motorcycle was in serviceable condition at the time of our inspection.

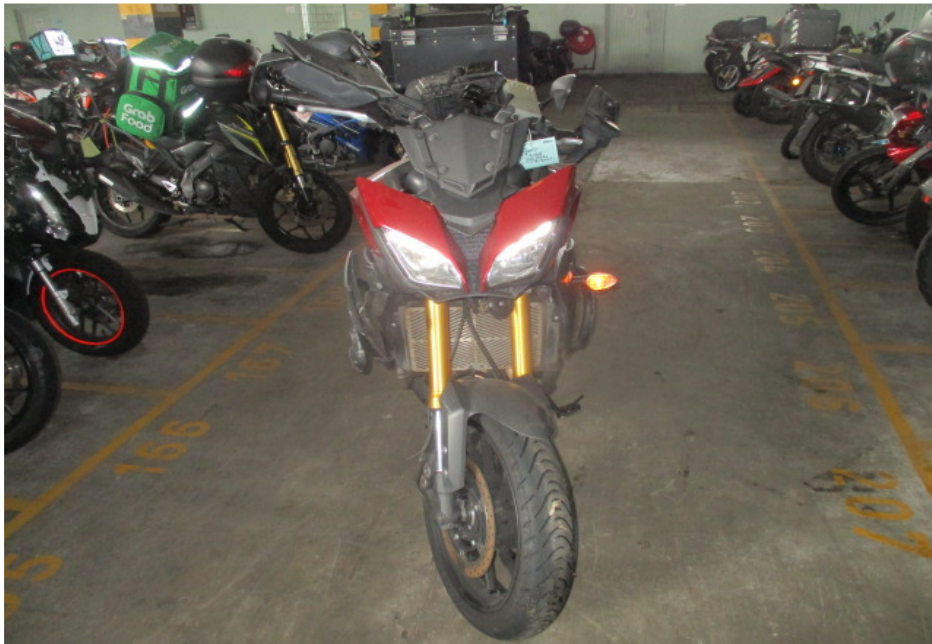
Photo 20 shows the front wheel of the Motorcycle turned towards its full left. Turning the Motorcycle's handle bar towards the left and right did not produce any abnormal free play and/or resistance. This would indicate that the steering system of the Motorcycle was in serviceable condition at the time of our inspection.

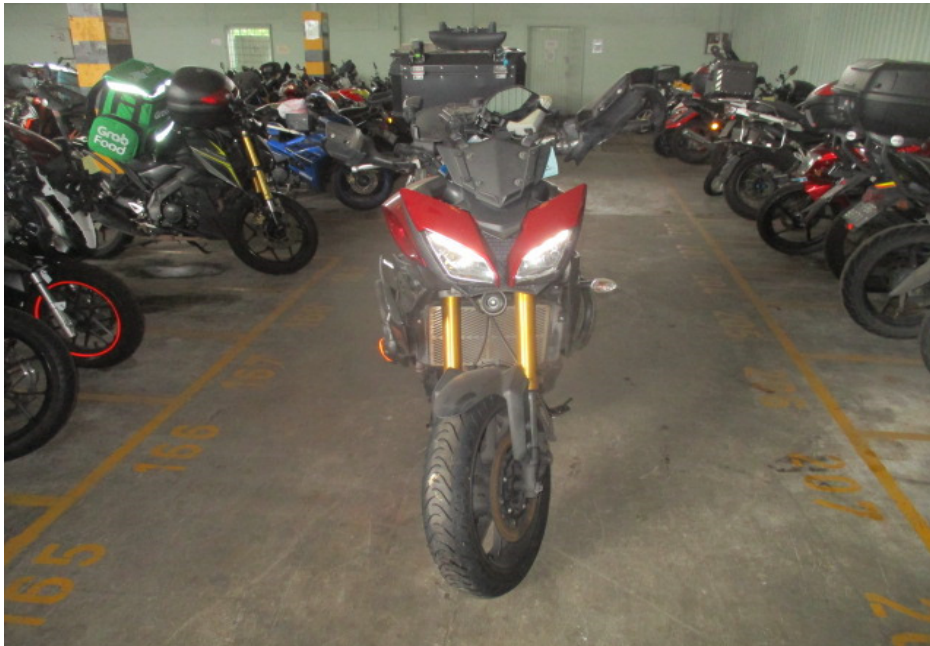
Photo 21 shows the front wheel of the Motorcycle turned towards its full right. Turning the Motorcycle's handle bar towards the left and right did not produce any abnormal free play and/or resistance. This would indicate that the steering system of the Motorcycle was in serviceable condition at the time of our inspection.

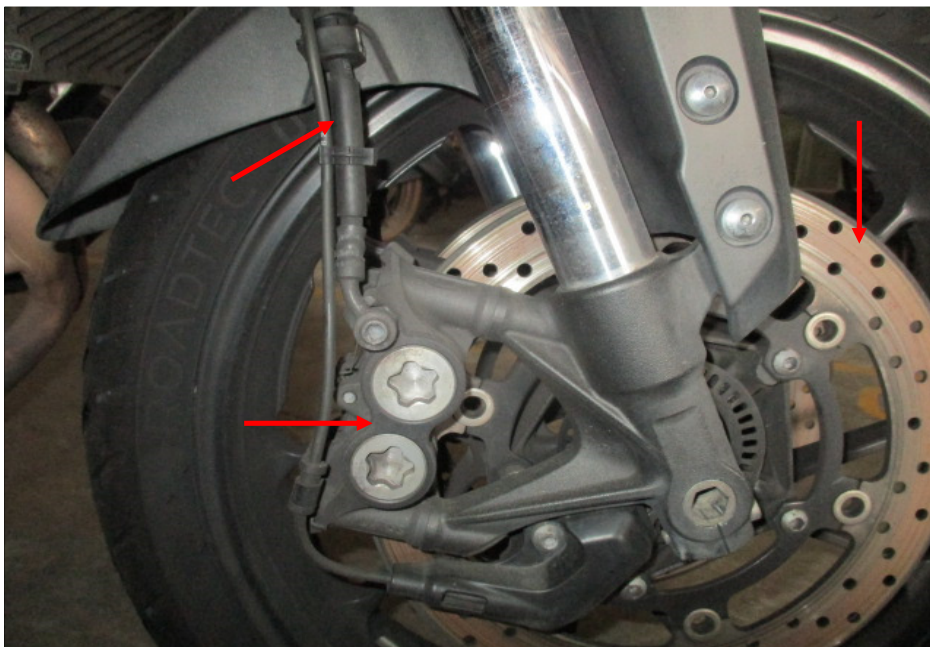
Photo 22 shows a close up view of the front brake caliper, front brake disc and front brake hose (arrowed) at the right side of the Motorcycle's front wheel, which are all part of the components in the hydraulic front brake system of the Motorcycle. Our visual checks of these various components had revealed all to be intact with no visible damage. No leakage of brake fluid was also observed.

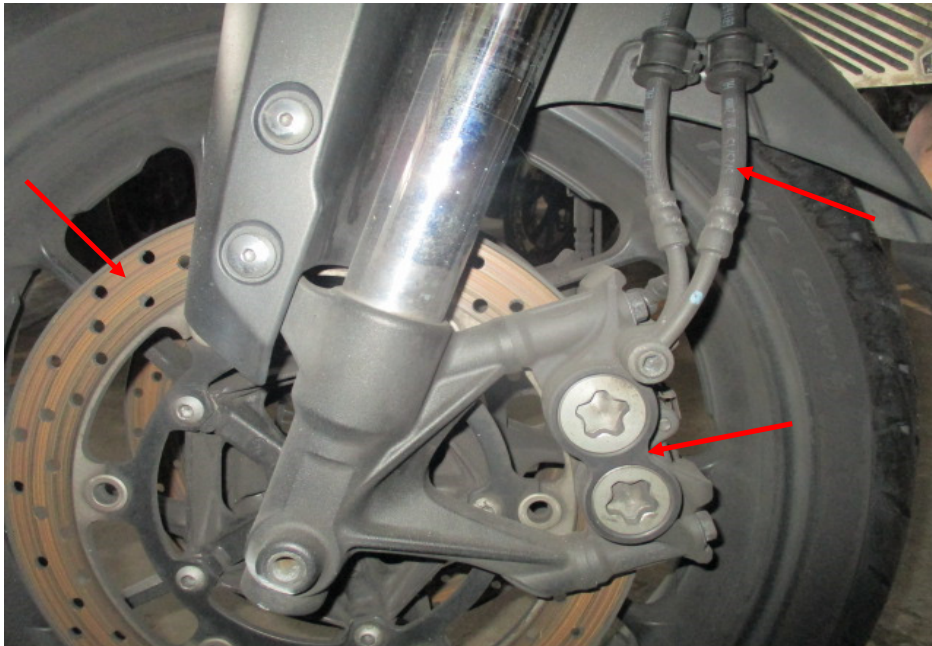
Photo 23 shows a close up view of the front brake caliper, front brake disc and front brake hose (arrowed) at the left side of the Motorcycle's front wheel, which are all part of the components in the hydraulic front brake system of the Motorcycle. Our visual checks of these various components had revealed all to be intact with no visible damage. No leakage of brake fluid was also observed.

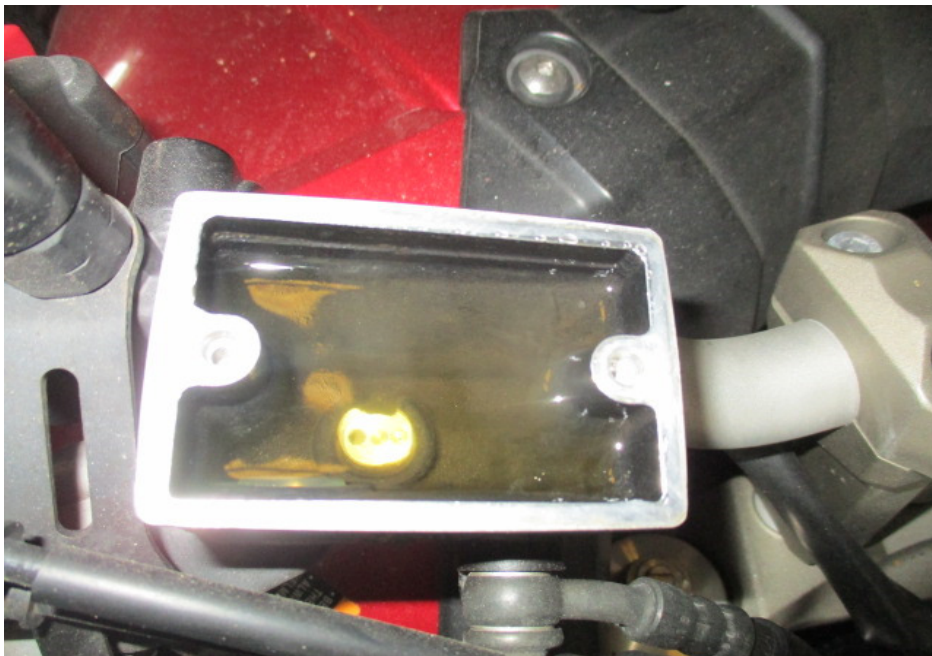
Photo 24 shows the brake fluid reservoir for the front brake of the Motorcycle. The brake fluid was observed to be of sufficient level and without contamination for operational purposes.

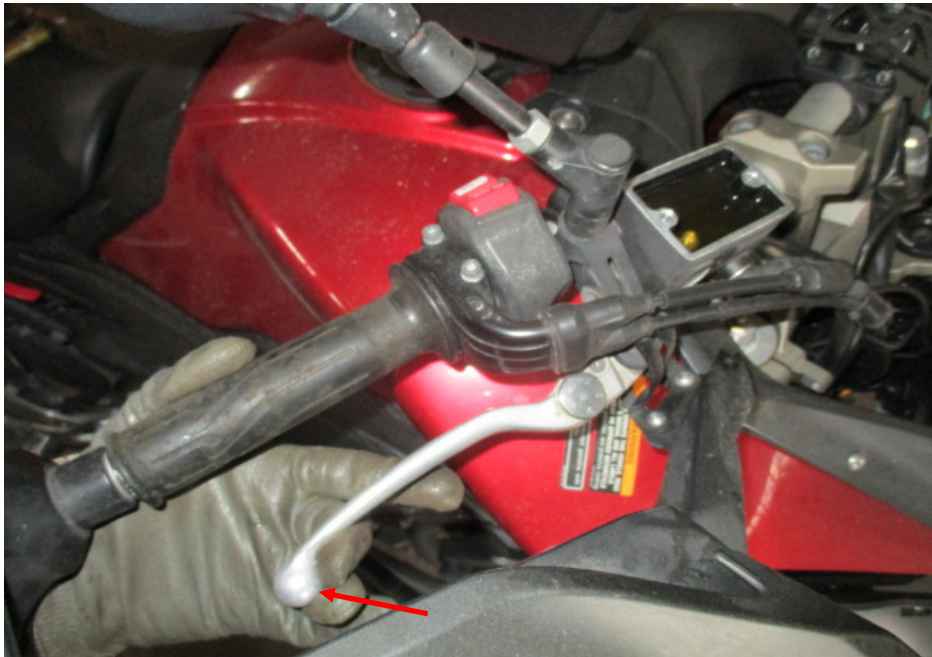
Photo 25 shows the front brake lever being depressed. There was some resistance felt (spongy like feel) upon pressing the front brake lever (arrowed). This would indicate that there is no leakage of pressure/vacuum in the brake system.

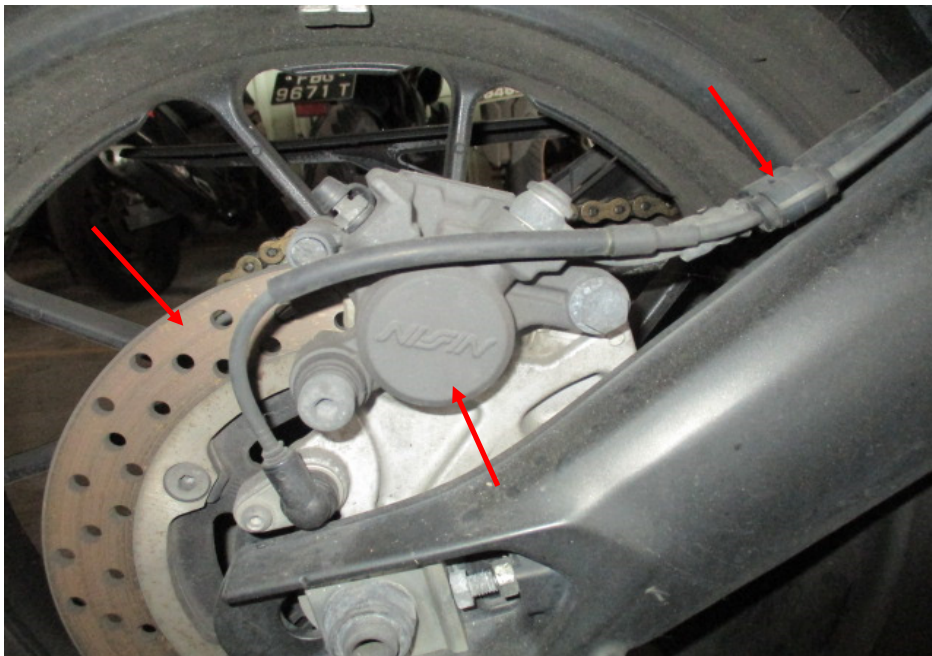
Photo 26 shows a close up view of the rear brake caliper, rear brake disc and rear brake hose (arrowed) of the Motorcycle, which are all part of the components in the hydraulic rear brake system of the Motorcycle. Our visual checks of these various components had revealed all to be intact with no visible damage. No leakage of brake fluid was also observed.
