Your Ref: TP/IP/49353/2020
Our Ref : CI/TPD21000484/N

Fatal Accident Investigation Team

INSPECTION REPORT OF MOTORCYCLE FBK 7687R

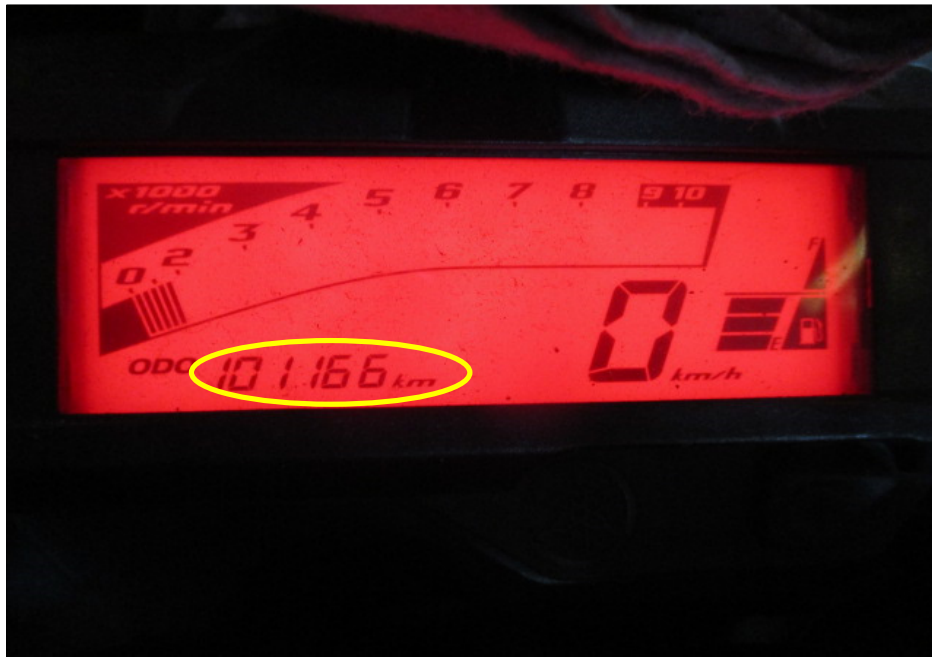
Photo 1 shows the speedometer gauge of the Motorcycle. The mileage of the Motorcycle at the time of our inspection was 101, 166km (circled).

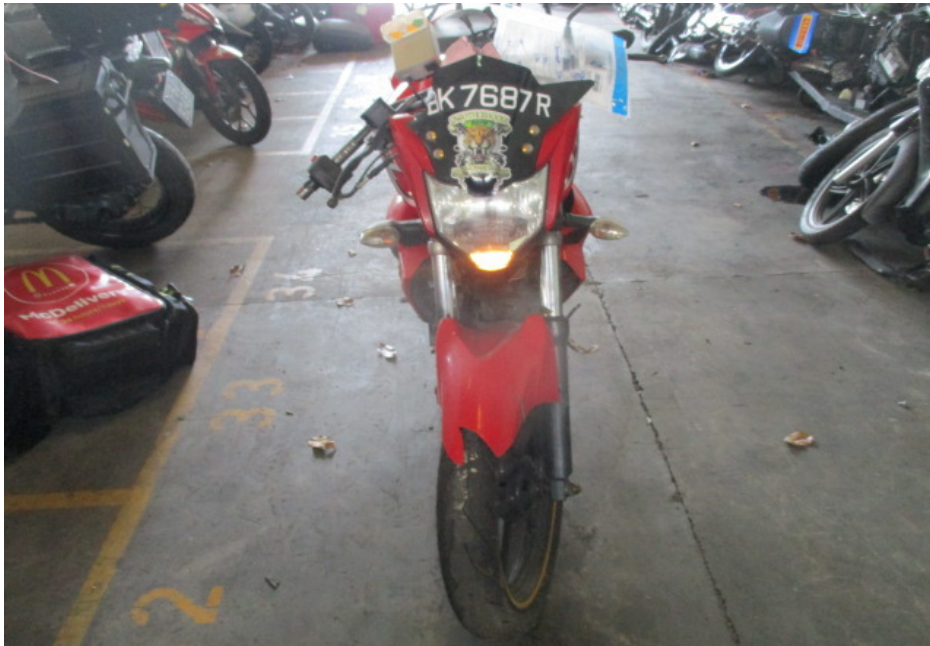
Photo 2 shows a general view of the frontal portion of the Motorcycle at the time of our inspection. The Motorcycle was observed to have sustained damages all around.

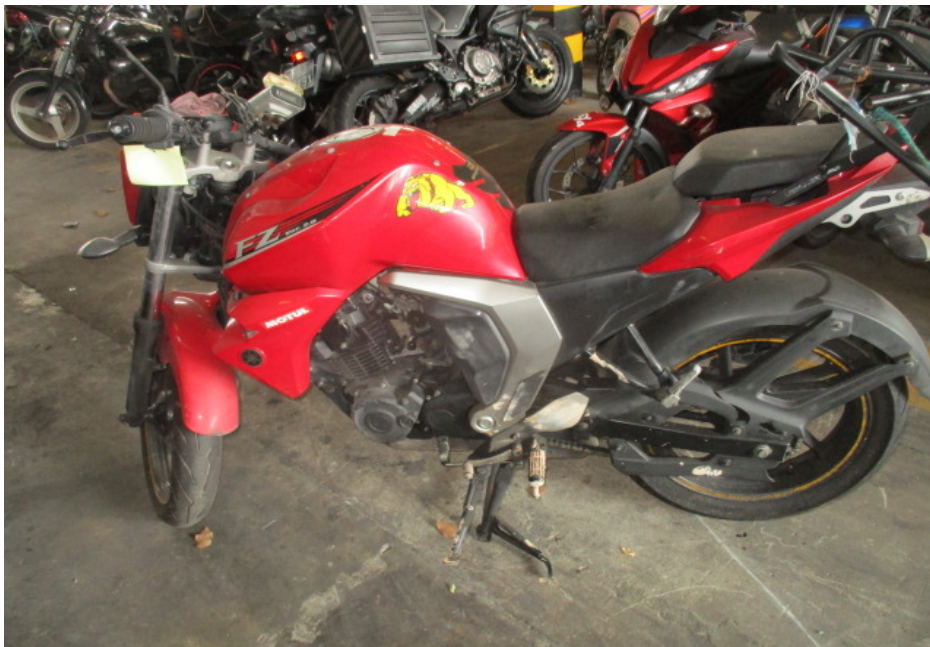
Photo 3 shows a general view of the left body of the Motorcycle at the time of our inspection. The Motorcycle was observed to have sustained damages all around. Amongst the body parts that were found to have been damaged include its windshield, front mudguard, left cowling, clutch lever, side mirrors, handlebar, fuel tank, left pillion foot peg, rear side covers, right front footrest, exhaust muffler, exhaust muffler heat shield, top box rack and rear mudguard, amongst others.

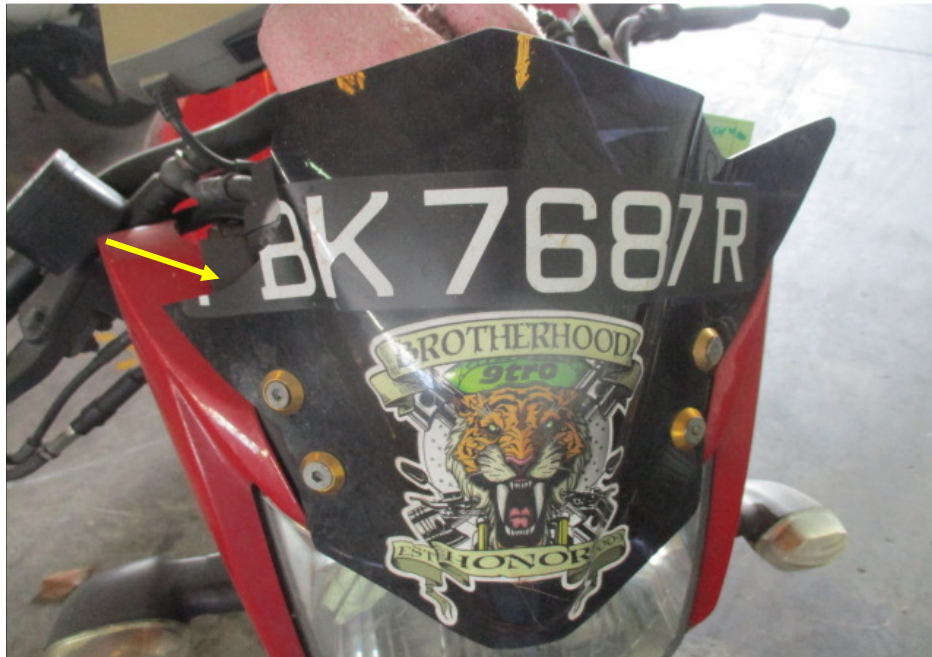
Photo 4 shows a close up view of the windshield which was amongst the body parts at the front of the Motorcycle that had sustained damage as a result of the accident (arrowed).

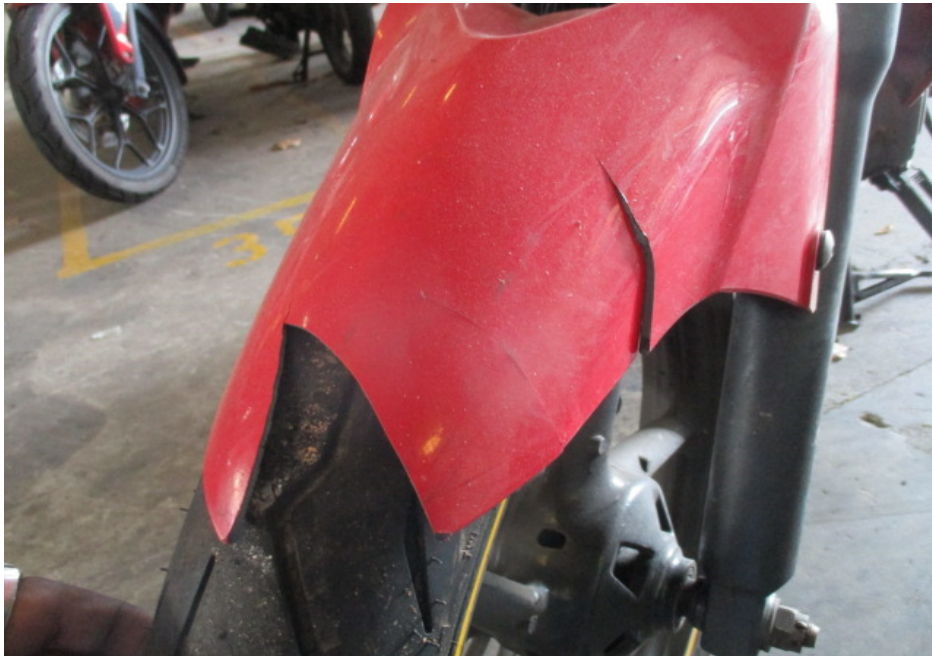
Photo 5 shows a closer view of the cracked front mudguard of the Motorcycle as a result of the accident.

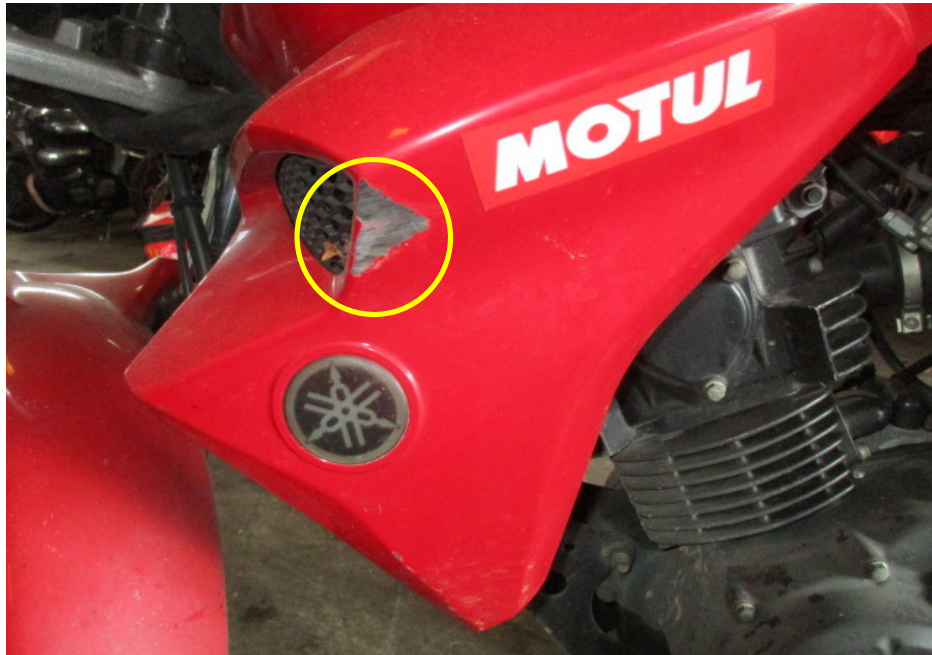
Photo 6 shows a closer view of the left cowling which was amongst the body parts of the Motorcycle that had sustained damage as a result of the accident (circled).

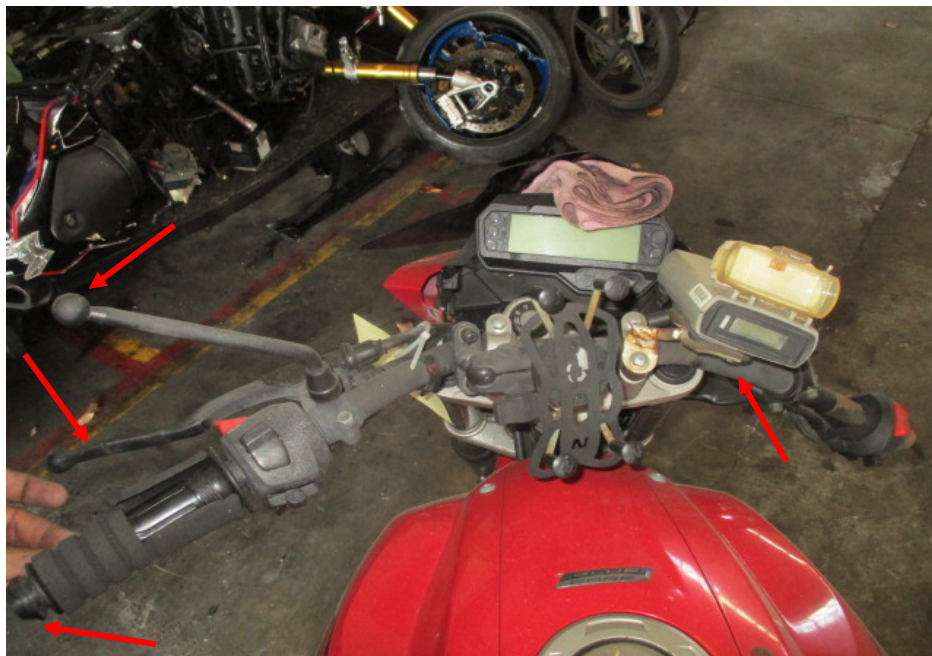
Photo 7 shows the clutch lever, left handlebar end, side mirrors and handlebar (arrowed), which were amongst the body parts of the Motorcycle that had sustained damage as a result of the accident.

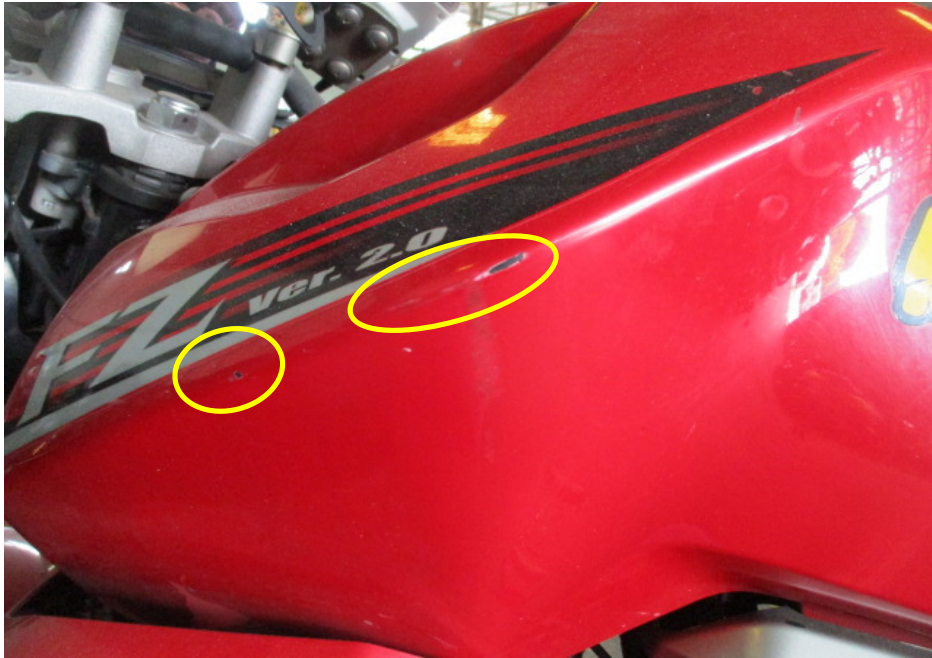
Photo 8 shows a closer view of the fuel tank (circled) which was amongst the body parts of the Motorcycle that had sustained damage as a result of the accident.

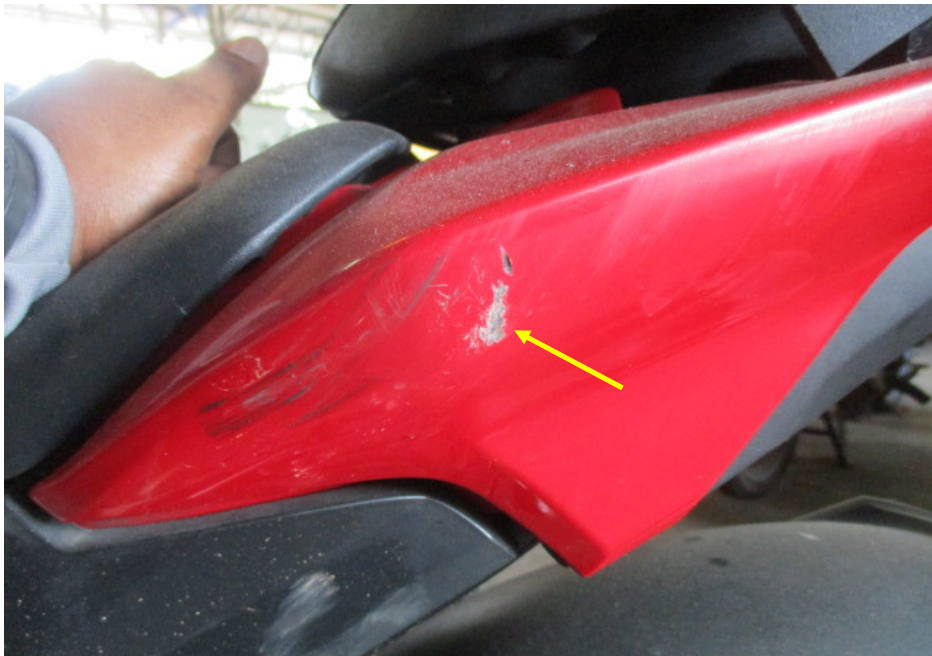
Photo 9 shows a closer view of the left rear side cover which was amongst the body parts of the Motorcycle that had sustained damages of grazing nature as a result of the accident (arrowed).

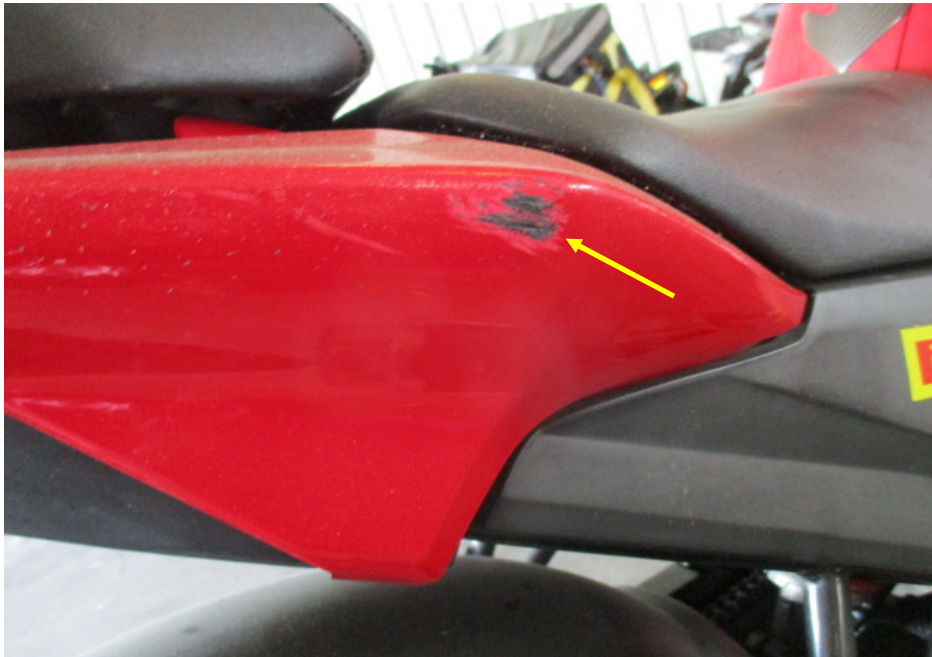
Photo 10 shows a closer view of the right rear side cover which was amongst the body parts of the Motorcycle that had sustained damages of grazing nature as a result of the accident (arrowed).

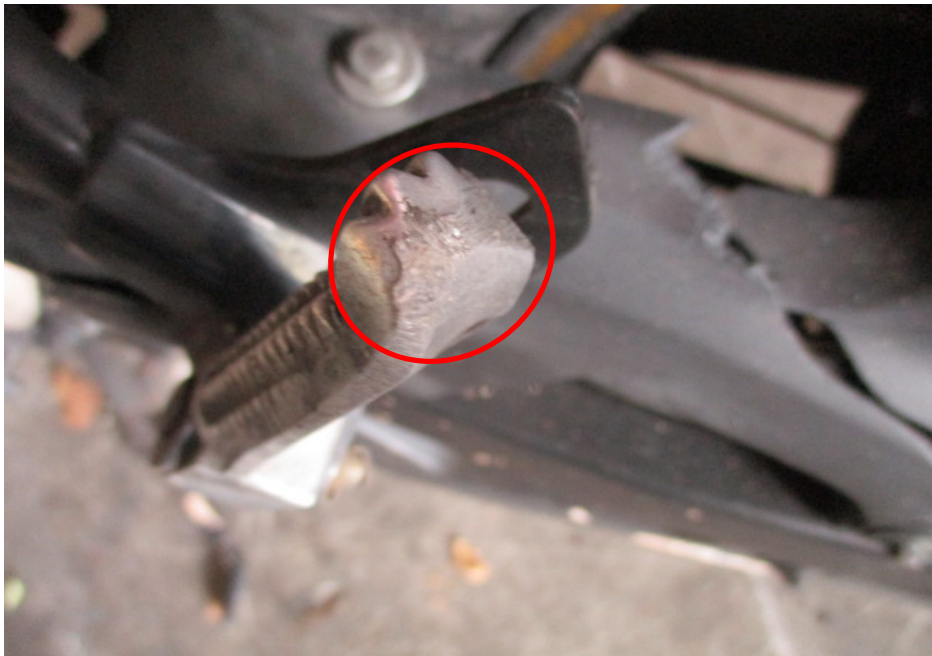
Photo 11 shows a closer view of the left pillion foot peg which was amongst the body parts of the Motorcycle that had sustained damages of grazing nature as a result of the accident (circled).

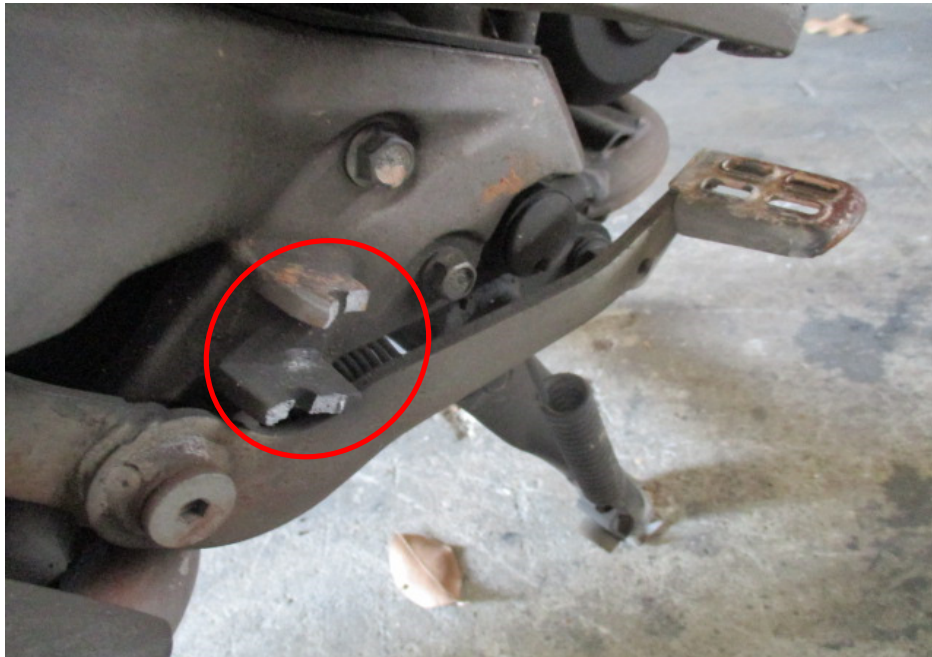
Photo 12 shows a closer view of the broken right footrest of the Motorcycle as a result of the accident (circled).

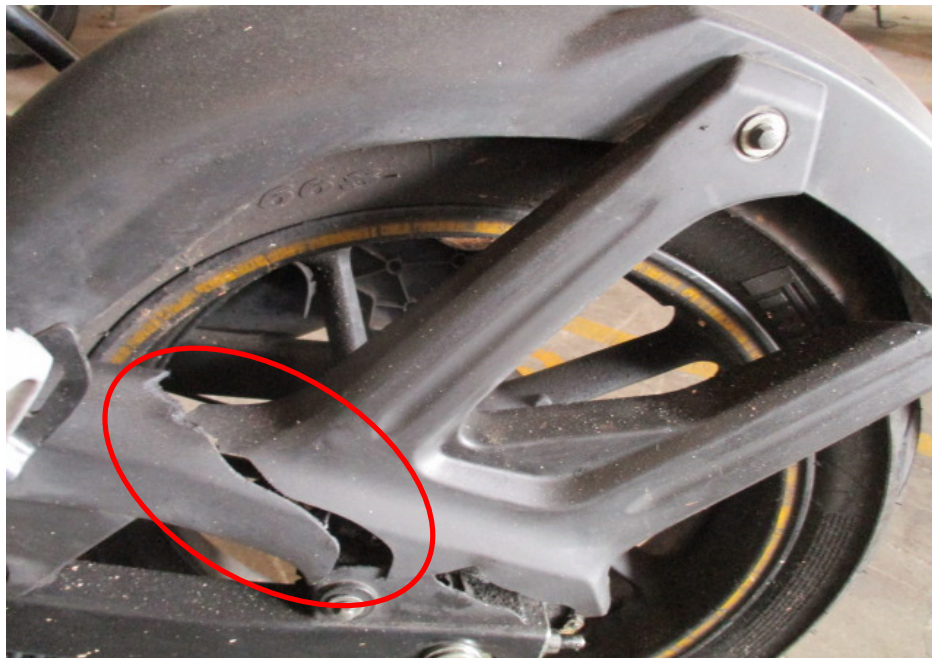
Photo 13 shows the cracked rear mudguard (circled) of the Motorcycle as a result of the accident.

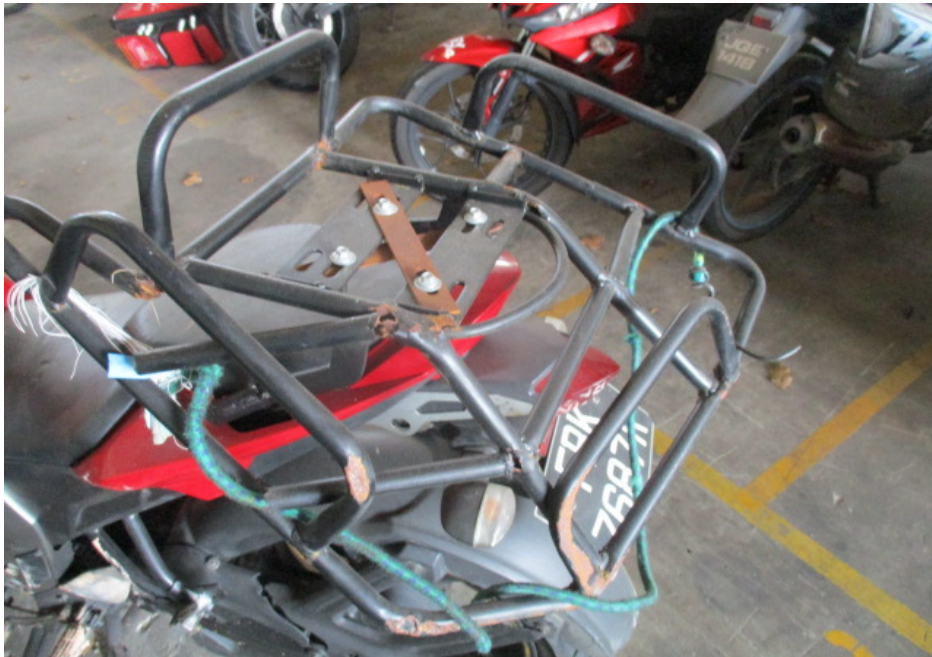
Photo 14 shows the top box rack of the Motorcycle that had sustained extensive damage as a result of the accident.

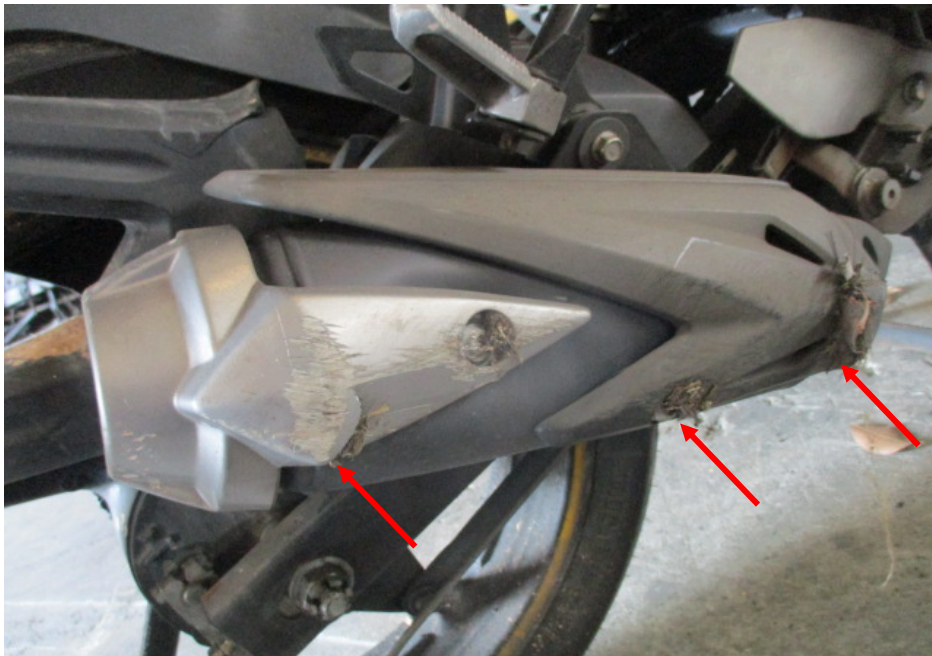
Photo 15 shows a closer view of the exhaust muffler and exhaust muffler heat shield which were amongst the body parts of the Motorcycle that had sustained damages of grazing nature as a result of the accident (circled).

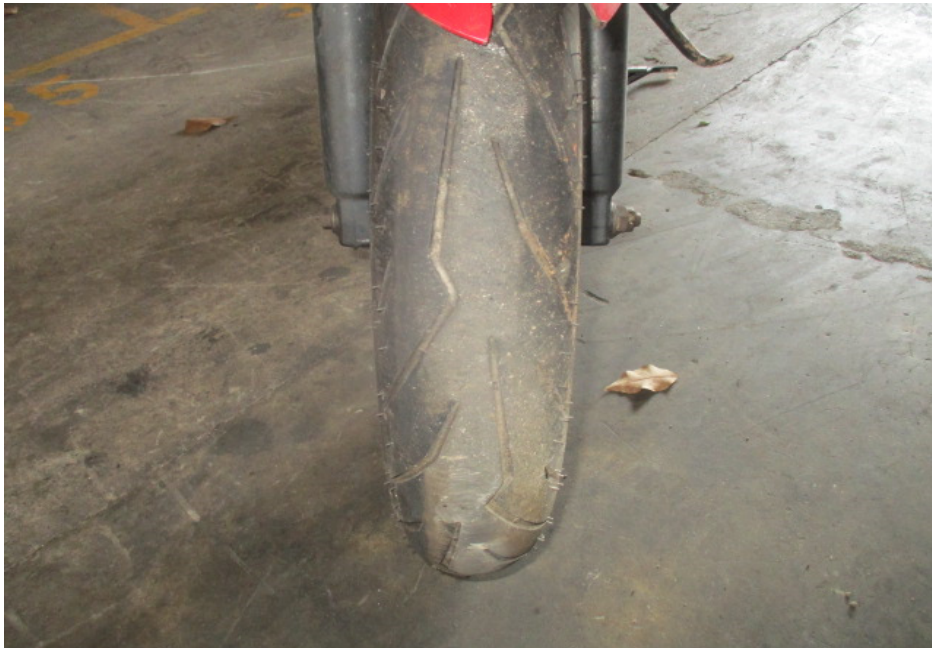
Photo 16 shows the front tyre of the Motorcycle at the time of our inspection. The front tyre was observed to be in serviceable condition with remaining tread depth of approximately 3mm. The pattern of the tread was also clearly visible. There was no tear, burst mark(s) and/or punctured hole(s) on the sidewalls as well as across the tread of the front tyre.

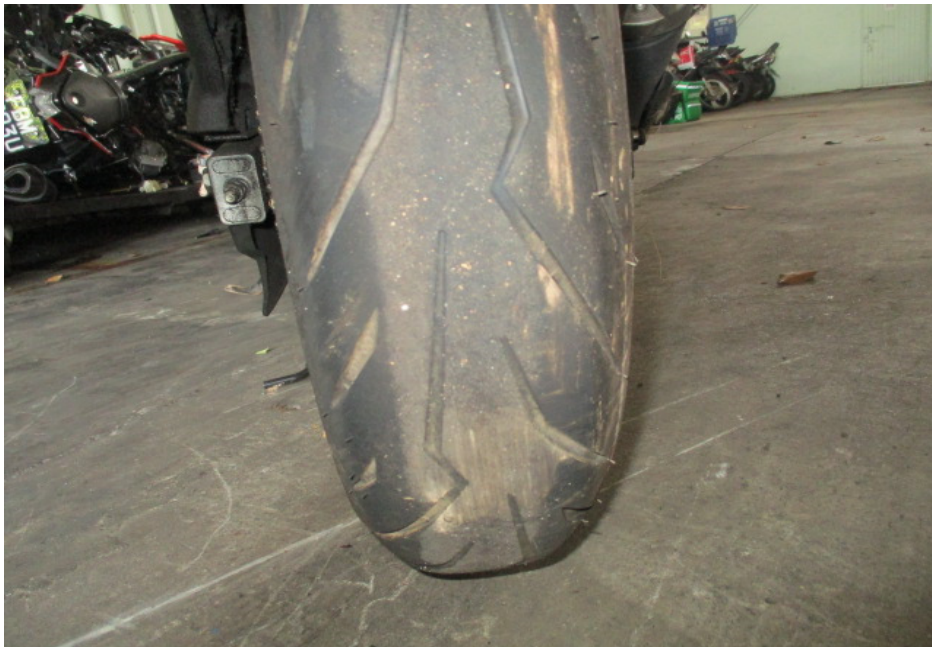
Photo 17 shows the condition of the Motorcycle's rear tyre. The rear tyre was observed to be in serviceable condition with remaining tread depth of approximately 3mm. The tyre was also observed to be sufficiently inflated for vehicular operation. We did not observe any tear, burst mark(s) and/or punctured hole(s) on the sidewalls as well as across the tread of the rear tyre.

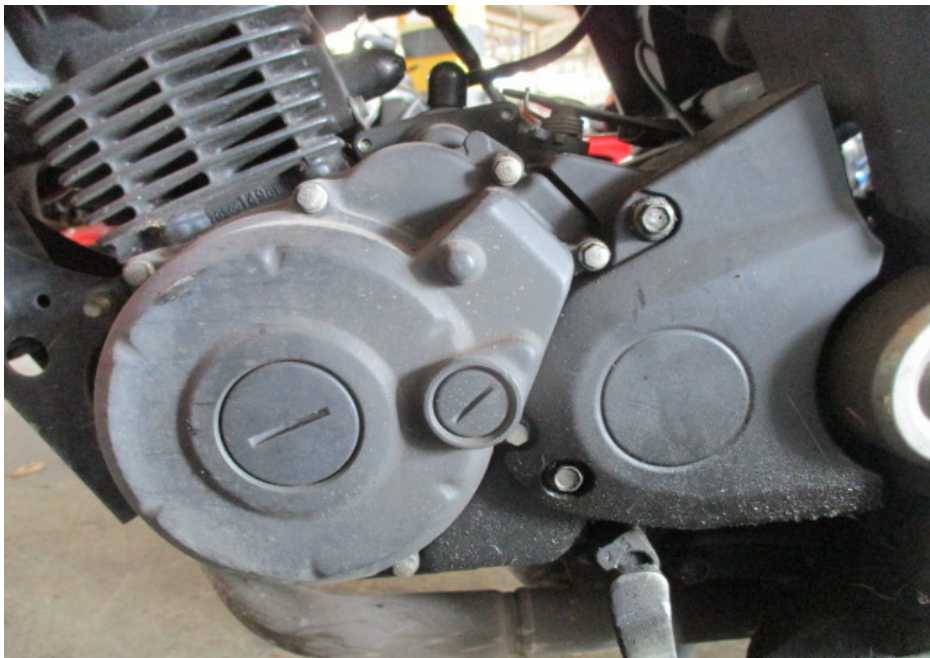
Photo 18 shows the left side of the engine of the Motorcycle at the time of our inspection. The various engine related parts and components were found to be intact with no visible damage. There was also no sign(s) or indication(s) of fluid leak observed around the left engine area of the Motorcycle.

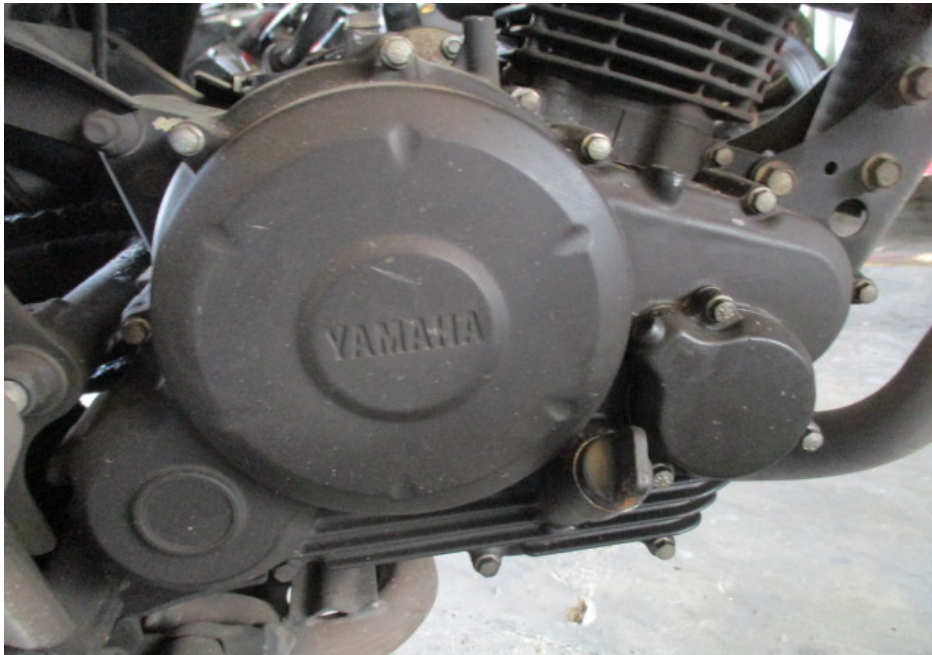
Photo 19 shows the right side of the engine of the Motorcycle at the time of our inspection. The various engine related parts and components were found to be intact with no visible damage. There was also no sign(s) or indication(s) of fluid leak observed around the right engine area of the Motorcycle.

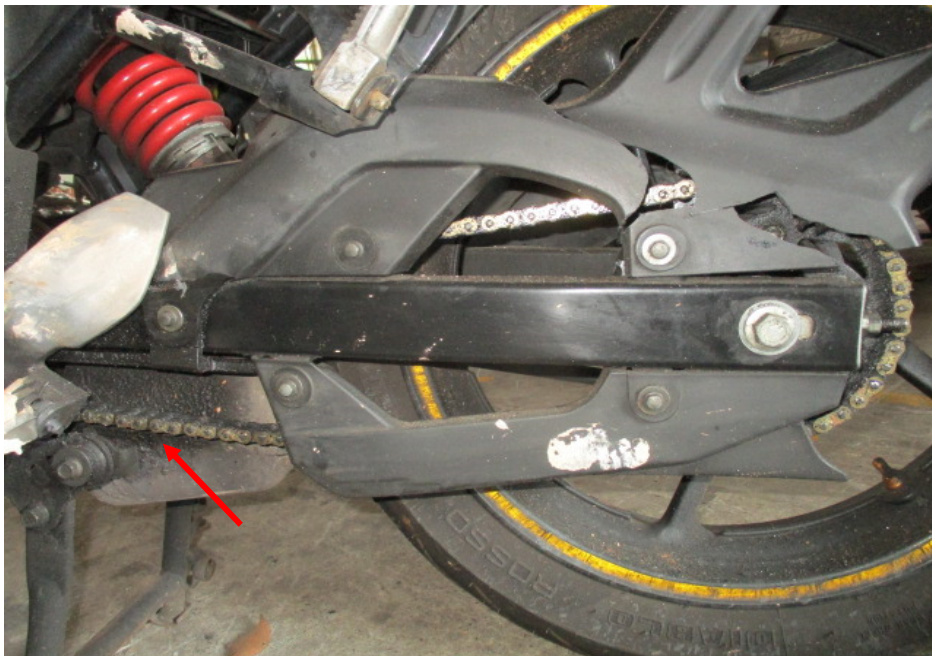
Photo 20 shows the general view of the gear train (arrowed) of the Motorcycle, which was observed to be intact with no misalignment. It was also adequately lubricated for operating purposes.

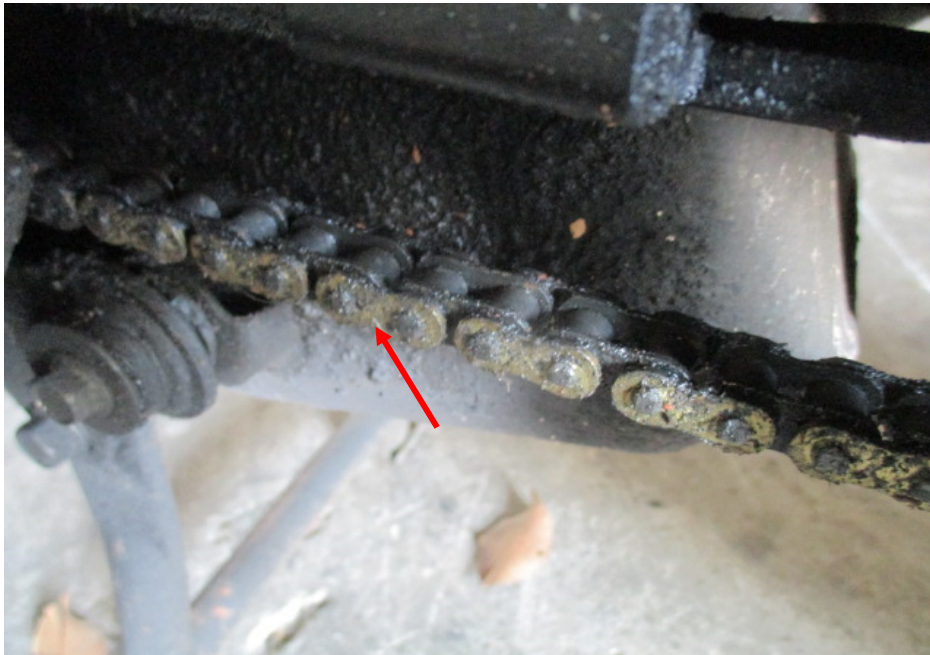
Photo 21 shows a closer view of the gear train (arrowed) of the Motorcycle, which was observed to be intact with no misalignment. It was also adequately lubricated for operating purposes.

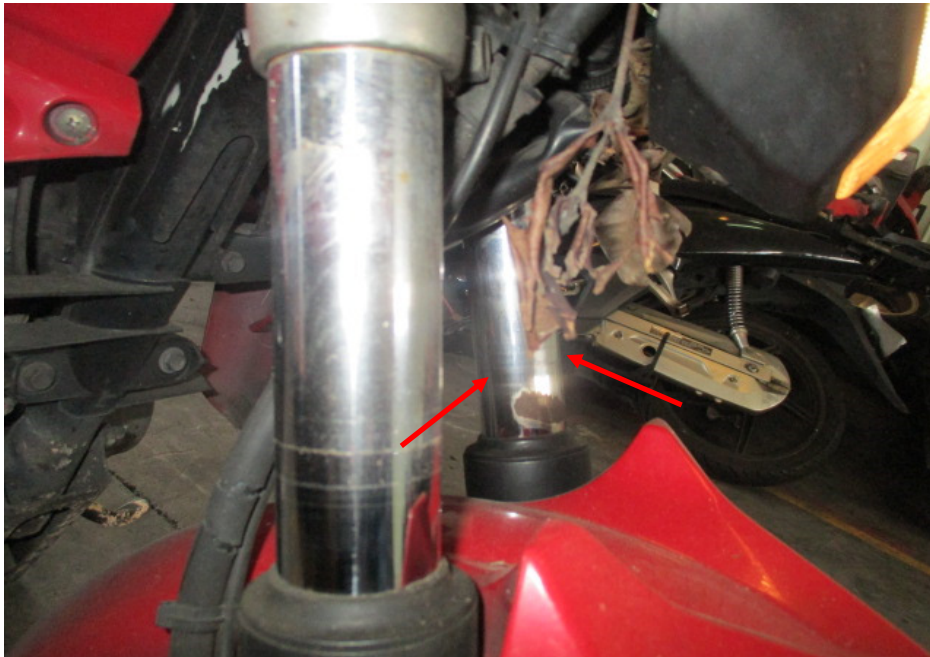
11. For this case, we were not able to conduct any test(s) on the steering system of the Motorcycle due to the damage of its left front fork. The left front fork was found to be bent inwards as a result of the accident.

Photo 22 shows the front forks of the Motorcycle. The left front fork was found to be bent inwards as a result of the accident (arrowed).

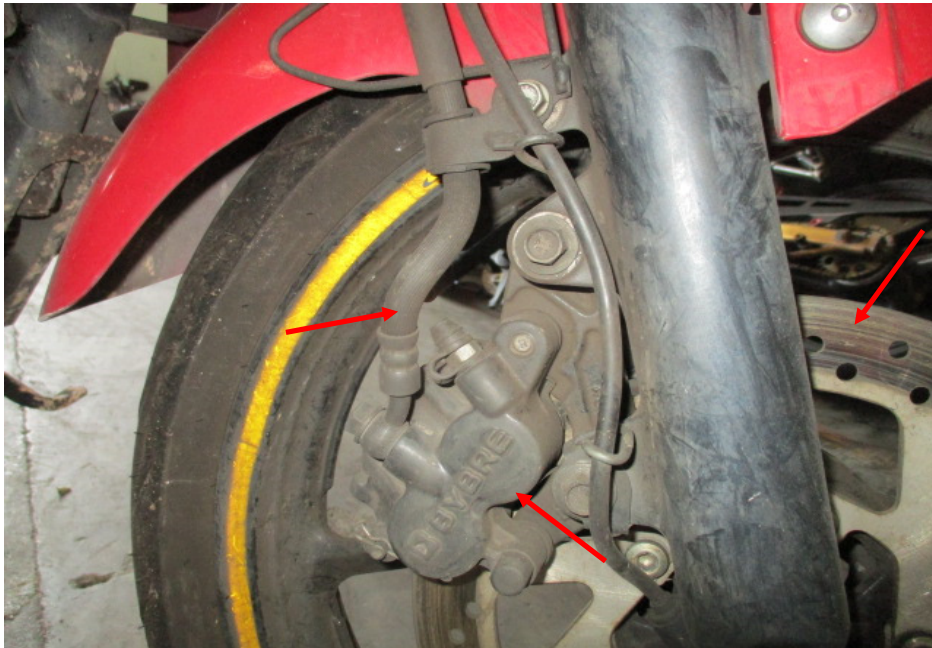
Photo 23 shows a close up view of the front brake caliper, front brake disc and front brake hose (arrowed) of the Motorcycle, which are all part of the components in the hydraulic front brake system of the Motorcycle. Our visual checks of these various components had revealed all to be intact with no visible damage. No leakage of brake fluid was also observed.

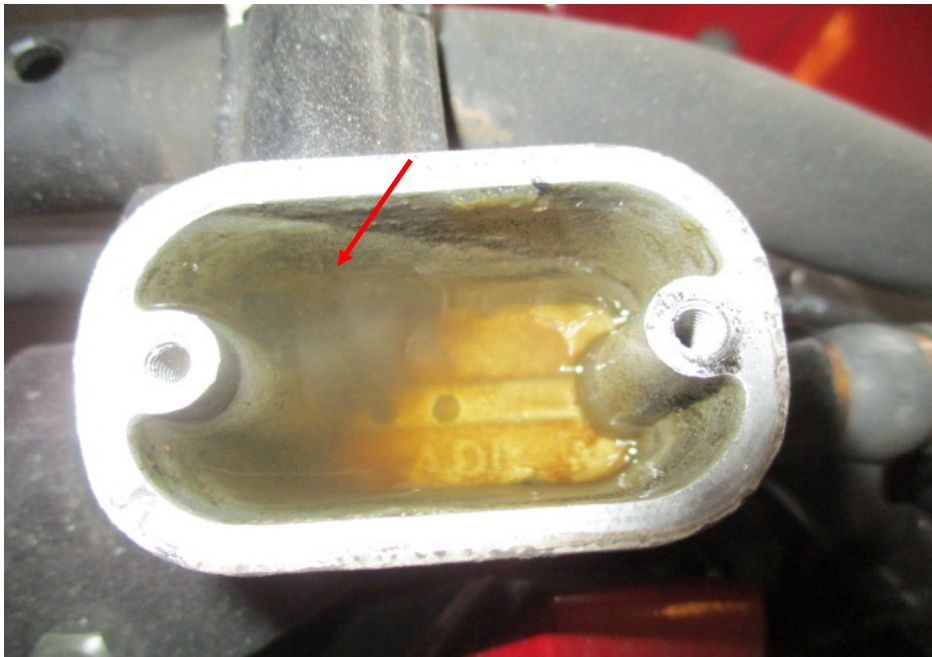
Photo 24 shows the brake fluid reservoir for the front brake of the Motorcycle. The brake fluid was found to be of sufficient level for operating purposes. However the brake fluid was found to be slightly contaminated (arrowed).

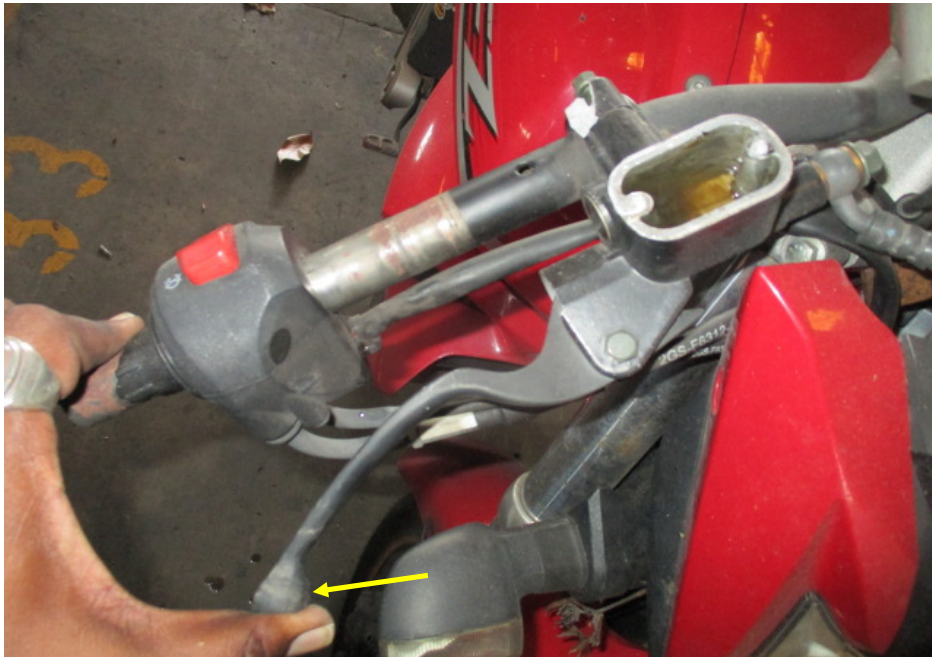
Photo 25 shows the front brake lever being depressed. There was some resistance felt (spongy like feel) upon pressing the front brake lever (arrowed). This would indicate that there is no leakage of pressure/vacuum in the brake system.

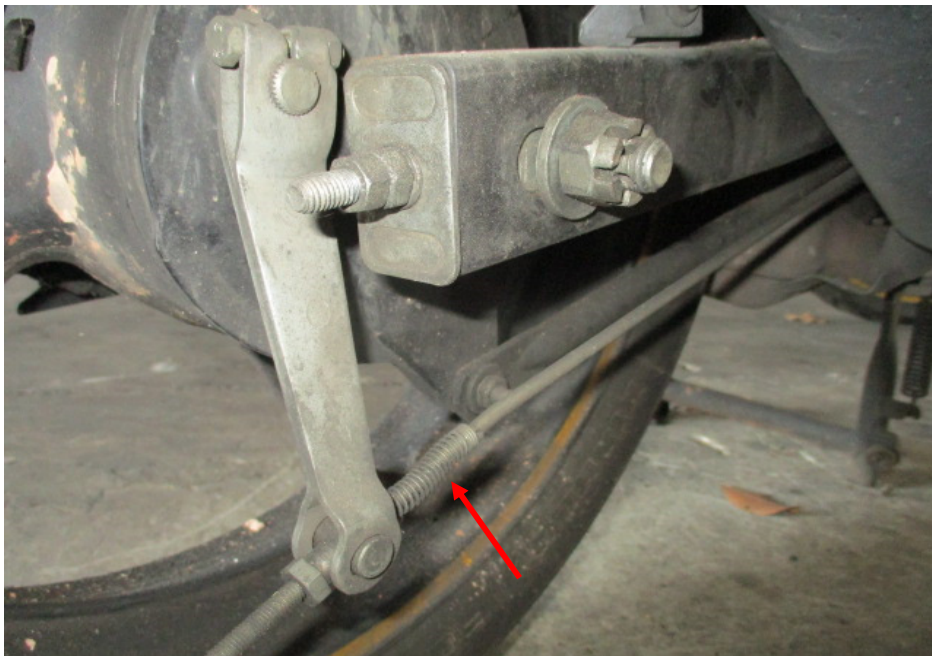
Photo 26 shows the rear wheel of the Motorcycle. The type of brake system for the rear wheel was of a mechanical type, controlled by the brake foot pedal of the Motorcycle. Our checks of the cable (arrowed), spring and drum which are all part of the components in the rear brake system of the Motorcycle reveal all to be intact and without damage.
