Your Ref: TP/IP/50993/2020  
Our Ref : CI/TPD21000487/N

3 March 2021

**Fatal Accident Investigation Team**

**INSPECTION REPORT OF MOTORCYCLE FBK 1245Y**

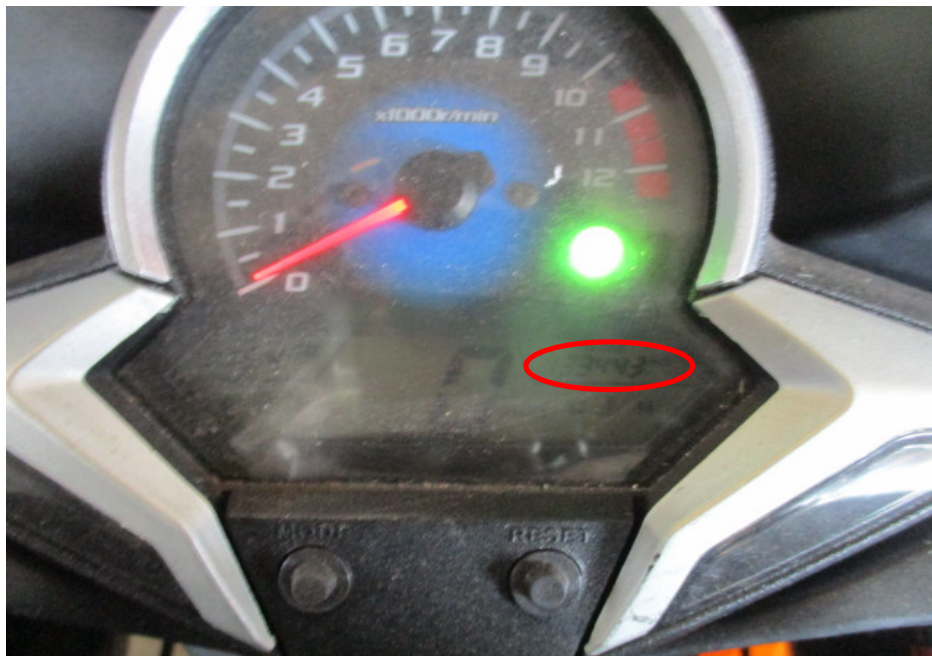
4. The mileage of the Motorcycle at the time of our inspection was 133, 443km.
5. The Motorcycle was observed to have sustained damages all around. The body parts that were found to have been damaged include its front mudguard, head cowlings, side cowlings, left handlebar grip, side mirrors, front brake lever, clutch lever, gear shift pedal, rear brake pedal, left front footrest, right front footrest, rear side covers and exhaust muffler, amongst others.

**Photo 1** shows the speedometer gauge of the Motorcycle where the mileage recorded at the time of our inspection was 133, 443km (circled).

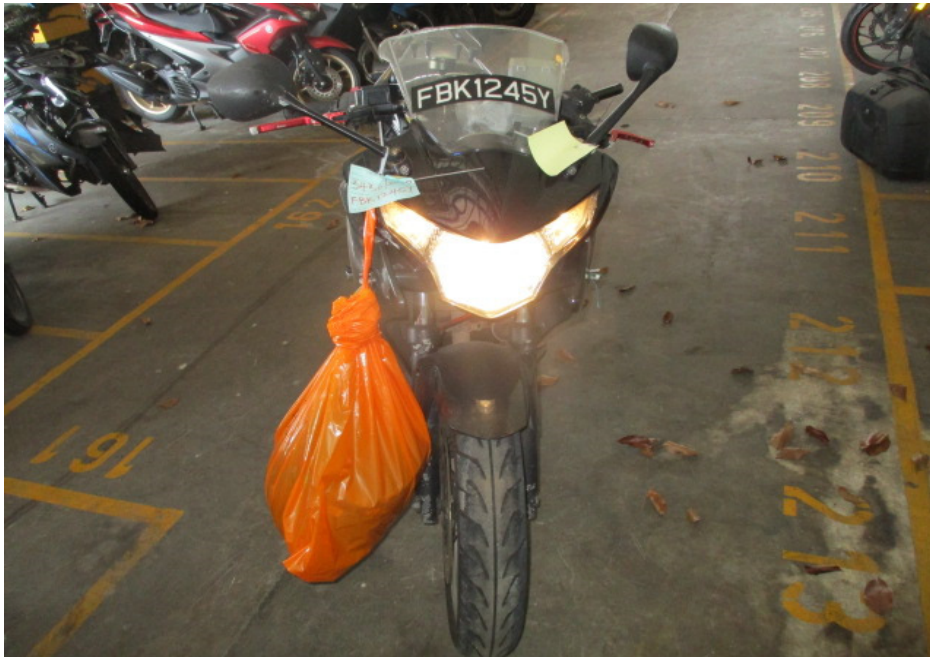
**Photo 2** shows a general view of the frontal portion of the Motorcycle at the time of our inspection. The Motorcycle was observed to have sustained damages all around.

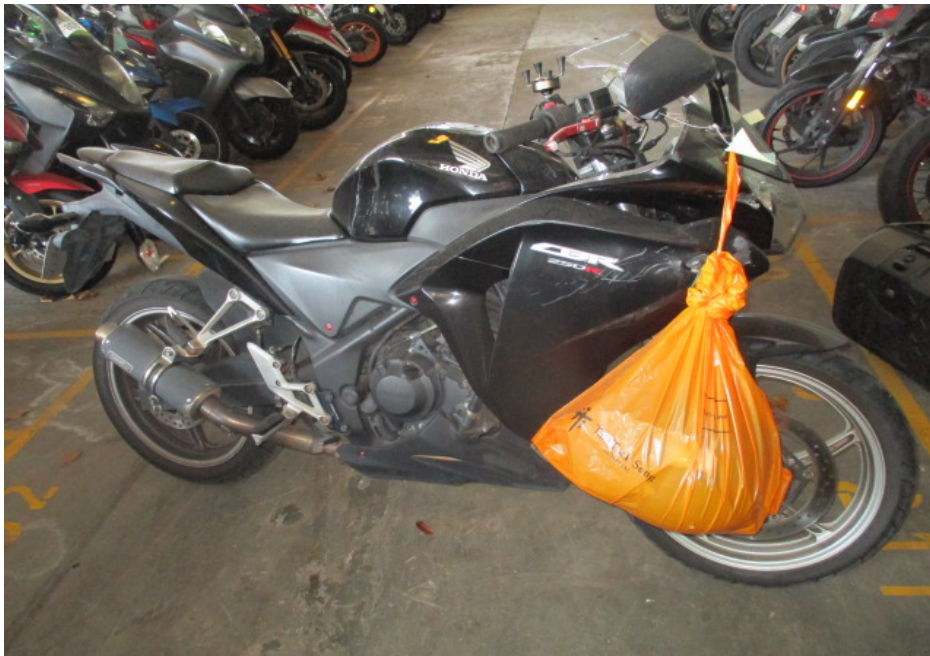
**Photo 3** shows a general view of the right body of the Motorcycle at the time of our inspection. The Motorcycle was observed to have sustained damages all around.

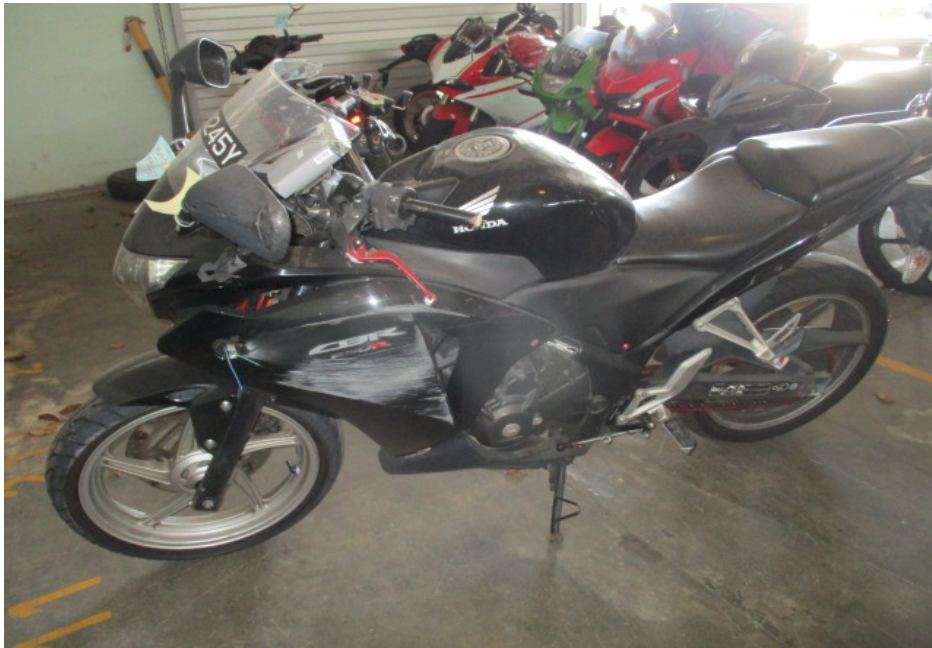
**Photo 4** shows a general view of the left body of the Motorcycle at the time of our inspection. The Motorcycle was observed to have sustained damages all around. Amongst the body parts that were found to have been damaged include its front mudguard, head cowl, side cowlings, left handlebar grip, side mirrors, front brake lever, clutch lever, gear shift pedal, rear brake pedal, left front footrest, right front footrest, rear side covers and exhaust muffler, amongst others.

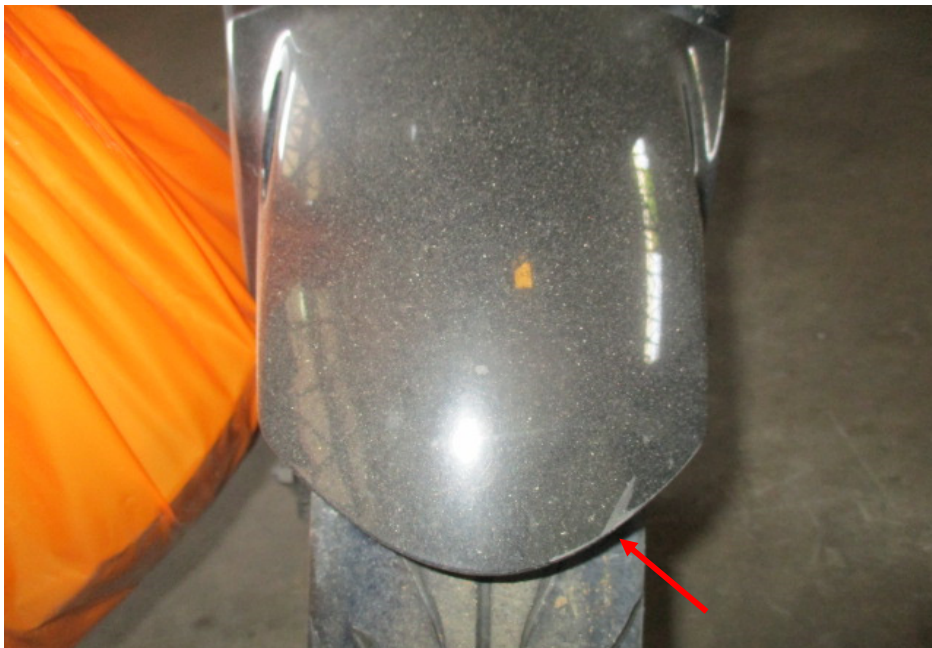
**Photo 5** shows a closer view of the front mudguard which was amongst the body parts at the front body of the Motorcycle that had sustained damage as a result of the accident (arrowed).

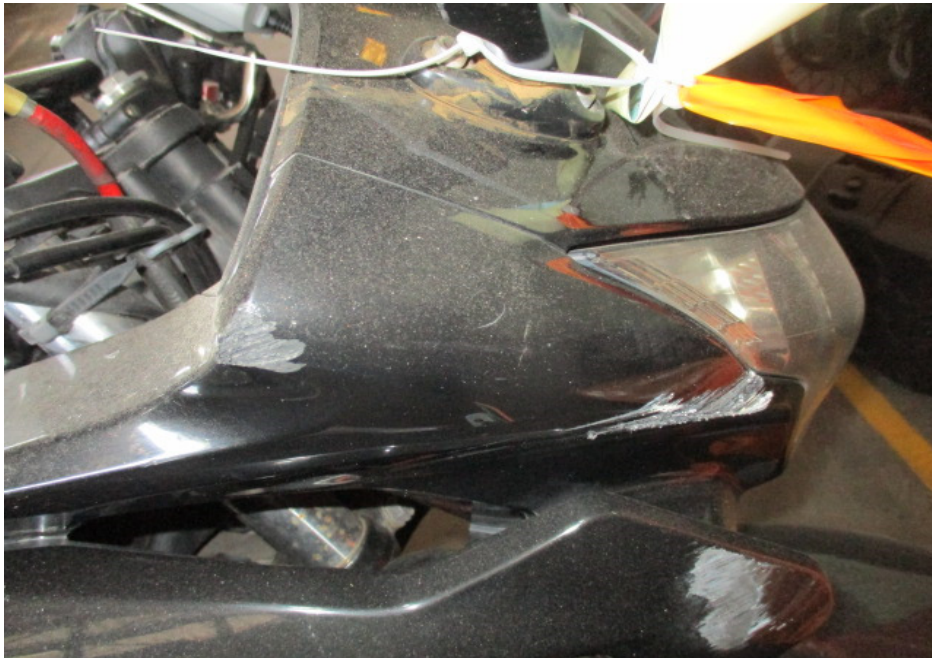
**Photo 6** shows a close up view of the head cowl which was amongst the body parts of the Motorcycle that had sustained damage as a result of the accident.

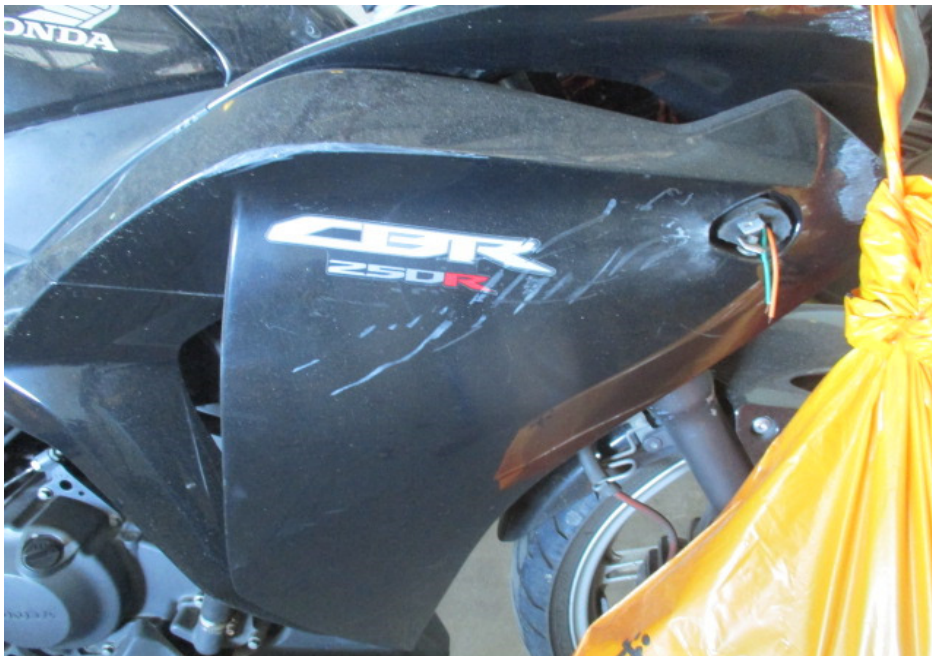
**Photo 7** shows a closer view of the right cowl of the Motorcycle that had sustained damages of grazing nature as a result of the accident.

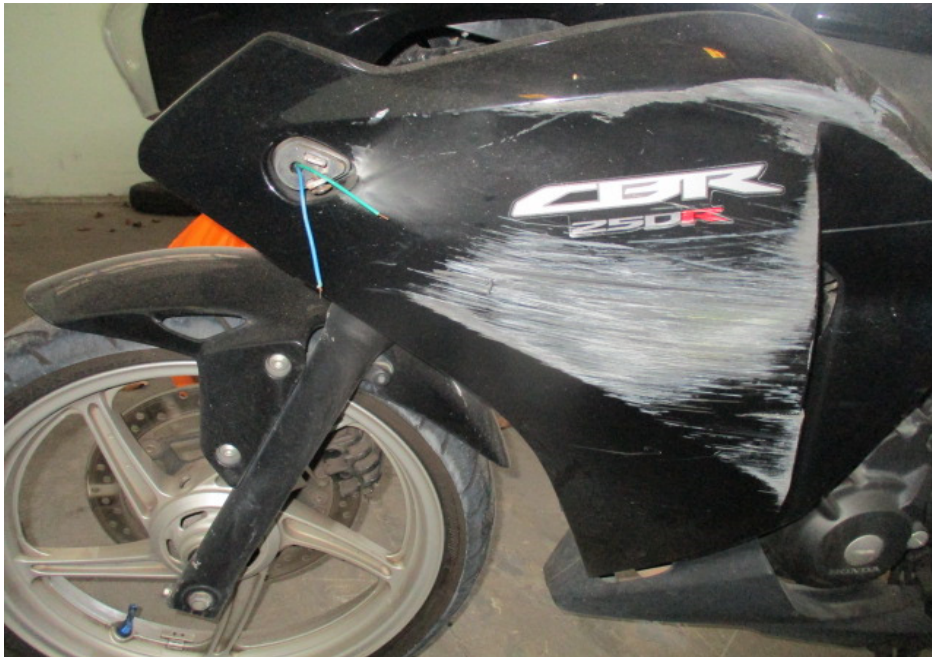
**Photo 8** shows a closer view of the left cowling of the Motorcycle that had sustained damages of grazing nature as a result of the accident.

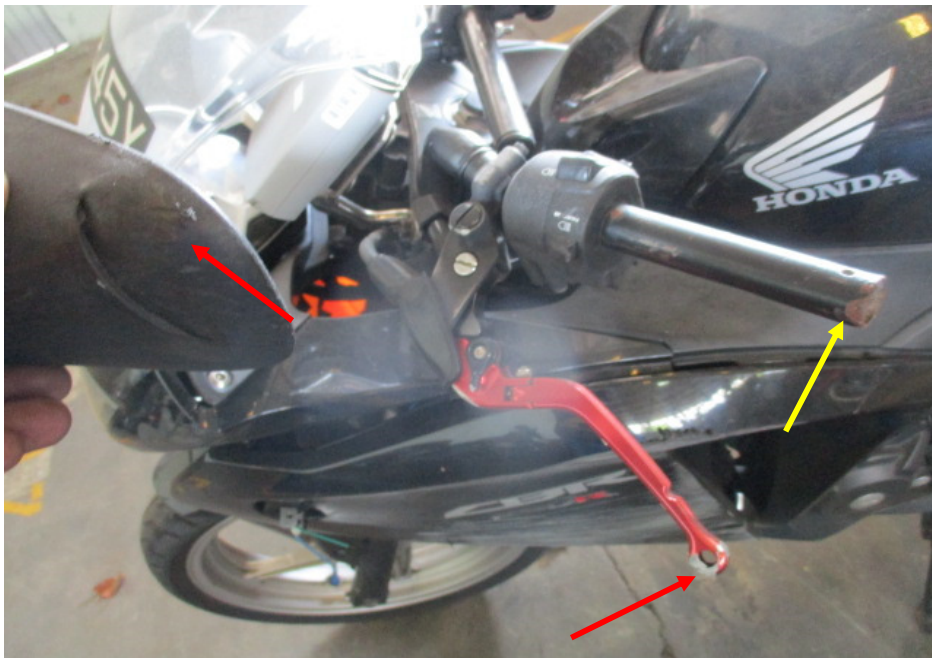
**Photo 9** shows a closer view of the missing left handlebar grip (yellow arrow), clutch lever and left side mirror (red arrows) which were amongst the body parts of the Motorcycle that had sustained damage as a result of the accident.

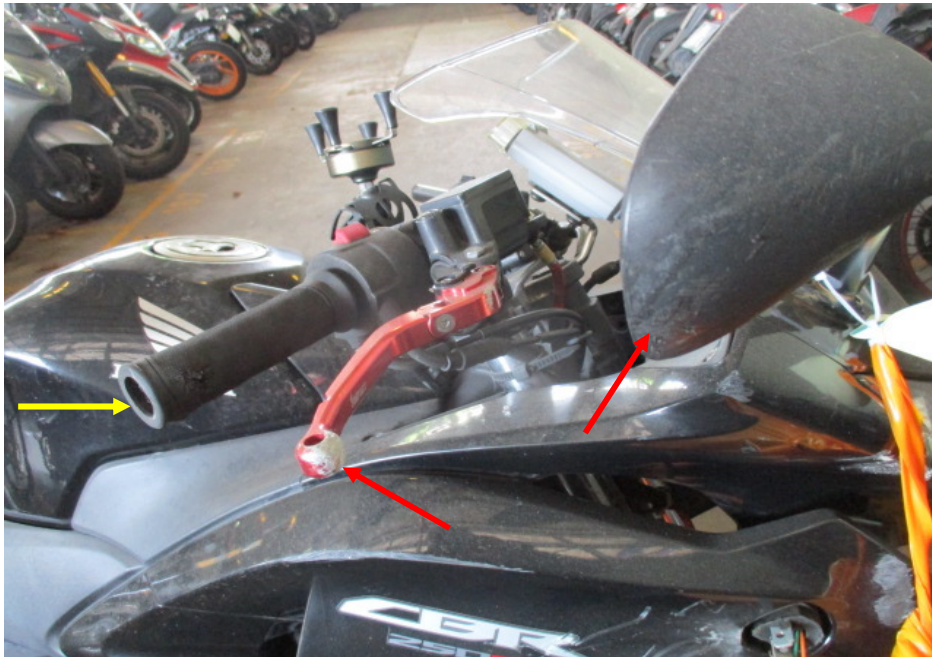
**Photo 10** shows a closer view of the missing right handlebar end (yellow arrow), front brake lever and right side mirror (red arrows) which were amongst the body parts of the Motorcycle that had sustained damage as a result of the accident.

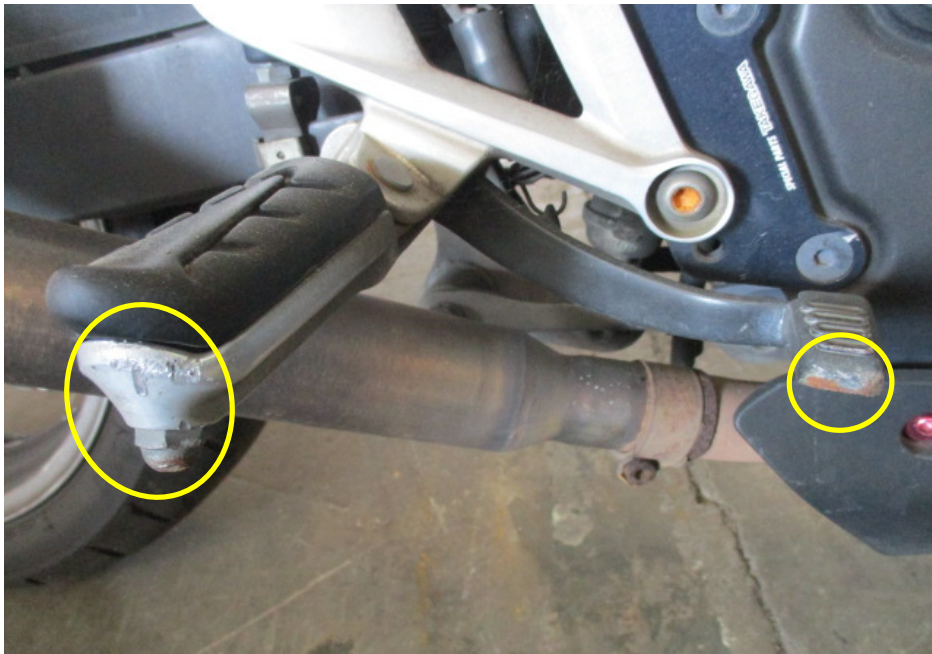
**Photo 11** shows a closer view of the rear brake pedal and right front footrest which were amongst the body parts of the Motorcycle that had sustained damage as a result of the accident (circled).

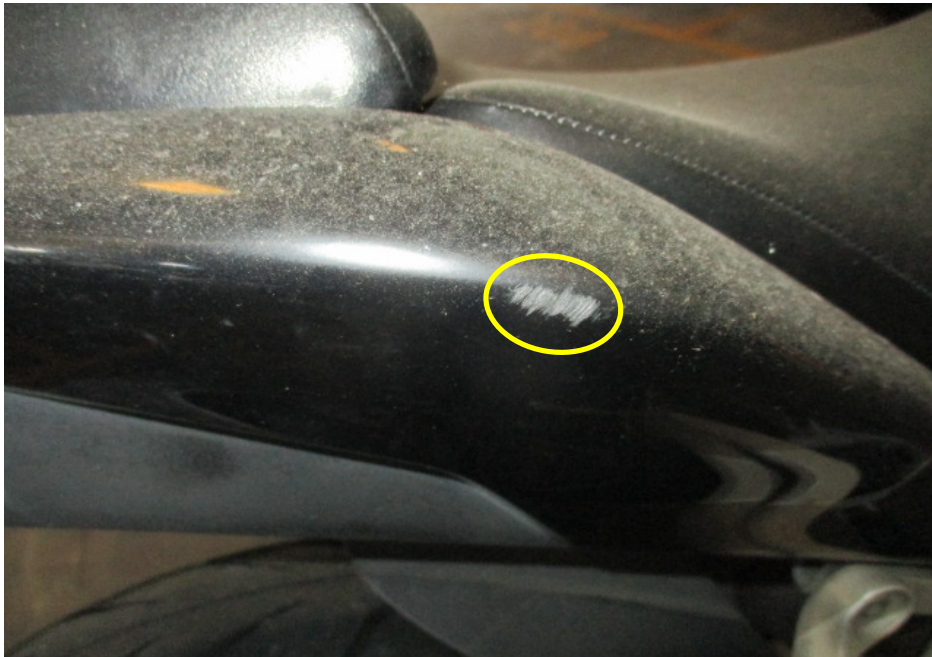
**Photo 12** shows the right rear side cover of the Motorcycle that had sustained damages of grazing nature as a result of the accident (circled).

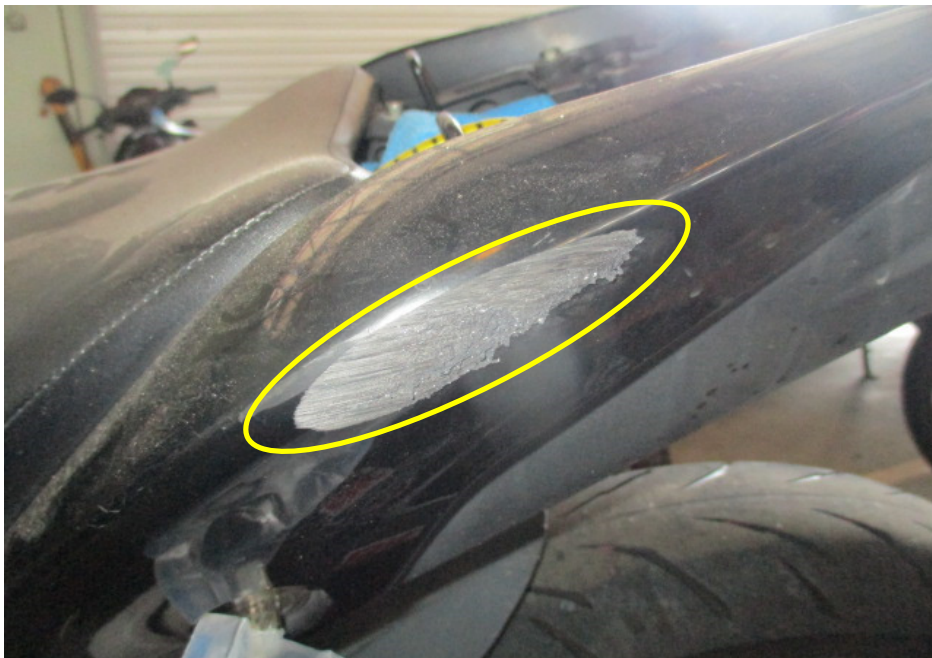
**Photo 13** shows the left rear side cover of the Motorcycle that had sustained damages of grazing nature as a result of the accident (circled).

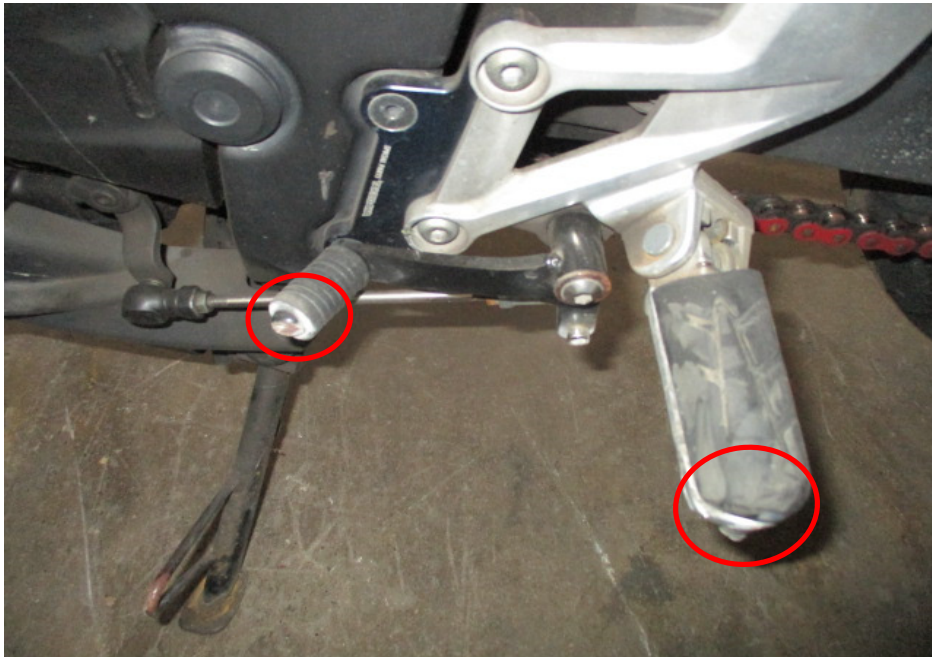
**Photo 14** shows a closer view of the gear shift pedal and left front footrest which were amongst the body parts of the Motorcycle that had sustained damage as a result of the accident (circled).

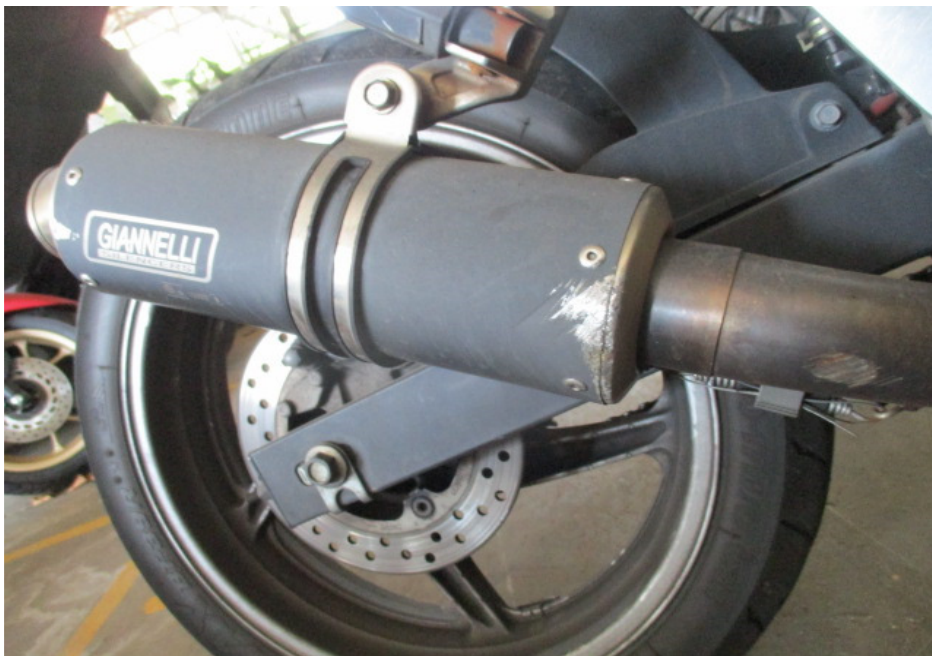
**Photo 15** shows a closer view of the exhaust muffler of the Motorcycle that had sustained damages of grazing nature as a result of the accident.

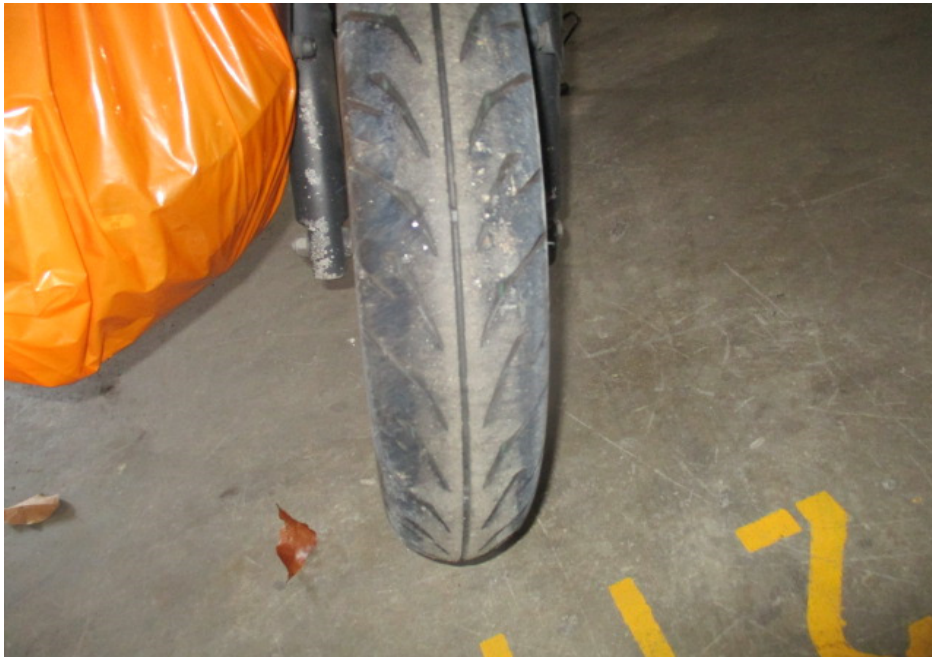
**Photo 16** shows the condition of the Motorcycle's front tyre. The front tyre was observed to be in serviceable condition with remaining tread depth of approximately 3mm. There was no tear, burst mark(s) and/or punctured hole(s) on the sidewalls as well as across the tread of the front tyre.

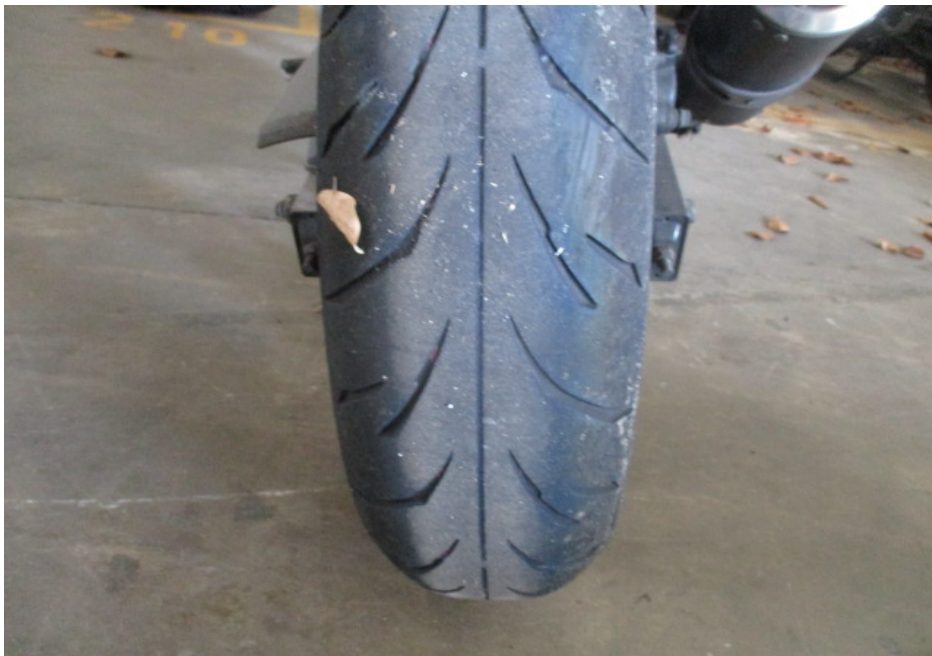
**Photo 17** shows the condition of the Motorcycle's rear tyre. The rear tyre was observed to be in serviceable condition with remaining tread depth of approximately 3mm. The tyre was also observed to be sufficiently inflated for vehicular operation. We did not observe any tear, burst mark(s) and/or punctured hole(s) on the sidewalls as well as across the tread of the rear tyre.

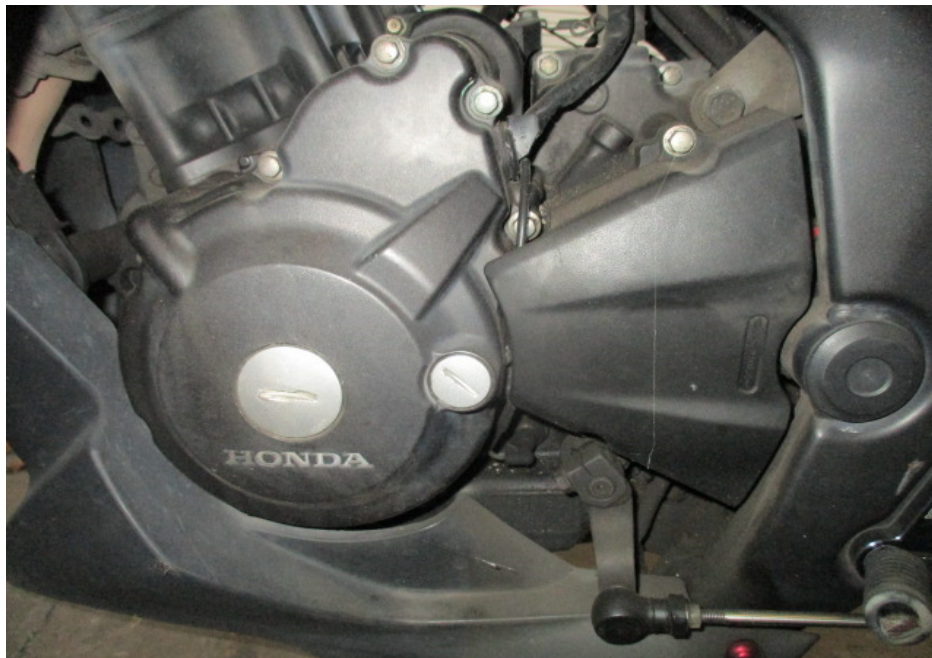
**Photo 18** shows the left side of the engine of the Motorcycle at the time of our inspection. The various engine related parts and components were found to be intact with no visible damage. There was also no sign(s) or indication(s) of fluid leak observed around the left engine area of the Motorcycle.

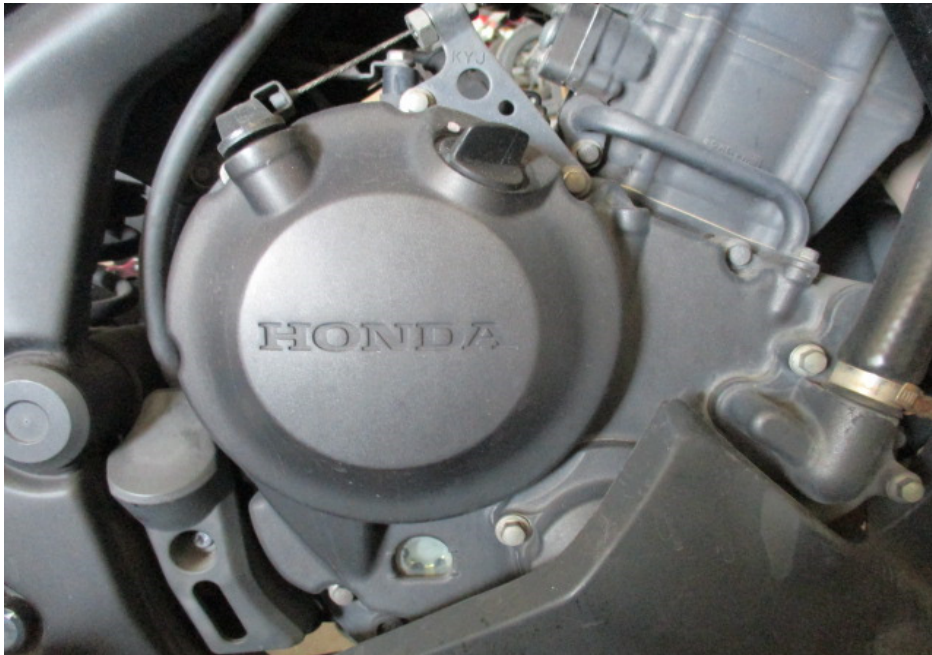
**Photo 19** shows the right side of the engine of the Motorcycle at the time of our inspection. The various engine related parts and components were found to be intact with no visible damage. There was also no sign(s) or indication(s) of fluid leak observed around the right engine area of the Motorcycle.

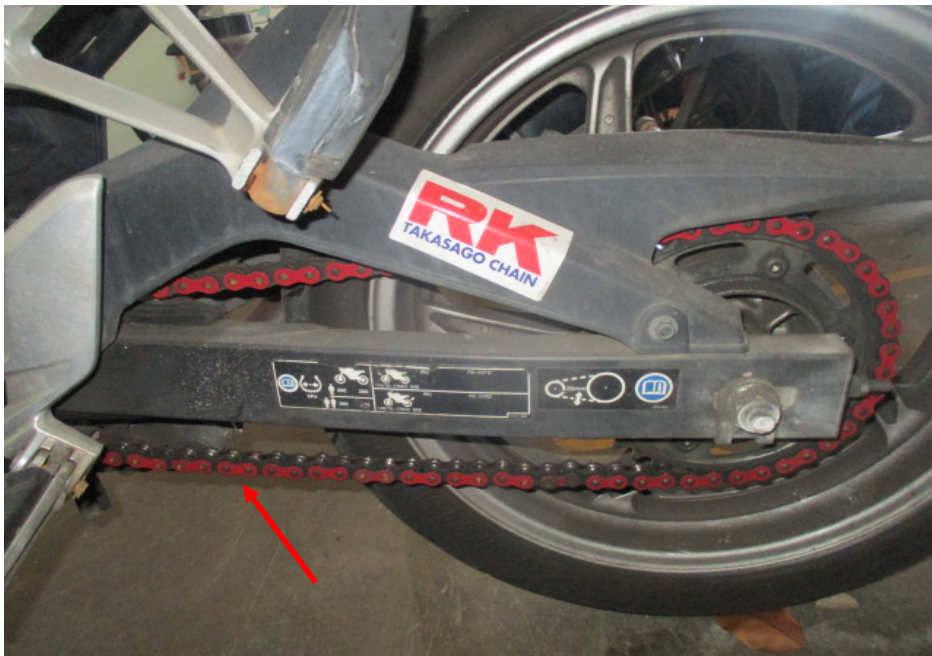
**Photo 20** shows the general view of the gear train (arrowed) of the Motorcycle, which was observed to be intact with no misalignment. It was also adequately lubricated for operating purposes.

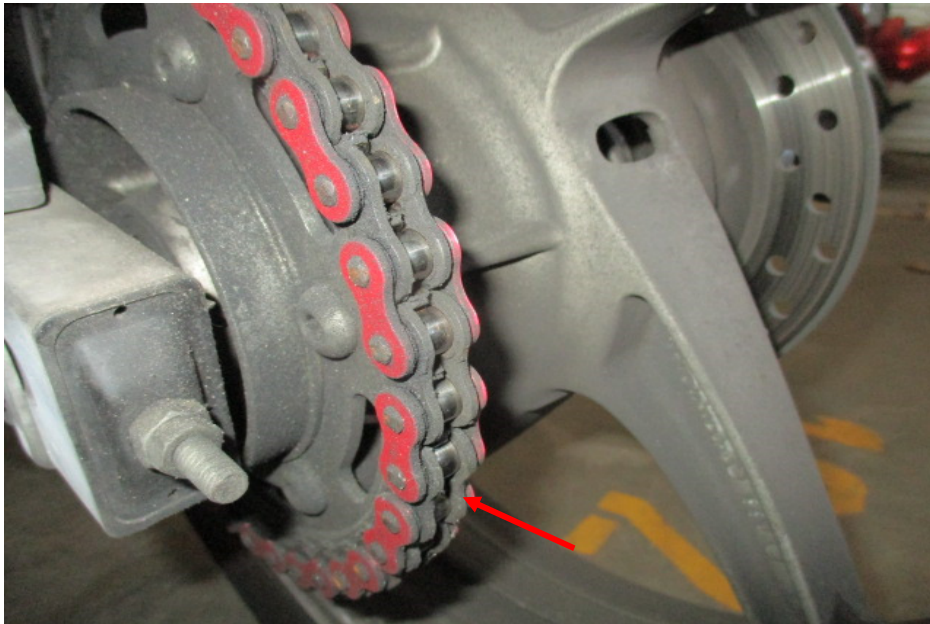
**Photo 21** shows a closer view of the gear train (arrowed) of the Motorcycle, which was observed to be intact with no misalignment. It was also adequately lubricated for operating purposes.

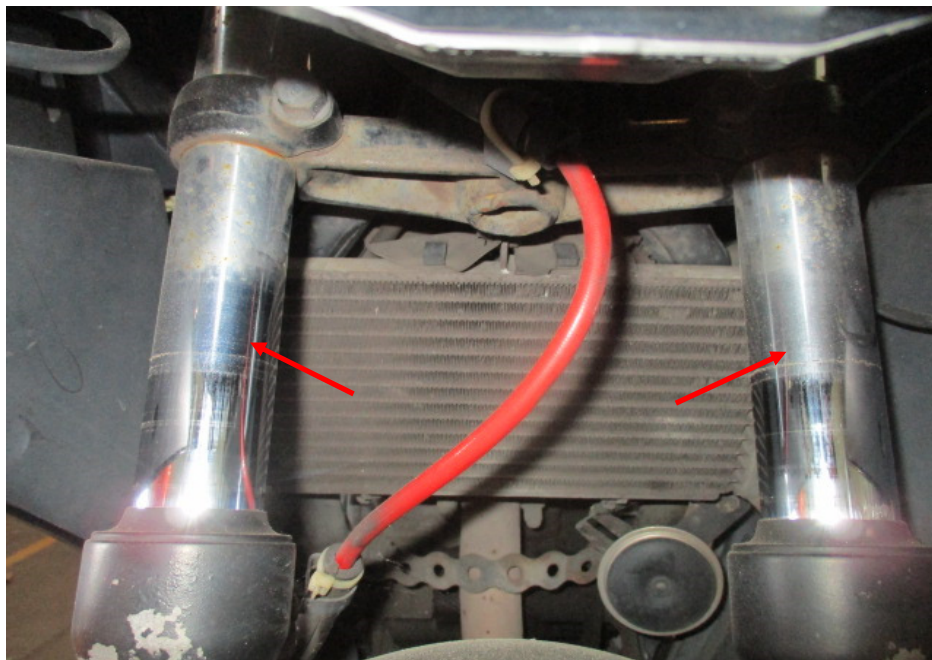
**Photo 22** shows the front fork (arrowed) of the Motorcycle. The front fork and fork bracket of the Motorcycle were both found to be intact and undamaged. Turning the Motorcycle's handle bar towards the left and right did not produce any abnormal free play and/or resistance. The steering system of the Motorcycle was in serviceable condition at the time of our inspection.

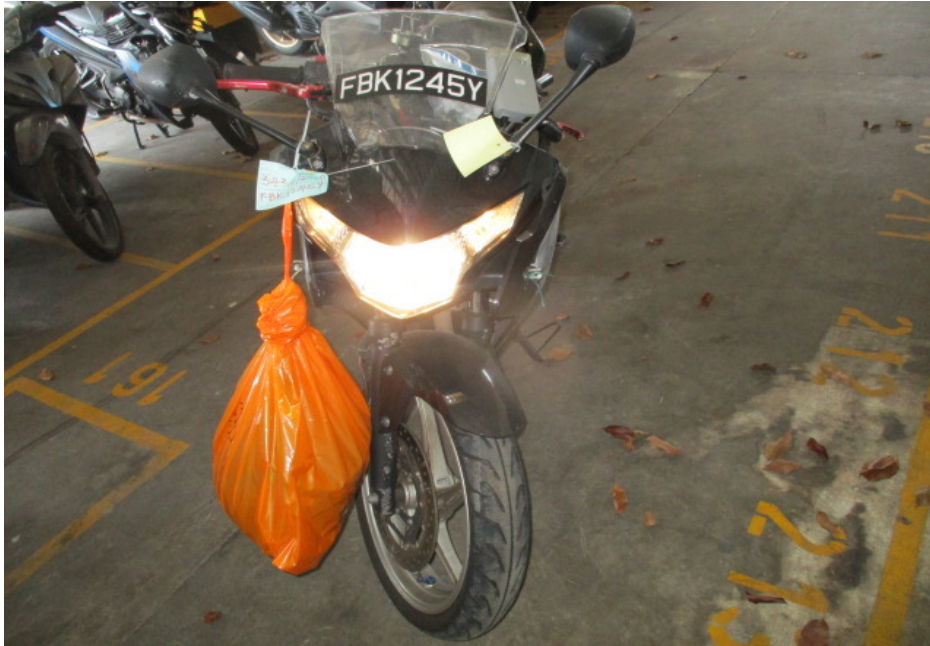
**Photo 23** shows the front wheel of the Motorcycle turned towards its full left. Turning the Motorcycle's handle bar towards the left and right did not produce any abnormal free play and/or resistance. This would indicate that the steering system of the Motorcycle was in serviceable condition at the time of our inspection.

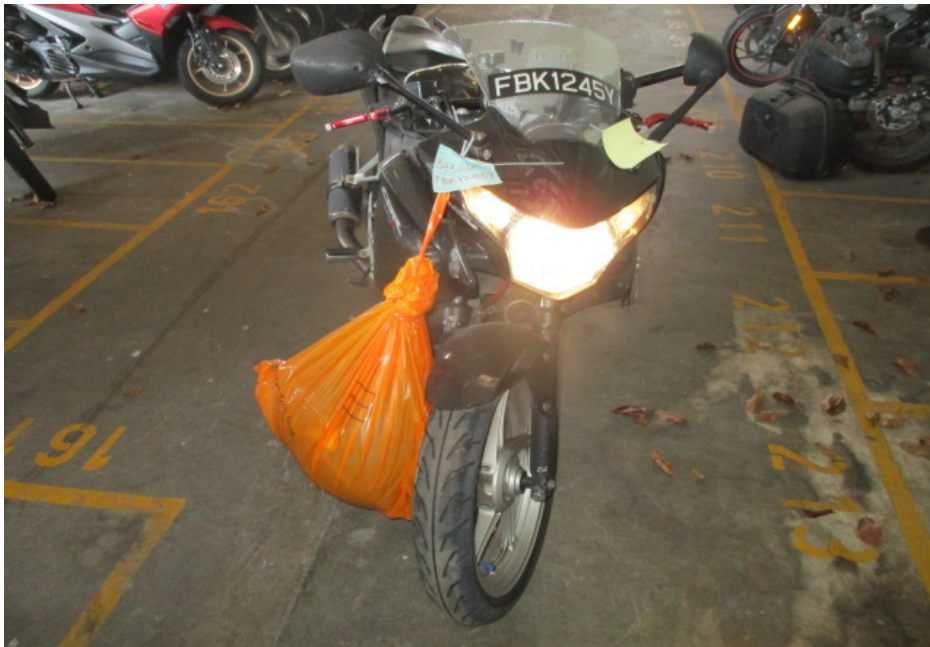
**Photo 24** shows the front wheel of the Motorcycle turned towards its full right. Turning the Motorcycle's handle bar towards the left and right did not produce any abnormal free play and/or resistance. This would indicate that the steering system of the Motorcycle was in serviceable condition at the time of our inspection.

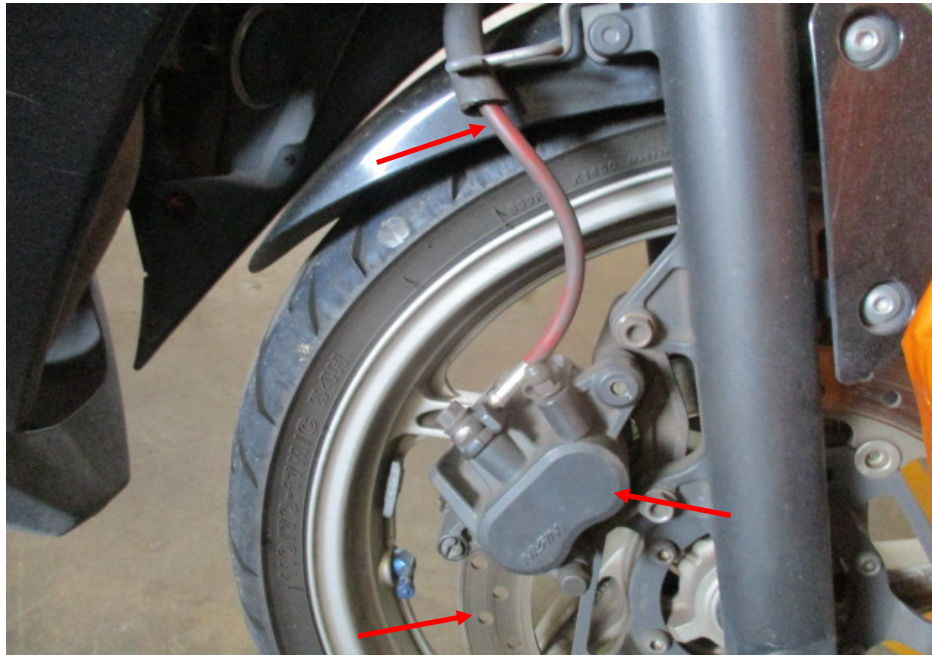
**Photo 25** shows a close up view of the front brake caliper, front brake disc and front brake hose (arrowed) of the Motorcycle, which are all part of the components in the hydraulic front brake system of the Motorcycle. Our visual checks of these various components had revealed all to be intact with no visible damage. No leakage of brake fluid was also observed.

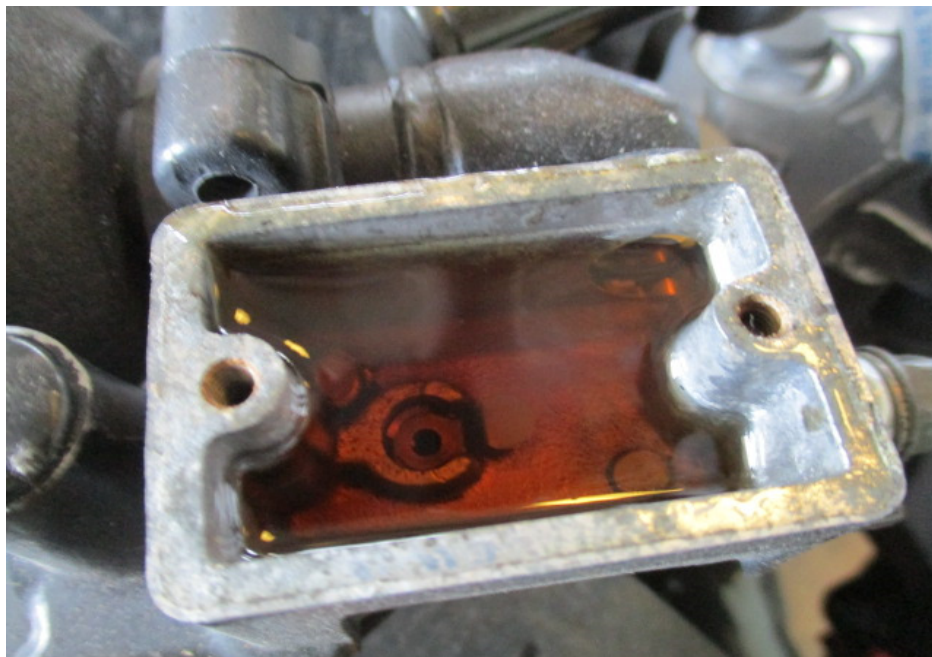
**Photo 26** shows the brake fluid reservoir for the front brake of the Motorcycle. The brake fluid was observed to be of sufficient level for operational purposes and without contamination.

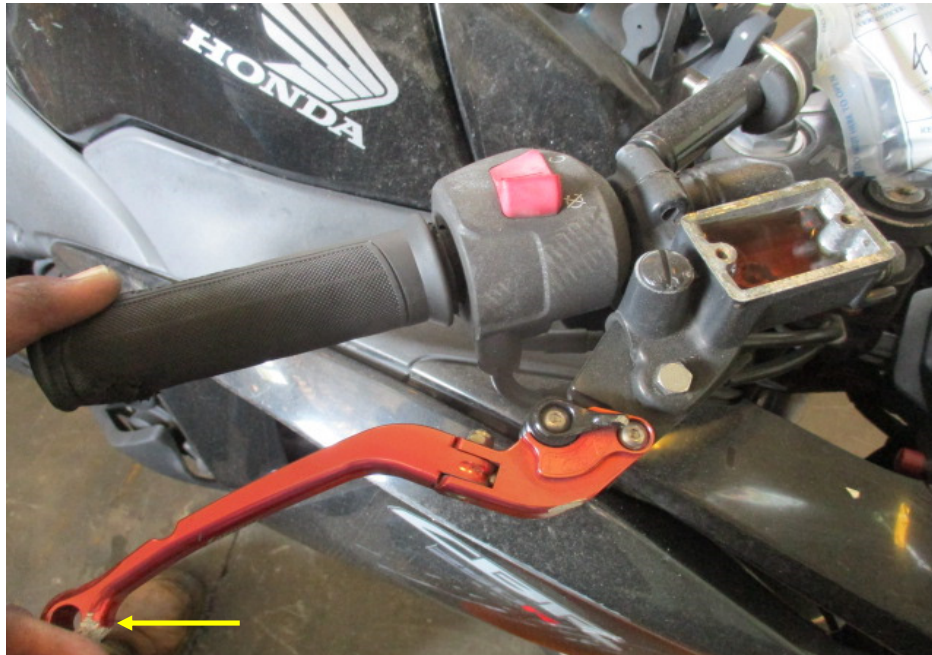
**Photo 27** shows the front brake lever being depressed. There was some resistance felt (spongy like feel) upon pressing the front brake lever (arrowed). This would indicate that there is no leakage of pressure/vacuum in the brake system.

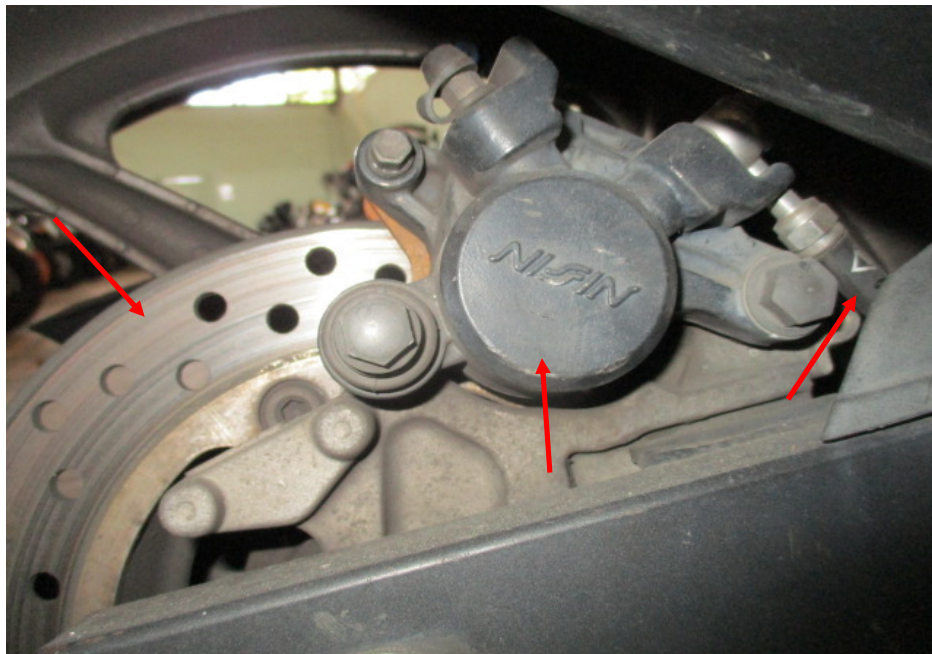
**Photo 28** shows a close up view of the rear brake caliper, rear brake disc and rear brake hose (arrowed) of the Motorcycle, which are all part of the components in the hydraulic rear brake system of the Motorcycle. Our visual checks of these various components had revealed all to be intact with no visible damage. No leakage of brake fluid was also observed.
