Your Ref: TP/IP/56197/2020
Our Ref : CI/TPD21000488/N

3 March 2021

INSPECTION REPORT OF MOTORCYCLE FBR 1272G

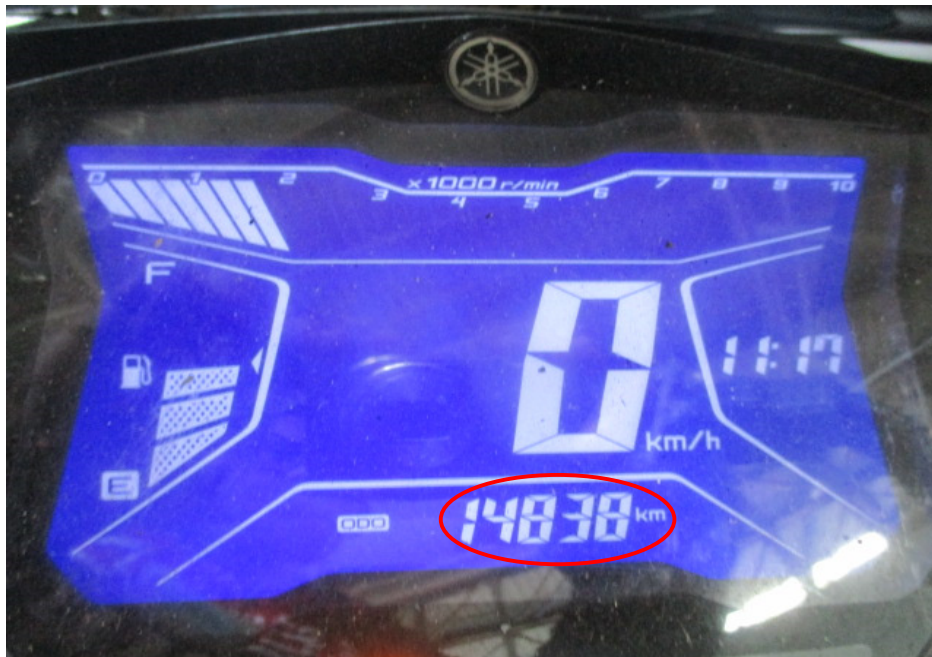
Photo 1 shows the speedometer gauge of the Motorcycle where the mileage recorded at the time of our inspection was 14, 838km (circled).

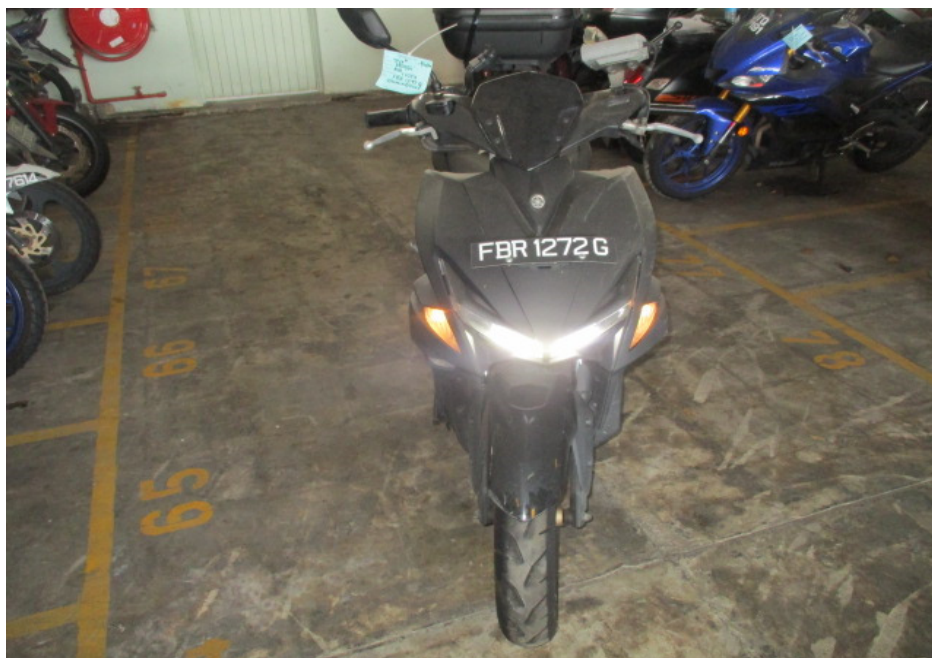
Photo 2 shows a general view of the frontal portion of the Motorcycle at the time of our inspection. The Motorcycle was observed to have sustained damages all around.

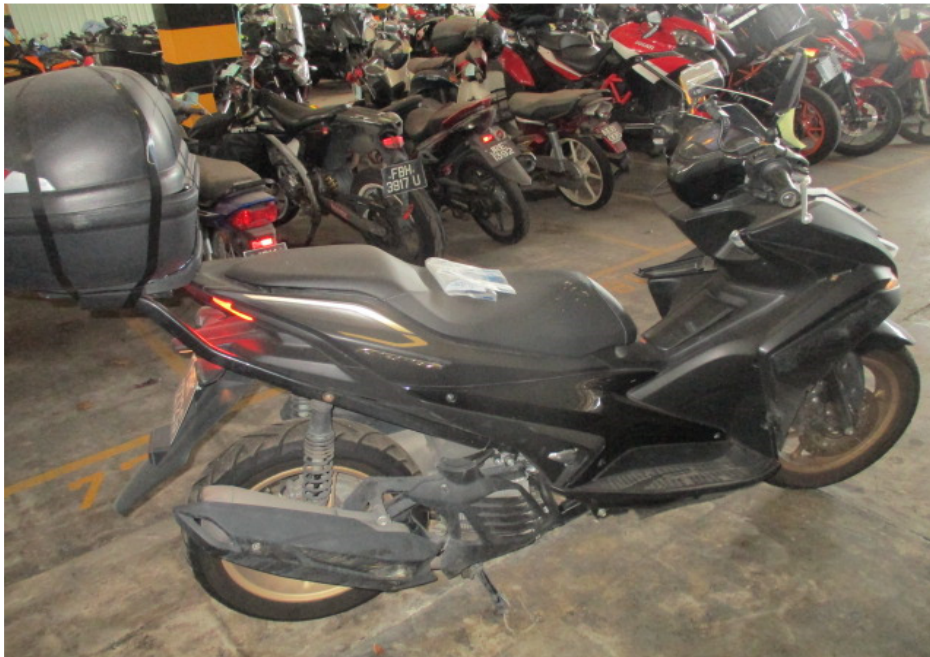
Photo 3 shows a general view of the right body of the Motorcycle at the time of our inspection. The Motorcycle was observed to have sustained damages all around. The body parts that were found to have been damaged include its head cowling, side mirrors, side cowlings, front mudguard, brake levers, drive train cover, bottom cowlings, rear side covers and top box, amongst others as a result of the accident.

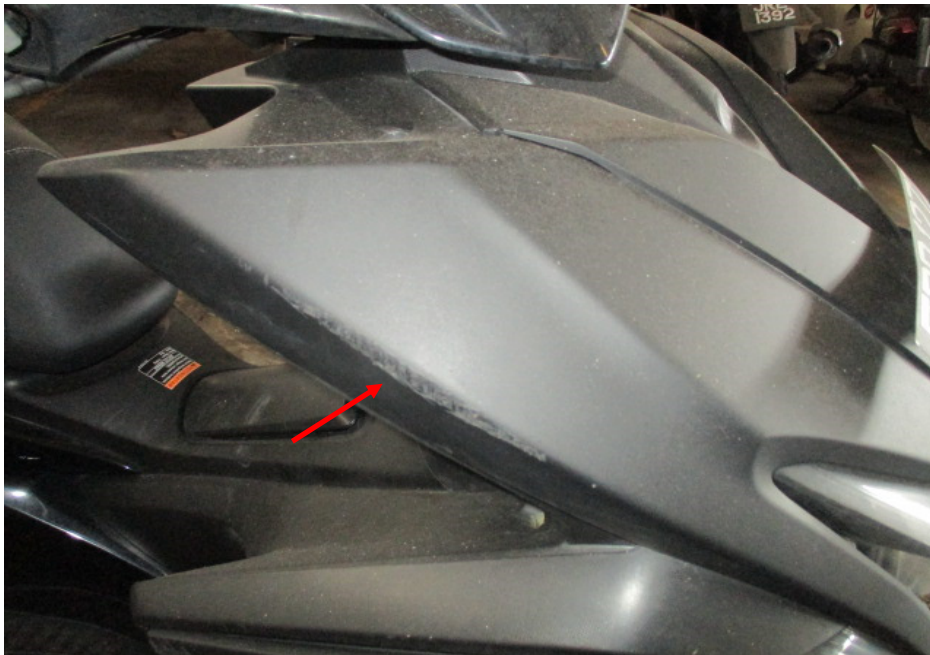
Photo 4 shows a closer view of the grazed head cowling (arrowed) which was amongst the body parts at the front body of the Motorcycle that had sustained damage as a result of the accident.

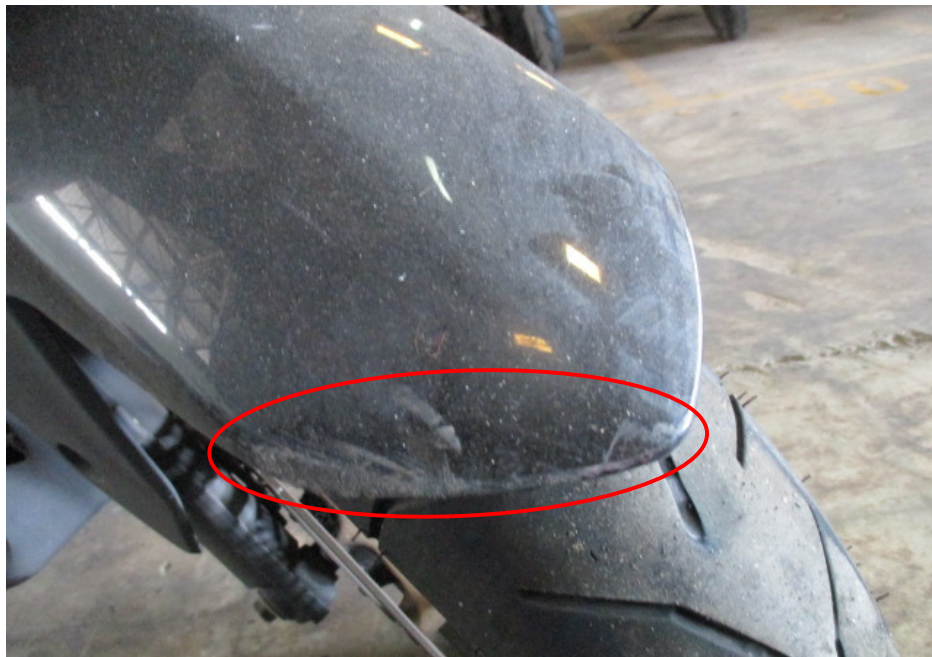
Photo 5 shows a closer view of the front mudguard (circled) which was amongst the body parts at the front body of the Motorcycle that had sustained damage as a result of the accident.

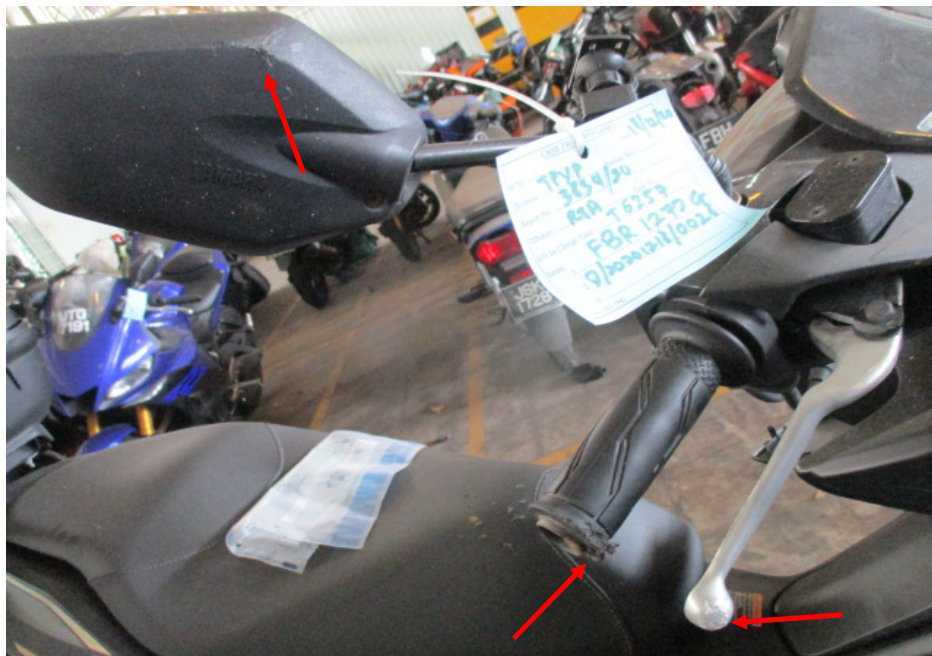
Photo 6 shows a closer view of the front brake lever, right side mirror and right handlebar end of the Motorcycle which were observed to be damaged due to the accident (arrowed).

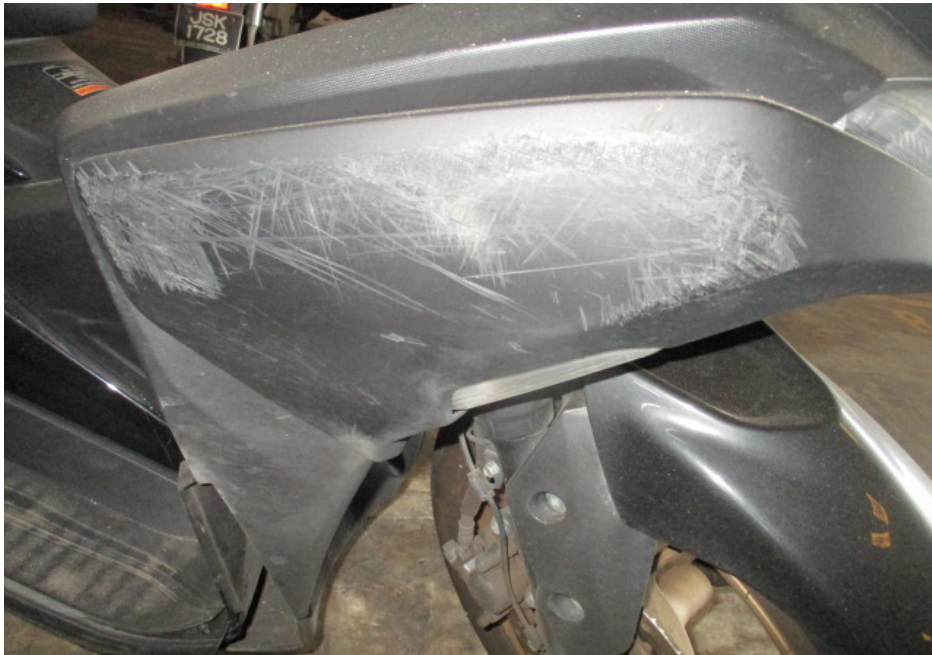
Photo 7 shows a closer view of the right cowling which was amongst the body parts at the front body of the Motorcycle that had sustained damage as a result of the accident.

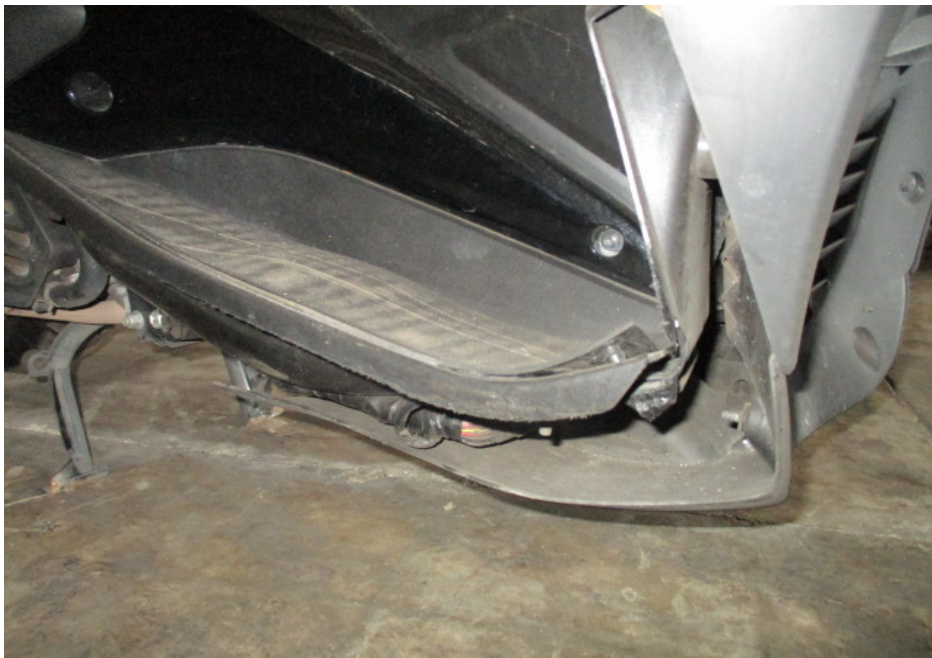
Photo 8 shows a closer view of the cracked right bottom cowling of the Motorcycle as a result of the accident.

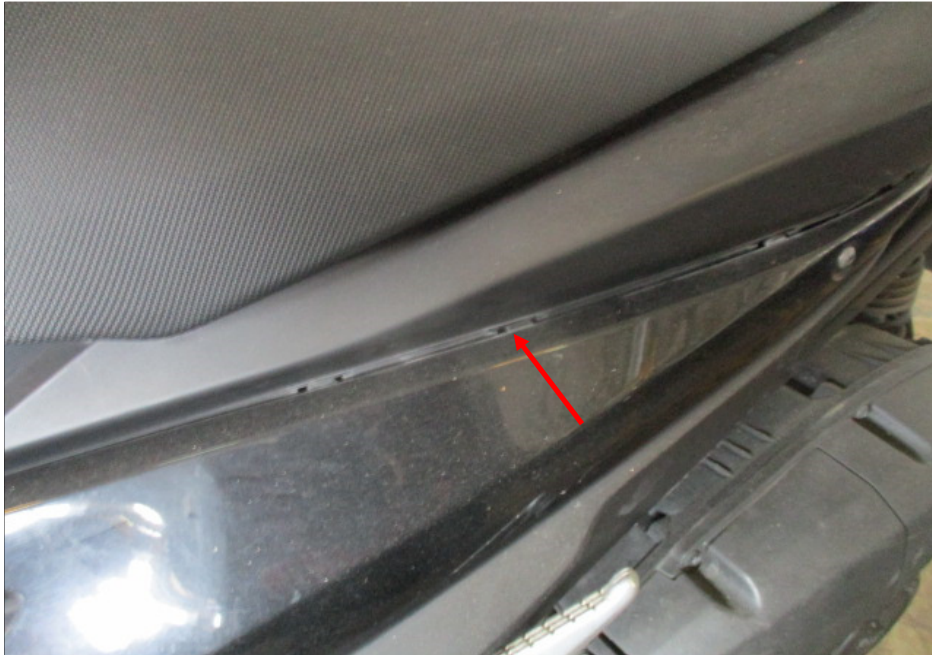
Photo 9 shows a closer view of the deformed left rear side cover (circled) of the Motorcycle at the time of our inspection.

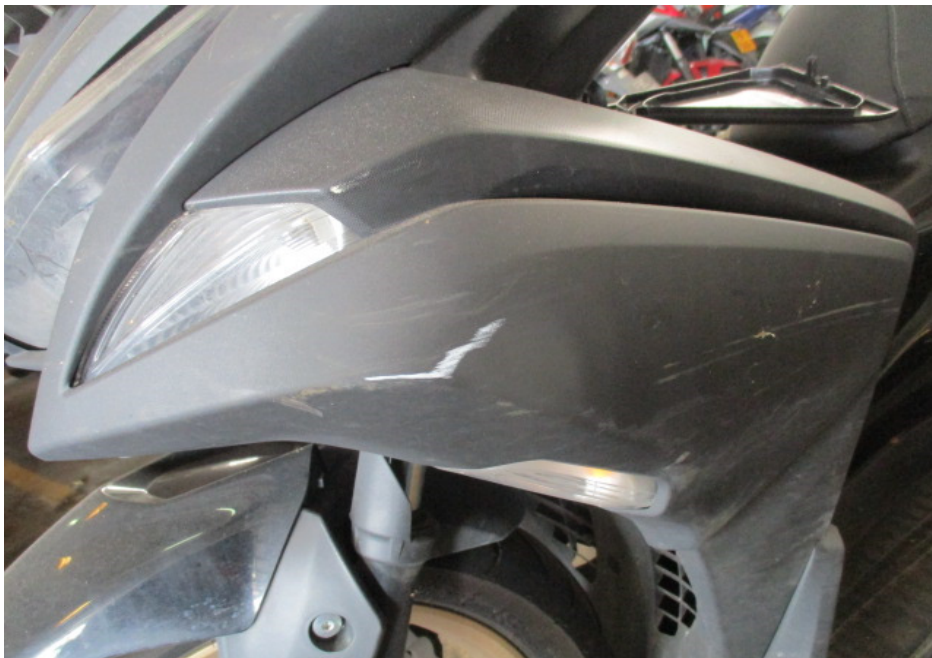
Photo 10 shows a closer view of the left cowling which was amongst the body parts at the front body of the Motorcycle that had sustained damage as a result of the accident.

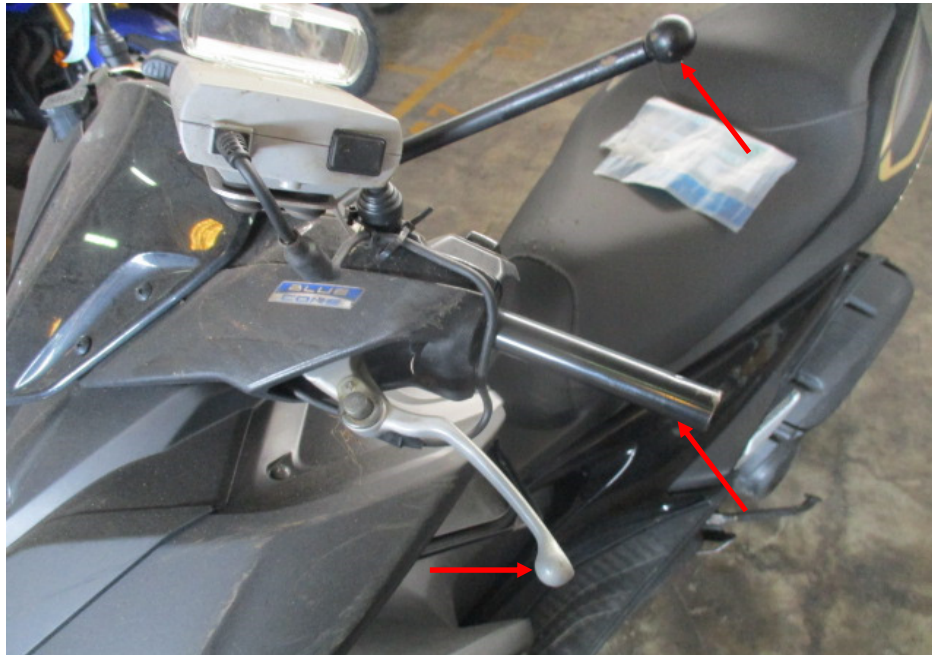
Photo 11 shows a closer view of the rear brake lever, left side mirror and left handlebar grip of the Motorcycle which were observed to be damaged due to the accident (arrowed).

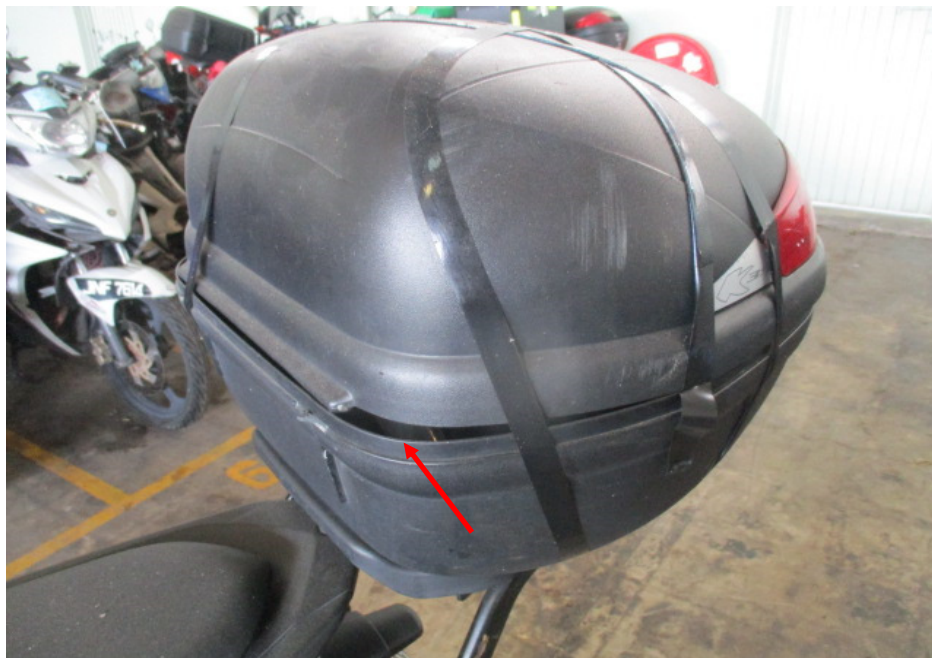
Photo 12 shows the broken top box of the Motorcycle as a result of the accident (arrowed).

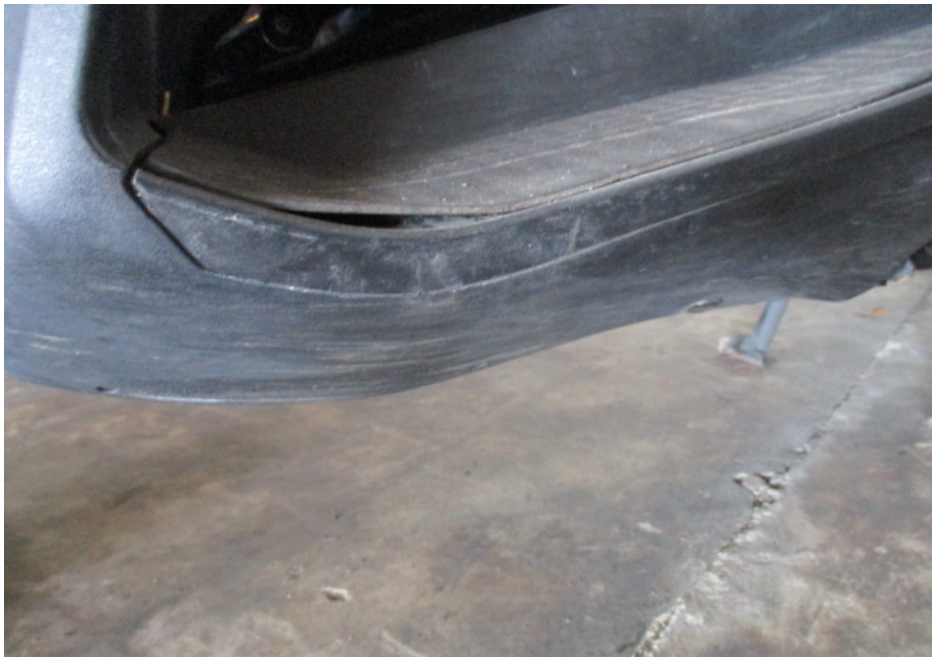
Photo 13 show a closer view of the left bottom cowling of the Motorcycle which was observed to be damaged due to the accident.

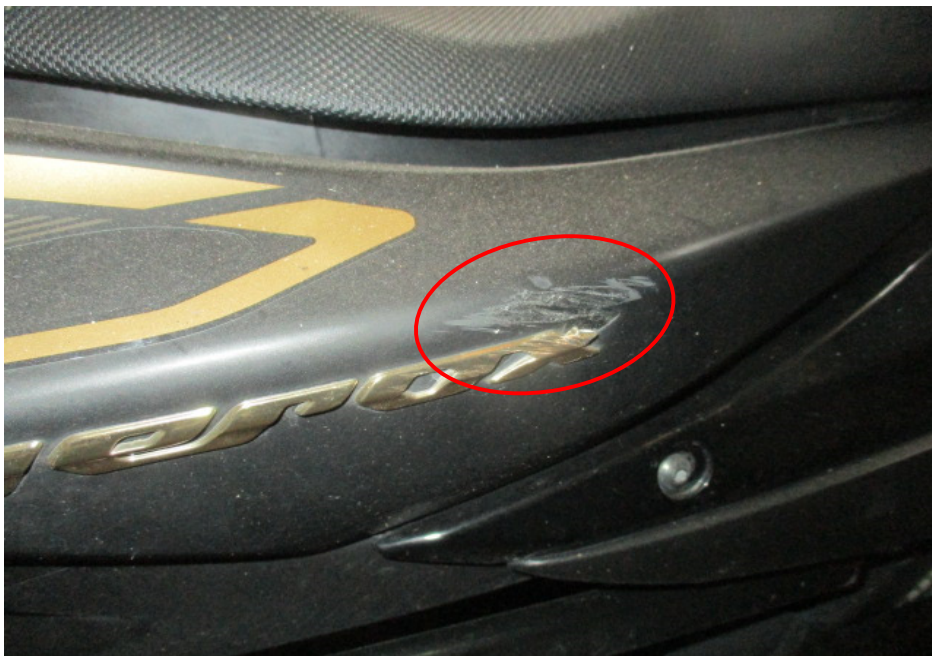
Photo 14 shows a closer view of the grazed right rear side cover (circled) of the Motorcycle at the time of our inspection.

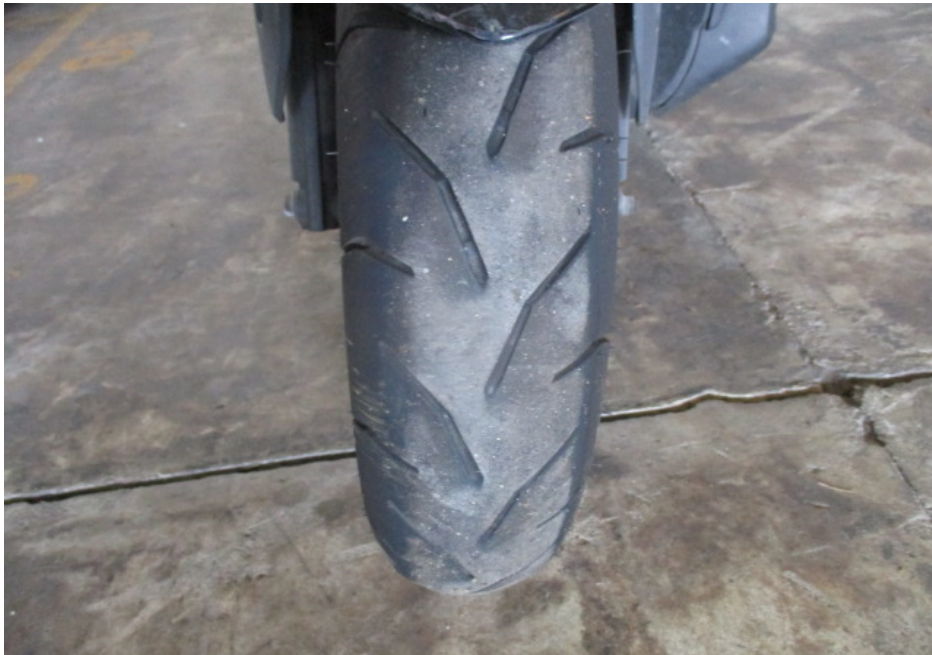
Photo 15 shows the condition of the Motorcycle's front tyre. The front tyre was observed to be in serviceable condition with remaining tread depth of approximately 3mm. There was no tear, burst mark(s) and/or punctured hole(s) on the sidewalls as well as across the tread of the front tyre.

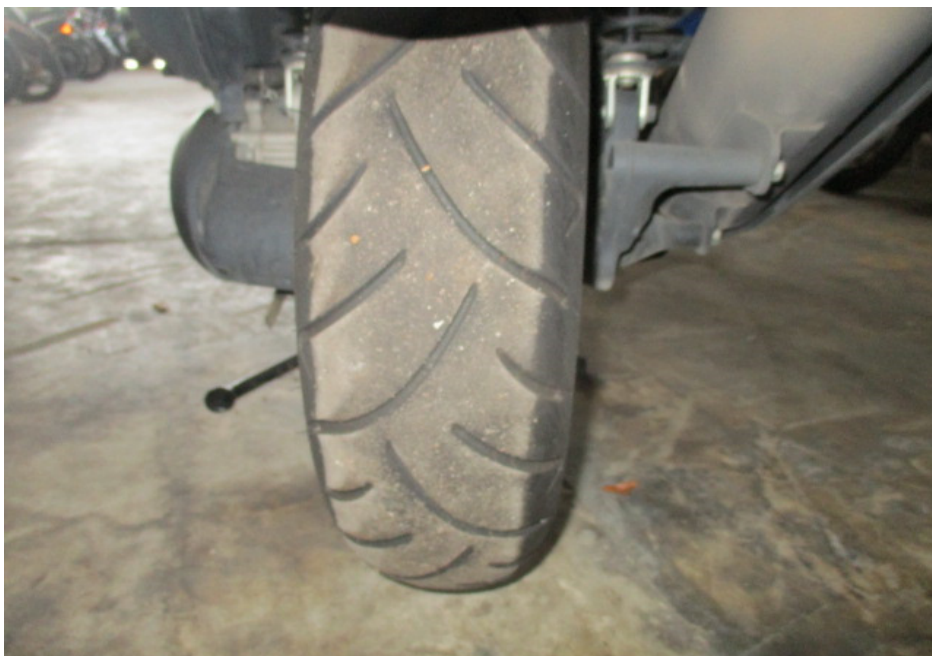
Photo 16 shows the condition of the Motorcycle's rear tyre. The rear tyre was observed to be in serviceable condition with remaining tread depth of approximately 3mm. The tyre was also observed to be sufficiently inflated for vehicular operation. We did not observe any tear, burst mark(s) and/or punctured hole(s) on the sidewalls as well as across the tread of the rear tyre.

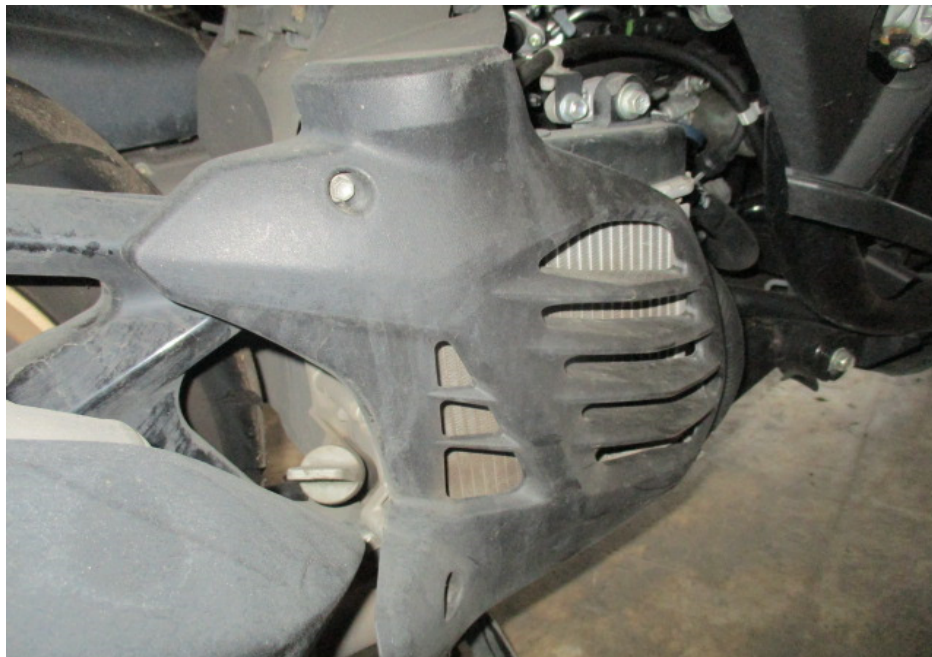
Photo 17 shows the radiator of the Motorcycle at the time of our inspection. The radiator was found to be intact with no visible damage. There was also no sign(s) or indication(s) of fluid leak observed around the radiator of the Motorcycle.

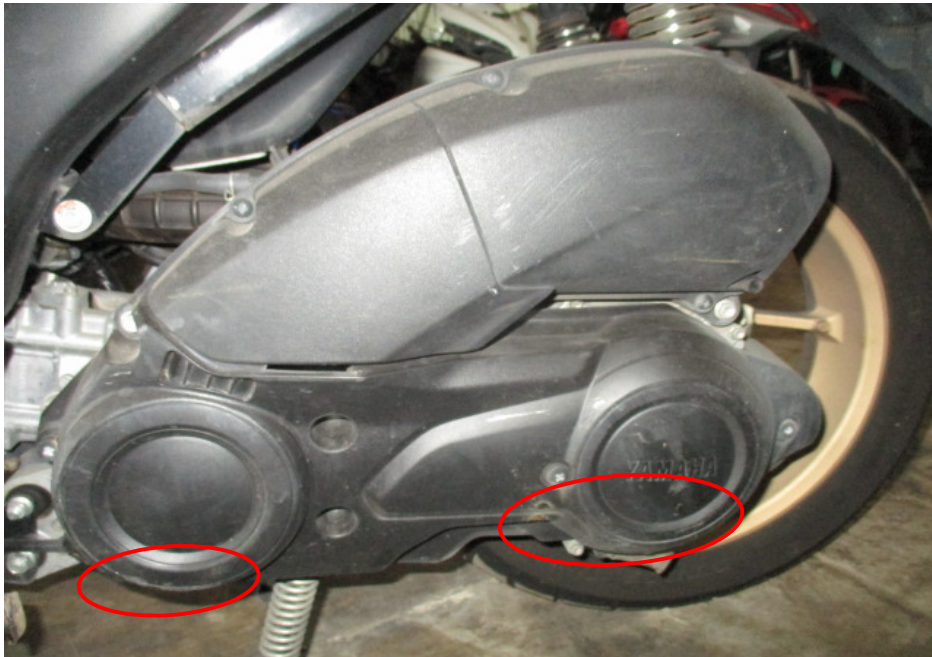
Photo 18 shows the drive train cover of the Motorcycle which had sustained damages of grazing nature as a result of the accident (circled) however the engine components were still intact.

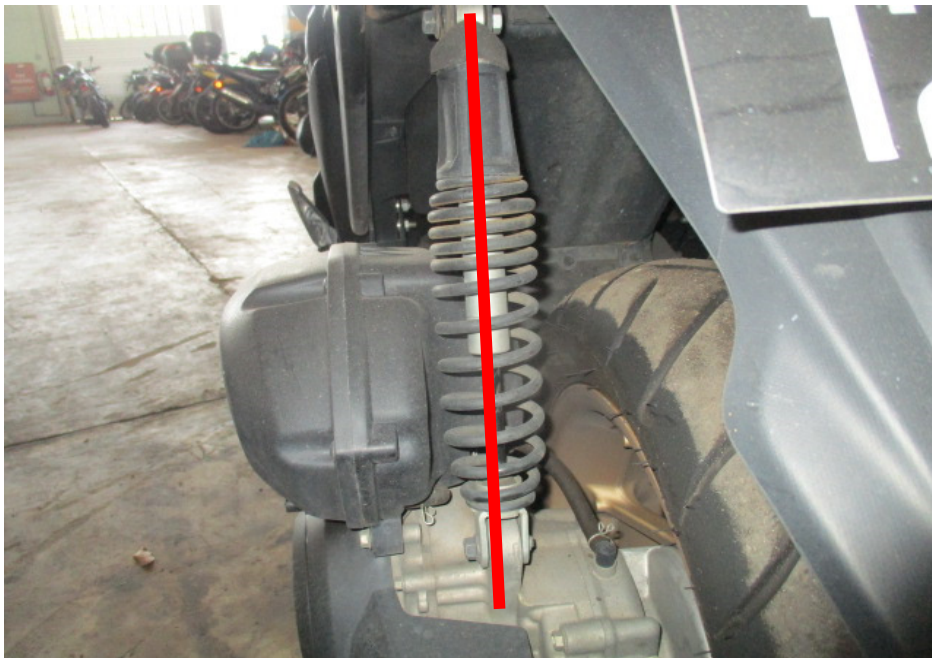
Photo 19 shows the left shock absorber of the Motorcycle which was found to be intact without any misalignment.

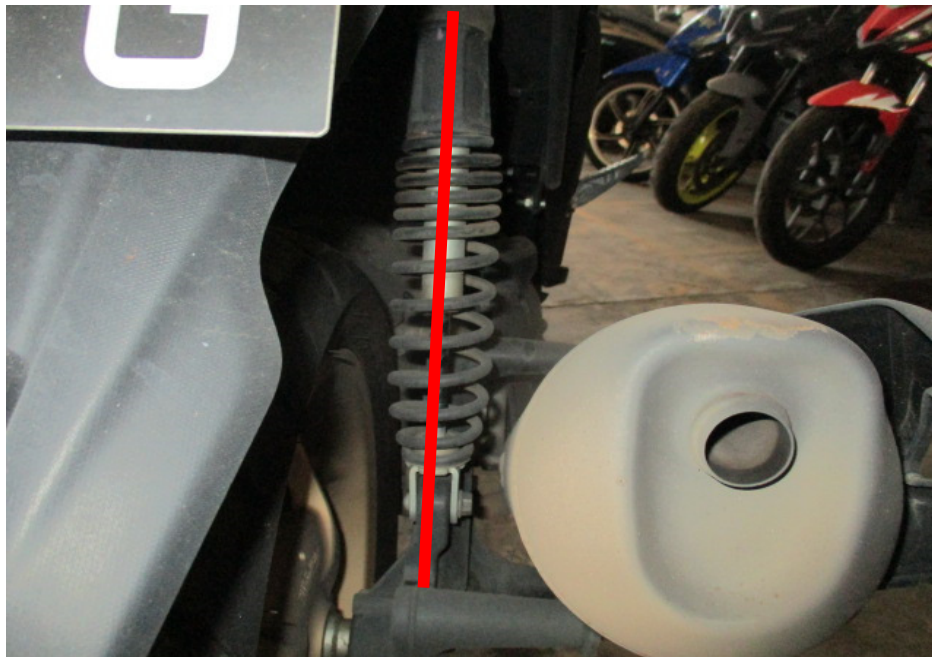
Photo 20 shows the right shock absorber of the Motorcycle which was found to be intact without any misalignment.

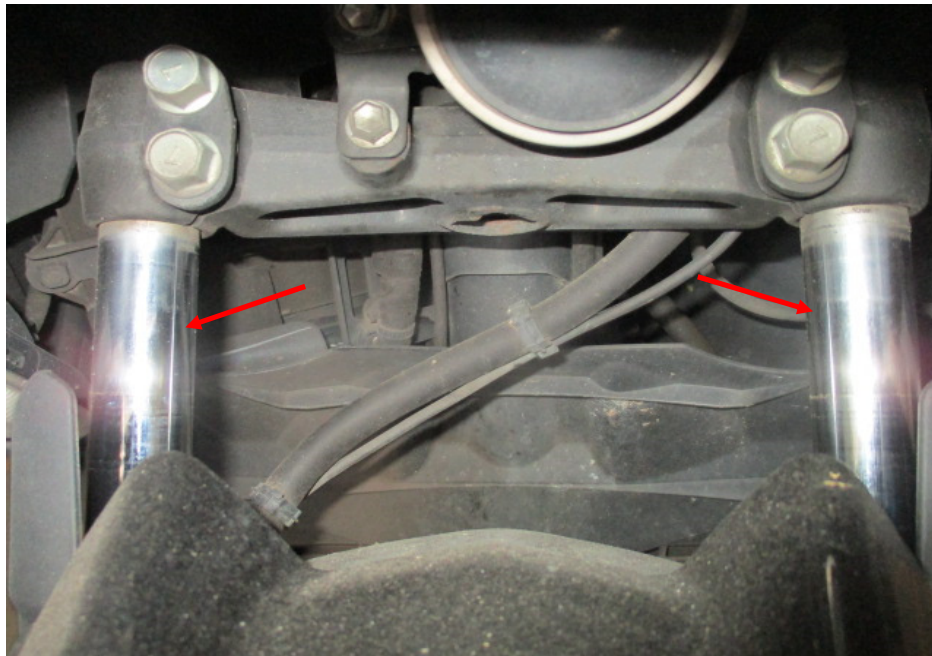
Photo 21 shows the front forks (arrowed) of the Motorcycle. The front forks and fork brackets of the Motorcycle were both found to be intact and undamaged. Turning the Motorcycle's handle bar towards the left and right did not produce any abnormal free play and/or resistance. The steering system of the Motorcycle was in serviceable condition at the time of our inspection.

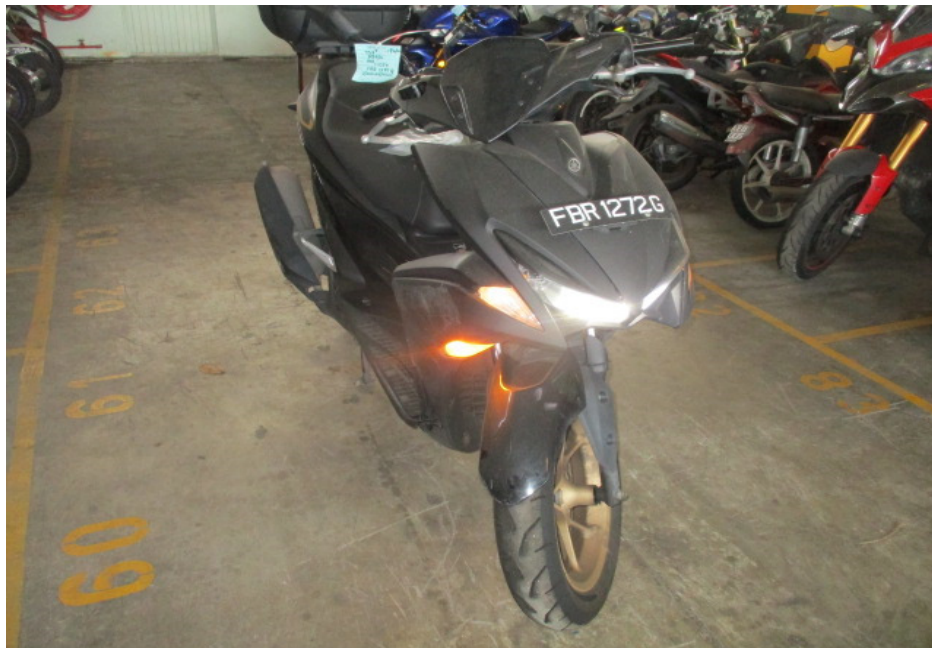
Photo 22 shows the front wheel of the Motorcycle turned towards its full right. Turning the Motorcycle's handle bar towards the left and right did not produce any abnormal free play and/or resistance. This would indicate that the steering system of the Motorcycle was in serviceable condition at the time of our inspection.

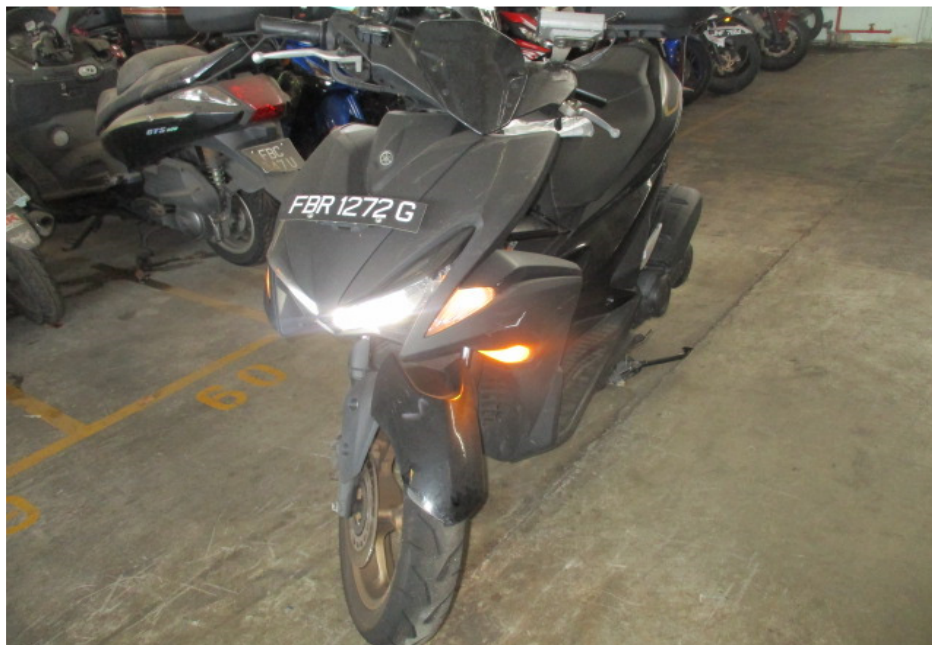
Photo 23 shows the front wheel of the Motorcycle turned towards its full left. Turning the Motorcycle's handle bar towards the left and right did not produce any abnormal free play and/or resistance. This would indicate that the steering system of the Motorcycle was in serviceable condition at the time of our inspection.

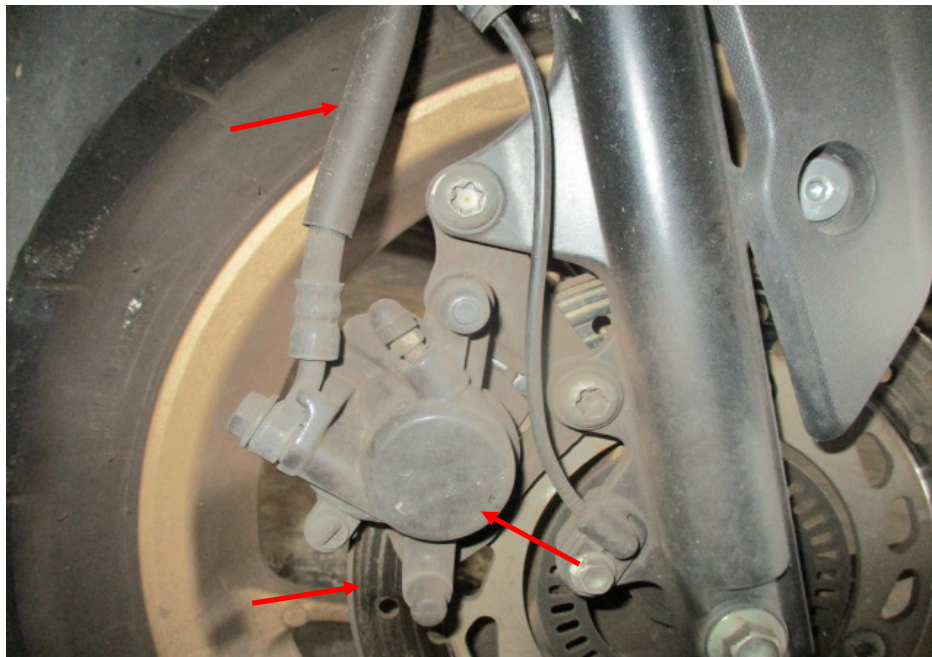
Photo 24 shows a close up view of the front brake caliper, front brake disc and front brake hose (arrowed) of the Motorcycle, which are all part of the components in the hydraulic front brake system of the Motorcycle. Our visual checks of these various components had revealed all to be intact with no visible damage. No leakage of brake fluid was also observed.

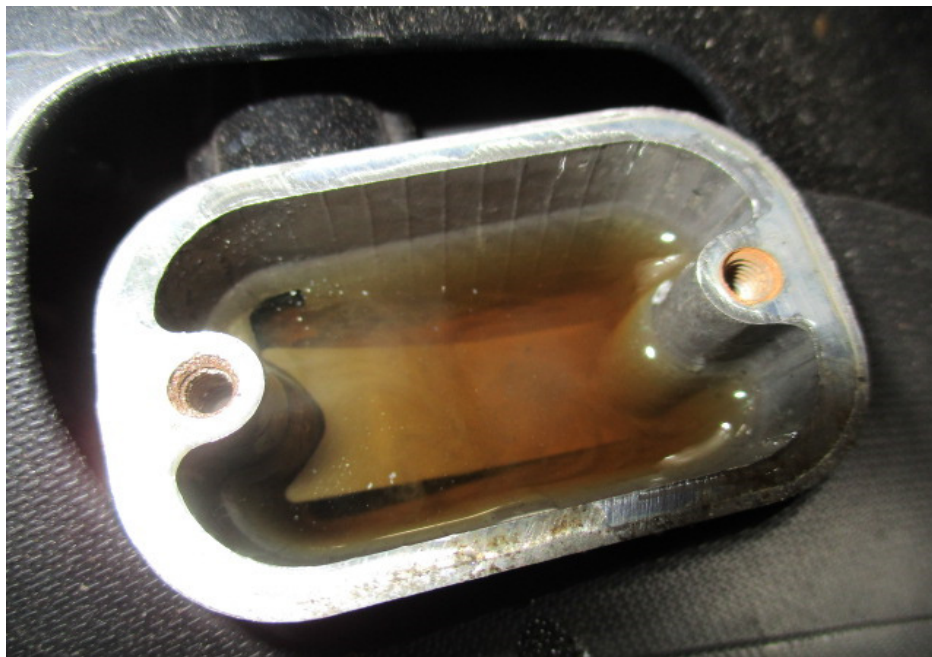
Photo 25 shows a close up view of the brake fluid reservoir for the front brake of the Motorcycle. The brake fluid was observed to be of sufficient level and without contamination for operational purposes.

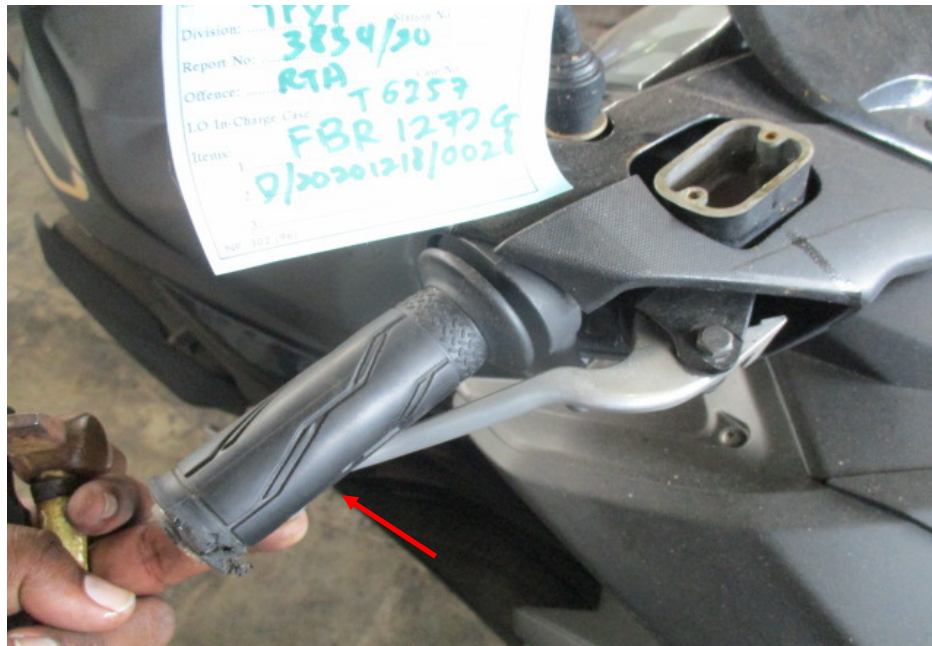
11. The brake system of the Motorcycle was of a semi-hydraulic type, where hydraulic (brake fluid) pressure controls the brake for the front wheel while the brake for the rear wheel is controlled by mechanical means (cables and springs). Our visual examination of the various components in the brake system, like the brake disc, brake caliper, drum and left hand brake lever, revealed all to be intact and without damage. There was also no leakage of brake fluid observed along the front brake hose. This was from the respective front brake fluid reservoir to the front brake caliper of the Motorcycle. The brake fluid for the front brake was found to be without any contamination and of sufficient level for operating purposes. There was also no visible tear or cut observed on the connecting hoses and cables. However, the right hand brake lever was observed to be broken as a result of the accident.

12. We were unable to conduct static brake tests on the front braking system of the Motorcycle due to the broken right hand lever. Hence we were unable to indicate if there was any leakage of pressure/vacuum in the front brake system.

13. We subsequently carried out an operational test of the Motorcycle's braking system. This was done by manually pushing the Motorcycle forward and backward, simulating the Motorcycle in motion, and thereafter engaging the front brake and rear brake of the Motorcycle. At the end of the short operational test, we did not observe any abnormal behaviour of the Motorcycle's rear braking system. The rear wheel of the Motorcycle was able to stop rotating immediately upon depressing the left hand brake lever. However the front wheel of the Motorcycle was unable to stop rotating immediately upon depressing the right hand brake lever.

Photo 26 shows the broken right hand brake lever as a result of the accident (arrowed). We were unable to conduct static brake tests on the front braking system of the Motorcycle due to the broken right hand lever. Hence we were unable to indicate if there was any leakage of pressure/vacuum in the front brake system.

15. Basing on our physical inspection of the Motorcycle, it appears that the steering system and rear braking system of the Motorcycle were all in serviceable condition. However the front braking system of the Motorcycle was damaged as a result of the accident.
16. The tyres of the Motorcycle were found to be in a serviceable condition. There was no tear, cut or burst mark(s) on the outer and the inner sidewalls as well as across the tread of the tyres. It was sufficiently inflated for vehicular operation with remaining tread depth of approximately 3mm each.

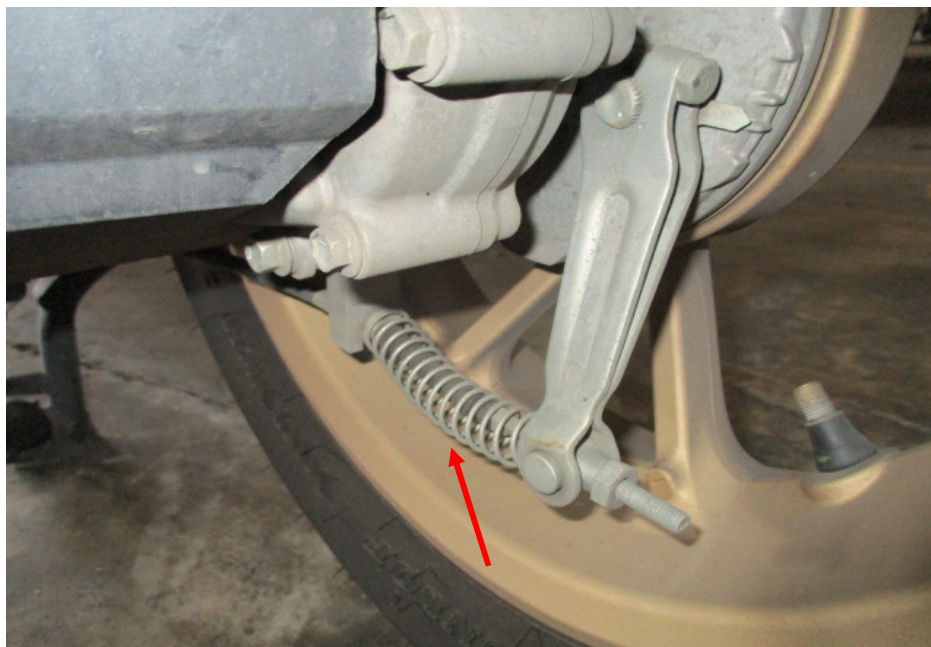
Photo 27 shows the rear wheel of the Motorcycle. The type of brake system for the rear wheel was of a mechanical type, controlled by the brake foot pedal of the Motorcycle. Our checks of the cable (arrowed), spring and drum which are all part of the components in the rear brake system of the Motorcycle reveal all to be intact and without damage.
