Your Ref: Honda Engine  
(number K20A6540371)  
Our Ref : CI/TP21000536/D

09 January 2021

**INSPECTION REPORT OF A HONDA ENGINE WITH NUMBER K20A6540371**

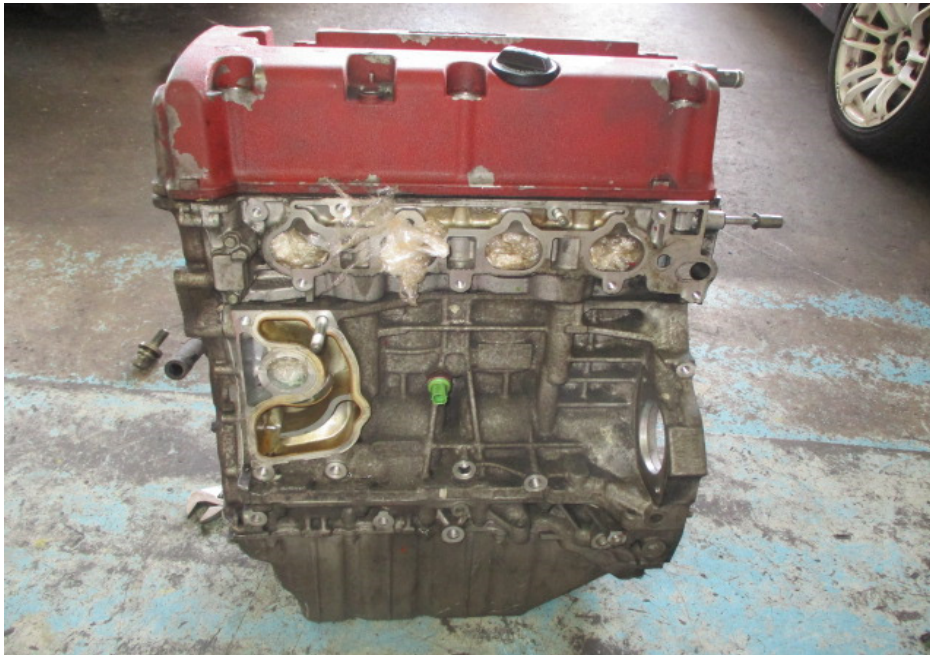
**Photo 1** shows a general view of the Honda engine that I had inspected. The Honda engine was observed to be a used engine and was not fitted on any motor car. It was also observed to be a complete assembly with all mechanical parts still intact, within the engine housing.

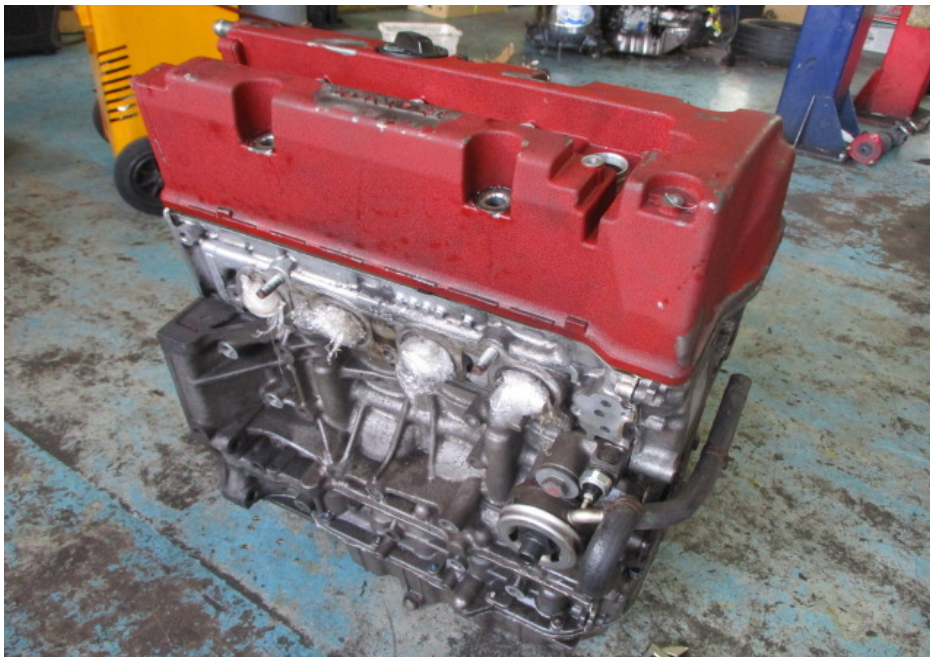
**Photo 2** shows a general view of the Honda engine that I had inspected. My visual examination of the engine housing revealed the housing to be of serviceable/satisfactory condition. There was no crack and/or hole observed on the engine housing.

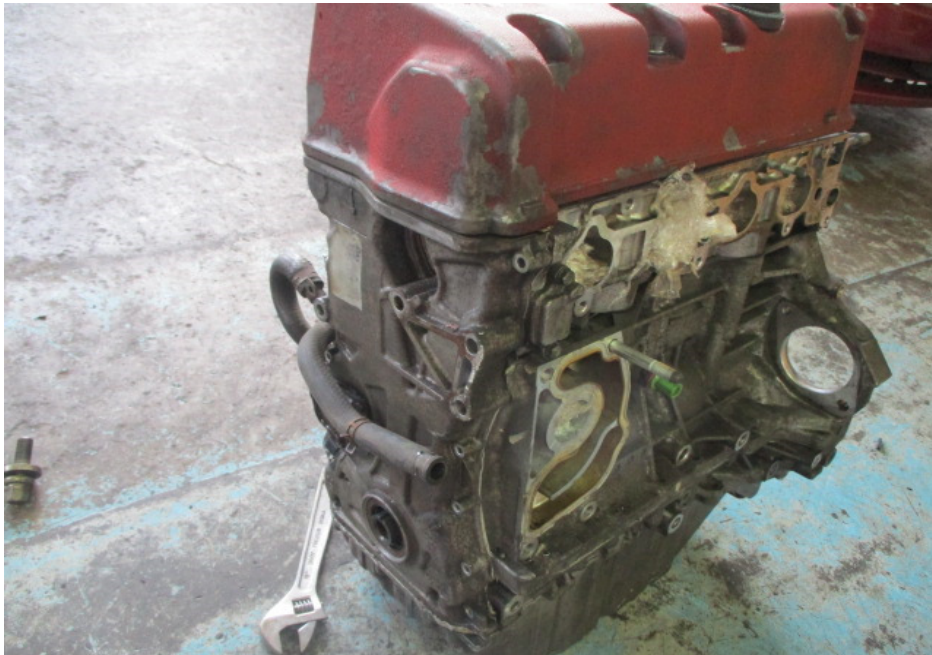
**Photo 3** shows a general view of the Honda engine that I had inspected. My visual examination of the engine housing revealed the housing to be of serviceable/satisfactory condition. There was no crack and/or hole observed on the engine housing.

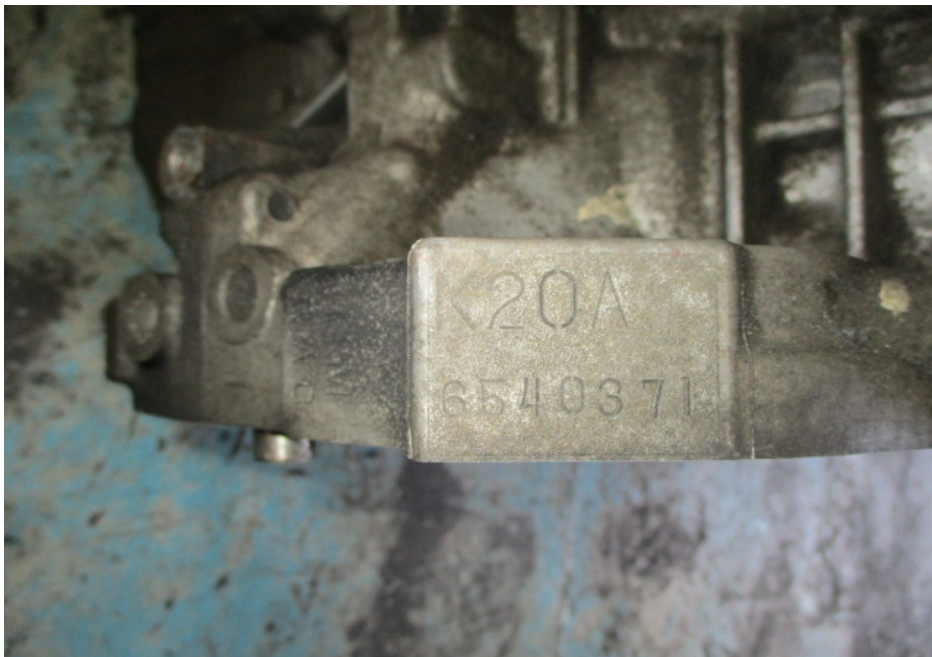
**Photo 4** shows the engine number engraved on the housing of the Honda engine that I had inspected. The engine number was K20A6540371.

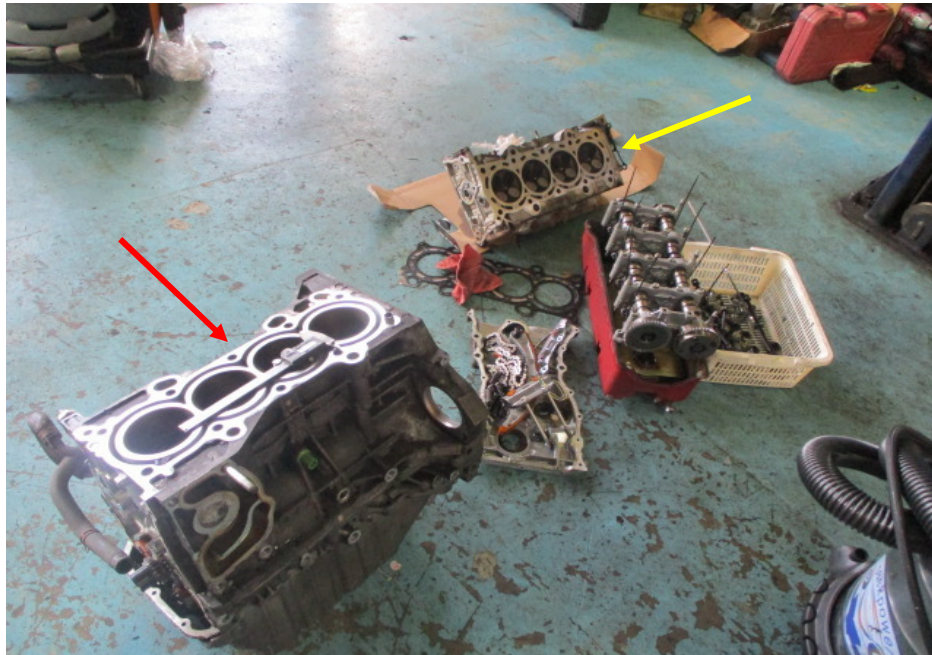
**Photo 5** shows the top block (yellow arrow) of the Honda engine separated from its bottom block (red arrow). This was to enable me to carry out measurements of its cylinders, in particular the bore and stroke measurements of each cylinder, which typically can be used to determine the engine displacement or more commonly referred to as engine cc.

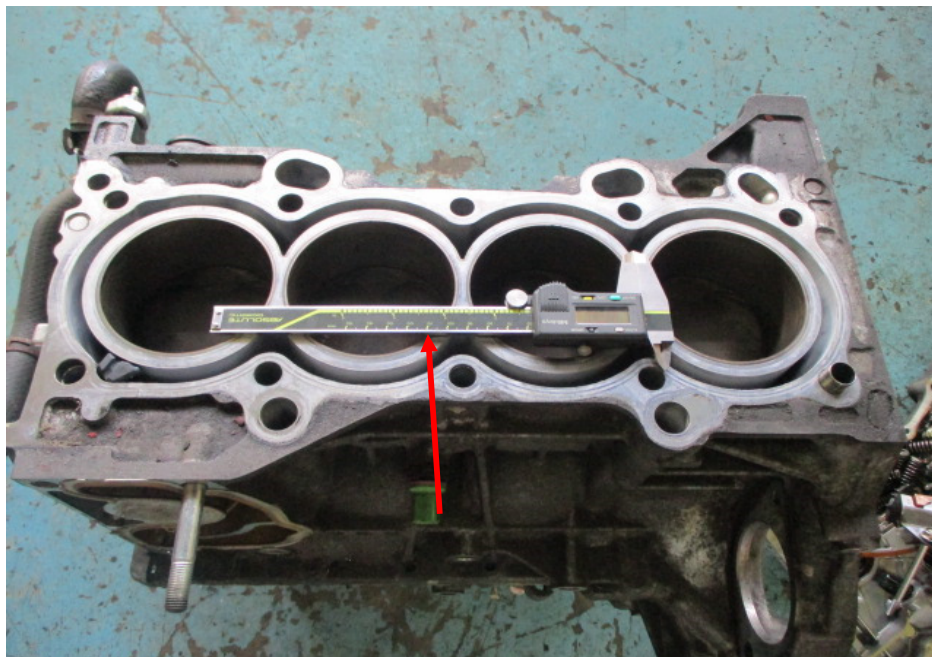
**Photo 6** shows the bottom block of the Honda engine and the digital Vernier Caliper (arrowed) that was used to measure the bore and stroke measurements of each cylinder, which typically can be used to determine the engine displacement or more commonly referred to as engine cc. The digital Vernier Caliper was calibrated before the start of the measurements.

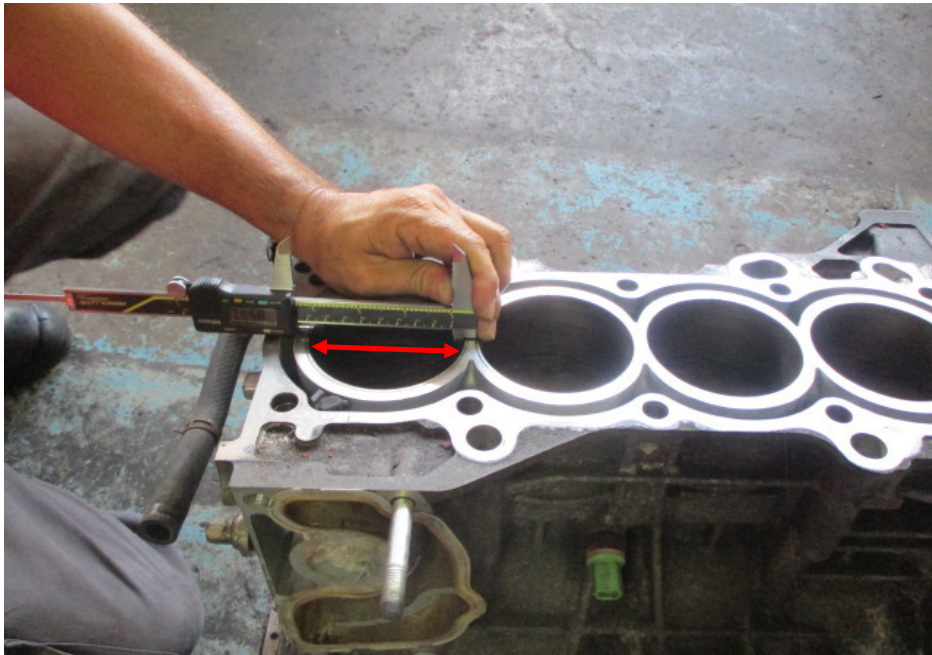
**Photo 7** shows measurement being carried out to the bore (arrowed) of cylinder 1 of the Honda engine. The measurements were carried out using a digital Vernier Caliper that was calibrated before the start of the measurements.

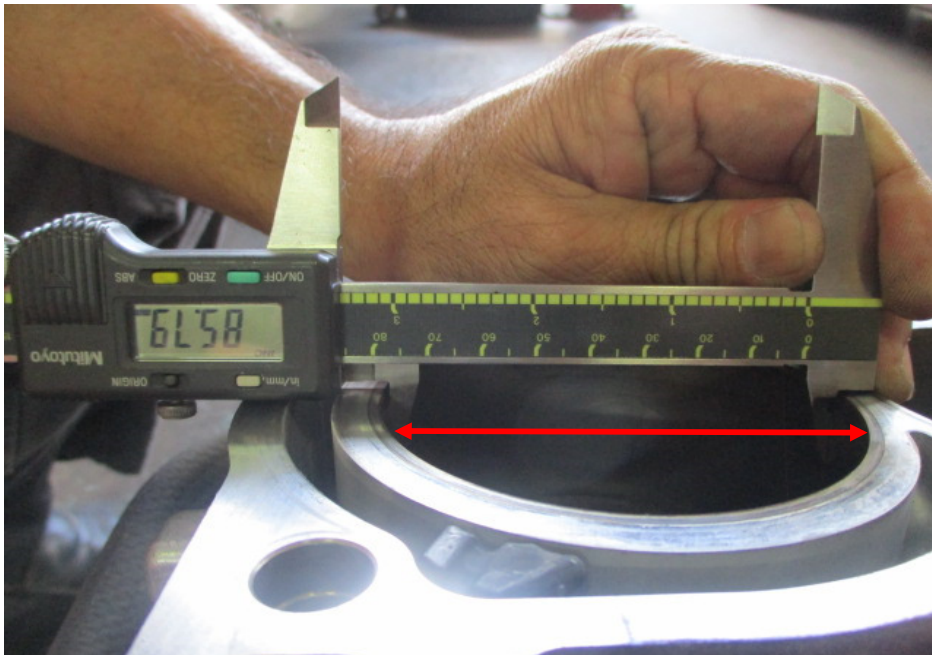
| | <b>Bore (mm)</b> | <b>Stroke (mm)</b> |
|---|---|---|
| <b>Cylinder 1</b> | 85.79 | 85.95 |

**Photo 8** shows the bore measurement of cylinder 1, which was recorded to be 85.79mm.

12. Upon comparison, I note that the bore and stroke measurements of the Honda engine that I had inspected (shown in paragraph 10 above) had corresponded to the bore and stroke measurements as stated in the technical specifications of a Honda K20A model engine. The measurements recorded from the Honda engine were all slightly lesser (at maximum 0.30mm lesser). This difference can be attributed to carbon accumulation within the cylinders, as the Honda engine that I had inspected was a used engine.

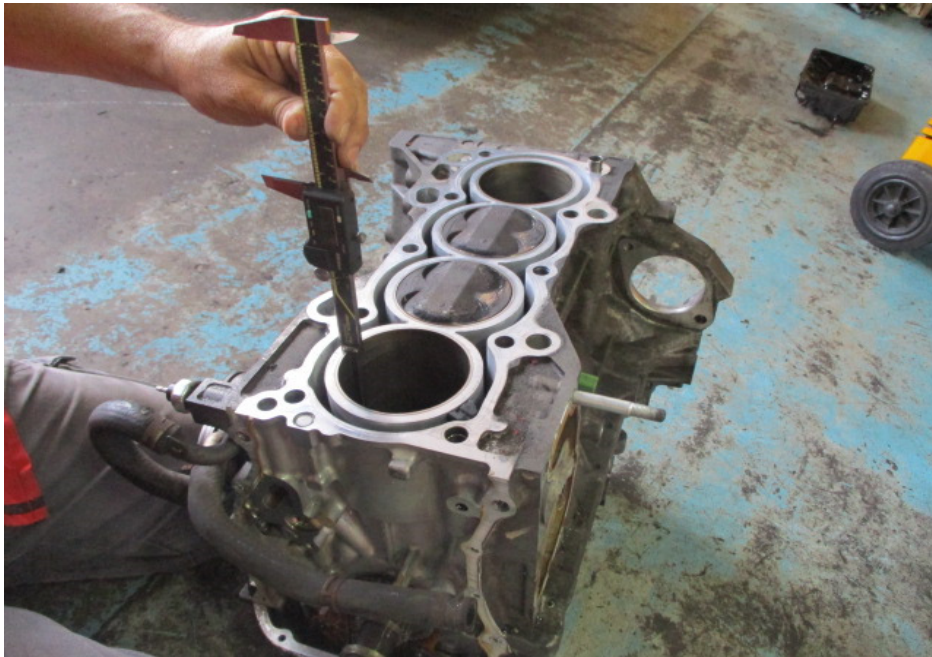
**Photo 9** shows measurement being carried out to the stroke of cylinder 1 of the Honda engine. The bore and stroke measurements of the Honda engine were carried out using a digital Vernier Caliper.

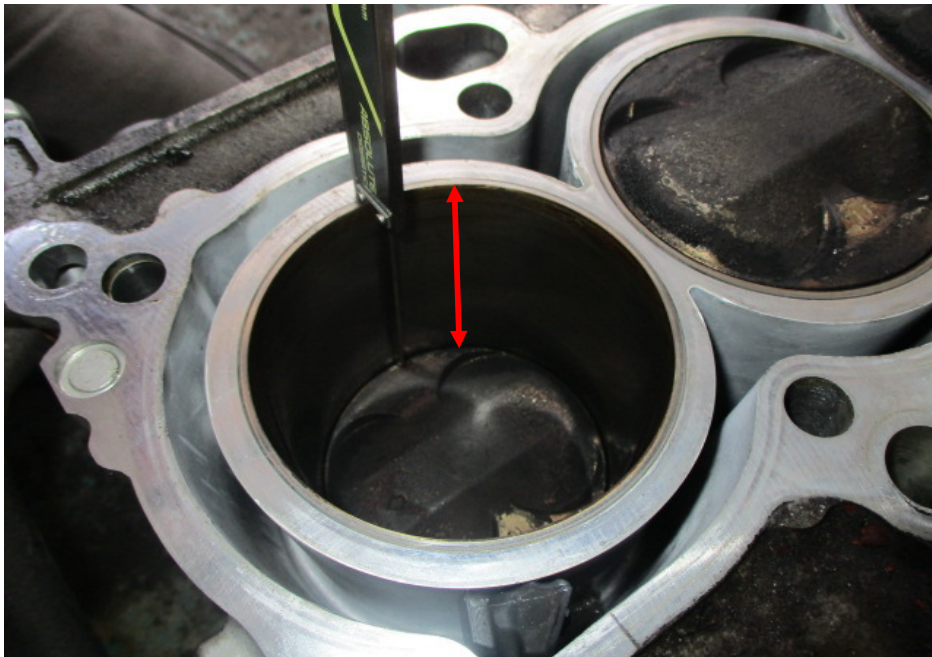
**Photo 10** shows measurement being carried out to the stroke (arrowed) of cylinder 1 of the Honda engine. The bore and stroke measurements of the Honda engine were carried out using a digital Vernier Caliper that was calibrated before the start of the measurements,

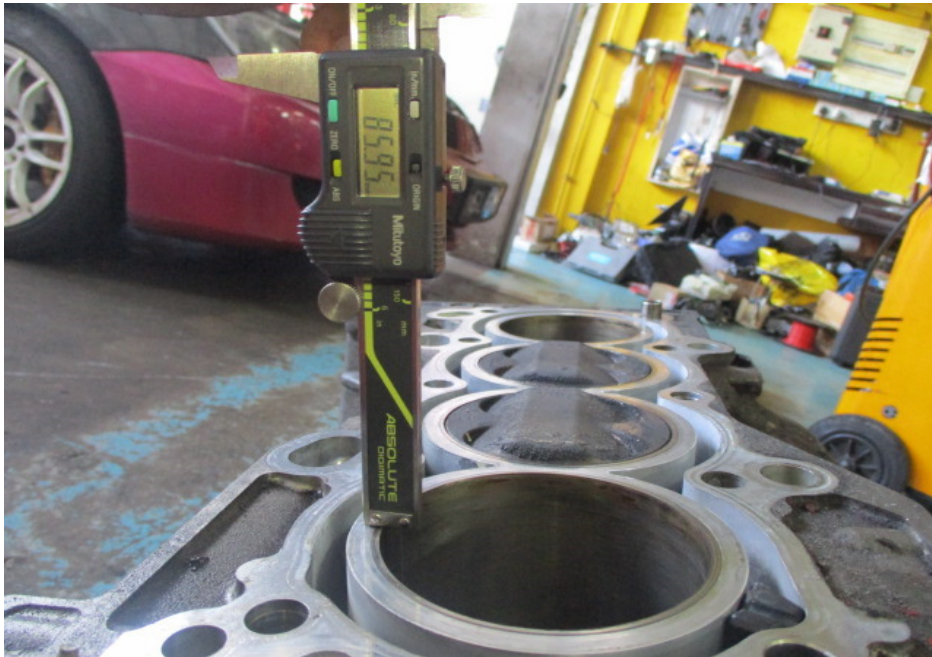
**Photo 11** shows the stroke measurement of cylinder 1, which was recorded to be 85.95mm.

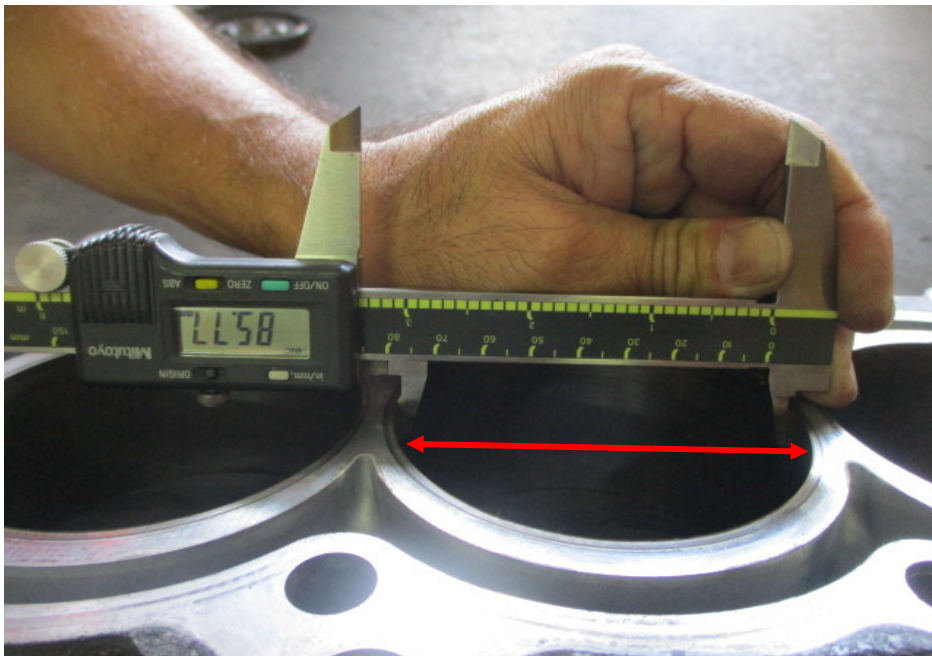
| | <b>Bore (mm)</b> | <b>Stroke (mm)</b> |
|---|---|---|
| <b>Cylinder 2</b> | 85.77 | 85.93 |

**Photo 12** shows measurement being carried out to the bore (arrowed) of cylinder 2 of the Honda engine. The bore measurement of cylinder 2 was recorded to be 85.77mm.

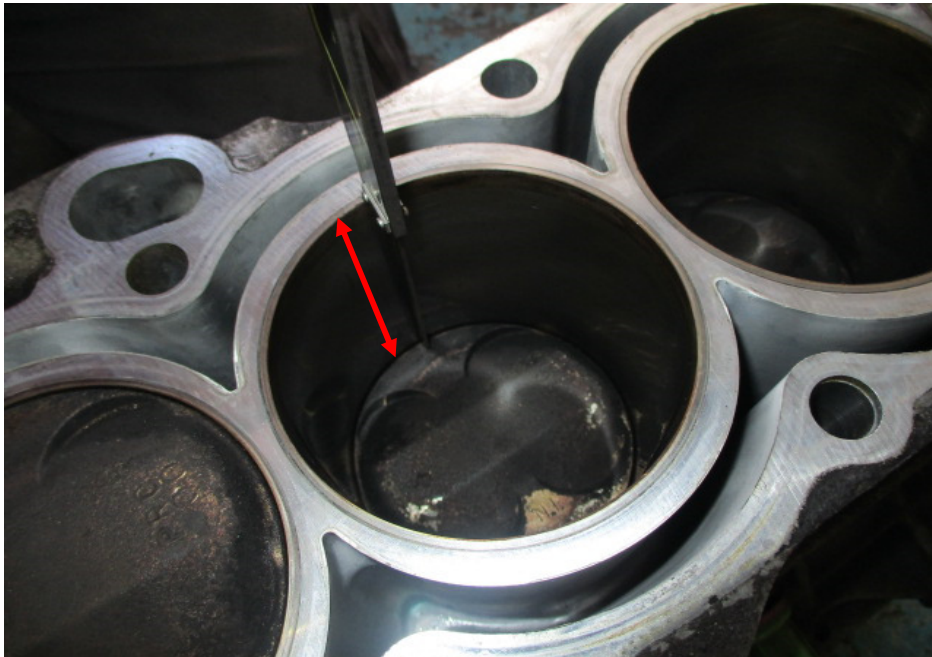
**Photo 13** shows measurement of the stroke (arrowed) for cylinder 2 of the Honda engine that I had inspected.

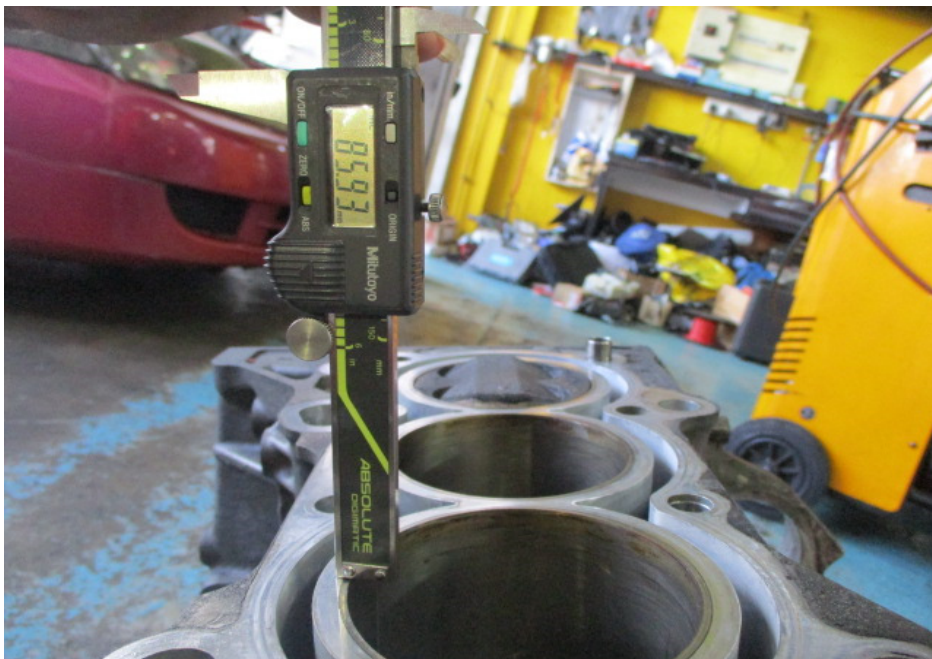
**Photo 14** shows the stroke measurement of cylinder 2, which was recorded to be 85.93mm.

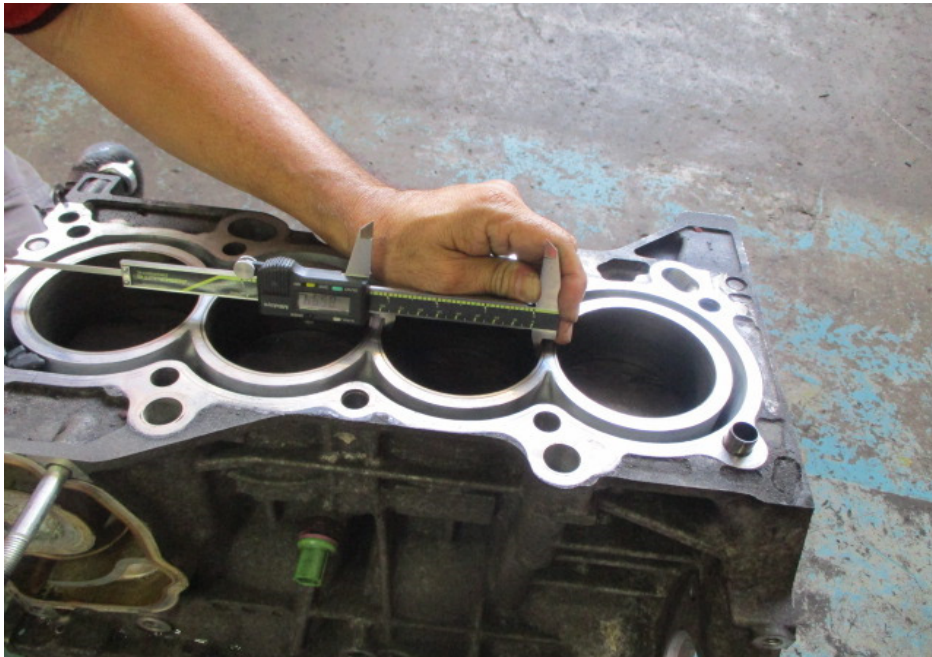
**Photo 15** shows measurement being carried out to the bore of cylinder 3 of the Honda engine. The bore and stroke measurements of the Honda engine were carried out using a digital Vernier Caliper.

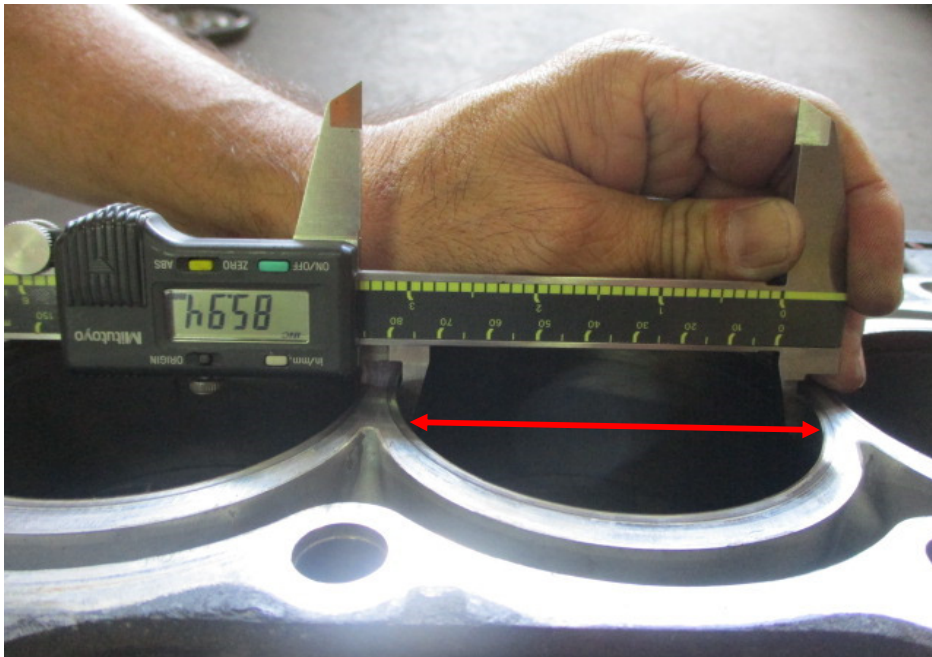
| | <b>Bore (mm)</b> | <b>Stroke (mm)</b> |
|---|---|---|
| <b>Cylinder 3</b> | 85.94 | 85.94 |

**Photo 16** shows measurement being carried out to the bore (arrowed) of cylinder 3 of the Honda engine. The bore measurement of cylinder 3 was recorded to be 85.94mm.

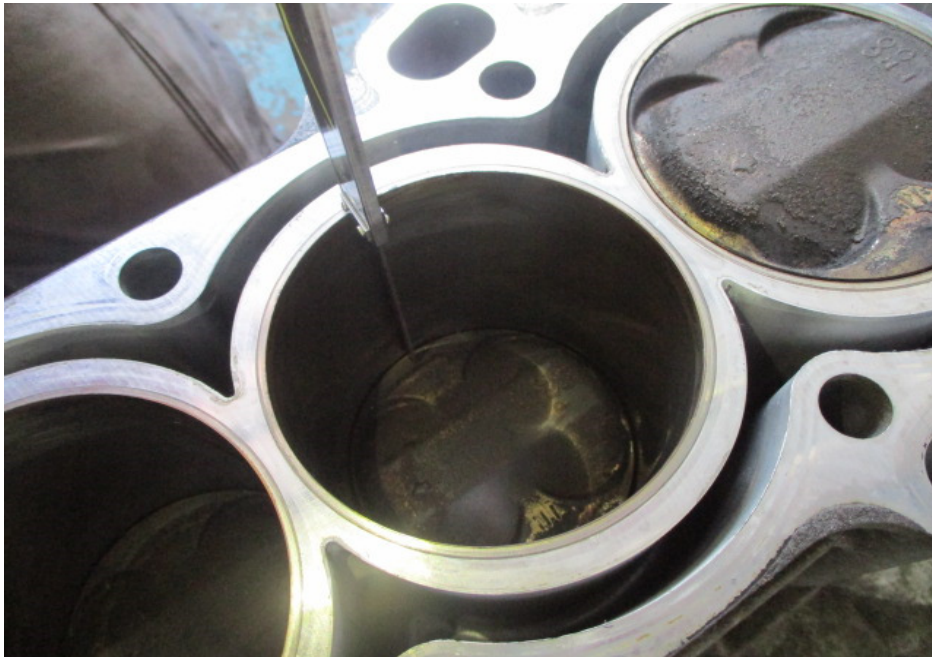
**Photo 17** shows measurement of the stroke for cylinder 3 of the Honda engine that I had inspected. The bore and stroke measurements of the Honda engine were carried out using a digital Vernier Caliper that was calibrated before the start of measurements.

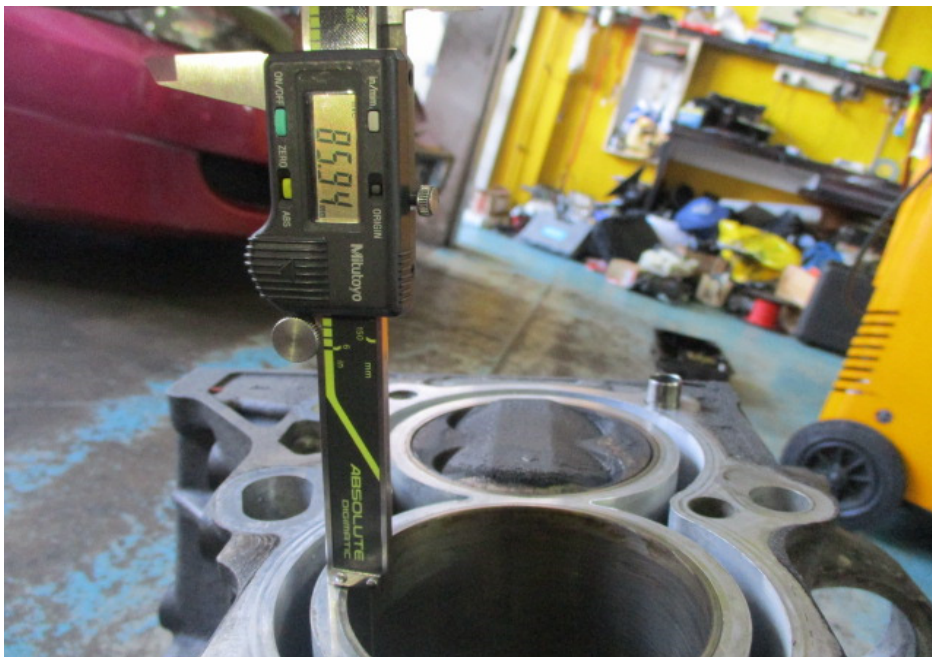
**Photo 18** shows the stroke measurement of cylinder 3, which was recorded to be 85.94mm.

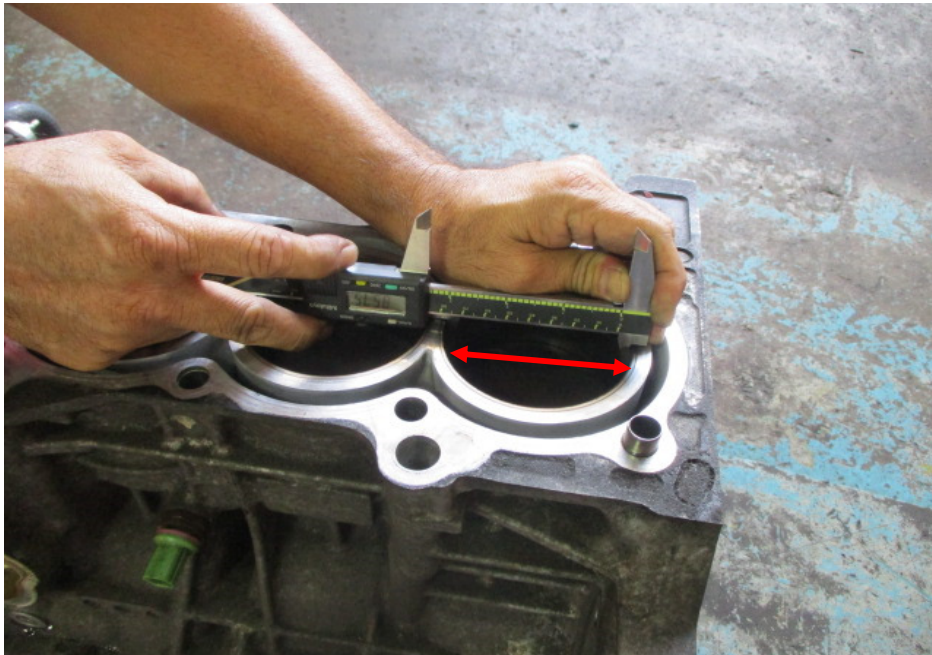
**Photo 19** shows measurement being carried out to the bore (arrowed) of cylinder 4 of the Honda engine. The bore and stroke measurements of the Honda engine were carried out using a digital Vernier Caliper.

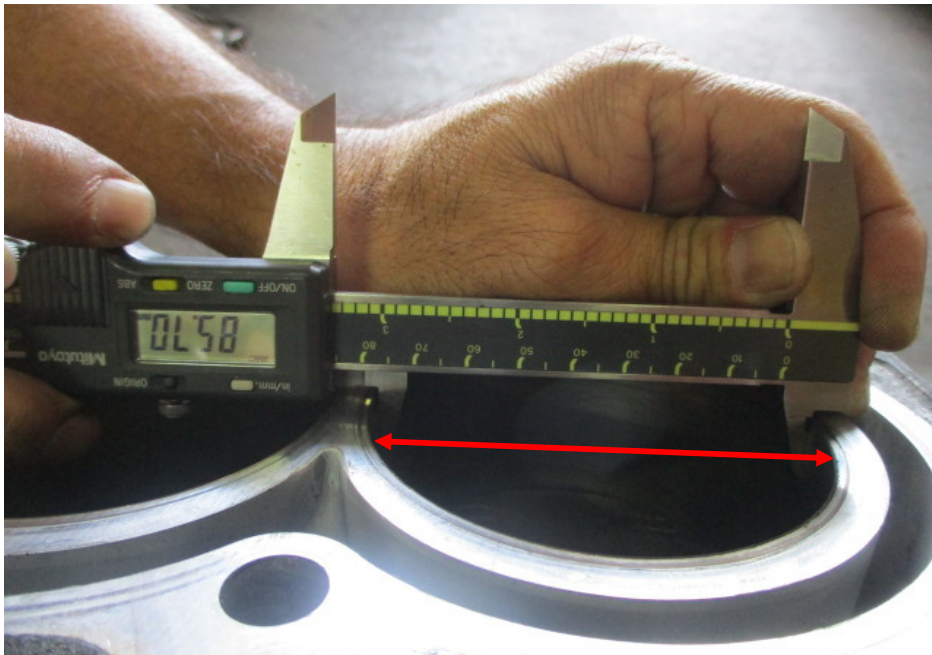
| | <b>Bore (mm)</b> | <b>Stroke (mm)</b> |
|---|---|---|
| <b>Cylinder 4</b> | 85.70 | 85.97 |

**Photo 20** shows the bore measurement of cylinder 4, which was recorded to be 85.70mm.

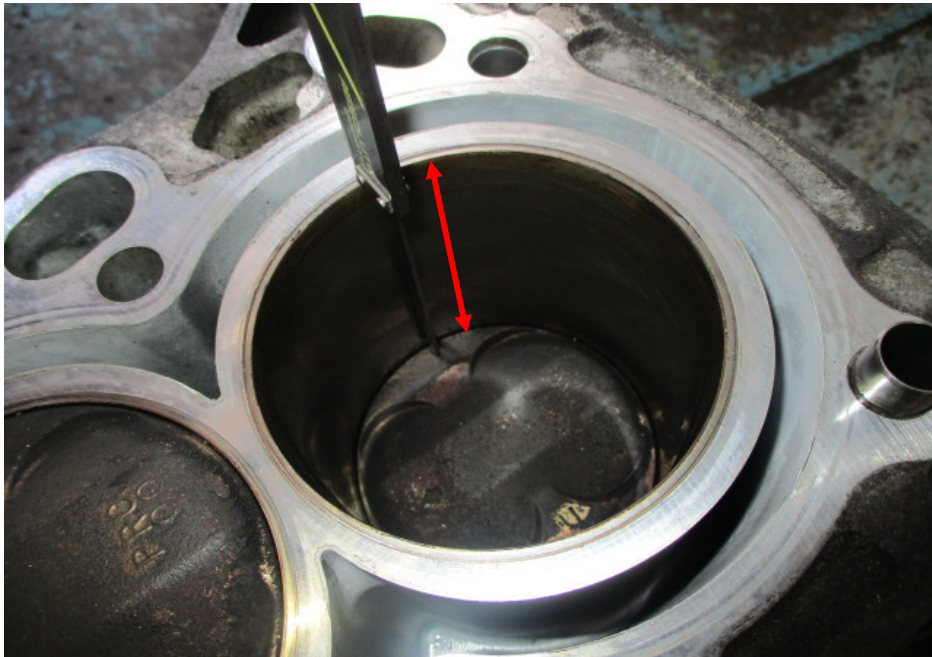
**Photo 21** shows measurement being carried out to the stroke (arrowed) of cylinder 4 of the Honda engine. The bore and stroke measurements of the Honda engine were carried out using a digital Vernier Caliper that was calibrated prior to the start of measurements.

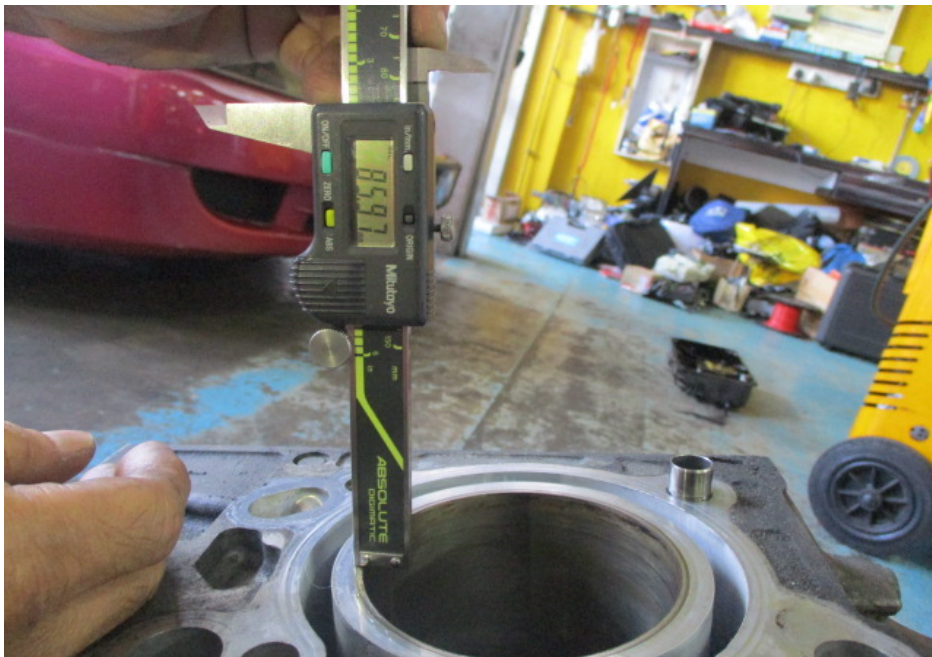
**Photo 22** shows the stroke measurement of cylinder 4, which was recorded to be 85.97mm.
