Your Ref: BMW 440i Coupe  
(chassis number WBA4W72080AF06806)  
Our Ref : CI/TP21000537/D

09 January 2021

**INSPECTION REPORT OF AN UNREGISTERD BMW 440i MOTOR CAR WITH CHASSIS NUMBER WBA4W72080AF06806**

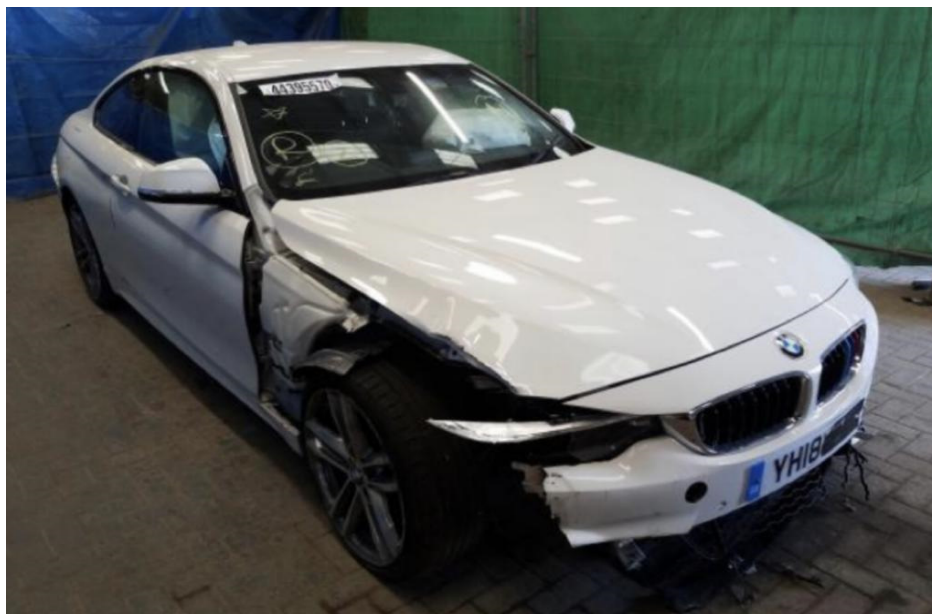
**Photo 1** shows the front right body of the Motor Car (photograph provided to me). The Motor Car was observed to have sustained damage at its front right portion. The front bumper, front bumper right lower grille, front bonnet, front right fender and front right wheel rim were amongst the body parts that were observed to have been damaged. The front right wheel and front left wheel (refer to photograph 2 below) were orientated in different directions, which suggests to me that the front right undercarriage parts of the Motor Car were also damaged.

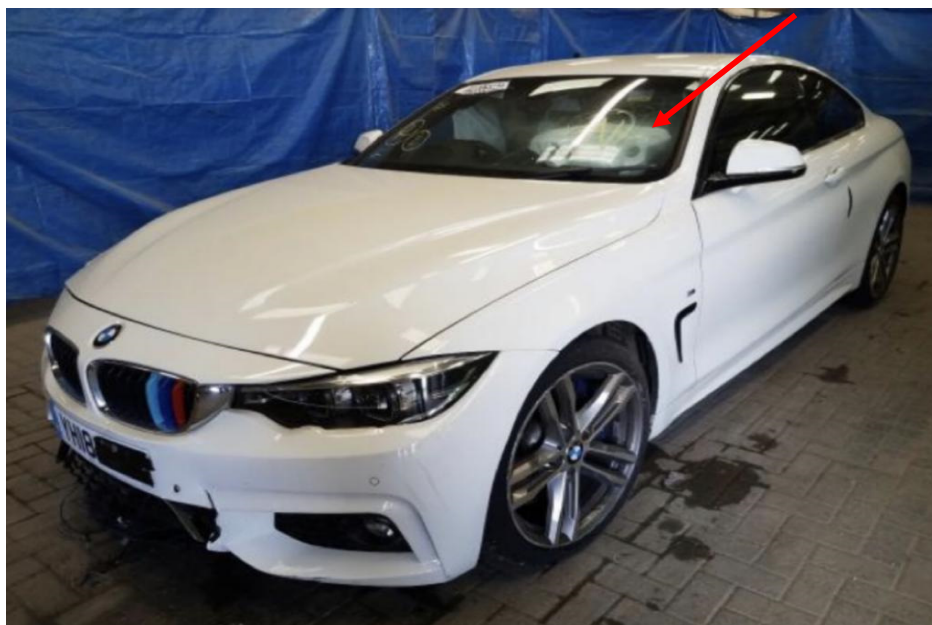
**Photo 2** shows the front left body of the Motor Car (photograph provided to me). The front left passenger airbag (arrowed) was observed to be deployed. The front left wheel was orientated slightly to the right as compared to the front right wheel, which was orientated straight (refer to photograph 1 above). This would indicate to me that there was damage to the front right undercarriage parts of the Motor Car, given that the front left portion of the Motor Car was seen to be undamaged.

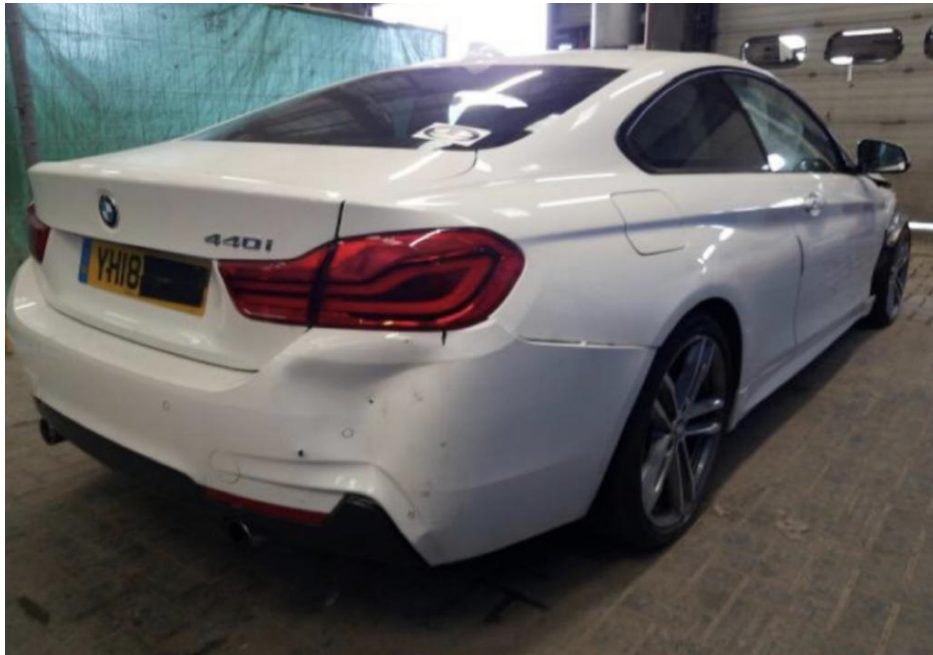
**Photo 3** shows the rear right body of the Motor Car (photograph provided to me). Apart for the front right portion, I had also observed damage to the rear right portion of the Motor Car. The rear bumper and rear bumper lower garnish were observed to be damaged.

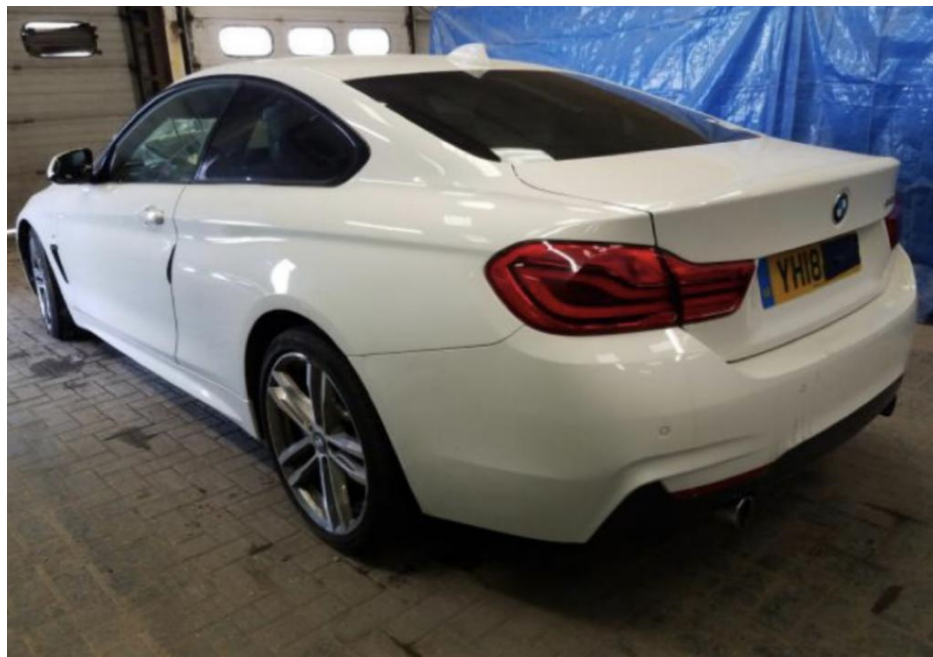
**Photo 4** shows the rear left body of the Motor Car (photograph provided to me). Apart for the front right portion and rear right portion, there was no physical damage seen to other areas of the Motor Car.

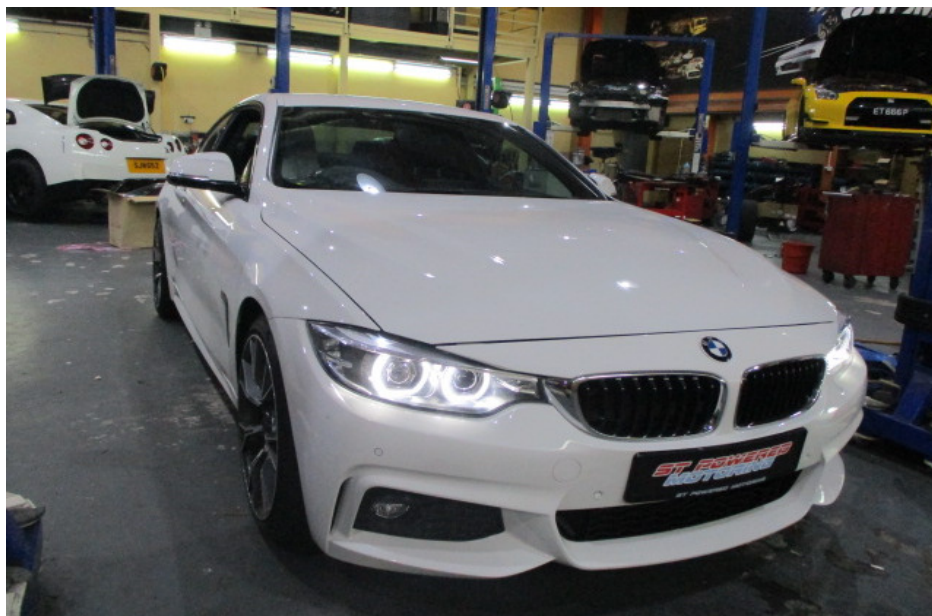
22. The body parts at the front right portion and rear right portion of the Motor Car were visually examined and it was noted that the repair/restoration works carried out to the damaged area of the Motor Car (refer to photograph 1 & 3 above) were reasonably adequate and in order.

**Photo 5** shows a general view of the front right body of the Motor Car at the time of my inspection. The Motor Car was observed to be in a relatively good general condition with no loose exterior fittings observed. The body parts at the front right portion of the Motor Car were visually examined and it was observed that the repair/restoration works carried out to the damaged area of the Motor Car (refer to photograph 1 above) were reasonably adequate and in order.

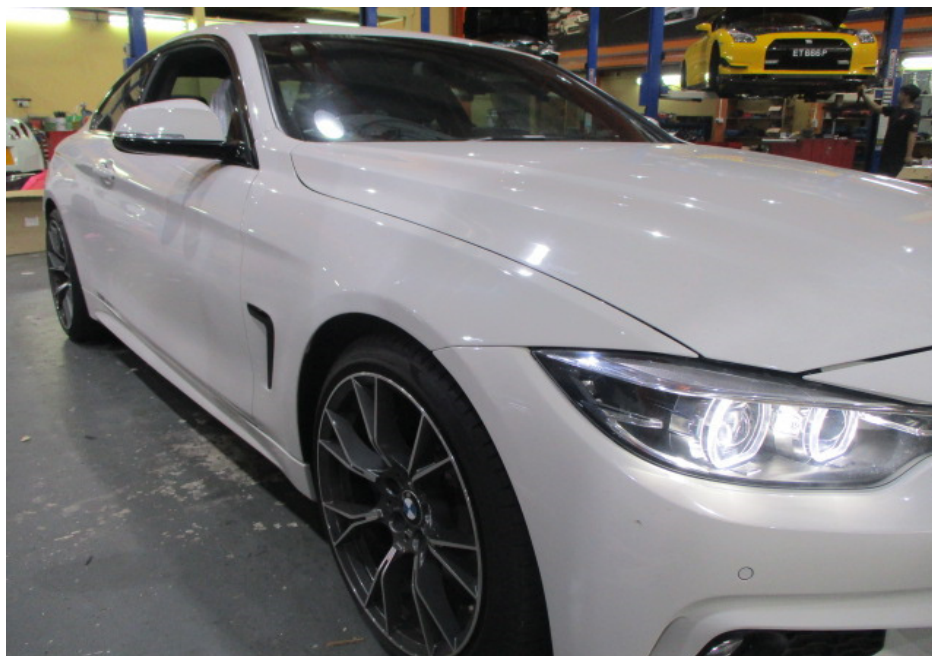
**Photo 6** shows a closer view of the front bumper, front right headlamp, front bonnet and front right fender of the Motor Car at the time of my inspection. The body parts at the front right portion of the Motor Car were visually examined and it was observed that the repair/restoration works carried out to the damaged area of the Motor Car (refer to photograph 1 above) were reasonably adequate and in order.

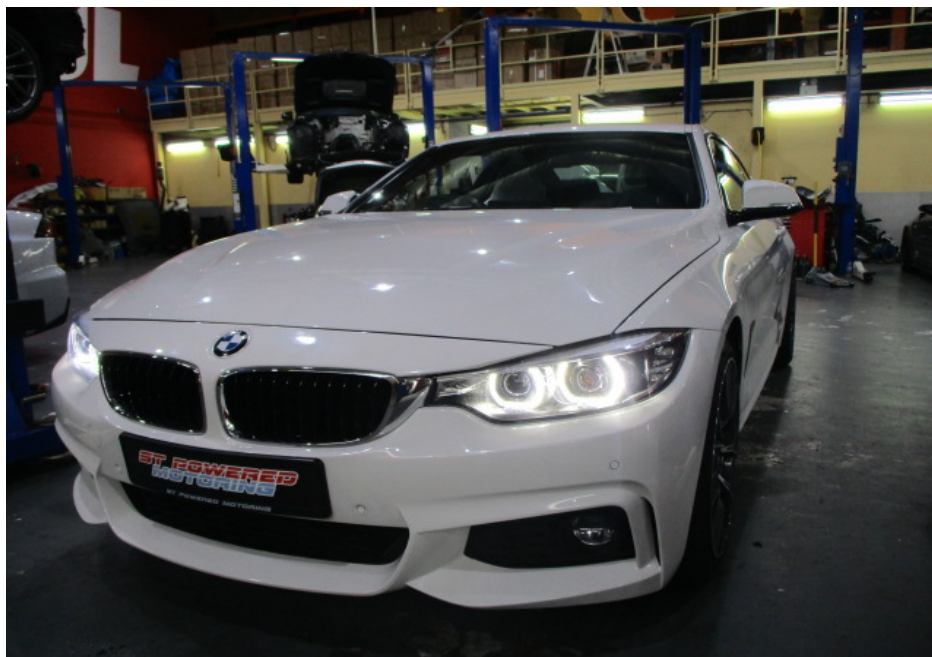
**Photo 7** shows a general view of the front left body of the Motor Car at the time of my inspection. The Motor Car was observed to be in a relatively good general condition with no loose exterior fittings observed. The mileage of the Motor Car recorded at the time of my inspection was 6,865km.

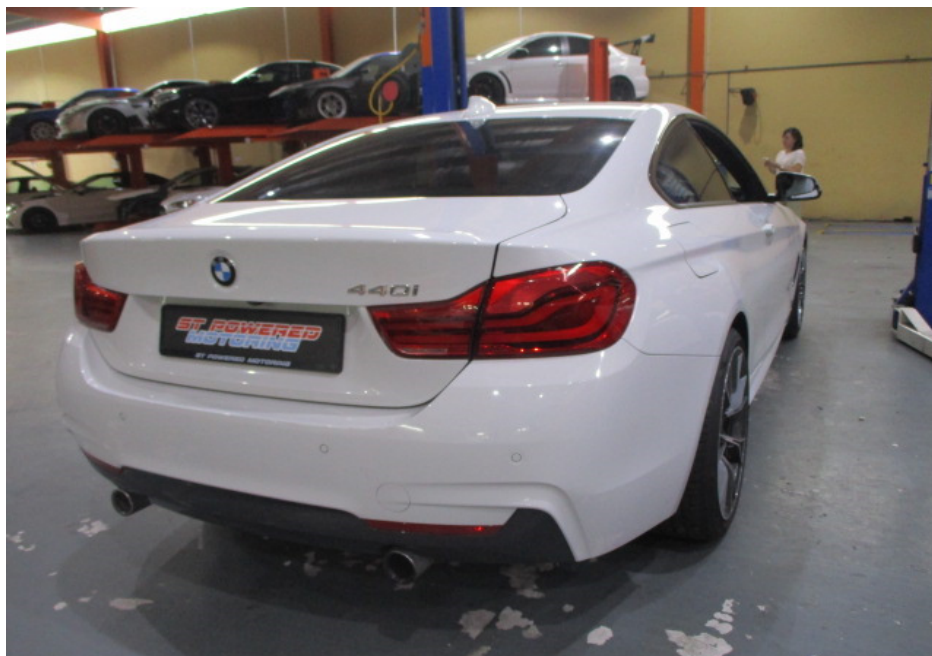
**Photo 8** shows a general view of the rear right body of the Motor Car at the time of my inspection. The Motor Car was observed to be in a relatively good general condition with no loose exterior fittings observed. The body parts at the rear right portion of the Motor Car were visually examined and it was observed that the repair/restoration works carried out to the damaged area of the Motor Car (refer to photograph 3 above) were reasonably adequate and in order.

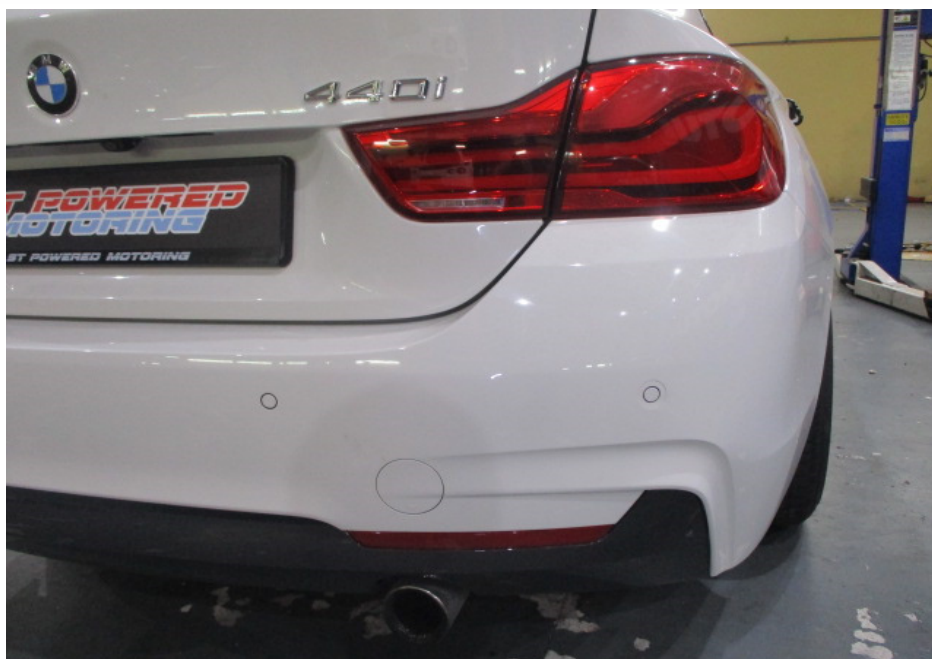
**Photo 9** shows a closer view of the rear bumper and rear bumper lower garnish of the Motor Car at the time of my inspection. The body parts at the rear right portion of the Motor Car were visually examined and it was observed that the repair/restoration works carried out to the damaged area of the Motor Car (refer to photograph 3 above) were reasonably adequate and in order.

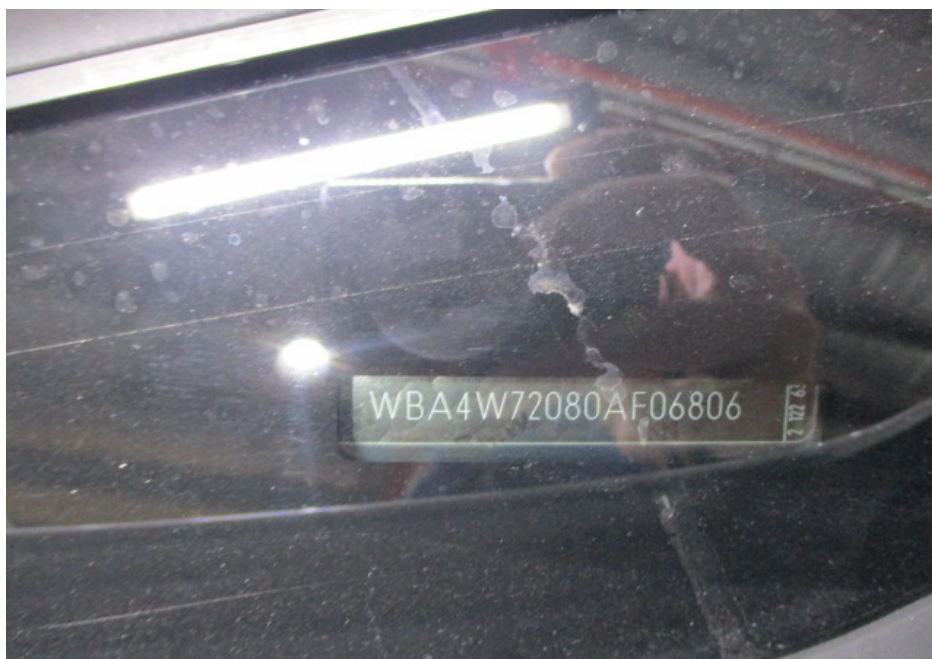
**Photo 10** shows the chassis number of the Motor Car. The chassis number recorded was WBA4W72080AF06806.

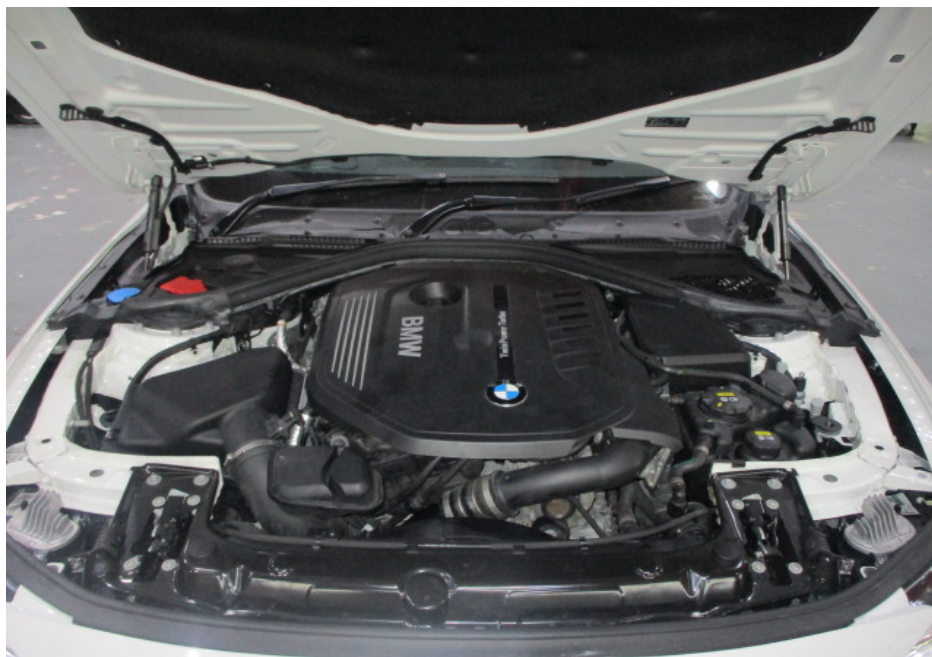
14. My examination of the engine compartment of the Motor Car revealed that the various parts and components inside the engine compartment were all intact and properly fitted. The engine oil, brake fluid and engine coolant were all found to be of sufficient level for operating purposes. Visually, there was also no contamination found to these fluids.
15. My checks on the underside of the Motor Car revealed no sign(s) or indication(s) of fluid leakage and/or fluid stain(s). The engine block and automatic transmission assembly were both secured properly. All undercarriage components of the Motor Car were also observed to be intact and secured in an appropriate manner.

**Photo 11** shows a general view of the engine compartment of the Motor Car at the time of my inspection. The various parts and components inside the engine compartment were all observed to be intact and properly fitted. There was also no sign(s) or indication(s) of fluid leak and/or fluid stain found inside the engine compartment.

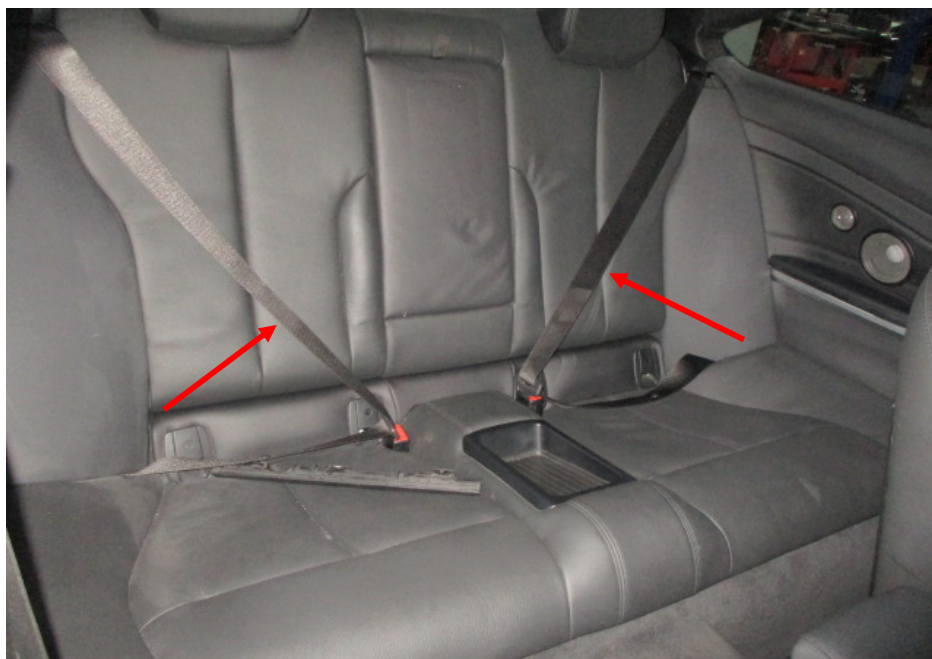
12. The seats of the Motor Car were found to be secured to the floorboard of the Motor Car via seat rails bolted onto the floorboard. Retractable seat belt reels and pre-tensioners were fitted on all seats of the Motor Car. The seat belts were tested and were able to be fastened securely into the respective pre-tensioners that were fixed to the side of all the seats.

**Photo 12** shows the rear seats of the Motor Car. All the seats of the Motor Car were secured via seat rails to the floorboard. They were also fitted with a retractable seat belt reel and a pre-tensioner. The seat belts (arrowed) were tested and were able to be fastened into the respective pre-tensions that were fitted on the side of each individual seat.

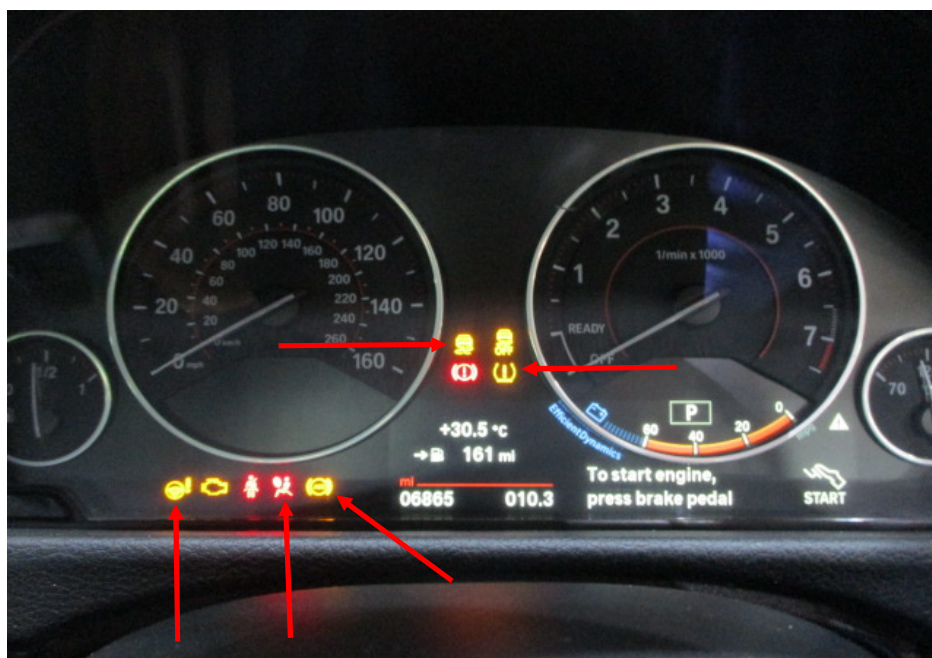
**Photo 13** shows the warning lights for the various electronic safety features appearing on the instrument panel of the Motor Car during its self-test when the engine is cranked, in particular the ABS, SRS, IAS, TPM and DSC lights (arrowed).

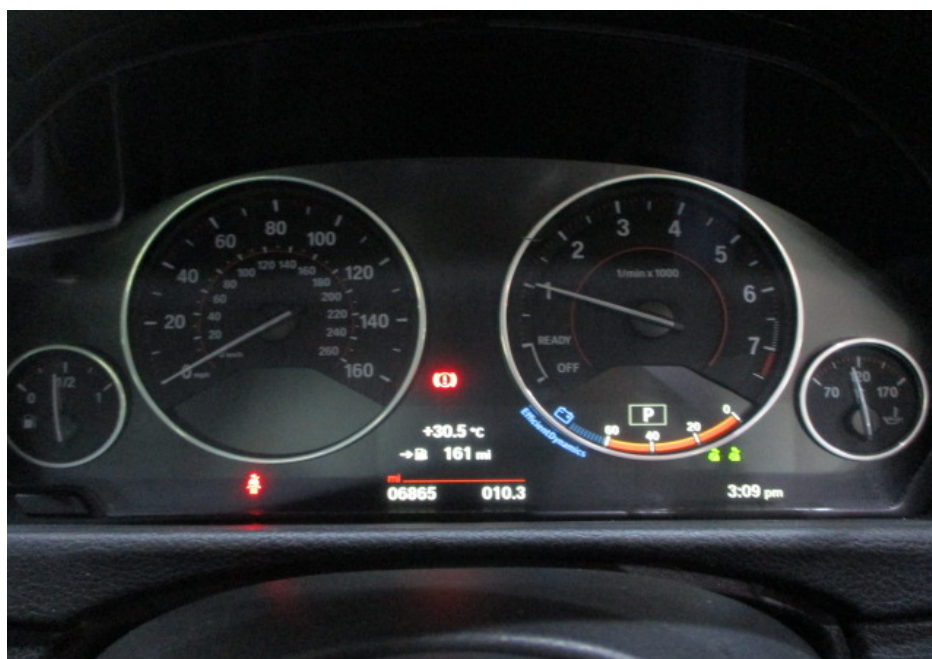
13. The Motor Car's automatic self-test of the functionality of its various electronic safety features like the Anti-Lock Brake System (ABS), Supplemental Restraint System (SRS), Integral Active Steering (IAS), Tyre Pressure Monitor (TPM) and Dynamic Stability Control (DSC) during cranking of the engine had indicated that these electronic systems were in working condition. This was determined from the respective warning lights disappearing from the instrument panel after the self-test.

**Photo 14** shows the respective warning lights no longer illuminated, indicating that there is no fault detected to the ABS, SRS, IAS, TPM and DSC systems of the Motor Car during the self-test. These electronic systems were hence in working condition at the time of inspection.

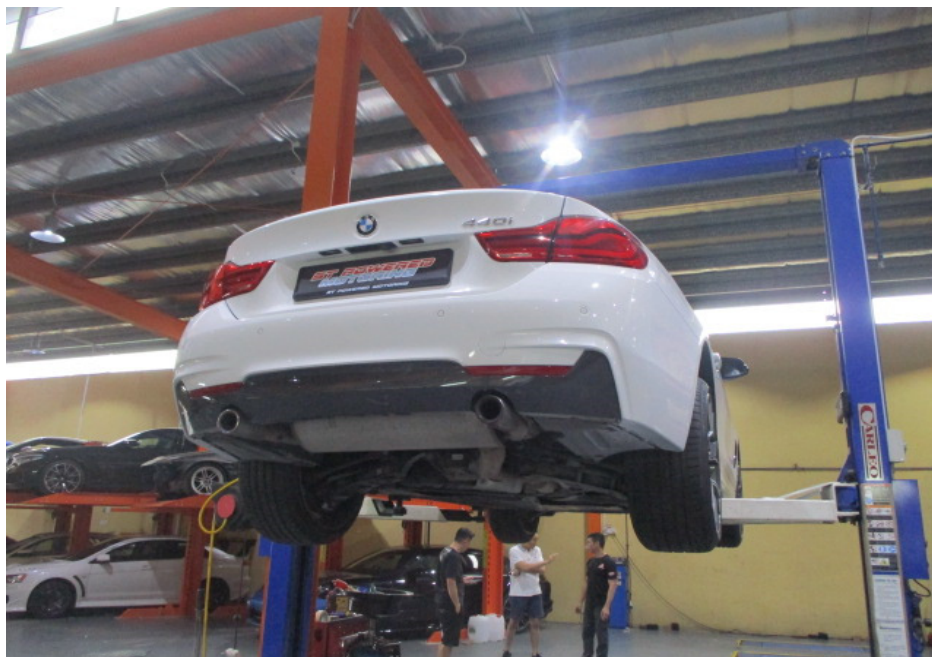
**Photo 15** shows the Motor Car hoisted up for checks on its undercarriage. There was no sign(s) or indication(s) of fluid leakage and/or fluid stain(s) on the underside of the Motor Car. The undercarriage components of the Motor Car were also all observed to be intact and secured in an appropriate manner.

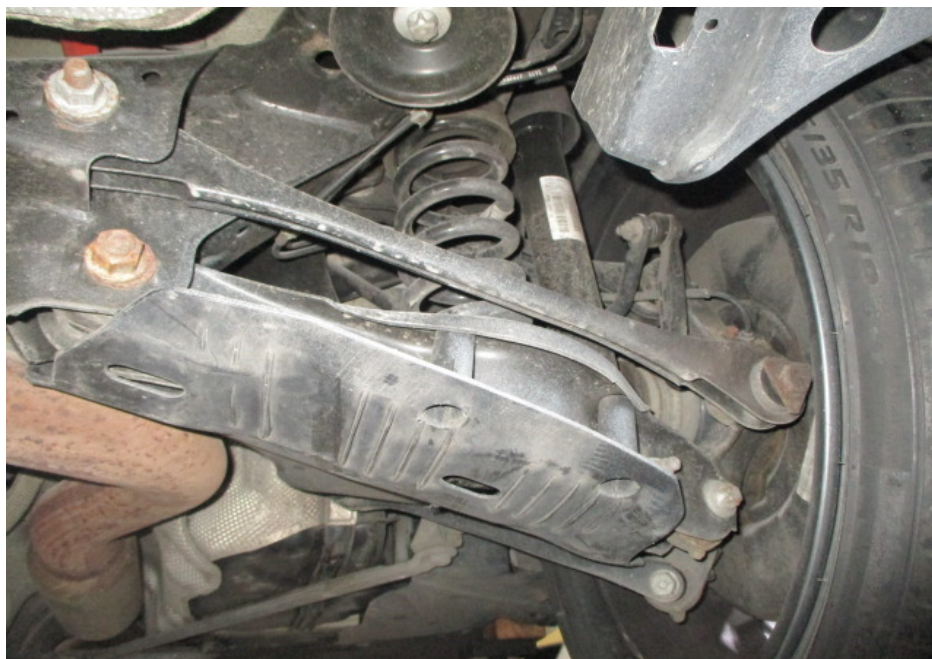
**Photo 16** shows a general view of the control arms and linkages at the rear right wheel of the Motor Car. I did not observe any fluid leak and/or fluid stain on the underside of the Motor Car. All of the Motor Car's undercarriage components were observed to be intact and secured in an appropriate manner.

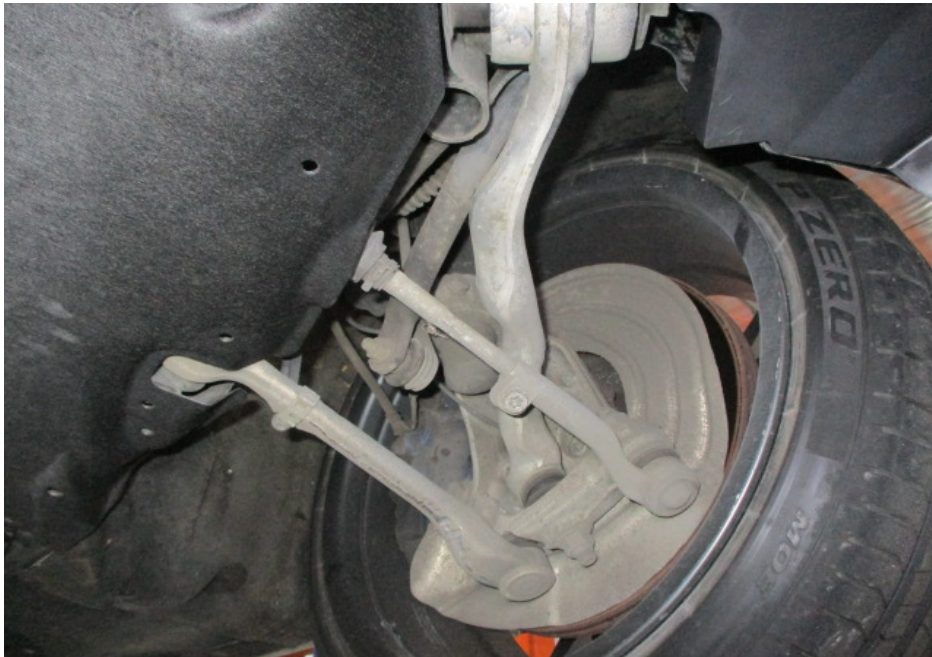
**Photo 17** shows the various undercarriage components at the front left wheel of the Motor Car. The mechanical components, control arms and linkages were all found to be intact and secured in an appropriate manner.

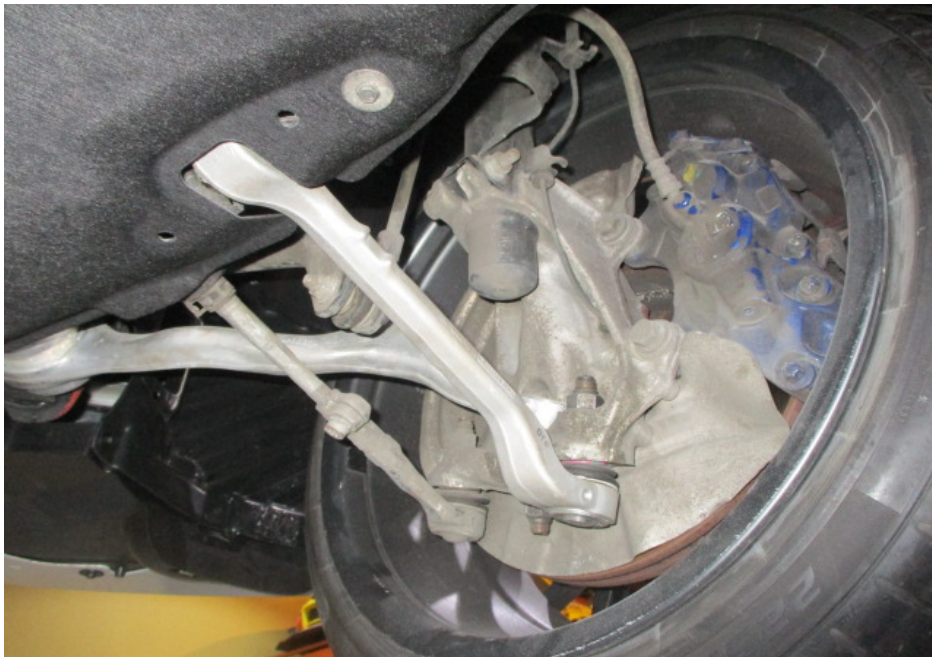
**Photo 18** shows the various undercarriage components at the front right wheel of the Motor Car. The mechanical components, control arms and linkages were all found to be intact and secured in an appropriate manner. I also did not observe any fluid leak and/or fluid stain on the underside of the Motor Car.

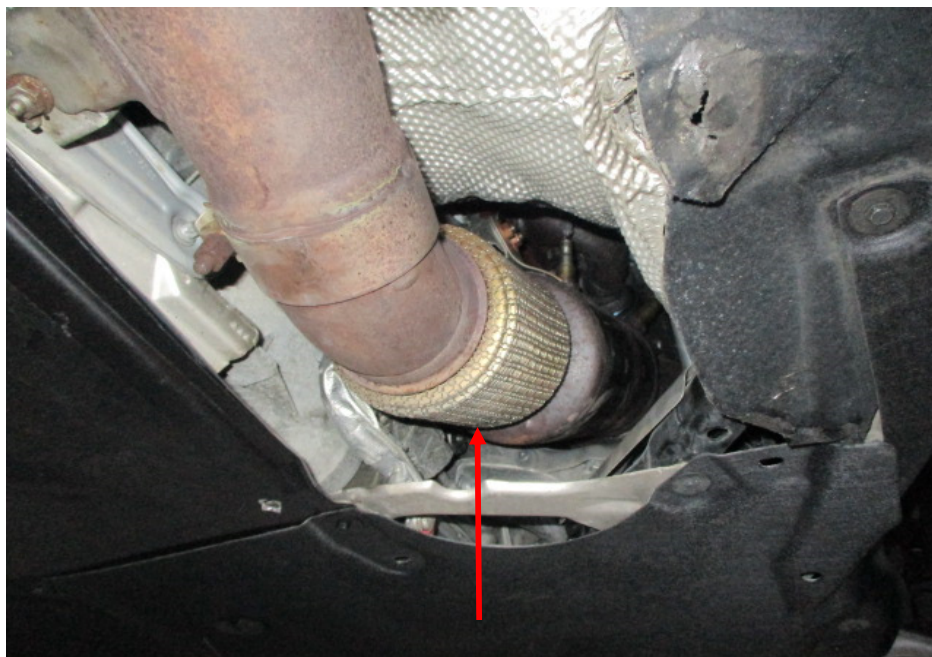
**Photo 19** shows the Motor Car's catalytic converter (arrowed). My examination of the Motor Car's exhaust system revealed no sign(s) or indication(s) of any cut or weld marks along its exhaust pipes and on its rear muffler.

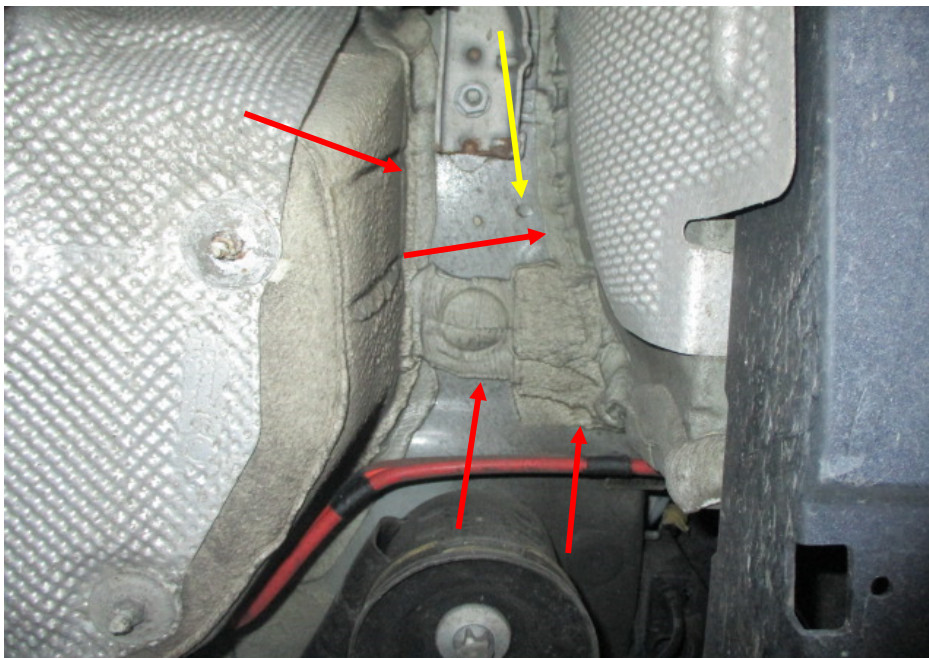
11. Visually, I did not find any weld marks, other than the original spot weld marks, on the chassis/structural body of the Motor Car. The original factory sealant at the joints along the chassis/structural body was also untouched, again indicating that no replacement of the chassis/structural body was carried out; and that the chassis/structural body was originally fitted.

**Photo 20** shows the chassis/structural body at the underside rear right of the Motor Car. I did not find any weld marks other than original spot weld marks (yellow arrow) on the chassis/structural body of the Motor Car. The original factory sealant (red arrow) at the joints along the chassis/structural body was untouched, indicating no work was done on the chassis/structural body of the Motor Car and that the chassis/structural body was originally fitted.

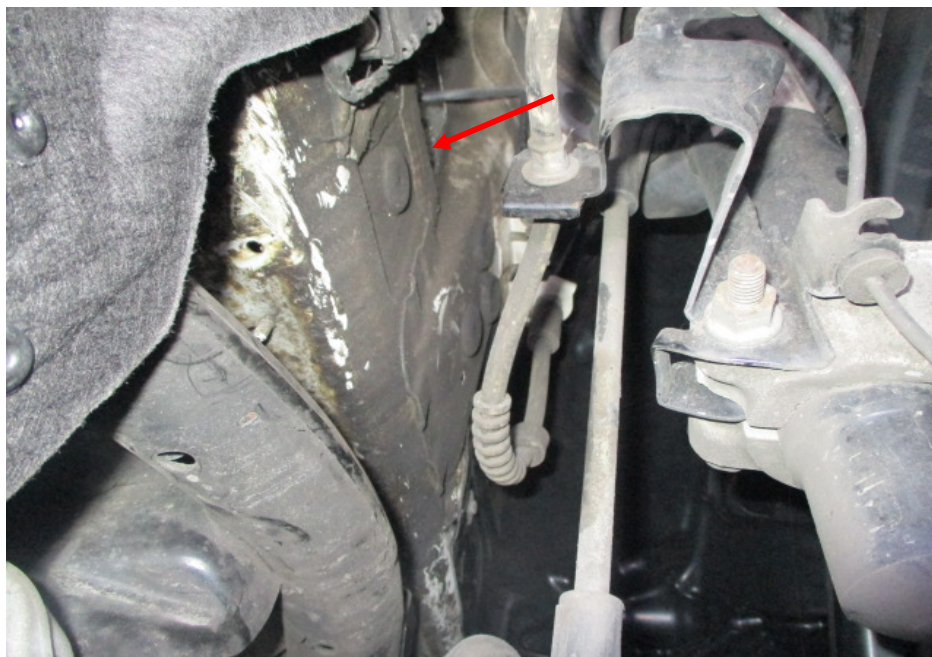
**Photo 21** shows the chassis/structural body at the underside front right of the Motor Car. The original factory sealant (arrowed) at the joints along the chassis/structural body was observed to be untouched. In general, I had found no work was carried out on the chassis/structural body of the Motor Car. The chassis/structural body of the Motor Car was originally fitted.

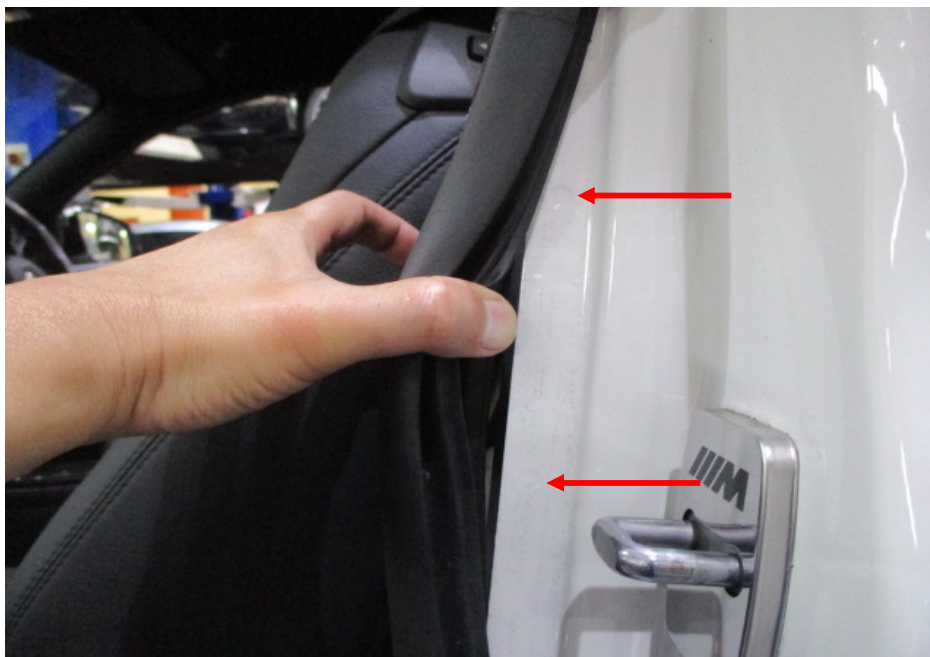
**Photo 23** shows the left rear body panel of the Motor Car. I did not find any weld marks other than original spot weld marks (arrowed) on the left rear body panel of the Motor Car which, indicates that there was no re-welding works carried out. In general, I had found all the non-detachable body panels of the Motor Car to be originally fitted at the time of my inspection.
