Your Ref: Mercedes Benz E300 Coupe  
(chassis number WDD2383482F102522)

10 January 2021

Our Ref : CI/TP21000539/D

**INSPECTION REPORT OF AN UNREGISTERED MERCEDES BENZ E300  
MOTOR CAR WITH CHASSIS NUMBER WDD2383482F102522**

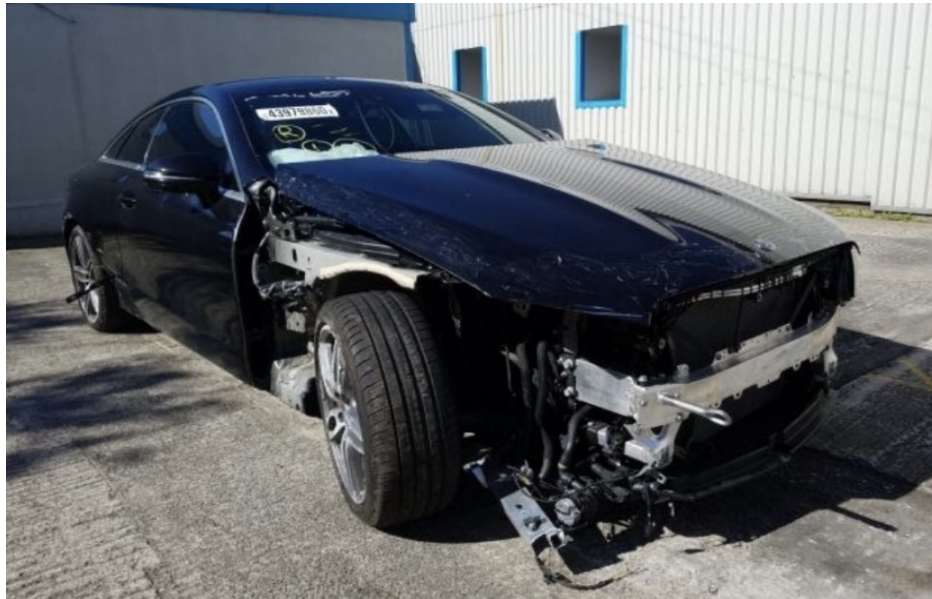
3. From the photographs provided to me, it was observed that the Motor Car had sustained damages at its front right portion and right rear portion. Body parts damaged at the front right portion include the front bumper and all its related parts, front right headlamp, front bonnet, front right fender, front right fender inner shield and front right wheel rim amongst others. With regard to the right rear portion, I had observed damage to the Motor Car's rear bumper and rear right body panel.
4. The orientation of the front right wheel and front left wheel, as seen from the photographs, indicates to me that the front right undercarriage parts of the Motor Car were also damaged. See photo 1 – 3 below.

**Photo 1** shows the front right body of the Motor Car (photograph provided to me). The Motor Car was observed to have sustained damage at its front right portion. The front bumper and all its related parts, front right headlamp, front bonnet, front right fender, front right fender inner shield and front right wheel rim were amongst the body parts that were observed to have been damaged. The front right wheel and front left wheel (refer to photograph 2 below) were orientated in different directions, which suggests to me that the front right undercarriage parts of the Motor Car were also damaged.

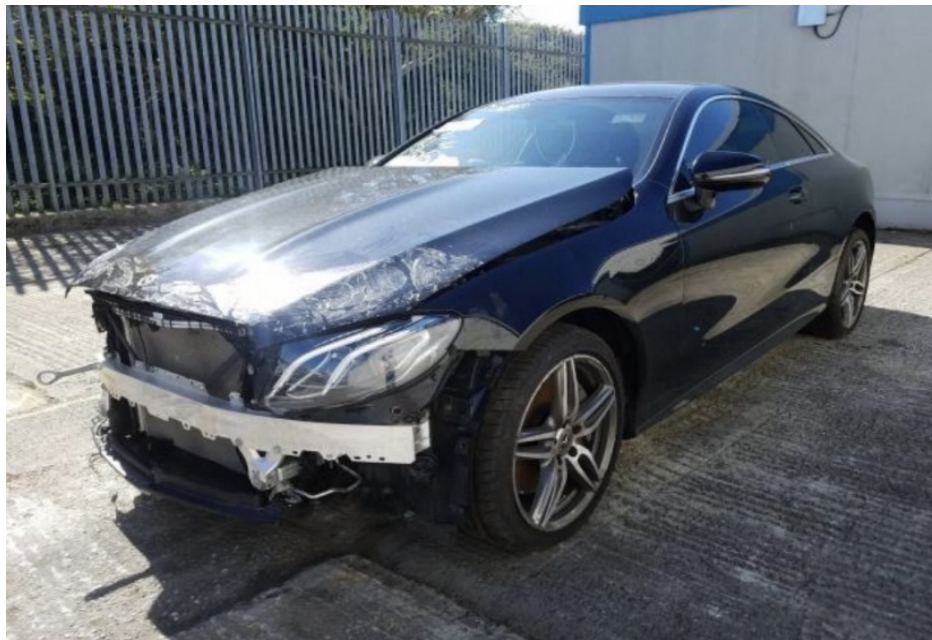
**Photo 2** shows the front left body of the Motor Car (photograph provided to me). The front left wheel was observed to be orientated straight as compared to the front right wheel, which was orientated to the right (refer to photograph 1 above). This would indicate to me that there was damage to the front right undercarriage parts of the Motor Car.

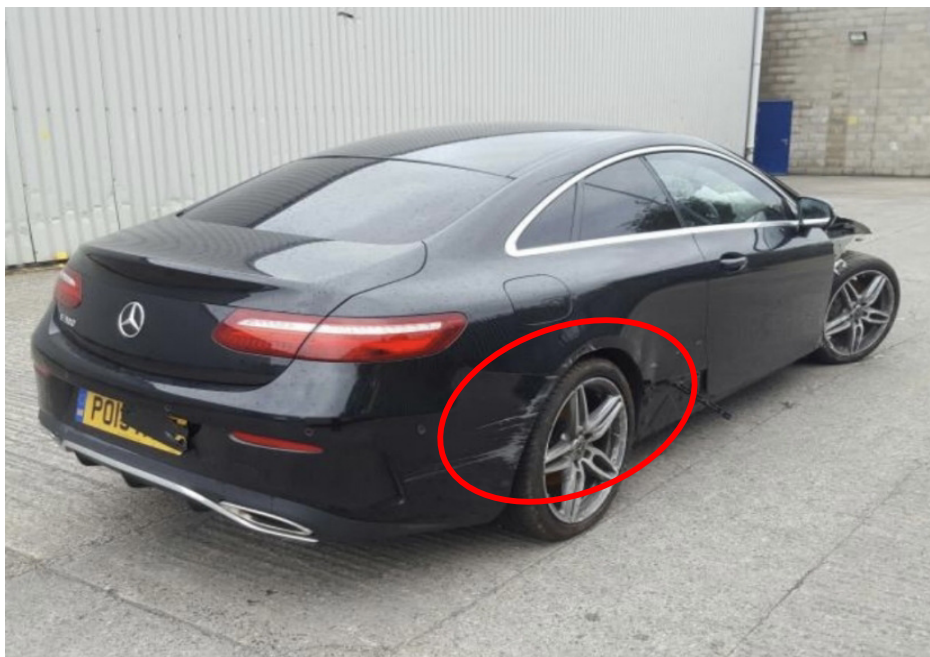
**Photo 3** shows the rear right body of the Motor Car (photograph provided to me). Apart for the front right portion, I had also observed damage to the right rear portion (circled) of the Motor Car. The rear bumper and right rear body panel were observed to be damaged.

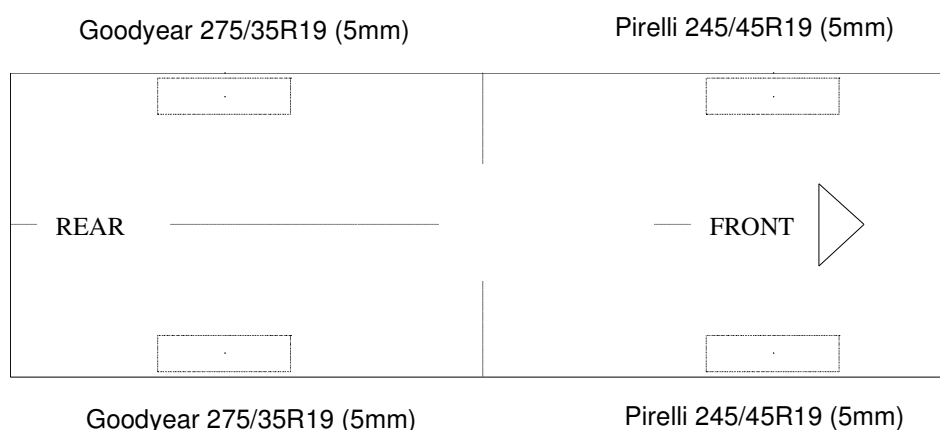
8. It was fitted with 19inch sport wheel rims that were wrapped with tyres that were observed to be of serviceable condition. The tyres were also sufficiently inflated for vehicular operation. The tyre brand, tyre size and approximate remaining tread depth of the 4 tyres of the Motor Car were recorded as follows: -

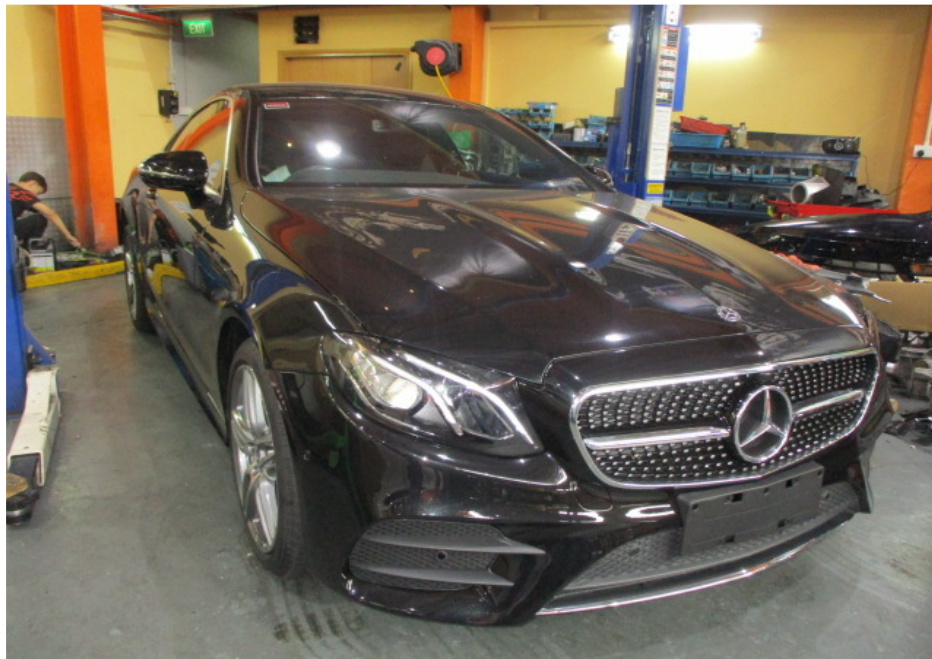
**Photo 4** shows a general view of the front right body of the Motor Car at the time of my inspection. The Motor Car was observed to be in a relatively good general condition with no loose exterior fittings observed. The body parts at the front right portion of the Motor Car were visually examined and it was observed that the repair/restoration works carried out to the damaged area of the Motor Car (refer to photograph 1 above) were reasonably adequate and in order.

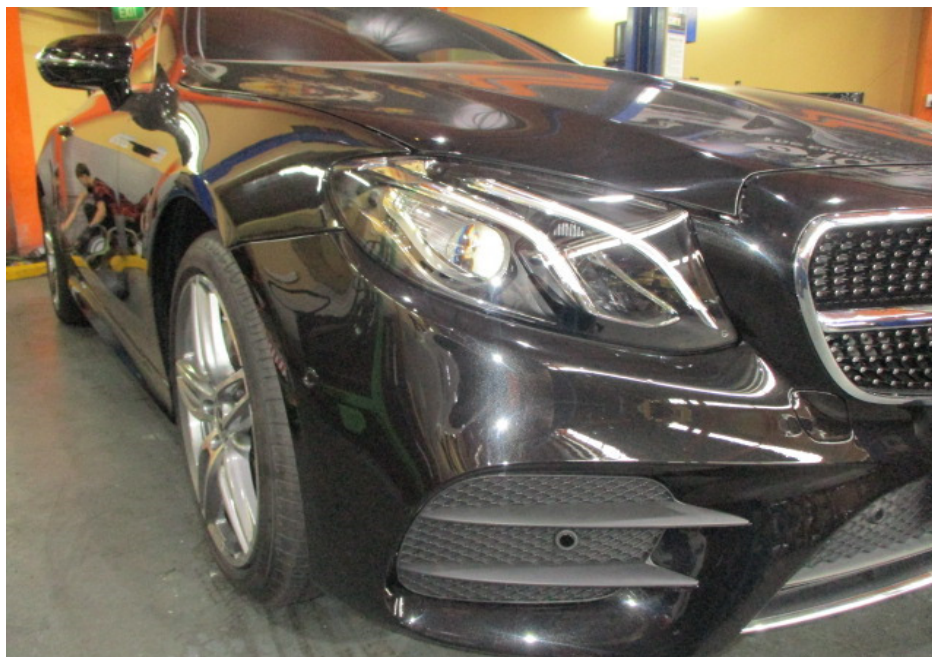
**Photo 5** shows a closer view of the front bumper, front bumper right lower grille, front grille, front right headlamp and front bonnet of the Motor Car at the time of my inspection. The body parts at the front right portion of the Motor Car were visually examined and it was observed that the repair/restoration works carried out to the damaged area of the Motor Car (refer to photograph 1 above) were reasonably adequate and in order.

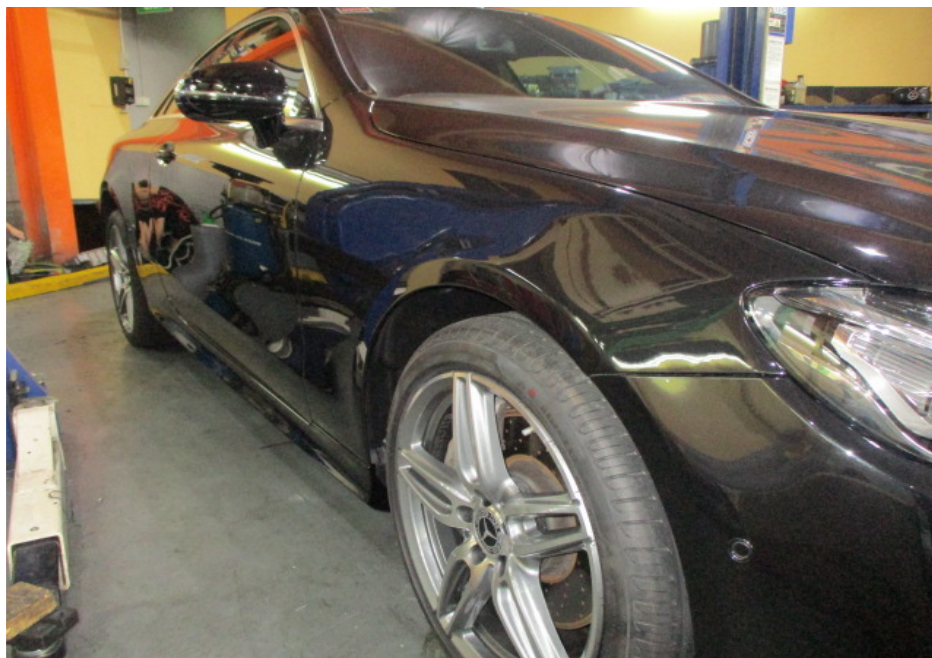
**Photo 6** shows a closer view of the front bonnet, front right fender and front right wheel rim of the Motor Car at the time of my inspection. The body parts at the front right portion of the Motor Car were visually examined and it was observed that the repair/restoration works carried out to the damaged area of the Motor Car (refer to photograph 1 above) were reasonably adequate and in order.

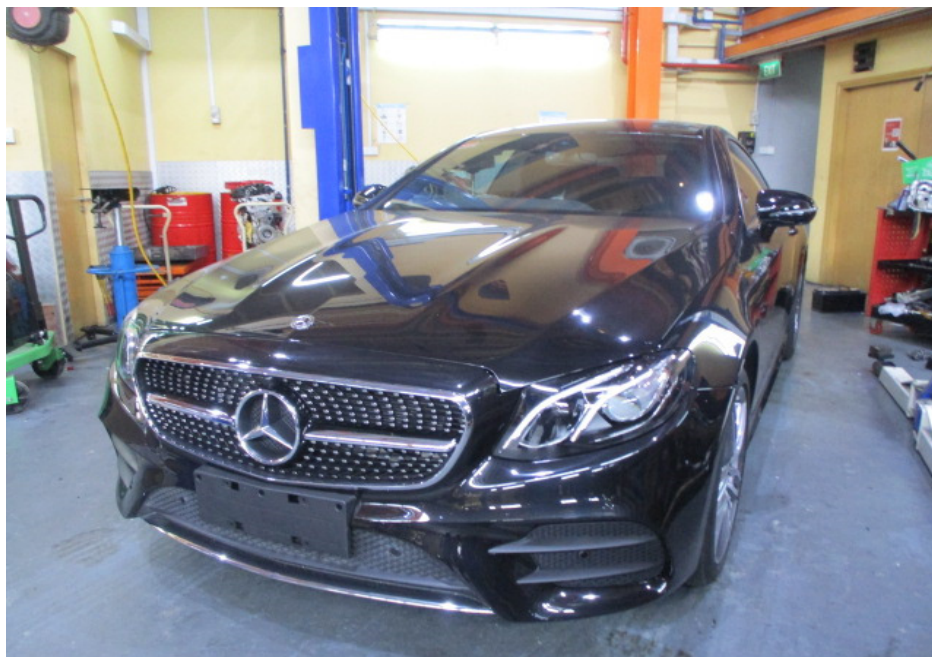
**Photo 7** shows a general view of the front left body of the Motor Car at the time of my inspection. The Motor Car was observed to be in a relatively good general condition with no loose exterior fittings observed. The mileage of the Motor Car recorded at the time of my inspection was 13,431km.

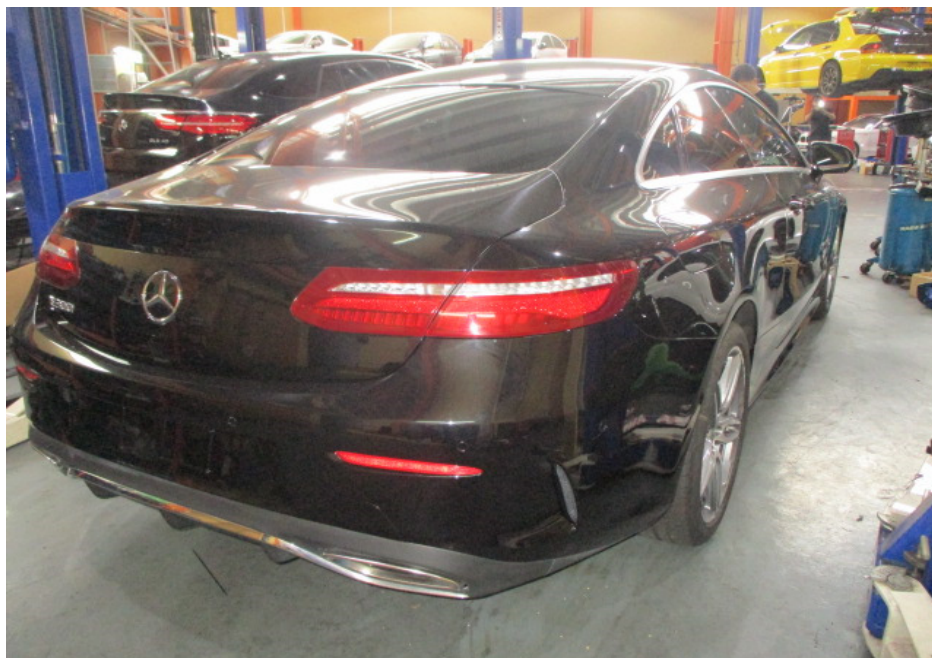
**Photo 8** shows a general view of the rear right body of the Motor Car at the time of my inspection. The Motor Car was observed to be in a relatively good general condition with no loose exterior fittings observed. The body parts at the right rear portion of the Motor Car were visually examined and it was observed that the repair/restoration works carried out to the damaged area of the Motor Car (refer to photograph 3 above) were reasonably adequate and in order.

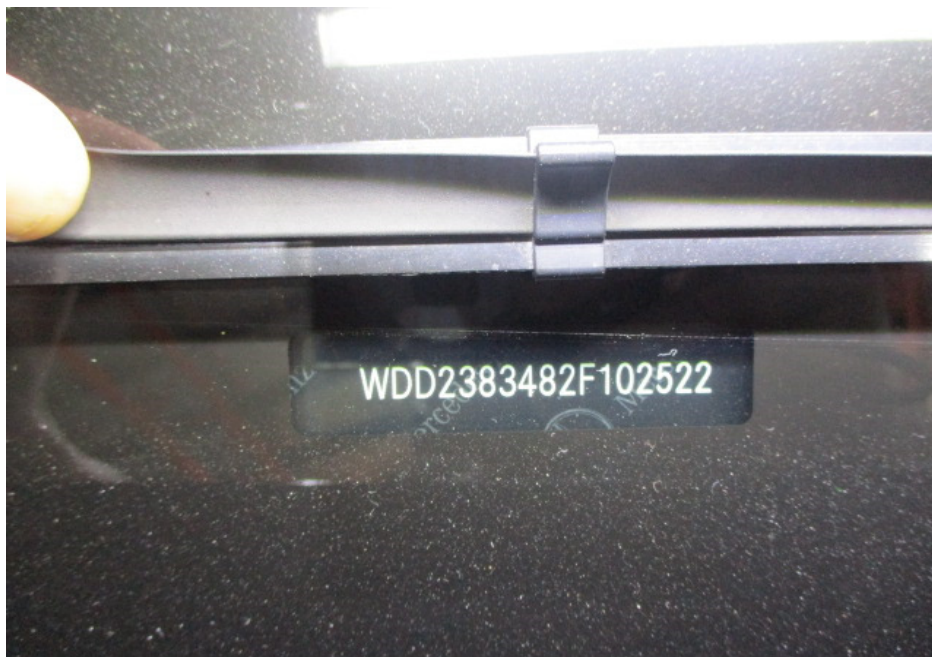
**Photo 9** shows the chassis number of the Motor Car. The chassis number recorded was WDD2383482F102522.

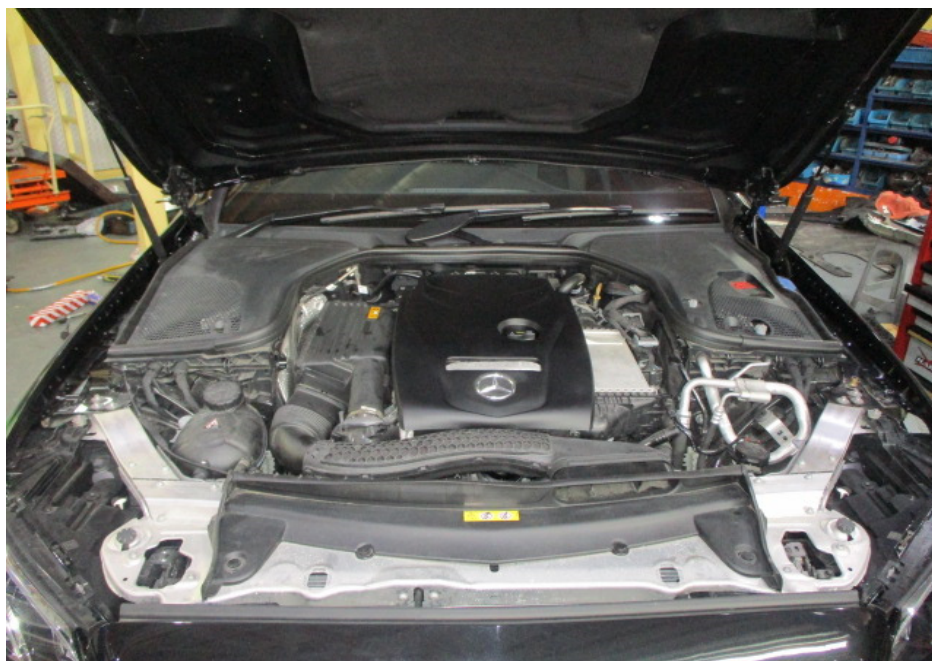
**Photo 10** shows a general view of the engine compartment of the Motor Car at the time of my inspection. The various parts and components inside the engine compartment were all observed to be intact and properly fitted. There was also no sign(s) or indication(s) of fluid leak and/or fluid stain found inside the engine compartment.

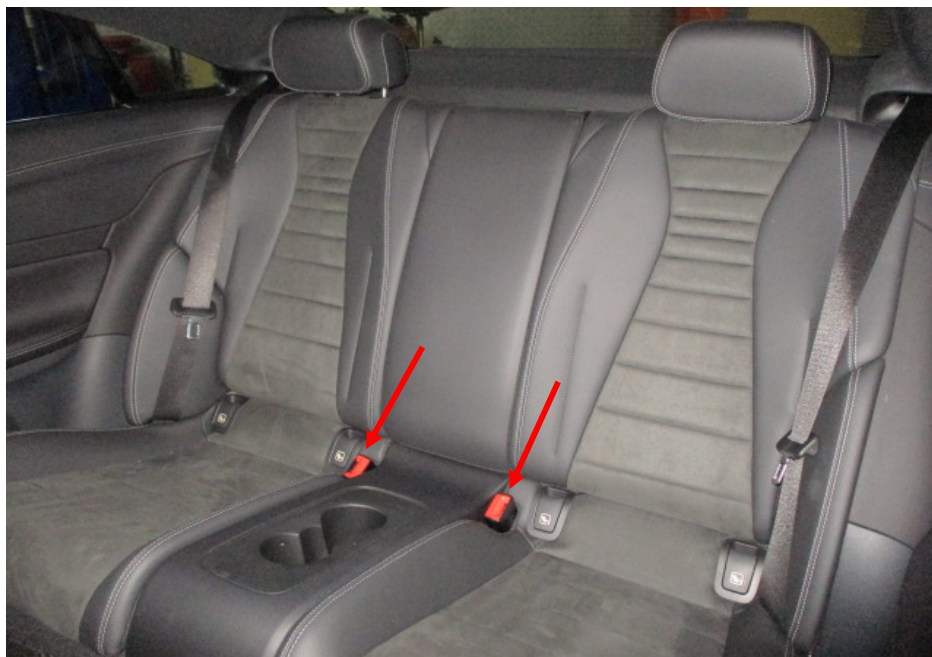
**Photo 11** shows the rear seats of the Motor Car. All the seats of the Motor Car were secured via seat rails to the floorboard. They were also fitted with a retractable seat belt reel and a pre-tensioner (arrowed). The seat belts were tested and were able to be fastened into the respective pre-tensions that were fitted on the side of each individual seat.

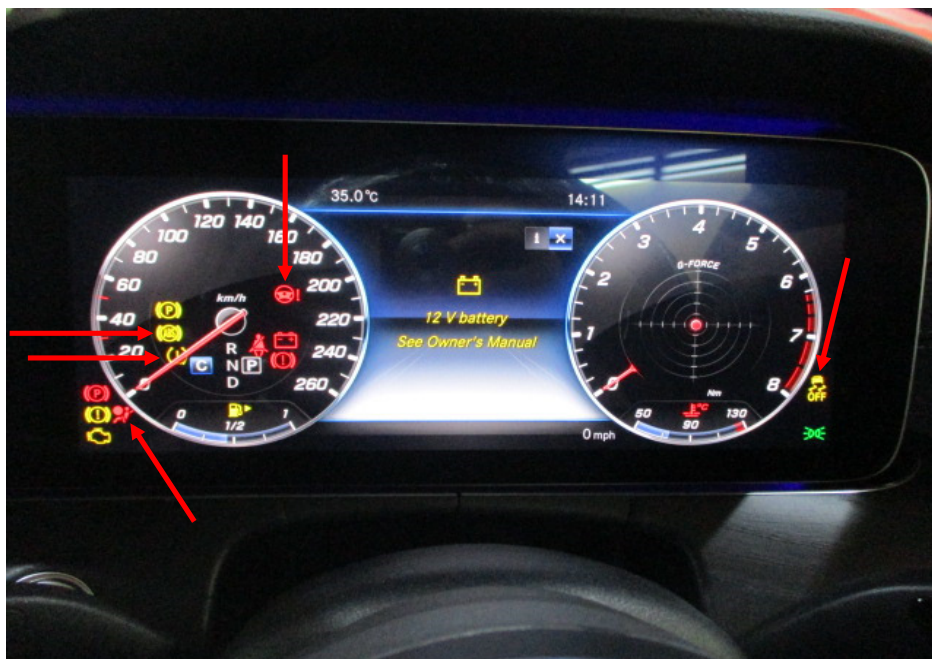
**Photo 12** shows the warning lights for the various electronic safety features appearing on the instrument panel of the Motor Car during its self-test when the engine is cranked, in particular the ABS, SRS, EPS, TPM and TCS lights (arrowed).

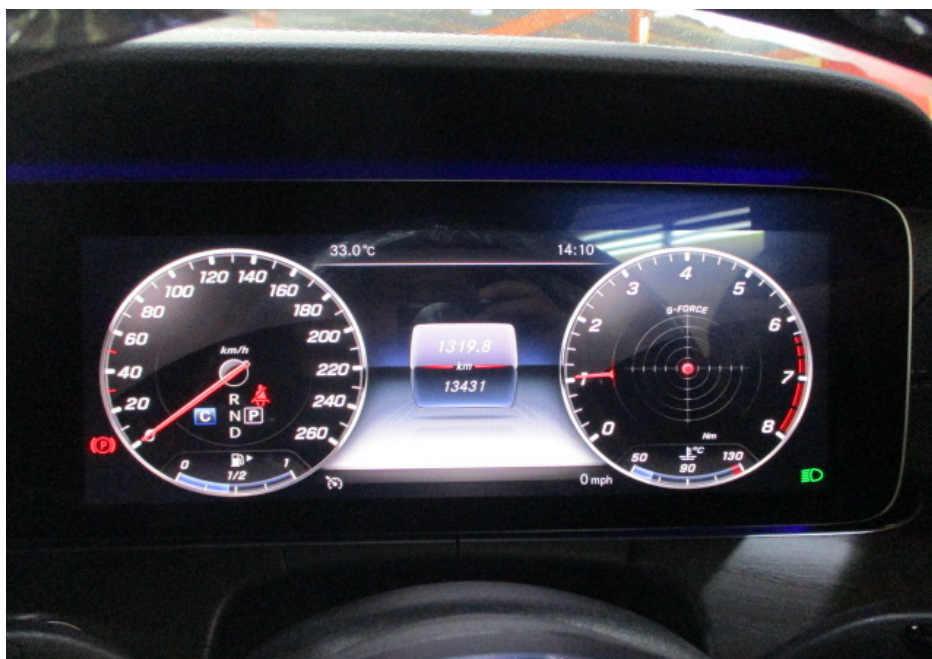
**Photo 13** shows the respective warning lights no longer illuminated, indicating that there is no fault detected to the ABS, SRS, EPS, TPM and TCS systems of the Motor Car during the self-test. These electronic systems were hence in working condition at the time of my inspection.

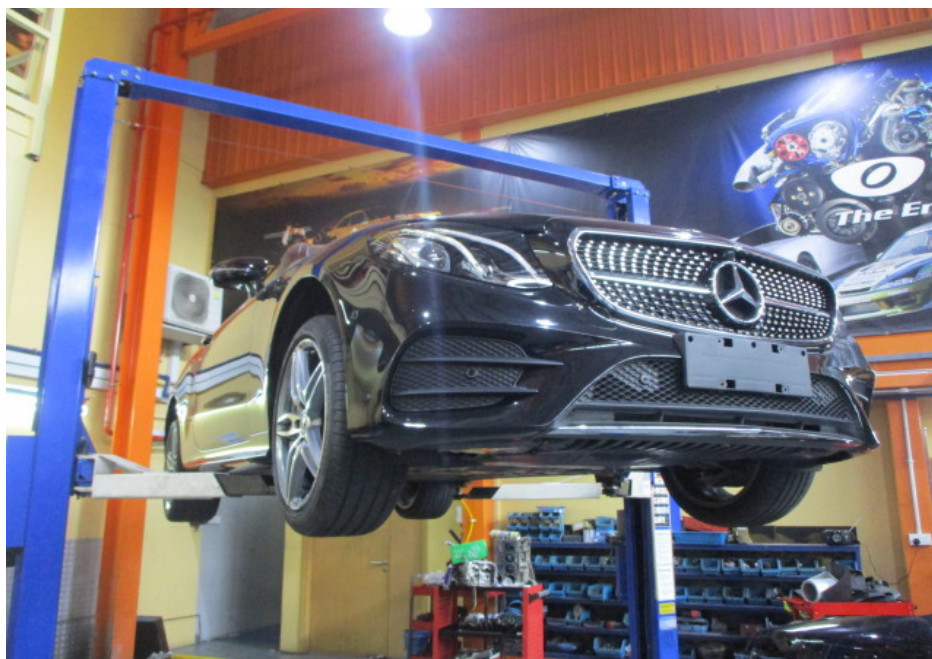
**Photo 14** shows the Motor Car hoisted up for checks on its undercarriage. There was no sign(s) or indication(s) of fluid leakage and/or fluid stain(s) on the underside of the Motor Car. The undercarriage components of the Motor Car were also all observed to be intact and secured in an appropriate manner.

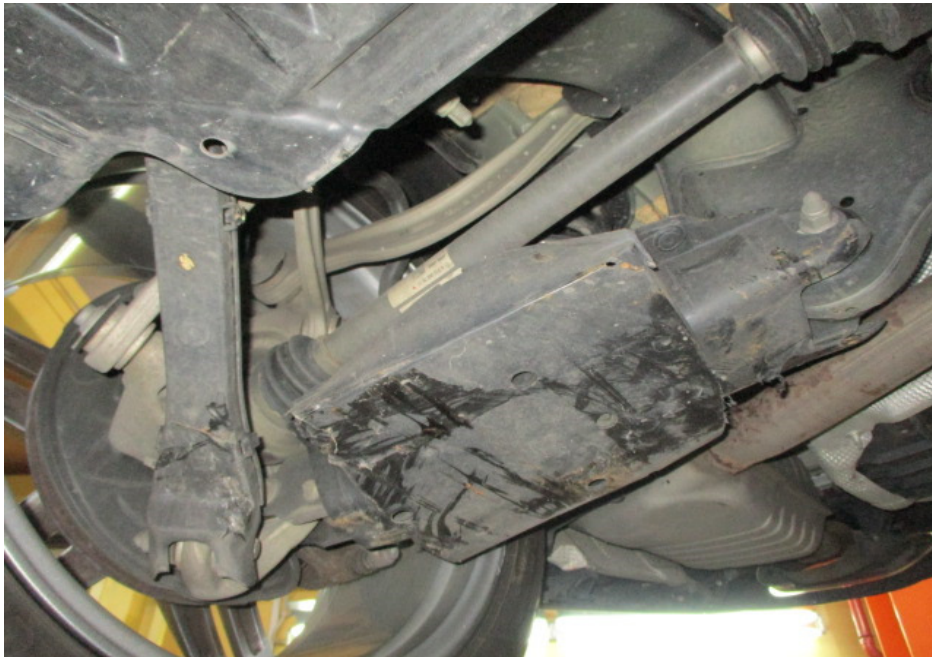
**Photo 15** shows a general view of the control arms and linkages at the rear right wheel of the Motor Car. I did not observe any fluid leak and/or fluid stain on the underside of the Motor Car. All of the Motor Car's undercarriage components were observed to be intact and secured in an appropriate manner.

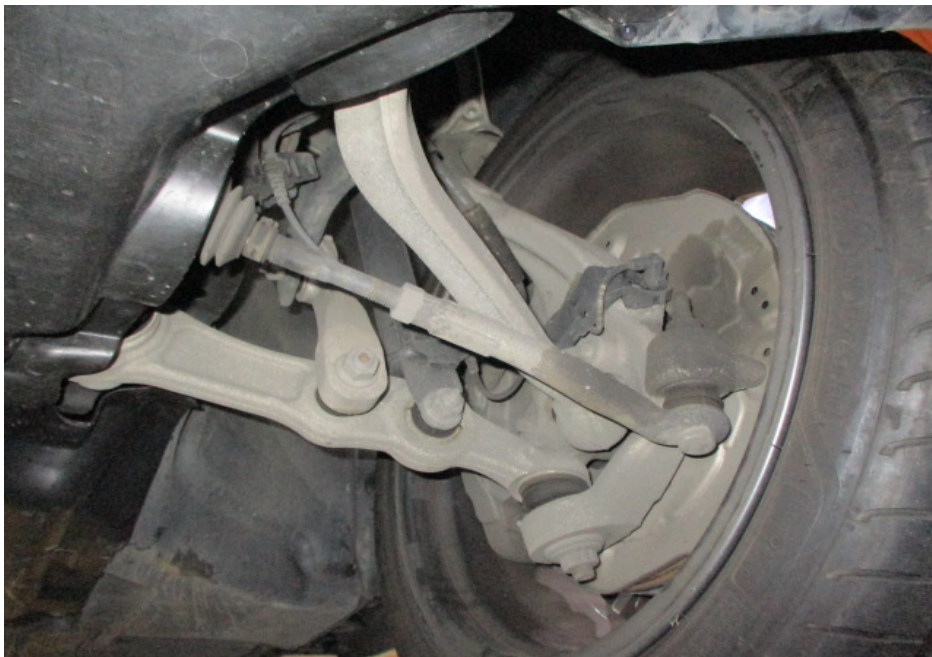
**Photo 16** shows the various undercarriage components at the front left wheel of the Motor Car. The mechanical components, control arms and linkages were all found to be intact and secured in an appropriate manner.

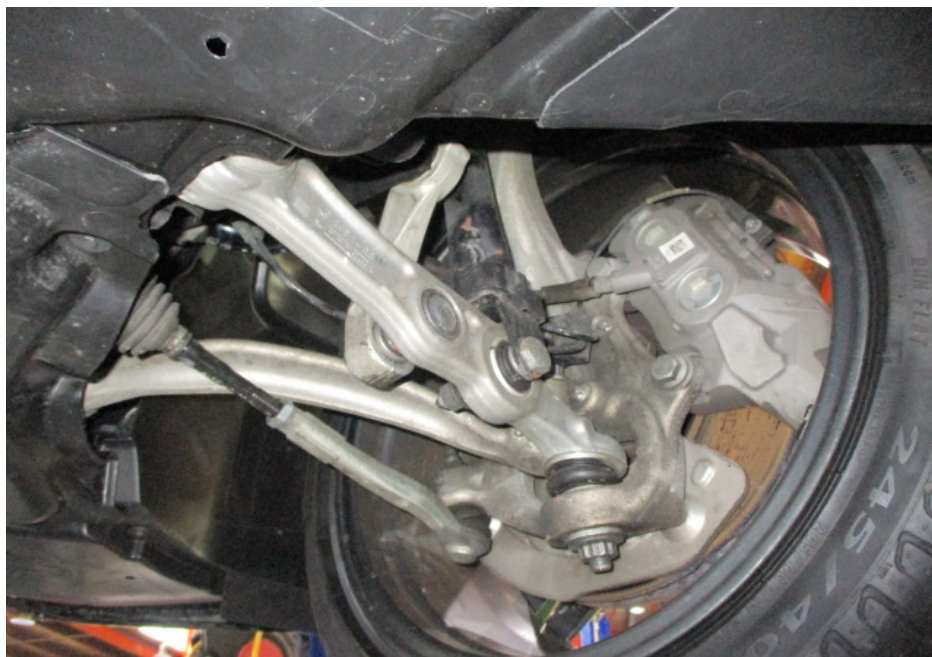
**Photo 17** shows the various undercarriage components at the front right wheel of the Motor Car. The mechanical components, control arms and linkages were all found to be intact and secured in an appropriate manner. I also did not observe any fluid leak and/or fluid stain on the underside of the Motor Car.

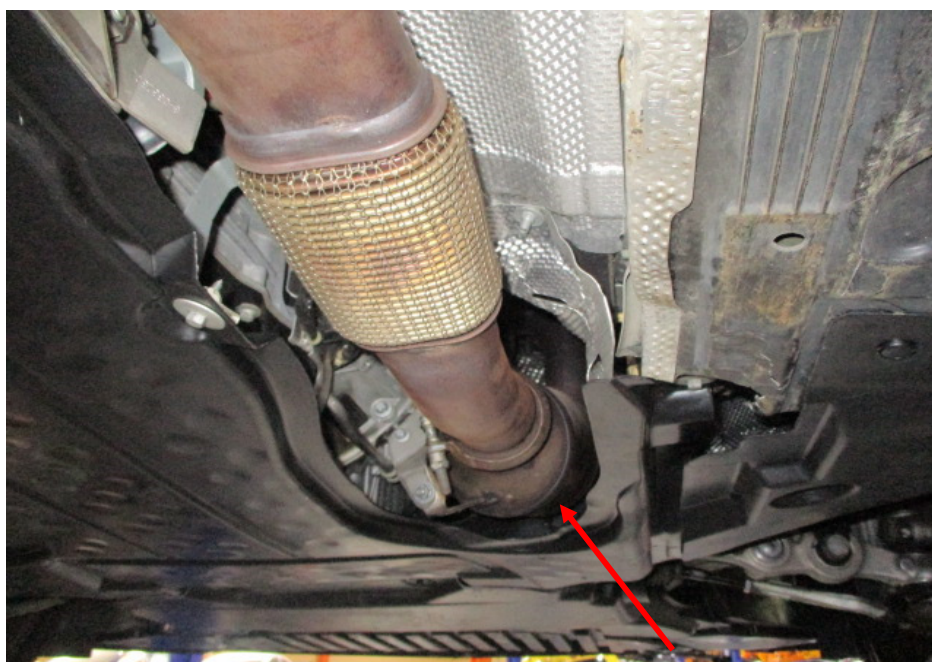
**Photo 18** shows the Motor Car's catalytic converter (arrowed). My examination of the Motor Car's exhaust system revealed no sign(s) or indication(s) of any cut or weld marks along its exhaust pipes and on its rear mufflers.

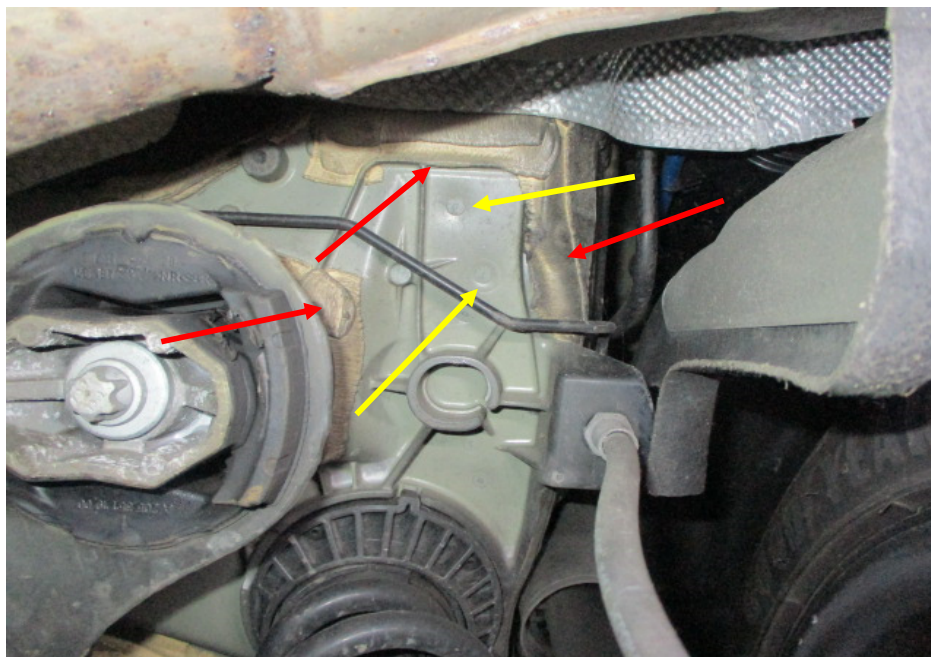
**Photo 19** shows the chassis/structural body at the underside rear right of the Motor Car. I did not find any weld marks other than original spot weld marks (yellow arrow) on the chassis/structural body of the Motor Car. The original factory sealant (red arrow) at the joints along the chassis/structural body was untouched, indicating no work was done on the chassis/structural body of the Motor Car and that the chassis/structural body was originally fitted.

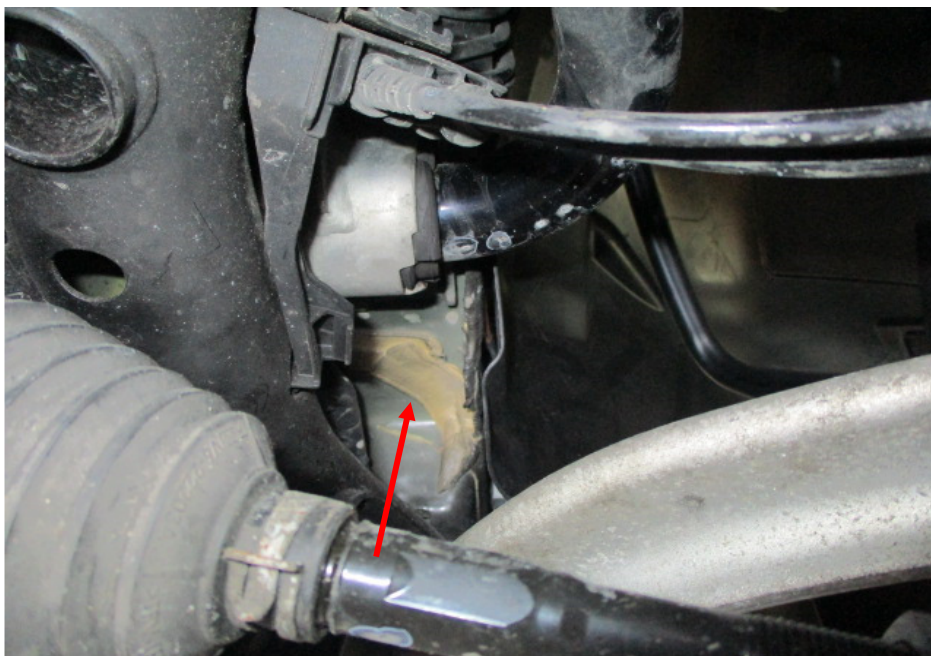
**Photo 20** shows the chassis/structural body at the underside front right of the Motor Car. The original factory sealant (arrowed) at the joints along the chassis/structural body was observed to be untouched. In general, I had found no work was carried out on the chassis/structural body of the Motor Car. The chassis/structural body of the Motor Car was originally fitted.

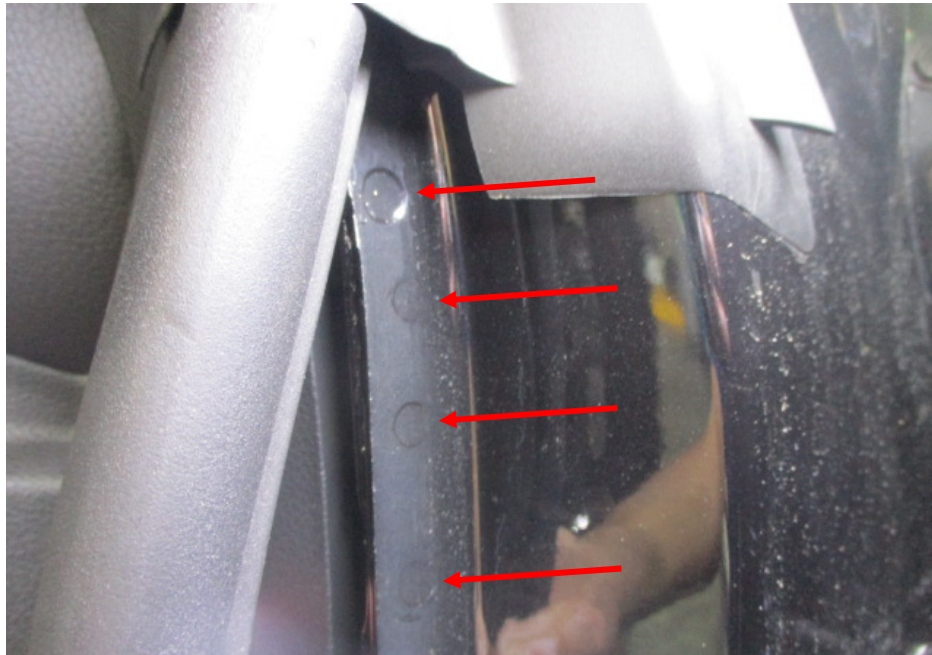
**Photo 21** shows the right side “A” pillar of the Motor Car. I did not find any weld marks other than original spot weld marks (arrowed) on the right side “A” pillar of the Motor Car which, indicates that there was no re-welding works carried out. In general, I had found all the non-detachable body panels of the Motor Car to be originally fitted at the time of my inspection.
