Your Ref: Mercedes Benz GLE 43
(chassis number WDC2923642A131439)
Our Ref : CI/TP21000561/D

11 January 2021

**INSPECTION REPORT OF AN UNREGISTERD MERCEDES BENZ GLE 43
MOTOR CAR WITH CHASSIS NUMBER WDC2923642A131439**

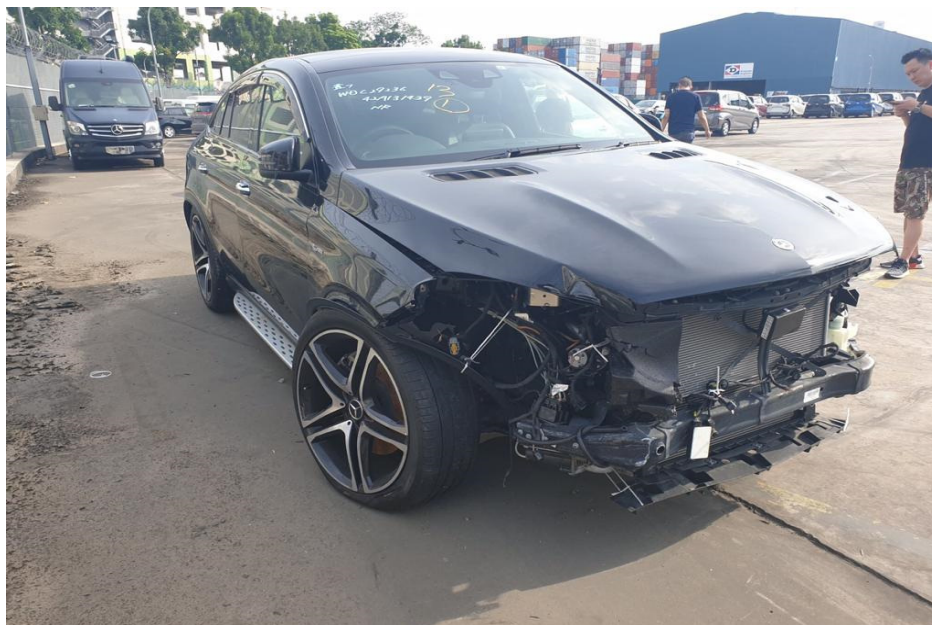
Photo 1 shows the front right body of the Motor Car (photograph provided to me). The Motor Car was observed to have sustained damage at its frontal portion. The front bumper and all its related parts, front right headlamp, front bonnet, front right fender and front right wheel arc garnish were amongst the body parts that were observed to have been damaged. The front right wheel and front left wheel (refer to photograph 2 below) were both orientated inwards, which suggests to me that the front undercarriage parts of the Motor Car were also damaged.

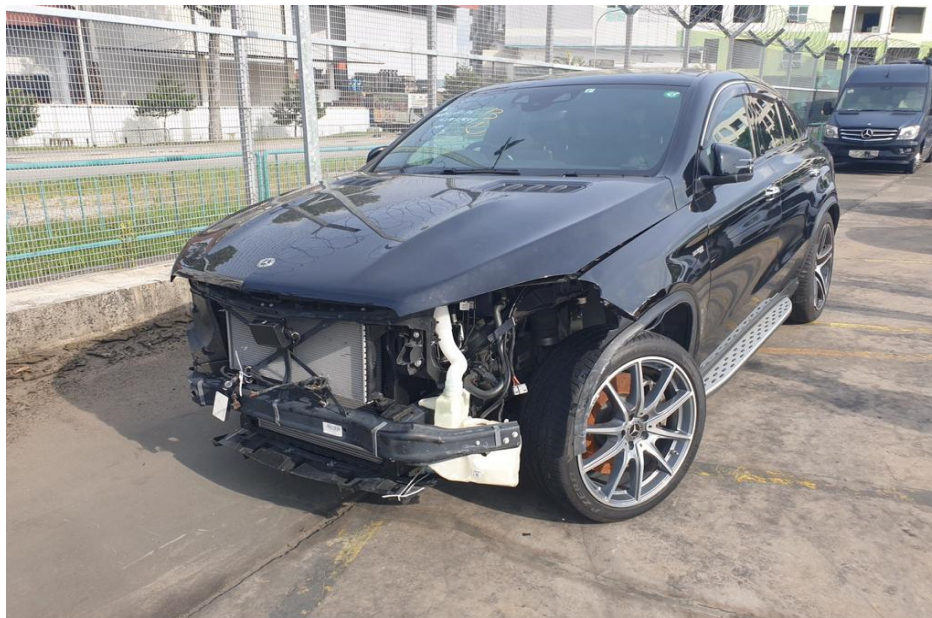
Photo 2 shows the front left body of the Motor Car (photograph provided to me). The front left headlamp, front left fender and front left wheel arc garnish were amongst the body parts that were observed to have been damaged. The front left wheel and front right wheel (refer to photograph 1 above) were both observed to be orientated inwards. This would indicate to me that there was damage to the front undercarriage parts of the Motor Car.

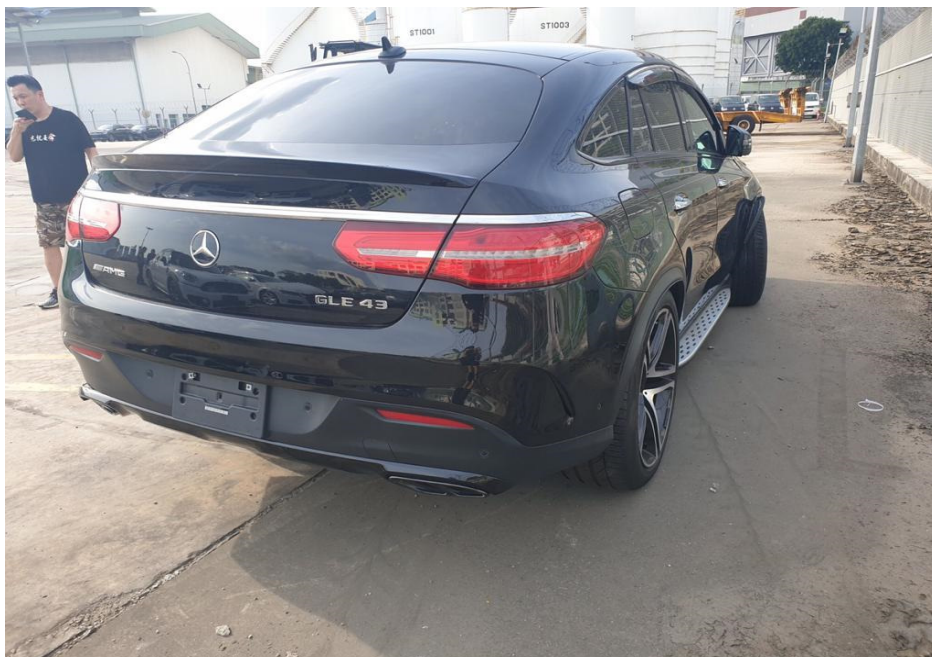
Photo 3 shows the rear right body of the Motor Car (photograph provided to me). Apart for the frontal portion, there was no physical damage seen to other areas of the Motor Car.

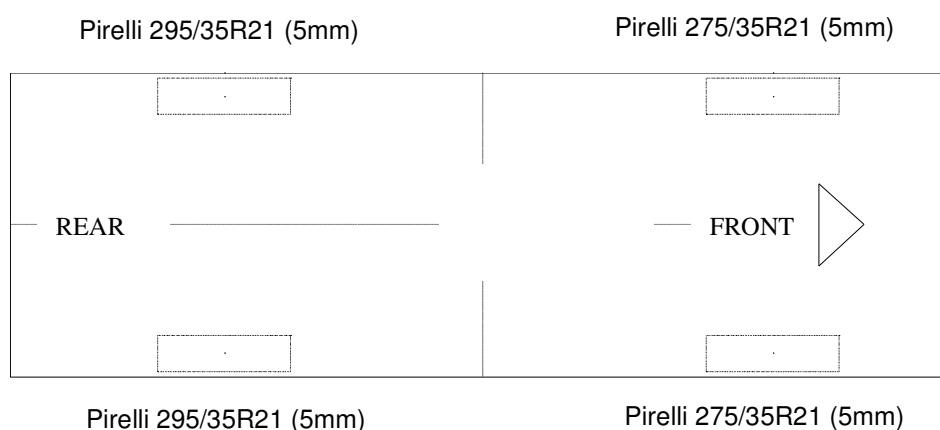
8. It was fitted with 21inch sport wheel rims that were wrapped with tyres that were observed to be of serviceable condition. The tyres were also sufficiently inflated for vehicular operation. The tyre brand, tyre size and approximate remaining tread depth of the 4 tyres of the Motor Car were recorded as follows: -

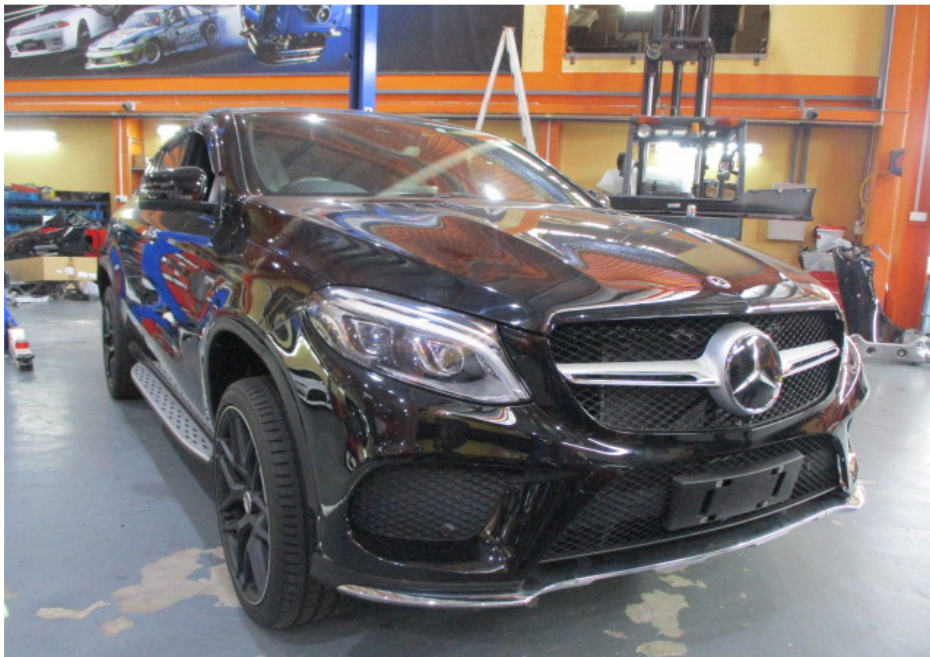
Photo 4 shows a general view of the front right body of the Motor Car at the time of my inspection. The Motor Car was observed to be in a relatively good general condition with no loose exterior fittings observed. The body parts at the frontal portion of the Motor Car were visually examined and it was observed that the repair/restoration works carried out to the damaged area of the Motor Car (refer to photograph 1 & 2 above) were reasonably adequate and in order.

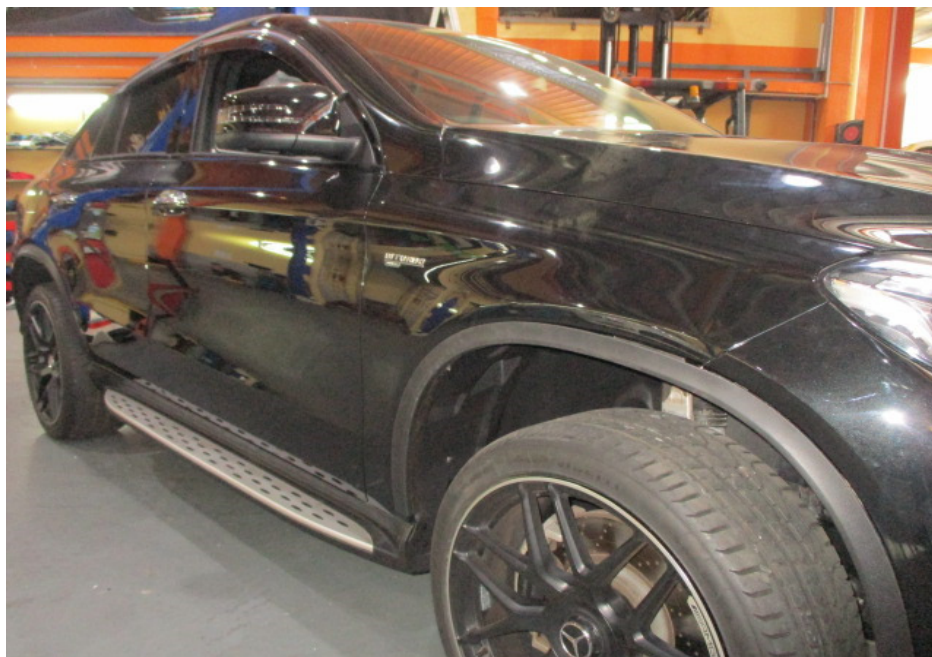
Photo 5 shows a closer view of the front right fender and front right wheel arc garnish of the Motor Car at the time of my inspection. The body parts at the frontal portion of the Motor Car were visually examined and it was observed that the repair/restoration works carried out to the damaged area of the Motor Car (refer to photograph 1 above) were reasonably adequate and in order.

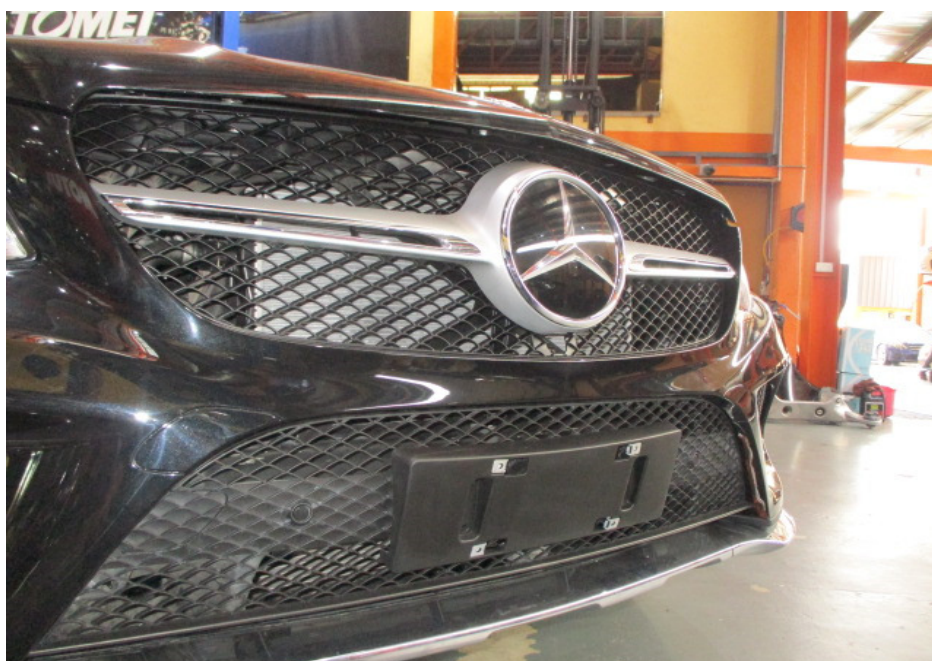
Photo 6 shows a closer view of the front bumper, radiator grille and front bumper centre lower grille of the Motor Car at the time of my inspection. The body parts at the frontal portion of the Motor Car were visually examined and it was observed that the repair/restoration works carried out to the damaged area of the Motor Car (refer to photograph 1 & 2 above) were reasonably adequate and in order.

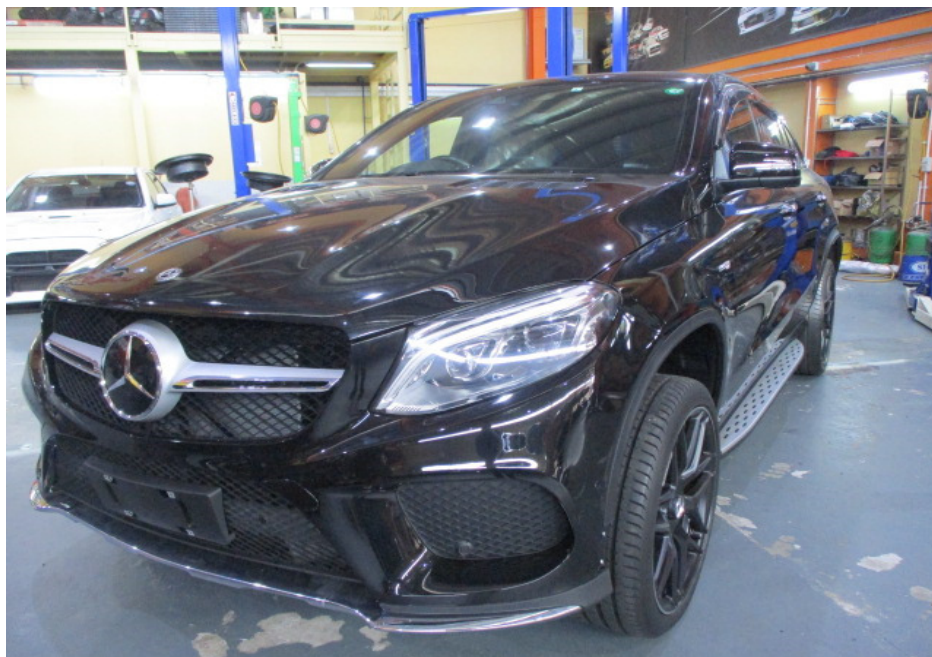
Photo 7 shows a general view of the front left body of the Motor Car at the time of my inspection. The Motor Car was observed to be in a relatively good general condition with no loose exterior fittings observed. The body parts at the frontal portion of the Motor Car were visually examined and it was observed that the repair/restoration works carried out to the damaged area of the Motor Car (refer to photograph 1 & 2 above) were reasonably adequate and in order.

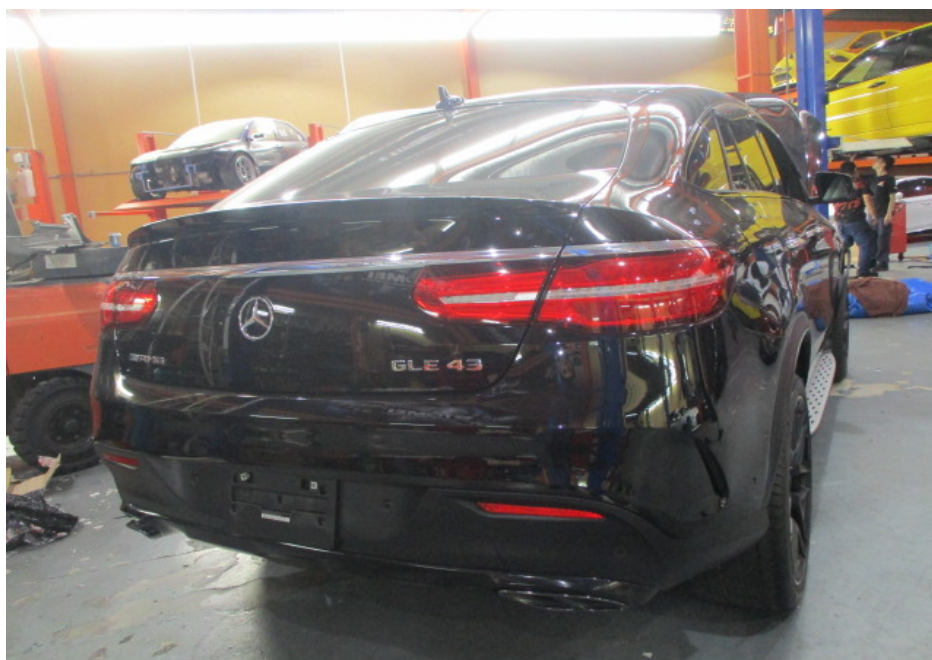
Photo 8 shows a general view of the rear right body of the Motor Car at the time of my inspection. The Motor Car was observed to be in a relatively good general condition with no loose exterior fittings observed. The mileage of the Motor Car recorded at the time of my inspection was 14,498km.

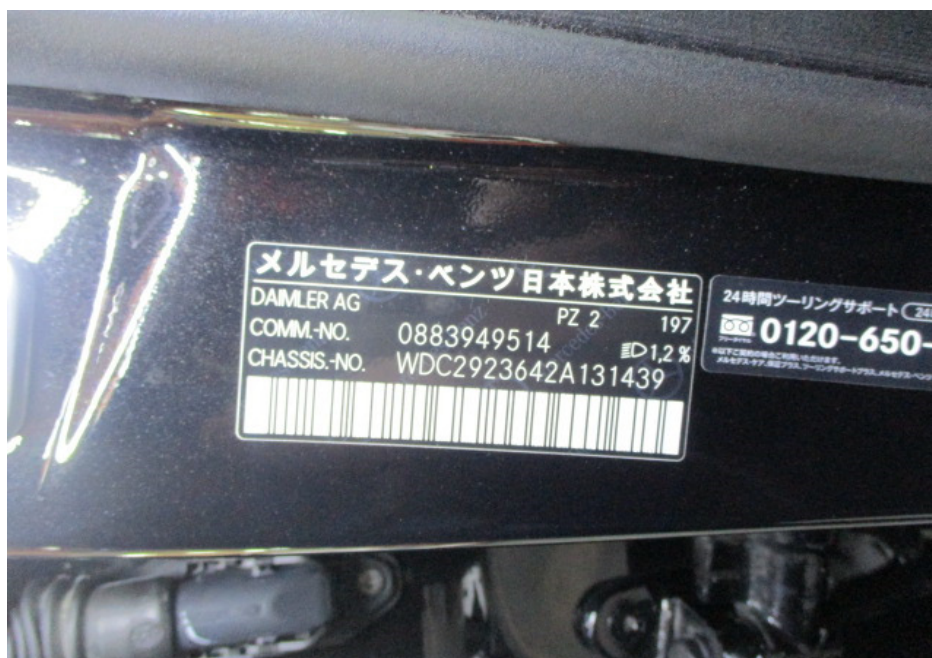
Photo 9 shows the chassis number of the Motor Car. The chassis number recorded was WDC2923642A131439.

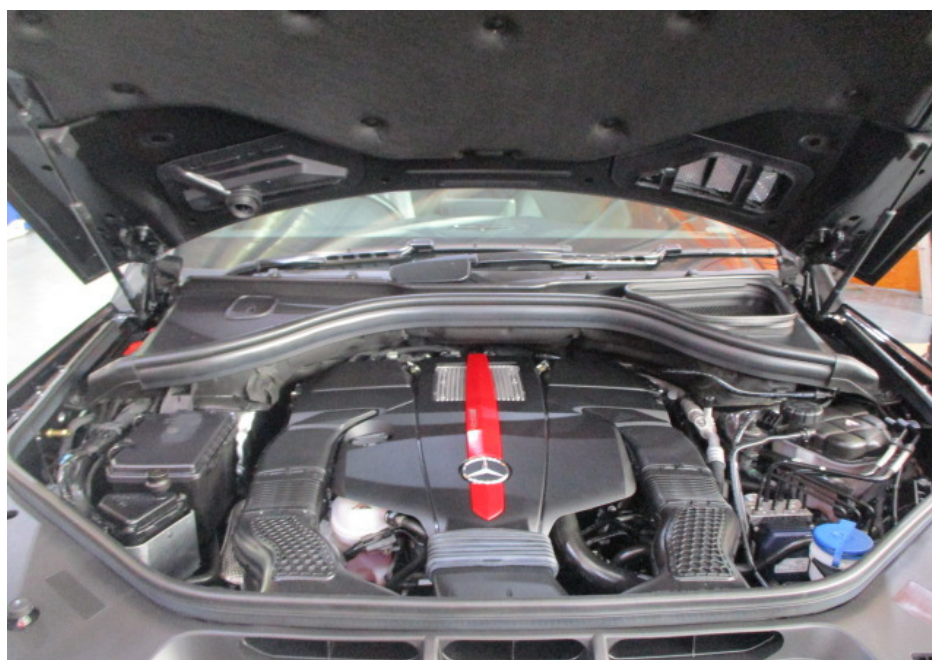
Photo 10 shows a general view of the engine compartment of the Motor Car at the time of my inspection. The various parts and components inside the engine compartment were all observed to be intact and properly fitted. There was also no sign(s) or indication(s) of fluid leak and/or fluid stain found inside the engine compartment.

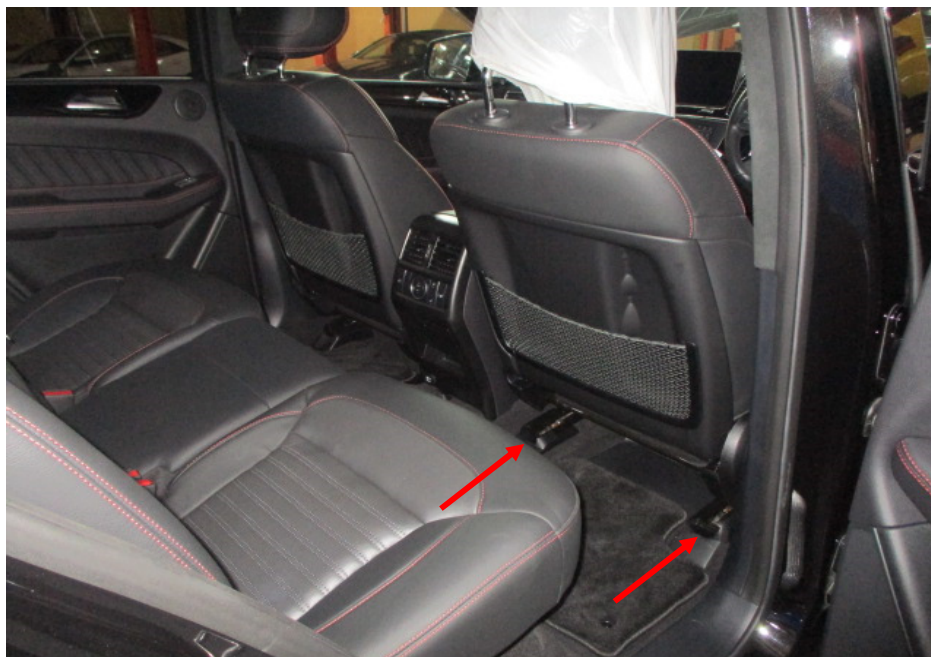
Photo 11 shows the seats of the Motor Car, which were secured via seat rails (arrowed) to the floorboard. All the seats of the Motor Car were fitted with a retractable seat belt reel and pre-tensioner. The seat belts were tested and were able to be fastened into the respective pre-tensions that were fitted on the side of each individual seat.

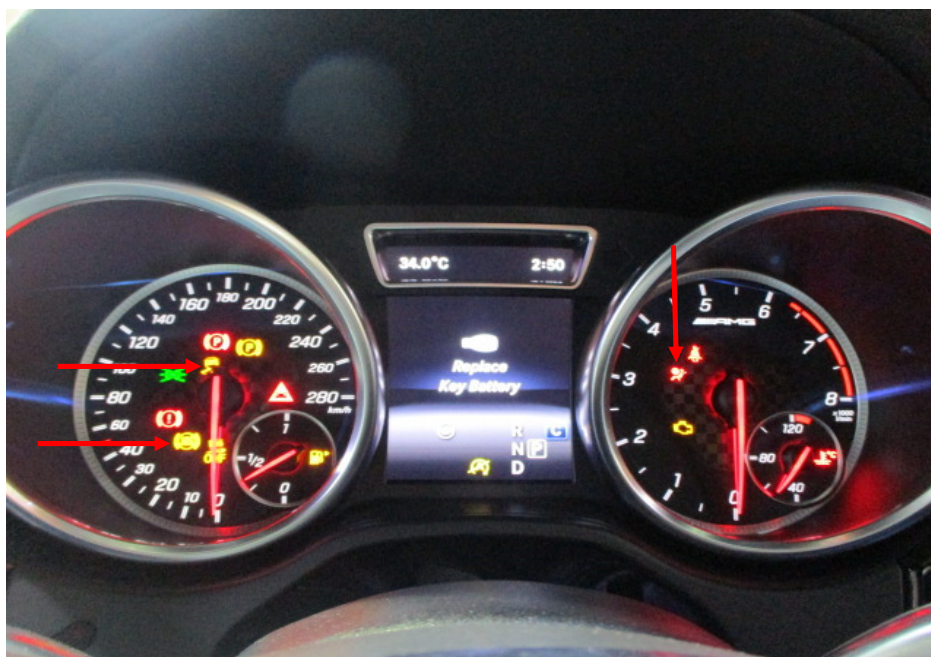
Photo 12 shows the warning lights for the various electronic safety features appearing on the instrument panel of the Motor Car during its self-test when the engine is cranked, in particular the ABS, SRS and TCS lights (arrowed).

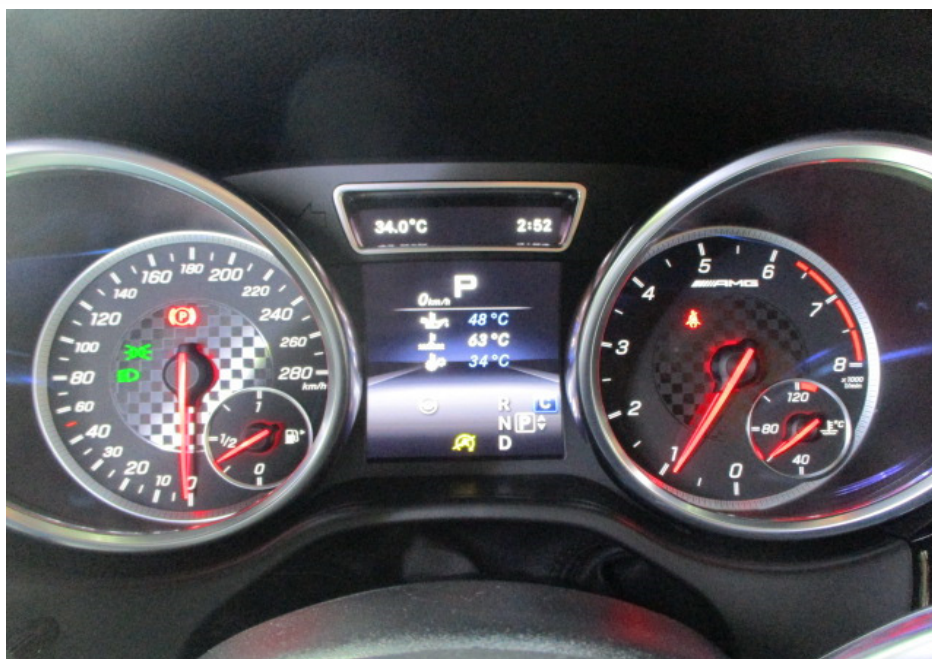
Photo 13 shows the respective warning lights no longer illuminated, indicating that there is no fault detected to the ABS, SRS and TCS systems of the Motor Car during the self-test. These electronic systems were hence in working condition at the time of my inspection.

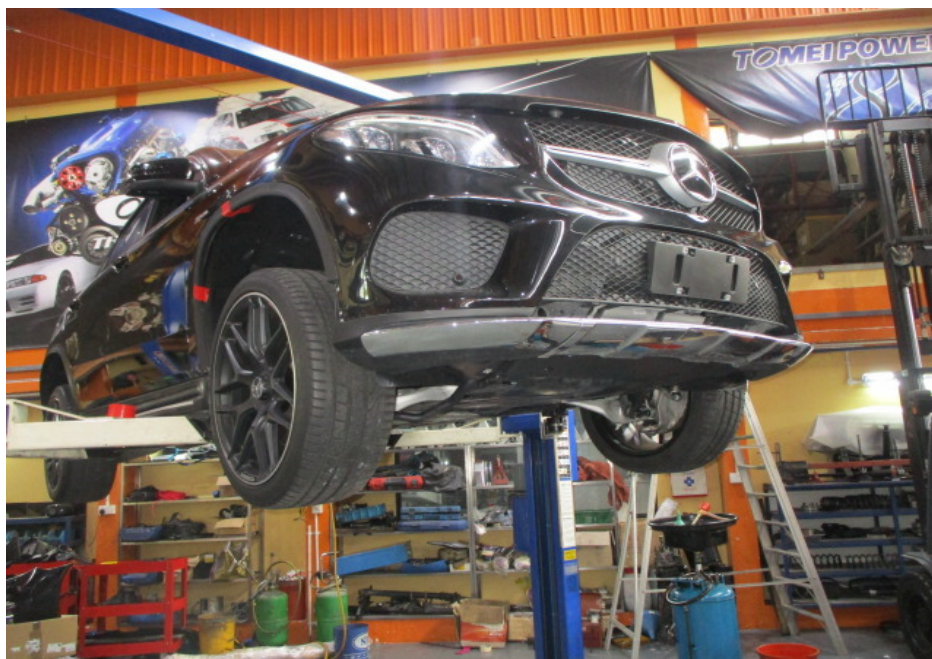
Photo 14 shows the Motor Car hoisted up for checks on its undercarriage. There was no sign(s) or indication(s) of fluid leakage and/or fluid stain(s) on the underside of the Motor Car. The undercarriage components of the Motor Car were also all observed to be intact and secured in an appropriate manner.

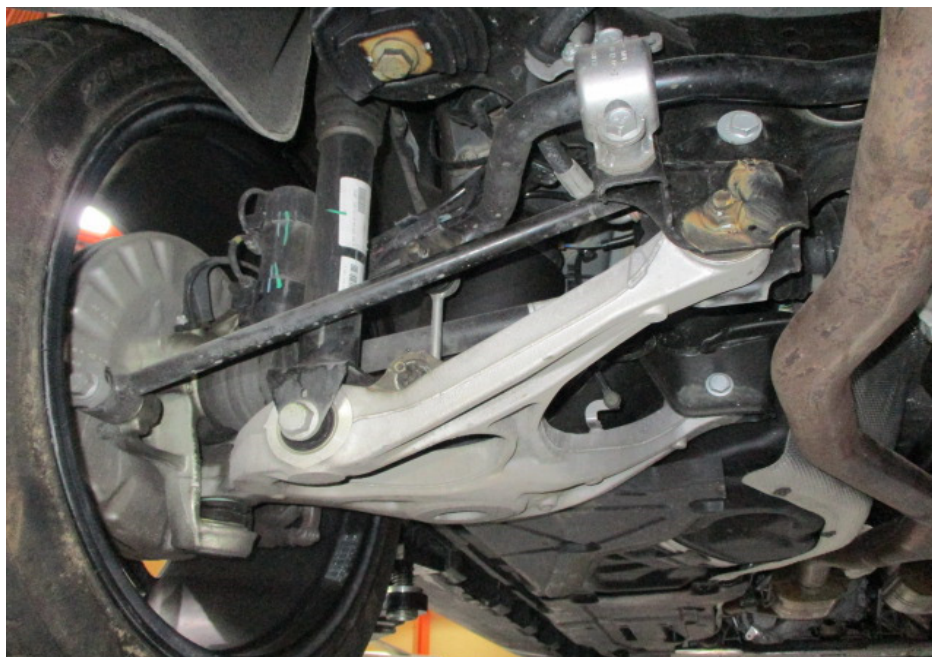
Photo 15 shows a general view of the control arms and linkages at the rear left wheel of the Motor Car. I did not observe any fluid leak and/or fluid stain on the underside of the Motor Car. All of the Motor Car's undercarriage components were observed to be intact and secured in an appropriate manner.

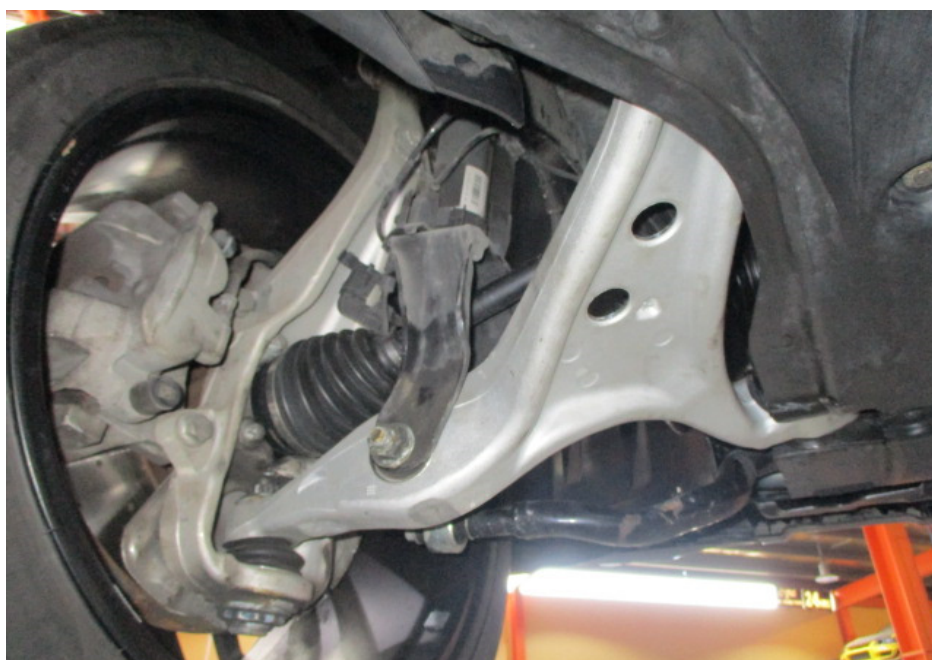
Photo 16 shows the various undercarriage components at the front left wheel of the Motor Car. The mechanical components, control arms and linkages were all found to be intact and secured in an appropriate manner.

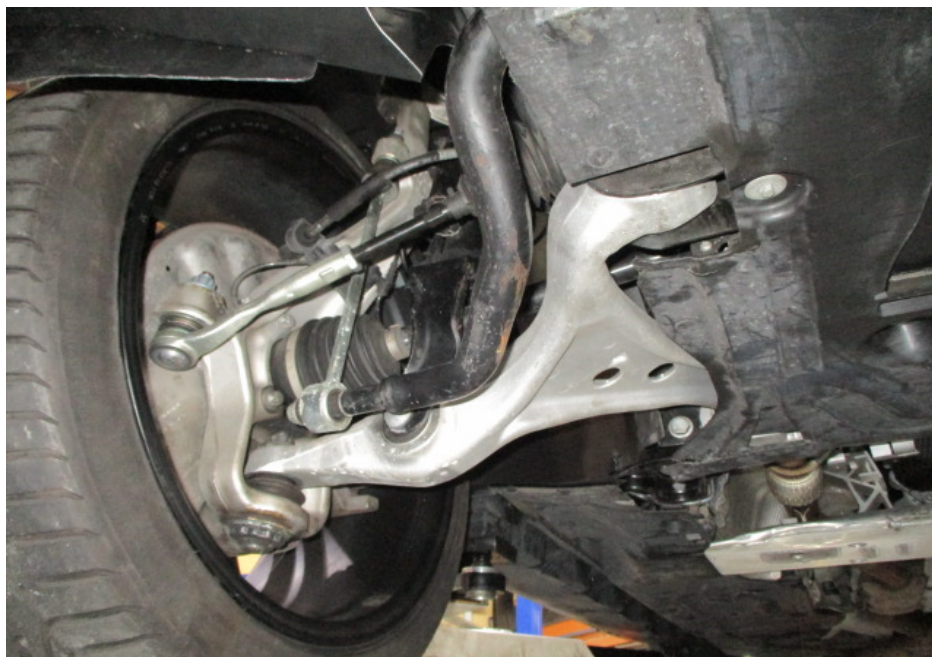
Photo 17 shows the various undercarriage components at the front right wheel of the Motor Car. The mechanical components, control arms and linkages were all found to be intact and secured in an appropriate manner. I also did not observe any fluid leak and/or fluid stain on the underside of the Motor Car.

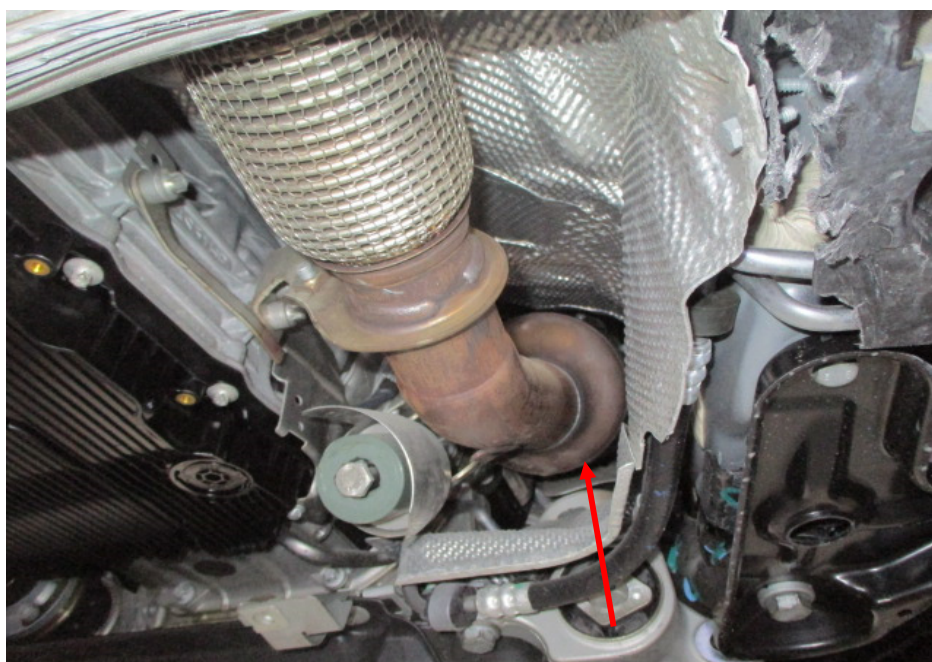
Photo 18 shows the Motor Car's catalytic converter (arrowed). My examination of the Motor Car's exhaust system revealed no sign(s) or indication(s) of any cut or weld marks along its exhaust pipes and on its rear muffler.

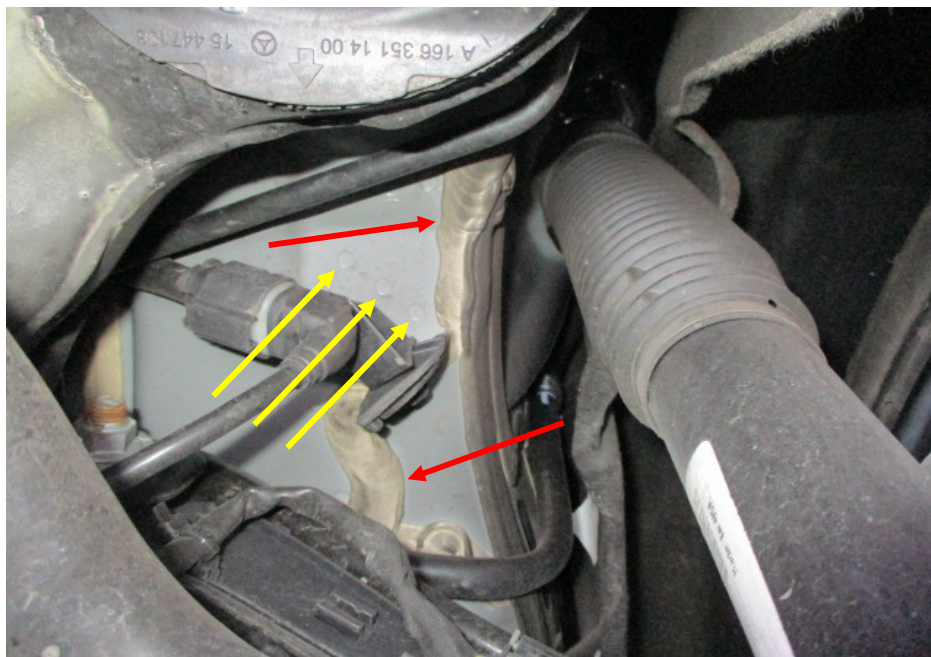
Photo 19 shows the chassis/structural body at the underside rear right of the Motor Car. I did not find any weld marks other than original spot weld marks (yellow arrow) on the chassis/structural body of the Motor Car. The original factory sealant (red arrow) at the joints along the chassis/structural body was untouched, indicating no work was done on the chassis/structural body of the Motor Car and that the chassis/structural body was originally fitted.

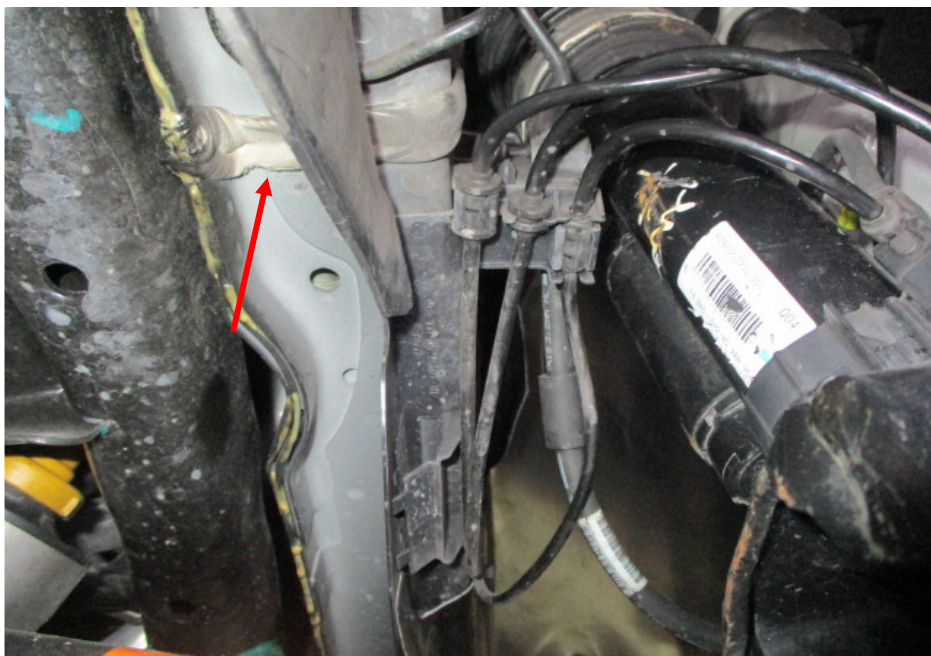
Photo 20 shows the chassis/structural body at the underside front right of the Motor Car. The original factory sealant (arrowed) at the joints along the chassis/structural body was observed to be untouched. In general, I had found no work was carried out on the chassis/structural body of the Motor Car. The chassis/structural body of the Motor Car was originally fitted.

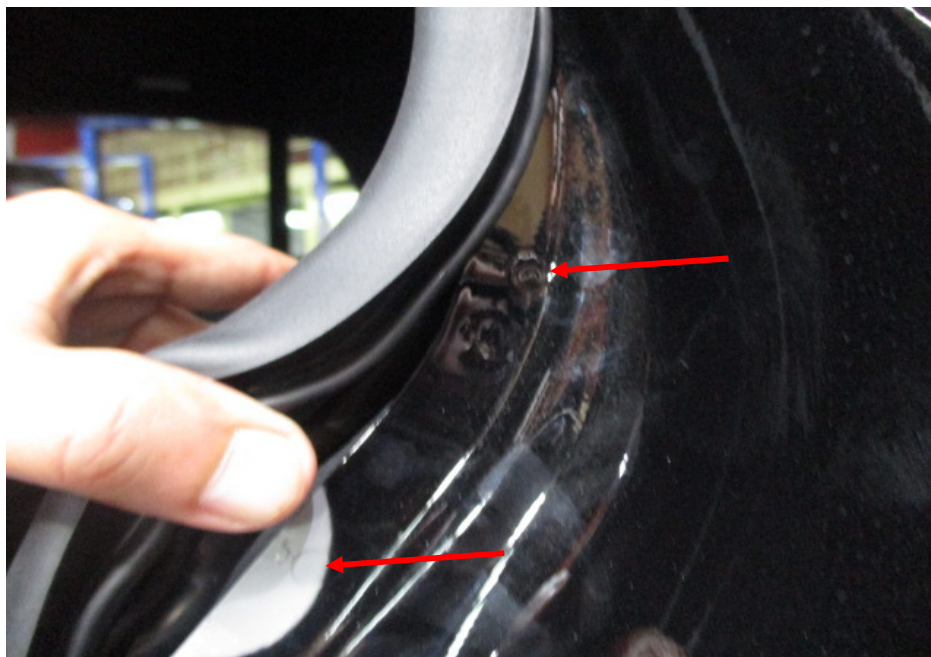
Photo 21 shows the left side "C" pillar of the Motor Car. I did not find any weld marks other than original spot weld marks (arrowed) on the left side "C" pillar of the Motor Car which, indicates that there was no re-welding works carried out. In general, I had found all the non-detachable body panels of the Motor Car to be originally fitted at the time of my inspection.
