Your Ref: Mercedes Benz S350d  
(chassis number W1K2221202A564022)  
Our Ref : CI/TP21000562/D

11 January 2021

**INSPECTION REPORT OF AN UNREGISTERD MERCEDES BENZ S350d  
MOTOR CAR WITH CHASSIS NUMBER W1K2221202A564022**

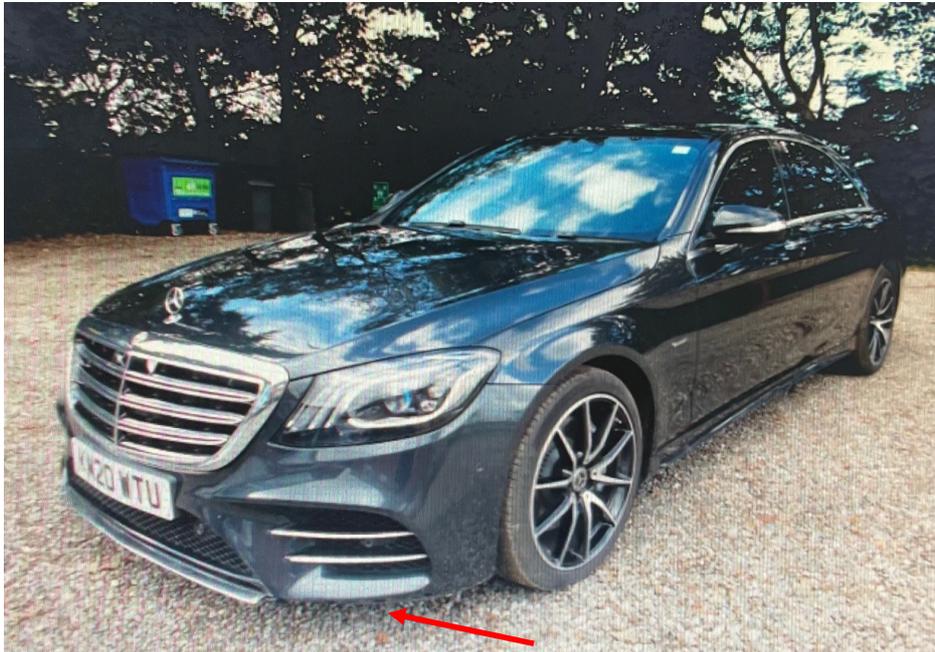
**Photo 1** shows the front left body of the Motor Car (photograph provided to me). The Motor Car was observed to have sustained damage at its front left portion. The front bumper left lower chrome moulding was observed to be dislodged (arrowed). Apart for this, there appears to be no other physical damage observed to the front left portion of the Motor Car.

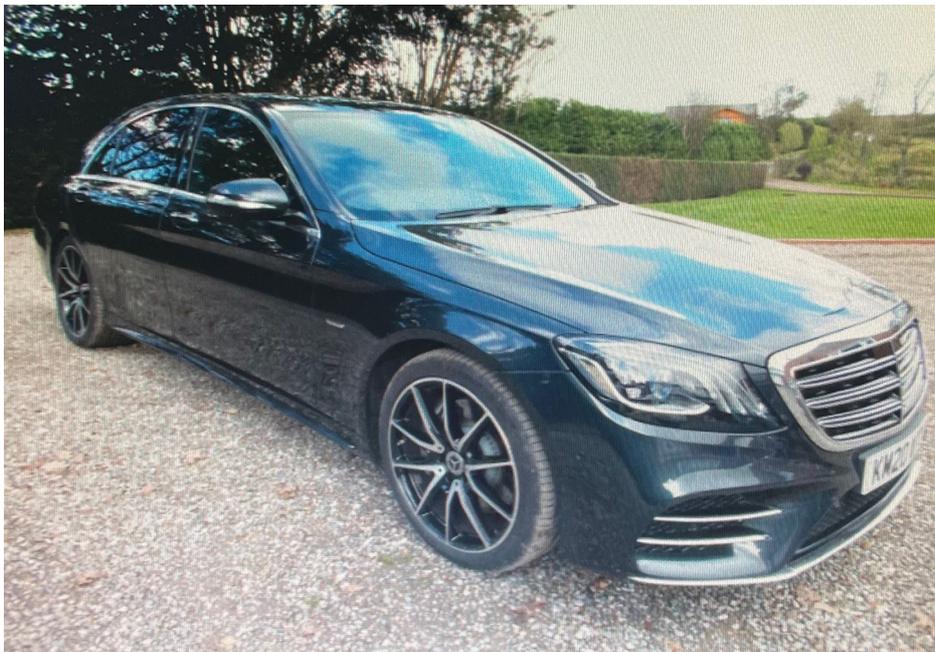
**Photo 2** shows the front right body of the Motor Car (photograph provided to me). No physical damage was seen to the front right portion of the Motor Car. The airbags of the Motor Car were also not activated.

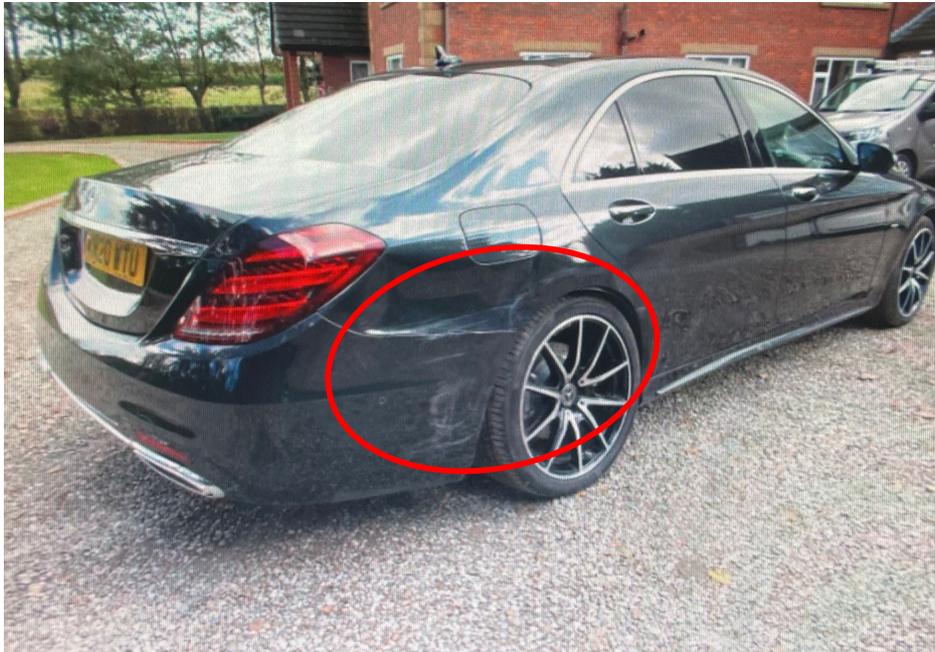
**Photo 3** shows the rear right body of the Motor Car (photograph provided to me). Apart for the front left portion, I had also observed damage to the right rear portion (circled) of the Motor Car. The rear bumper and right rear fender were observed to be damaged.

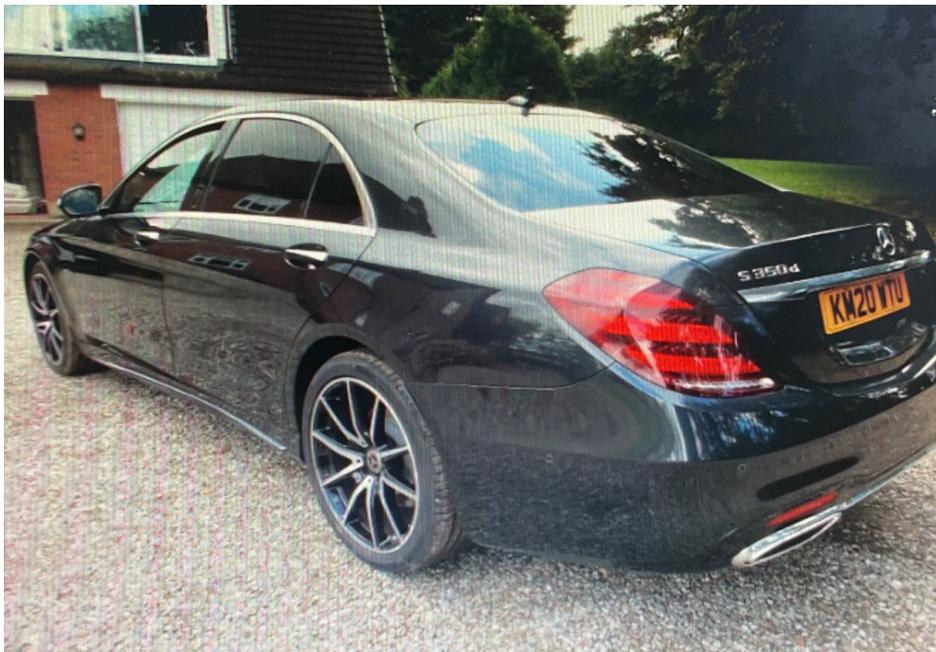
**Photo 4** shows the rear left body of the Motor Car (photograph provided to me). Apart for the front left portion and right rear portion, there was no physical damage seen to other areas of the Motor Car. The airbags of the Motor Car were also not activated.

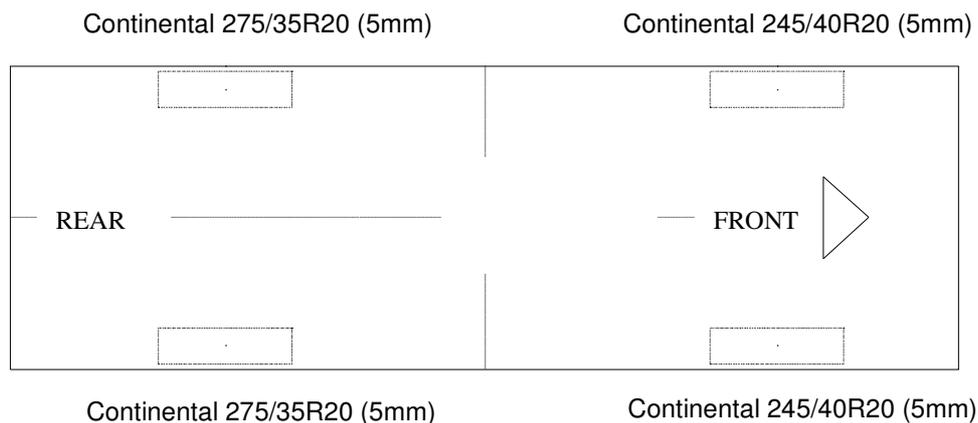
- It was fitted with 20inch sport wheel rims that were wrapped with tyres that were observed to be of serviceable condition. The tyres were also sufficiently inflated for vehicular operation. The tyre brand, tyre size and approximate remaining tread depth of the 4 tyres of the Motor Car were recorded as follows: -

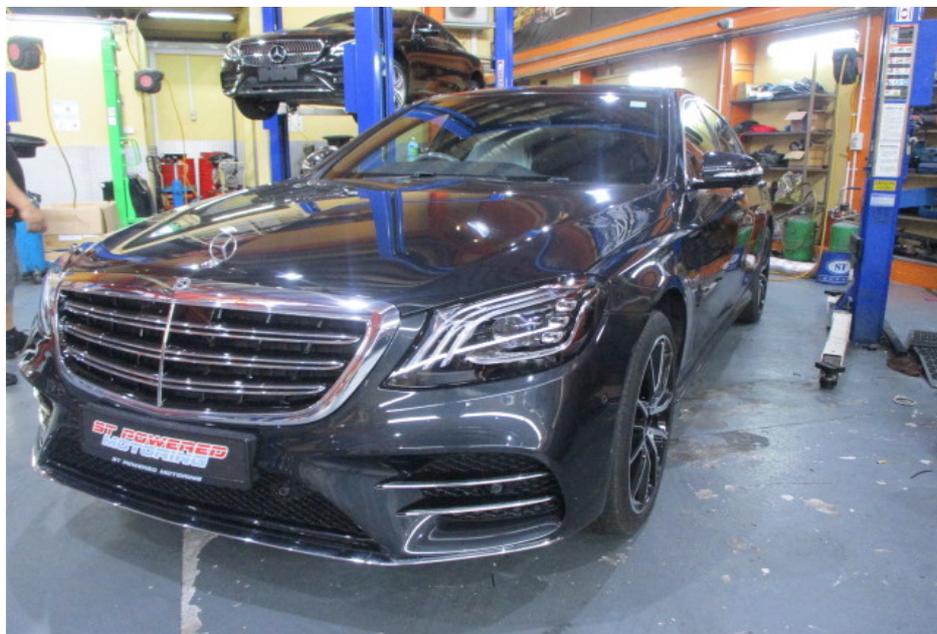
22. The body parts at the front left portion and right rear portion of the Motor Car were visually examined and it was noted that the repair/restoration works carried out to the damaged area of the Motor Car (refer to photograph 1 & 3 above) were reasonably adequate and in order.

**Photo 5** shows a general view of the front left body of the Motor Car at the time of my inspection. The Motor Car was observed to be in a relatively good general condition with no loose exterior fittings observed. The body parts at the front left portion of the Motor Car were visually examined and it was observed that the repair/restoration works carried out to the damaged area of the Motor Car (refer to photograph 1 above) were reasonably adequate and in order.

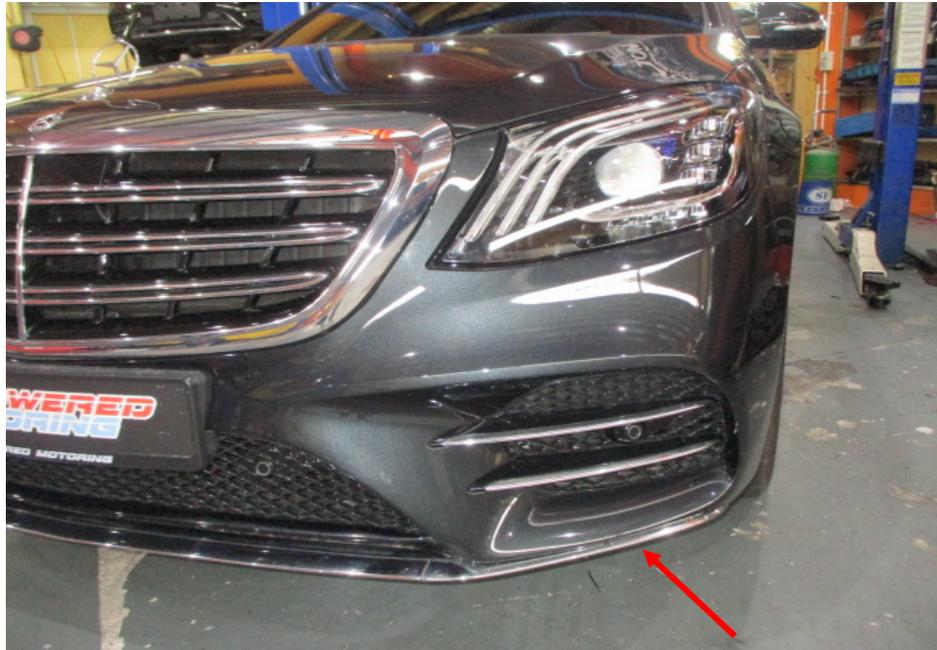
**Photo 6** shows a closer view of the front bumper of the Motor Car at the time of my inspection, in particular the front bumper left lower chrome moulding (arrowed). The body parts at the front left portion of the Motor Car were visually examined and it was observed that the repair/restoration works carried out to the damaged area of the Motor Car (refer to photograph 1 above) were reasonably adequate and in order.

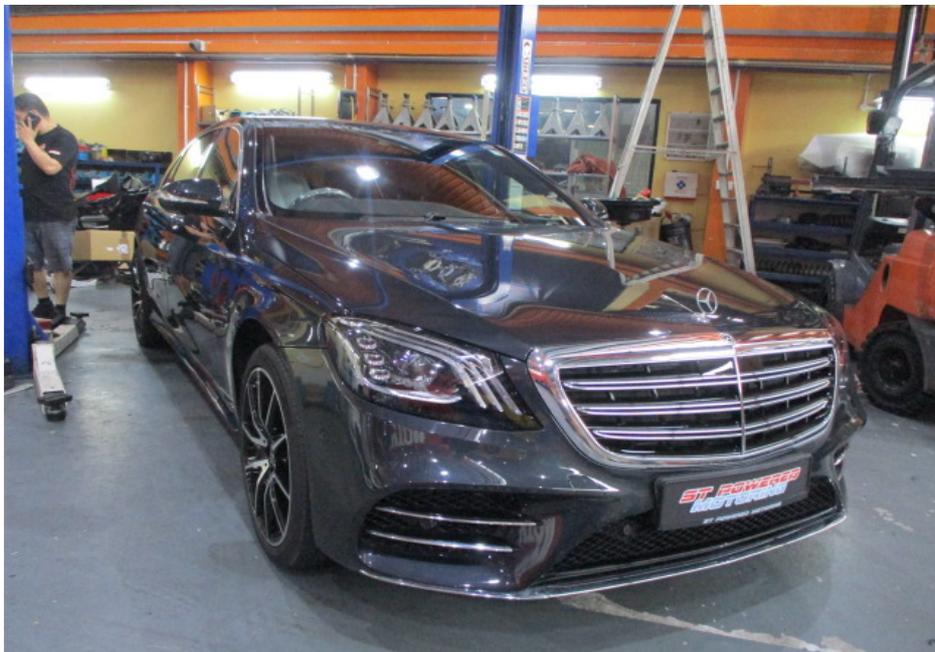
**Photo 7** shows a general view of the front right body of the Motor Car at the time of my inspection. The Motor Car was observed to be in a relatively good general condition with no loose exterior fittings observed. The mileage of the Motor Car recorded at the time of my inspection was 894km.

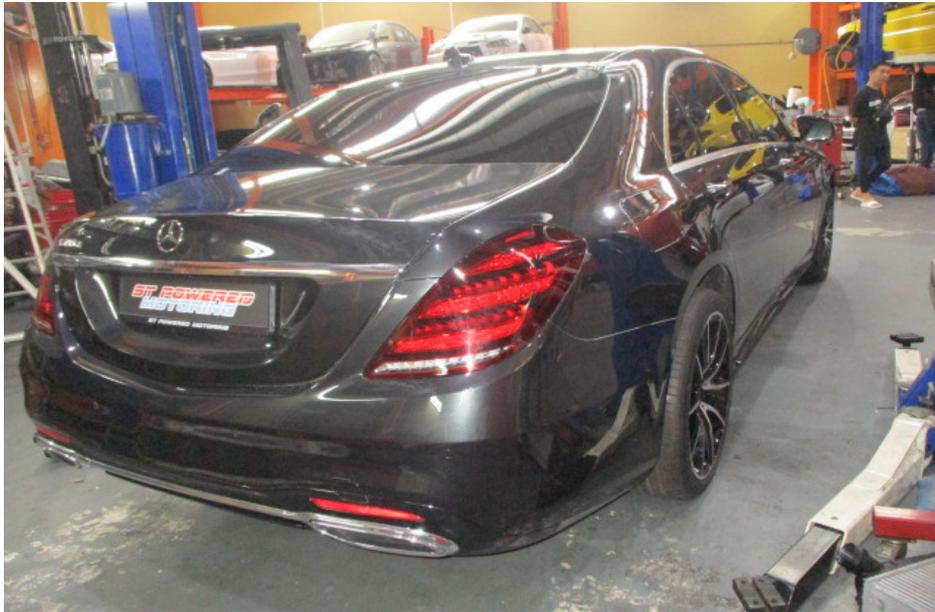
**Photo 8** shows a general view of the rear right body of the Motor Car at the time of my inspection. The Motor Car was observed to be in a relatively good general condition with no loose exterior fittings observed. The body parts at the right rear portion of the Motor Car were visually examined and it was observed that the repair/restoration works carried out to the damaged area of the Motor Car (refer to photograph 3 above) were reasonably adequate and in order.

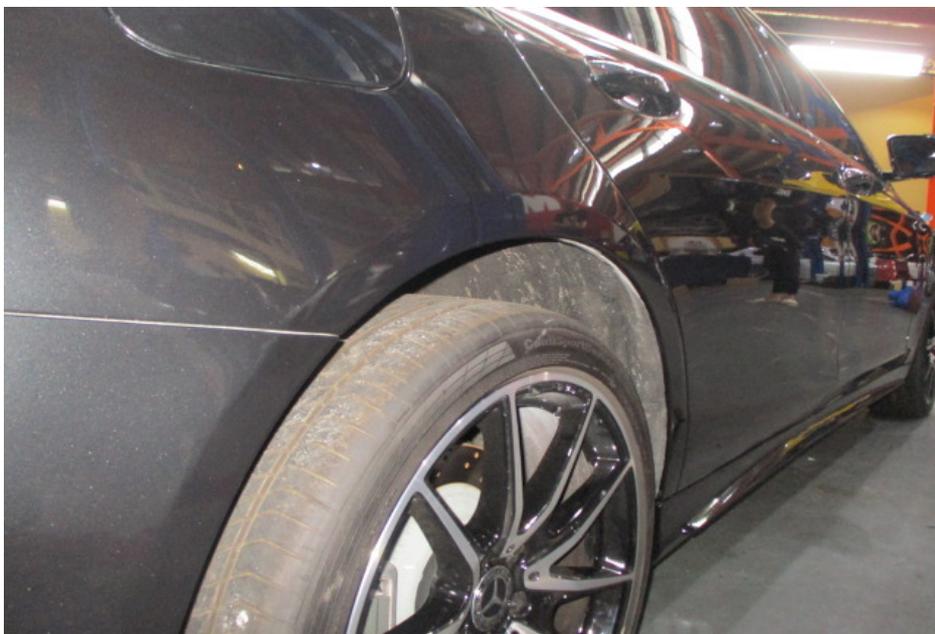
**Photo 9** shows a closer view of the rear bumper and right rear fender of the Motor Car at the time of my inspection. The Motor Car was observed to be in a relatively good general condition with no loose exterior fittings observed. The body parts at the right rear portion of the Motor Car were visually examined and it was observed that the repair/restoration works carried out to the damaged area of the Motor Car (refer to photograph 3 above) were reasonably adequate and in order.

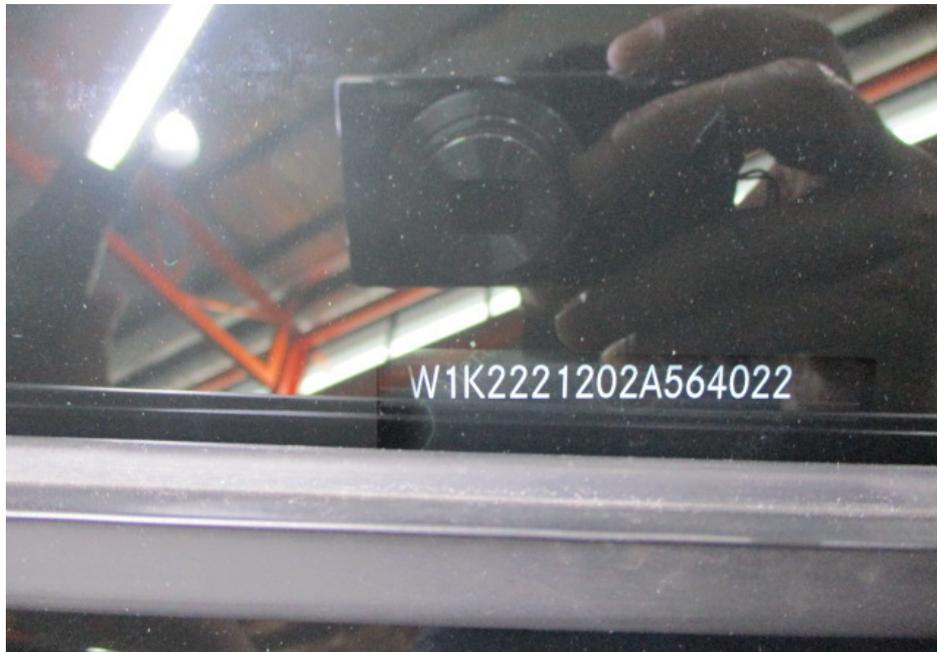
**Photo 10** shows the chassis number of the Motor Car. The chassis number recorded was W1K2221202A564022.

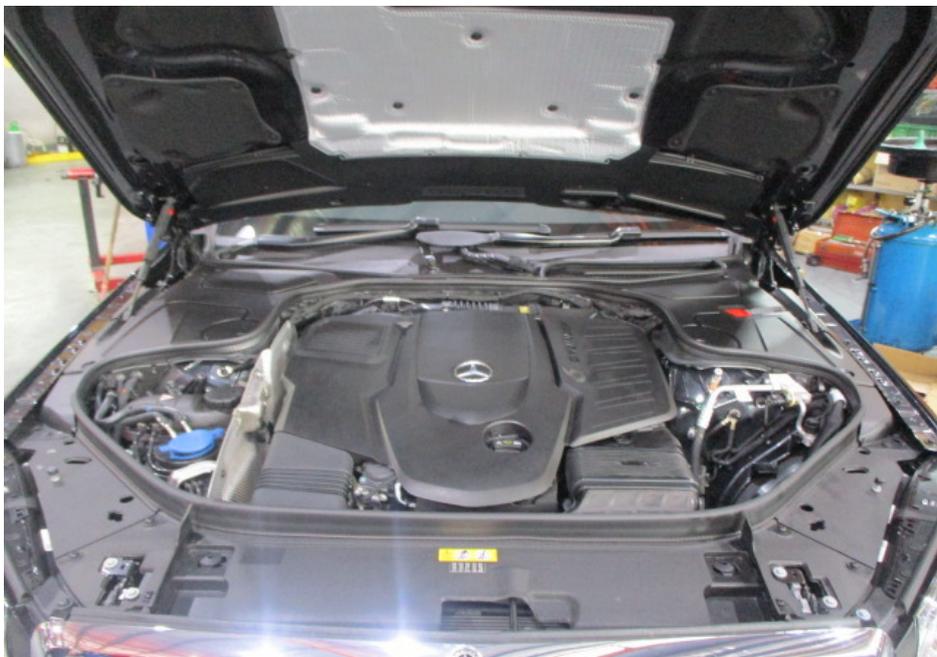
14. My examination of the engine compartment of the Motor Car revealed that the various parts and components inside the engine compartment were all intact and properly fitted. The engine oil, brake fluid and engine coolant were all found to be of sufficient level for operating purposes. Visually, there was also no contamination found to these fluids.

**Photo 11** shows a general view of the engine compartment of the Motor Car at the time of my inspection. The various parts and components inside the engine compartment were all observed to be intact and properly fitted. There was also no sign(s) or indication(s) of fluid leak and/or fluid stain found inside the engine compartment.

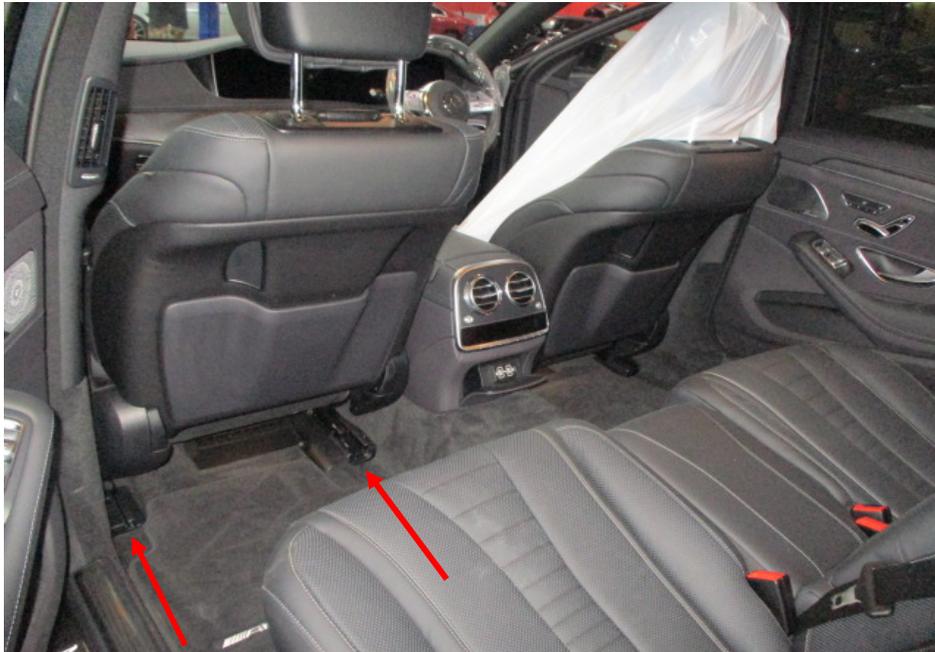
12. The seats of the Motor Car were found to be secured to the floorboard of the Motor Car via seat rails bolted onto the floorboard. Retractable seat belt reels and pre-tensioners were fitted on all seats of the Motor Car. The seat belt reels were tested and were able to be fastened securely into the respective pre-tensioners that were fixed to the side of all the seats.

**Photo 12** shows the seats of the Motor Car, which were secured via seat rails (arrowed) to the floorboard. All the seats of the Motor Car were fitted with a retractable seat belt reel and pre-tensioner. The seat belts were tested and were able to be fastened into the respective pre-tensions that were fitted on the side of each individual seat.

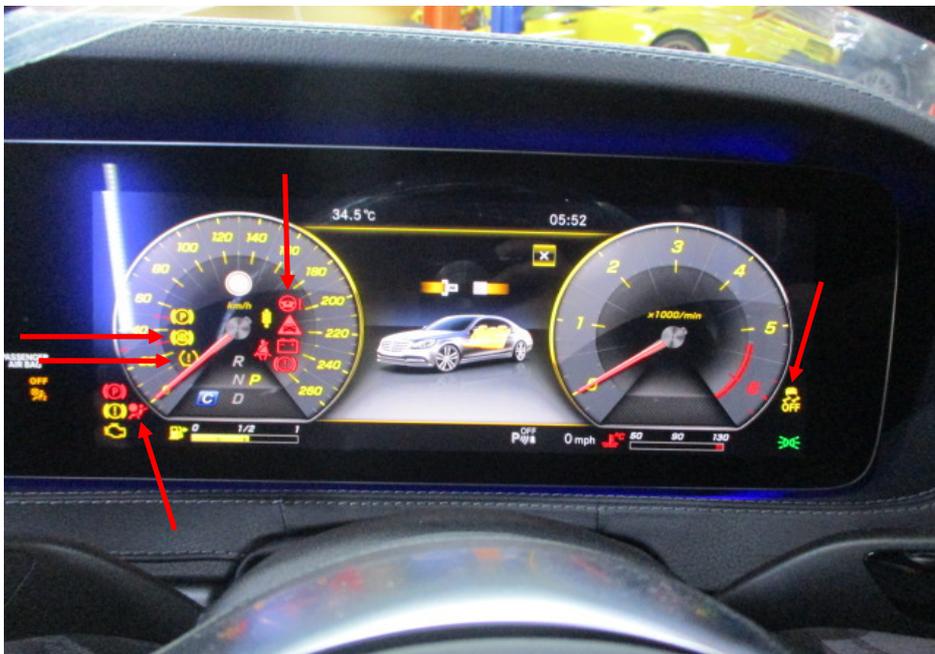
**Photo 13** shows the warning lights for the various electronic safety features appearing on the instrument panel of the Motor Car during its self-test when the engine is cranked, in particular the ABS, SRS, EPS, TPM and TCS lights (arrowed).

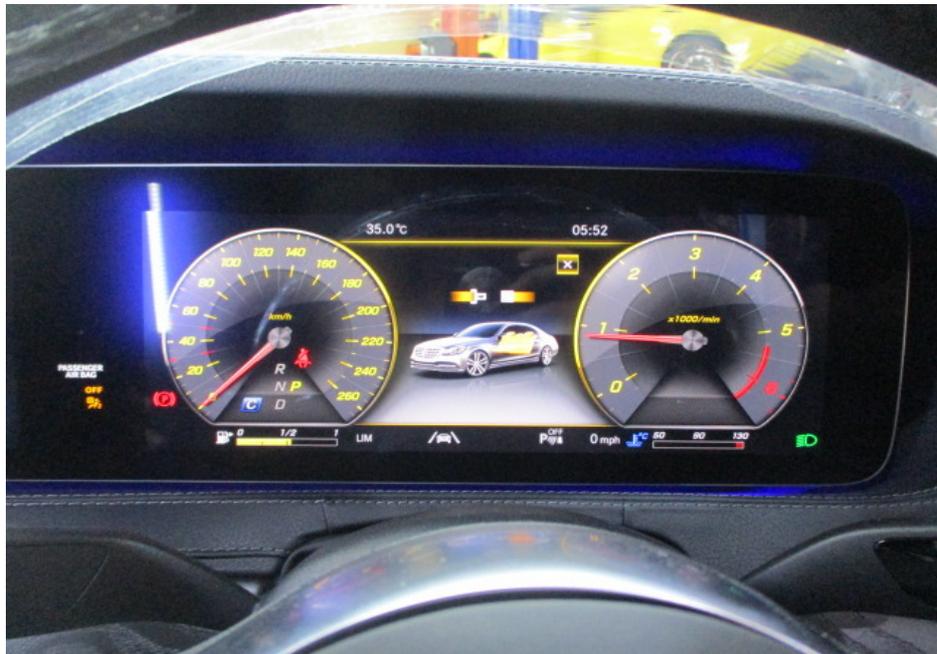
13. The Motor Car's automatic self-test of the functionality of its various electronic safety features like the Anti-Brake Lock System (ABS), Supplemental Restraint System (SRS), Electric Power Steering (EPS), Tyre Pressure Monitor (TPM) and Traction Control System (TCS) during cranking of the engine had indicated that these electronic systems were in working condition. This was determined from the respective warning lights disappearing from the instrument panel after the self-test.

**Photo 14** shows the respective warning lights no longer illuminated, indicating that there is no fault detected to the ABS, SRS, EPS, TPM and TCS systems of the Motor Car during the self-test. These electronic systems were hence in working condition at the time of my inspection.

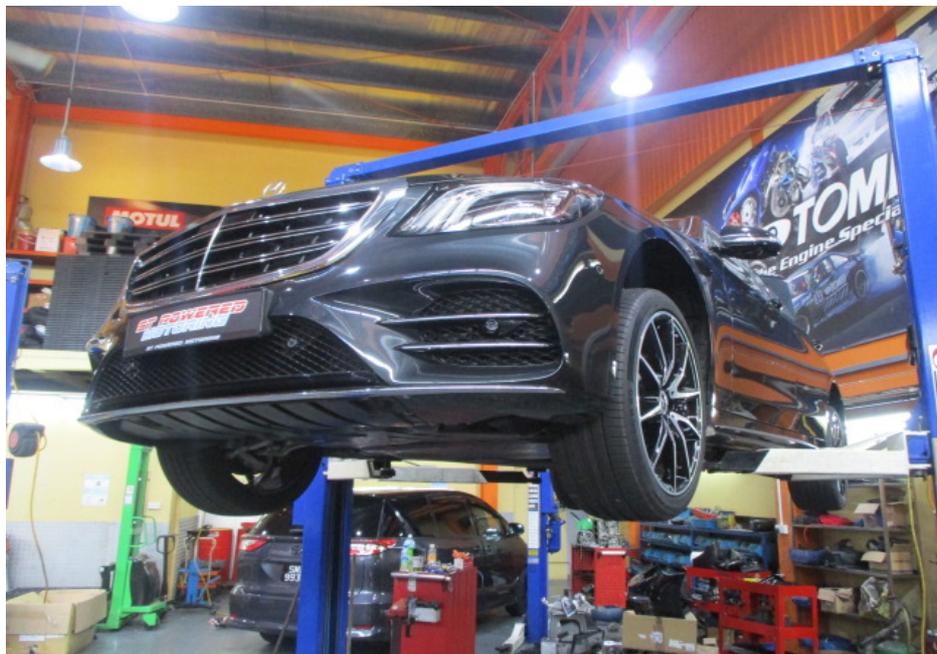
15. My checks on the underside of the Motor Car revealed no sign(s) or indication(s) of fluid leakage and/or fluid stain(s). The engine block and automatic transmission assembly were both secured properly. All undercarriage components of the Motor Car were also observed to be intact and secured in an appropriate manner.

**Photo 15** shows the Motor Car hoisted up for checks on its undercarriage. There was no sign(s) or indication(s) of fluid leakage and/or fluid stain(s) on the underside of the Motor Car. The undercarriage components of the Motor Car were also all observed to be intact and secured in an appropriate manner.

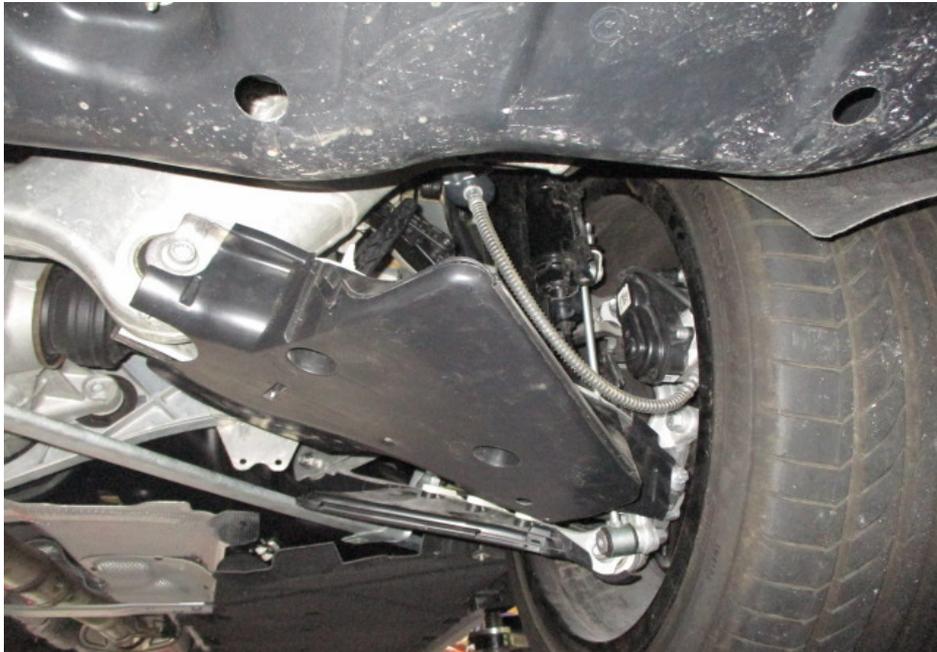
**Photo 16** shows a general view of the control arms and linkages at the rear right wheel of the Motor Car. I did not observe any fluid leak and/or fluid stain on the underside of the Motor Car. All of the Motor Car's undercarriage components were observed to be intact and secured in an appropriate manner.

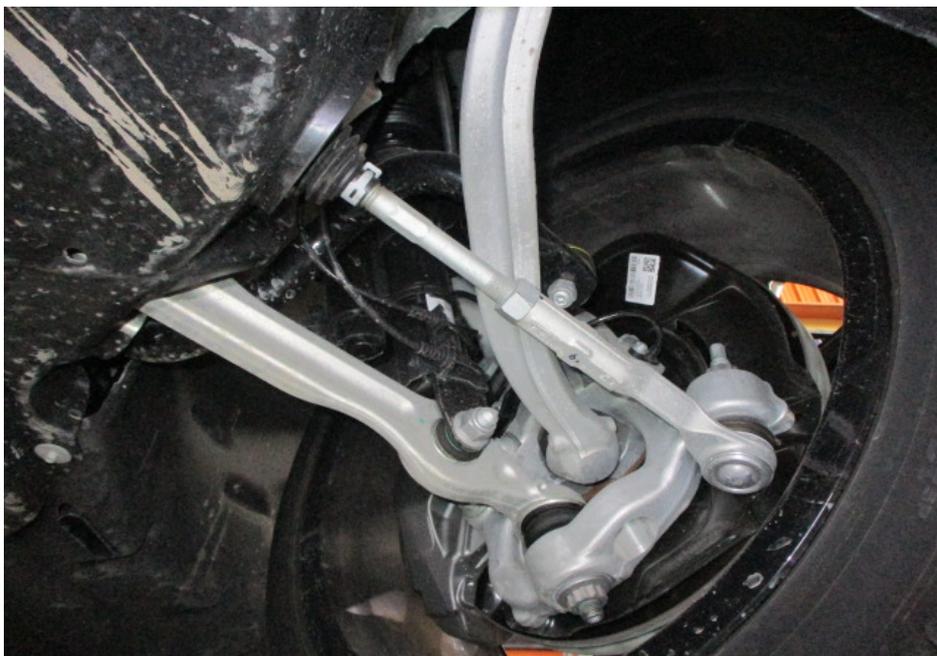
**Photo 17** shows the various undercarriage components at the front left wheel of the Motor Car. The mechanical components, control arms and linkages were all found to be intact and secured in an appropriate manner.

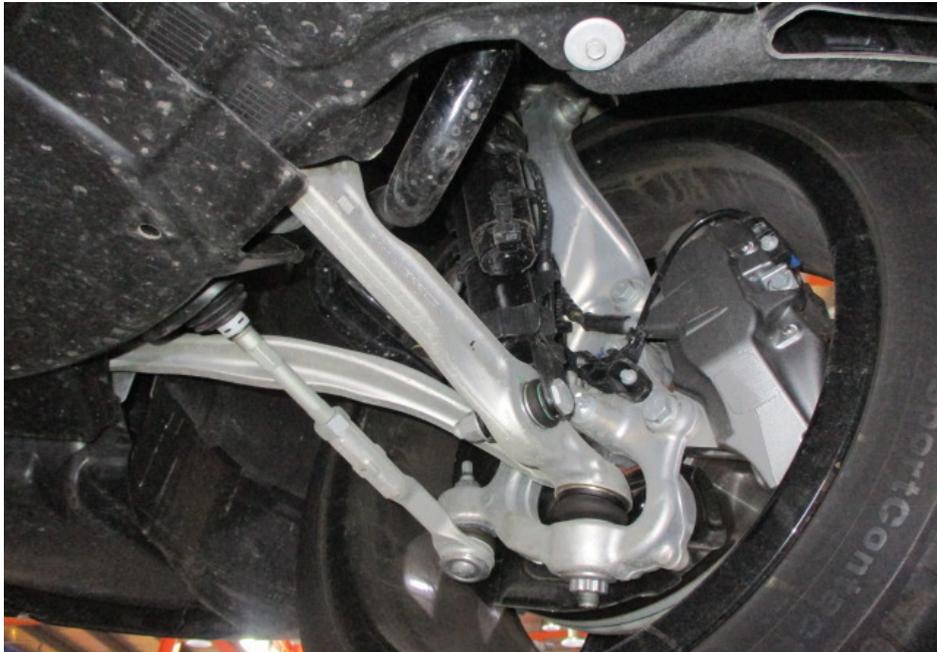
**Photo 18** shows the various undercarriage components at the front right wheel of the Motor Car. The mechanical components, control arms and linkages were all found to be intact and secured in an appropriate manner. I also did not observe any fluid leak and/or fluid stain on the underside of the Motor Car.

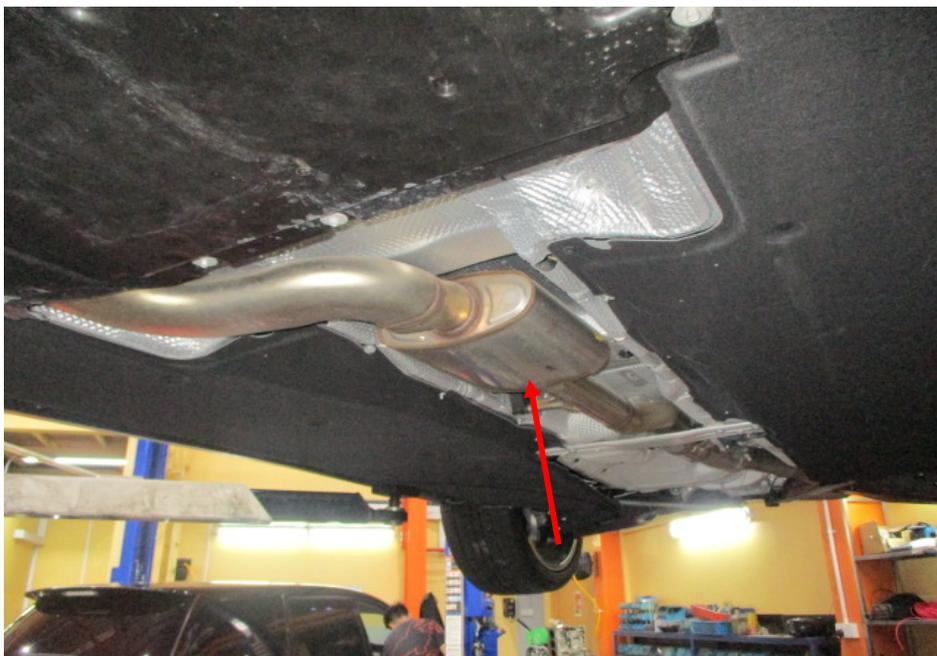
**Photo 19** shows the Motor Car's centre resonator (arrowed). My examination of the Motor Car's exhaust system revealed no sign(s) or indication(s) of any cut or weld marks along its exhaust pipes, catalytic converter and on its muffler.

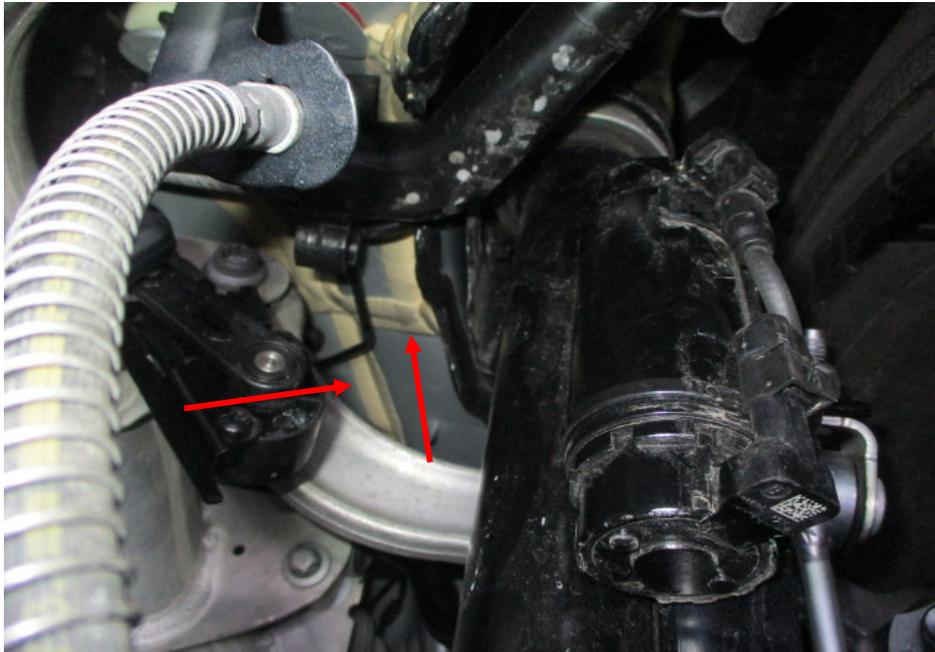
11. Visually, I did not find any weld marks, other than the original spot weld marks, on the chassis/structural body of the Motor Car. The original factory sealant at the joints along the chassis/structural body was also untouched, again indicating that no replacement of the chassis/structural body was carried out; and that the chassis/structural body was originally fitted.

**Photo 20** shows the chassis/structural body at the underside rear right of the Motor Car. I did not find any weld marks other than original spot weld marks on the chassis/structural body of the Motor Car. The original factory sealant (arrowed) at the joints along the chassis/structural body was untouched, indicating no work was done on the chassis/structural body of the Motor Car and that the chassis/structural body was originally fitted.

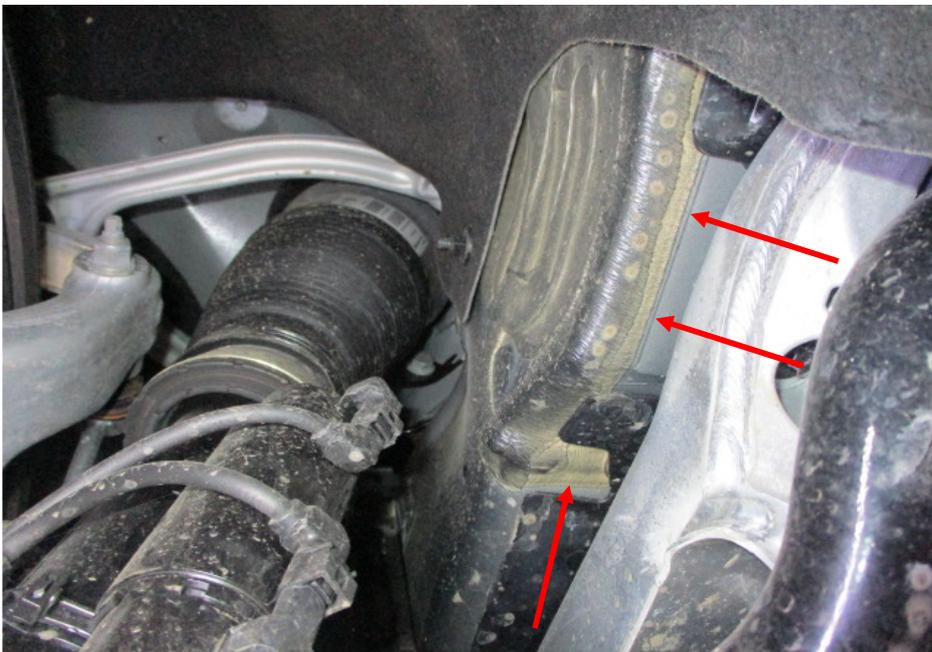
**Photo 21** shows the chassis/structural body at the underside front left of the Motor Car. The original factory sealant (arrowed) at the joints along the chassis/structural body was observed to be untouched. In general, I had found no work was carried out on the chassis/structural body of the Motor Car. The chassis/structural body of the Motor Car was originally fitted.

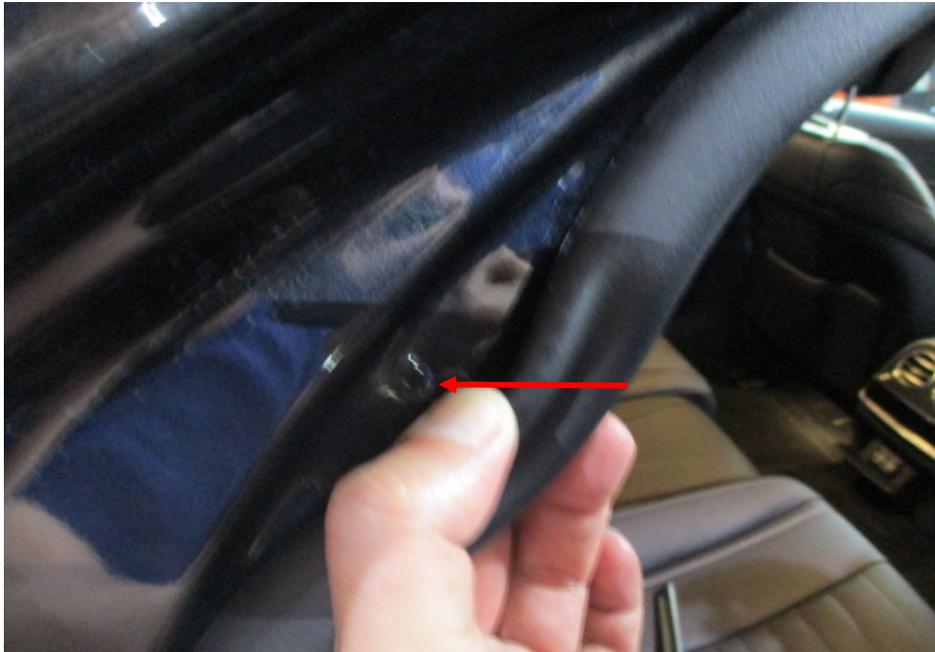
10. Checks on the non-detachable body panels like the rear fenders, floorboard, roof panel, pillars and rocker panels amongst others, revealed that these body panels were spot welded onto the chassis/structural body of the Motor Car. The original factory sealant at the joints of the non-detachable body panels was all untouched indicating no replacement of the non-detachable body panels was carried out; and that these body panels were all originally fitted.

**Photo 22** shows the right side "C" pillar of the Motor Car. I did not find any weld marks other than original spot weld marks (arrowed) on the right side "C" pillar of the Motor Car, which indicates that there was no re-welding works carried out. In general, I had found all the non-detachable body panels of the Motor Car to be originally fitted at the time of my inspection.
